2017 LUC-00280-0375\_L (SB NORTH APPROACH) ROUTINE  
INSPECTION REPORT  
BRIDGE INSPECTION REPORT

Structure File Number: 4806115

I-280 over SUMMIT TO CHAMPLAIN NSRR

Inspection Date: 09/17/2017

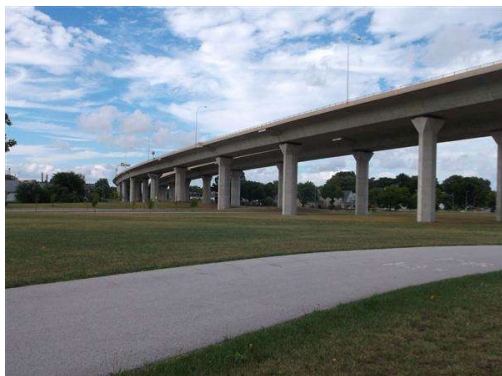
Photo 1

General elevation of the Southbound North approach

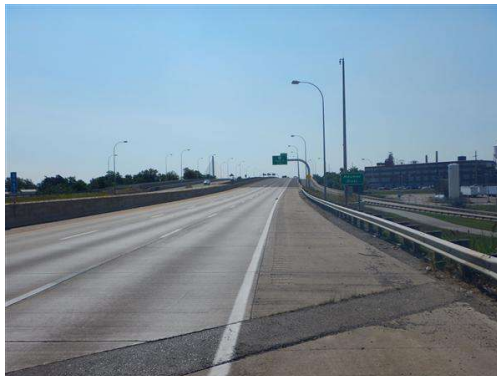
Photo 2

End view of the Southbound North approach

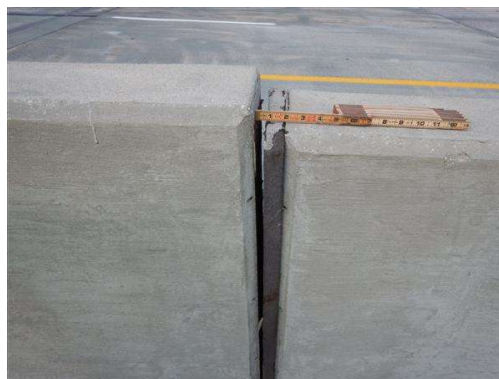
Photo 6 0.75" gap in the East parapet

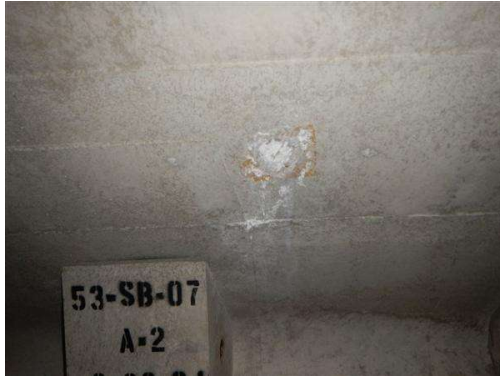
Numerous delaminated or unsound patches were observed in the lift holes at the top flange/slab along the edges of the interior segments. A majority of these areas exhibited efflorescence over the length of the bridge. See Photo 1. At multiple locations, spalls with exposed reinforcement were observed. See Photo 2. Other patches and construction joints in the interior of the segments, both webs and top/bottom flanges/slabs exhibited delaminated and spalled concrete. See Photos 3 and 4. At multiple locations, cracks and spalls were observed in the deviator wall, primarily at the edges of the joints between the top and bottom flanges/slabs. See Photo 5. The access hole patch in Span 37SB exhibited spalling with cracks and efflorescence. See Photo 6.

Photo 1 Efflorescence leaching from lift holes in Span 53SB

Numerous delaminated or unsound patches were observed in the lift holes at the top flange/slab along the edges of the interior segment. A majority of these areas exhibited efflorescence over the length of the bridge. See Photo 1 in the Superstructure section. At multiple locations, spalls with exposed reinforcement were observed. See Photo 2 in the Superstructure section. Other patches and construction joints in the interior, both webs and top/bottom flanges/slabs exhibited delaminated and spalled concrete. See Photos 3 and 4 in the Superstructure section. At multiple locations, cracks and spalls were observed in the deviator wall, primarily at the edges of joints between the top and bottom flanges/slabs. See Photo 5 in the Superstructure section. The construction access hole patch in Span 37SB had cracks and efflorescence. See Photo 6 in the Superstructure section.

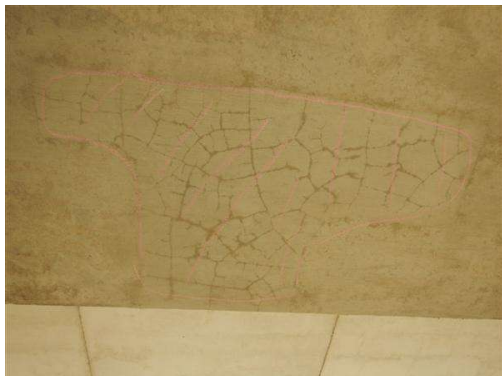
Along the exterior web and bottom flange/slab, several delaminated and spalled patches were noted along the length of the bridge. See Photos 7 through 9. At Piers 33SB, 36SB and 52SB, at the bottom flange near the bearings, concrete spalls with exposed reinforcement were noted. See Photos 10 and 11. The exterior PT end blocks at Piers 33SB and 36SB had multiple patches with cracking. See Photo 12.

Photo 7 Delaminated patch with discoloration in the web in Span 57SB

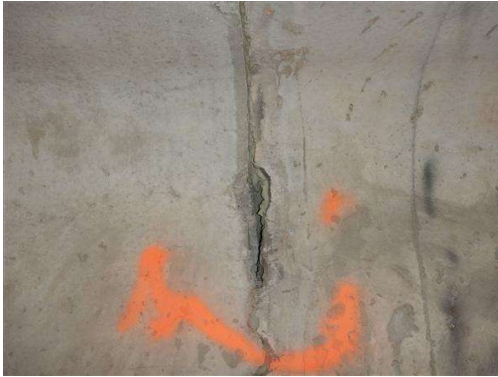
Voids were present in the segment construction joints, both interior and exterior, varying size and depth. Some of the voids were observed to be 12" deep. See Photos 19 and 20. In Span 37SB, the joint between segments 12 and 13 contained no epoxy or joint filler. See Photo 21. Spalls and delaminated areas were noted throughout the interior and exterior of the pier segment closure pours and the future exterior stressing blocks located at the top of the webs and along the floor slab. See Photos 13 and 22.

Photo 19 12" deep void in the interior segment joint in Span 34SB

Voids were present in the segment construction joints, varying size and depth. Some of the voids were observed to be 12" deep. See Photo 19 in the Superstructure section.

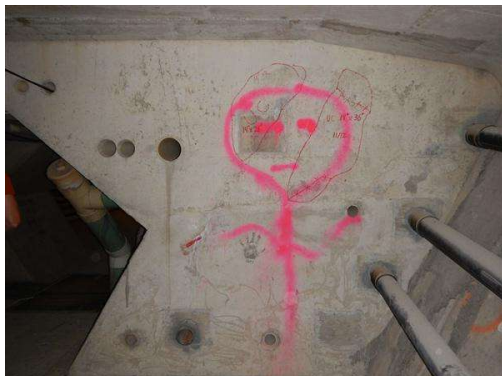
The interior diaphragms exhibited typical hairline to moderate vertical and map cracking ranging from 0.005" to 0.04" in width. Efflorescence was noted at some locations although these areas did not appear to be active. See Photo 25. Additionally, several diaphragms had areas of delaminated concrete on the vertical faces along the length of the bridge. See Photo 26.

Photo 25 Delaminated concrete in the vertical face of the diaphragm at Pier 47SB looking North

The interior diaphragms exhibited typical hairline to moderate vertical and map cracking ranging from 0.005" to 0.04" in width. Efflorescence was noted at some locations although these areas did not appear to be active. See Photo 25 in the Superstructure section. Additionally, several diaphragms had areas of delaminated concrete on the vertical faces along the length of the bridge. See Photo 26 in the Superstructure section.

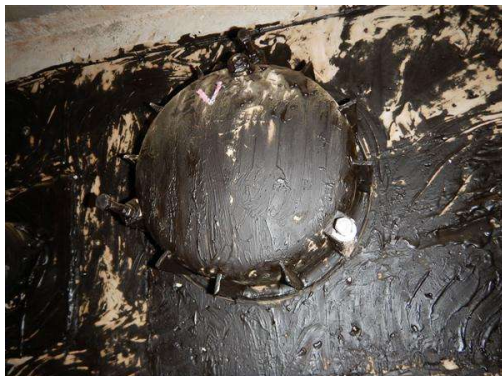
Photo 1 Voids in the PT anchor cap at Pier 39SB looking South

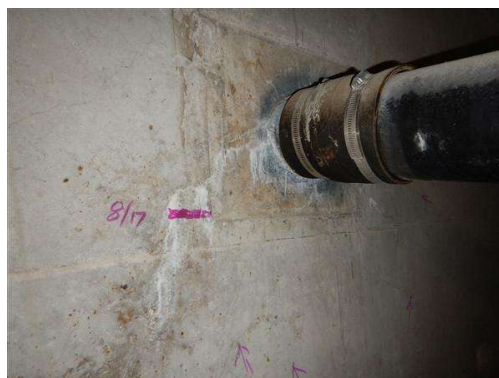
In Span 44SB, at Segment 16E, efflorescence was noted to be leaching from a PT duct . See Photo 4.

Photo 4 Leaching efflorescence from PT duct in Span 44SB

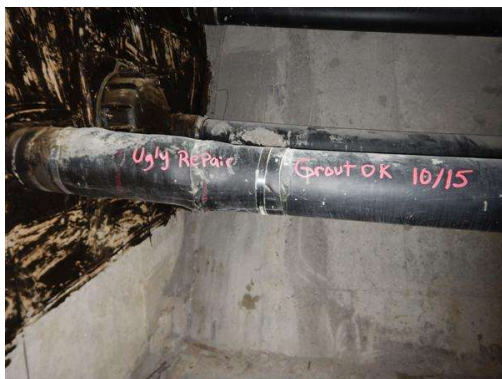
Photo 5 Poor sheathing work on PT duct in Span 39SB looking West
