2017 LUC-00280-0375\_R (NB NORTH APPROACH) ROUTINE  
INSPECTION REPORT  
BRIDGE INSPECTION REPORT

Structure File Number: 4806107

Inventory Bridge Number: LUC 00280 03.750 R

IR-280 over SUMMIT TO CHAMPLAIN, NSRR

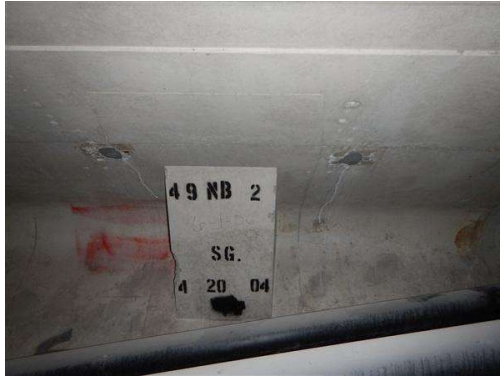
Numerous unsound or delaminated patches were observed in the lift holes at the top flange/ceiling slab along the edges of the interior segment. A majority of these areas exhibited efflorescence over the length of the bridge. See Photo 1. At multiple locations concrete spalls with exposed reinforcement were observed. See Photo 2. Other patches and construction joints in the interior of the segments, both webs and top/bottom flanges/slabs exhibited delaminated and spalled concrete. See Photos 3 and 4. Temporary jacking stiffeners/corbels were removed exposing reinforcement in Spans 43NB and 48NB. These areas have been painted, however the concrete was not patched. See Photo 5. The construction access hole patches in Spans 33NB and 37NB had cracks with efflorescence. See Photo 6.

Photo 1 Efflorescence leaching from lift holes in Span 49NB

Numerous unsound patches were observed in the lift holes at the top flange/ceiling slab along the edges of the interior segment. A majority of these patches exhibited efflorescence over the length of the bridge. See Photo 1 in the Superstructure section. At multiple locations concrete spalls with exposed reinforcement were observed. See Photo 2 in the Superstructure section. Other patches and construction joints in the interior of the segments, both webs and top/bottom flanges/slabs, exhibited delaminated and spalled concrete. See Photos 3 and 4 in the Superstructure section. Temporary jacking stiffeners/corbels were removed exposing reinforcement in Spans 43NB and 48NB. These areas have been painted. See Photo 5 in the Superstructure section. The construction access hole patch in Spans 33NB and 37NB had cracks with efflorescence. See Photo 6 in the Superstructure section.

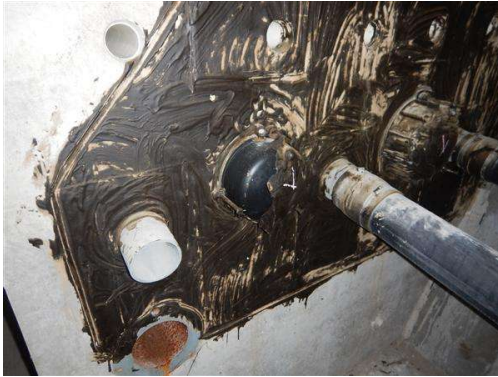
Photo 1 Voids in the PT anchor cap
