**BOX GIRDER - ELEVATION**

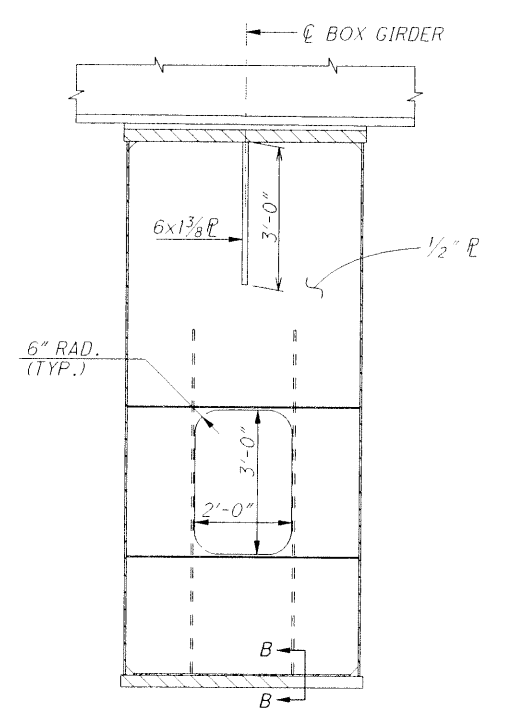
**BEARING STIFFENER AT GIRDERS**

PHOTO # 3972 (BEFORE) & ~~PHOTO~~ 3973 (AFTER)  
 PACK RUST, SOME SECTION LOSS TO WEB OF VERTICAL PLATE & TO WEB OF DIAPHRAGM. 1/8" SECTION LOSS NEXT TO BOTTOM WELD.

PHOTO # 3975 - BOLTS & BOTTOM FLANGE OF DIAPHRAGM RUSTY WITH MINOR SECTION LOSS (TYP. THRU OUT).

PHOTO # 3976 (SOUTH SIDE OF DIAPHRAGM) } BOTTOM OF PIGG CAP HIT WITH OVER HEIGHT LOAD.  
 PHOTO # 3977 (NORTH SIDE OF DIAPHRAGM) } BROKE 3 BOLTS OFF (1 ON SOUTH SIDE & 2 ON NORTH SIDE OF GIRDER H DIAPHRAGM)

PHOTO # 3978 - 1 BROKEN BOLT ON BOTTOM SPLICE PLATE.

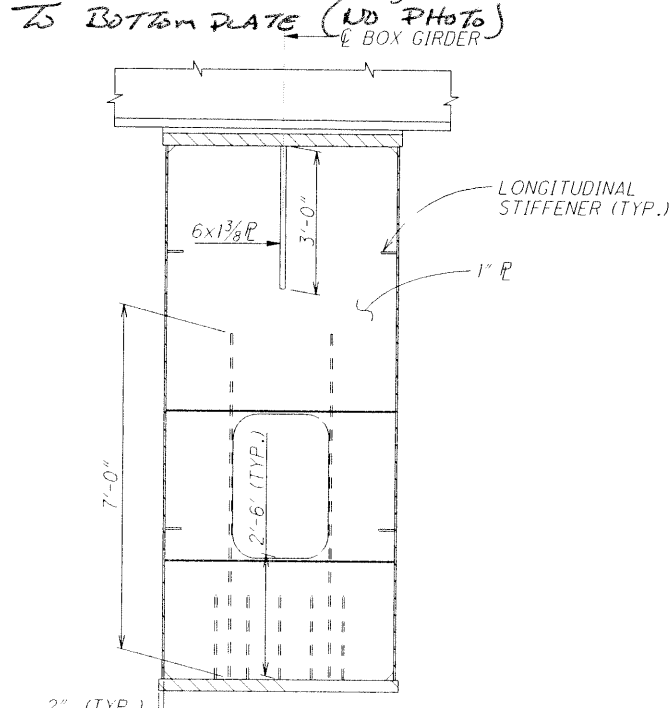
**SECTION A - A BEARING STIFFENER AT COLUMNS**

PHOTO # 3979 - PACK RUST AT CORNER OF DIAPHRAGM & BOTTOM PLATE  
 PHOTO # 3980 (CLEANED WITH CHIPPING HAMMER & BRUSH)

PHOTO # 3981 - PACK RUST ON BOTTOM PLATE AT BOLT LINE.

PHOTO # 3982 - END PLATE NOT WELDED ON INSIDE
