**GUE-70-0994R
3001385**

**Identification and Inspection
of Fatigue Cracks
in the Built-up Welded Beams**

Re-inspection

**10-4 and 10-6-2011
By: Albert Abel
Bridge Specialist II**

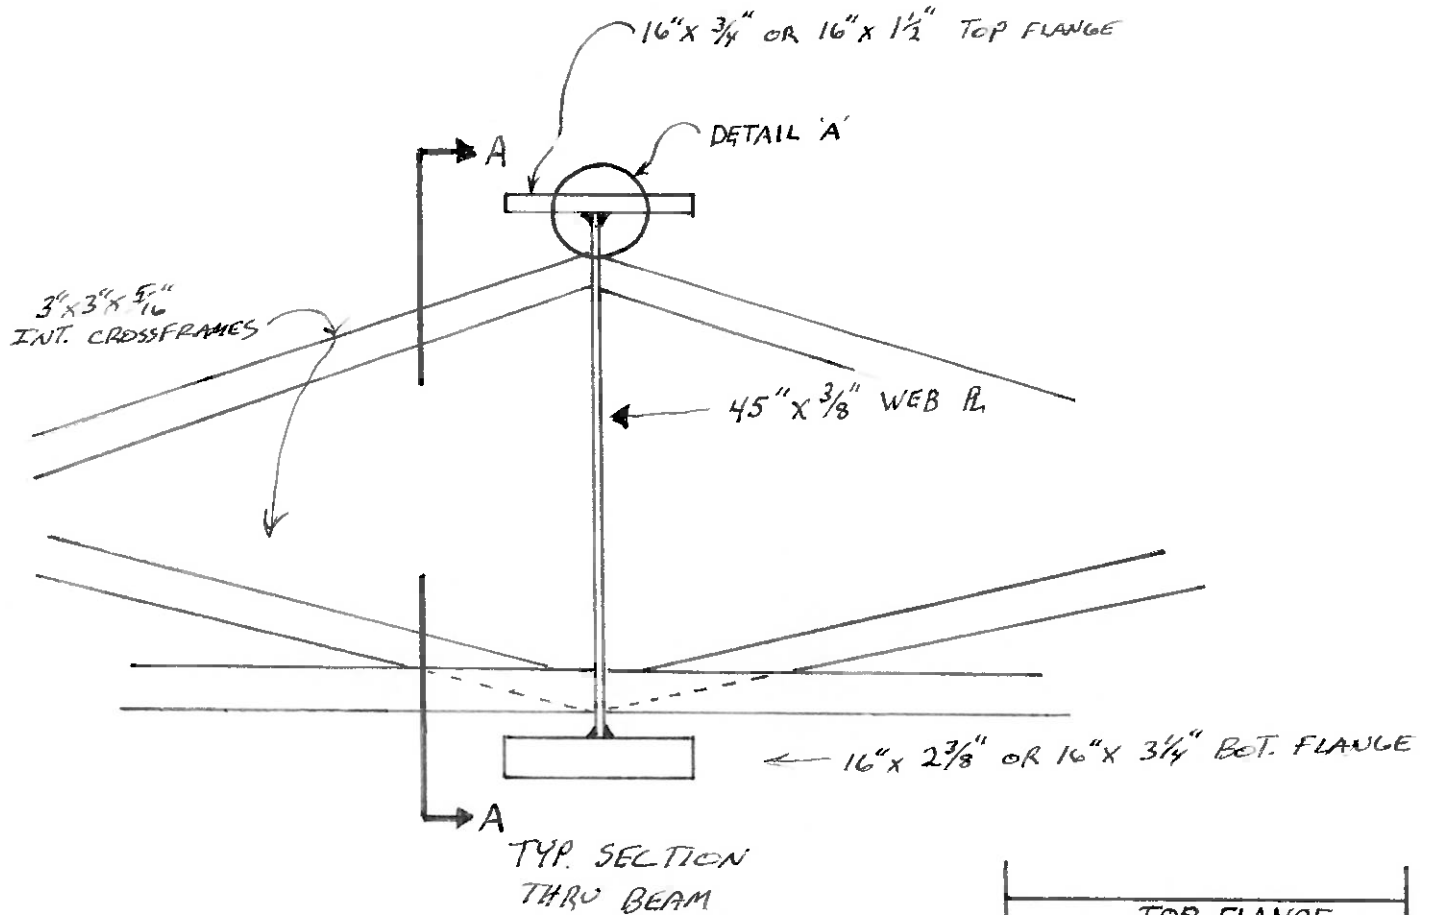
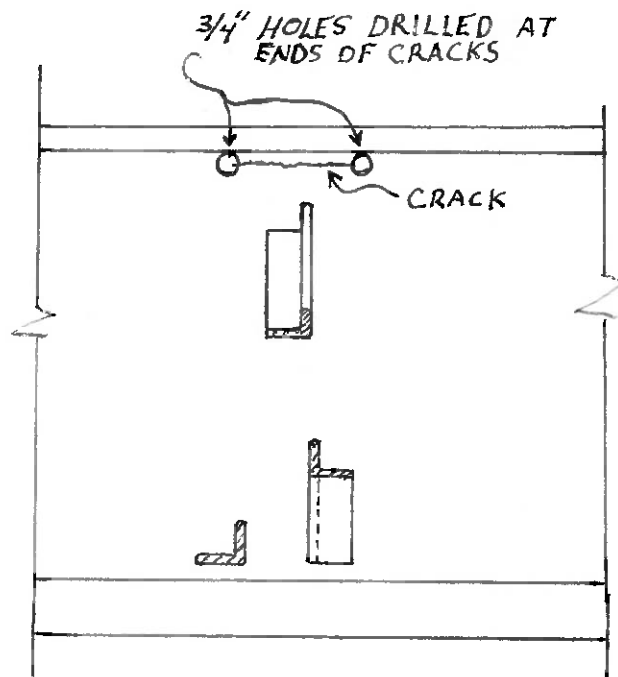
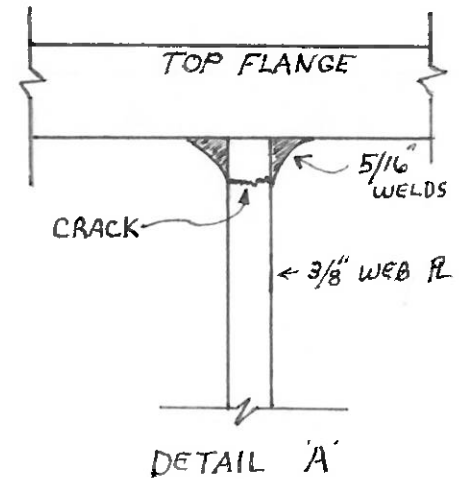
TYPICAL CRACK DETAILS

- #1. 1.5" long crack, .75" hole drilled at ends.
- #2. 3" long crack, .75" hole drilled at ends.
- #3. 3.25" long crack, .75" holes drilled at ends.
- #4. 1.5" long crack, .75" holes drilled at ends.
- #5. 2" long crack, .75" holes drilled at ends.
- #6. 1" long crack, .75" holes drilled at ends.
- #7. 1" long crack detected on right side of the beam, this crack was not drilled..
- #8. 1.75" long crack, .75" holes drilled at ends.
- #9. 2" long crack, .75" holes drilled at ends.
- #10. 2" long crack, this crack was not drilled.

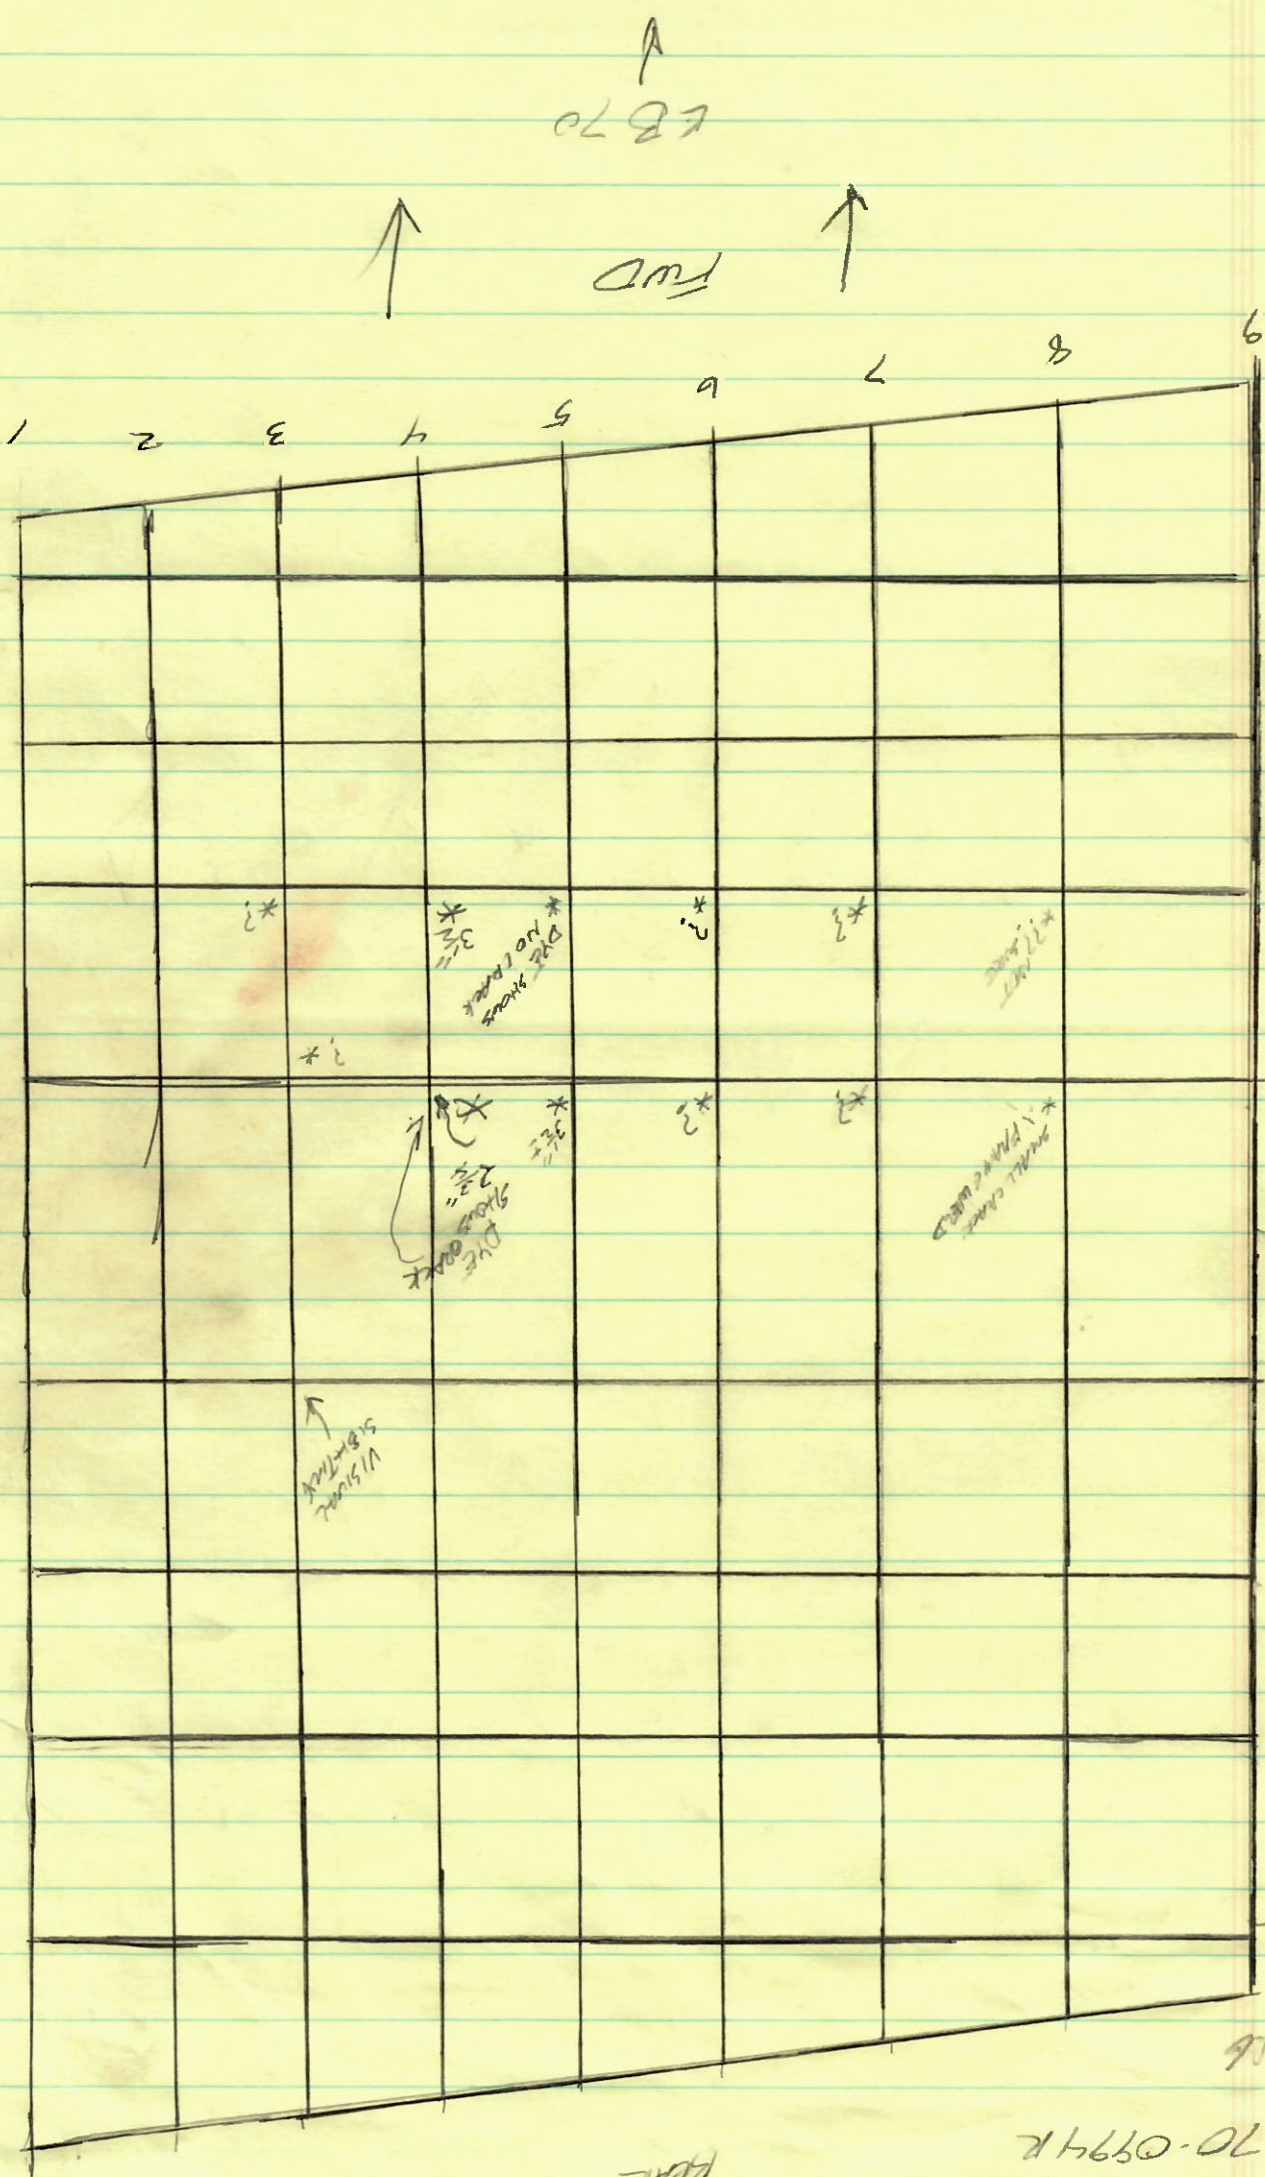
On 4-20-06 a re-inspection of the cracked girders was performed. Dye penetrant was used to see if any further growth of the drilled cracks had occurred. No growth of the cracks was detected.

- #1. 1.5" long crack, .75" hole drilled at ends. NO CHANGE
- #2. 3" long crack, .75" hole drilled at ends. NO CHANGE
- #3. 3.25" long crack, .75" holes drilled at ends. NO CHANGE
- #4. 1.5" long crack, .75" holes drilled at ends. NO CHANGE
- #5. 2" long crack, .75" holes drilled at ends. - POSSIBLE 1 1/2" CRACK PAST FWD HOLE RT SIDE OF WEB (NOT SURE)
- #6. 1" long crack, .75" holes drilled at ends. - 3/8" NEW CRACKS PAST HOLES
- #7. 1" long crack detected on right side of the beam, this crack was not drilled.. NOW 2 1/2" LONG
- #8. 1.75" long crack, .75" holes drilled at ends. NO CHANGE
- #9. 2" long crack, .75" holes drilled at ends. NO CHANGE
- #10. 2" long crack, this crack was not drilled. - NOW 4" LONG
