ODOT District 8  
2024 Fracture Critical and In-Depth  
Element Level Inspection Report

Bridge No. HAM-50-0376L  
SFN: 3102521

**2024 NON-REDUNDANT STEEL TENSION MEMBER AND IN-DEPTH ELEMENT LEVEL  
PHYSICAL CONDITION REPORT**

Inspected on:  
July 8-10, 2024

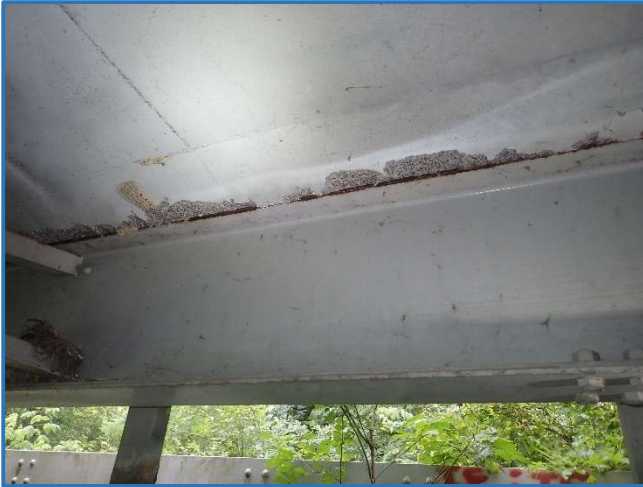
The underside of the reinforced concrete deck is visible and is in satisfactory condition with isolated minor spalls and areas of 1/16" wide map cracking (see Photo 1) and transverse hairline cracks. The fascia stringer haunches typically exhibit up to 6" wide by 1" deep spall or delamination along the length of the stringer (see Photo 2). The north end of the deck above Floorbeam 0 in Span 3 exhibits a 6" by 6" spall along the bottom edge (see Photo 3).

Photo 2 - Typical haunch spall. Shown 15' long by 6" high by 0.5" deep in Span 4, top of Stringer 1, looking north

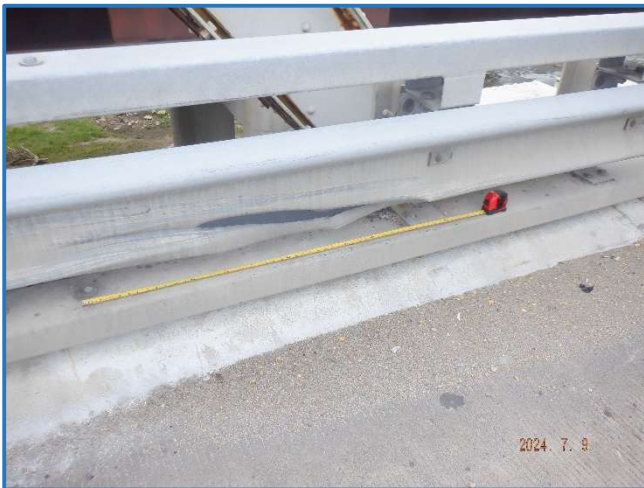
- Span 3, south railing between Panel Points 0 and 1, four linear feet in length (see Photo 9).
- Span 3, south railing, between Panel Points 1 and 2, six linear feet in length (see Photo 10).
- Span 3, north railing, between Panel Points 3 and 4.
- Span 3, north railing, at Panel Point 7.

Photo 9 - Impact damage to metal railing, showing Span 3, south railing, between Panel Points 0 and 1

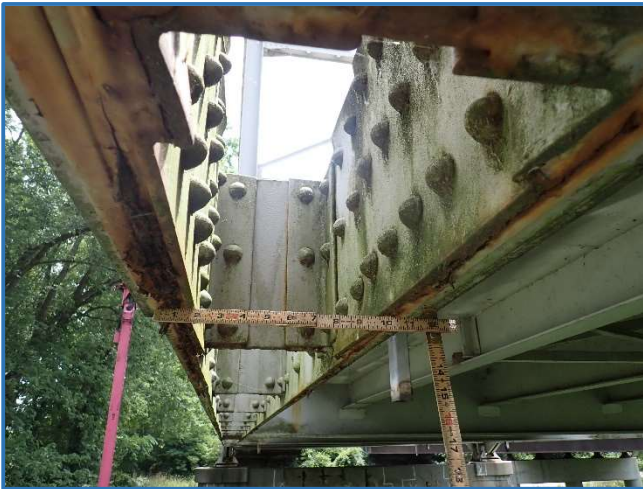
Pack rust, typically between 1/8" and 1/4" thick, is present between the lower chord plates throughout each span. Lower chord member L7L8 exhibits 1/2" thick pack rust in Span 2 of the North Truss (see [Photo 14](#)) and 3/4" pack rust on member L7L8 in Span 3 of the North Truss (see [Photo 15](#)). Up to 3/4" pack rust is present between the lower chord and diaphragms in all spans (see [Photo 16](#)). The pack rust has caused bowing of the lower chord plates and diaphragm angles in some locations (see [Photo 14](#) and [Photo 17](#)).

*Photo 15 - 3/4" pack rust in lower chord plates in Span 3, North Truss, member L7L8, looking east*

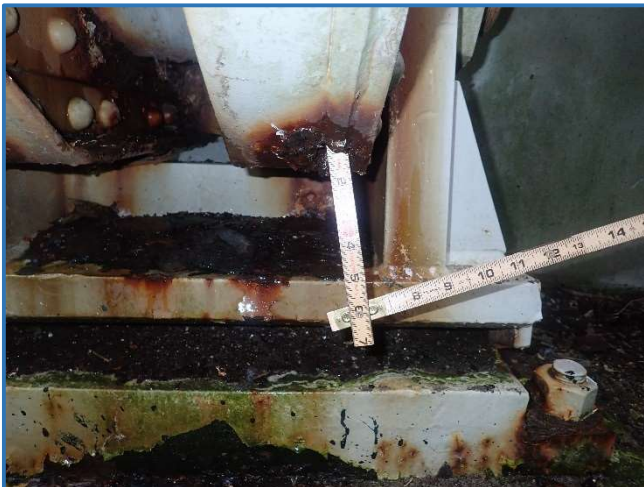
- Span 2, North Truss at L10, with 100% section loss on the lower chord stiffener.
- Span 4, North Truss, at L8, with up to 100% section loss on the lower chord stiffener (see [Photo 22](#)).
- Span 1, North Truss, member L6L7 at L7, section loss on the web of the lower chord below the vertical connection (see [Photo 23](#)).

Photo 22 - Up to 100% section loss on the lower chord stiffener, Span 4, North Truss, at L8, looking east

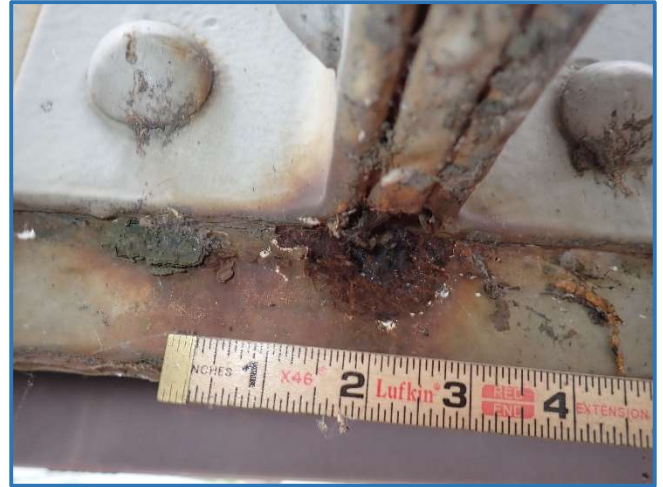
Photo 23 - 2" wide section loss on the web of the lower chord below the vertical connection, Span 1, North Truss, at Panel Point 7, looking south

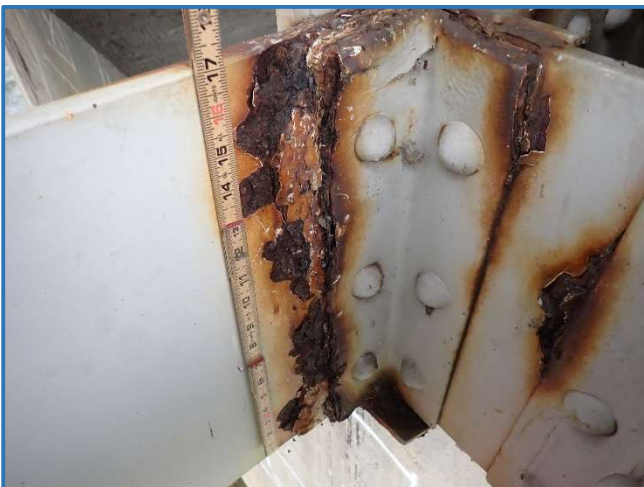
- Span 2, North Truss, member L0L1 near L0, active laminar corrosion throughout the connection with 1/8" section loss (see Photo 24).
- Span 4, South Truss, member L0L1 near L0, 12" long paper-thin section of stiffener.

Photo 24 - Active laminar corrosion throughout the connection, Span 2, North Truss, at Panel Point 0, looking west

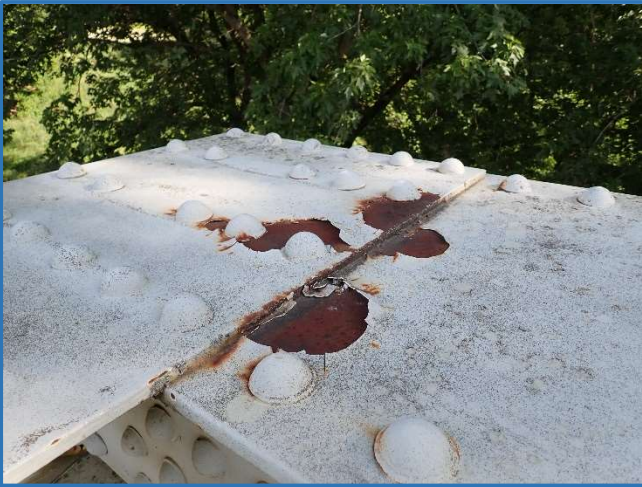
The upper chord exhibits minor spot rust and surface corrosion throughout due to paint failure (see [Photo 25](#)). Reactivated corrosion is present between the channels and web plates (see [Photo 26](#)). The areas of spot rust and surface corrosion are typically less than one square foot with no measurable section loss. Two areas of 6" long by 4" width on Span 4 North Truss, on members U5U6 (see [Photo 27](#)) and U6U7 (see [Photo 28](#)).

*Photo 25 - Typical paint spot failure on top of upper chord, with active corrosion. Shown Span 4, North Truss, east of U1, looking northwest*

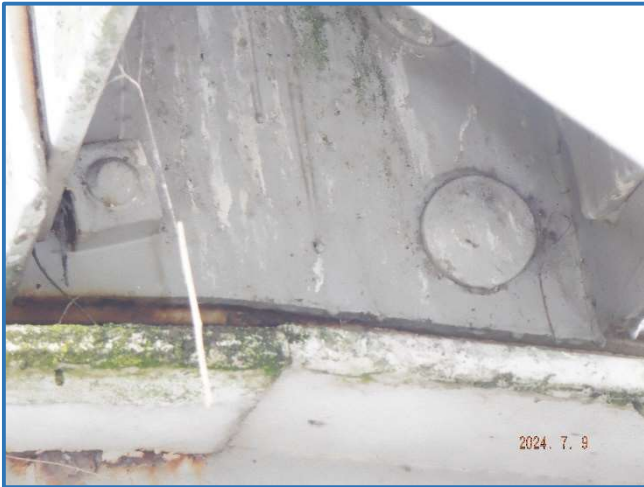
On the south stiffener plate of the upper chord in Span 2, South Truss, at Panel Point 3, some connections have bolts and square nuts instead of rivets and others have flattened heads (see Photo 32).

Photo 32 - Bolt with square nut and flattened rivet head on upper chord stiffener plate, Span 2, South Truss, at Panel Point 3, looking south

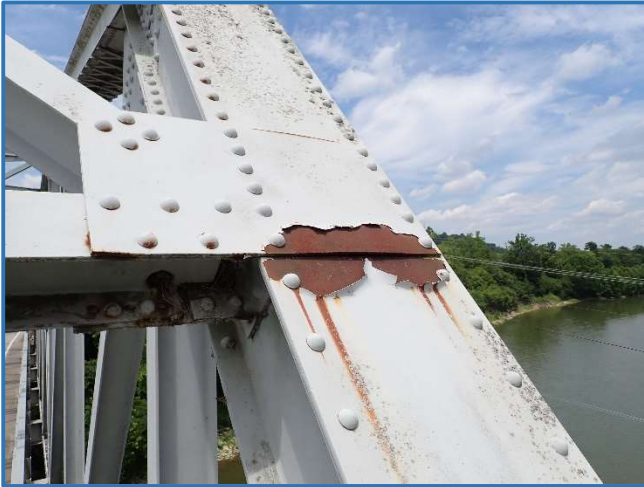
Photo 35 - Paint failure with surface corrosion on top face of end post in Span 1, North Truss, between Panel Points 7 and 8, looking west

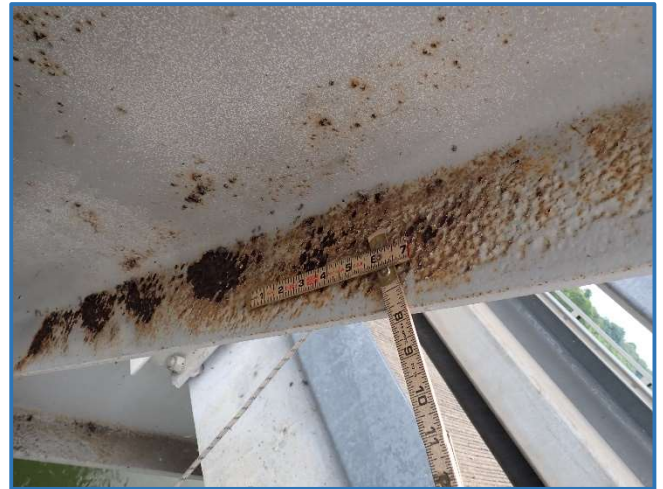
The diagonal members exhibit areas of isolated painted over pitting, pack rust, and active corrosion. Isolated diagonal members exhibit reactivated corrosion and 1/8" deep pitting due to paint failure (See Photo 42 and 43).

Photo 43 - Pitting on interior of flange in Span 1, South Truss, member L5U6, looking northwest

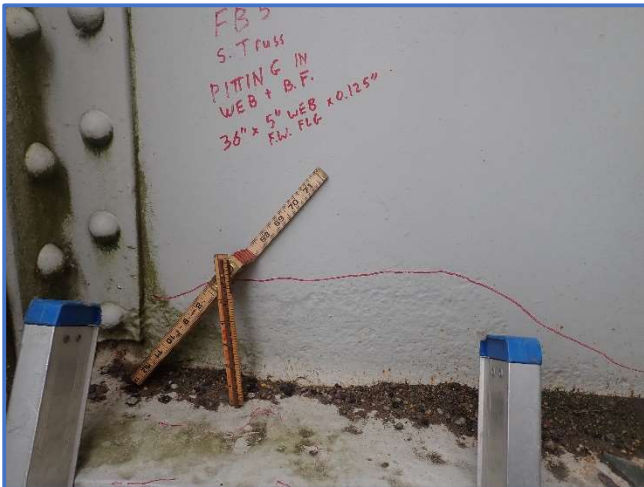
- Span 1, Floorbeam 7, north end, west face.
- Span 4, Floorbeam 5, south end, east face, 36" long by 5" wide (see [Photo 47](#)).
- Span 4, Floorbeam 7, south end, west face, 10' long by 2" wide (see [Photo 48](#)).

Photo 47 - Pitting along bottom of floorbeam web and top of bottom flange of Floorbeam 5 east face, Span 4, at Stringer 5, looking west

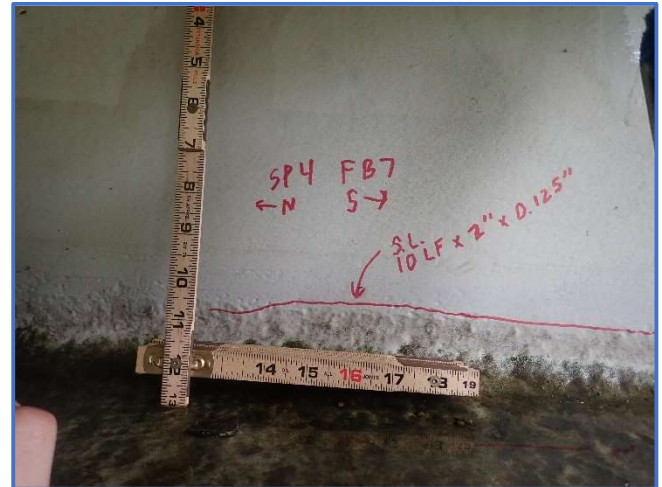
Photo 48 - Pitting along bottom edge of Floorbeam 7 web west face, Span 4, at Stringer 5, looking east

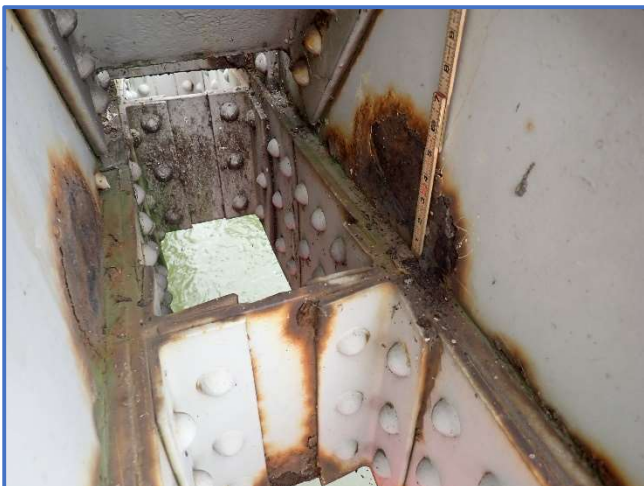
Photo 55 - Laminar corrosion with section loss on interior lower gusset plate. Span 2, North Truss, Panel Point 6, 3" long by 3" wide by 1/8" deep, looking west

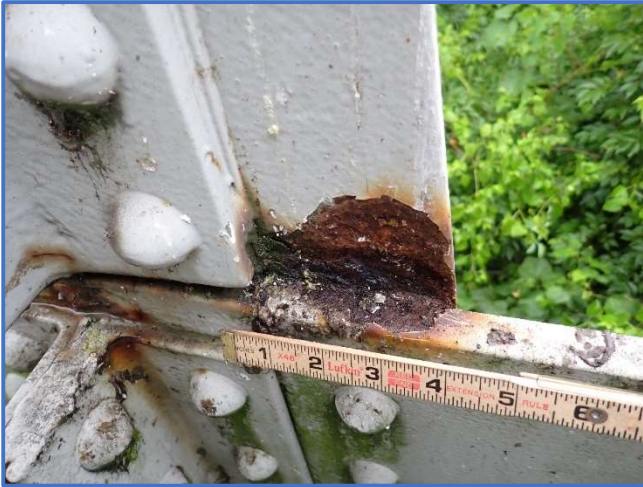
*Photo 57 - Section loss on east edge of lower gusset plate at top of lower chord, Span 1, North Truss, at Panel Point 1, looking north*

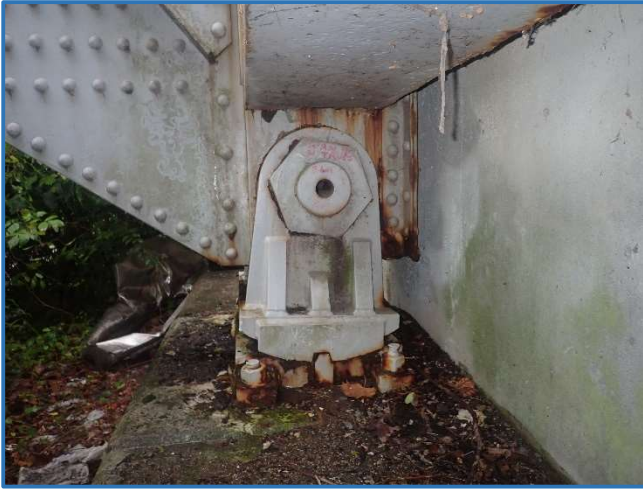
Photo 61 - 5-degree tilt of north bearing at forward abutments, looking north

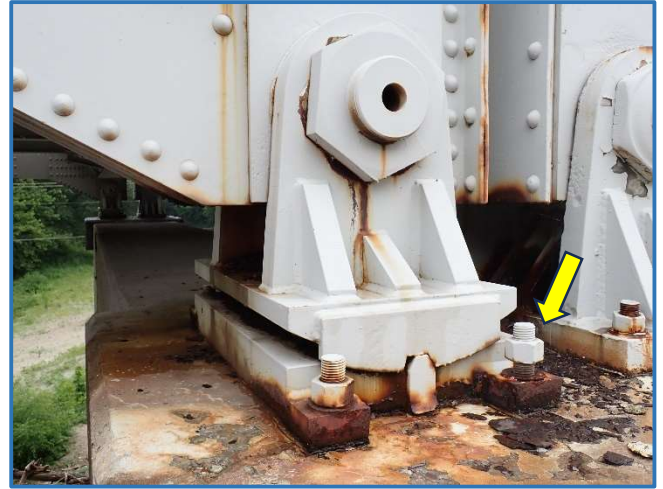
Photo 62 - Backed off nut on southeast anchor bolt on south bearing in Span 2, at Pier 3, looking north

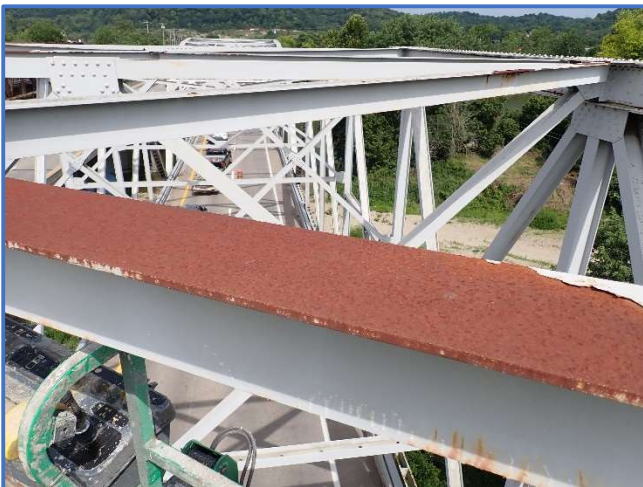
The structure was painted in 1992 with OZEU paint. Overall, the steel protective coating is in fair condition. The upper half of the trusses, above the splash zone, exhibits isolated areas of paint failure with surface corrosion (see Photo 63). The verticals and diagonals have areas of paint failure. The lower chord gusset plates and bearings have widespread areas of missing paint with active corrosion (see Photo 64). The paint on the floorbeams and stringers is in good condition (see Photo 65), with minor isolated spots of paint failures and areas of rust staining at the floorbeam ends. The upper lateral bracing has isolated areas of peeling paint with surface corrosion (see Photo 66).

Photo 63 - Upper lateral bracing paint failure with surface corrosion. Shown is worst case in Span 3, North Truss, between Panel Points 5 and 6, looking southeast

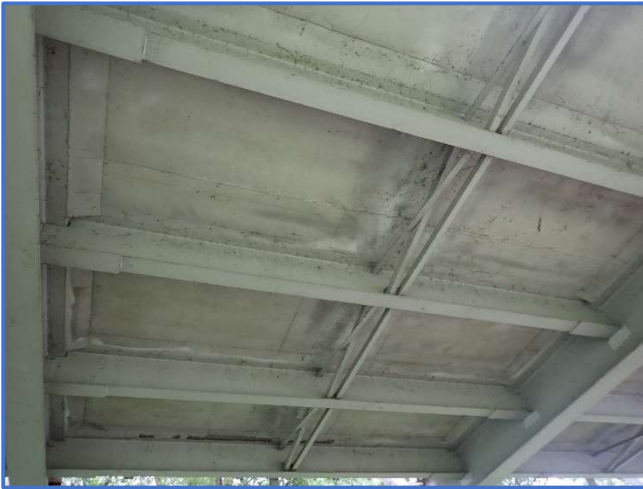
Photo 65 - Typical protective coating condition of floorbeam and stringers. Shown in Span 4

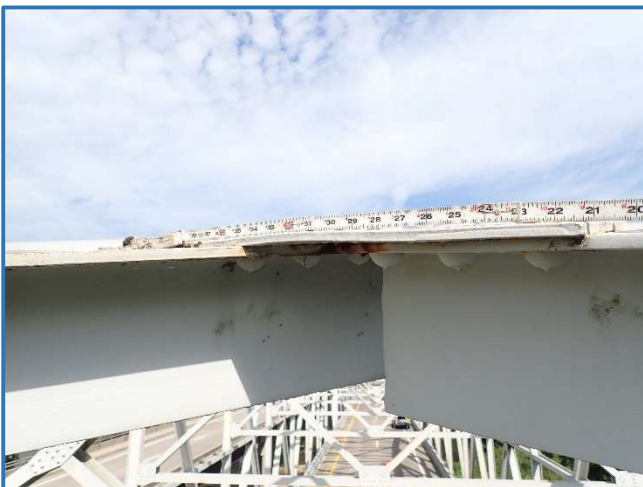
Photo 68 - Bowing in upper lateral bracing connection plate in Span 3, between Panel Points 8 and 9, looking west

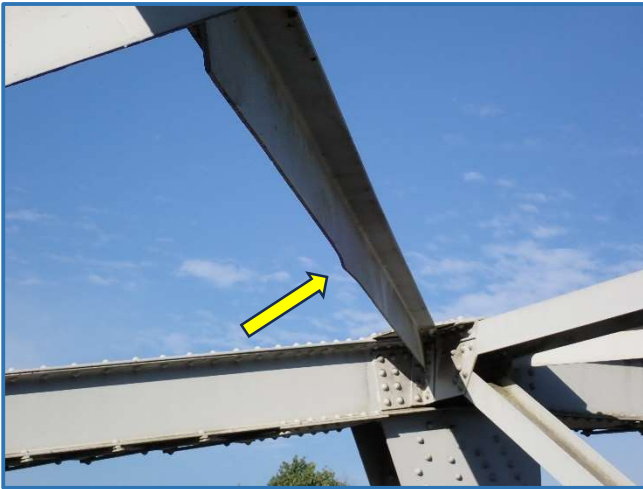
- Span 4, upper lateral brace going from Panel Point 6 South Truss to Panel Point 7 North Truss, impact damage of 1" over 5' (see Photo 69).

Photo 69 - Bowing in bottom leg of upper lateral bracing in Span 4, between Panel Points 6 and 7, looking south

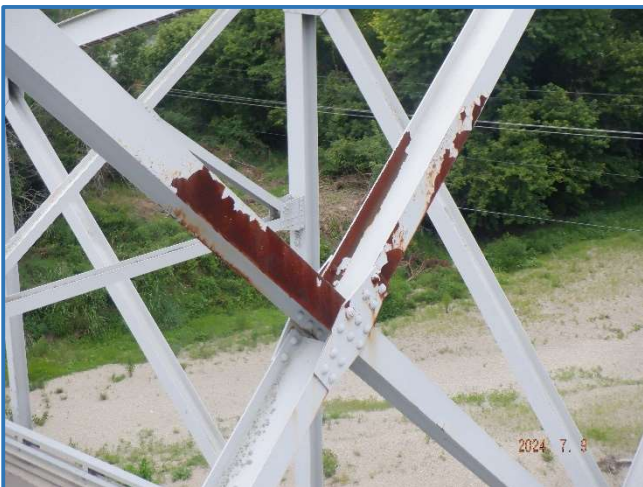
Photo 72 - Surface corrosion on diagonal sway braces in Span 3, at Panel Point 3, looking west

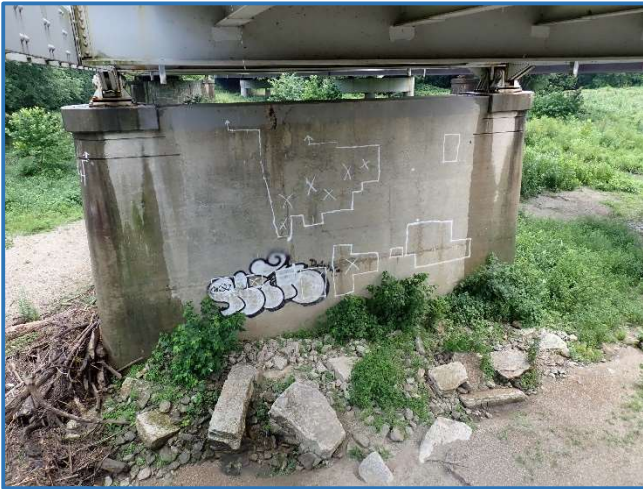
Photo 77 - Large delaminated area at the top of west face of Pier 3

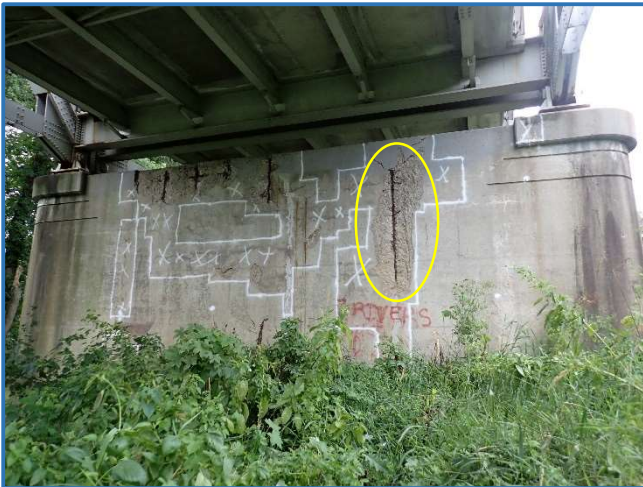
The west face of Pier 4 (see Photo 80) has one large spall under Stringer 4 that is 10' in length. A debonded rebar with 25% section loss is exposed for most of the length (see Photo 81).

Photo 80 - Large spall under Stringer 4 on West face of Pier 4

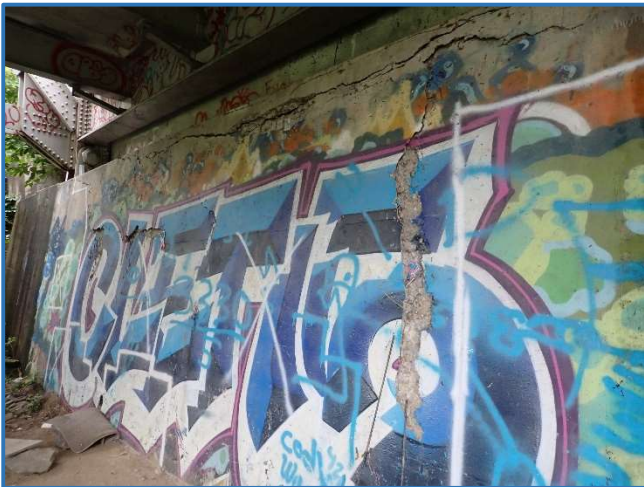
Photo 86 - Rear abutment with cracking and delaminations

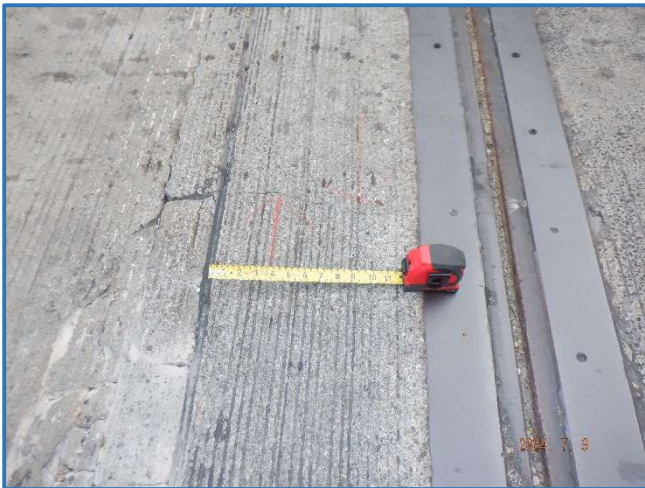
Photo 90 - Longitudinal crack in top of header of rear abutment, looking north

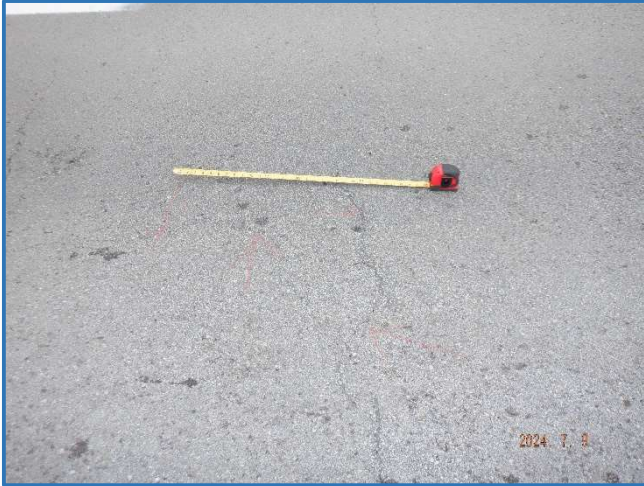
The asphalt approach roadway is in satisfactory condition, with up to 1/8" wide longitudinal and transverse cracks throughout (see [Photo 93](#)). Map cracking up to 1/8" wide is present at the west approach (see [Photo 94](#)).

Photo 93 - Longitudinal cracks up to 1/8" wide in east approach pavement, looking north

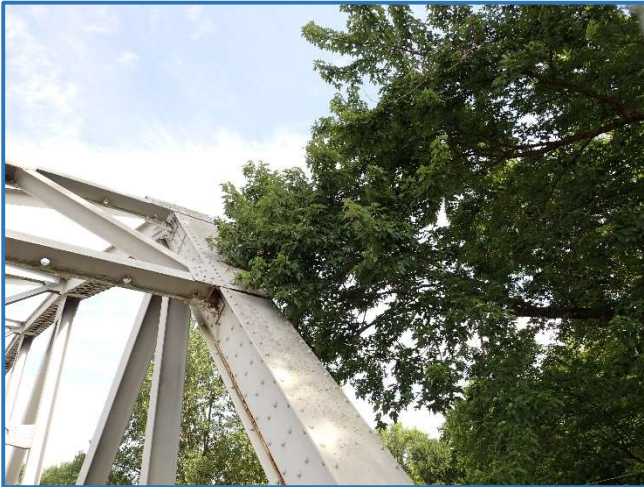
The embankments are in satisfactory condition and covered in heavy vegetation, hindering the verification of previously noted erosion at the northwest corner. There are two areas where vegetation has encroached onto/near the bridge. In Span 3, North Truss, on member U9L10, there is a tree reaching over the upper chord end post (see [Photo 95](#)). In Span 4, South Truss, on member U7L8, there is vegetation growth along the length of the underside of the end post (see [Photo 96](#)).

*Photo 95 - Tree encroaching on end post in Span 3, North Truss, between Panel Points 9 and 10, looking northwest*

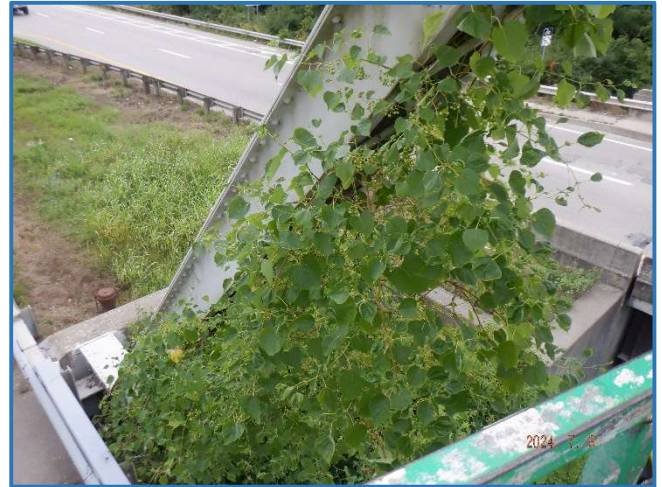
*Photo 96 - Vegetation growth along underside of end post in Span 4, South Truss, between Panel Points 7 and 8, looking northeast*
