UNDERWATER BRIDGE INSPECTION REPORT

SFN: 3102548	c38 Pier Columns:	1	Bridge Number: HAM-50-0376R
Substructure: 8	c42 Scour:	1	Inspection Date: 08/30/2019
Channel: 6	c51 Alignment:	2	Division: District 8
	c53 Hydraulic Opening:	1	River: Great Miami River

Structure ID #: HAM-50-0376R, US 50 over Great Miami River Date: 08/30/2019

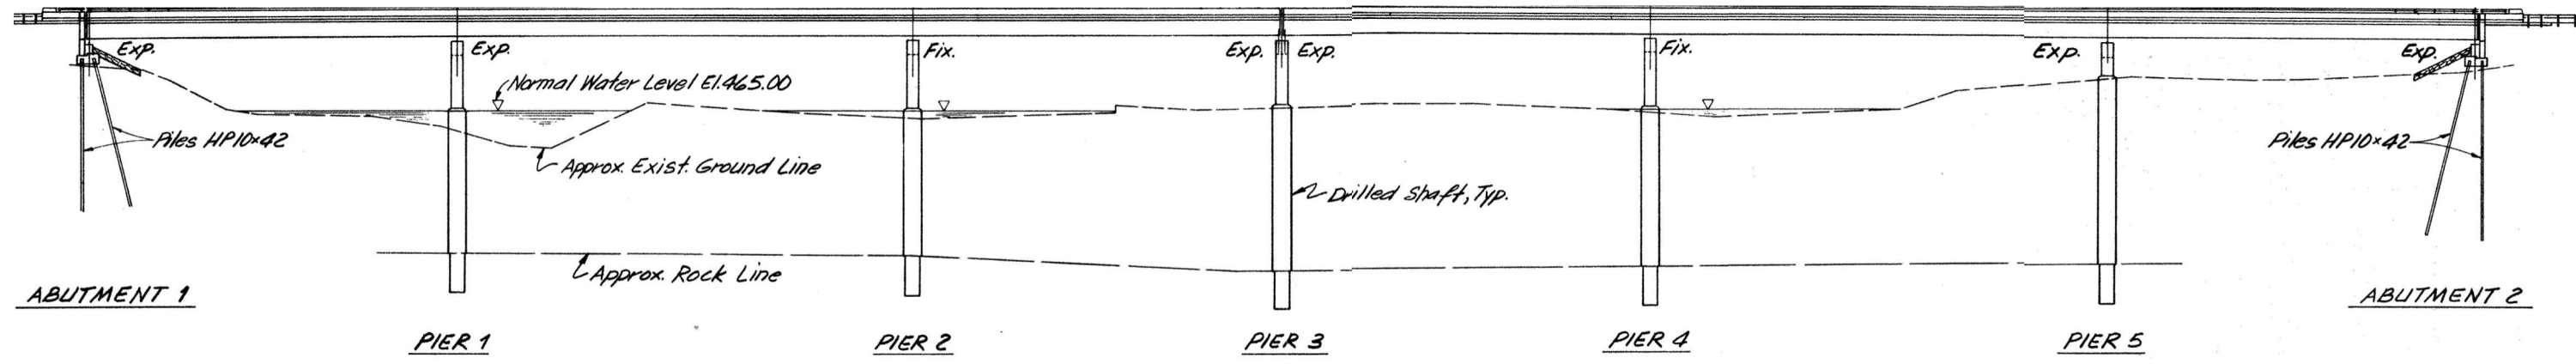
BRIDGE PROFILE
NOT TO SCALE

- ◆ 6.3' INDICATES WATER DEPTH IN FEET AT THE TIME OF INSPECTION
- 🌳 TREE DEBRIS

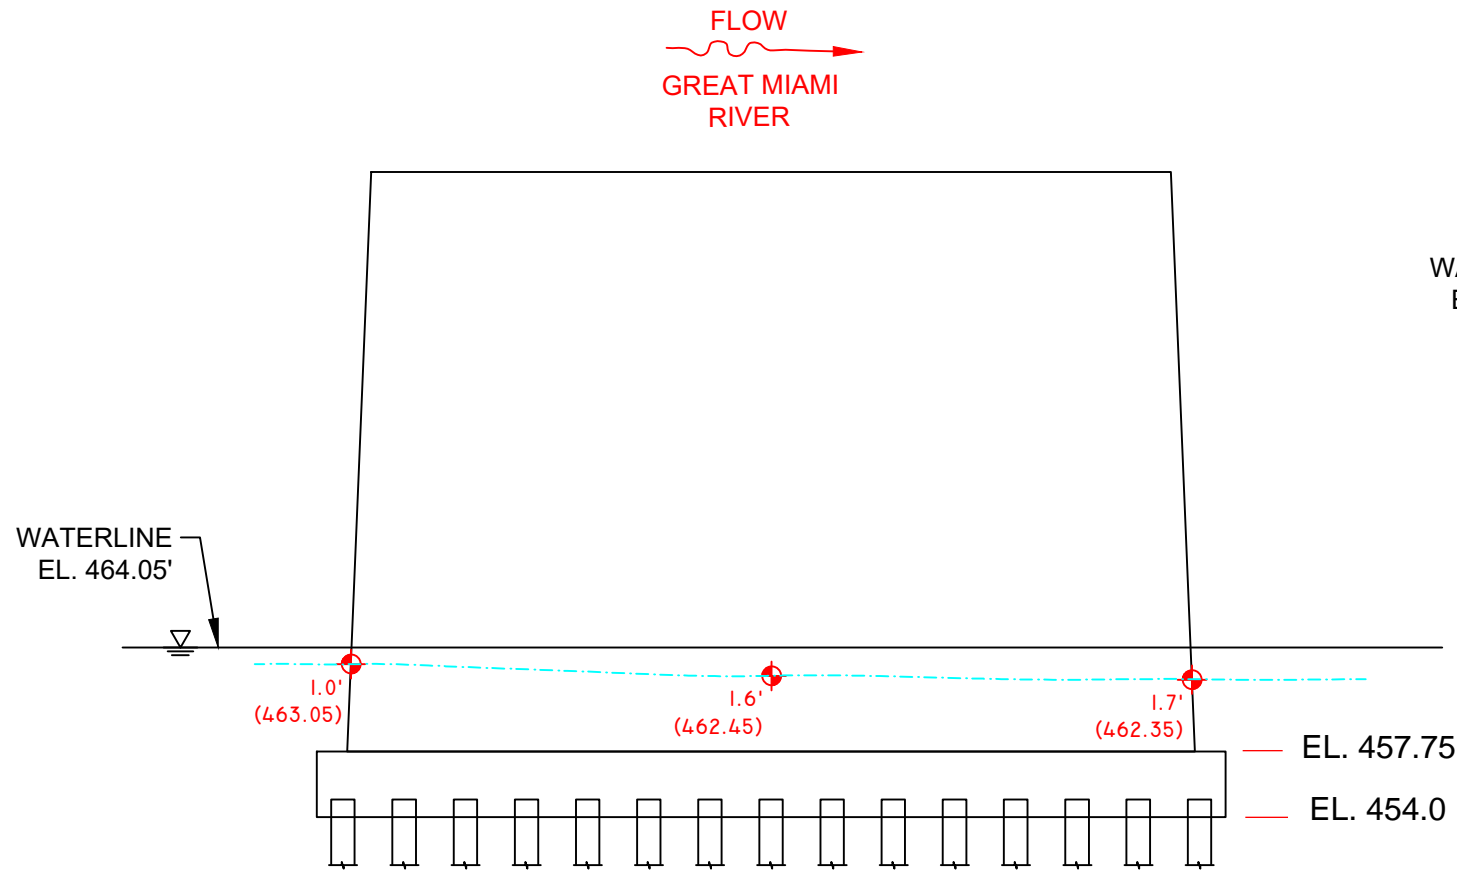
PIER 2L ELEVATION
NOT TO SCALE

1. Light marine growth (algae).
2. Visibility less than 6".
3. No foundation or footing exposure.
4. The bottom substrate around the base of pier 2 consists of silty sand, gravel and cobbles.
5. Hammer soundings of the exposed concrete were performed along the entire length of the pier columns; no areas of unsound concrete (delaminations, voids, etc.) were noted.
6. The drilled shaft columns are encased in steel casing and at the time of the inspection approximately 10" of the steel casing was found to be above the water line.
7. The steel casing was noted to be lightly corroded, with minor pitting.
8. The concrete condition at the interface between the cased and uncased portion was good.

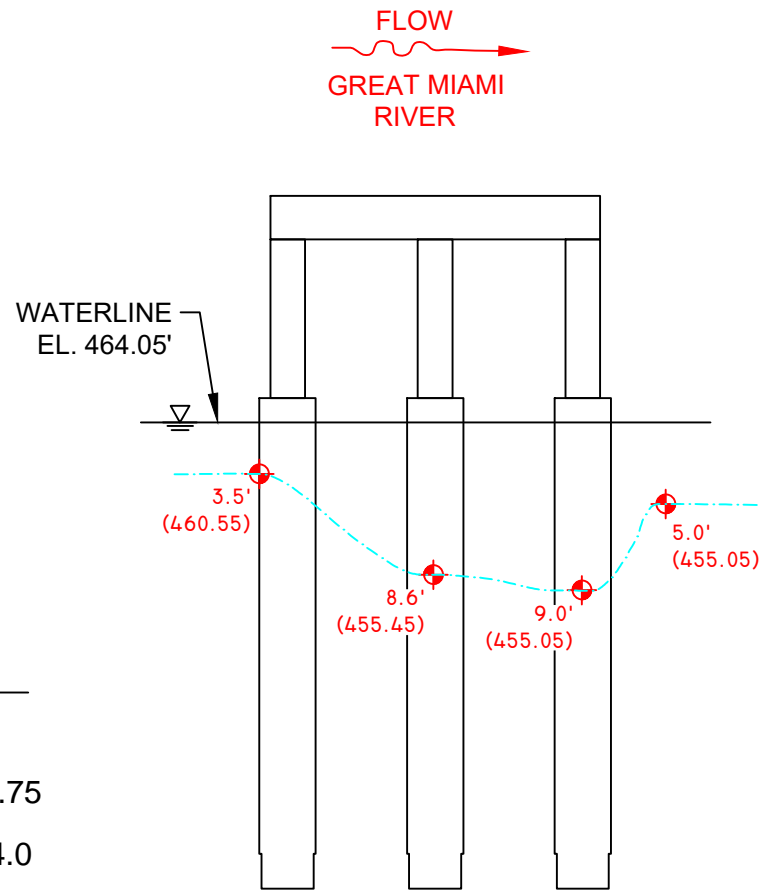
PIER 1R ELEVATION
NOT TO SCALE

1. Light marine growth (algae).
2. Visibility less than 6".
3. No foundation or footing exposure.
4. The bottom substrate around the base of pier 1 consists of silty sand, gravel and cobbles.

5. Hammer soundings of the exposed concrete were performed along the entire length of the pier columns; no areas of unsound concrete (delaminations, voids, etc.) were noted.

6. The drilled shaft columns are encased in steel casing and at the time of the inspection approximately 10" of the steel casing was found to be above the water line.

7. The steel casing was noted to be lightly corroded, with minor pitting.
8. The concrete condition at the interface between the cased and uncased portion was good.

9. Moderate to heavy tree debris was noted along the west side of column 1 (south column) and column 2 (middle column), including two large trees with root balls. The west side of these pier columns could not be fully inspected due to the tree debris. While these pier columns are encased in steel casing and the foundation of the pier are drilled shafts, we recommend the removal of the debris, as it could be a contributor to the channel degradation.

Remove tree debris from pier 1.
