2023 IN-DEPTH INSPECTION REPORT
BRIDGE NO: HAM-71-0000R, SFN 3105970
VAR-DISTRICT 8 Bridge Inspections
Brent Spence Approach Bridges

Cincinnati, Ohio

September 11th – September 19th, 2023

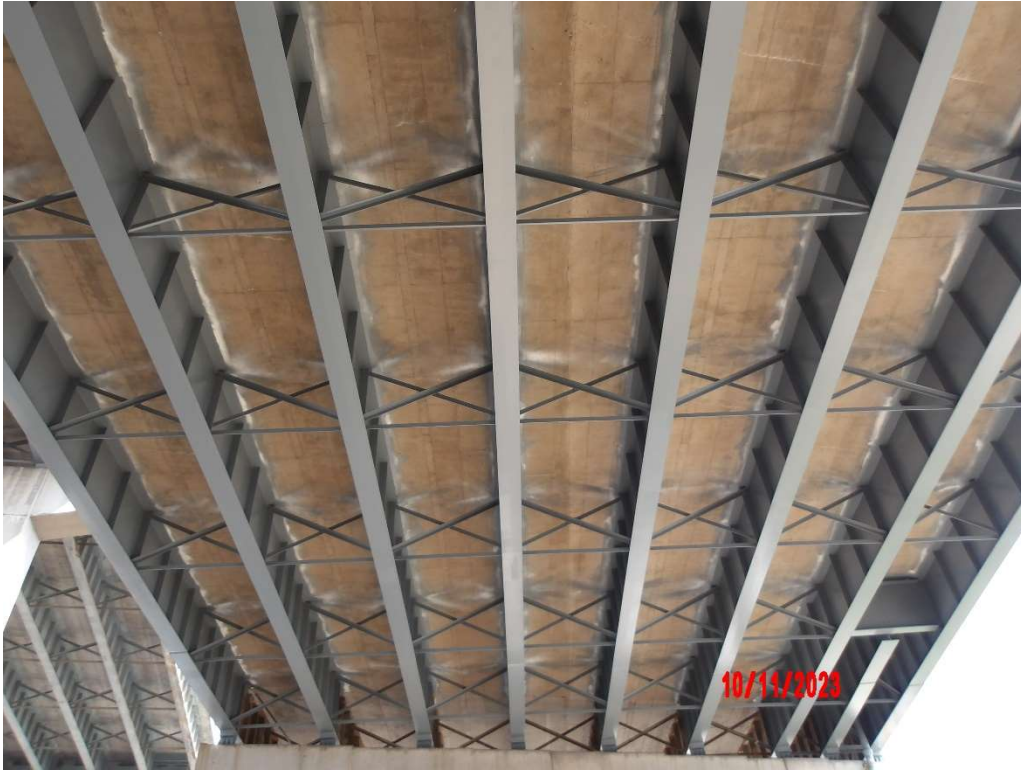
Photo 5- Span 14, Typical Underside

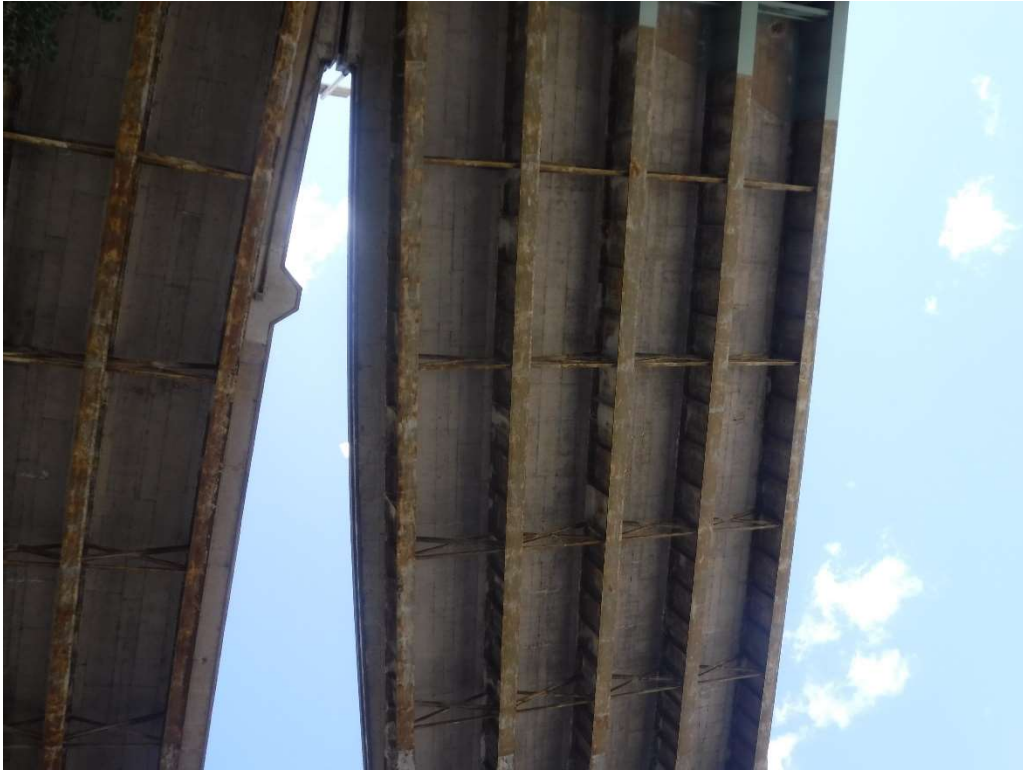
Photo 7- Typical Underside, Span 16

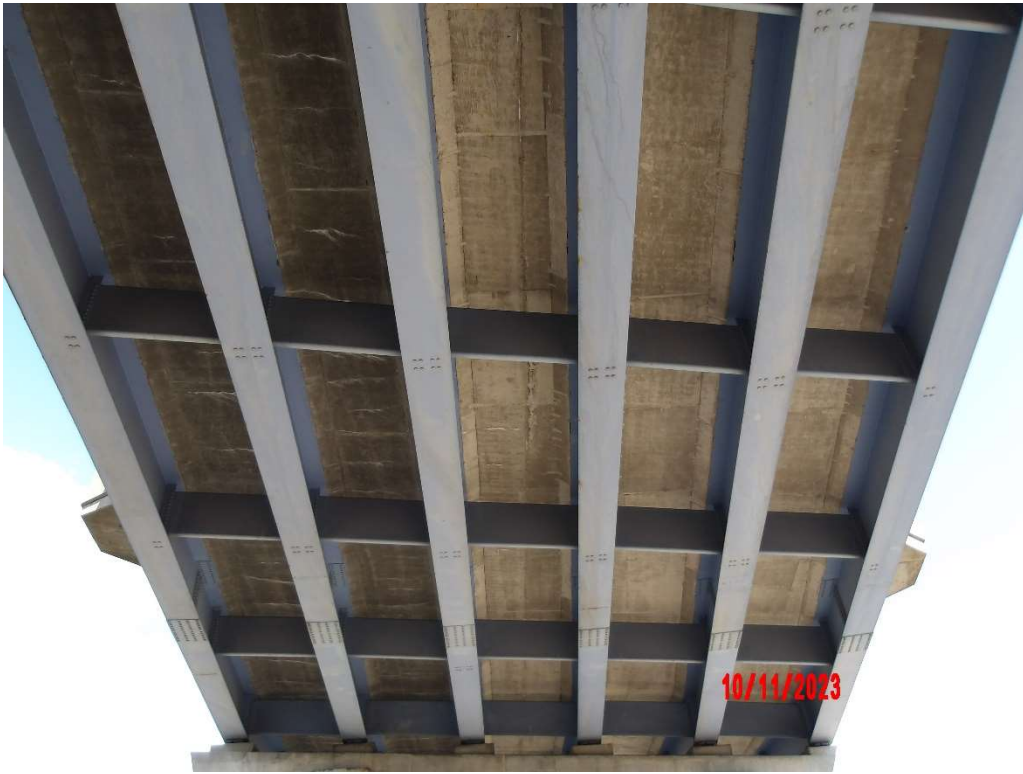
Photo 9- Span 21, Typical Underside, Typical

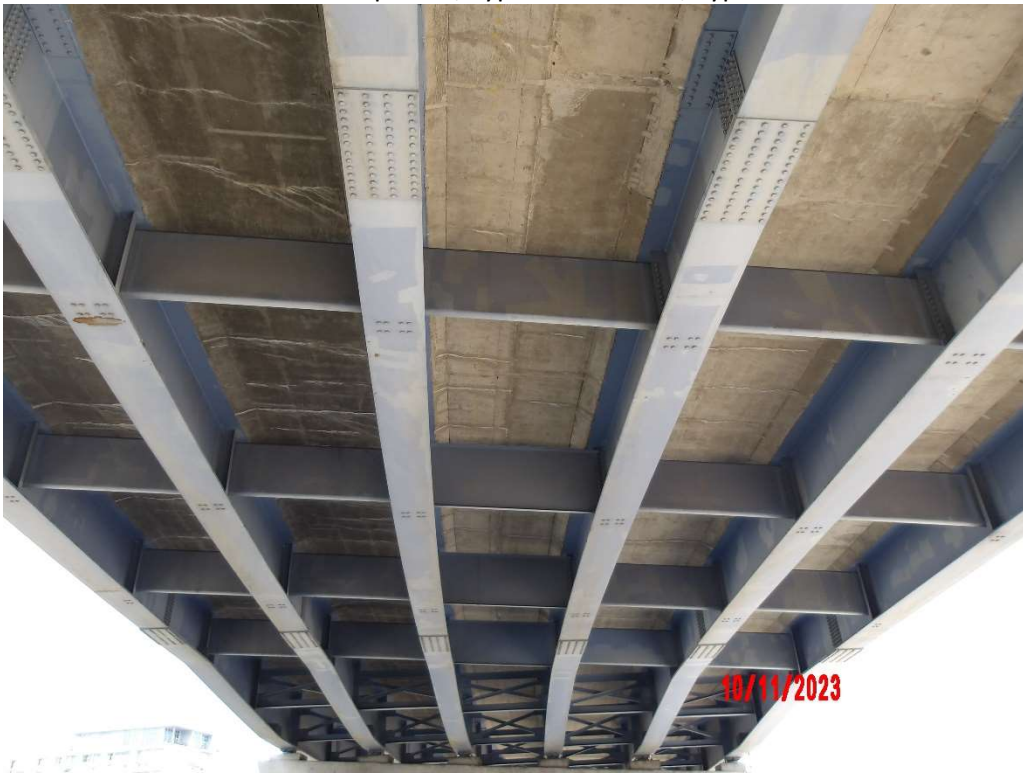
Photo 10- Span 22, Typical Underside

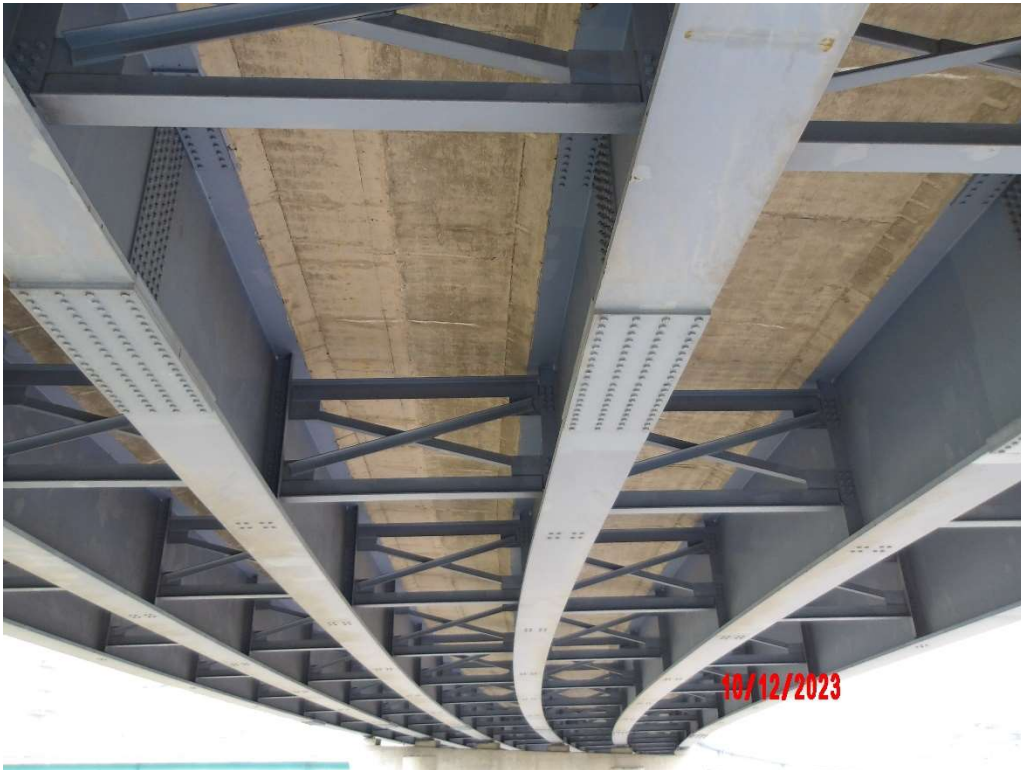
Photo 11- Span 23, Typical Underside

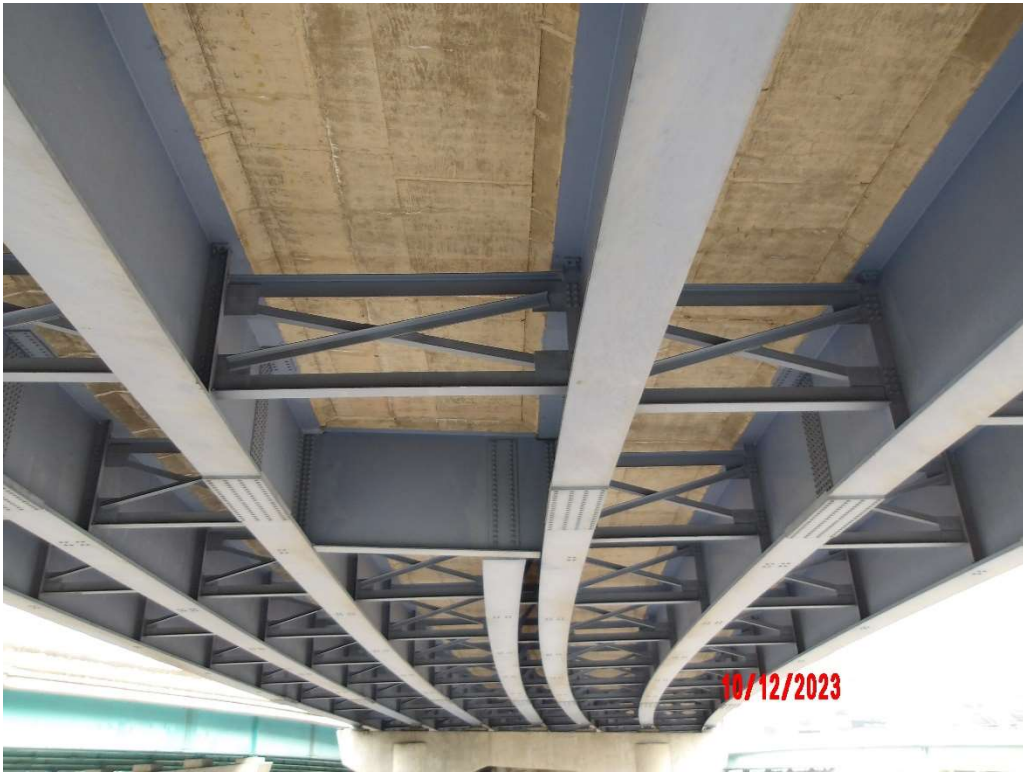
Photo 13- Span 24, Typical Underside

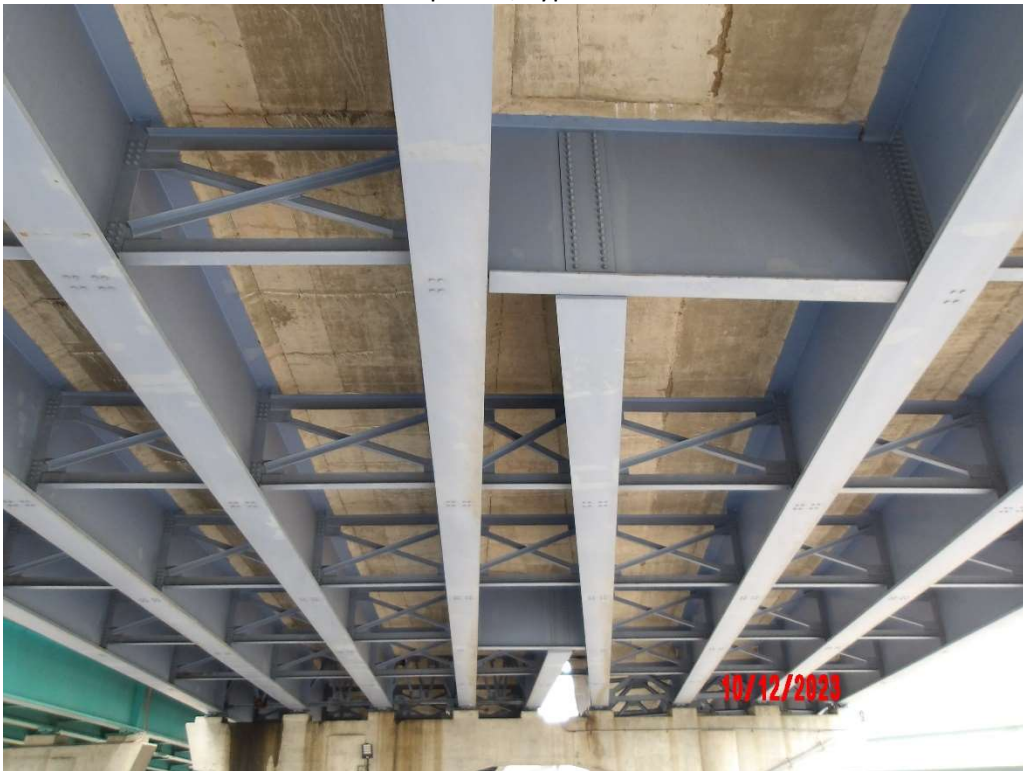
Photo 14- Typical Underside, Span 25

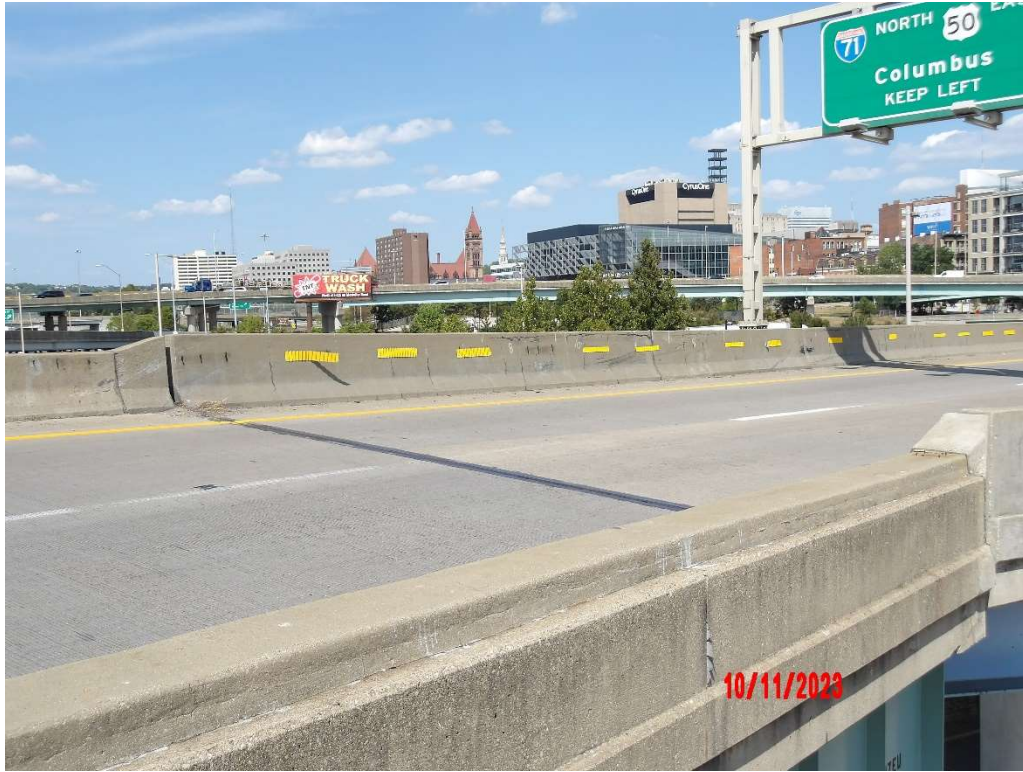
The wearing surface is in SATISFACTORY (6) condition. The wearing surface was inspected visually from the sides using the boom lift. There were locations of hairline to moderate transverse, diagonal, and longitudinal cracks and minor pop-out spalls present throughout the surface of the wearing surface. The bridge deck was sounded by ODOT in December 2020, and multiple delaminated areas were found throughout the wearing surface (See Appendix B).

Photo 15- Typical Wearing Surface

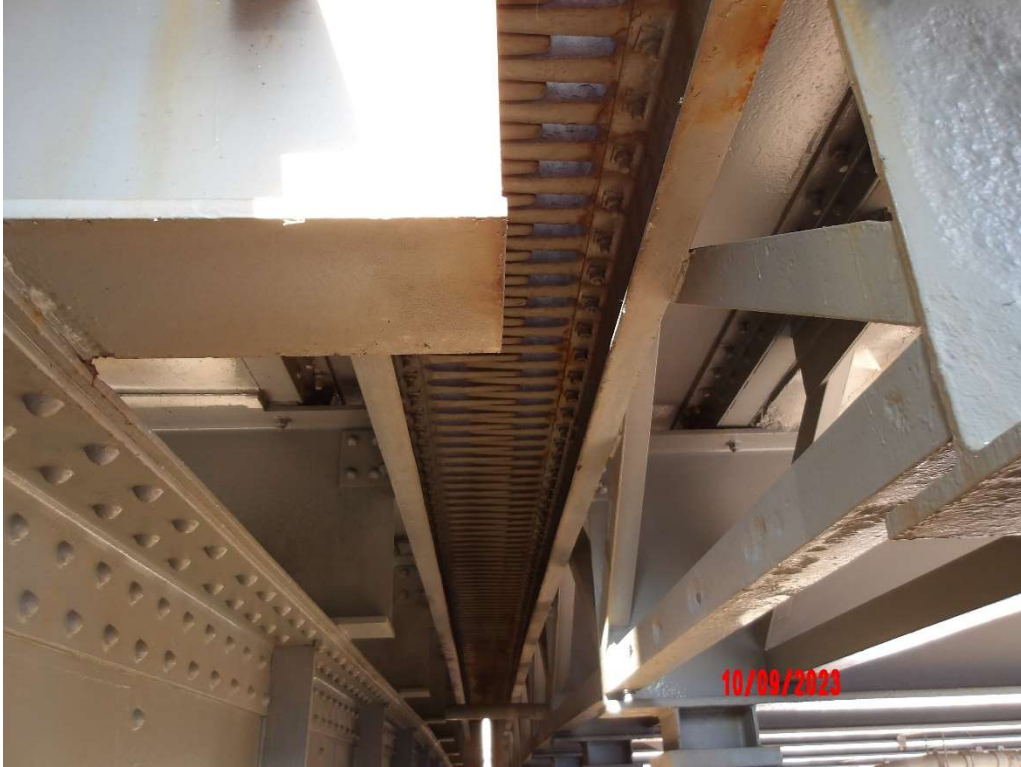
Photo 16- Truss Finger Joint at Pier 0

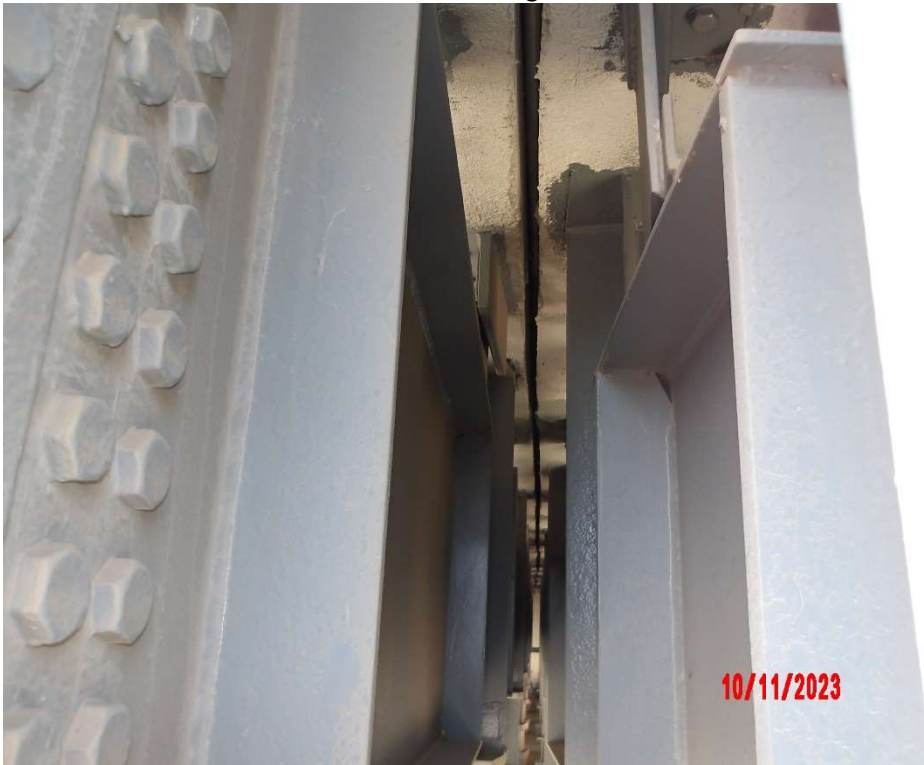
Photo 17- Pier 12 Joint, Typical

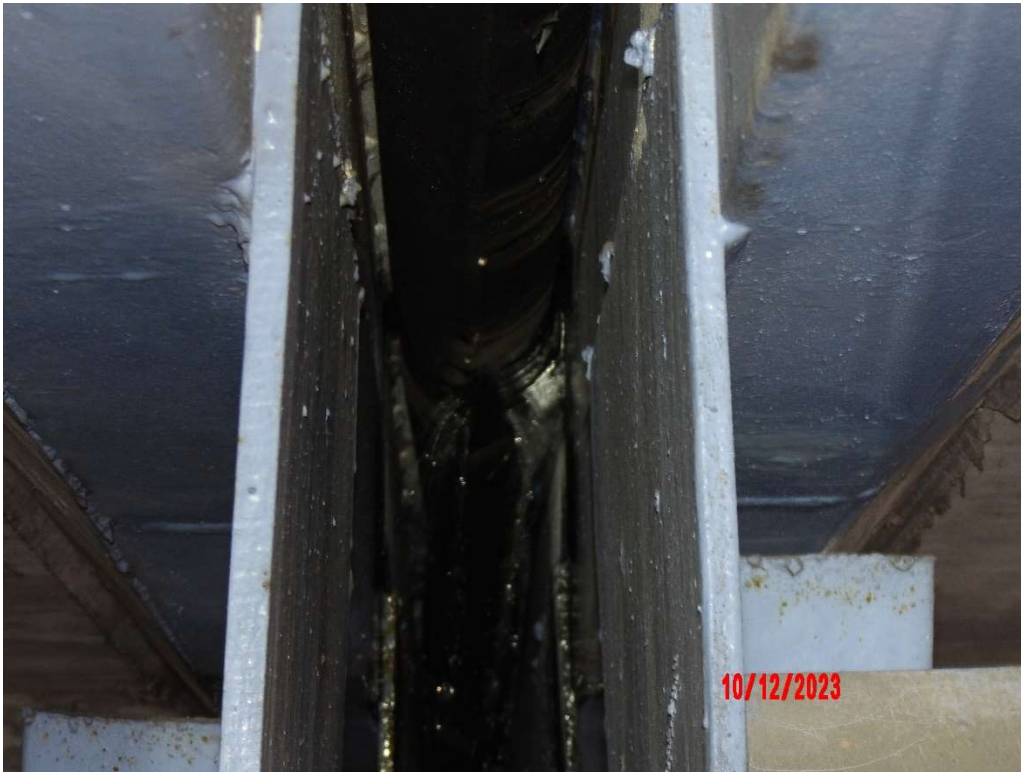
The expansion joints are in FAIR (5) condition. Expansion joints are located at Piers 4A, 8A, 12C, 15C, and 17C and were replaced in 2016. The expansion joints at Pier 20D and Pier 5 (Reconstructed Spans) were constructed during the 1999 reconstruction. There is loosely packed debris in all expansion joints on the deck. The expansion joints at Pier 20D are leaking with debris on the pier caps below due to seal adhesion failure. There is a large tear on Pier 5 allowing free flow water through the joint (see photo 18). Leakage on cap is evident as well as active corrosion on the girders and bearings below these joints.

Photo 18- Pier 25C, Joint Tear, Free Flow Water

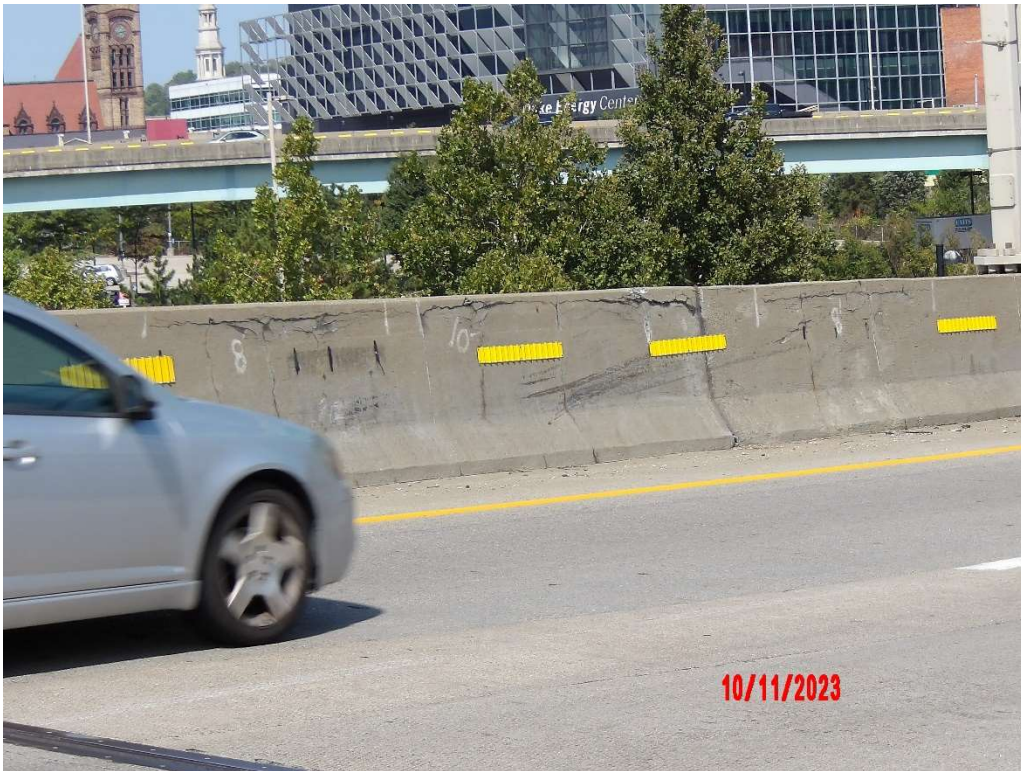
The reinforced concrete bridge railings are in FAIR (5) condition. There are moderate to wide transverse cracks on the top and moderate width vertical cracks on the interior and exterior faces of both bridge railings. Cracks are spaced 1ft-3ft apart with most exhibiting efflorescence, rust staining, or moisture staining throughout all spans. There is heavy wide cracking in Span 2 (Reconstructed Span) in the west barrier for 20ft. There is a spall on the top portion of the west and east railing at the expansion joint at the River Pier. There is a concrete spall on the top portion of the East rail in Span 12A. There is a 24" x 3" x 1" spall in the inside corner of the west railing in Span 6. There is a similar 4ft long spall due to impact in the west rail in Span 16D.

Photo 19- Barrier, Typical Conditions

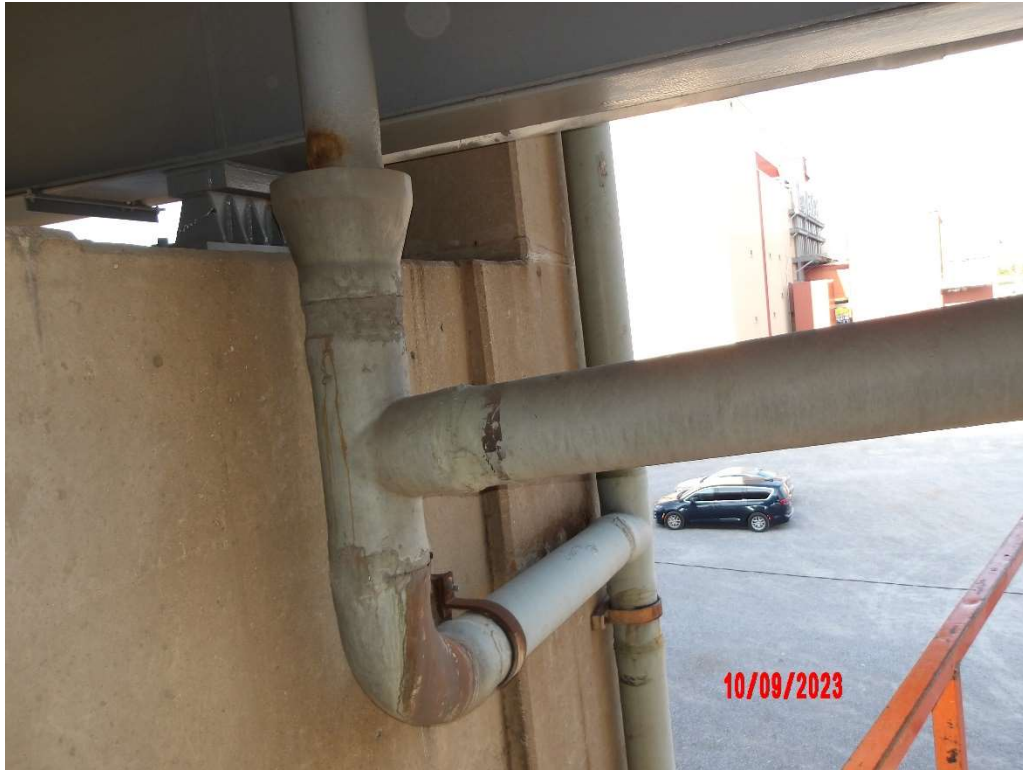
Photo 22- Drainage, Span 1, Pier 2

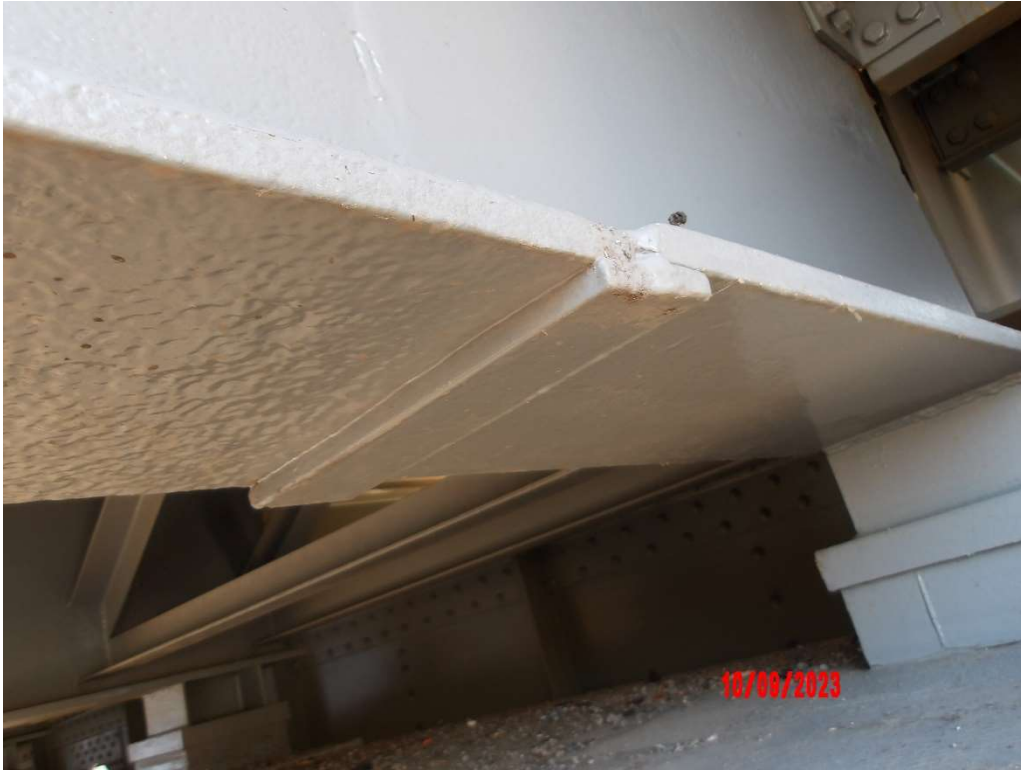
Photo 28- Girder A, Span 1, Backing Plate on Bottom Flange

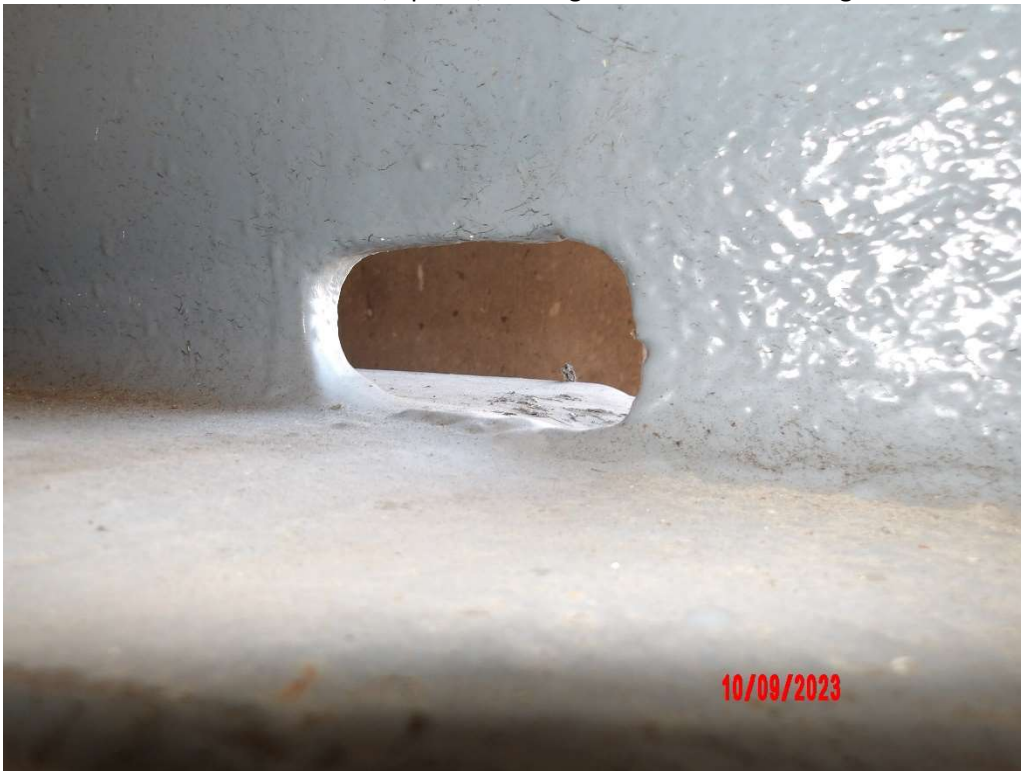
Photo 29- Girder A, Web, Hole, Near Pier 0

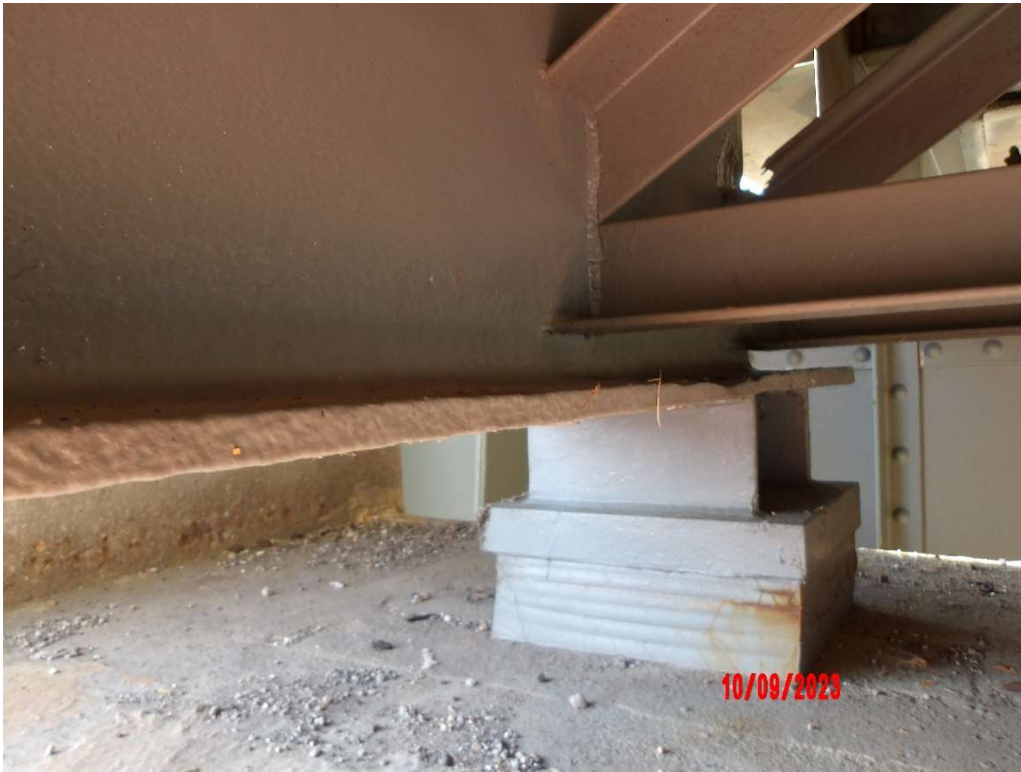
Photo 30- Girder G, Pier 0, Bottom Flange and Web, Up to 3/8" Section Loss, 9' L

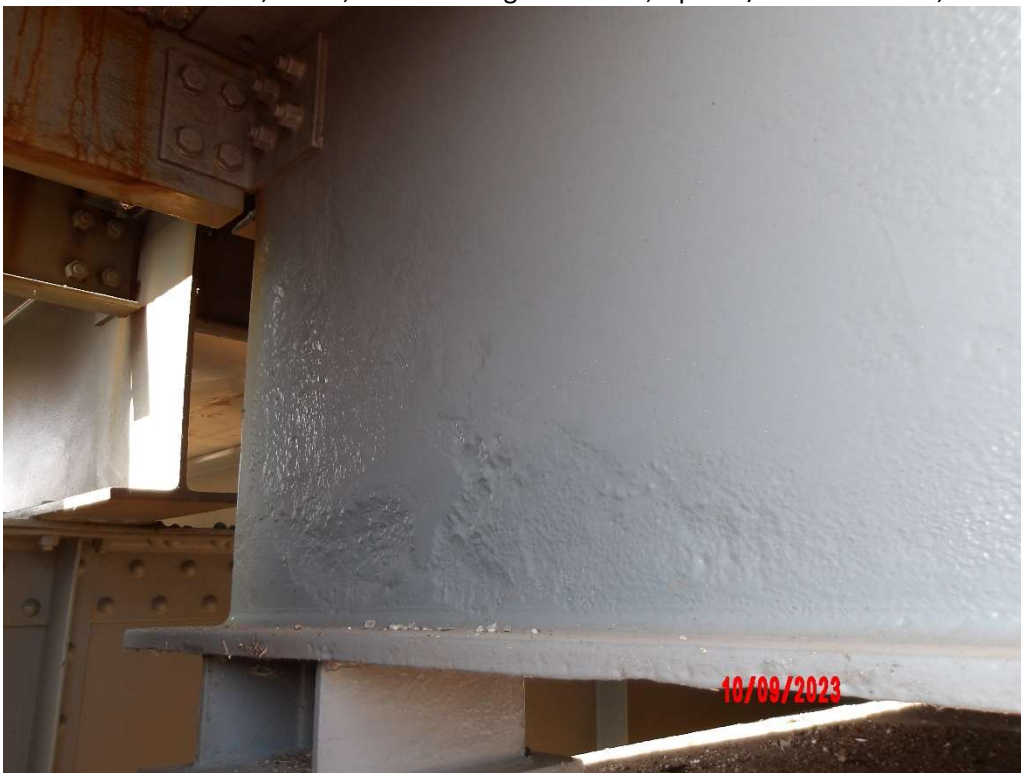
Photo 31- Girder G, Pier 0, Bottom Flange and Web, Up to 3/8" Section Loss, 9' L

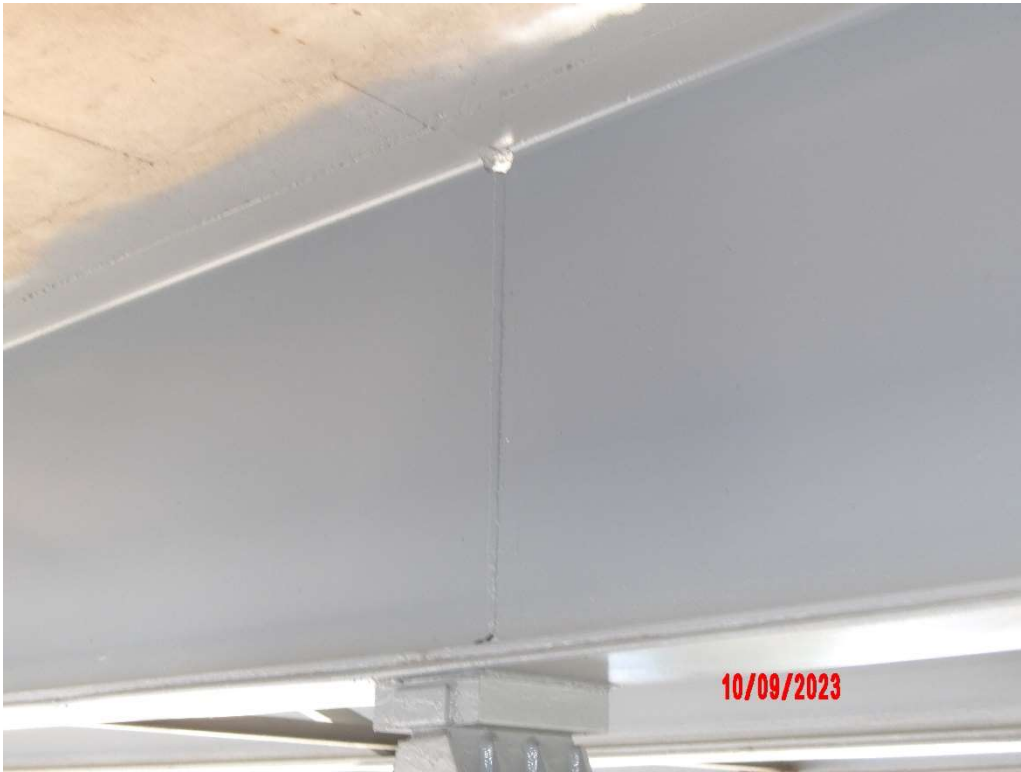
Photo 32- Girders at Pier 1, Typical Web Weld with Holes

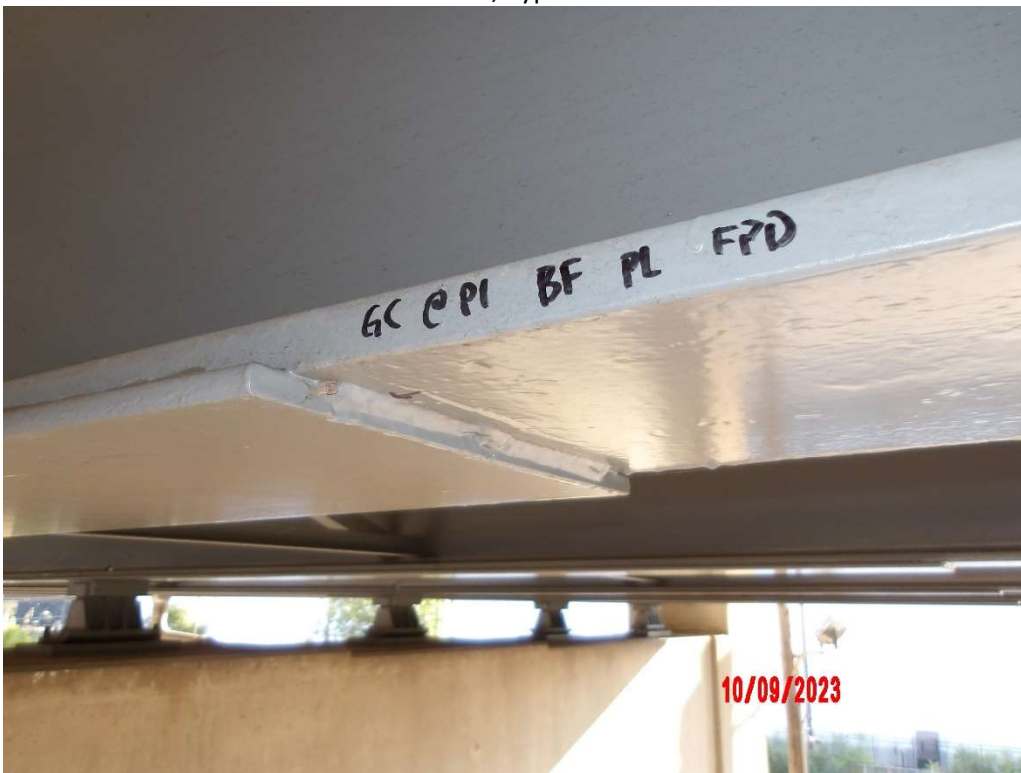
Photo 33- Girder C, Span 2, Bottom Flange Plate with End Weld

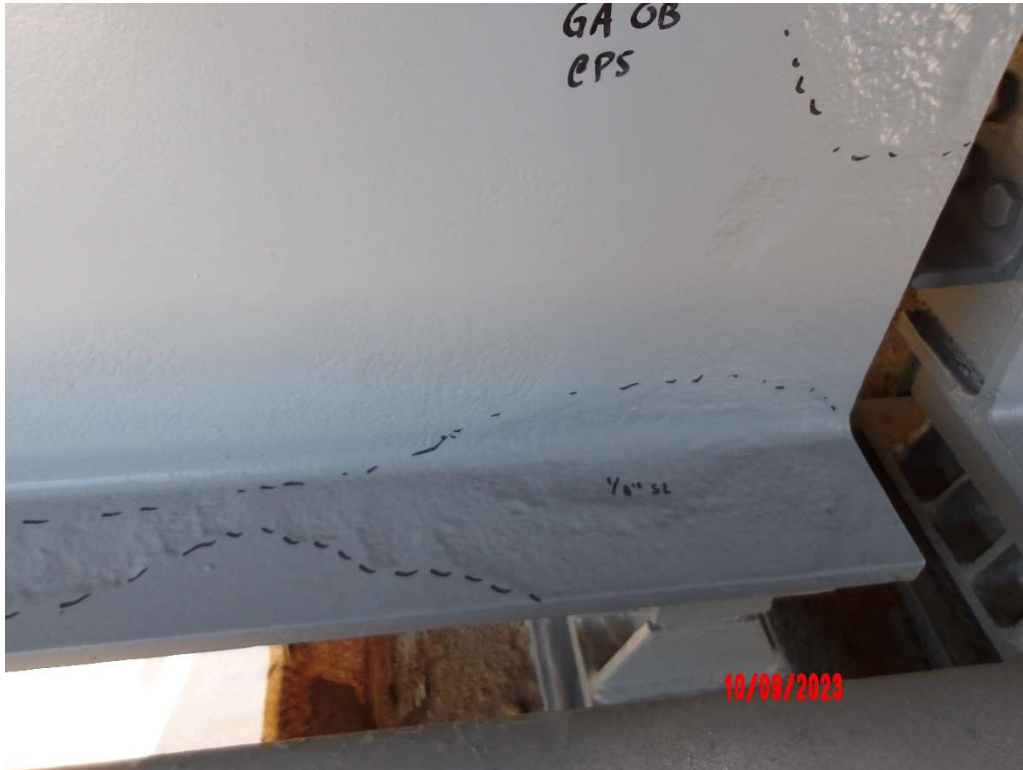
Photo 34- Girder A, Bottom Flange at Pier 5, Section Loss 1/8" Web

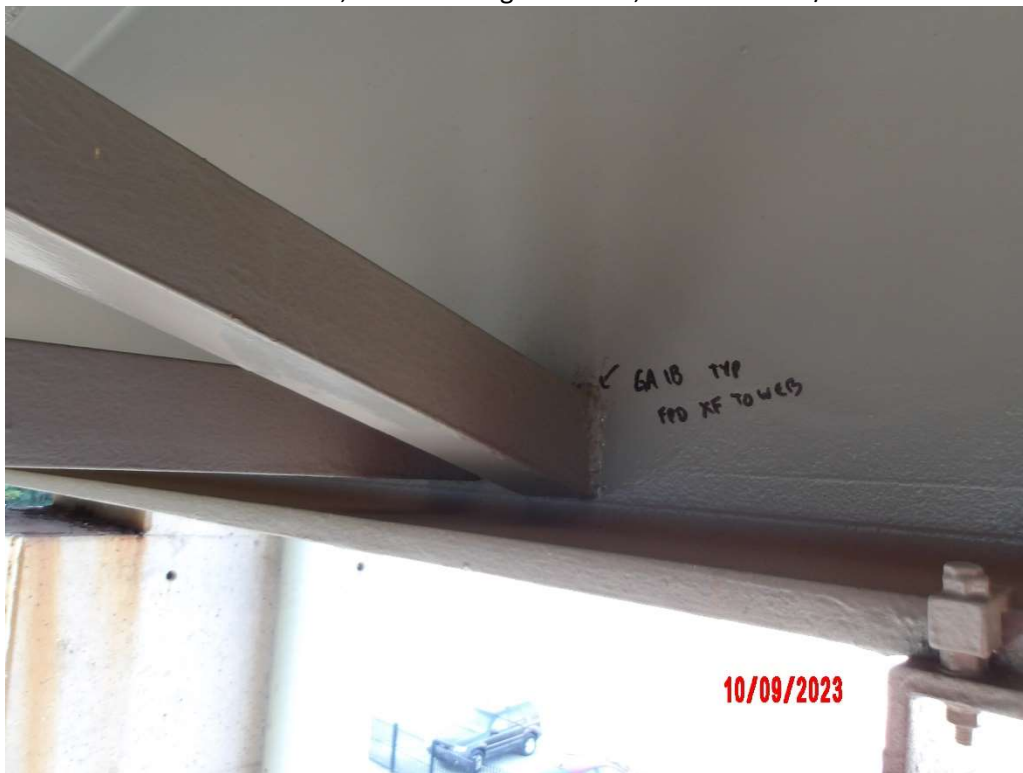
Photo 35- Girder A, Span 5, Inboard, Typical Cross Frame Weld to Web

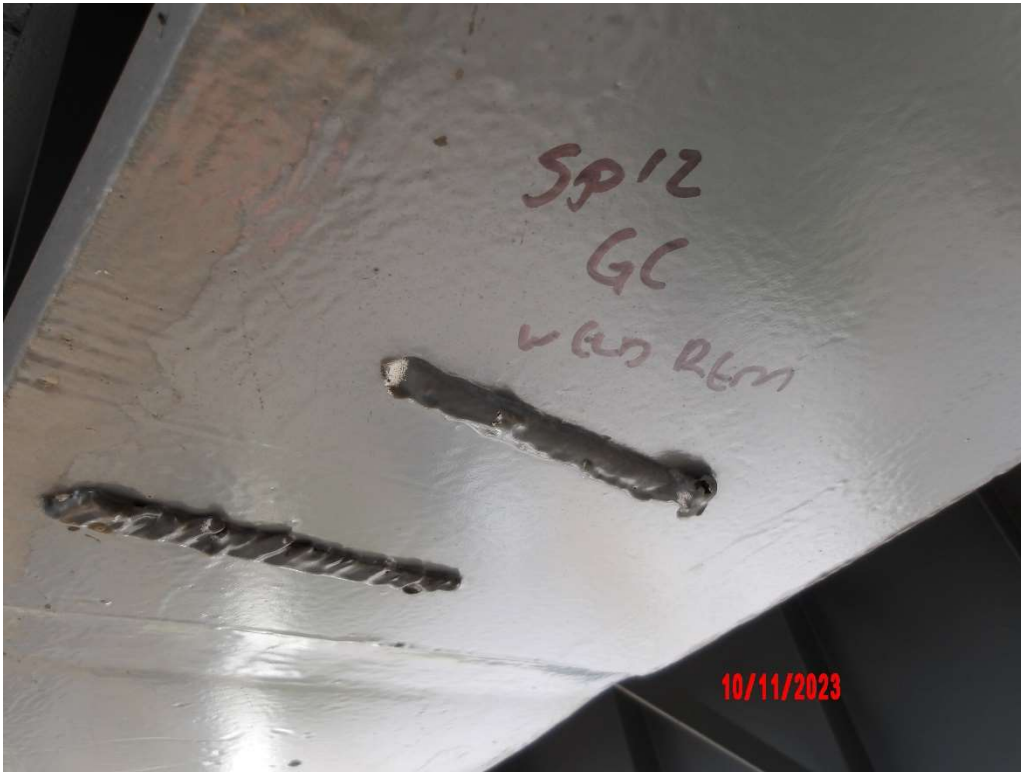
Photo 40- Girder C, Span 12, Typical Weld Remnants on Bottom Flange

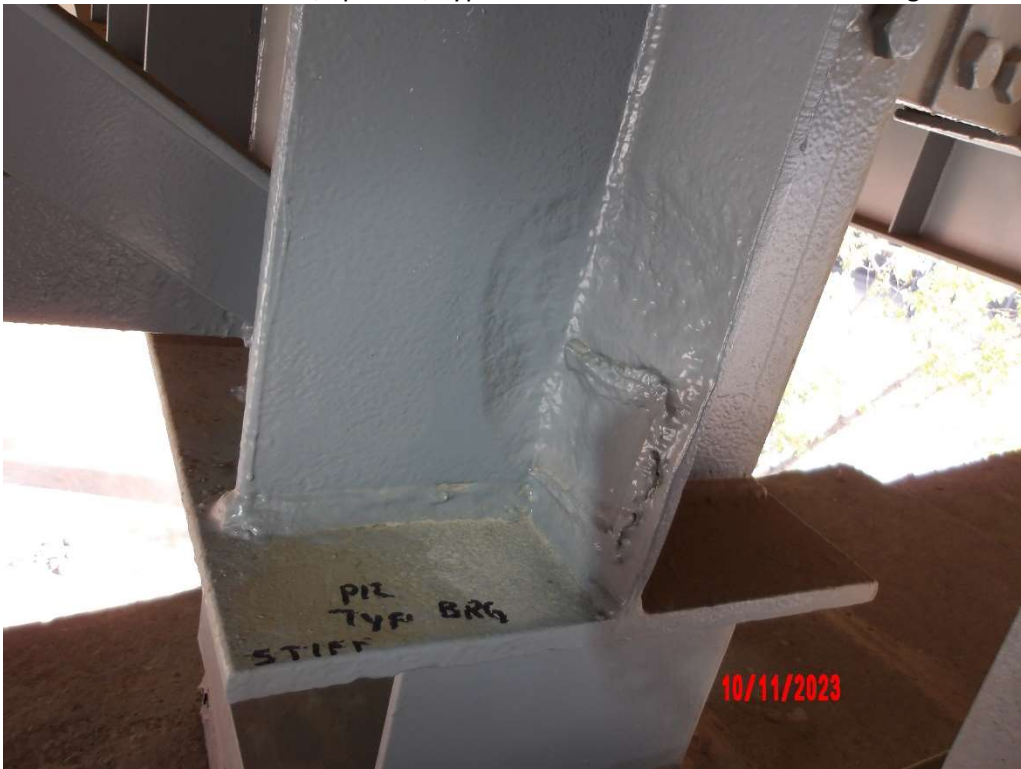
Photo 41- Girder D, Span 12 at Pier 12 OB, Weld Remnants

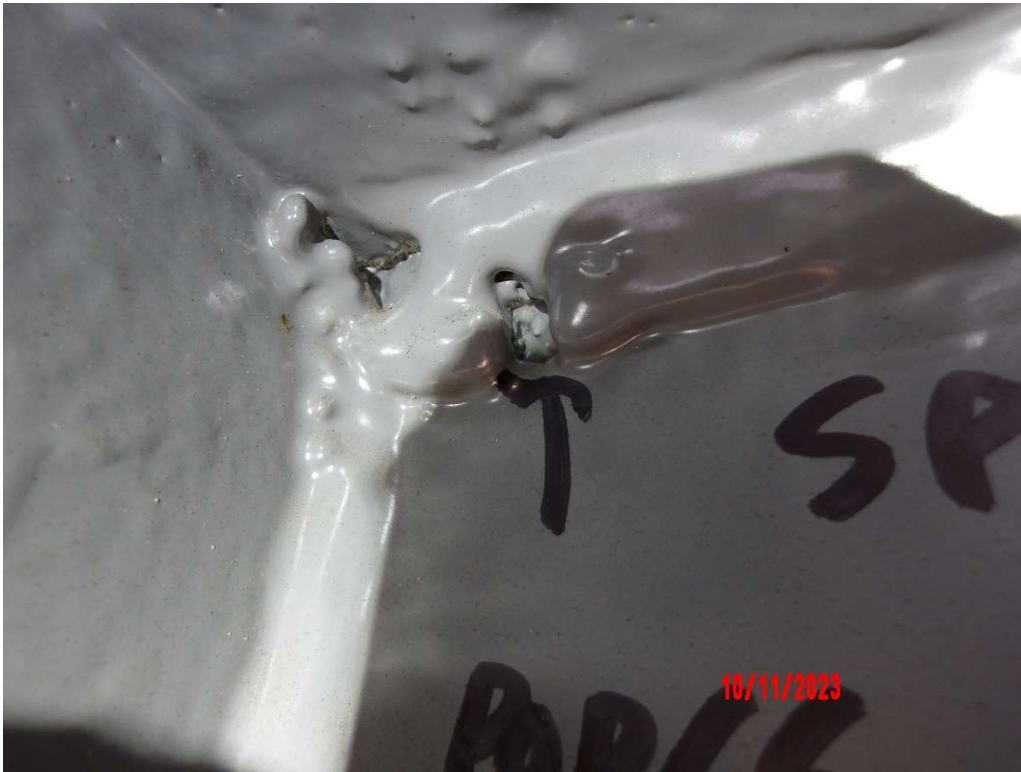
Photo 42- Girder D, Span 12, Pores

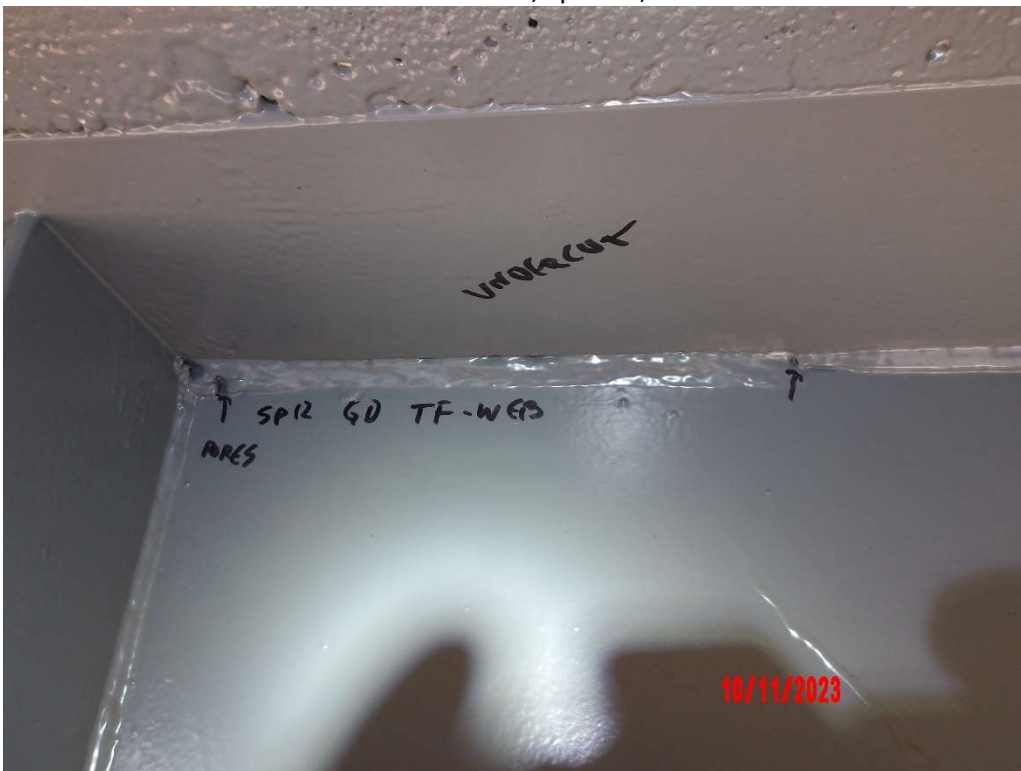
Photo 43- Girder D, Span 12, Undercut Weld and Pores

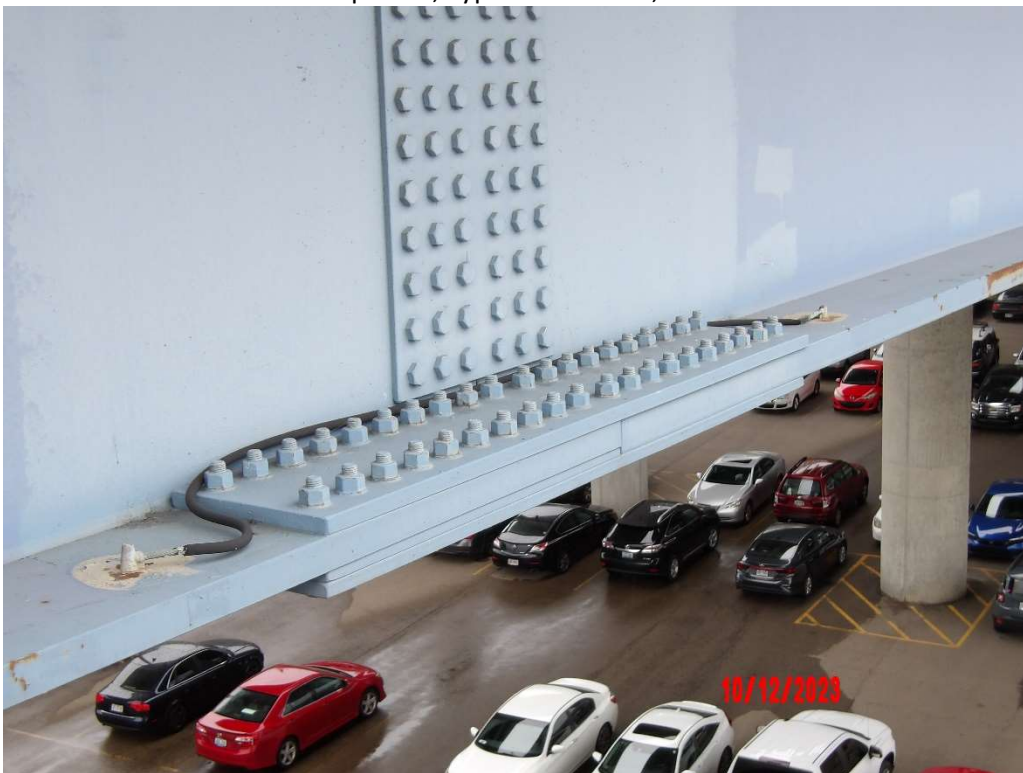
Photo 47- Grounding Wire Detail, Span 24 Fascia at Splice Plate

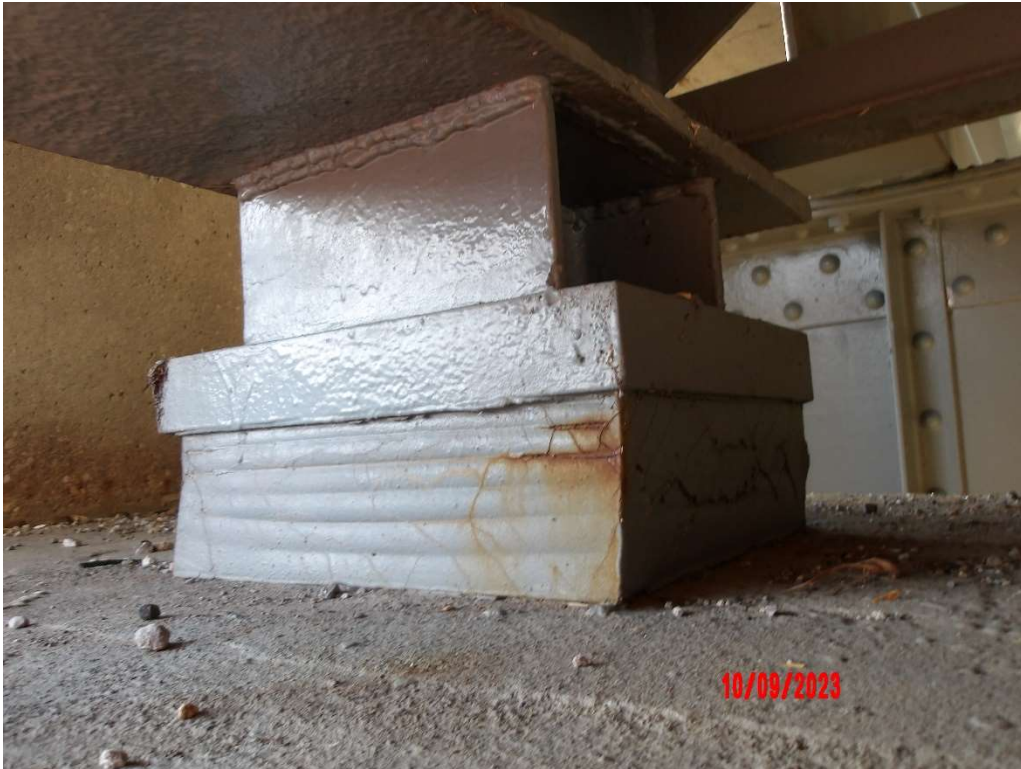
Photo 48- Pier 0, Bearing G

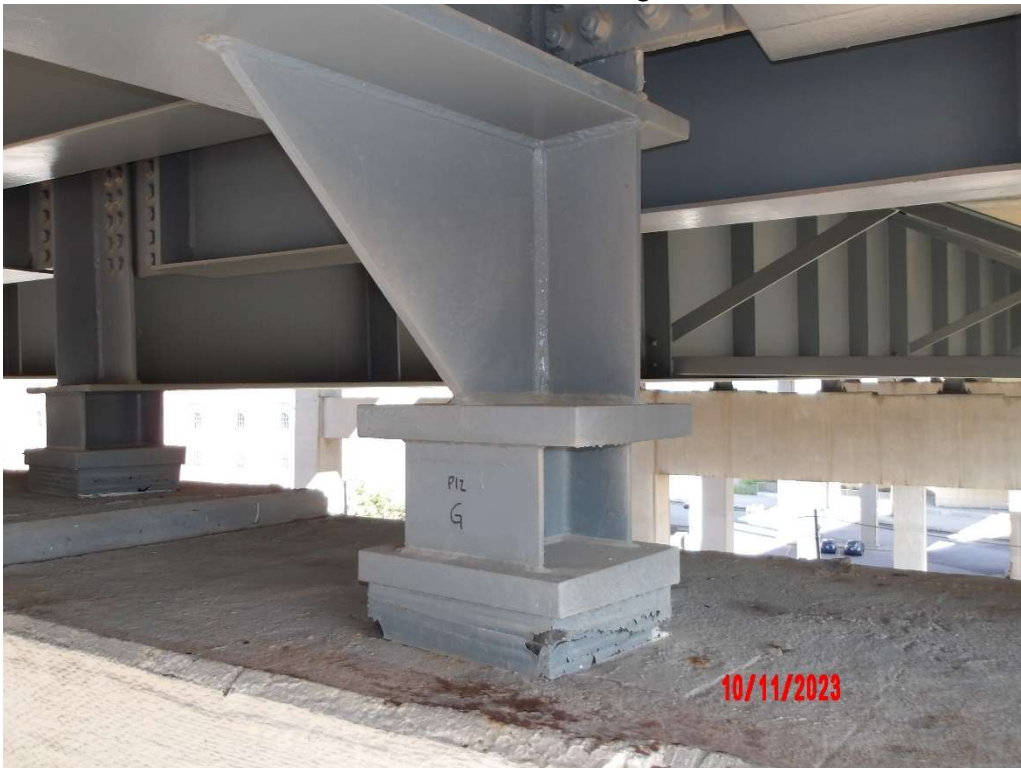
Photo 49- Pier 12 Bearing G, Span 12
