2023 IN-DEPTH INSPECTION REPORT
BRIDGE NO: HAM-71-0000R, SFN 3105970
VAR-DISTRICT 8 Bridge Inspections
Brent Spence Approach Bridges

Cincinnati, Ohio

September 11th – September 19th, 2023

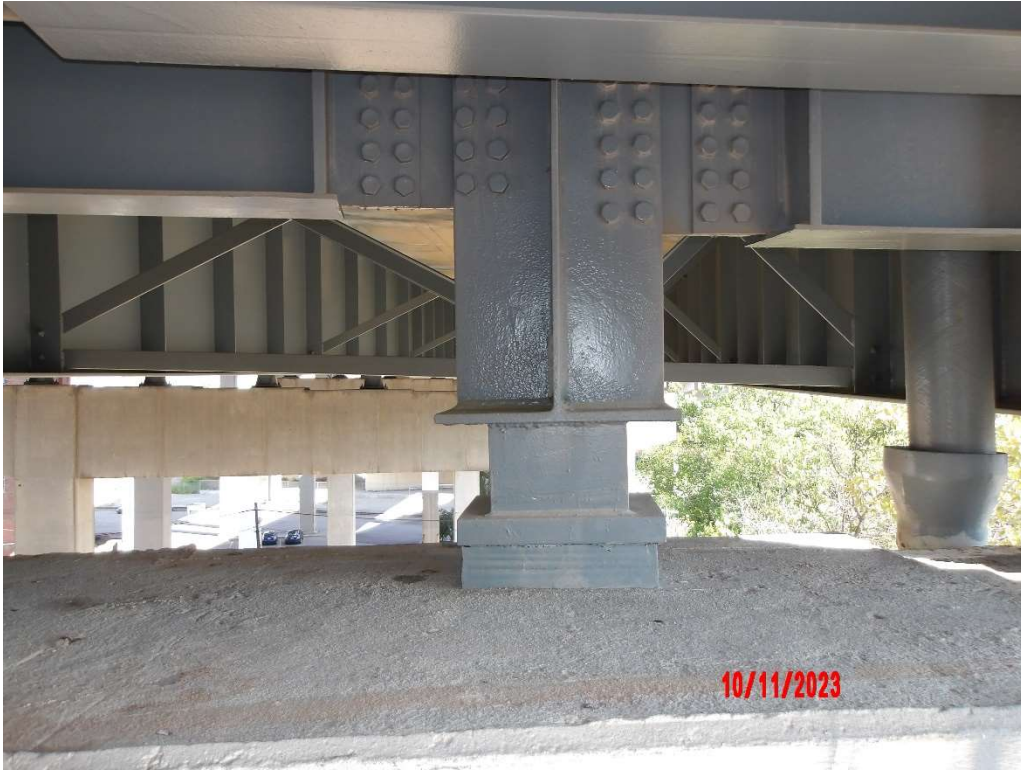
Photo 50- Pier 12 Bearing G, Span 13

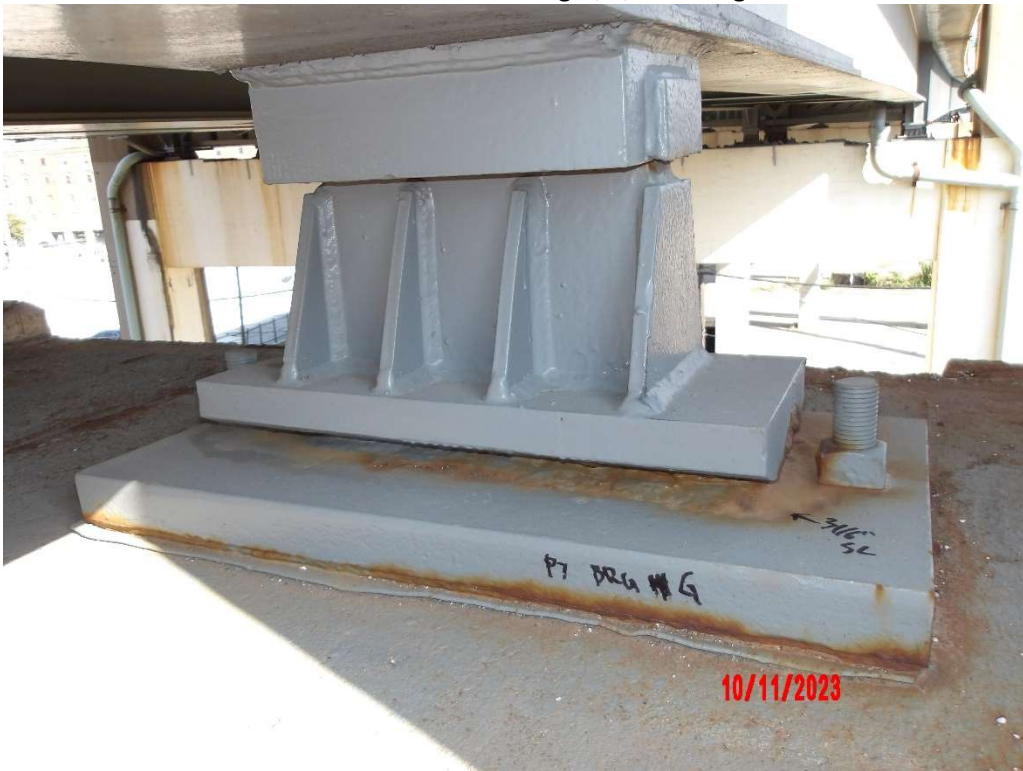
The Moveable Bearings are in FAIR (5) condition overall. The original steel rocker bearings typically exhibit moderate section *loss* below expansion joints. The rocker bearings south of Pier 14C were blast cleaned and painted as part of the 2021 painting contract. The active corrosion and pack rust between the rocker and masonry plate, previously noted, has been blasted away and painted. Intermittent areas of painted-over pitting exist (See Photos 51 & 52). There is pack rust between the rockers and masonry plates on the exterior bearings at Pier 19D.

Photo 52- Pier 7 Bearing G, 3/16" Section Loss Masonry Plate

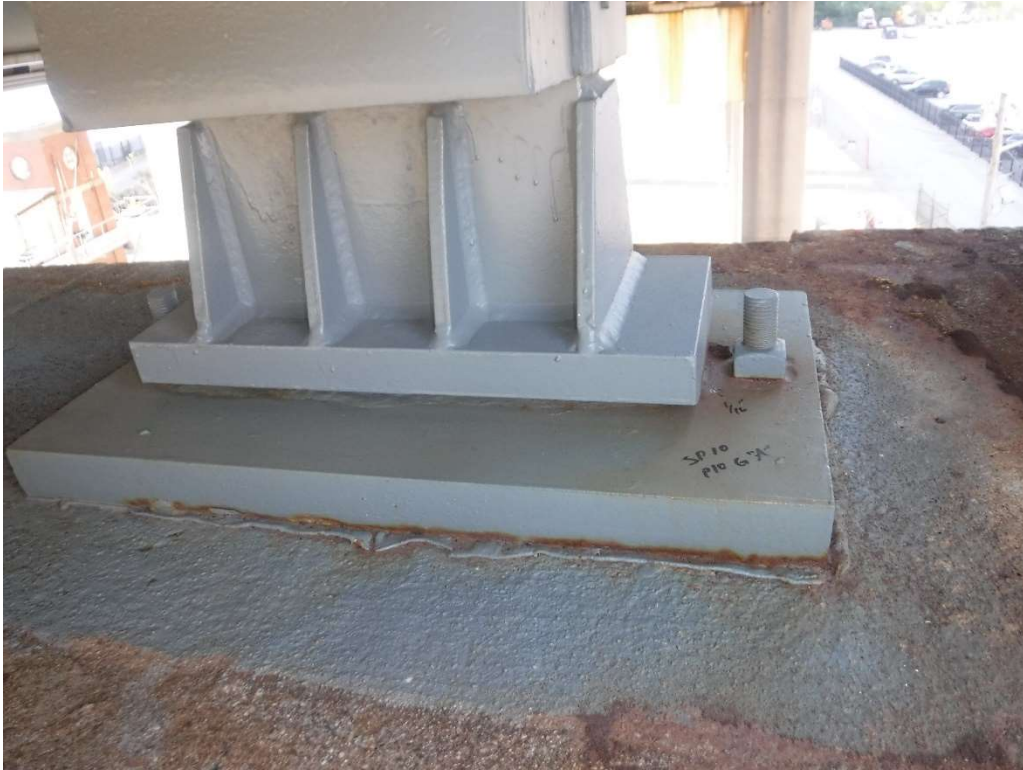
Photo 53- Pier 10, Bearing A, 1/16" Pitting Underneath

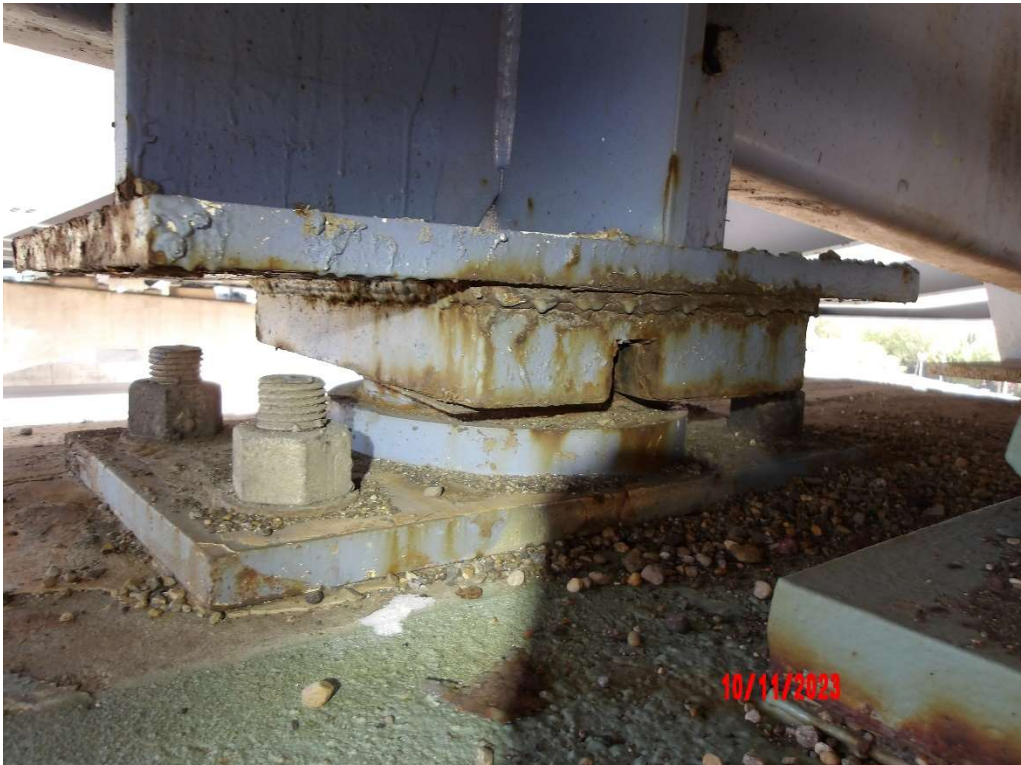
Photo 59- Pier 20D, Bearing B, Span 21, Typical Condition

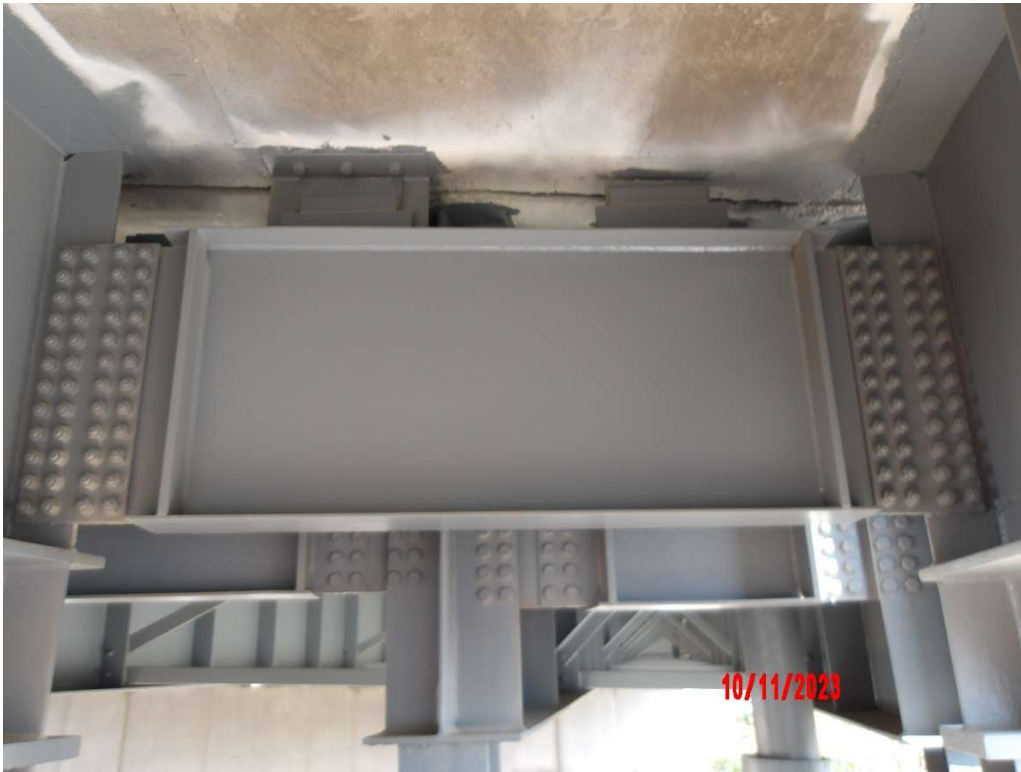
Photo 63- Cross Frame Detail, Span 12 Pier 12

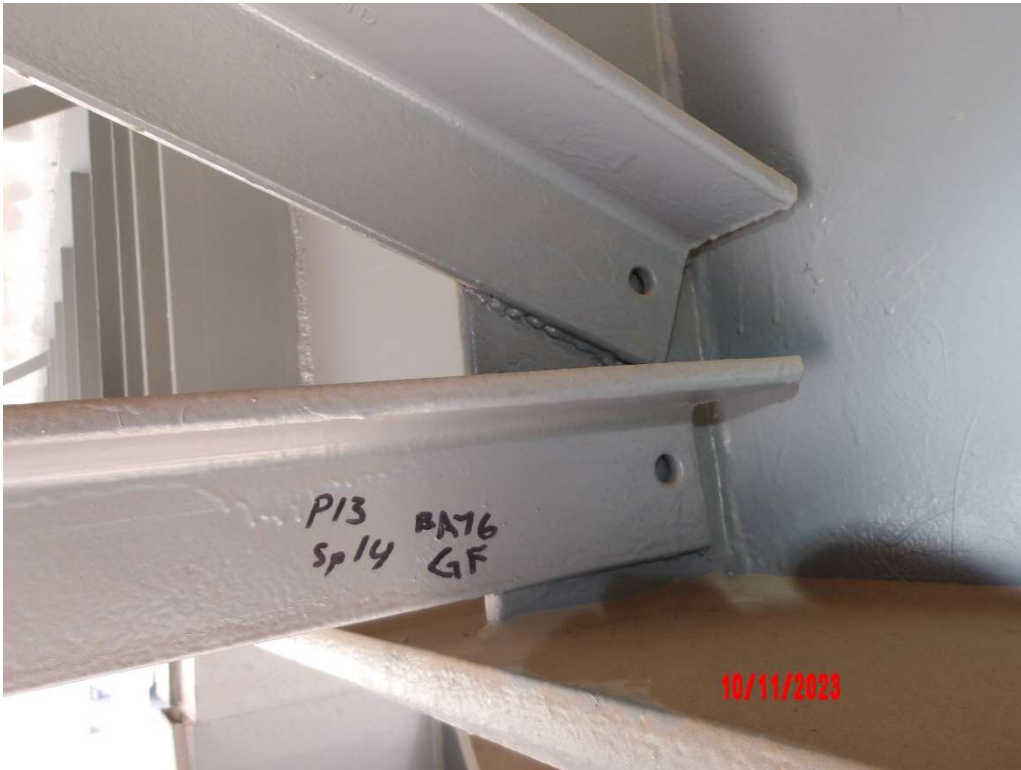
Photo 65- Pier 13, Span 14, Bay 6, Girder F, Typical Welded Cross Frame Details

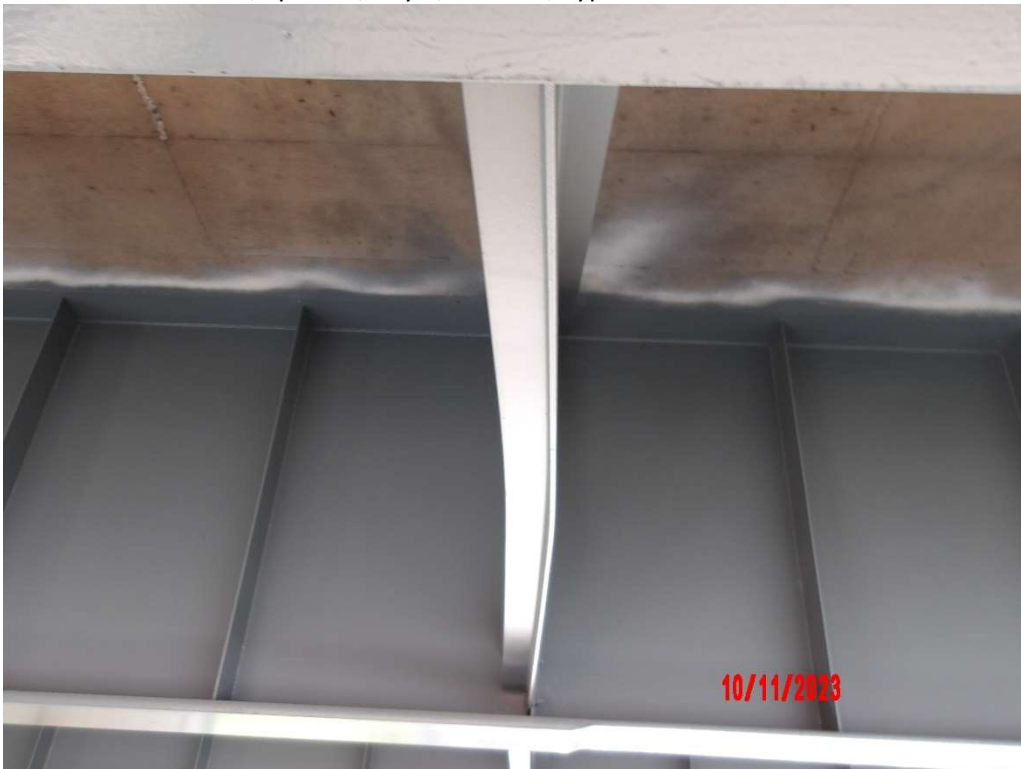
Photo 66- Cross Frame #5, Span 14, Bent

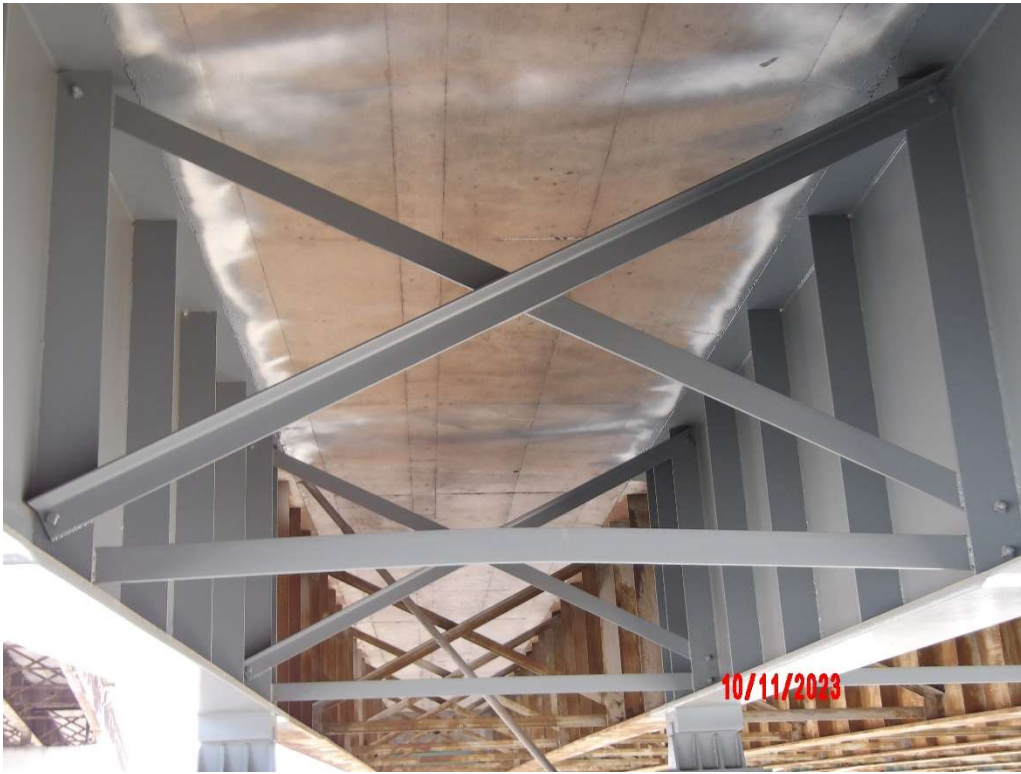
The Steel cross-frames were in GOOD (7) condition during the inspection and no significant defects were noted. There was paint failure on the non-painted spans. Cross frame #5 on Span 14 is bent out of plane (See Photo 66-67) The curved girders are primary members in the curved girder spans and are included in the superstructure rating.

Photo 67- Cross Frame #5, Span 14, Bent

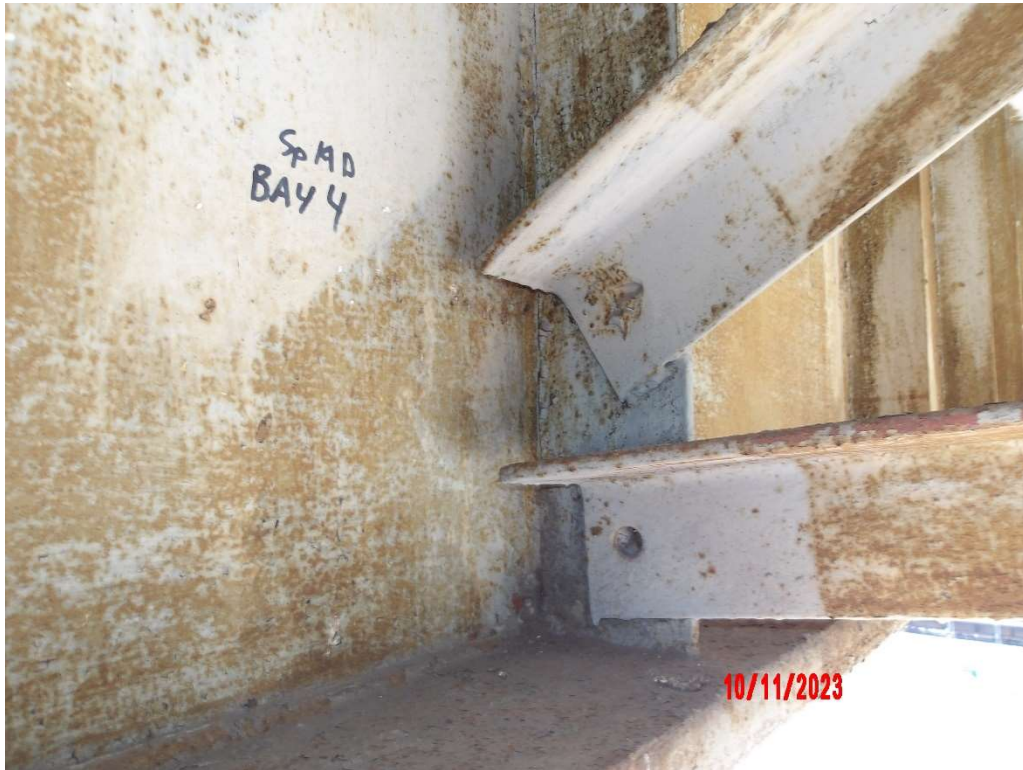
Photo 69- Cross Frame Details, Span 19, Bay 4

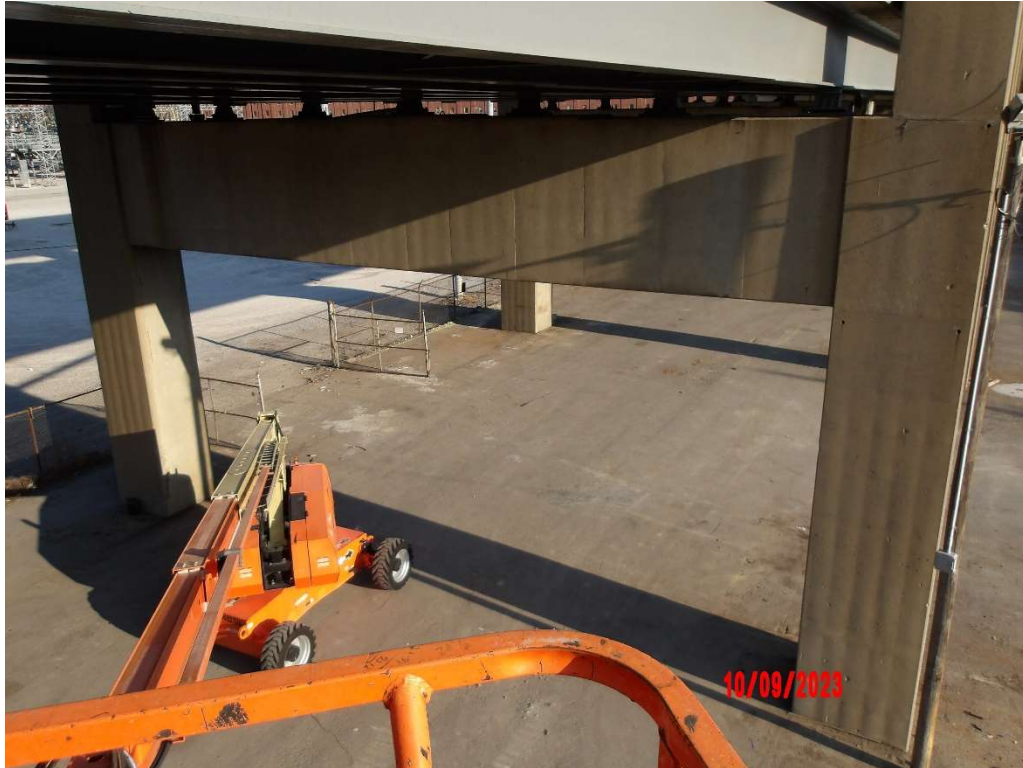
Photo 71- Pier 1, Back Face

At Pier 1, west column, there is wide map cracking 53” vertical x 6” wide at the southeast corner. There are various other small spalls without any exposed reinforcing mainly on the corners including Piers 1A, 5A, 6A, and 19D. There is also moderate cracking and exposed rebar due to lack of cover common throughout. Pier 3, Column 2 has vertical cracking extending from the cap (See Photo 81)

- Patch concrete spalls and seal wide concrete cracks on pier caps and pier columns.
- Clean Repair broken ground wire on Pier 13.

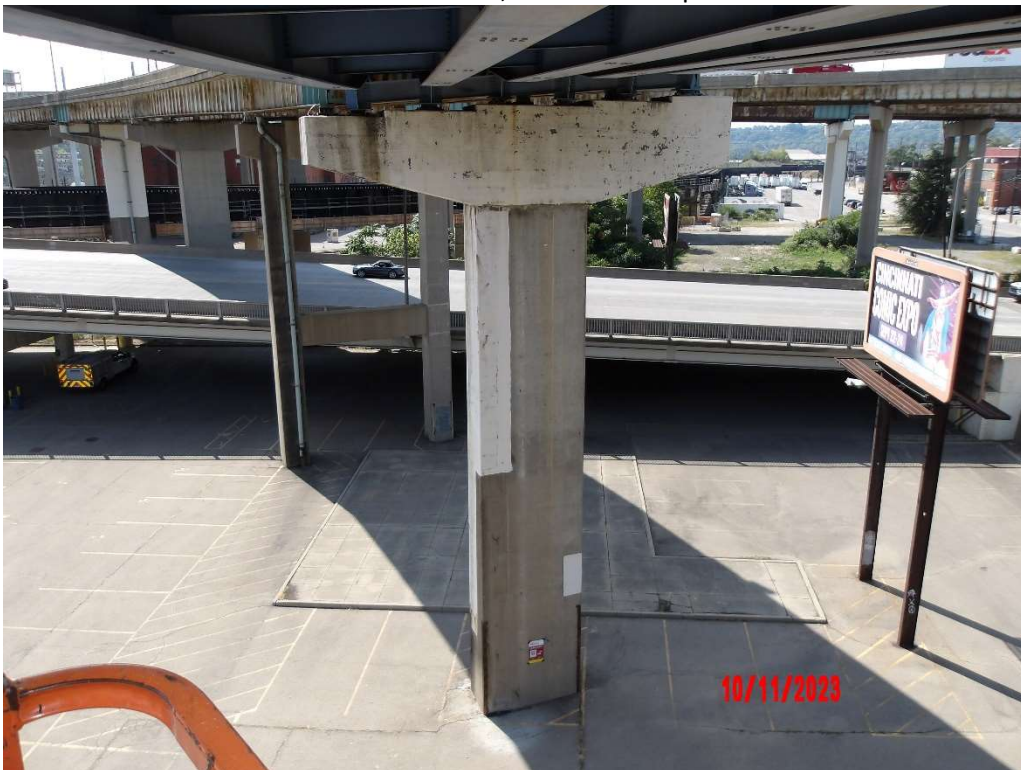
Piers 16D, 17D, 19D, and 20D are hammerhead piers and they are in GOOD (7) condition. There are spalls with exposed rebar at the base of Piers 16D and 20D where protective guards used to be. Pier 20D has been patched with FRP wrap and there is rust staining coming through near the cap (See Photo 85).

Photo 85- Pier 20D Front Face, Note FRP Wrap Delaminations

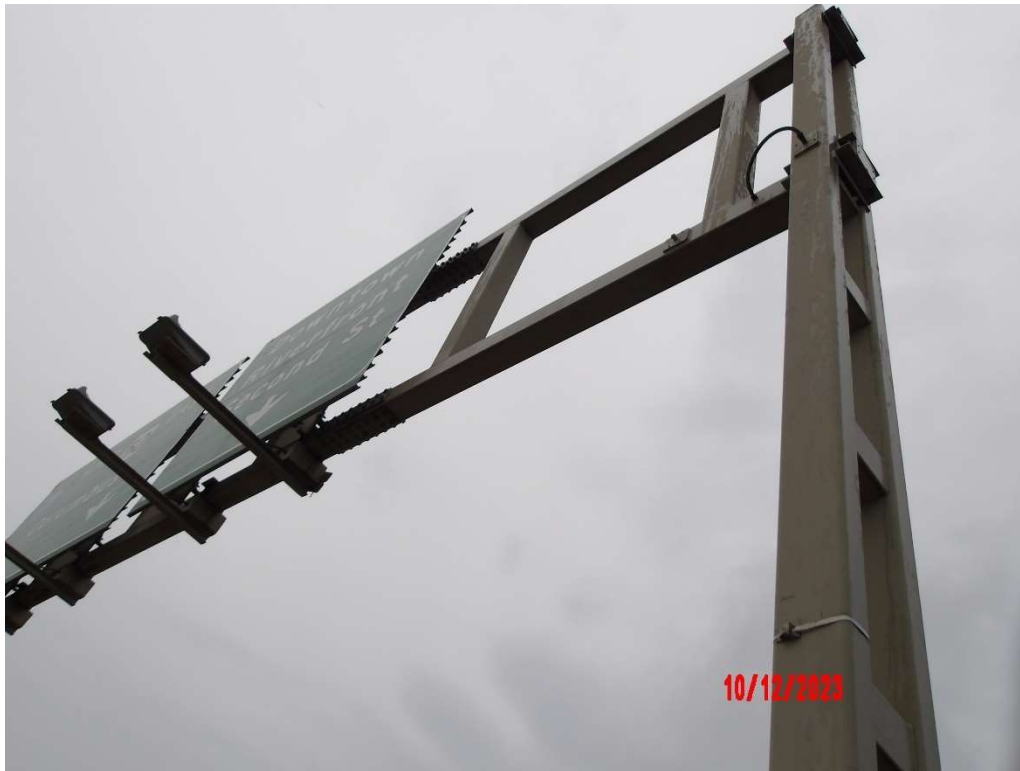
The sign supports on the structure are in GOOD (7) condition with no significant problems noted to the supports or connections to the structure. (See Photo 97)

Photo 97- Sign Supports, Typical Good Condition
