# FRACTURE CRITICAL PIER CAP INSPECTION REPORT

SFN3101215 (HAM-42-0257R)

I-71 NB RAMP OVER US-42 NB (READING RD)

June 2023

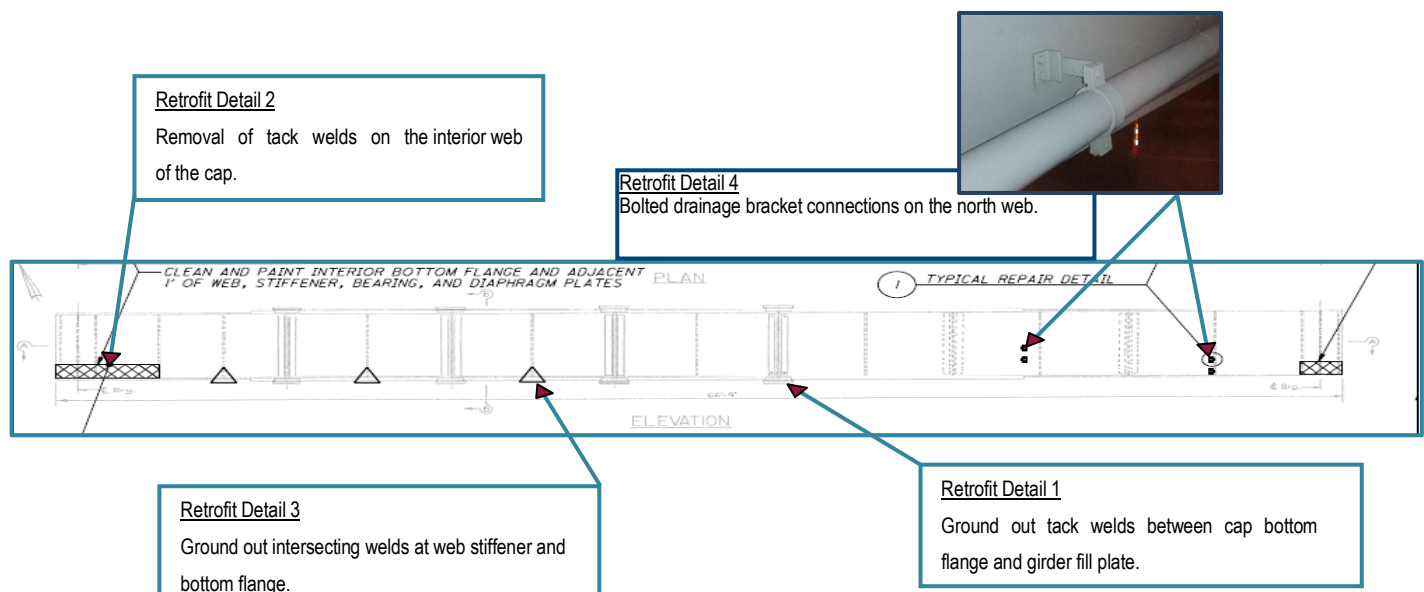
Figure 3: Pier Cap 1 Retrofit Details

- The original welded drainage pipe support brackets were removed, ground smooth, and replaced with bolted drainage pipe support brackets.

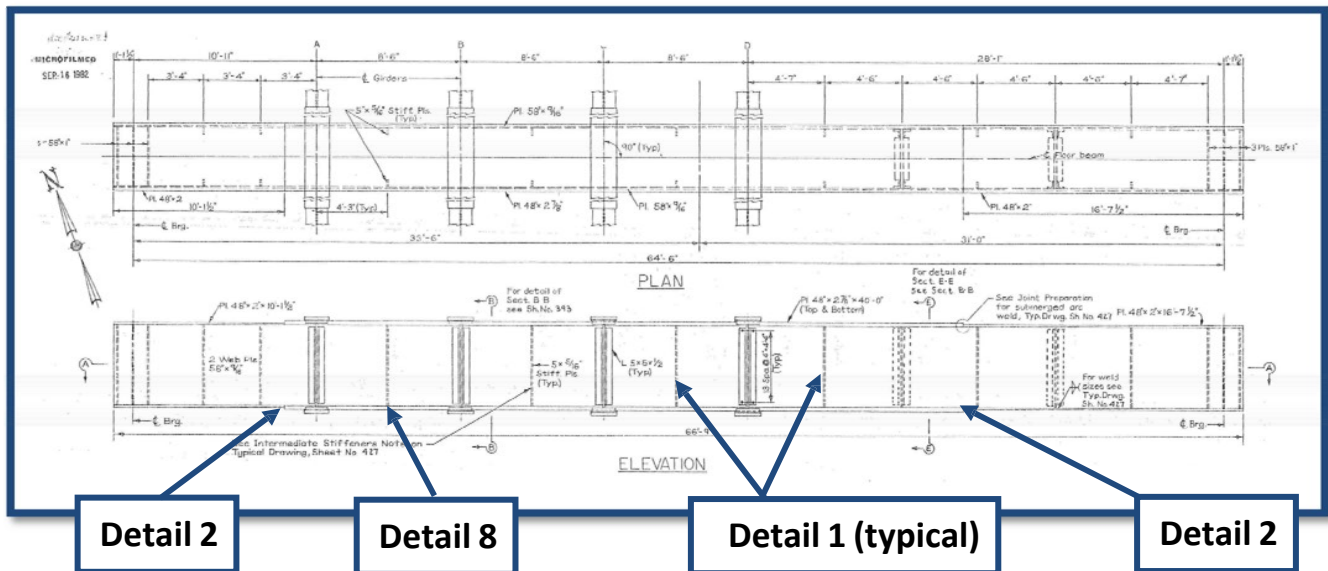
Figure 4: Pier Cap 1 Fatigue Prone Details

Category: E

Location: Fillet welds of bottom flange and north web plate intersecting fillet weld of north web plate and stiffener between Girders A and B.
