# FRACTURE CRITICAL PIER CAP INSPECTION REPORT

SFN3102807 (HAM-50-1903L)  
US 50 WB OVER MILL CREEK/CSX  
TRANSPORTATION/CENTRAL  
RAILROAD OF INDIANA  
HAMILTON COUNTY, OH  
DISTRICT 8

July 2023

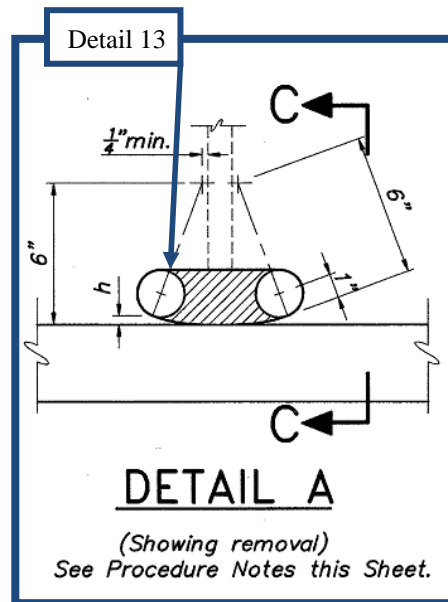
**Figure 5:** Weld intersection retrofit.

Weld intersection removal holes in web plates. Category: C

Location: Bottom of web plates at all transverse stiffeners.
