# **Lytle Tunnel (HAM-71-0134) Inspection Report Fall 2020**

PID 105470

November, 2020

Ohio Department of  
Transportation  
District 8  
505 South State Route 741  
Lebanon, OH 45036

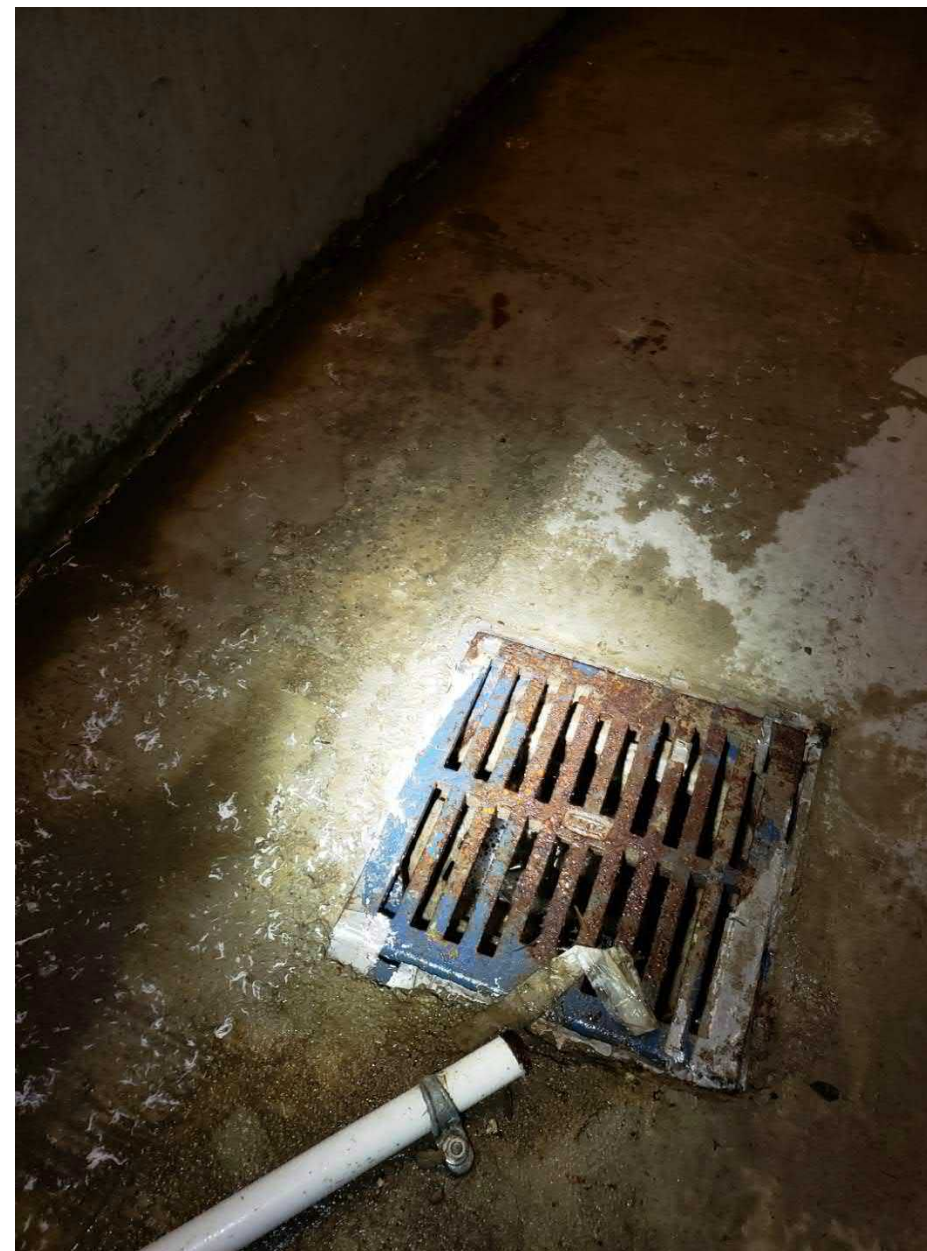
Facility floor drains are clogged with debris which is preventing groundwater and condensate from draining properly.

#### 3-3 Facility Floor Drain Water Pooling

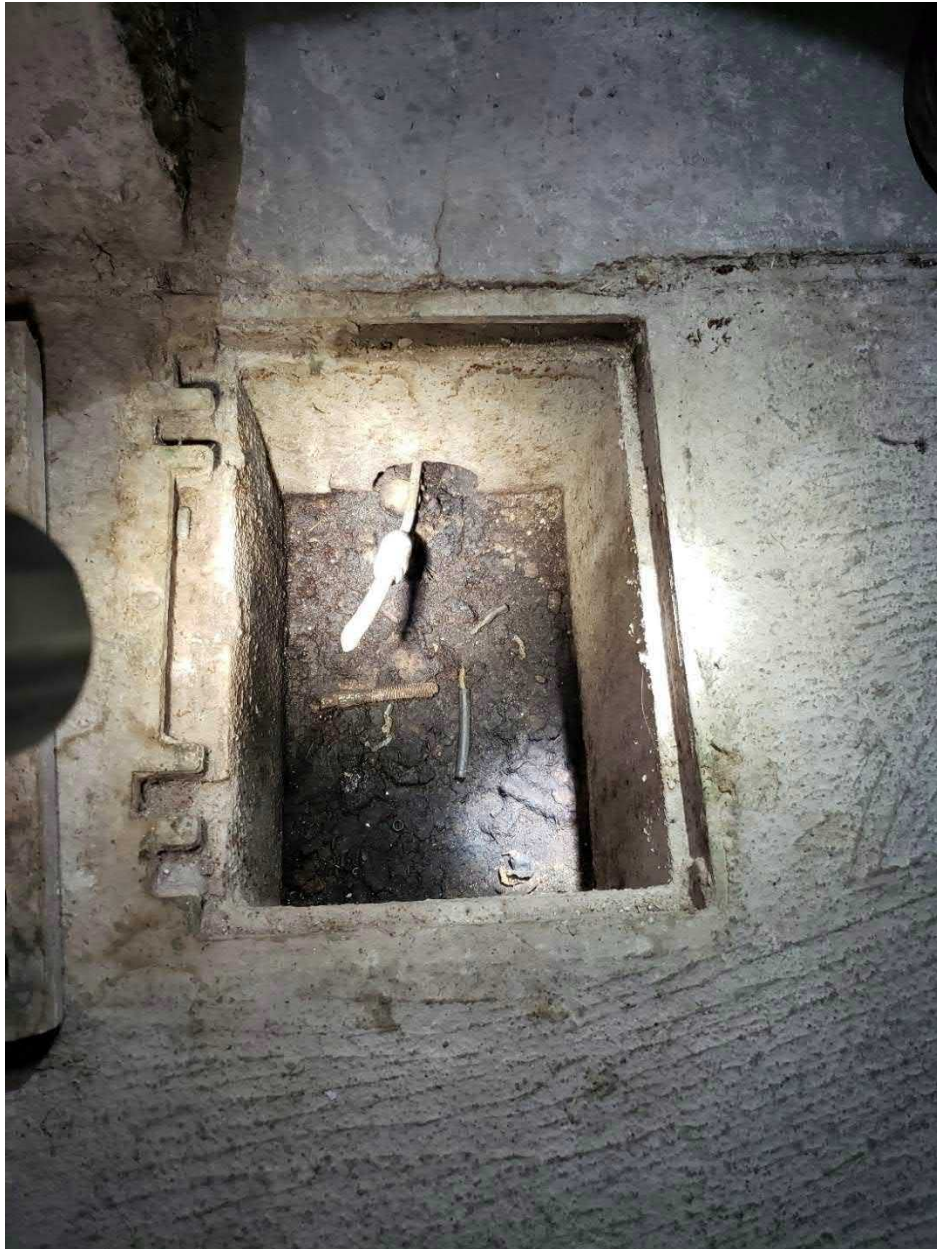
**3-4 Facility Floor Drain Debris Blockage**

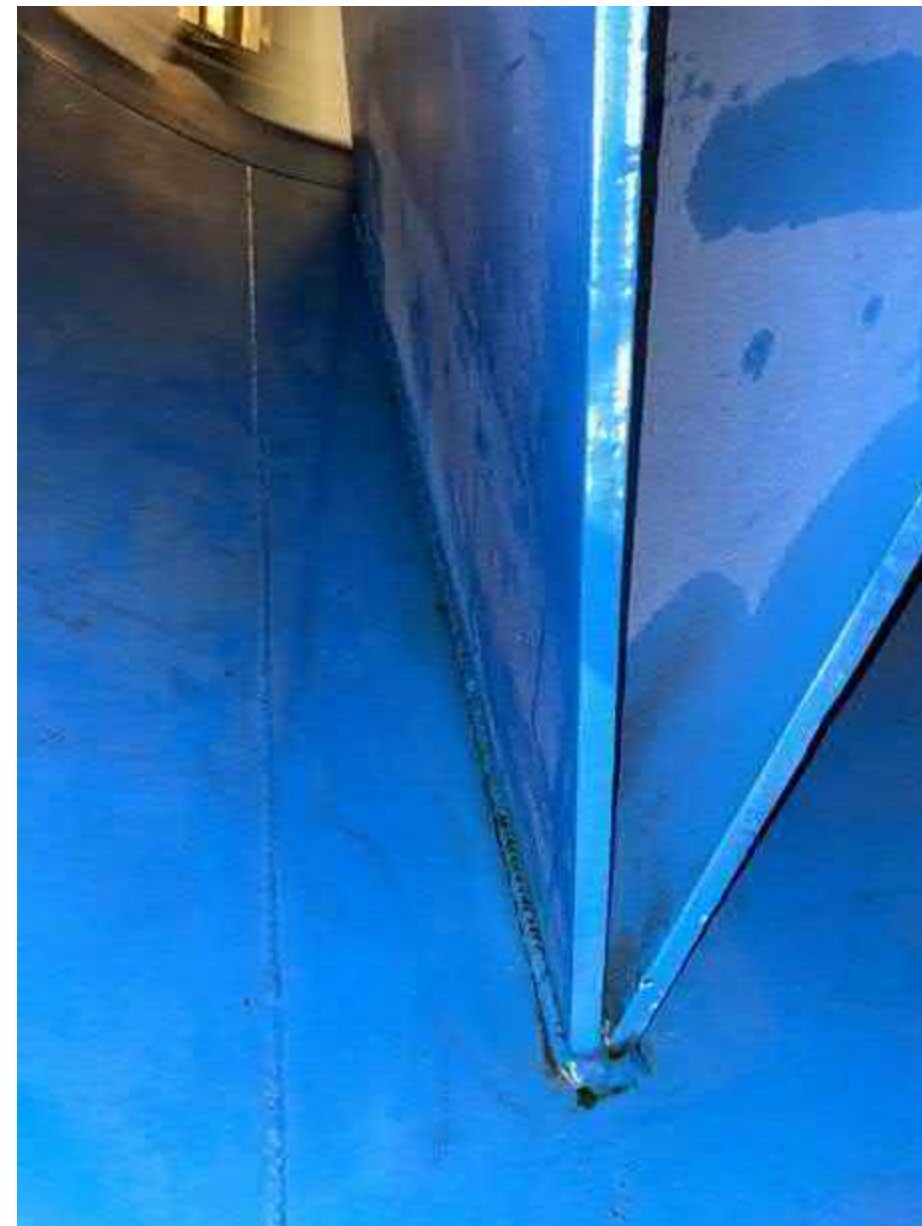
Grease leaking down towards the sound attenuation

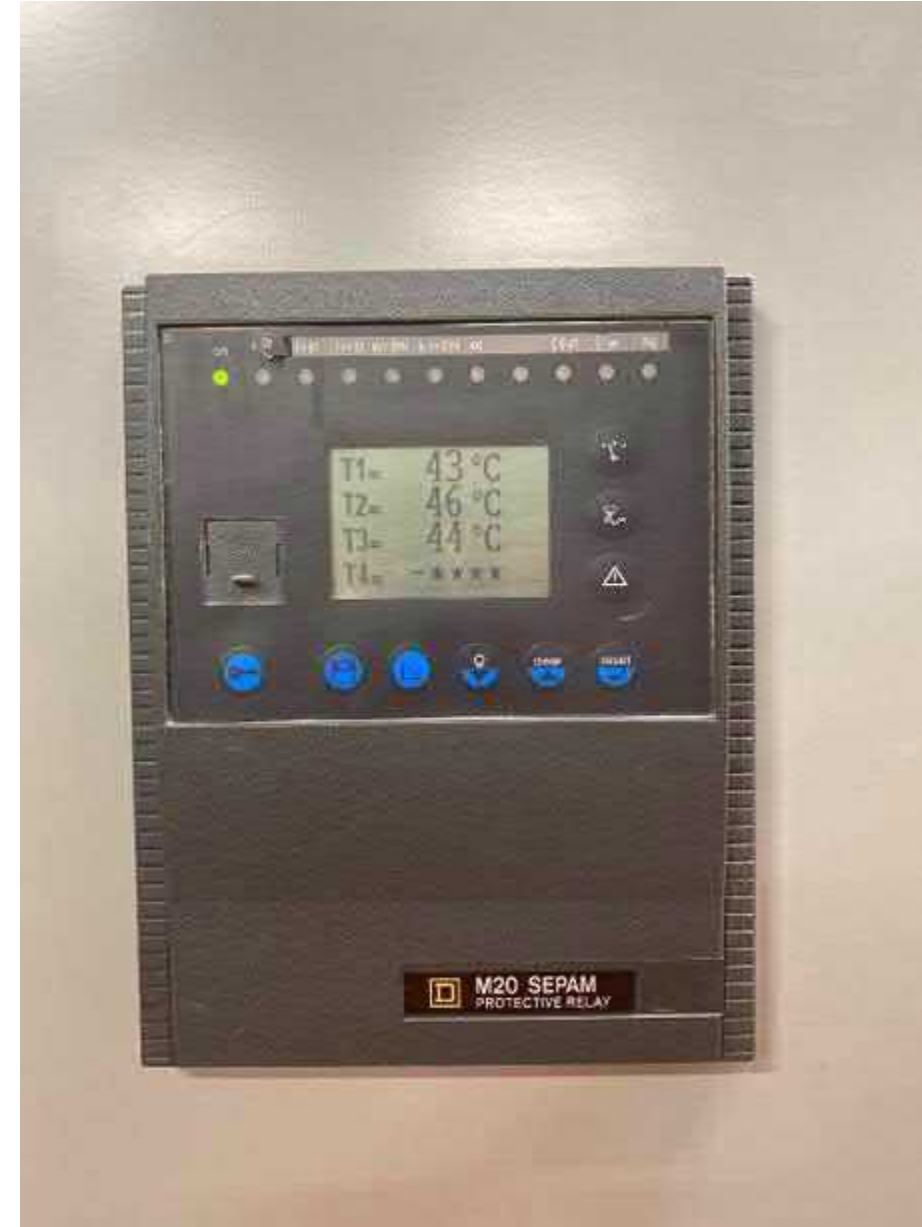
Winding temperatures

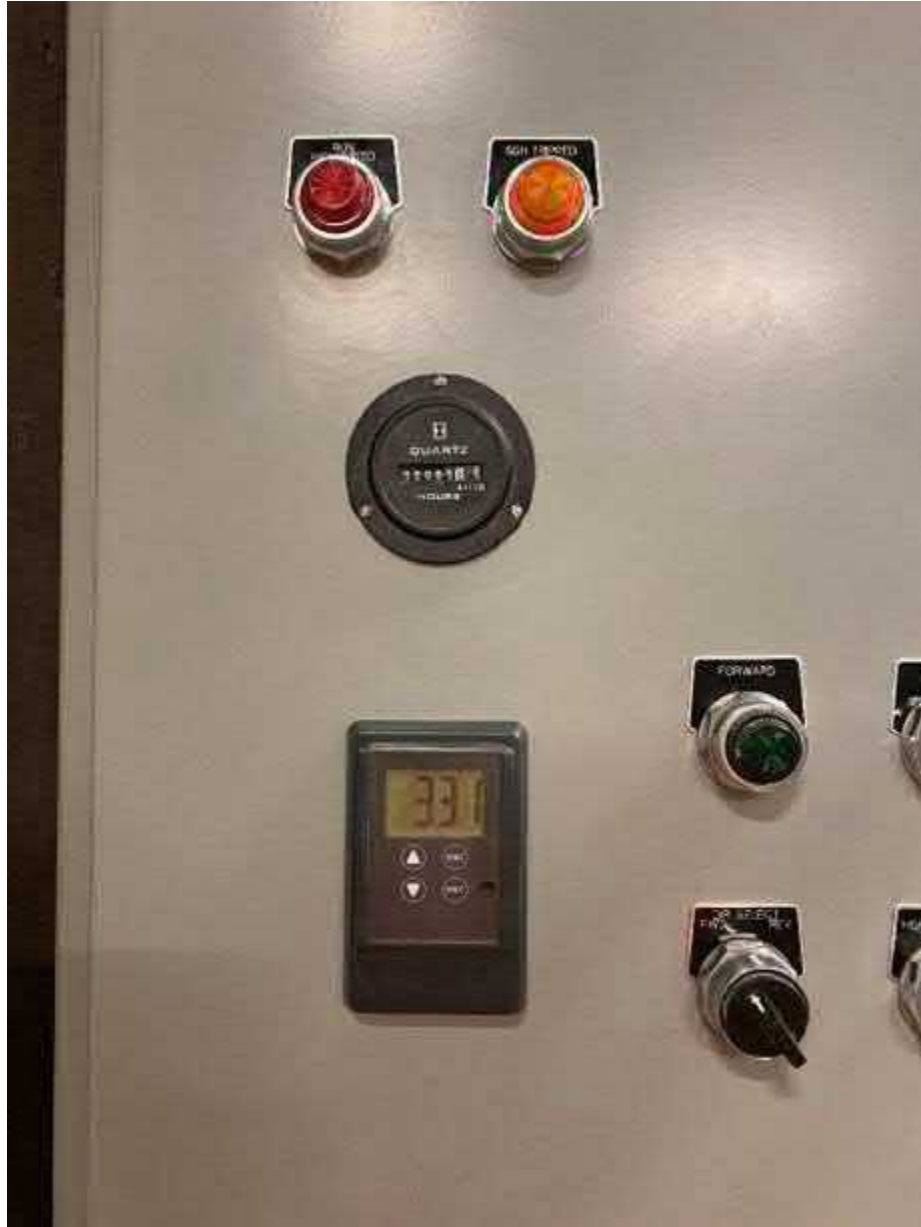
Full load current

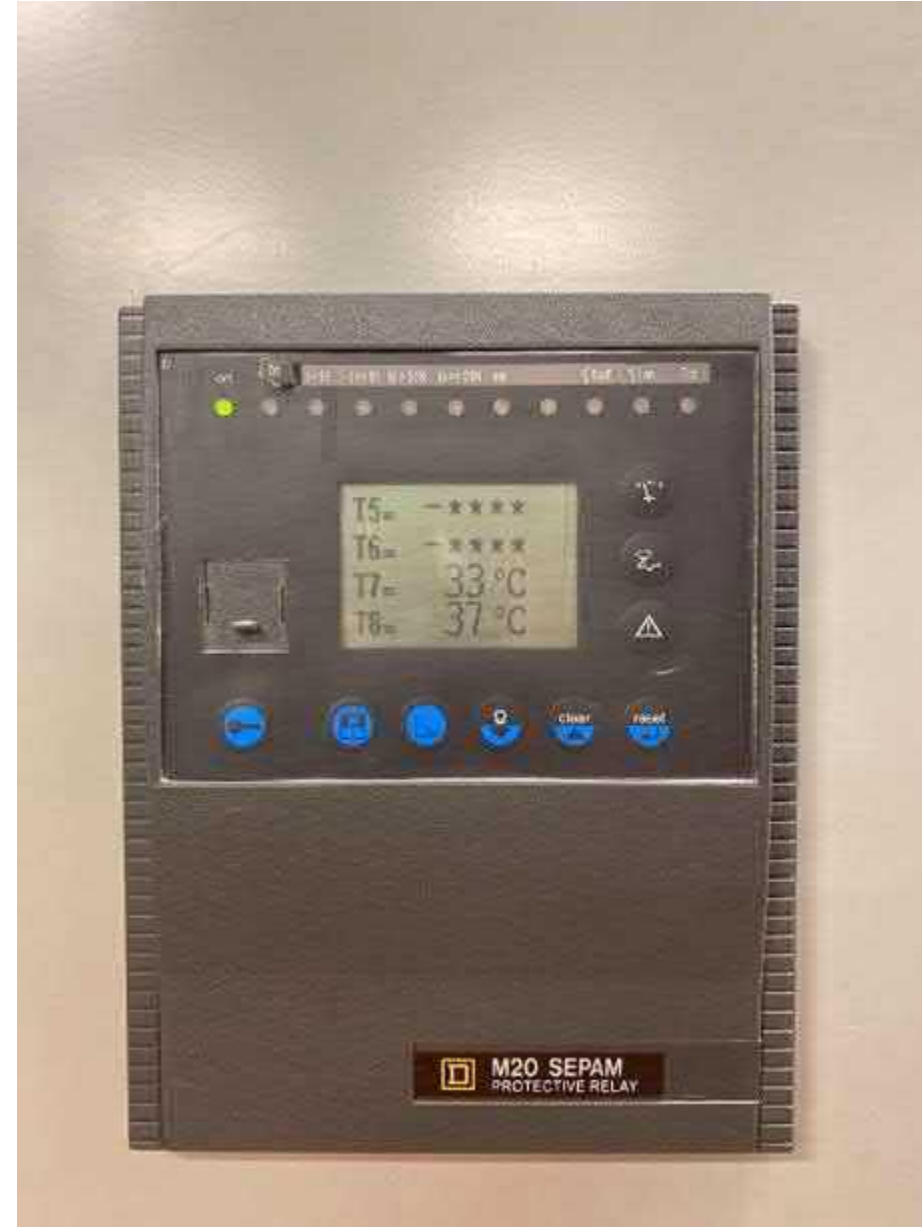
Motor bearing temperature

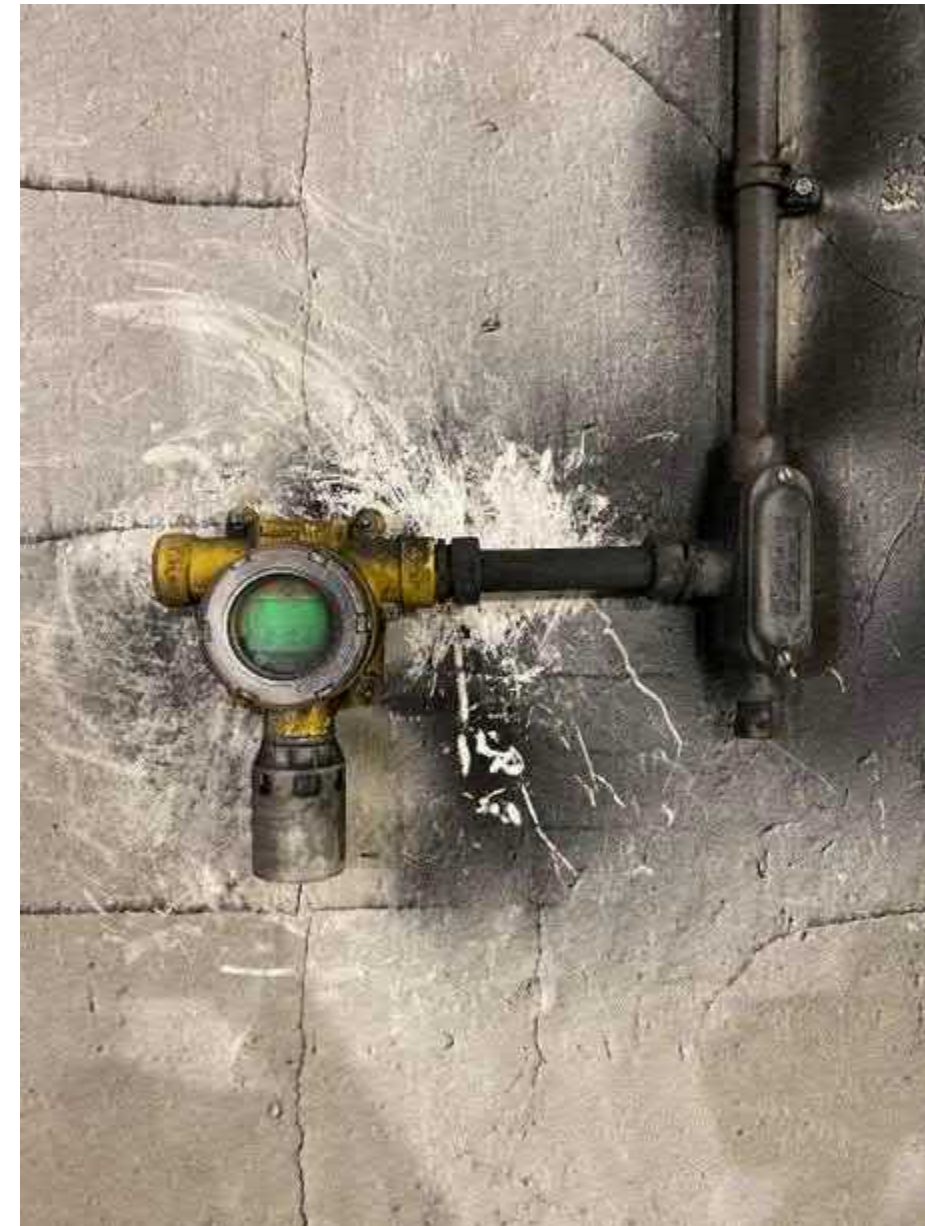
This sensor is noted on the drawings as NB2. SCADA says NB1. CS1

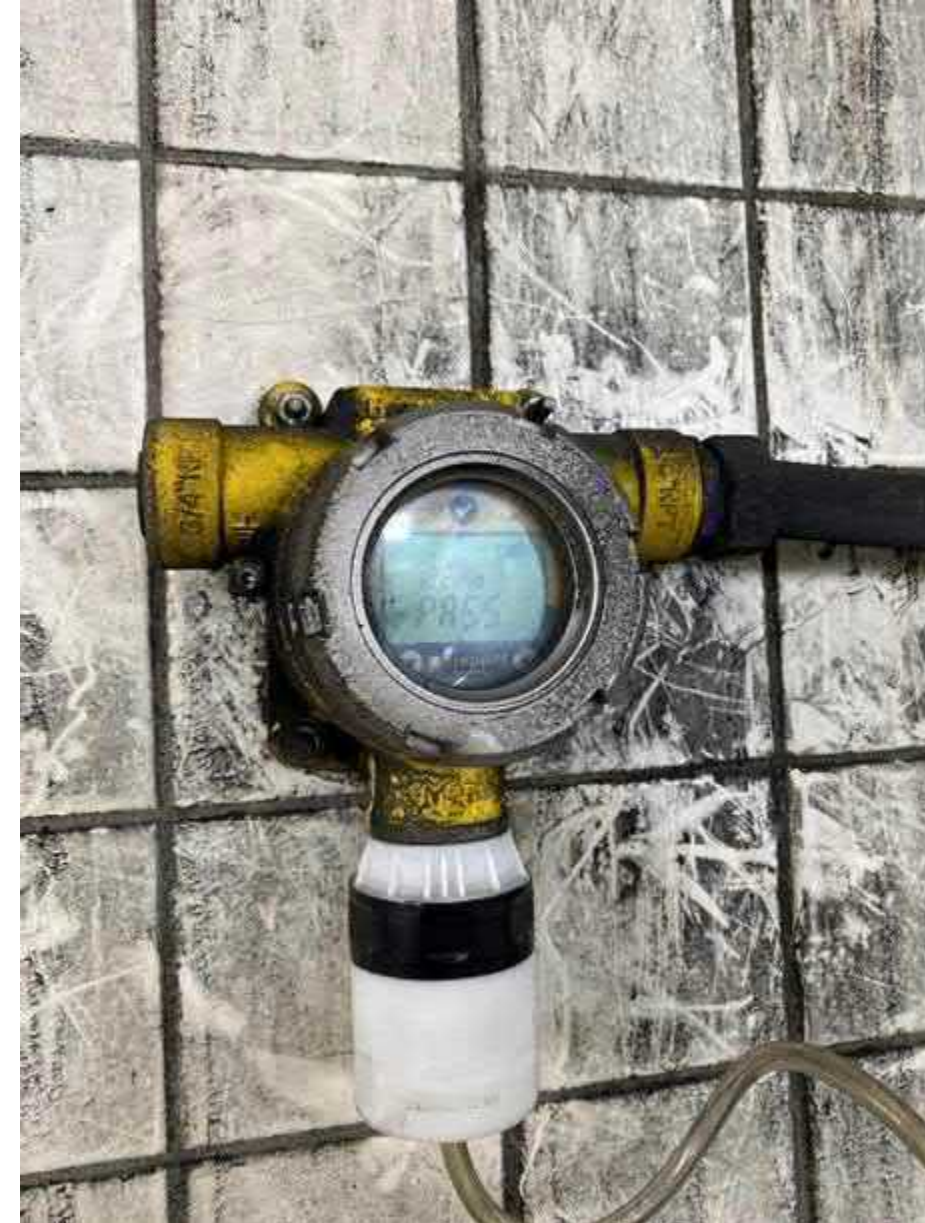
On the drawings this is noted as sensor NB1. CS1.

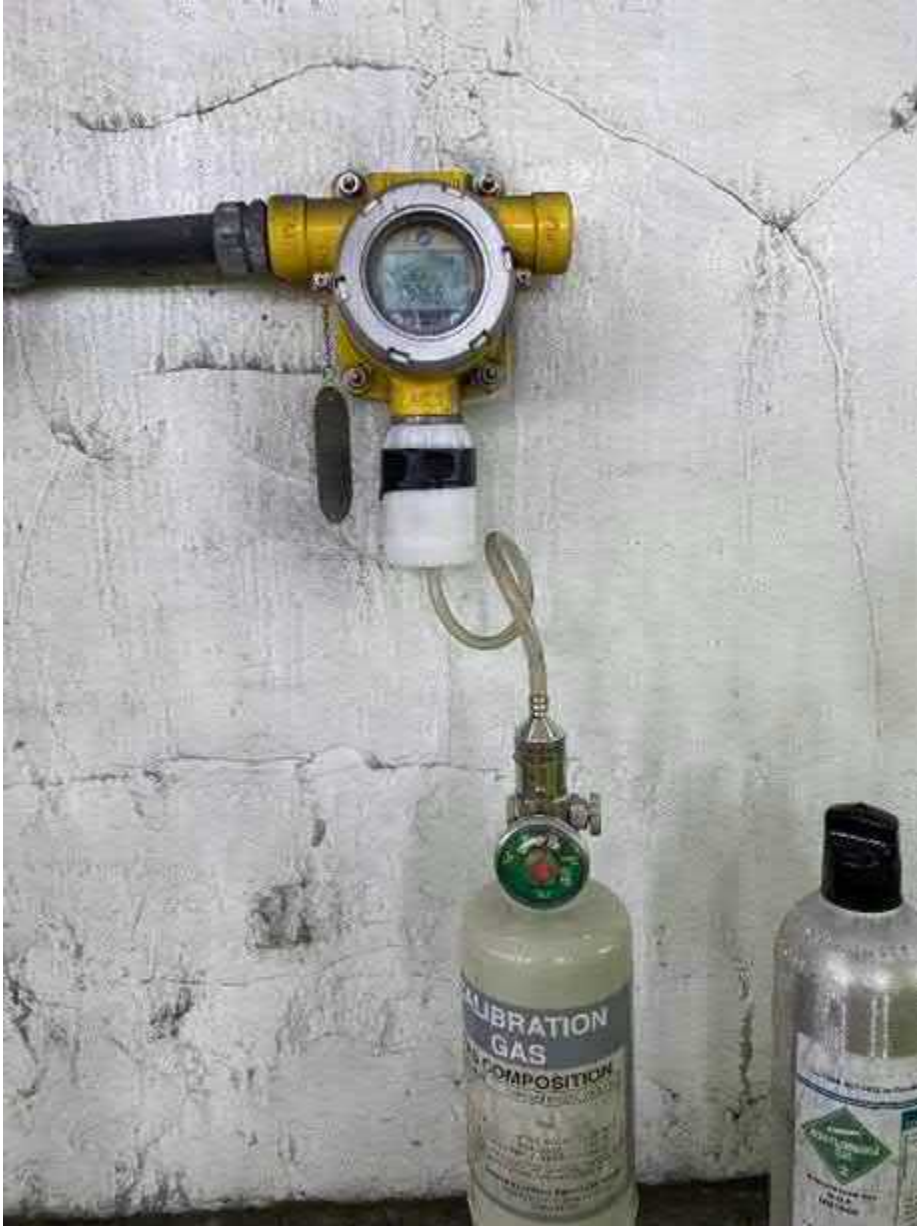
0 calibration pass

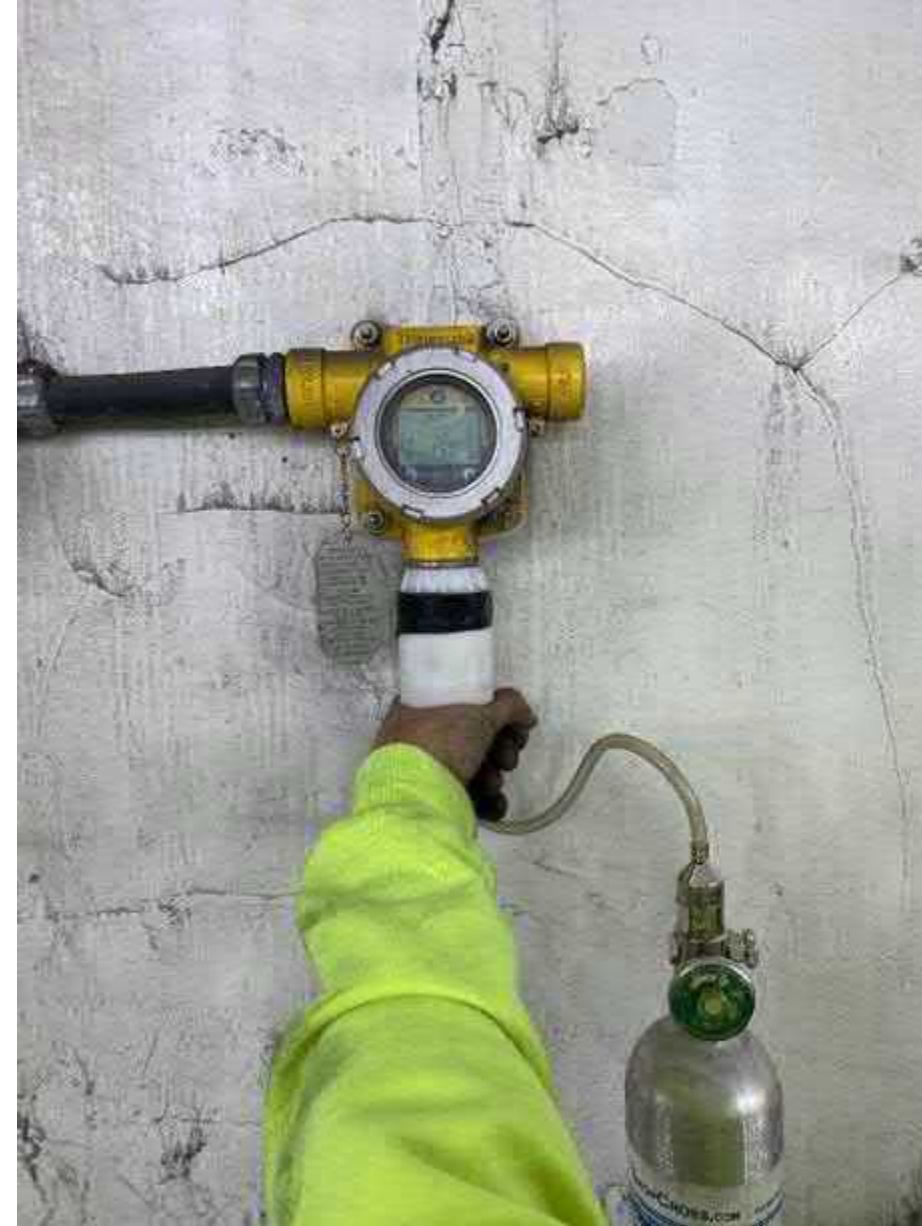
150 calibration

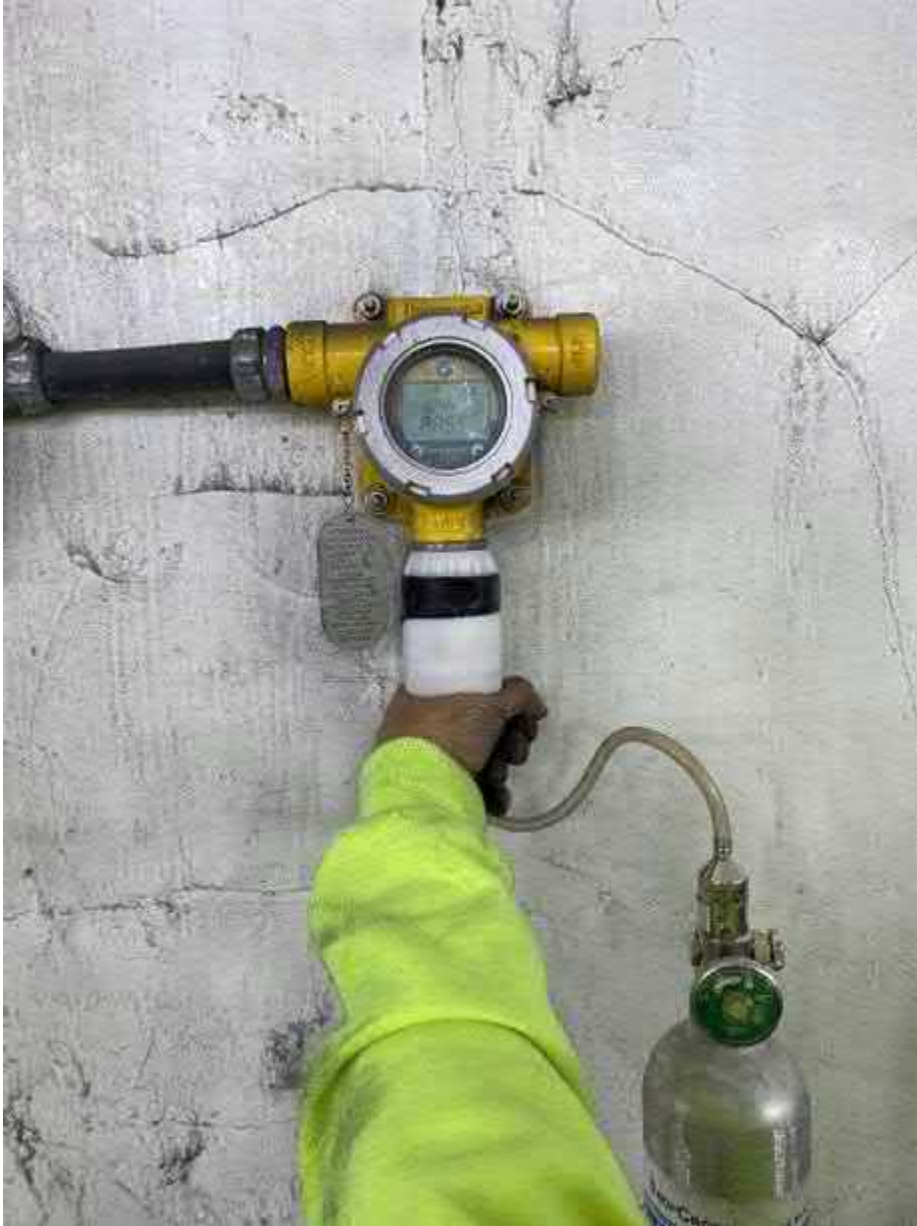
150 pass

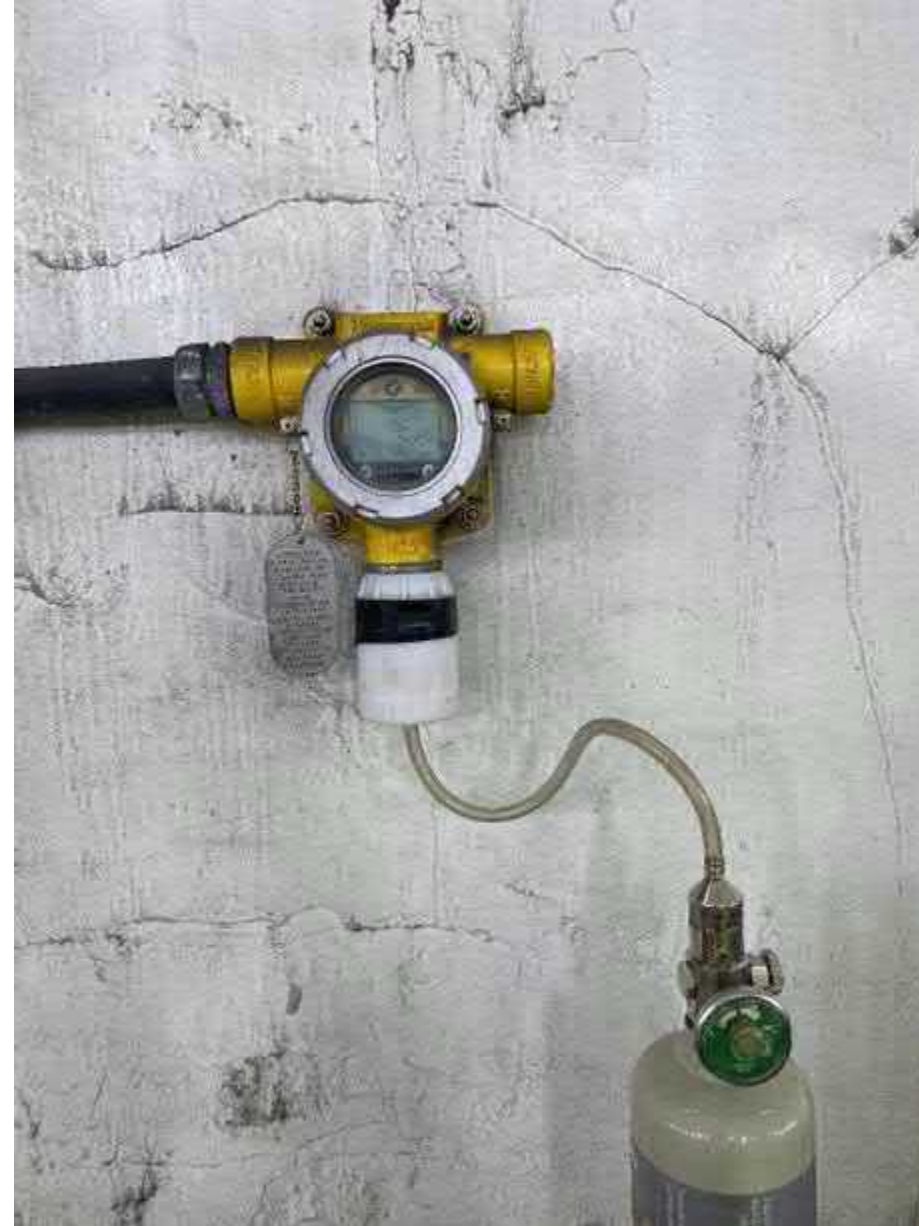
35 test pass

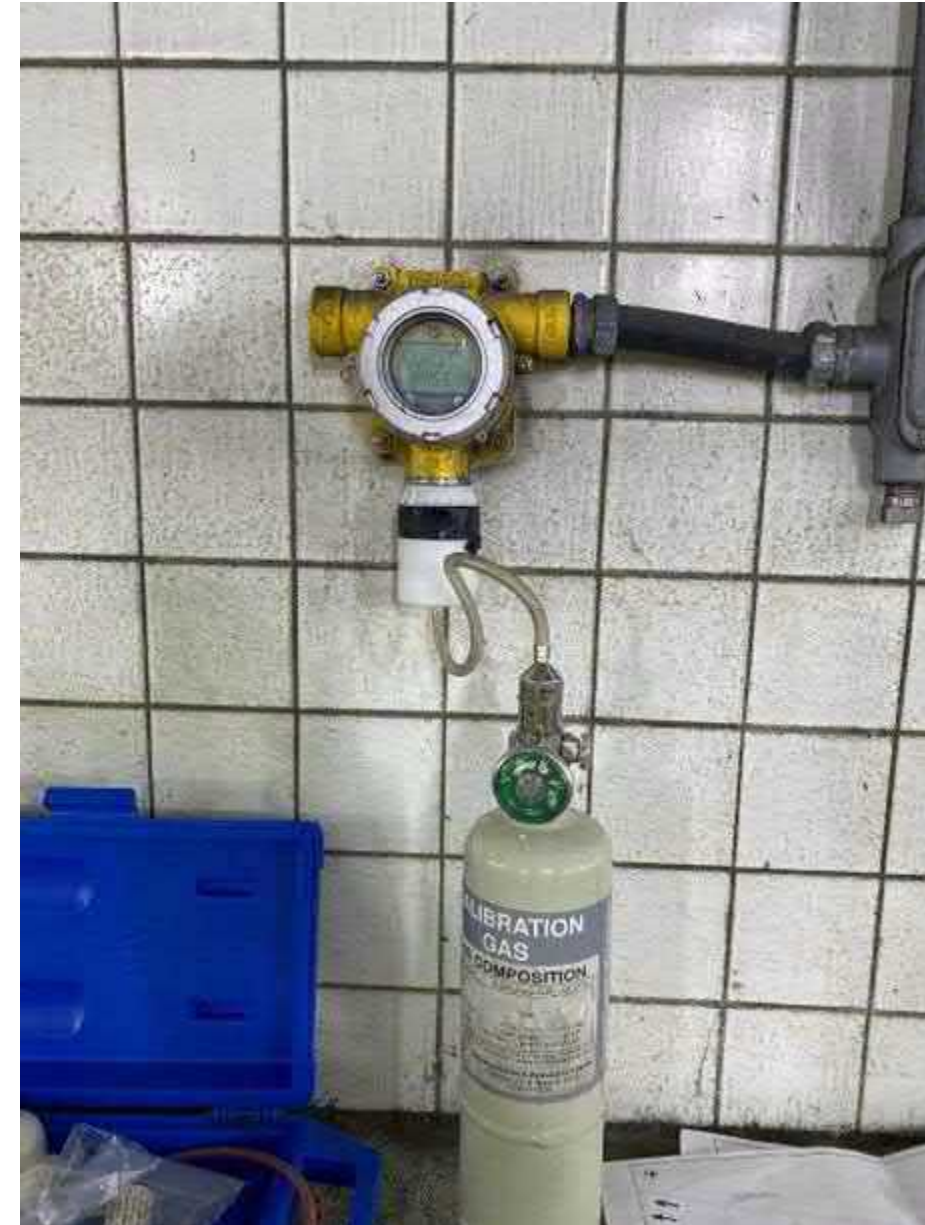
0 calibration

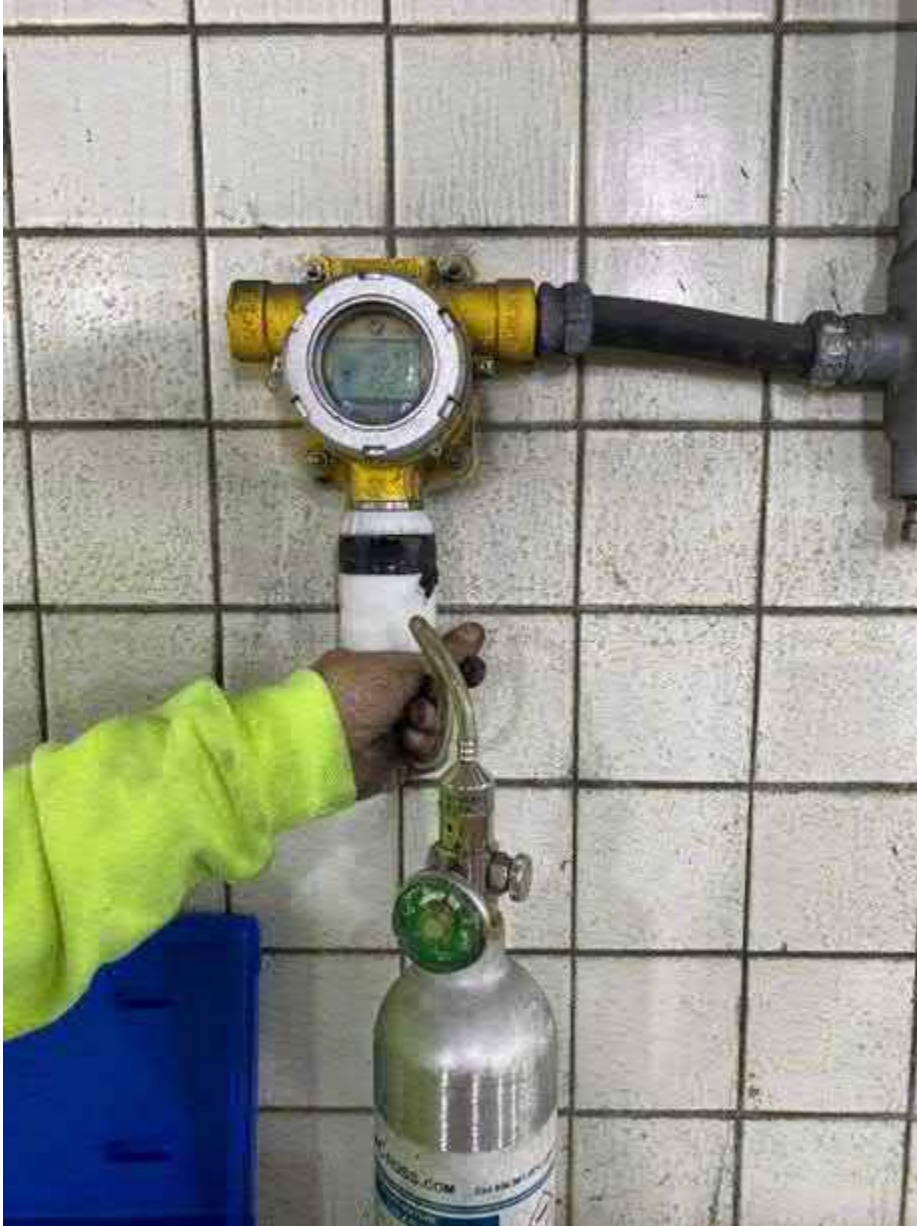
150 calibration

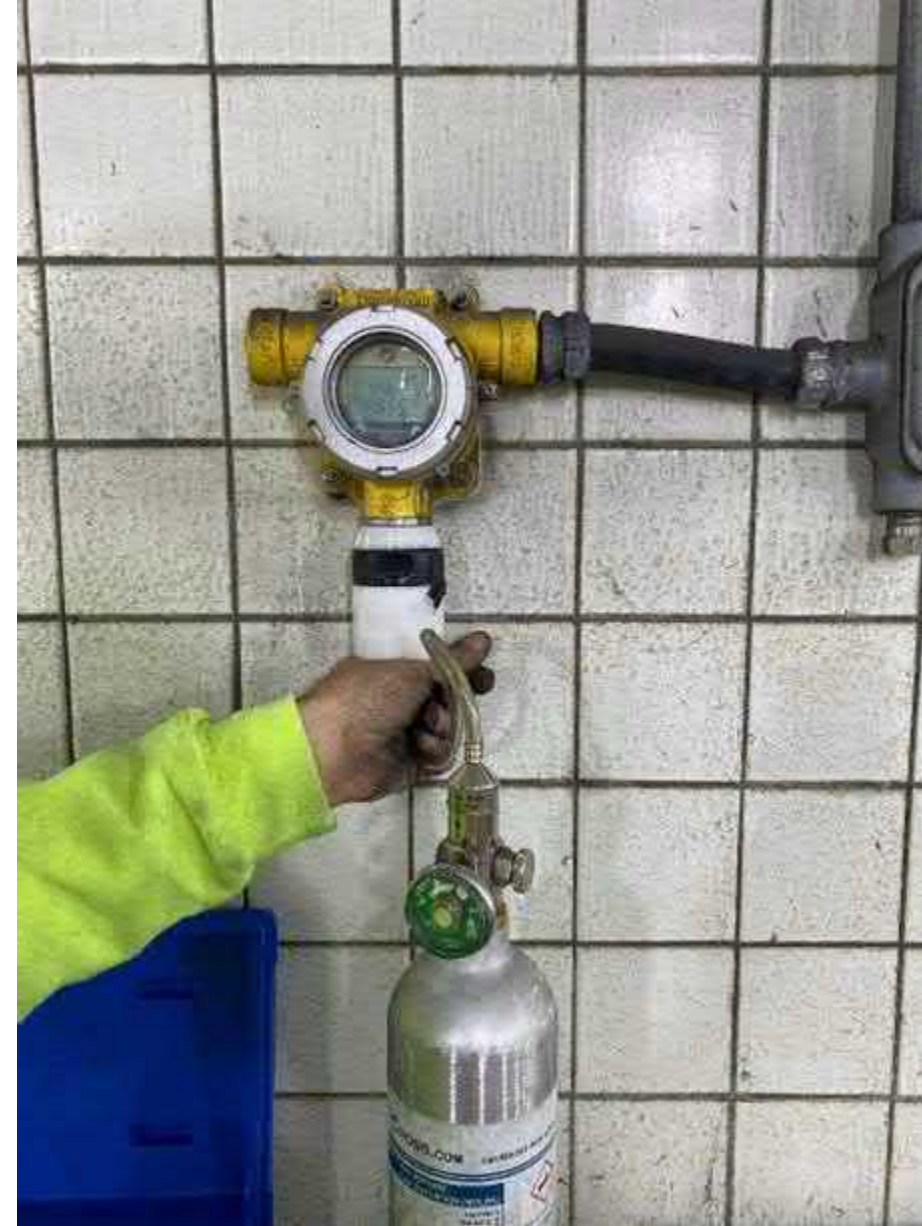
150 calibration pass

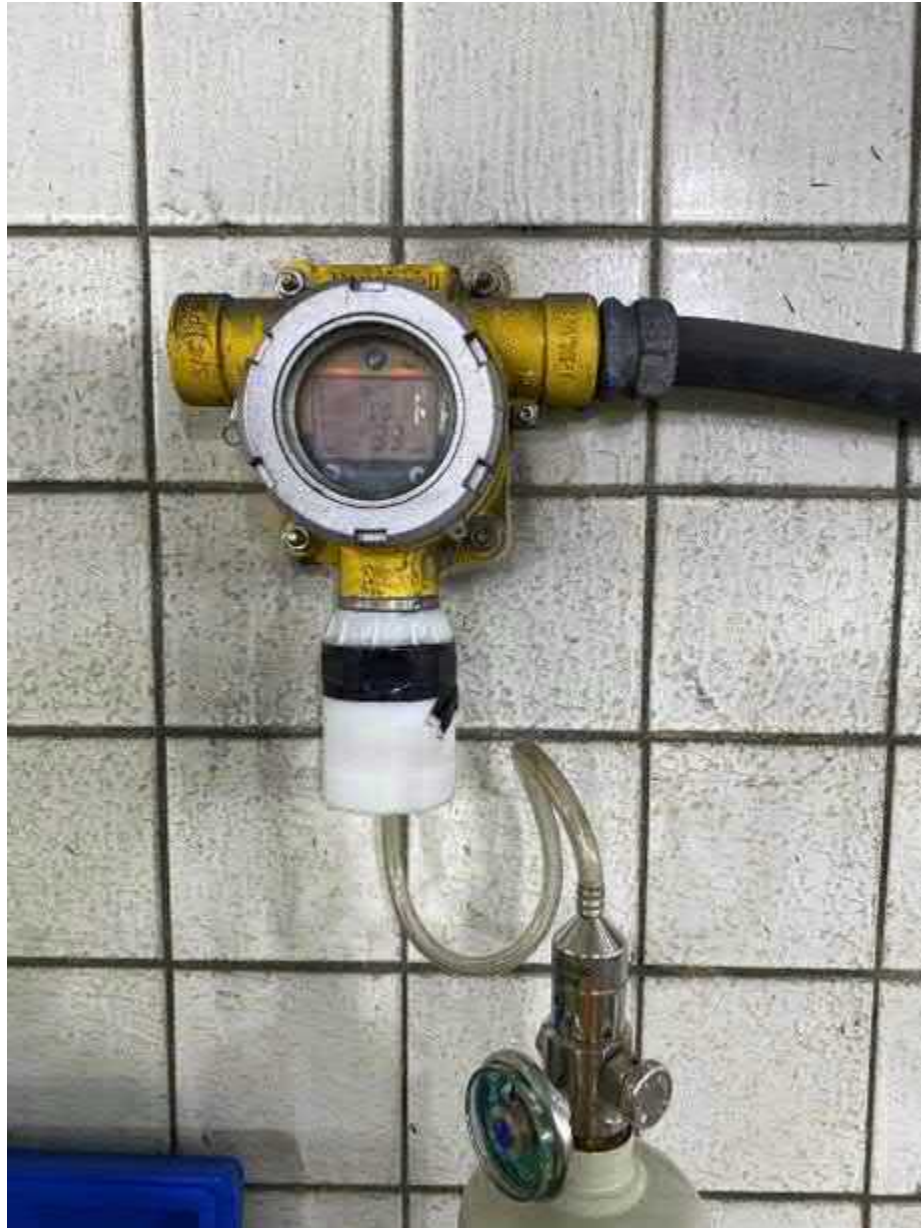
35 test pass

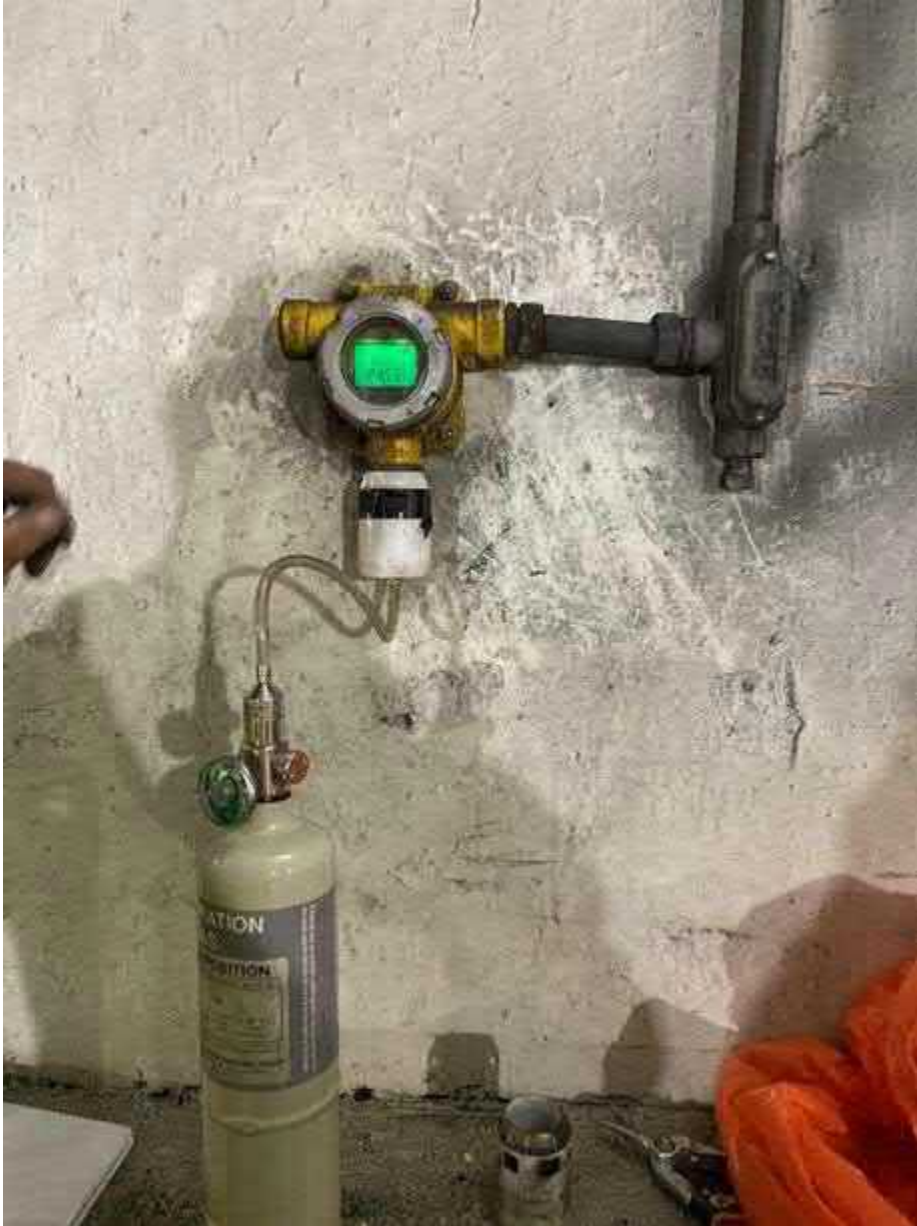
0 test

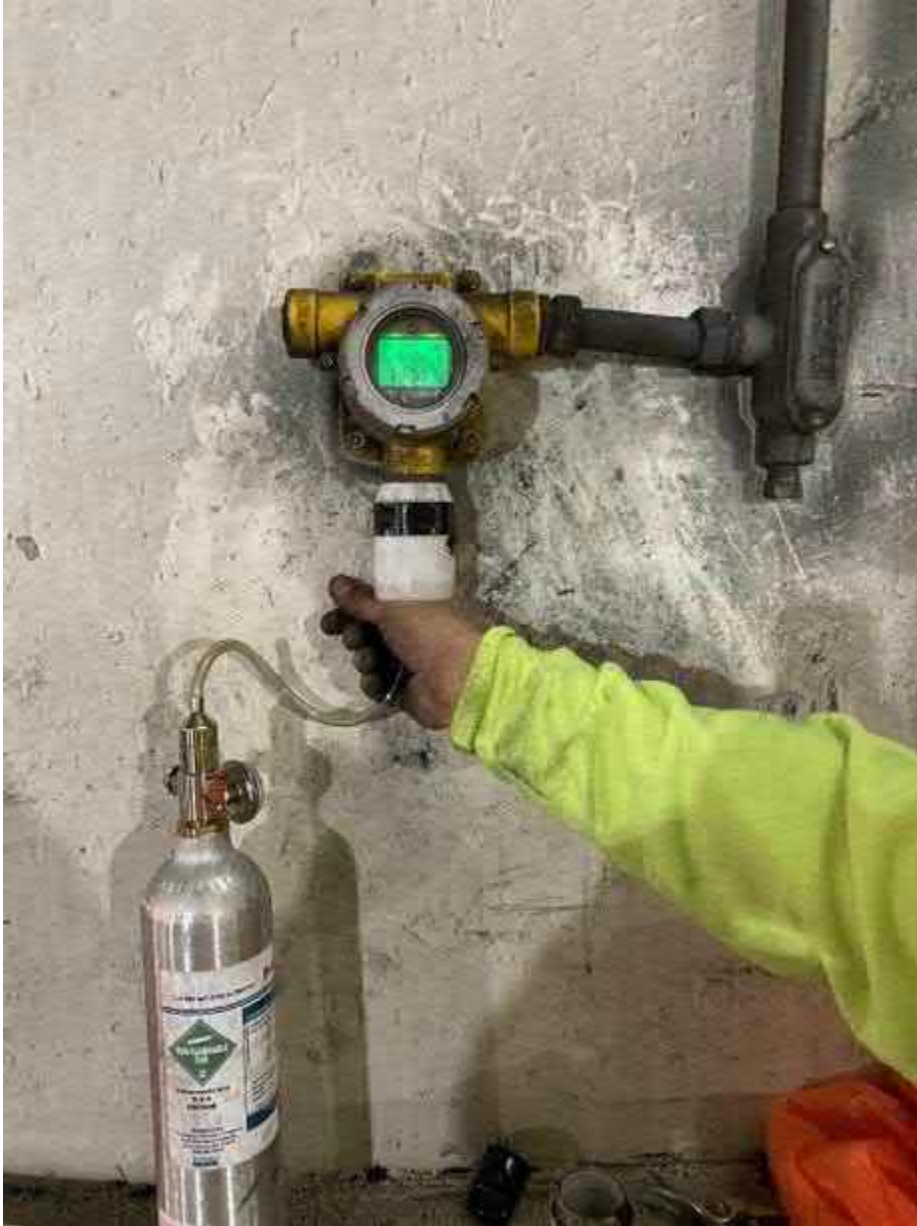
150 pass

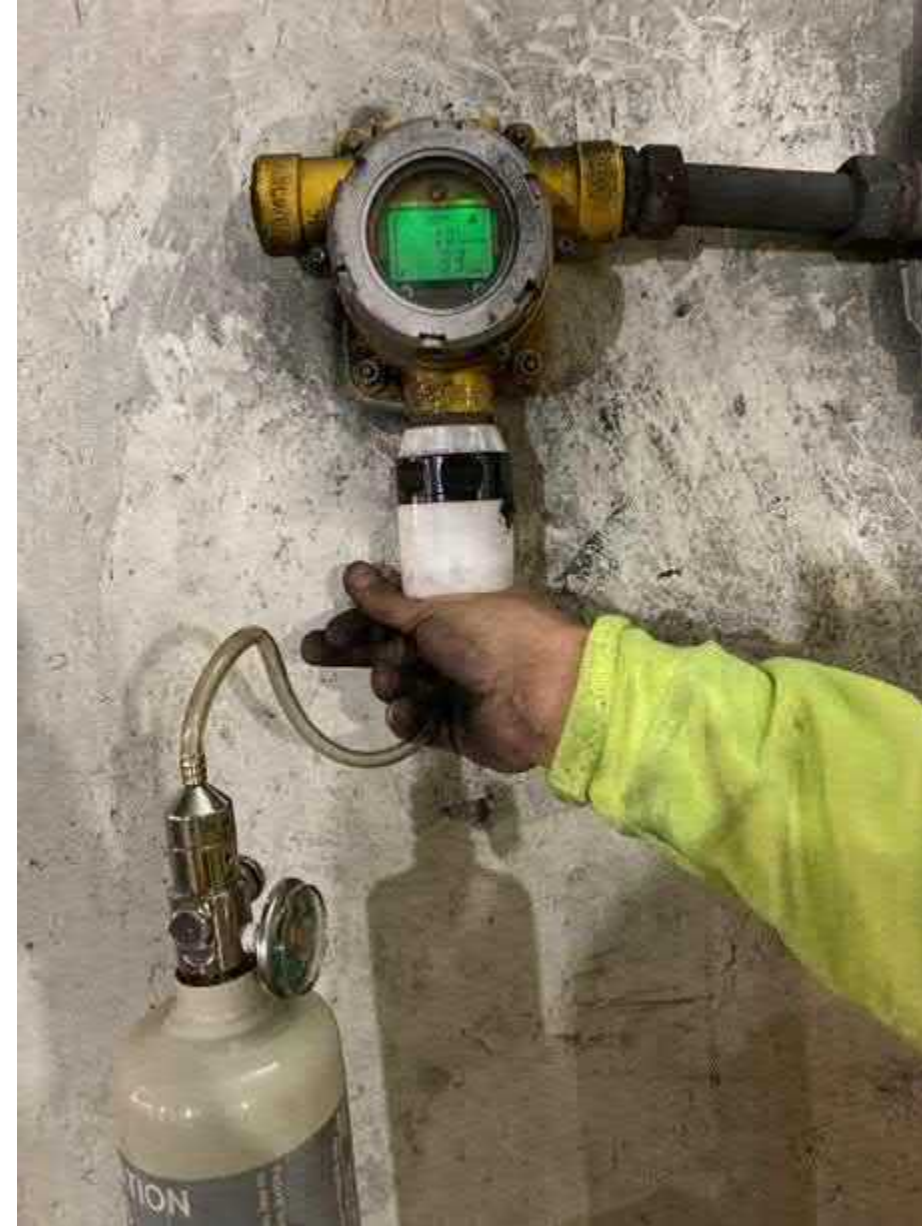
33 ppm

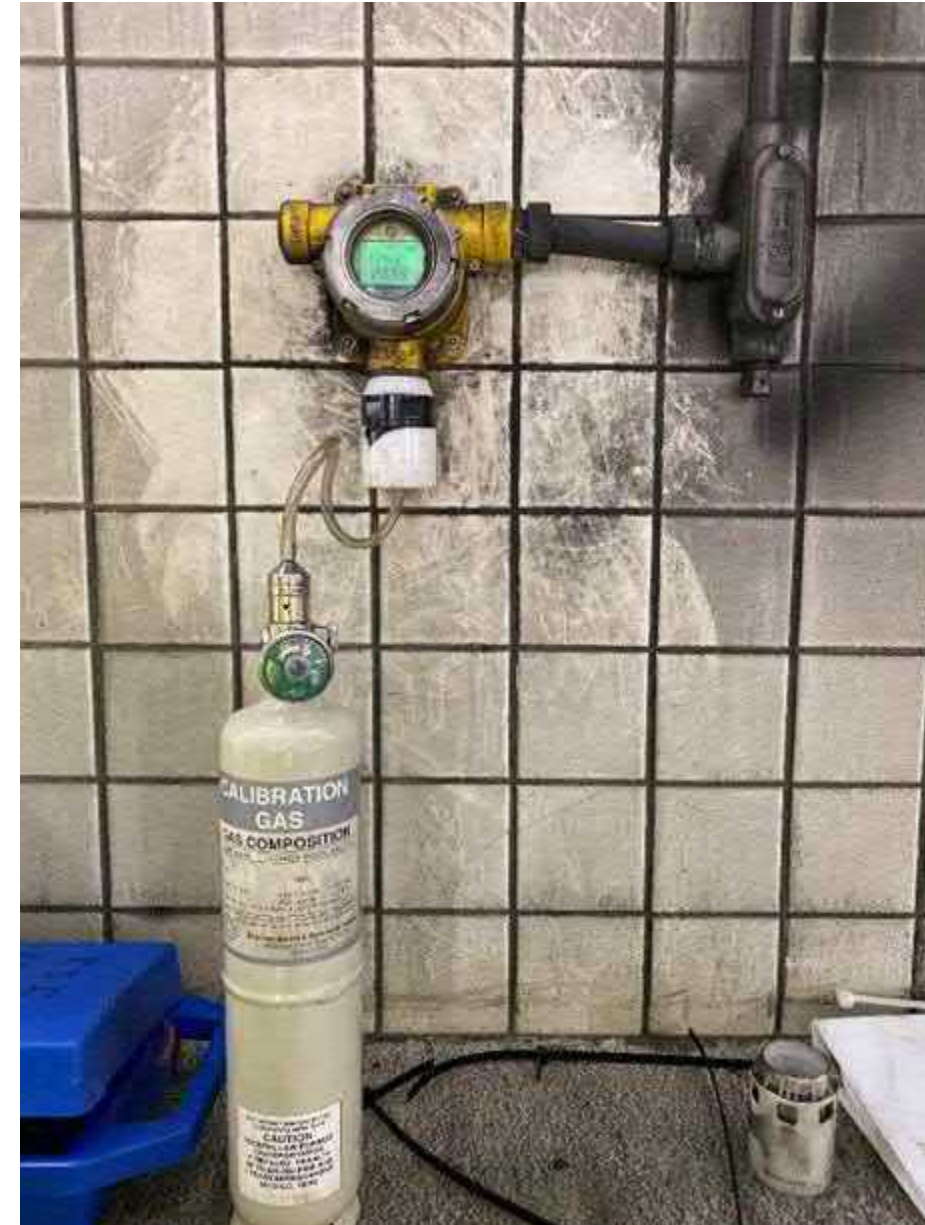
0 test pass
