# **Lytle Tunnel (HAM-71-0134) Inspection Report Fall 2020**

PID 105470

November, 2020

Ohio Department of  
Transportation  
District 8  
505 South State Route 741  
Lebanon, OH 45036

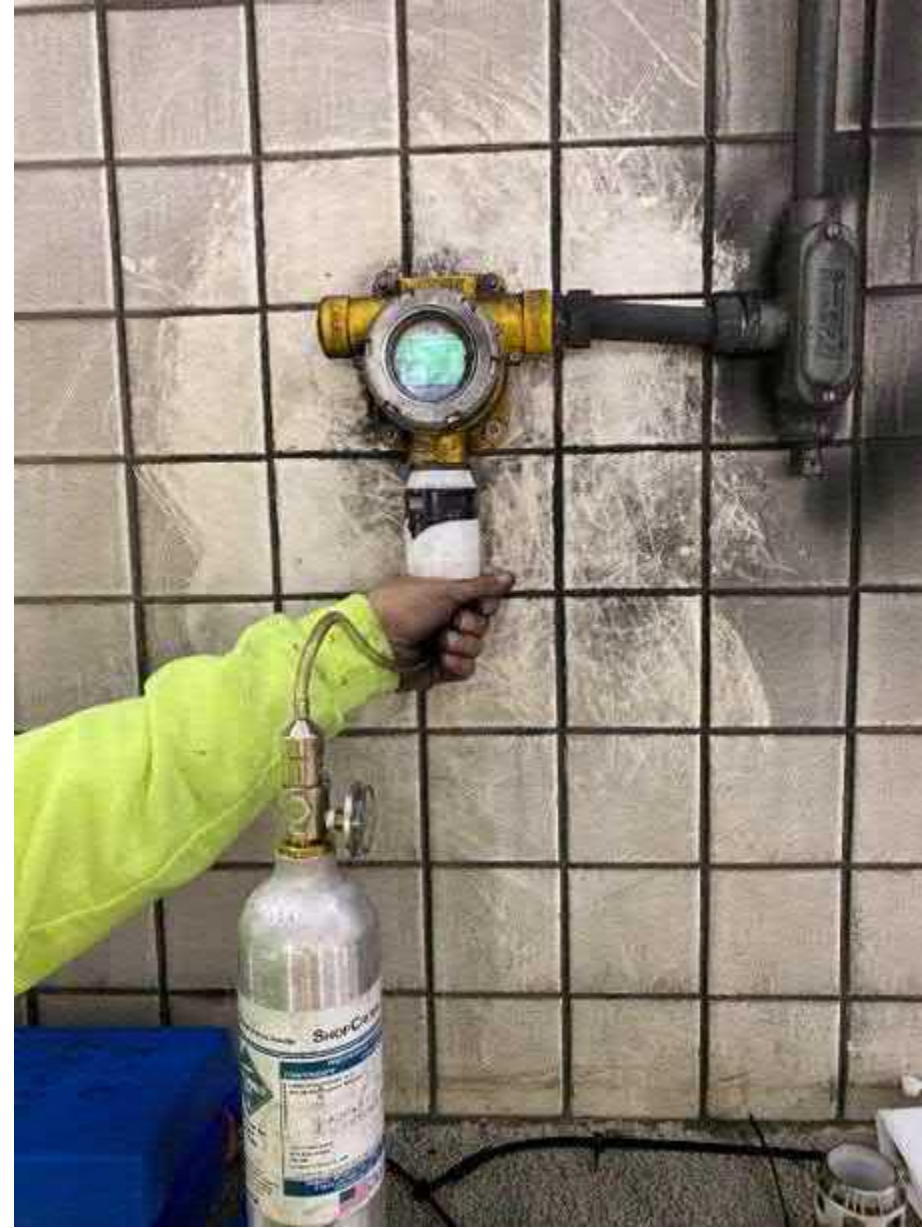
150 test pass

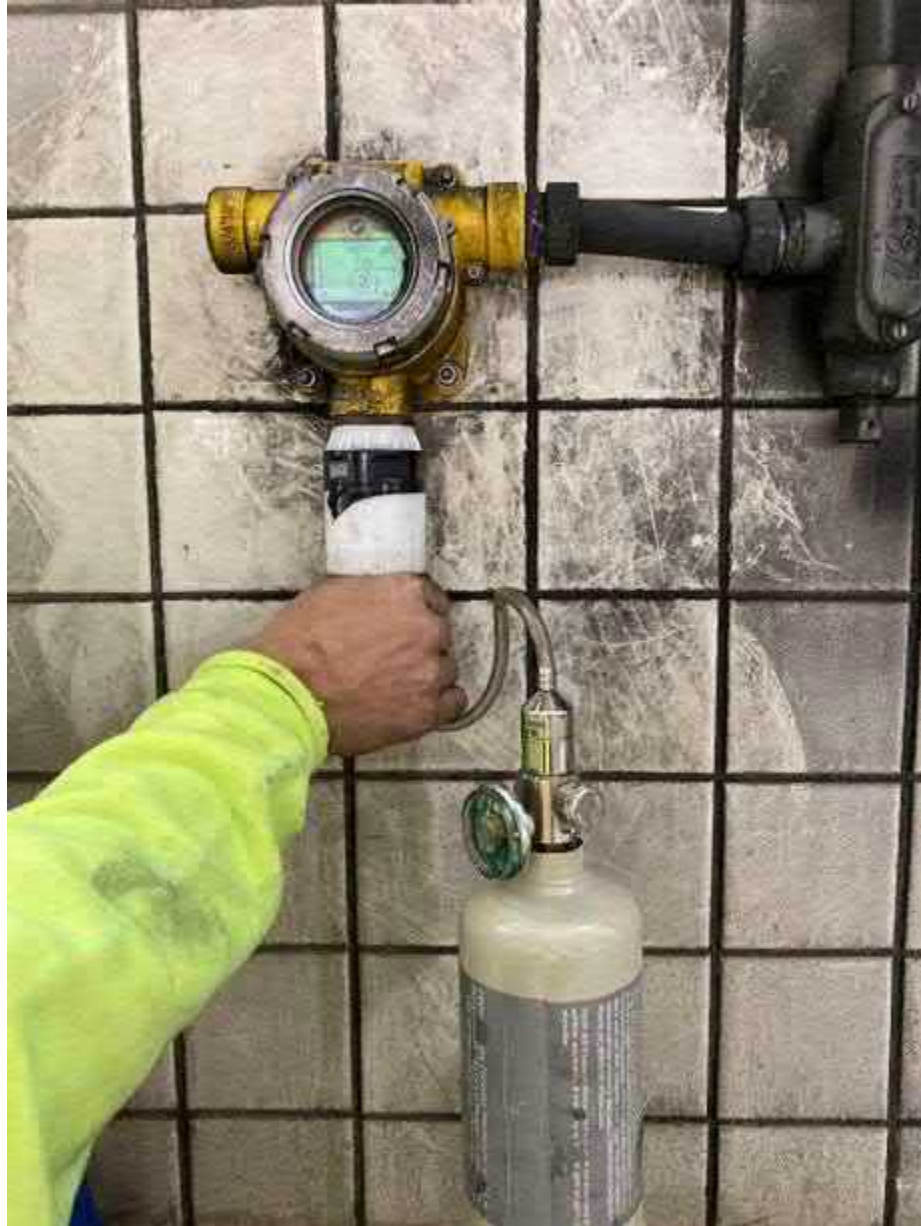
35 test pass

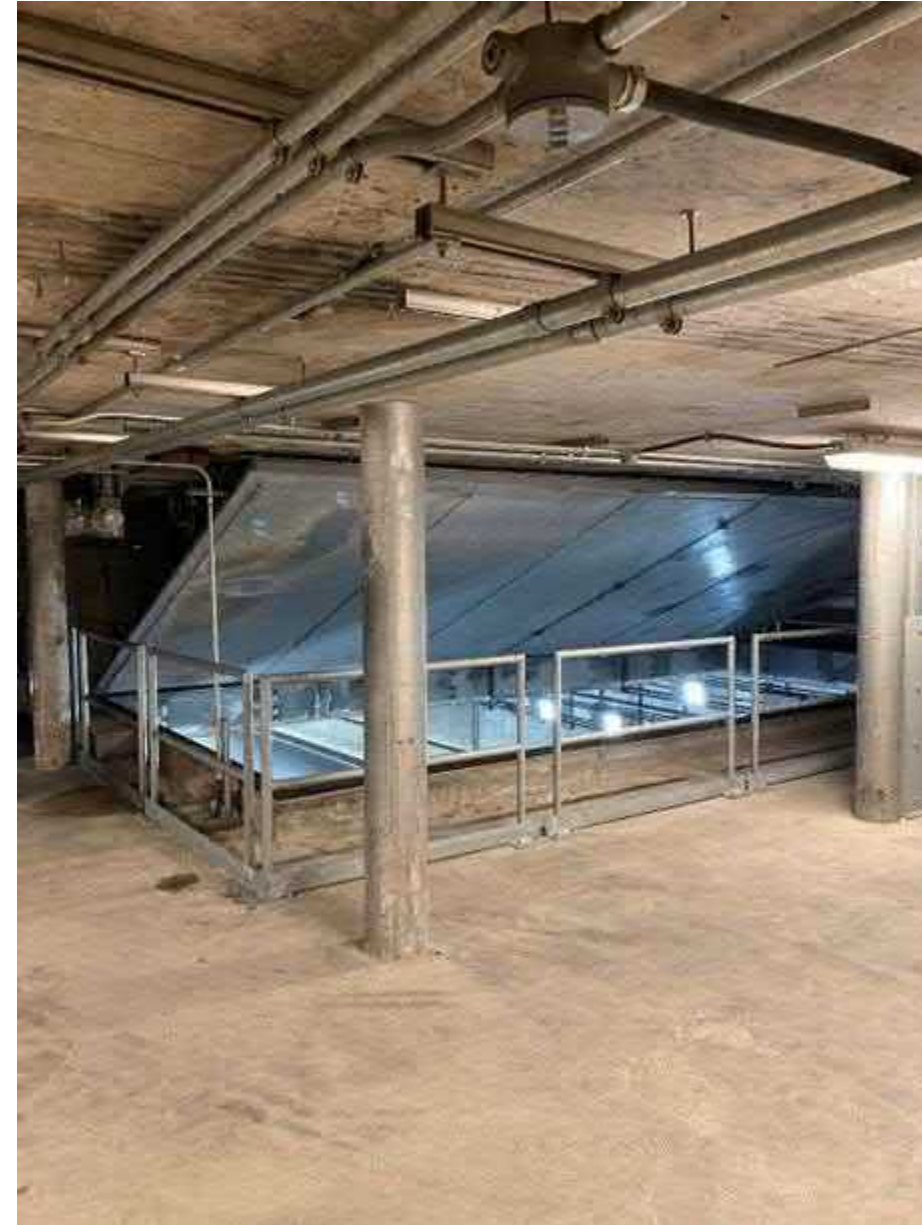
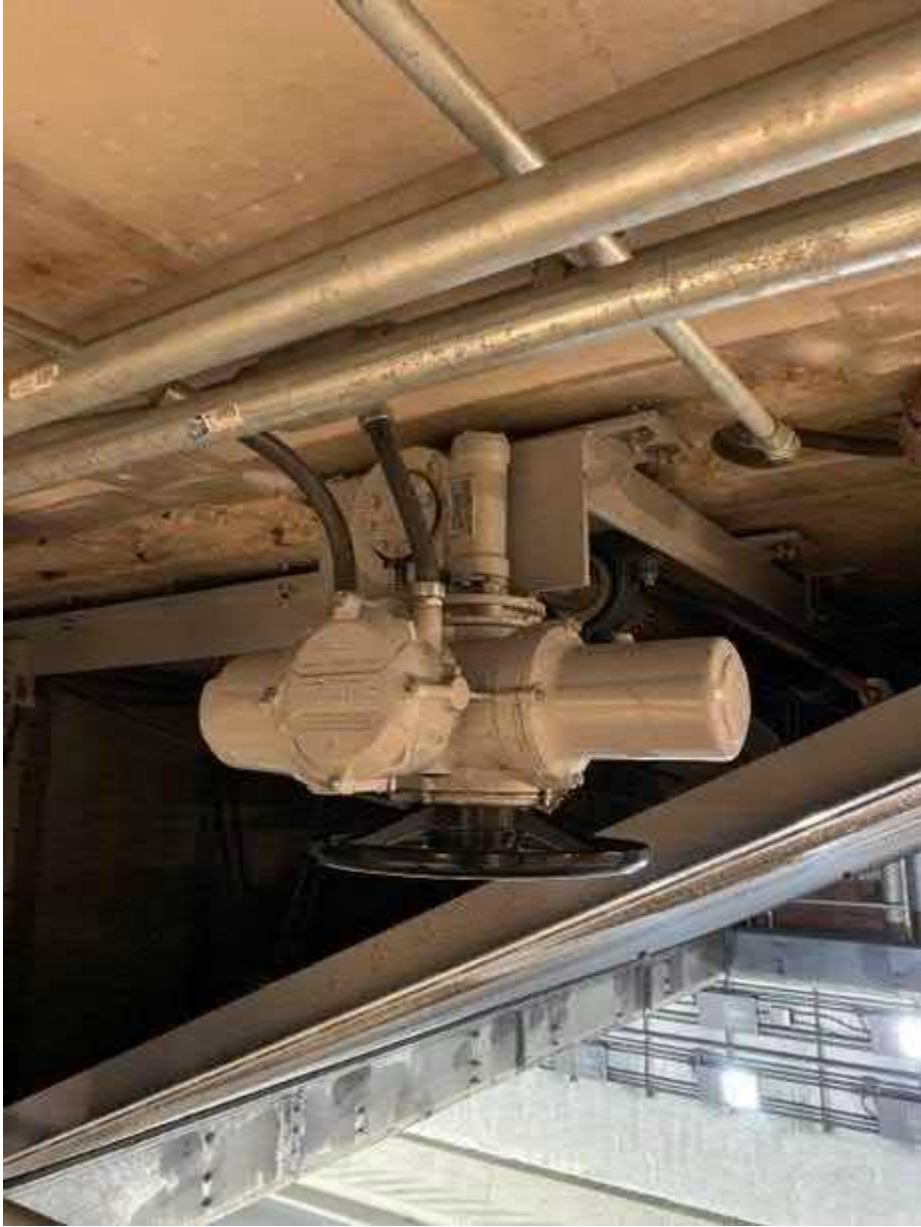
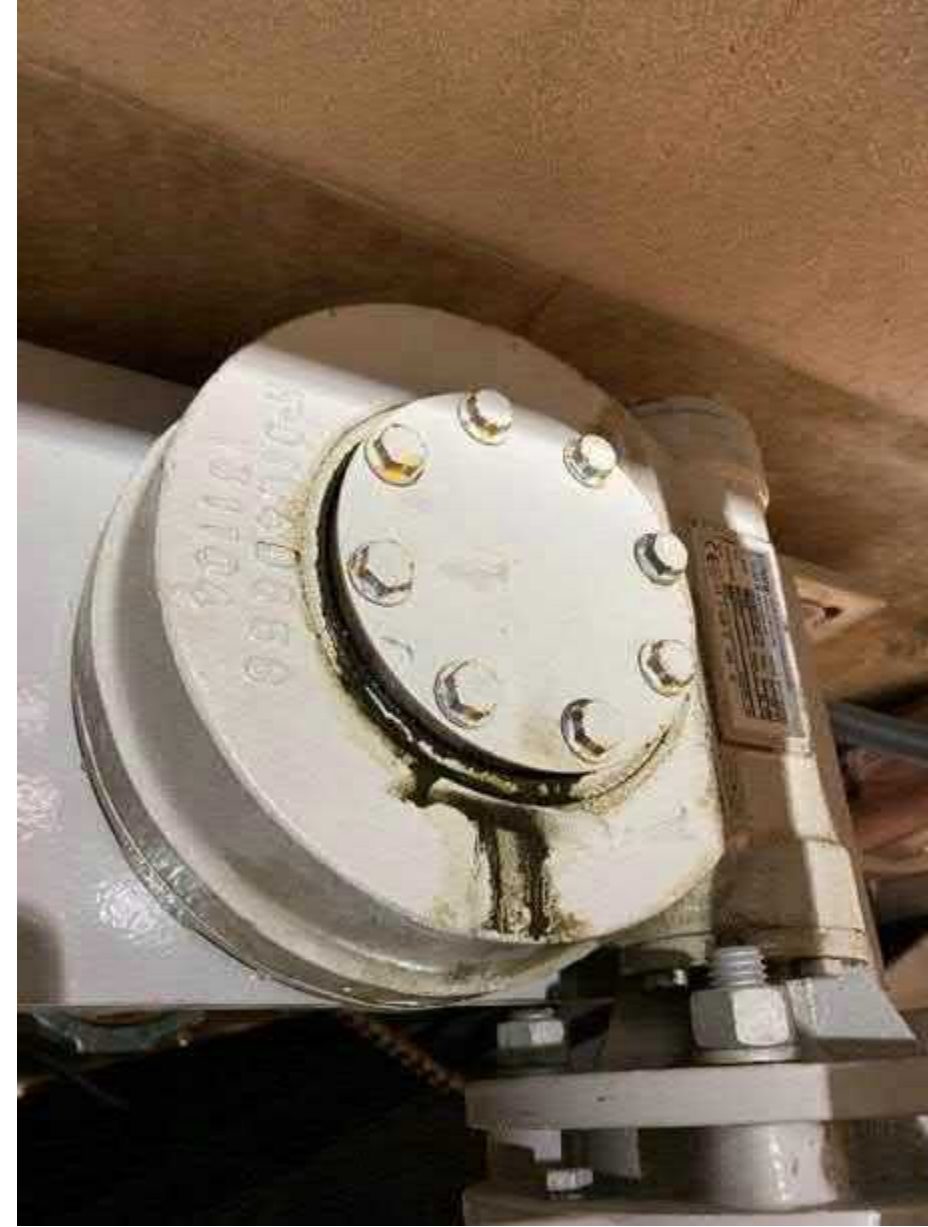
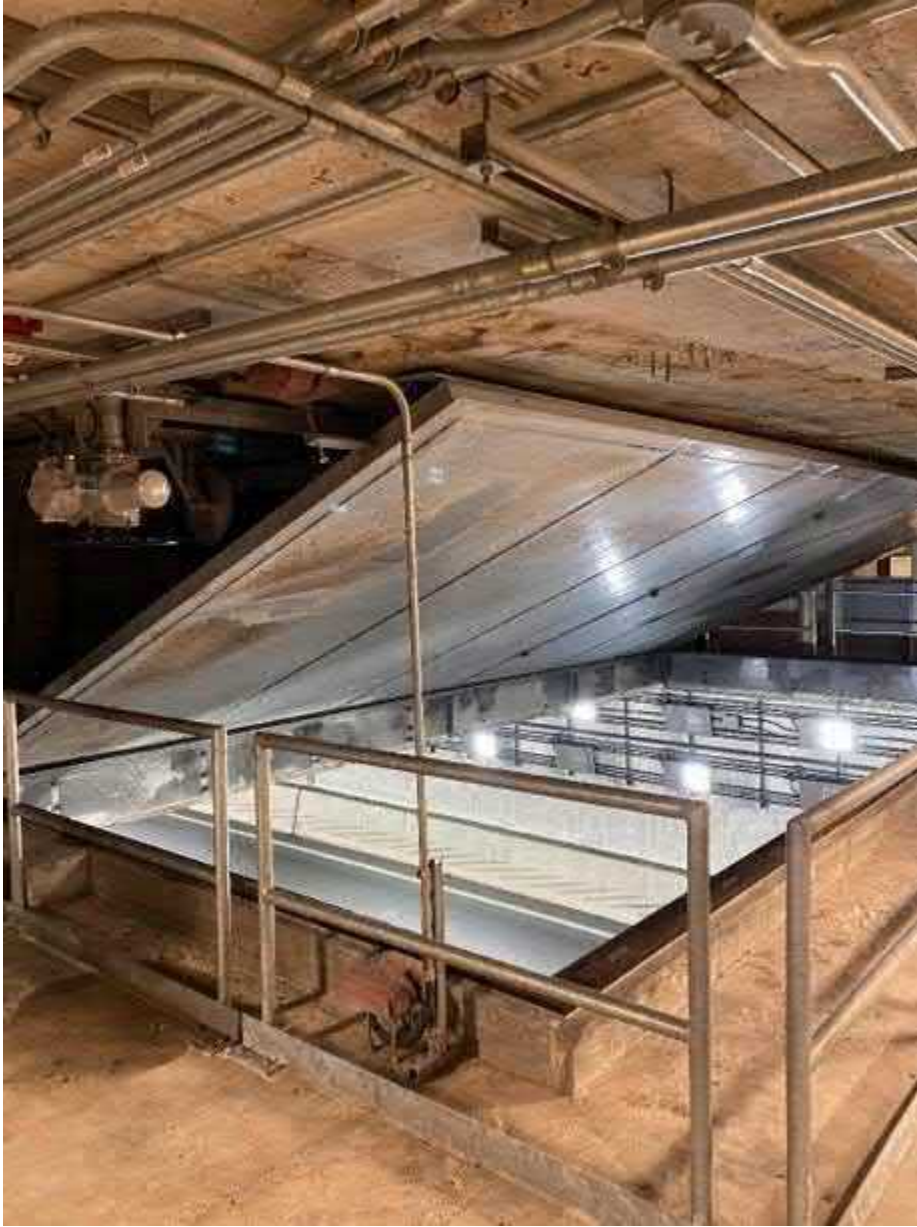
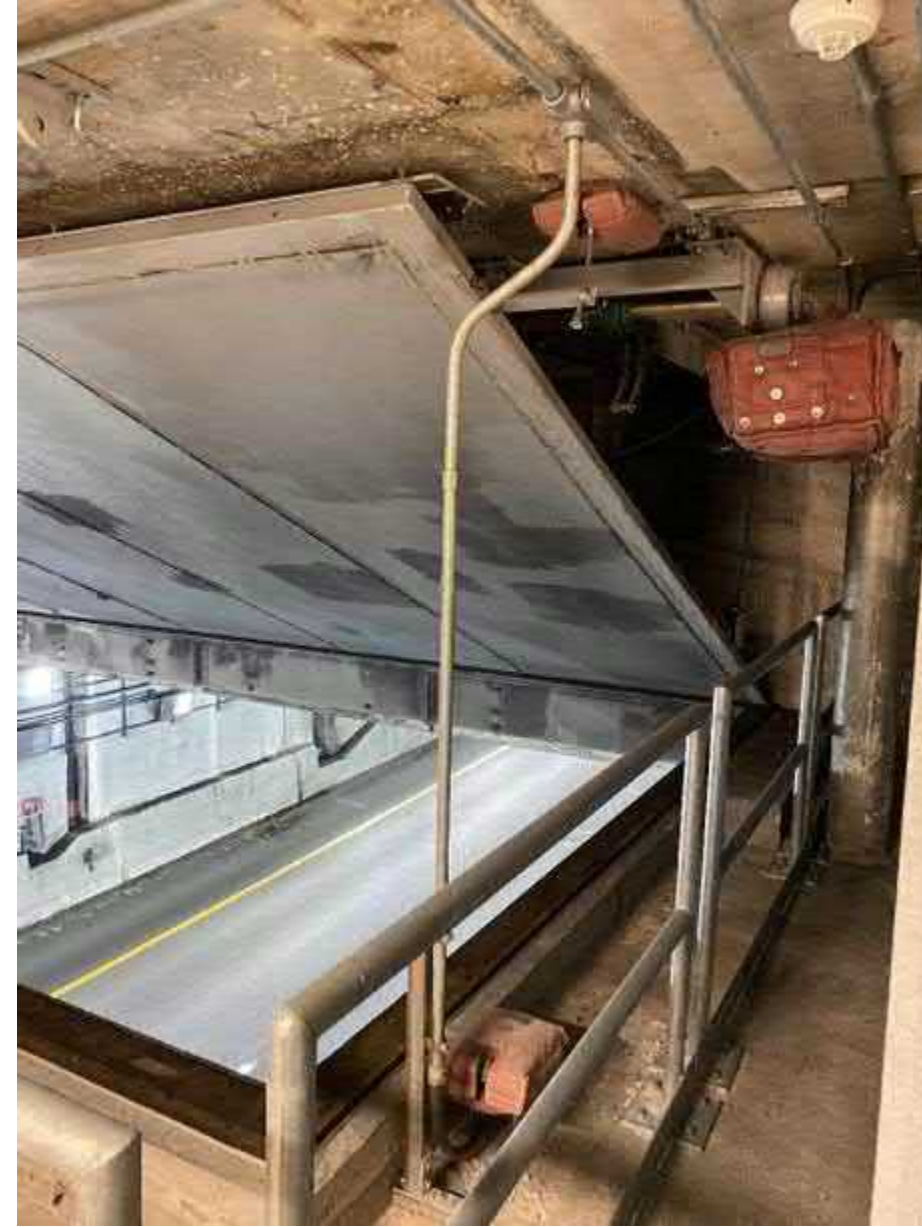
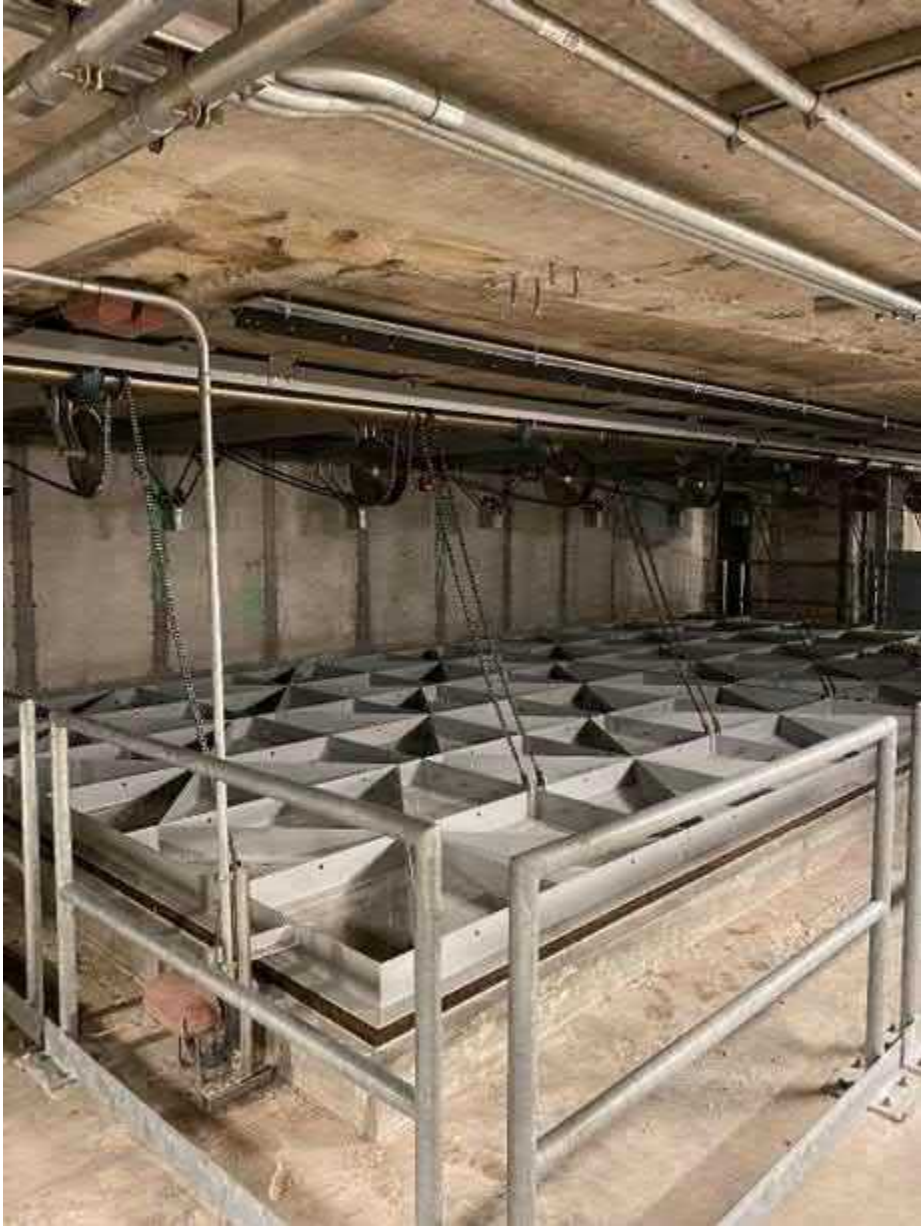
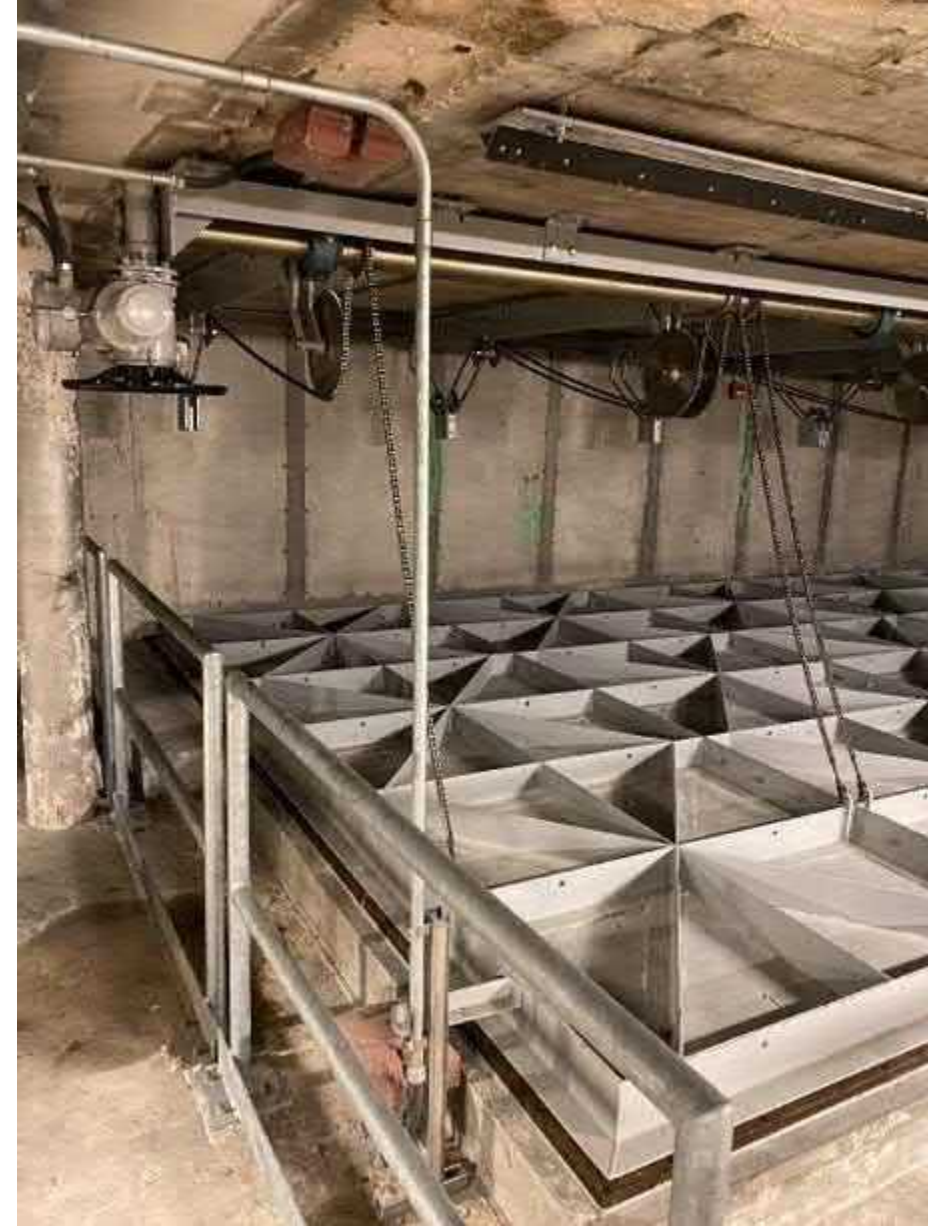
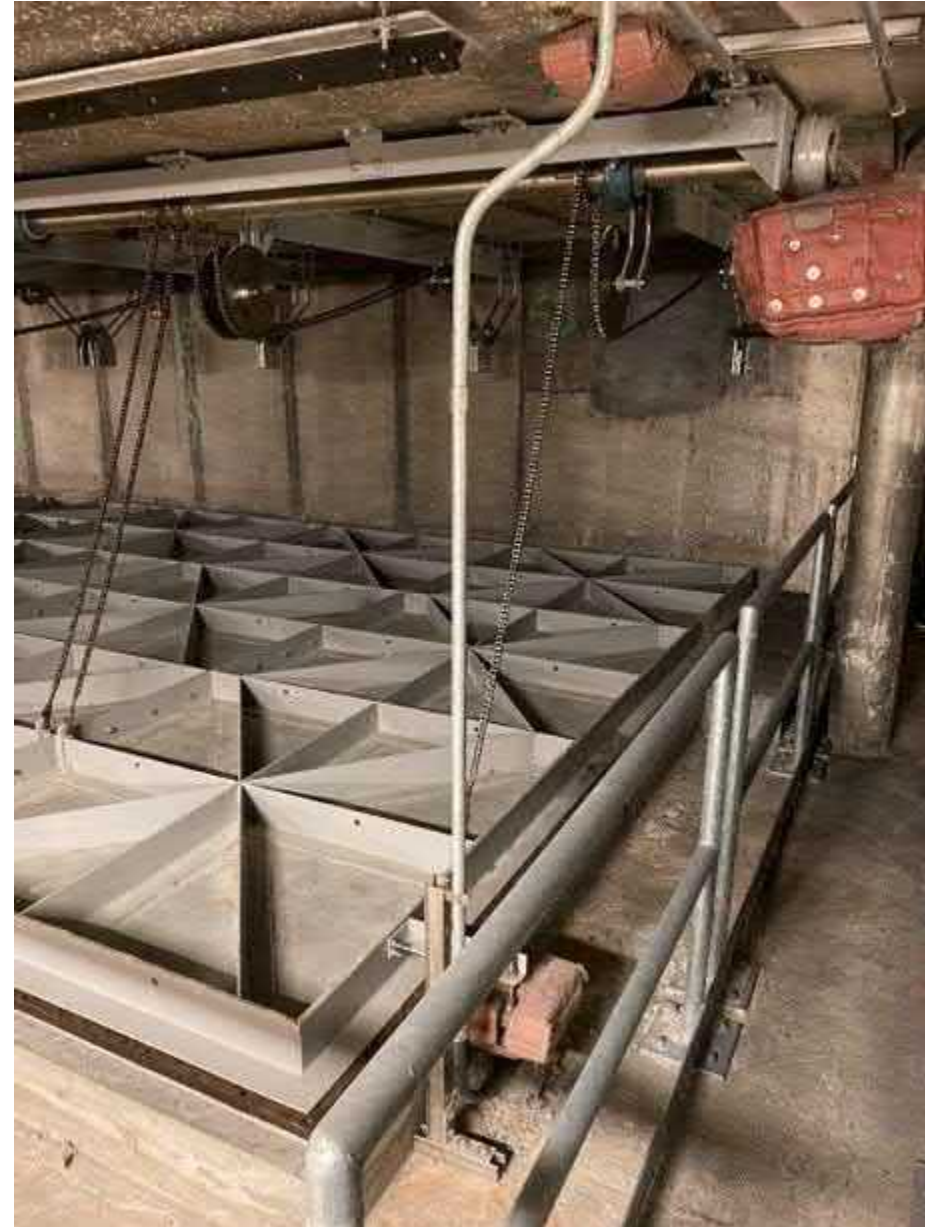
Rotork actuator on the left hand side (looking North) leaks are both the hand wheel and the gearbox. Actuator is currently out of warranty. CS2.

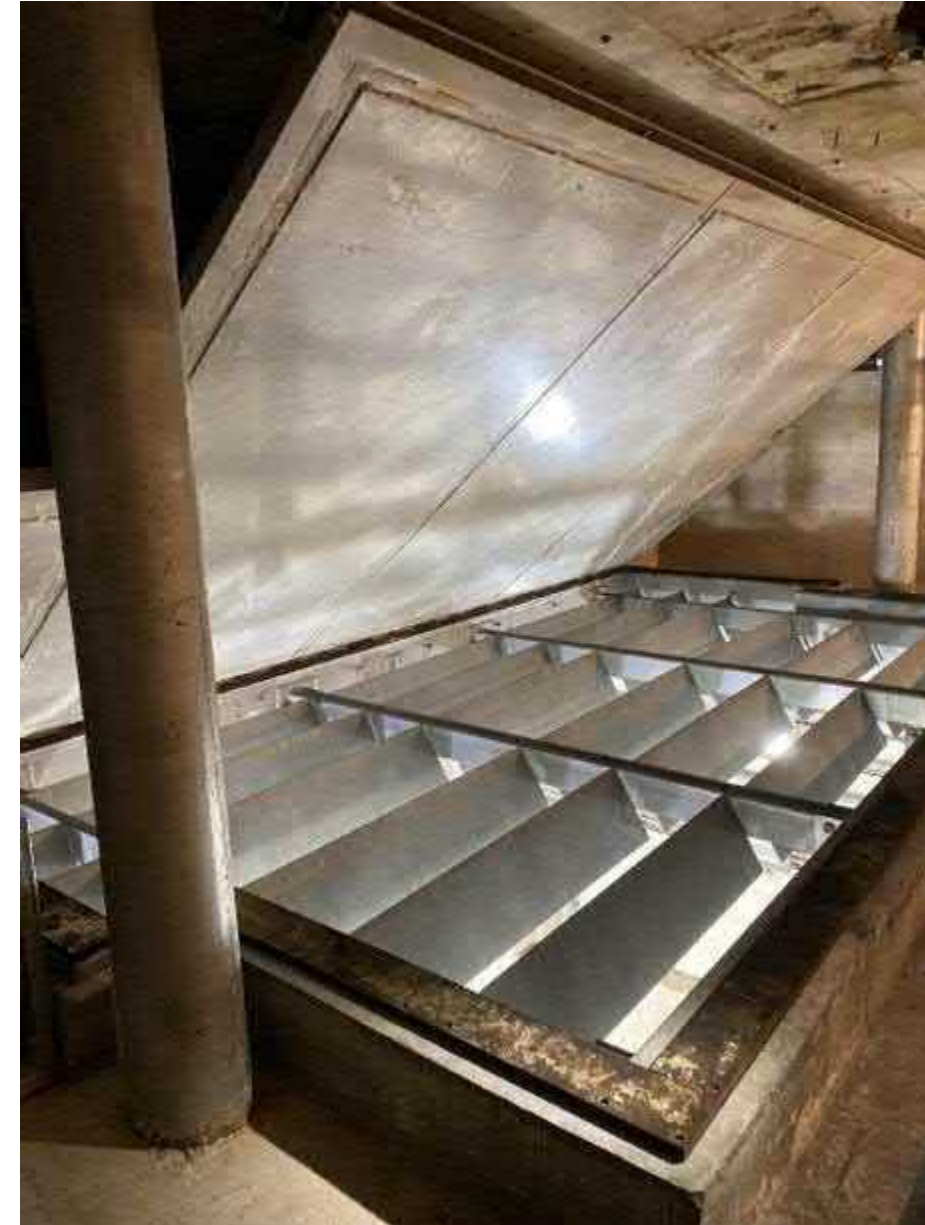
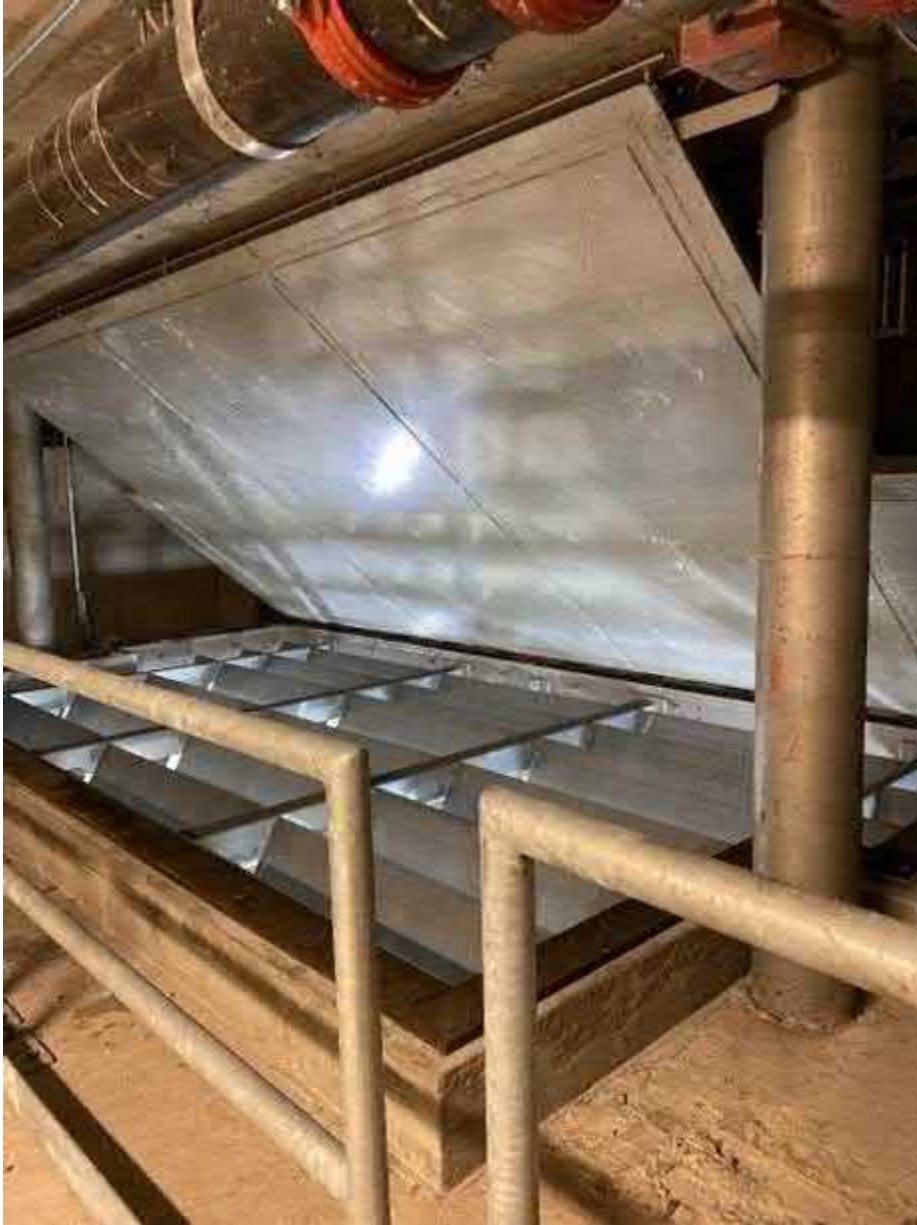
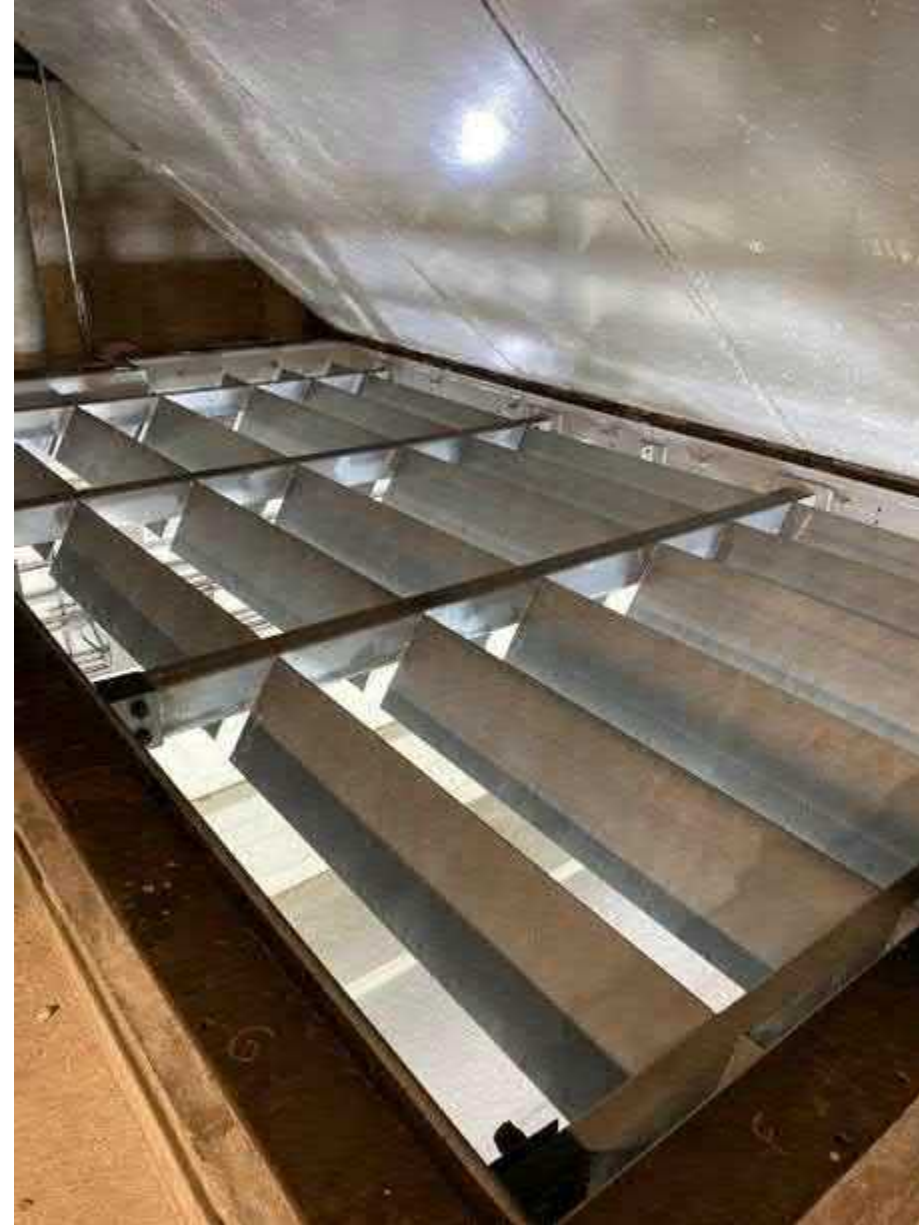
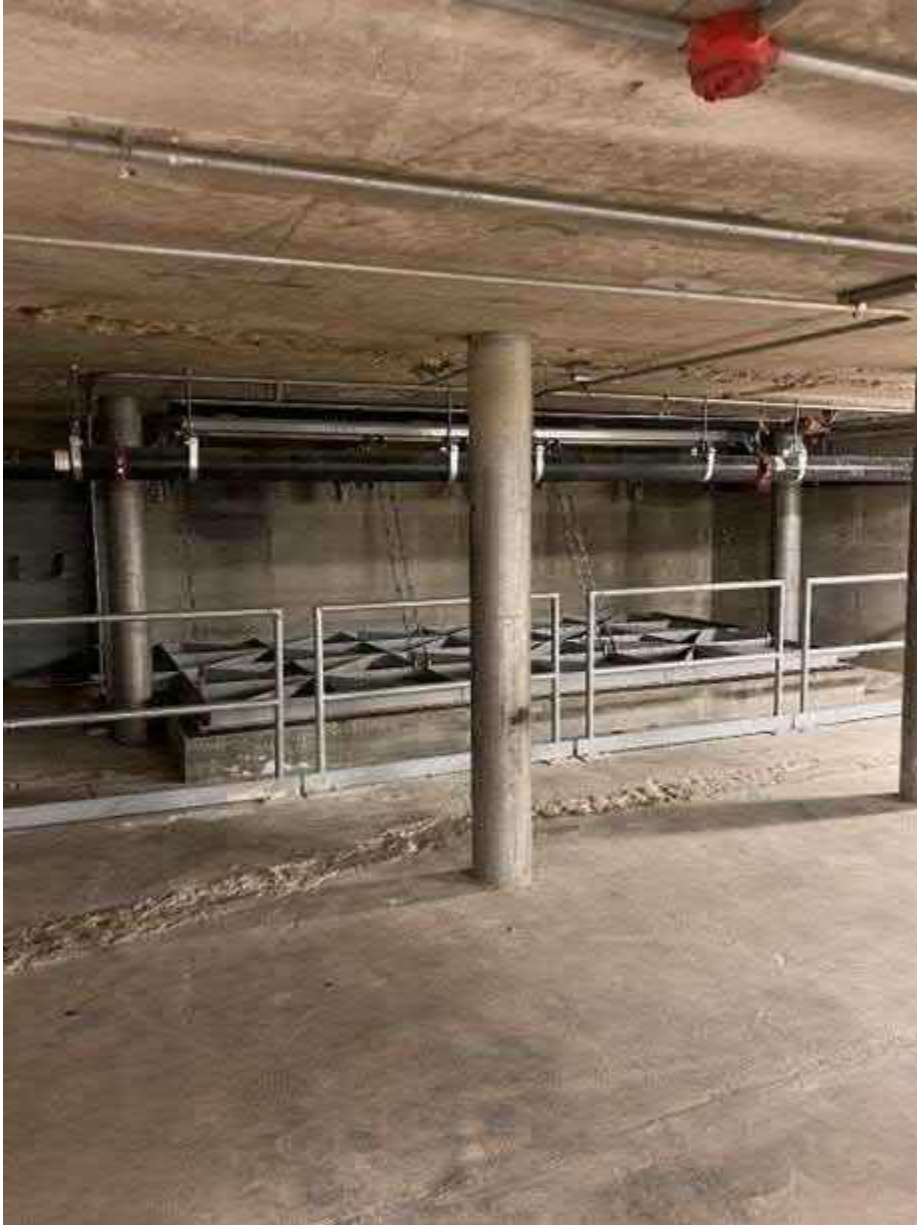
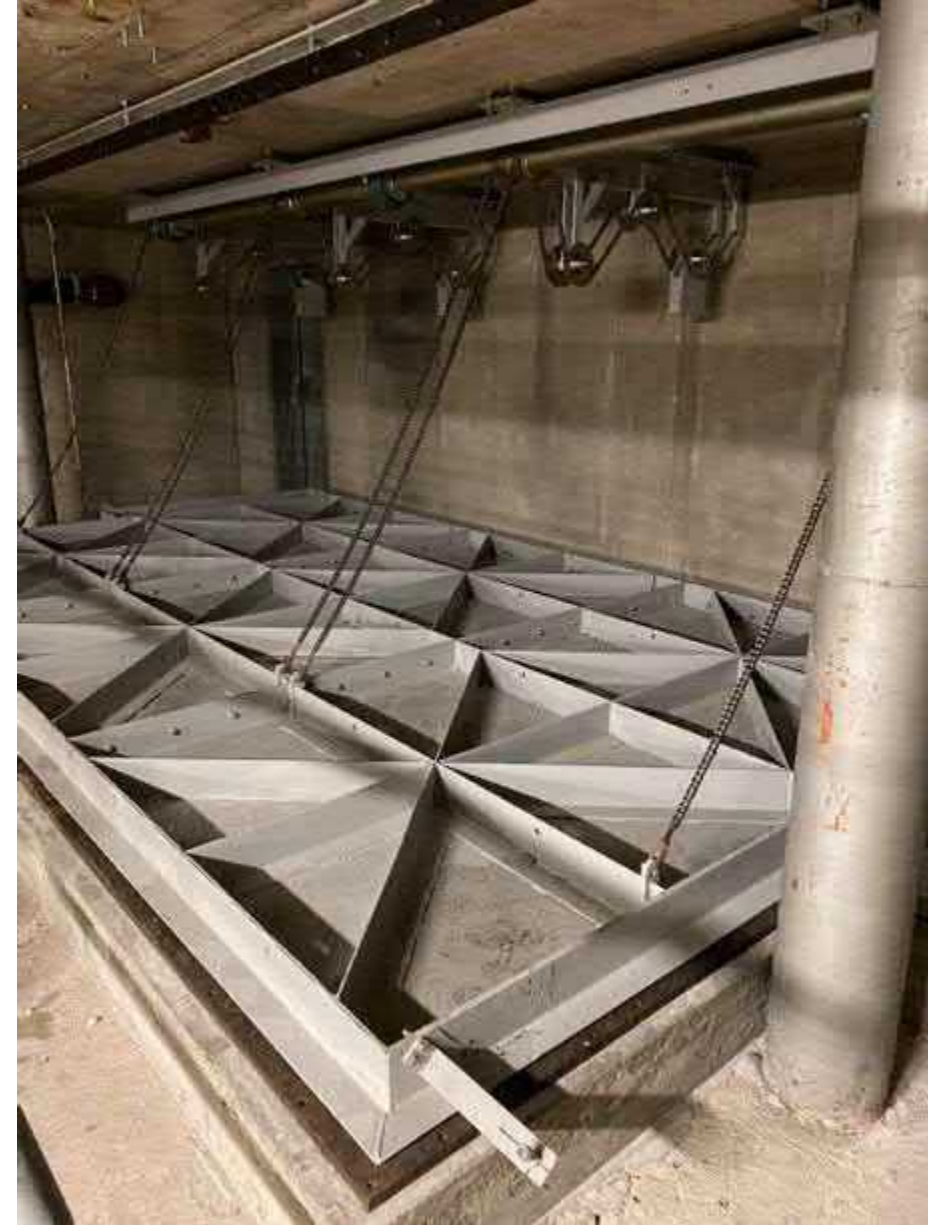
In good condition. No issues during opening. CS1.
