# **Lytle Tunnel (HAM-71-0134) Inspection Report Fall 2020**

PID 105470

November, 2020

Ohio Department of  
Transportation  
District 8  
505 South State Route 741  
Lebanon, OH 45036

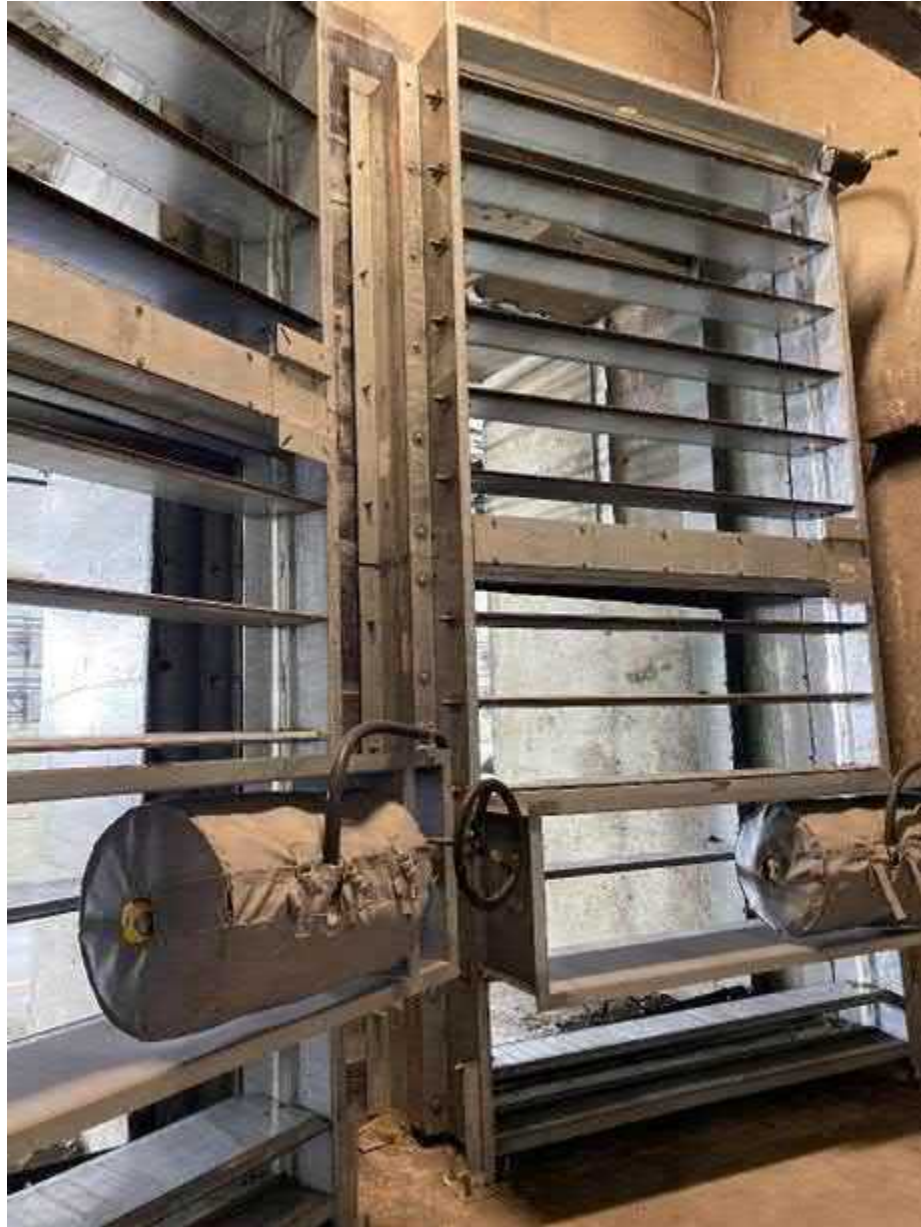
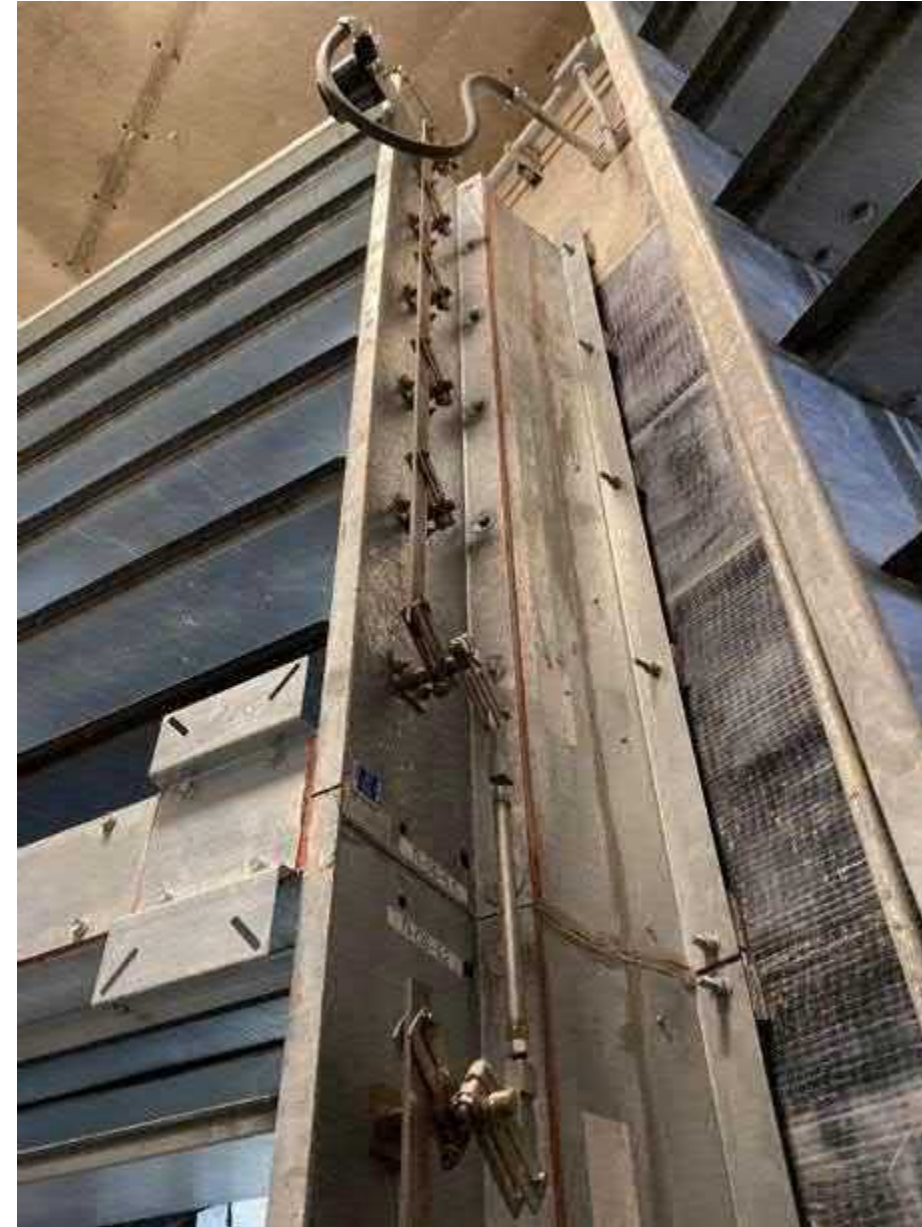
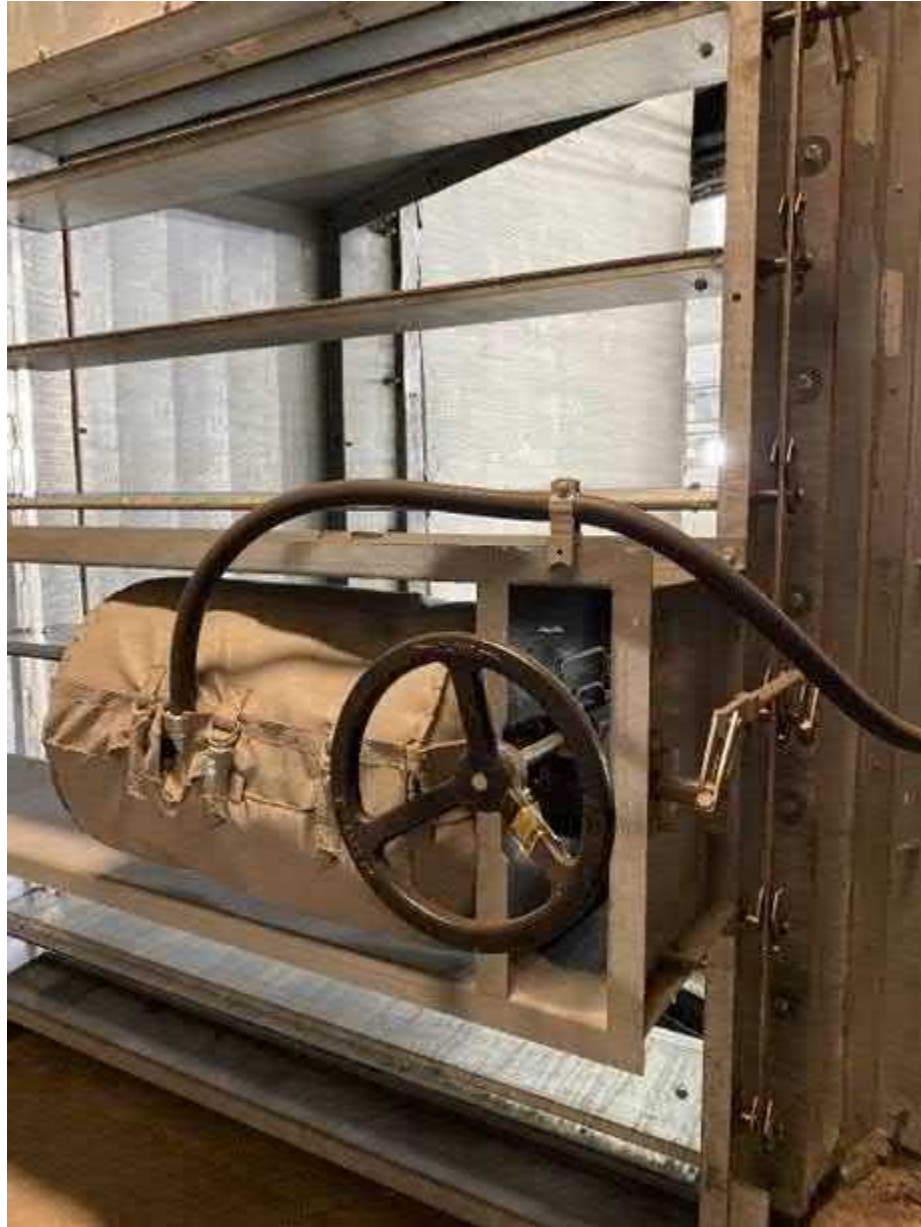
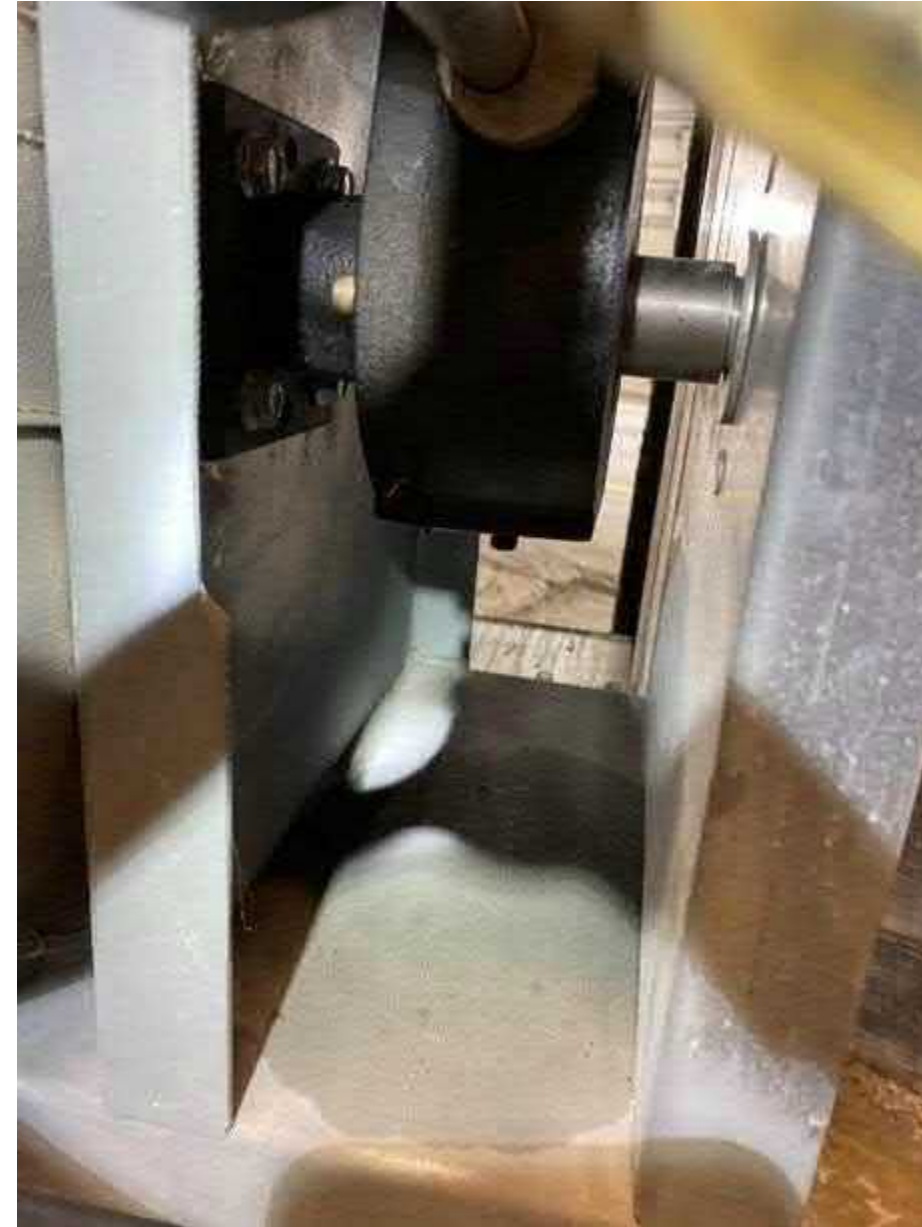
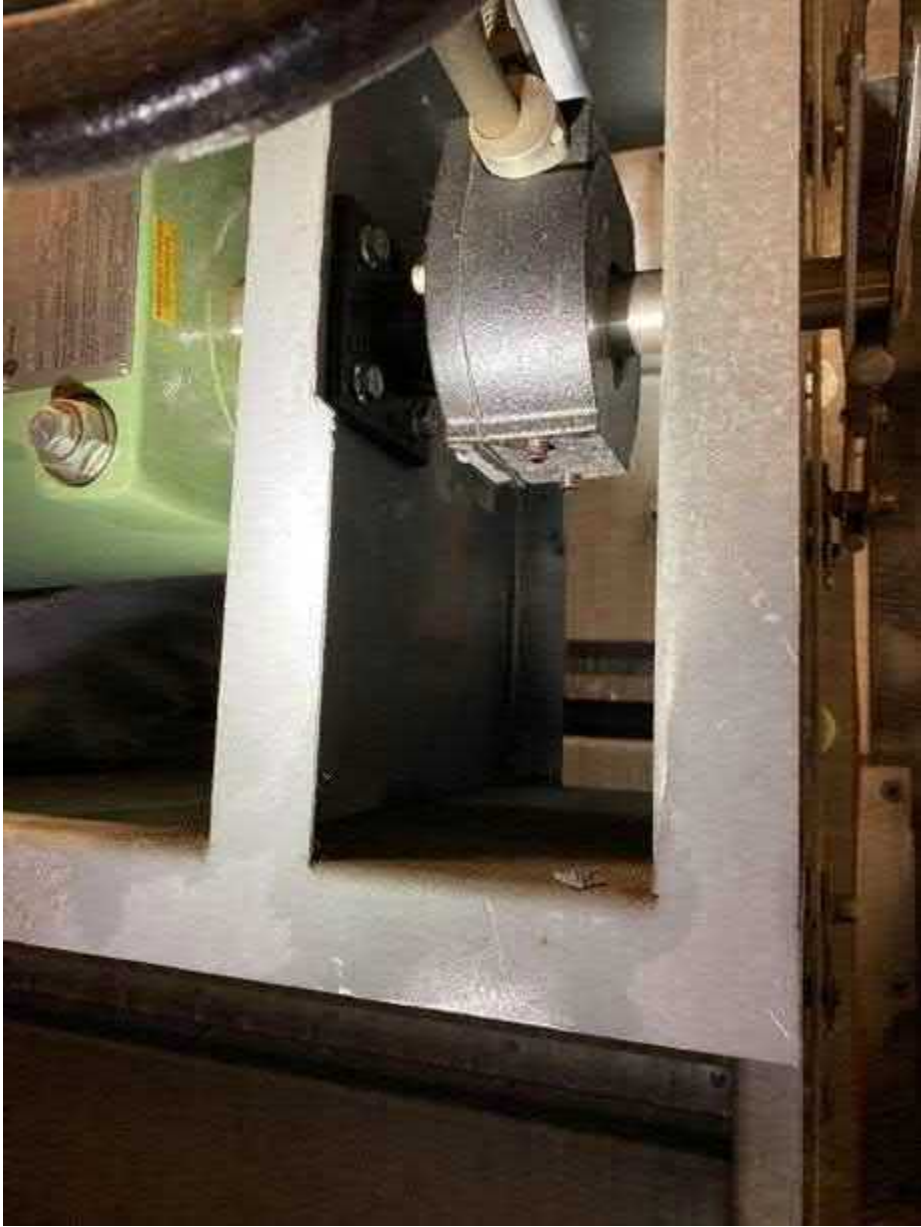
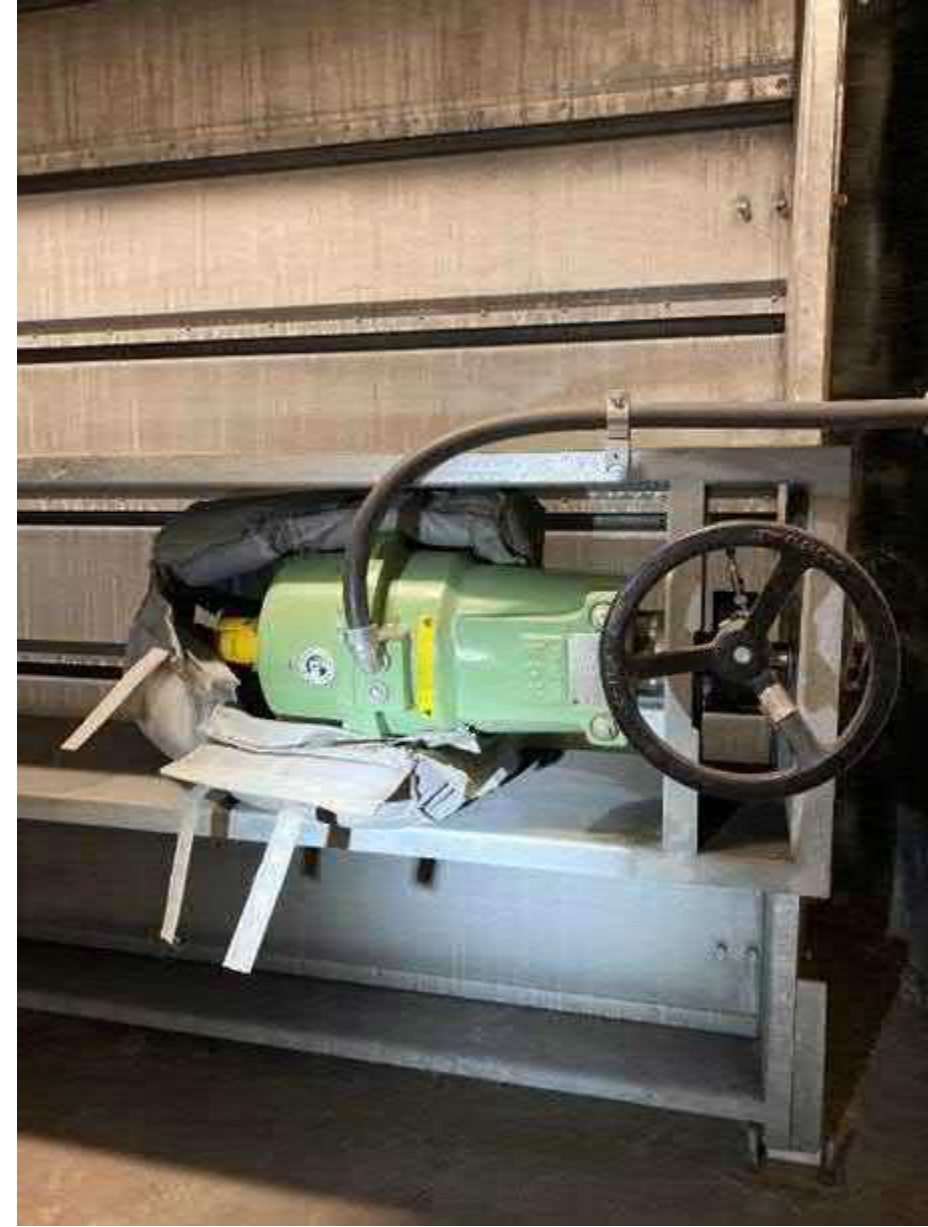
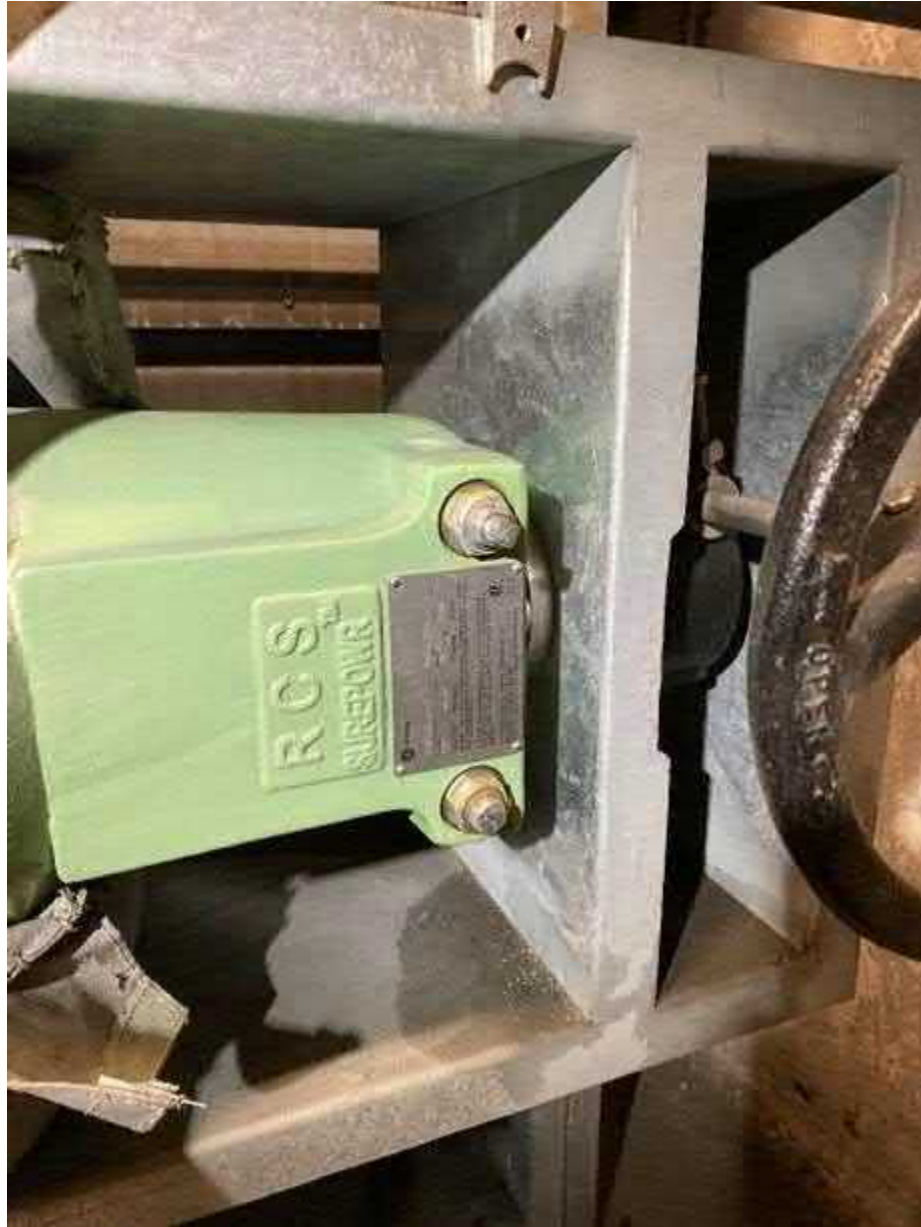
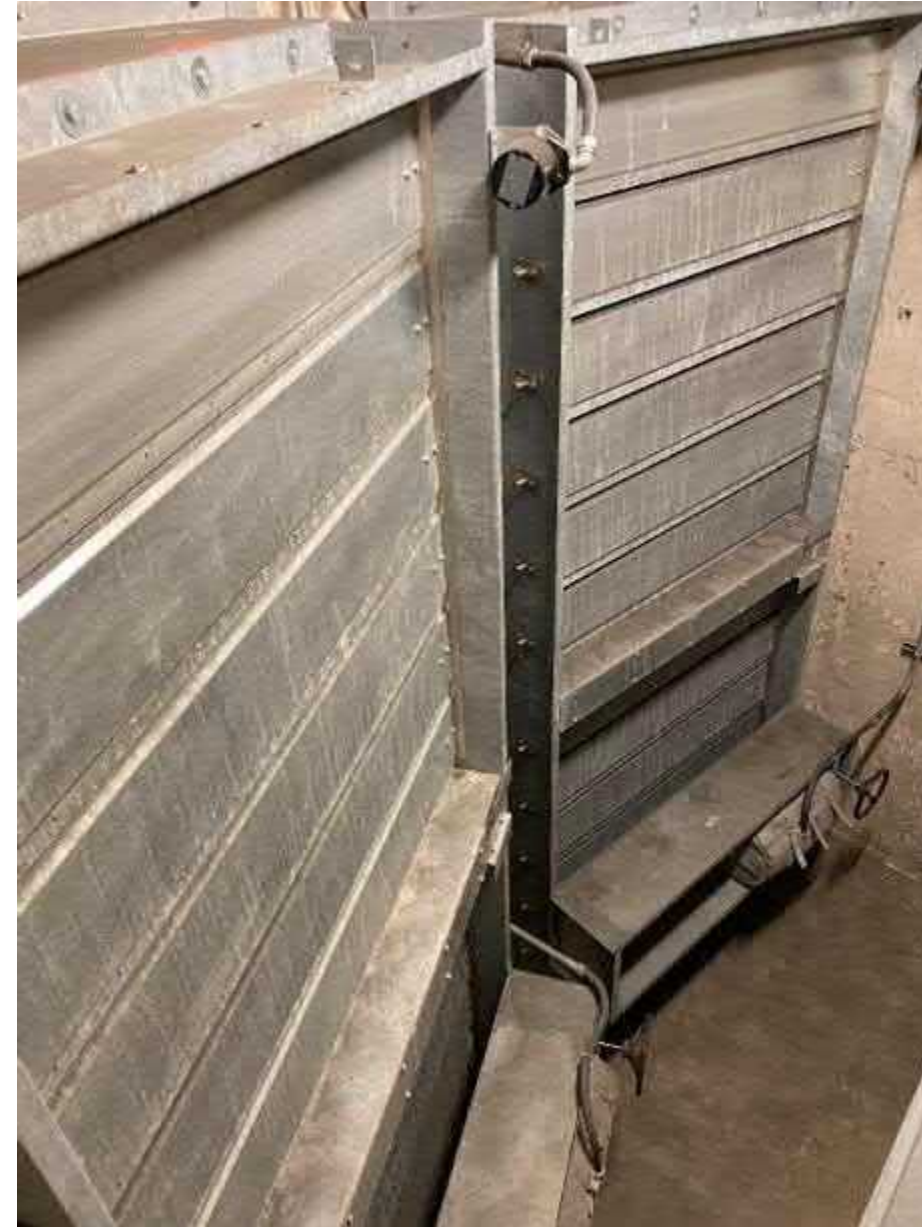
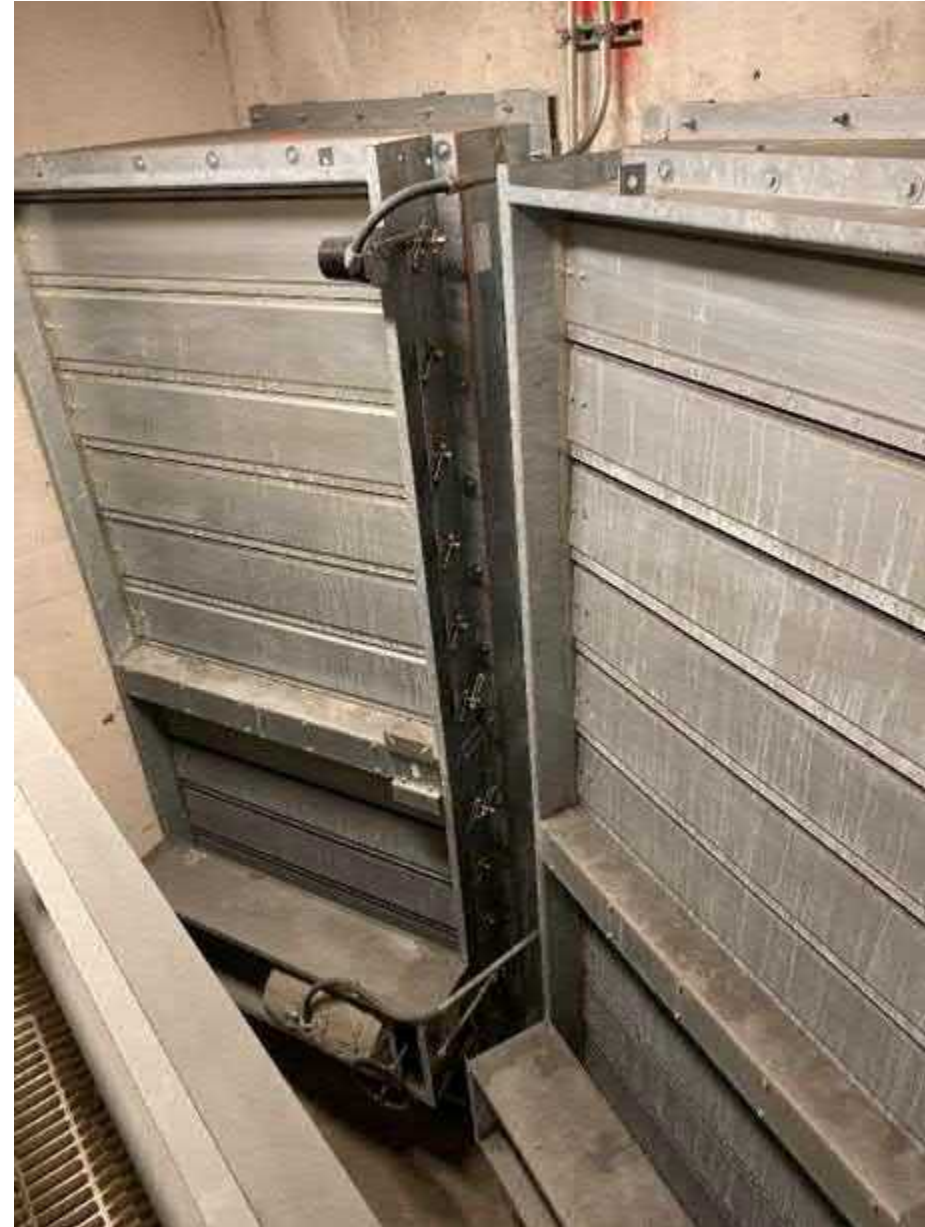
In good condition. Damper actuators have minor leaks, see photos. No other signs of visual defects.

In good condition. Operates as intended. Minor leaks as shown in photos. CS2

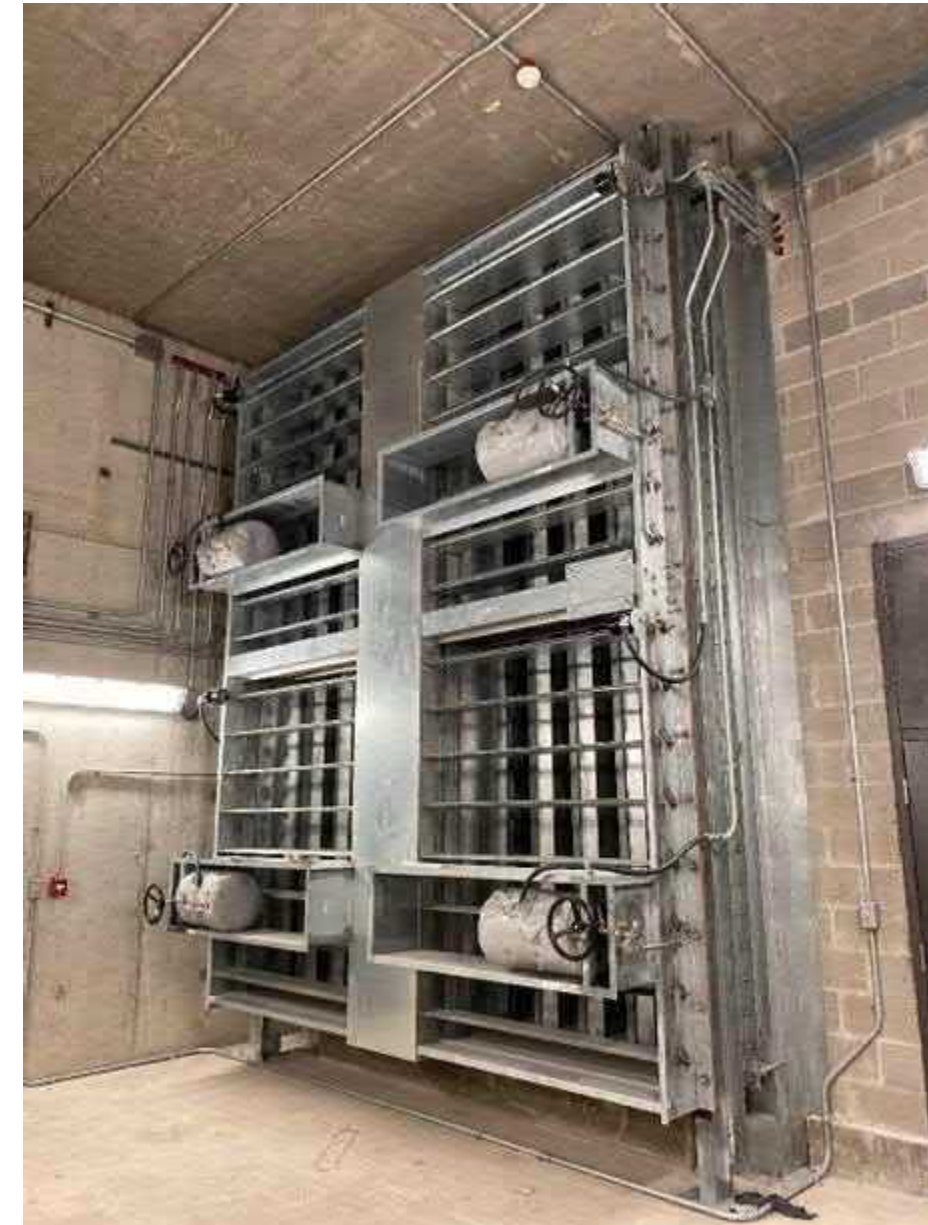
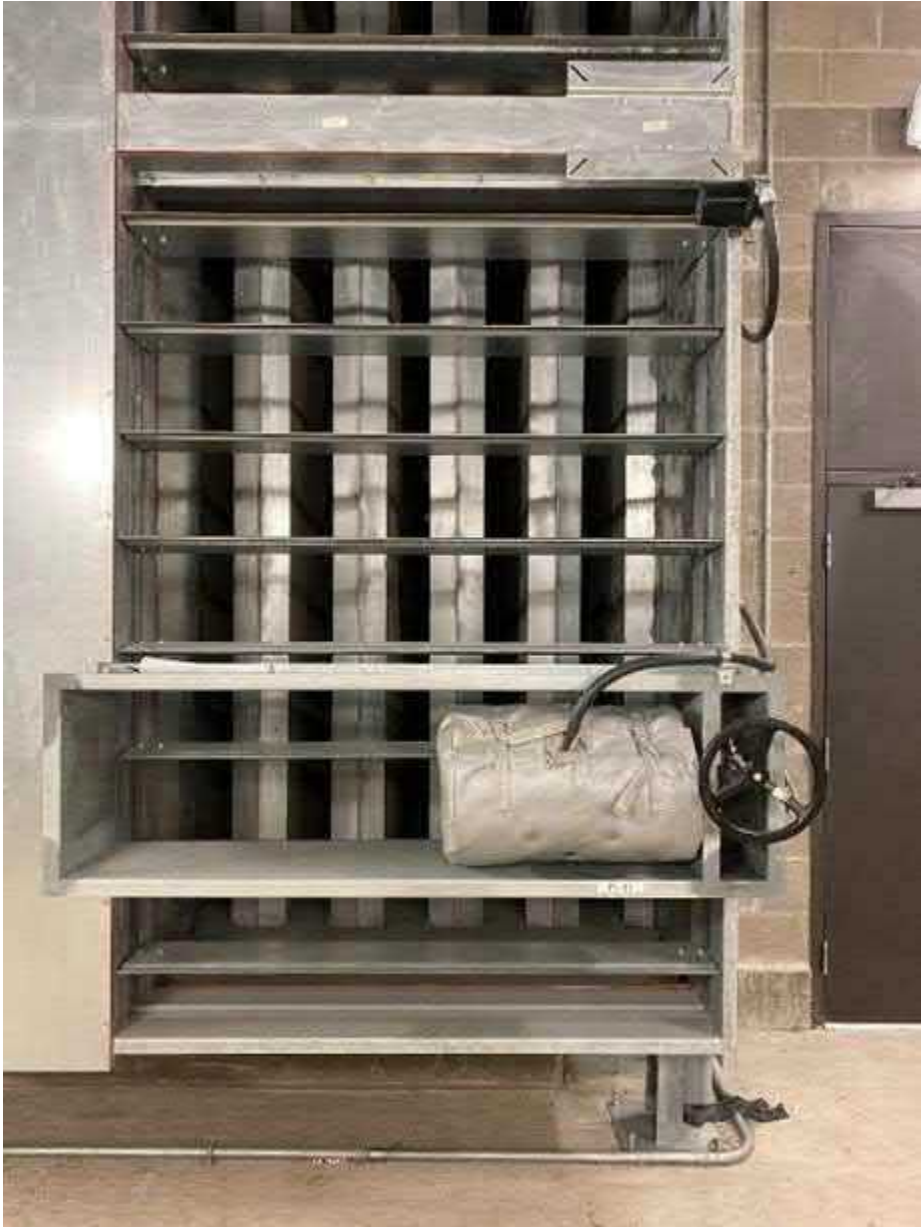
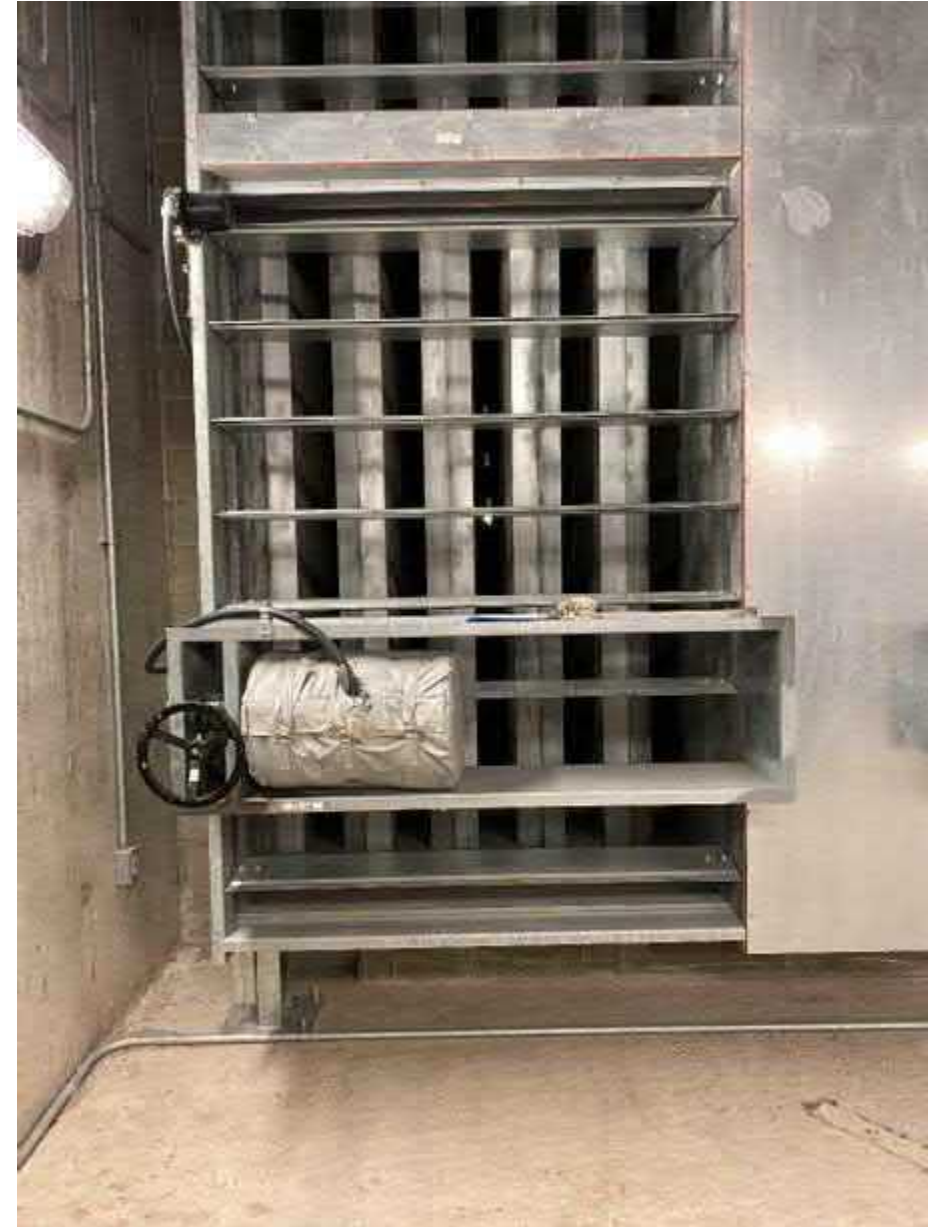
Good condition. No issues. CS1

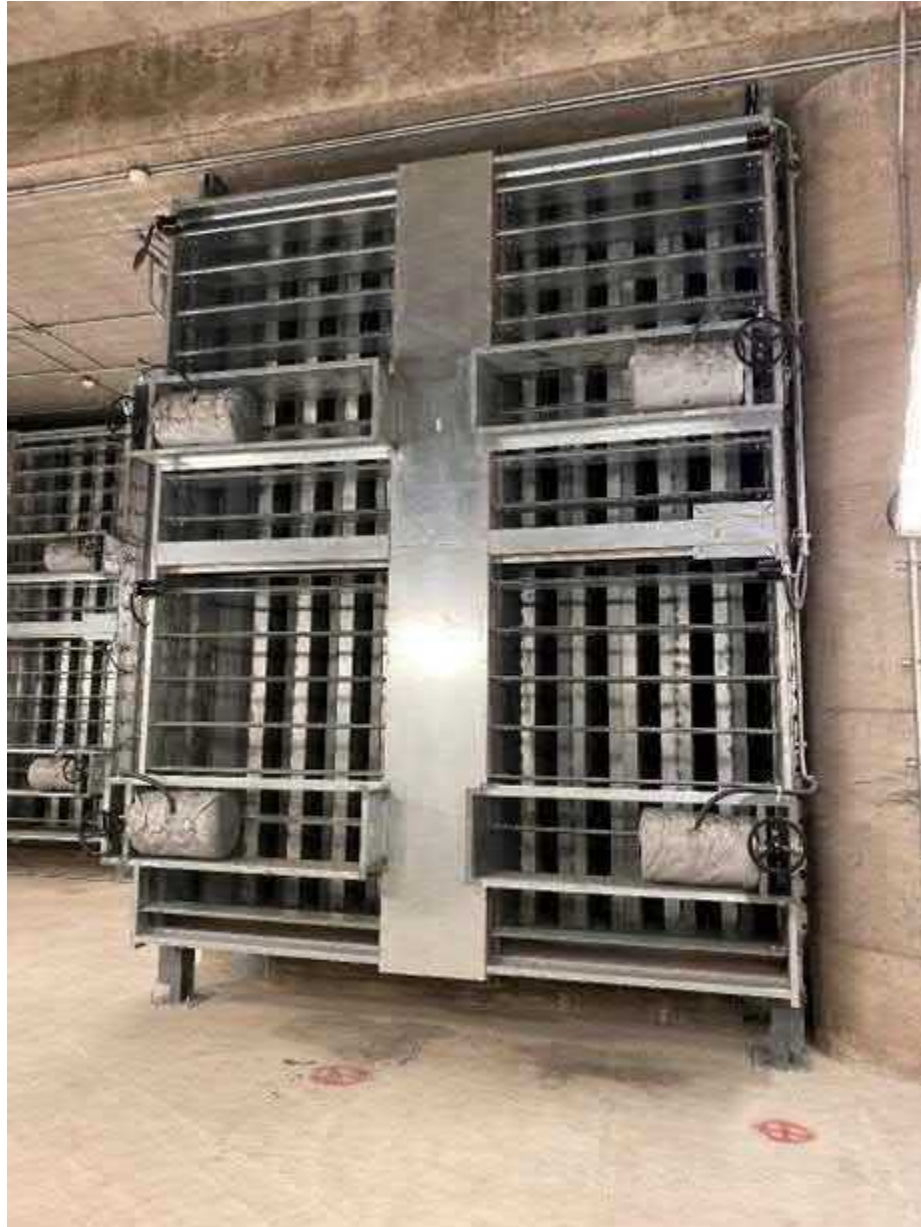
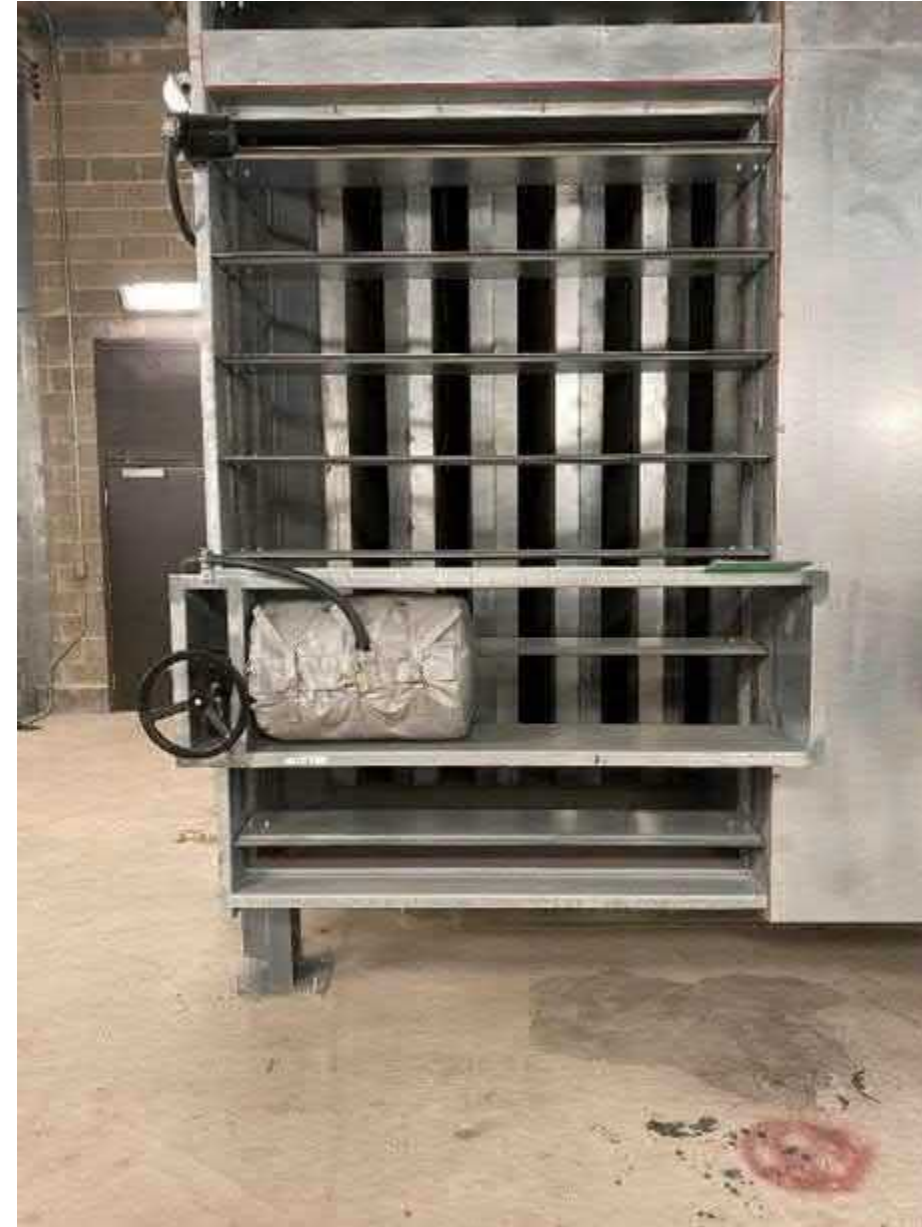
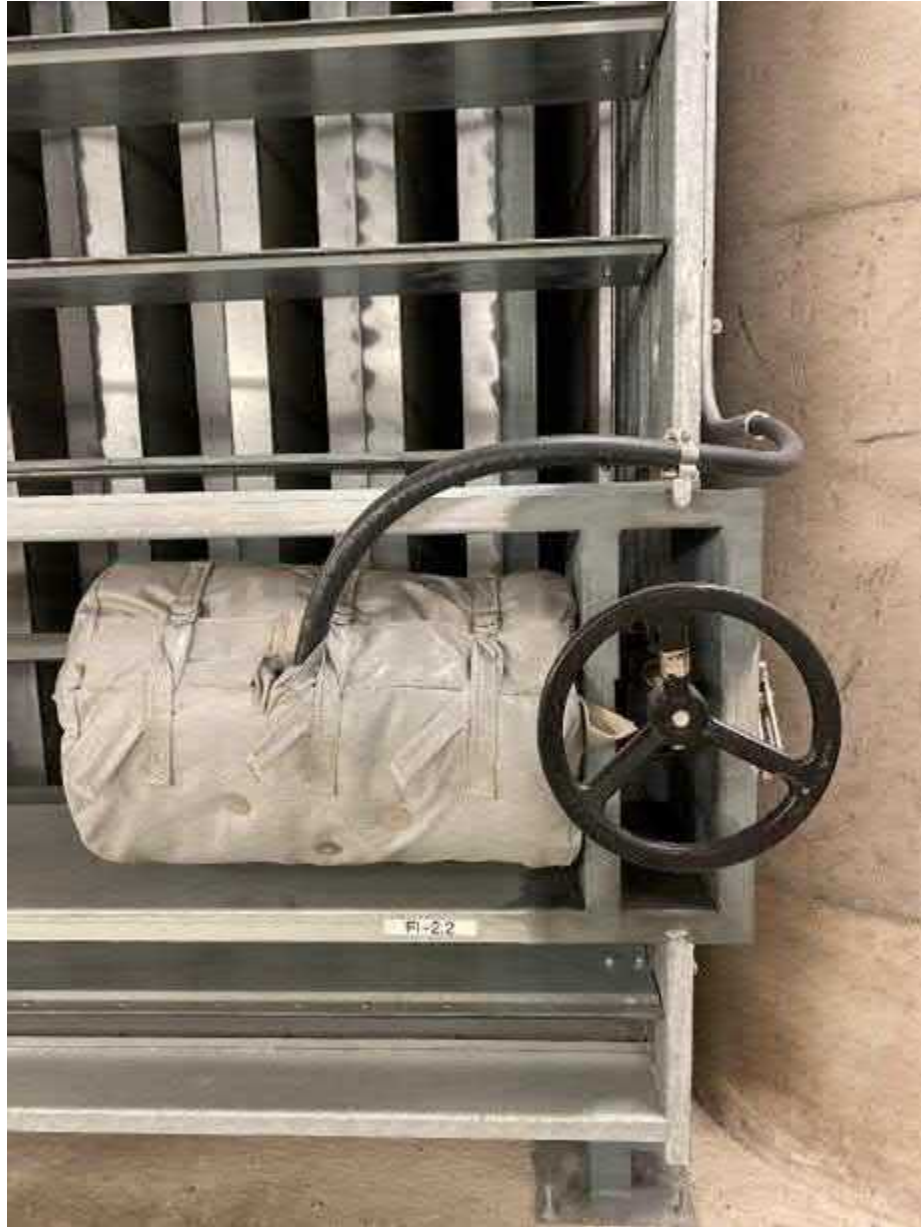
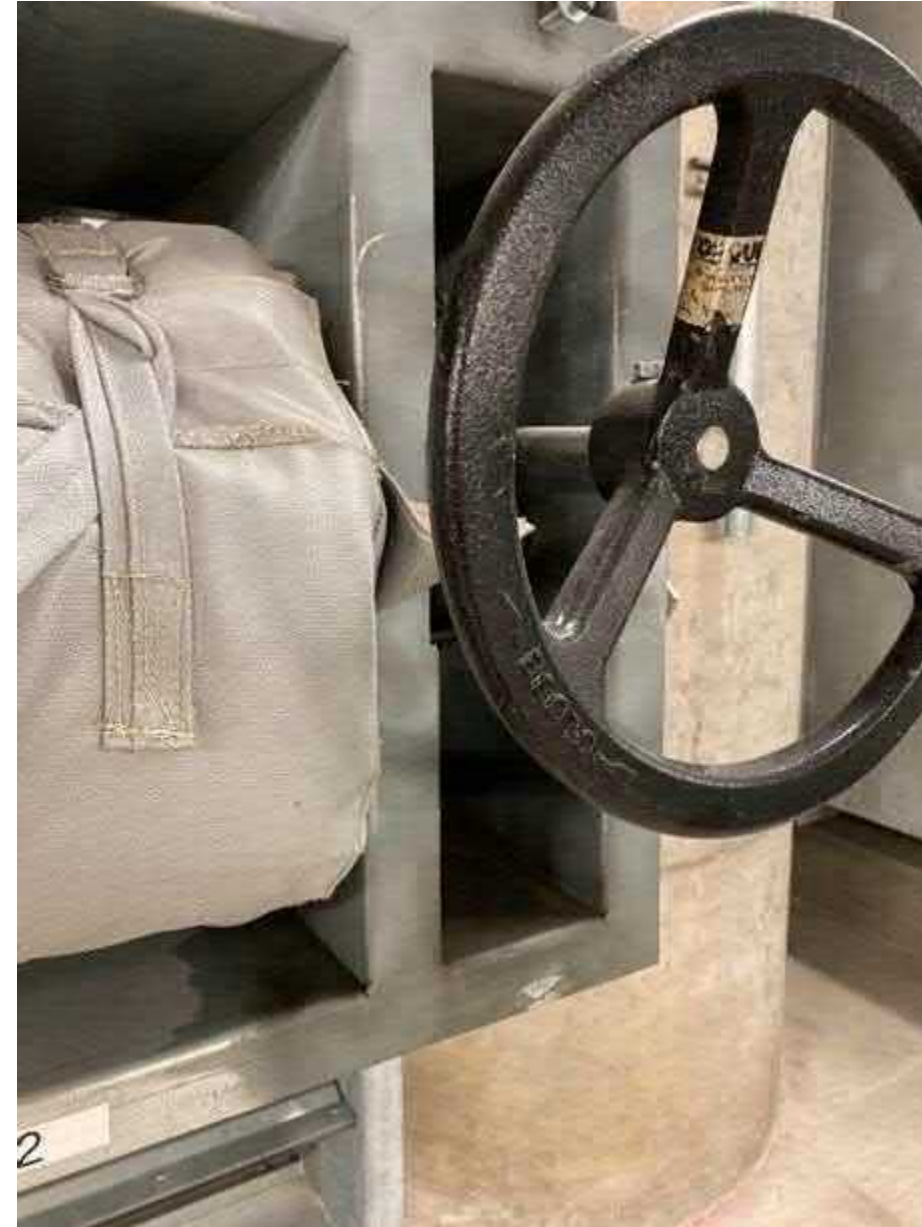
Good. Minor leaks on damper actuators.

Good condition. Minor leaks. CS1.

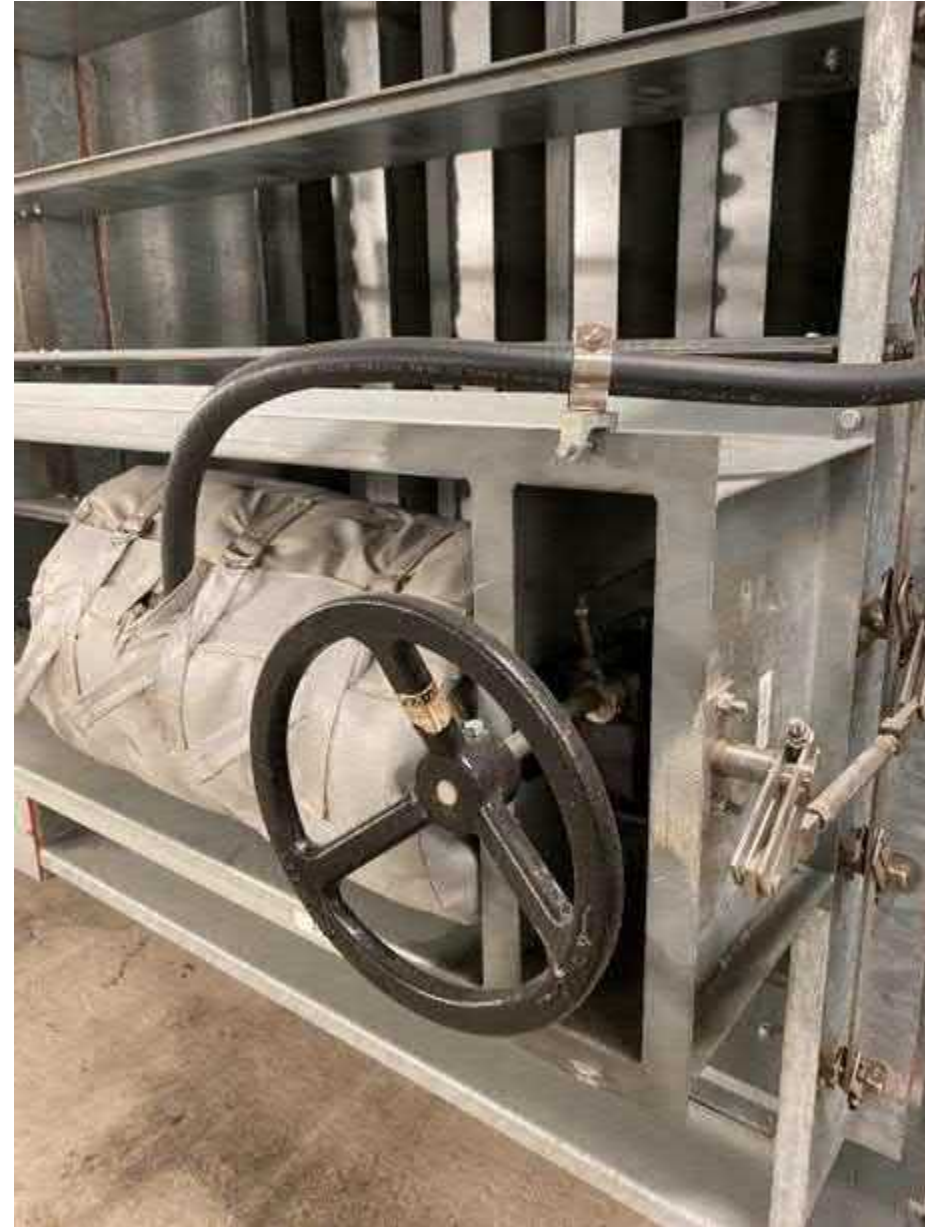
Minor leak

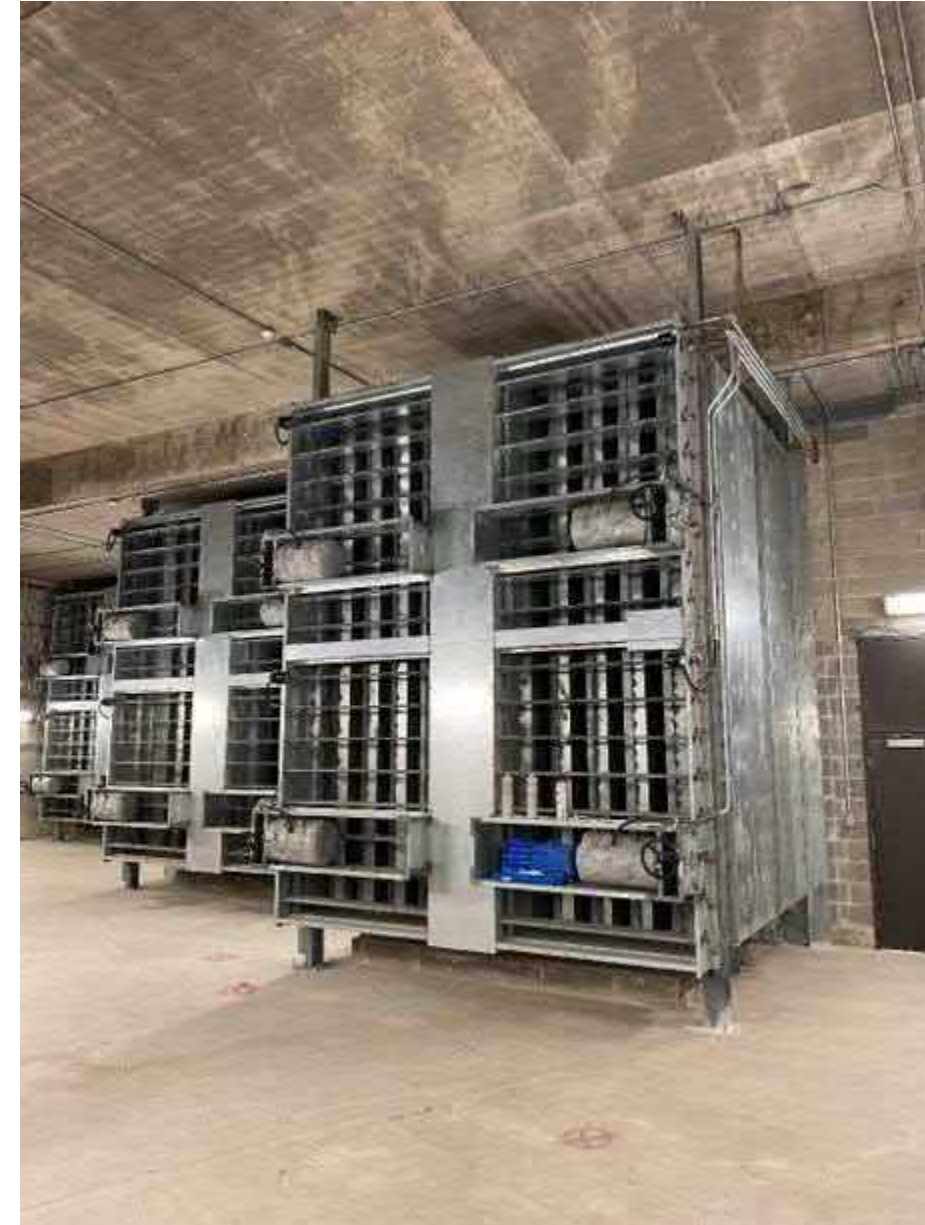
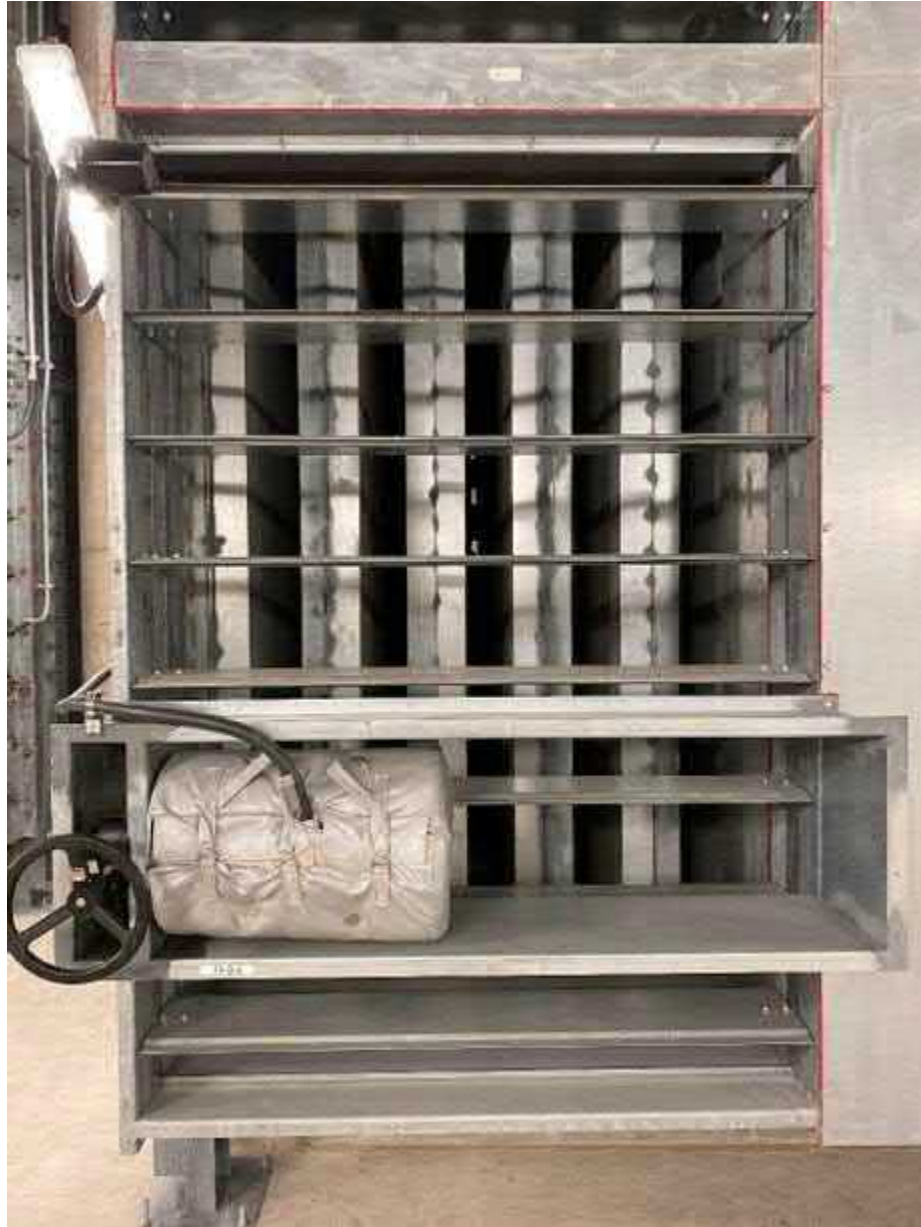
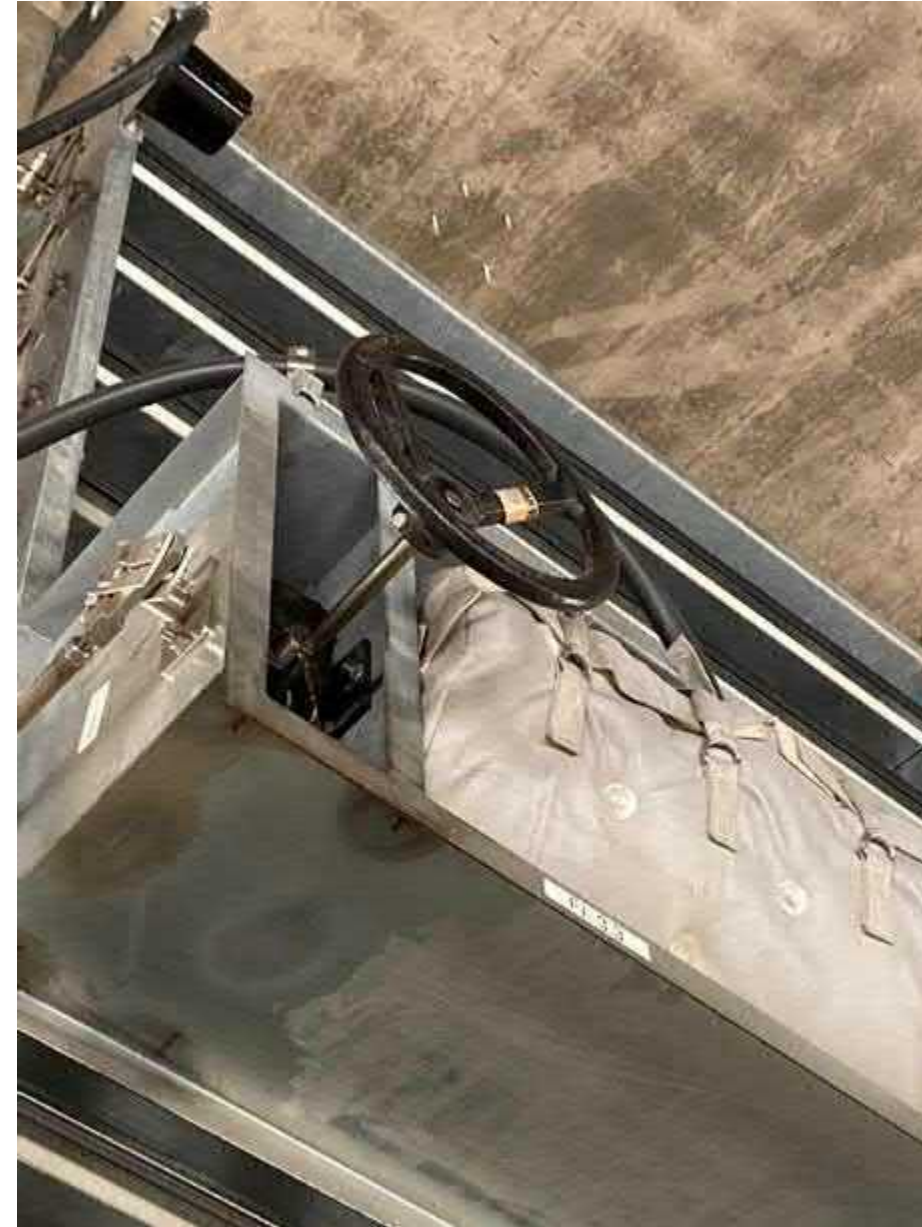
Good condition with minor leaks on actuators. CS1.
