# **Lytle Tunnel (HAM-71-0134) Inspection Report Fall 2020**

PID 105470

November, 2020

Ohio Department of  
Transportation  
District 8  
505 South State Route 741  
Lebanon, OH 45036

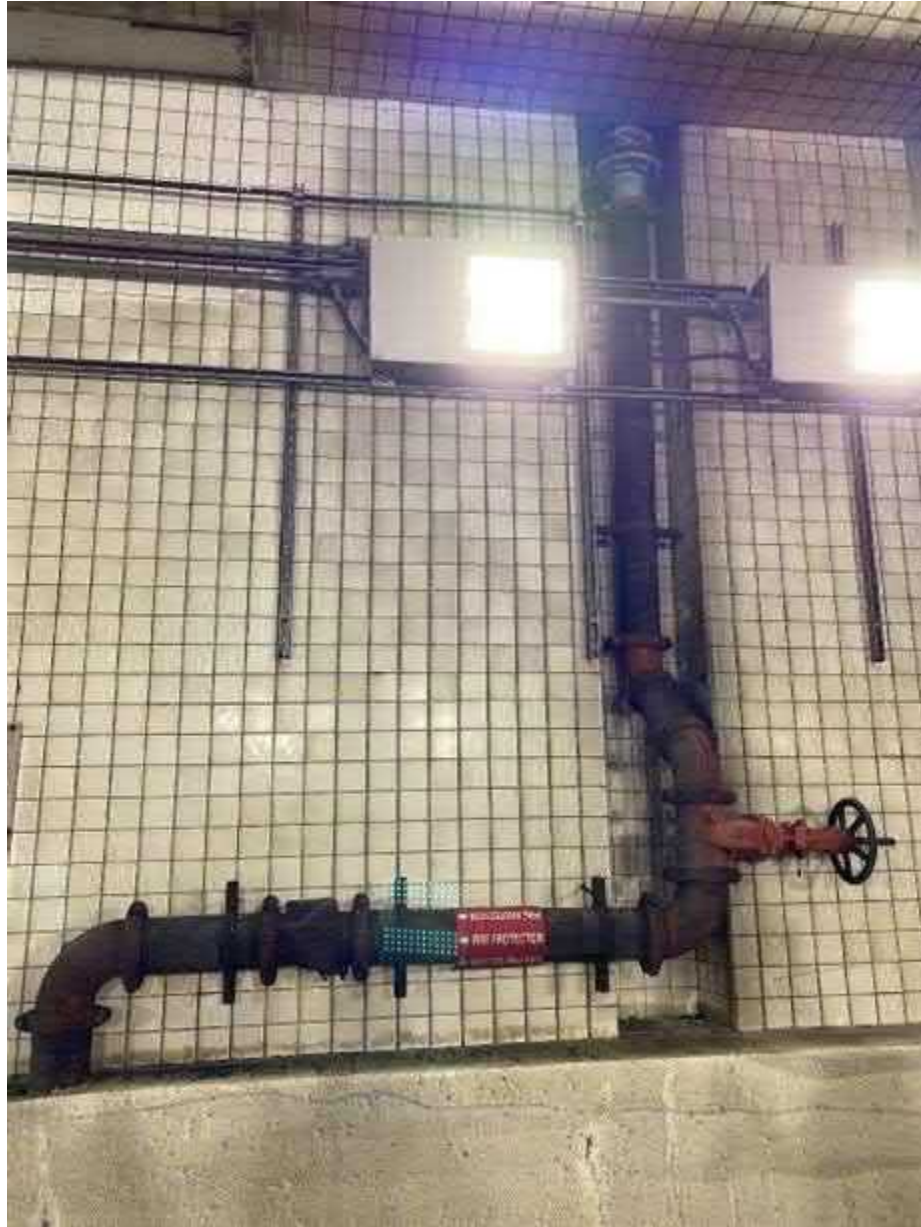
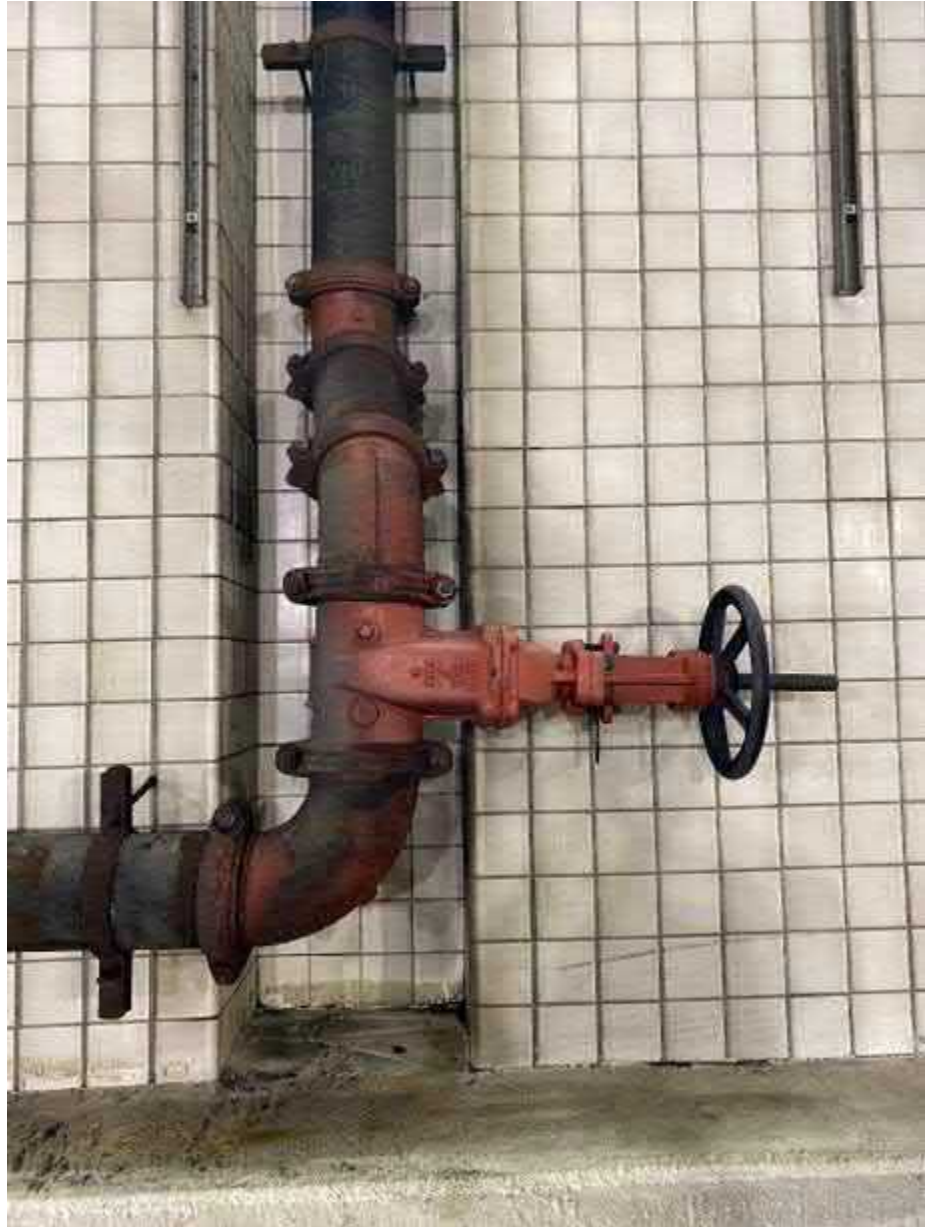
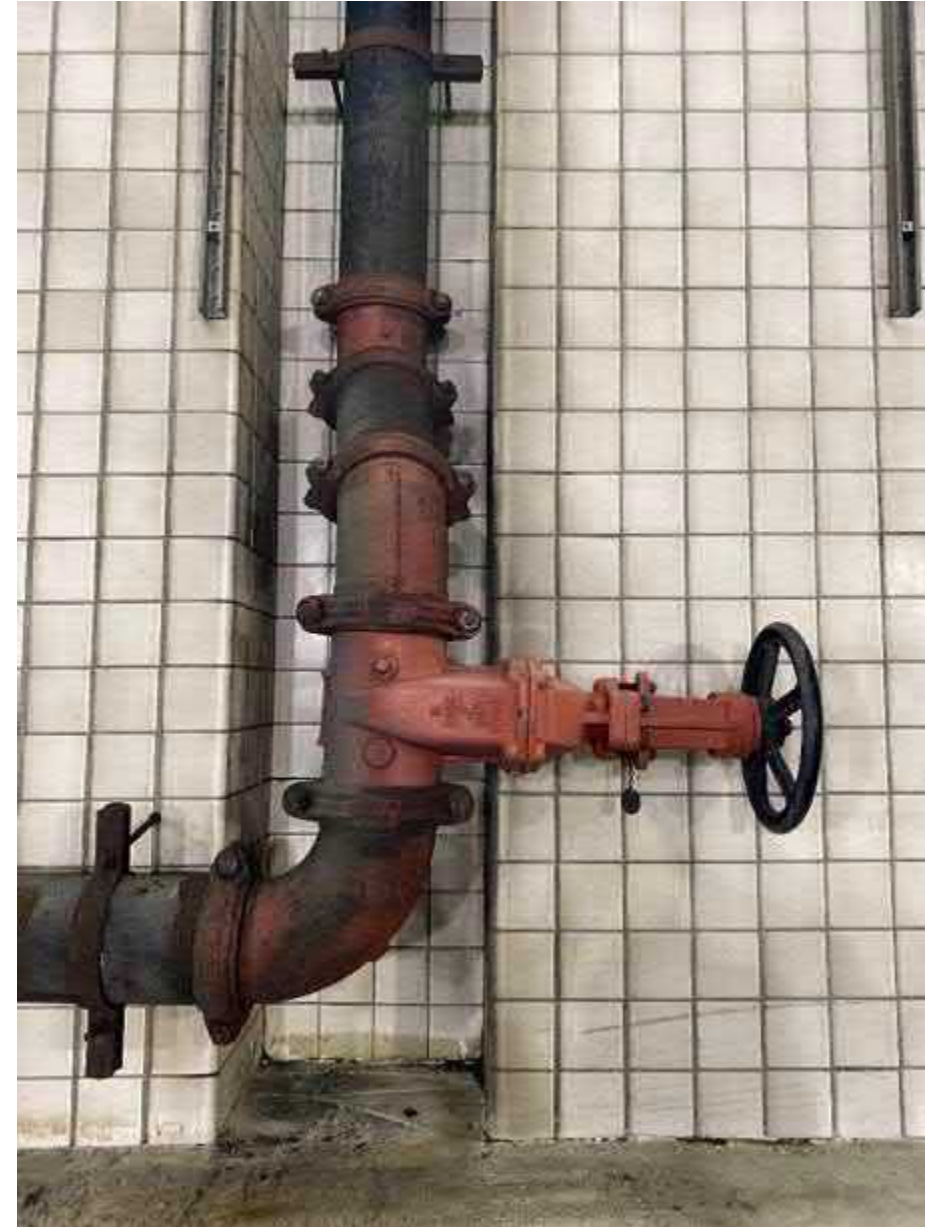
Minor surface rust on check valve, gate valve and riser. CS1

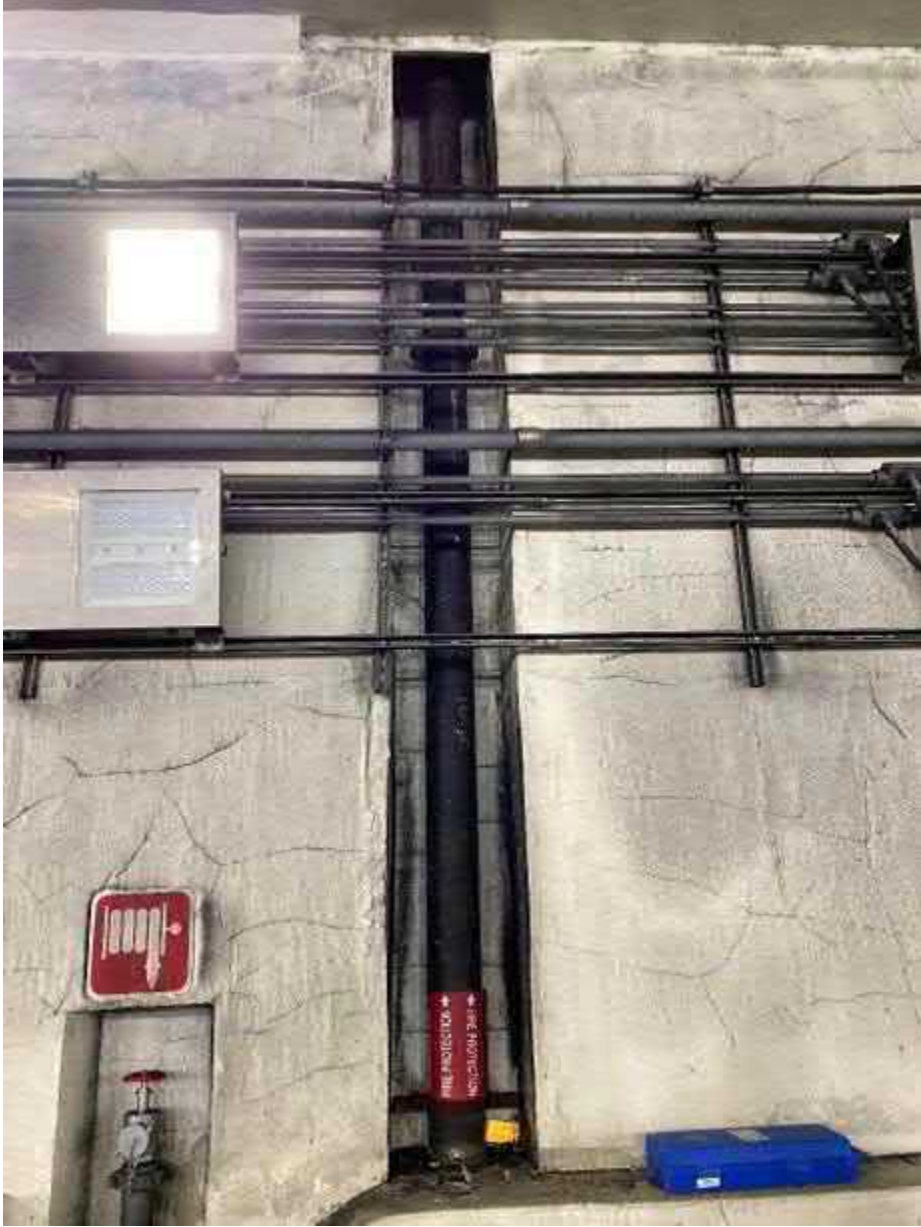
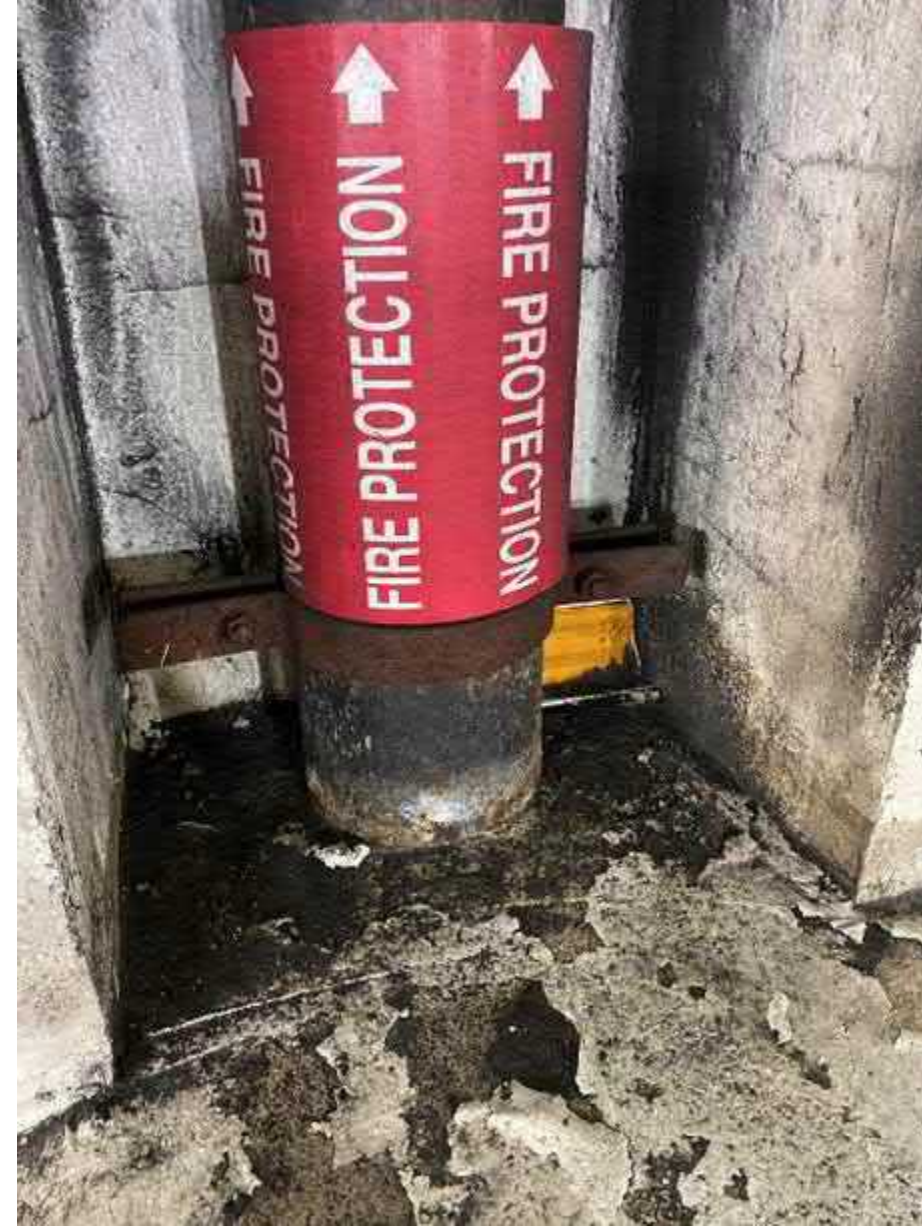
Good condition. CS1

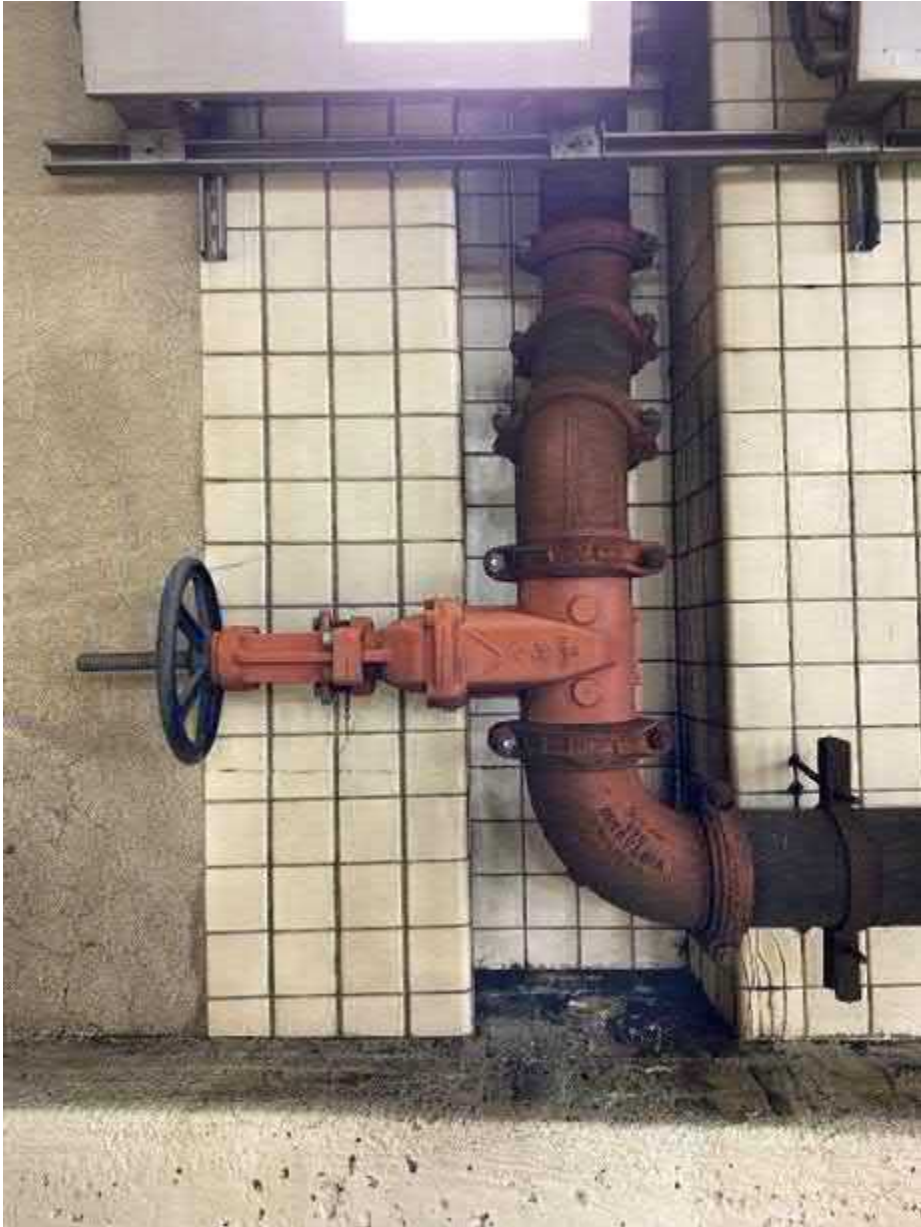
Riser and gate valve in good condition. CS1

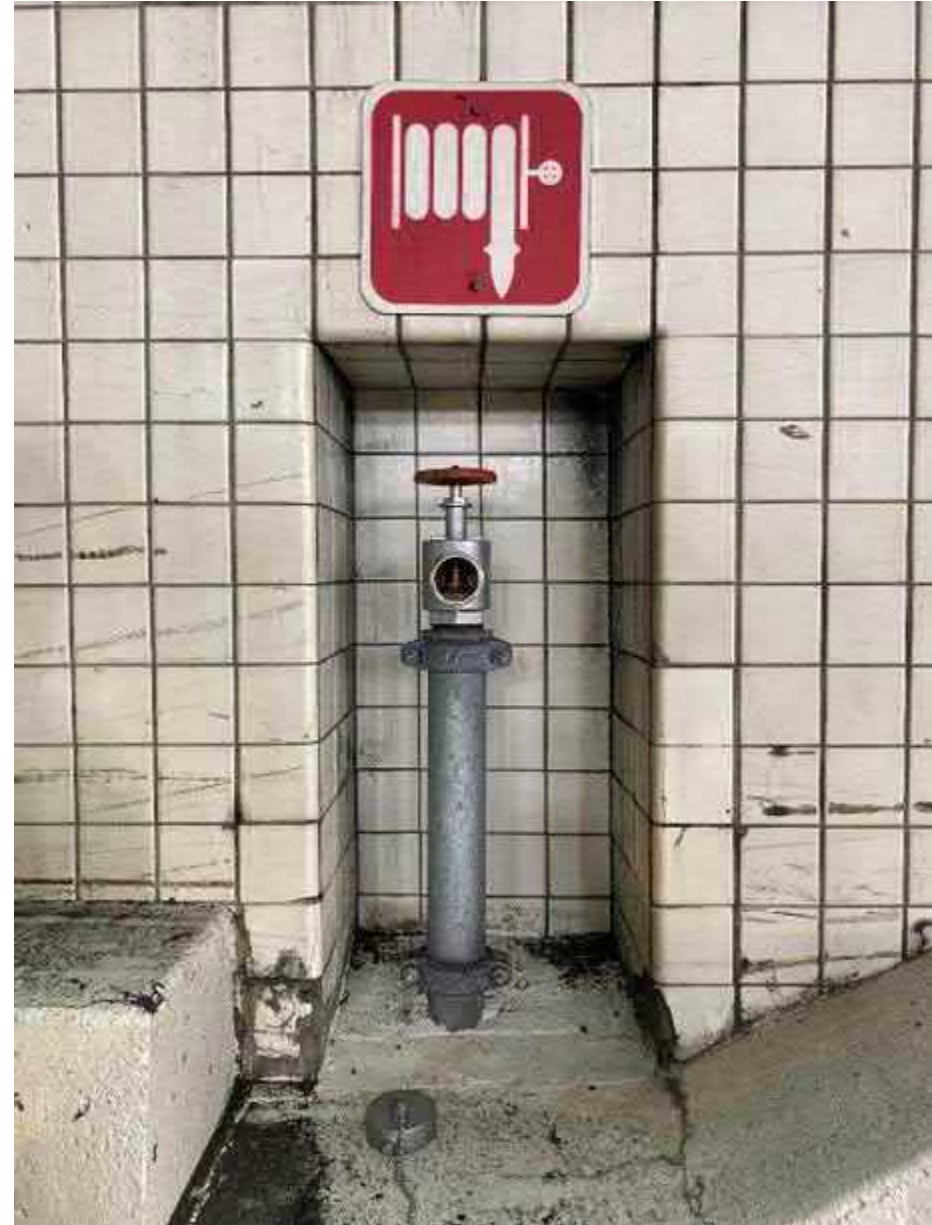
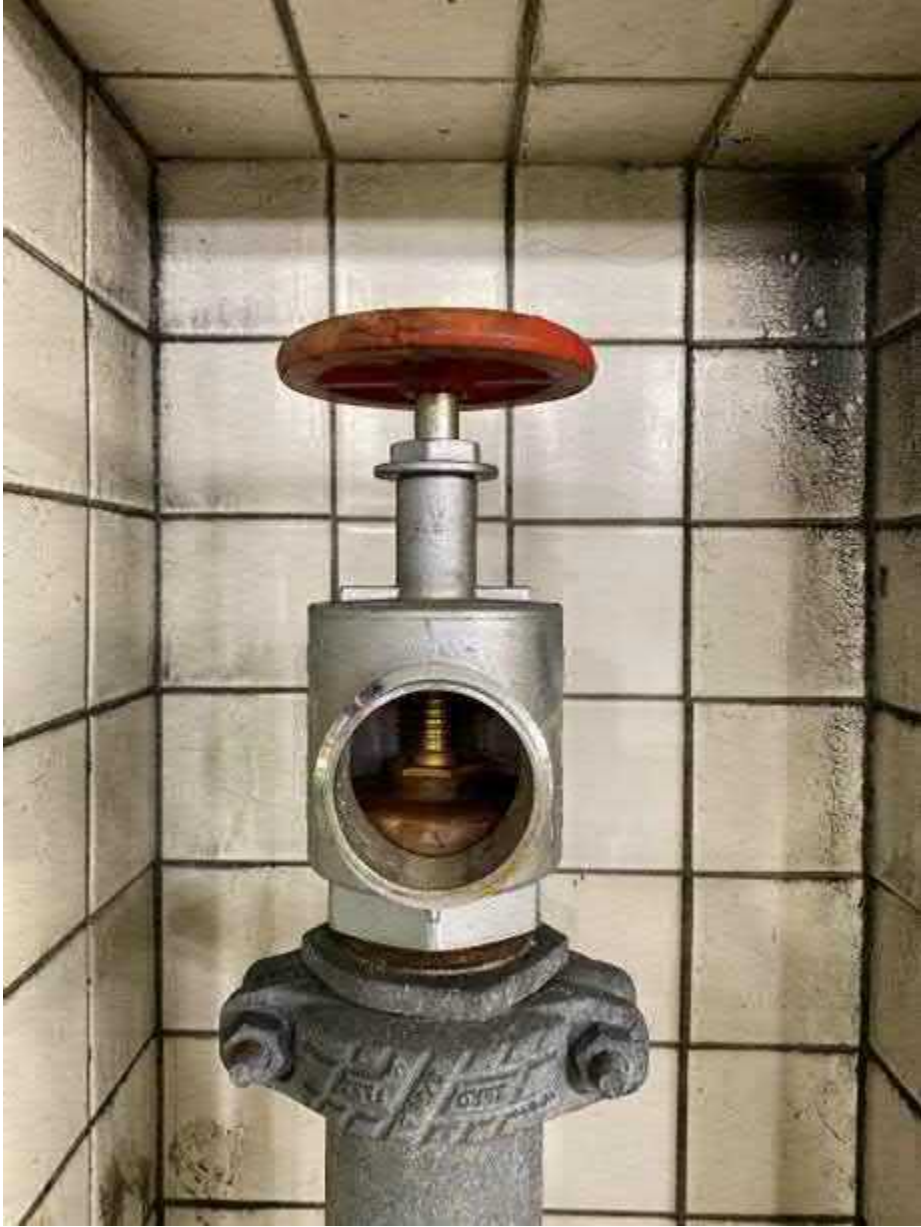
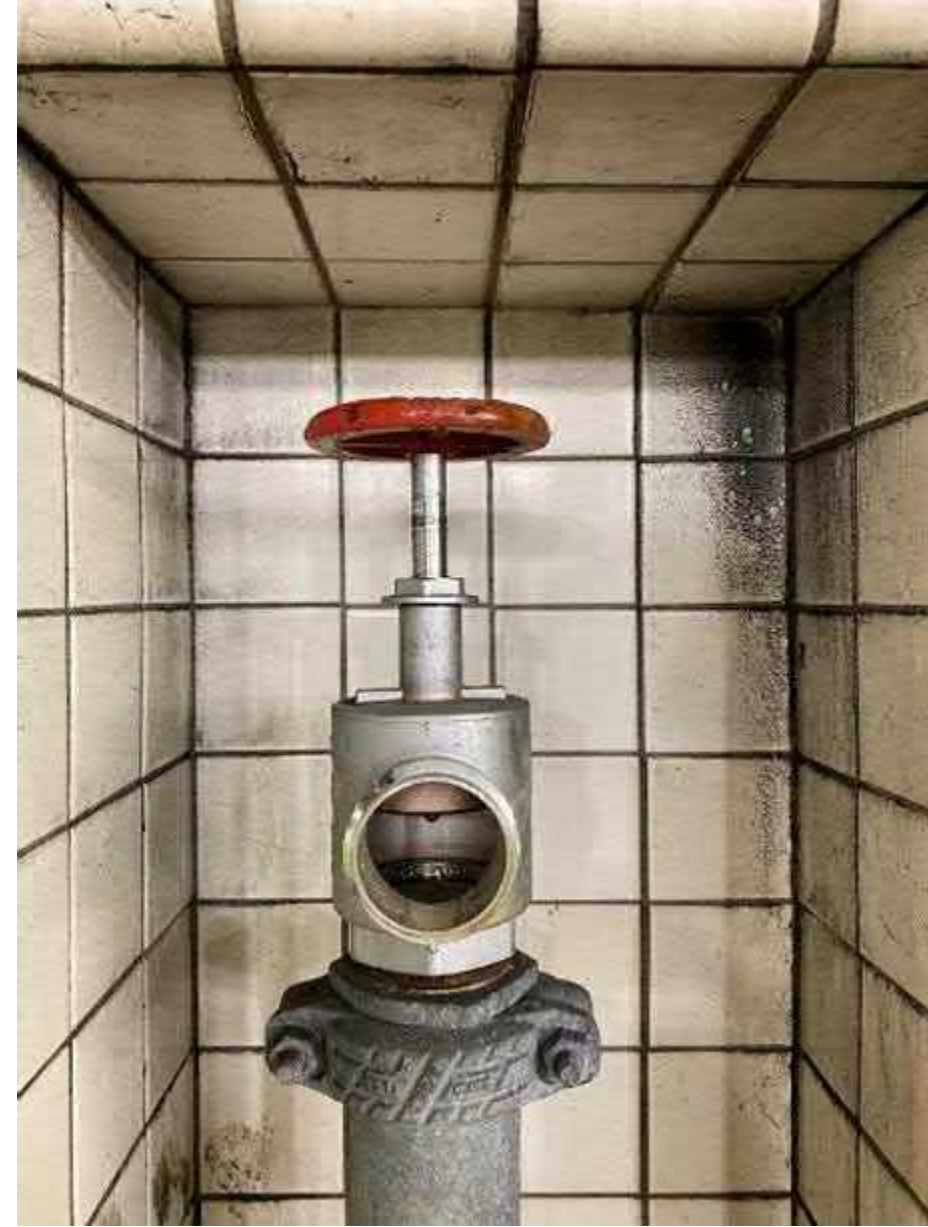
Good condition. CS1

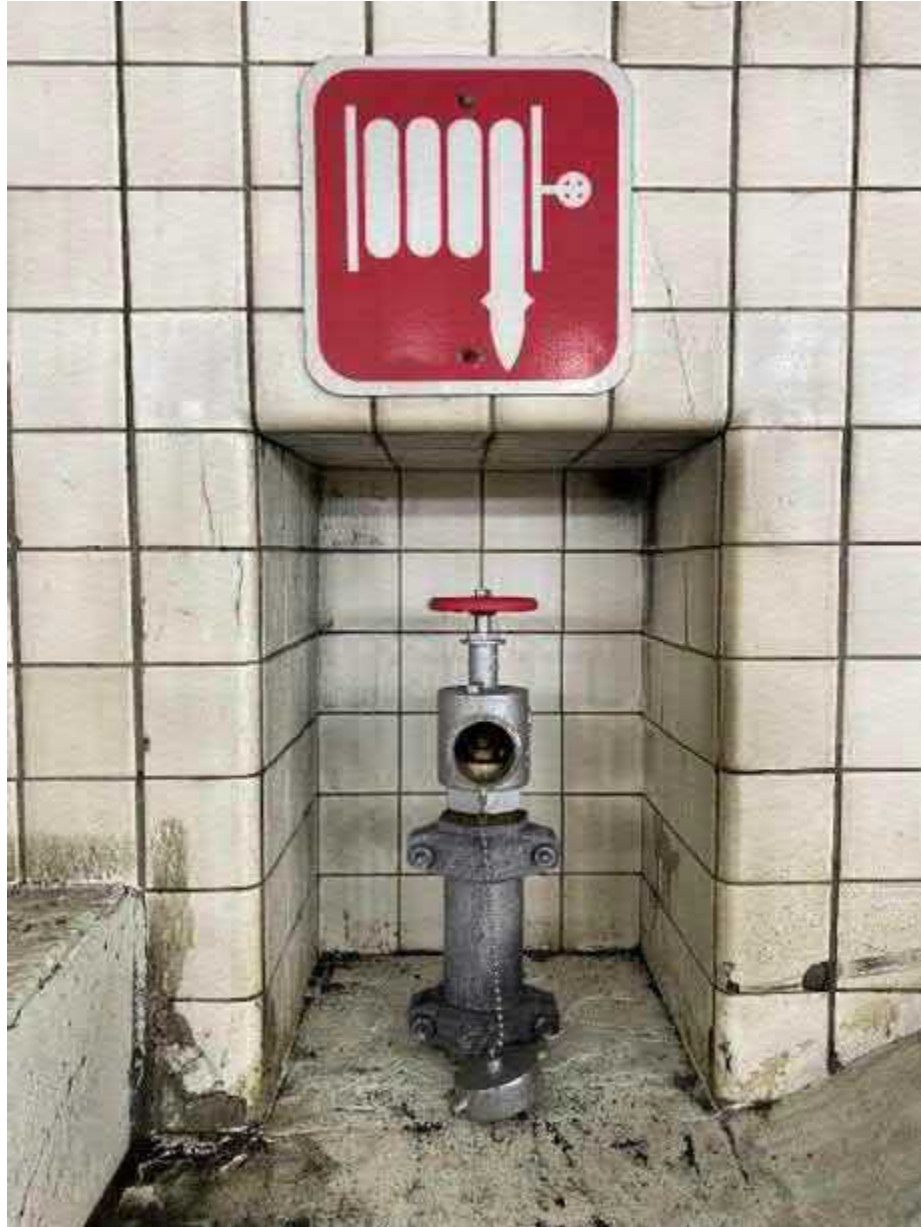
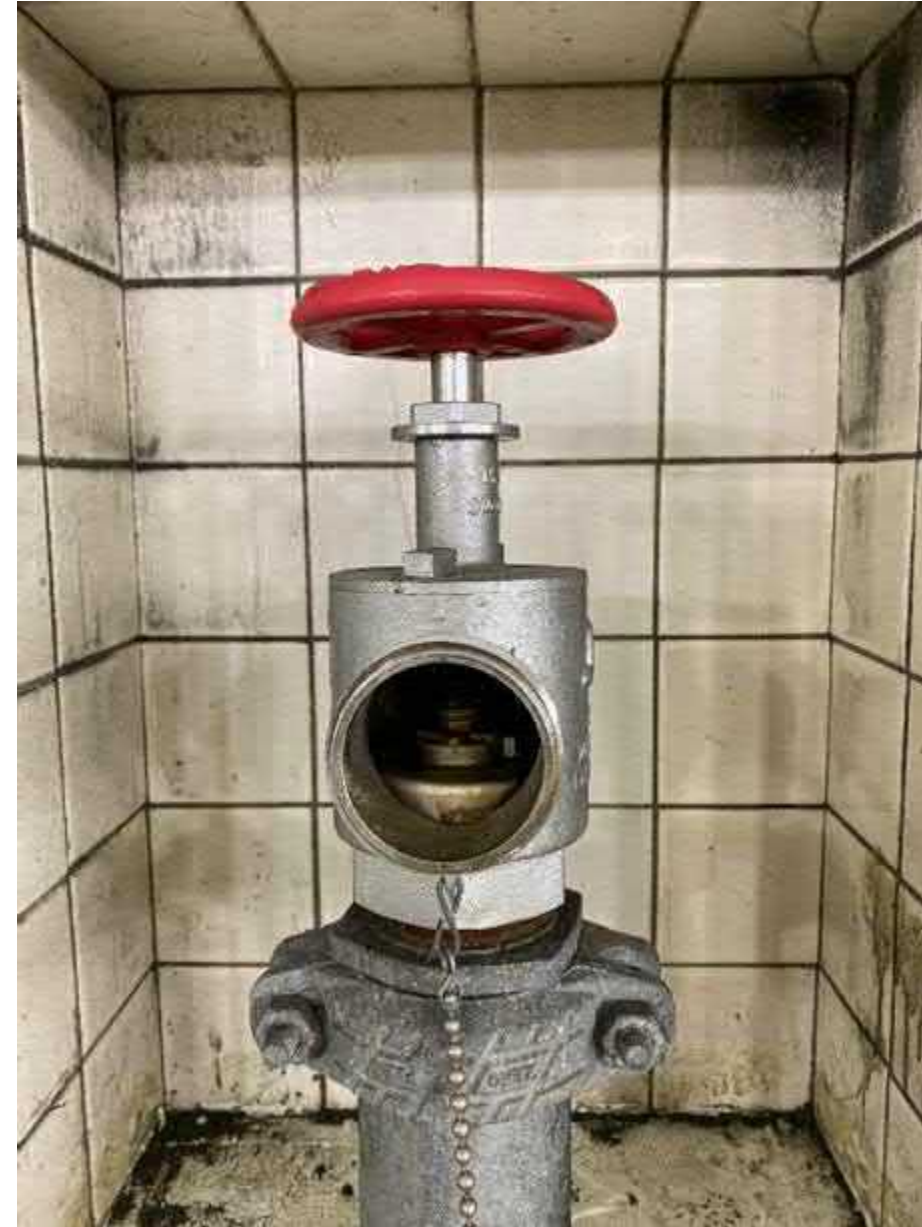
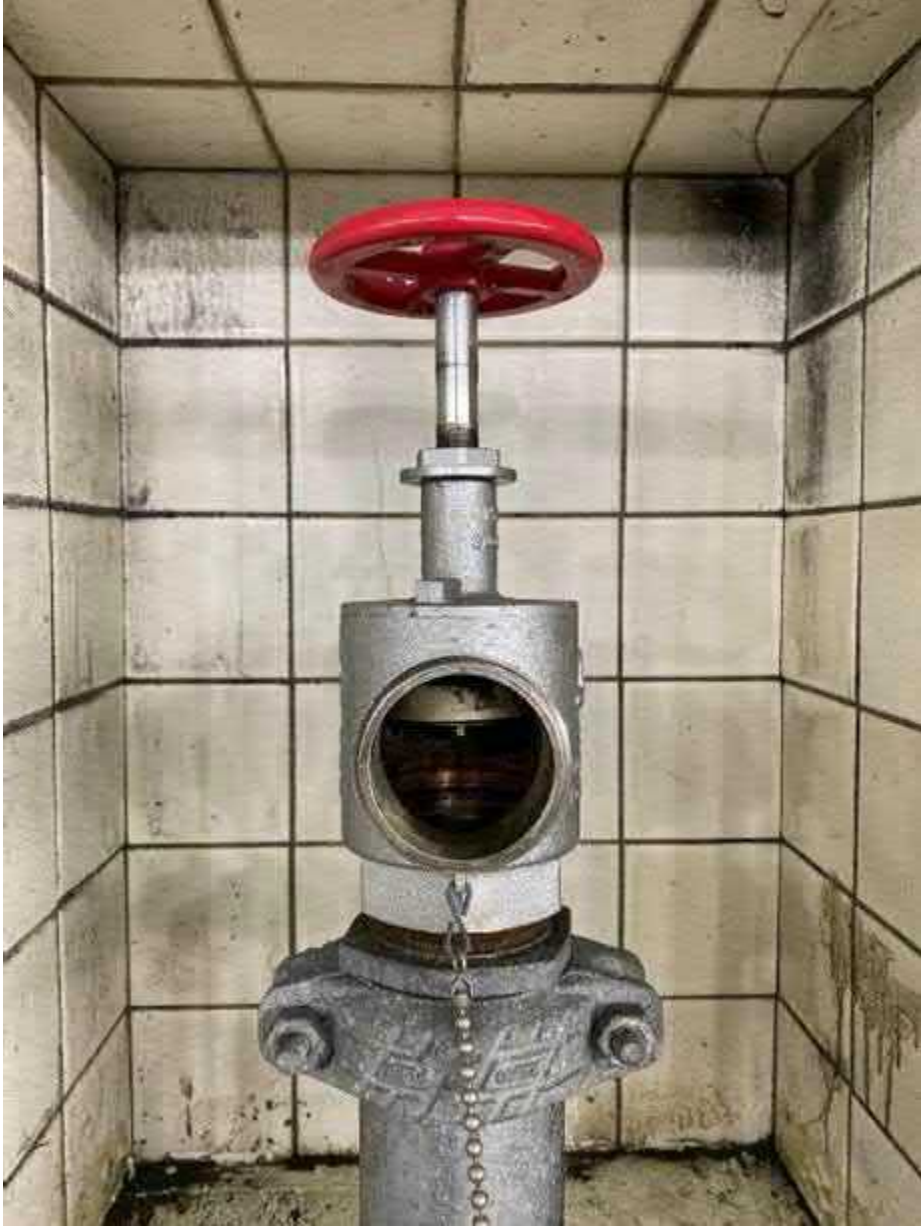
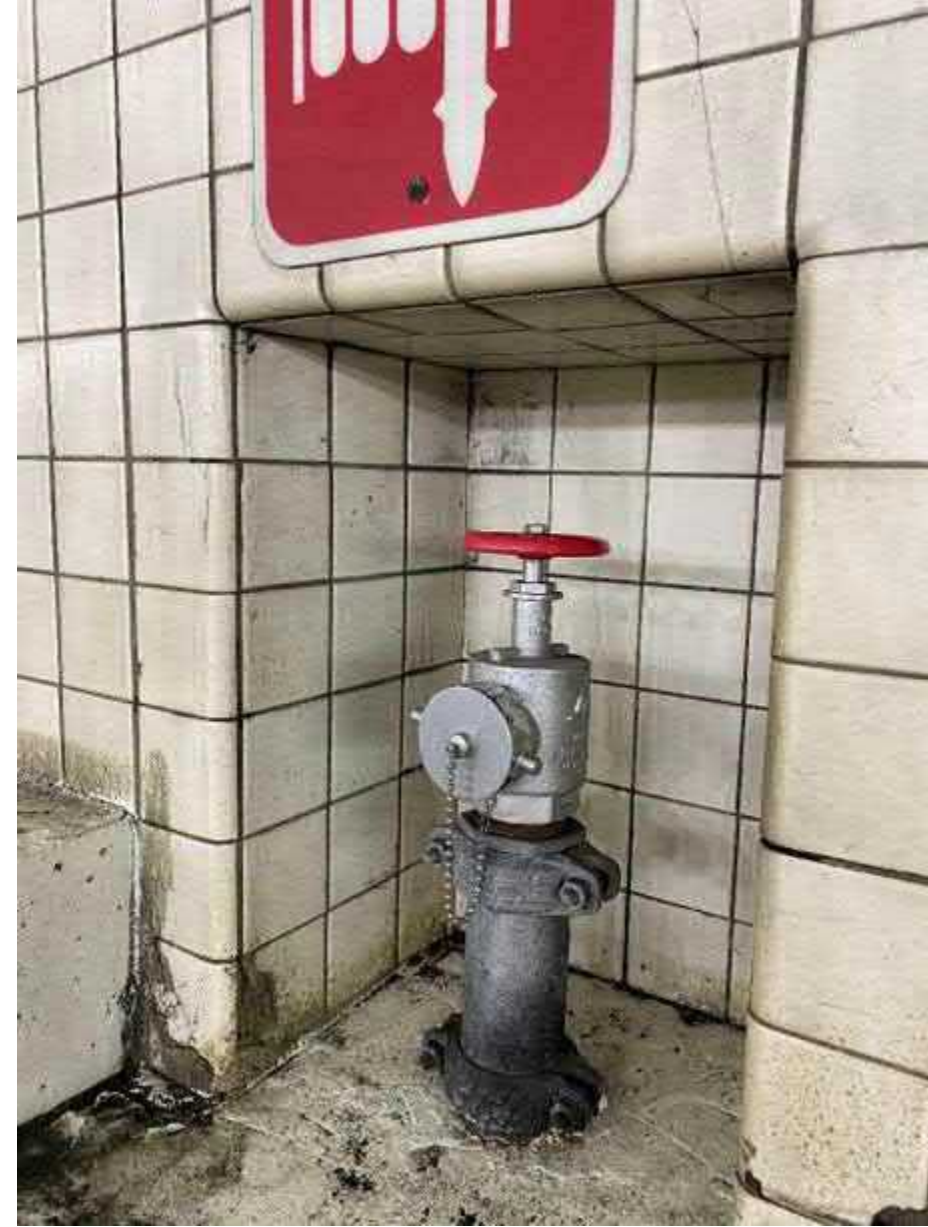
Good condition. CS1

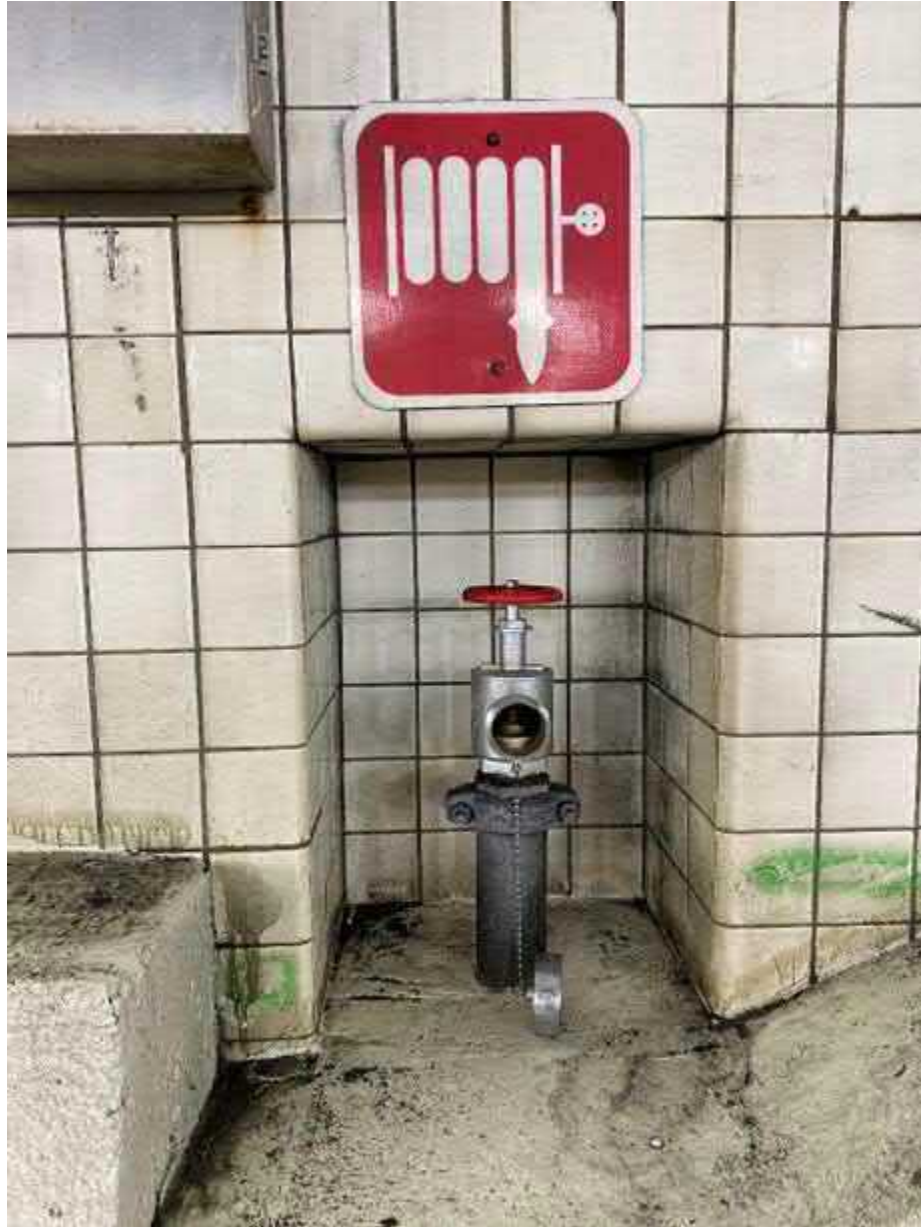
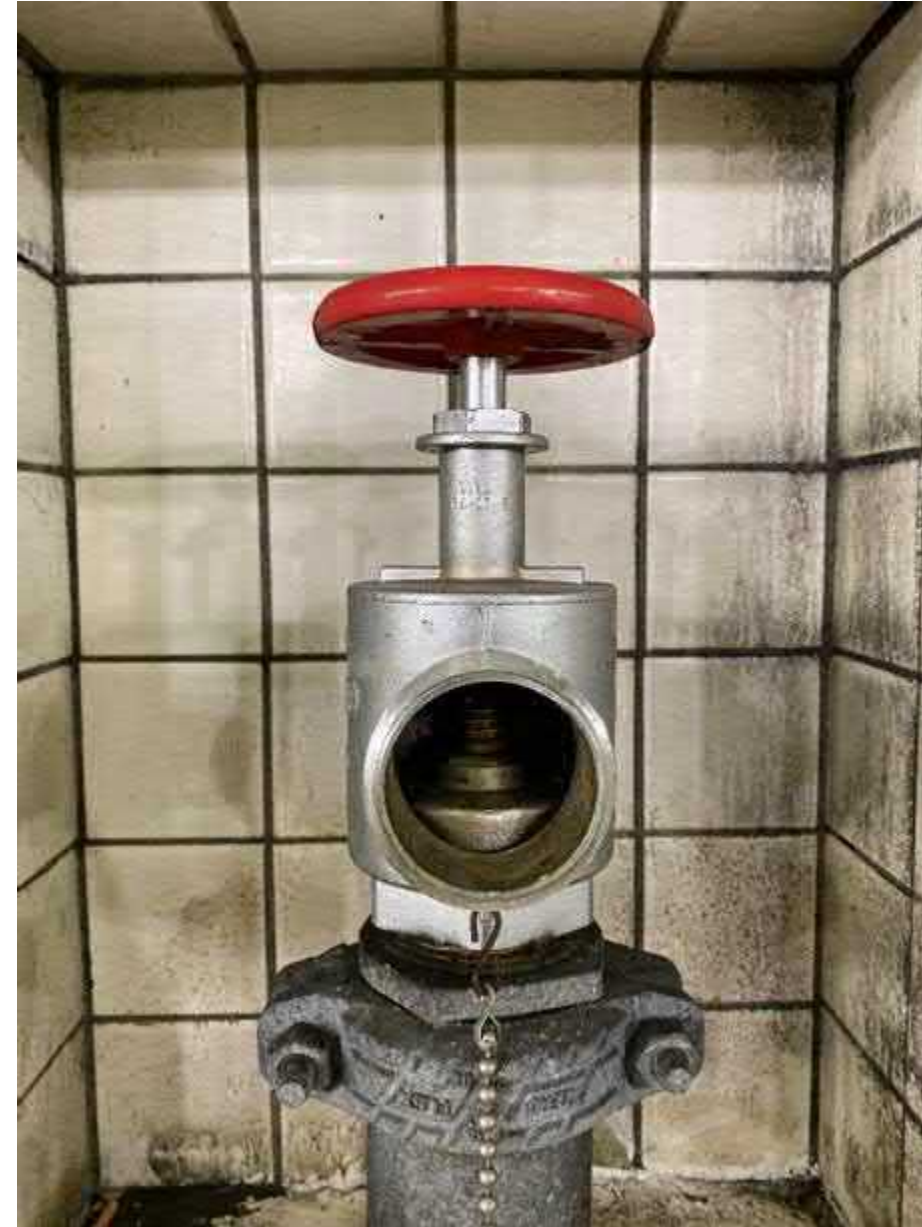
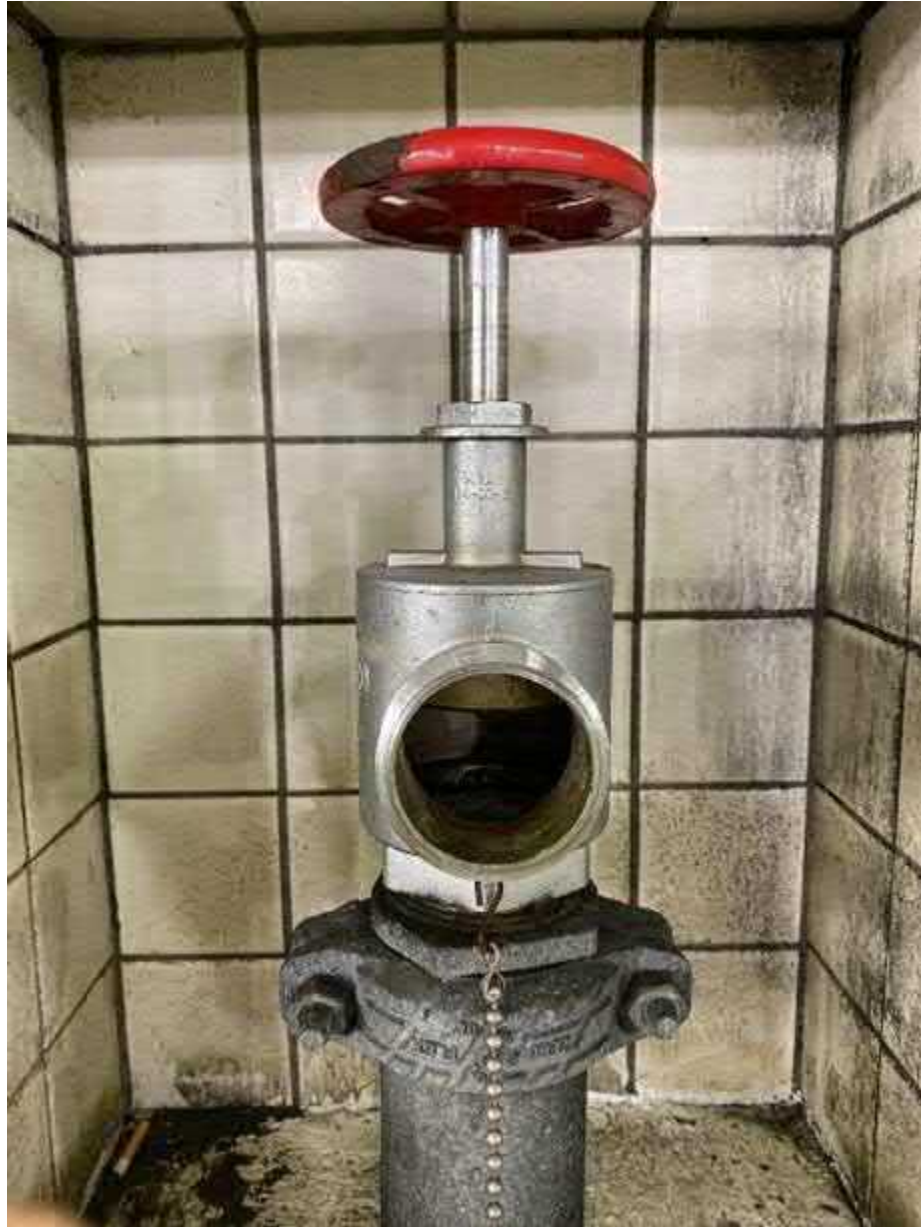
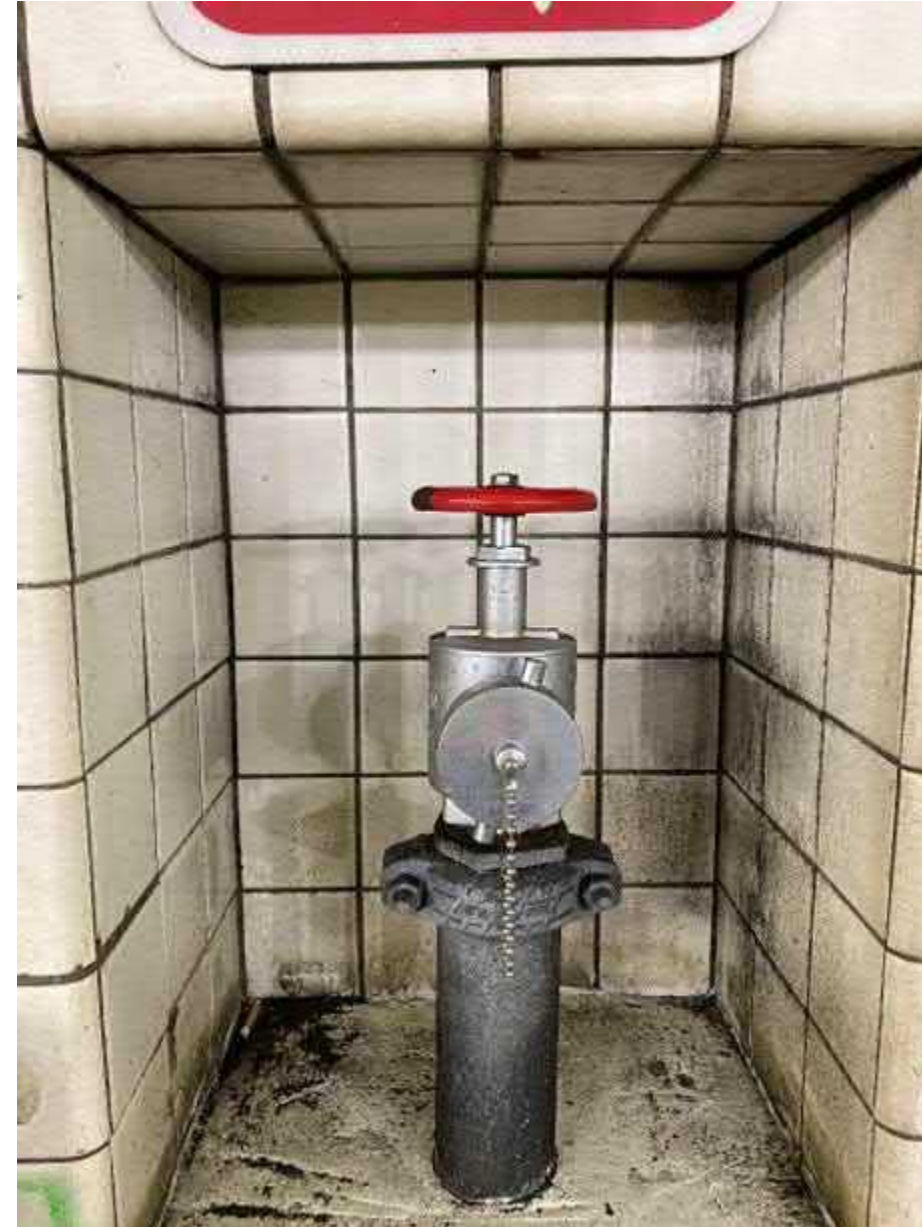
Good condition. CS1

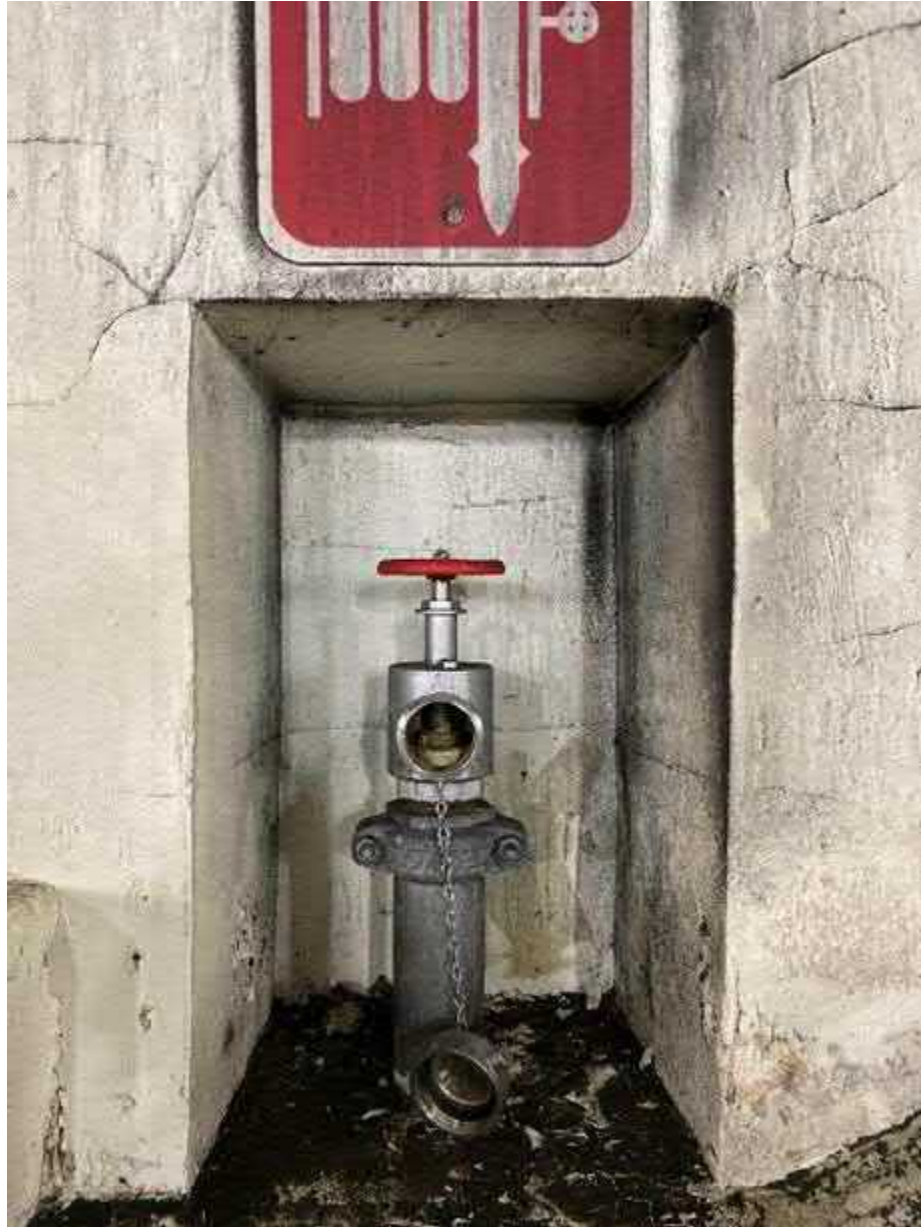
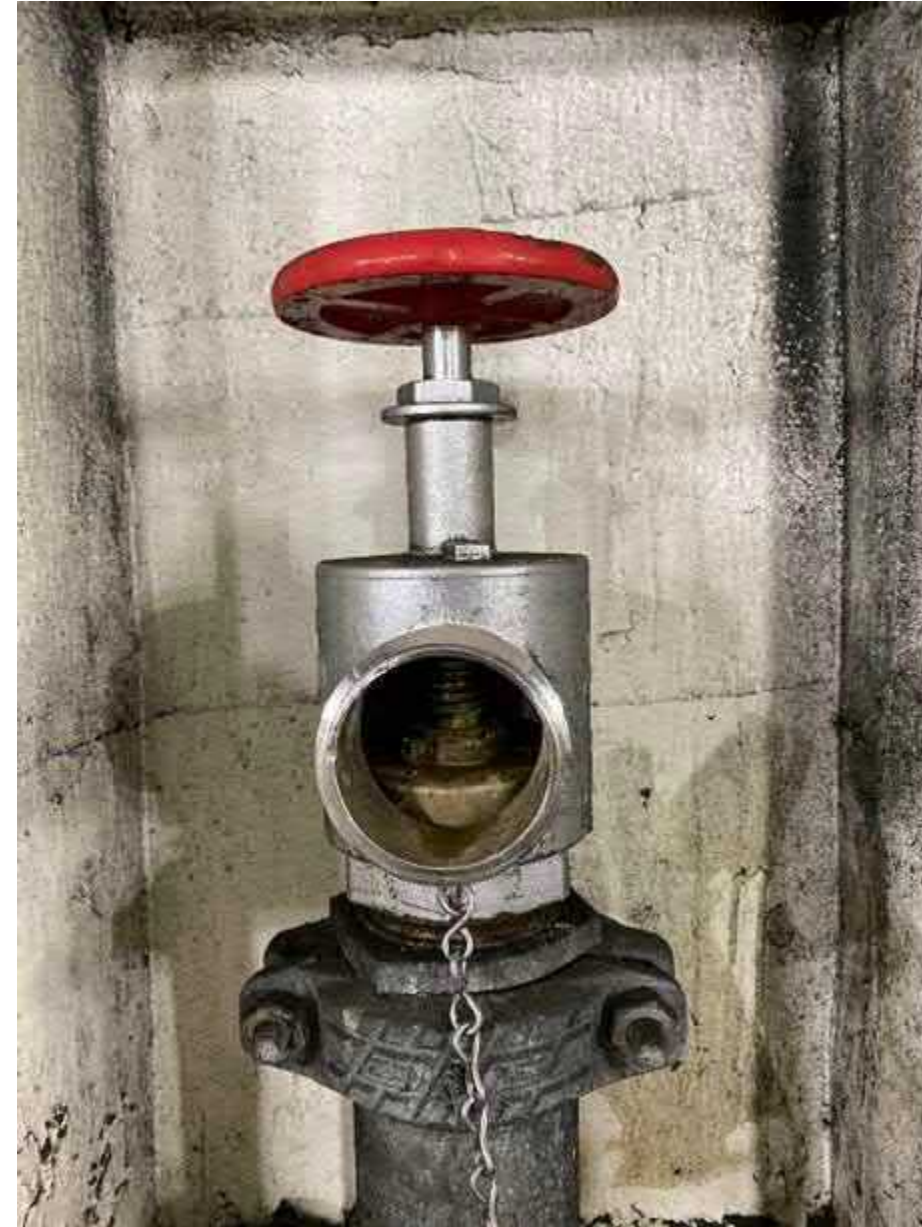
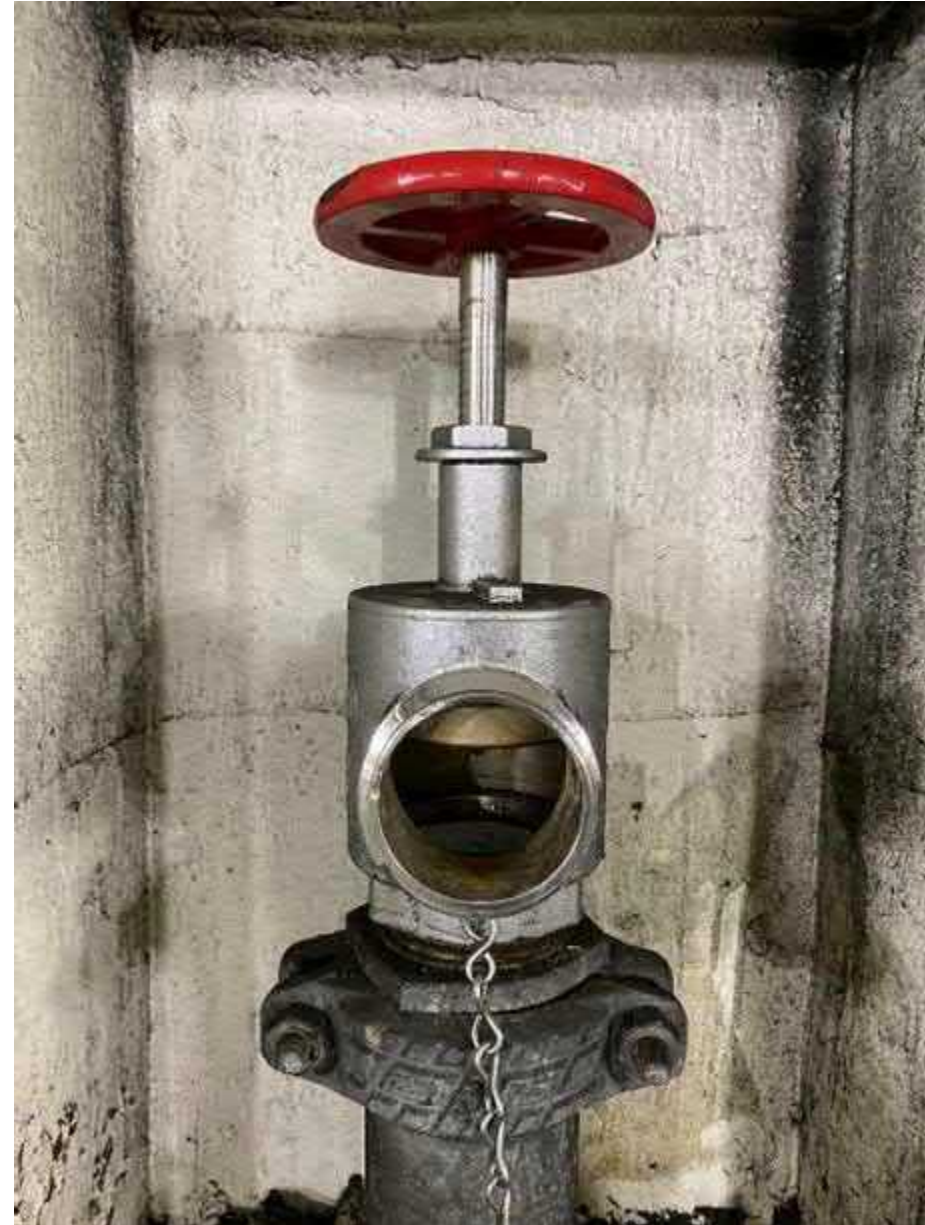
Good condition. CS1
