# **Lytle Tunnel (HAM-71-0134) Inspection Report Fall 2020**

PID 105470

November, 2020

Ohio Department of  
Transportation  
District 8  
505 South State Route 741  
Lebanon, OH 45036

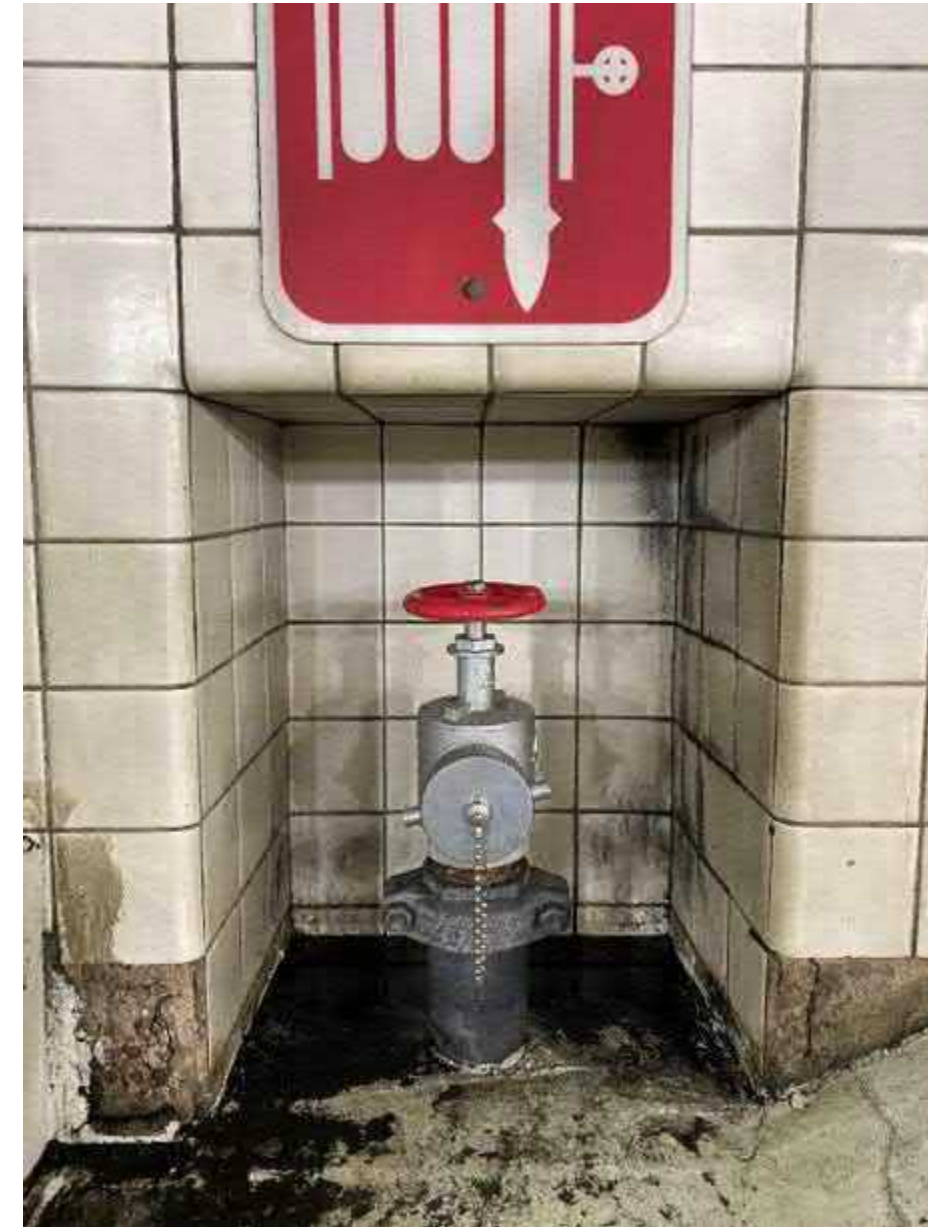
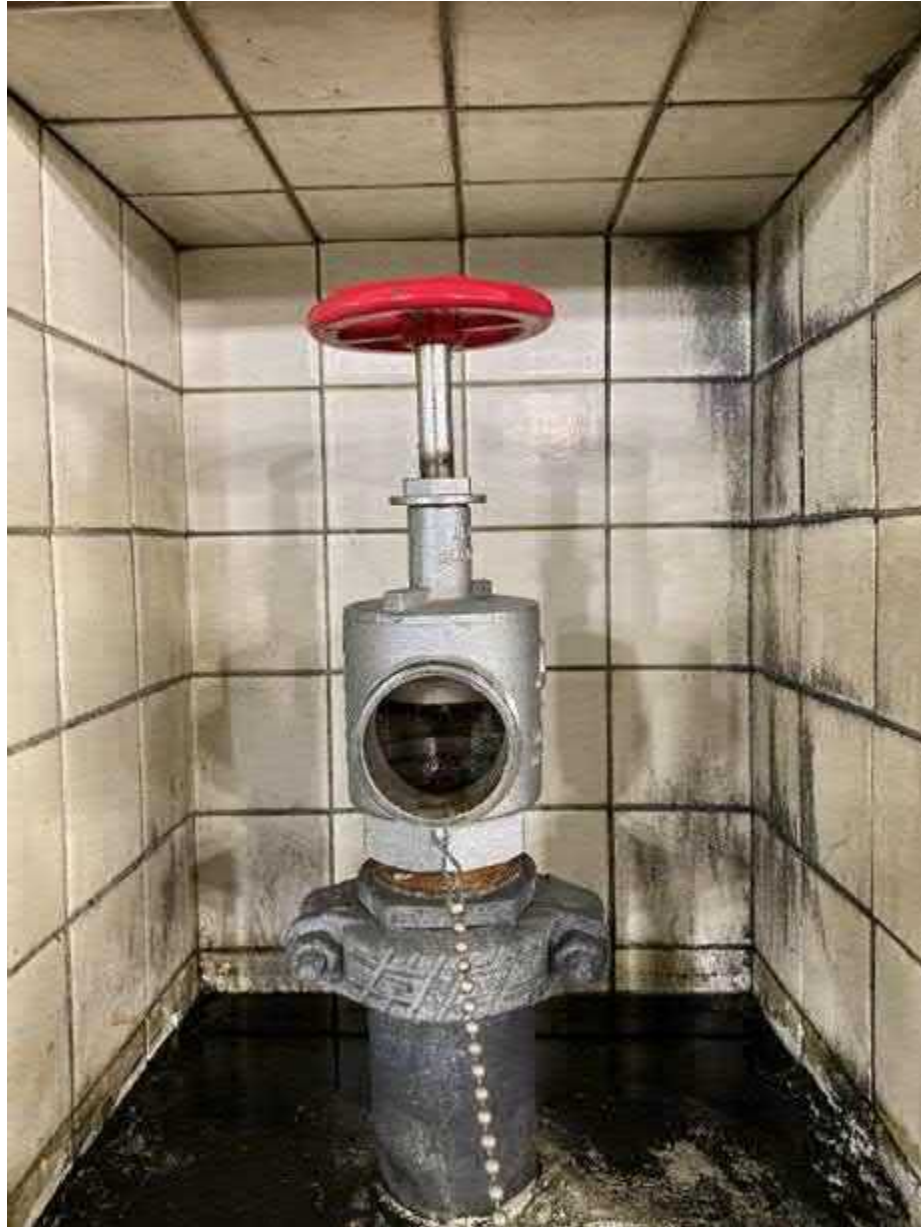
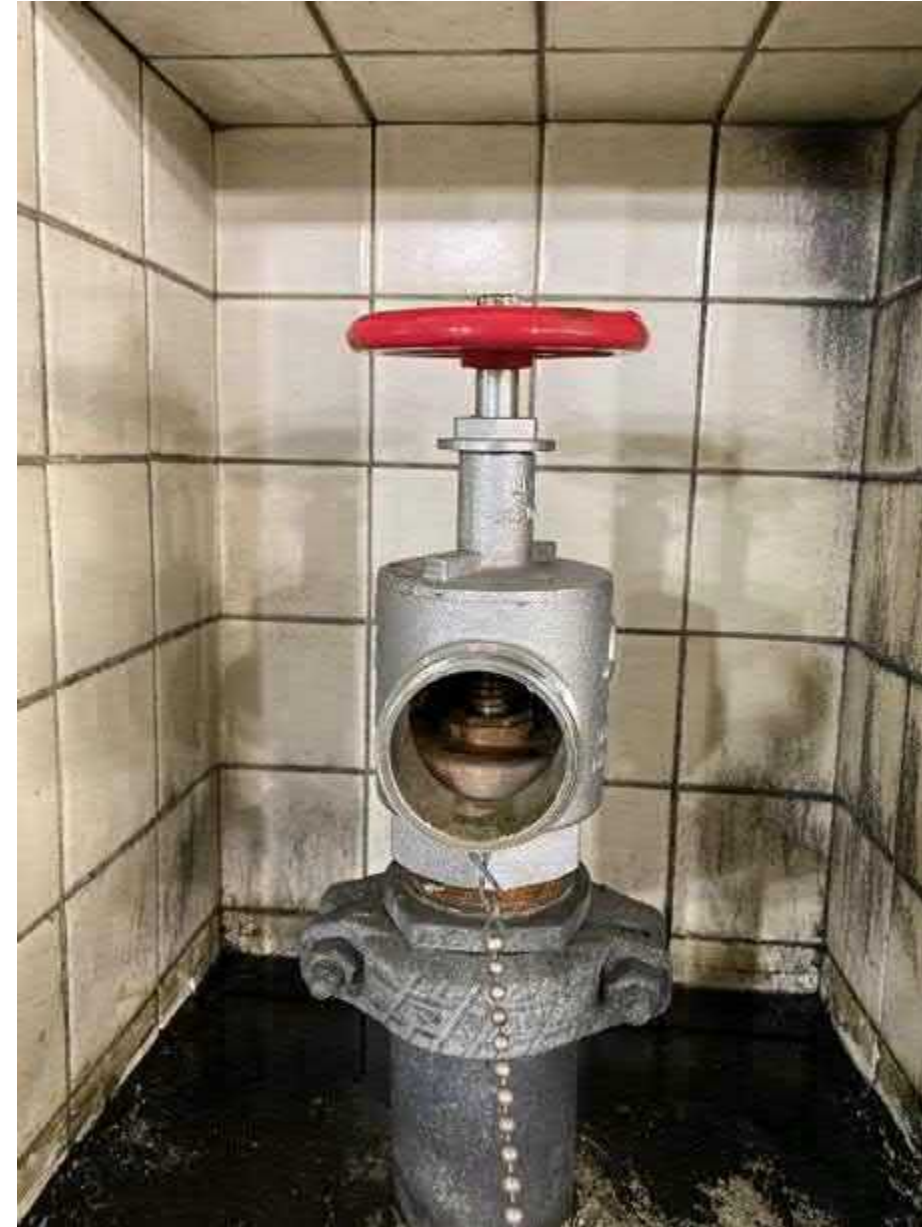
Good condition. CS1

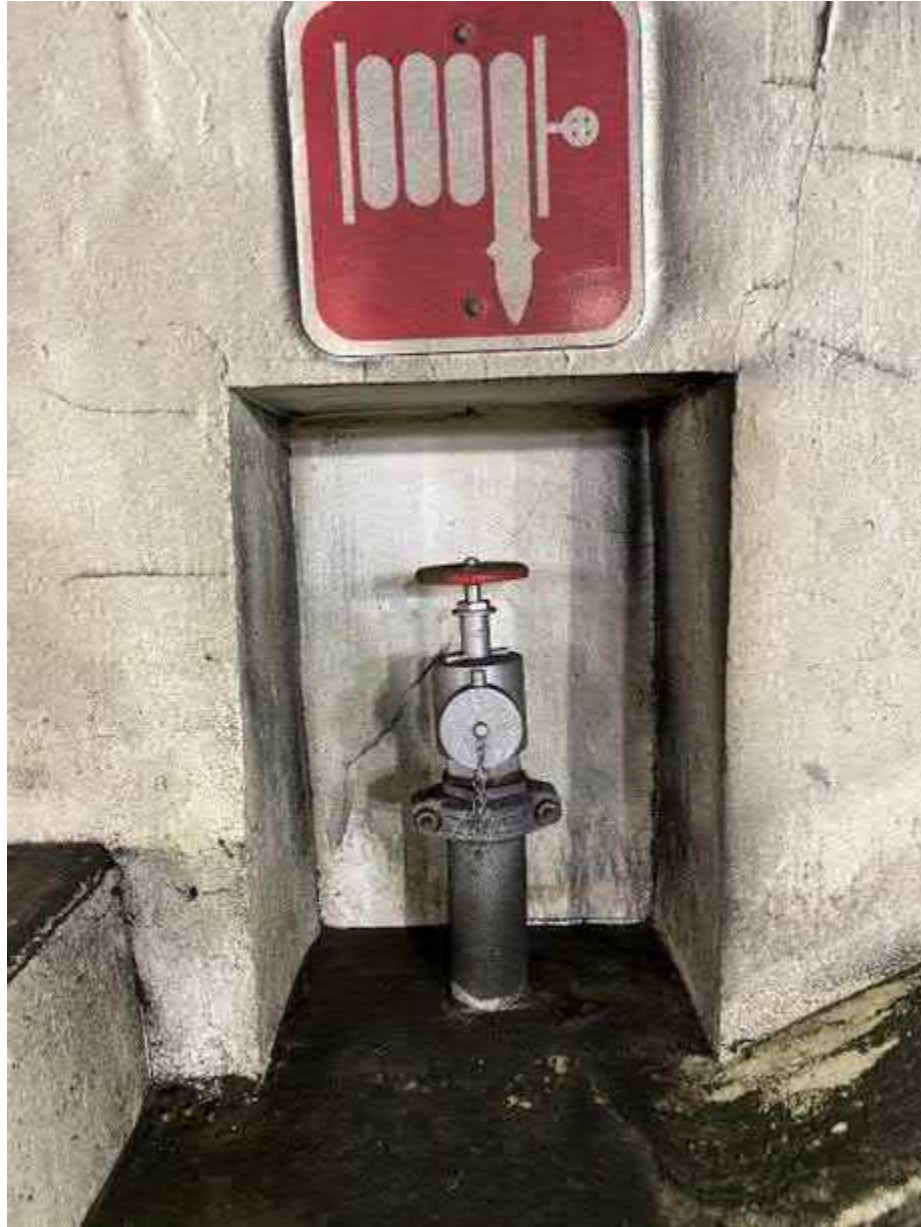
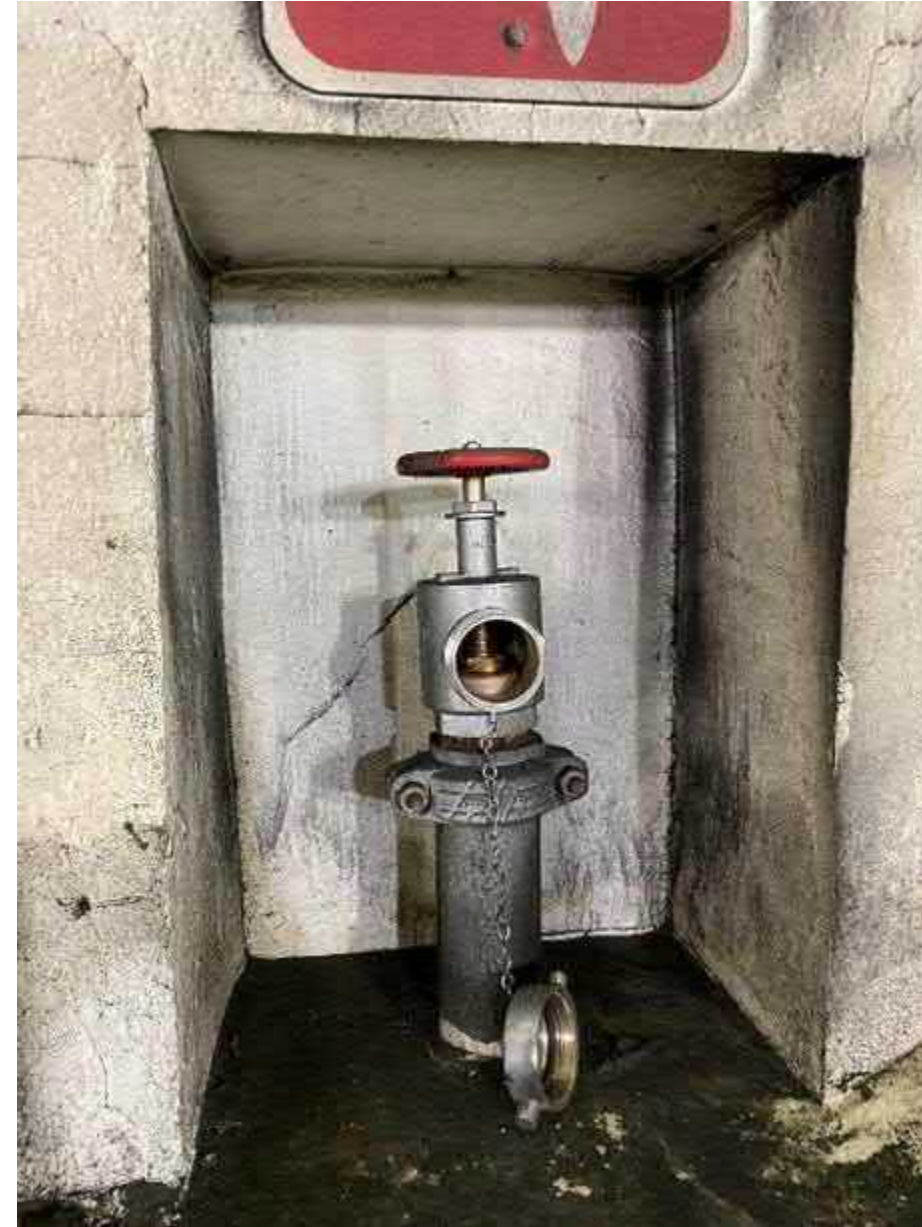
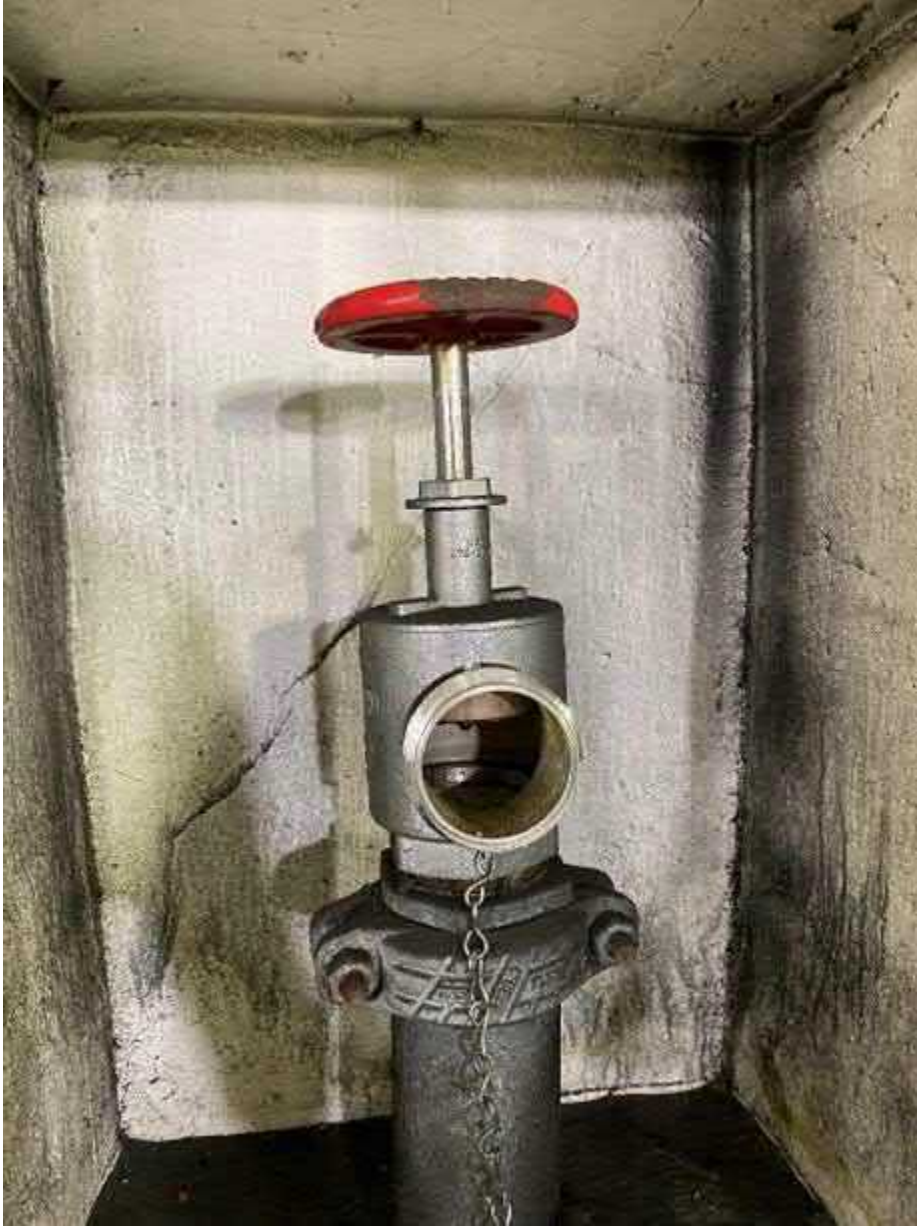
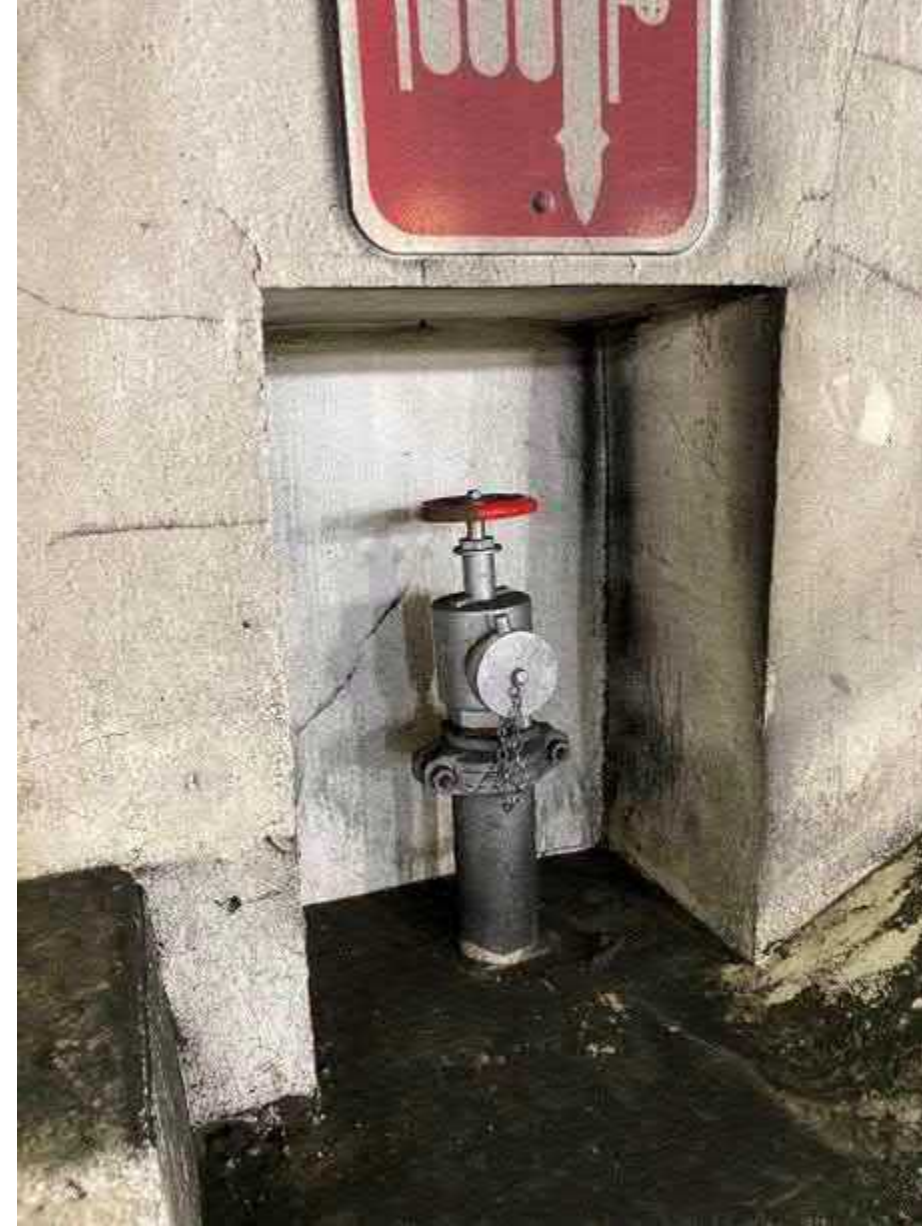
Good condition. CS1

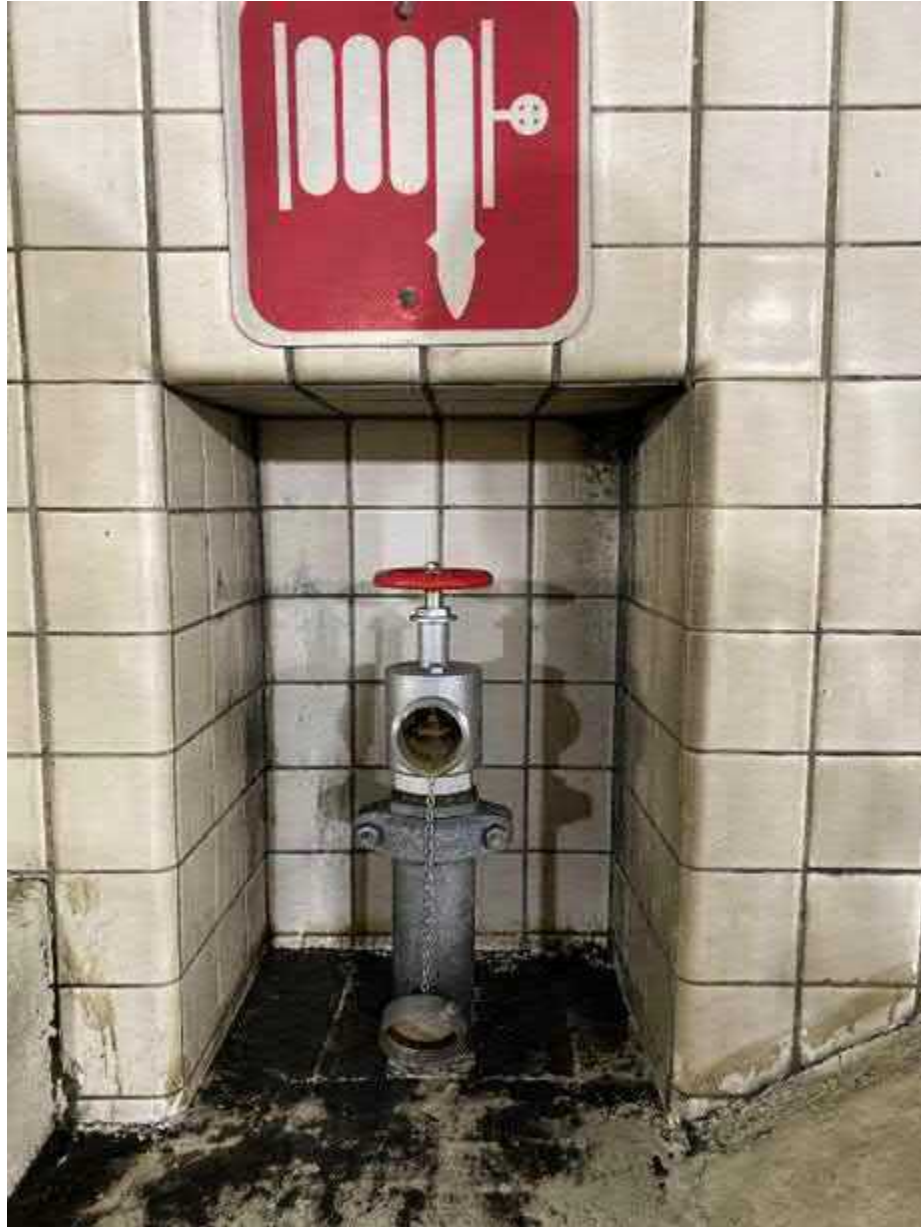
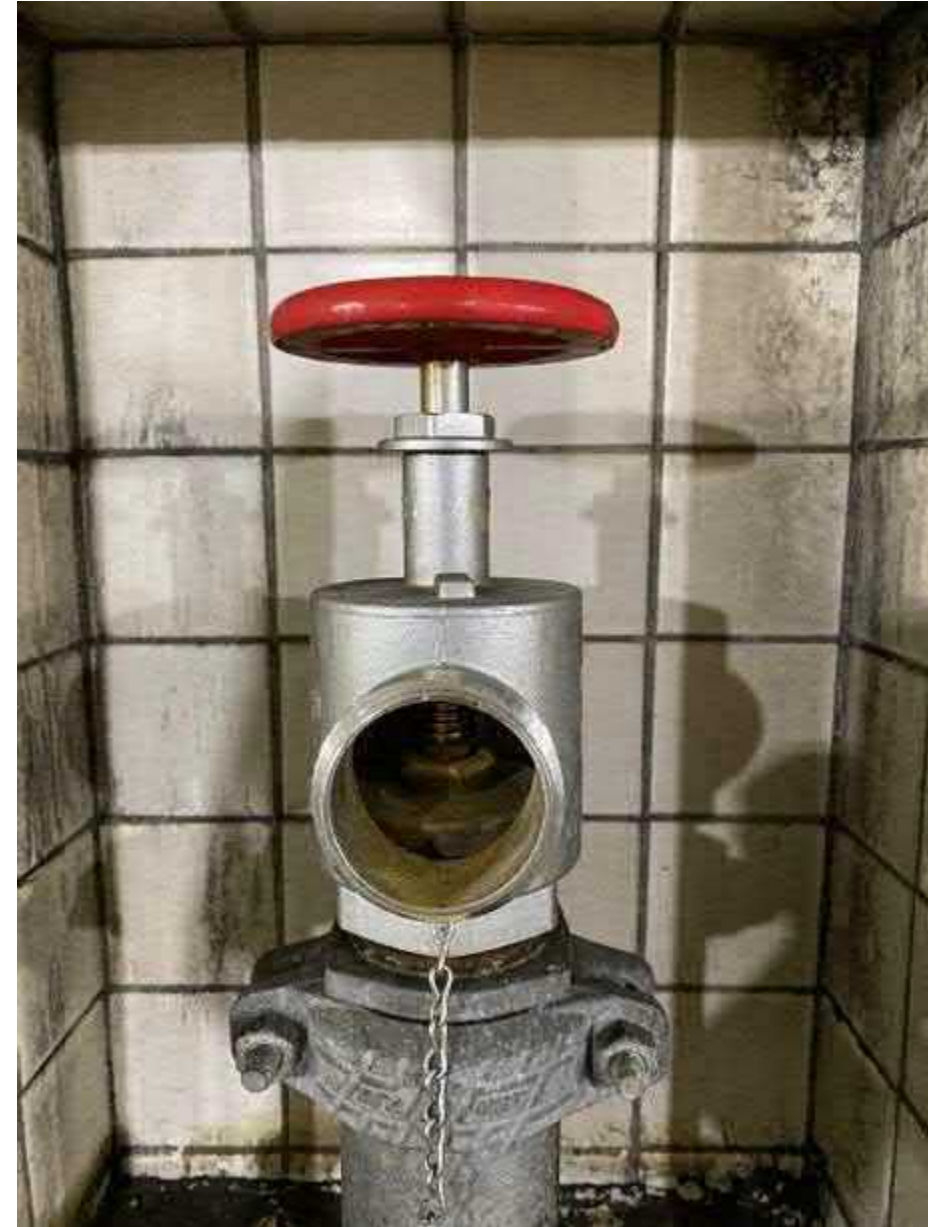
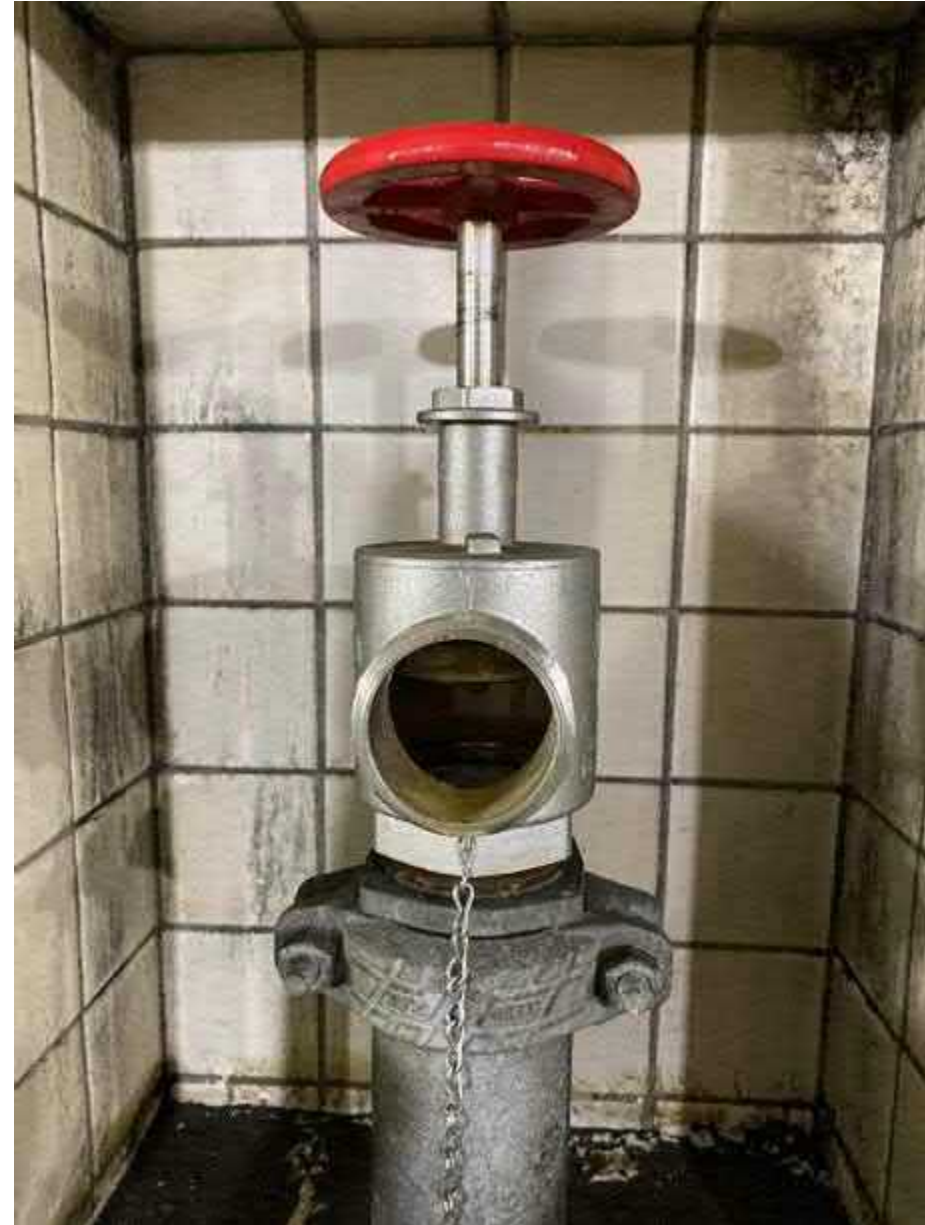
Good condition. CS1

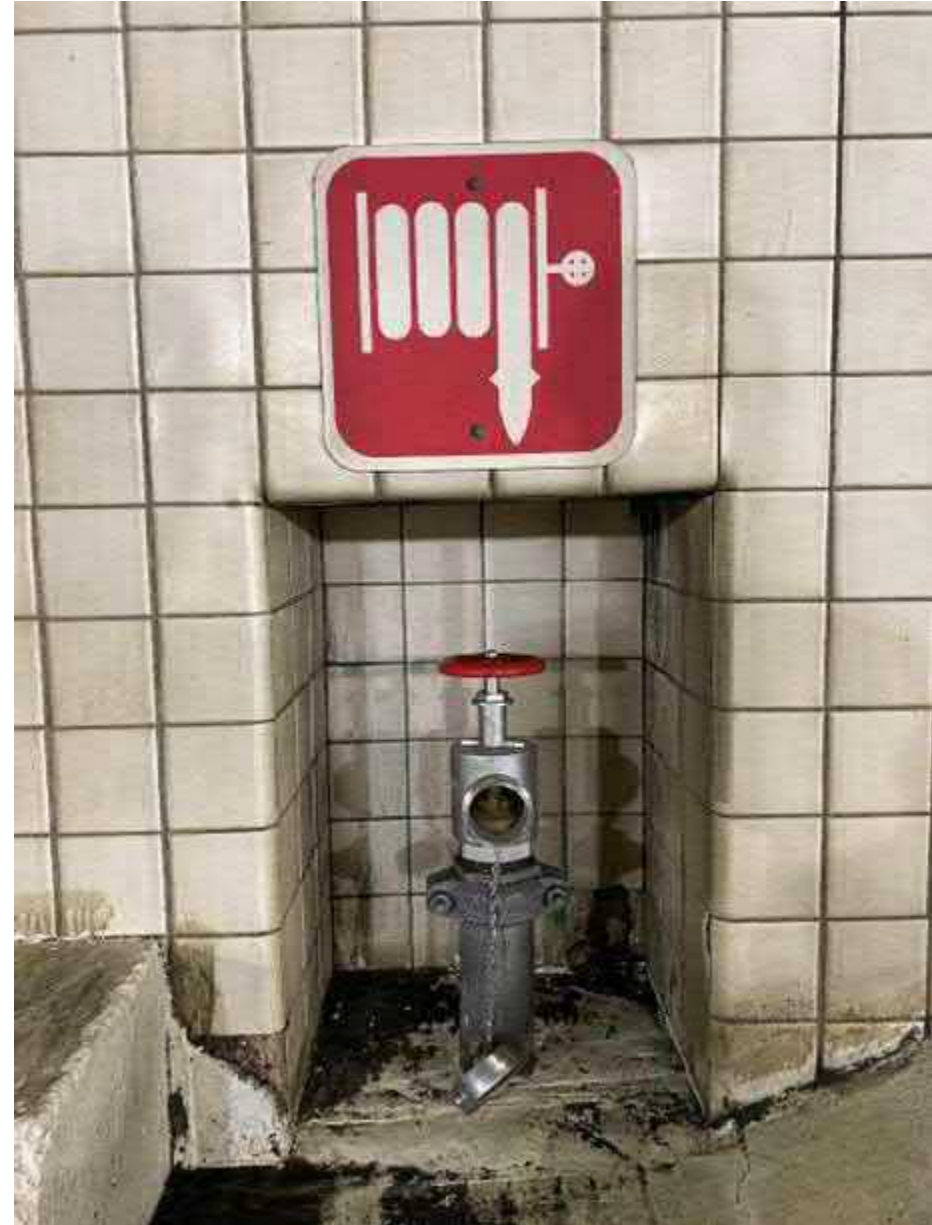
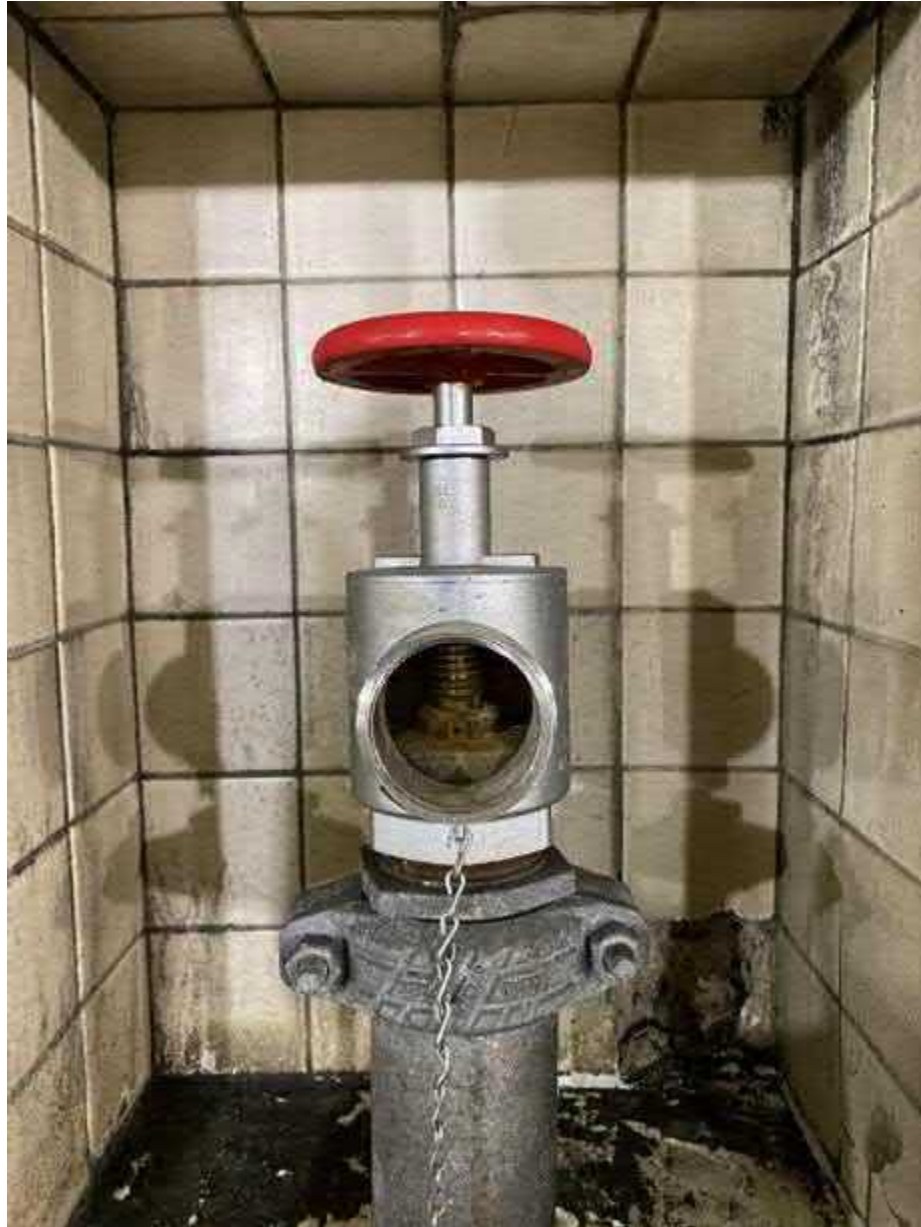
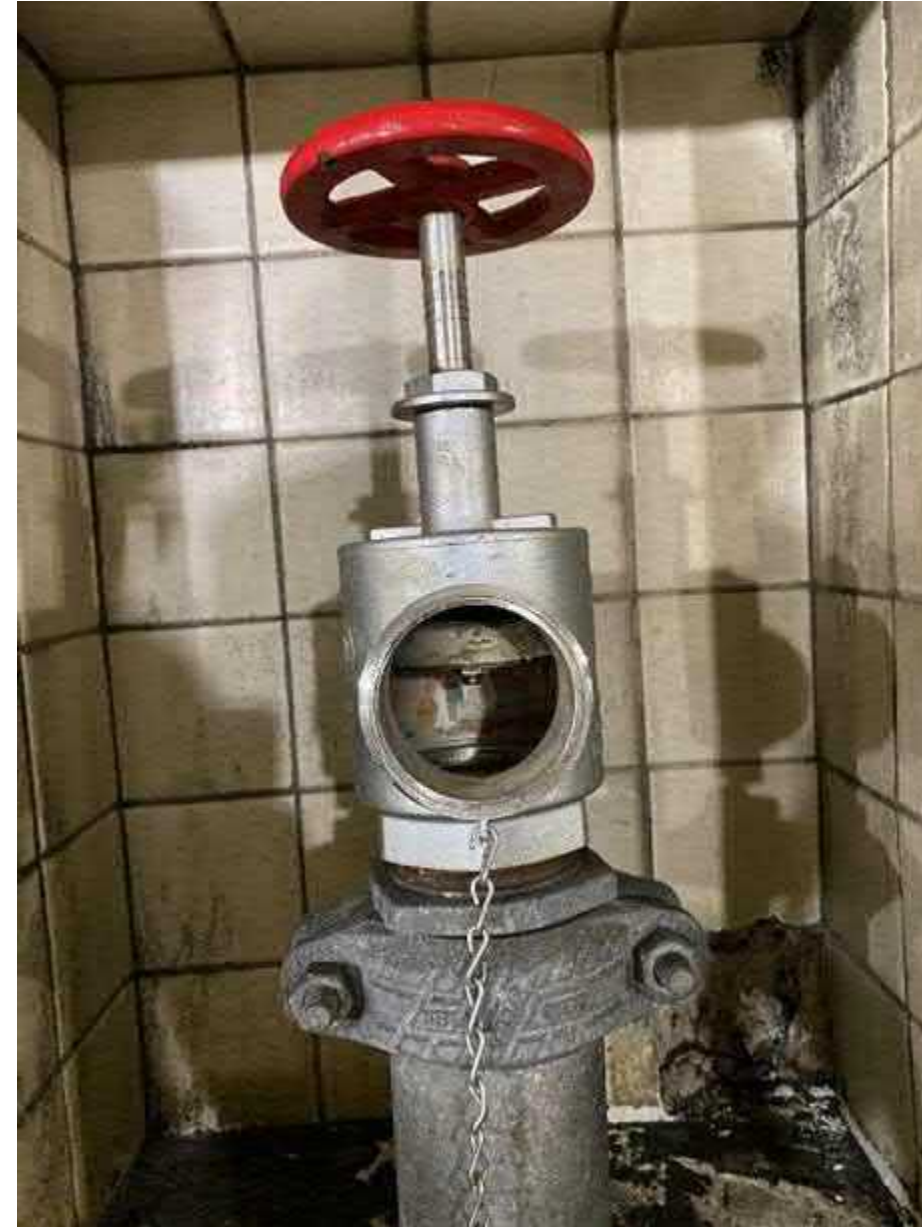
Good condition. CS1

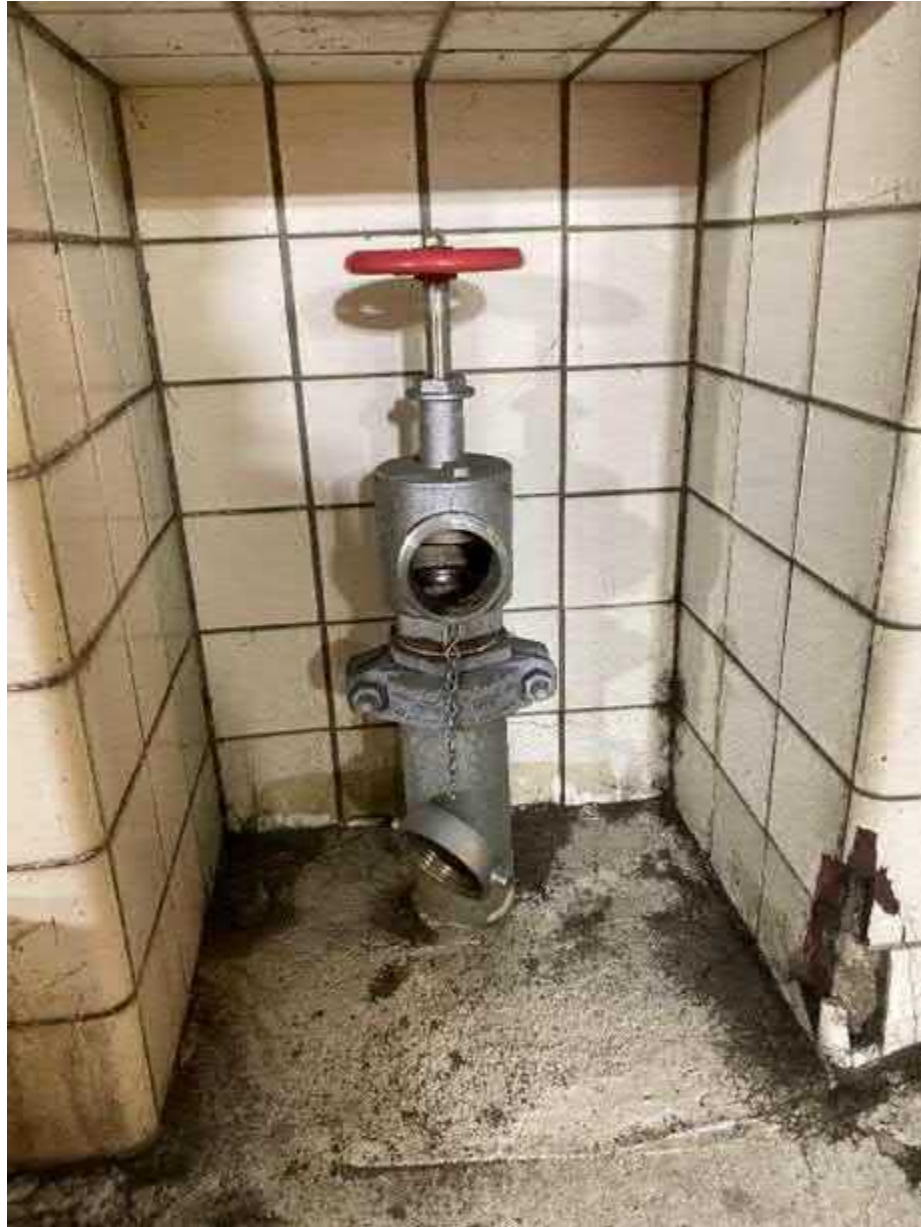
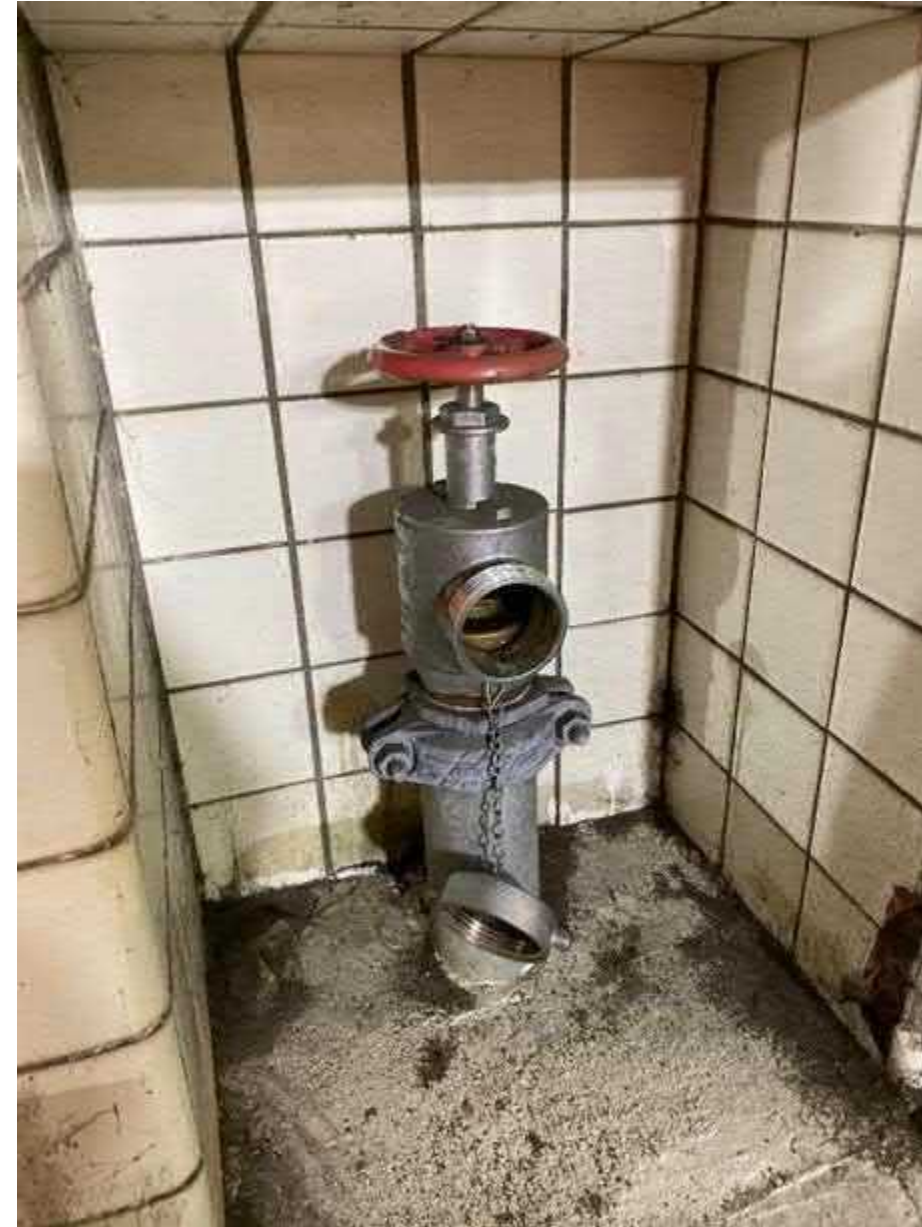
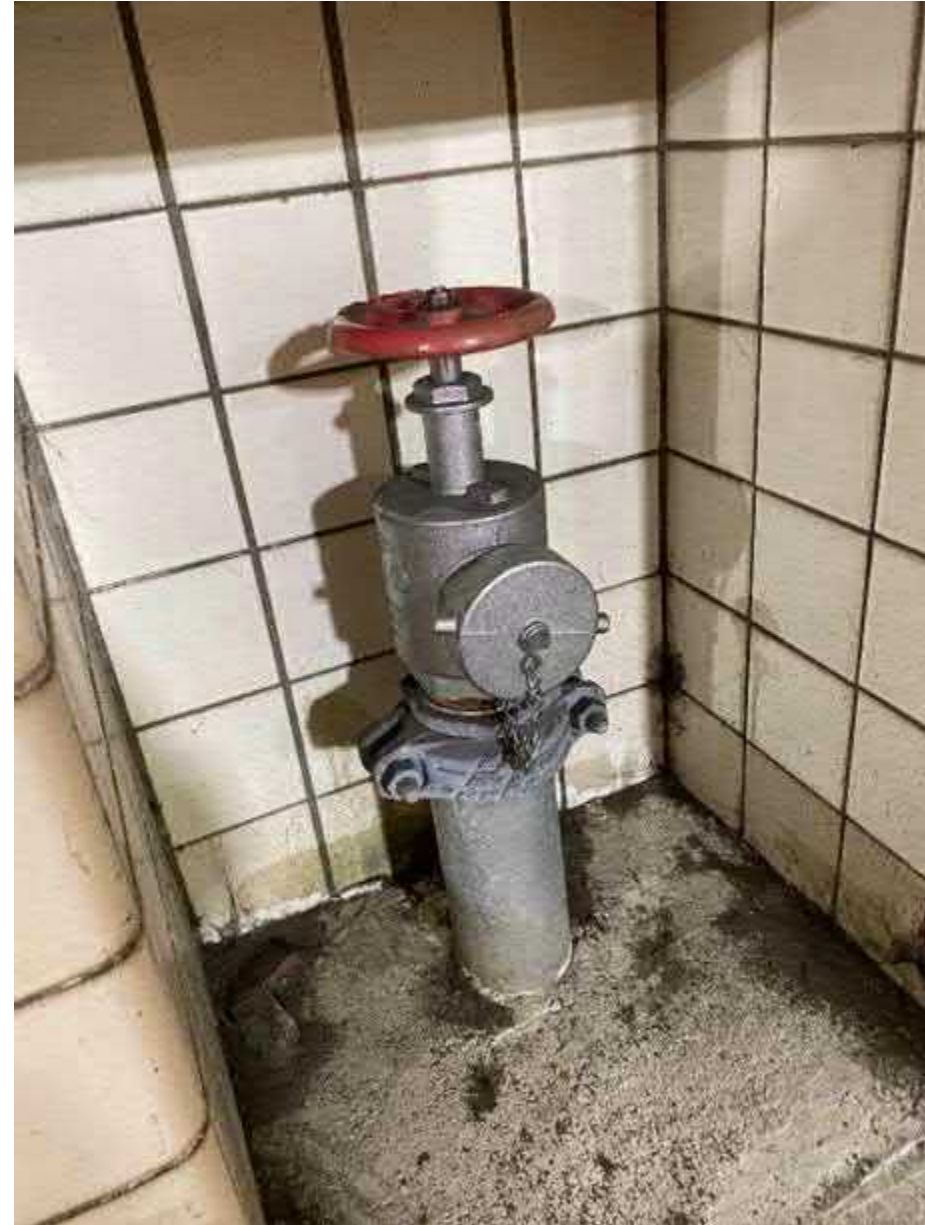
Good condition. CS1

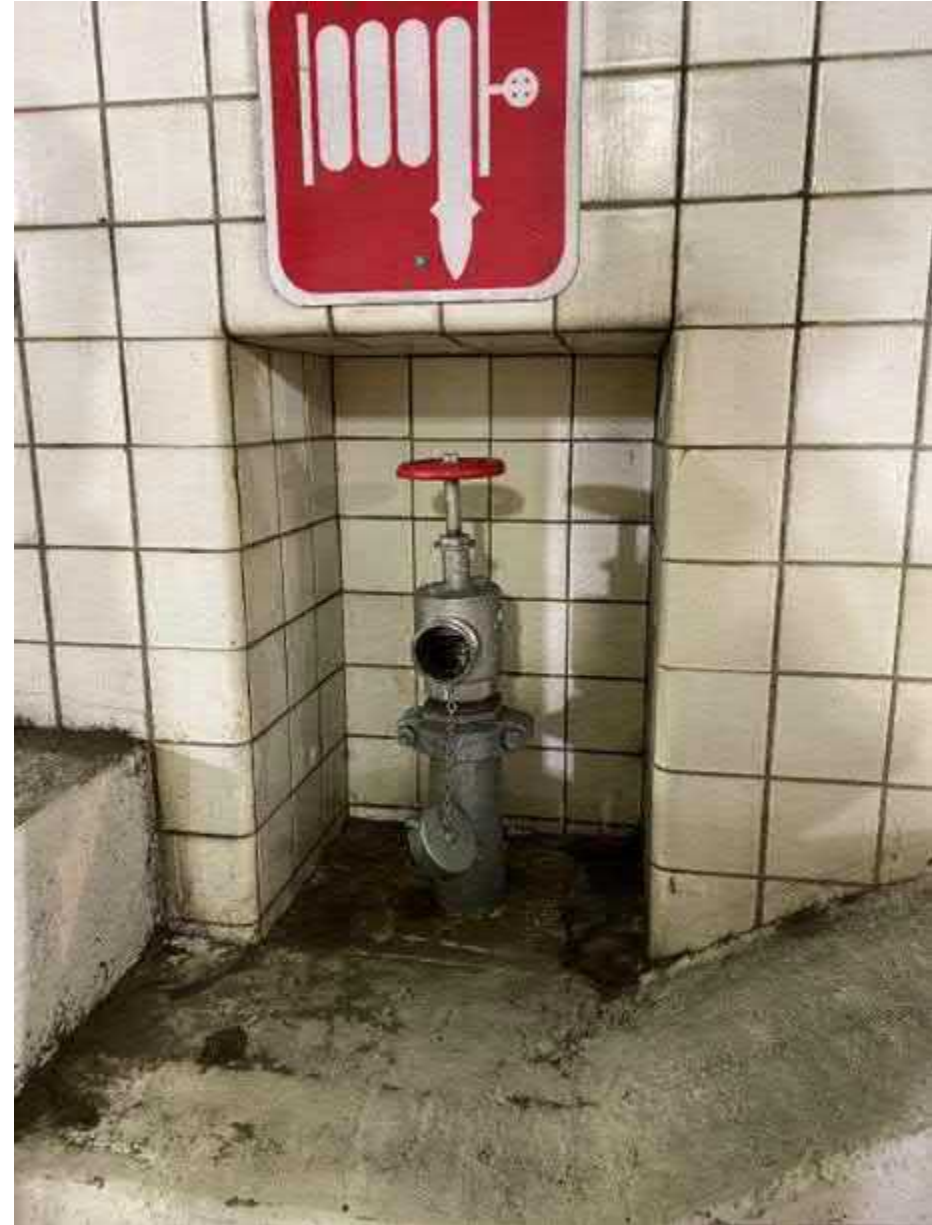
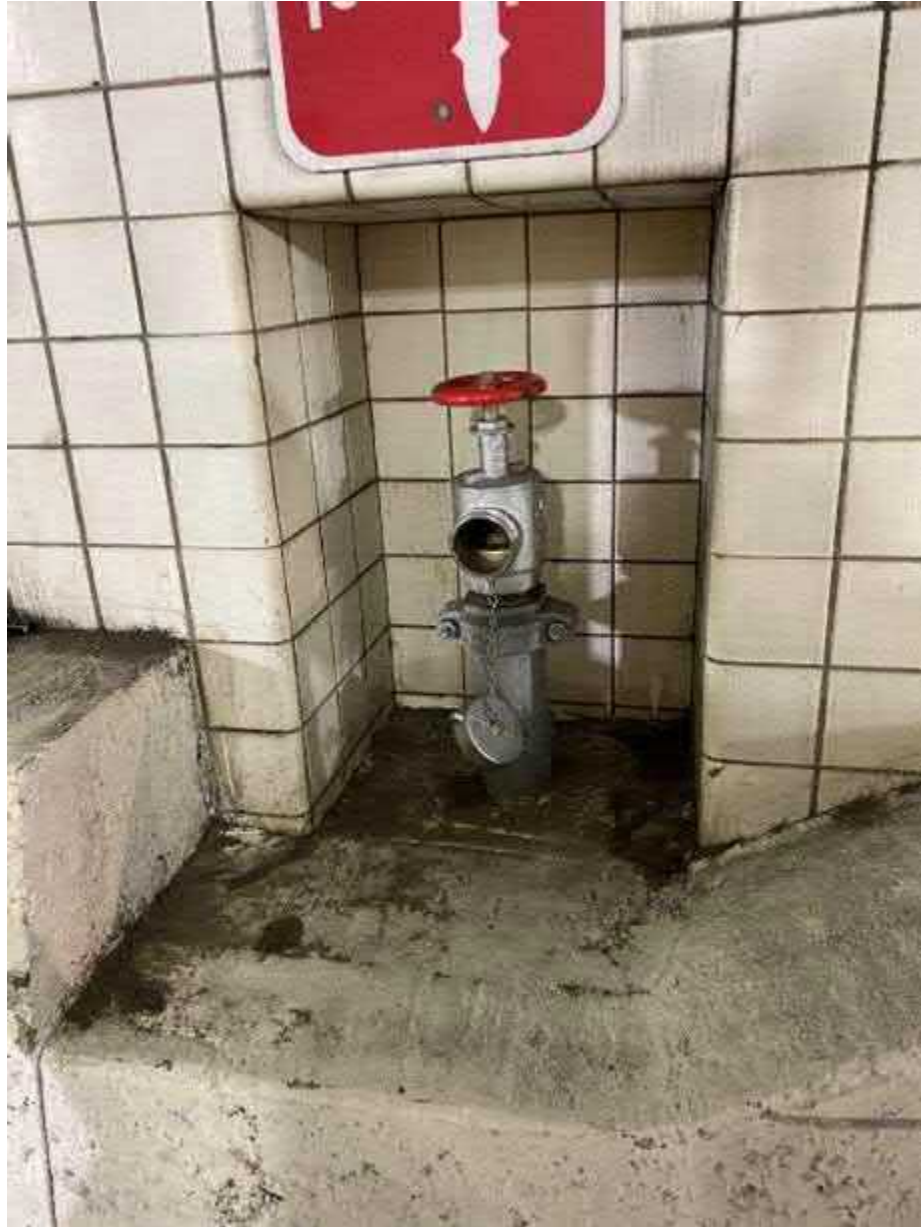
Good condition. CS1

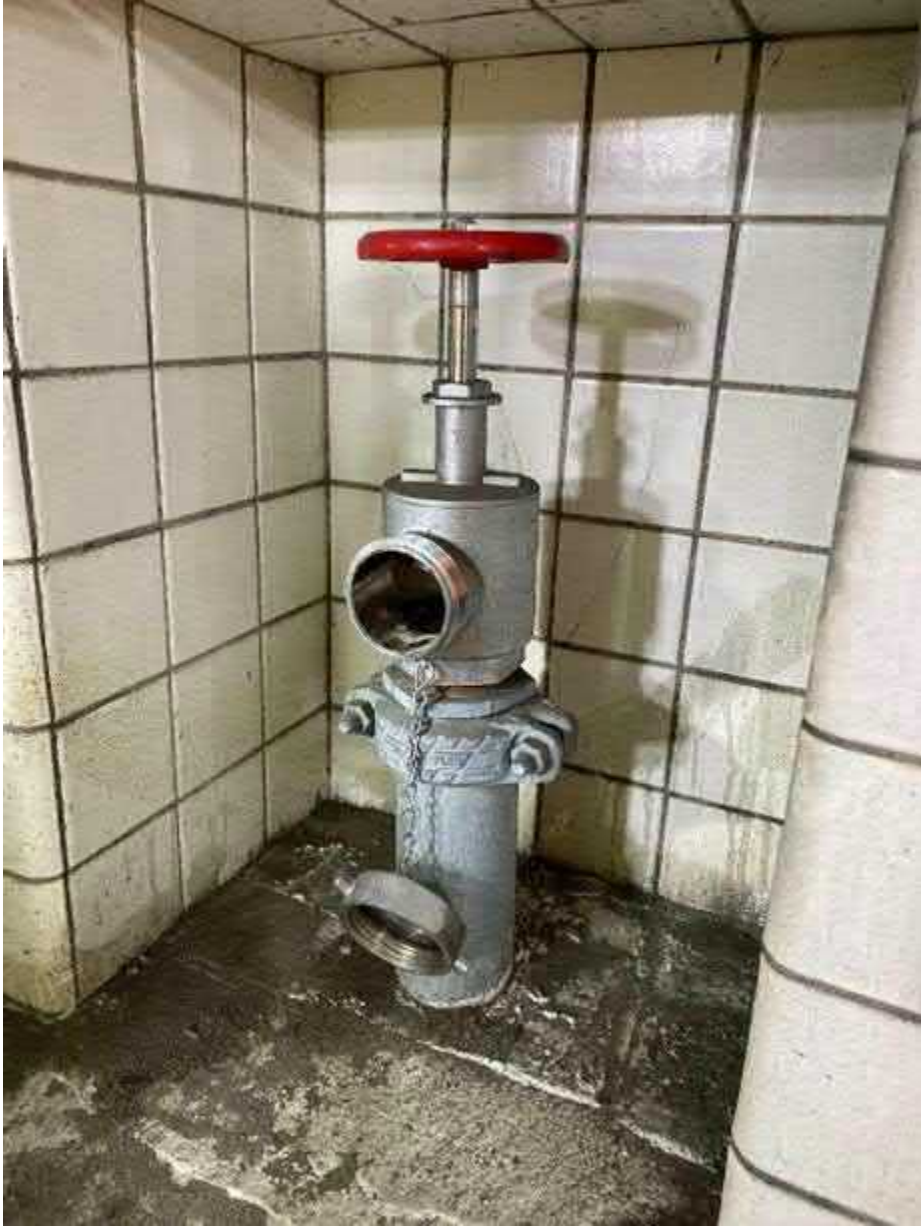
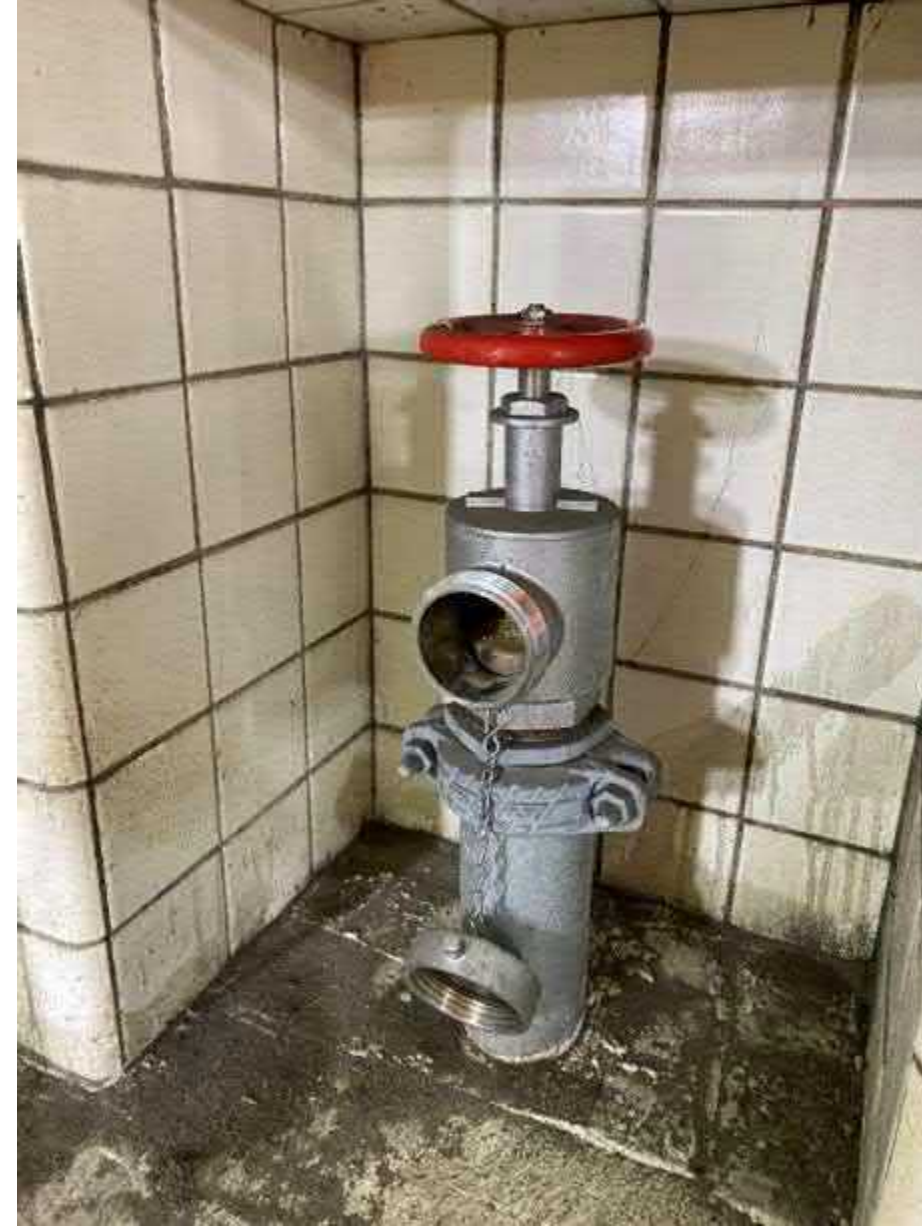
Good condition. CS1
