# **Lytle Tunnel (HAM-71-0134) Inspection Report Fall 2020**

PID 105470

November, 2020

Ohio Department of  
Transportation  
District 8  
505 South State Route 741  
Lebanon, OH 45036

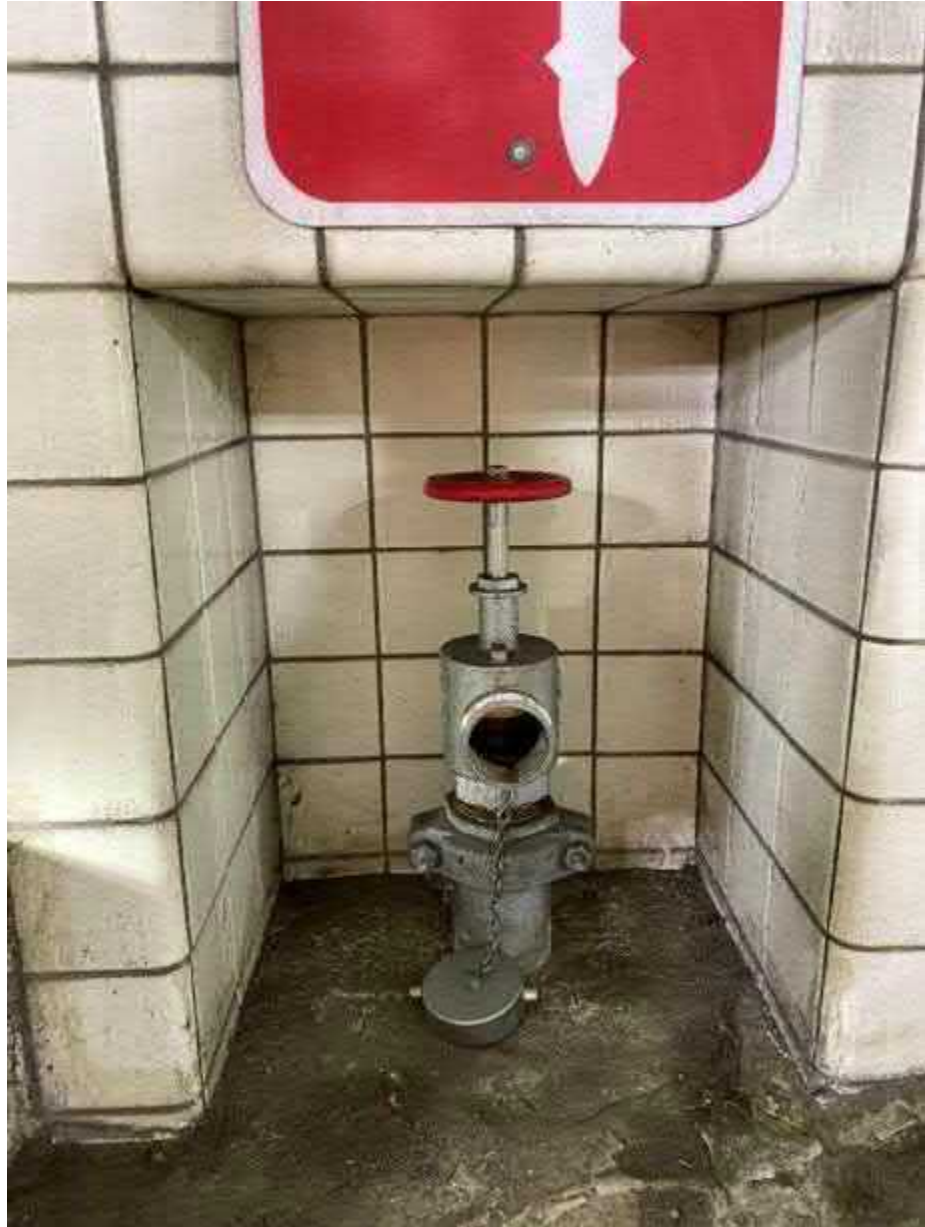
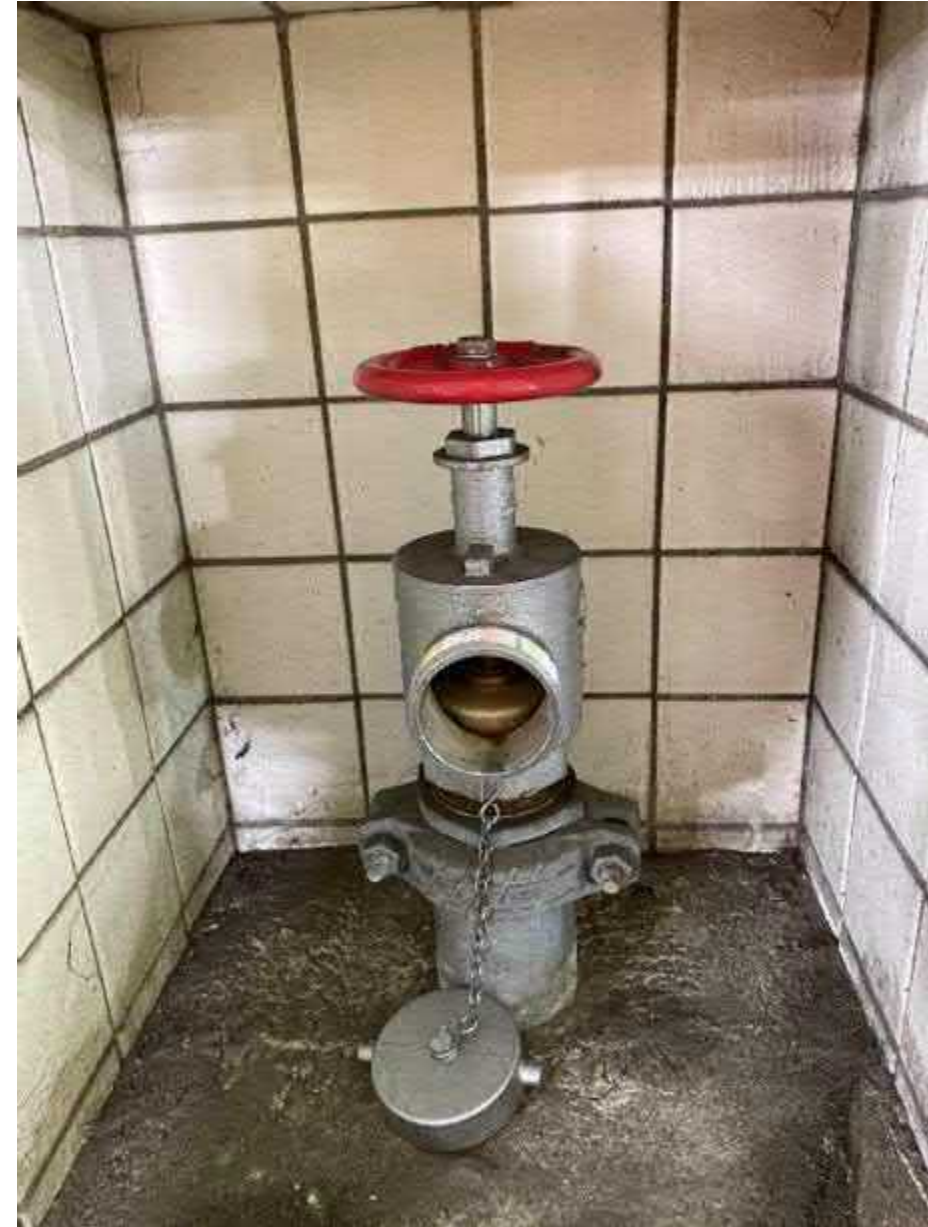
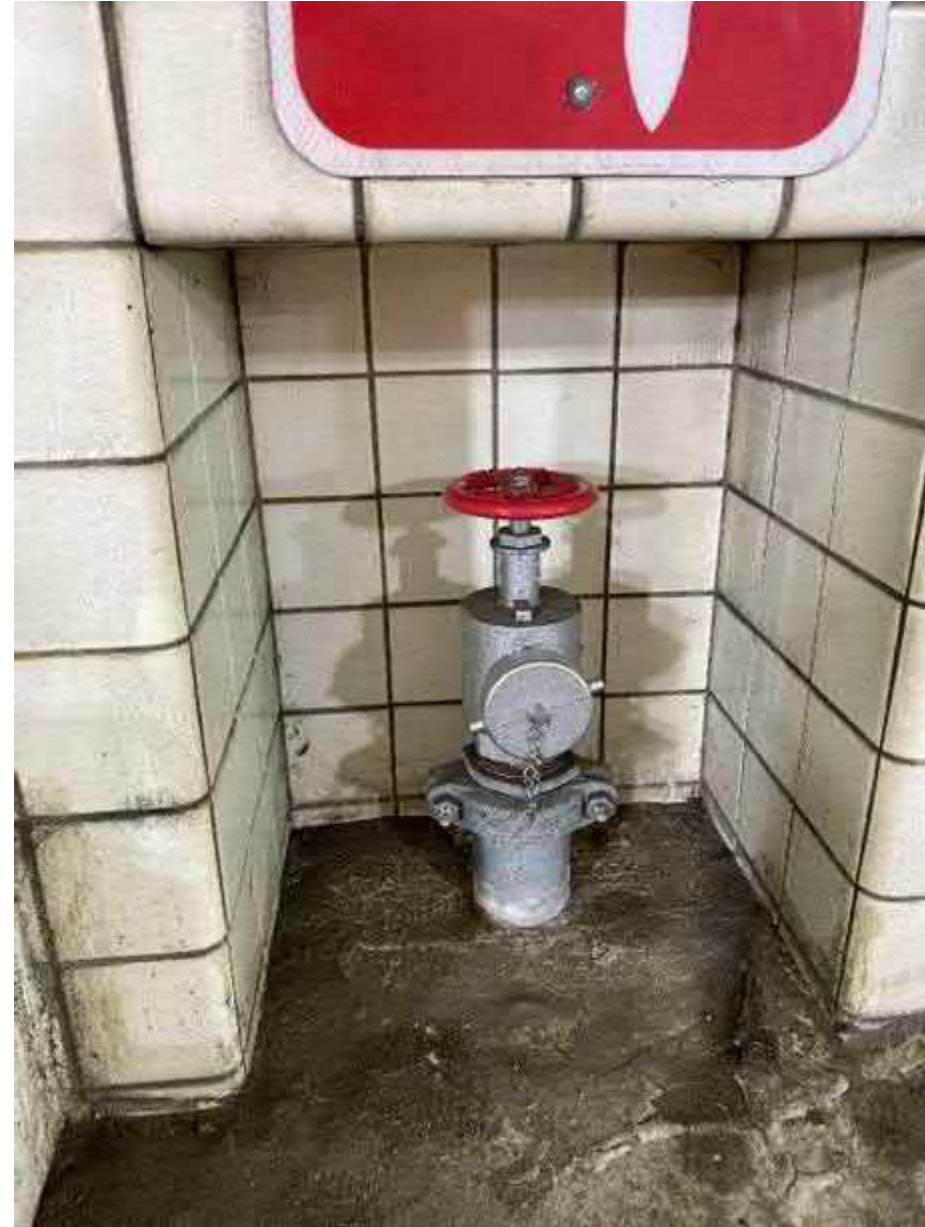
Good condition. CS1

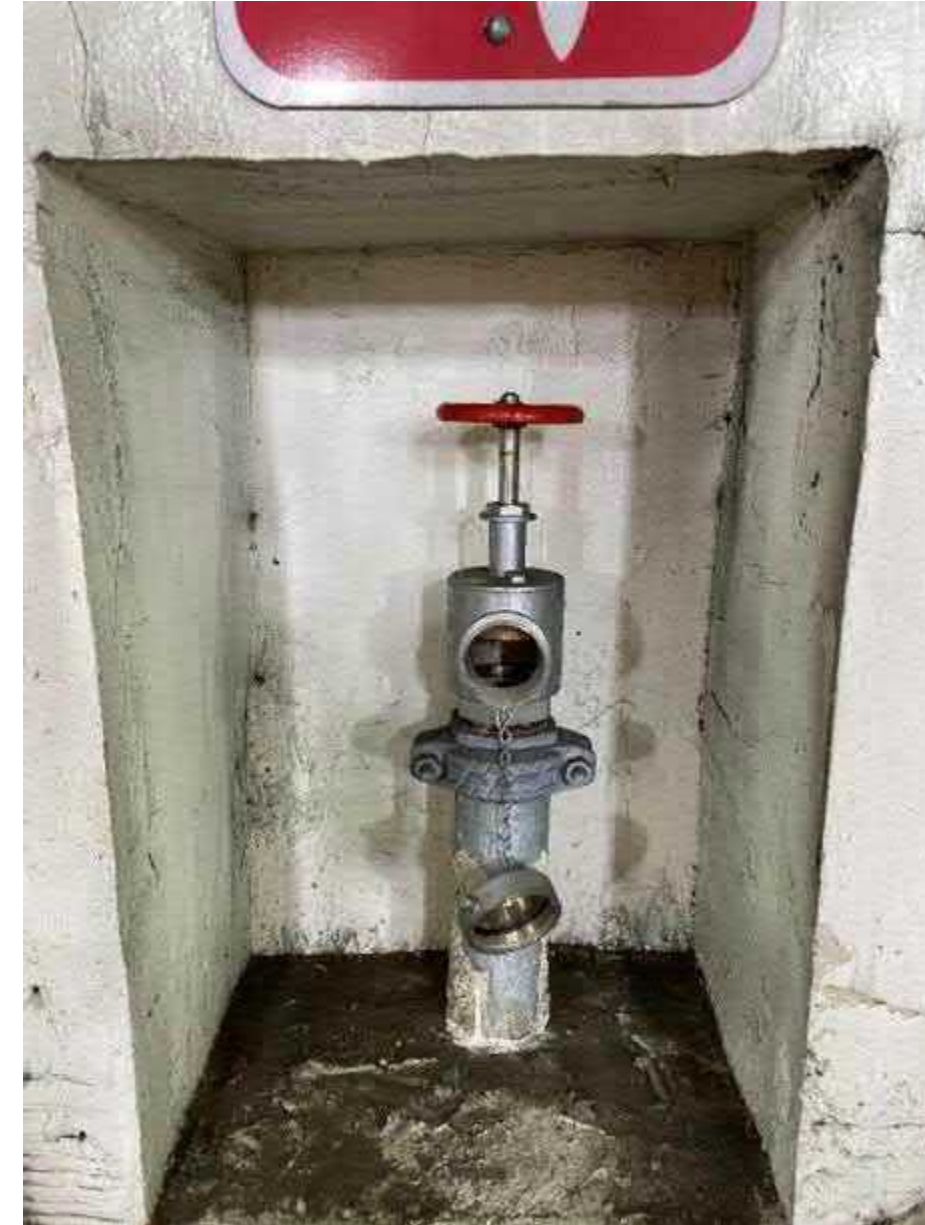
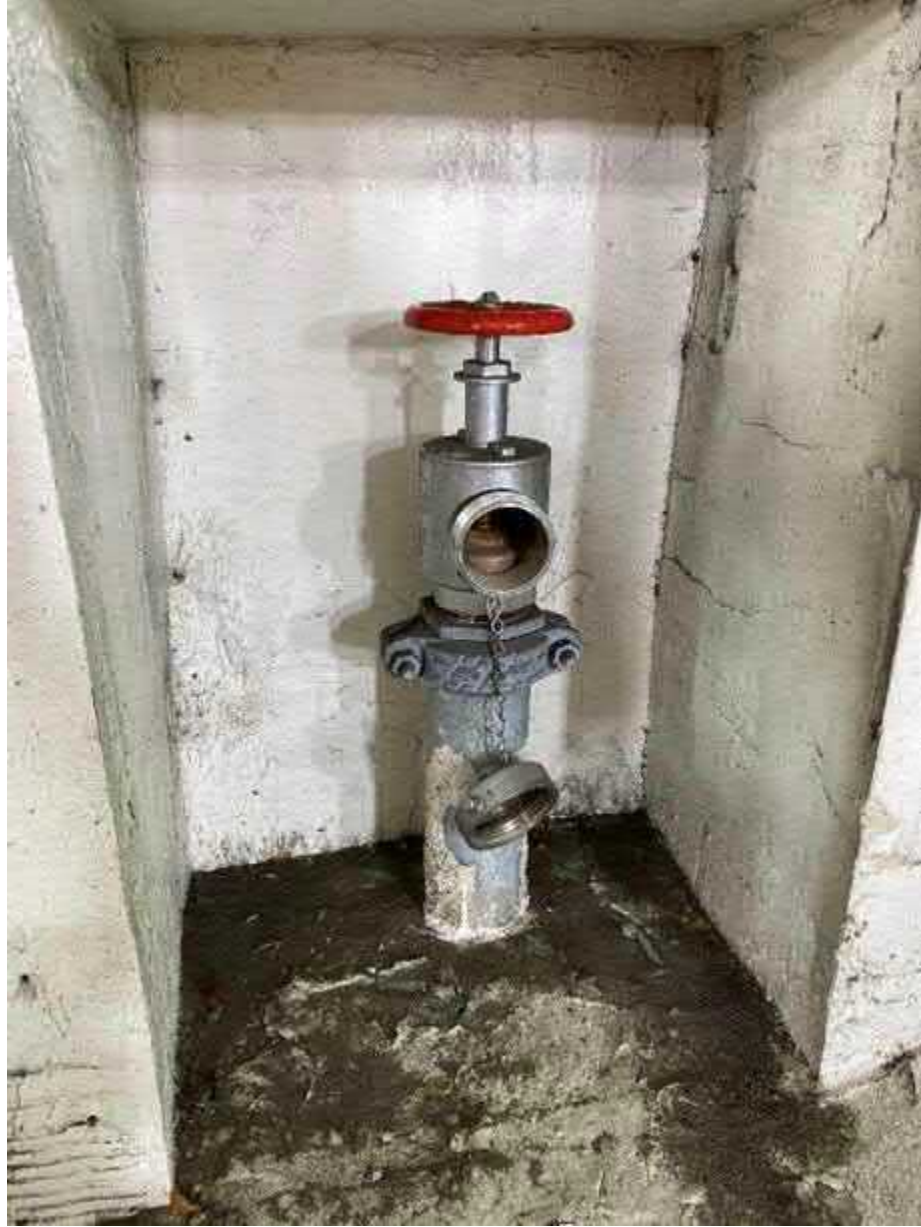
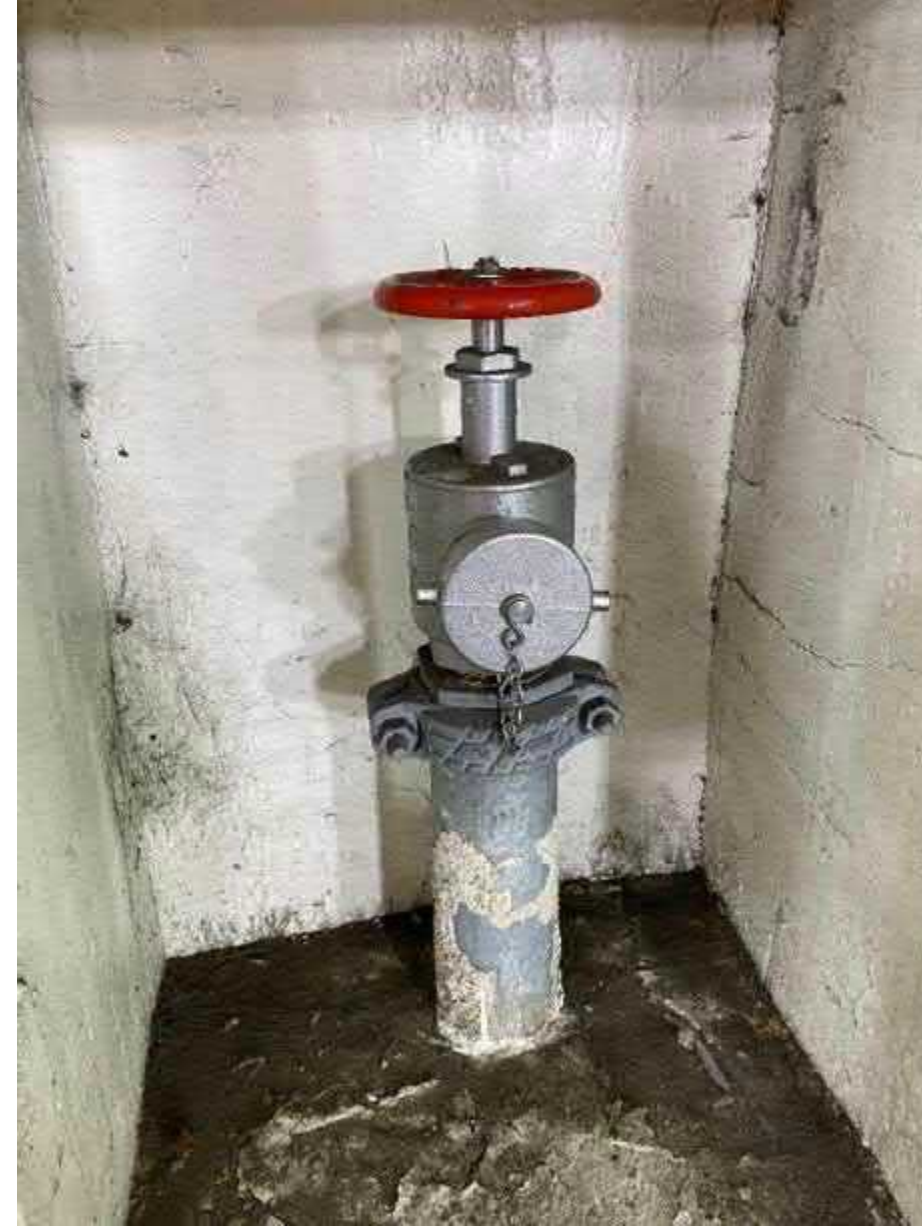
Good condition. CS1

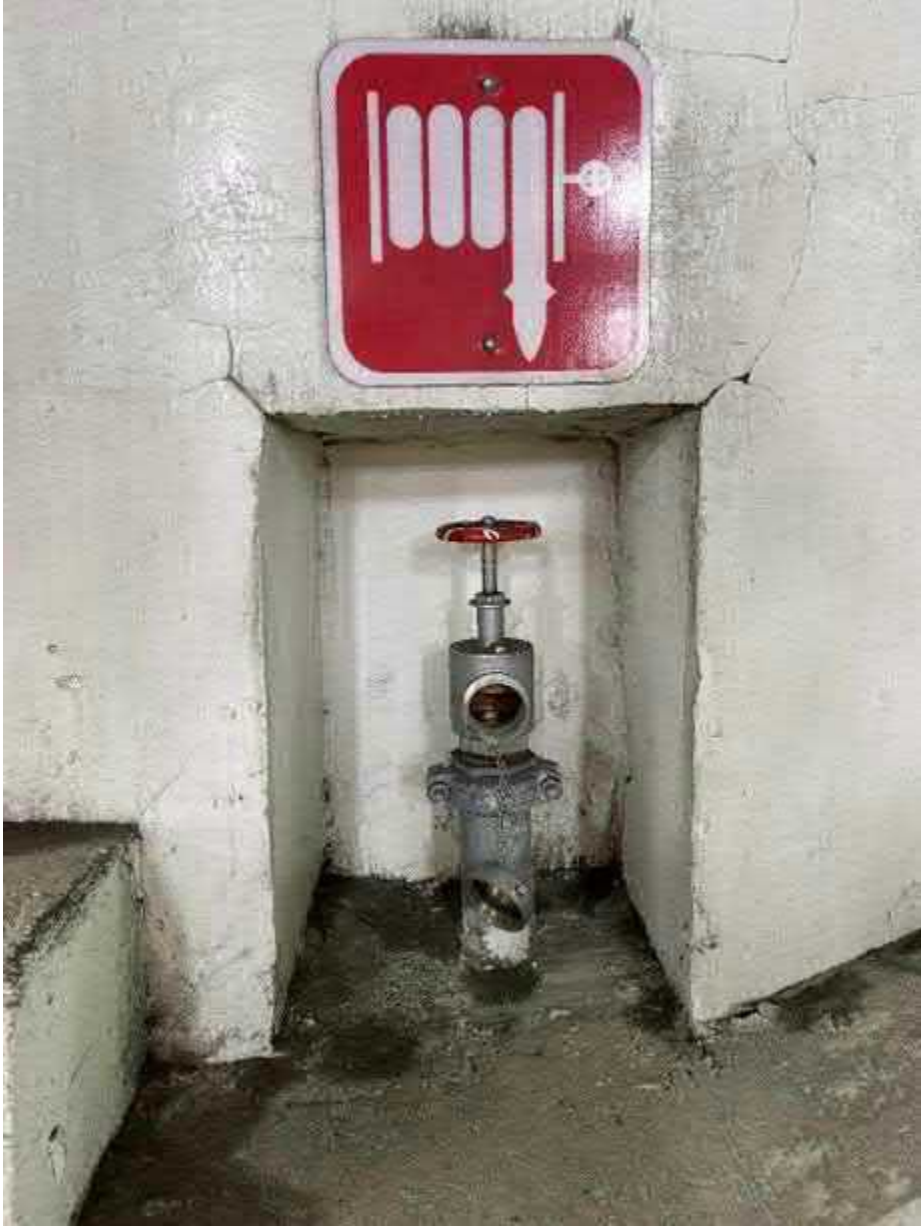
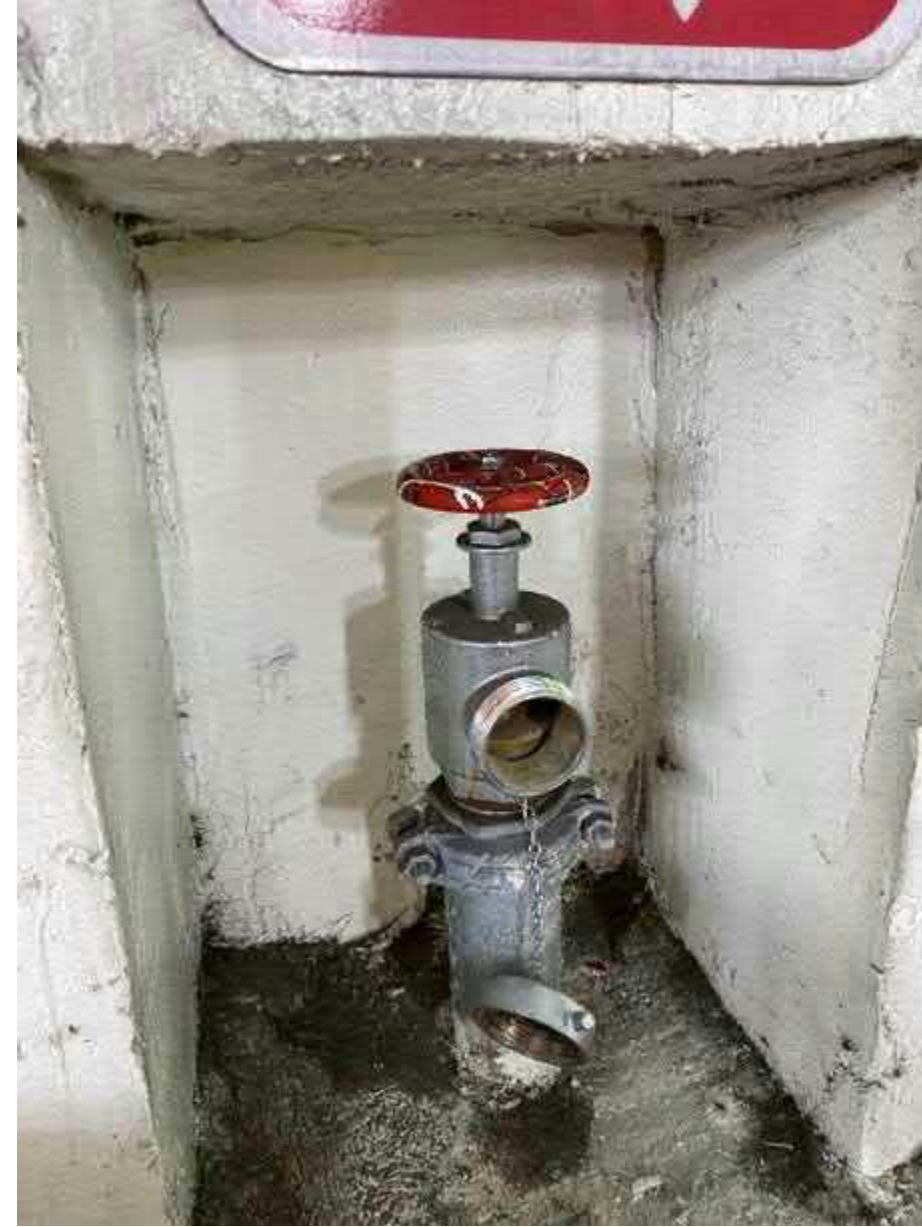
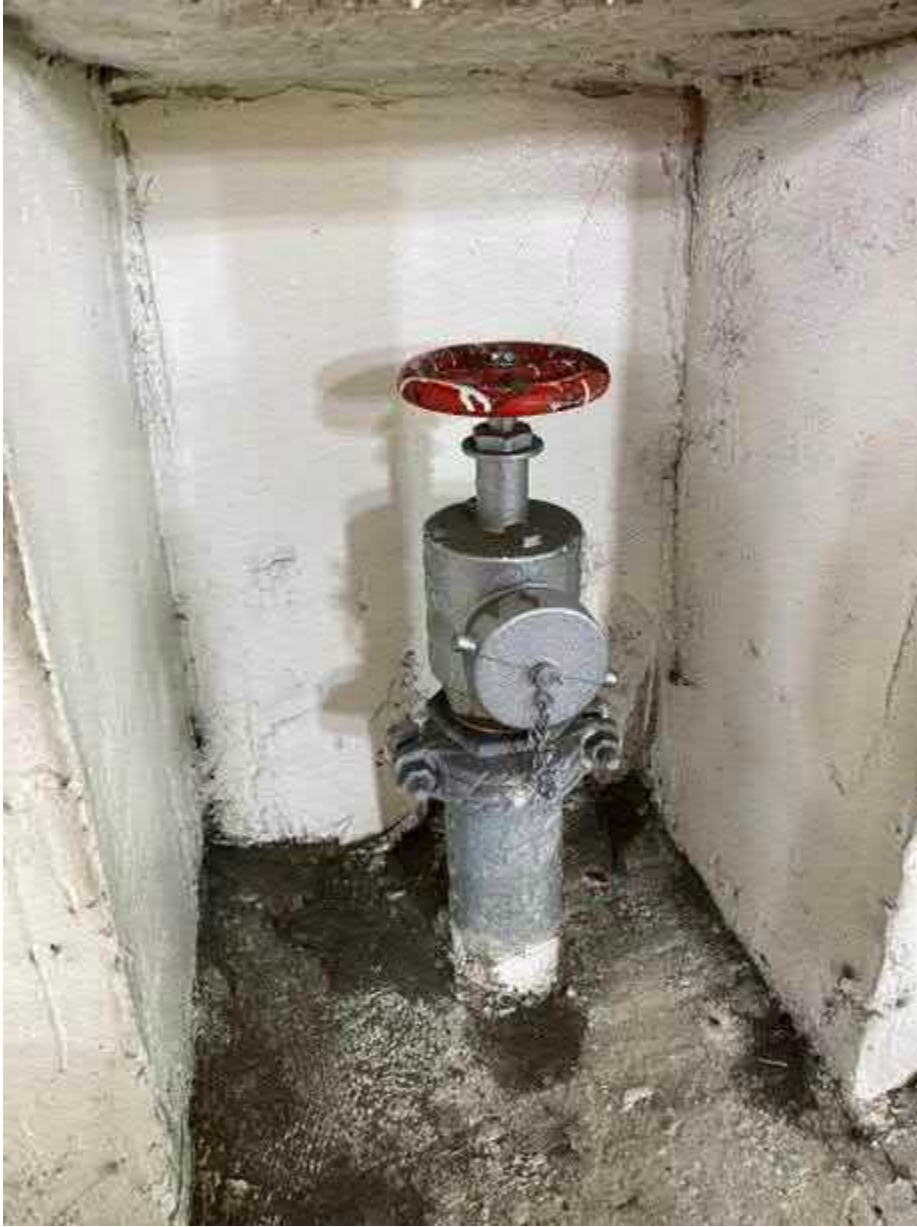
Good condition. CS1

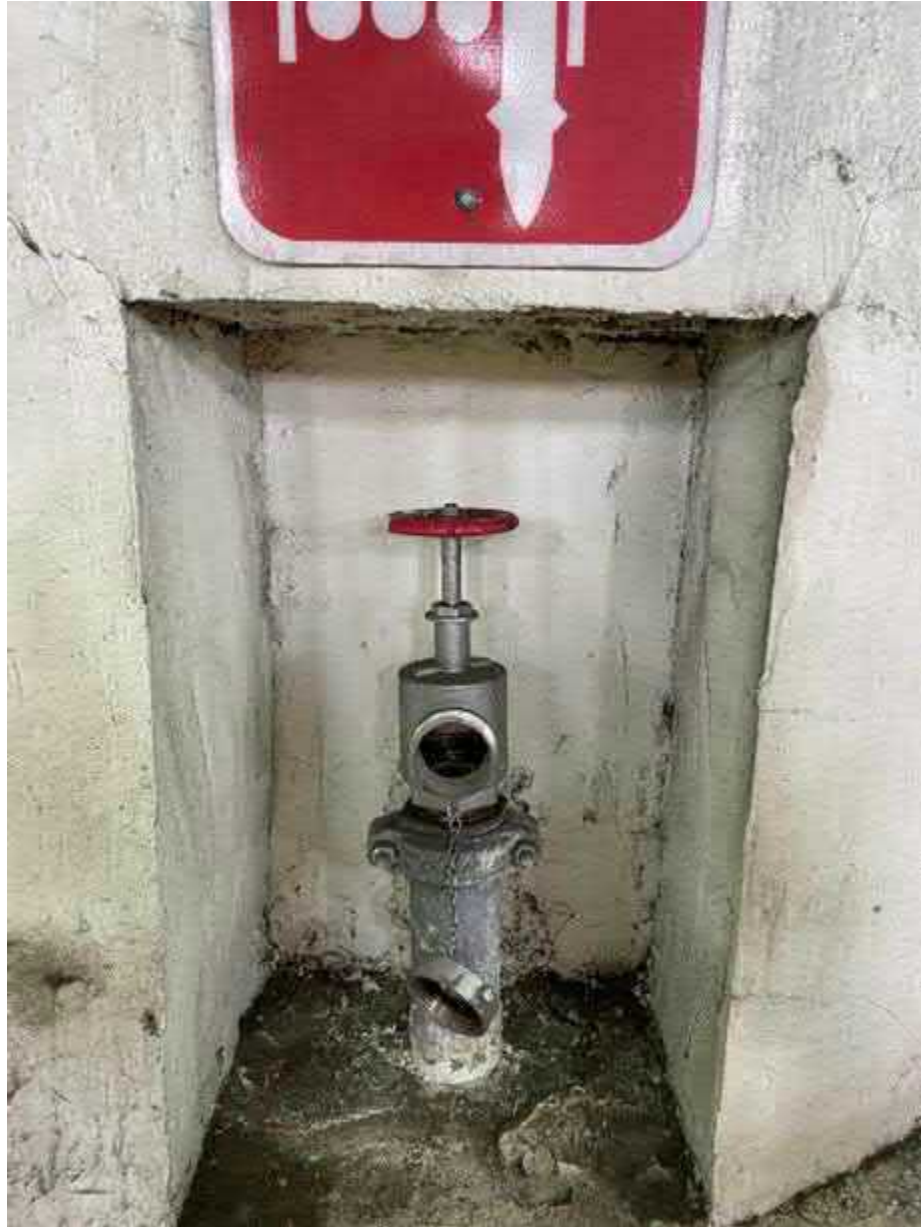
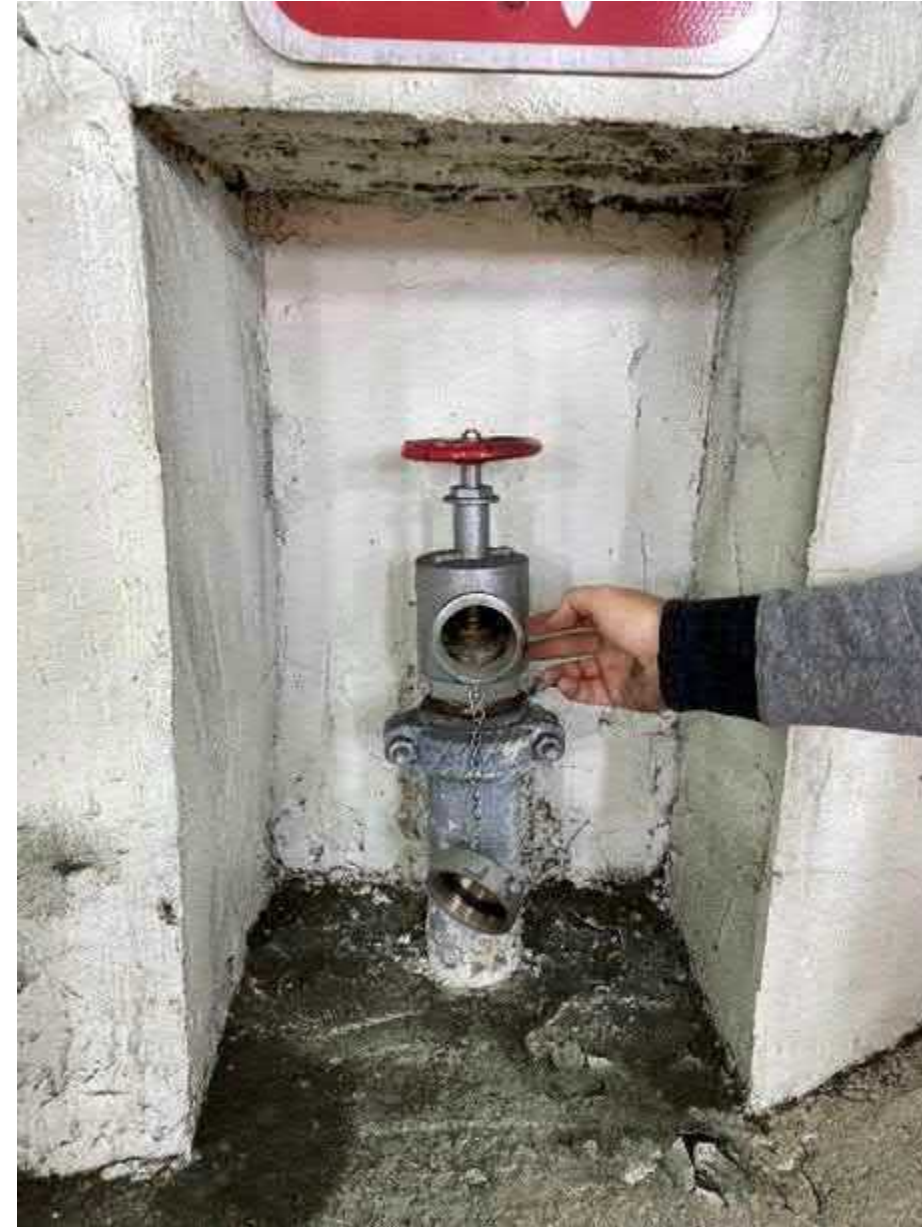
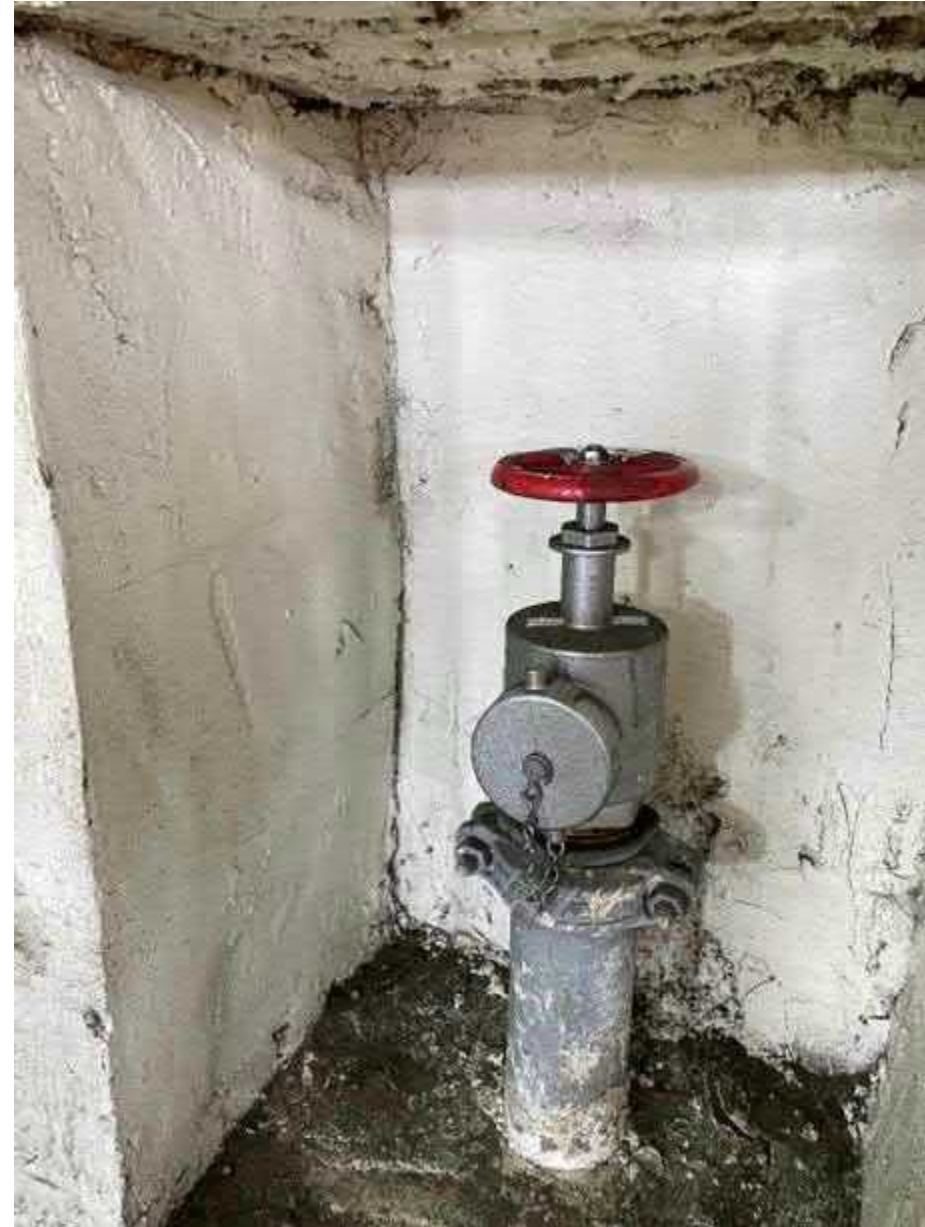
Good condition. CS1

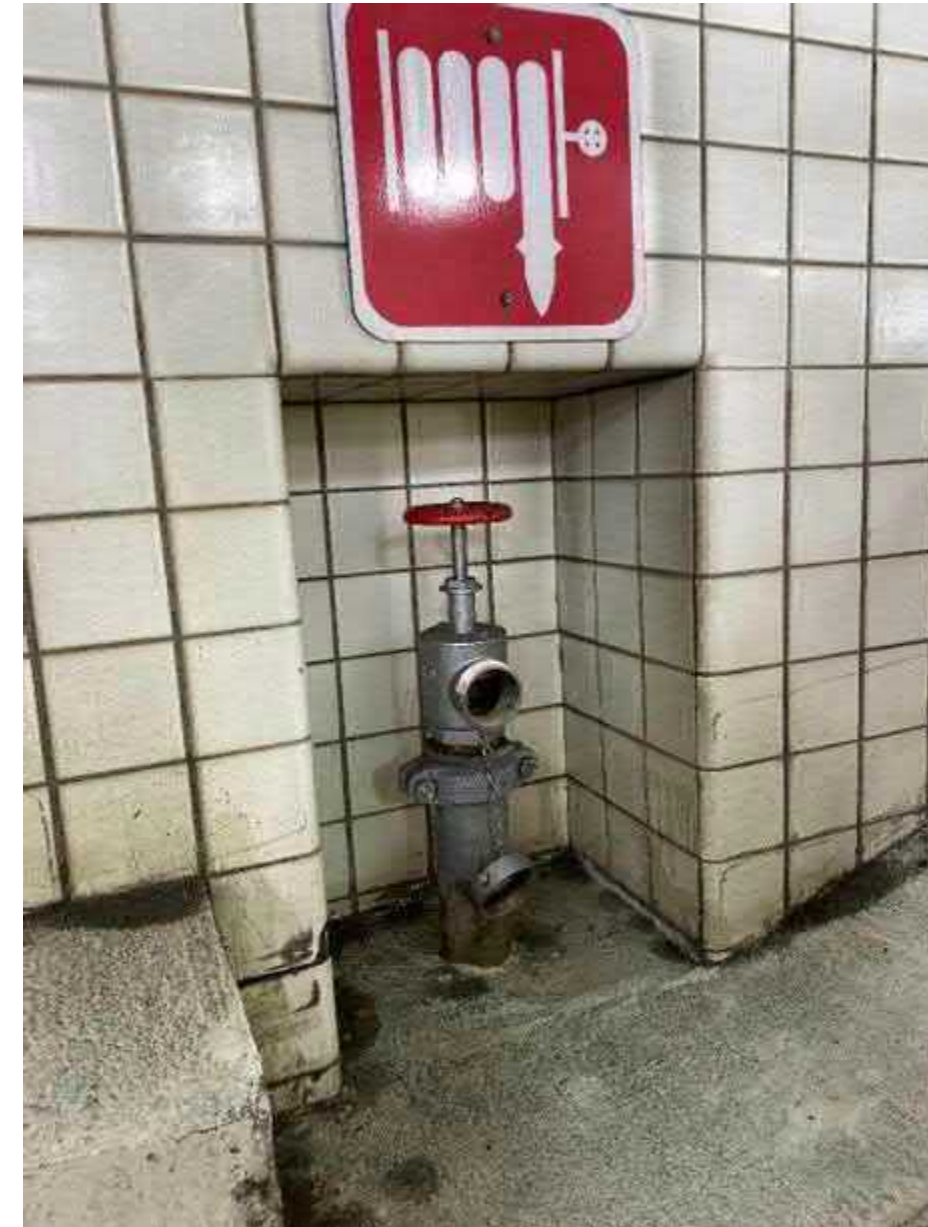
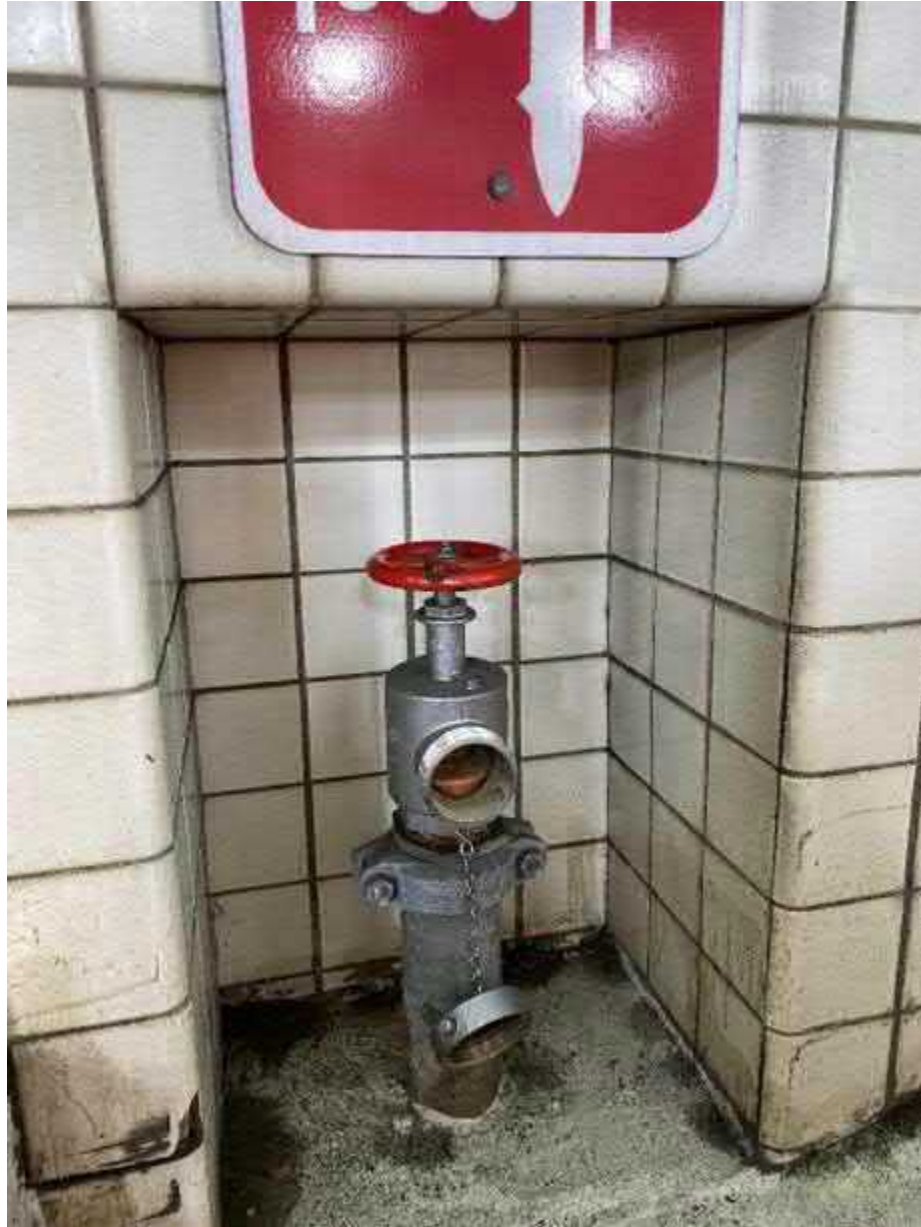
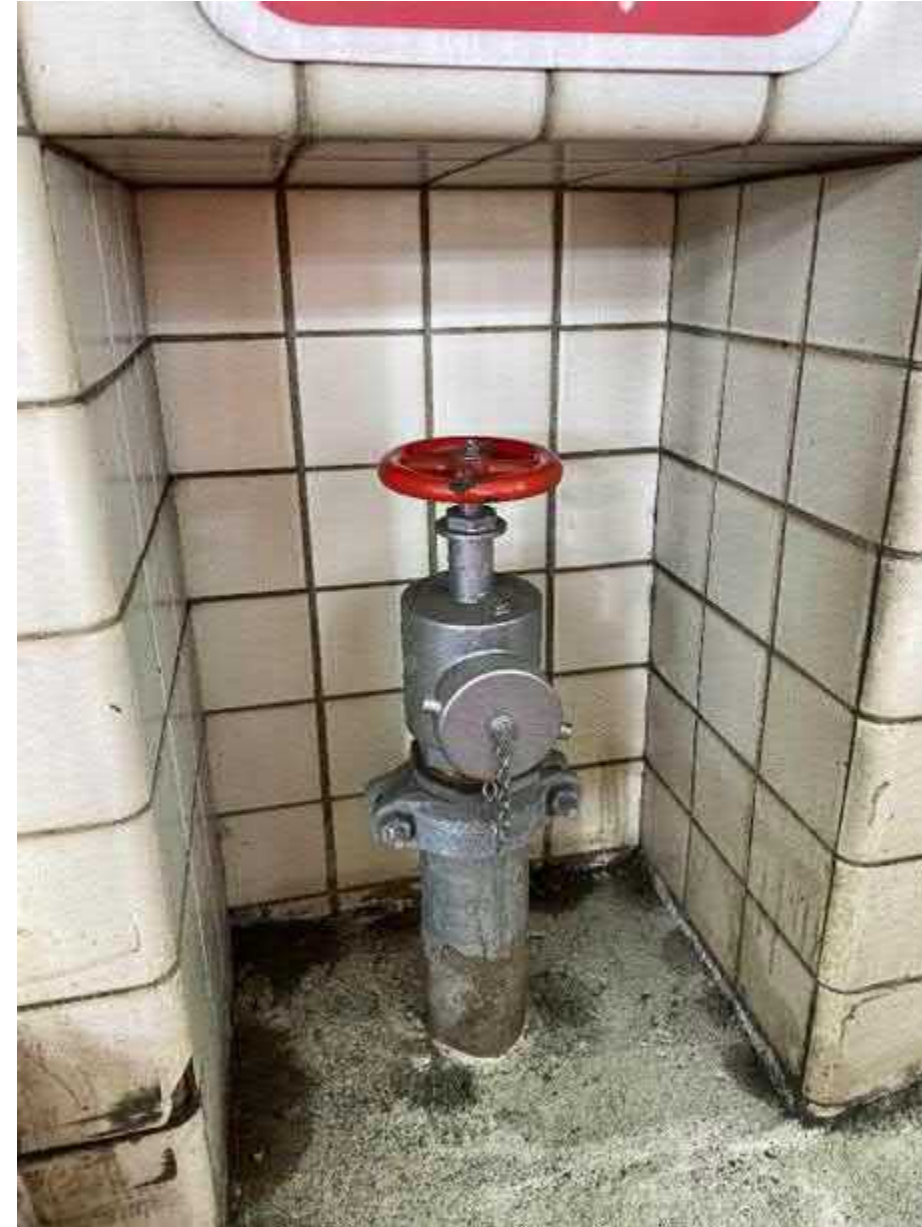
Good condition. CS1

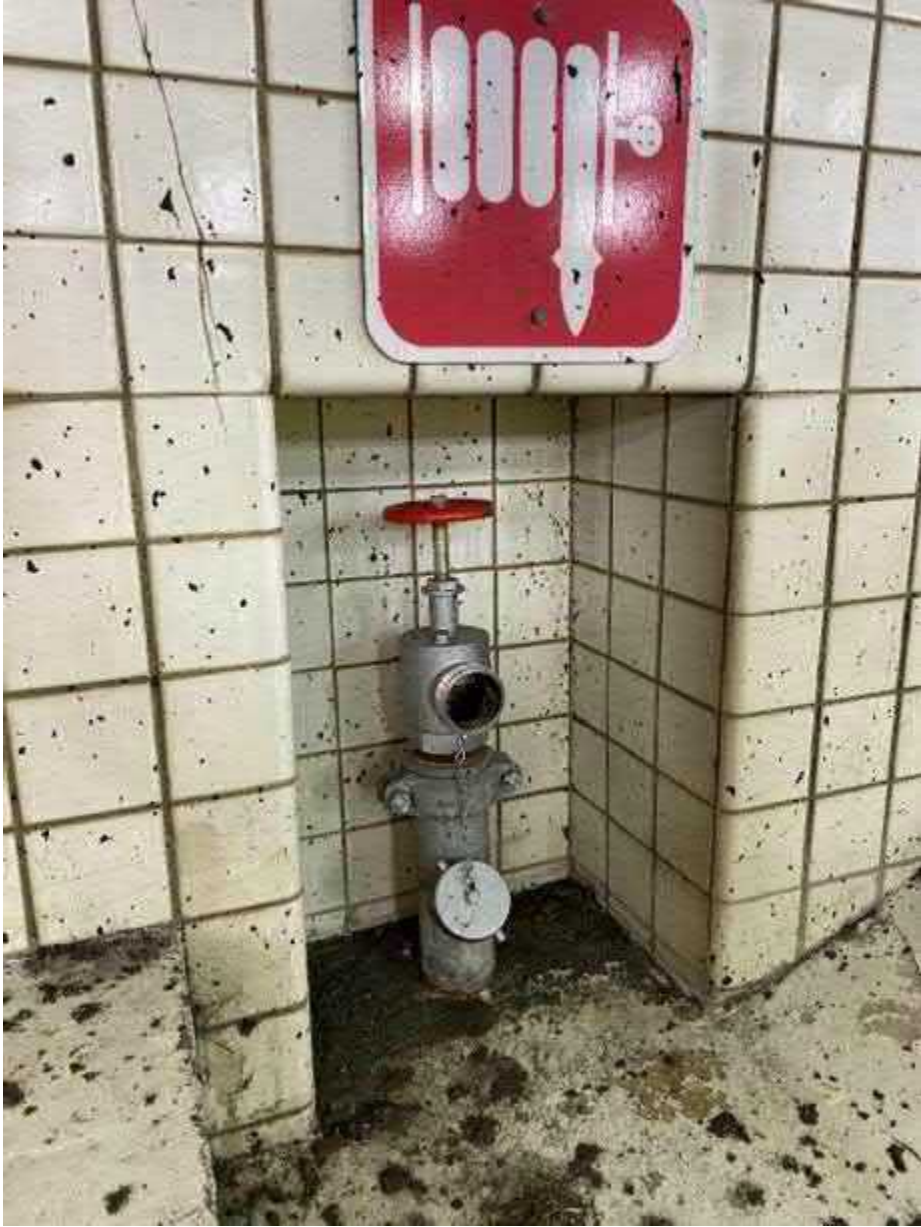
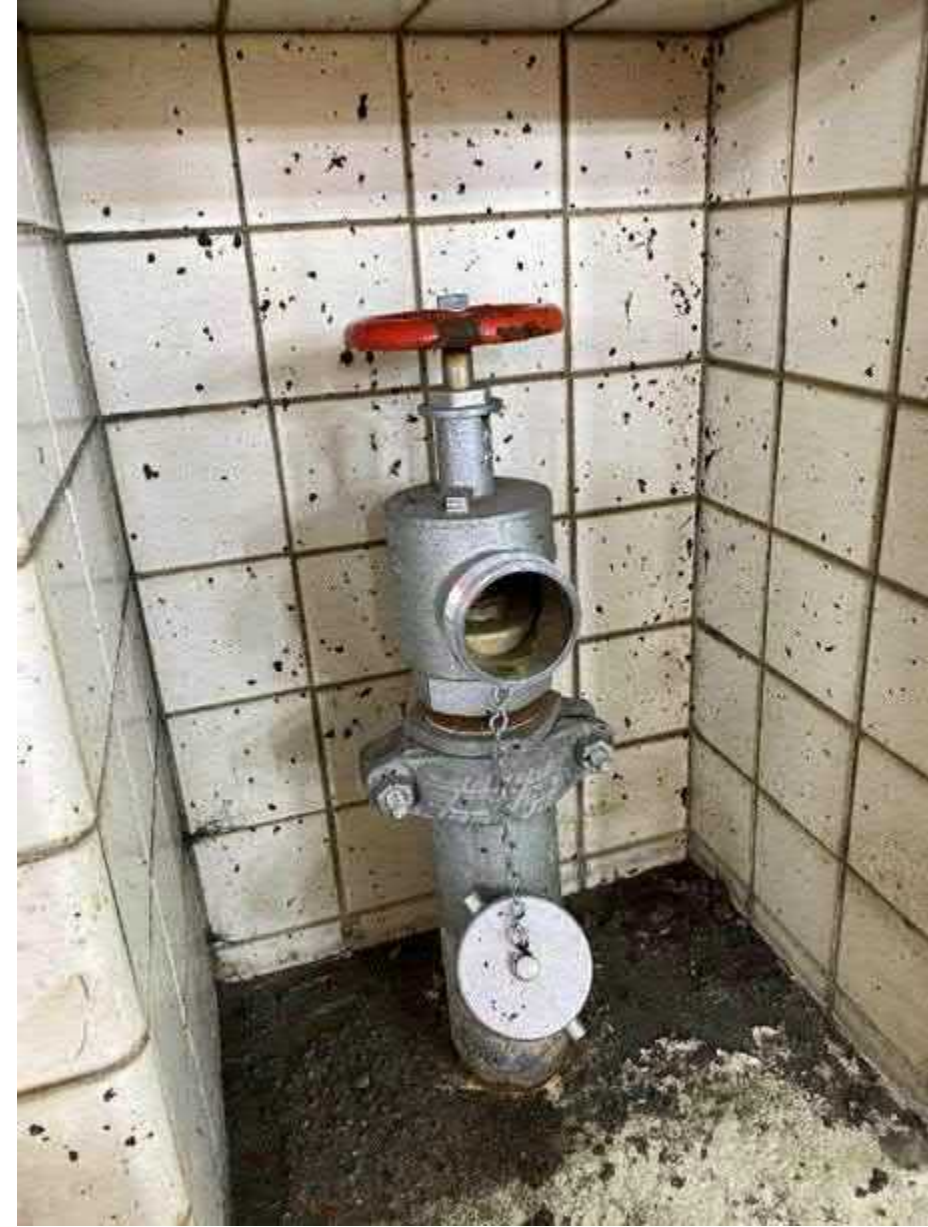
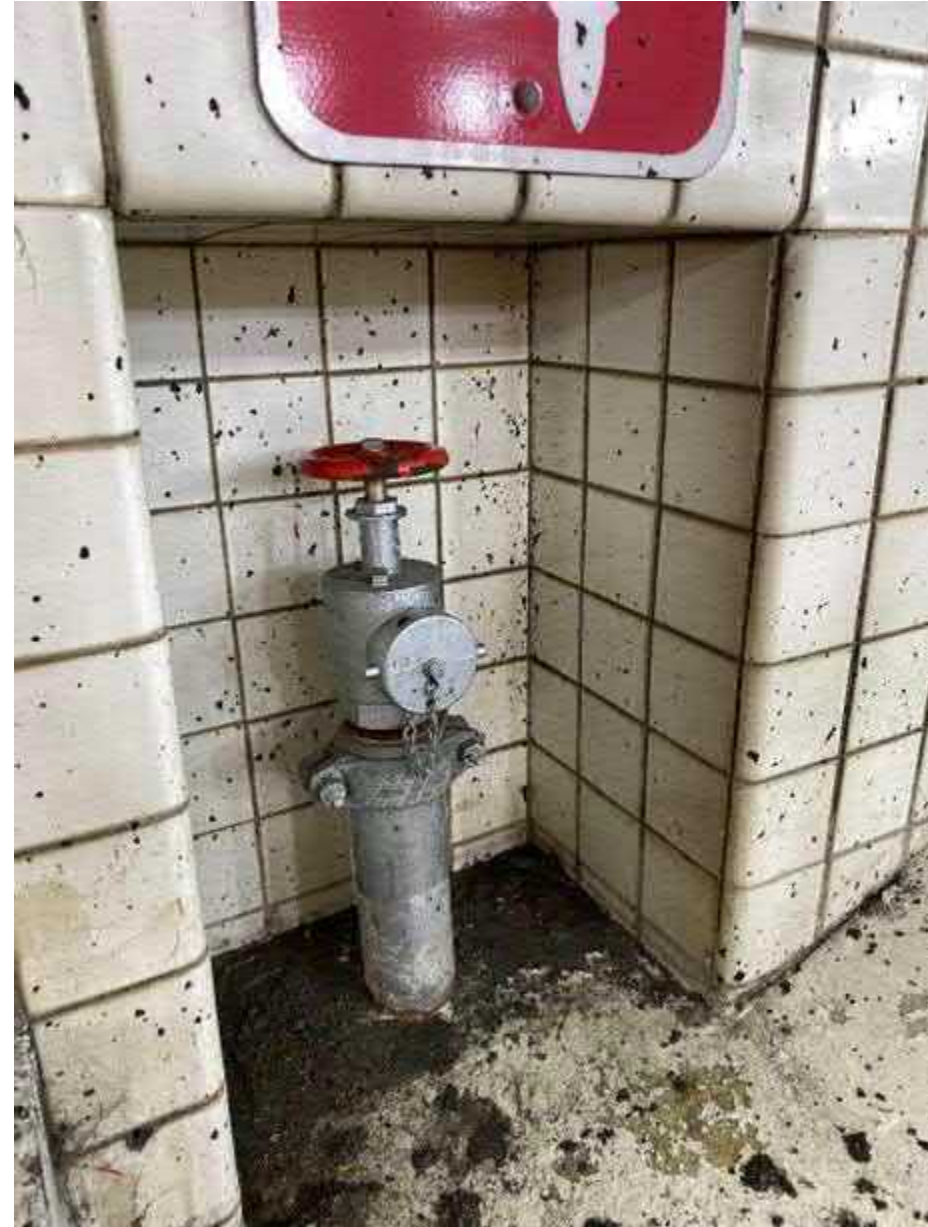
Good condition. CS1

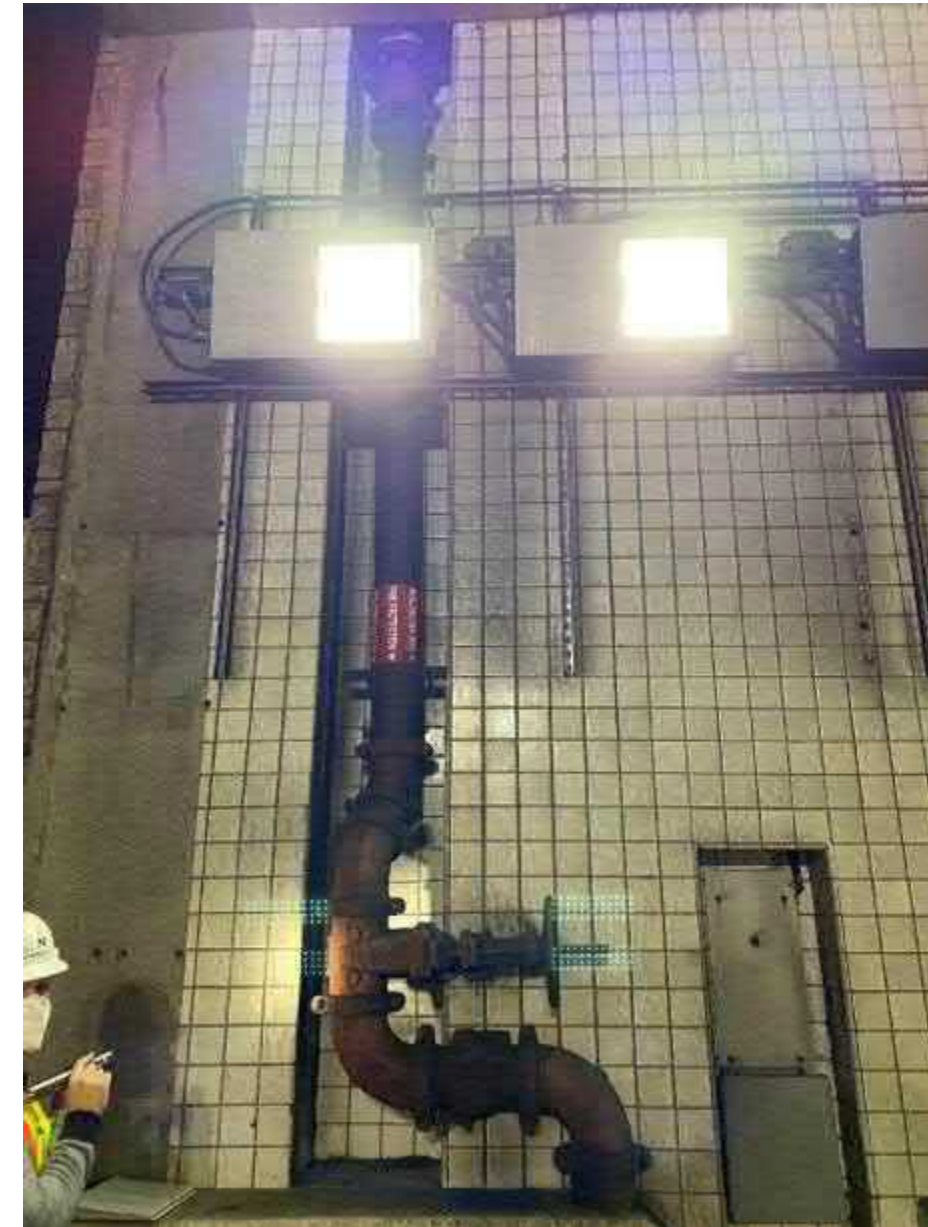
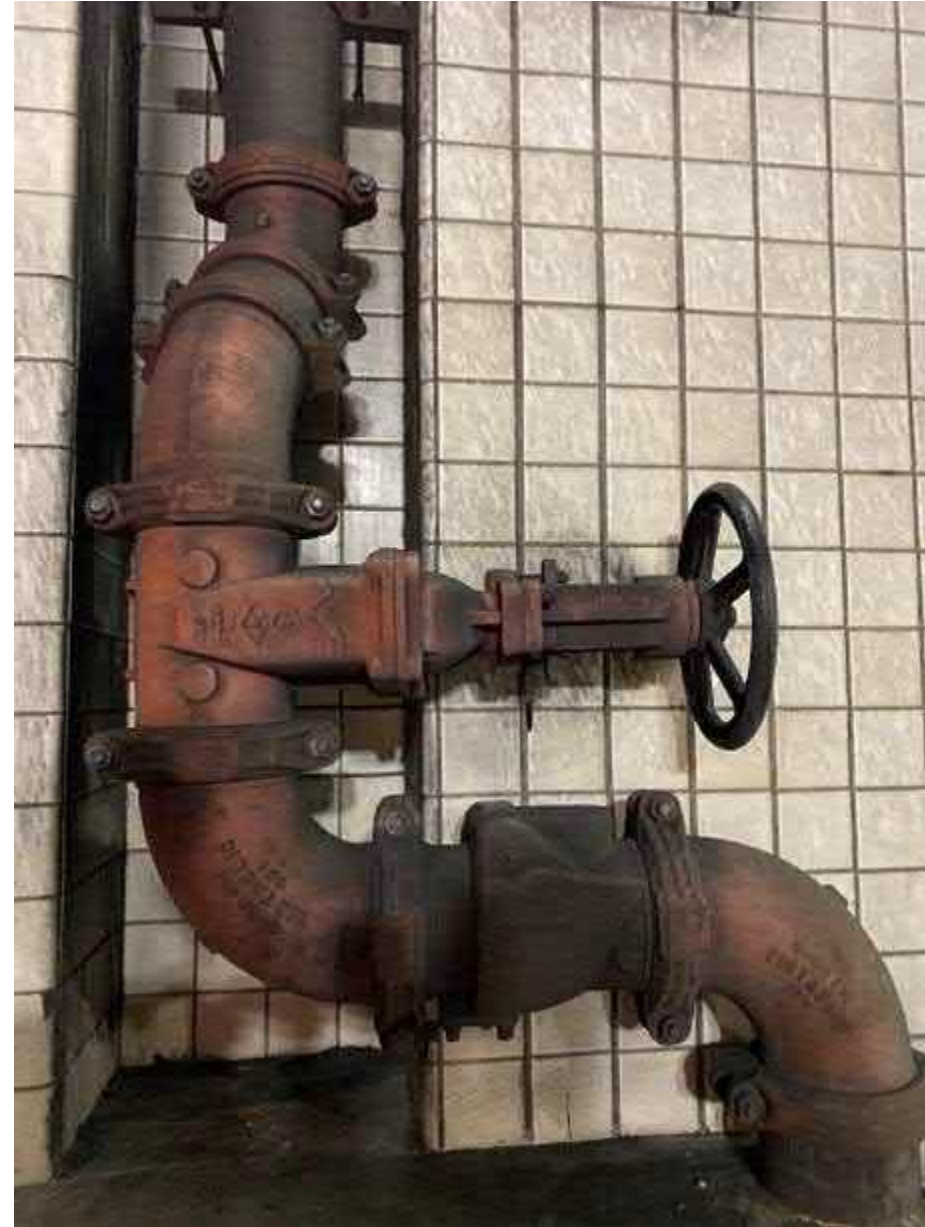
Minor surface rust on gate and check valve. CS1
