# **Lytle Tunnel (HAM-71-0134) Inspection Report Fall 2020**

PID 105470

November, 2020

Ohio Department of  
Transportation  
District 8  
505 South State Route 741  
Lebanon, OH 45036

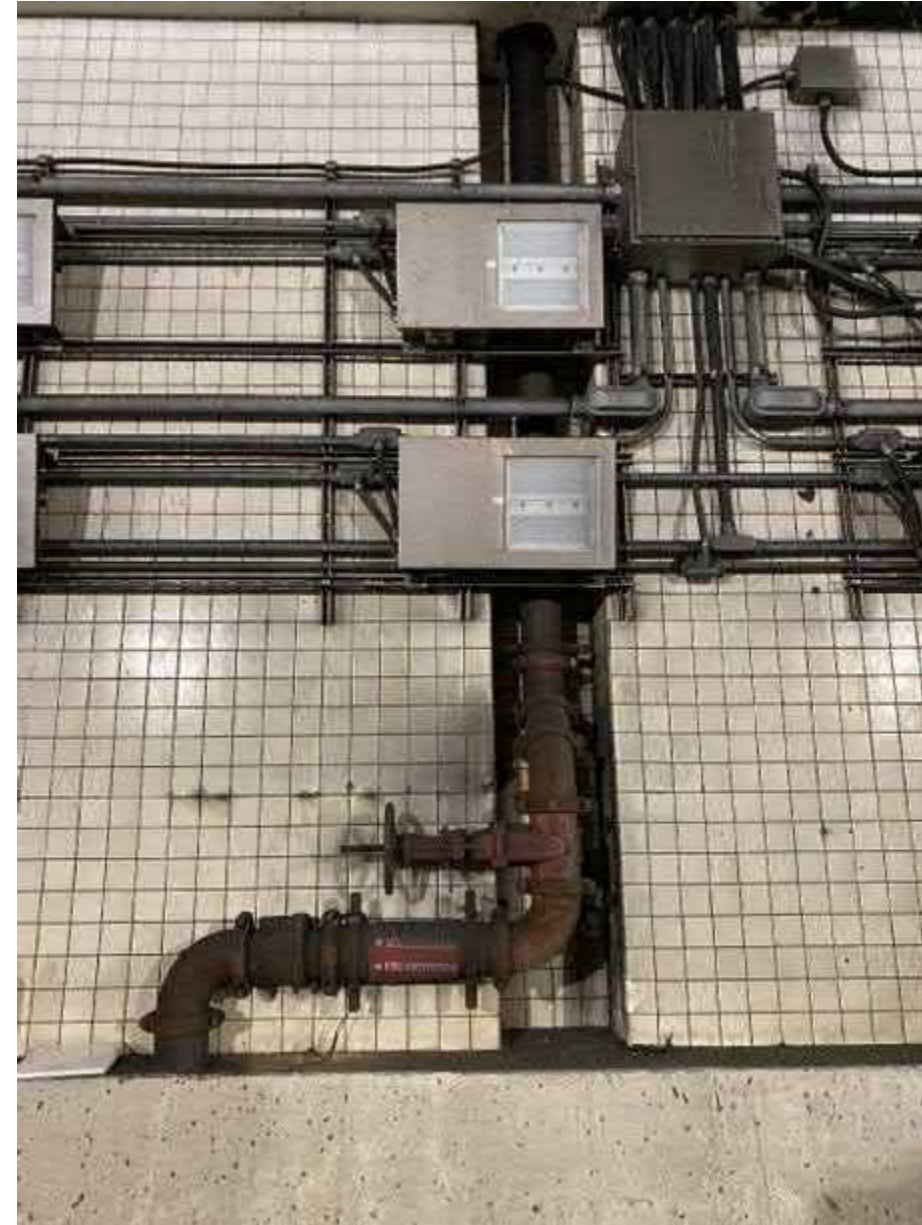
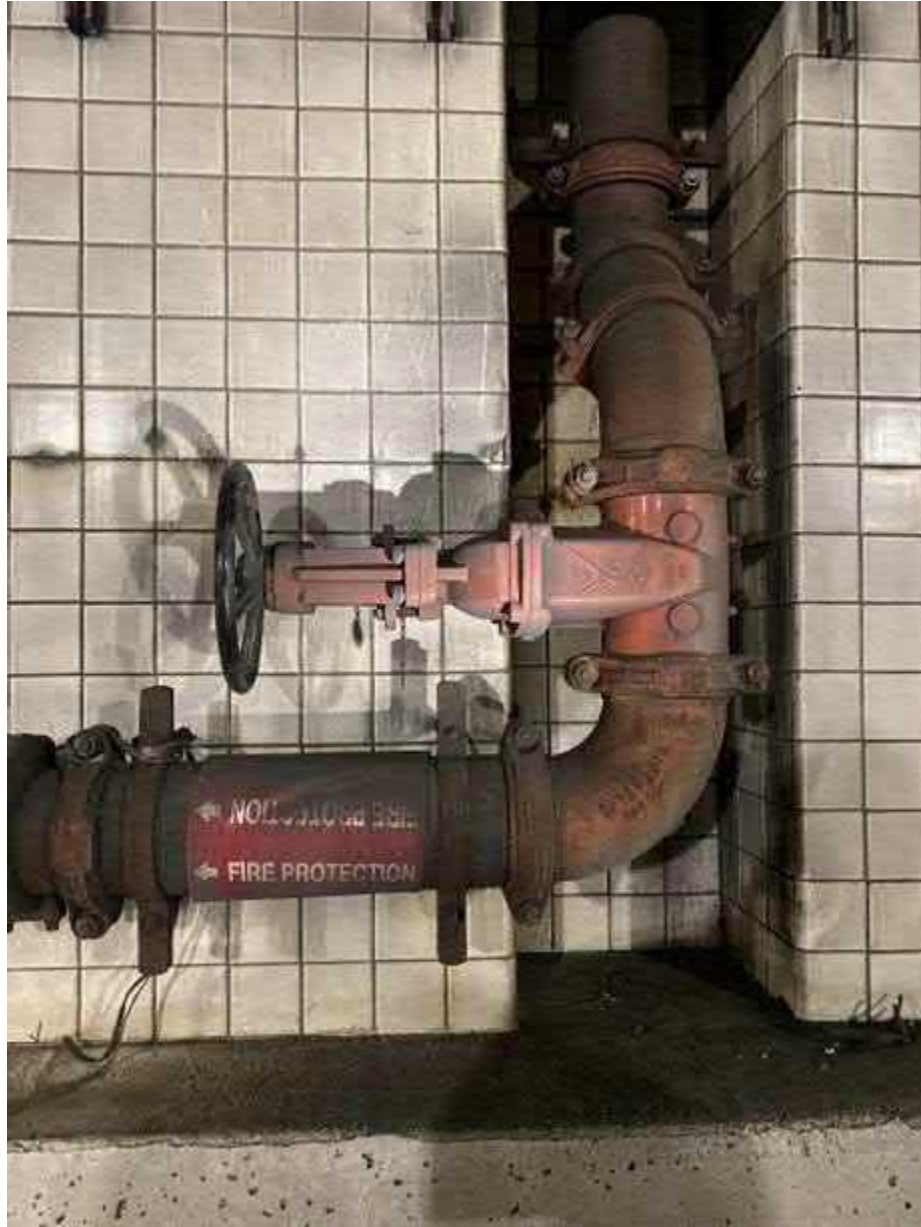
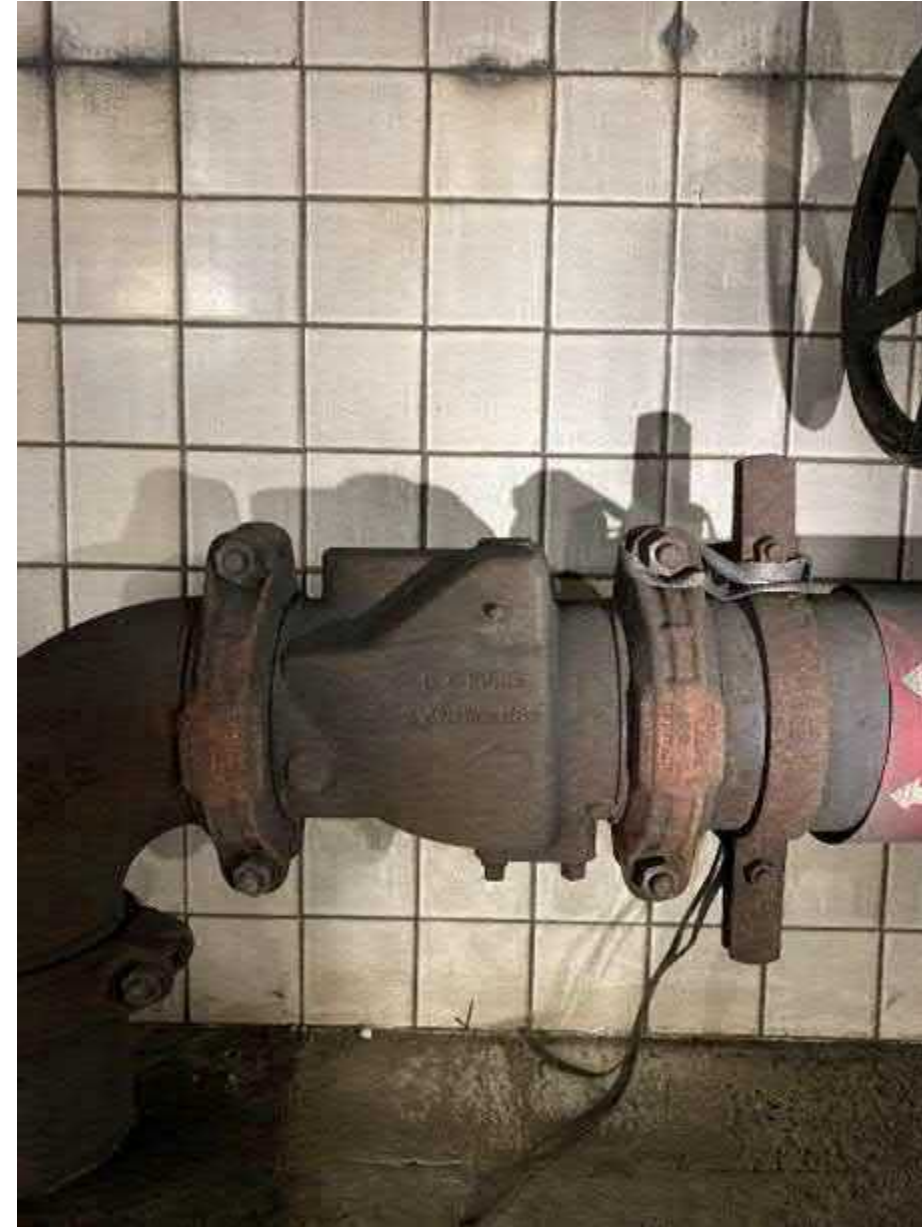
Minor surface rust on gate and check valve . CS1

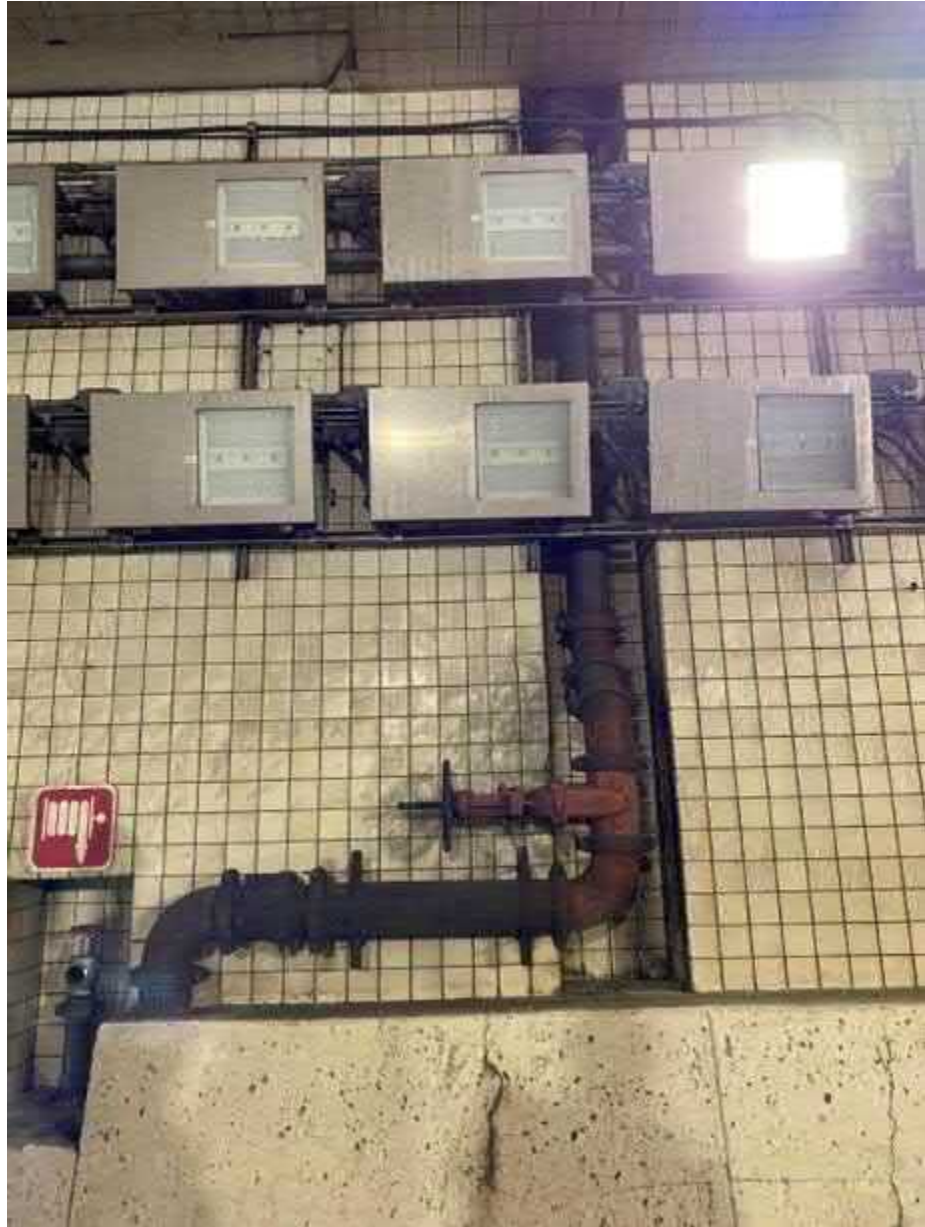
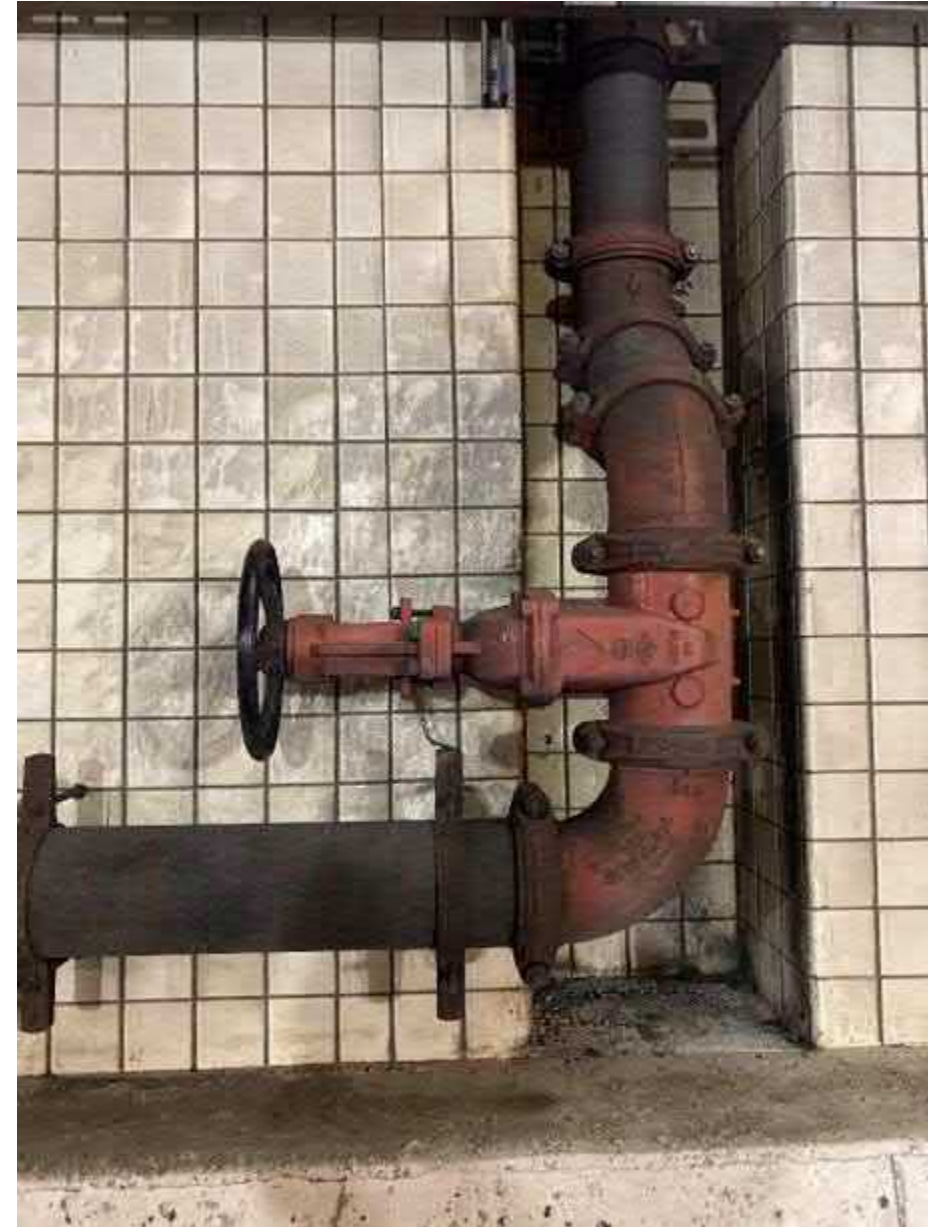
Good condition. Minor surface rust. CS1

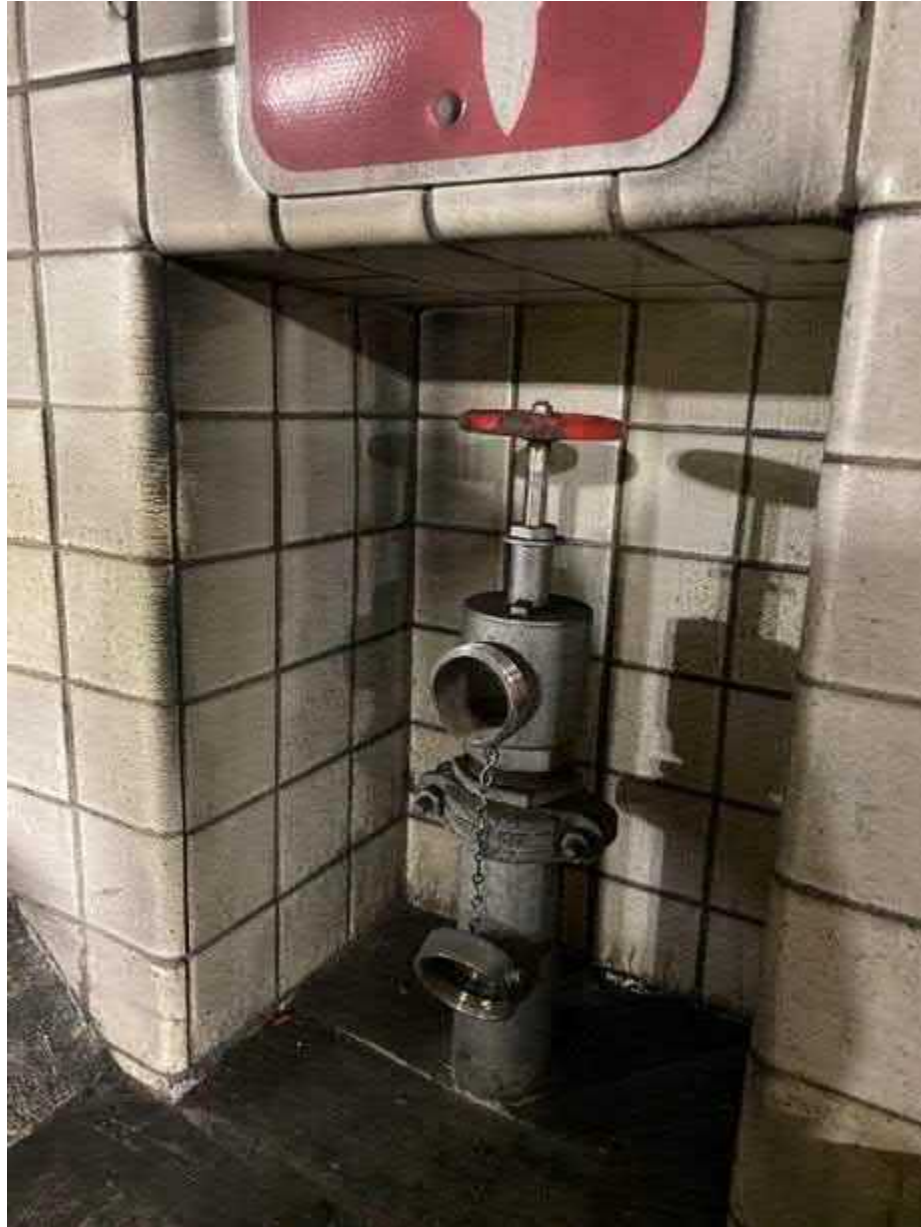
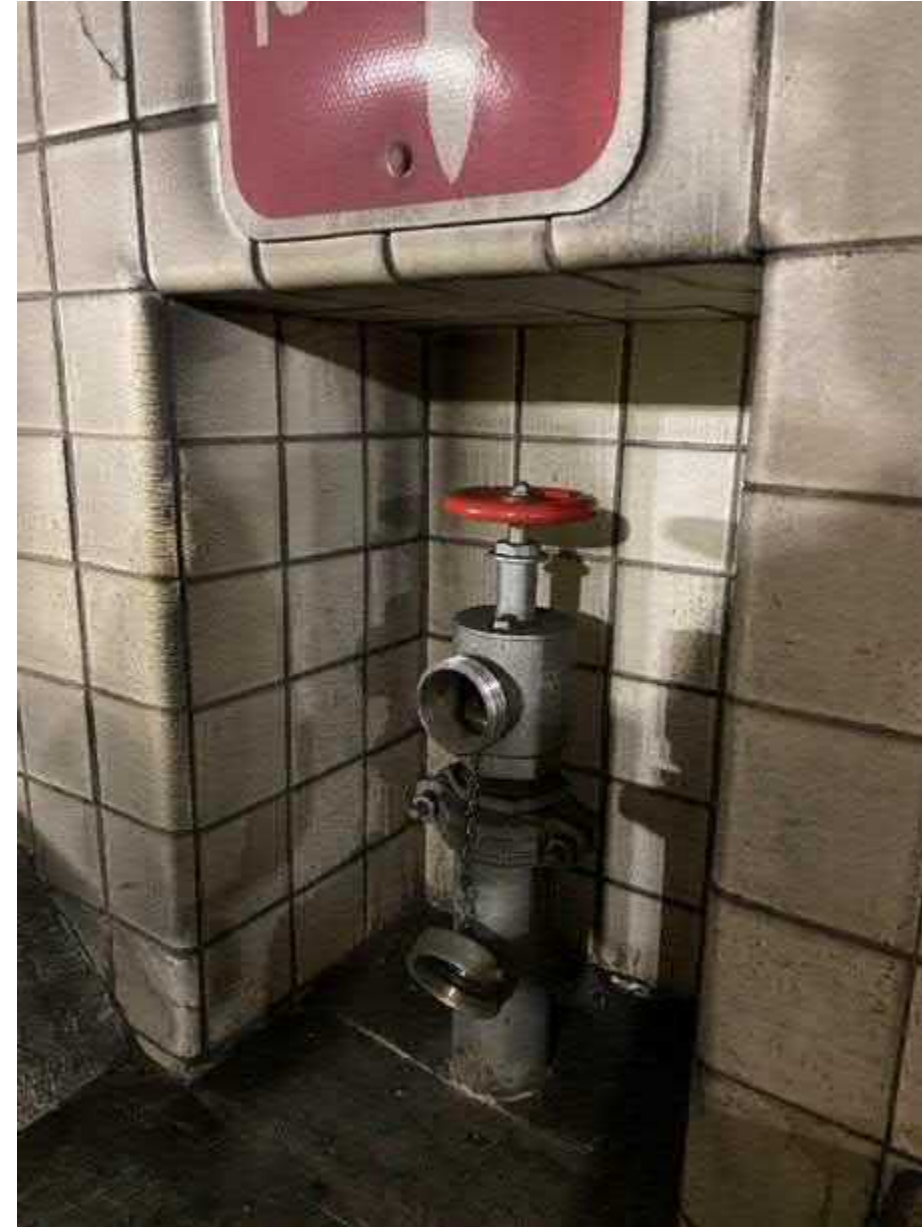
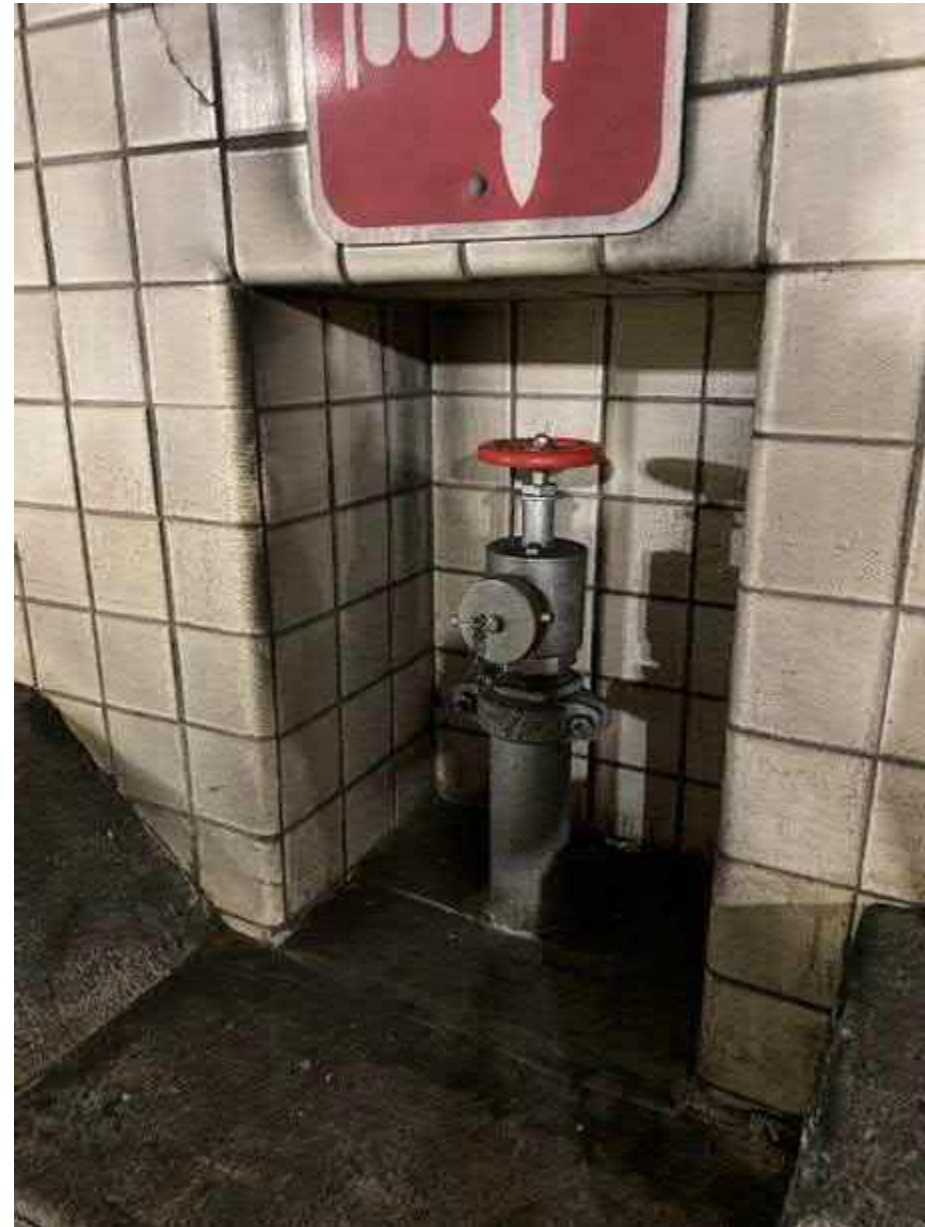
Good condition. CS1

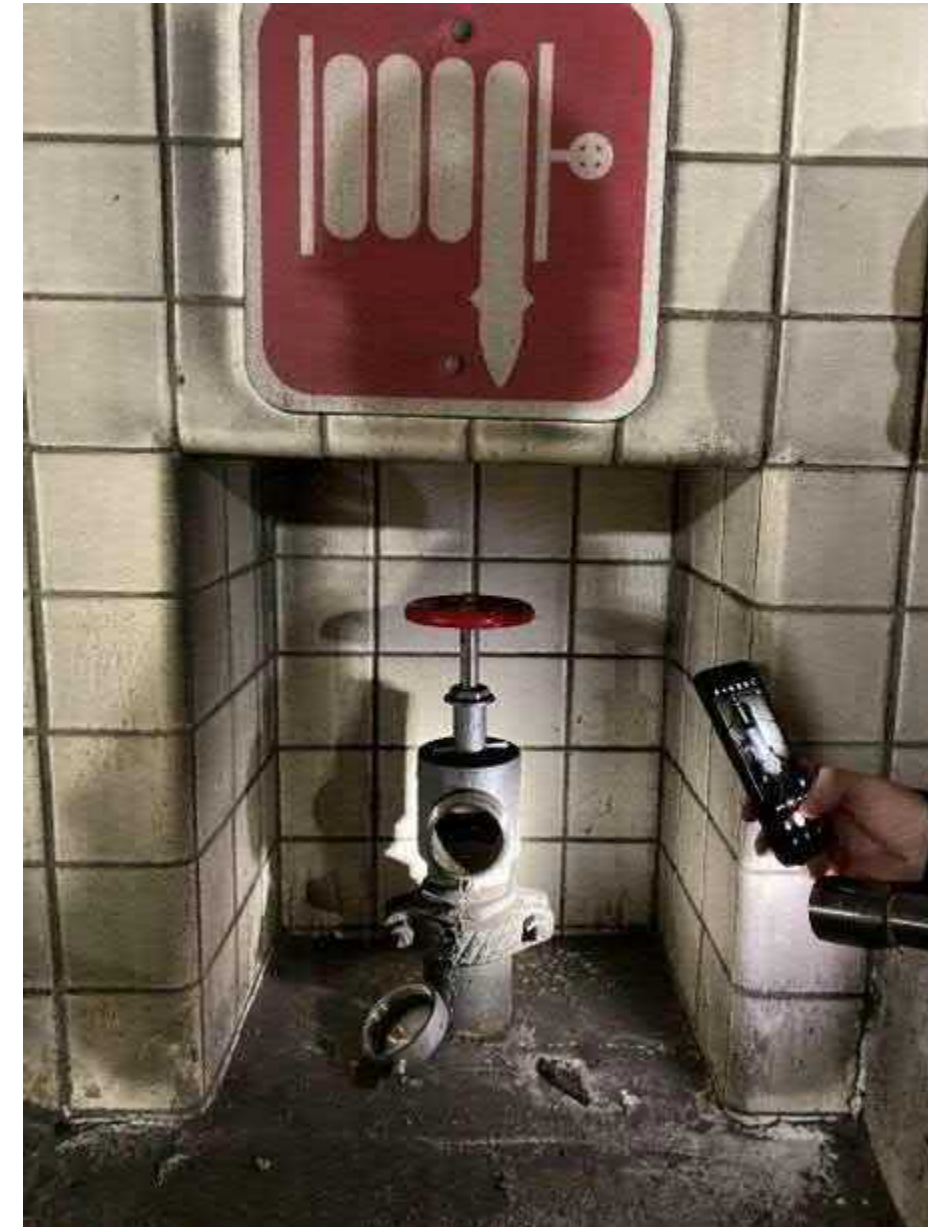
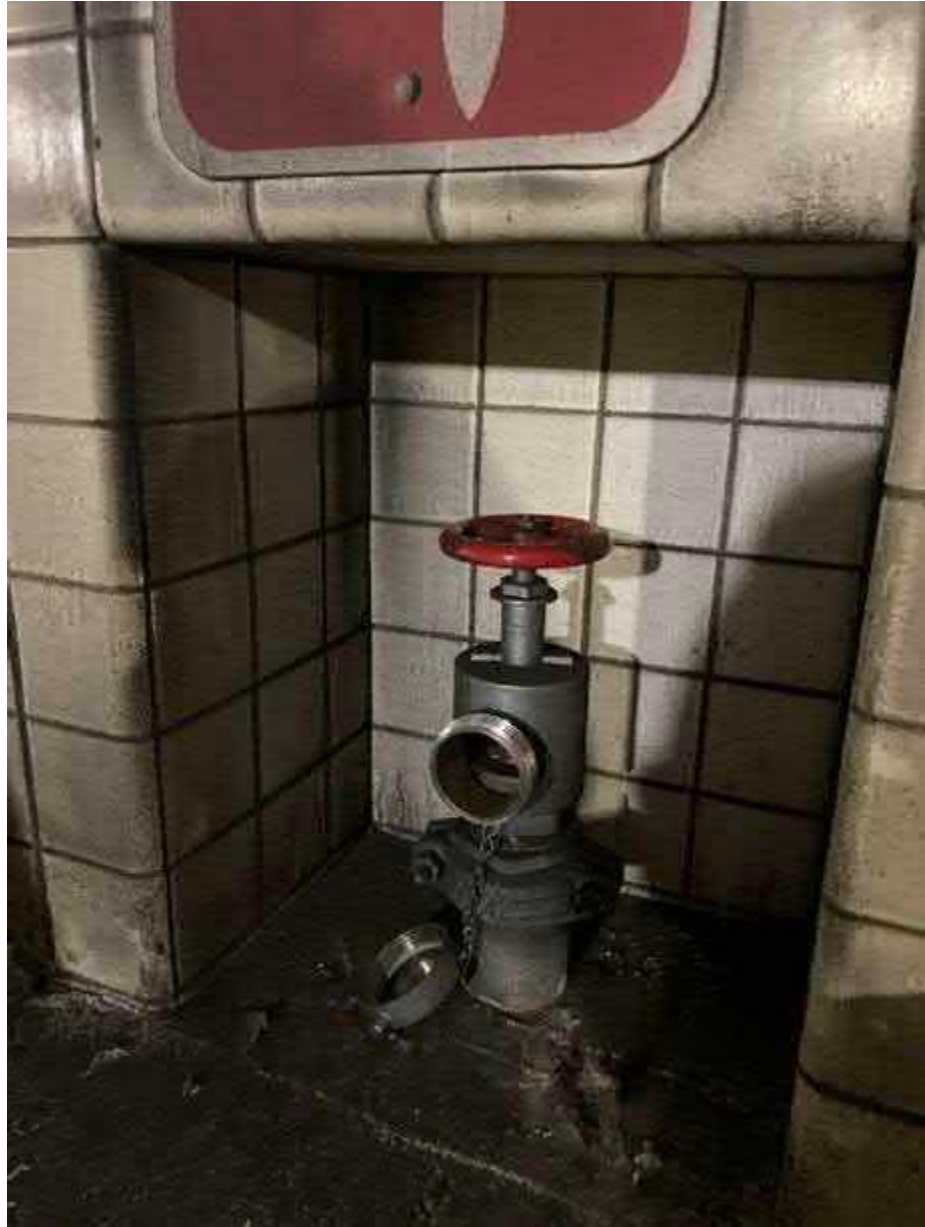
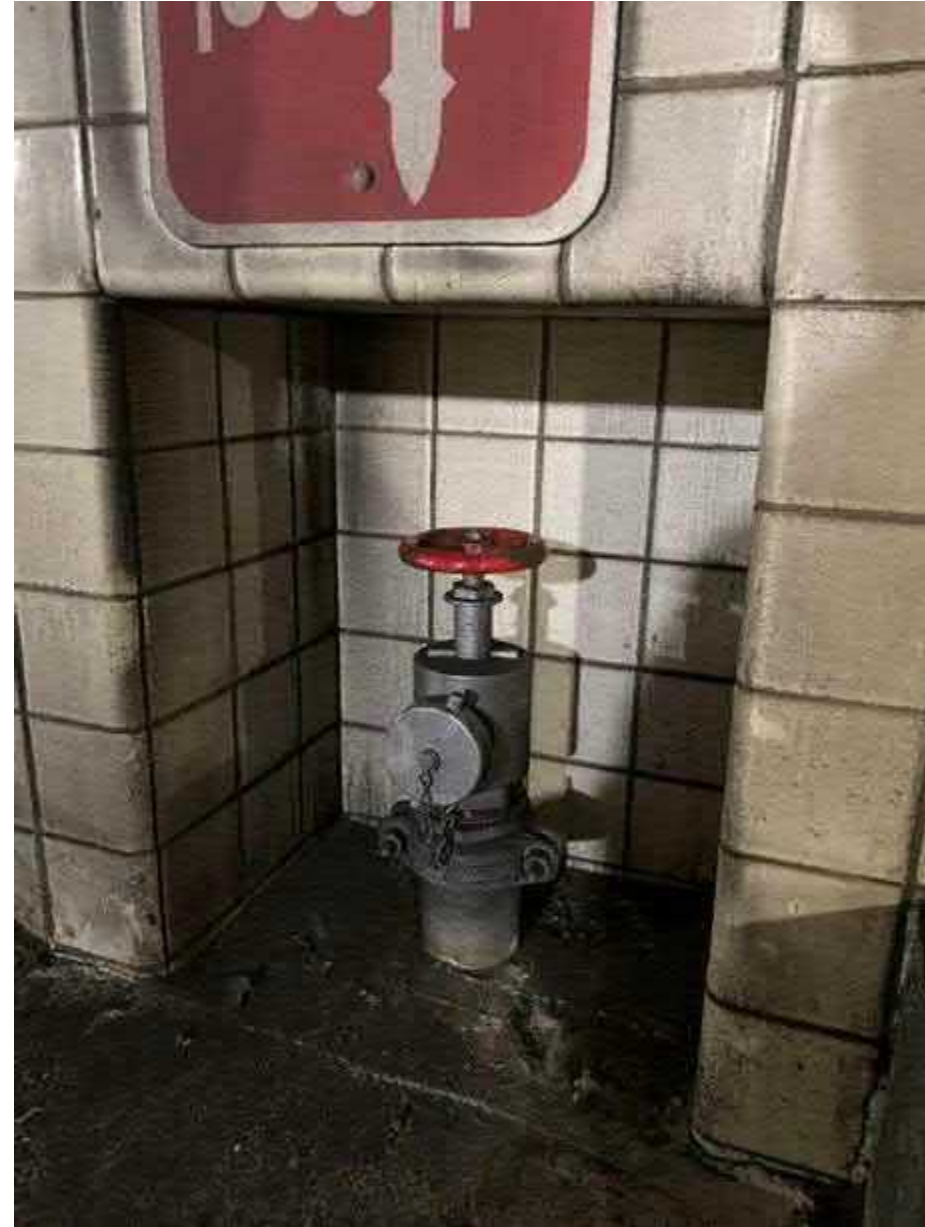
Good condition. CS1

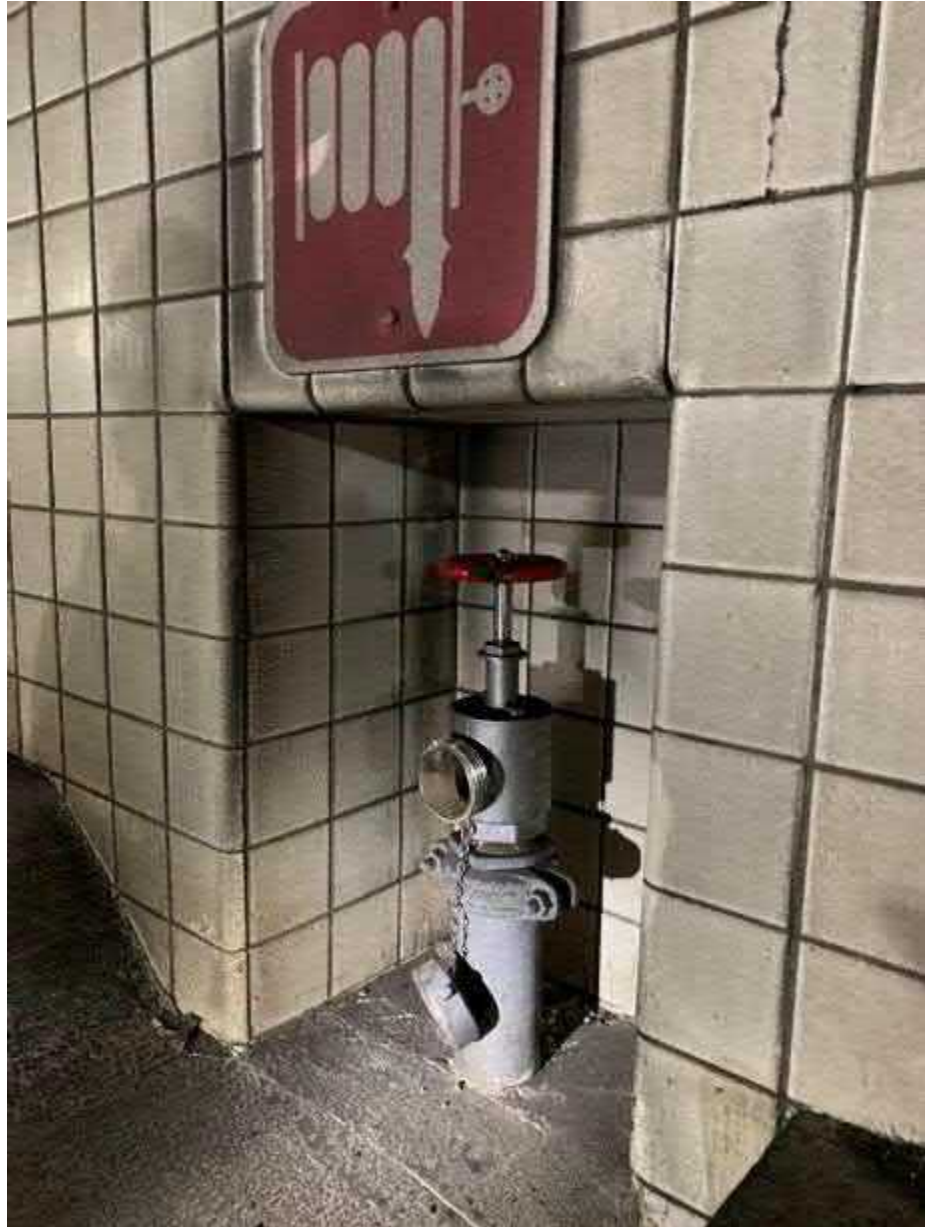
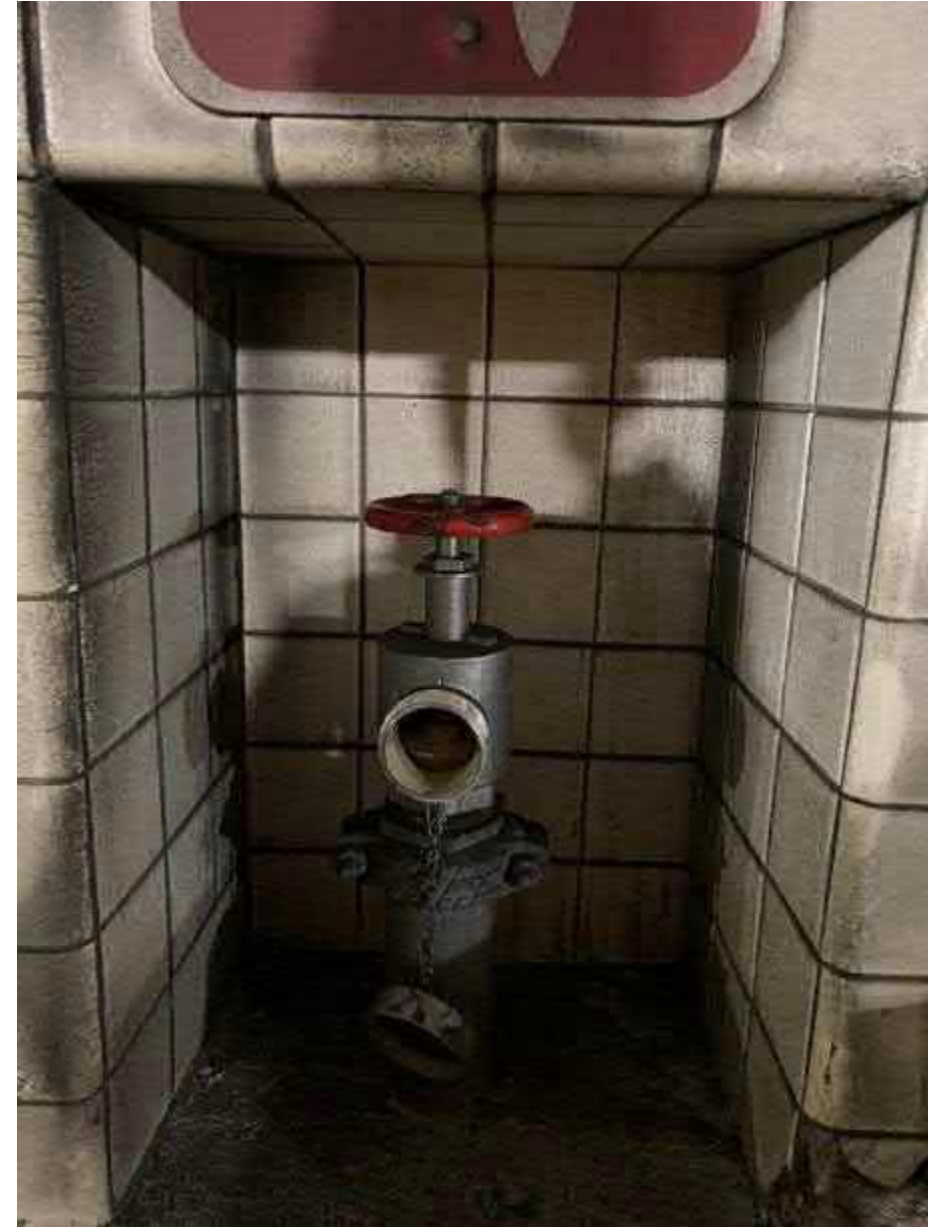
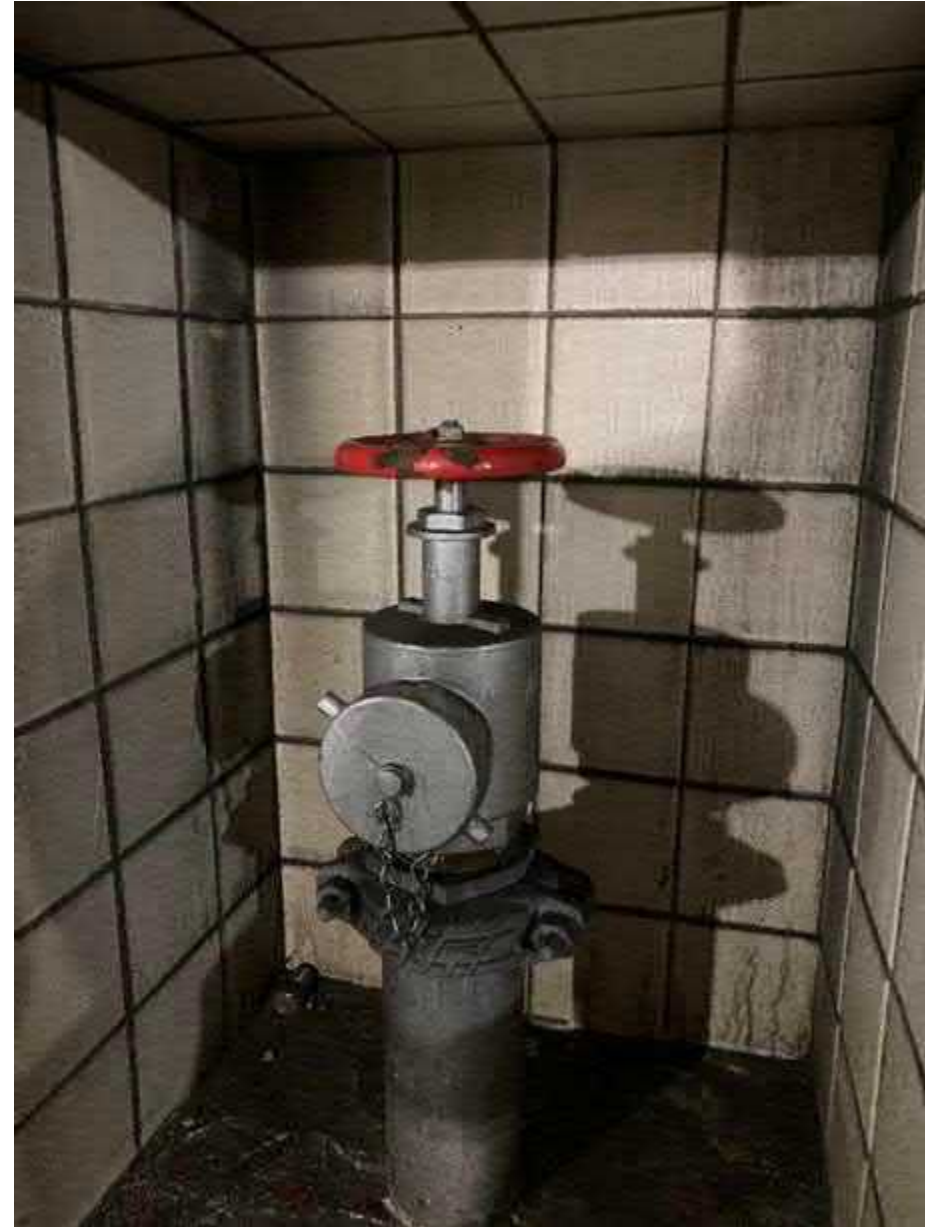
Good condition. CS1

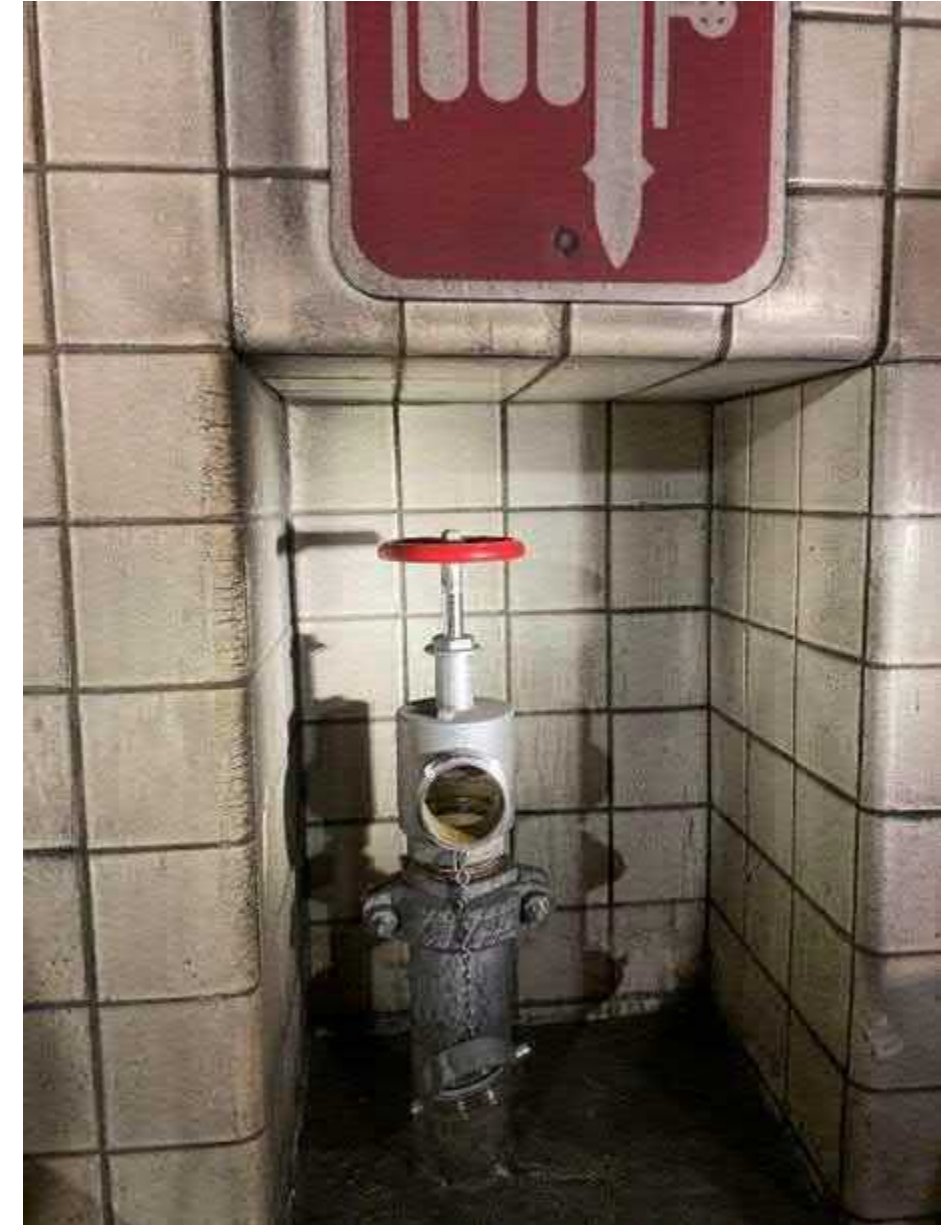
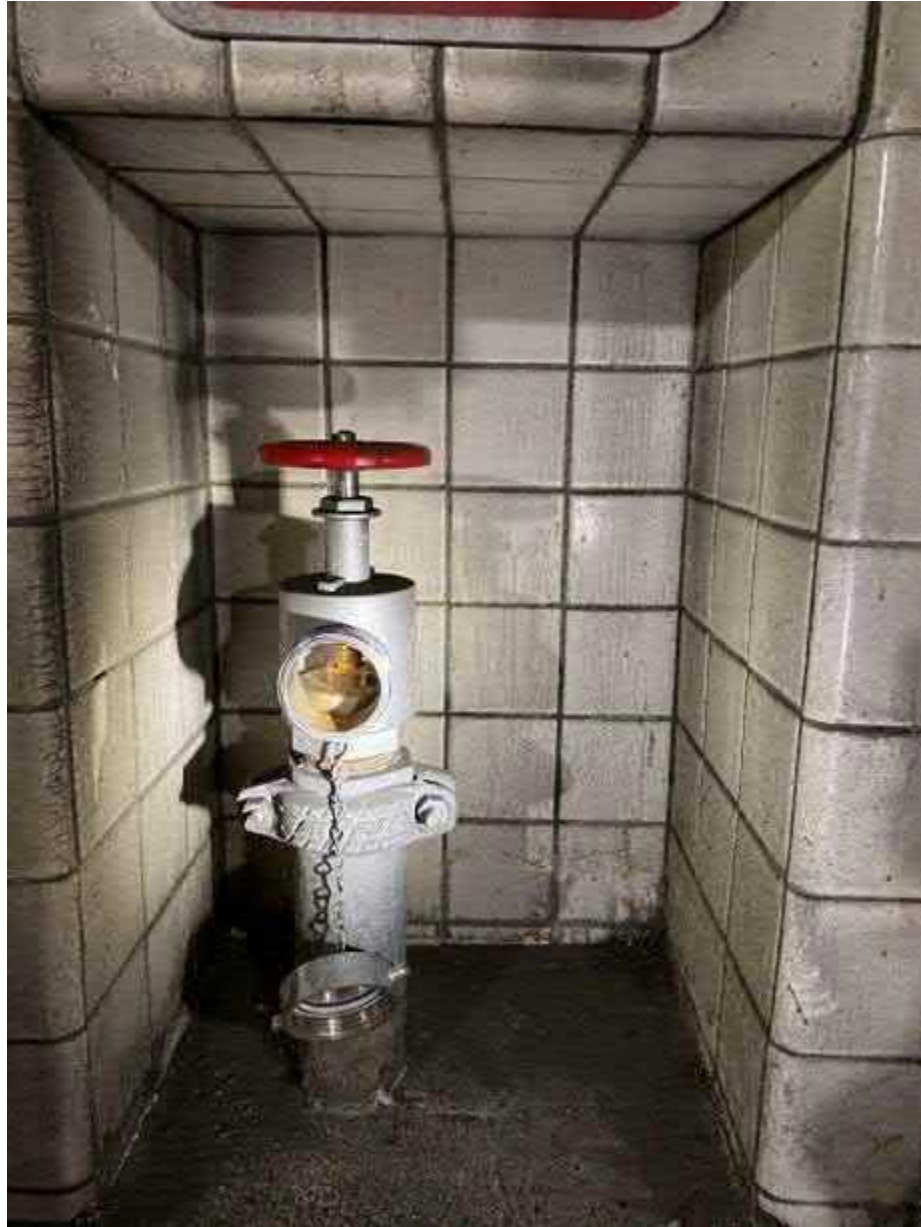
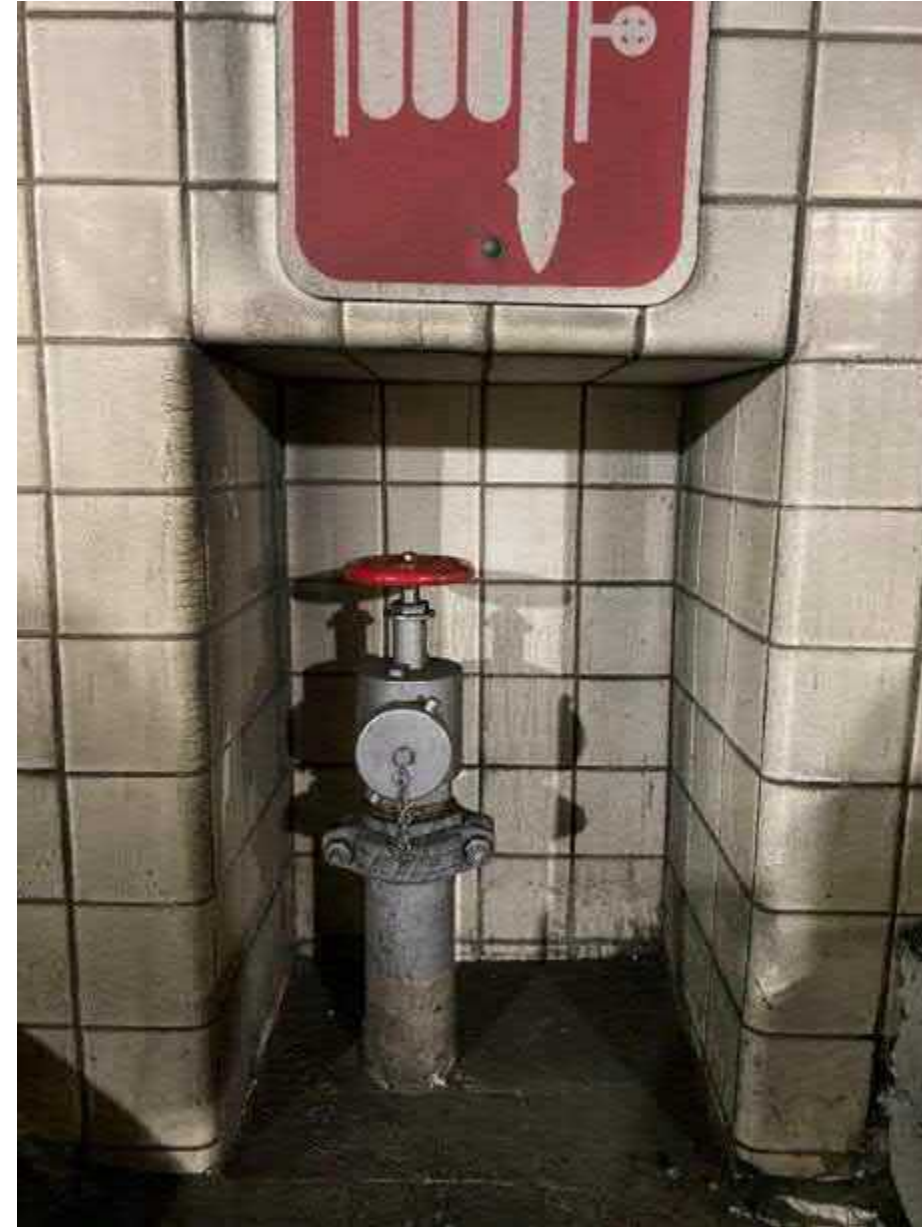
Good condition. CS1

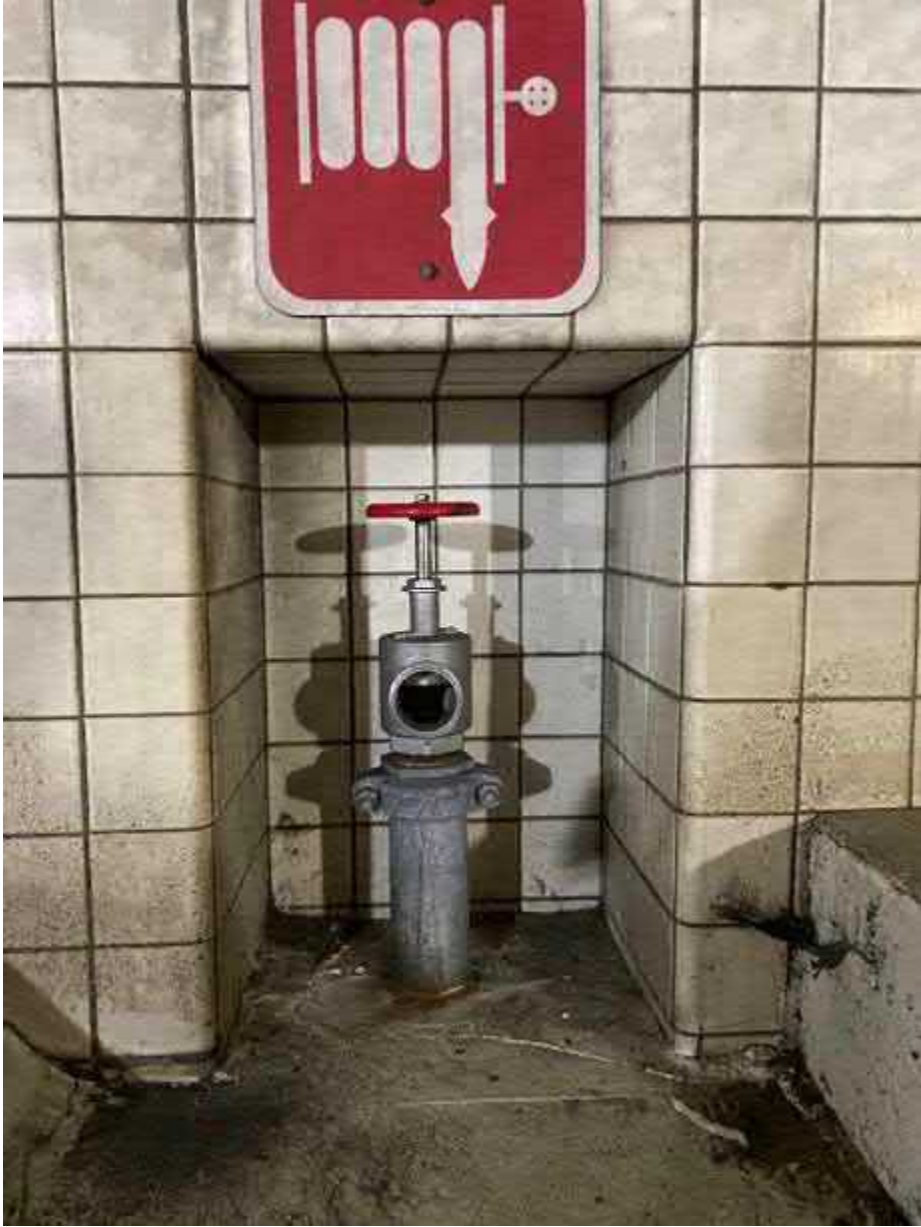
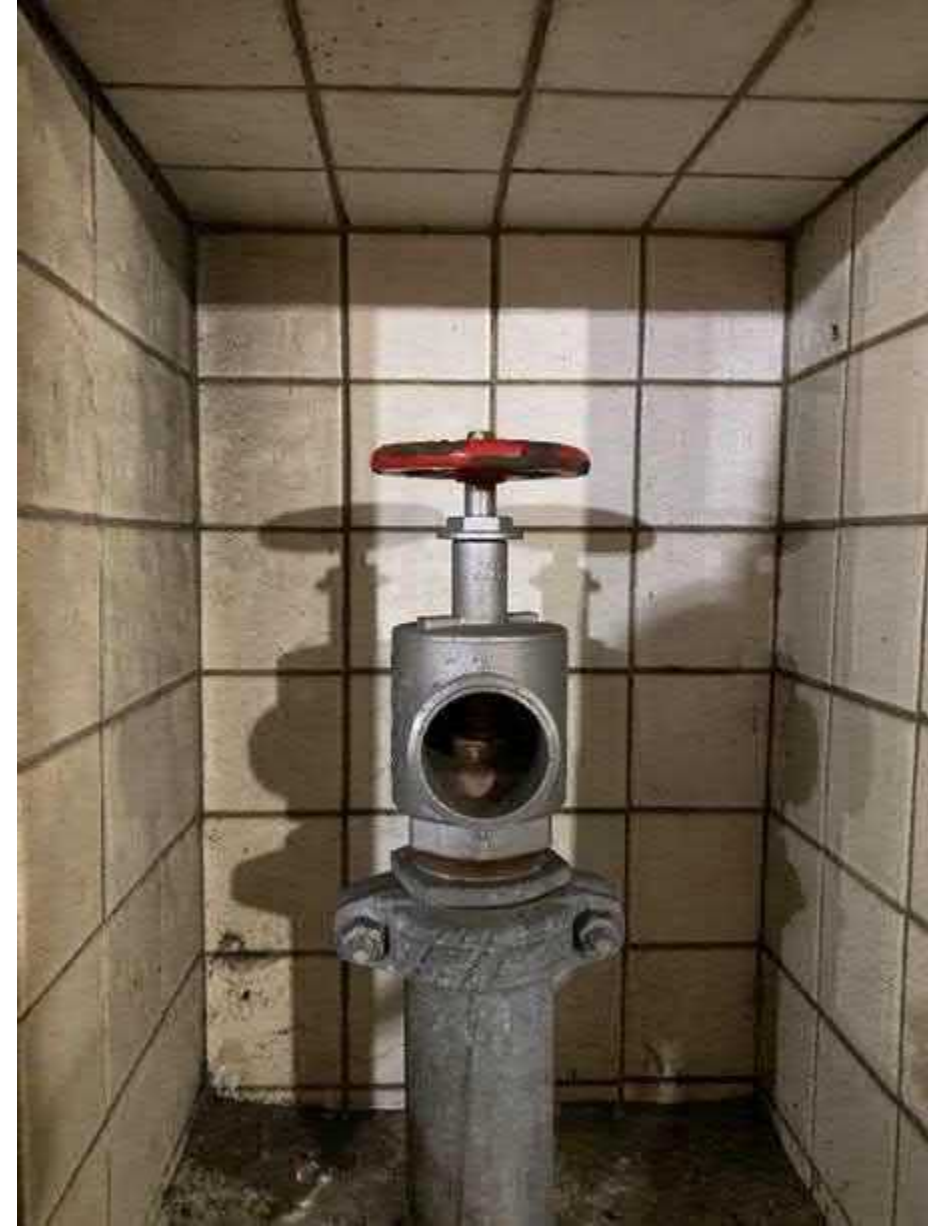
Missing cap and chain. CS2
