# **Lytle Tunnel (HAM-71-0134) Inspection Report Fall 2020**

PID 105470

November, 2020

Ohio Department of  
Transportation  
District 8  
505 South State Route 741  
Lebanon, OH 45036

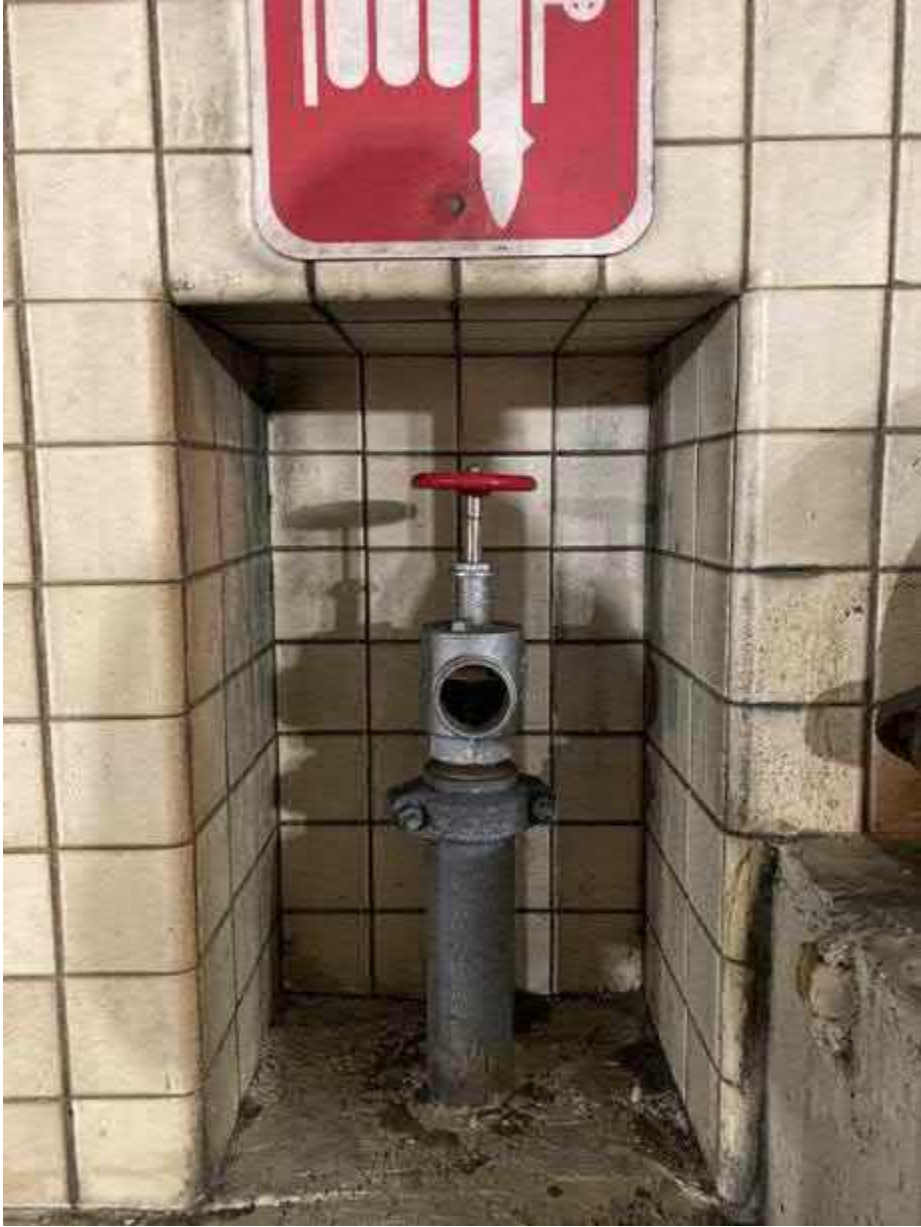
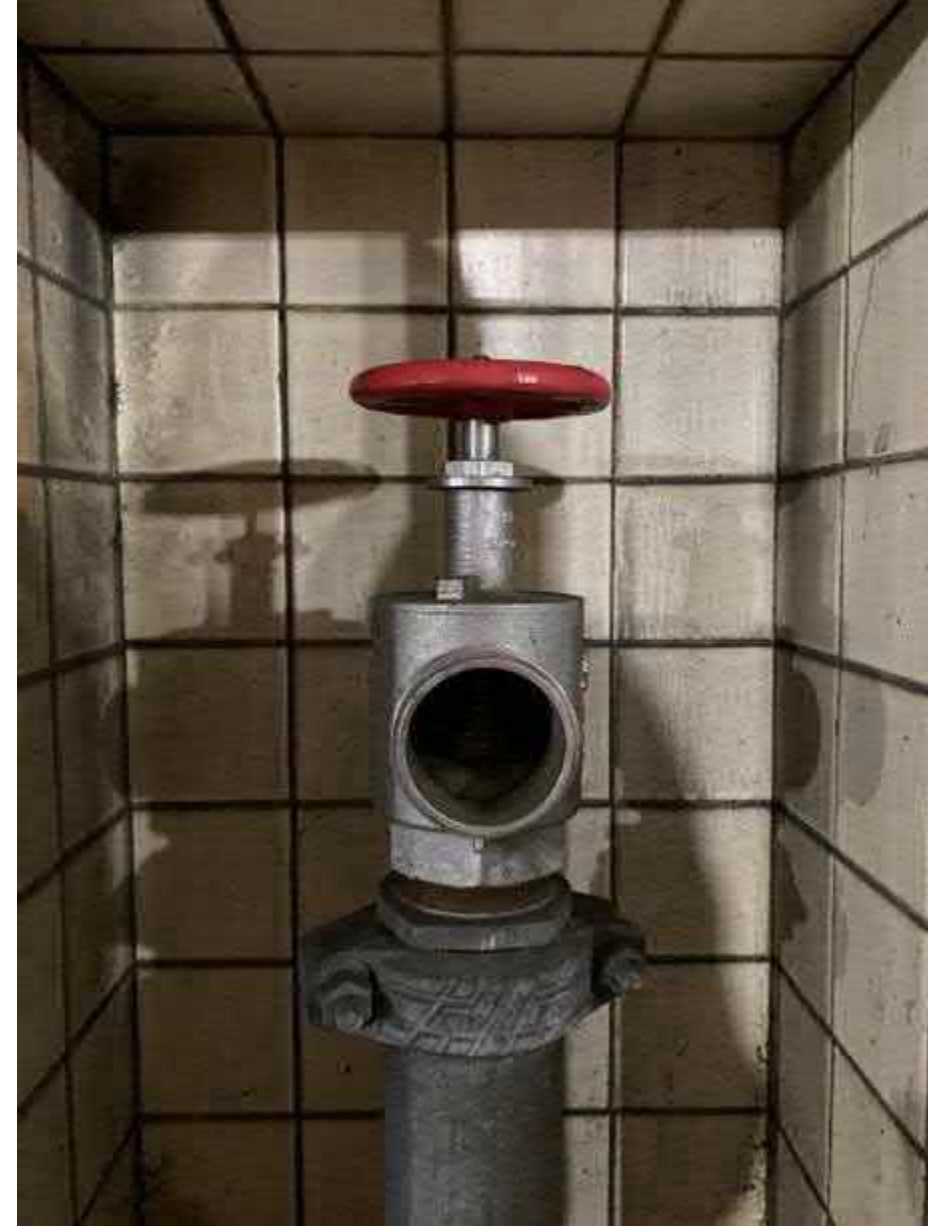
Missing cap and chain. CS2.

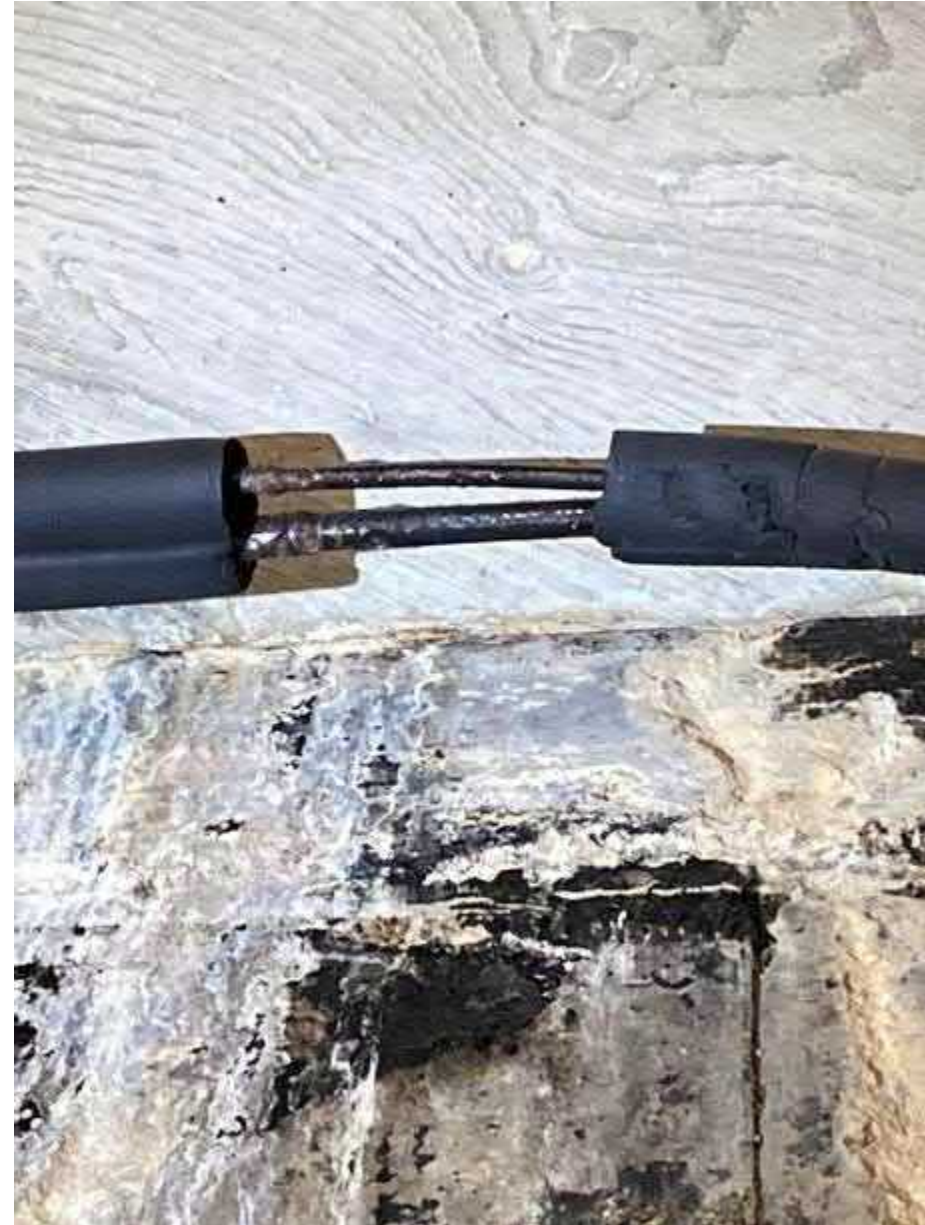
Minor corrosion and leaking on the return for the split unit.

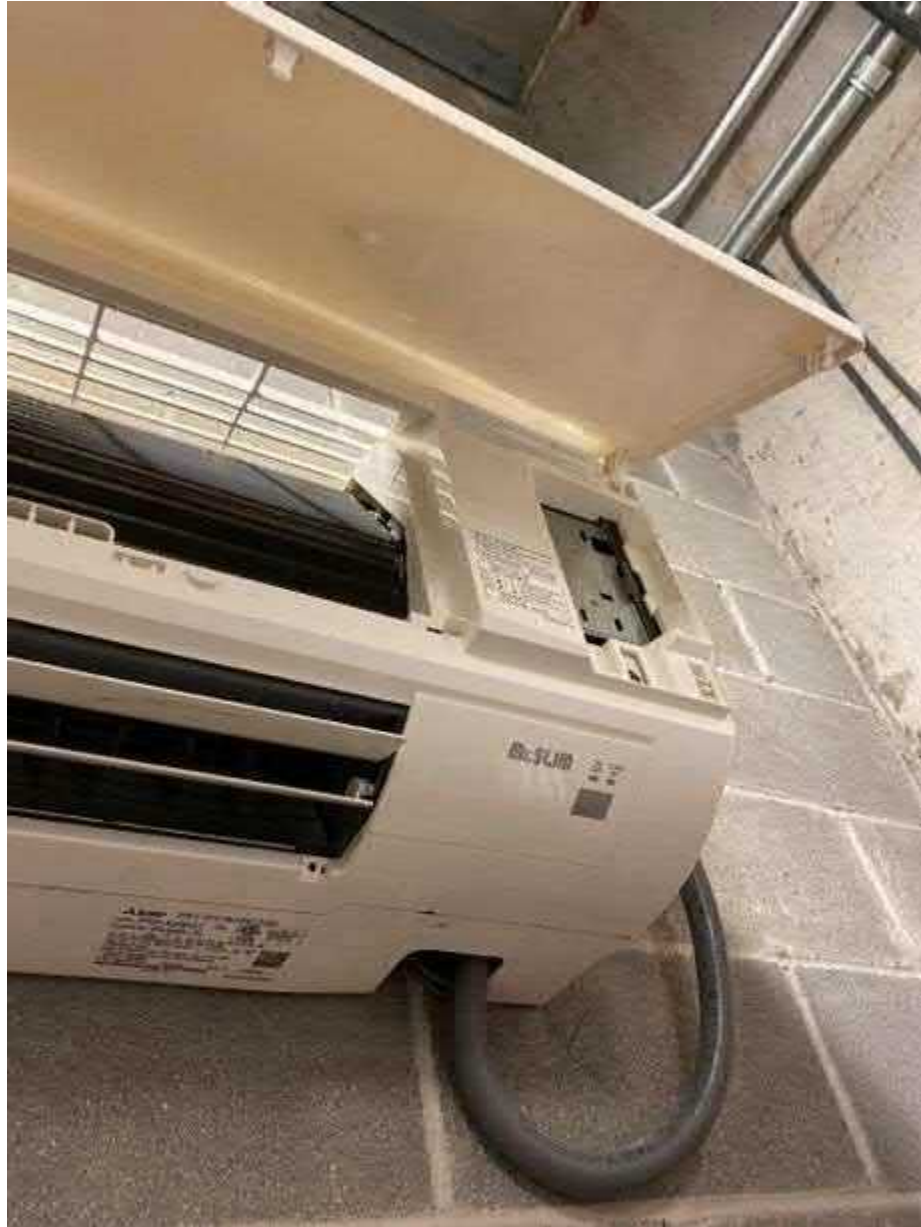
On/Off light bulb is not working

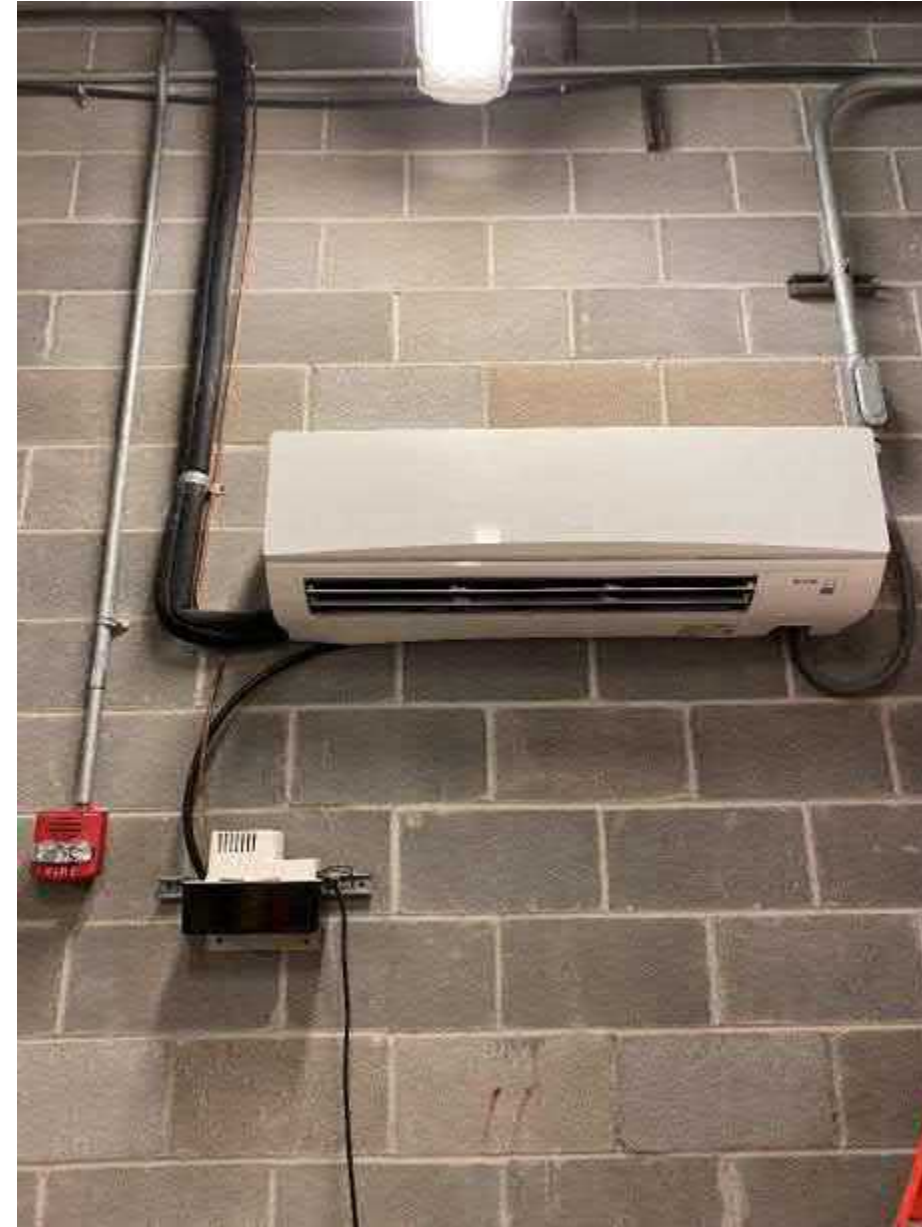
On/Off light bulb is not working

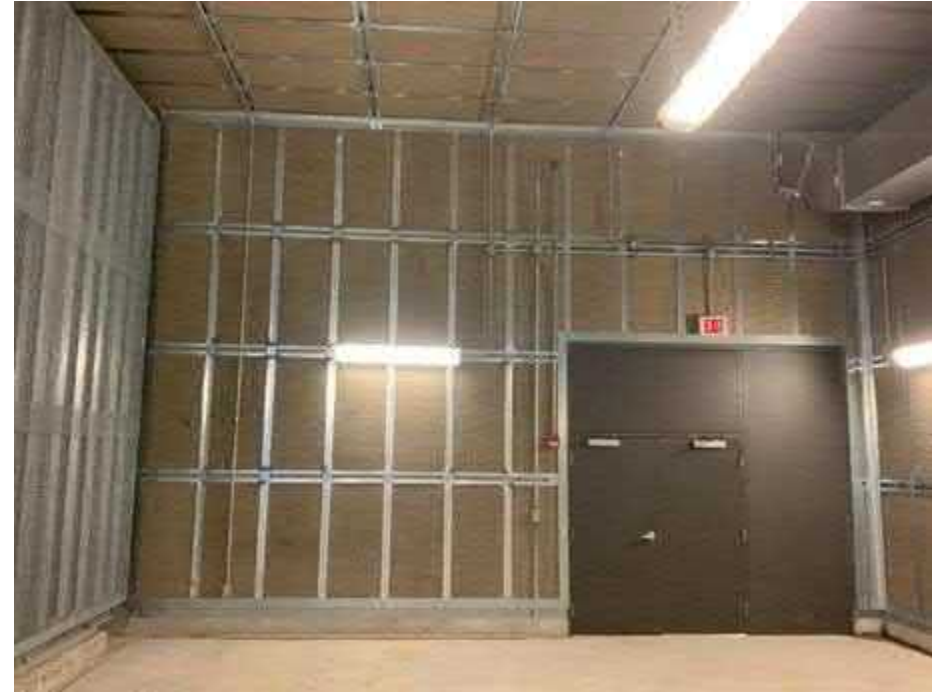
Soundproof boards

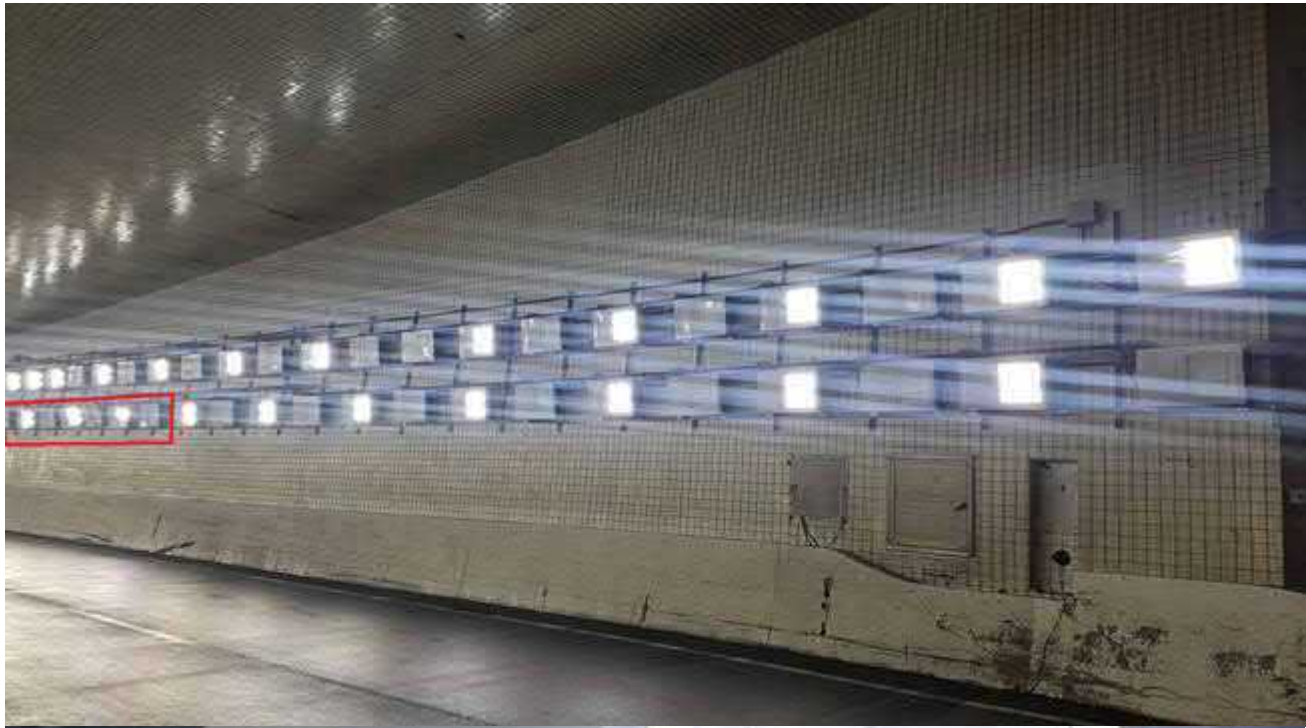
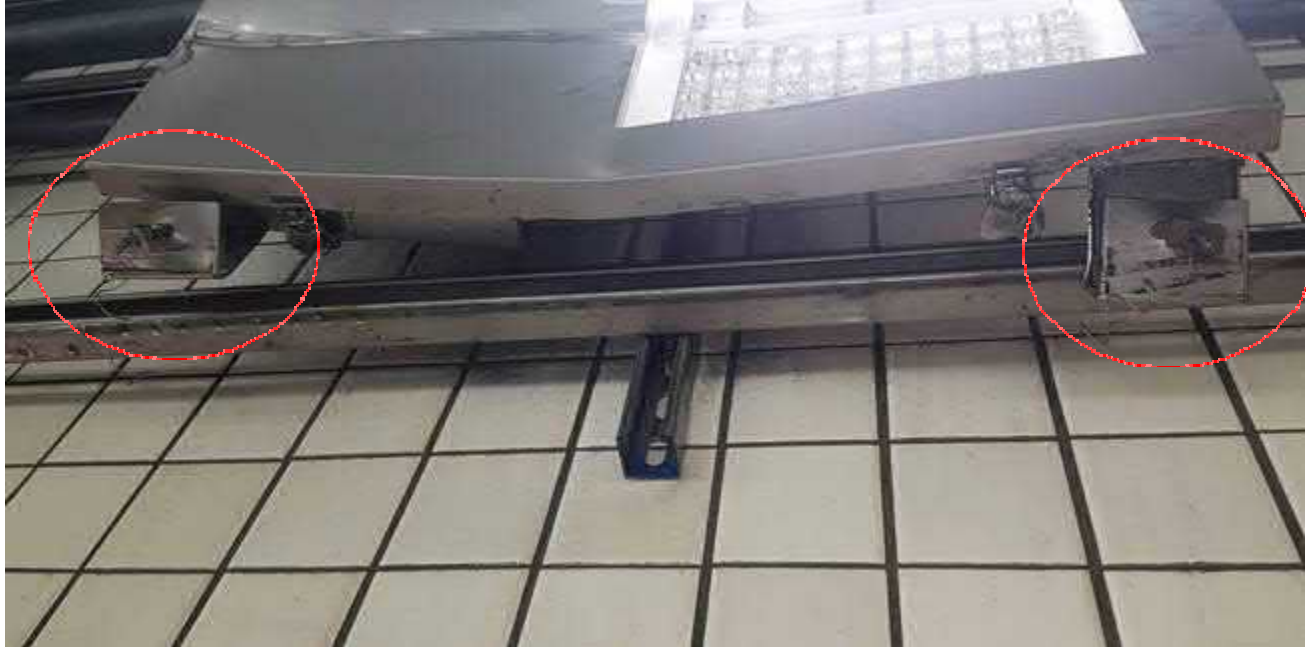
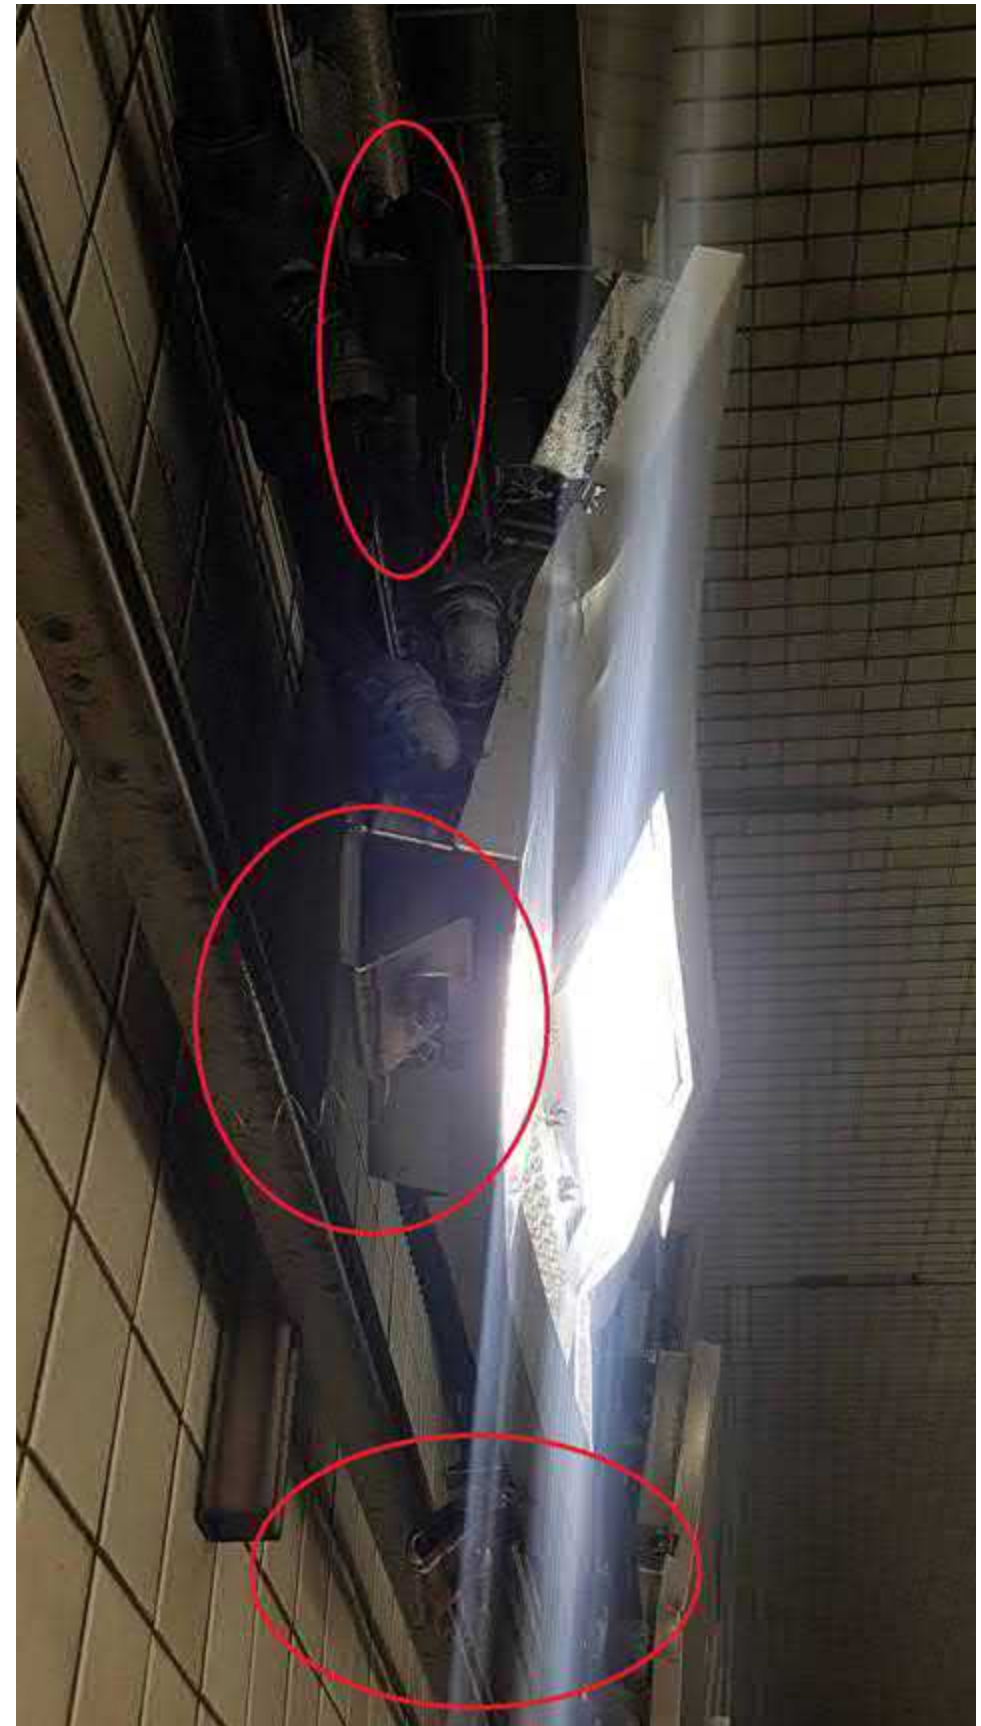
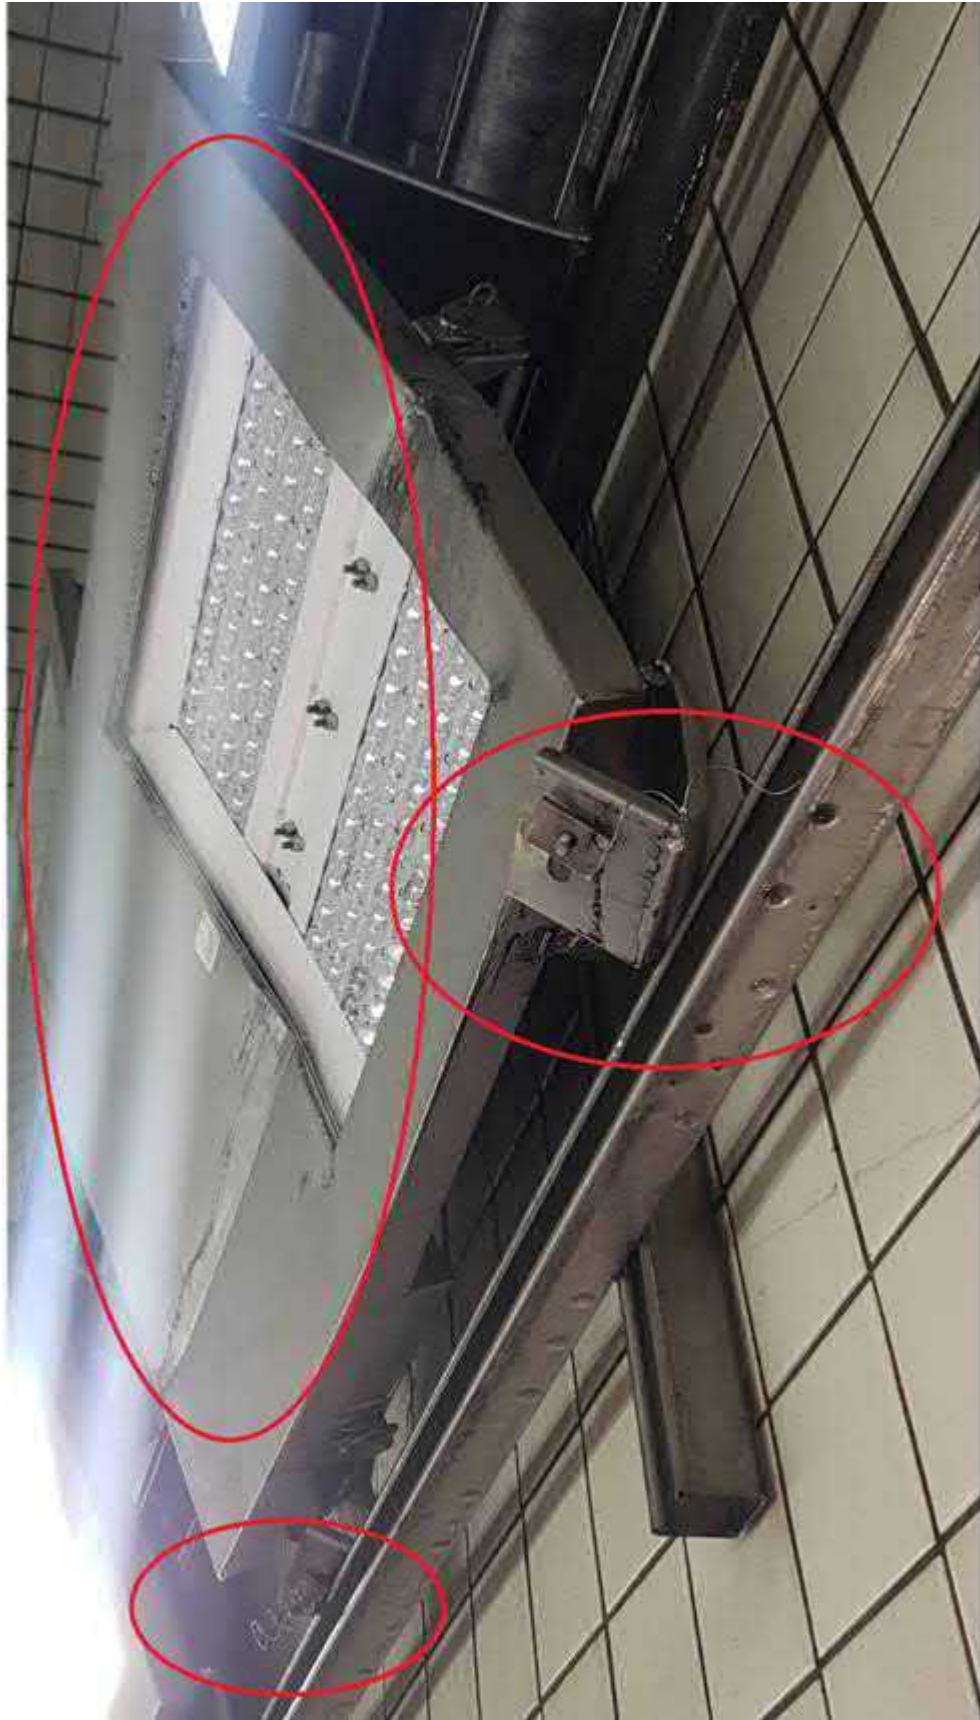
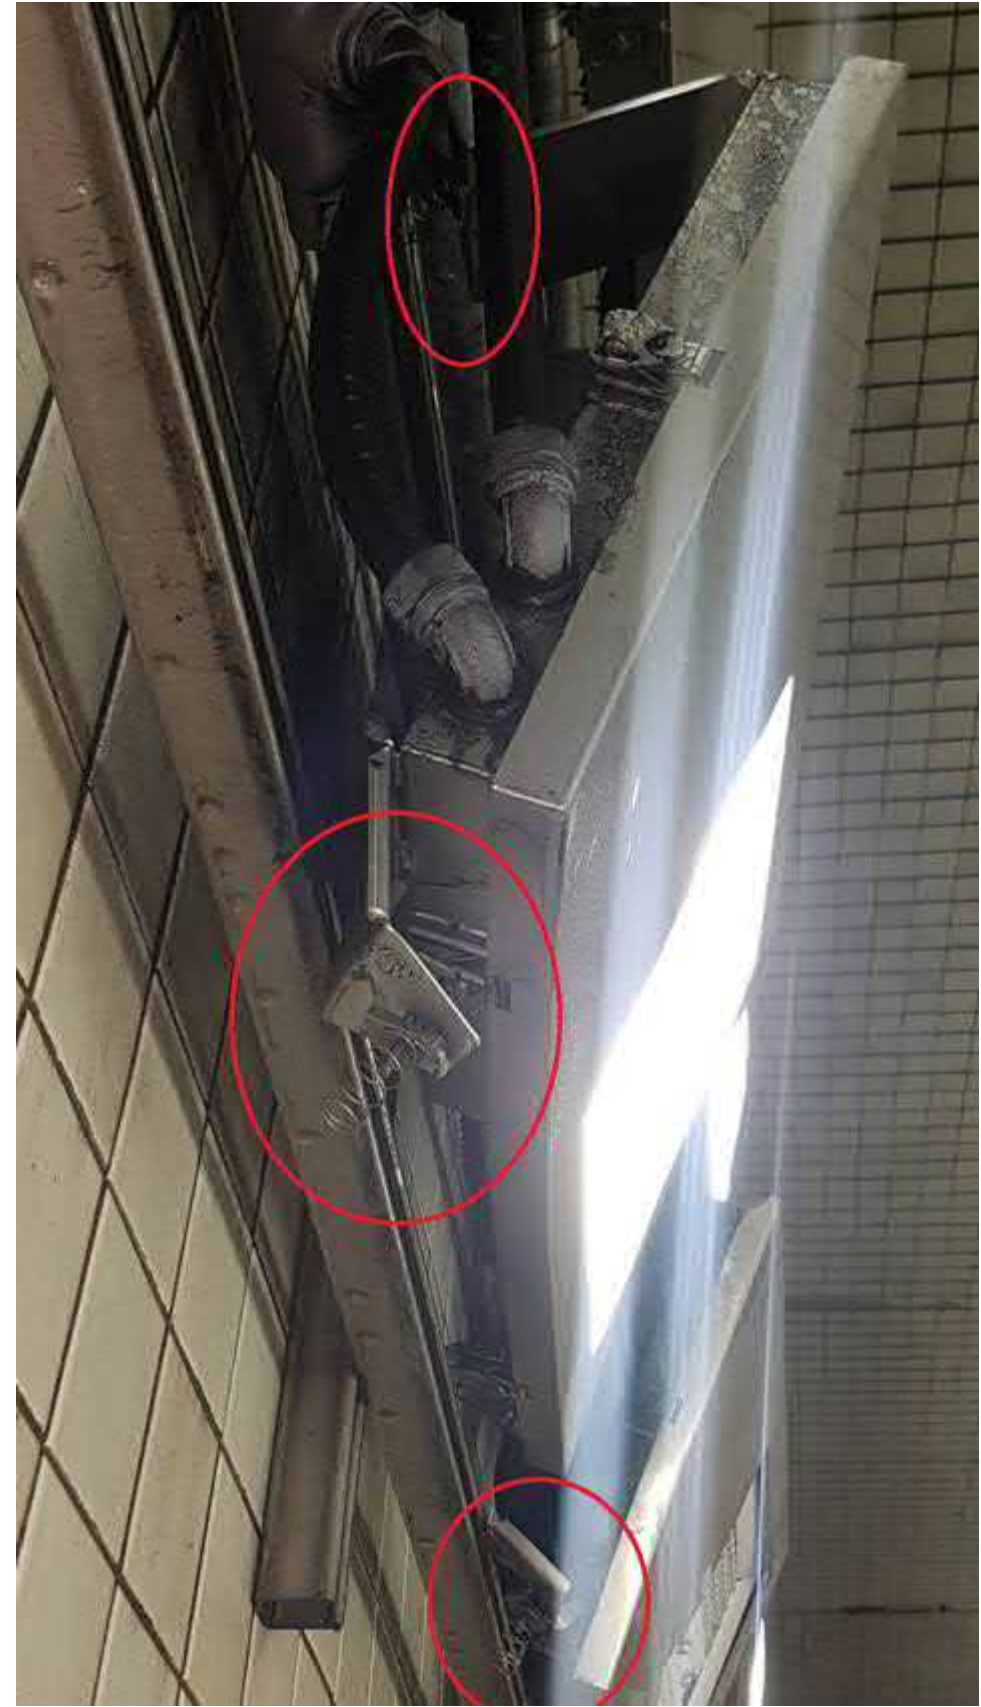
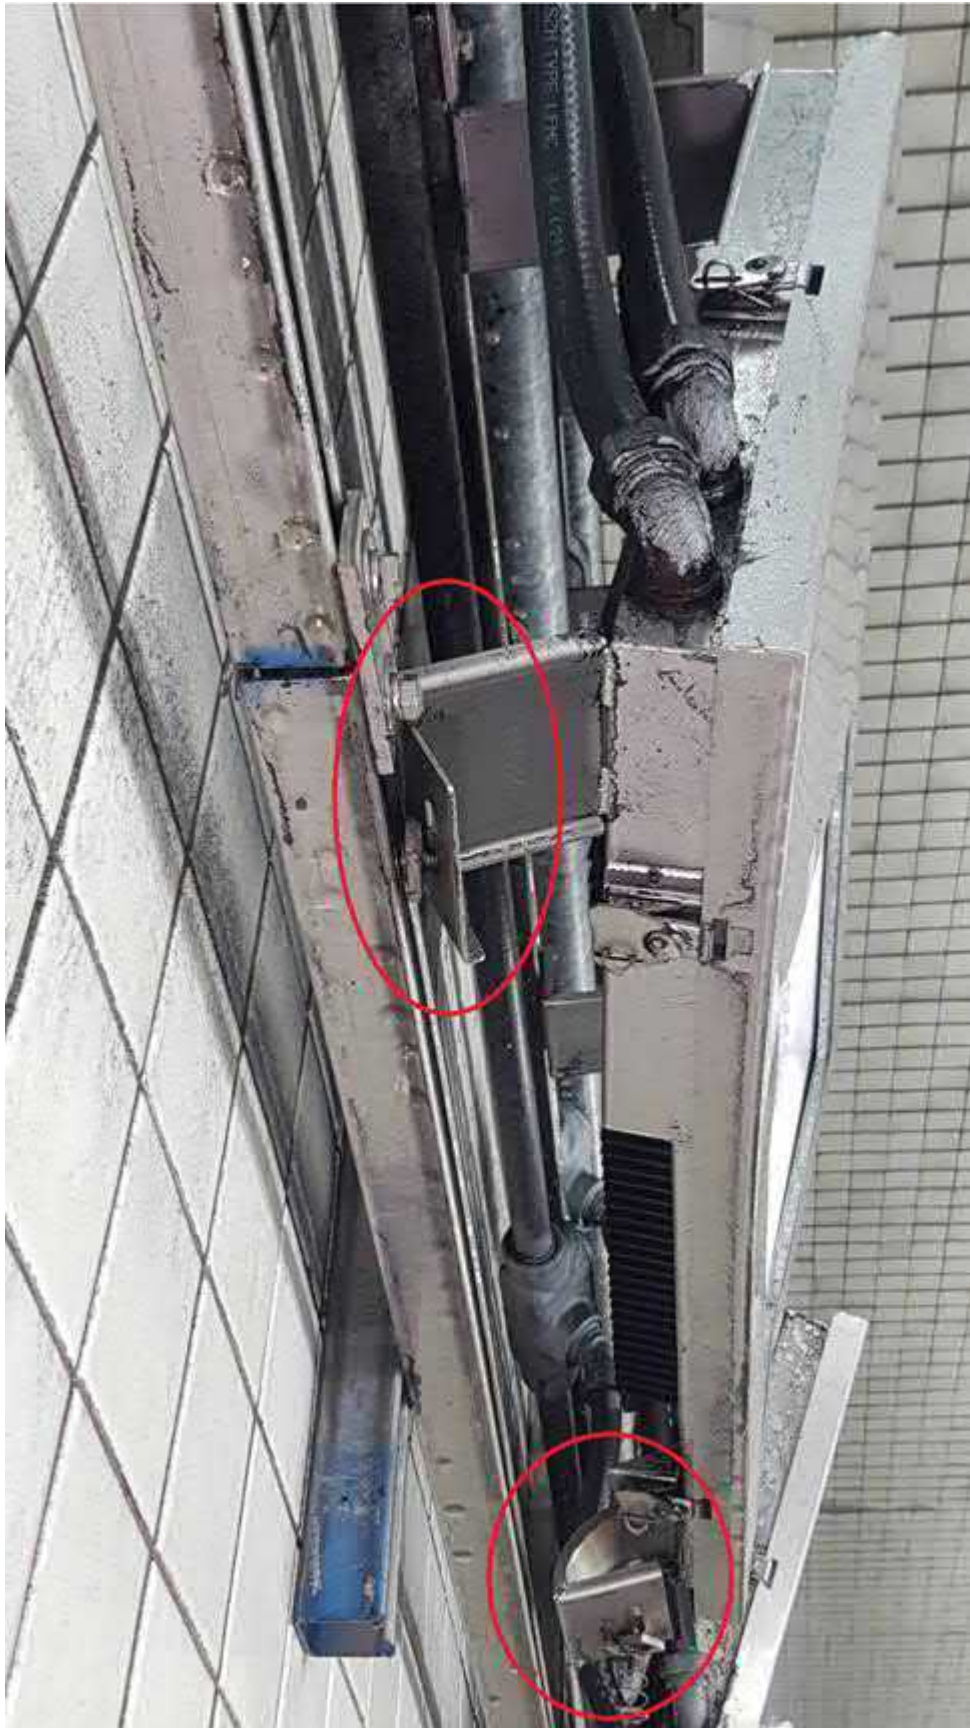
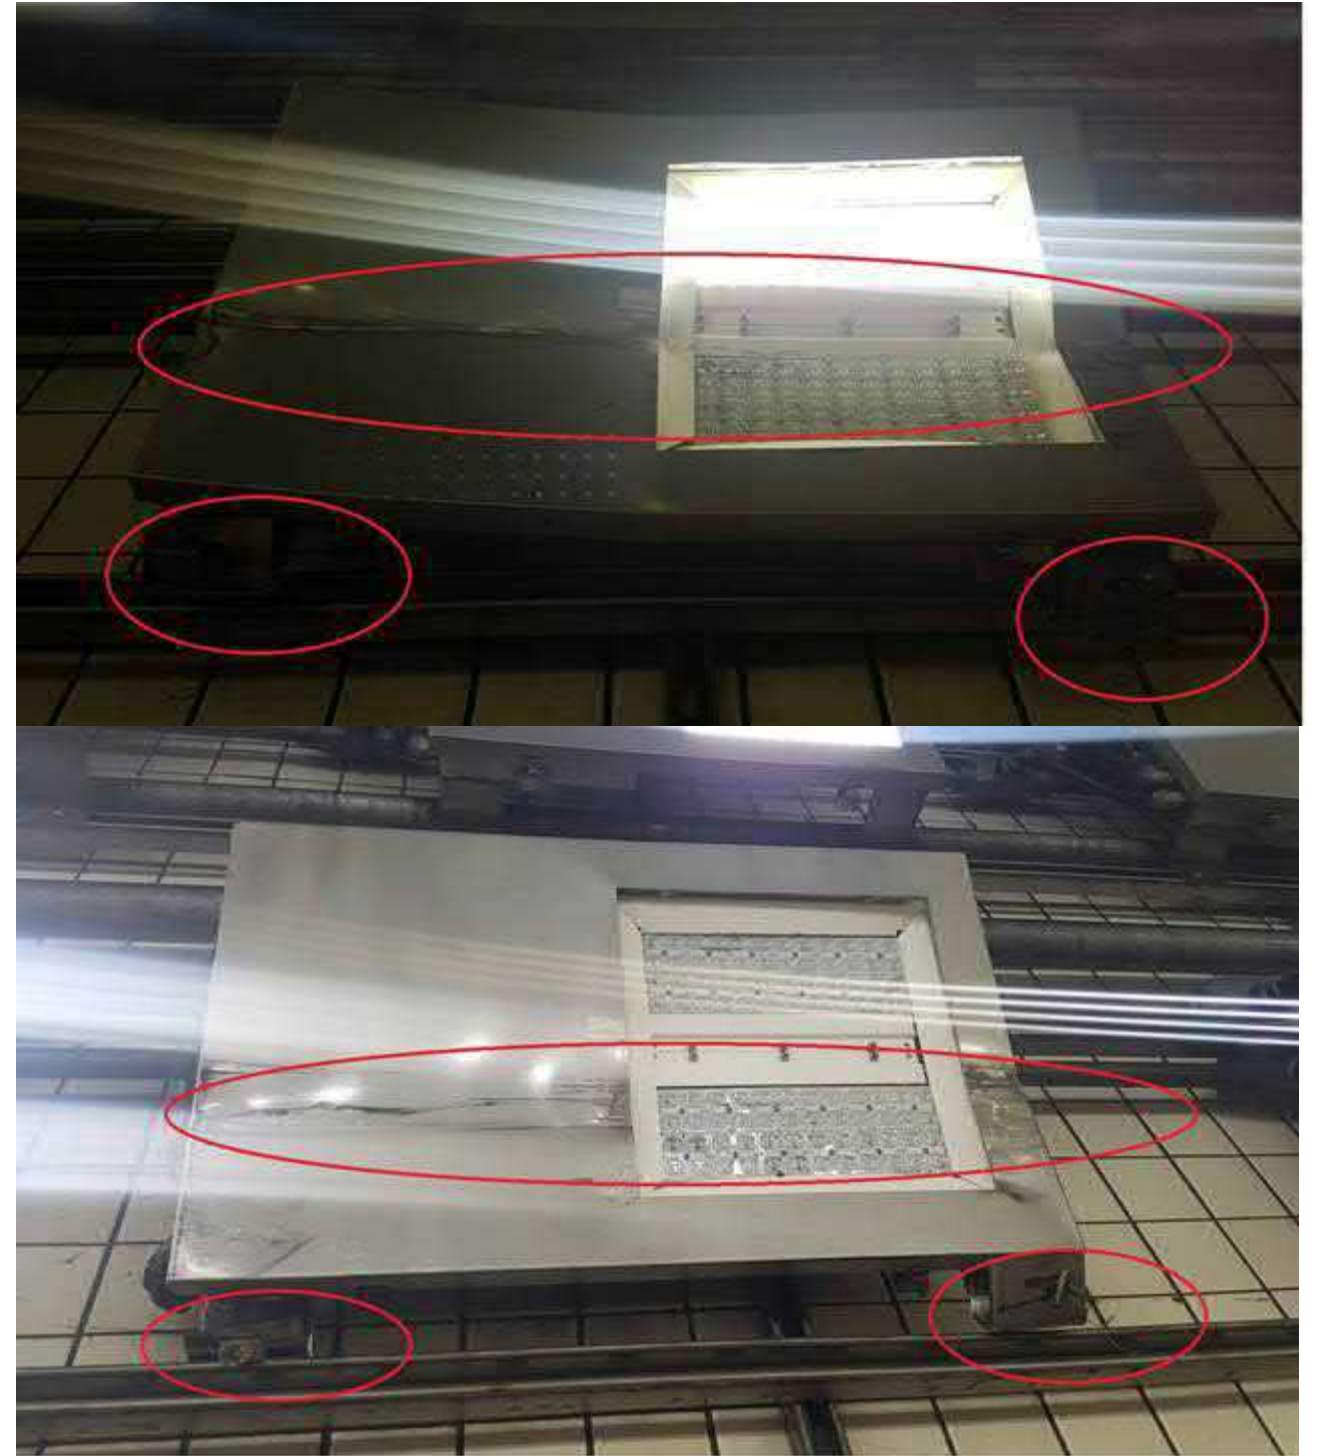
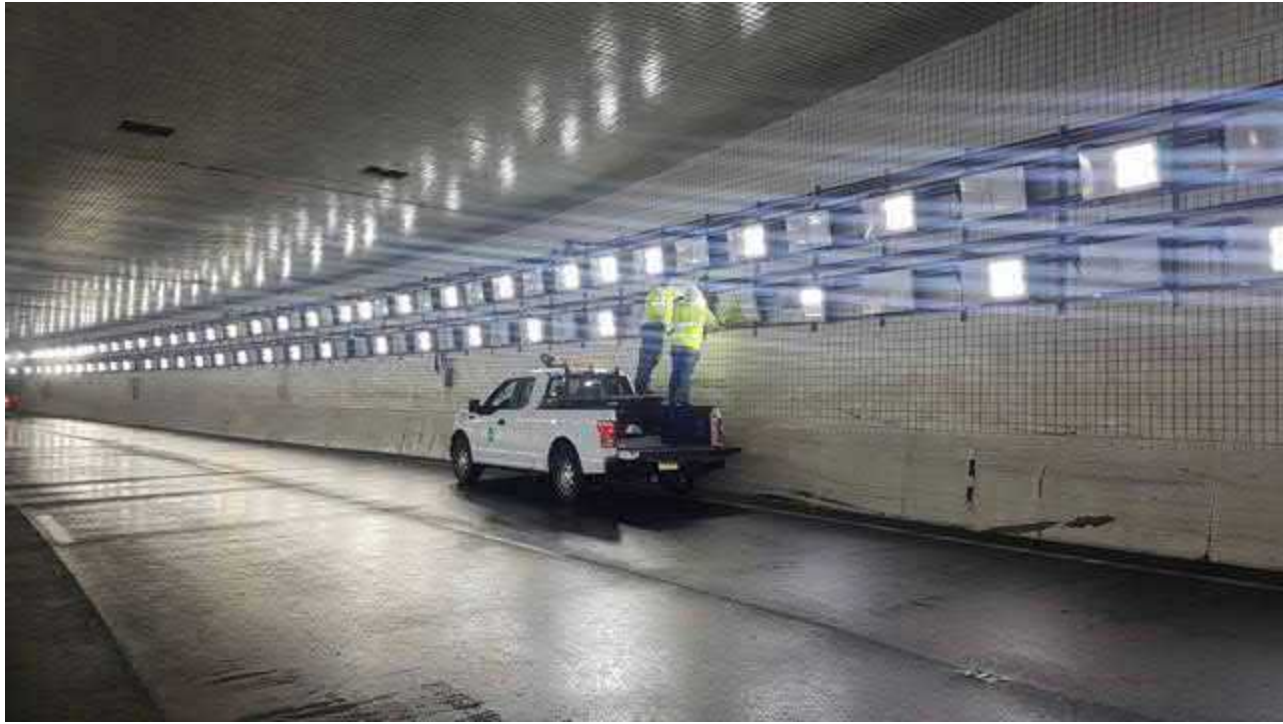
2. North Bound Tunnel Lighting Fixtures #15-19 on the bottom row of the east wall at the south portal have been struck and are badly damaged with one fixture nonoperational and one half – operational. Two fixtures (#16 & #18)) are being held by only 1 bolt, two fixtures (#17 & #19) are being held by only 2 bolts and #15 is being held by 3 bolts. There is no telling when the remaining bolts on #16-#19 are going to fail due to the impact they received after which the only thing that would prevent them from falling onto the roadway are the flexible side entry conduits. I flagged this to an ODOT gentleman on duty (Zack Gillespie I believe) and they addressed the issue temporarily with multiple heavy duty cable ties per loose bracket. It is strongly recommended that ODOT replace these damaged units ASAP, I see they have spares ready to go in the control room – the ODOT gentleman did mention that he thinks these are scheduled for replacement but wasn't 100% sure.

With respect to the damaged tunnel lights, I believe ODOT has forces on hand planned to address such issues.

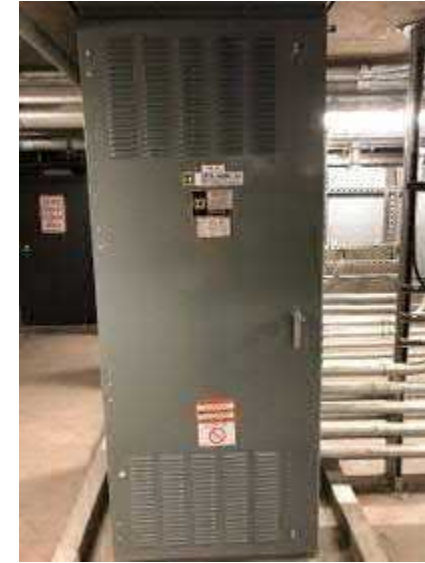
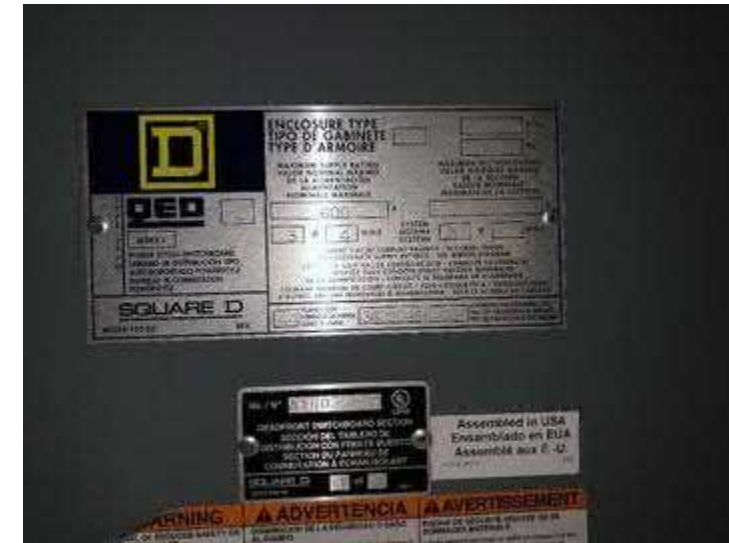
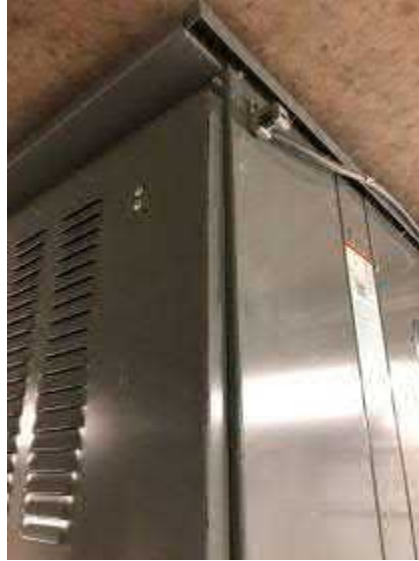
Panel Information		Panel Ratings	
Name or Tag:	DP-W	Voltage:	480Y/277V
Serial Number and/or Manufacturing Date:	36220488-006	Amperage:	600
Panel Location Description:	Lighting Control Room	Phase:	34
		Wire:	
Additional information: Scratch on door.

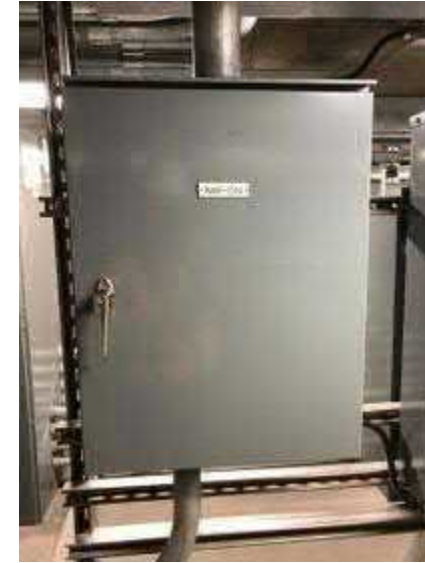
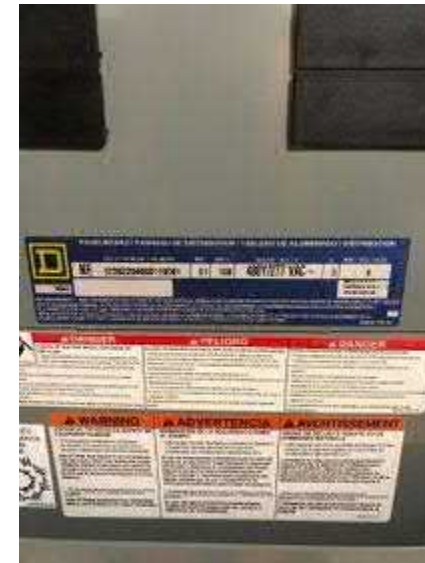
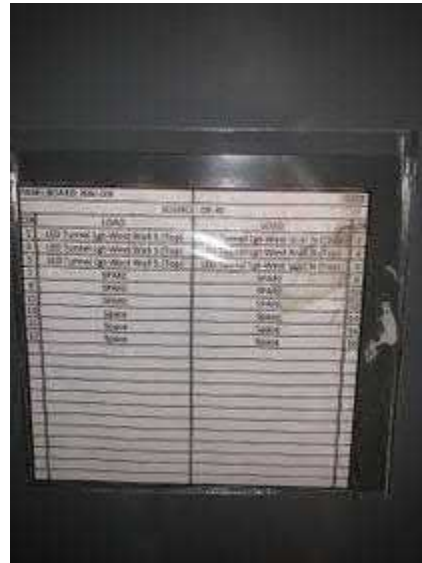
Panel Information		Panel Ratings	
Name or Tag:	NW-DN	Voltage:	480Y/277V
Serial Number and/or Manufacturing Date:	12362204880110001	Amperage:	100
Panel Location Description:	Lighting Control Room	Phase:	3
		Wire:	4
Additional information: No Printed Labels Scratches on door Transparent pocket doesnt fit the schedule

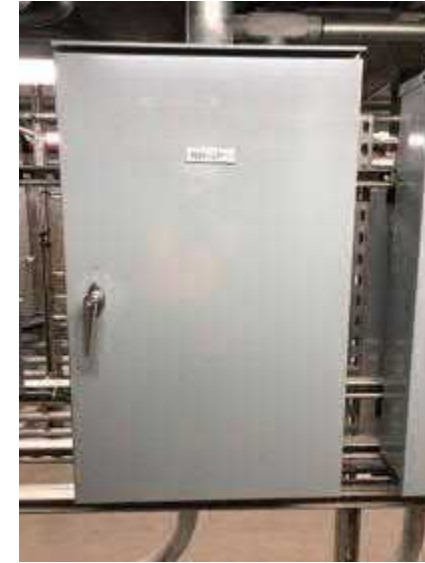
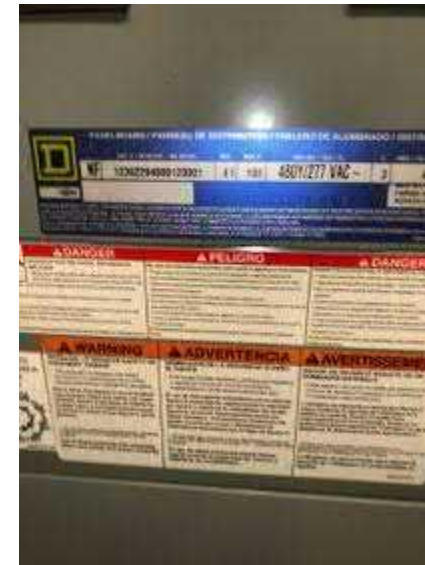
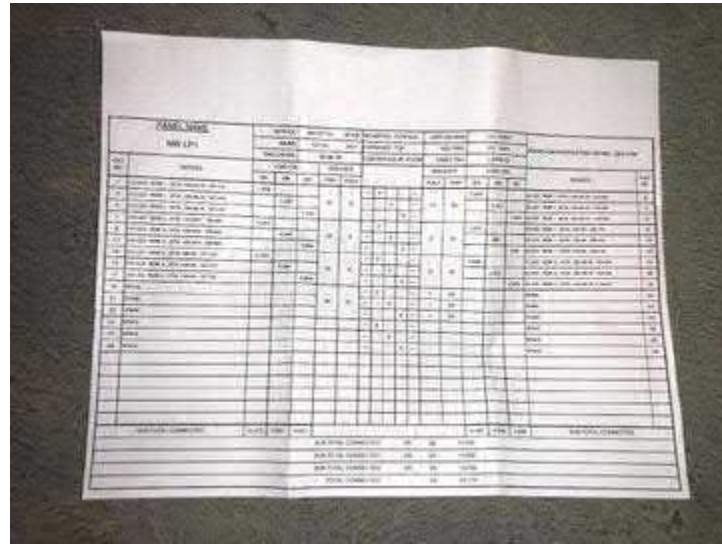
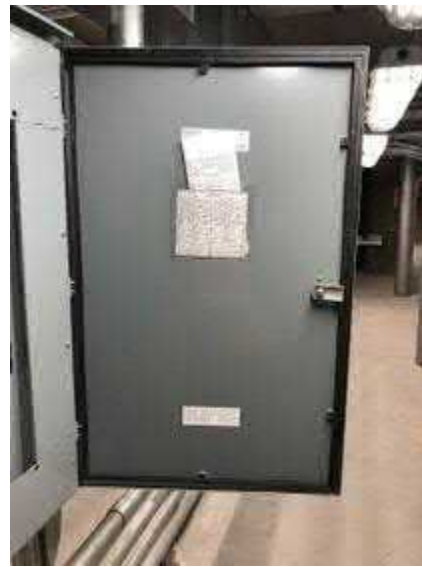
Panel Information		Panel Ratings	
Name or Tag:	NW-LP1	Voltage:	480Y/277V
Serial Number and/or Manufacturing Date:	12362204880120001	Amperage:	100
Panel Location Description:	Lighting Control Room	Phase:	3
		Wire:	4
Additional information: No Printed Labels Scratches on door Transparent pocket doesnt fit the panel schedule Panel achedule inconsistent with breaker arrangement

Does the surge protector function properly?	No
Is a surge protector provided for the panel?	No
Are there any tripped circuit breakers?	No
Are all spare breaker blanking plates intact and installed?	Yes
Are the panel schedules correct and consistent with the circuit breaker arrangement?	No
Is the front panel secure with no missing screws?	Yes

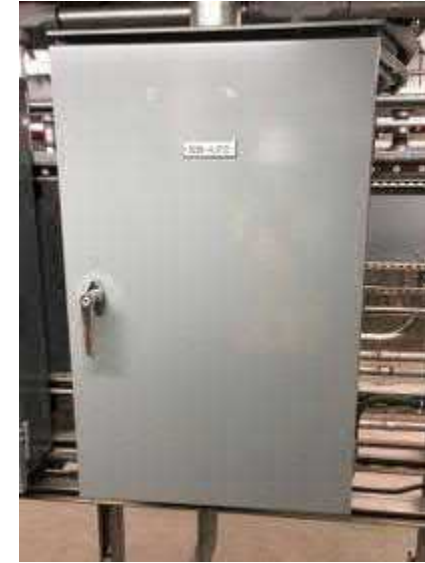
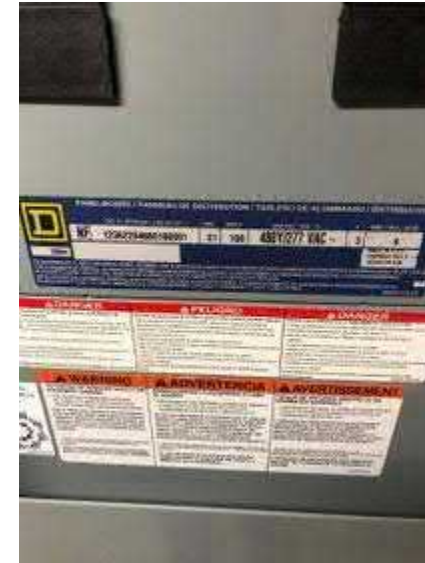
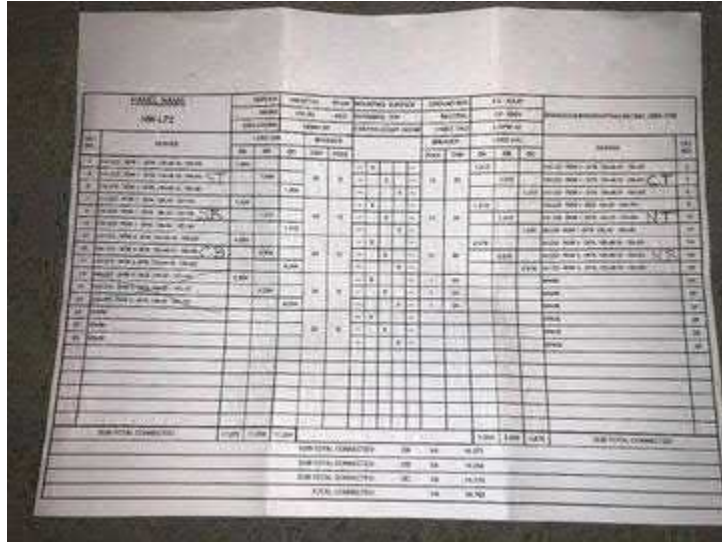
Panel Information		Panel Ratings	
Name or Tag:	NW-LP2	Voltage:	480Y/277V
Serial Number and/or Manufacturing Date:	12362204880100001	Amperage:	100
Panel Location Description:	Lighting Control Room	Phase:	3
		Wire:	4
Additional information: No Printed Labels Scratches on door Transparent pocket doesnt fit the panel schedule Panel schedule inconsistent with breaker arrangement Handwritten changes on panel schedule

Does the surge protector function properly?	No
Is a surge protector provided for the panel?	No
Are there any tripped circuit breakers?	No
Are all spare breaker blanking plates intact and installed?	Yes
Are the panel schedules correct and consistent with the circuit breaker arrangement?	No
Is the front panel secure with no missing screws?	Yes

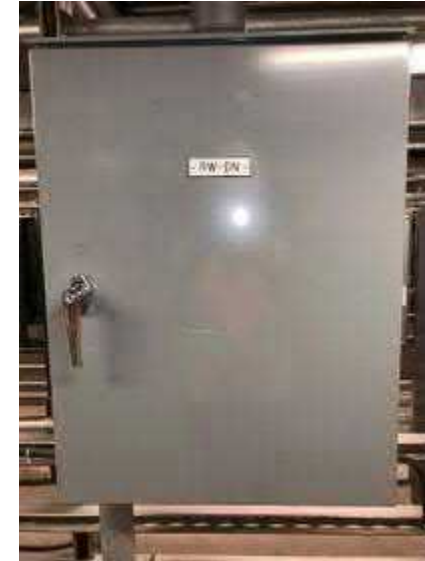
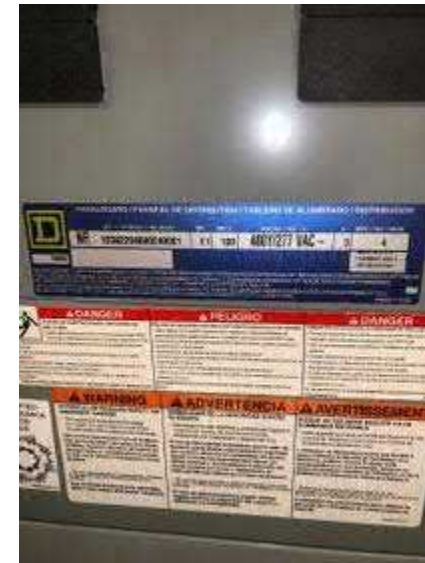
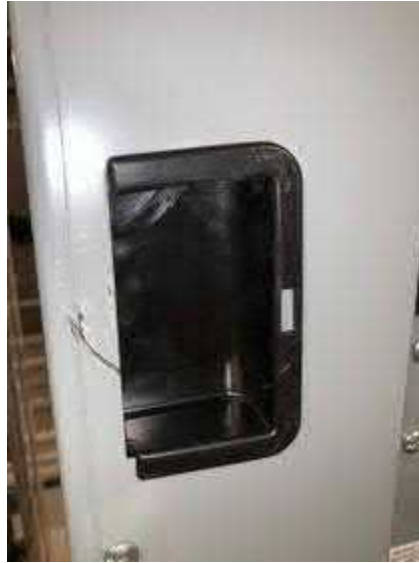
Panel Information		Panel Ratings	
Name or Tag:	RW-DN	Voltage:	480Y/277V
Serial Number and/or Manufacturing Date:	12362204880240001	Amperage:	100
Panel Location Description:	Lighting Control Room	Phase:	3
		Wire:	4
Additional information: No Printed Labels Scratches on door Transparent pocket doesnt fit the panel schedule Handwritten changes on panel schedule
