# **Lytle Tunnel (HAM-71-0134) Inspection Report Fall 2020**

PID 105470

November, 2020

Ohio Department of  
Transportation  
District 8  
505 South State Route 741  
Lebanon, OH 45036

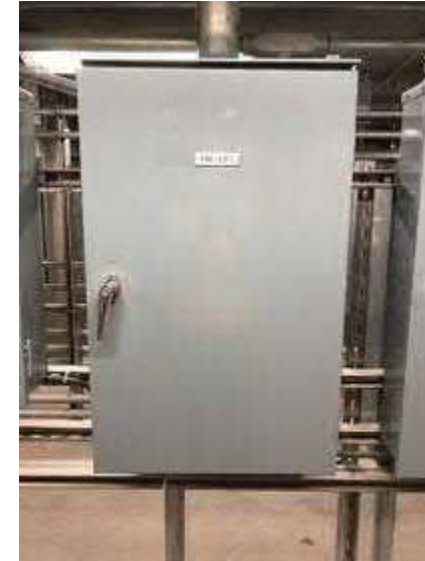
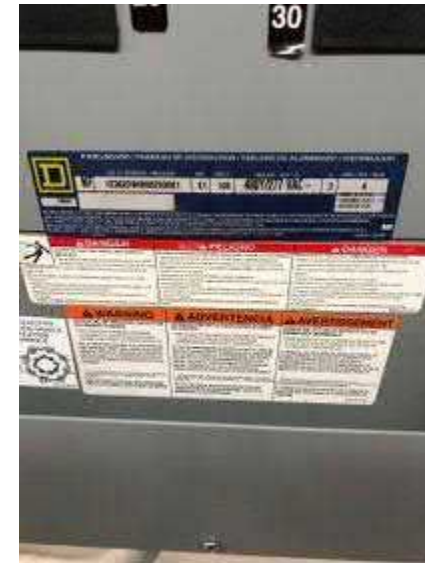
Panel Information		Panel Ratings	
Name or Tag:	RW-LP1	Voltage:	480Y/277V
Serial Number and/or Manufacturing Date:	12362204880250001	Amperage:	100
Panel Location Description:	Lighting Control Room	Phase:	3
		Wire:	4
Additional information: No Printed Labels Scratches on door Transparent pocket doesnt fit the panel schedule Panel schedule missing

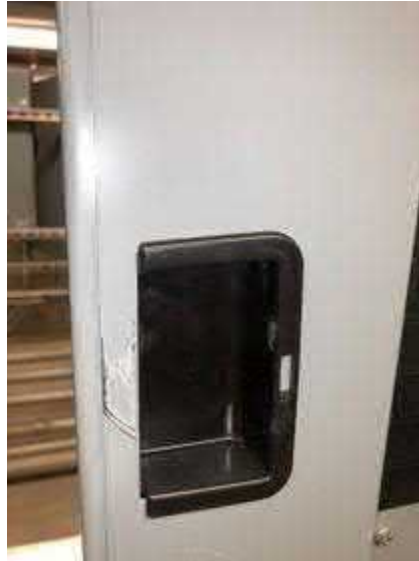
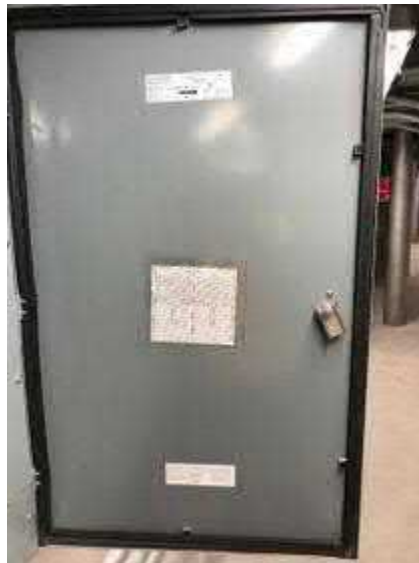
Does the surge protector function properly?	No
Is a surge protector provided for the panel?	No
Are there any tripped circuit breakers?	No
Are all spare breaker blanking plates intact and installed?	Yes
Are the panel schedules correct and consistent with the circuit breaker arrangement?	No
Is the front panel secure with no missing screws?	No

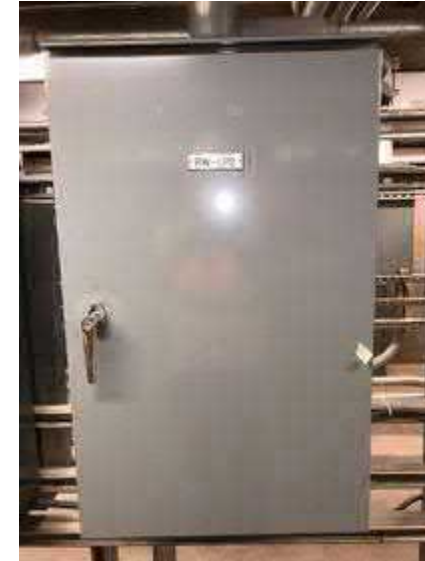
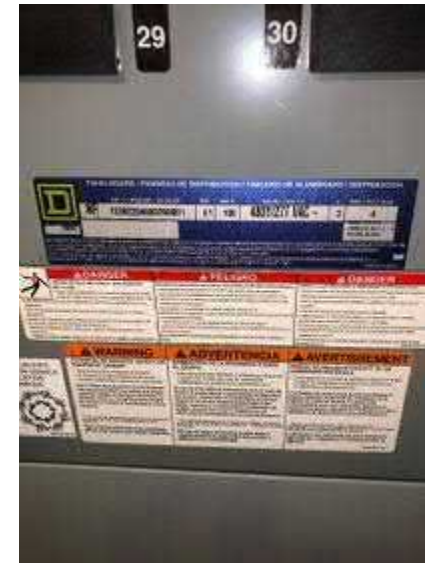
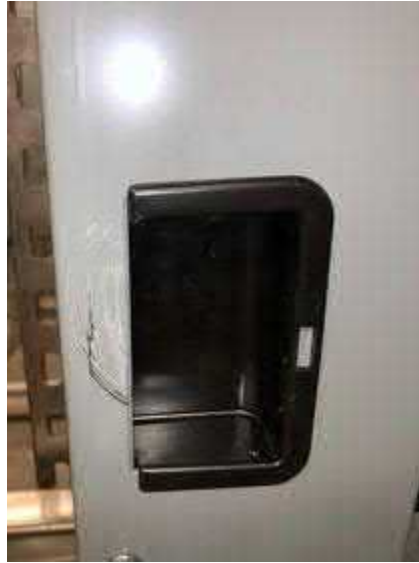
Panel Information		Panel Ratings	
Name or Tag:	RW-LP2	Voltage:	480Y/277V
Serial Number and/or Manufacturing Date:	12362204880260001	Amperage:	100
Panel Location Description:	Lighting Control Room	Phase:	3
		Wire:	4
Additional information: No Printed Labels Scratches on door Transparent pocket doesnt fit the panel schedule Panel schedule inconsistent with breaker arrangements

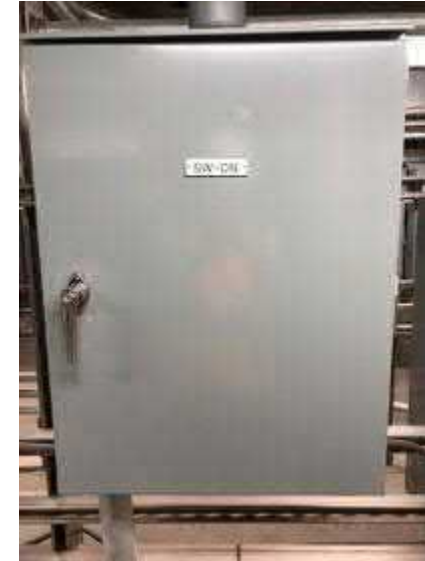
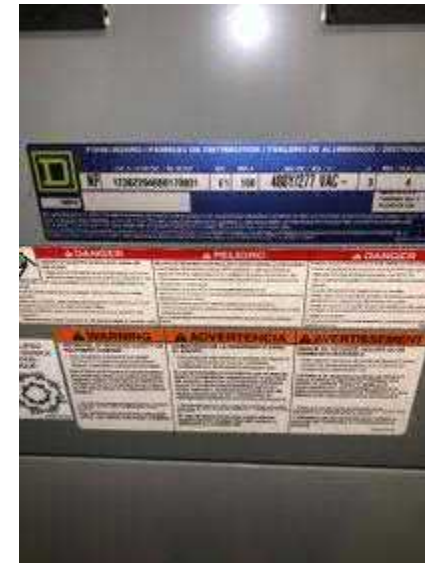
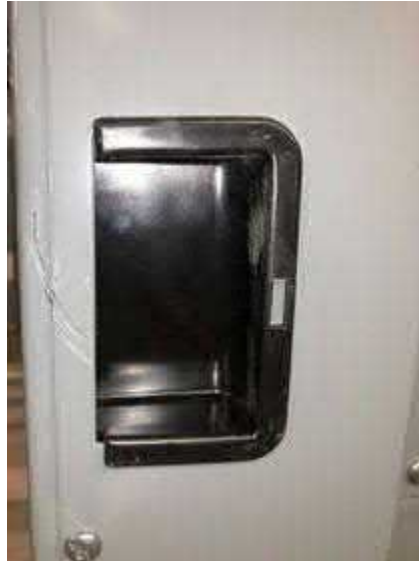
Panel Information		Panel Ratings	
Name or Tag:	SW-DN	Voltage:	480Y/277V
Serial Number and/or Manufacturing Date:	12362204880170001	Amperage:	100
Panel Location Description:	Lighting Control Room	Phase:	3
		Wire:	4
Additional information: No Printed Labels Scratches on door Transparent pocket doesnt fit the panel schedule

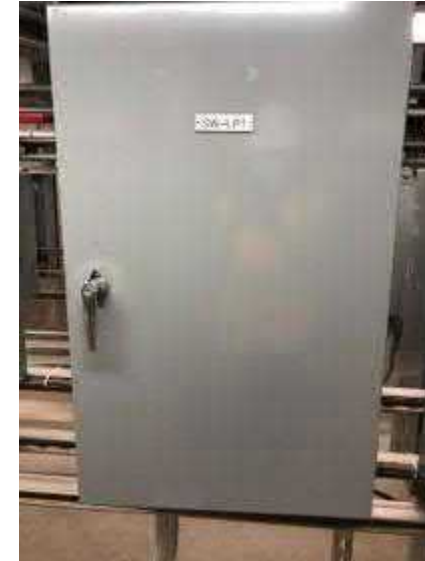
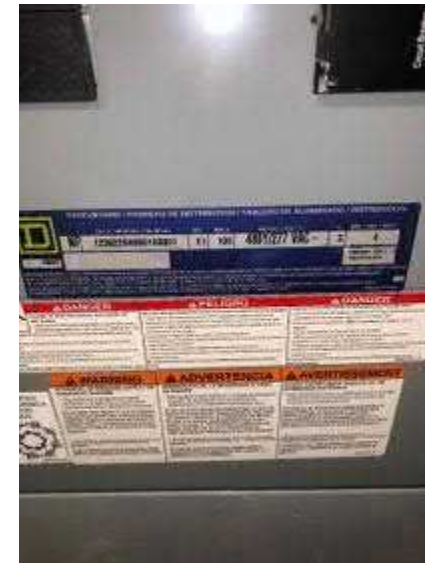
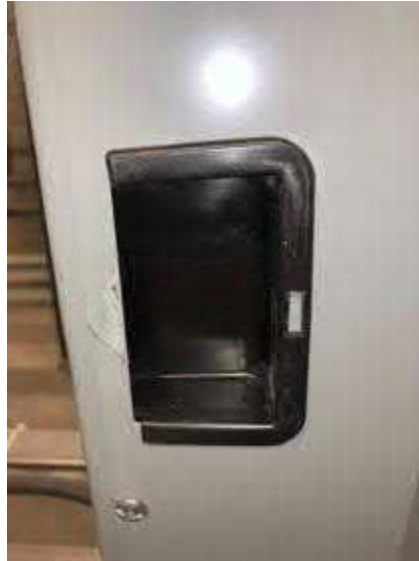
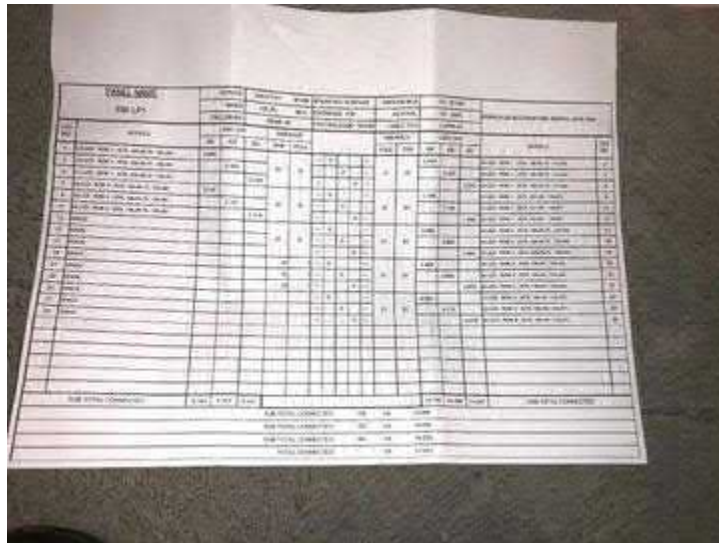
Panel Information		Panel Ratings	
Name or Tag:	SW-LP1	Voltage:	480Y/277V
Serial Number and/or Manufacturing Date:	12362204880180001	Amperage:	100
Panel Location Description:	Lighting Control Room	Phase:	3
		Wire:	4
Additional information: No Printed Labels Scratches on door Transparent pocket doesnt fit the panel schedule Panel schedule inconsistent with breaker arrangement

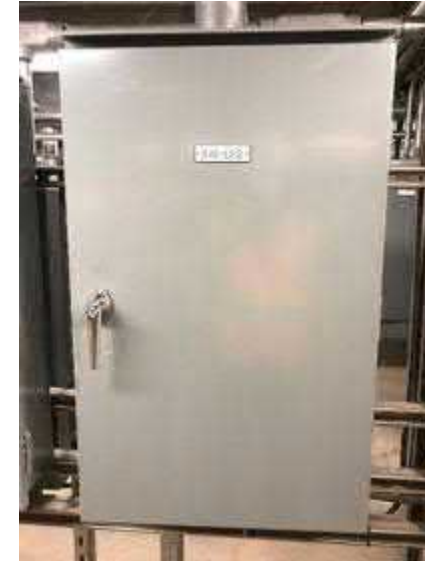
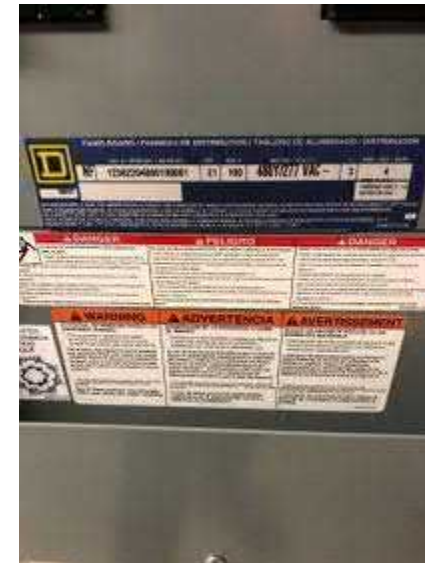
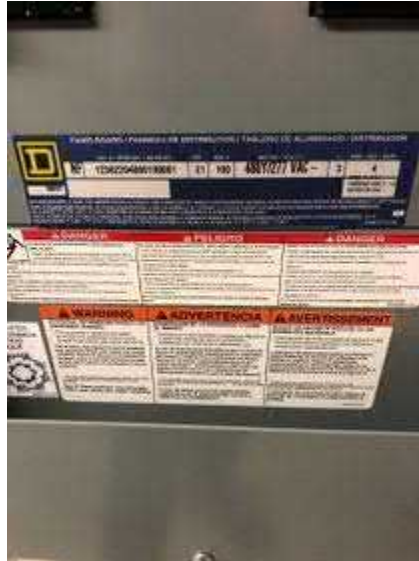
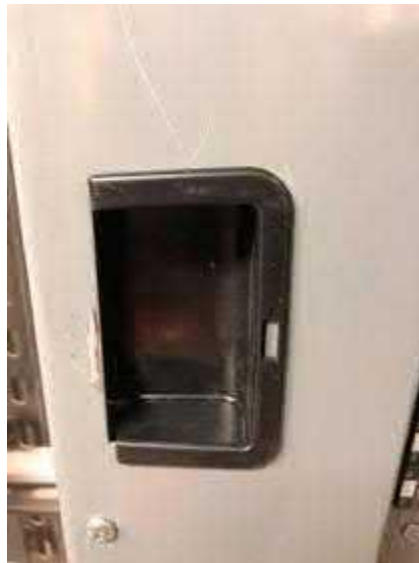
Panel Information		Panel Ratings	
Name or Tag:	SW-LP2	Voltage:	480Y/277V
Serial Number and/or Manufacturing Date:	12362204880190001	Amperage:	100
Panel Location Description:	Lighting Control Room	Phase:	3
		Wire:	4
Additional information: No Printed Labels Scratches on door Transparent pocket doesnt fit the panel schedule

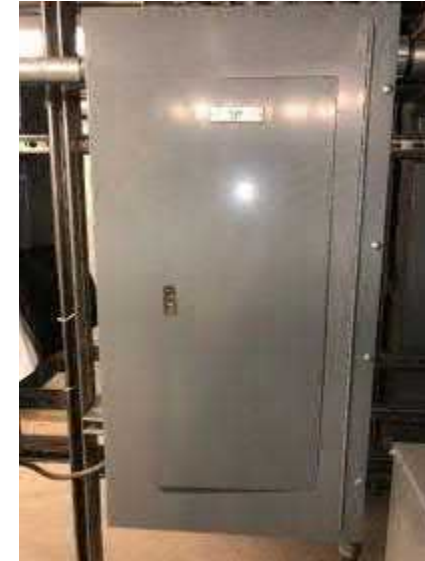
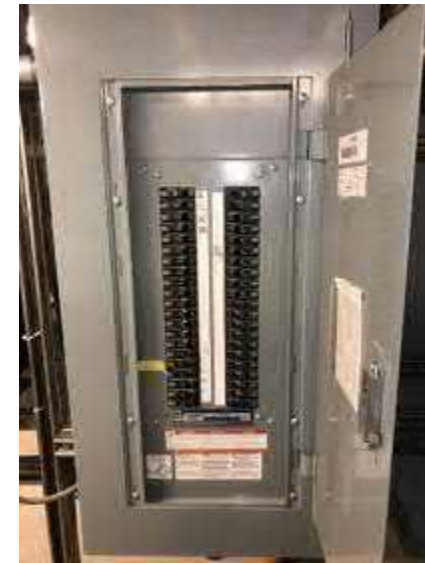
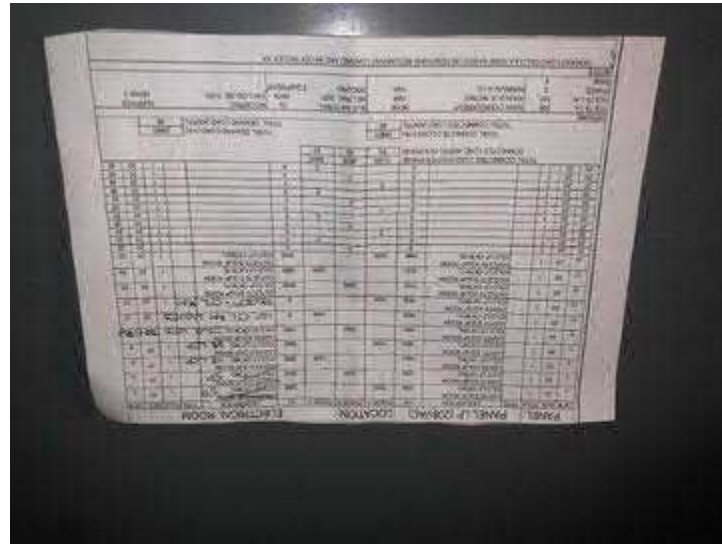
Panel Information		Panel Ratings	
Name or Tag:	LP	Voltage:	208Y/120V
Serial Number and/or Manufacturing Date:	12362204880320001	Amperage:	100
Panel Location Description:	Lighting Control Room	Phase:	3
		Wire:	4
Additional information: Handwritten Labels Scratches on door Transparent pocket cant show full panel schedule Panel schedule inconsistent with breaker arrangement Handwritten panel schedule Missing Screws

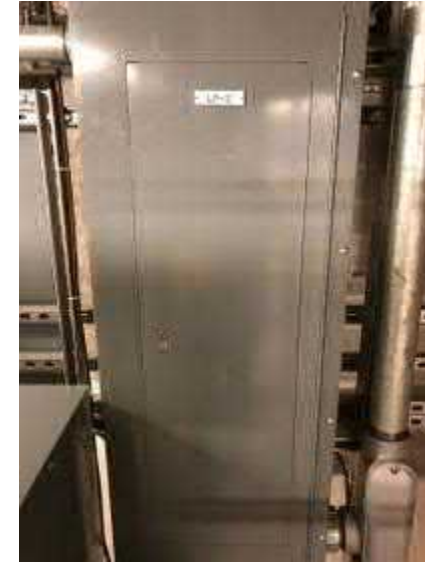
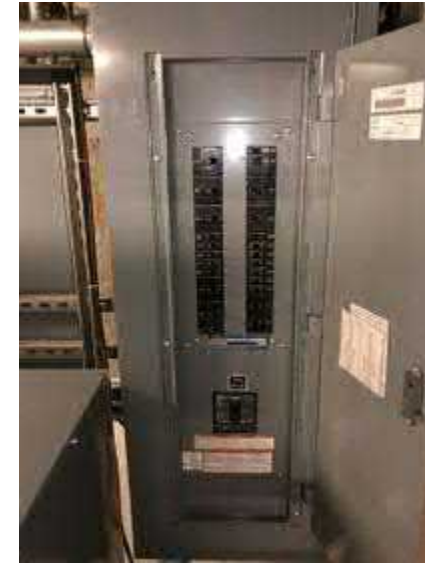
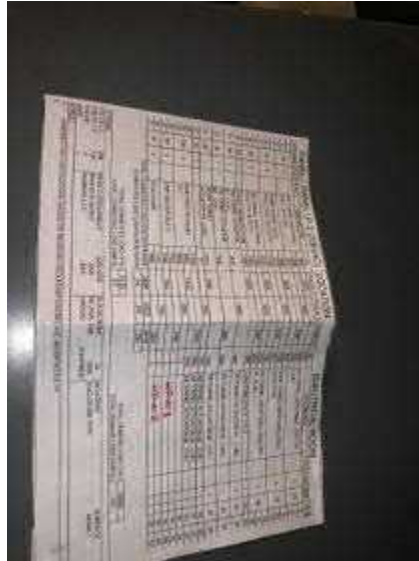
Panel Information		Panel Ratings	
Name or Tag:	LP-2	Voltage:	208Y/120V
Serial Number and/or Manufacturing Date:	12362204880340001	Amperage:	100
Panel Location Description:	Lighting Control Room	Phase:	3
		Wire:	4
Additional information: No Printed Labels Scratches Transparent pocket cant show full panel schedule Panel schedule inconsistent with breaker arrangement Handwritten panel schedule Missing Screws

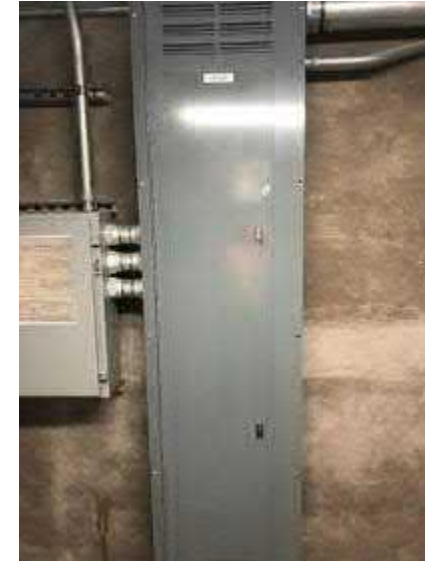
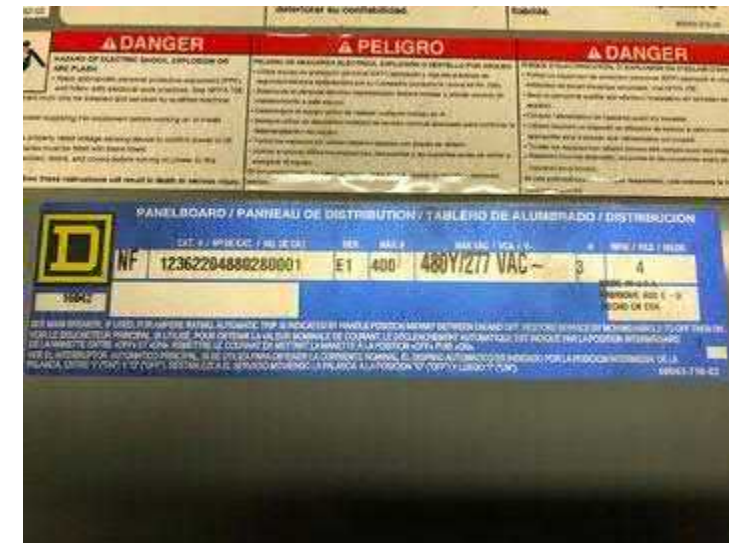
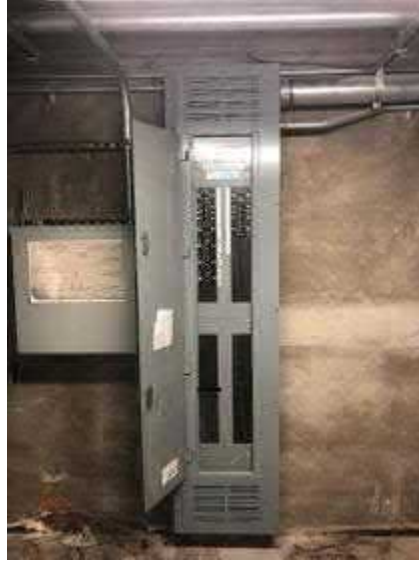
Panel Information		Panel Ratings	
Name or Tag:	LP-DP	Voltage:	480Y/277V
Serial Number and/or Manufacturing Date:	12362204880280001	Amperage:	400
Panel Location Description:	Lighting Control Room	Phase:	3
		Wire:	4
Additional information: Handwritten Labels Scratches Transparent pocket cant show full panel schedule Panel schedule inconsistent with breaker arrangement Handwritten panel schedule Missing Screws

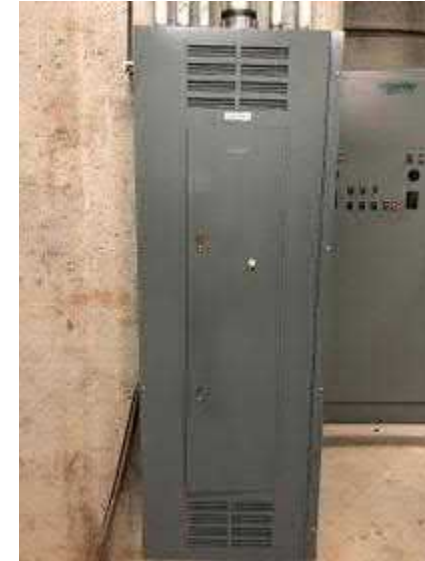
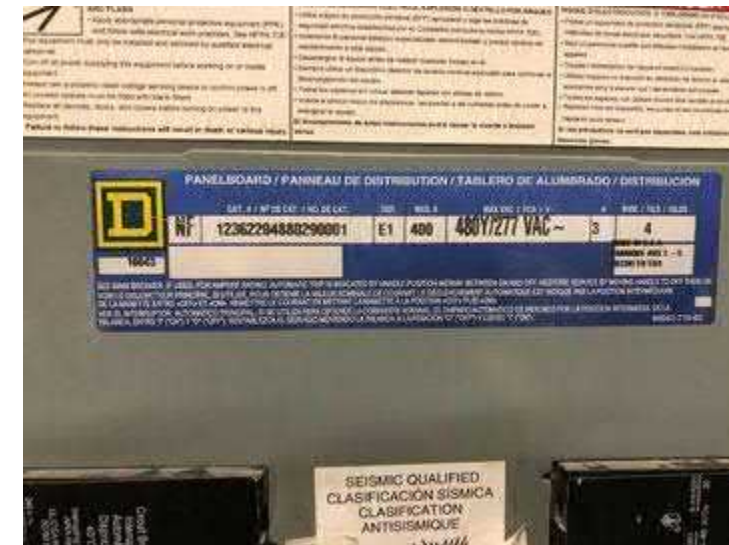
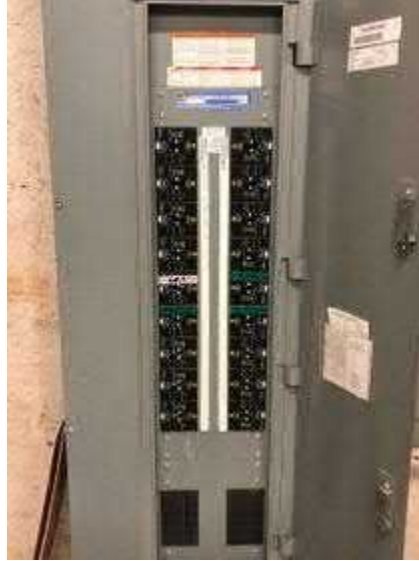
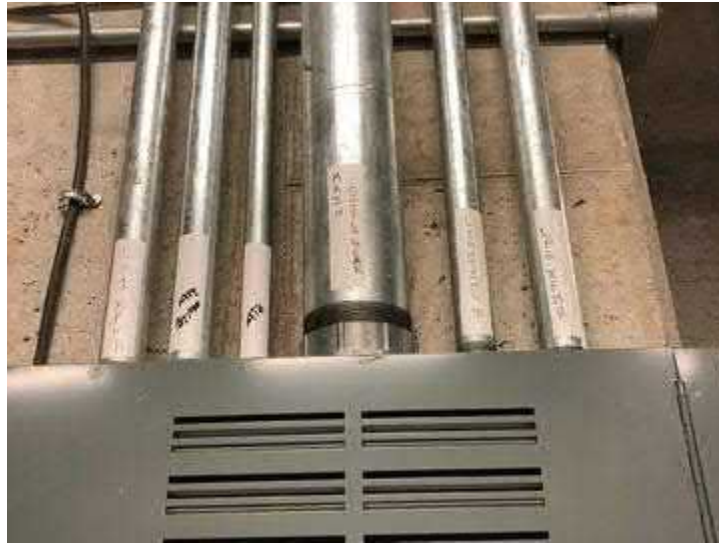
Panel Information		Panel Ratings	
Name or Tag:	LP-PP	Voltage:	480Y/277V
Serial Number and/or Manufacturing Date:	12362204880290001	Amperage:	400
Panel Location Description:	Electrical Room	Phase:	3
		Wire:	4
Additional information:

Does the surge protector function properly?	No
Is a surge protector provided for the panel?	No
Are there any tripped circuit breakers?	No
Are all spare breaker blanking plates intact and installed?	Yes
Are the panel schedules correct and consistent with the circuit breaker arrangement?	No
Is the front panel secure with no missing screws?	Yes

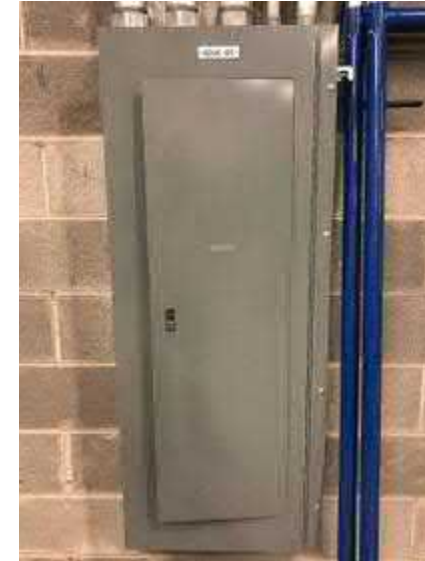
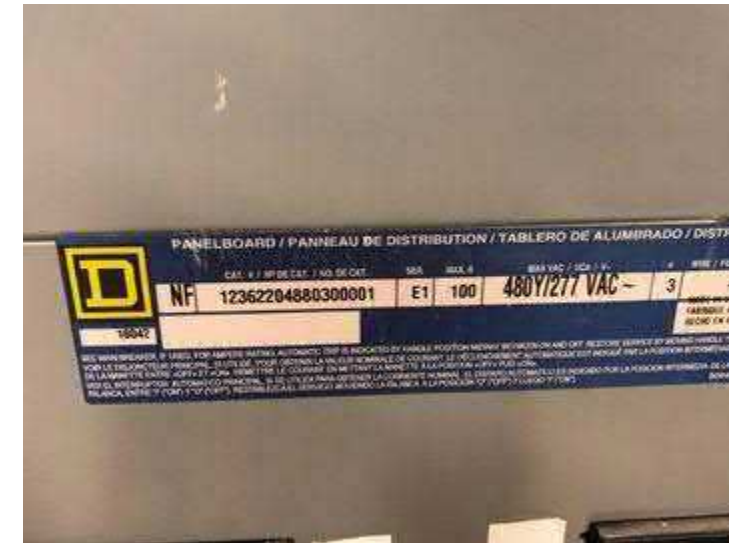
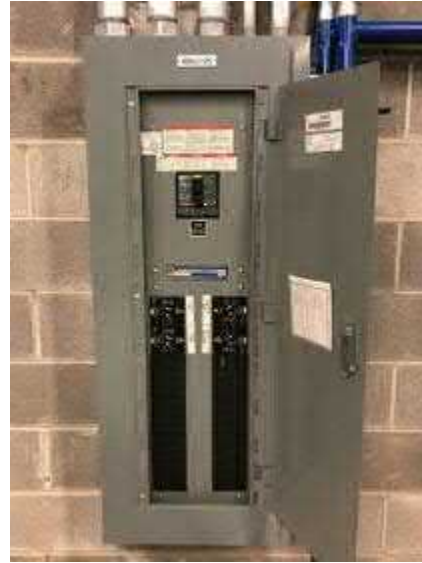
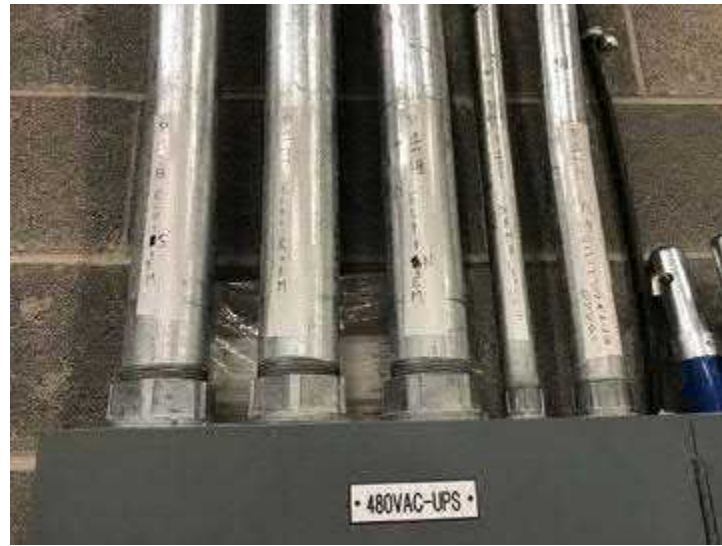
Panel Information		Panel Ratings	
Name or Tag:	480VAC-UPS	Voltage:	480Y/277V
Serial Number and/or Manufacturing Date:	12362204880300001	Amperage:	100
Panel Location Description:	Electrical Room	Phase:	3
		Wire:	4
Additional information: Handwritten Labels Scratches Transparent pocket cant show full panel schedule Panel schedule inconsistent with breaker arrangement Missing Screws Handwritten Incoming Conduit Labels

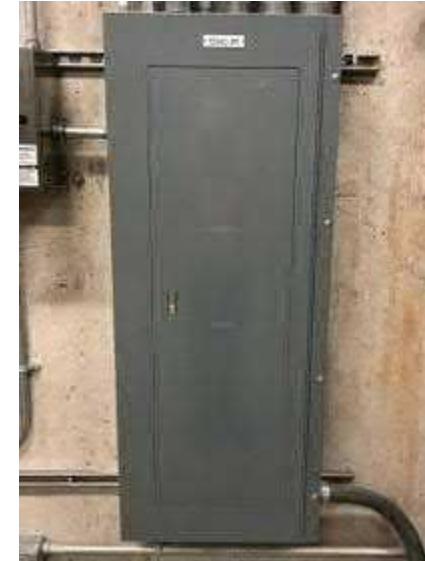
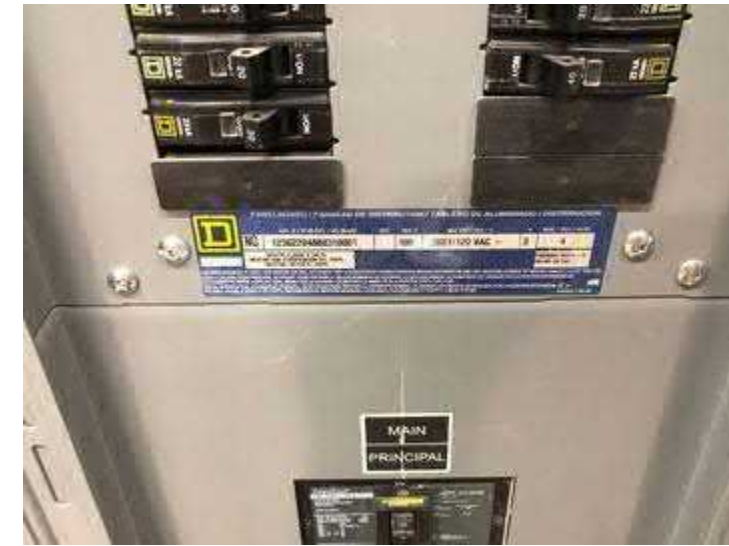
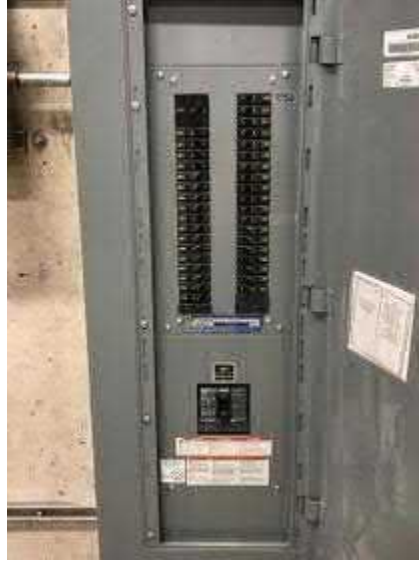
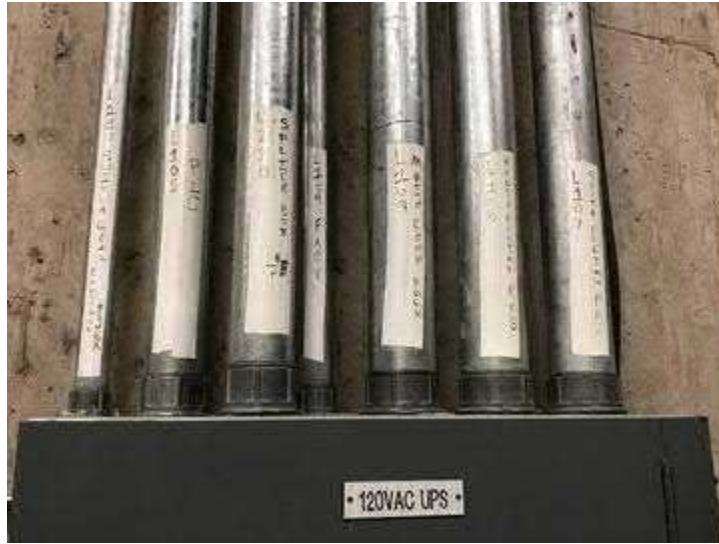
Panel Information		Panel Ratings	
Name or Tag:	120VAC-UPS	Voltage:	208Y/120V
Serial Number and/or Manufacturing Date:	12362204880310001	Amperage:	100
Panel Location Description:	Electrical Room	Phase:	3
		Wire:	4
Additional information: Missing Labels Scratches Transparent pocket cant show full panel schedule Panel schedule inconsistent with breaker arrangement Handwritten panel schedule Missing Screws Handwritten Incoming Conduit Labels

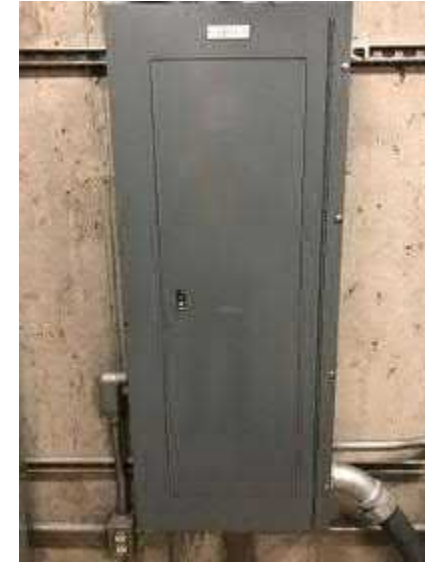
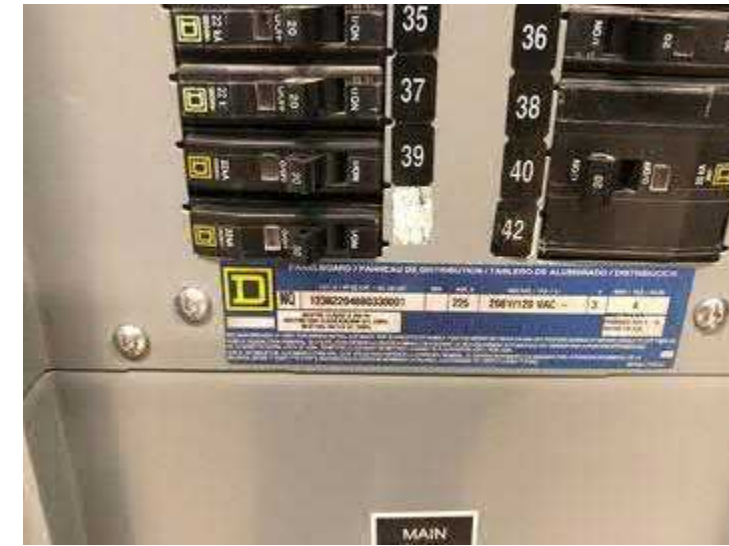
Panel Information		Panel Ratings	
Name or Tag:	LP-1	Voltage:	208Y/120V
Serial Number and/or Manufacturing Date:	12362204880330001	Amperage:	225
Panel Location Description:	Electrical Room	Phase:	3
		Wire:	4
Additional information: Missing Labels Scratches Transparent pocket cant show full panel schedule Panel schedule inconsistent with breaker arrangement Handwritten panel schedule Missing Screws Handwritten Incoming Conduit Labels

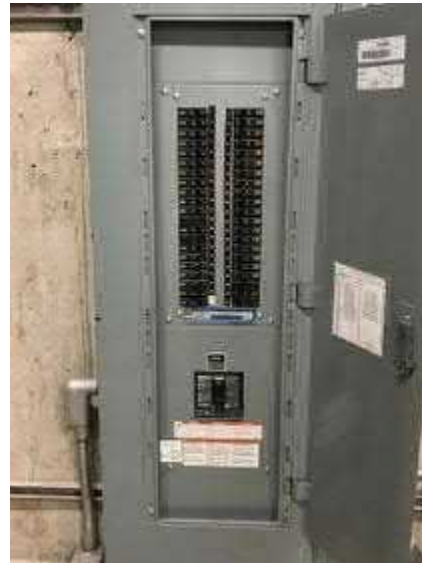
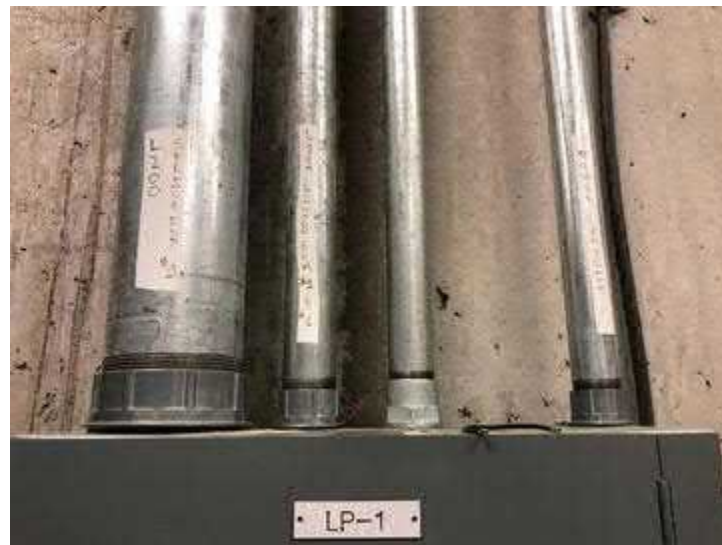
Does the surge protector function properly?	No
Is a surge protector provided for the panel?	No
Are there any tripped circuit breakers?	No
Are all spare breaker blanking plates intact and installed?	Yes
Are the panel schedules correct and consistent with the circuit breaker arrangement?	No
Is the front panel secure with no missing screws?	No

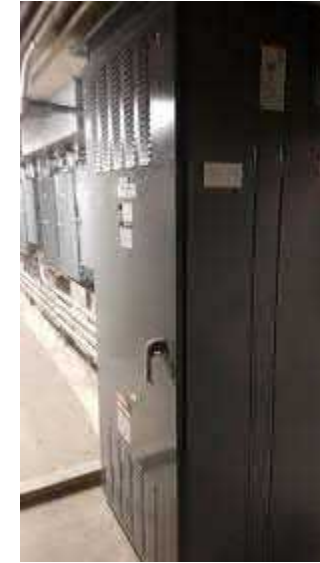
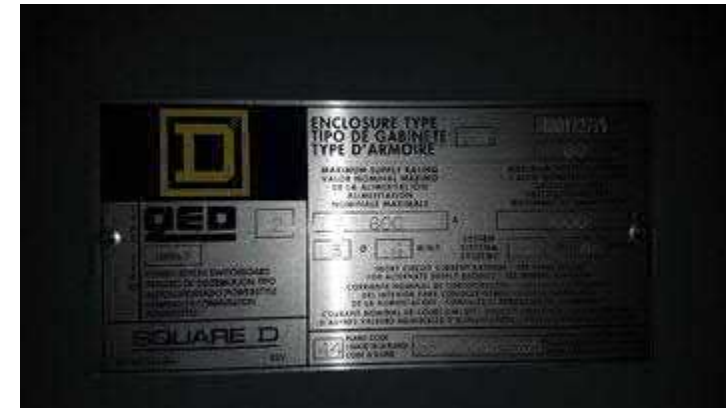
Panel Information		Panel Ratings	
Name or Tag:	DP-E	Voltage:	480Y/277V
Serial Number and/or Manufacturing Date:	36220488-005	Amperage:	600
Panel Location Description:	Lighting Control Room	Phase:	3
		Wire:	4
Additional information: Transparent pocket cant show full panel schedule

Does the surge protector function properly?	No	Is a surge protector provided for the panel?	No	Are there any tripped circuit breakers?	No	Are all spare breaker blanking plates intact and installed?	N/A	Are the panel schedules correct and consistent with the circuit breaker arrangement?	Yes	Is the front panel secure with no missing screws?	Yes
---	----	--	----	---	----	---	-----	--	-----	---	-----

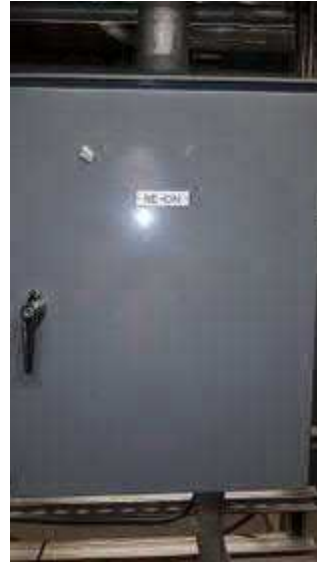
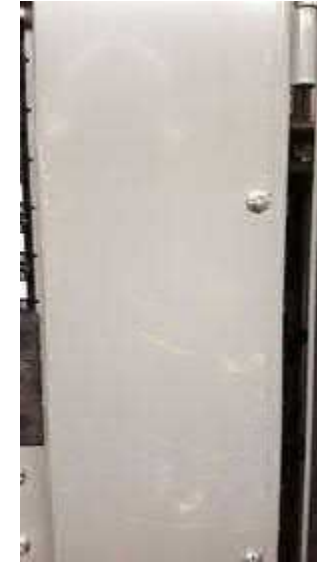
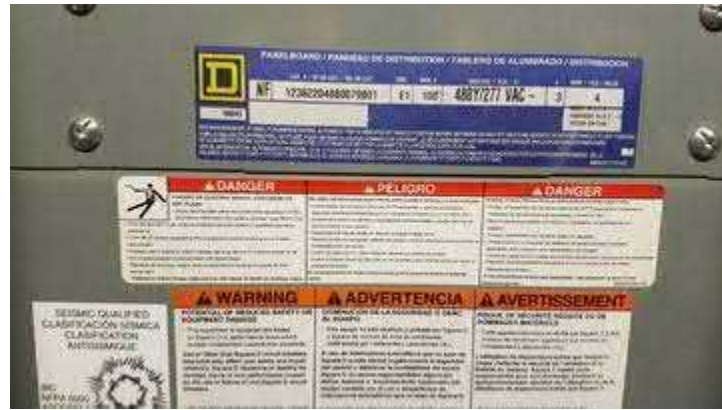
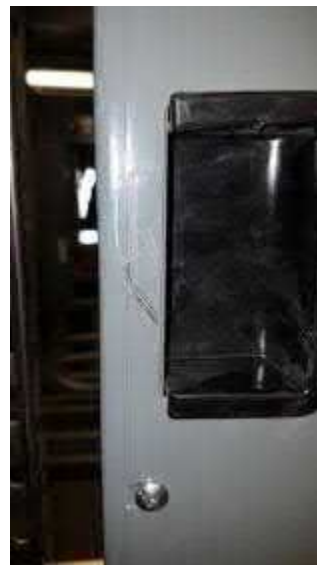
Panel Information		Panel Ratings	
Name or Tag:	NE-DN	Voltage:	480Y/277V
Serial Number and/or Manufacturing Date:	12362204880070001	Amperage:	100
Panel Location Description:	Lighting Control Room	Phase:	3
		Wire:	4
Additional information: Missing Labels Scratches on Door Transparent pocket cant show full panel schedule

Does the surge protector function properly?	No	Is a surge protector provided for the panel?	No	Are there any tripped circuit breakers?	No	Are all spare breaker blanking plates intact and installed?	Yes	Are the panel schedules correct and consistent with the circuit breaker arrangement?	No	Is the front panel secure with no missing screws?	
---	----	--	----	---	----	---	-----	--	----	---	--

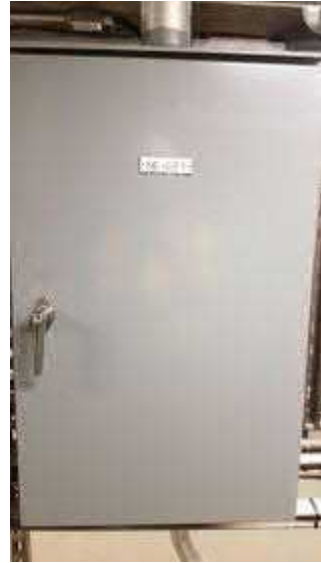
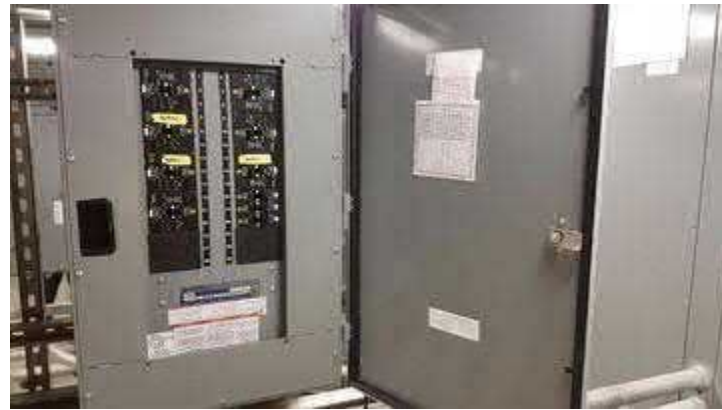
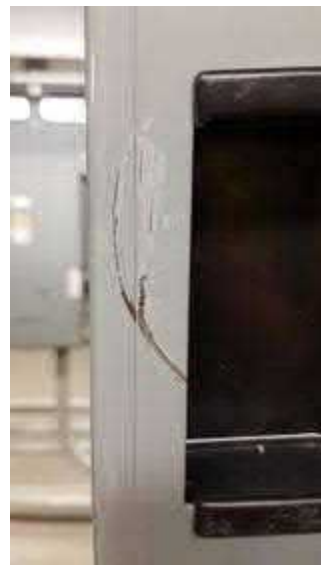
Panel Information		Panel Ratings	
Name or Tag:	NE-LP1	Voltage:	480Y/277V
Serial Number and/or Manufacturing Date:	12362204880080001	Amperage:	100
Panel Location Description:	Lighting Control Room	Phase:	3
		Wire:	4
Additional information: Missing Labels Scratches Transparent pocket cant show full panel schedule

Does the surge protector function properly?	No	Is a surge protector provided for the panel?	No	Are there any tripped circuit breakers?	No	Are all spare breaker blanking plates intact and installed?	Yes	Are the panel schedules correct and consistent with the circuit breaker arrangement?	Yes	Is the front panel secure with no missing screws?	Yes
---	----	--	----	---	----	---	-----	--	-----	---	-----

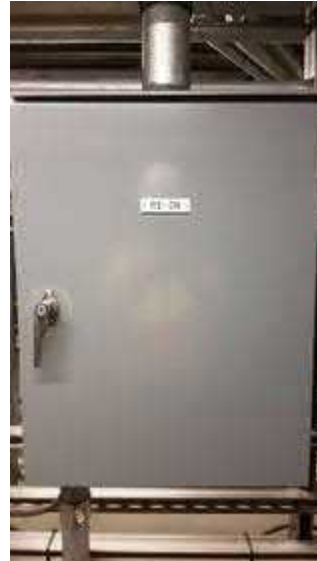
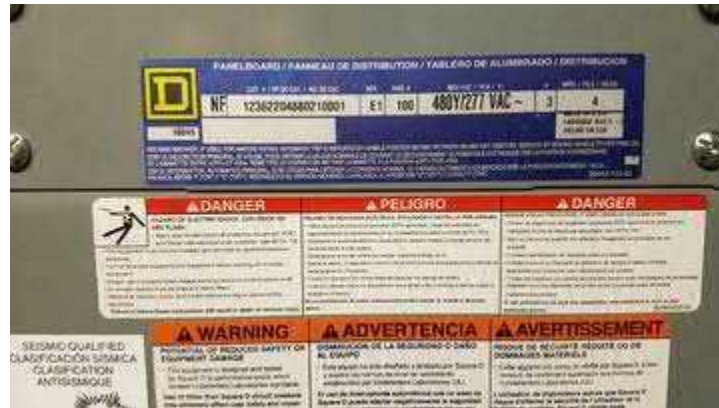
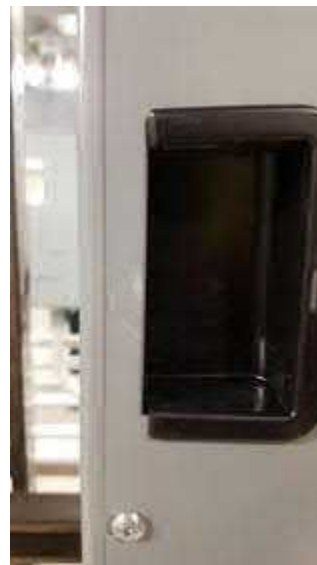
Panel Information		Panel Ratings	
Name or Tag:	RE-DN	Voltage:	480Y/277V
Serial Number and/or Manufacturing Date:	12362204880210001	Amperage:	100
Panel Location Description:	Lighting Control Room	Phase:	3
		Wire:	4
Additional information: Missing Labels Scratches Transparent pocket cant show full panel schedule

Does the surge protector function properly?	No	Is a surge protector provided for the panel?	No	Are there any tripped circuit breakers?	No	Are all spare breaker blanking plates intact and installed?	No	Are the panel schedules correct and consistent with the circuit breaker arrangement?	Yes	Is the front panel secure with no missing screws?	Yes
---	----	--	----	---	----	---	----	--	-----	---	-----

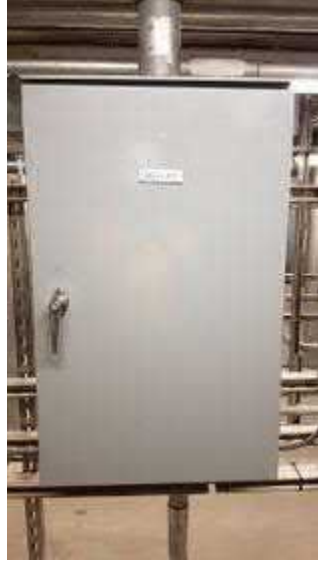
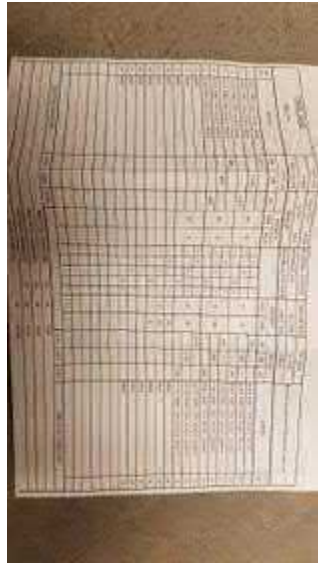
Panel Information		Panel Ratings	
Name or Tag:	RE-LP1	Voltage:	480Y/277V
Serial Number and/or Manufacturing Date:	12362204880220001	Amperage:	100
Panel Location Description:	Lighting Control Room	Phase:	3
		Wire:	4
Additional information: Missing Labels Scratches Transparent pocket cant show full panel schedule Panel schedule inconsistent with breaker arrangement

Does the surge protector function properly?	No
Is a surge protector provided for the panel?	No
Are there any tripped circuit breakers?	No
Are all spare breaker blanking plates intact and installed?	Yes
Are the panel schedules correct and consistent with the circuit breaker arrangement?	No
Is the front panel secure with no missing screws?	Yes

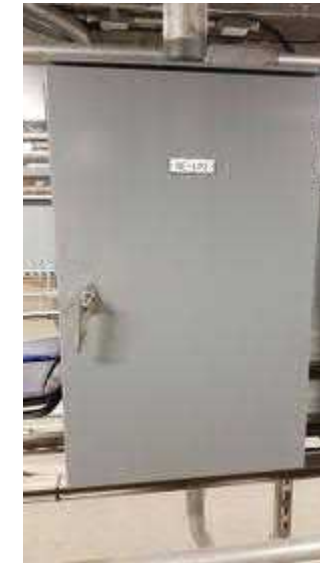
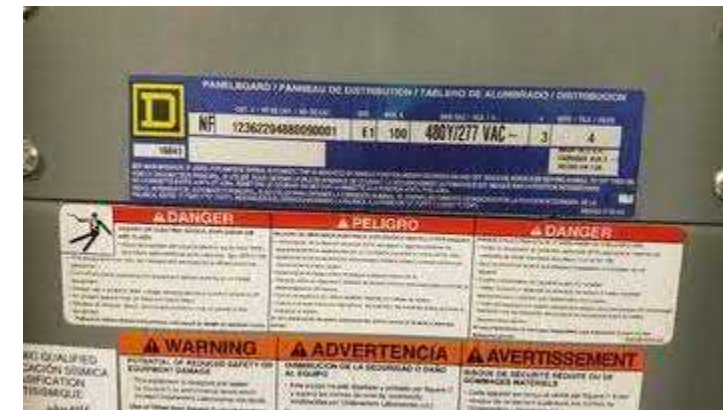
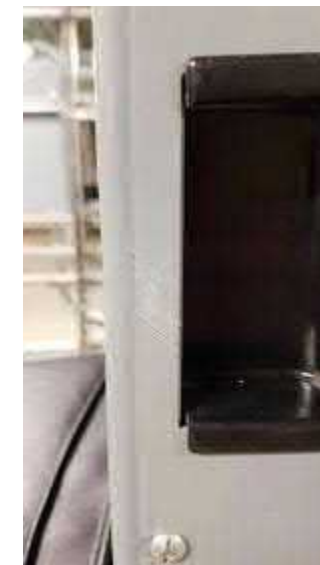
Panel Information		Panel Ratings	
Name or Tag:	NE-LP2	Voltage:	480Y/277V
Serial Number and/or Manufacturing Date:	12362204880090001	Amperage:	100
Panel Location Description:	Lighting Control Room	Phase:	3
		Wire:	4
Additional information: Missing Labels Scratches Transparent pocket cant show full panel schedule Panel schedule inconsistent with breaker arrangement

Does the surge protector function properly?	No
Is a surge protector provided for the panel?	No
Are there any tripped circuit breakers?	No
Are all spare breaker blanking plates intact and installed?	Yes
Are the panel schedules correct and consistent with the circuit breaker arrangement?	No
Is the front panel secure with no missing screws?	Yes

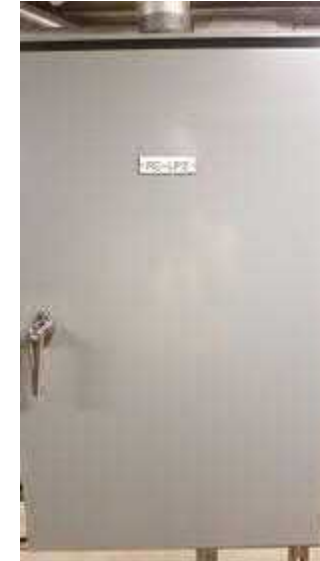
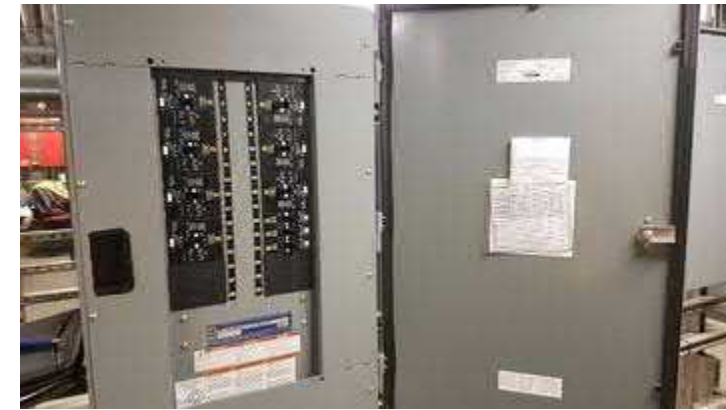
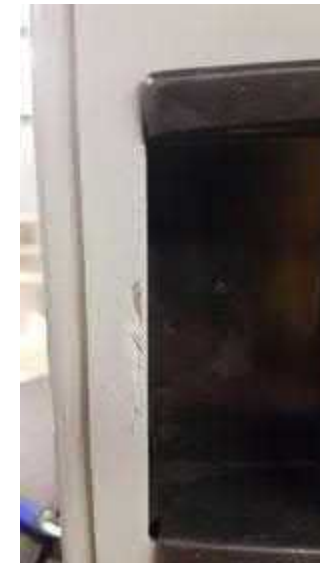
Panel Information		Panel Ratings	
Name or Tag:	RE-LP2	Voltage:	480Y/277V
Serial Number and/or Manufacturing Date:	12362204880230001	Amperage:	100
Panel Location Description:	Lighting Control Room	Phase:	3
		Wire:	4
Additional information: Missing Labels Scratches Transparent pocket cant show full panel schedule

Does the surge protector function properly?	No	Are there any tripped circuit breakers?	No	Are all spare breaker blanking plates intact and installed?	Yes	Are the panel schedules correct and consistent with the circuit breaker arrangement?	Yes	Is the front panel secure with no missing screws?	No
---	----	---	----	---	-----	--	-----	---	----

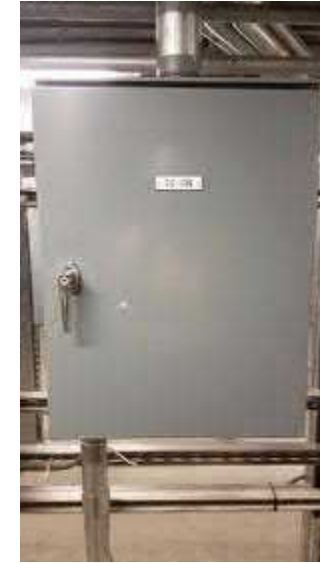
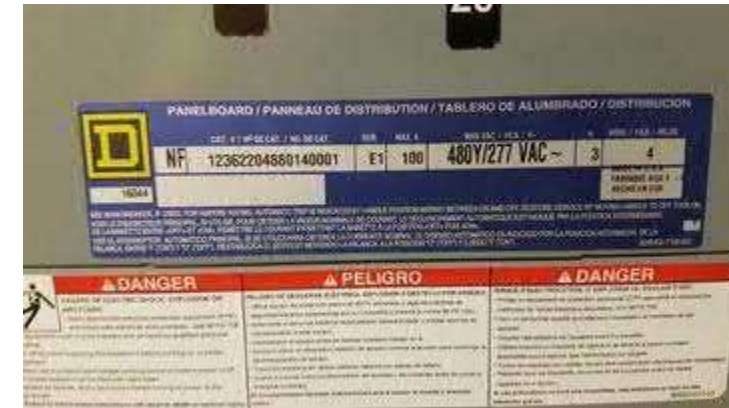
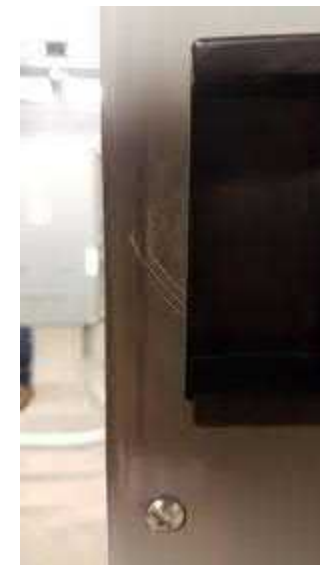
Panel Information		Panel Ratings	
Name or Tag:	SE-DN	Voltage:	480Y/277V
Serial Number and/or Manufacturing Date:	12362204880140001	Amperage:	100
Panel Location Description:	Lighting Control Room	Phase:	3
		Wire:	4
Additional information: Missing Labels Scratches Transparent pocket cant show full panel schedule No18 is installed as a spare CB, panel shcedule shows space

Does the surge protector function properly?	No
Is a surge protector provided for the panel?	No
Are there any tripped circuit breakers?	No
Are all spare breaker blanking plates intact and installed?	Yes
Are the panel schedules correct and consistent with the circuit breaker arrangement?	No
Is the front panel secure with no missing screws?	Yes

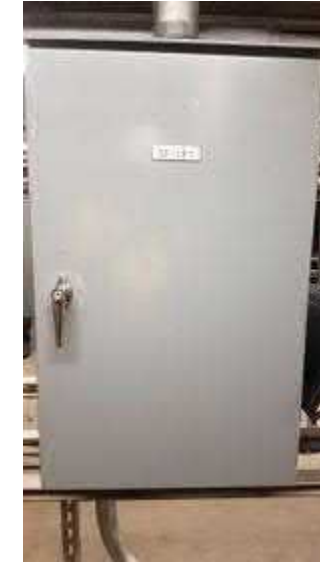
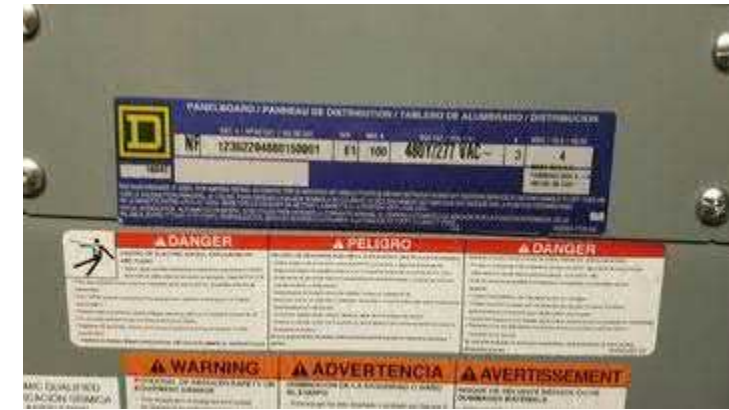
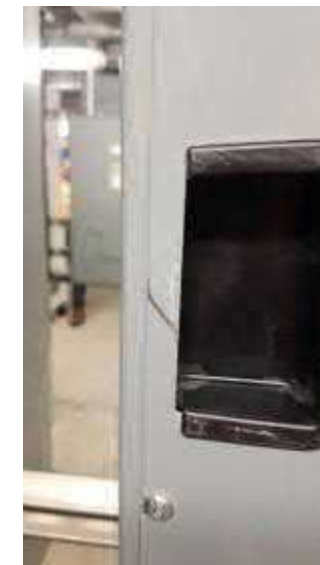
Panel Information		Panel Ratings	
Name or Tag:	SE-LP1	Voltage:	480Y/277V
Serial Number and/or Manufacturing Date:	12362204880150001	Amperage:	100
Panel Location Description:	Lighting Control Room	Phase:	3
		Wire:	4
Additional information: Missing Labels Scratches Transparent pocket cant show full panel schedule Panel schedule inconsistent with breaker arrangement - 26,28,30 shown as off position

Does the surge protector function properly?	No
Is a surge protector provided for the panel?	No
Are there any tripped circuit breakers?	No
Are all spare breaker blanking plates intact and installed?	Yes
Are the panel schedules correct and consistent with the circuit breaker arrangement?	No
Is the front panel secure with no missing screws?	Yes

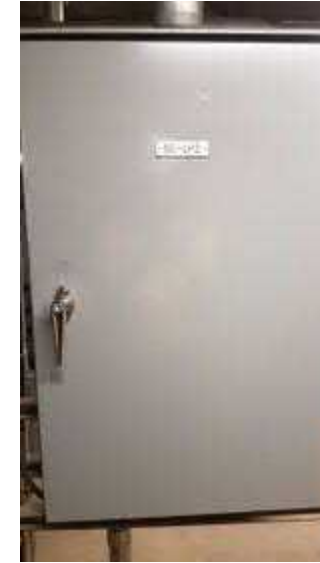
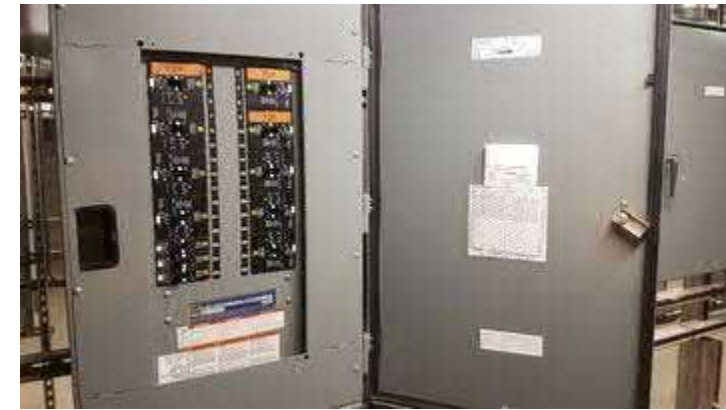
Panel Information		Panel Ratings	
Name or Tag:	SE-LP2	Voltage:	480Y/277V
Serial Number and/or Manufacturing Date:	12362204880160001	Amperage:	100
Panel Location Description:	Lighting Control Room	Phase:	3
		Wire:	4
Additional information: Missing Labels Transparent pocket cant show full panel schedule Panel schedule inconsistent with breaker arrangement - 20-30 shown in off position

Does the surge protector function properly?	Is a surge protector provided for the panel?	Are there any tripped circuit breakers?	Are all spare breaker blanking plates intact and installed?	Are the panel schedules correct and consistent with the circuit breaker arrangement?	Is the front panel secure with no missing screws?
	No	No	Yes	No	No

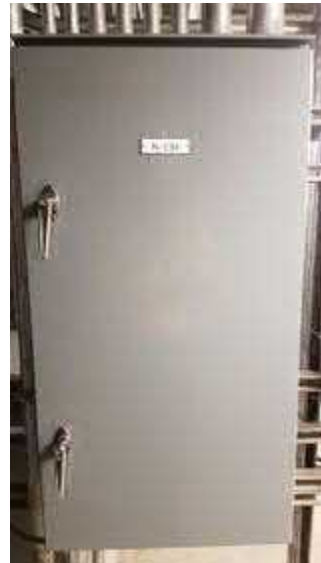
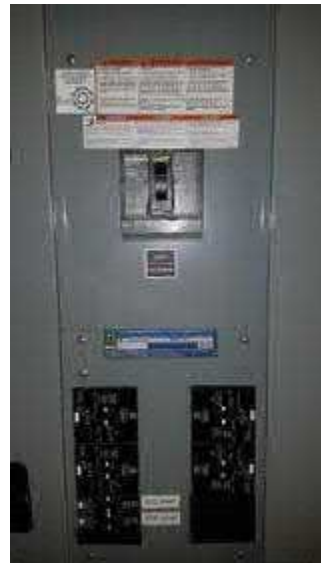
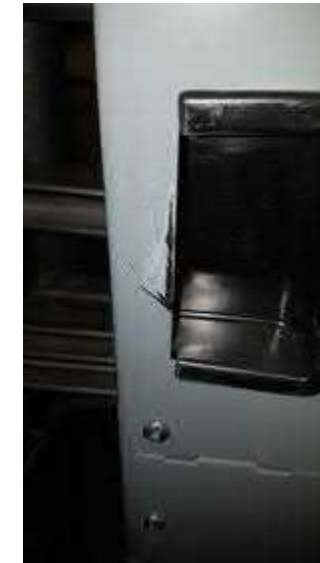
Panel Information		Panel Ratings	
<b>Name or Tag:</b>	N-EM	<b>Voltage:</b>	480Y/277V
<b>Serial Number and/or Manufacturing Date:</b>	12362204880130001	<b>Amperage:</b>	100
<b>Panel Location Description:</b>	Missing Labels Scratches Transparent pocket cant show full panel schedule	<b>Phase:</b>	3
		<b>Wire:</b>	4
<b>Additional information:</b> Missing Labels Scratches Transparent pocket cant show full panel schedule

Does the surge protector function properly?	No	Is a surge protector provided for the panel?	No	Are there any tripped circuit breakers?	No	Are all spare breaker blanking plates intact and installed?	Yes	Are the panel schedules correct and consistent with the circuit breaker arrangement?	Yes	Is the front panel secure with no missing screws?	No
---	----	--	----	---	----	---	-----	--	-----	---	----
