# **Lytle Tunnel (HAM-71-0134) Inspection Report Fall 2020**

PID 105470

November, 2020

Ohio Department of  
Transportation  
District 8  
505 South State Route 741  
Lebanon, OH 45036

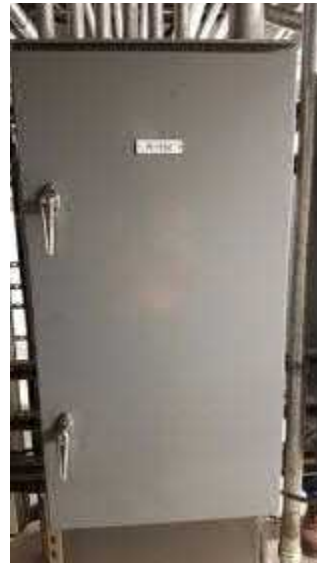
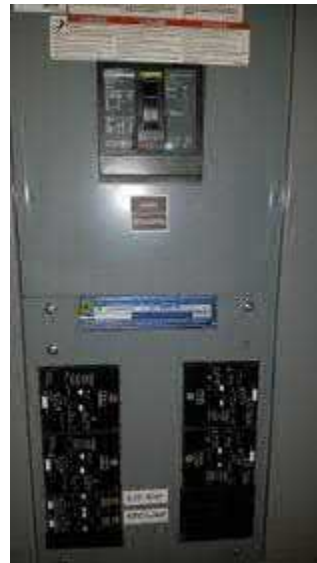
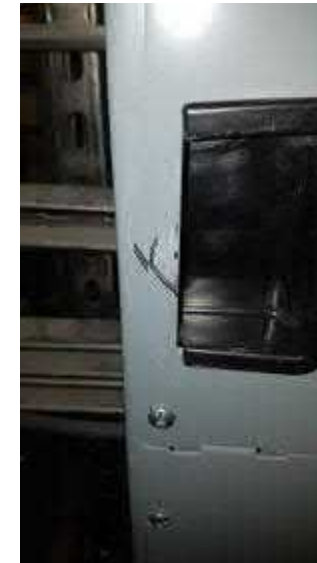
Panel Information		Panel Ratings	
<b>Name or Tag:</b>	R-EM	<b>Voltage:</b>	480Y/277V
<b>Serial Number and/or Manufacturing Date:</b>	12362204880270001	<b>Amperage:</b>	60
<b>Panel Location Description:</b>	Lighting Control Room	<b>Phase:</b>	3
		<b>Wire:</b>	4
<b>Additional information:</b> Missing Labels Scratches Transparent pocket cant show full panel schedule Panel schedule inconsistent with breaker arrangement -13 & 15 shown as aspace

Does the surge protector function properly?	No	Is a surge protector provided for the panel?	No	Are there any tripped circuit breakers?	No	Are all spare breaker blanking plates intact and installed?	Yes	Are the panel schedules correct and consistent with the circuit breaker arrangement?	No	Is the front panel secure with no missing screws?	Yes
---	----	--	----	---	----	---	-----	--	----	---	-----

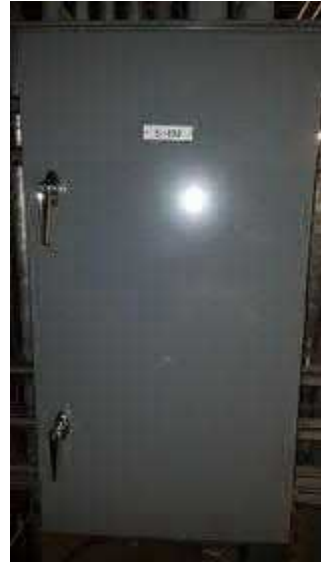
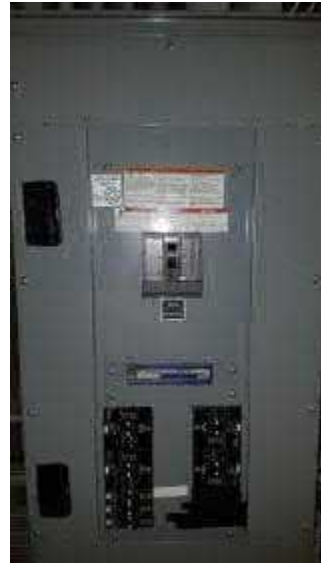
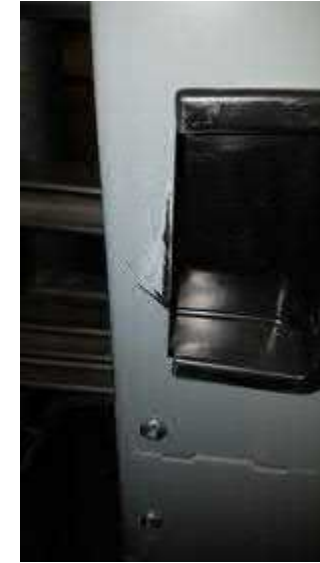
Panel Information		Panel Ratings	
Name or Tag:	S-EM	Voltage:	480Y/277V
Serial Number and/or Manufacturing Date:	12362204880200001	Amperage:	60
Panel Location Description:	Lighting Control Room	Phase:	3
		Wire:	4
Additional information: Missing Labels Scratches Transparent pocket cant show full panel schedule Panel schedule inconsistent with breaker arrangement Blank Plates covered with Tape

Does the surge protector function properly?	No	Is a surge protector provided for the panel?	No	Are there any tripped circuit breakers?	No	Are all spare breaker blanking plates intact and installed?	No	Are the panel schedules correct and consistent with the circuit breaker arrangement?	No	Is the front panel secure with no missing screws?	Yes
---	----	--	----	---	----	---	----	--	----	---	-----

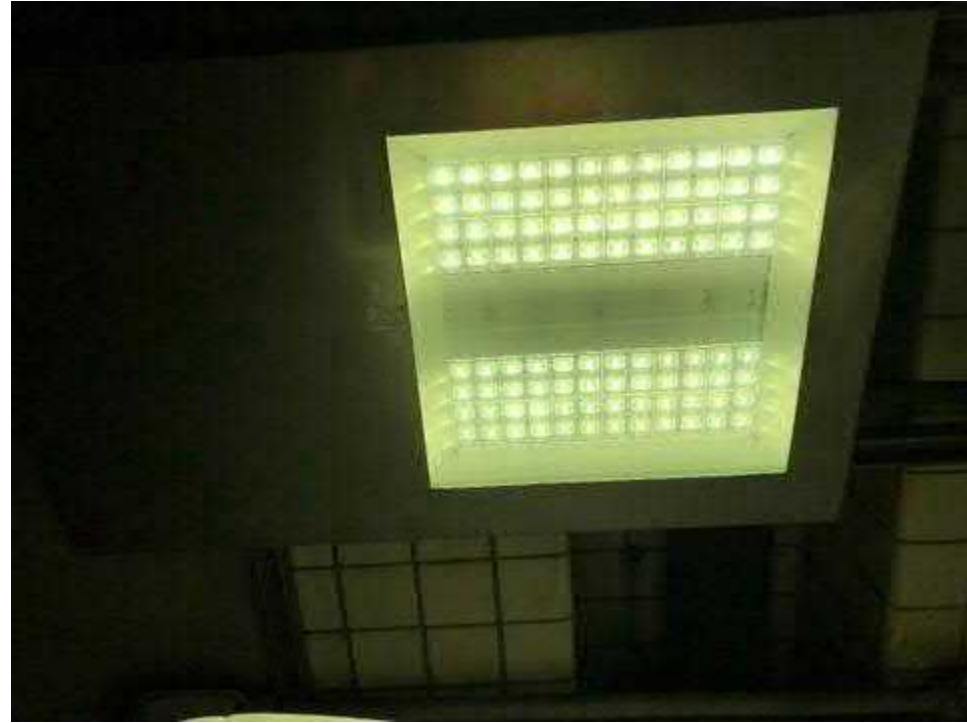
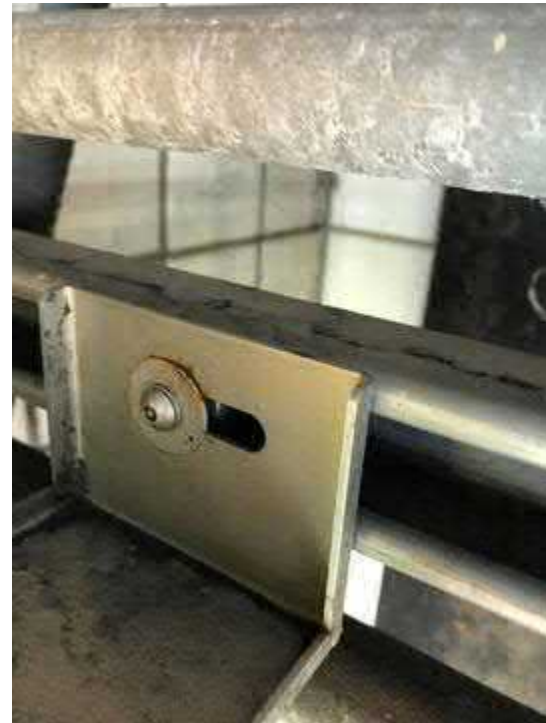
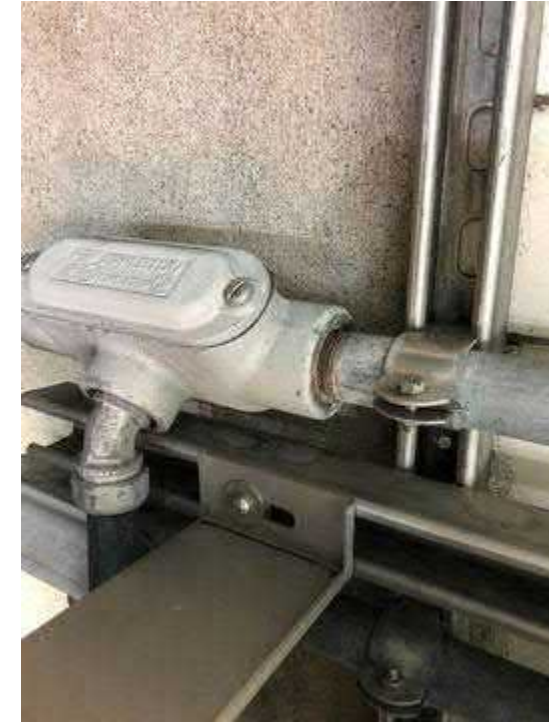
Lighting Fixture Information	
<b>Luminaire Tag or Number:</b>	NB - West Wall - 1A
<b>Tunnel Direction and Side:</b>	NB - West Wall
<b>Additional Information:</b>	Top right springnut misaligned. Conduit corrosion

Are there any signs of corrosion evident on the tunnel lighting system raceways?	Yes
Are the side entry conduits into the fixture tightly secured?	Yes
Are there any signs of corrosion on the fixture?	No
Is there any damage to the component housing or enclosure?	No
Is the light fixture secure to the mounting channels?	Yes
Long channel springnut misaligned?	No
Long channel springnut cracked?	No
Trans channel springnut misaligned?	Yes
Trans channel springnut cracked?	No
Trans channel wireway clip?	Yes
Housing clip disengaged?	No
Housing clip missing?	No
Lens clip disengaged?	No
Lens clip broken?	No
Lens cover cracked?	No
Wireway ears broken?	No
Luminaire functioning?	Yes

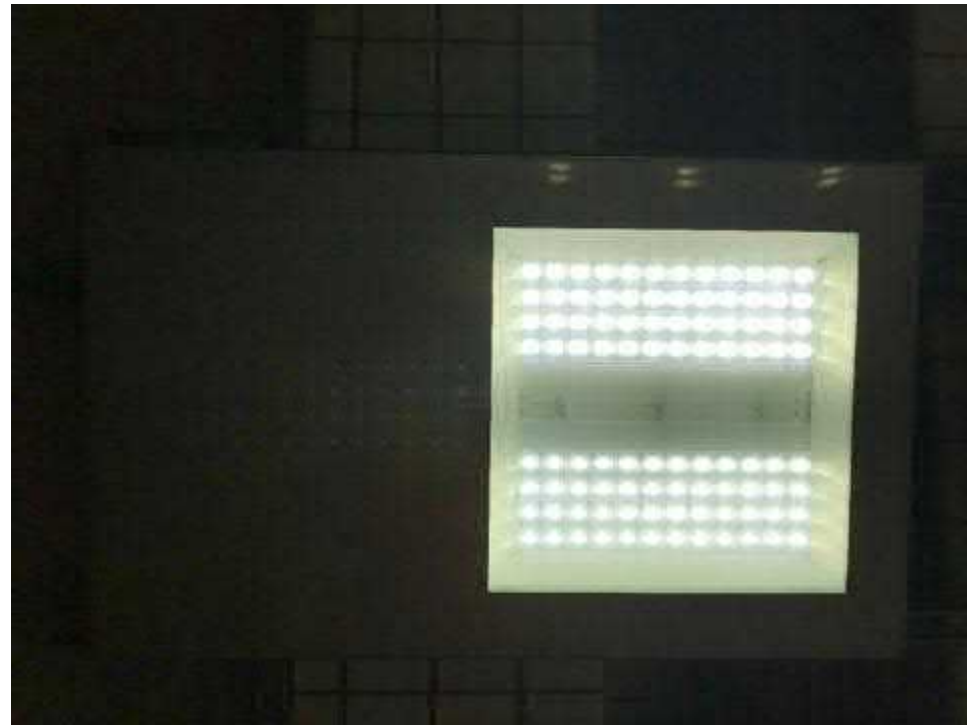
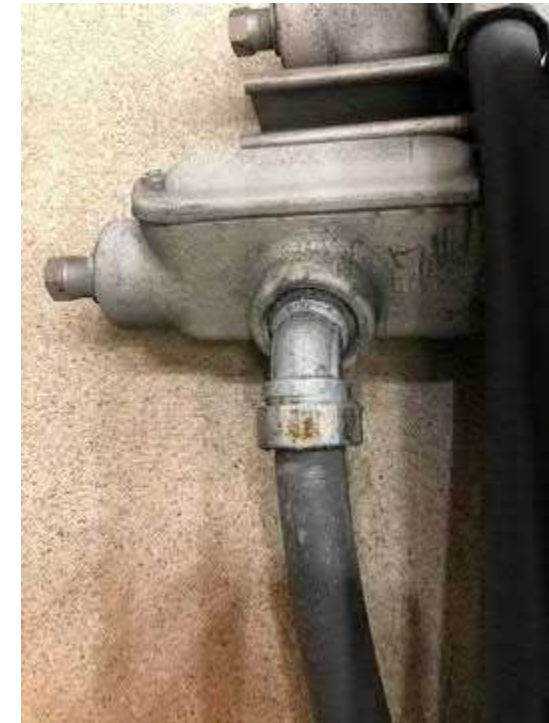
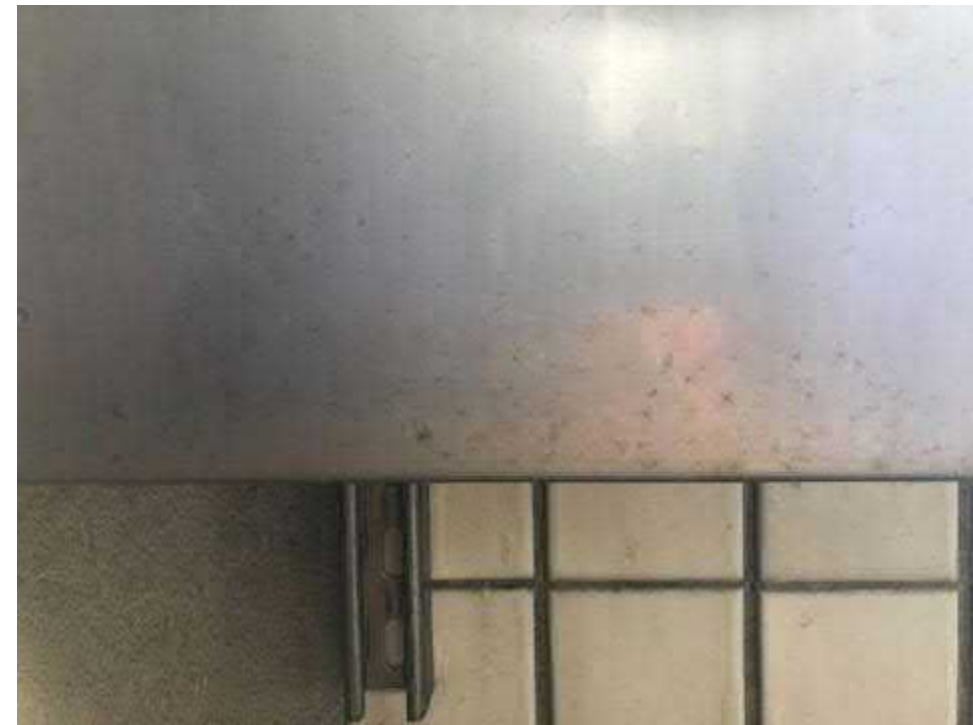
Lighting Fixture Information	
Luminaire Tag or Number:	NB - West Wall - 1B
Tunnel Direction and Side:	NB - West Wall
Additional Information:	Corrosion on fixture. T corroded

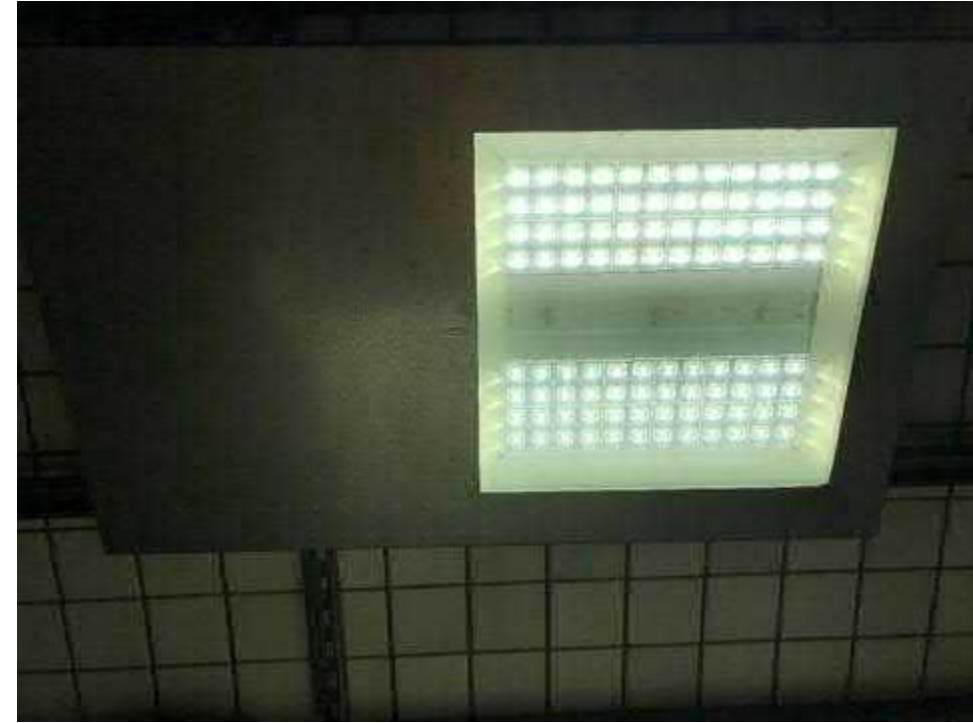
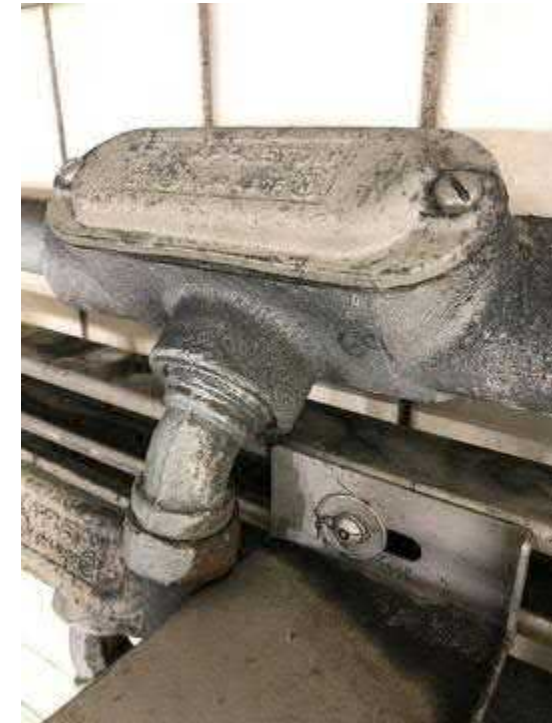
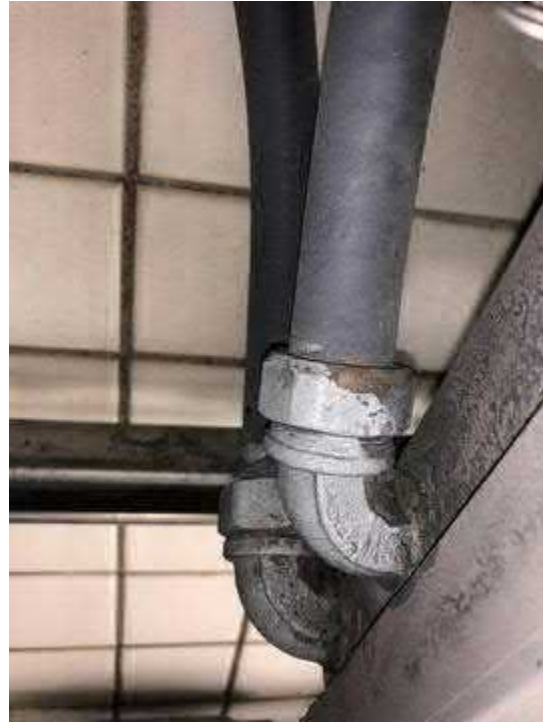
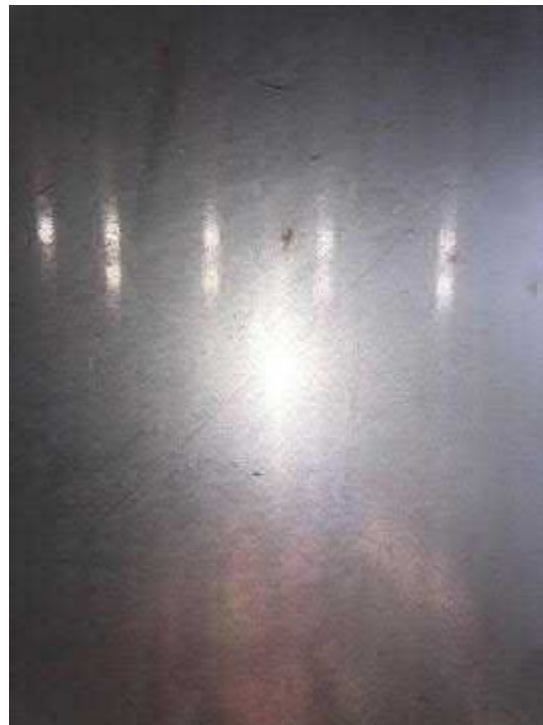
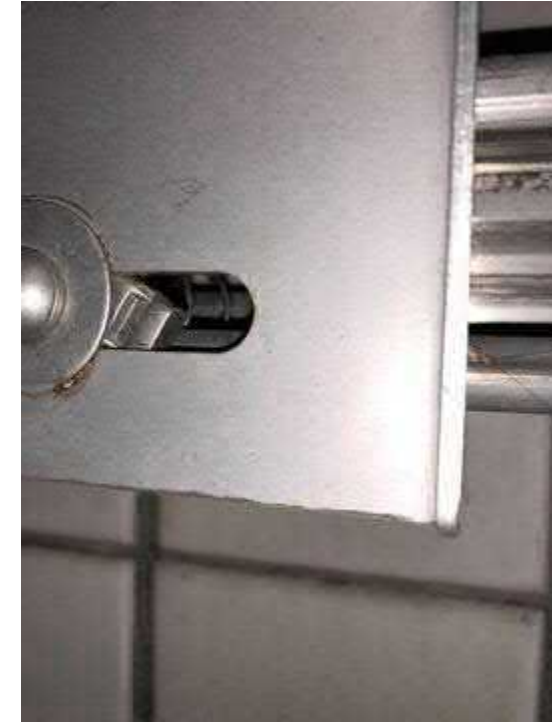
Lighting Fixture Information	
Luminaire Tag or Number:	NB - West Wall - 6A
Tunnel Direction and Side:	NB - West Wall
Additional Information:	T corrosion Side conduit L corrision Fixture corrosion Bottom right housing clip misaligned

Are there any signs of corrosion evident on the tunnel lighting system raceways?	Yes
Are the side entry conduits into the fixture tightly secured?	Yes
Are there any signs of corrosion on the fixture?	Yes
Is there any damage to the component housing or enclosure?	Yes
Is the light fixture secure to the mounting channels?	Yes
Long channel springnut misaligned?	No
Long channel springnut cracked?	No
Trans channel springnut misaligned?	Yes
Trans channel springnut cracked?	No
Trans channel wireway clip?	Yes
Housing clip disengaged?	No
Housing clip missing?	No
Lens clip disengaged?	No
Lens clip broken?	No
Lens cover cracked?	No
Wireway ears broken?	No
Luminaire functioning?	Yes

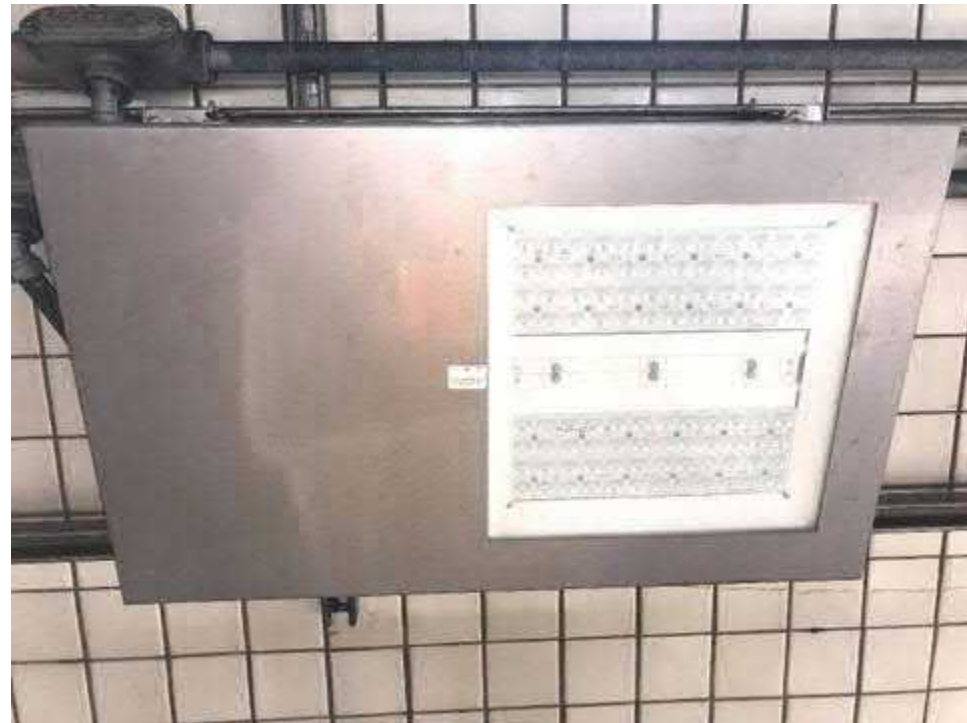
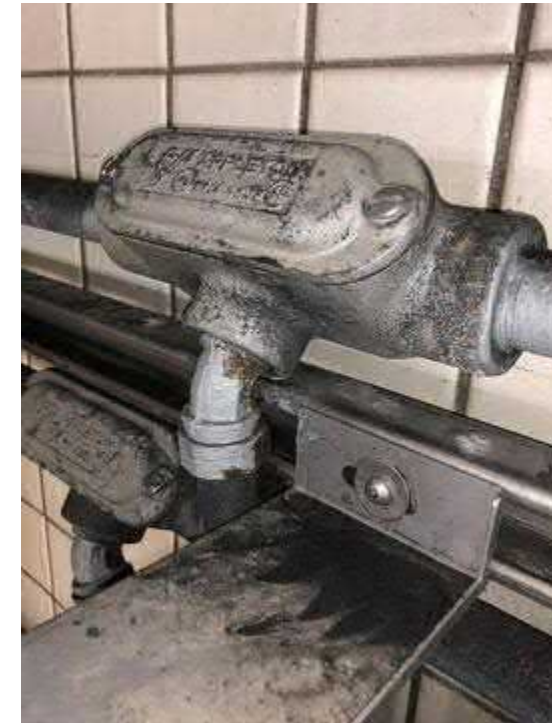
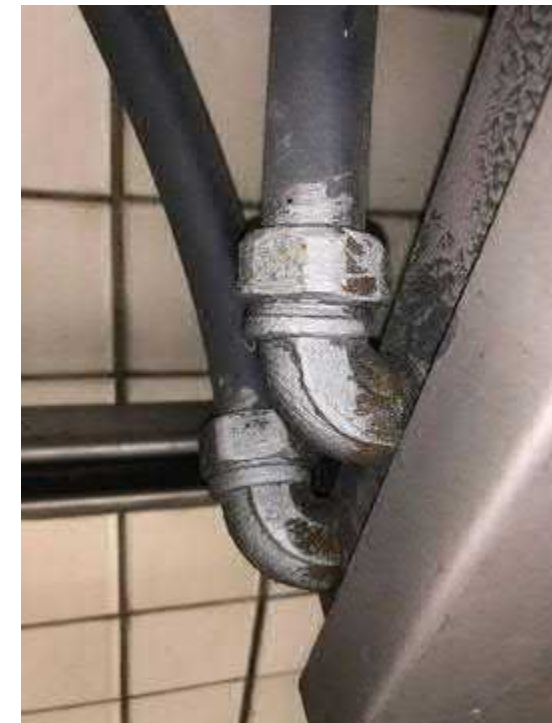
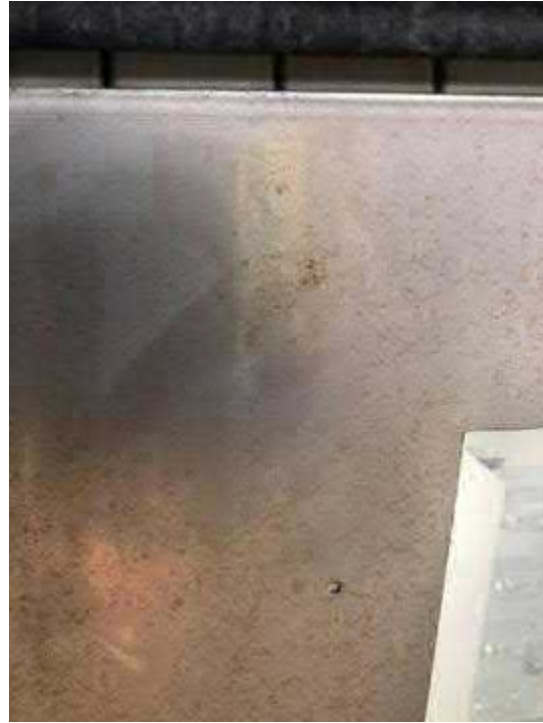
Lighting Fixture Information	
<b>Luminaire Tag or Number:</b>	NB - West Wall - 5B
<b>Tunnel Direction and Side:</b>	NB - West Wall
<b>Additional Information:</b>	T corrosion Side entry L corrosion Fixture corrosion

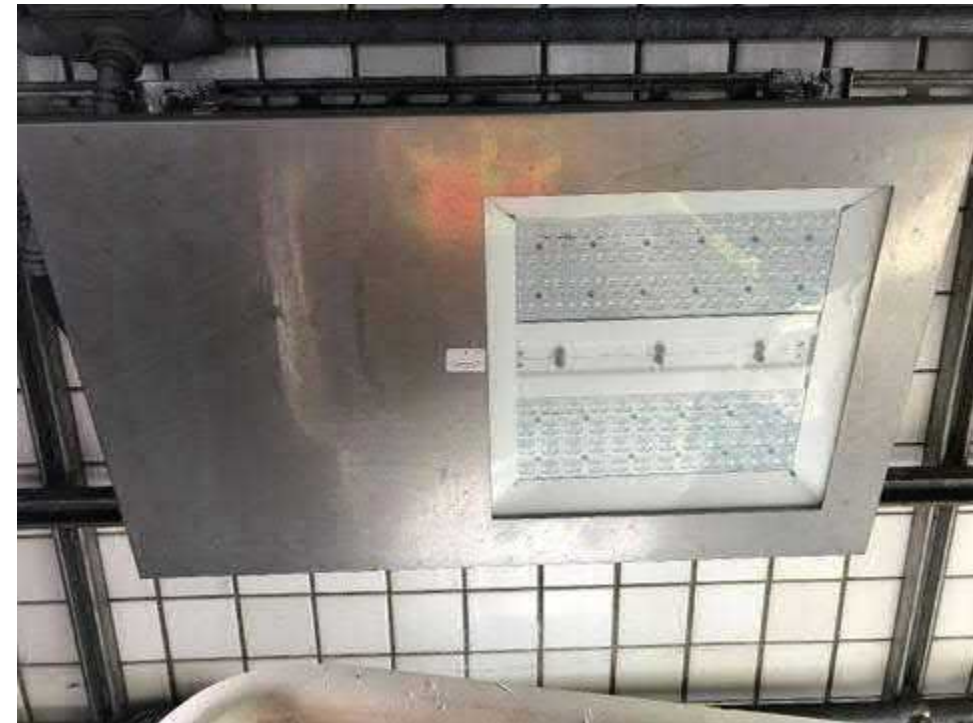
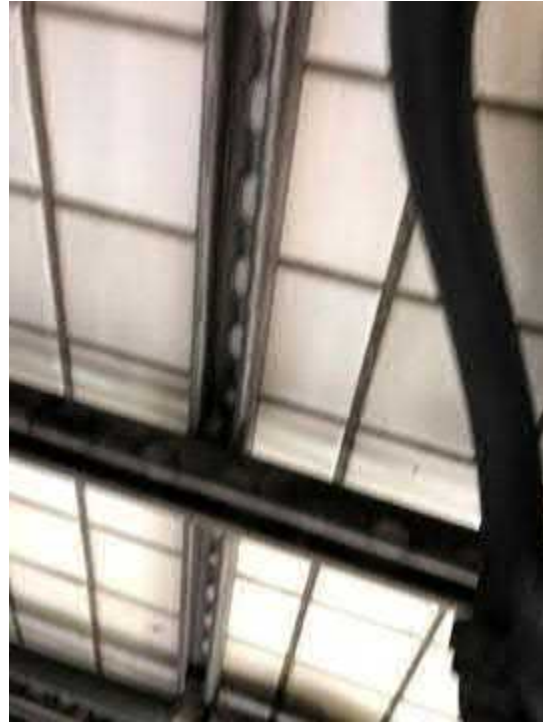
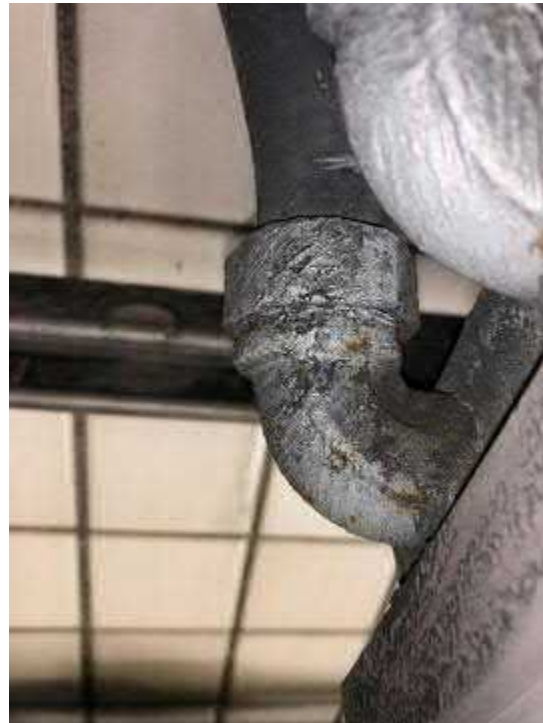
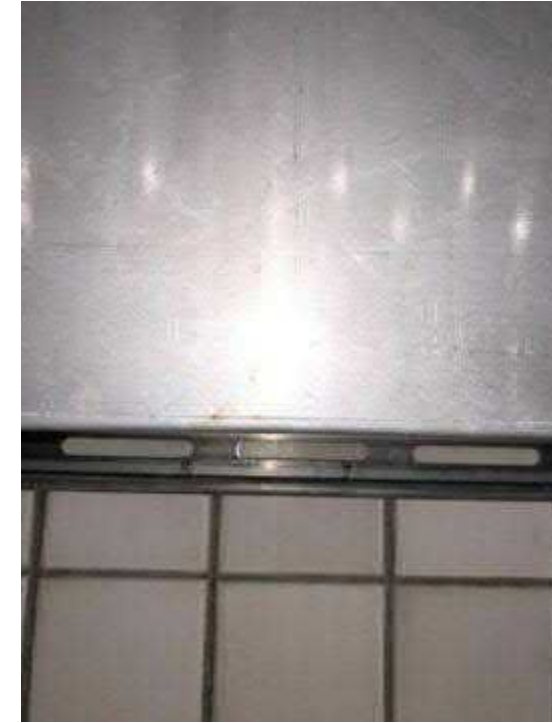
<b>Luminaire Tag or Number:</b>	NB - West Wall - 11A
<b>Tunnel Direction and Side:</b>	NB - West Wall
<b>Additional Information:</b>	T Corrosion Side Conduit L corrosion Fixture corrosion

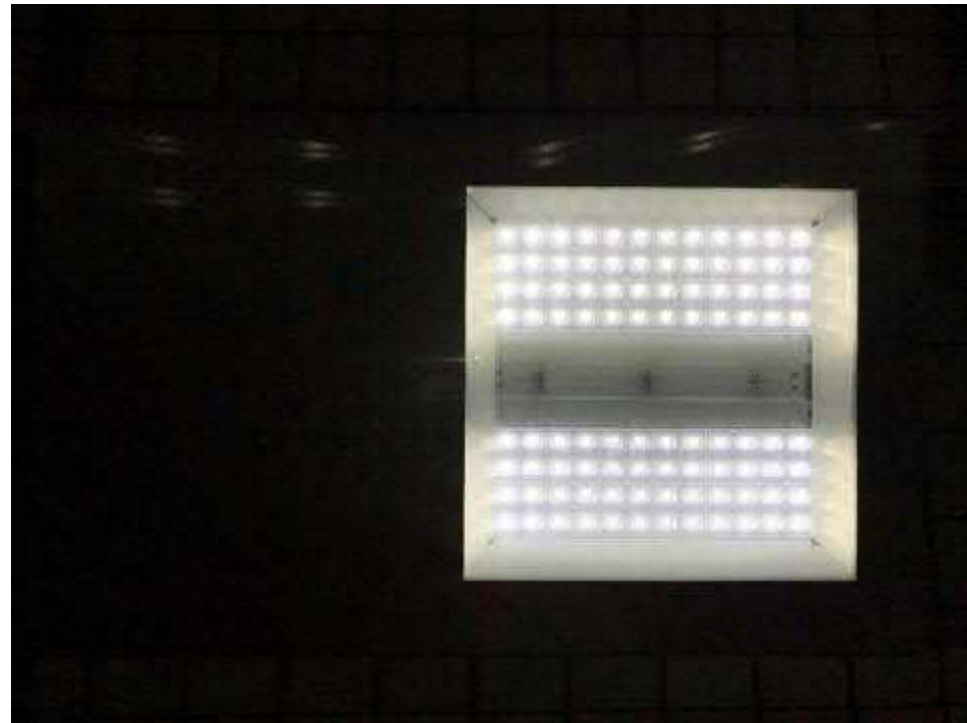
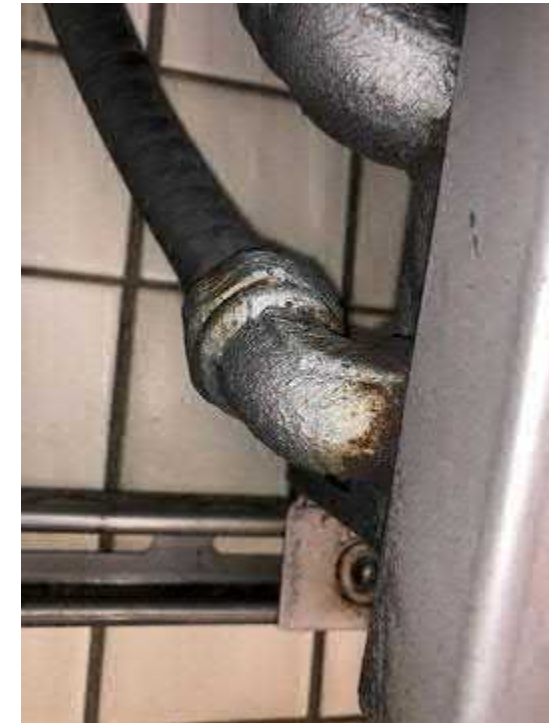
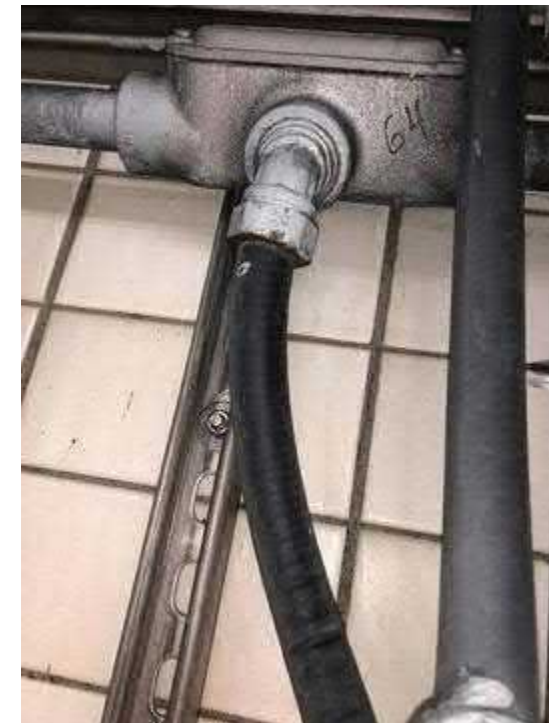
Lighting Fixture Information	
<b>Luminaire Tag or Number:</b>	NB - West Wall - 11B
<b>Tunnel Direction and Side:</b>	NB - West Wall
<b>Additional Information:</b>	T Corrosion Side Conduit L Corrosion Fixture Corrosion

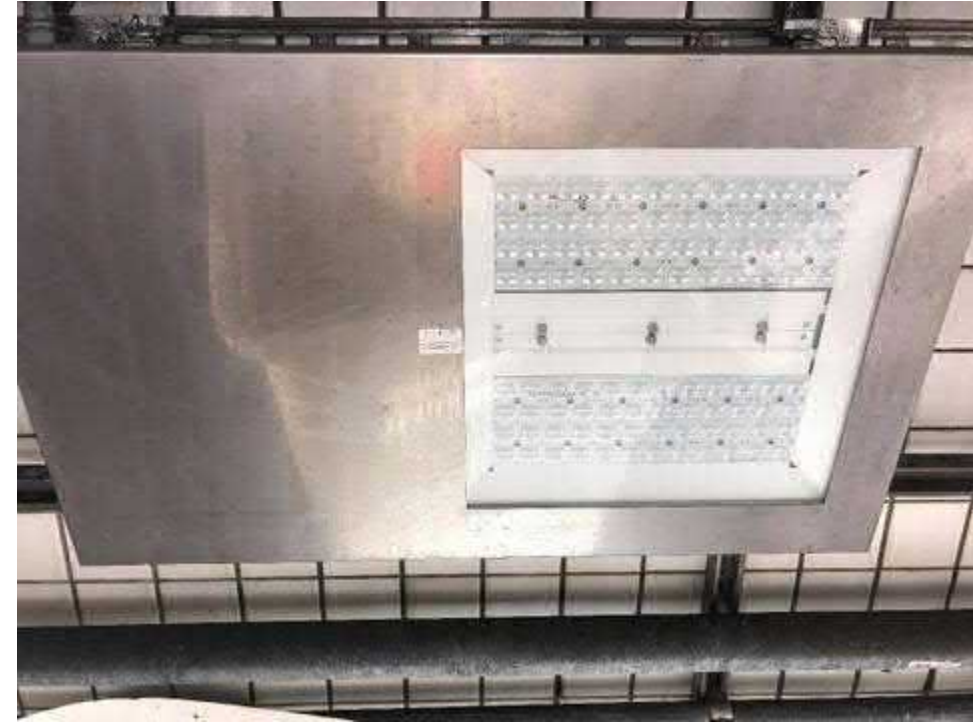
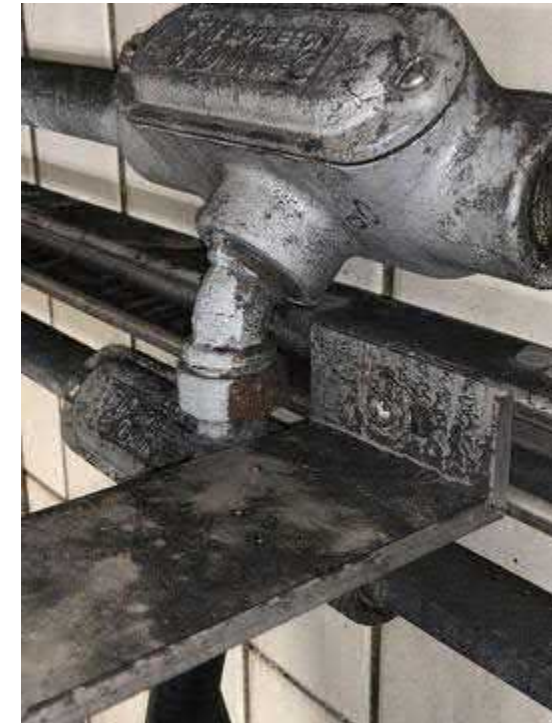
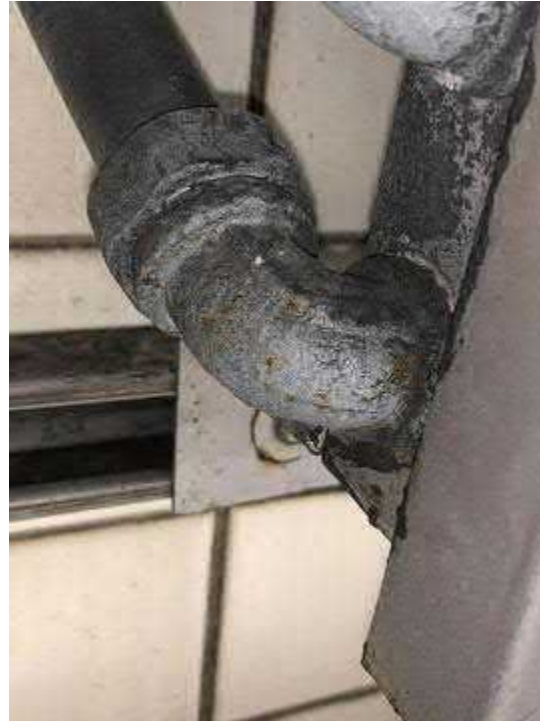
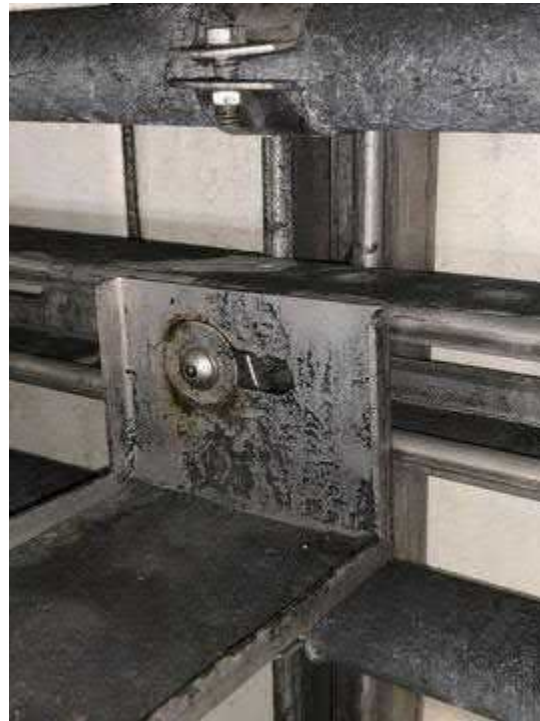
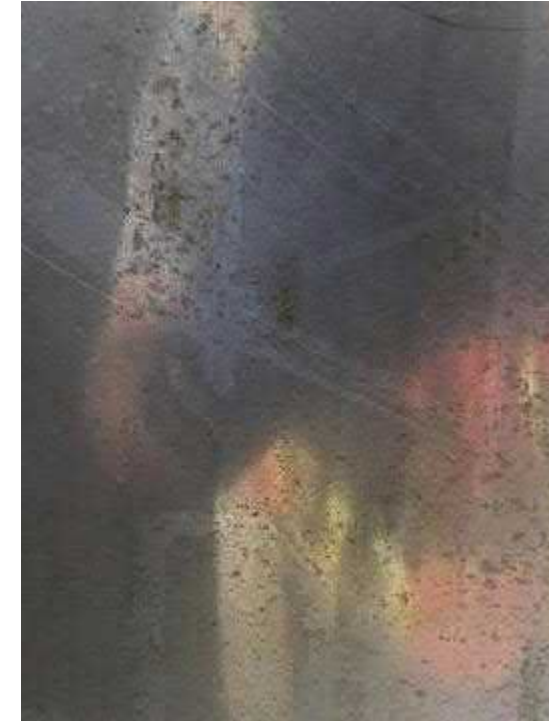
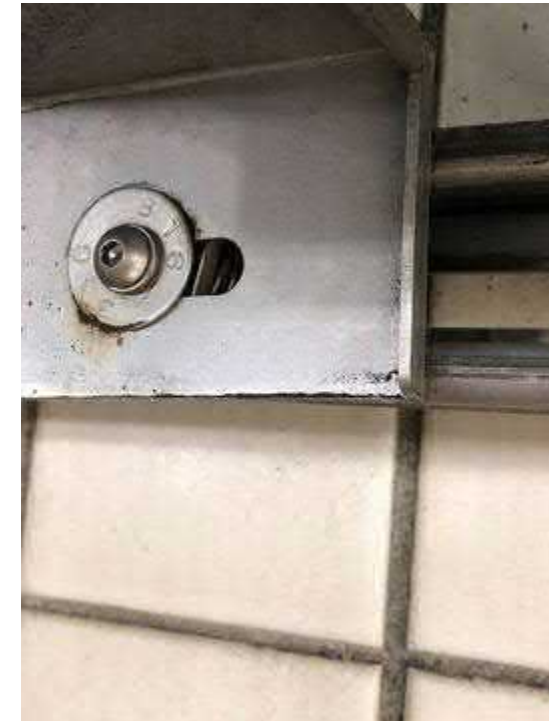
Lighting Fixture Information	
Luminaire Tag or Number:	NB - West Wall - 16A
Tunnel Direction and Side:	NB - West Wall Corrisio
Additional Information:	T Corrision Side Entry L Corrision Fixture Corrision Top right misaligned Bottom Left Misaligned

Are there any signs of corrosion evident on the tunnel lighting system raceways?	Yes
Are the side entry conduits into the fixture tightly secured?	Yes
Are there any signs of corrosion on the fixture?	Yes
Is there any damage to the component housing or enclosure?	No
Is the light fixture secure to the mounting channels?	Yes
Long channel springnut misaligned?	No
Long channel springnut cracked?	No
Trans channel springnut misaligned?	Yes
Trans channel springnut cracked?	No
Trans channel wireway clip?	Yes
Housing clip disengaged?	No
Housing clip missing?	No
Lens clip disengaged?	No
Lens clip broken?	No
Lens cover cracked?	No
Wireway ears broken?	No
Luminaire functioning?	Yes

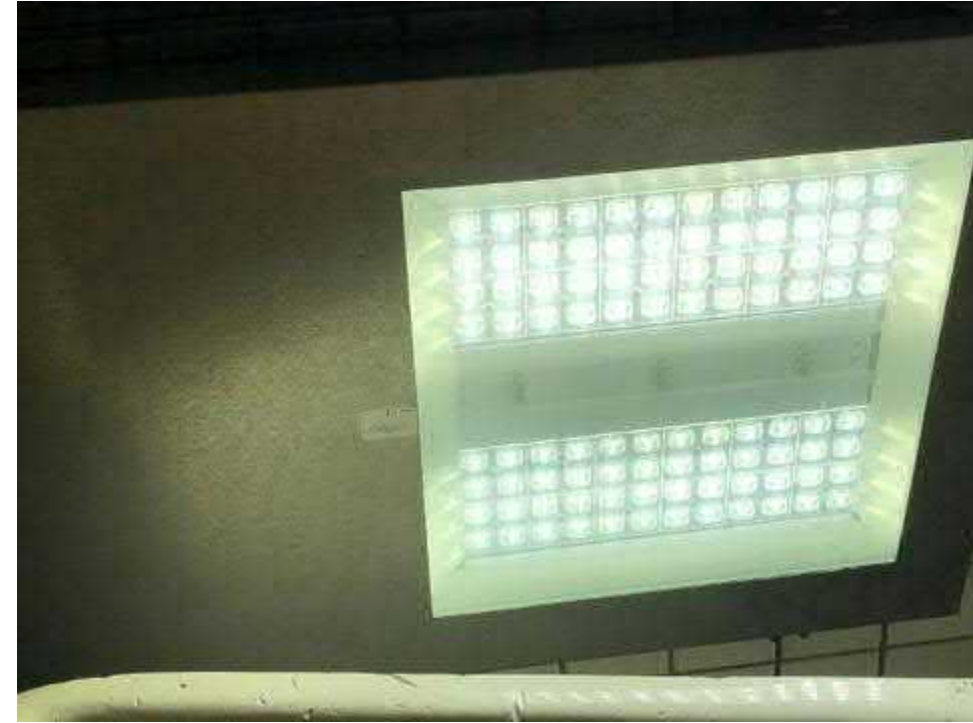
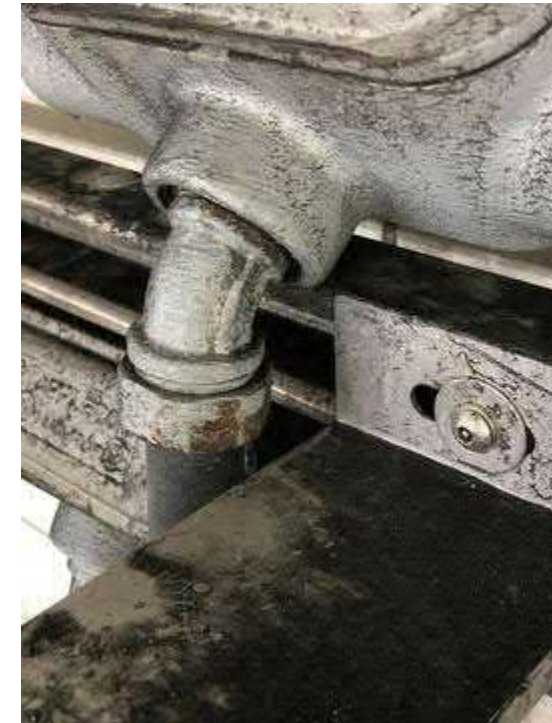
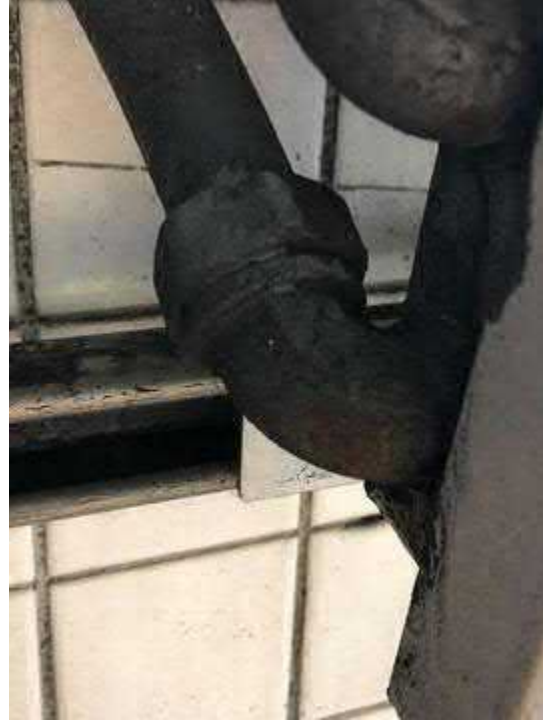
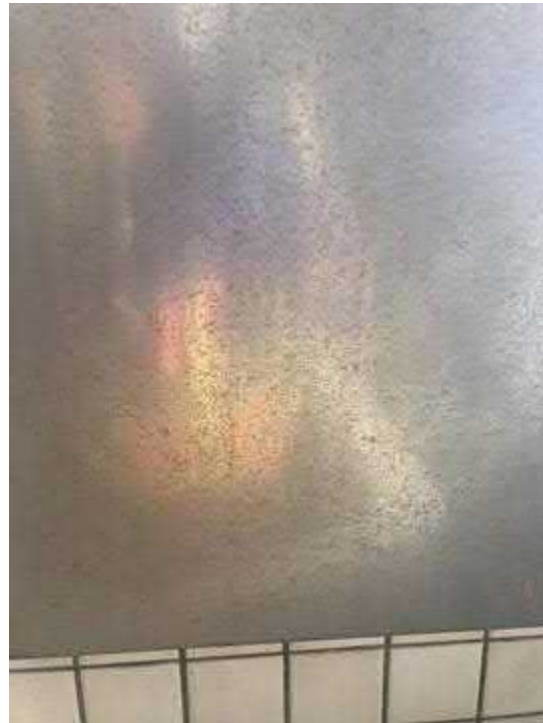
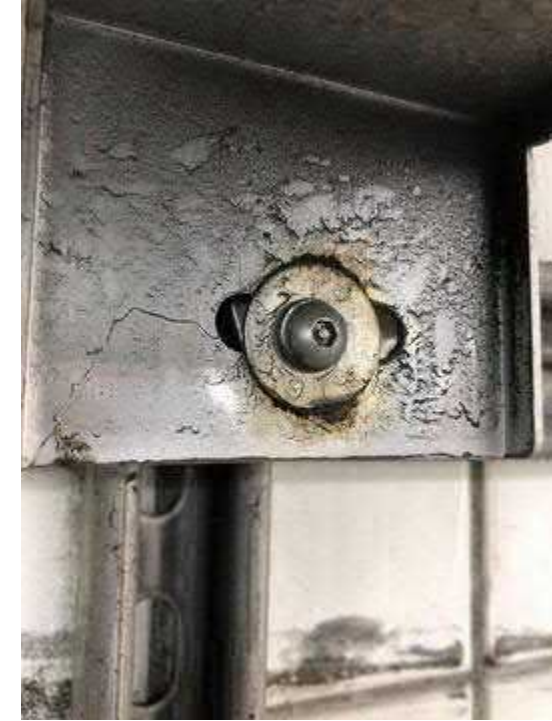
Lighting Fixture Information	
Luminaire Tag or Number:	NB - West Wall - 16B
Tunnel Direction and Side:	NB - West Wall
Additional Information:	T Corrision Side Entry L Corrision Fixture Corrision Bottom Right Misaligned

Are there any signs of corrosion evident on the tunnel lighting system raceways?	Yes
Are the side entry conduits into the fixture tightly secured?	Yes
Are there any signs of corrosion on the fixture?	Yes
Is there any damage to the component housing or enclosure?	No
Is the light fixture secure to the mounting channels?	Yes
Long channel springnut misaligned?	No
Long channel springnut cracked?	No
Trans channel springnut misaligned?	No
Trans channel springnut cracked?	No
Trans channel wireway clip?	No
Housing clip disengaged?	No
Housing clip missing?	No
Lens clip disengaged?	No
Lens clip broken?	No
Lens cover cracked?	No
Wireway ears broken?	No
Luminaire functioning?	Yes

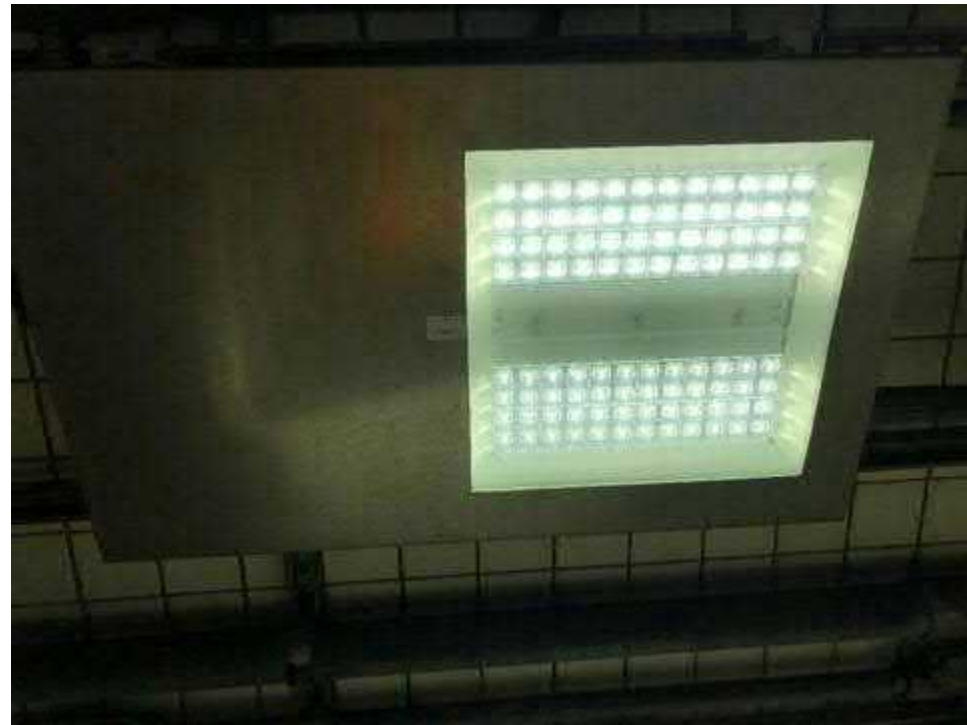
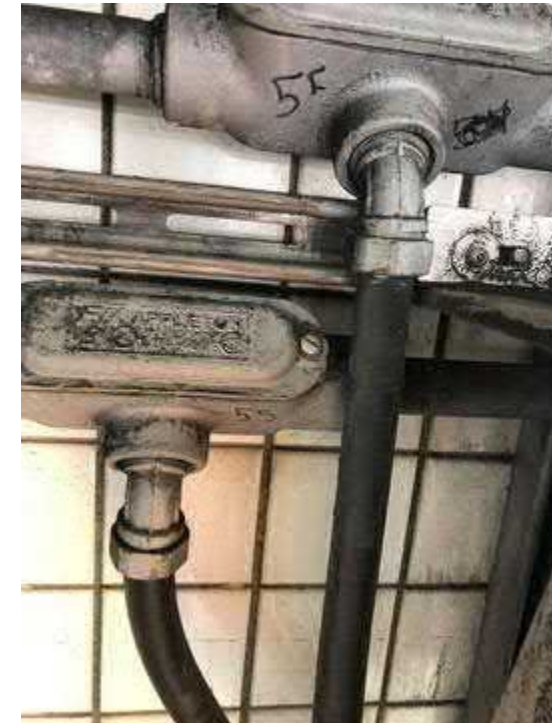
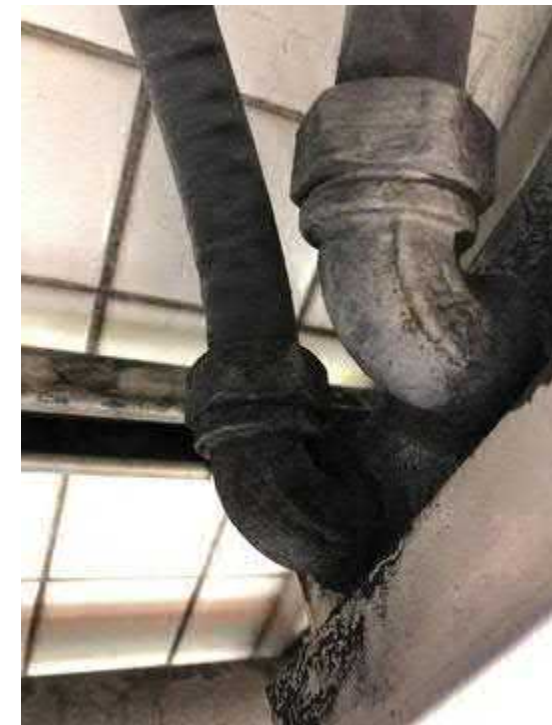
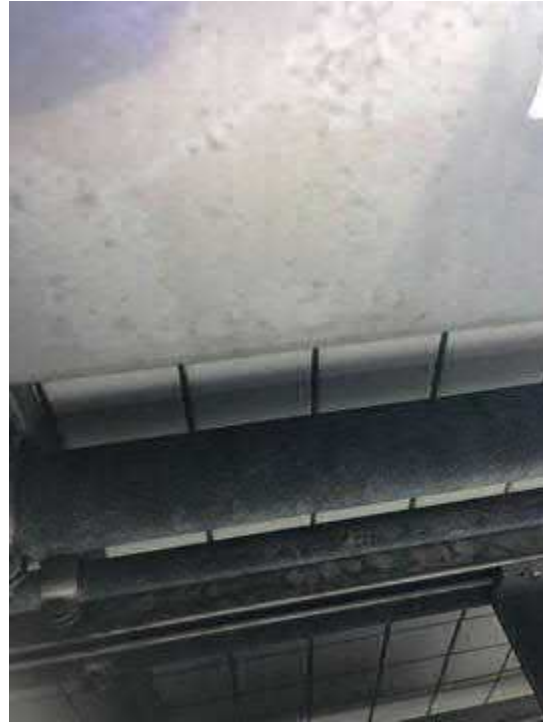
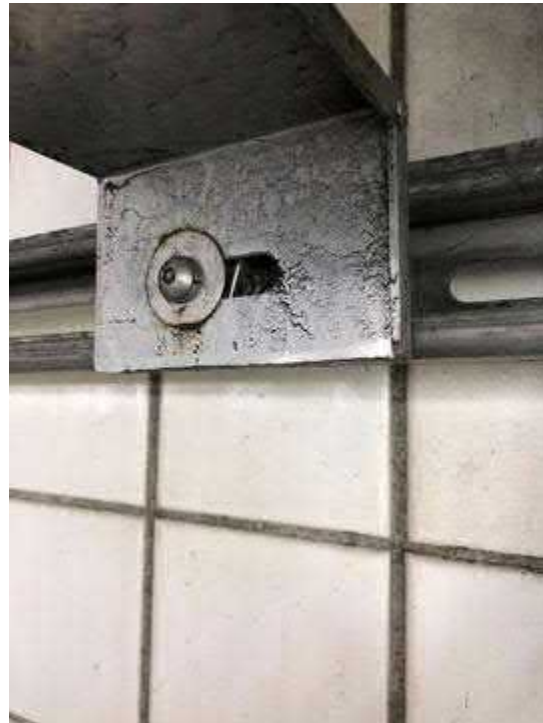
Lighting Fixture Information	
<b>Luminaire Tag or Number:</b>	NB - West Wall - 21A
<b>Tunnel Direction and Side:</b>	NB - West Wall
<b>Additional Information:</b>	T Corrosion Side Entry L Corrosion Fixture Corrosion Bottom Left Misaligned
