# **Lytle Tunnel (HAM-71-0134) Inspection Report Fall 2020**

PID 105470

November, 2020

Ohio Department of  
Transportation  
District 8  
505 South State Route 741  
Lebanon, OH 45036

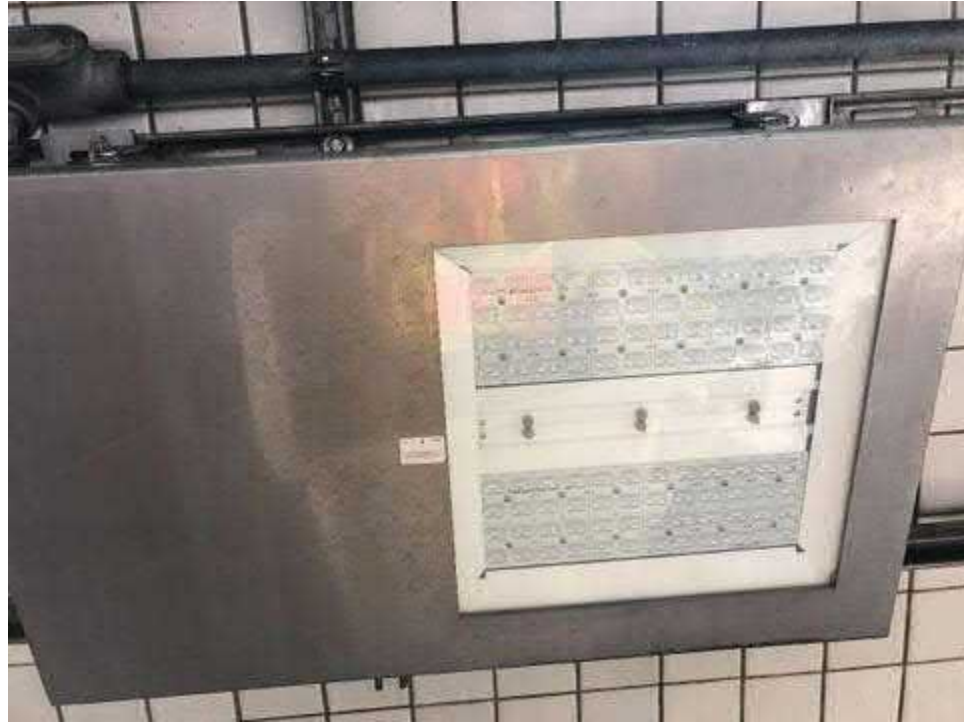
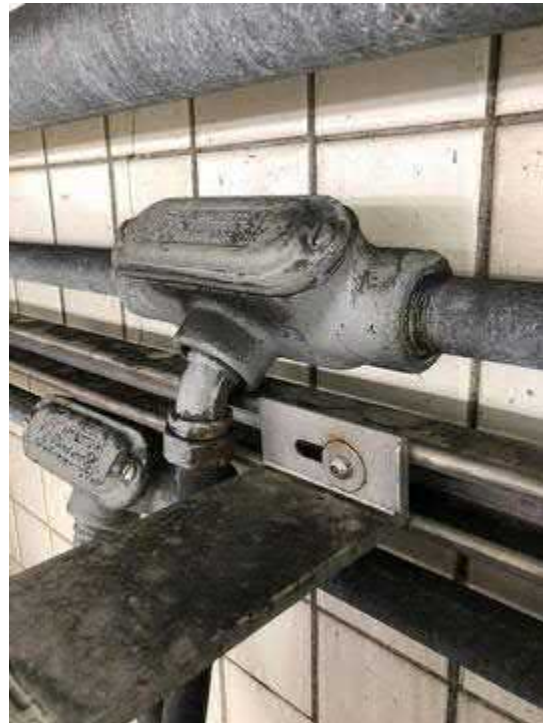
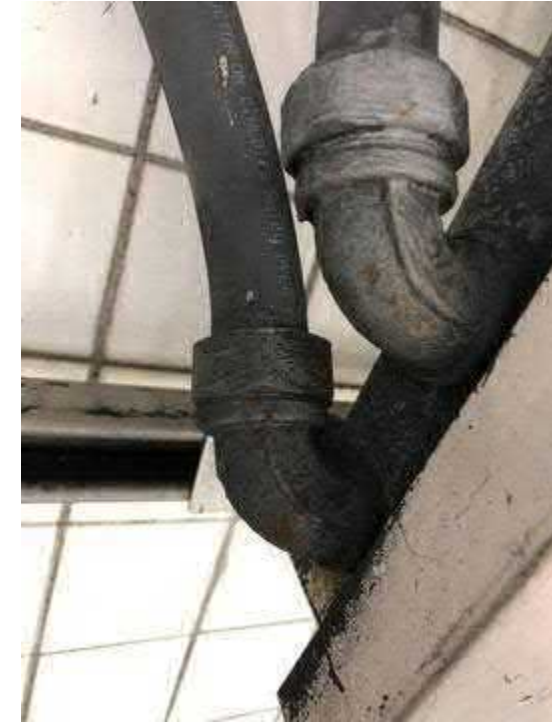
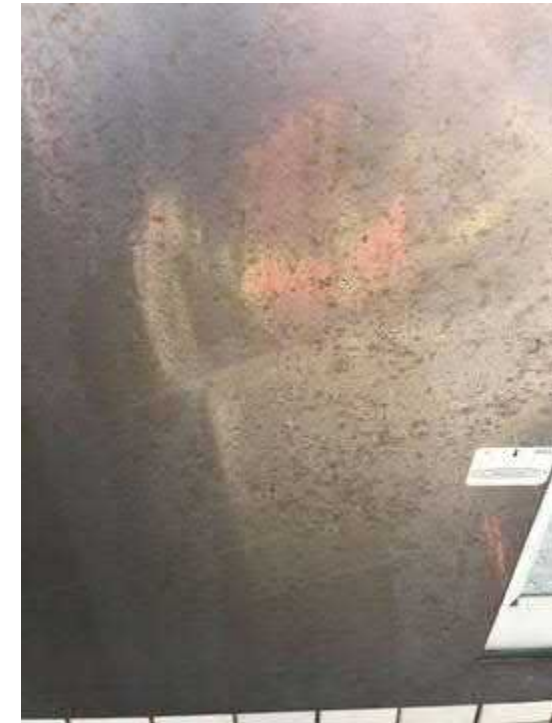
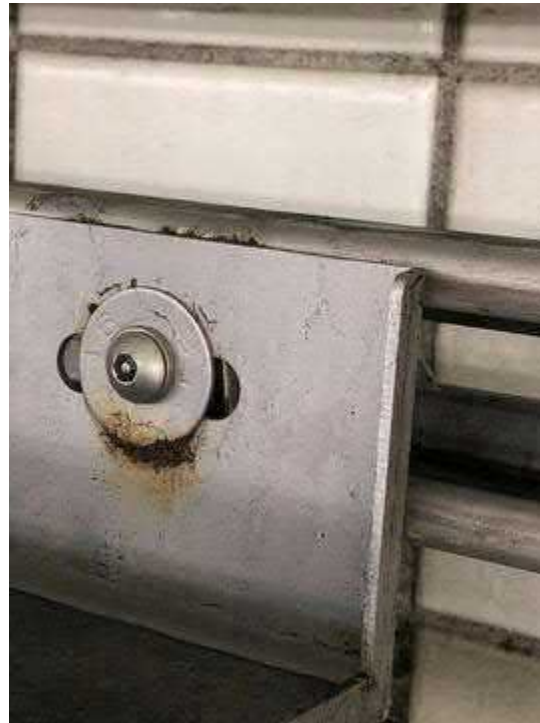
Lighting Fixture Information	
Luminaire Tag or Number:	NB - West Wall - 21B
Tunnel Direction and Side:	NB - West Wall
Additional Information:	T Corrosion Side Entry L Corrosion Fixture Corrosion Top Right Corrosion

Are there any signs of corrosion evident on the tunnel lighting system raceways?	Yes
Are the side entry conduits into the fixture tightly secured?	Yes
Are there any signs of corrosion on the fixture?	Yes
Is there any damage to the component housing or enclosure?	No
Is the light fixture secure to the mounting channels?	Yes
Long channel springnut misaligned?	No
Long channel springnut cracked?	
Trans channel springnut misaligned?	Yes
Trans channel springnut cracked?	No
Trans channel wireway clip?	Yes
Housing clip disengaged?	No
Housing clip missing?	No
Lens clip disengaged?	No
Lens clip broken?	No
Lens cover cracked?	No
Wireway ears broken?	No
Luminaire functioning?	Yes

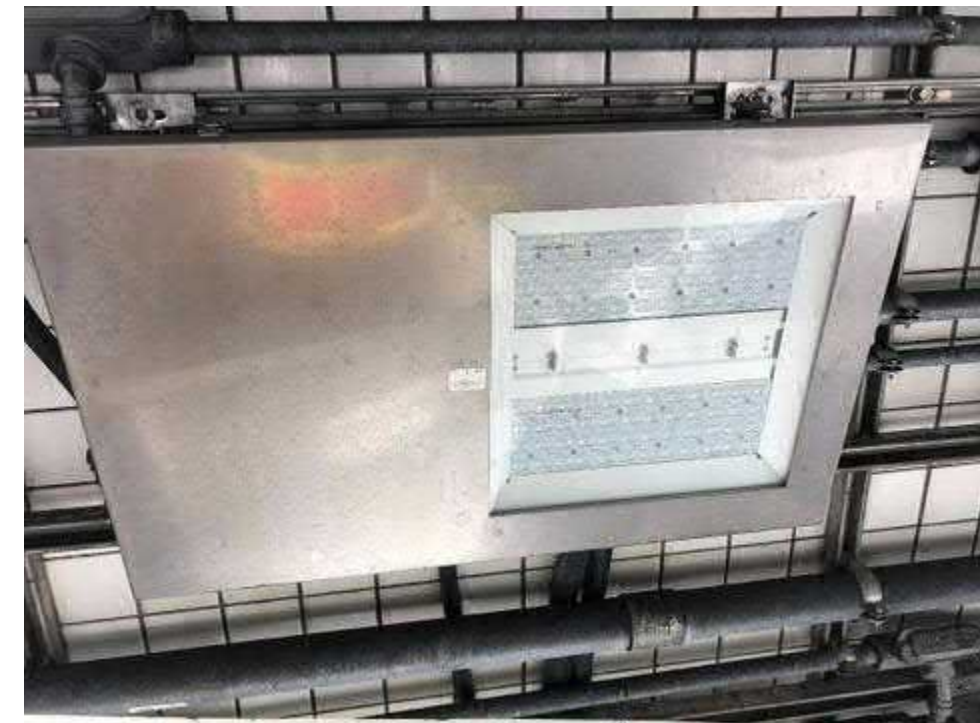
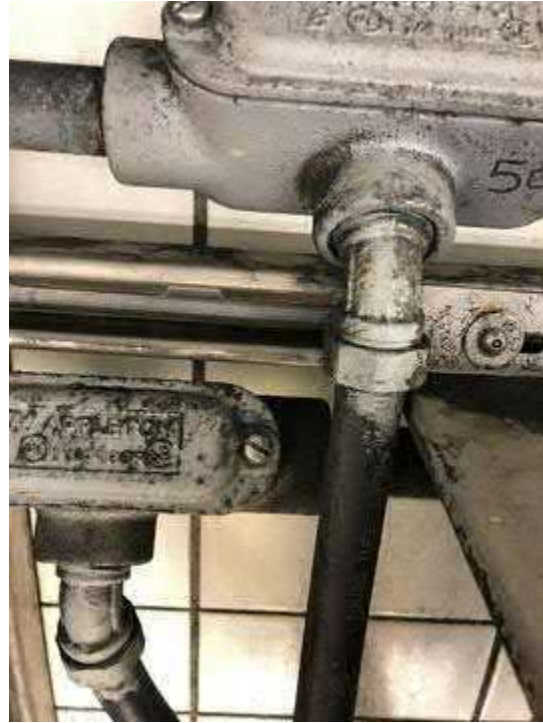
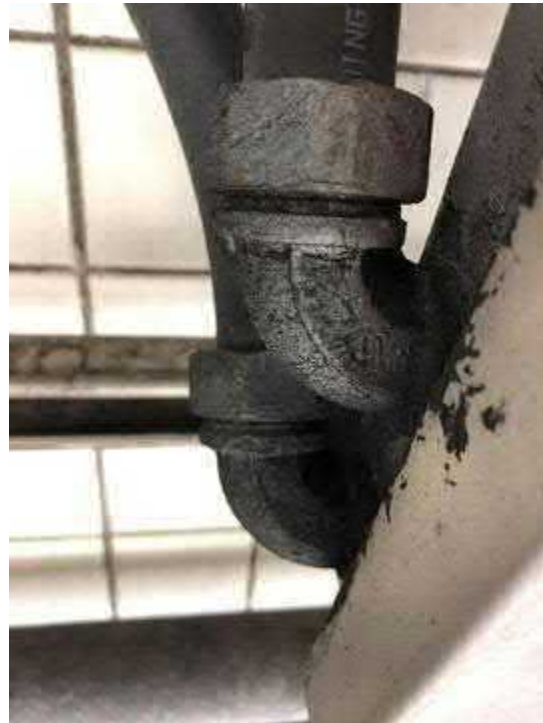
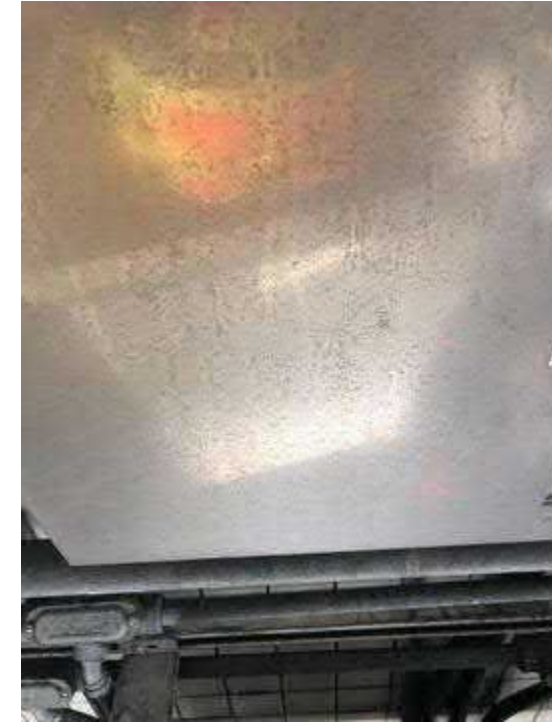
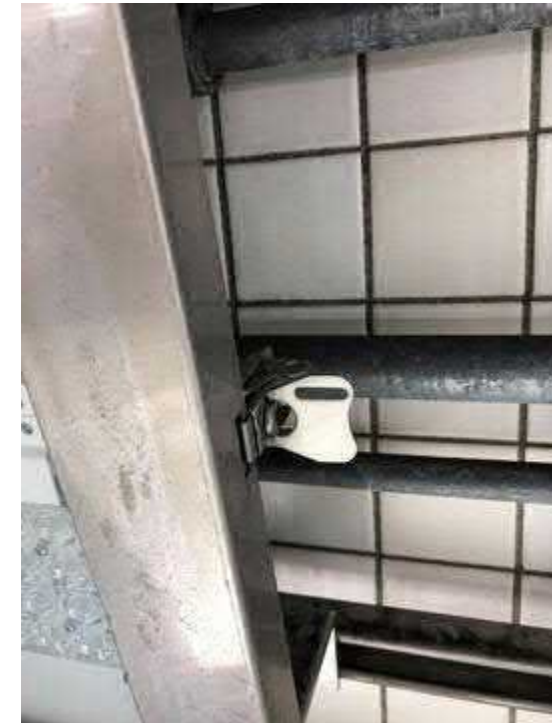
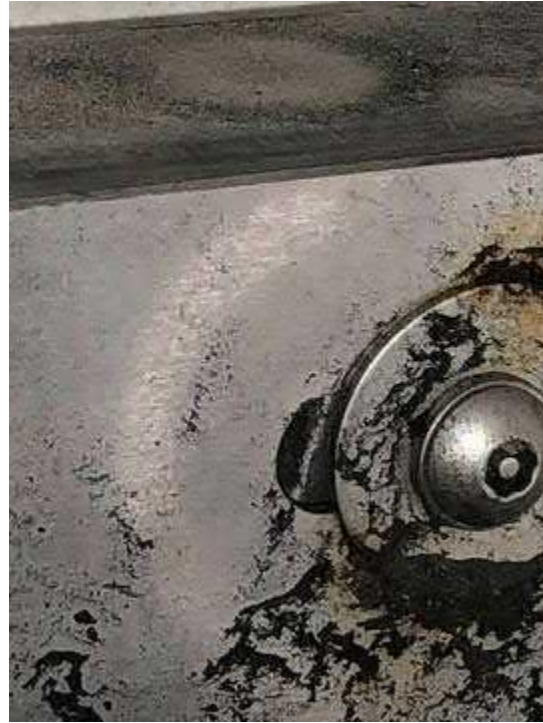
Lighting Fixture Information	
Luminaire Tag or Number:	NB - West Wall - 26A
Tunnel Direction and Side:	NB - West Wall -1
Additional Information:	Right clip disanged Top Right Musaligned

Are there any signs of corrosion evident on the tunnel lighting system raceways?
Are the side entry conduits into the fixture tightly secured?
Are there any signs of corrosion on the fixture?
Is there any damage to the component housing or enclosure?
Is the light fixture secure to the mounting channels?
Long channel springnut misaligned?
Long channel springnut cracked?
Trans channel springnut cracked?
Trans channel springnut misaligned?
Trans channel wireway clip?
Housing clip disengaged?
Housing clip missing?
Lens clip disengaged?
Lens clip broken?
Lens cover cracked?
Wireway ears broken?
Luminaire functioning?

Yes	No	No	No	Yes	No	No	Yes	No	Yes	No	No	Yes	No	Yes	Yes	Yes
-----	----	----	----	-----	----	----	-----	----	-----	----	----	-----	----	-----	-----	-----

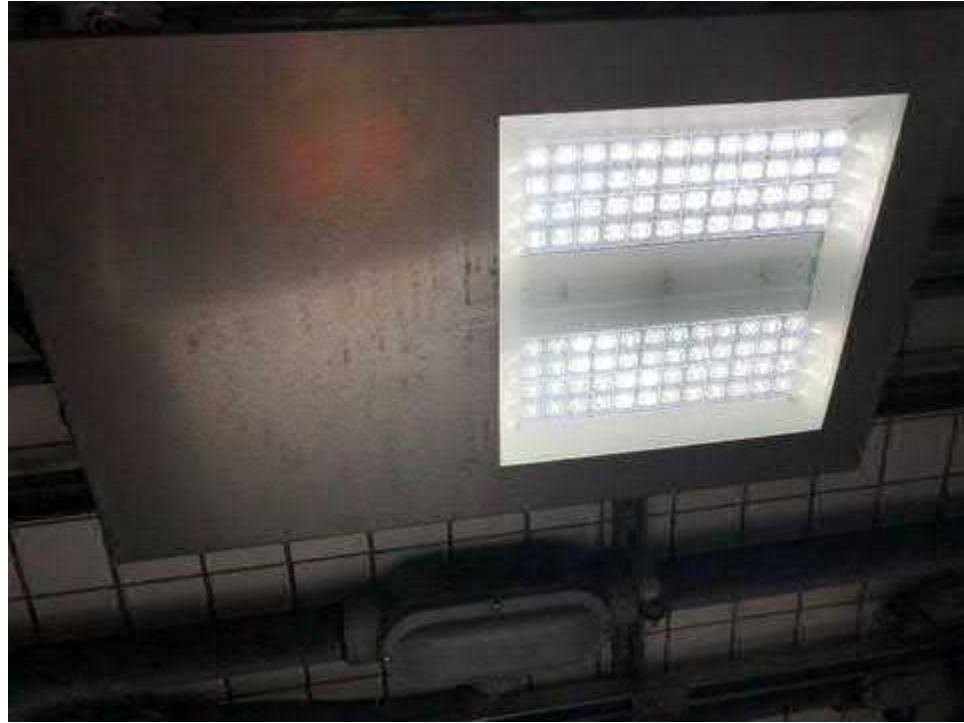
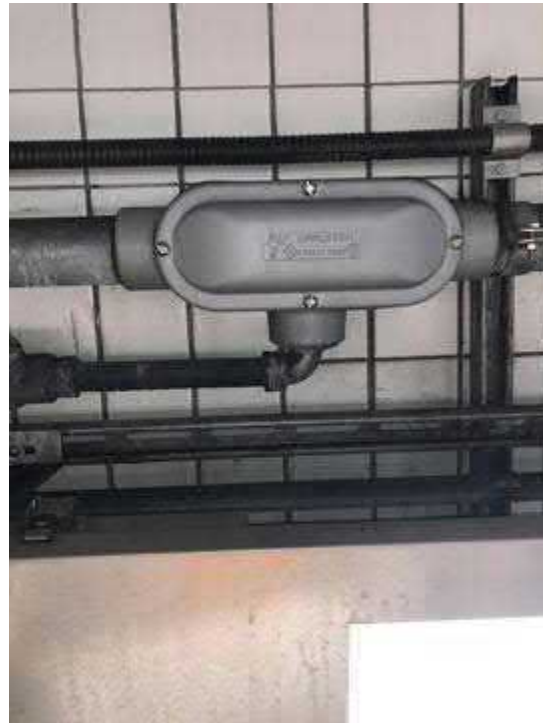
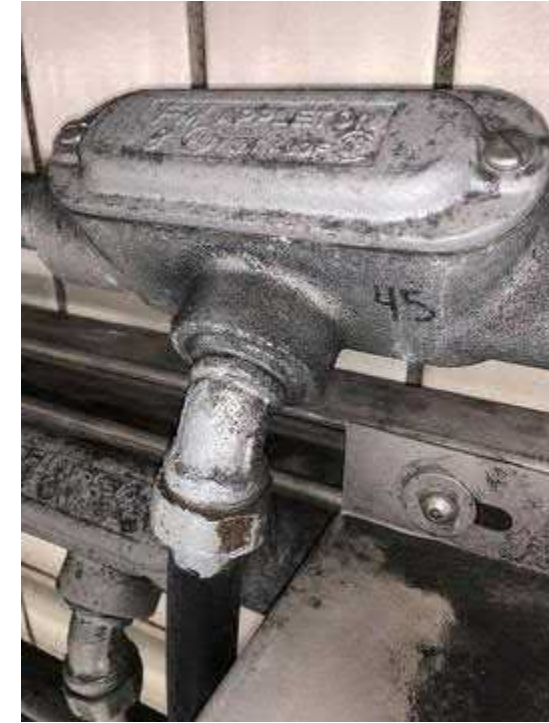
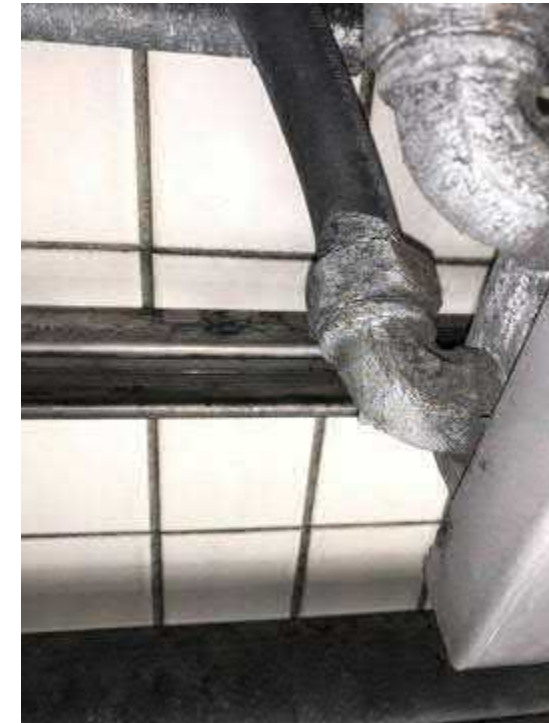
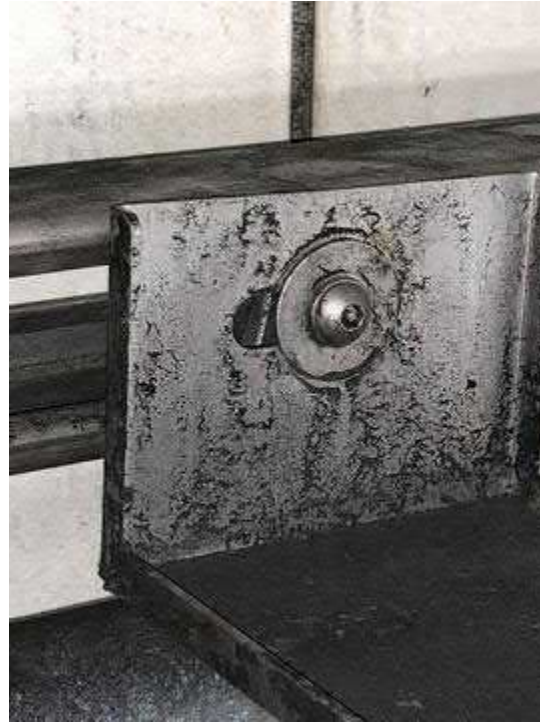
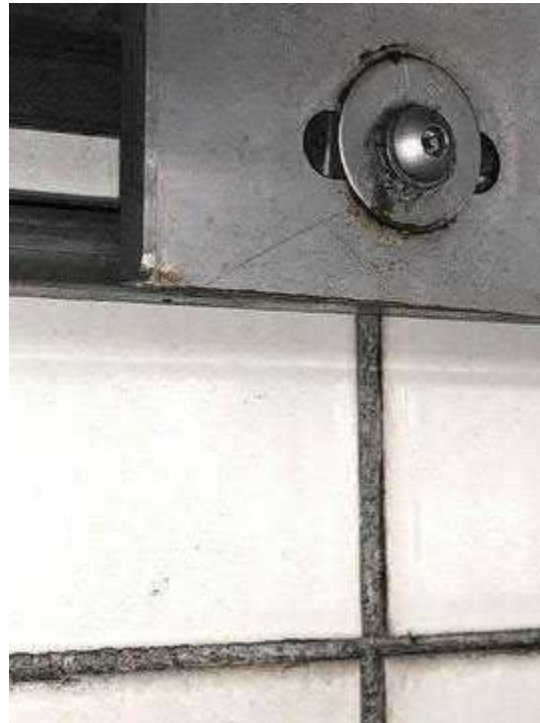
Lighting Fixture Information	
Luminaire Tag or Number:	NB - West Wall - 31A
Tunnel Direction and Side:	NB - West Wall
Additional Information:	Top 6 inch Tee T Side entry Top Right Bottom Right

Are there any signs of corrosion evident on the tunnel lighting system raceways?	Yes
Are the side entry conduits into the fixture tightly secured?	Yes
Are there any signs of corrosion on the fixture?	Yes
Is there any damage to the component housing or enclosure?	No
Is the light fixture secure to the mounting channels?	Yes
Long channel springnut misaligned?	Yes
Long channel springnut cracked?	No
Trans channel springnut misaligned?	No
Trans channel springnut cracked?	No
Trans channel wireway clip?	Yes
Housing clip disengaged?	No
Housing clip missing?	No
Lens clip disengaged?	No
Lens clip broken?	No
Lens cover cracked?	No
Wireway ears broken?	Yes
Luminaire functioning?	Yes

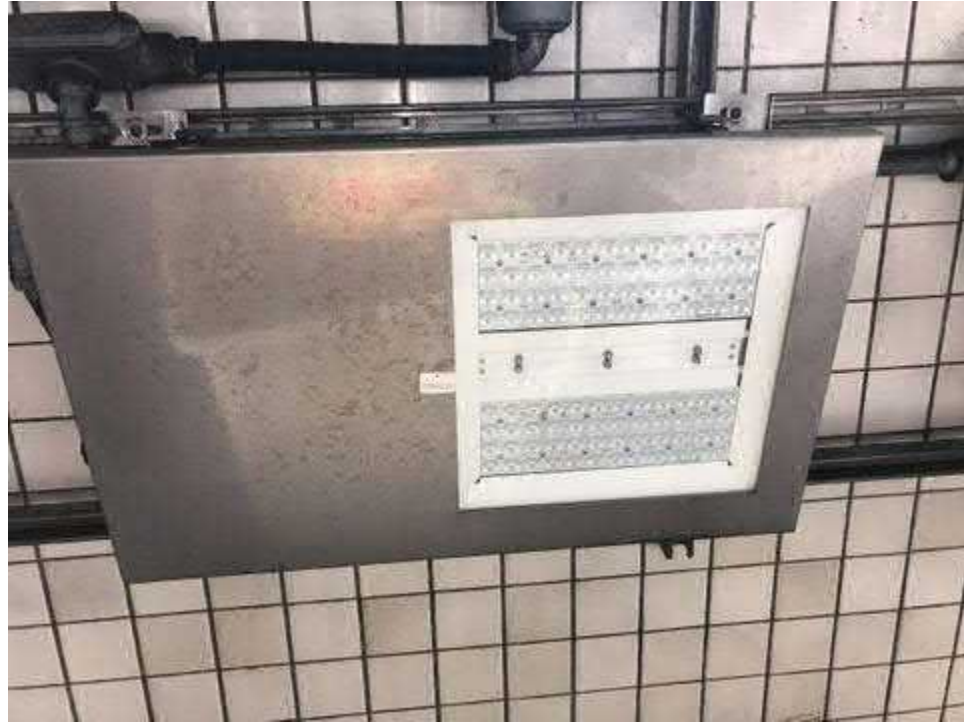
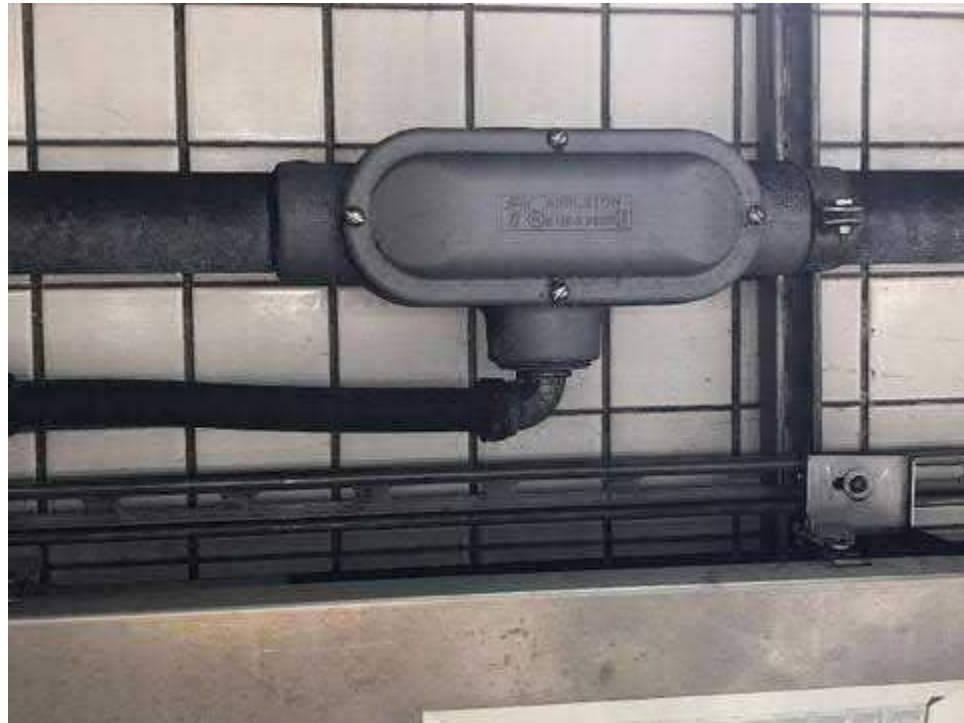
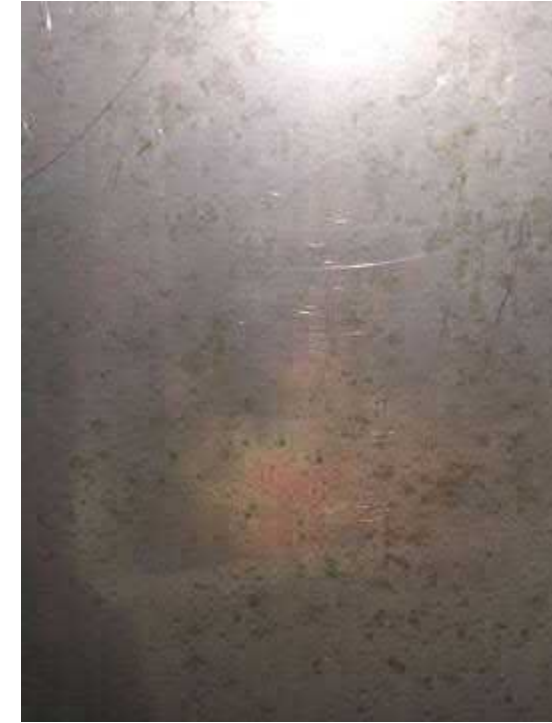
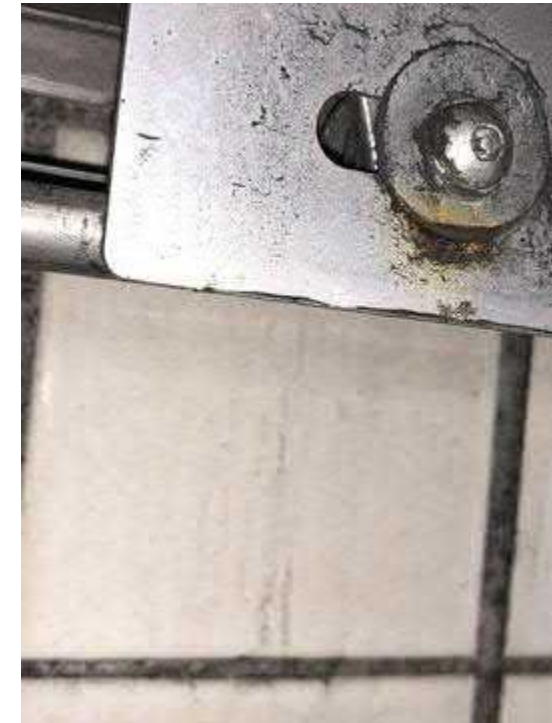
Lighting Fixture Information	
Luminaire Tag or Number:	NB - West Wall - 31B
Tunnel Direction and Side:	NB - West Wall
Additional Information:	Bottom 6 inch t Sude entry l Fuxture Bottom Left

Are there any signs of corrosion evident on the tunnel lighting system raceways?	Yes
Are the side entry conduits into the fixture tightly secured?	Yes
Are there any signs of corrosion on the fixture?	Yes
Is there any damage to the component housing or enclosure?	No
Is the light fixture secure to the mounting channels?	Yes
Long channel springnut misaligned?	No
Long channel springnut cracked?	No
Trans channel springnut misaligned?	Yes
Trans channel springnut cracked?	No
Trans channel wireway clip?	Yes
Housing clip disengaged?	No
Housing clip missing?	No
Lens clip disengaged?	No
Lens clip broken?	No
Lens cover cracked?	No
Wireway ears broken?	No
Luminaire functioning?	Yes

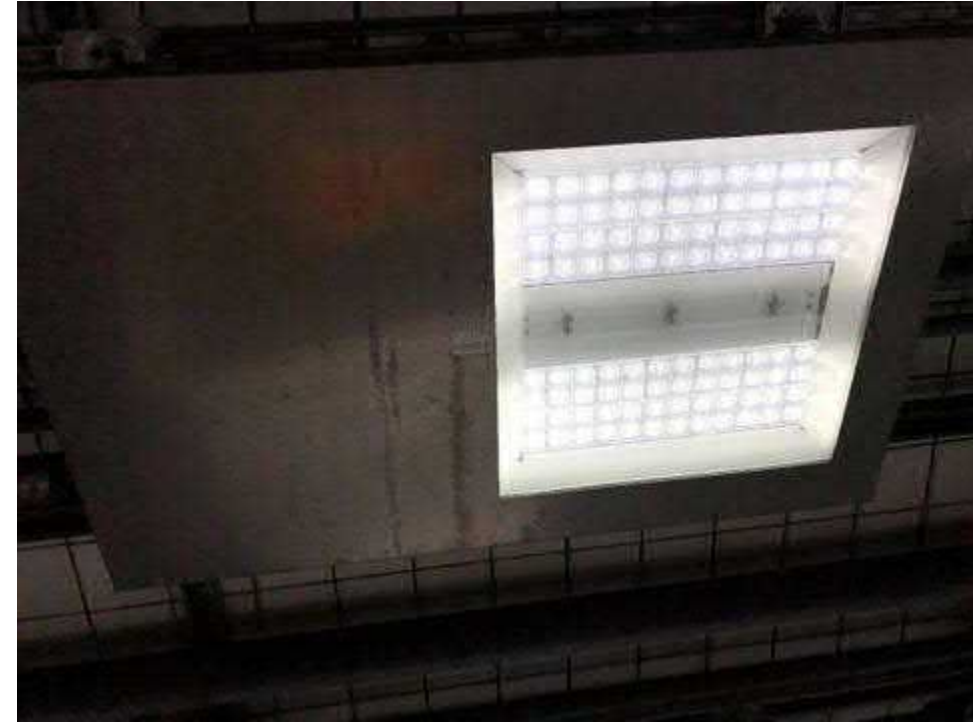
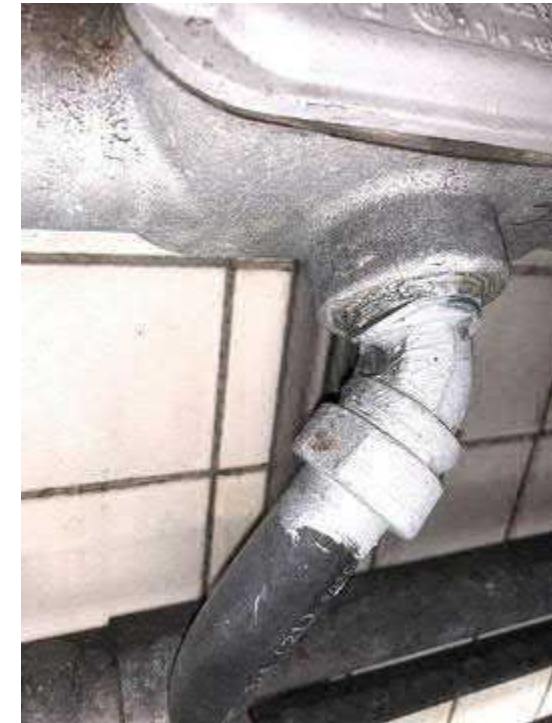
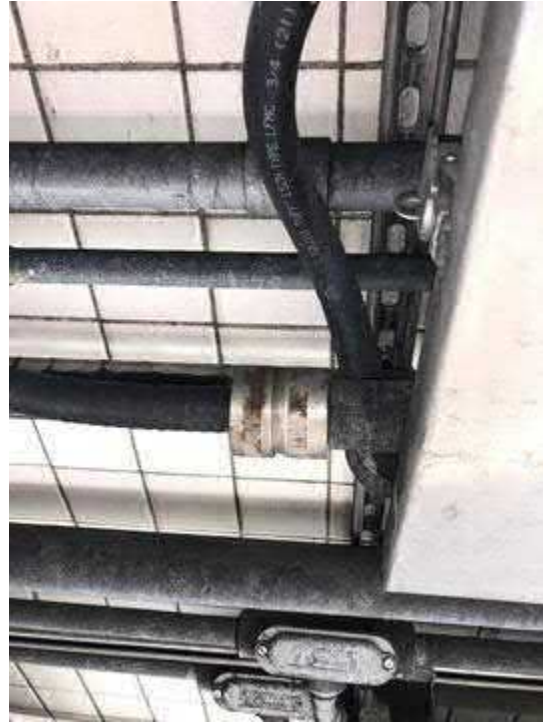
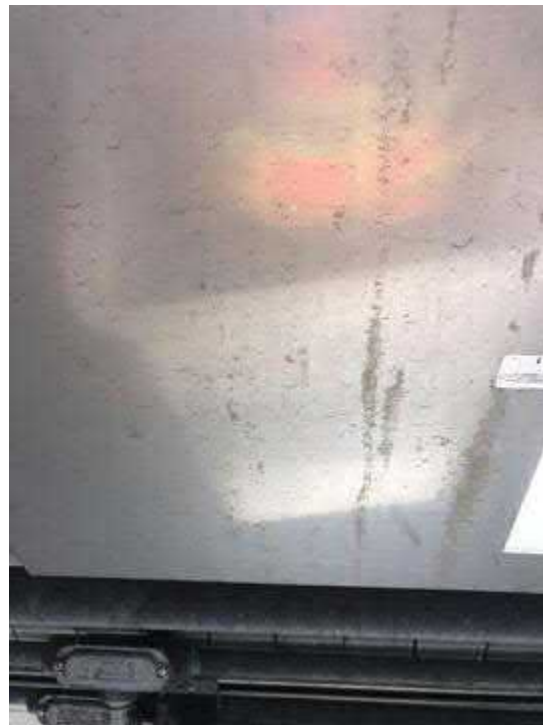
Lighting Fixture Information	
Luminaire Tag or Number:	NB - West Wall - 40A
Tunnel Direction and Side:	NB - West Wall
Additional Information:	T Sude Fuxture

Are there any signs of corrosion evident on the tunnel lighting system raceways?	Yes
Are the side entry conduits into the fixture tightly secured?	Yes
Are there any signs of corrosion on the fixture?	Yes
Is there any damage to the component housing or enclosure?	No
Is the light fixture secure to the mounting channels?	Yes
Long channel springnut misaligned?	No
Long channel springnut cracked?	No
Trans channel springnut misaligned?	No
Trans channel springnut cracked?	No
Trans channel wireway clip?	Yes
Housing clip disengaged?	No
Housing clip missing?	No
Lens clip disengaged?	No
Lens clip broken?	No
Lens cover cracked?	No
Wireway ears broken?	No
Luminaire functioning?	Yes

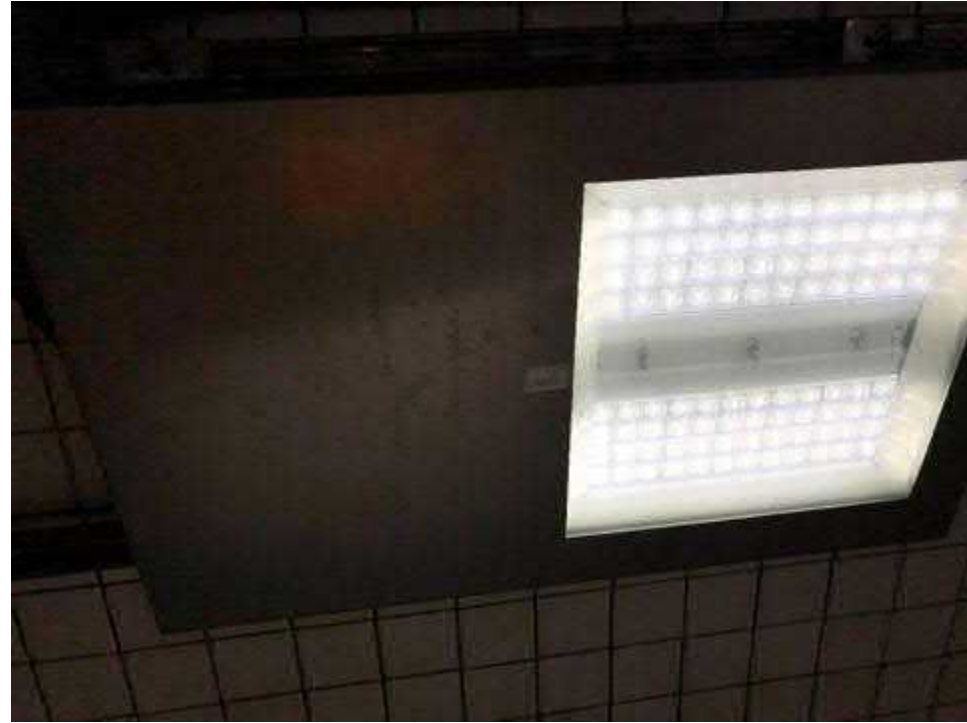
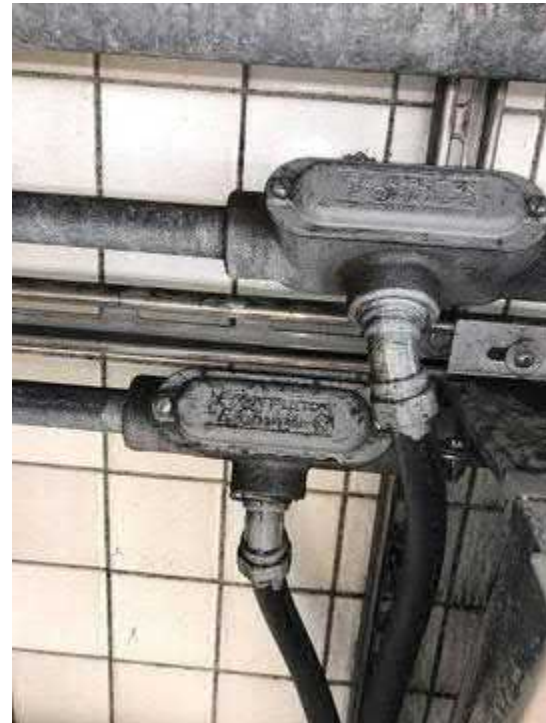
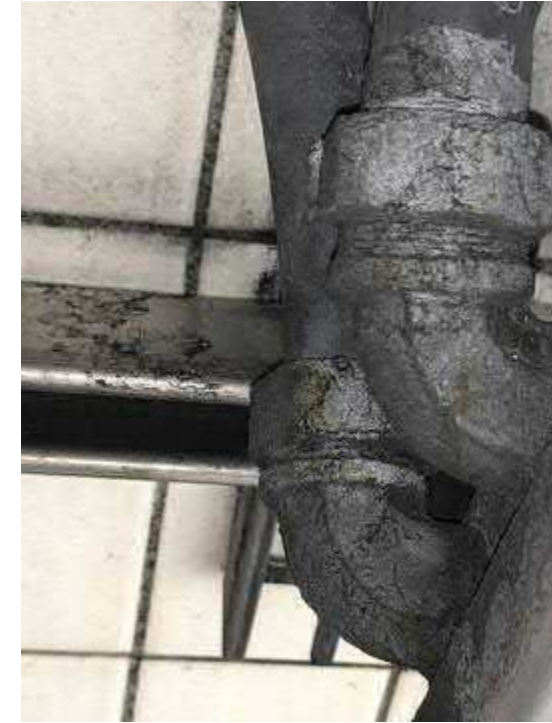
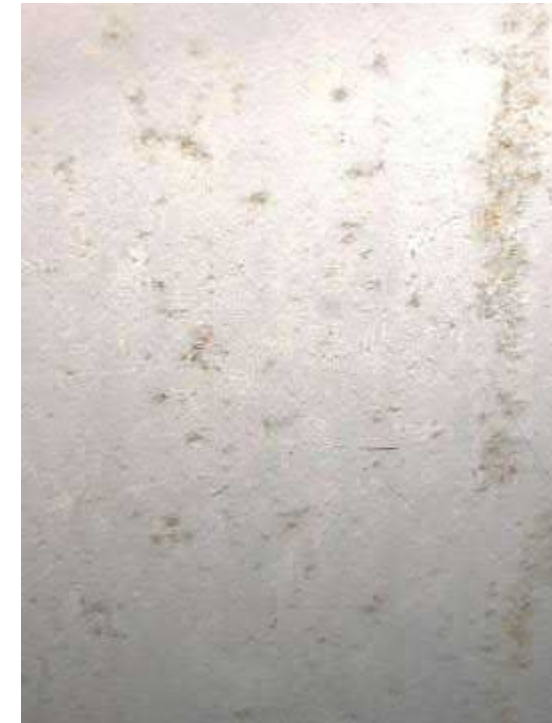
Lighting Fixture Information	
Luminaire Tag or Number:	NB - West Wall - 40B
Tunnel Direction and Side:	NB - West Wall
Additional Information:	Side T Fuxture

Are there any signs of corrosion evident on the tunnel lighting system raceways?	Yes
Are the side entry conduits into the fixture tightly secured?	Yes
Are there any signs of corrosion on the fixture?	Yes
Is there any damage to the component housing or enclosure?	No
Is the light fixture secure to the mounting channels?	Yes
Long channel springnut misaligned?	No
Long channel springnut cracked?	No
Trans channel springnut misaligned?	No
Trans channel springnut cracked?	No
Trans channel wireway clip?	Yes
Housing clip disengaged?	No
Housing clip missing?	No
Lens clip disengaged?	No
Lens clip broken?	No
Lens cover cracked?	No
Wireway ears broken?	No
Luminaire functioning?	Yes

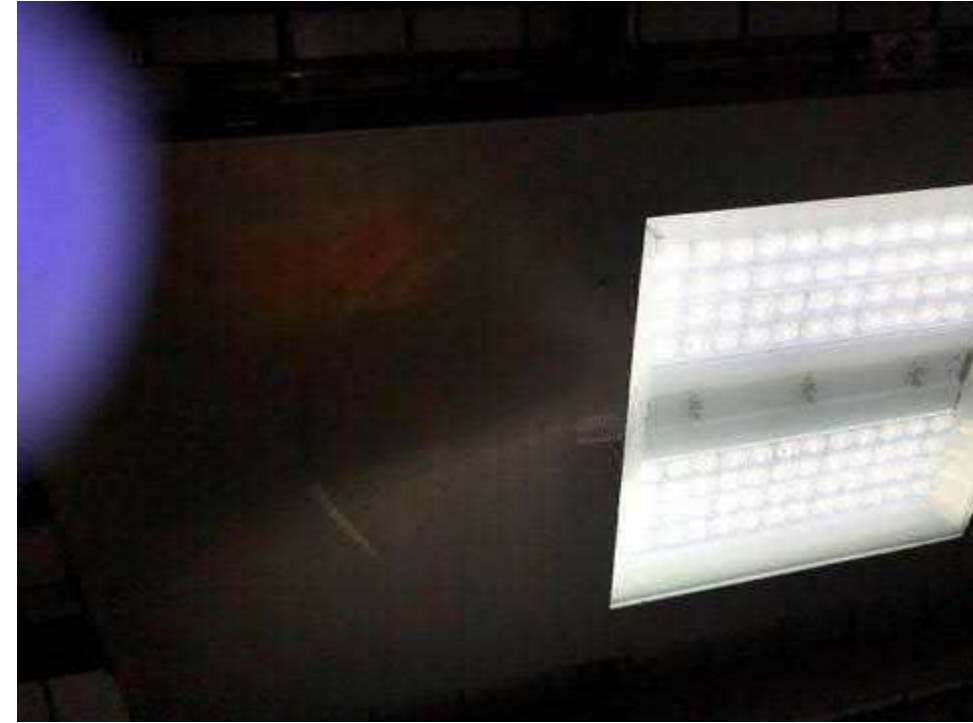
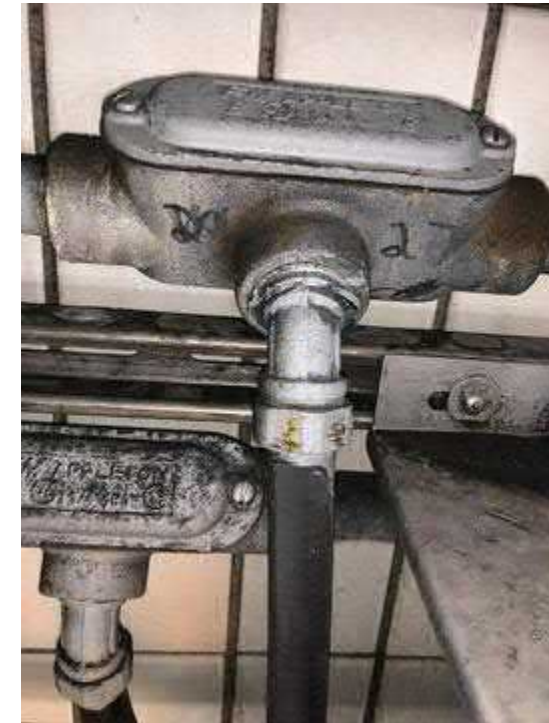
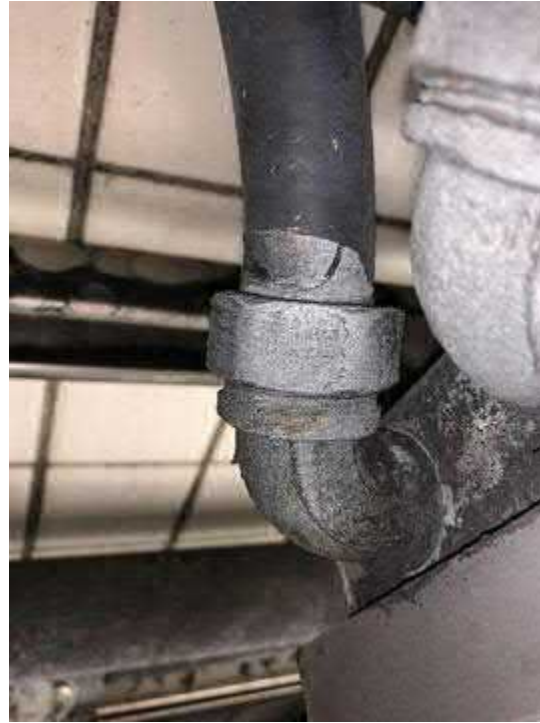
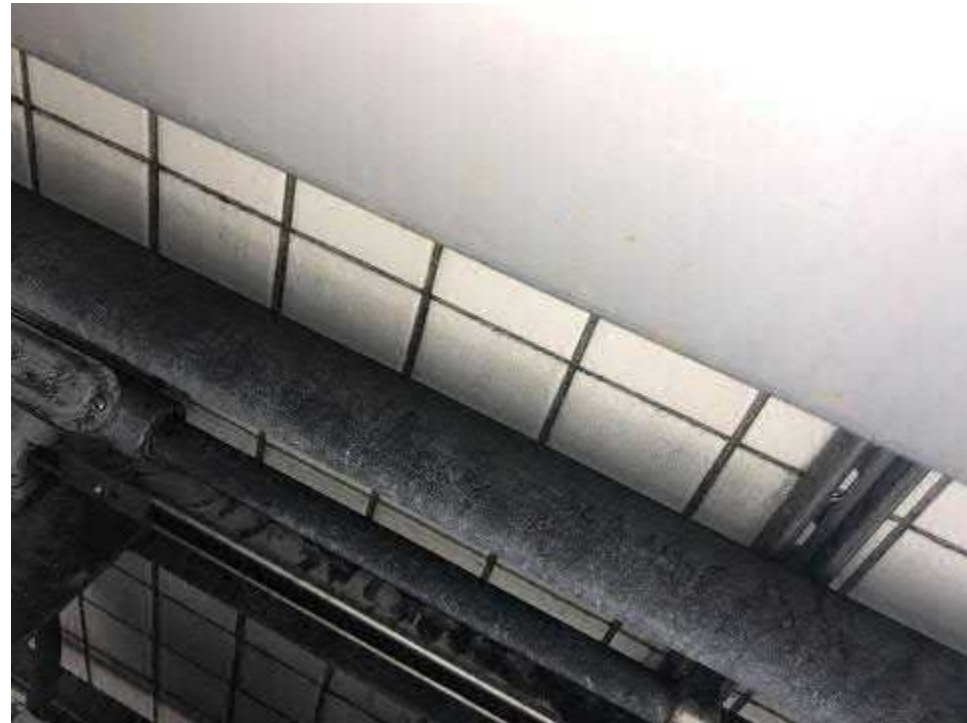
Lighting Fixture Information	
Luminaire Tag or Number:	NB - West Wall - 49A
Tunnel Direction and Side:	NB - West Wall -
Additional Information:	T Side entry Bittom sude wntry loose

Are there any signs of corrosion evident on the tunnel lighting system raceways?	Yes
Are the side entry conduits into the fixture tightly secured?	No
Are there any signs of corrosion on the fixture?	Yes
Is there any damage to the component housing or enclosure?	No
Is the light fixture secure to the mounting channels?	Yes
Long channel springnut misaligned?	No
Long channel springnut cracked?	No
Trans channel springnut misaligned?	No
Trans channel springnut cracked?	No
Trans channel wireway clip?	Yes
Housing clip disengaged?	No
Housing clip missing?	No
Lens clip disengaged?	No
Lens clip broken?	No
Lens cover cracked?	No
Wireway ears broken?	No
Luminaire functioning?	Yes

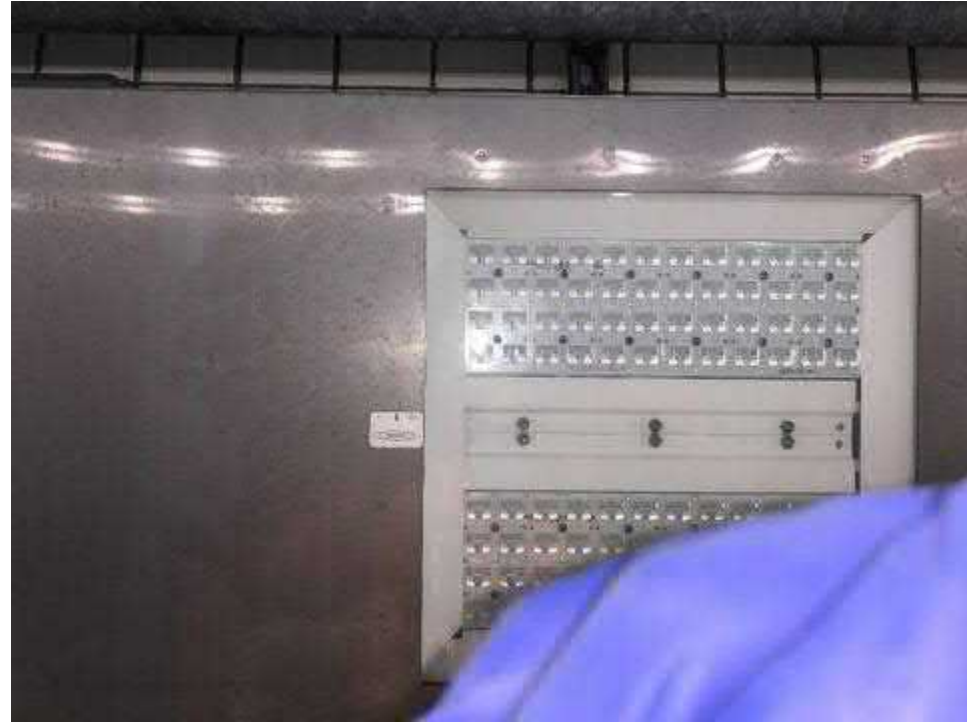
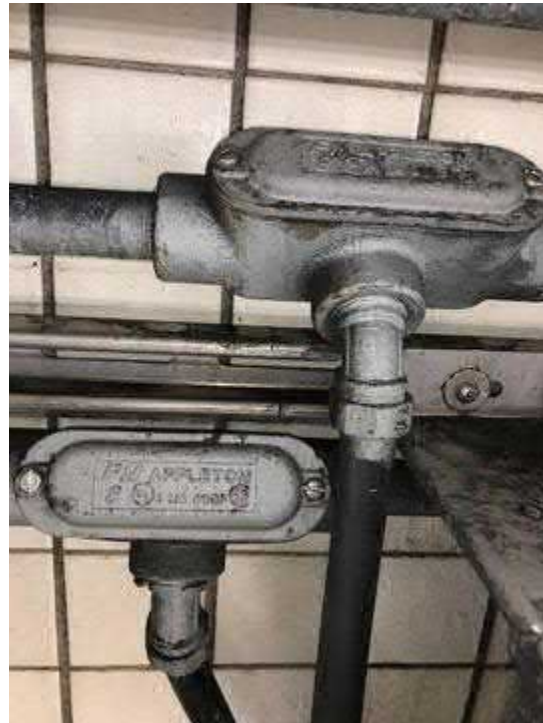
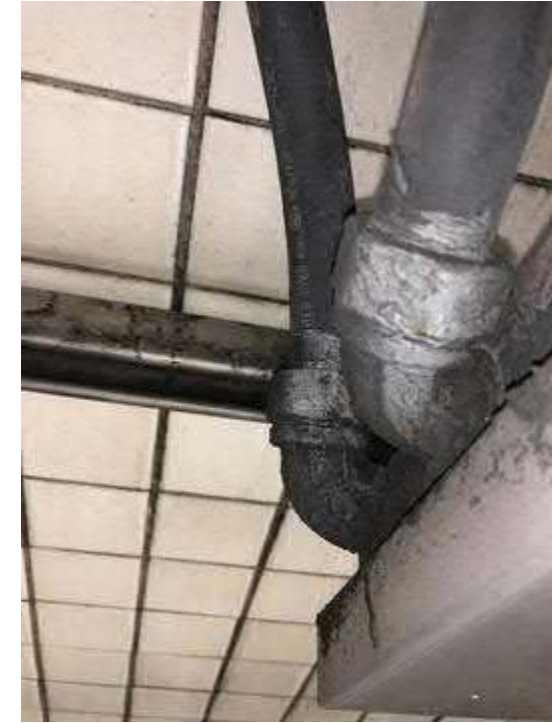
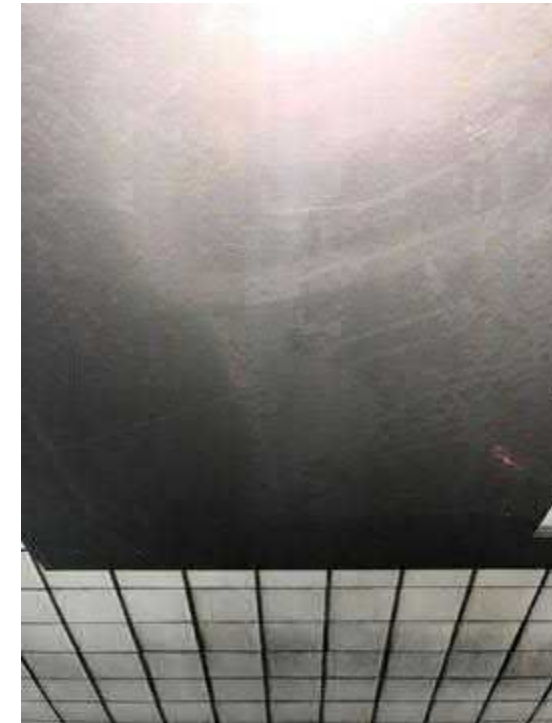
Lighting Fixture Information	
Luminaire Tag or Number:	NB - West Wall - 49B
Tunnel Direction and Side:	NB - West Wall
Additional Information:	T Side entry Top sode entry loose Fixture Top left

Are there any signs of corrosion evident on the tunnel lighting system raceways?	Yes
Are the side entry conduits into the fixture tightly secured?	No
Are there any signs of corrosion on the fixture?	Yes
Is there any damage to the component housing or enclosure?	No
Is the light fixture secure to the mounting channels?	Yes
Long channel springnut misaligned?	No
Long channel springnut cracked?	No
Trans channel springnut misaligned?	Yes
Trans channel springnut cracked?	No
Trans channel wireway clip?	Yes
Housing clip disengaged?	No
Housing clip missing?	No
Lens clip disengaged?	No
Lens clip broken?	No
Lens cover cracked?	No
Wireway ears broken?	No
Luminaire functioning?	Yes

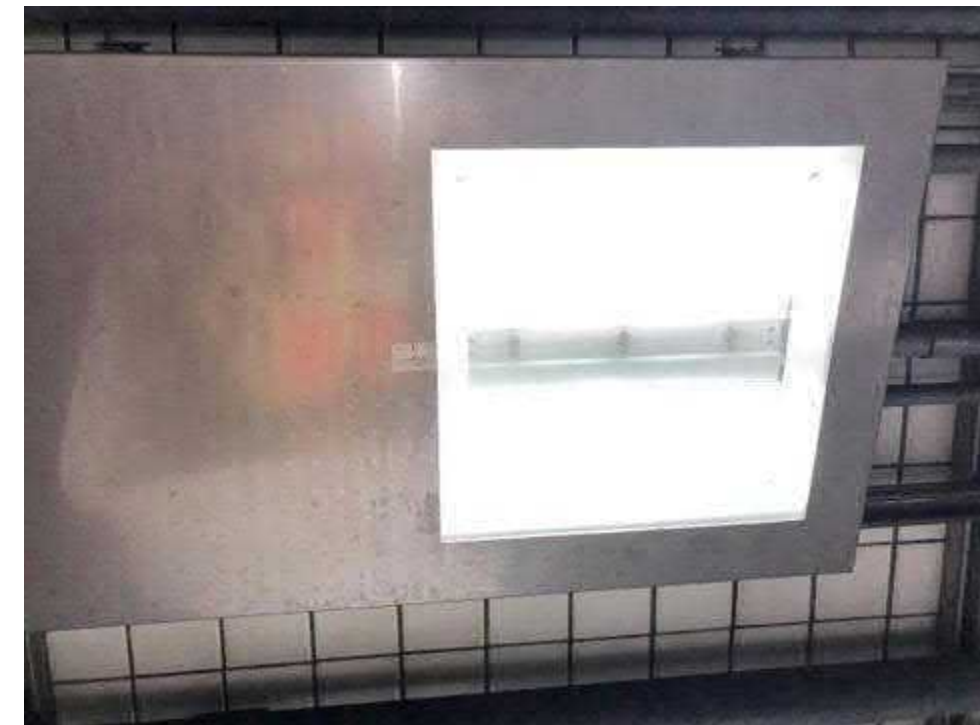
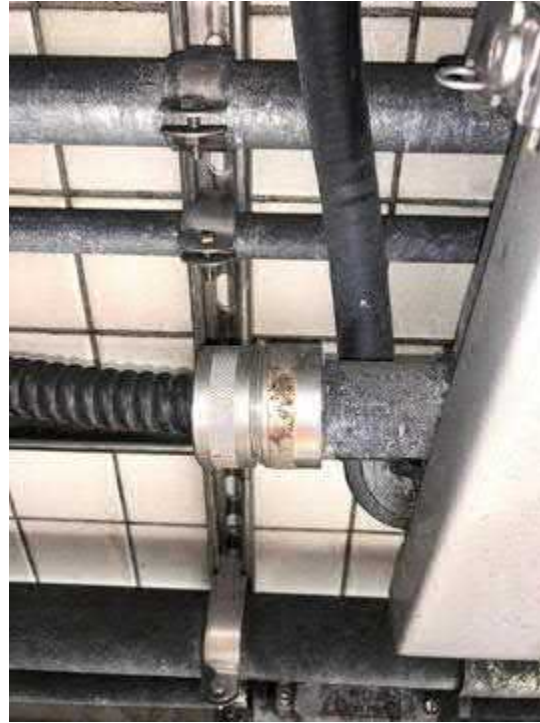
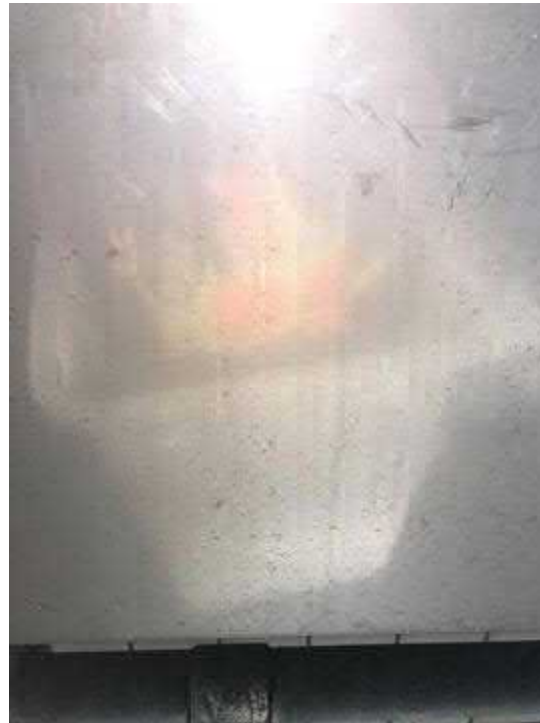
Lighting Fixture Information	
Luminaire Tag or Number:	NB - West Wall - 58A
Tunnel Direction and Side:	NB - West Wall
Additional Information:	Side entry Fixture

Are there any signs of corrosion evident on the tunnel lighting system raceways?
Are the side entry conduits into the fixture tightly secured?
Are there any signs of corrosion on the fixture?
Is there any damage to the component housing or enclosure?
Is the light fixture secure to the mounting channels?
Long channel springnut misaligned?
Long channel springnut cracked?
Trans channel springnut cracked?
Trans channel springnut misaligned?
Trans channel wireway clip?
Housing clip disengaged?
Housing clip missing?
Lens clip disengaged?
Lens clip broken?
Lens cover cracked?
Wireway ears broken?
Luminaire functioning?

Yes	No	No	No		No	No	Yes	No	No	No	No	Yes	No	Yes	Yes	Yes
-----	----	----	----	--	----	----	-----	----	----	----	----	-----	----	-----	-----	-----

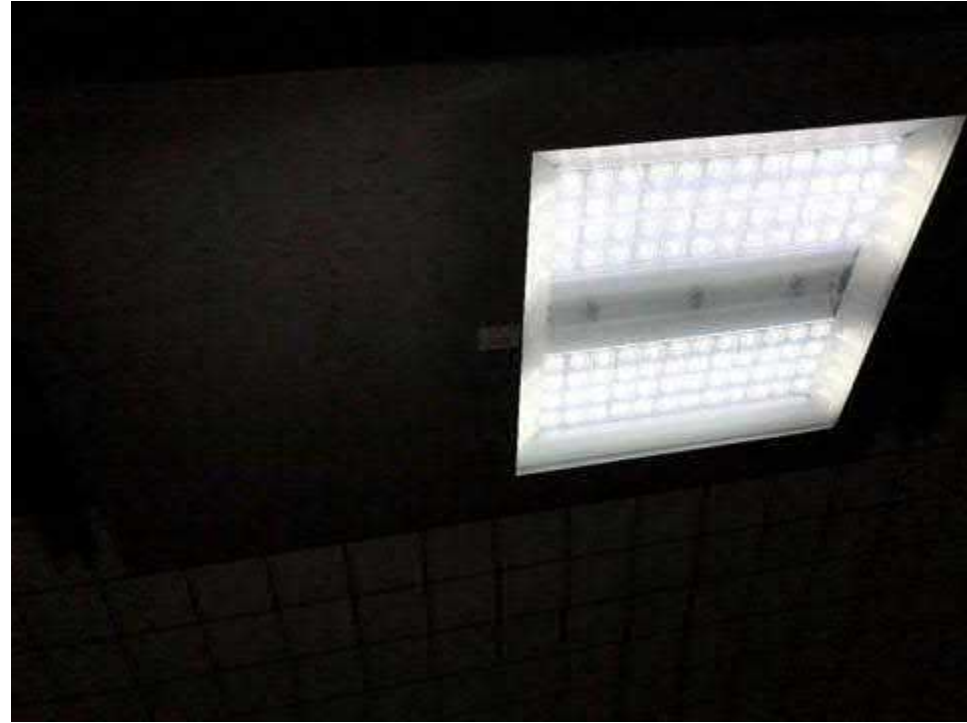
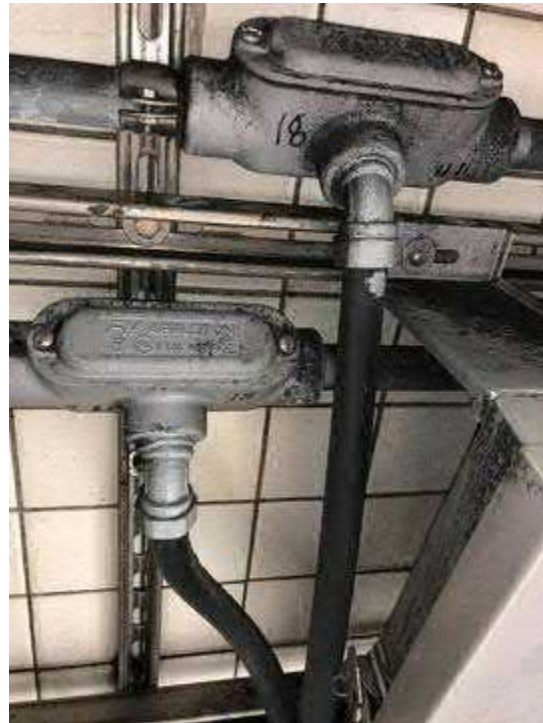
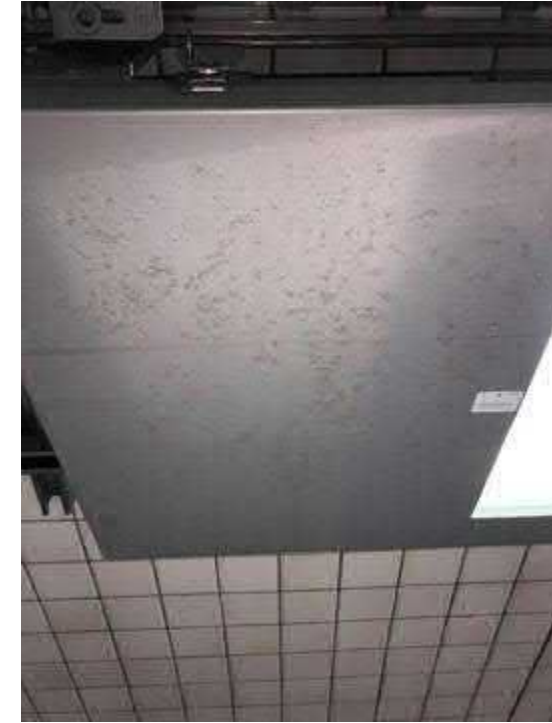
Lighting Fixture Information	
Luminaire Tag or Number:	NB - West Wall - 58B
Tunnel Direction and Side:	NB - West Wall
Additional Information:	T Side emtry Fixture

Are there any signs of corrosion evident on the tunnel lighting system raceways?	Yes
Are the side entry conduits into the fixture tightly secured?	Yes
Are there any signs of corrosion on the fixture?	Yes
Is there any damage to the component housing or enclosure?	No
Is the light fixture secure to the mounting channels?	Yes
Long channel springnut misaligned?	No
Long channel springnut cracked?	No
Trans channel springnut misaligned?	No
Trans channel springnut cracked?	No
Trans channel wireway clip?	Yes
Housing clip disengaged?	No
Housing clip missing?	No
Lens clip disengaged?	No
Lens clip broken?	No
Lens cover cracked?	No
Wireway ears broken?	No
Luminaire functioning?	Yes
