# **Lytle Tunnel (HAM-71-0134) Inspection Report Fall 2020**

PID 105470

November, 2020

Ohio Department of  
Transportation  
District 8  
505 South State Route 741  
Lebanon, OH 45036

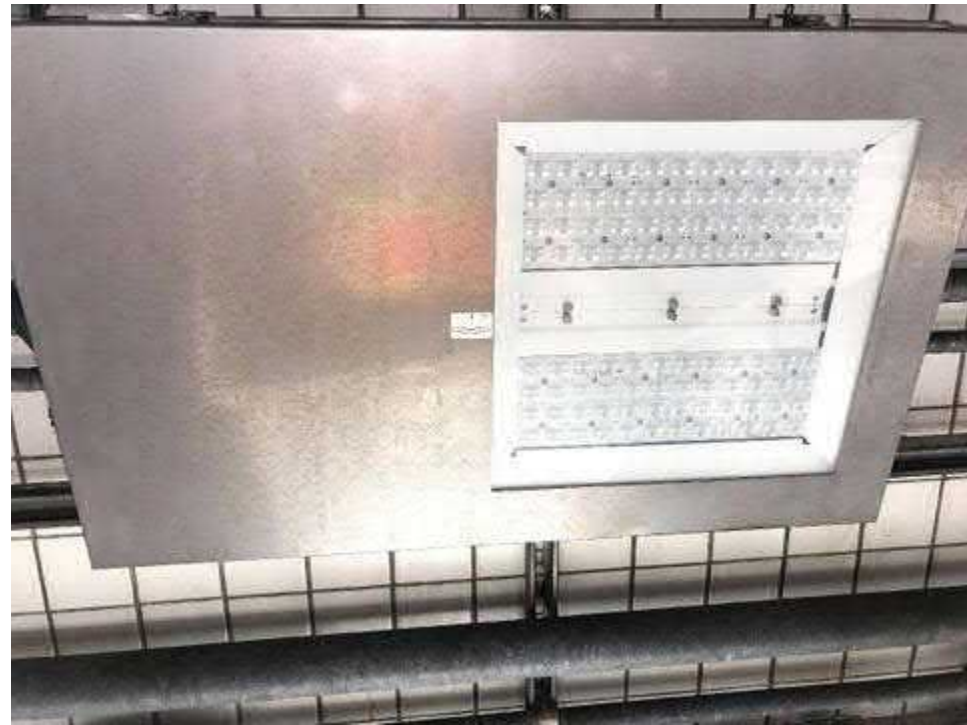
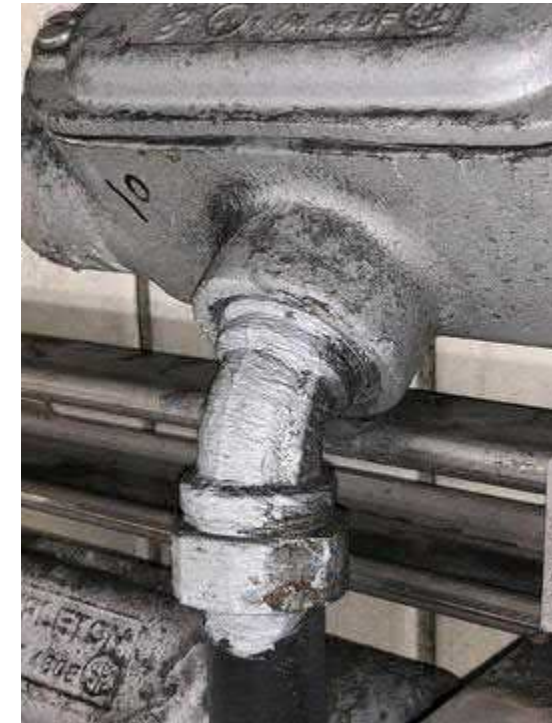
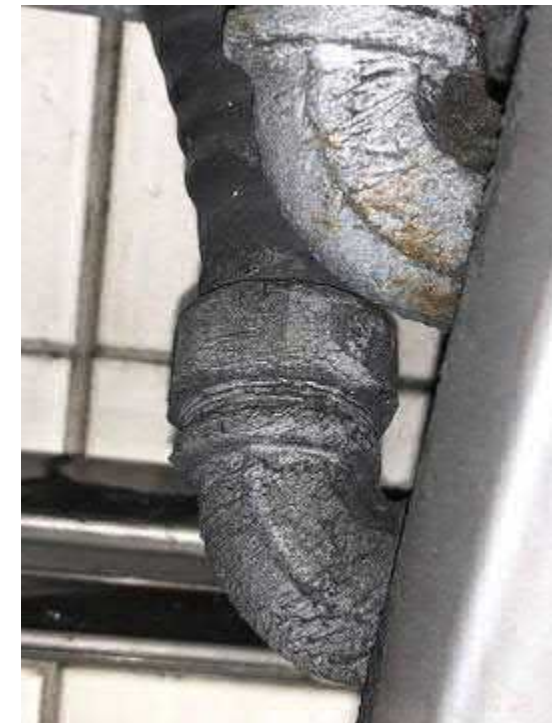
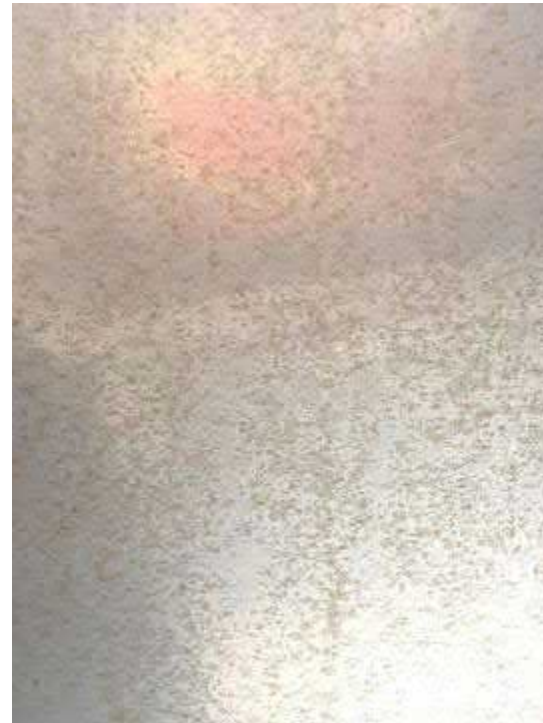
Lighting Fixture Information	
Luminaire Tag or Number:	NB - West Wall - 67A
Tunnel Direction and Side:	NB - West Wall
Additional Information:	T Side Entry Fixture Top side entry loose

Are there any signs of corrosion evident on the tunnel lighting system raceways?
Are the side entry conduits into the fixture tightly secured?
Are there any signs of corrosion on the fixture?
Is there any damage to the component housing or enclosure?
Is the light fixture secure to the mounting channels?
Long channel springnut misaligned?
Long channel springnut cracked?
Trans channel springnut misaligned?
Trans channel springnut cracked?
Trans channel wireway clip?
Housing clip disengaged?
Housing clip missing?
Lens clip disengaged?
Lens clip broken?
Lens cover cracked?
Wireway ears broken?
Luminaire functioning?

Yes	No	No	No	No	No	No	Yes	No	No	No	No	Yes	No	Yes	No	Yes
-----	----	----	----	----	----	----	-----	----	----	----	----	-----	----	-----	----	-----

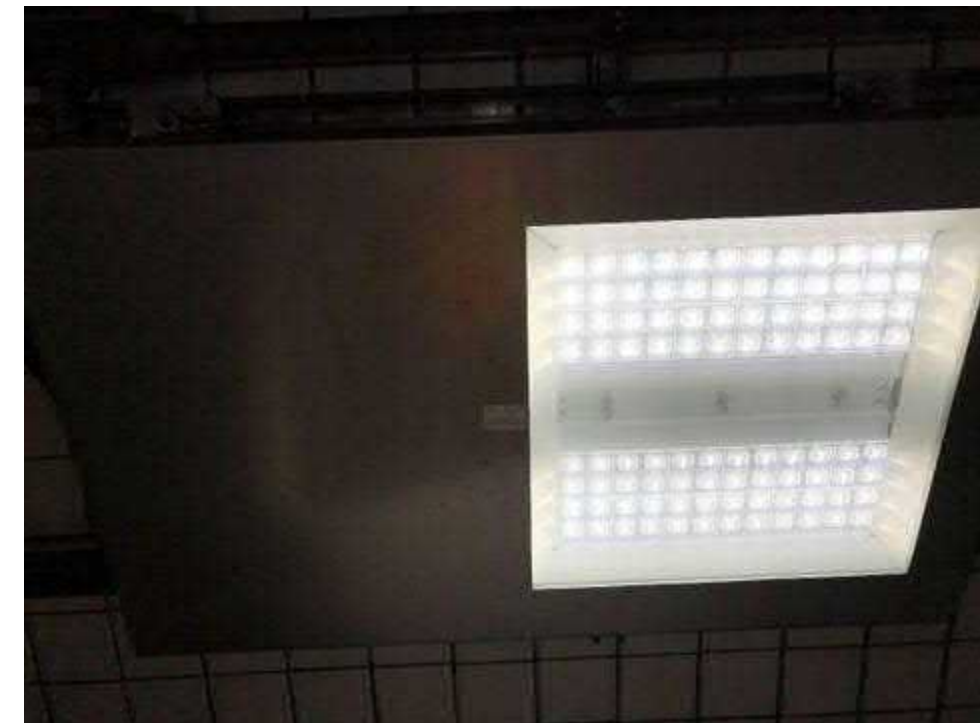
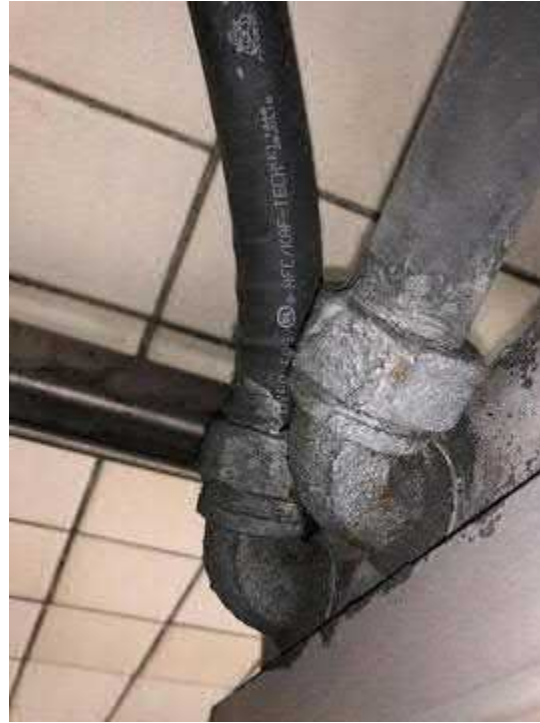
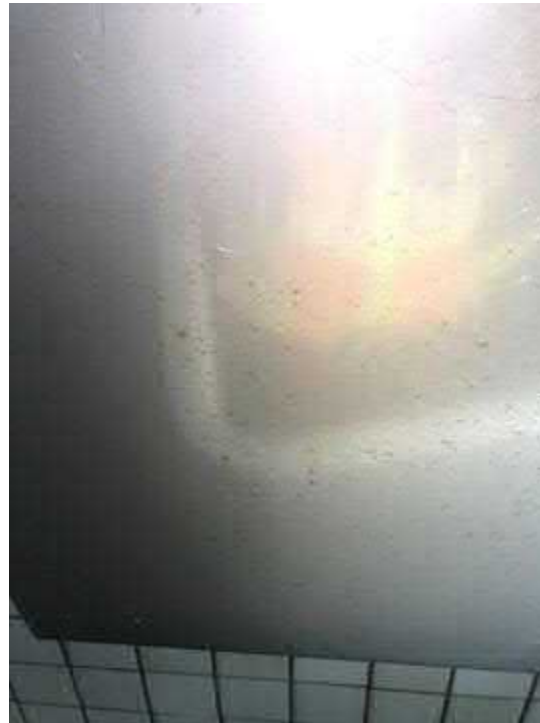
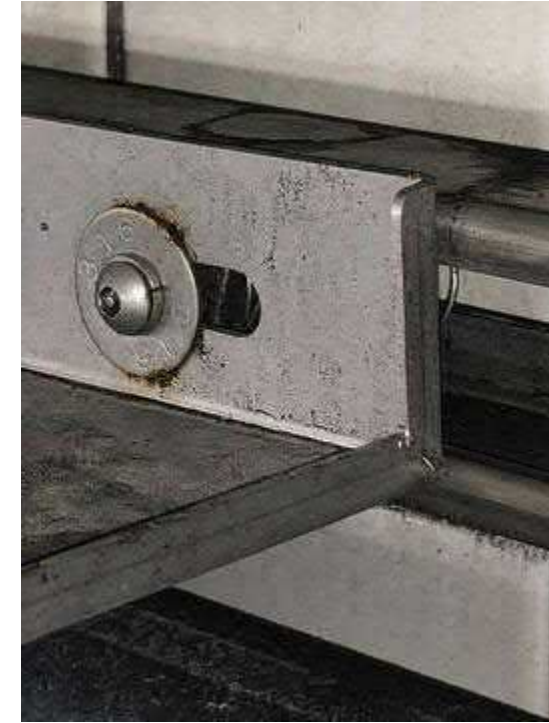
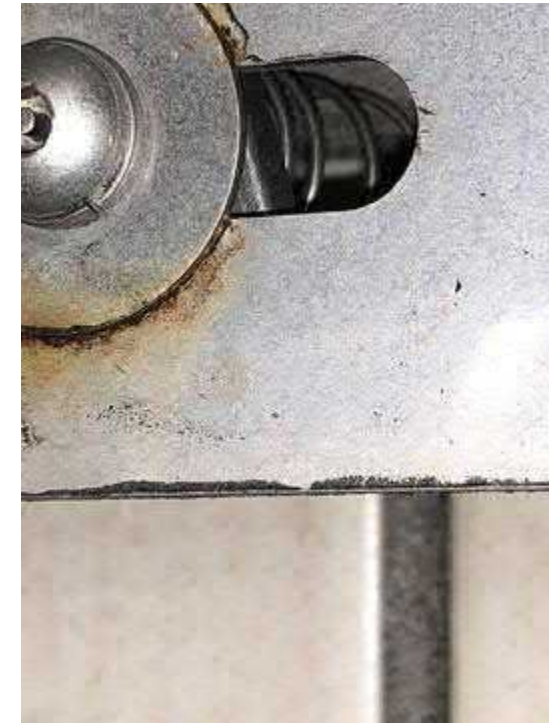
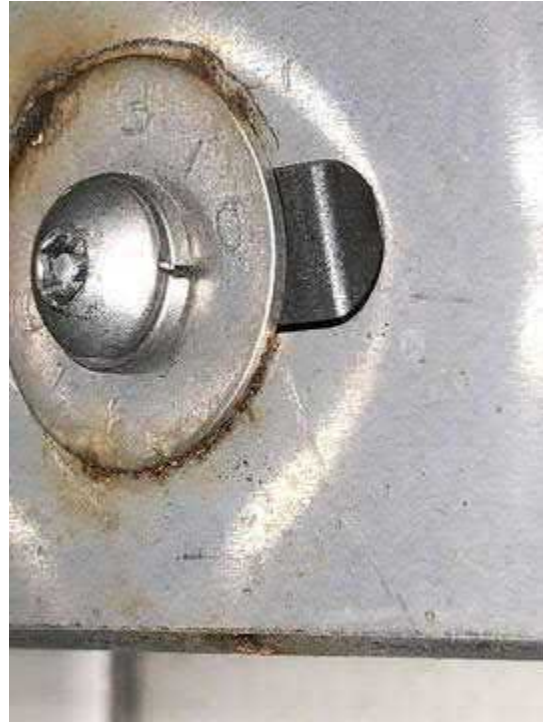
Lighting Fixture Information	
Luminaire Tag or Number:	NB - West Wall - 67B
Tunnel Direction and Side:	NB - West Wall
Additional Information:	Sode entry All misaligned Top side entry Fuxture

Are there any signs of corrosion evident on the tunnel lighting system raceways?
Are the side entry conduits into the fixture tightly secured?
Are there any signs of corrosion on the fixture?
Is there any damage to the component housing or enclosure?
Is the light fixture secure to the mounting channels?
Long channel springnut misaligned?
Long channel springnut cracked?
Trans channel springnut misaligned?
Trans channel springnut cracked?
Trans channel wireway clip?
Housing clip disengaged?
Housing clip missing?
Lens clip disengaged?
Lens clip broken?
Lens cover cracked?
Wireway ears broken?
Luminaire functioning?

Yes	No	No	No	No	No	No	Yes	No	Yes	No		Yes	No	Yes	No	Yes
-----	----	----	----	----	----	----	-----	----	-----	----	--	-----	----	-----	----	-----

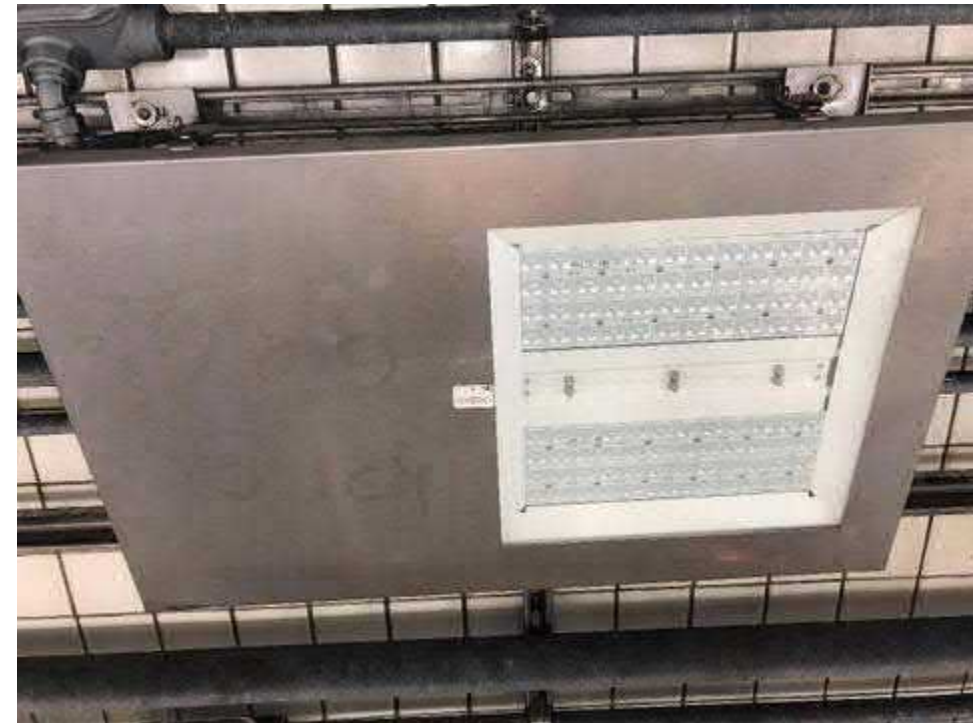
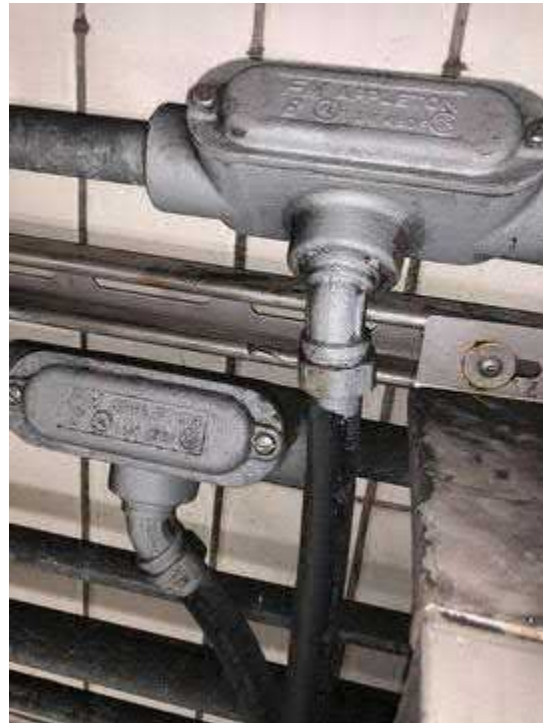
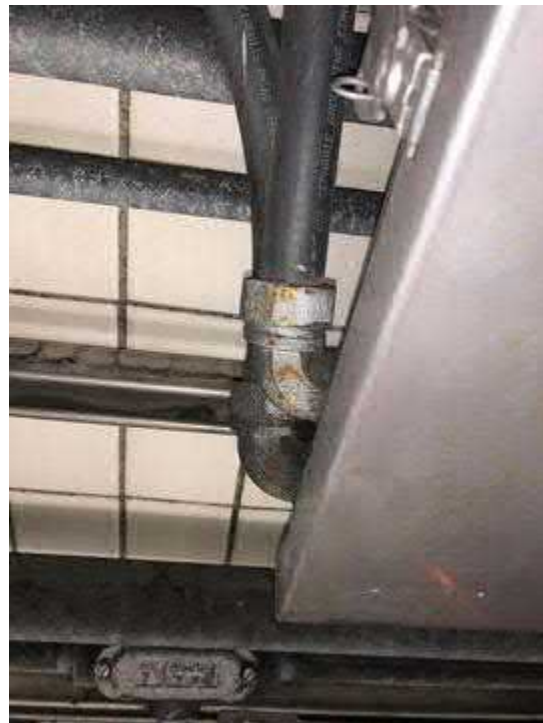
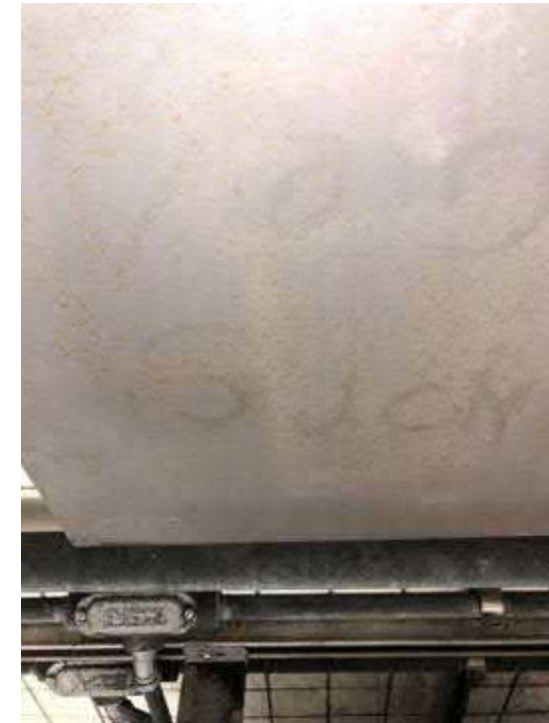
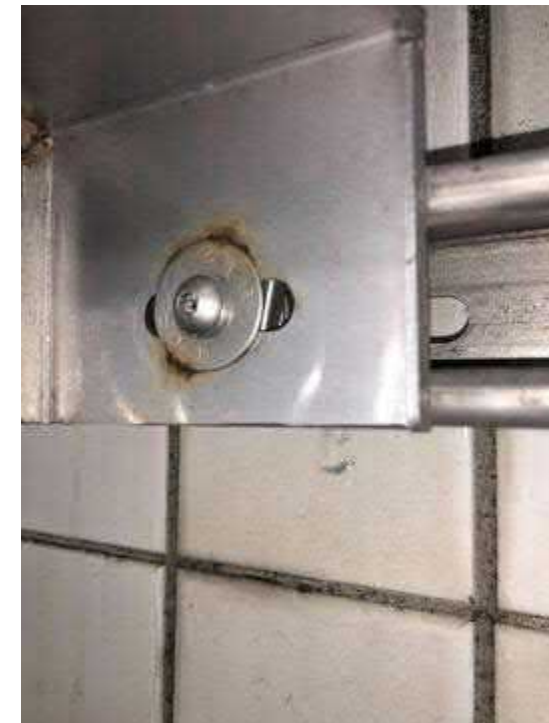
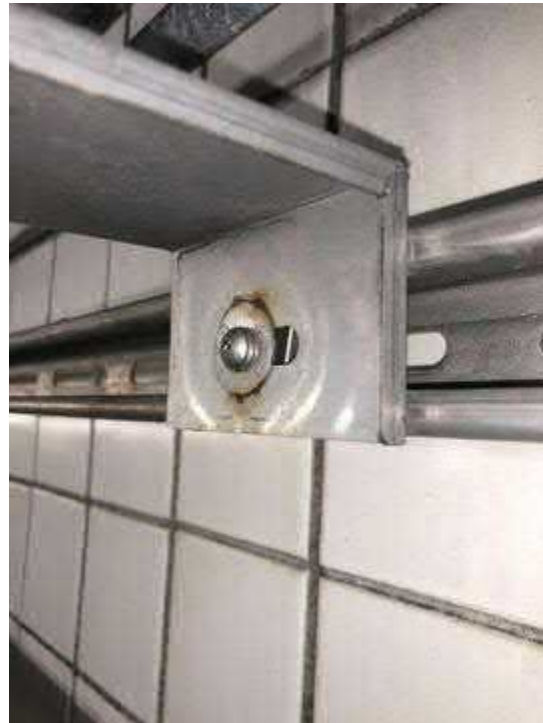
<b>Luminaire Tag or Number:</b>	NB - West Wall - 76A
<b>Tunnel Direction and Side:</b>	NB - West Wall
<b>Additional Information:</b>	T Side entry Both side entry loose Fuxture Both Bottom misaligned

Are there any signs of corrosion evident on the tunnel lighting system raceways?
Are the side entry conduits into the fixture tightly secured?
Are there any signs of corrosion on the fixture?
Is there any damage to the component housing or enclosure?
Is the light fixture secure to the mounting channels?
Long channel springnut misaligned?
Long channel springnut cracked?
Trans channel springnut misaligned?
Trans channel springnut cracked?
Trans channel wireway clip?
Housing clip disengaged?
Housing clip missing?
Lens clip disengaged?
Lens clip broken?
Lens cover cracked?
Wireway ears broken?
Luminaire functioning?

Yes	No	No	No	No	No	No	Yes	No	Yes	No	No	Yes	No	Yes	No	Yes
-----	----	----	----	----	----	----	-----	----	-----	----	----	-----	----	-----	----	-----

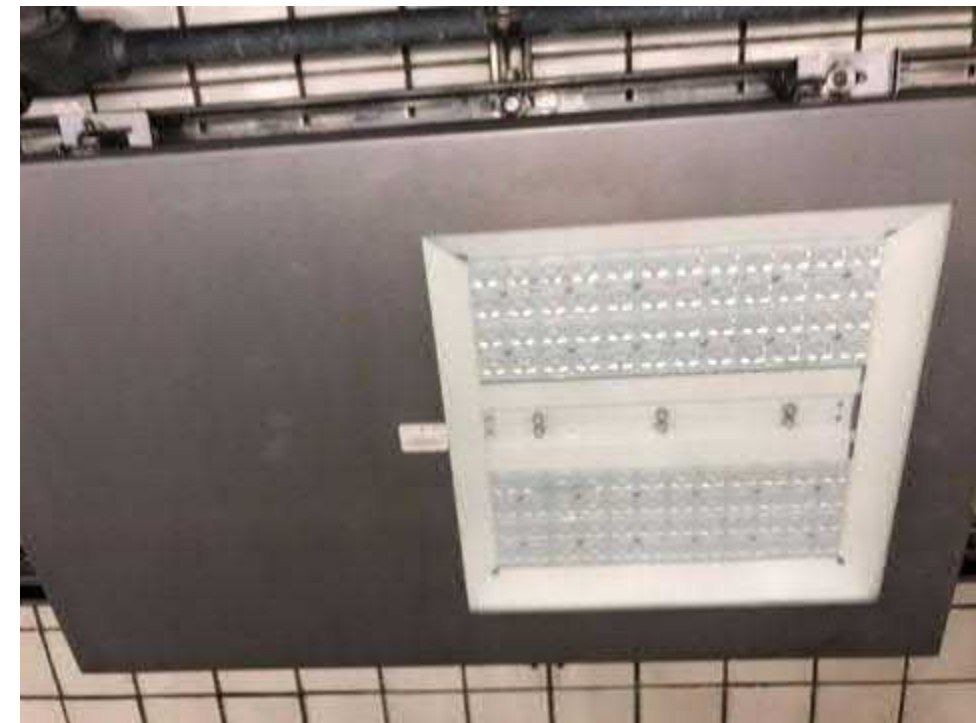
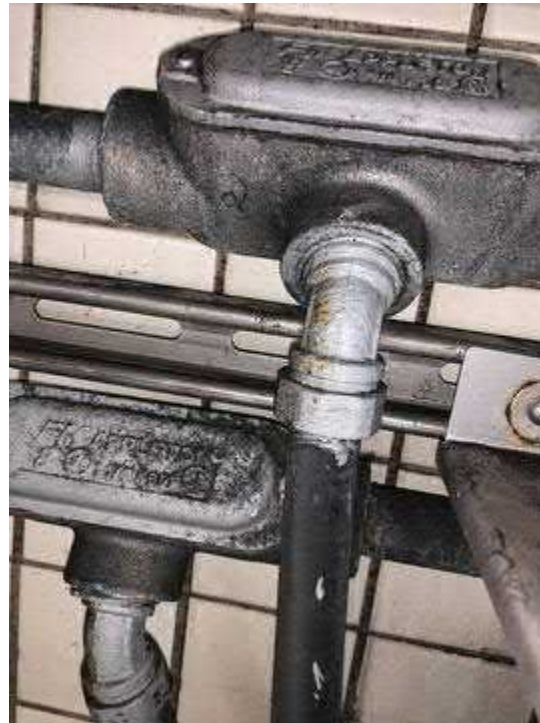
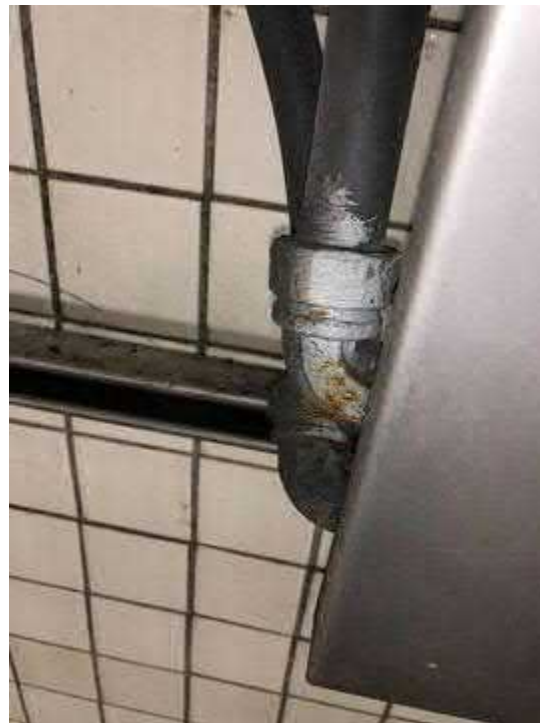
Lighting Fixture Information	
Luminaire Tag or Number:	NB - West Wall - 76B
Tunnel Direction and Side:	NB - West Wall
Additional Information:	T Side entry 1 Fixture

Are there any signs of corrosion evident on the tunnel lighting system raceways?
Are the side entry conduits into the fixture tightly secured?
Are there any signs of corrosion on the fixture?
Is there any damage to the component housing or enclosure?
Is the light fixture secure to the mounting channels?
Long channel springnut misaligned?
Long channel springnut cracked?
Trans channel springnut cracked?
Trans channel wireway clip?
Housing clip disengaged?
Housing clip missing?
Lens clip disengaged?
Lens clip broken?
Lens cover cracked?
Wireway ears broken?
Luminaire functioning?

Yes	No	No	No	No	No	No	Yes	No	No	No	No	Yes		Yes	Yes	Yes
-----	----	----	----	----	----	----	-----	----	----	----	----	-----	--	-----	-----	-----

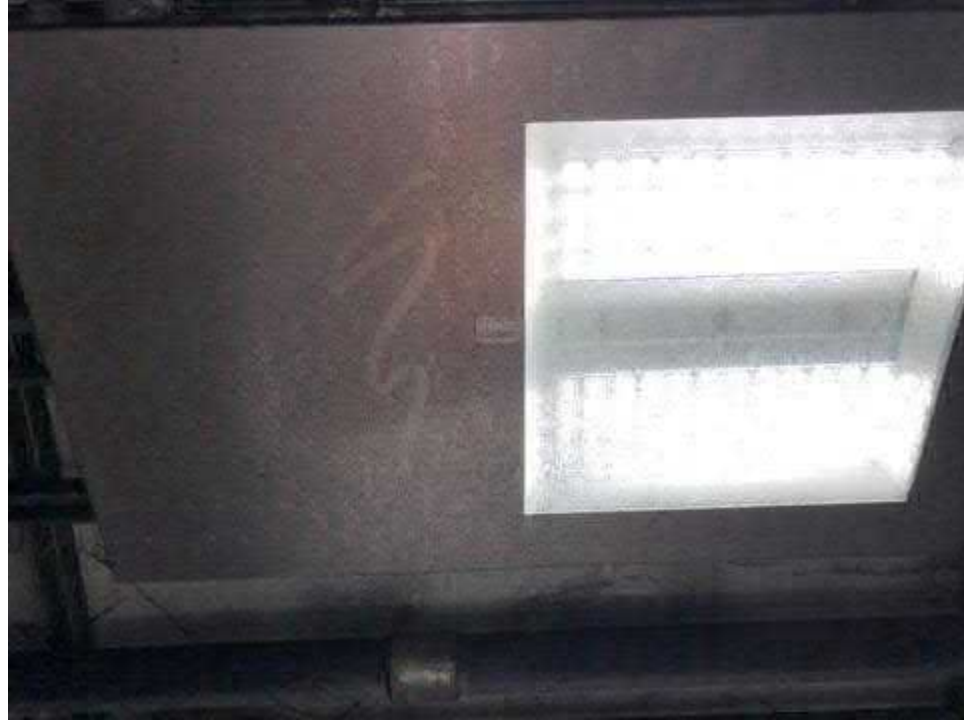
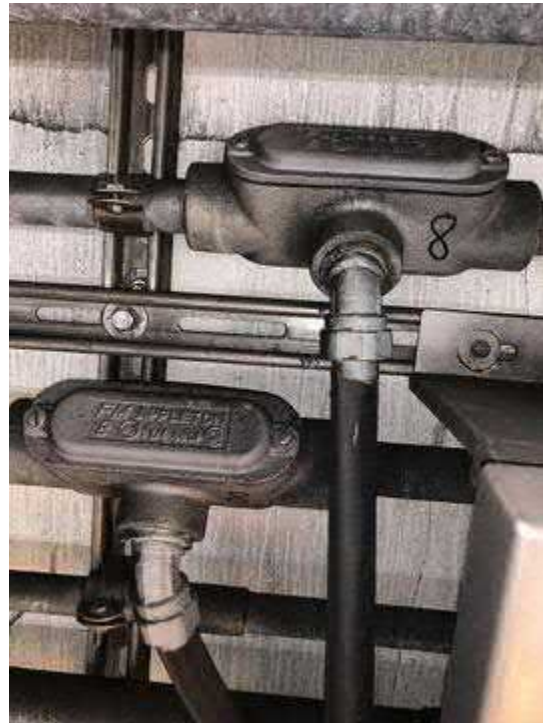
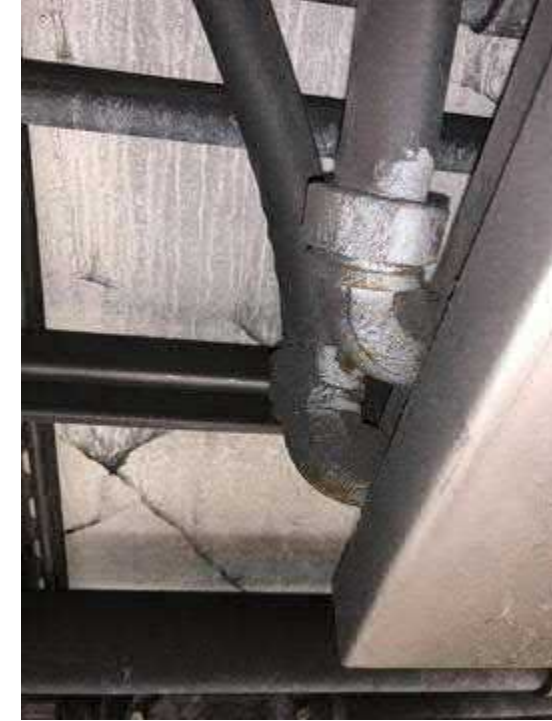
Lighting Fixture Information	
Luminaire Tag or Number:	NB - West Wall - 85A
Tunnel Direction and Side:	NB - West Wall
Additional Information:	T Side entry L Fixture

Are there any signs of corrosion evident on the tunnel lighting system raceways?	Yes
Are the side entry conduits into the fixture tightly secured?	Yes
Are there any signs of corrosion on the fixture?	Yes
Is there any damage to the component housing or enclosure?	No
Is the light fixture secure to the mounting channels?	Yes
Long channel springnut misaligned?	No
Long channel springnut cracked?	No
Trans channel springnut misaligned?	No
Trans channel springnut cracked?	No
Trans channel wireway clip?	Yes
Housing clip disengaged?	No
Housing clip missing?	No
Lens clip disengaged?	No
Lens clip broken?	No
Lens cover cracked?	No
Wireway ears broken?	No
Luminaire functioning?	Yes

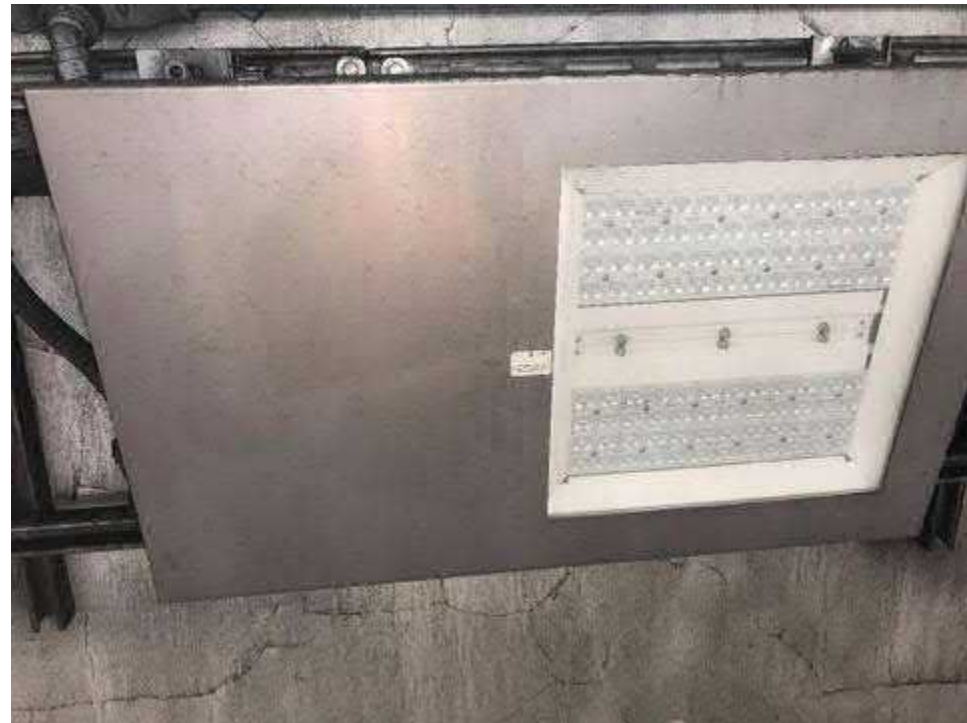
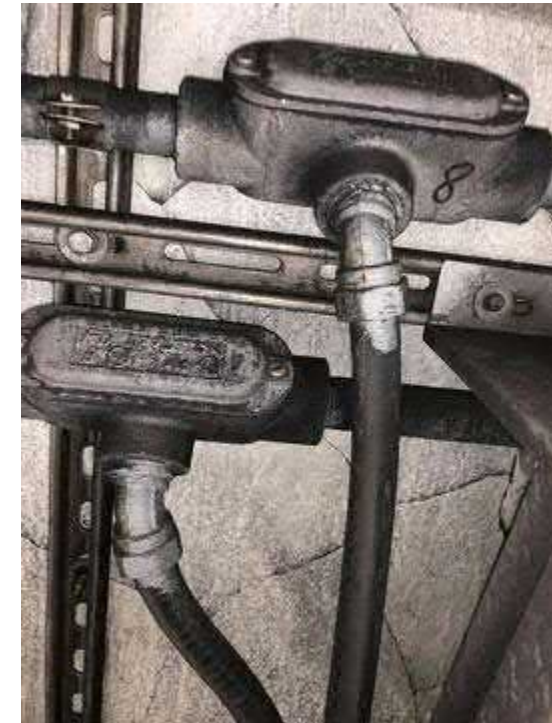
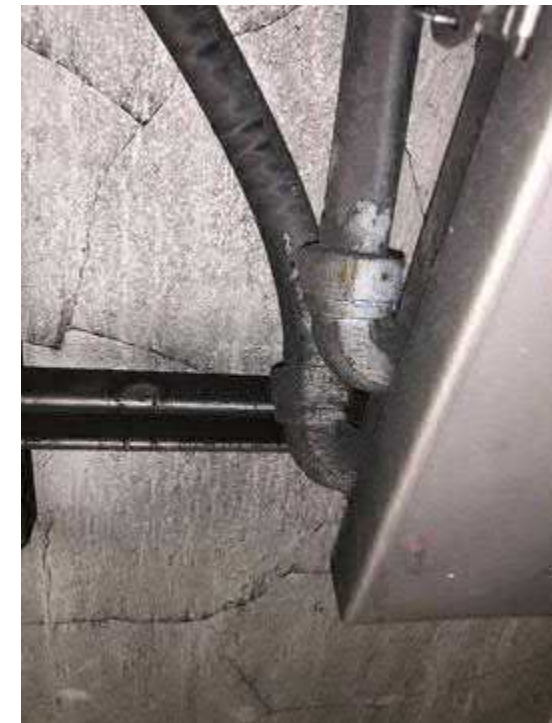
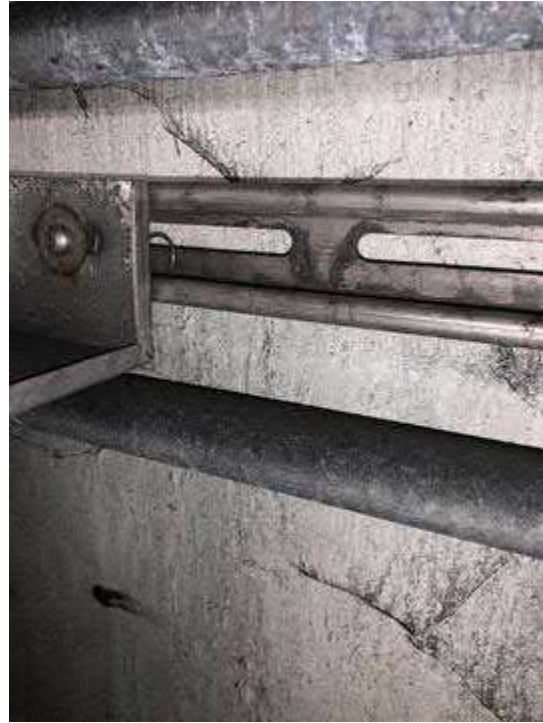
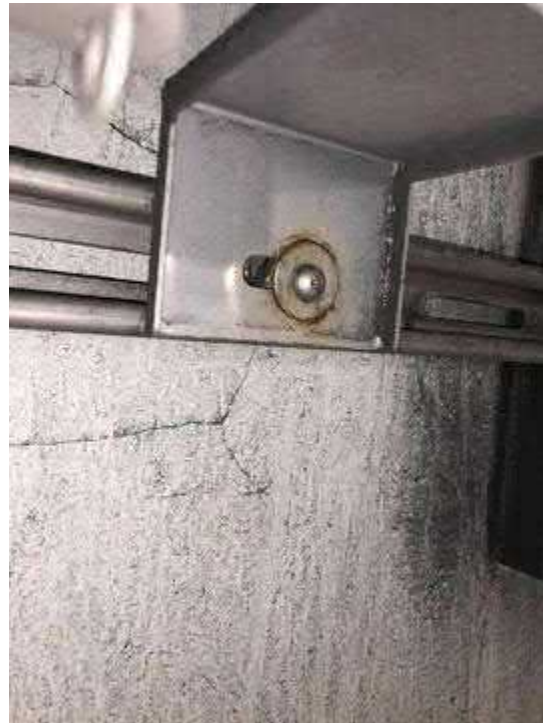
Lighting Fixture Information	
<b>Luminaire Tag or Number:</b>	NB - West Wall - 85B
<b>Tunnel Direction and Side:</b>	NB - West Wall
<b>Additional Information:</b>	T Side entry L Fixture Top right misaligned Bottom right

Are there any signs of corrosion evident on the tunnel lighting system raceways?
Are the side entry conduits into the fixture tightly secured?
Are there any signs of corrosion on the fixture?
Is there any damage to the component housing or enclosure?
Is the light fixture secure to the mounting channels?
Long channel springnut misaligned?
Long channel springnut cracked?
Trans channel springnut misaligned?
Trans channel springnut cracked?
Trans channel wireway clip?
Housing clip disengaged?
Housing clip missing?
Lens clip disengaged?
Lens clip broken?
Lens cover cracked?
Wireway ears broken?
Luminaire functioning?

Yes	No	No	No	No	No	No	Yes	No	Yes	No	No	Yes	No	Yes	Yes	Yes
-----	----	----	----	----	----	----	-----	----	-----	----	----	-----	----	-----	-----	-----

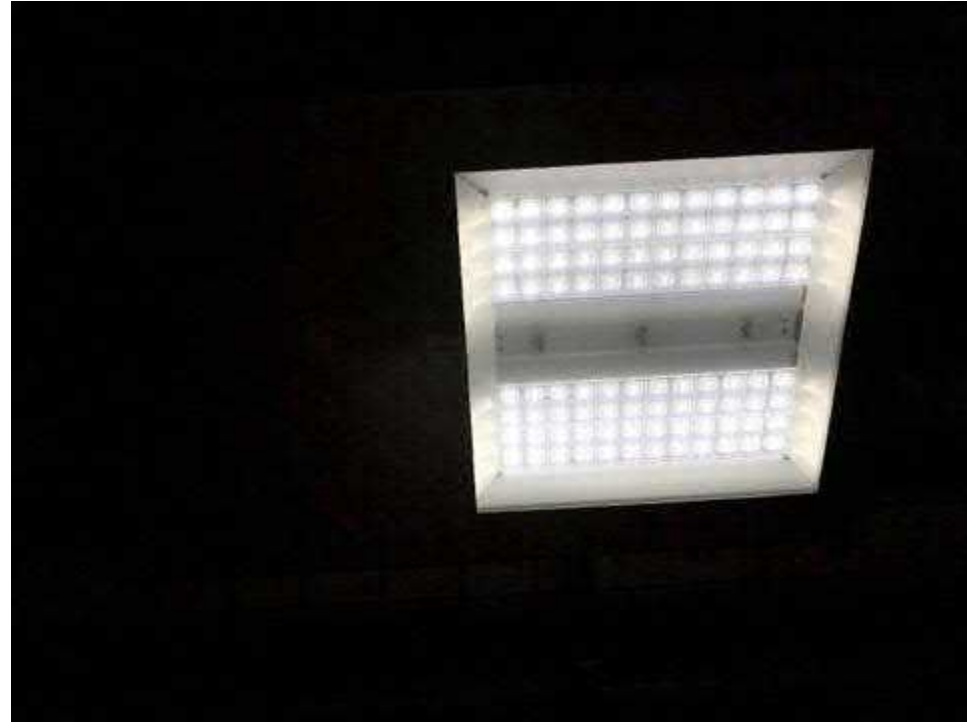
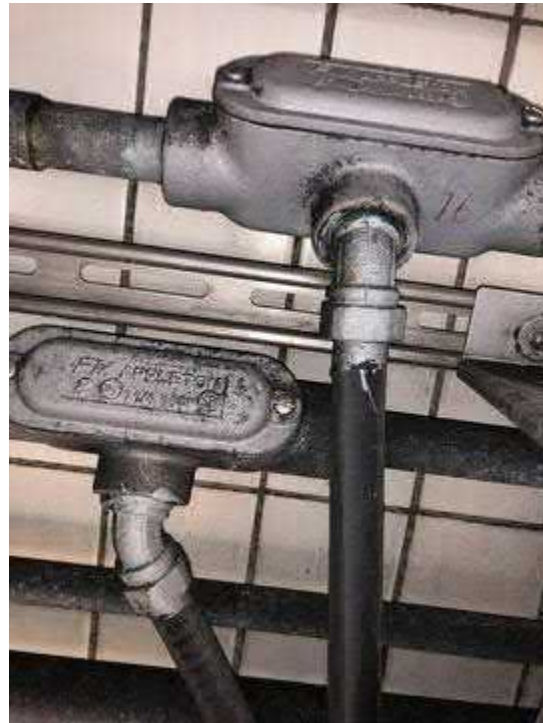
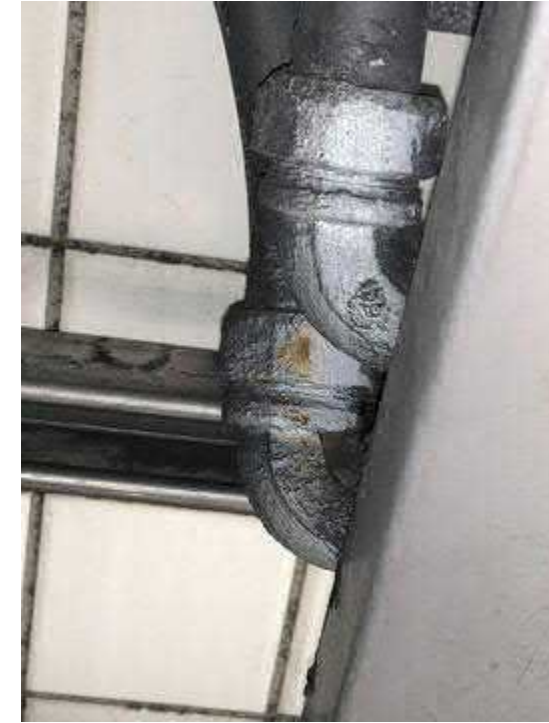
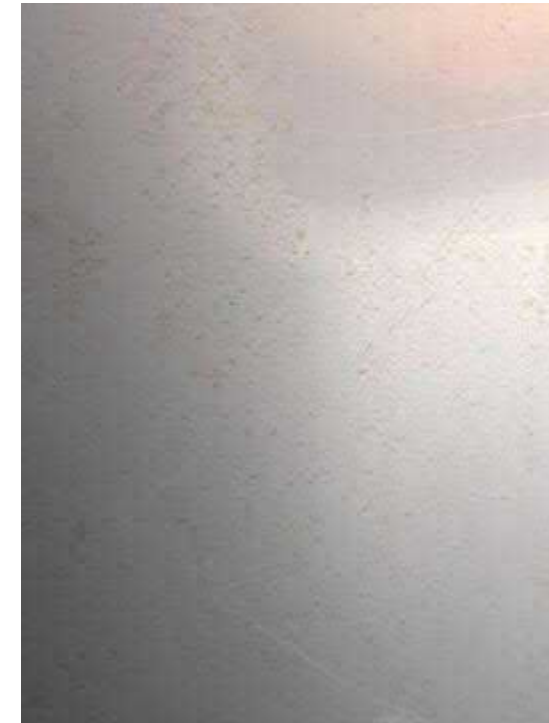
Lighting Fixture Information	
Luminaire Tag or Number:	NB - West Wall - 94A
Tunnel Direction and Side:	NB - West Wall T
Additional Information:	T Side entry L Fixture

Are there any signs of corrosion evident on the tunnel lighting system raceways?	Yes
Are the side entry conduits into the fixture tightly secured?	Yes
Are there any signs of corrosion on the fixture?	Yes
Is there any damage to the component housing or enclosure?	No
Is the light fixture secure to the mounting channels?	Yes
Long channel springnut misaligned?	No
Long channel springnut cracked?	No
Trans channel springnut misaligned?	No
Trans channel springnut cracked?	No
Trans channel wireway clip?	Yes
Housing clip disengaged?	No
Housing clip missing?	No
Lens clip disengaged?	No
Lens clip broken?	No
Lens cover cracked?	No
Wireway ears broken?	No
Luminaire functioning?	Yes

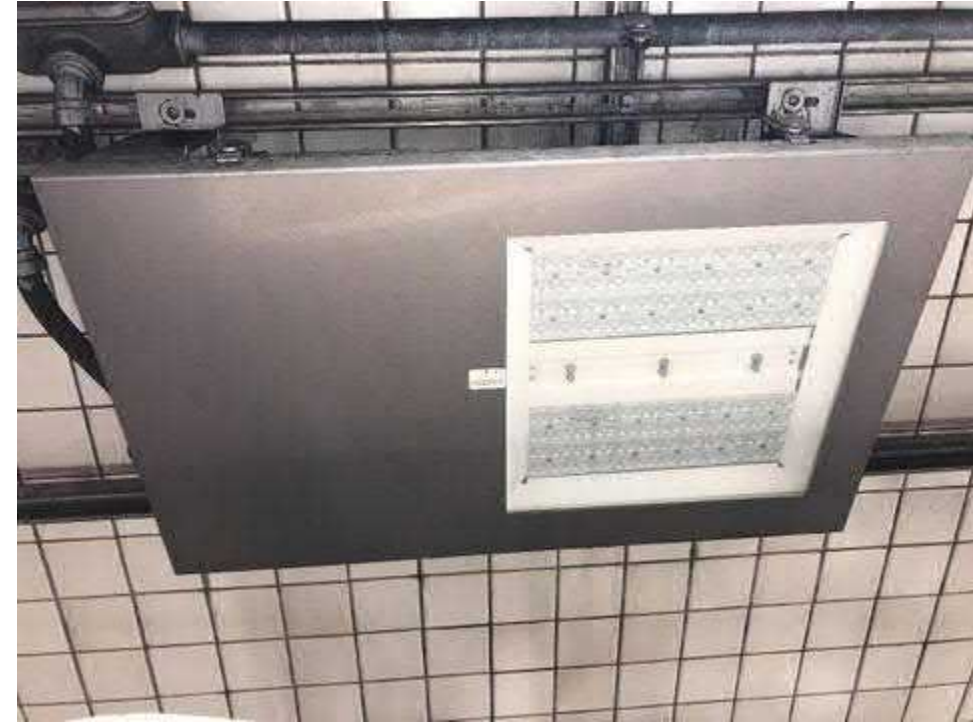
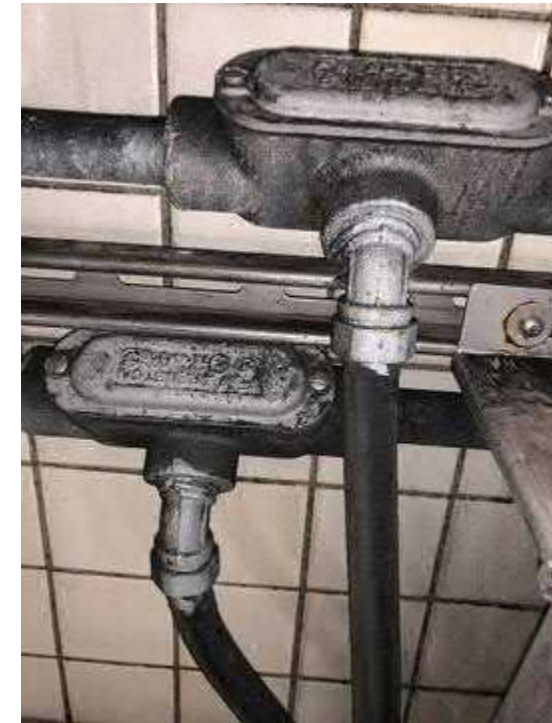
Lighting Fixture Information	
Luminaire Tag or Number:	NB - West Wall - 94B
Tunnel Direction and Side:	NB - West Wall
Additional Information:	T Sude Entry L Fixture

Are there any signs of corrosion evident on the tunnel lighting system raceways?	Yes
Are the side entry conduits into the fixture tightly secured?	Yes
Are there any signs of corrosion on the fixture?	Yes
Is there any damage to the component housing or enclosure?	No
Is the light fixture secure to the mounting channels?	Yes
Long channel springnut misaligned?	No
Long channel springnut cracked?	No
Trans channel springnut misaligned?	No
Trans channel springnut cracked?	No
Trans channel wireway clip?	Yes
Housing clip disengaged?	No
Housing clip missing?	No
Lens clip disengaged?	No
Lens clip broken?	No
Lens cover cracked?	No
Wireway ears broken?	No
Luminaire functioning?	Yes

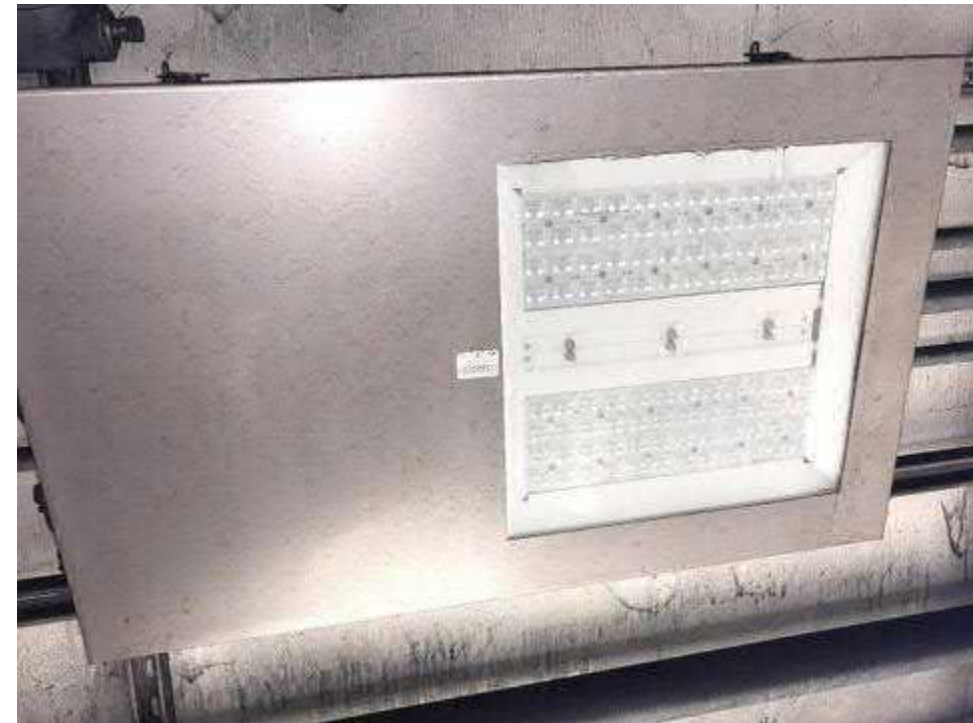
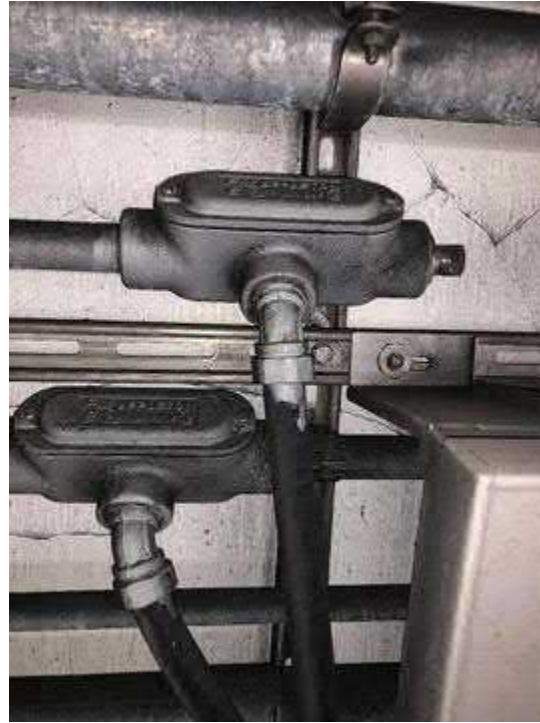
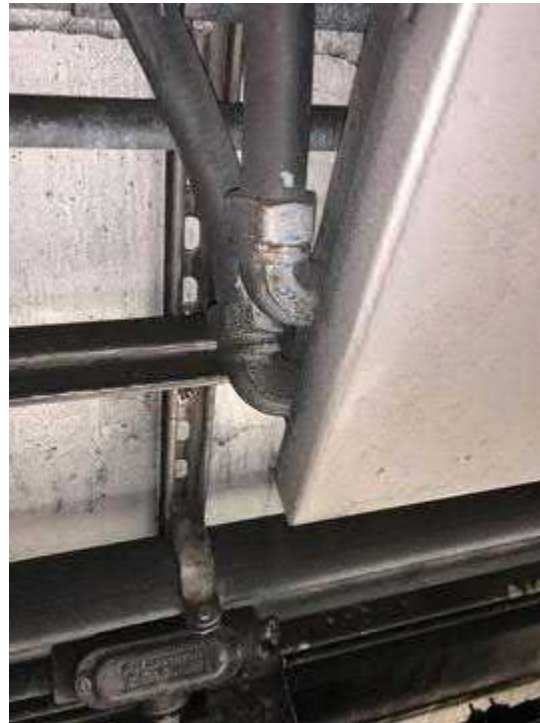
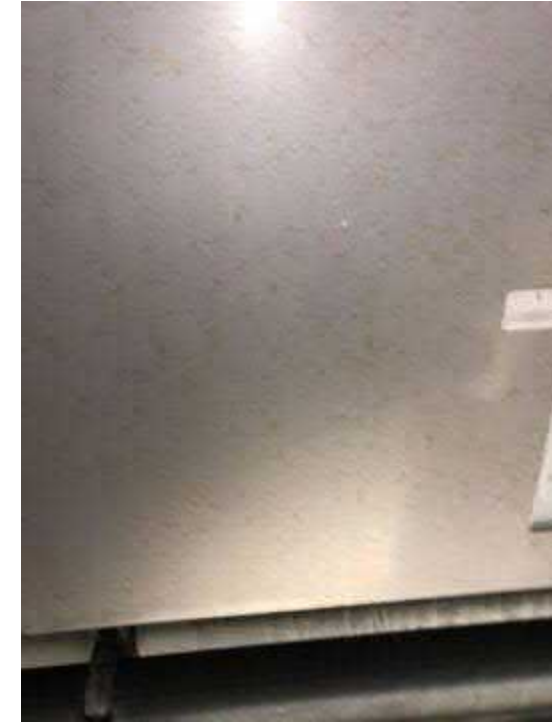
Lighting Fixture Information	
<b>Luminaire Tag or Number:</b>	NB - West Wall - 103B
<b>Tunnel Direction and Side:</b>	NB - West Wall - 85A
<b>Additional Information:</b>	T Side entry Conduits Fuxture

Yes	No	No	No	No	No	No	No	No	No	No	No	Yes		Yes		Yes
-----	----	----	----	----	----	----	----	----	----	----	----	-----	--	-----	--	-----

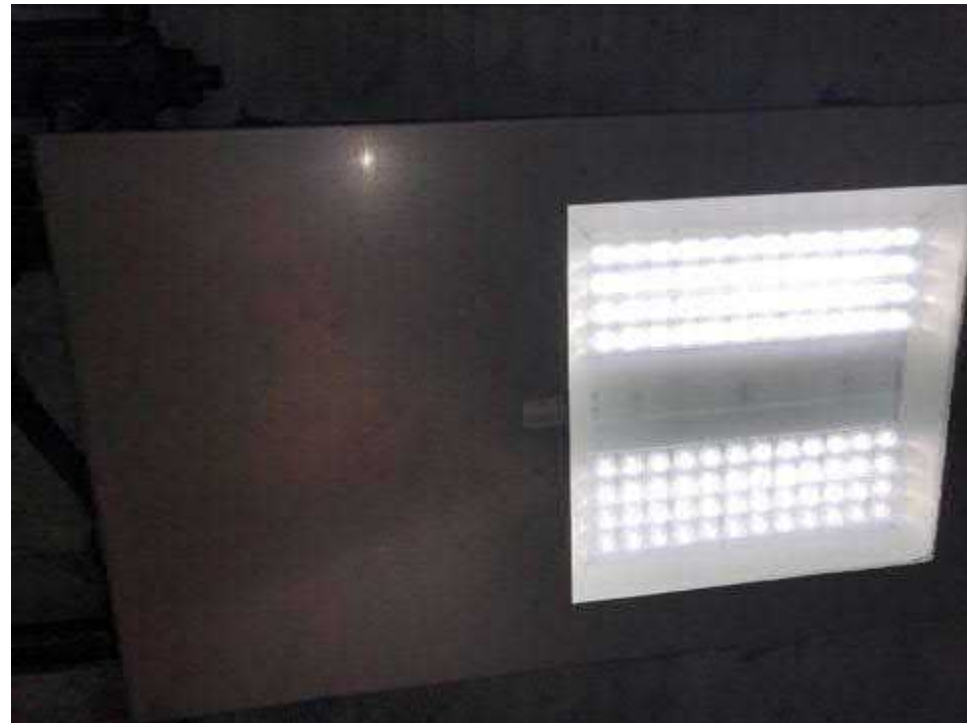
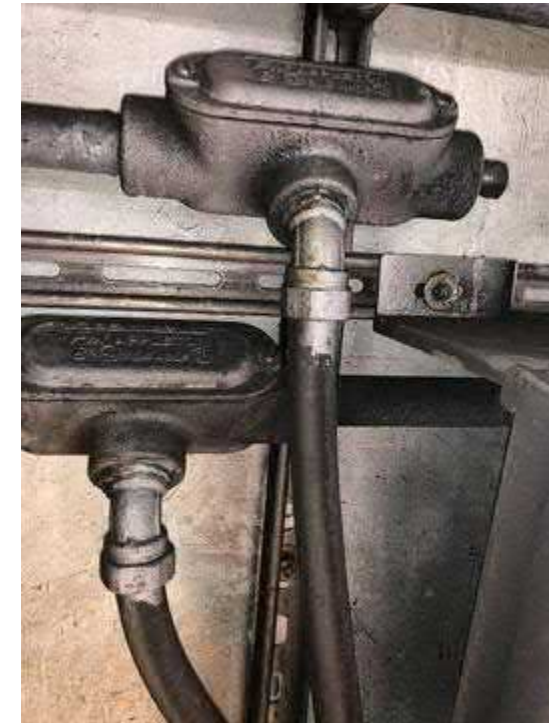
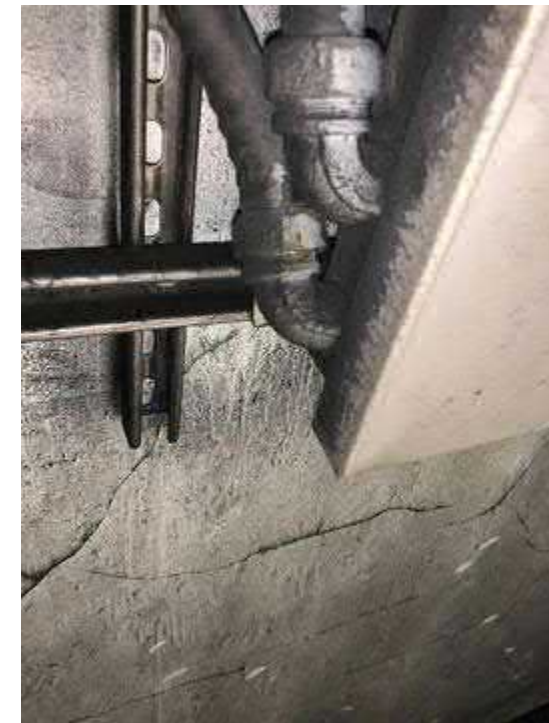
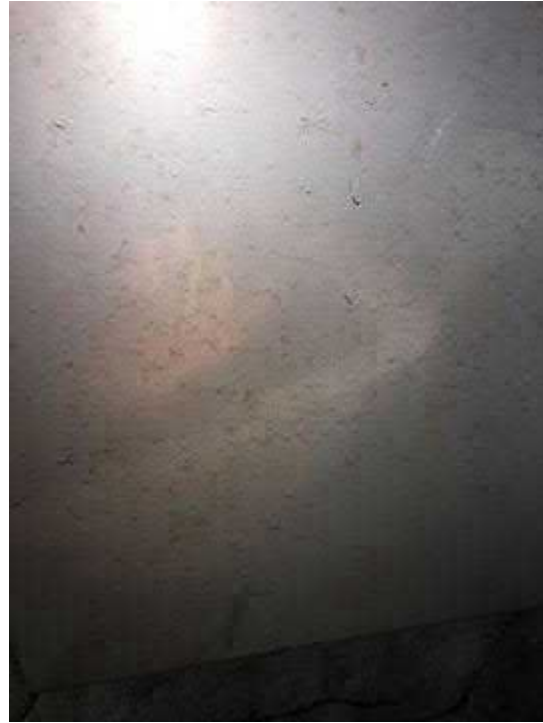
Lighting Fixture Information	
Luminaire Tag or Number:	NB - West Wall - 112
Tunnel Direction and Side:	NB - West Wall
Additional Information:	T Side Entry L Fuxture

Yes	No	No	No	No	No	No	No	Yes	No	No	No	No	Yes	No	Yes	Yes	Yes
-----	----	----	----	----	----	----	----	-----	----	----	----	----	-----	----	-----	-----	-----
