# **Lytle Tunnel (HAM-71-0134) Inspection Report Fall 2020**

PID 105470

November, 2020

Ohio Department of  
Transportation  
District 8  
505 South State Route 741  
Lebanon, OH 45036

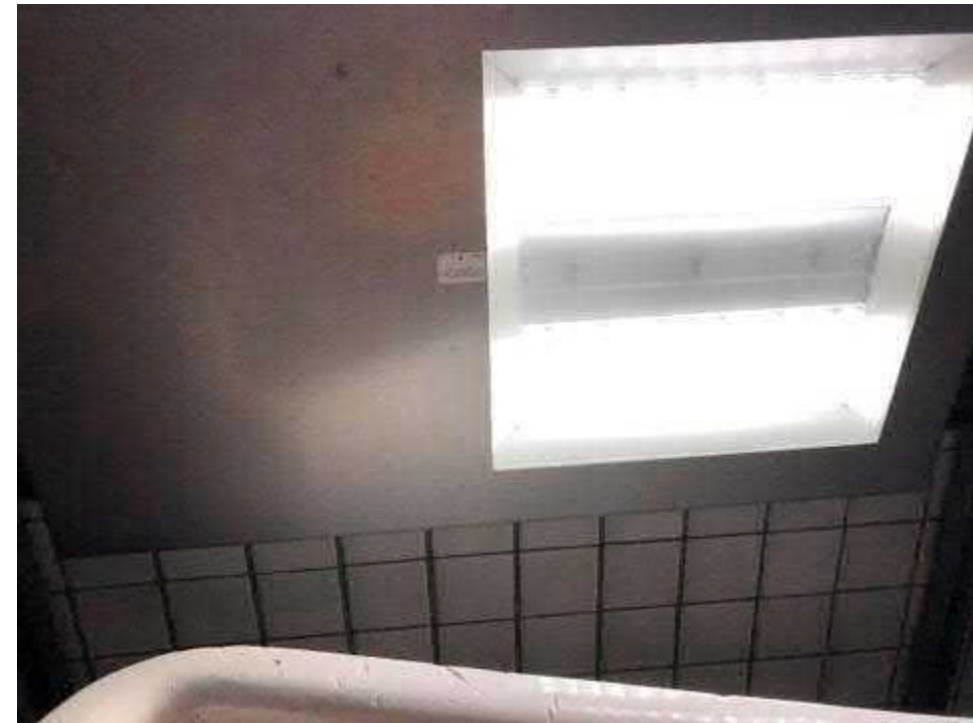
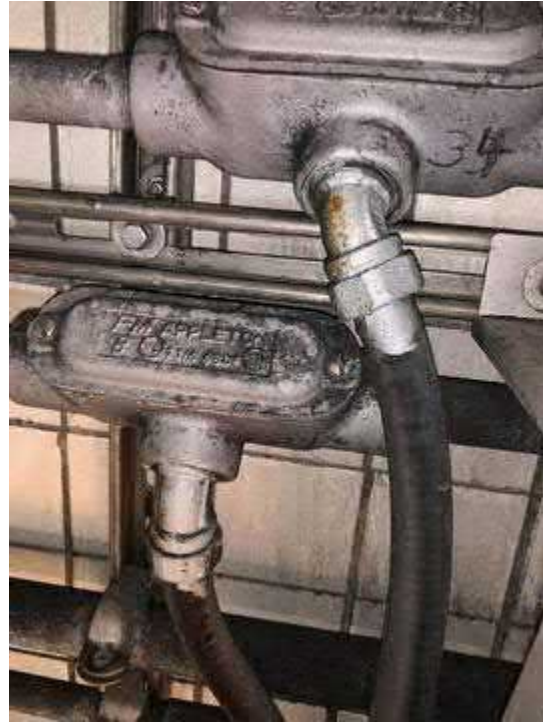
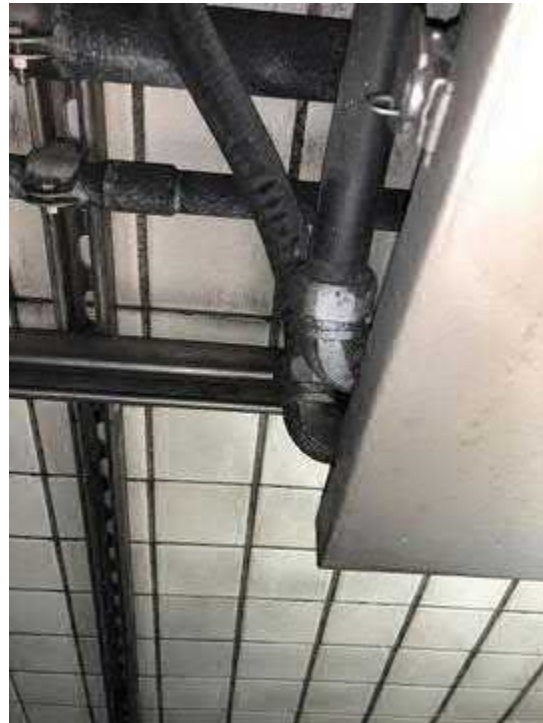
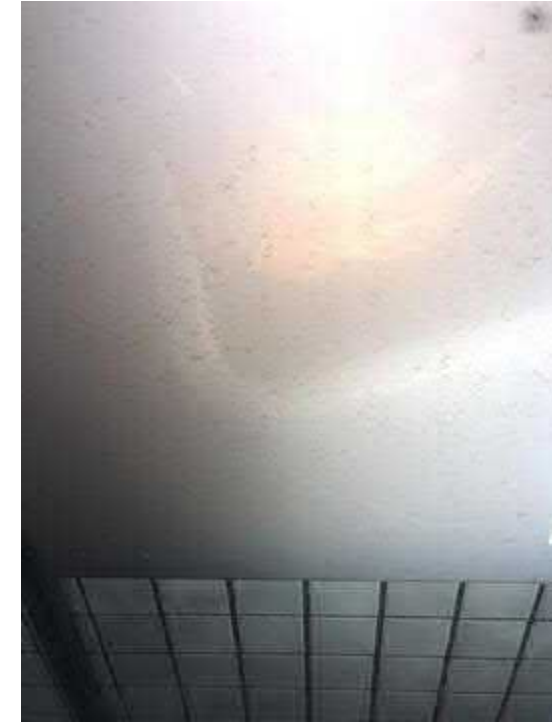
Lighting Fixture Information	
<b>Luminaire Tag or Number:</b>	NB - West Wall - 121
<b>Tunnel Direction and Side:</b>	NB - West Wall
<b>Additional Information:</b>	T Side Entry L Fixture Bottom Right

Yes	No	No	No	No	No	No	Yes	No	Yes	No	No	Yes	No	Yes	Yes	Yes
-----	----	----	----	----	----	----	-----	----	-----	----	----	-----	----	-----	-----	-----

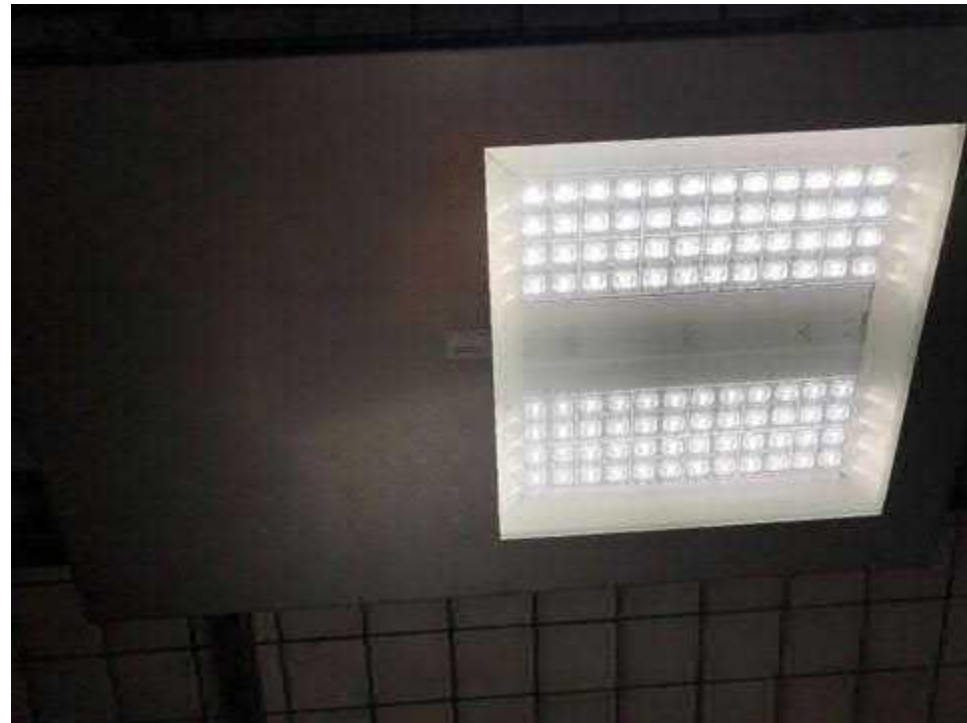
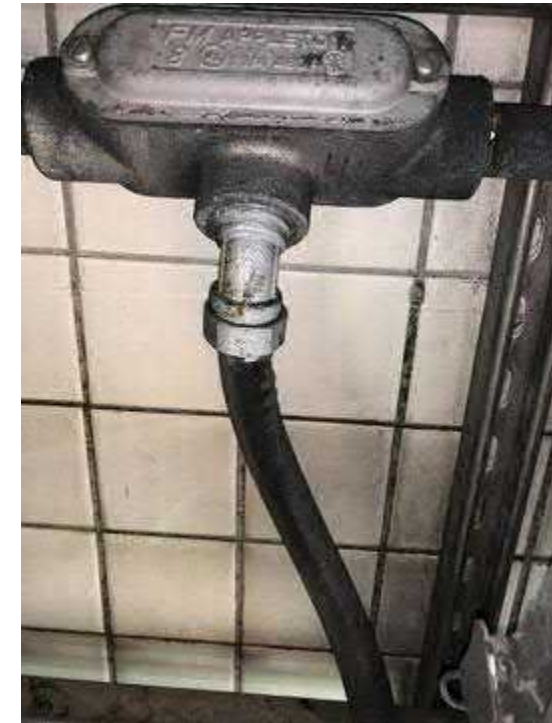
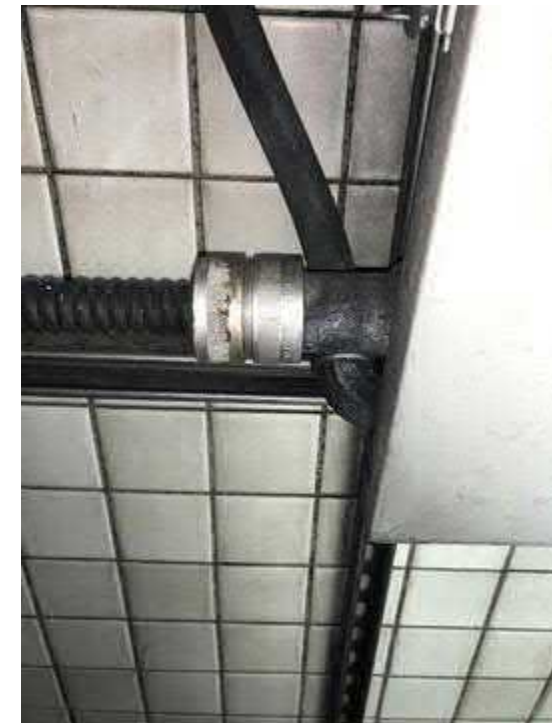
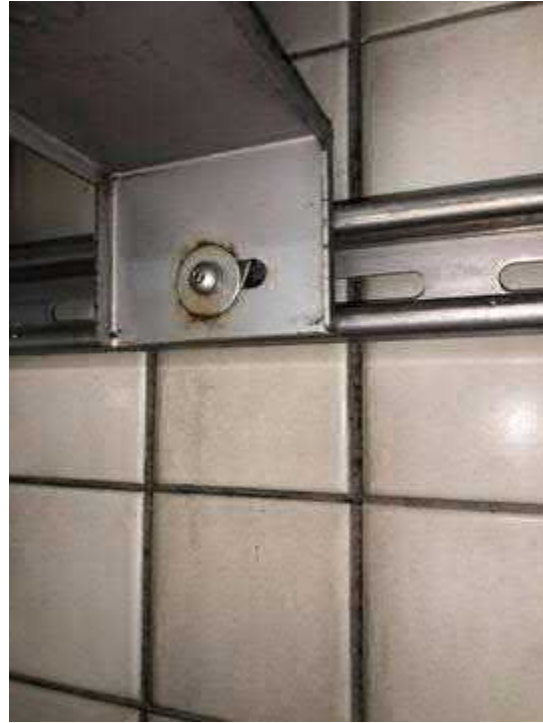
Lighting Fixture Information	
Luminaire Tag or Number:	NB - East Wall - 7B
Tunnel Direction and Side:	NB - East Wall
Additional Information:	T Side Entry L Fixture

Yes	No	No	No	No	No	No	Yes	No	No	No	No	Yes	Yes	No	Yes	Yes
-----	----	----	----	----	----	----	-----	----	----	----	----	-----	-----	----	-----	-----

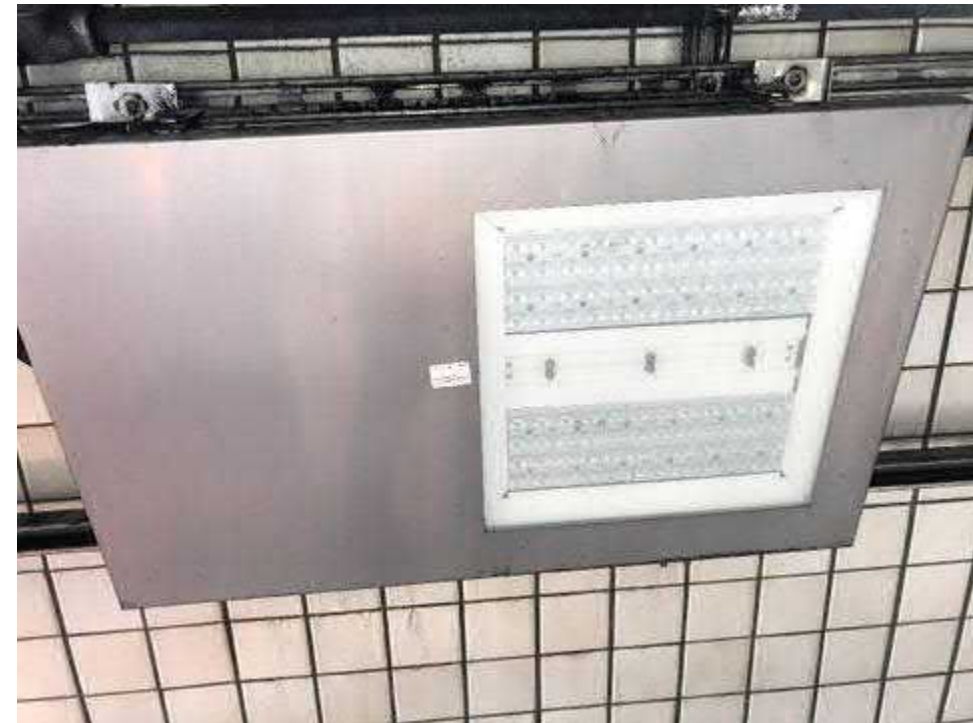
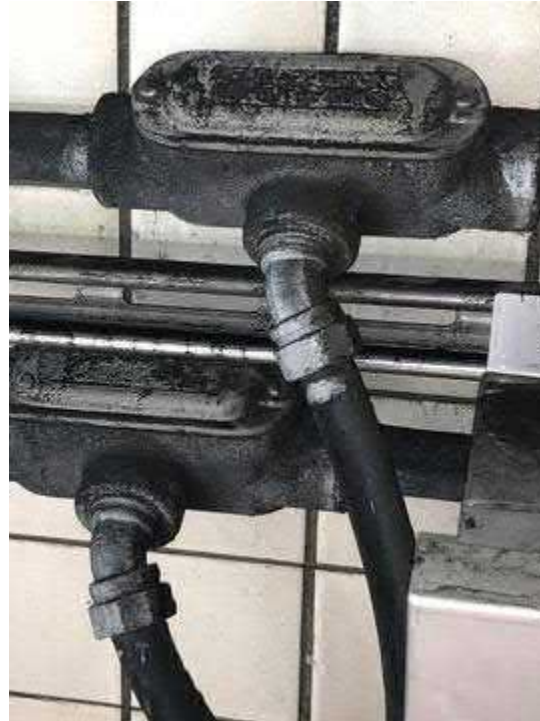
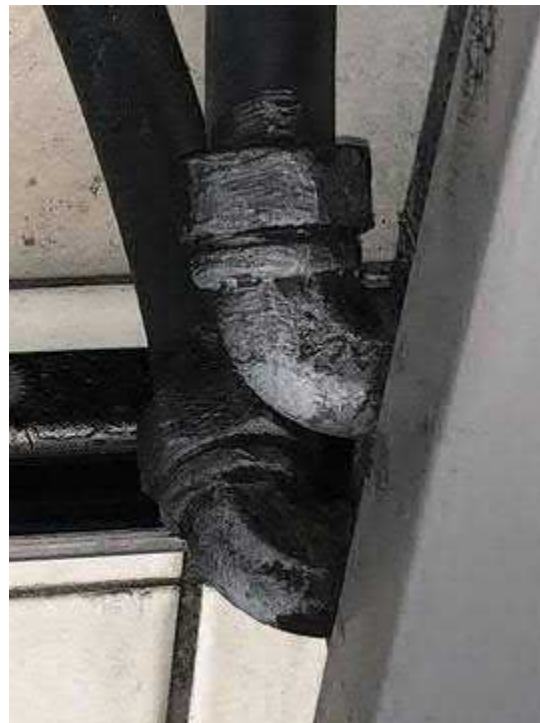
Lighting Fixture Information	
Luminaire Tag or Number:	NB - East Wall - 16 B
Tunnel Direction and Side:	NB - East Wall
Additional Information:	T Sude Entry L Top Left

Are there any signs of corrosion evident on the tunnel lighting system raceways?	Yes
Are the side entry conduits into the fixture tightly secured?	No
Are there any signs of corrosion on the fixture?	
Is there any damage to the component housing or enclosure?	No
Is the light fixture secure to the mounting channels?	Yes
Long channel springnut misaligned?	No
Long channel springnut cracked?	No
Trans channel springnut misaligned?	Yes
Trans channel springnut cracked?	No
Trans channel wireway clip?	No
Housing clip disengaged?	No
Housing clip missing?	No
Lens clip disengaged?	No
Lens clip broken?	No
Lens cover cracked?	No
Wireway ears broken?	No
Luminaire functioning?	Yes

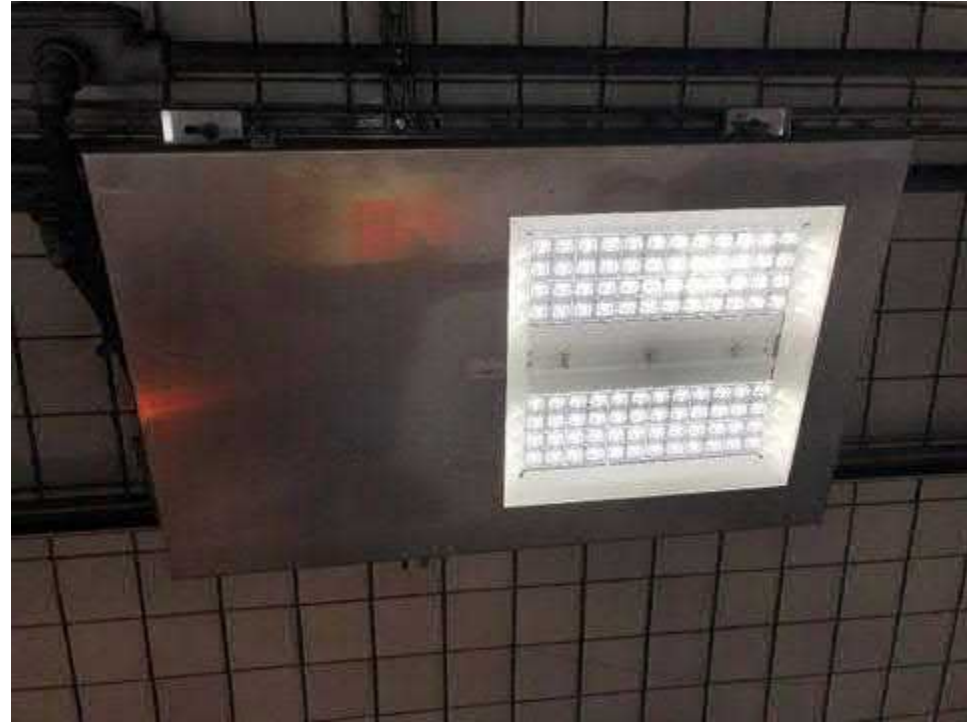
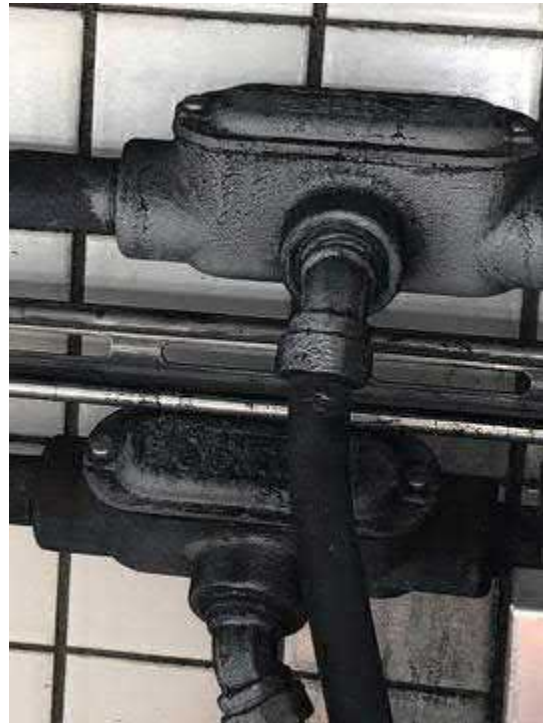
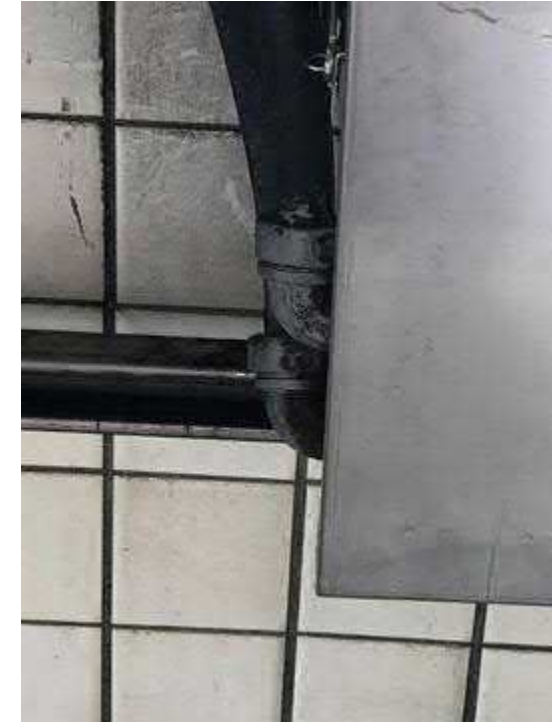
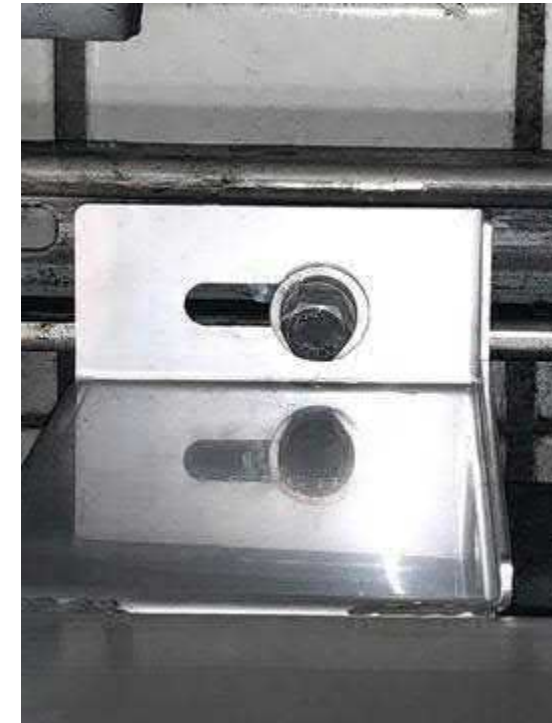
Lighting Fixture Information	
Luminaire Tag or Number:	NB - East Wall - 25B
Tunnel Direction and Side:	NB - East Wall
Additional Information:	T Side Entry L Fixture

Are there any signs of corrosion evident on the tunnel lighting system raceways?	Yes
Are the side entry conduits into the fixture tightly secured?	Yes
Are there any signs of corrosion on the fixture?	Yes
Is there any damage to the component housing or enclosure?	No
Is the light fixture secure to the mounting channels?	No
Long channel springnut misaligned?	No
Long channel springnut cracked?	No
Trans channel springnut misaligned?	No
Trans channel springnut cracked?	No
Trans channel wireway clip?	Yes
Housing clip disengaged?	No
Housing clip missing?	No
Lens clip disengaged?	No
Lens clip broken?	No
Lens cover cracked?	No
Wireway ears broken?	No
Luminaire functioning?	Yes

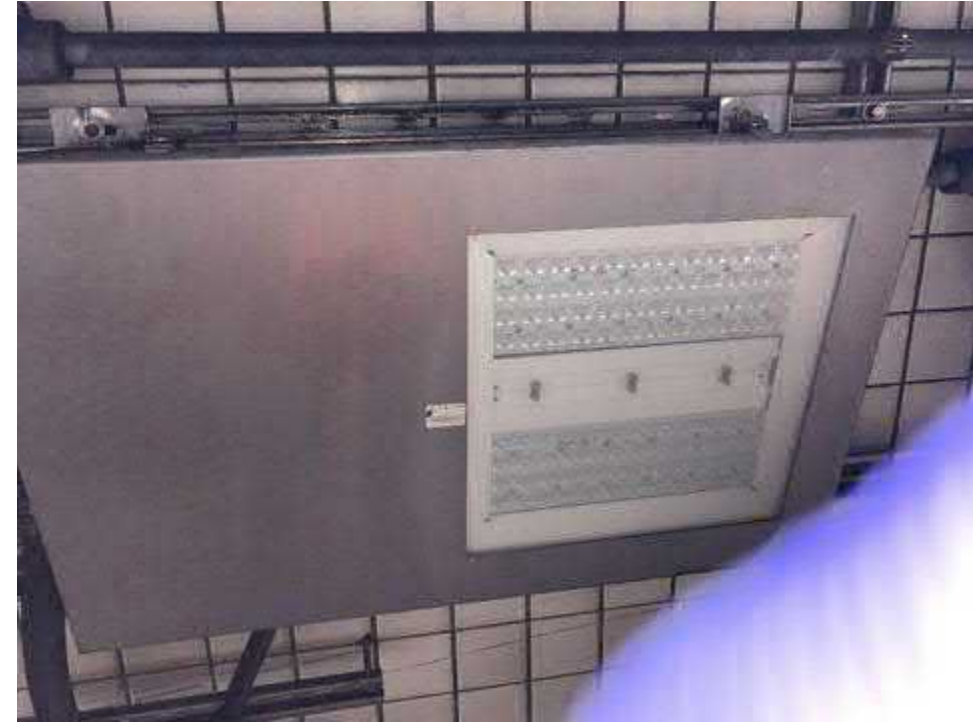
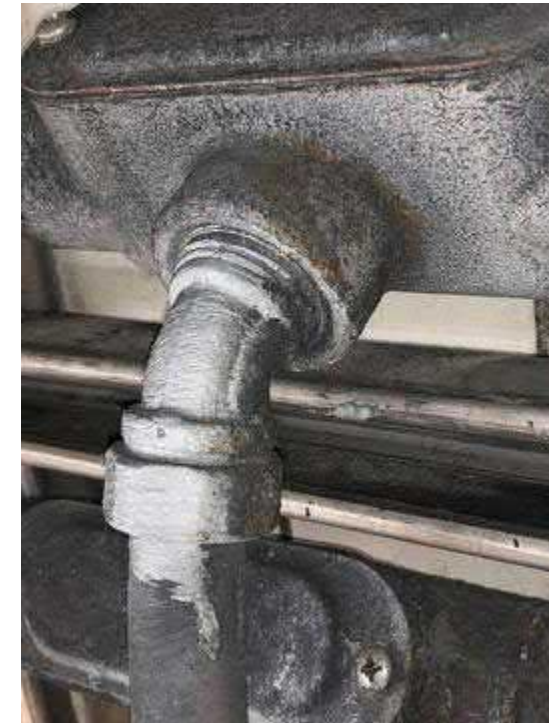
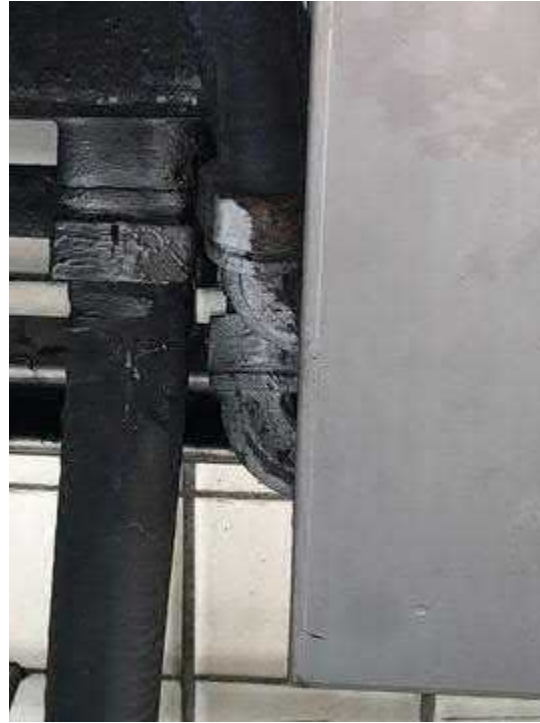
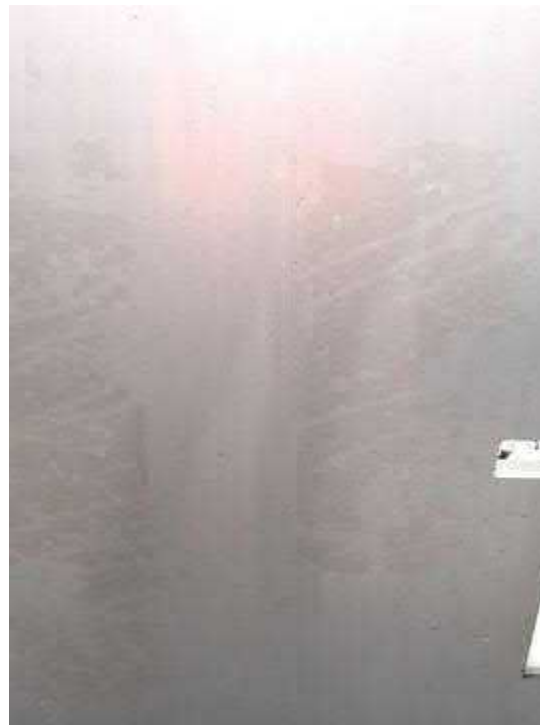
Lighting Fixture Information	
Luminaire Tag or Number:	NB - East Wall - 34B
Tunnel Direction and Side:	NB - East Wall - 7B
Additional Information:	Side Entry L Fixture Both Top misaligned

Are there any signs of corrosion evident on the tunnel lighting system raceways?	No
Are the side entry conduits into the fixture tightly secured?	Yes
Are there any signs of corrosion on the fixture?	Yes
Is there any damage to the component housing or enclosure?	No
Is the light fixture secure to the mounting channels?	Yes
Long channel springnut misaligned?	No
Long channel springnut cracked?	No
Trans channel springnut misaligned?	Yes
Trans channel springnut cracked?	No
Trans channel wireway clip?	Yes
Housing clip disengaged?	Yes
Housing clip missing?	No
Lens clip disengaged?	No
Lens clip broken?	No
Lens cover cracked?	No
Wireway ears broken?	No
Luminaire functioning?	Yes

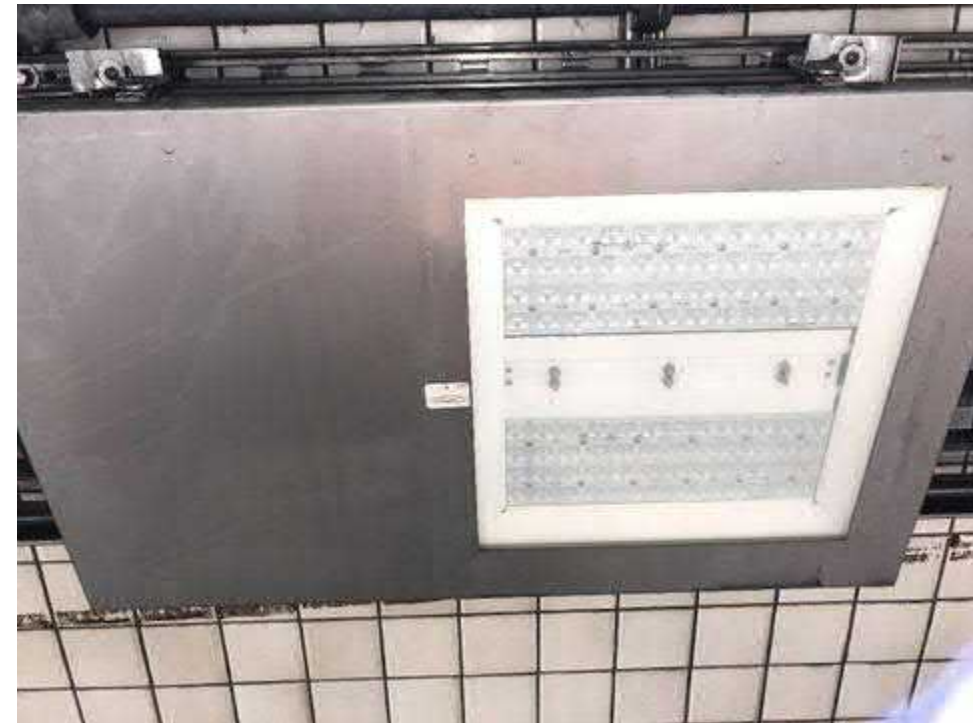
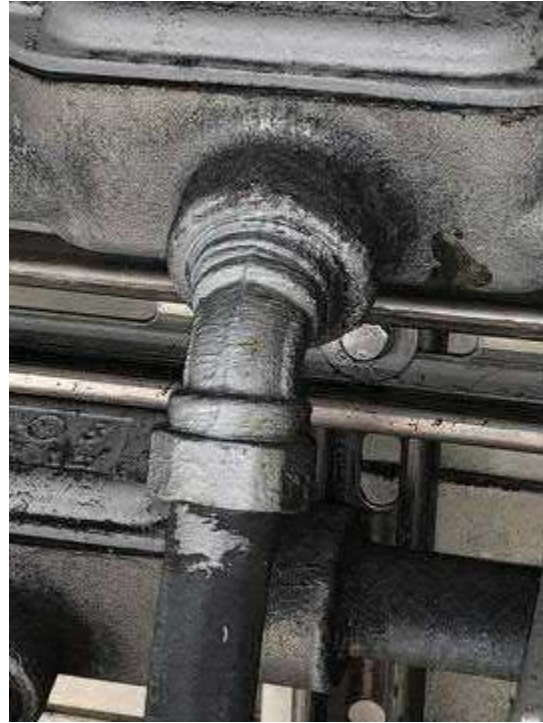
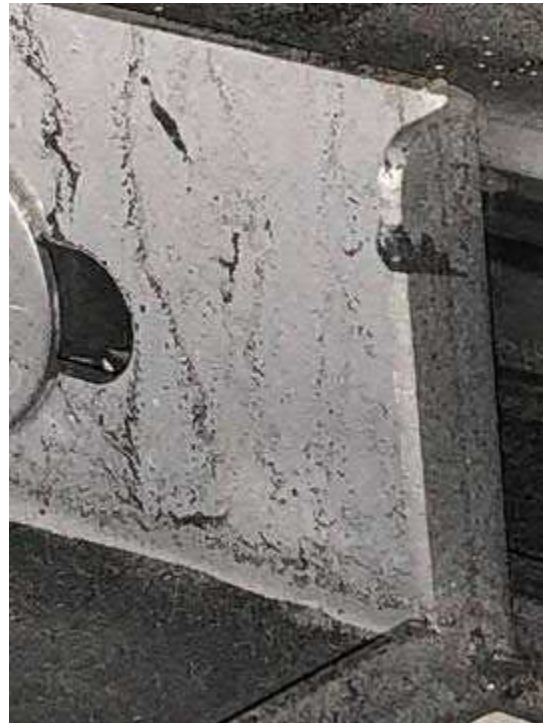
Lighting Fixture Information	
Luminaire Tag or Number:	NB - East Wall - 51B
Tunnel Direction and Side:	NB - East Wall
Additional Information:	T Both Top misaligned Fuxture

Are there any signs of corrosion evident on the tunnel lighting system raceways?	Yes
Are the side entry conduits into the fixture tightly secured?	Yes
Are there any signs of corrosion on the fixture?	Yes
Is there any damage to the component housing or enclosure?	No
Is the light fixture secure to the mounting channels?	Yes
Long channel springnut misaligned?	No
Long channel springnut cracked?	No
Trans channel springnut misaligned?	Yes
Trans channel springnut cracked?	No
Trans channel wireway clip?	Yes
Housing clip disengaged?	No
Housing clip missing?	No
Lens clip disengaged?	No
Lens clip broken?	No
Lens cover cracked?	No
Wireway ears broken?	No
Luminaire functioning?	Yes

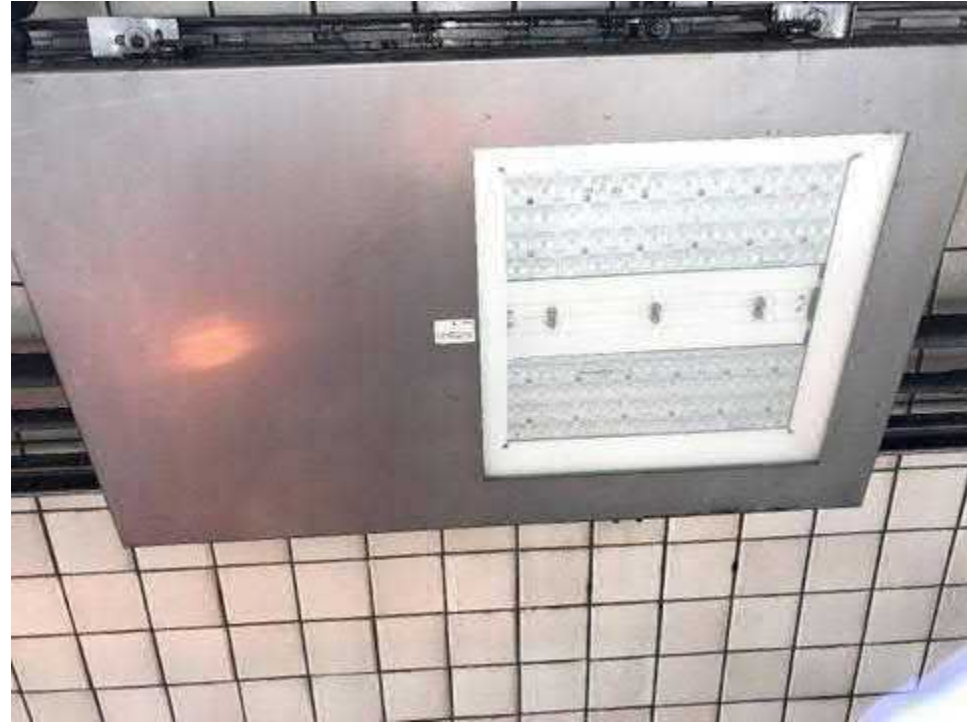
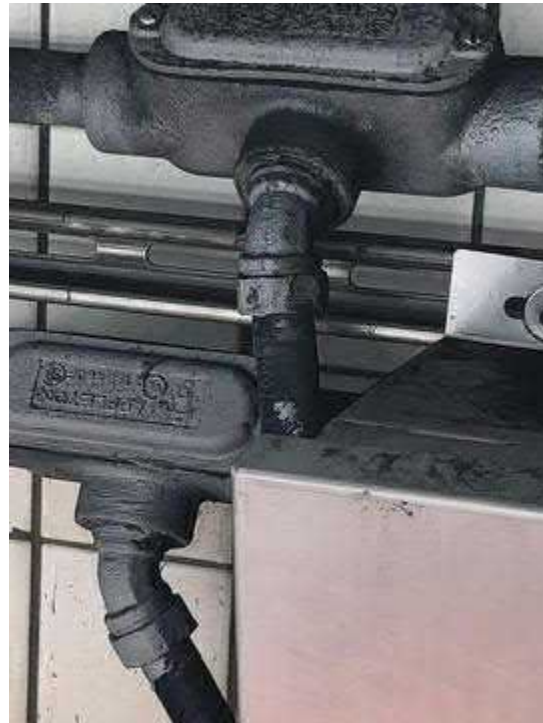
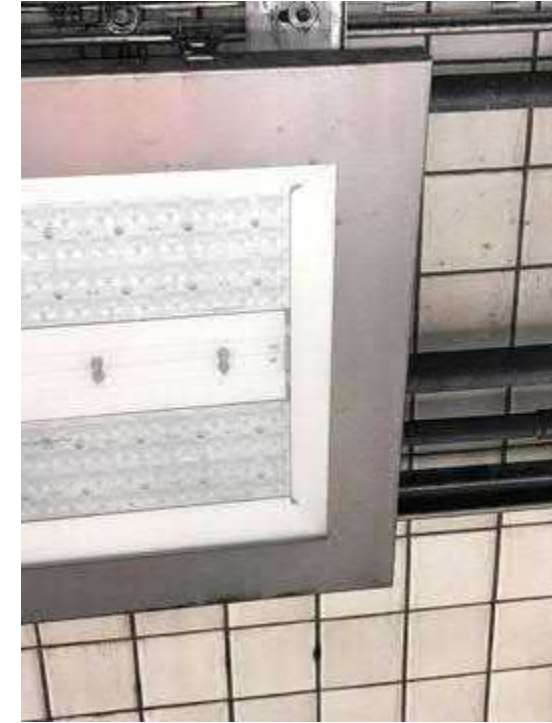
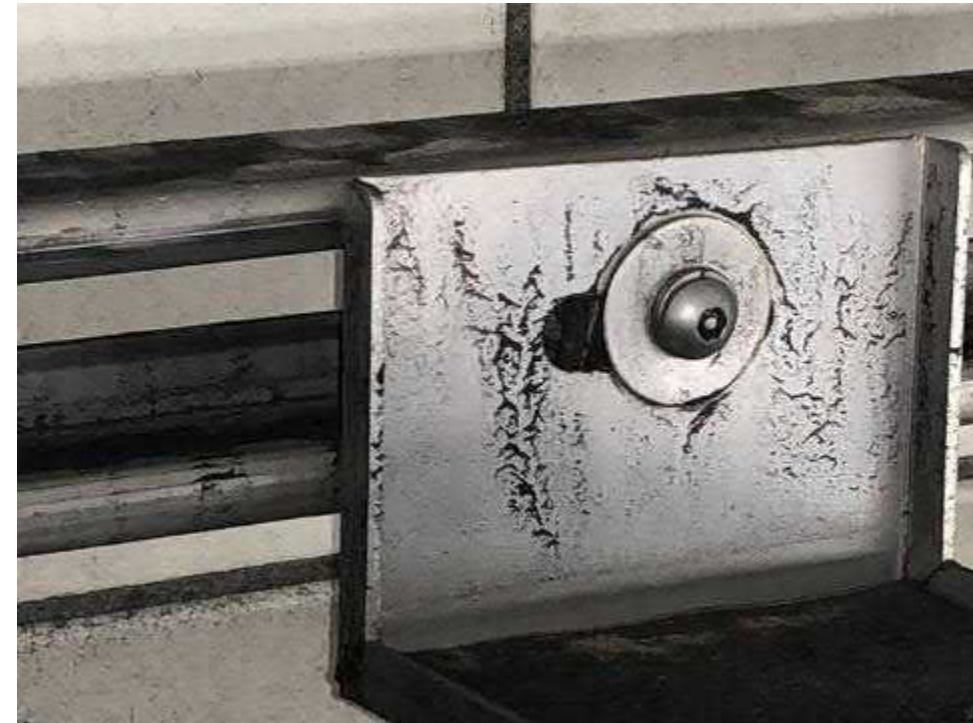
Lighting Fixture Information	
Luminaire Tag or Number:	NB - East Wall - 60B
Tunnel Direction and Side:	NB - East Wall
Additional Information:	T

Are there any signs of corrosion evident on the tunnel lighting system raceways?	Yes
Are the side entry conduits into the fixture tightly secured?	Yes
Are there any signs of corrosion on the fixture?	Yes
Is there any damage to the component housing or enclosure?	No
Is the light fixture secure to the mounting channels?	No
Long channel springnut misaligned?	No
Long channel springnut cracked?	No
Trans channel springnut misaligned?	No
Trans channel springnut cracked?	No
Trans channel wireway clip?	Yes
Housing clip disengaged?	No
Housing clip missing?	No
Lens clip disengaged?	No
Lens clip broken?	No
Lens cover cracked?	No
Wireway ears broken?	No
Luminaire functioning?	Yes

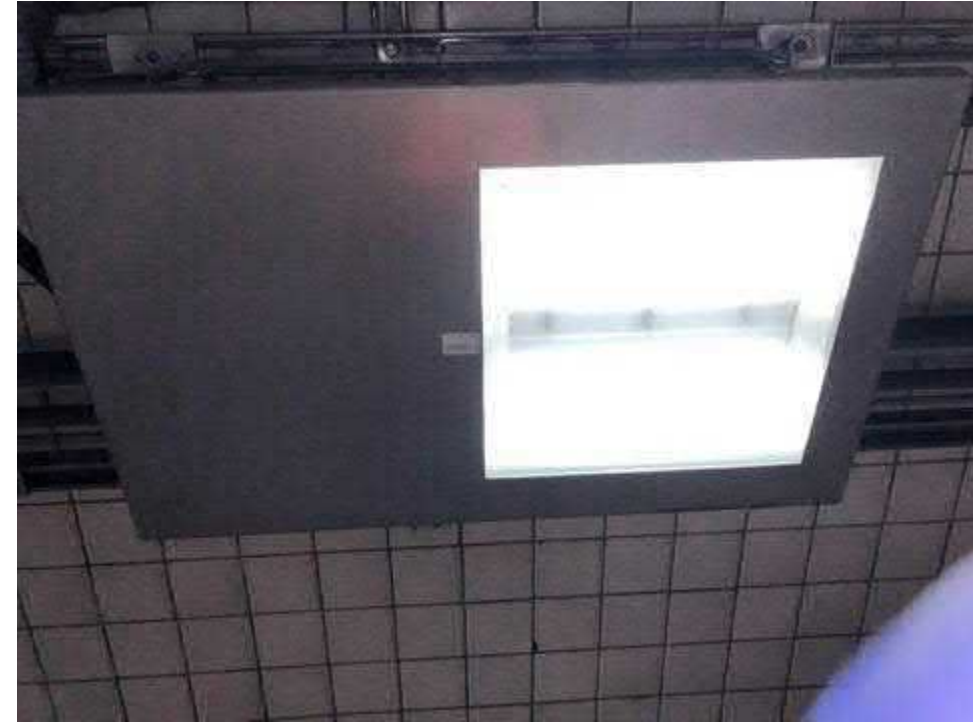
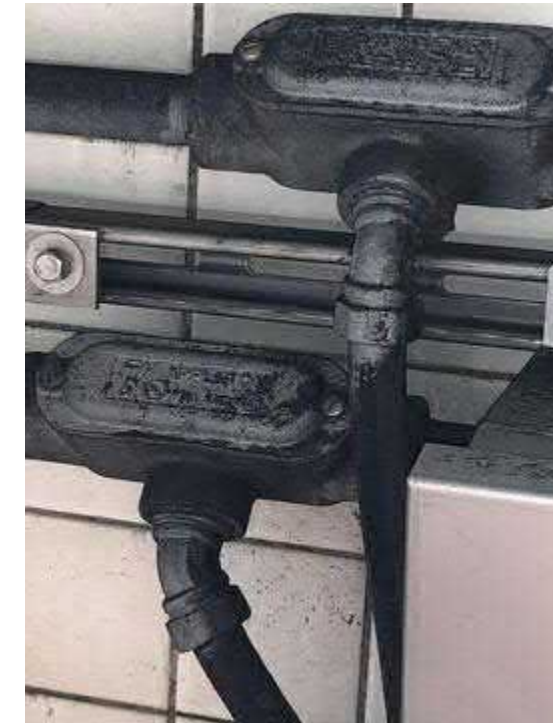
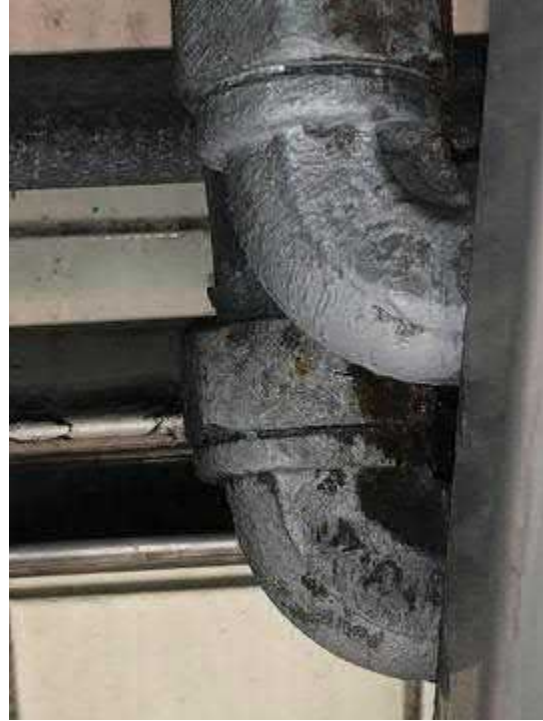
Lighting Fixture Information	
Luminaire Tag or Number:	NB - East Wall - 69B
Tunnel Direction and Side:	NB - East Wall
Additional Information:	T Side Entry L

Are there any signs of corrosion evident on the tunnel lighting system raceways?	Yes
Are the side entry conduits into the fixture tightly secured?	Yes
Are there any signs of corrosion on the fixture?	Yes
Is there any damage to the component housing or enclosure?	No
Is the light fixture secure to the mounting channels?	Yes
Long channel springnut misaligned?	No
Long channel springnut cracked?	No
Trans channel springnut misaligned?	No
Trans channel springnut cracked?	No
Trans channel wireway clip?	Yes
Housing clip disengaged?	No
Housing clip missing?	No
Lens clip disengaged?	No
Lens clip broken?	No
Lens cover cracked?	No
Wireway ears broken?	No
Luminaire functioning?	Yes

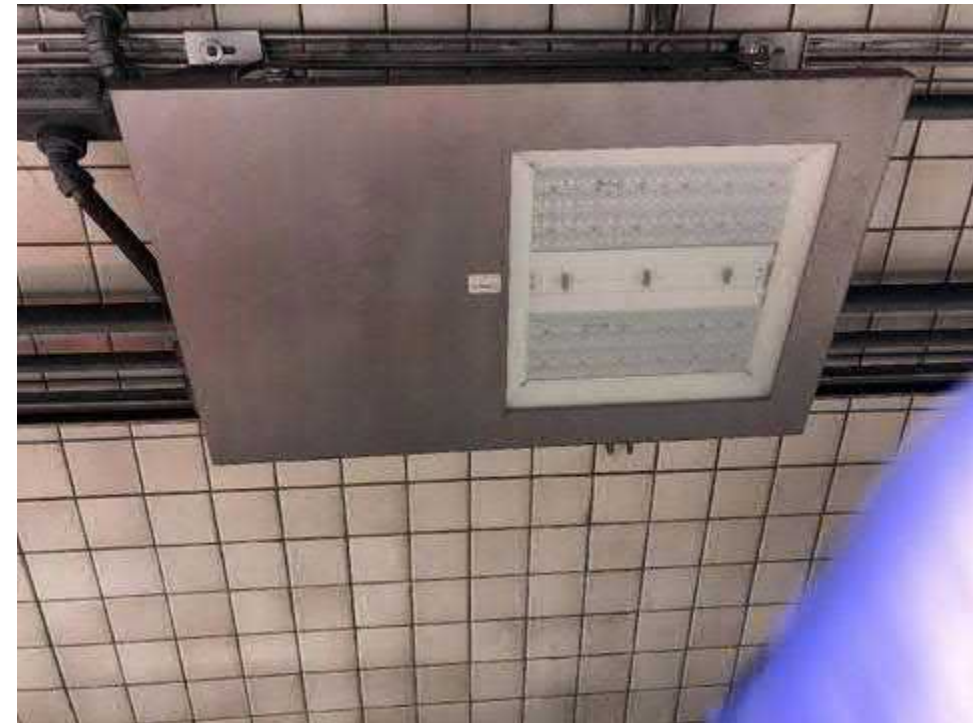
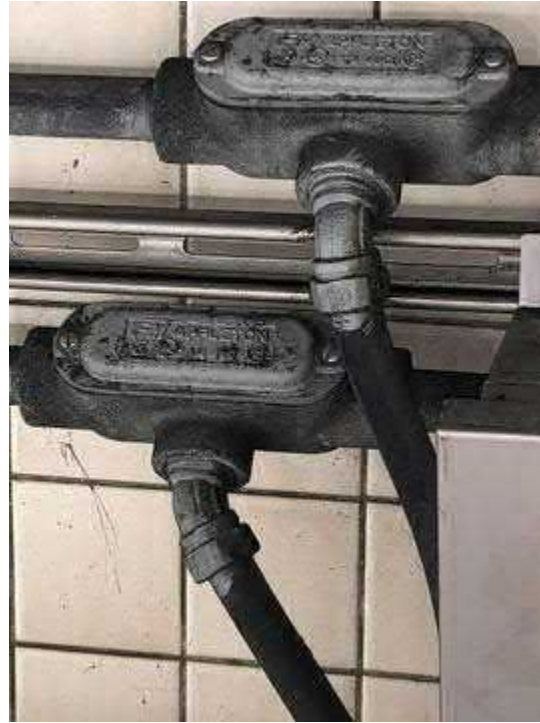
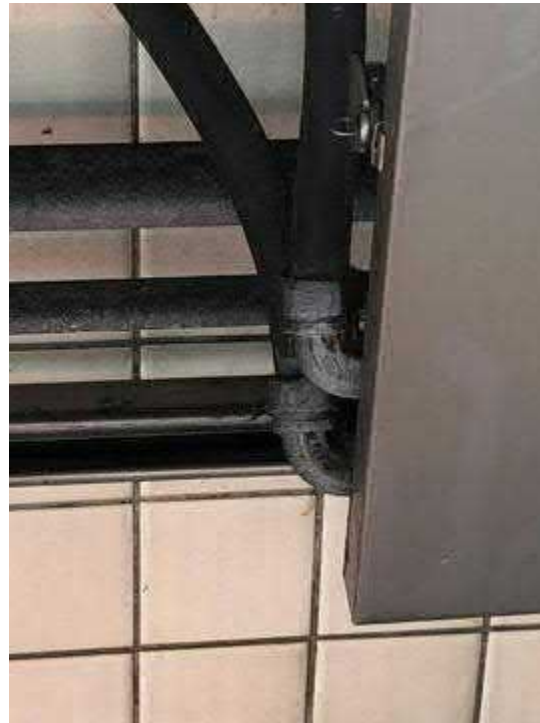
Lighting Fixture Information	
Luminaire Tag or Number:	NB - East Wall - 87B
Tunnel Direction and Side:	NB - East Wall
Additional Information:	T Side entry L Side Entry top loose

Are there any signs of corrosion evident on the tunnel lighting system raceways?
Are the side entry conduits into the fixture tightly secured?
Are there any signs of corrosion on the fixture?
Is there any damage to the component housing or enclosure?
Is the light fixture secure to the mounting channels?
Long channel springnut misaligned?
Long channel springnut cracked?
Trans channel springnut cracked?
Trans channel springnut misaligned?
Trans channel wireway clip?
Housing clip disengaged?
Housing clip missing?
Lens clip disengaged?
Lens clip broken?
Lens cover cracked?
Wireway ears broken?
Luminaire functioning?

Yes	No	No	No	No	No	No	Yes	No	No	No	No	Yes	No	Yes	Yes	Yes
-----	----	----	----	----	----	----	-----	----	----	----	----	-----	----	-----	-----	-----

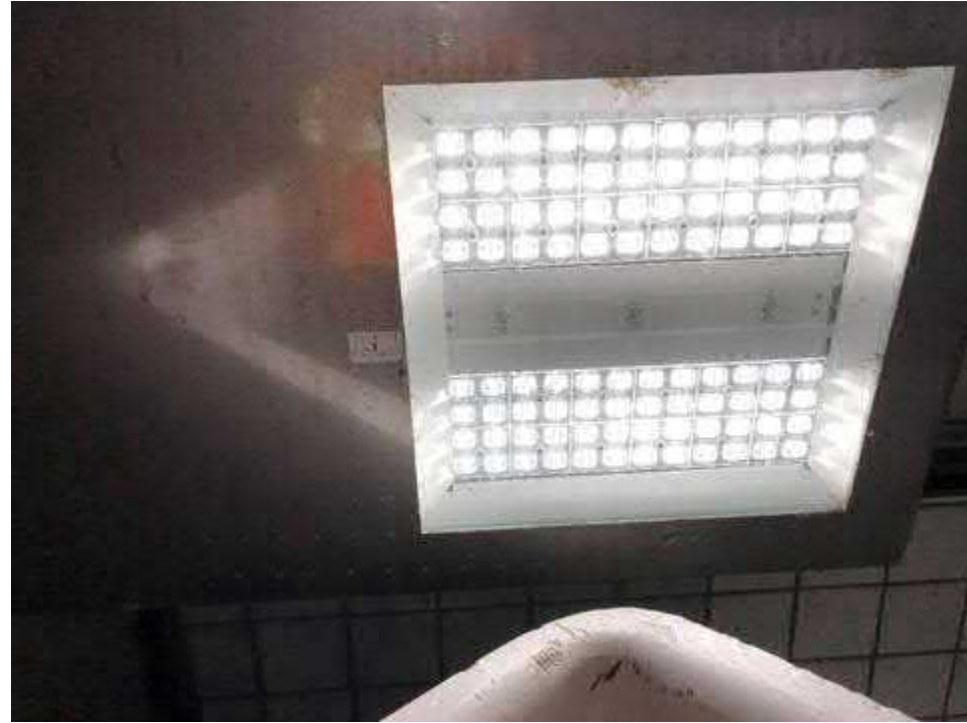
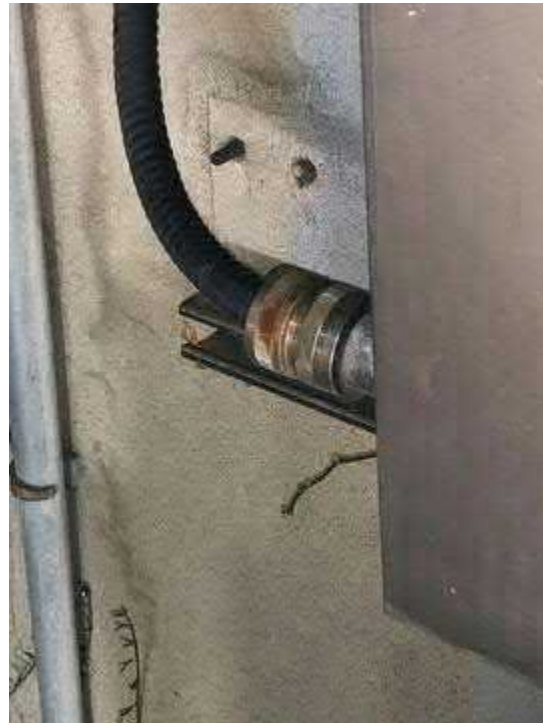
Lighting Fixture Information	
Luminaire Tag or Number:	SBR - West Wall - 1A
Tunnel Direction and Side:	SBR - West Wall
Additional Information:	Side Entry Conduit Corrosion

Are there any signs of corrosion evident on the tunnel lighting system raceways?	No
Are the side entry conduits into the fixture tightly secured?	Yes
Are there any signs of corrosion on the fixture?	No
Is there any damage to the component housing or enclosure?	No
Is the light fixture secure to the mounting channels?	Yes
Long channel springnut misaligned?	No
Long channel springnut cracked?	No
Trans channel springnut misaligned?	No
Trans channel springnut cracked?	No
Trans channel wireway clip?	Yes
Housing clip disengaged?	No
Housing clip missing?	No
Lens clip disengaged?	No
Lens clip broken?	No
Lens cover cracked?	No
Wireway ears broken?	No
Luminaire functioning?	Yes

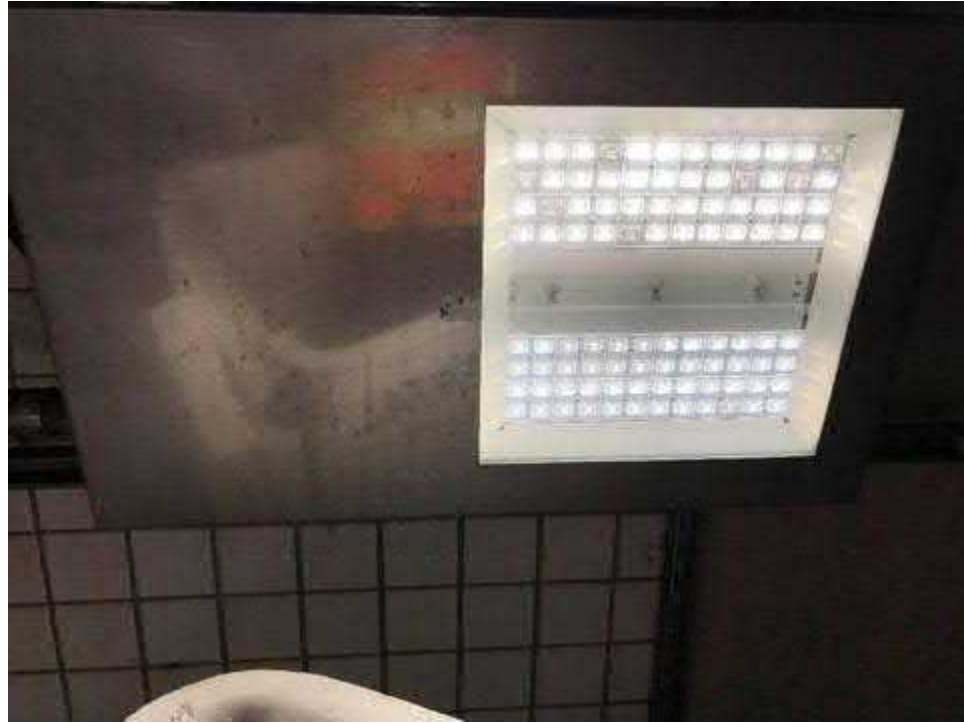
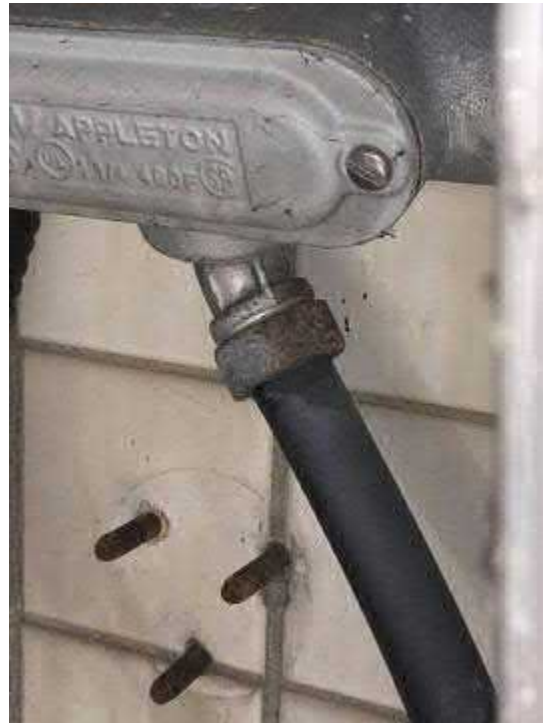
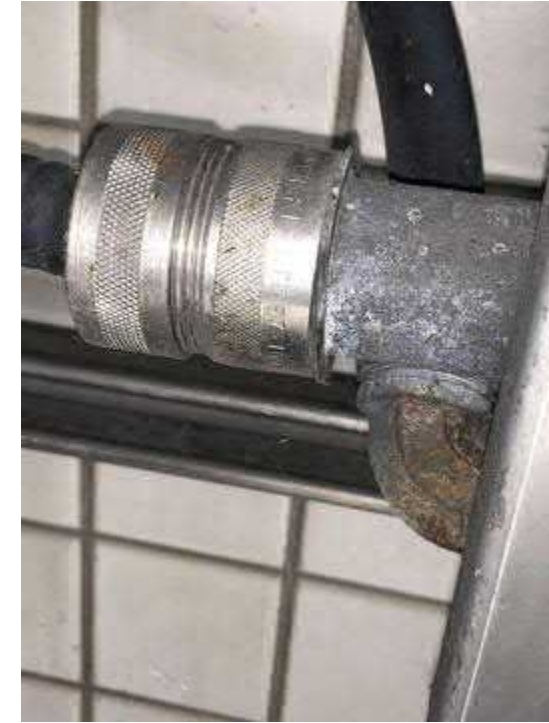
Lighting Fixture Information	
Luminaire Tag or Number:	SBR - East Wall - 1A
Tunnel Direction and Side:	SBR - East Wall
Additional Information:	T Side Entry L Top Right Side Entry Bottom loose

Are there any signs of corrosion evident on the tunnel lighting system raceways?	Yes
Are the side entry conduits into the fixture tightly secured?	No
Are there any signs of corrosion on the fixture?	No
Is there any damage to the component housing or enclosure?	No
Is the light fixture secure to the mounting channels?	No
Long channel springnut misaligned?	No
Long channel springnut cracked?	No
Trans channel springnut misaligned?	Yes
Trans channel springnut cracked?	No
Trans channel wireway clip?	Yes
Housing clip disengaged?	No
Housing clip missing?	No
Lens clip disengaged?	No
Lens clip broken?	No
Lens cover cracked?	No
Wireway ears broken?	No
Luminaire functioning?	Yes

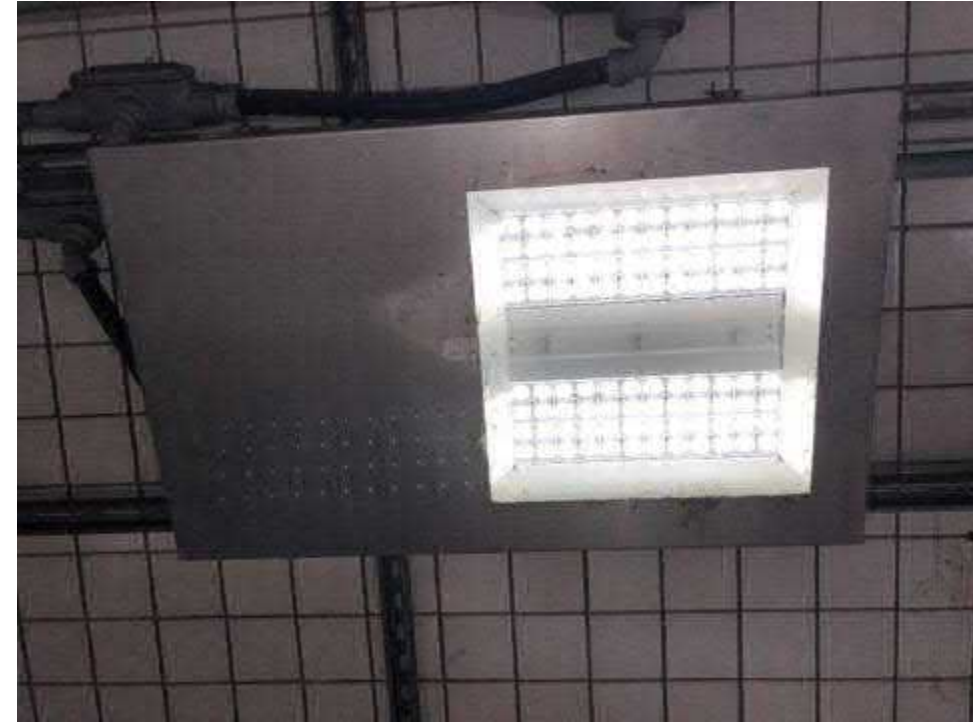
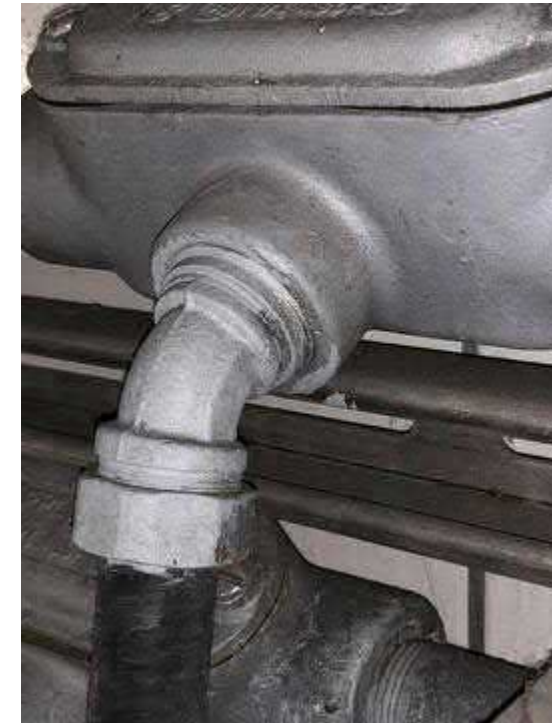
Lighting Fixture Information	
Luminaire Tag or Number:	SBR - West Wall - 6A
Tunnel Direction and Side:	SBR - West Wall
Additional Information:	T

Are there any signs of corrosion evident on the tunnel lighting system raceways?	Yes
Are the side entry conduits into the fixture tightly secured?	Yes
Are there any signs of corrosion on the fixture?	No
Is there any damage to the component housing or enclosure?	No
Is the light fixture secure to the mounting channels?	Yes
Long channel springnut misaligned?	No
Long channel springnut cracked?	No
Trans channel springnut misaligned?	No
Trans channel springnut cracked?	No
Trans channel wireway clip?	Yes
Housing clip disengaged?	No
Housing clip missing?	No
Lens clip disengaged?	No
Lens clip broken?	No
Lens cover cracked?	No
Wireway ears broken?	No
Luminaire functioning?	Yes
