# **Lytle Tunnel (HAM-71-0134) Inspection Report Fall 2020**

PID 105470

November, 2020

Ohio Department of  
Transportation  
District 8  
505 South State Route 741  
Lebanon, OH 45036

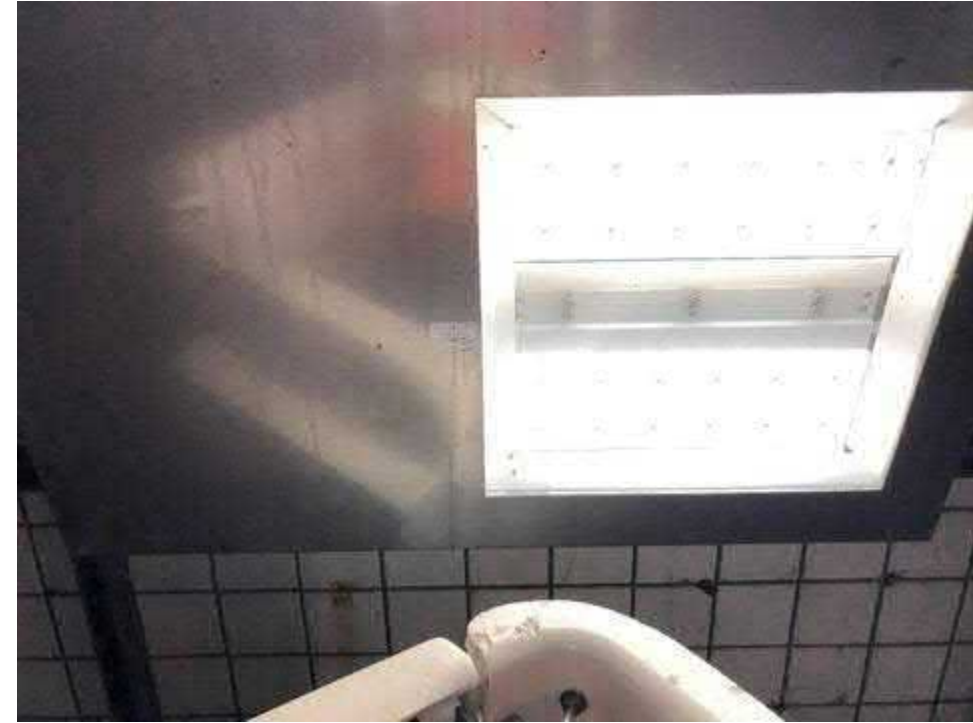
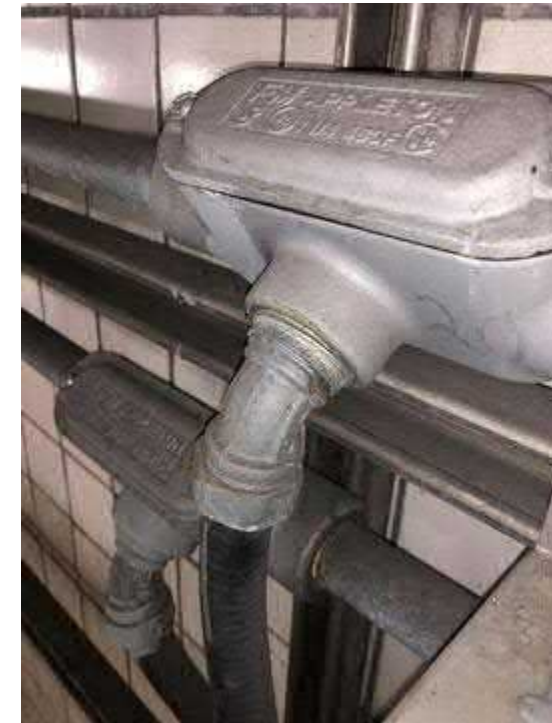
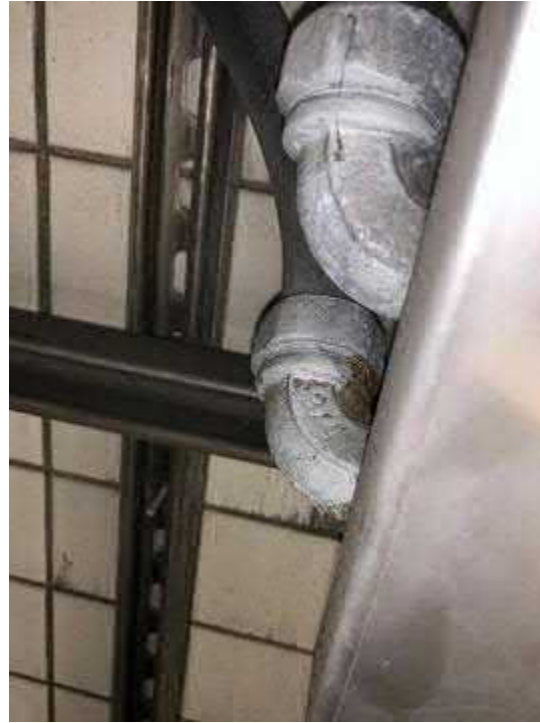
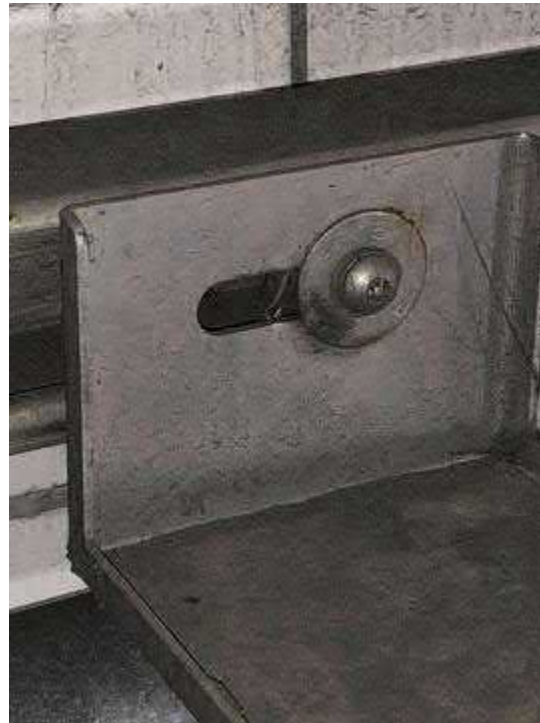
Lighting Fixture Information	
Luminaire Tag or Number:	SBR - East Wall - 6A
Tunnel Direction and Side:	SBR - East Wall
Additional Information:	T Side Entry L Top Right Misaligned Bottom Left

Are there any signs of corrosion evident on the tunnel lighting system raceways?	Yes
Are the side entry conduits into the fixture tightly secured?	Yes
Are there any signs of corrosion on the fixture?	No
Is there any damage to the component housing or enclosure?	No
Is the light fixture secure to the mounting channels?	Yes
Long channel springnut misaligned?	No
Long channel springnut cracked?	No
Trans channel springnut misaligned?	Yes
Trans channel springnut cracked?	No
Trans channel wireway clip?	Yes
Housing clip disengaged?	No
Housing clip missing?	No
Lens clip disengaged?	No
Lens clip broken?	No
Lens cover cracked?	No
Wireway ears broken?	No
Luminaire functioning?	Yes

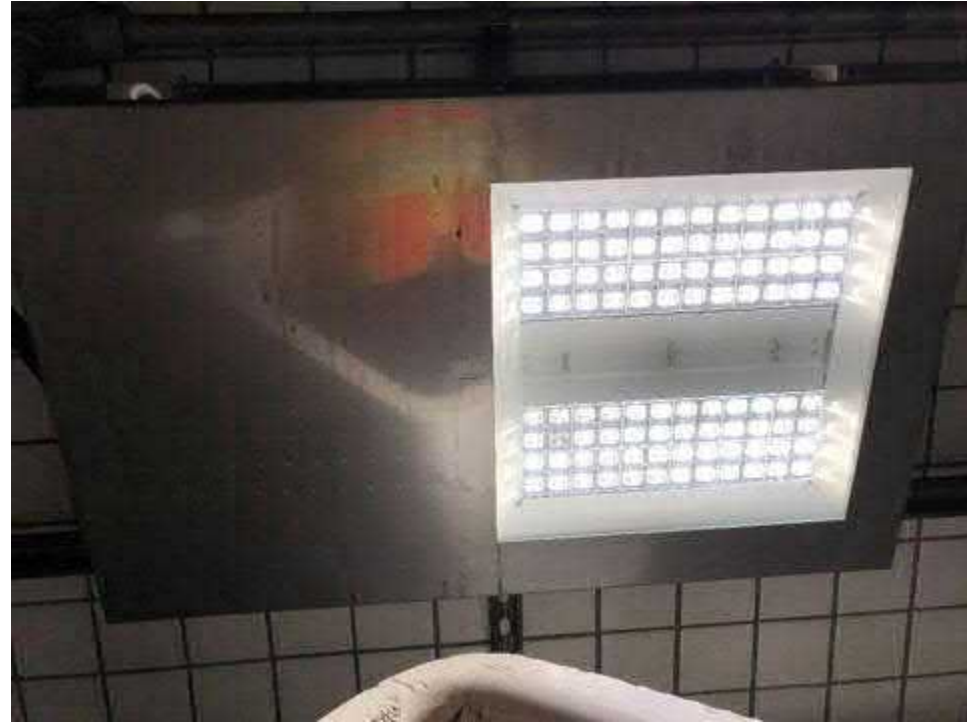
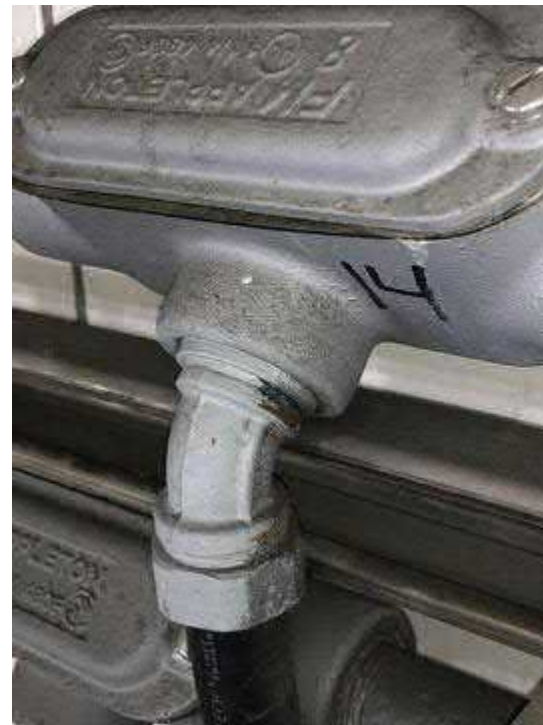
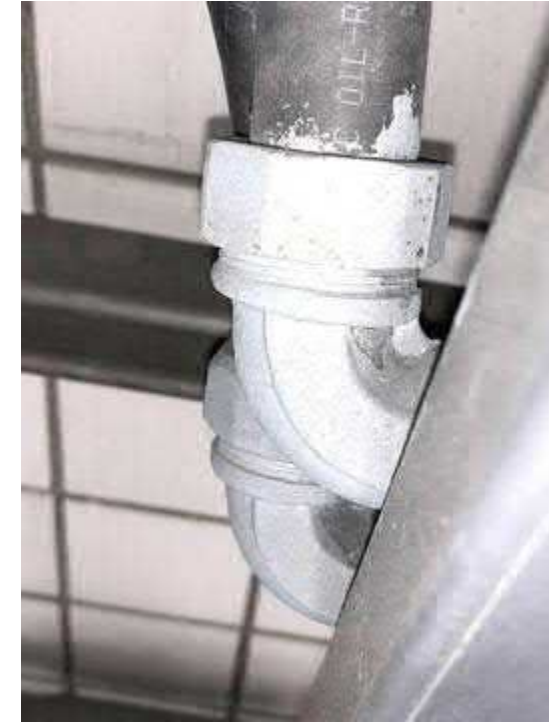
Lighting Fixture Information	
Luminaire Tag or Number:	SBR - West Wall - 11A
Tunnel Direction and Side:	SBR - West Wall -
Additional Information:	T Side Entry L

Are there any signs of corrosion evident on the tunnel lighting system raceways?	Yes
Are the side entry conduits into the fixture tightly secured?	Yes
Are there any signs of corrosion on the fixture?	No
Is there any damage to the component housing or enclosure?	No
Is the light fixture secure to the mounting channels?	Yes
Long channel springnut misaligned?	No
Long channel springnut cracked?	No
Trans channel springnut misaligned?	No
Trans channel springnut cracked?	No
Trans channel wireway clip?	Yes
Housing clip disengaged?	No
Housing clip missing?	No
Lens clip disengaged?	No
Lens clip broken?	No
Lens cover cracked?	No
Wireway ears broken?	No
Luminaire functioning?	Yes

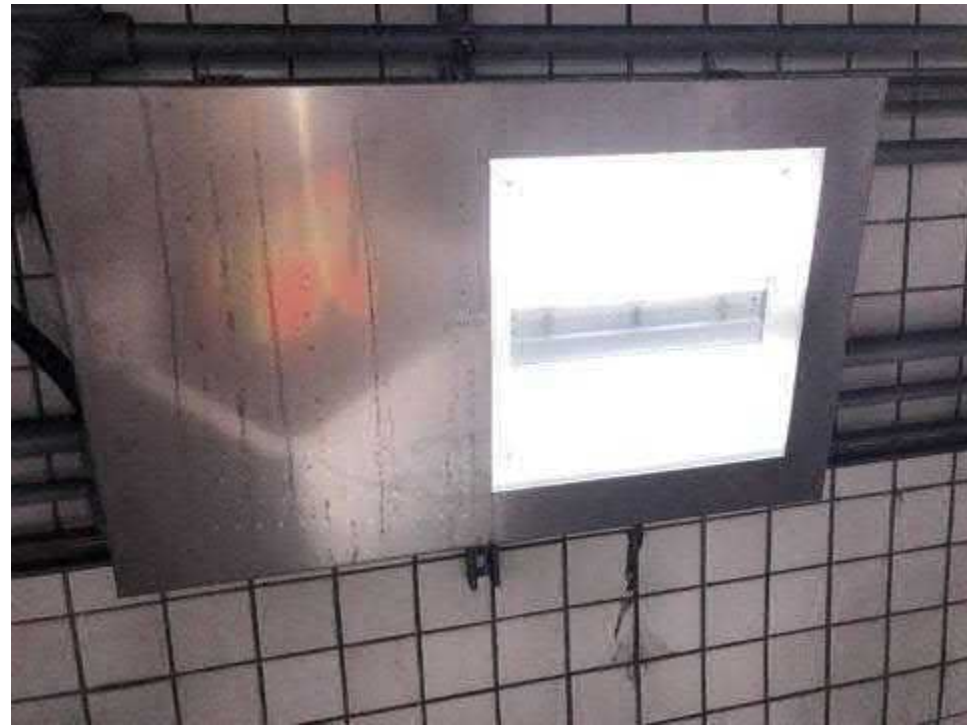
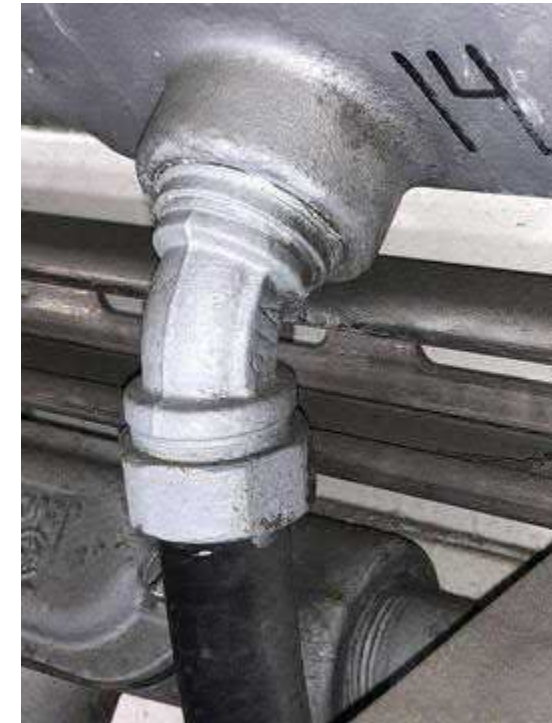
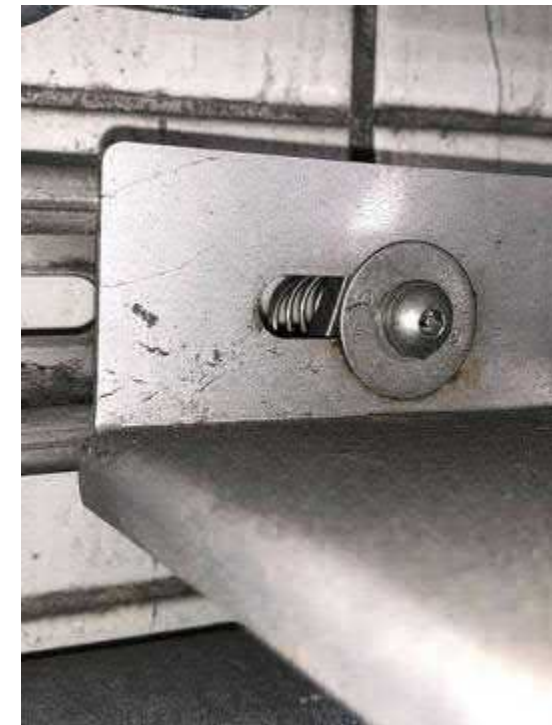
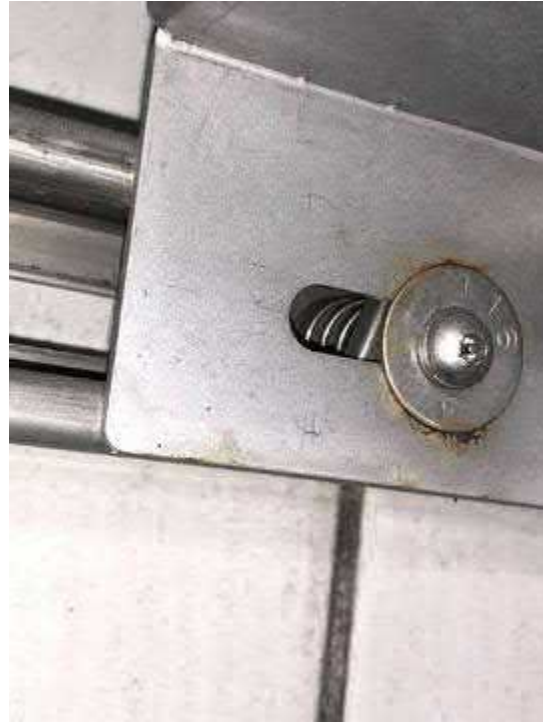
Lighting Fixture Information	
Luminaire Tag or Number:	SBR - West Wall - 11B
Tunnel Direction and Side:	SBR - West Wall
Additional Information:	T Top Left Bottom Left

Are there any signs of corrosion evident on the tunnel lighting system raceways?
Are the side entry conduits into the fixture tightly secured?
Are there any signs of corrosion on the fixture?
Is there any damage to the component housing or enclosure?
Is the light fixture secure to the mounting channels?
Long channel springnut misaligned?
Long channel springnut cracked?
Trans channel springnut misaligned?
Trans channel springnut cracked?
Trans channel wireway clip?
Housing clip disengaged?
Housing clip missing?
Lens clip disengaged?
Lens clip broken?
Lens cover cracked?
Wireway ears broken?
Luminaire functioning?

Yes	No	No	No	No	No	No	Yes	No	Yes	No	No	Yes	No	No	Yes	Yes
-----	----	----	----	----	----	----	-----	----	-----	----	----	-----	----	----	-----	-----

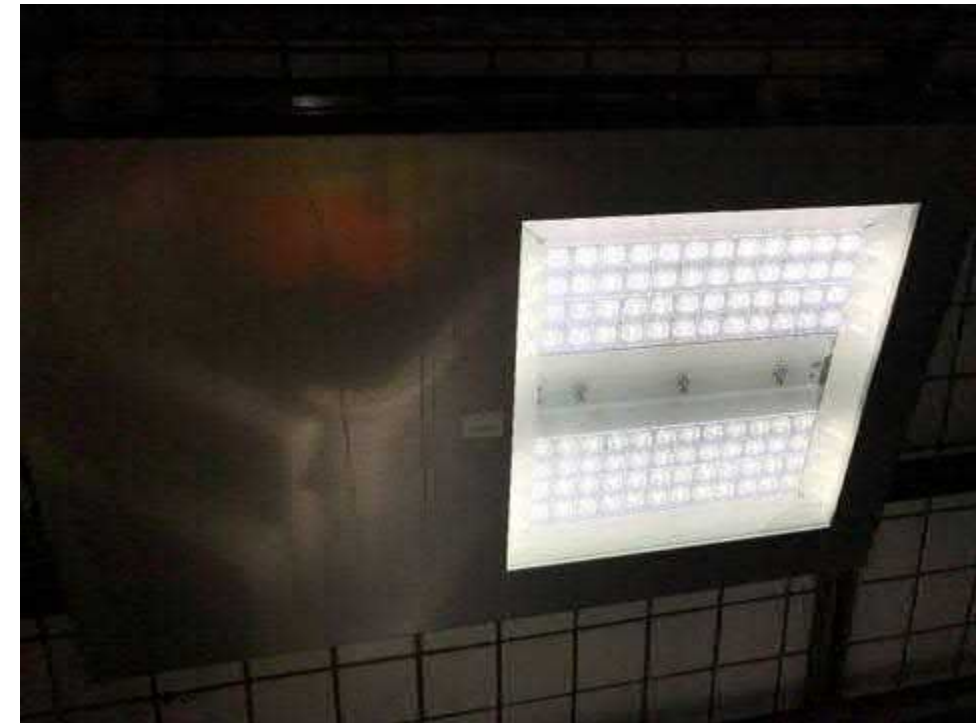
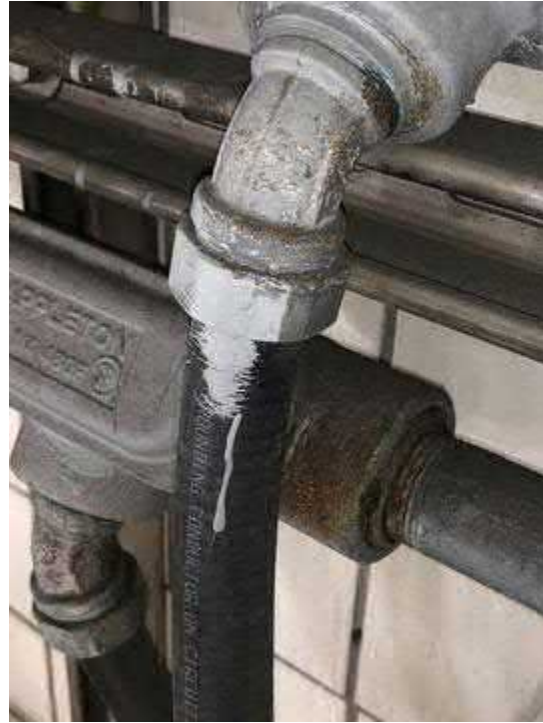
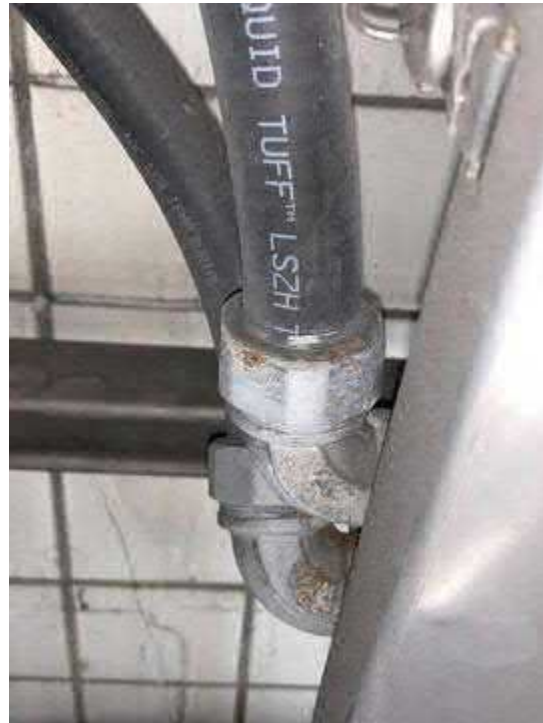
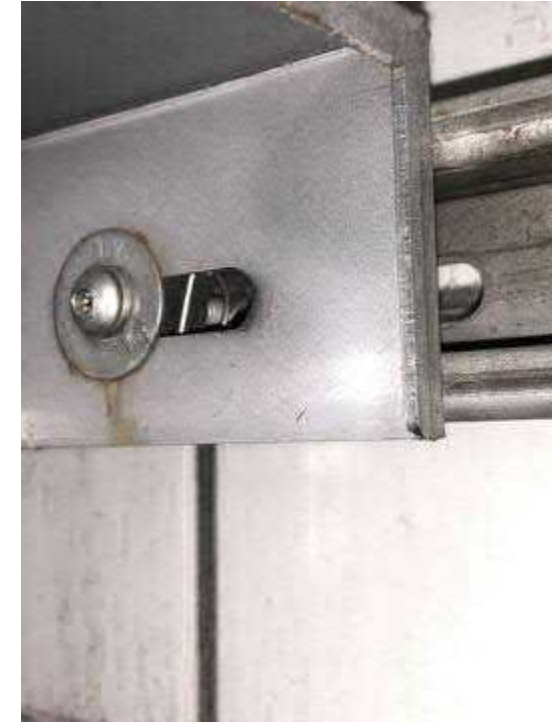
Lighting Fixture Information	
Luminaire Tag or Number:	SBR - East Wall - 11A
Tunnel Direction and Side:	SBR - East Wall
Additional Information:	T Side Entry L Side Entry Loose Bottom Left

Are there any signs of corrosion evident on the tunnel lighting system raceways?
Are the side entry conduits into the fixture tightly secured?
Are there any signs of corrosion on the fixture?
Is there any damage to the component housing or enclosure?
Is the light fixture secure to the mounting channels?
Long channel springnut misaligned?
Long channel springnut cracked?
Trans channel springnut cracked?
Trans channel springnut misaligned?
Trans channel wireway clip?
Housing clip disengaged?
Housing clip missing?
Lens clip disengaged?
Lens clip broken?
Lens cover cracked?
Wireway ears broken?
Luminaire functioning?

Yes	No	No	No	No	No	No	Yes	No	Yes	No	No	Yes	No	No	No	Yes
-----	----	----	----	----	----	----	-----	----	-----	----	----	-----	----	----	----	-----

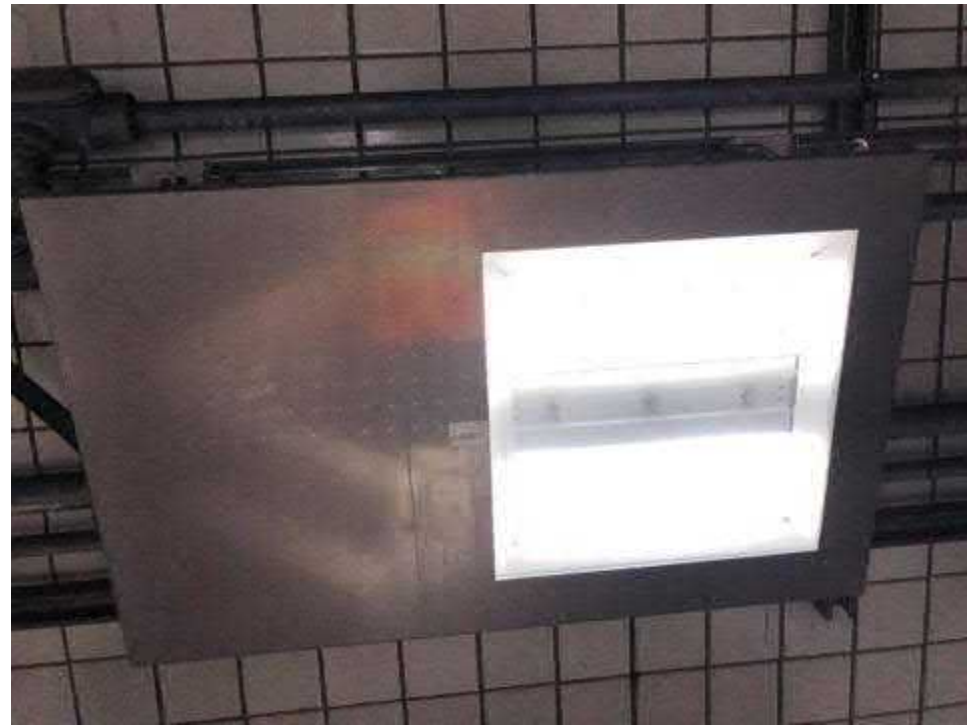
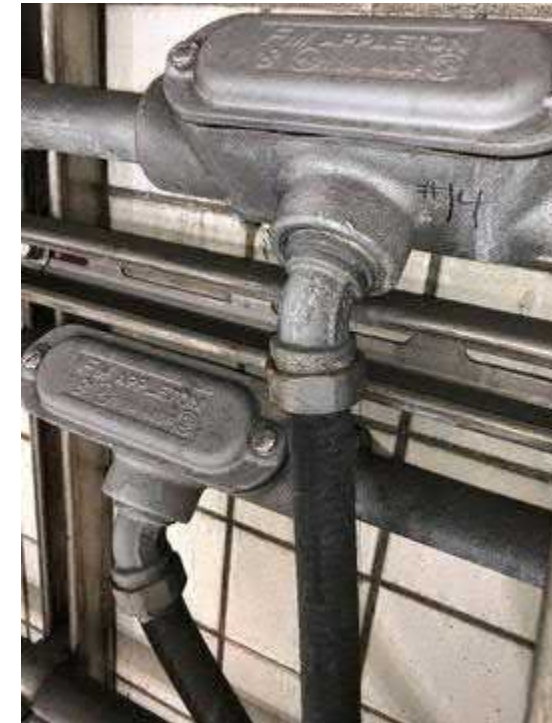
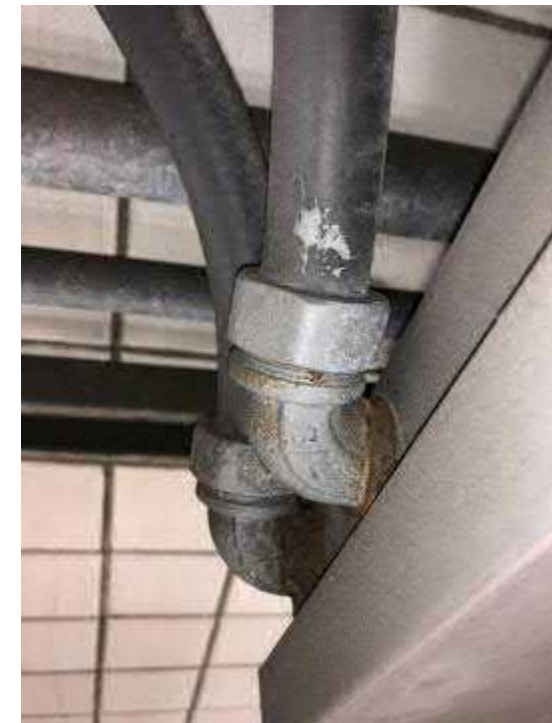
Lighting Fixture Information	
<b>Luminaire Tag or Number:</b>	SBR - East Wall - 11B
<b>Tunnel Direction and Side:</b>	SBR - East Wall
<b>Additional Information:</b>	T Side Entry L Top Left Both Bottom

Are there any signs of corrosion evident on the tunnel lighting system raceways?
Are the side entry conduits into the fixture tightly secured?
Are there any signs of corrosion on the fixture?
Is there any damage to the component housing or enclosure?
Is the light fixture secure to the mounting channels?
Long channel springnut misaligned?
Long channel springnut cracked?
Trans channel springnut misaligned?
Trans channel springnut cracked?
Trans channel wireway clip?
Housing clip disengaged?
Housing clip missing?
Lens clip disengaged?
Lens clip broken?
Lens cover cracked?
Wireway ears broken?
Luminaire functioning?

Yes	No	No	No	No	No	No	Yes	No	Yes	No	No	Yes	No	No	Yes	Yes
-----	----	----	----	----	----	----	-----	----	-----	----	----	-----	----	----	-----	-----

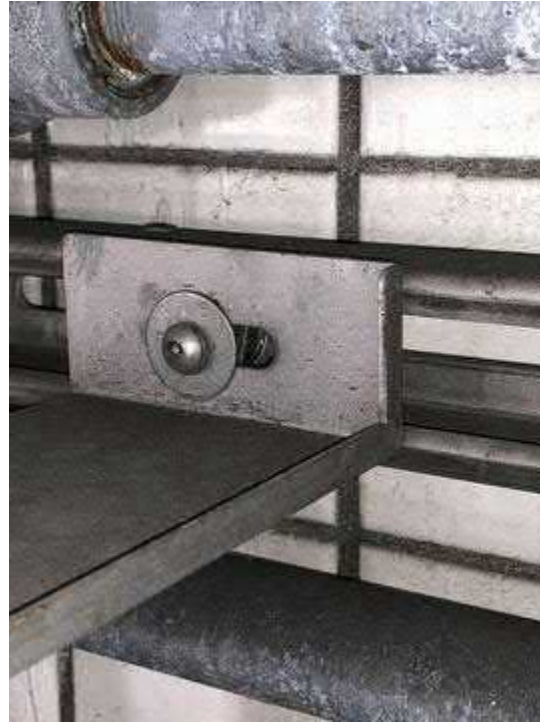
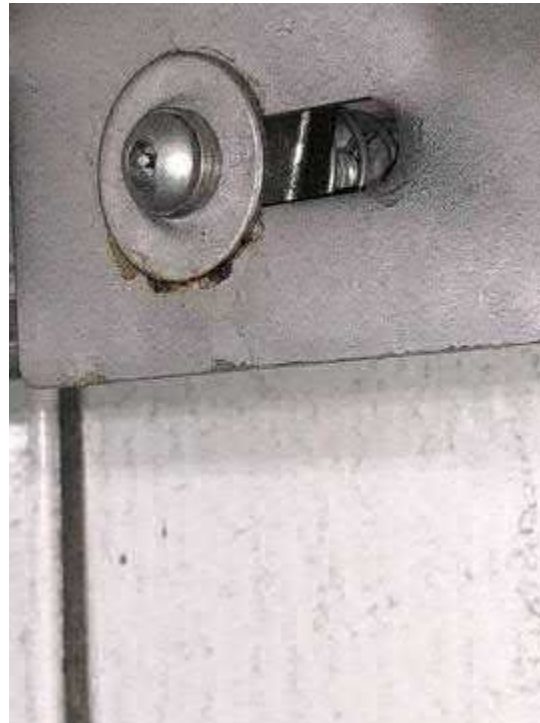
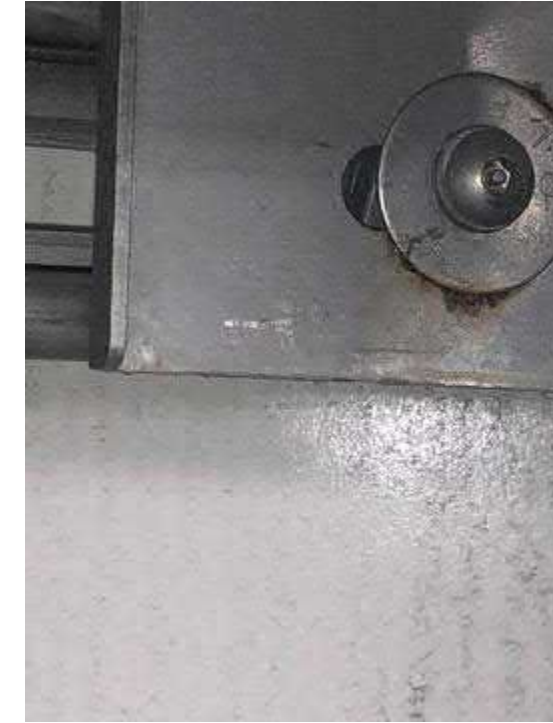
Lighting Fixture Information	
<b>Luminaire Tag or Number:</b>	SBR - West Wall - 18A
<b>Tunnel Direction and Side:</b>	SBR - West Wall
<b>Additional Information:</b>	Side Entry L Bottom Side Entry Loose Top Right Bottom Right

Are there any signs of corrosion evident on the tunnel lighting system raceways?
Are the side entry conduits into the fixture tightly secured?
Are there any signs of corrosion on the fixture?
Is there any damage to the component housing or enclosure?
Is the light fixture secure to the mounting channels?
Long channel springnut misaligned?
Long channel springnut cracked?
Trans channel springnut misaligned?
Trans channel springnut cracked?
Trans channel wireway clip?
Housing clip disengaged?
Housing clip missing?
Lens clip disengaged?
Lens clip broken?
Lens cover cracked?
Wireway ears broken?
Luminaire functioning?

Yes	No	No		No	No	No	Yes	No	Yes	No	No	No	No	No	No	Yes
-----	----	----	--	----	----	----	-----	----	-----	----	----	----	----	----	----	-----

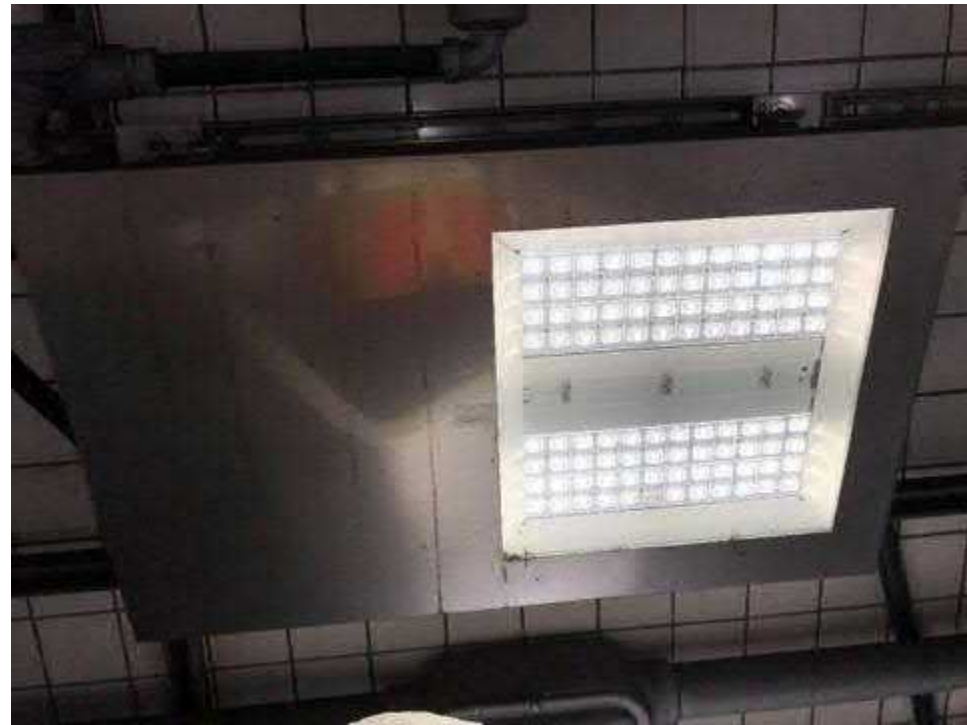
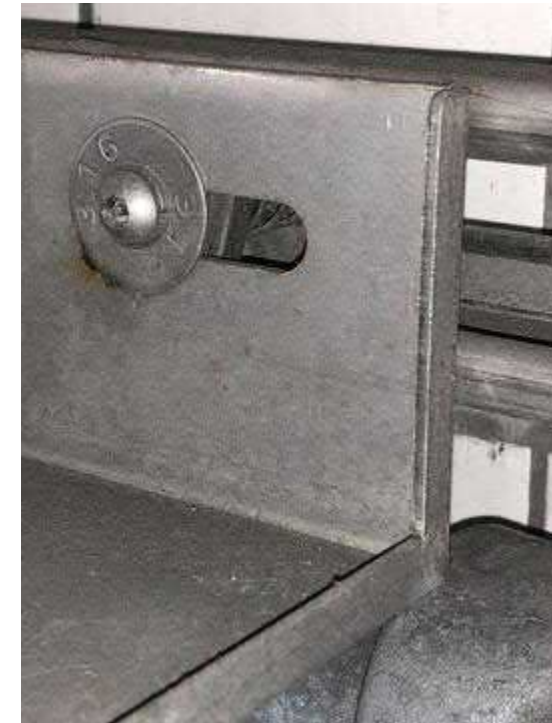
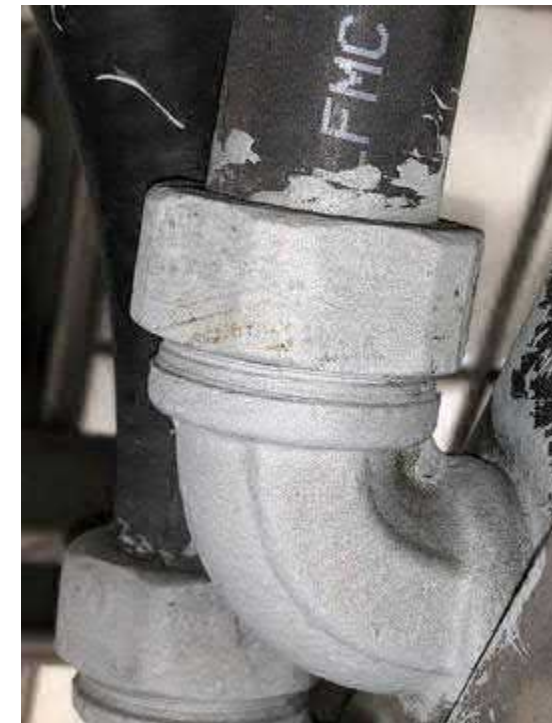
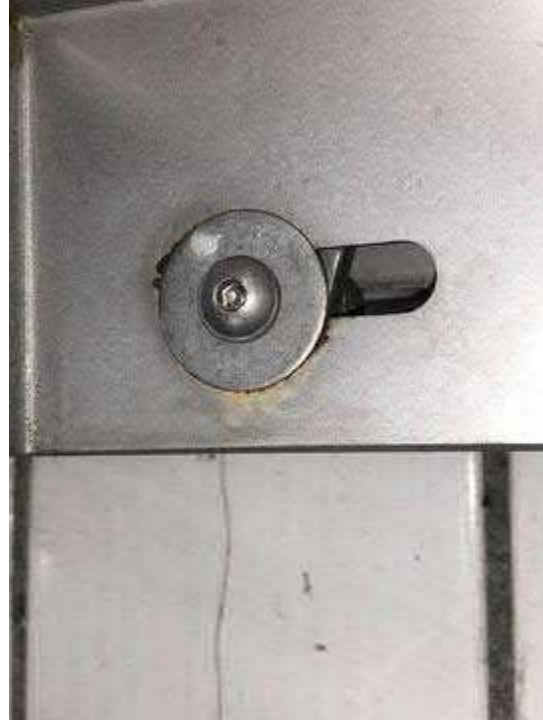
Are there any signs of corrosion evident on the tunnel lighting system raceways?
Are the side entry conduits into the fixture tightly secured?
Are there any signs of corrosion on the fixture?
Is there any damage to the component housing or enclosure?
Is the light fixture secure to the mounting channels?
Long channel springnut misaligned?
Long channel springnut cracked?
Trans channel springnut cracked?
Trans channel springnut misaligned?
Trans channel wireway clip?
Housing clip disengaged?
Housing clip missing?
Lens clip disengaged?
Lens clip broken?
Lens cover cracked?
Wireway ears broken?
Luminaire functioning?

Yes	No	No	No	No	No	No	Yes	No	No	No	No	Yes	No	No	Yes	Yes
-----	----	----	----	----	----	----	-----	----	----	----	----	-----	----	----	-----	-----

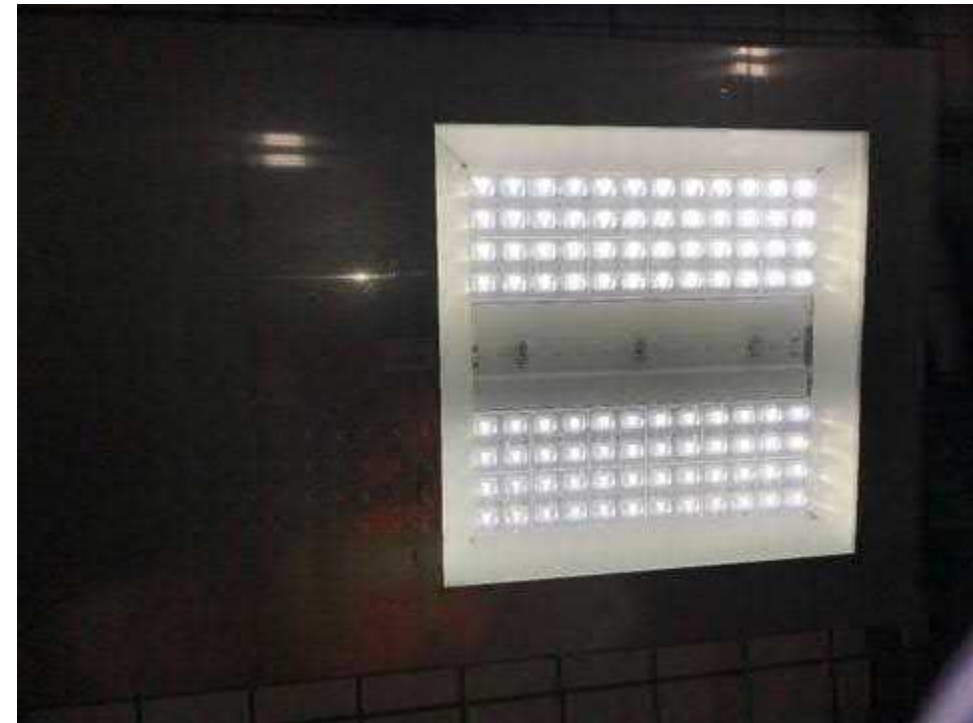
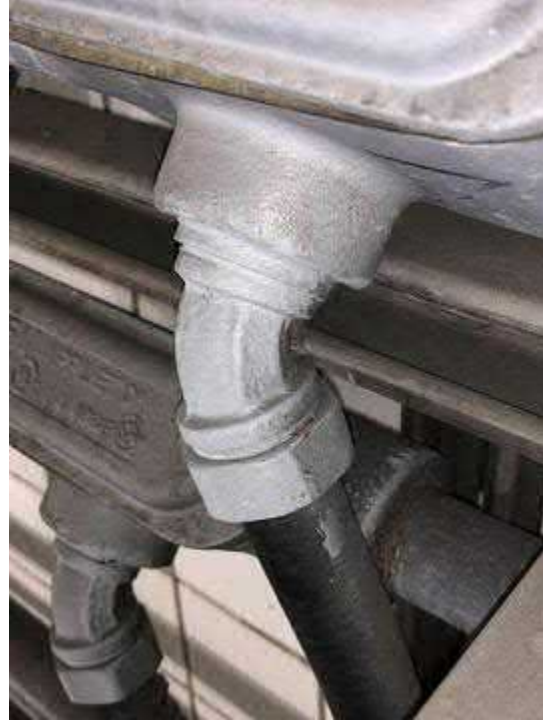
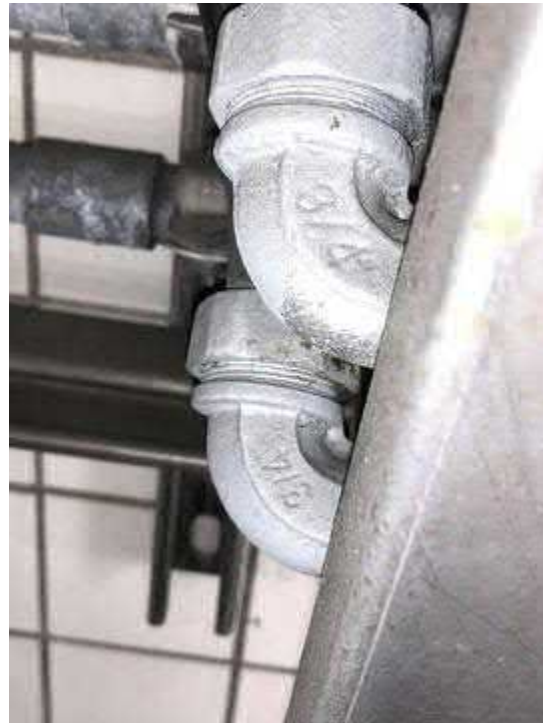
Lighting Fixture Information	
Luminaire Tag or Number:	SBR - East Wall - 18A
Tunnel Direction and Side:	SBR - East Wall
Additional Information:	T Side Entry L

Are there any signs of corrosion evident on the tunnel lighting system raceways?	Yes
Are the side entry conduits into the fixture tightly secured?	Yes
Are there any signs of corrosion on the fixture?	Yes
Is there any damage to the component housing or enclosure?	No
Is the light fixture secure to the mounting channels?	Yes
Long channel springnut misaligned?	
Long channel springnut cracked?	No
Trans channel springnut misaligned?	No
Trans channel springnut cracked?	No
Trans channel wireway clip?	Yes
Housing clip disengaged?	No
Housing clip missing?	No
Lens clip disengaged?	No
Lens clip broken?	No
Lens cover cracked?	
Wireway ears broken?	No
Luminaire functioning?	Yes

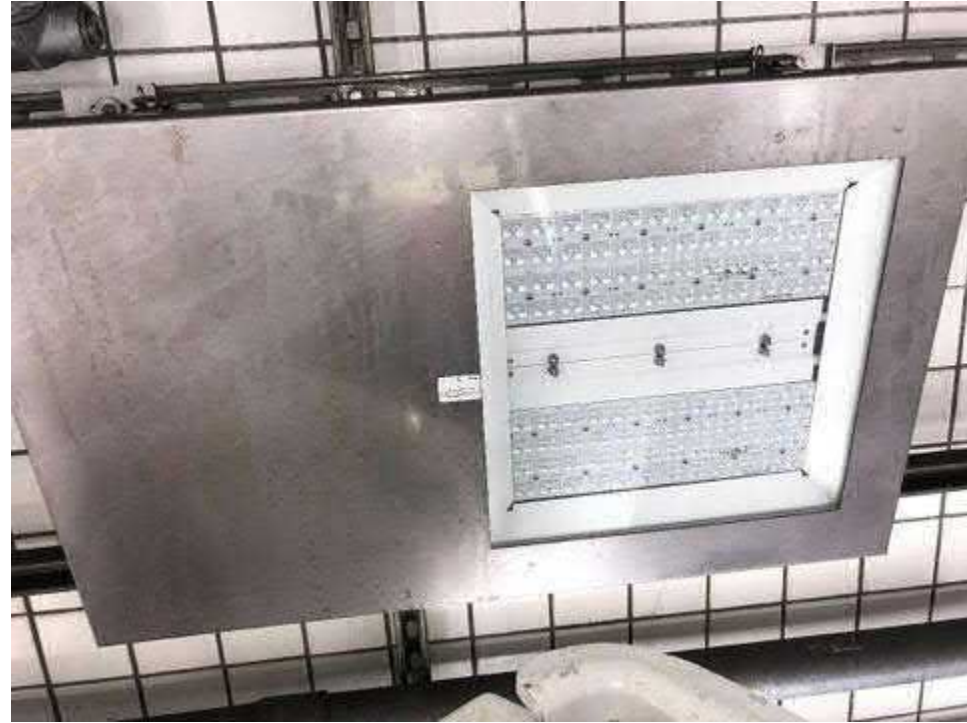
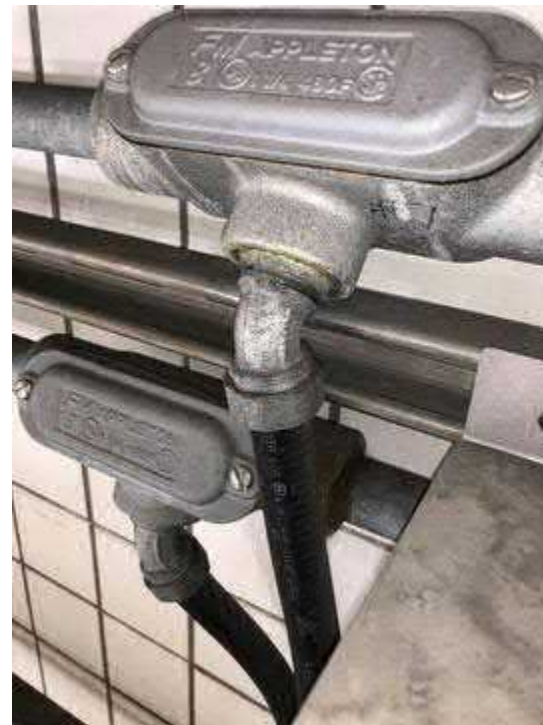
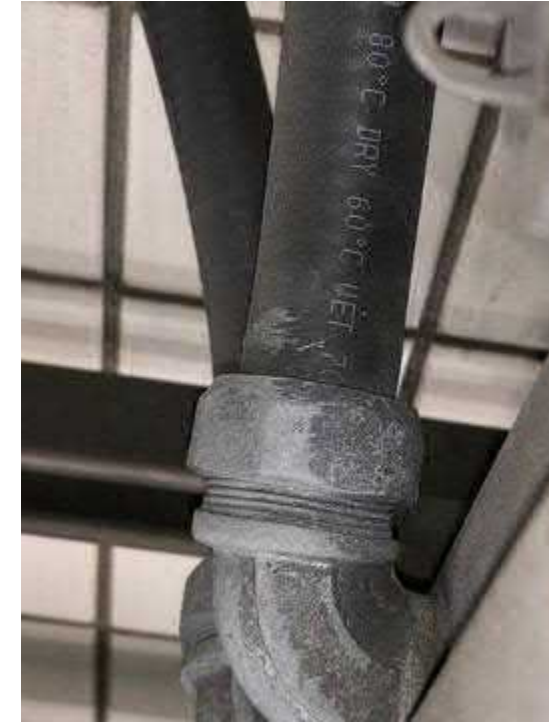
Lighting Fixture Information	
Luminaire Tag or Number:	SBR - East Wall - 18B
Tunnel Direction and Side:	SBR - East Wall
Additional Information:	T Side Entry L Top Left

Are there any signs of corrosion evident on the tunnel lighting system raceways?
Are the side entry conduits into the fixture tightly secured?
Are there any signs of corrosion on the fixture?
Is there any damage to the component housing or enclosure?
Is the light fixture secure to the mounting channels?
Long channel springnut misaligned?
Long channel springnut cracked?
Trans channel springnut misaligned?
Trans channel springnut cracked?
Trans channel wireway clip?
Housing clip disengaged?
Housing clip missing?
Lens clip disengaged?
Lens clip broken?
Lens cover cracked?
Wireway ears broken?
Luminaire functioning?

Yes	No	No	No	No	No	No	Yes	No	Yes	No	No	Yes	No	No	Yes	Yes
-----	----	----	----	----	----	----	-----	----	-----	----	----	-----	----	----	-----	-----

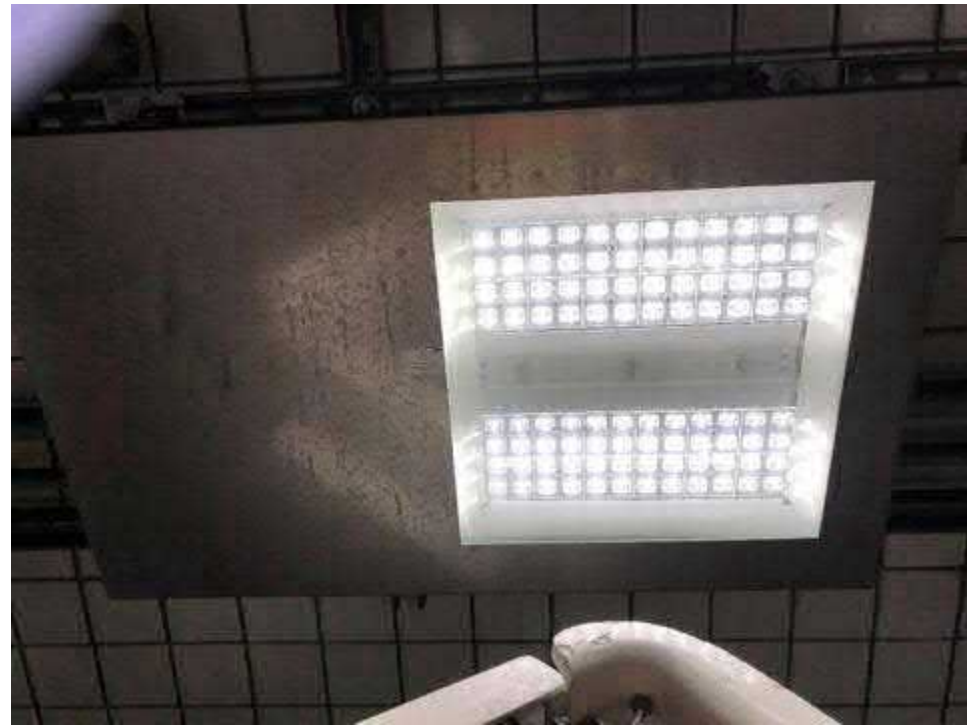
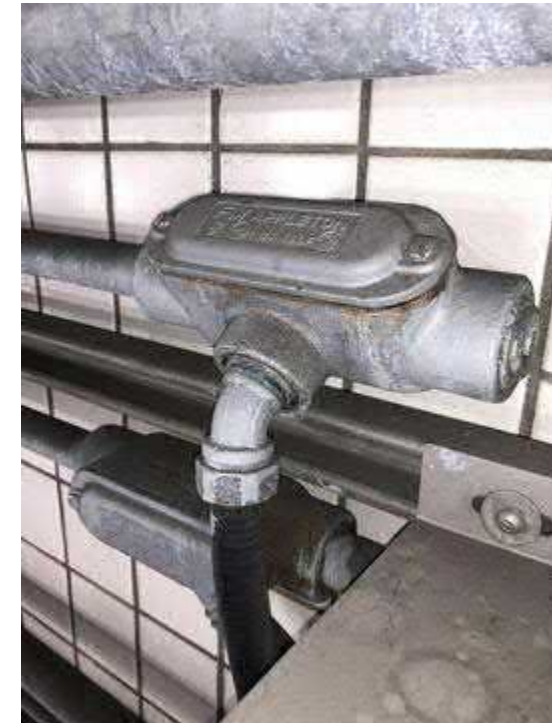
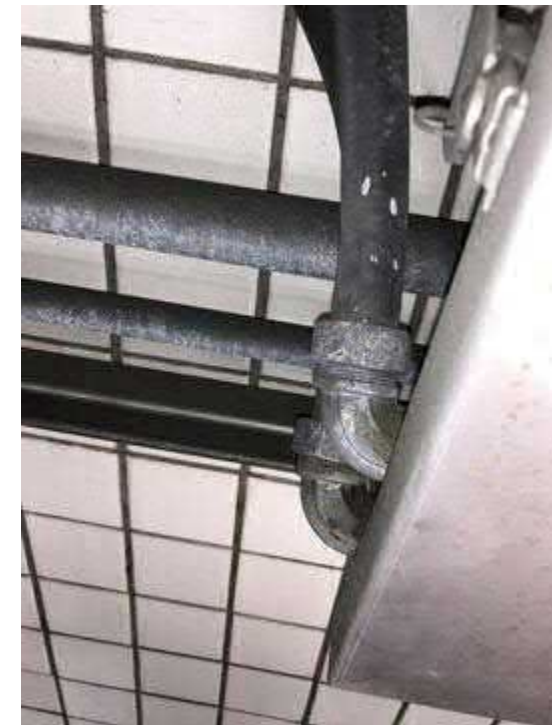
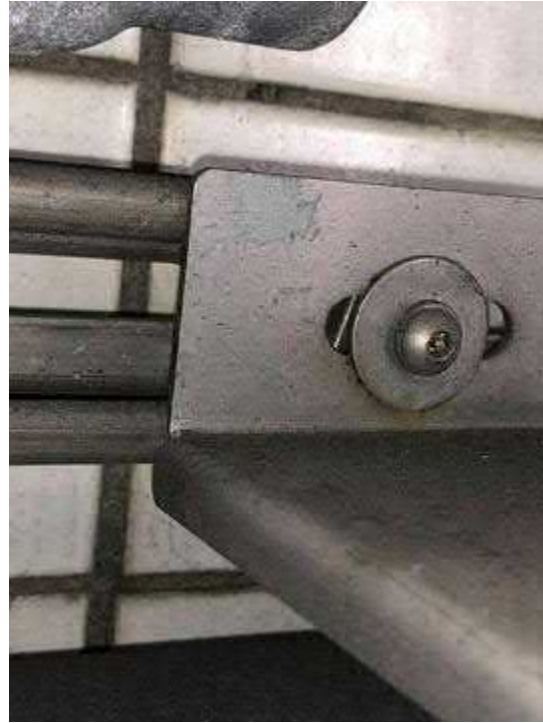
Lighting Fixture Information	
Luminaire Tag or Number:	SBR - West Wall - 22A
Tunnel Direction and Side:	SBR - West Wall
Additional Information:	T Top Left Top Fixture Hooks Misaligned

Are there any signs of corrosion evident on the tunnel lighting system raceways?
Are the side entry conduits into the fixture tightly secured?
Are there any signs of corrosion on the fixture?
Is there any damage to the component housing or enclosure?
Is the light fixture secure to the mounting channels?
Long channel springnut misaligned?
Long channel springnut cracked?
Trans channel springnut misaligned?
Trans channel springnut cracked?
Trans channel wireway clip?
Housing clip disengaged?
Housing clip missing?
Lens clip disengaged?
Lens clip broken?
Lens cover cracked?
Wireway ears broken?
Luminaire functioning?

Yes	No	No	No	No	No	No	Yes	No	Yes	No	No	No	Yes	No	Yes	Yes
-----	----	----	----	----	----	----	-----	----	-----	----	----	----	-----	----	-----	-----

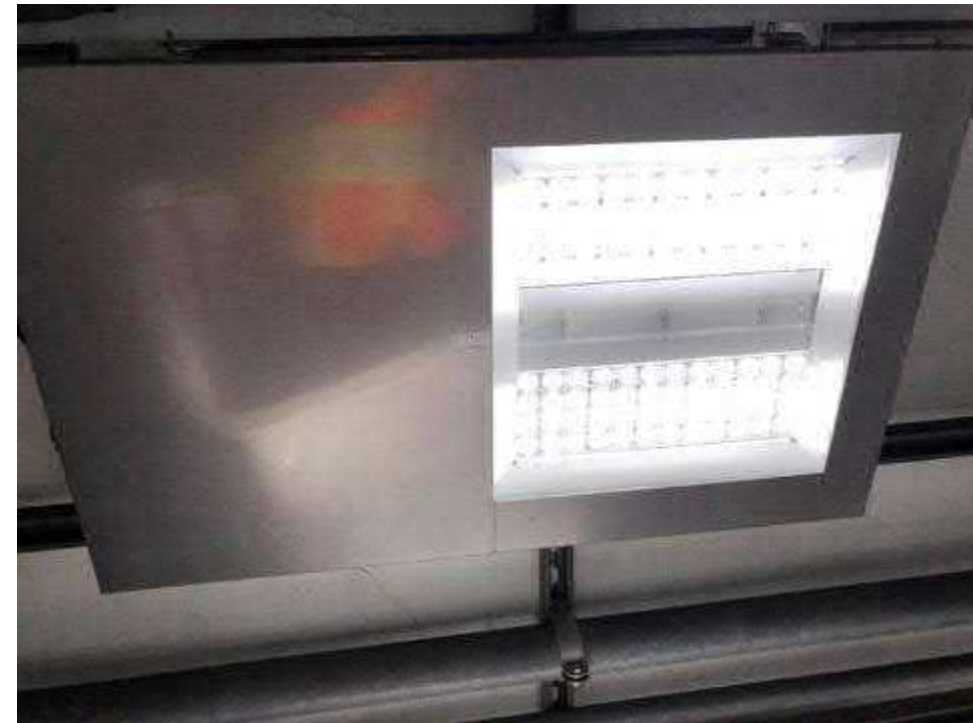
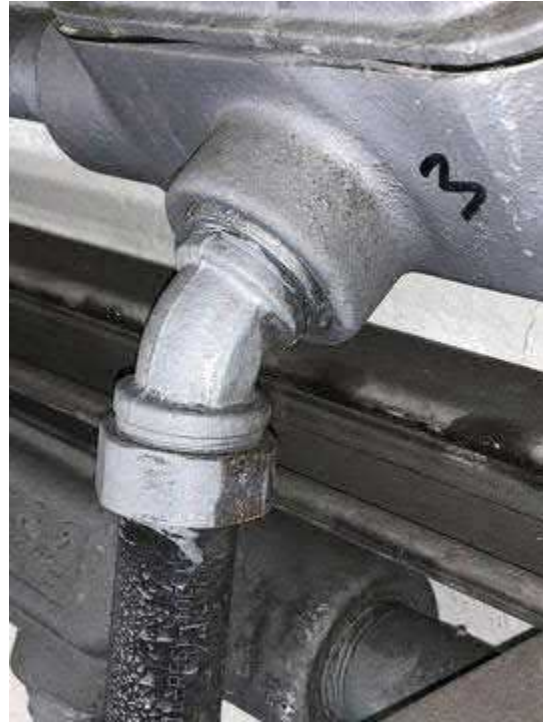
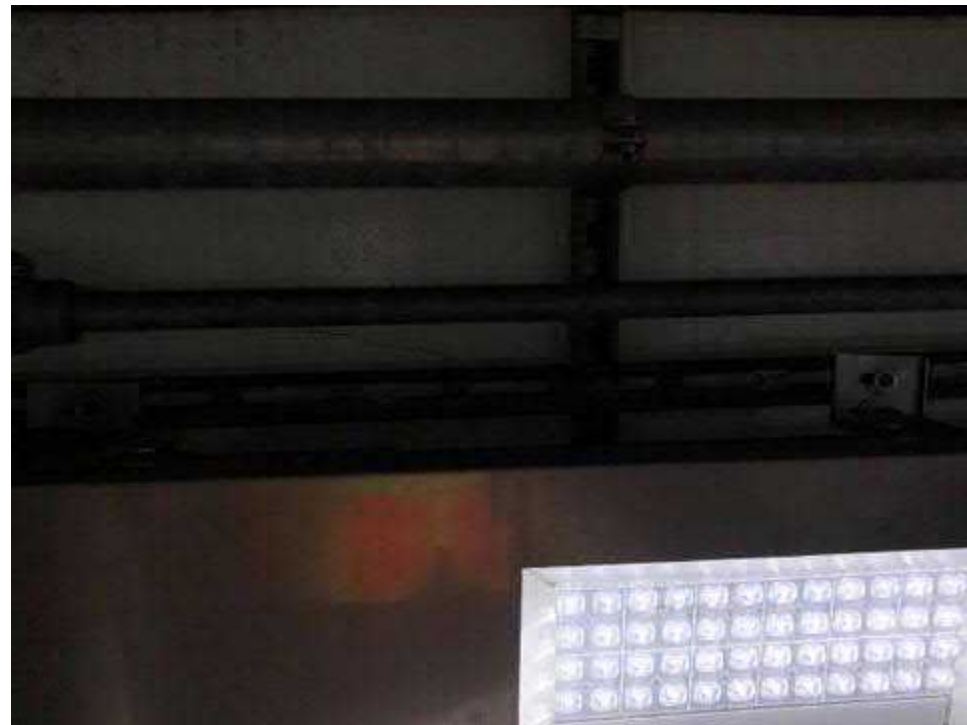
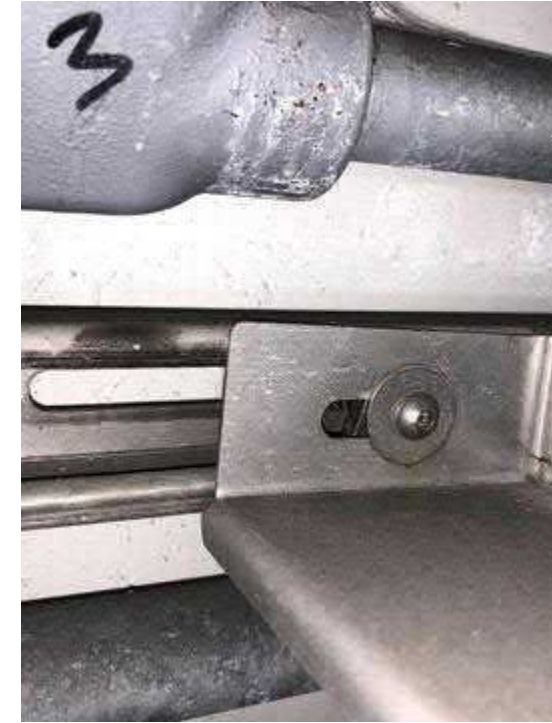
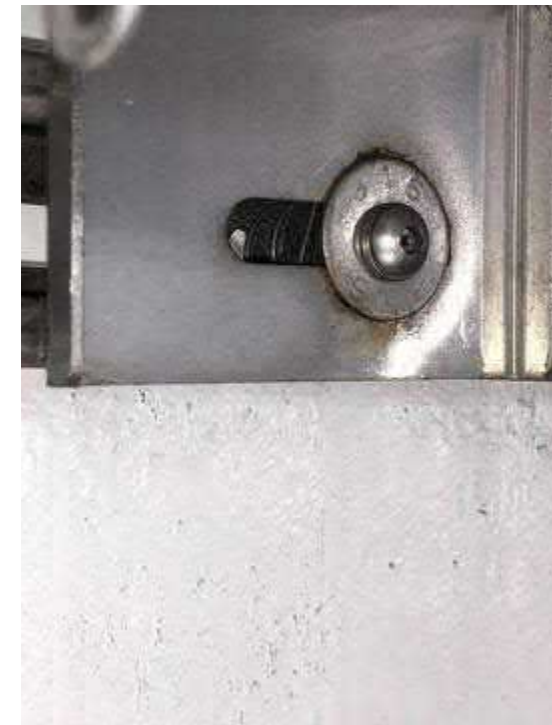
Lighting Fixture Information	
Luminaire Tag or Number:	SBR - West Wall - 22B
Tunnel Direction and Side:	SBR - West Wall
Additional Information:	T Side Entry L Both Top

Are there any signs of corrosion evident on the tunnel lighting system raceways?	Yes
Are the side entry conduits into the fixture tightly secured?	Yes
Are there any signs of corrosion on the fixture?	No
Is there any damage to the component housing or enclosure?	No
Is the light fixture secure to the mounting channels?	Yes
Long channel springnut misaligned?	No
Long channel springnut cracked?	No
Trans channel springnut misaligned?	Yes
Trans channel springnut cracked?	No
Trans channel wireway clip?	Yes
Housing clip disengaged?	No
Housing clip missing?	No
Lens clip disengaged?	No
Lens clip broken?	No
Lens cover cracked?	No
Wireway ears broken?	No
Luminaire functioning?	Yes
