# **Lytle Tunnel (HAM-71-0134) Inspection Report Fall 2020**

PID 105470

November, 2020

Ohio Department of  
Transportation  
District 8  
505 South State Route 741  
Lebanon, OH 45036

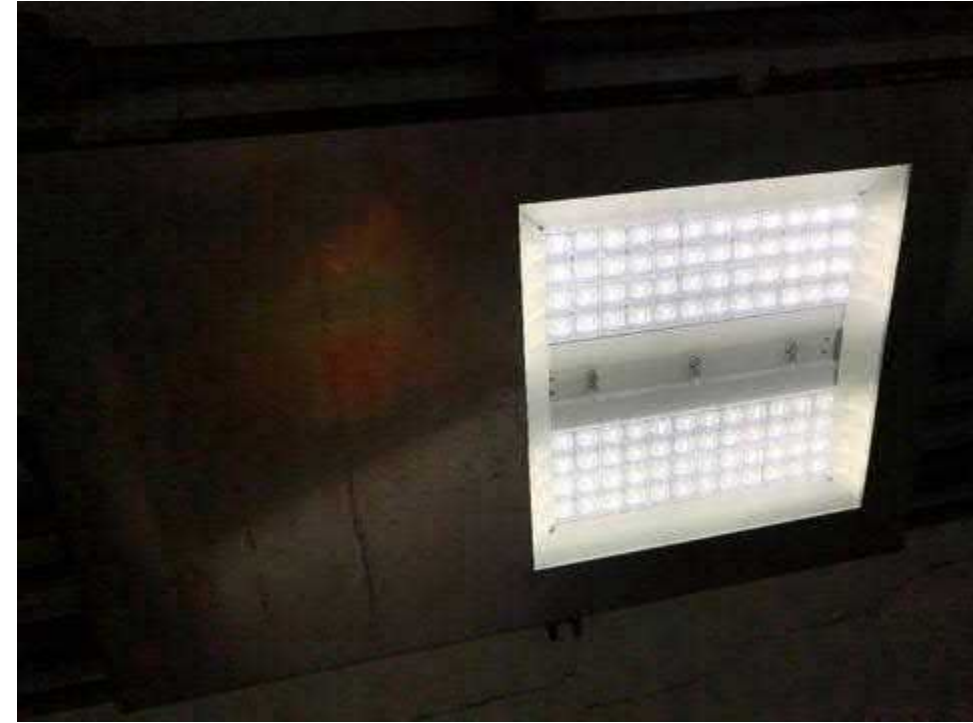
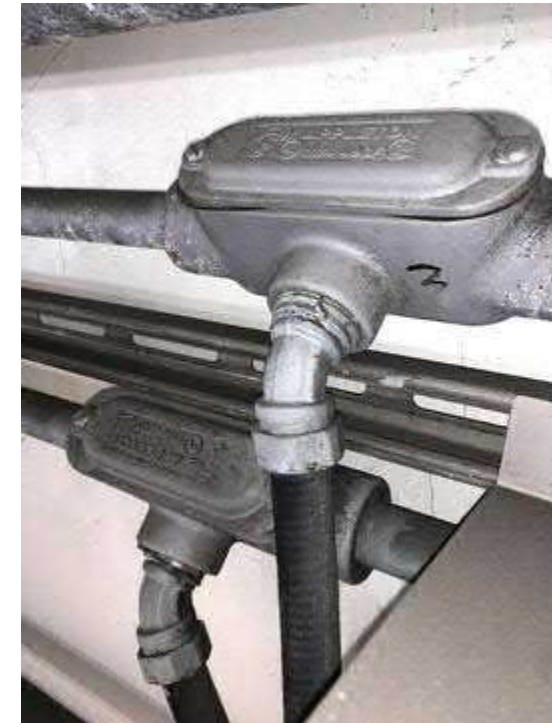
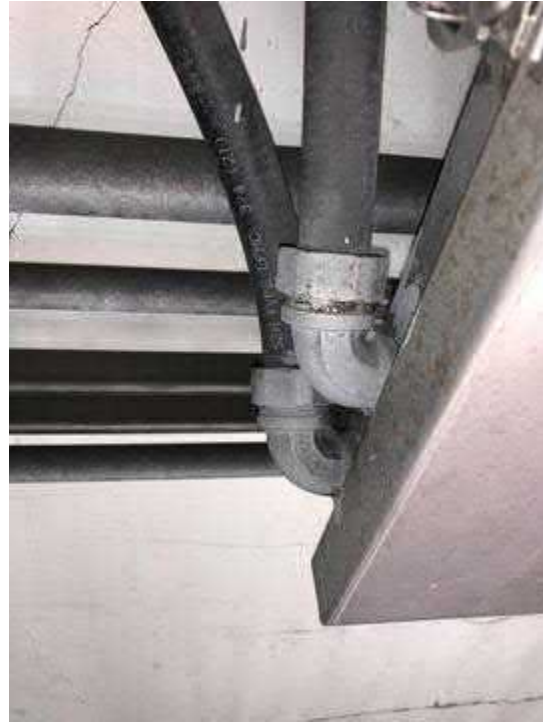
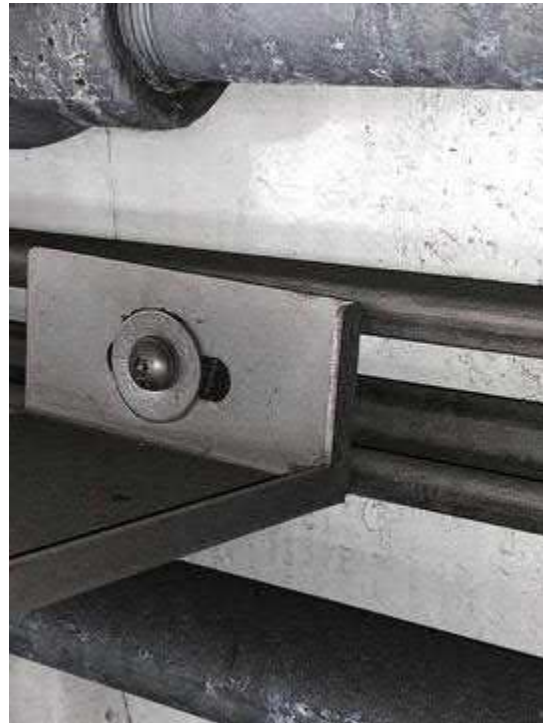
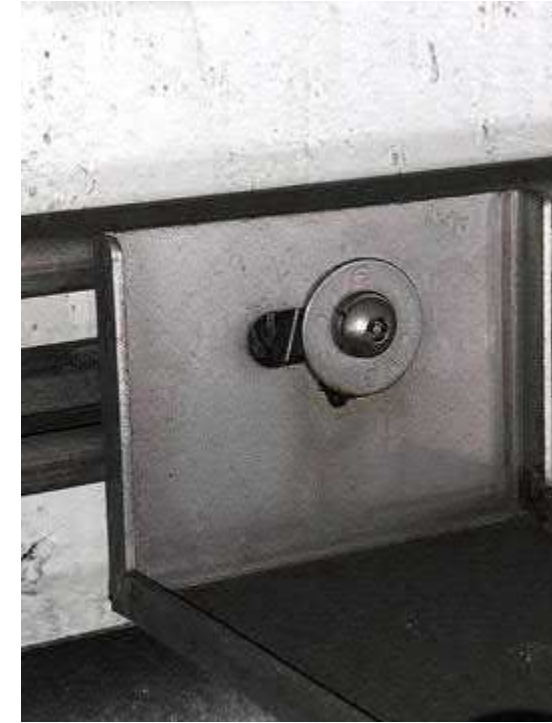
Lighting Fixture Information	
<b>Luminaire Tag or Number:</b>	SBR - East Wall - 22A
<b>Tunnel Direction and Side:</b>	SBR - East Wall
<b>Additional Information:</b>	T Side Entry L

Are there any signs of corrosion evident on the tunnel lighting system raceways?
Are the side entry conduits into the fixture tightly secured?
Are there any signs of corrosion on the fixture?
Is there any damage to the component housing or enclosure?
Is the light fixture secure to the mounting channels?
Long channel springnut misaligned?
Long channel springnut cracked?
Trans channel springnut misaligned?
Trans channel springnut cracked?
Trans channel wireway clip?
Housing clip disengaged?
Housing clip missing?
Lens clip disengaged?
Lens clip broken?
Lens cover cracked?
Wireway ears broken?
Luminaire functioning?

Yes	No	No	No	No	No	No	Yes	No	No	No	No	Yes	No	No	Yes	Yes
-----	----	----	----	----	----	----	-----	----	----	----	----	-----	----	----	-----	-----

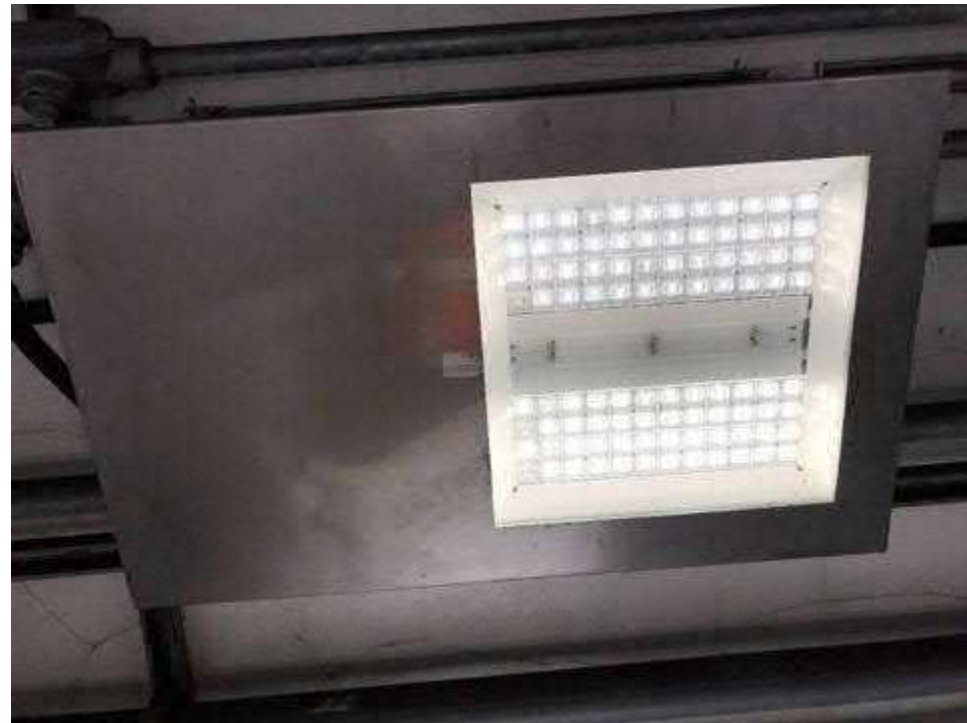
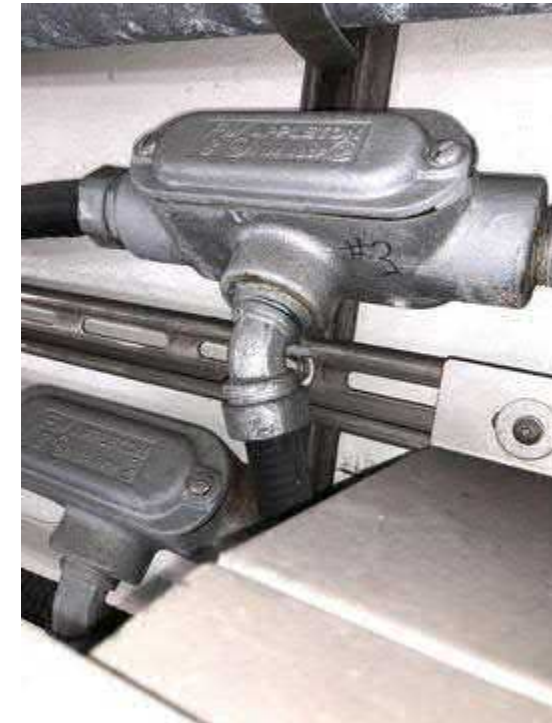
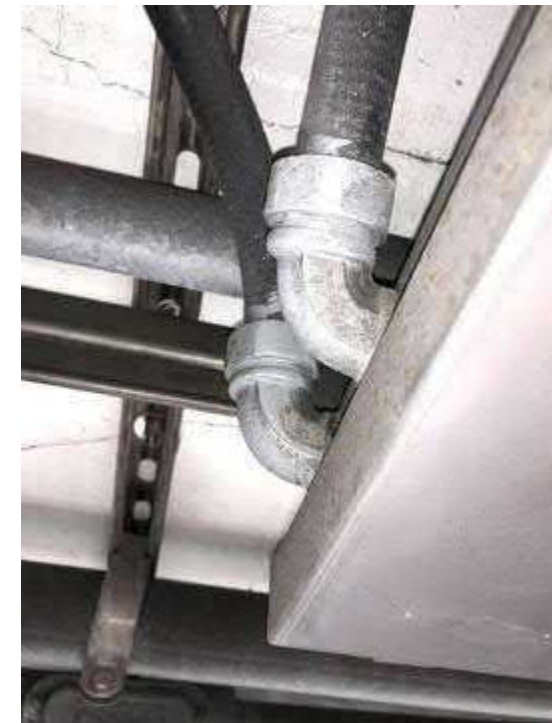
<b>Luminaire Tag or Number:</b>	SBR - East Wall - 22B
<b>Tunnel Direction and Side:</b>	SBR - East Wall
<b>Additional Information:</b>	T Side Entry L

Are there any signs of corrosion evident on the tunnel lighting system raceways?	No
Are the side entry conduits into the fixture tightly secured?	Yes
Are there any signs of corrosion on the fixture?	No
Is there any damage to the component housing or enclosure?	No
Is the light fixture secure to the mounting channels?	Yes
Long channel springnut misaligned?	No
Long channel springnut cracked?	No
Trans channel springnut misaligned?	No
Trans channel springnut cracked?	No
Trans channel wireway clip?	Yes
Housing clip disengaged?	No
Housing clip missing?	No
Lens clip disengaged?	No
Lens clip broken?	No
Lens cover cracked?	No
Wireway ears broken?	No
Luminaire functioning?	Yes

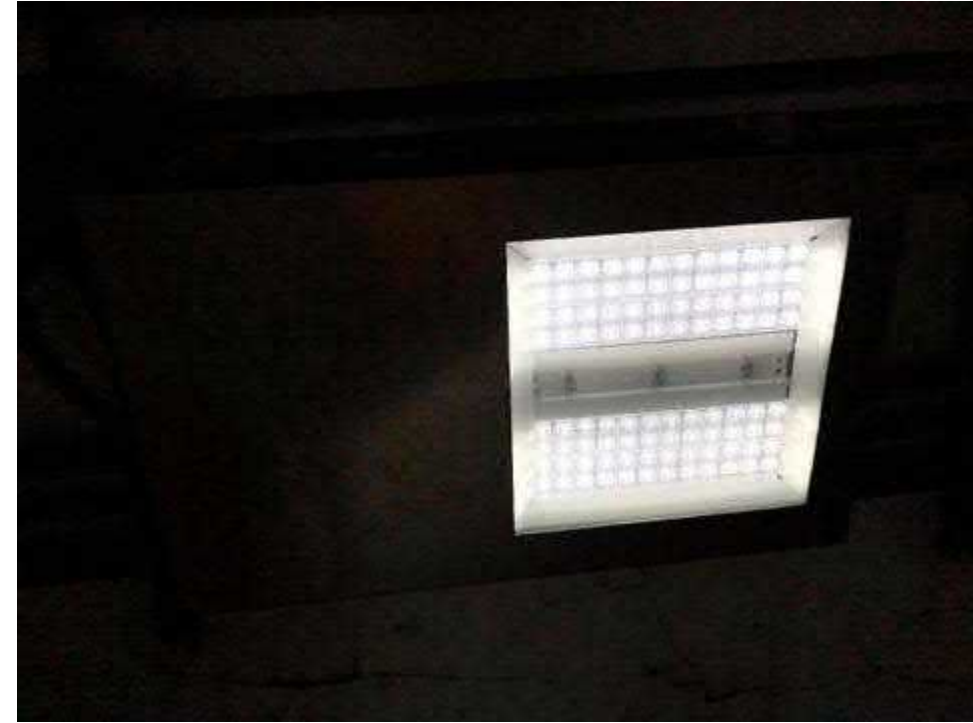
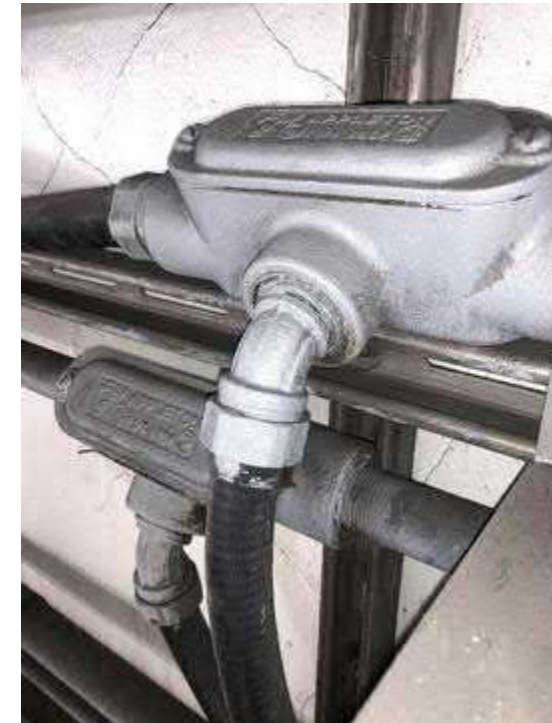
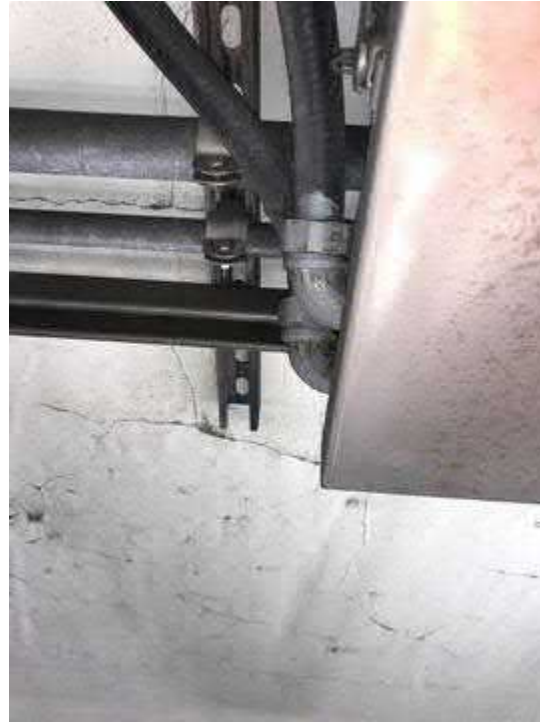
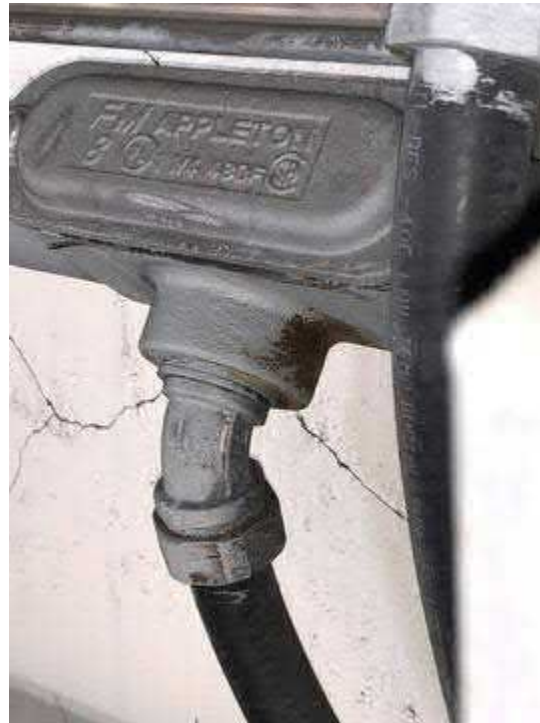
Lighting Fixture Information	
Luminaire Tag or Number:	SBR - West Wall - 28A
Tunnel Direction and Side:	SBR - West Wall
Additional Information:	T Both Side Entry Loose Bith Bottom

Are there any signs of corrosion evident on the tunnel lighting system raceways?	Yes
Are the side entry conduits into the fixture tightly secured?	No
Are there any signs of corrosion on the fixture?	No
Is there any damage to the component housing or enclosure?	No
Is the light fixture secure to the mounting channels?	Yes
Long channel springnut misaligned?	No
Long channel springnut cracked?	No
Trans channel springnut misaligned?	Yes
Trans channel springnut cracked?	No
Trans channel wireway clip?	Yes
Housing clip disengaged?	No
Housing clip missing?	No
Lens clip disengaged?	No
Lens clip broken?	No
Lens cover cracked?	No
Wireway ears broken?	No
Luminaire functioning?	Yes

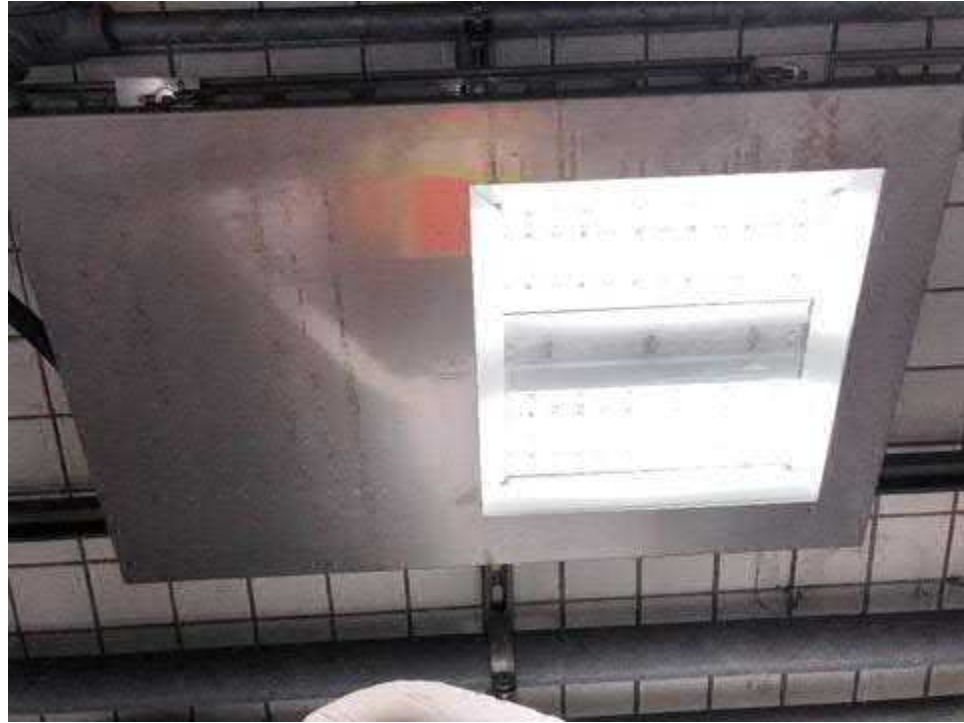
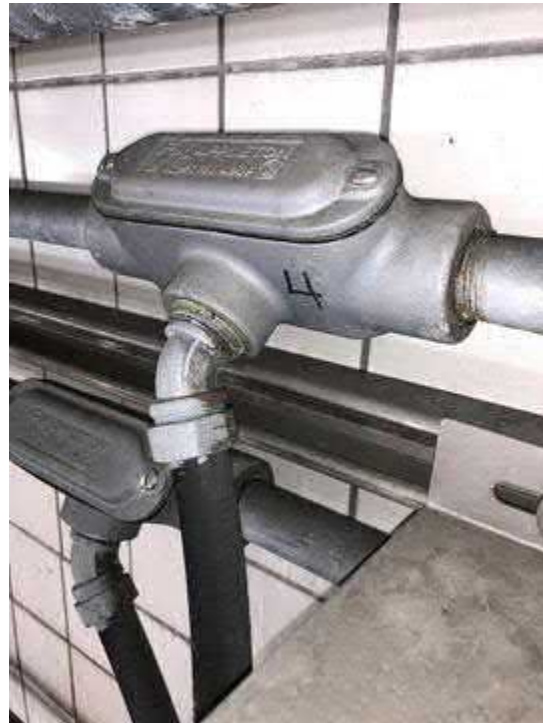
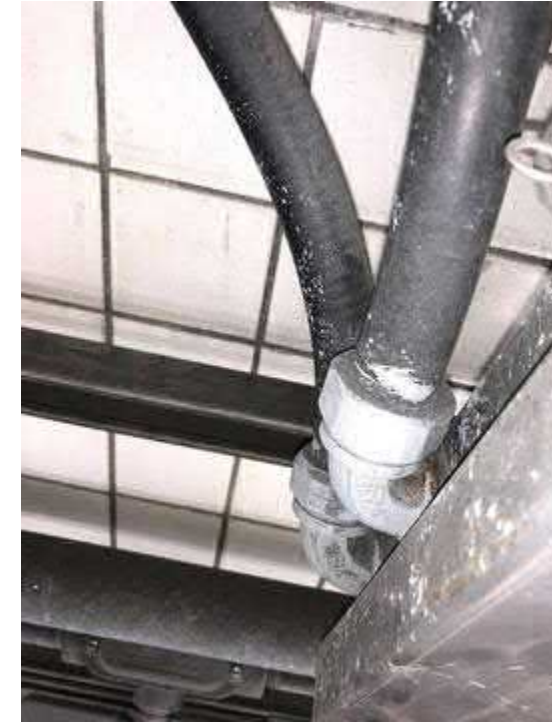
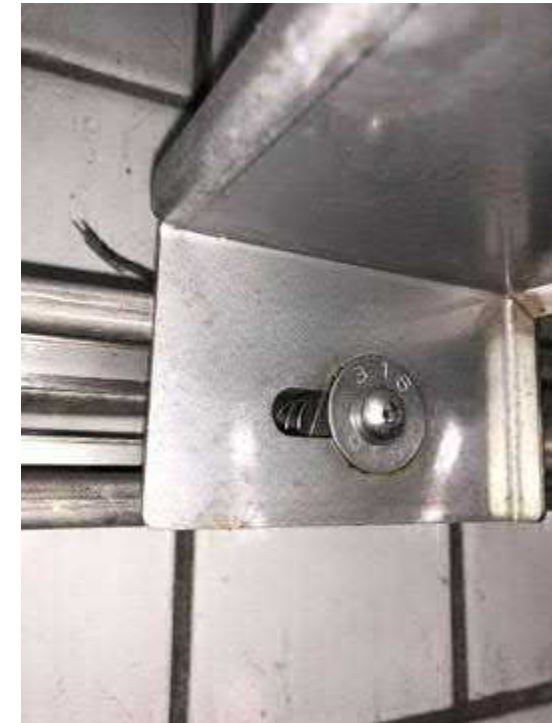
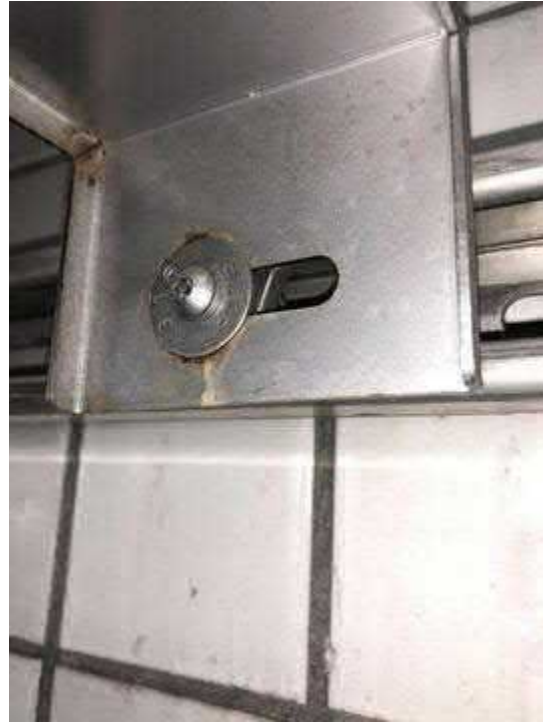
Lighting Fixture Information	
Luminaire Tag or Number:	SBR - West Wall - 28B
Tunnel Direction and Side:	SBR - West Wall
Additional Information:	T Both Side Entry Loose Both Top Misaligned Both Bottom Hooks Misaligned

Are there any signs of corrosion evident on the tunnel lighting system raceways?
Are the side entry conduits into the fixture tightly secured?
Are there any signs of corrosion on the fixture?
Is there any damage to the component housing or enclosure?
Is the light fixture secure to the mounting channels?
Long channel springnut misaligned?
Long channel springnut cracked?
Trans channel springnut misaligned?
Trans channel springnut cracked?
Trans channel wireway clip?
Housing clip disengaged?
Housing clip missing?
Lens clip disengaged?
Lens clip broken?
Lens cover cracked?
Wireway ears broken?
Luminaire functioning?

Yes	No	No	No	No	No	No	Yes	No	Yes	No	No	Yes	Yes	No	No	Yes
-----	----	----	----	----	----	----	-----	----	-----	----	----	-----	-----	----	----	-----

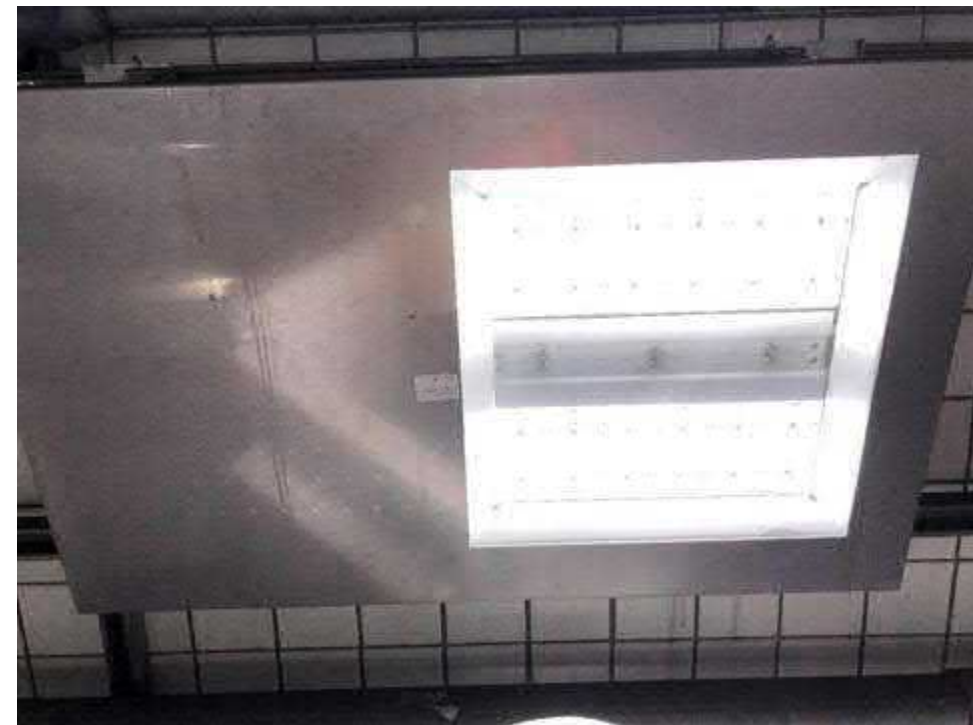
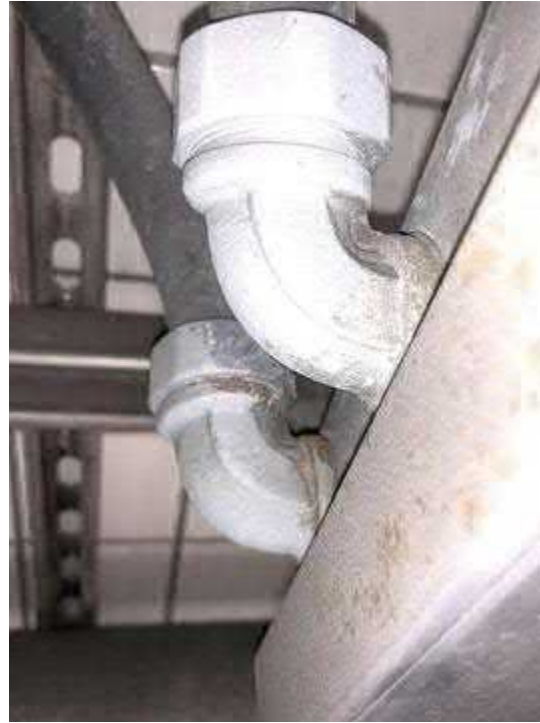
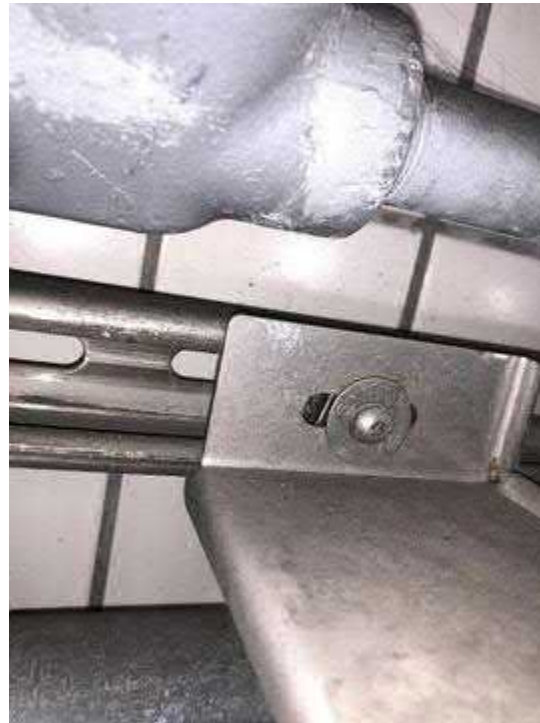
Lighting Fixture Information	
Luminaire Tag or Number:	SBR - East Wall - 28A
Tunnel Direction and Side:	SBR - East Wall - 28A
Additional Information:	Side Entry L Top Left

Are there any signs of corrosion evident on the tunnel lighting system raceways?
Are the side entry conduits into the fixture tightly secured?
Are there any signs of corrosion on the fixture?
Is there any damage to the component housing or enclosure?
Is the light fixture secure to the mounting channels?
Long channel springnut misaligned?
Long channel springnut cracked?
Trans channel springnut cracked?
Trans channel springnut misaligned?
Trans channel springnut cracked?
Trans channel wireway clip?
Housing clip disengaged?
Housing clip missing?
Lens clip disengaged?
Lens clip broken?
Lens cover cracked?
Wireway ears broken?
Luminaire functioning?

Yes	No	No	No	No	No	No	Yes	No	Yes	No	No	No	Yes	No	Yes	Yes
-----	----	----	----	----	----	----	-----	----	-----	----	----	----	-----	----	-----	-----

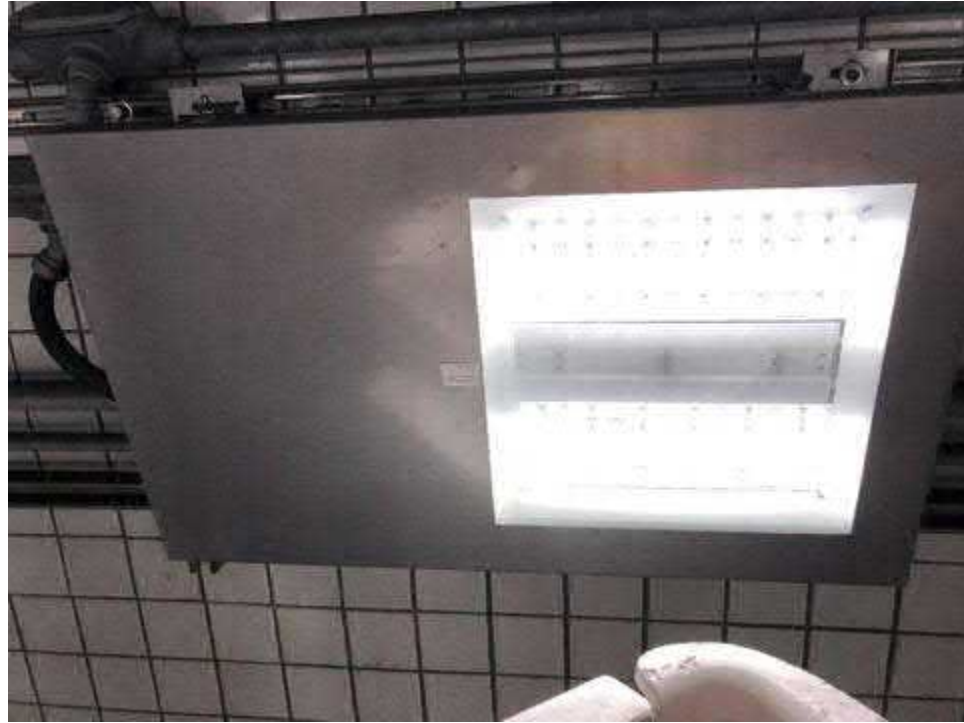
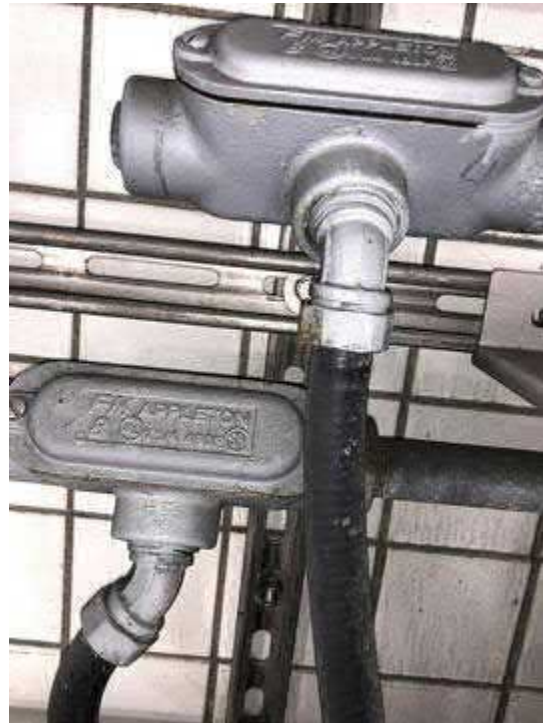
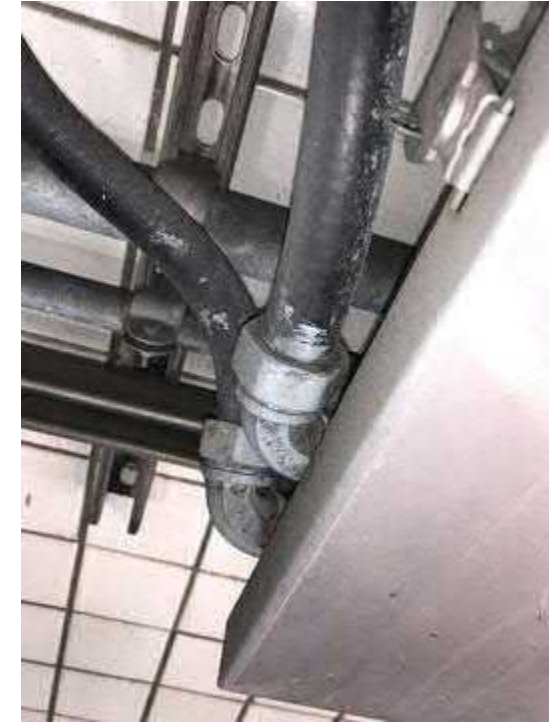
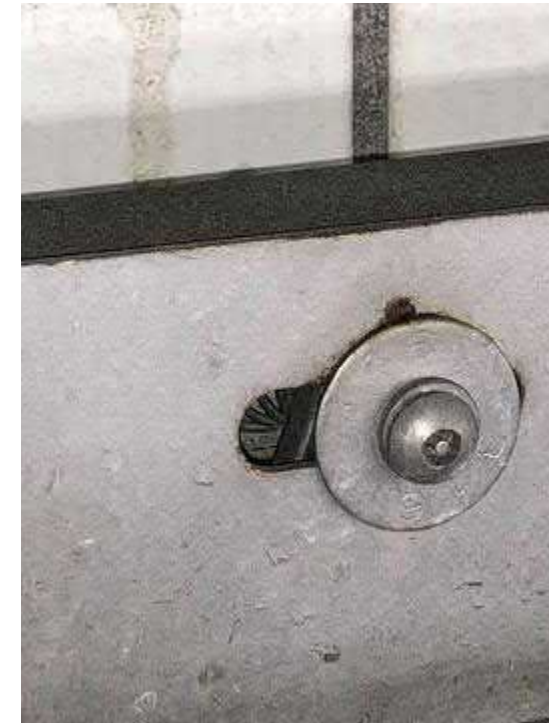
Lighting Fixture Information	
<b>Luminaire Tag or Number:</b>	SBR - East Wall - 28B
<b>Tunnel Direction and Side:</b>	SBR - East Wall
<b>Additional Information:</b>	T Side Entry L Side Entry Loose Top Right Bottom Right

Are there any signs of corrosion evident on the tunnel lighting system raceways?	Yes
Are the side entry conduits into the fixture tightly secured?	No
Are there any signs of corrosion on the fixture?	No
Is there any damage to the component housing or enclosure?	No
Is the light fixture secure to the mounting channels?	Yes
Long channel springnut misaligned?	No
Long channel springnut cracked?	No
Trans channel springnut misaligned?	Yes
Trans channel springnut cracked?	No
Trans channel wireway clip?	Yes
Housing clip disengaged?	No
Housing clip missing?	No
Lens clip disengaged?	No
Lens clip broken?	No
Lens cover cracked?	No
Wireway ears broken?	No
Luminaire functioning?	Yes

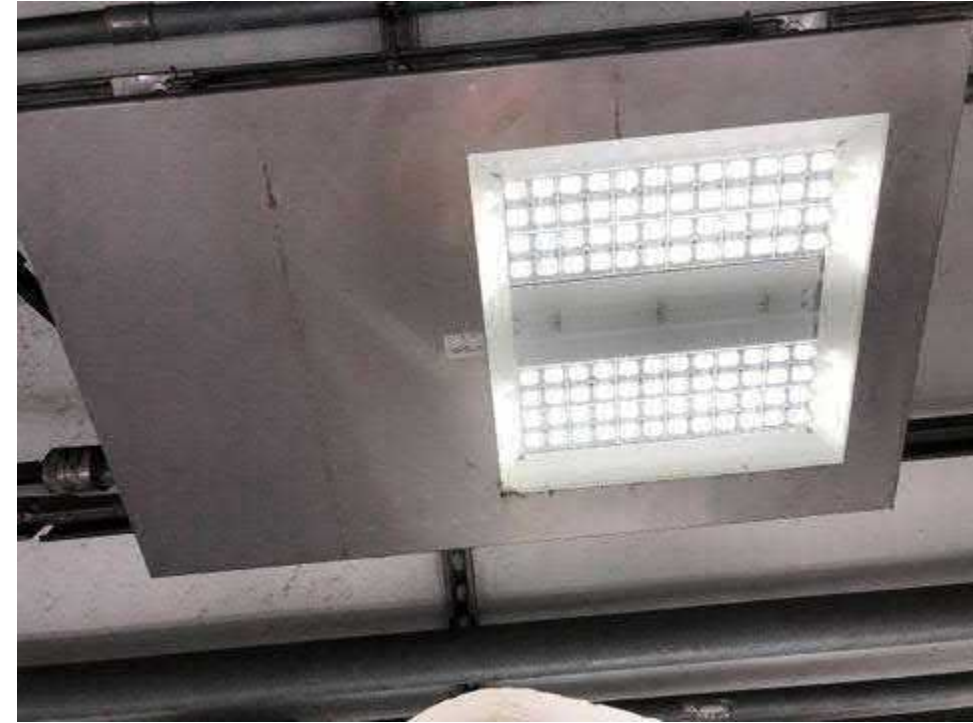
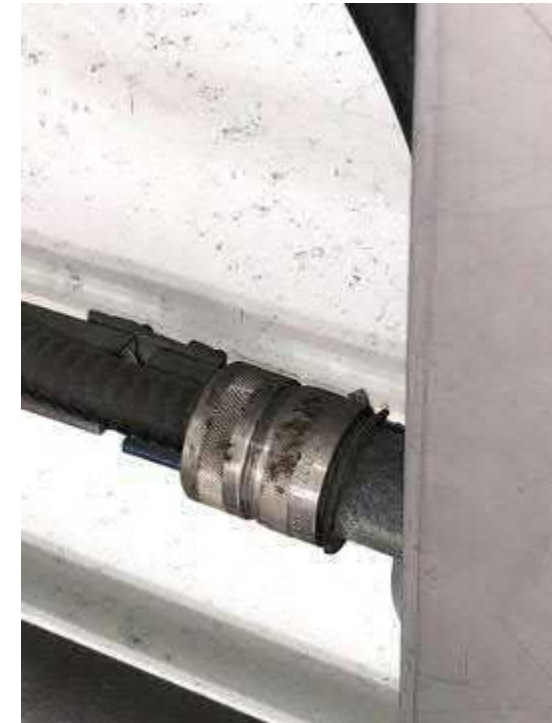
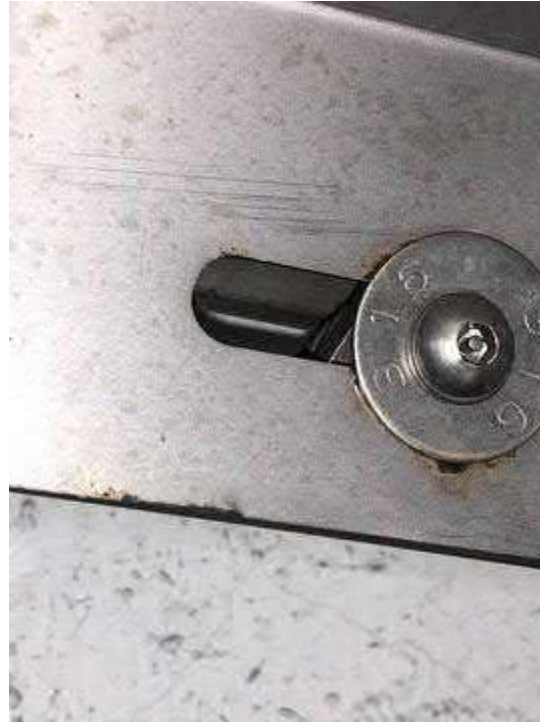
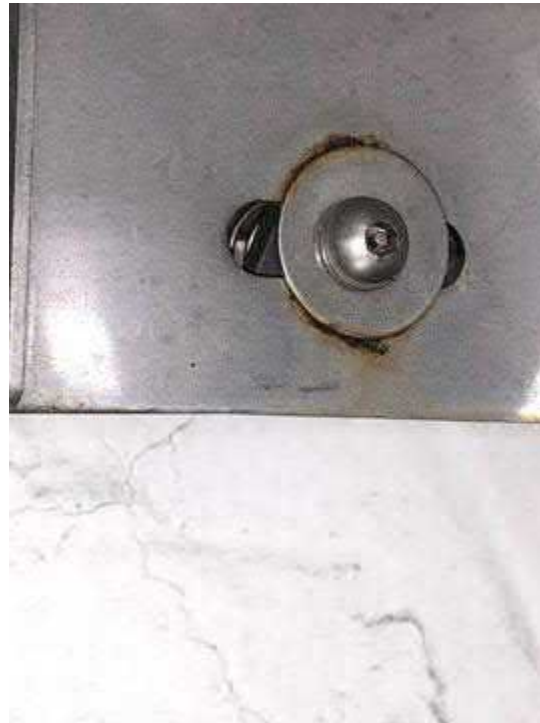
Lighting Fixture Information	
Luminaire Tag or Number:	SBR - West Wall - 33A
Tunnel Direction and Side:	SBR - West Wall
Additional Information:	Side Entry Both Bottom

Are there any signs of corrosion evident on the tunnel lighting system raceways?	Yes
Are the side entry conduits into the fixture tightly secured?	Yes
Are there any signs of corrosion on the fixture?	No
Is there any damage to the component housing or enclosure?	No
Is the light fixture secure to the mounting channels?	
Long channel springnut misaligned?	No
Long channel springnut cracked?	No
Trans channel springnut misaligned?	Yes
Trans channel springnut cracked?	No
Trans channel wireway clip?	Yes
Housing clip disengaged?	No
Housing clip missing?	
Lens clip disengaged?	No
Lens clip broken?	No
Lens cover cracked?	No
Wireway ears broken?	No
Luminaire functioning?	Yes

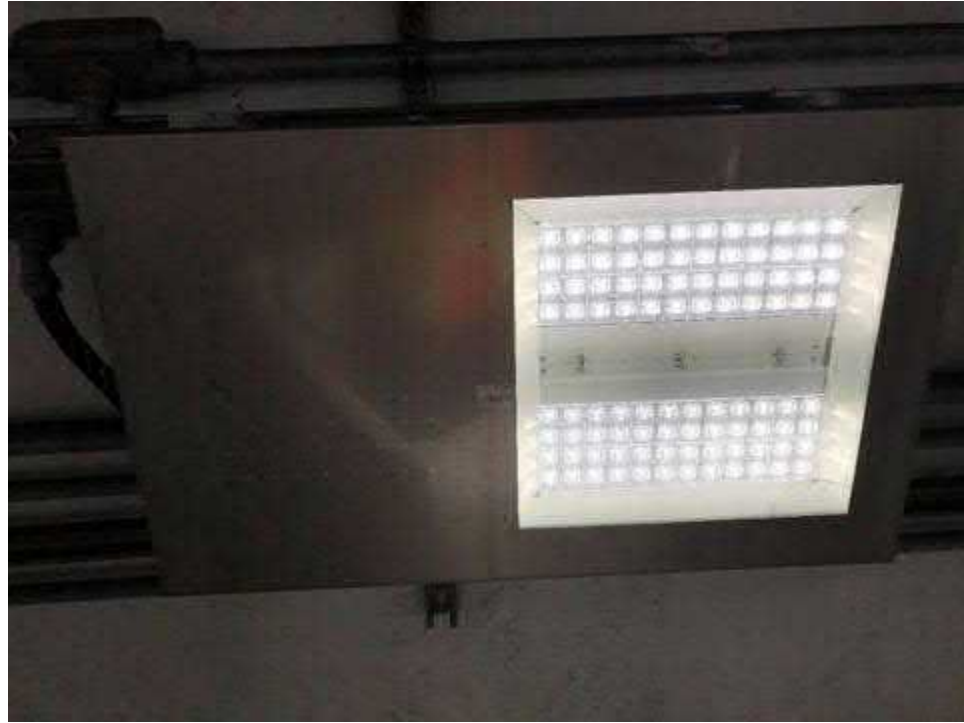
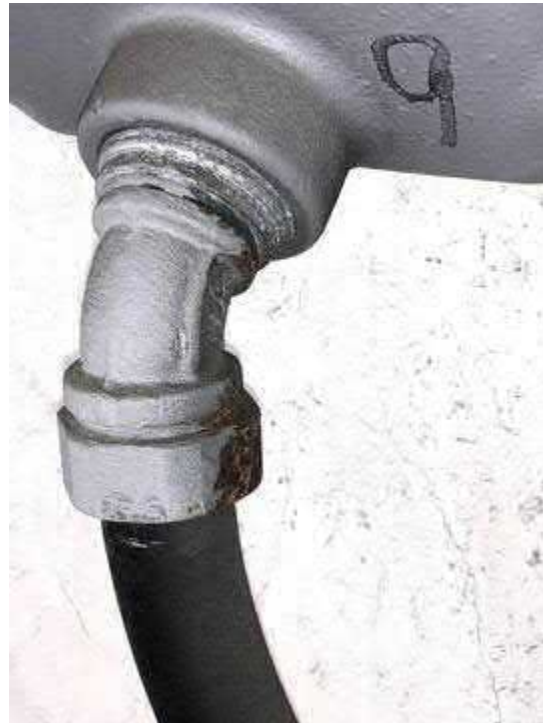
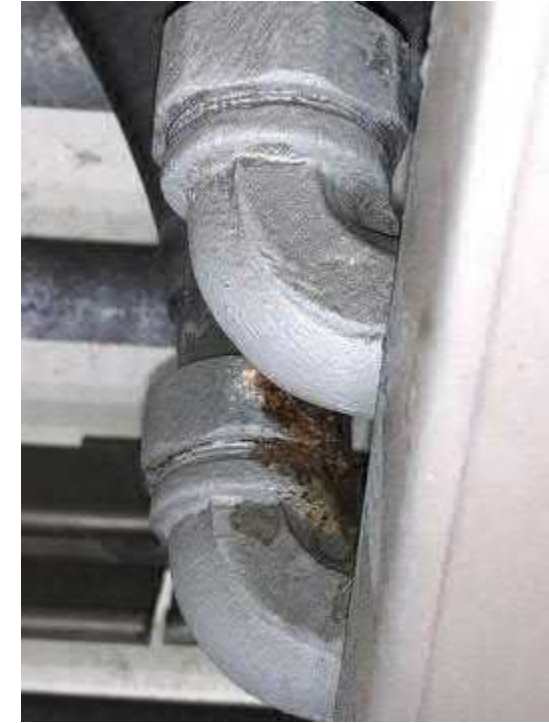
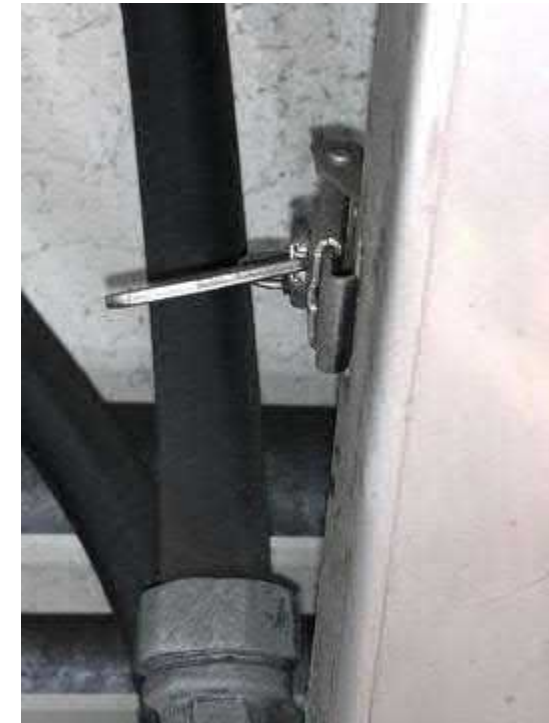
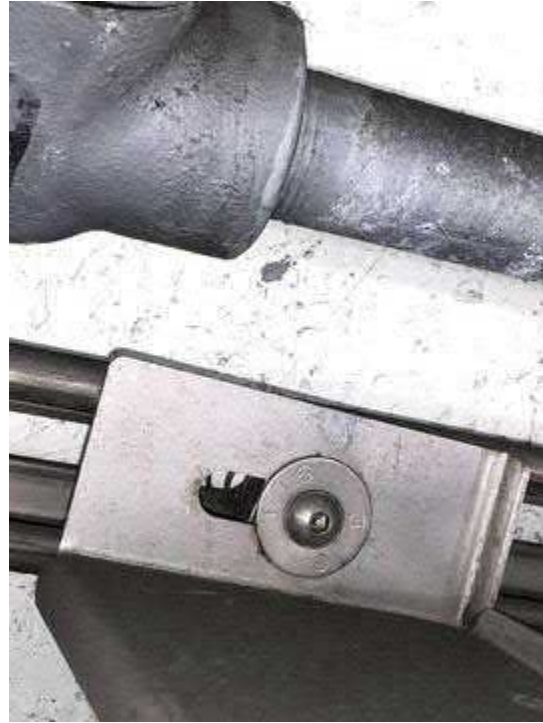
Lighting Fixture Information	
Luminaire Tag or Number:	SBR - West Wall - 33B
Tunnel Direction and Side:	SBR - West Wall t
Additional Information:	T Side Entry L Left lens Clip Top Left

Are there any signs of corrosion evident on the tunnel lighting system raceways?	Yes
Are the side entry conduits into the fixture tightly secured?	Yes
Are there any signs of corrosion on the fixture?	No
Is there any damage to the component housing or enclosure?	No
Is the light fixture secure to the mounting channels?	No
Long channel springnut misaligned?	No
Long channel springnut cracked?	No
Trans channel springnut misaligned?	Yes
Trans channel springnut cracked?	No
Trans channel wireway clip?	Yes
Housing clip disengaged?	No
Housing clip missing?	No
Lens clip disengaged?	Yes
Lens clip broken?	No
Lens cover cracked?	No
Wireway ears broken?	No
Luminaire functioning?	Yes

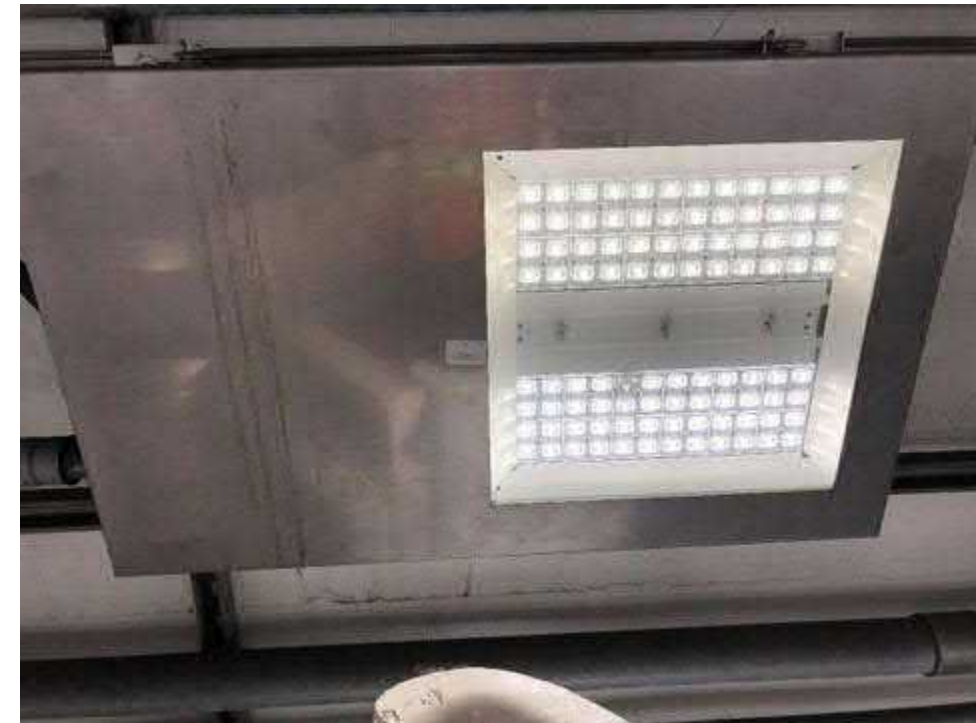
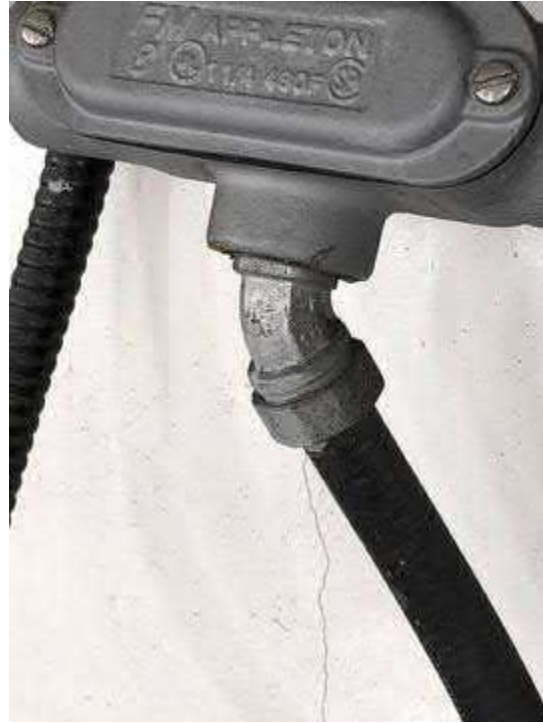
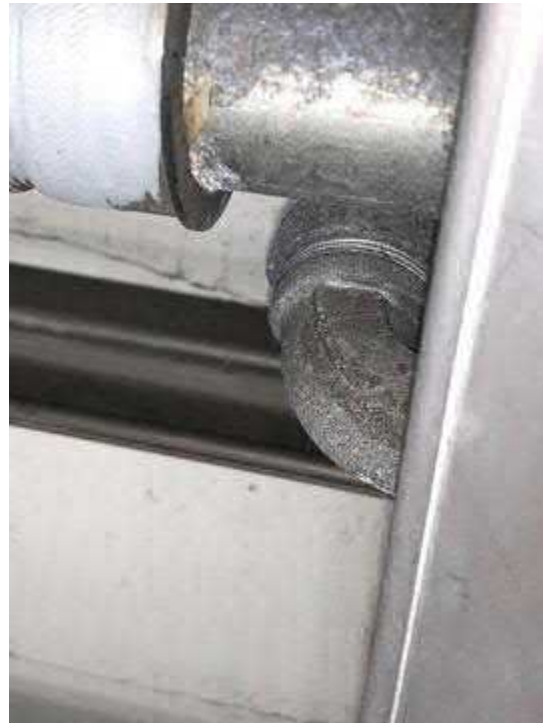
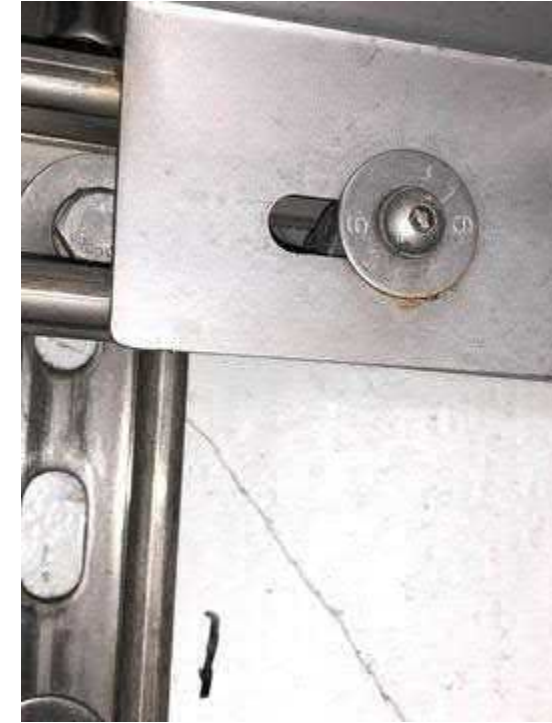
Lighting Fixture Information	
Luminaire Tag or Number:	SBR - East Wall - 33A
Tunnel Direction and Side:	SBR - East Wall - 33A
Additional Information:	T Side Entry L Bottom Left

Are there any signs of corrosion evident on the tunnel lighting system raceways?
Are the side entry conduits into the fixture tightly secured?
Are there any signs of corrosion on the fixture?
Is there any damage to the component housing or enclosure?
Is the light fixture secure to the mounting channels?
Long channel springnut misaligned?
Long channel springnut cracked?
Trans channel springnut misaligned?
Trans channel springnut cracked?
Trans channel wireway clip?
Housing clip disengaged?
Housing clip missing?
Lens clip disengaged?
Lens clip broken?
Lens cover cracked?
Wireway ears broken?
Luminaire functioning?

Yes	No	No	No	No	No	No	Yes	No	No	No	No	Yes	No	No	Yes	Yes
-----	----	----	----	----	----	----	-----	----	----	----	----	-----	----	----	-----	-----

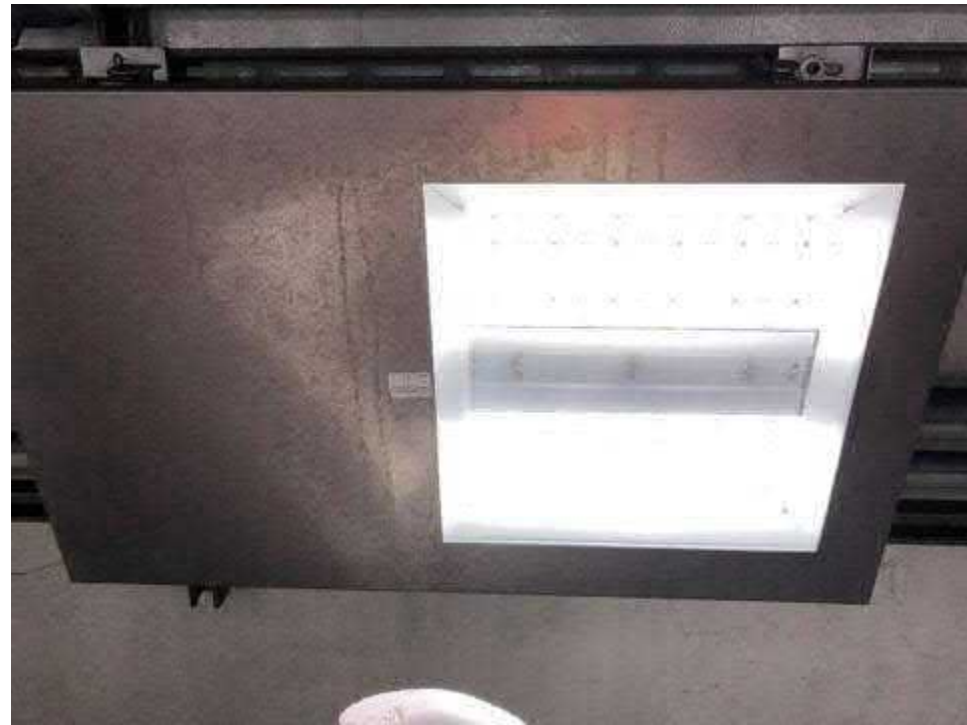
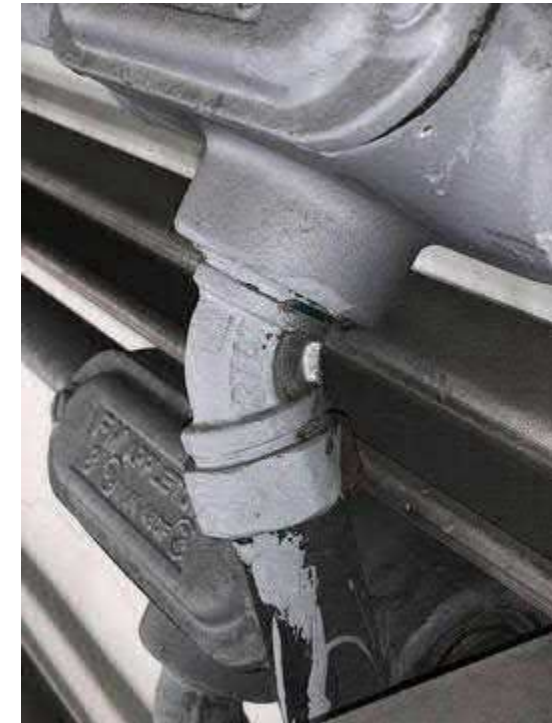
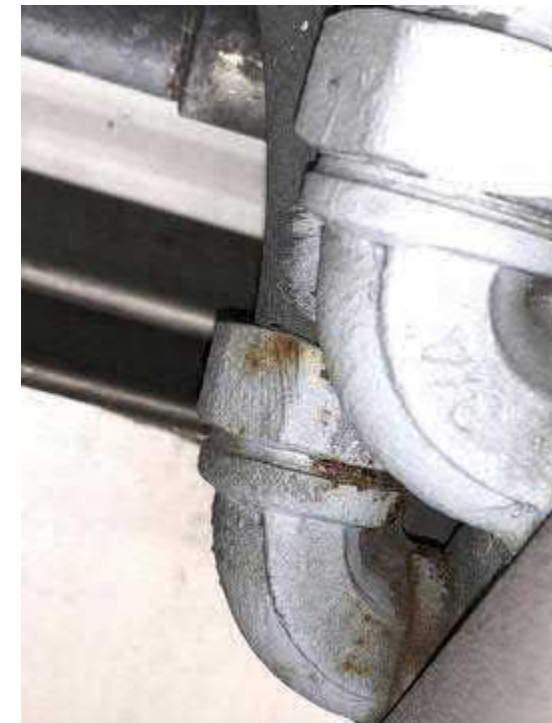
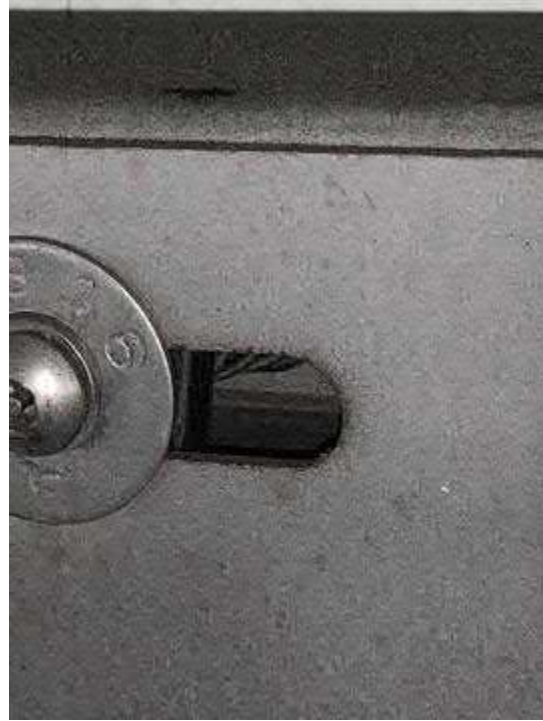
Lighting Fixture Information	
<b>Luminaire Tag or Number:</b>	SBR - East Wall - 33B
<b>Tunnel Direction and Side:</b>	SBR - East Wall
<b>Additional Information:</b>	T Side Entry L Top Right

Are there any signs of corrosion evident on the tunnel lighting system raceways?
Are the side entry conduits into the fixture tightly secured?
Are there any signs of corrosion on the fixture?
Is there any damage to the component housing or enclosure?
Is the light fixture secure to the mounting channels?
Long channel springnut misaligned?
Long channel springnut cracked?
Trans channel springnut misaligned?
Trans channel springnut cracked?
Trans channel wireway clip?
Housing clip disengaged?
Housing clip missing?
Lens clip disengaged?
Lens clip broken?
Lens cover cracked?
Wireway ears broken?
Luminaire functioning?

Yes	No	No	No	No	No	No	Yes	No	Yes	No	No	No	No	No	Yes	
-----	----	----	----	----	----	----	-----	----	-----	----	----	----	----	----	-----	--
