# **Lytle Tunnel (HAM-71-0134) Inspection Report Fall 2020**

PID 105470

November, 2020

Ohio Department of  
Transportation  
District 8  
505 South State Route 741  
Lebanon, OH 45036

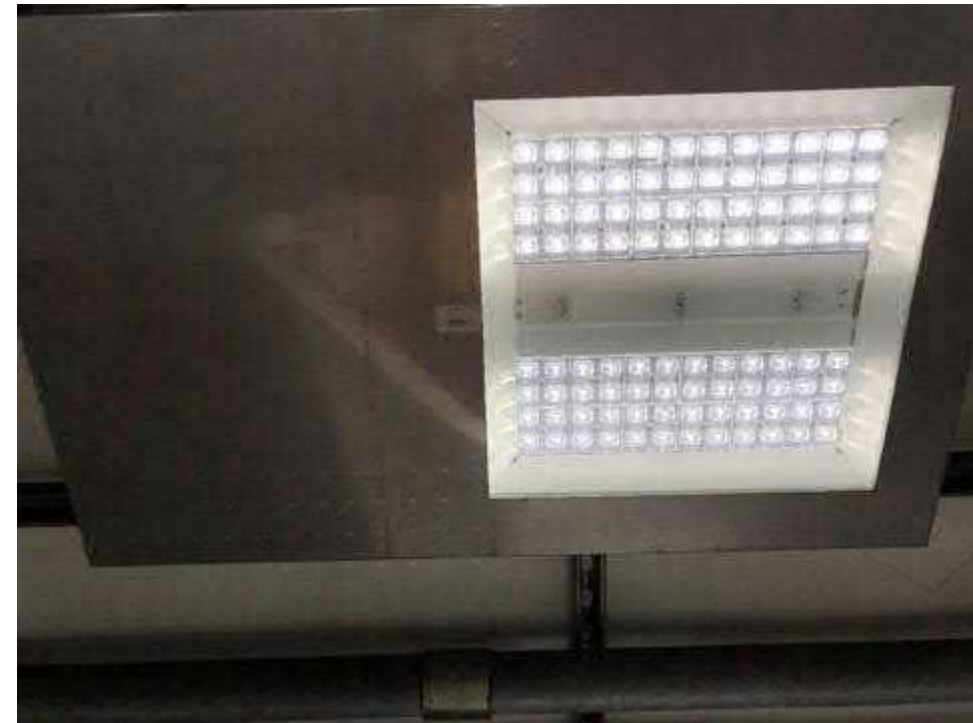
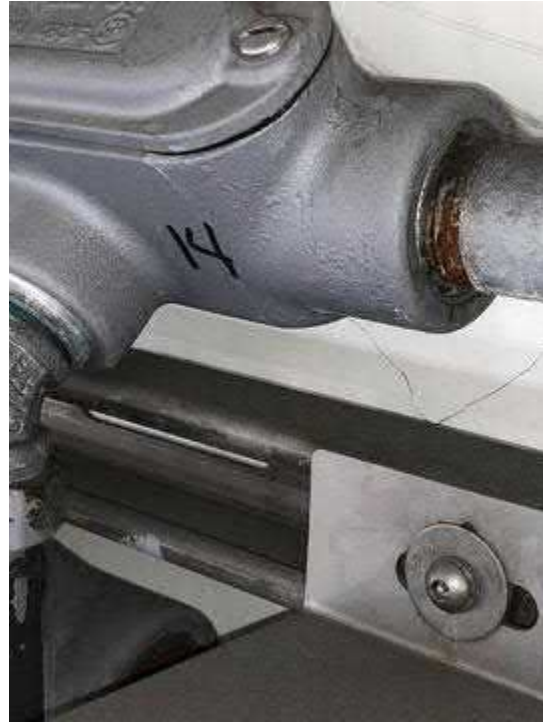
Lighting Fixture Information	
Luminaire Tag or Number:	SBR - West Wall - 38A
Tunnel Direction and Side:	SBR - West Wall
Additional Information:	T Both Side Entry Loose

Are there any signs of corrosion evident on the tunnel lighting system raceways?
Are the side entry conduits into the fixture tightly secured?
Are there any signs of corrosion on the fixture?
Is there any damage to the component housing or enclosure?
Is the light fixture secure to the mounting channels?
Long channel springnut misaligned?
Long channel springnut cracked?
Trans channel springnut cracked?
Trans channel springnut misaligned?
Trans channel wireway clip?
Housing clip disengaged?
Housing clip missing?
Lens clip disengaged?
Lens clip broken?
Lens cover cracked?
Wireway ears broken?
Luminaire functioning?

Yes	No	No		No	No	No	Yes	No	No	No	No	Yes	No	No	No	Yes
-----	----	----	--	----	----	----	-----	----	----	----	----	-----	----	----	----	-----

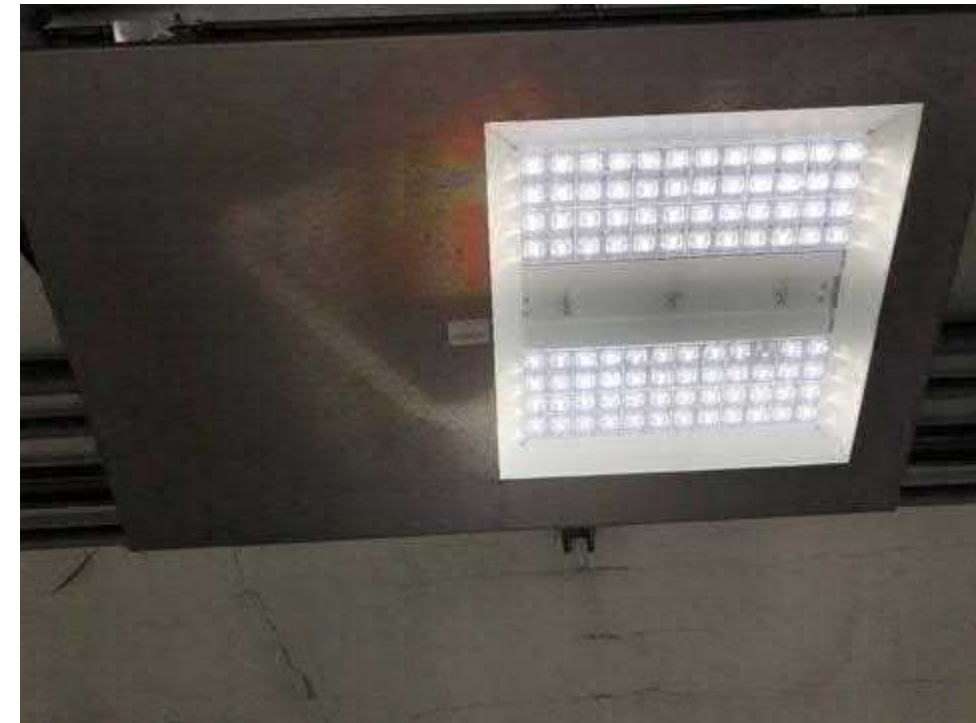
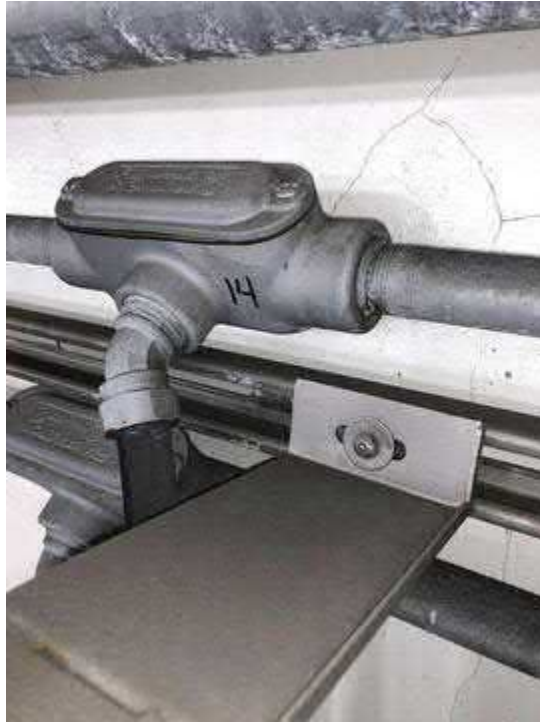
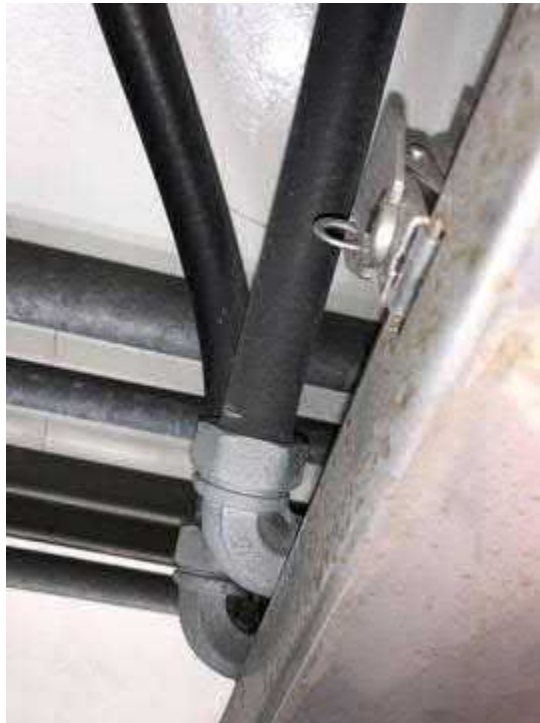
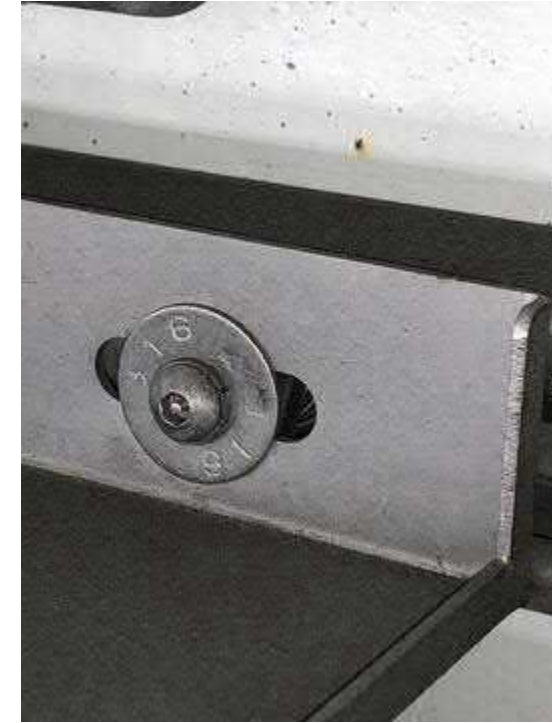
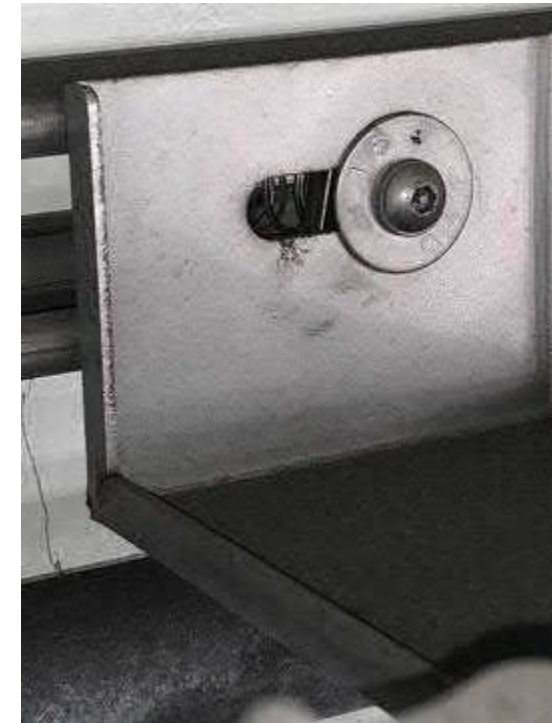
Lighting Fixture Information	
Luminaire Tag or Number:	SBR - West Wall - 38B
Tunnel Direction and Side:	SBR - West Wall
Additional Information:	T Both Top

Are there any signs of corrosion evident on the tunnel lighting system raceways?
Are the side entry conduits into the fixture tightly secured?
Are there any signs of corrosion on the fixture?
Is there any damage to the component housing or enclosure?
Is the light fixture secure to the mounting channels?
Long channel springnut misaligned?
Long channel springnut cracked?
Trans channel springnut cracked?
Trans channel springnut misaligned?
Trans channel wireway clip?
Housing clip disengaged?
Housing clip missing?
Lens clip disengaged?
Lens clip broken?
Lens cover cracked?
Wireway ears broken?
Luminaire functioning?

Yes	No	No	No	No	No	No	Yes	No	Yes	No	No	Yes	No	No	Yes	Yes
-----	----	----	----	----	----	----	-----	----	-----	----	----	-----	----	----	-----	-----

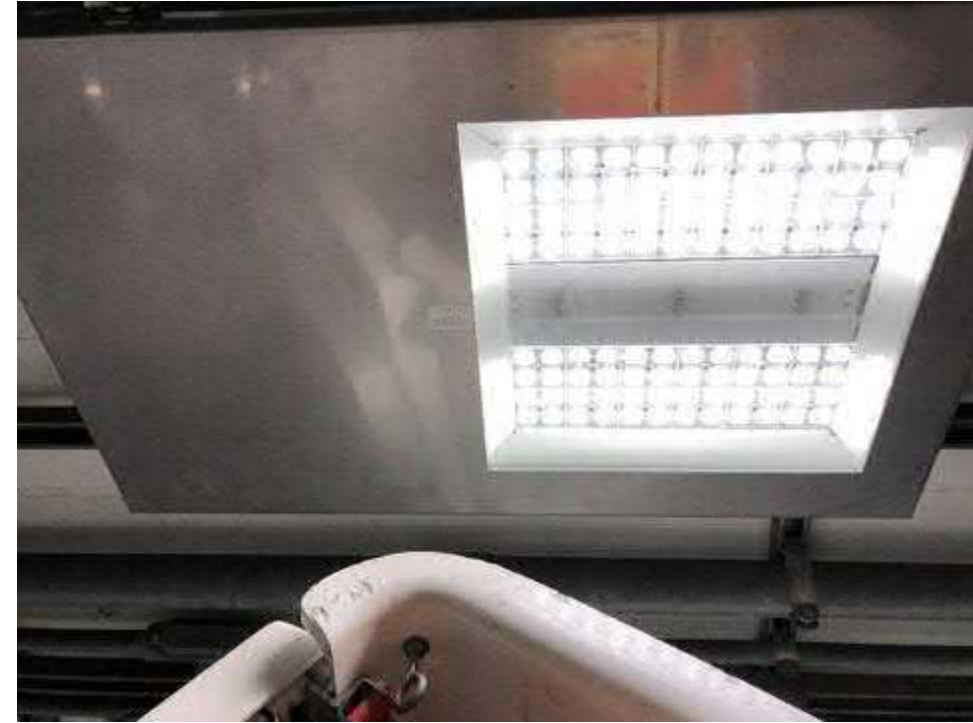
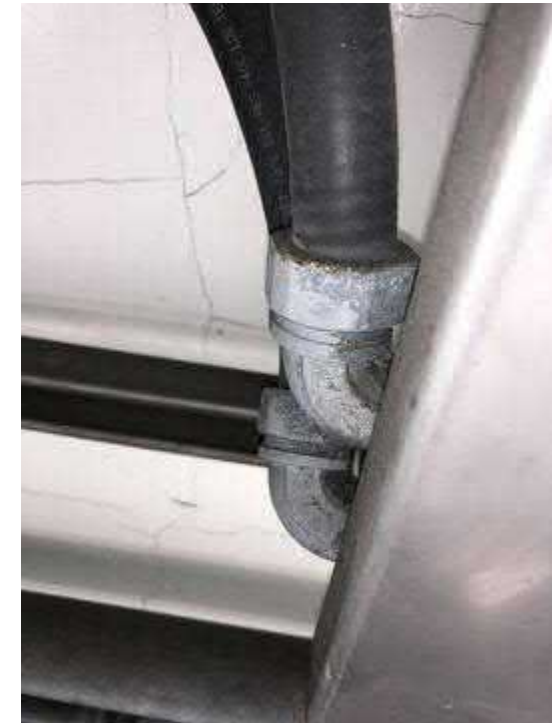
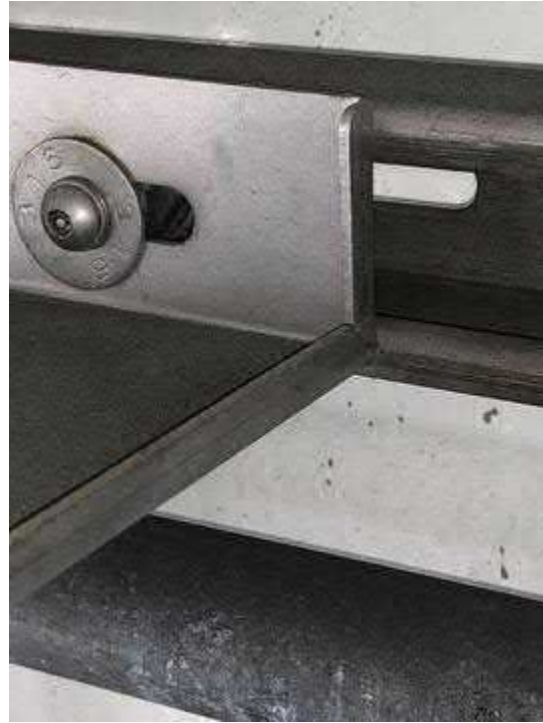
Lighting Fixture Information	
Luminaire Tag or Number:	SBR - East Wall - 38A
Tunnel Direction and Side:	SBR - East Wall - 38AT
Additional Information:	Side Entry L Side Entry Loose Top Left

Are there any signs of corrosion evident on the tunnel lighting system raceways?	Yes
Are the side entry conduits into the fixture tightly secured?	No
Are there any signs of corrosion on the fixture?	No
Is there any damage to the component housing or enclosure?	No
Is the light fixture secure to the mounting channels?	Yes
Long channel springnut misaligned?	Yes
Long channel springnut cracked?	No
Trans channel springnut misaligned?	Yes
Trans channel springnut cracked?	No
Trans channel wireway clip?	Yes
Housing clip disengaged?	No
Housing clip missing?	
Lens clip disengaged?	No
Lens clip broken?	No
Lens cover cracked?	No
Wireway ears broken?	No
Luminaire functioning?	Yes

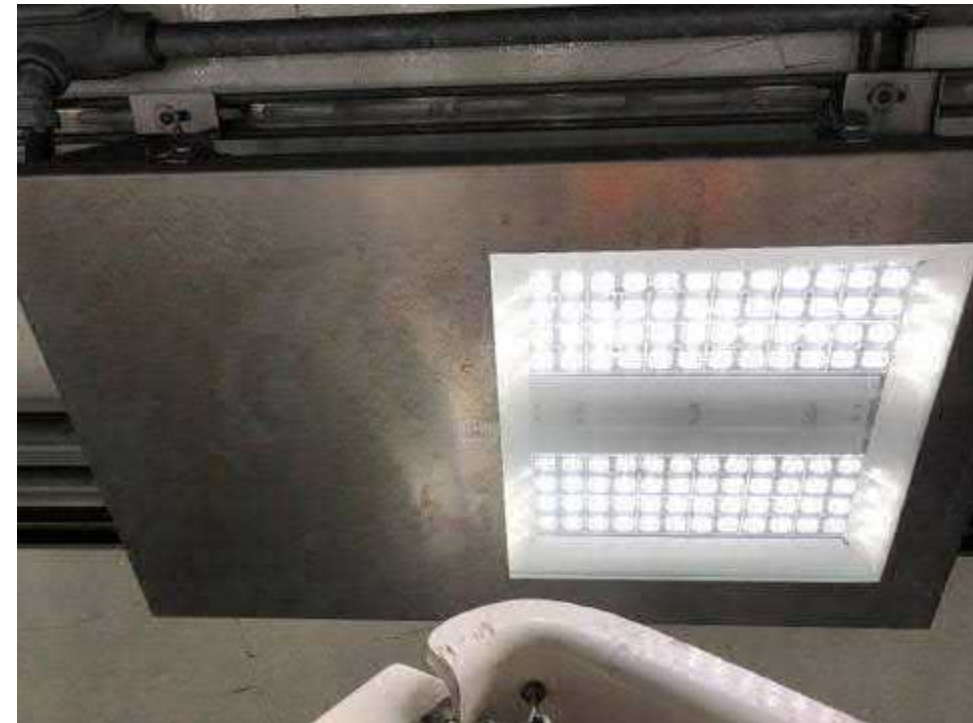
Lighting Fixture Information	
Luminaire Tag or Number:	SBR - East Wall - 38B
Tunnel Direction and Side:	SBR - East Wall
Additional Information:	T Side Entry Loose Both Bottom

Are there any signs of corrosion evident on the tunnel lighting system raceways?
Are the side entry conduits into the fixture tightly secured?
Are there any signs of corrosion on the fixture?
Is there any damage to the component housing or enclosure?
Is the light fixture secure to the mounting channels?
Long channel springnut misaligned?
Long channel springnut cracked?
Trans channel springnut cracked?
Trans channel springnut misaligned?
Trans channel wireway clip?
Housing clip disengaged?
Housing clip missing?
Lens clip disengaged?
Lens clip broken?
Lens cover cracked?
Wireway ears broken?
Luminaire functioning?

Yes	No	No	No	No	No	No	Yes	No	Yes	No	No	Yes	No	No	No	Yes
-----	----	----	----	----	----	----	-----	----	-----	----	----	-----	----	----	----	-----

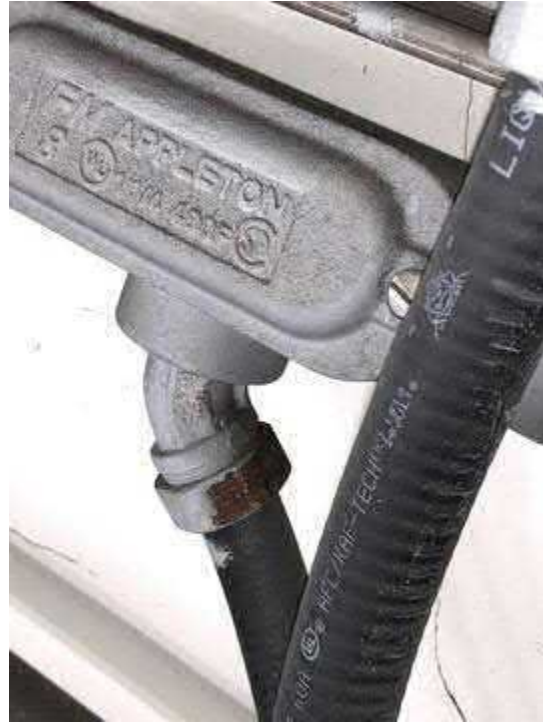
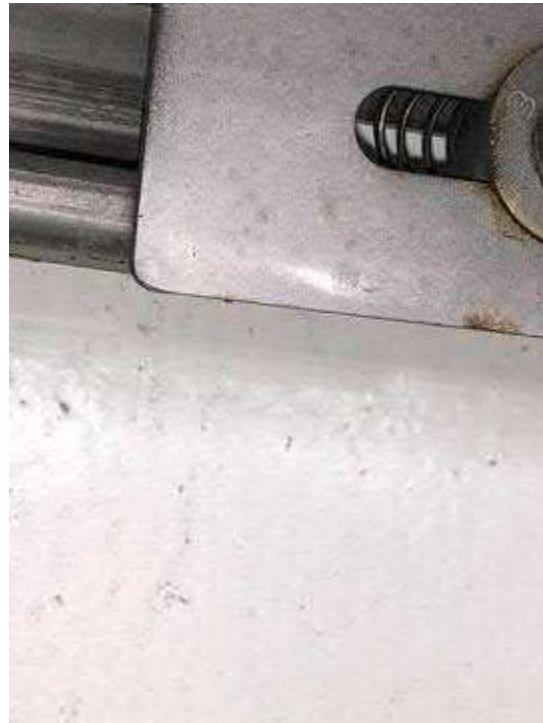
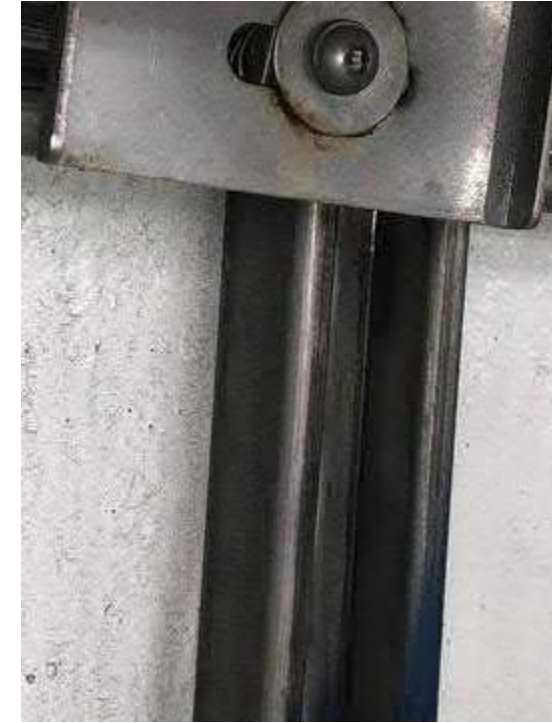
Lighting Fixture Information	
<b>Luminaire Tag or Number:</b>	SBR - West Wall - 43A
<b>Tunnel Direction and Side:</b>	SBR - West Wall -
<b>Additional Information:</b>	Side Entry L Bottom Right

Are there any signs of corrosion evident on the tunnel lighting system raceways?
Are the side entry conduits into the fixture tightly secured?
Are there any signs of corrosion on the fixture?
Is there any damage to the component housing or enclosure?
Is the light fixture secure to the mounting channels?
Long channel springnut misaligned?
Long channel springnut cracked?
Trans channel springnut misaligned?
Trans channel springnut cracked?
Trans channel wireway clip?
Housing clip disengaged?
Housing clip missing?
Lens clip disengaged?
Lens clip broken?
Lens cover cracked?
Wireway ears broken?
Luminaire functioning?

Yes	No	No	No	No	No	No	Yes	No	Yes	No	No	Yes	No	No	Yes	Yes
-----	----	----	----	----	----	----	-----	----	-----	----	----	-----	----	----	-----	-----

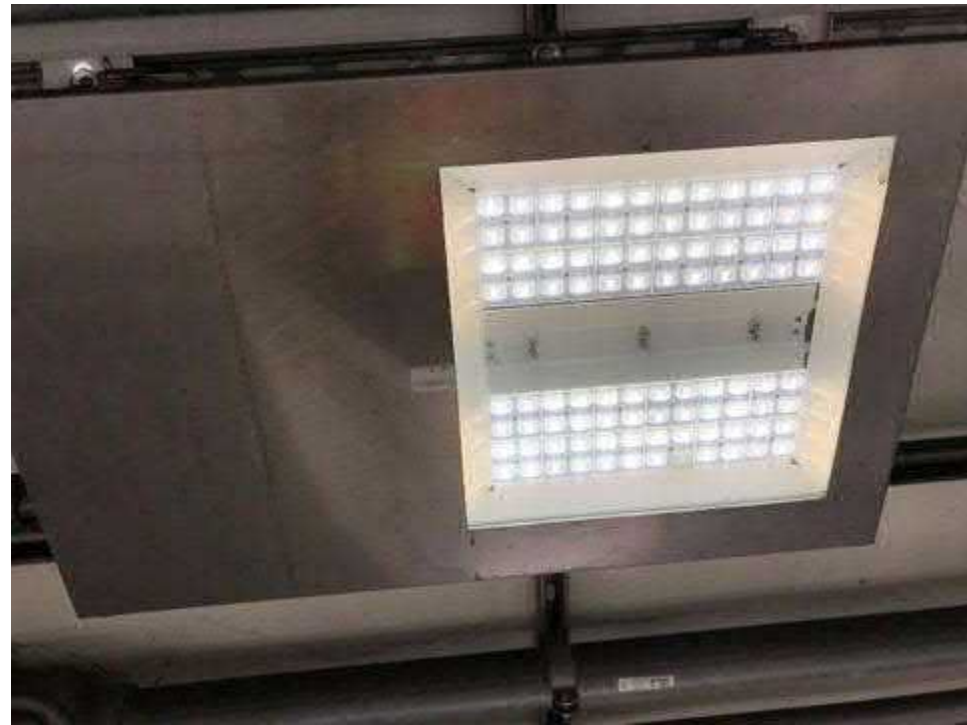
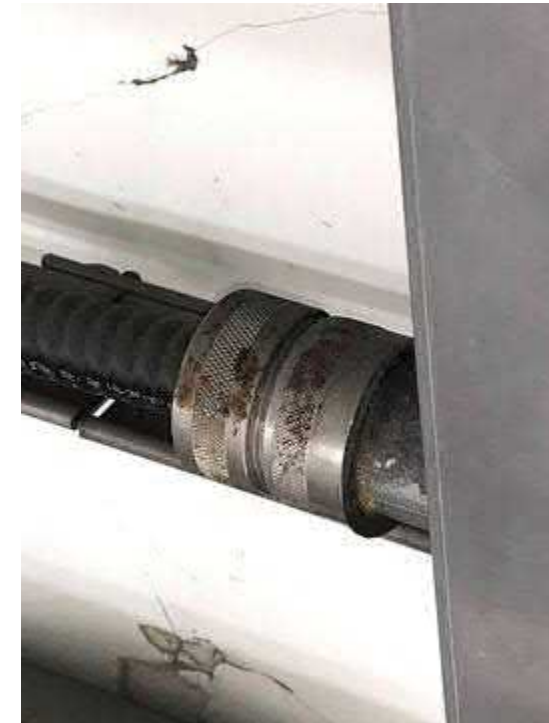
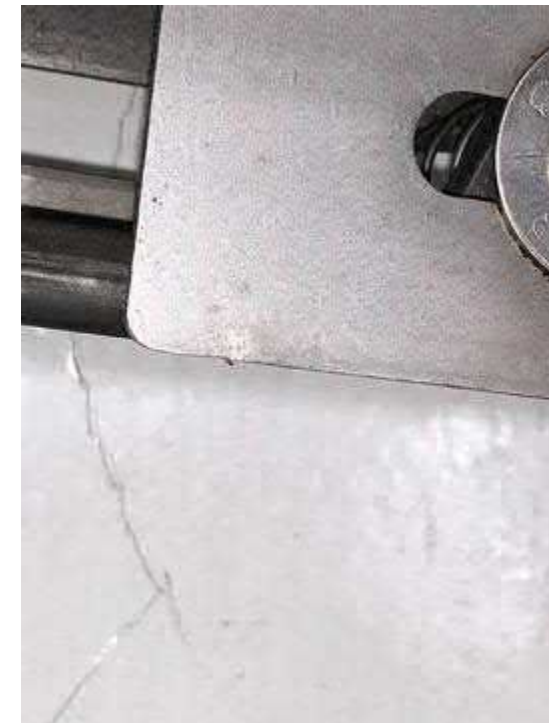
Lighting Fixture Information	
Luminaire Tag or Number:	SBR - West Wall - 43B
Tunnel Direction and Side:	SBR - West Wall
Additional Information:	T Side Entry Loose

Are there any signs of corrosion evident on the tunnel lighting system raceways?	Yes
Are the side entry conduits into the fixture tightly secured?	No
Are there any signs of corrosion on the fixture?	No
Is there any damage to the component housing or enclosure?	No
Is the light fixture secure to the mounting channels?	Yes
Long channel springnut misaligned?	No
Long channel springnut cracked?	No
Trans channel springnut misaligned?	No
Trans channel springnut cracked?	No
Trans channel wireway clip?	Yes
Housing clip disengaged?	No
Housing clip missing?	No
Lens clip disengaged?	No
Lens clip broken?	No
Lens cover cracked?	No
Wireway ears broken?	No
Luminaire functioning?	Yes

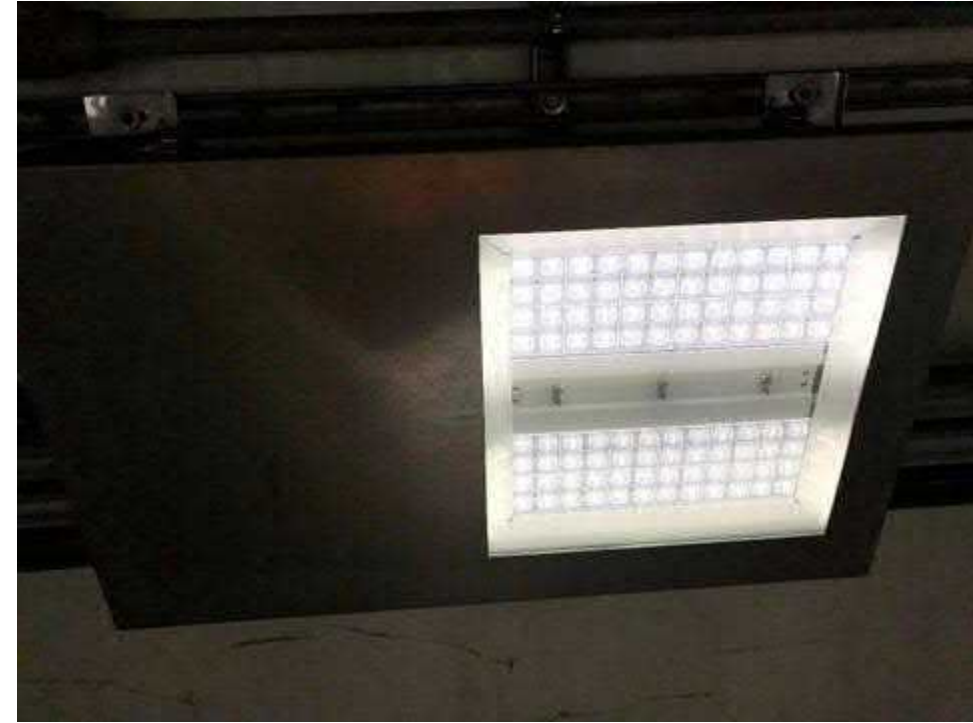
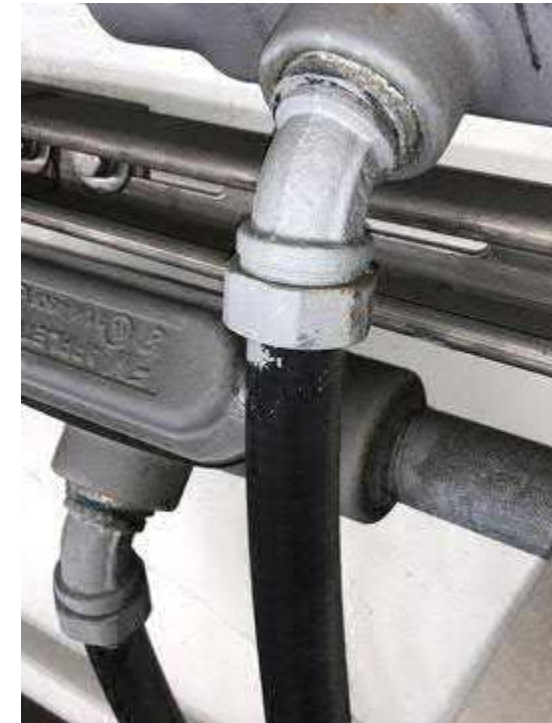
Lighting Fixture Information	
Luminaire Tag or Number:	SBR - East Wall - 43A
Tunnel Direction and Side:	SBR - East Wall - 43A
Additional Information:	T Side Entry L Top Left Bottom Right

Are there any signs of corrosion evident on the tunnel lighting system raceways?	Yes
Are the side entry conduits into the fixture tightly secured?	Yes
Are there any signs of corrosion on the fixture?	No
Is there any damage to the component housing or enclosure?	No
Is the light fixture secure to the mounting channels?	Yes
Long channel springnut misaligned?	No
Long channel springnut cracked?	No
Trans channel springnut misaligned?	Yes
Trans channel springnut cracked?	NA
Trans channel wireway clip?	Yes
Housing clip disengaged?	No
Housing clip missing?	No
Lens clip disengaged?	No
Lens clip broken?	No
Lens cover cracked?	No
Wireway ears broken?	No
Luminaire functioning?	Yes

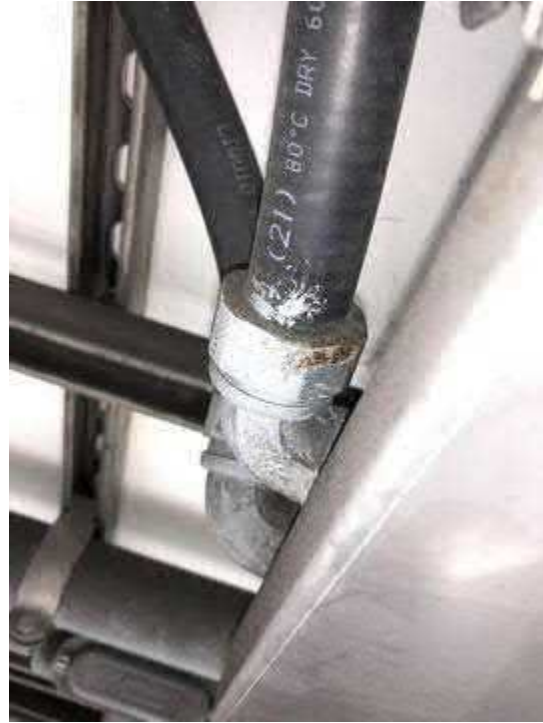
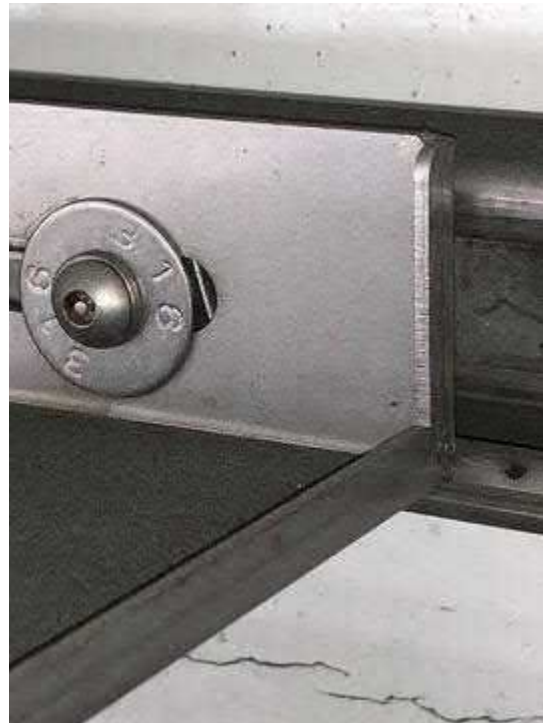
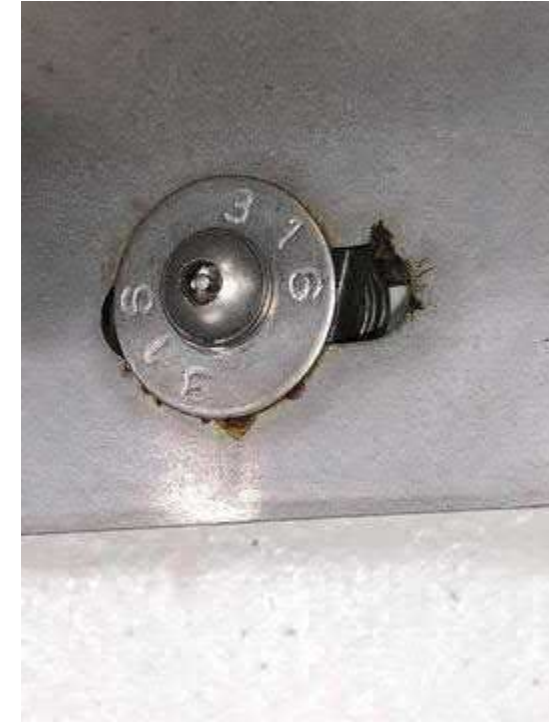
Lighting Fixture Information	
Luminaire Tag or Number:	SBR - East Wall - 43B
Tunnel Direction and Side:	SBR - East Wall
Additional Information:	T Side Entry L

Are there any signs of corrosion evident on the tunnel lighting system raceways?
Are the side entry conduits into the fixture tightly secured?
Are there any signs of corrosion on the fixture?
Is there any damage to the component housing or enclosure?
Is the light fixture secure to the mounting channels?
Long channel springnut misaligned?
Long channel springnut cracked?
Trans channel springnut misaligned?
Trans channel springnut cracked?
Trans channel wireway clip?
Housing clip disengaged?
Housing clip missing?
Lens clip disengaged?
Lens clip broken?
Lens cover cracked?
Wireway ears broken?
Luminaire functioning?

Yes	No	No	No	No	No	No	Yes	No	No	No	No	Yes	No	No	Yes	Yes
-----	----	----	----	----	----	----	-----	----	----	----	----	-----	----	----	-----	-----

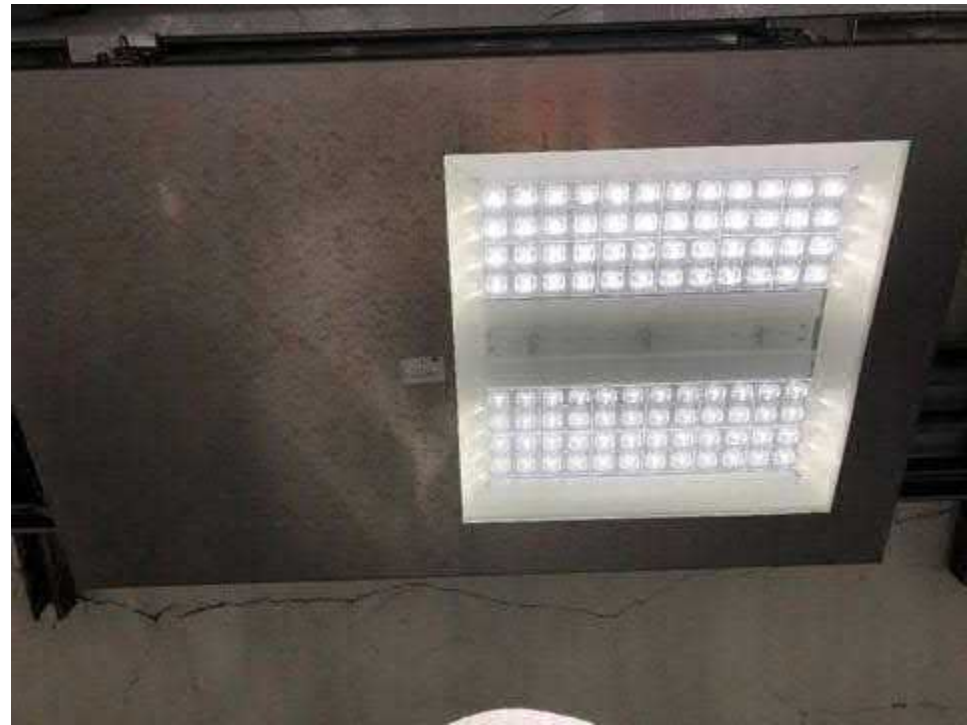
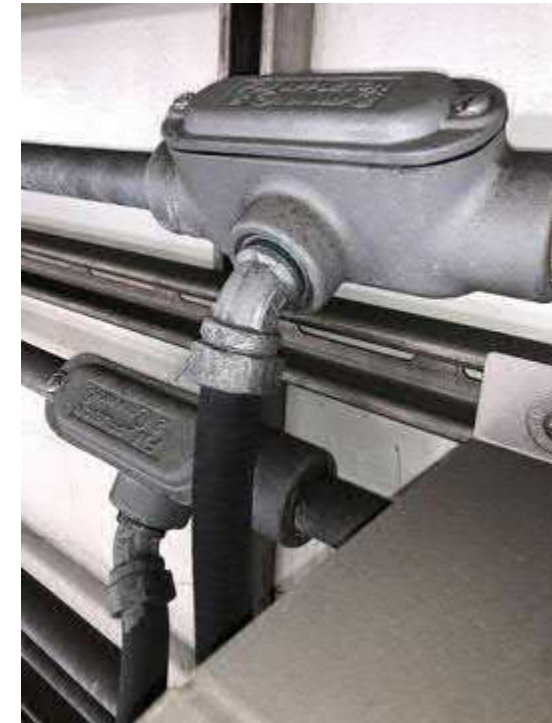
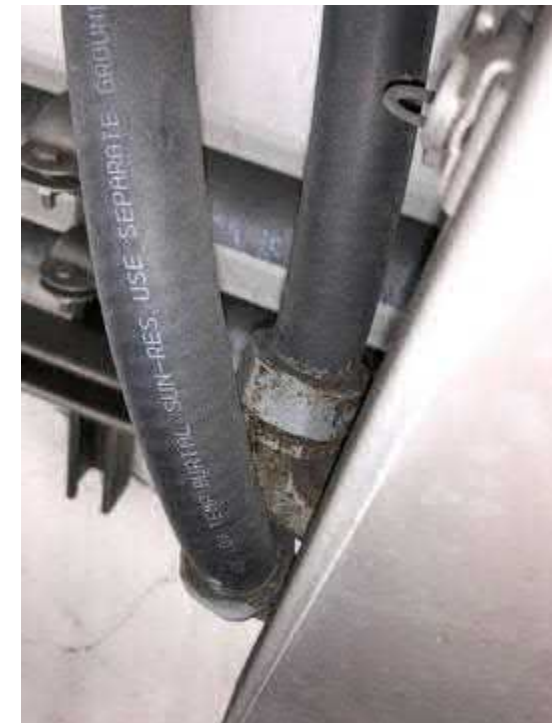
Lighting Fixture Information	
Luminaire Tag or Number:	SBR - West Wall - 48A
Tunnel Direction and Side:	SBR - West Wall
Additional Information:	T

Are there any signs of corrosion evident on the tunnel lighting system raceways?	Yes
Are the side entry conduits into the fixture tightly secured?	Yes
Are there any signs of corrosion on the fixture?	No
Is there any damage to the component housing or enclosure?	No
Is the light fixture secure to the mounting channels?	Yes
Long channel springnut misaligned?	No
Long channel springnut cracked?	No
Trans channel springnut misaligned?	No
Trans channel springnut cracked?	No
Trans channel wireway clip?	Yes
Housing clip disengaged?	No
Housing clip missing?	No
Lens clip disengaged?	No
Lens clip broken?	No
Lens cover cracked?	No
Wireway ears broken?	No
Luminaire functioning?	Yes

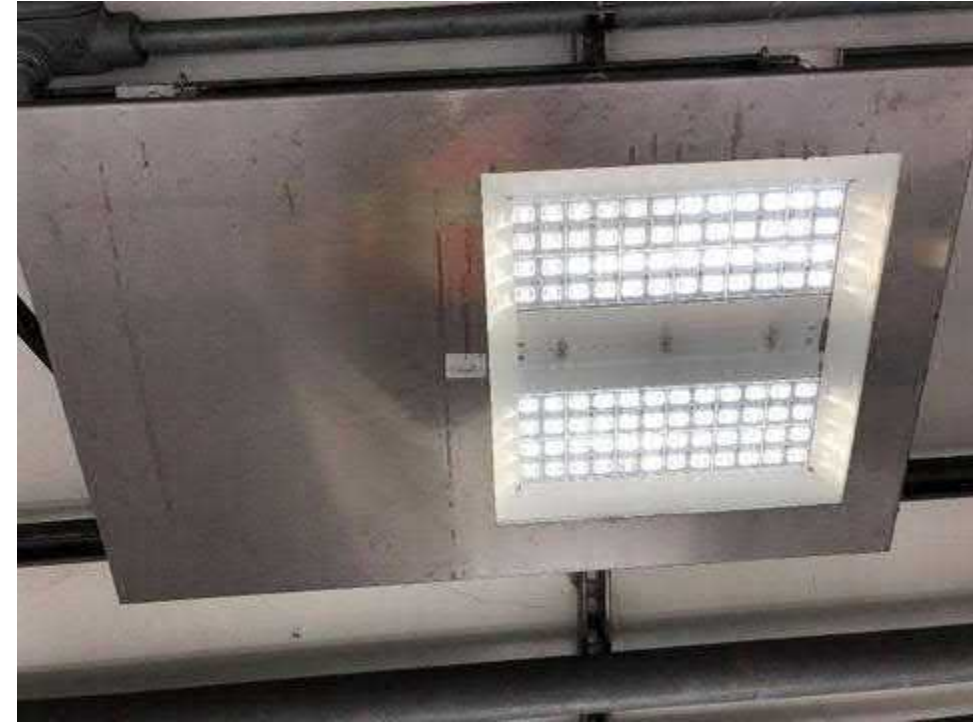
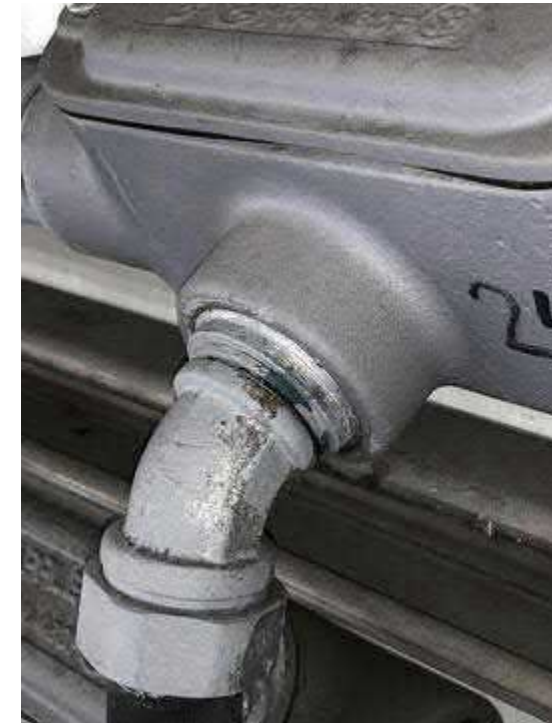
Lighting Fixture Information	
Luminaire Tag or Number:	SBR - West Wall - 48B
Tunnel Direction and Side:	SBR - West Wall
Additional Information:	Top Right Bottom Left

Are there any signs of corrosion evident on the tunnel lighting system raceways?	No
Are the side entry conduits into the fixture tightly secured?	Yes
Are there any signs of corrosion on the fixture?	No
Is there any damage to the component housing or enclosure?	No
Is the light fixture secure to the mounting channels?	Yes
Long channel springnut misaligned?	No
Long channel springnut cracked?	No
Trans channel springnut misaligned?	Yes
Trans channel springnut cracked?	No
Trans channel wireway clip?	Yes
Housing clip disengaged?	No
Housing clip missing?	No
Lens clip disengaged?	No
Lens clip broken?	No
Lens cover cracked?	No
Wireway ears broken?	No
Luminaire functioning?	Yes

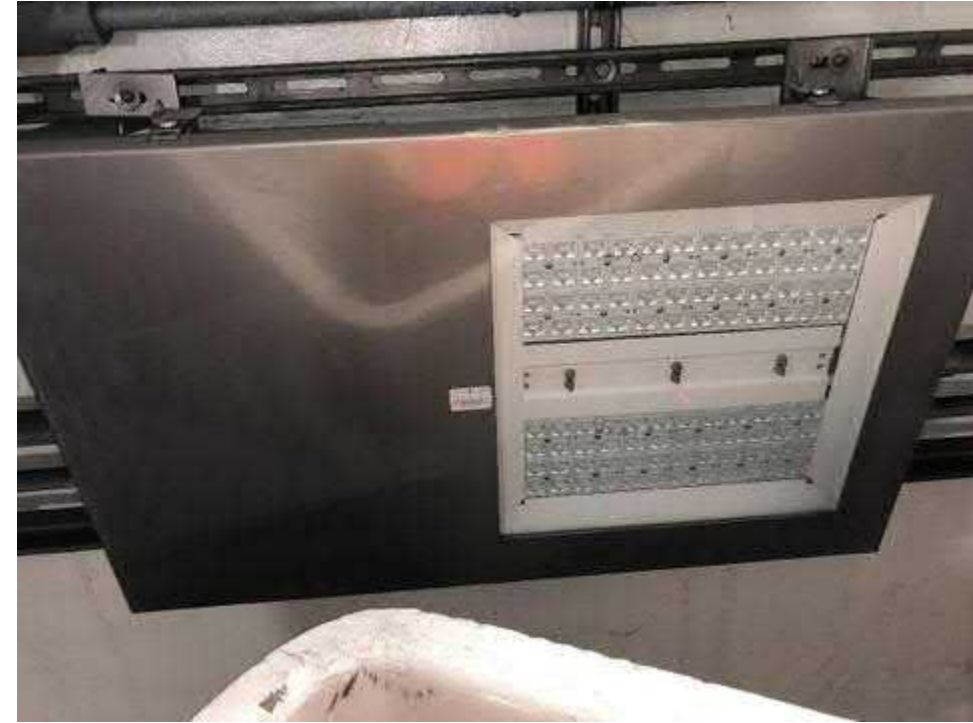
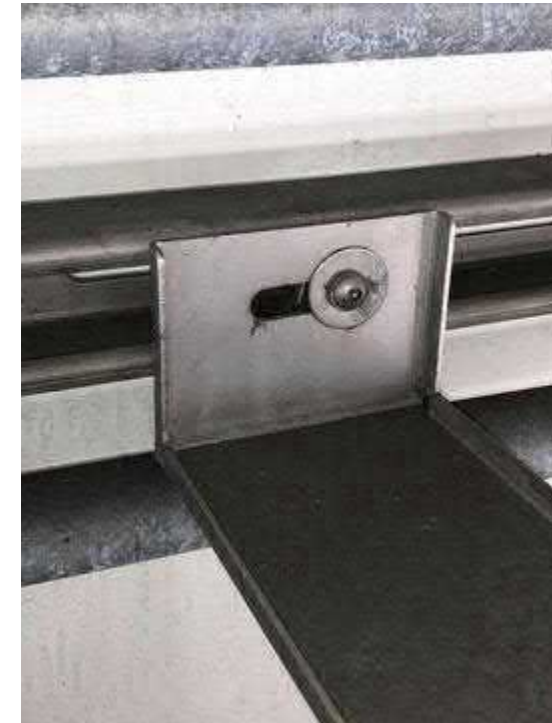
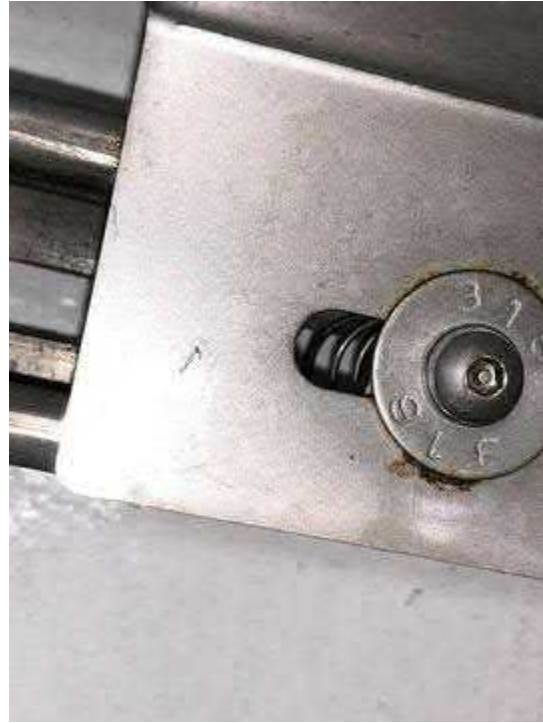
Lighting Fixture Information	
Luminaire Tag or Number:	SBR - East Wall - 48A
Tunnel Direction and Side:	SBR - East Wall
Additional Information:	T Fixture Corrosion

Are there any signs of corrosion evident on the tunnel lighting system raceways?
Are the side entry conduits into the fixture tightly secured?
Are there any signs of corrosion on the fixture?
Is there any damage to the component housing or enclosure?
Is the light fixture secure to the mounting channels?
Long channel springnut misaligned?
Long channel springnut cracked?
Trans channel springnut misaligned?
Trans channel springnut cracked?
Trans channel wireway clip?
Housing clip disengaged?
Housing clip missing?
Lens clip disengaged?
Lens clip broken?
Lens cover cracked?
Wireway ears broken?
Luminaire functioning?

Yes	No	No	No	No	No	No	Yes	No	No	No	No	Yes	No	Yes	Yes	Yes
-----	----	----	----	----	----	----	-----	----	----	----	----	-----	----	-----	-----	-----

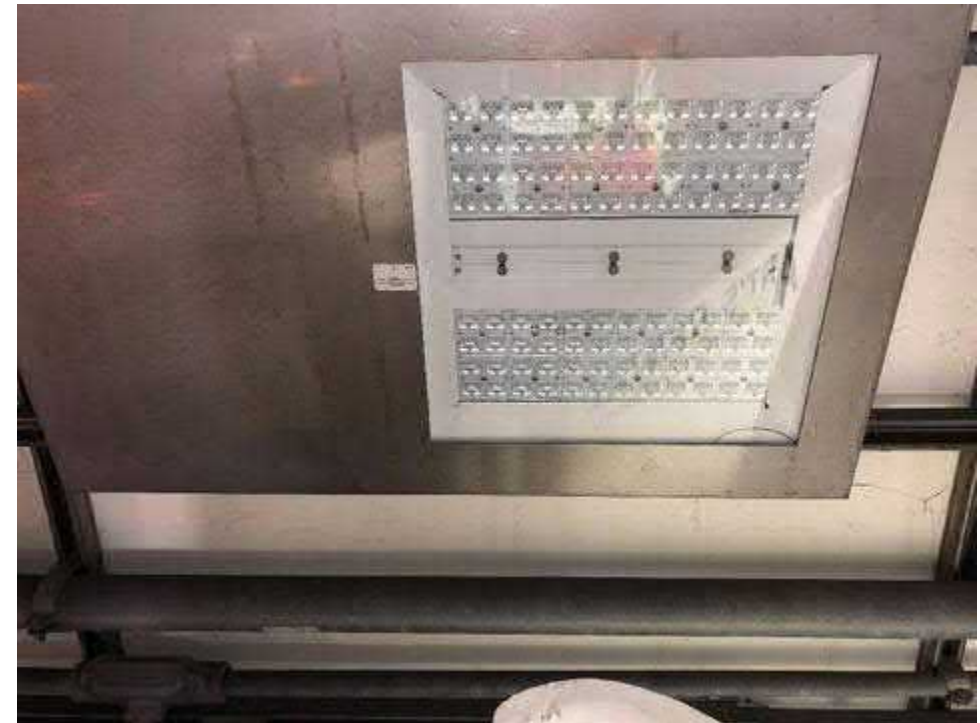
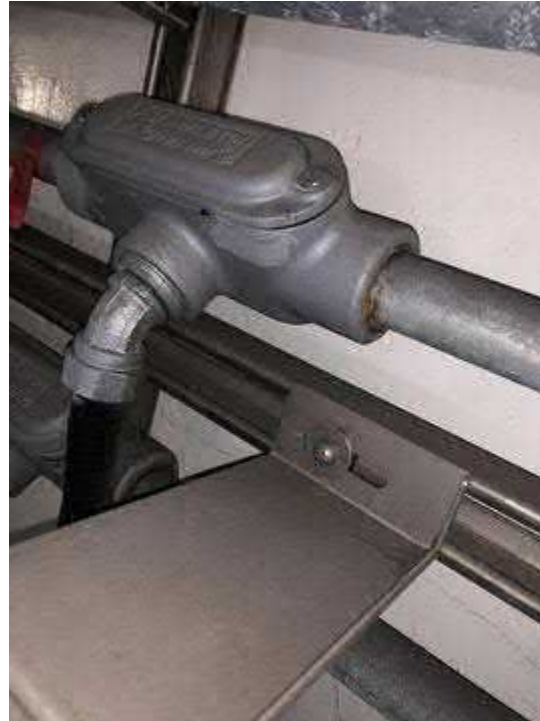
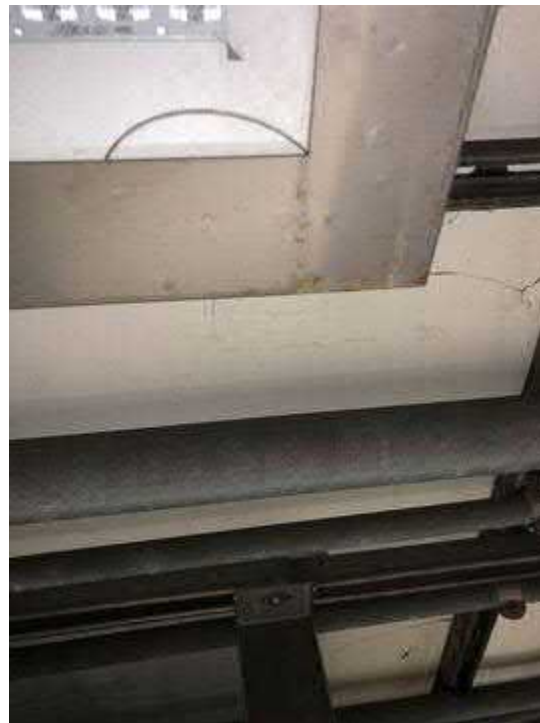
Lighting Fixture Information	
Luminaire Tag or Number:	SBR - East Wall - 48B
Tunnel Direction and Side:	SBR - East Wall
Additional Information:	T Side Entry L

Are there any signs of corrosion evident on the tunnel lighting system raceways?	Yes
Are the side entry conduits into the fixture tightly secured?	Yes
Are there any signs of corrosion on the fixture?	No
Is there any damage to the component housing or enclosure?	Yes
Is the light fixture secure to the mounting channels?	
Long channel springnut misaligned?	No
Long channel springnut cracked?	No
Trans channel springnut misaligned?	No
Trans channel springnut cracked?	No
Trans channel wireway clip?	Yes
Housing clip disengaged?	No
Housing clip missing?	No
Lens clip disengaged?	No
Lens clip broken?	No
Lens cover cracked?	No
Wireway ears broken?	No
Luminaire functioning?	Yes

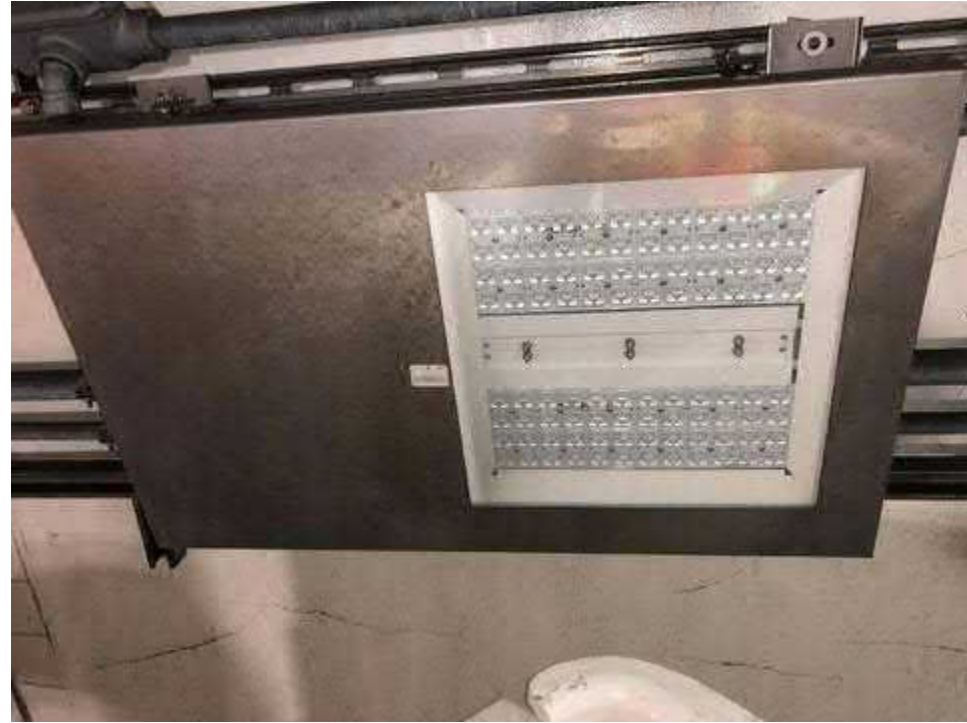
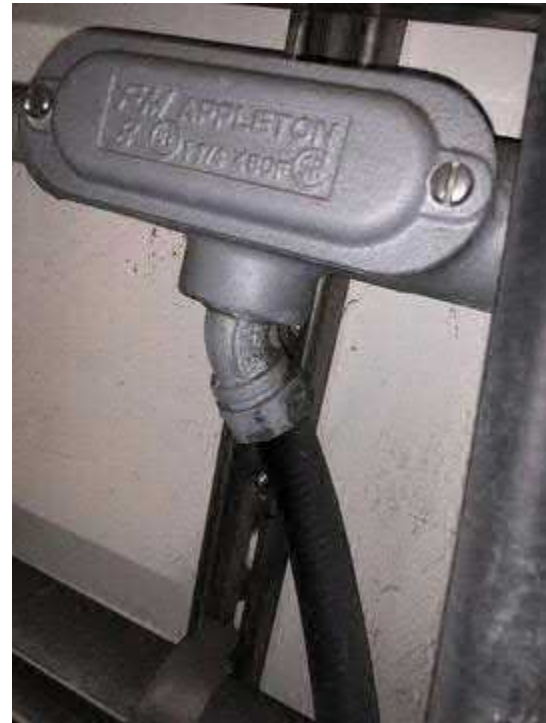
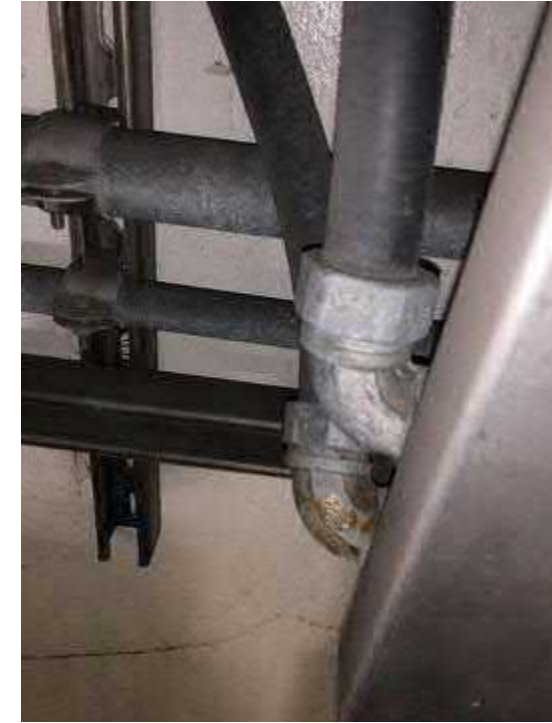
Lighting Fixture Information	
<b>Luminaire Tag or Number:</b>	SBR - West Wall - 53A
<b>Tunnel Direction and Side:</b>	SBR - West Wall
<b>Additional Information:</b>	T Side Entry Loose

Are there any signs of corrosion evident on the tunnel lighting system raceways?
Are the side entry conduits into the fixture tightly secured?
Are there any signs of corrosion on the fixture?
Is there any damage to the component housing or enclosure?
Is the light fixture secure to the mounting channels?
Long channel springnut misaligned?
Long channel springnut cracked?
Trans channel springnut misaligned?
Trans channel springnut cracked?
Trans channel wireway clip?
Housing clip disengaged?
Housing clip missing?
Lens clip disengaged?
Lens clip broken?
Lens cover cracked?
Wireway ears broken?
Luminaire functioning?

Yes	No	No	No	No	No	No	No	Yes	No	No		No	Yes	No	No	No	Yes
-----	----	----	----	----	----	----	----	-----	----	----	--	----	-----	----	----	----	-----

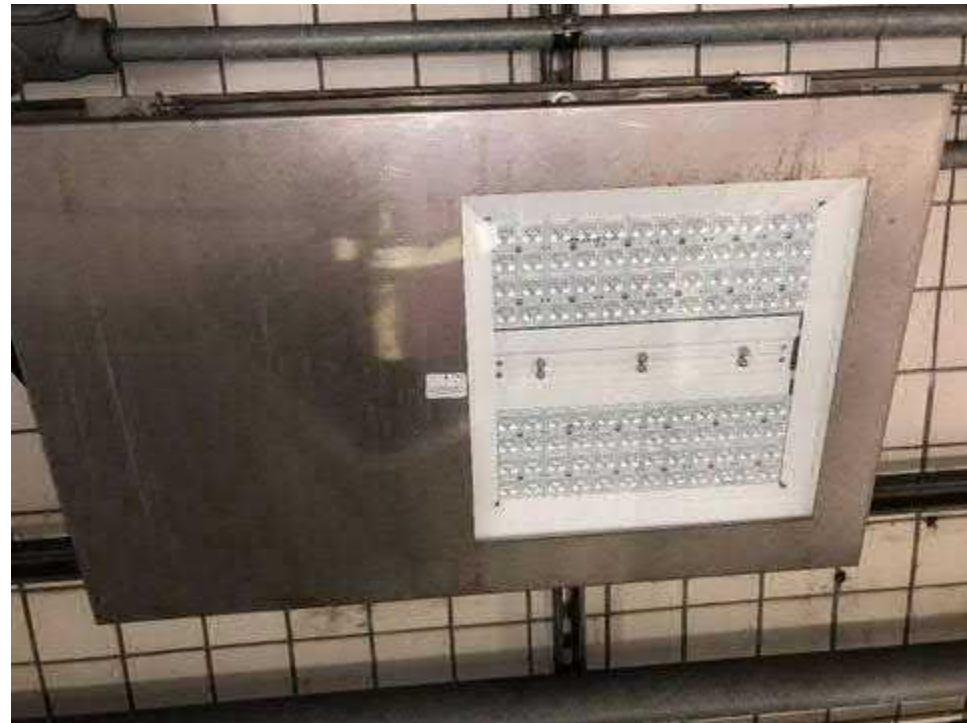
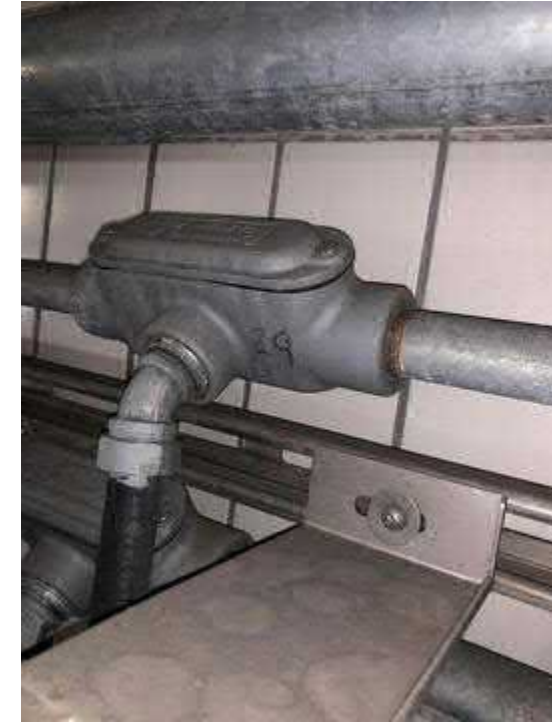
Lighting Fixture Information	
<b>Luminaire Tag or Number:</b>	SBR - West Wall - 53B
<b>Tunnel Direction and Side:</b>	SBR - West Wall
<b>Additional Information:</b>	Side Entry Loose Both Top

Are there any signs of corrosion evident on the tunnel lighting system raceways?
Are the side entry conduits into the fixture tightly secured?
Are there any signs of corrosion on the fixture?
Is there any damage to the component housing or enclosure?
Is the light fixture secure to the mounting channels?
Long channel springnut misaligned?
Long channel springnut cracked?
Trans channel springnut misaligned?
Trans channel springnut cracked?
Trans channel wireway clip?
Housing clip disengaged?
Housing clip missing?
Lens clip disengaged?
Lens clip broken?
Lens cover cracked?
Wireway ears broken?
Luminaire functioning?

Yes	No	No	No		No	No	No	No	Yes	No	No	Yes	No	No	No	Yes
-----	----	----	----	--	----	----	----	----	-----	----	----	-----	----	----	----	-----
