# **Lytle Tunnel (HAM-71-0134) Inspection Report Fall 2020**

PID 105470

November, 2020

Ohio Department of  
Transportation  
District 8  
505 South State Route 741  
Lebanon, OH 45036

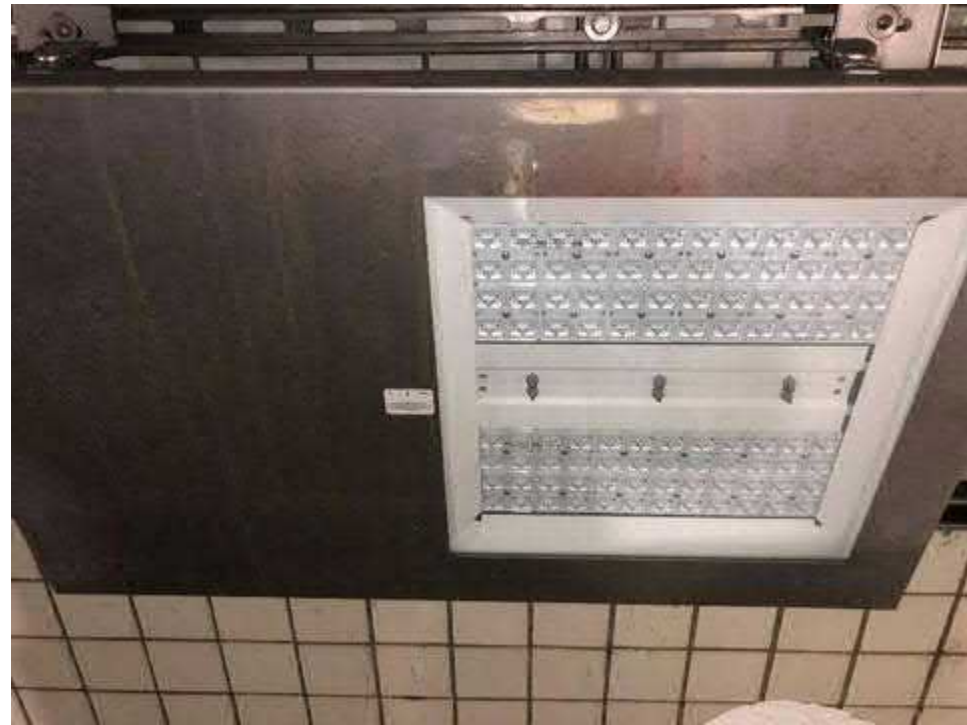
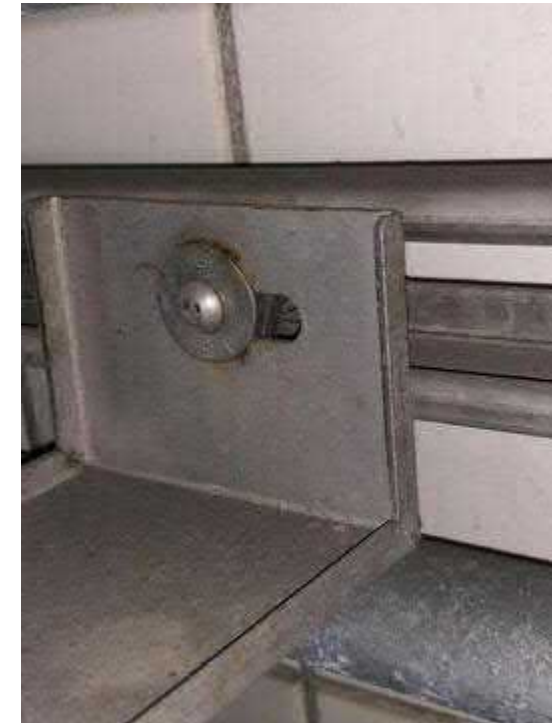
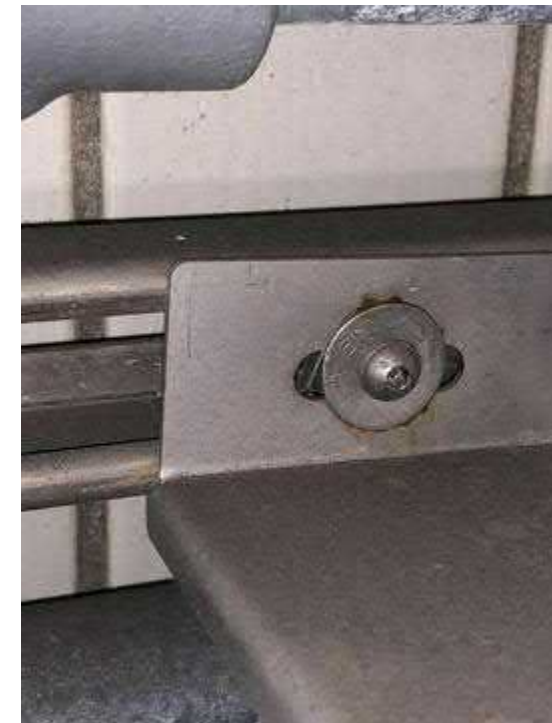
Lighting Fixture Information	
Luminaire Tag or Number:	SBR - East Wall - 53A
Tunnel Direction and Side:	SBR - East Wall - 53A
Additional Information:	T Side Entry L

Are there any signs of corrosion evident on the tunnel lighting system raceways?	Yes
Are the side entry conduits into the fixture tightly secured?	No
Are there any signs of corrosion on the fixture?	No
Is there any damage to the component housing or enclosure?	No
Is the light fixture secure to the mounting channels?	Yes
Long channel springnut misaligned?	No
Long channel springnut cracked?	No
Trans channel springnut misaligned?	No
Trans channel springnut cracked?	No
Trans channel wireway clip?	Yes
Housing clip disengaged?	No
Housing clip missing?	No
Lens clip disengaged?	No
Lens clip broken?	No
Lens cover cracked?	No
Wireway ears broken?	No
Luminaire functioning?	Yes

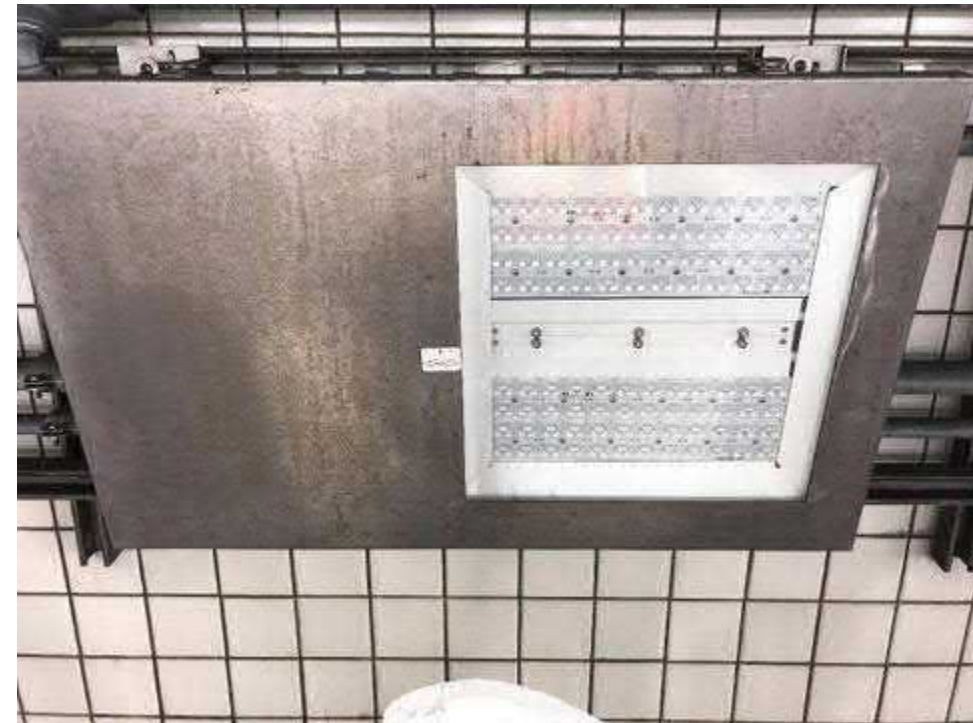
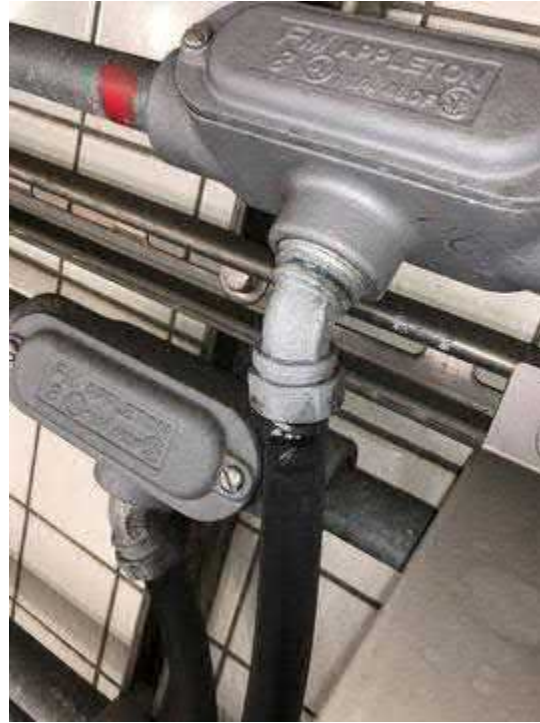
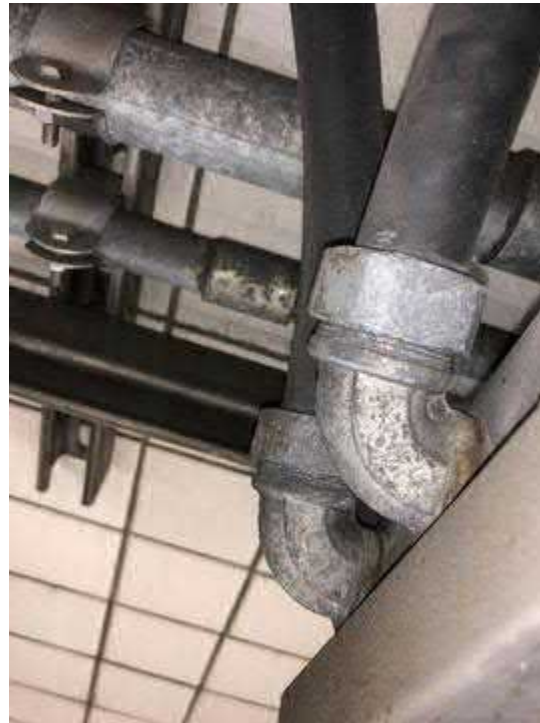
Lighting Fixture Information	
Luminaire Tag or Number:	SBR - West Wall - 59A
Tunnel Direction and Side:	SBR - West Wall
Additional Information:	Side Conduit L Bottom Right

Are there any signs of corrosion evident on the tunnel lighting system raceways?	Yes
Are the side entry conduits into the fixture tightly secured?	Yes
Are there any signs of corrosion on the fixture?	No
Is there any damage to the component housing or enclosure?	No
Is the light fixture secure to the mounting channels?	Yes
Long channel springnut misaligned?	No
Long channel springnut cracked?	No
Trans channel springnut misaligned?	Yes
Trans channel springnut cracked?	No
Trans channel wireway clip?	Yes
Housing clip disengaged?	No
Housing clip missing?	No
Lens clip disengaged?	No
Lens clip broken?	No
Lens cover cracked?	No
Wireway ears broken?	No
Luminaire functioning?	Yes

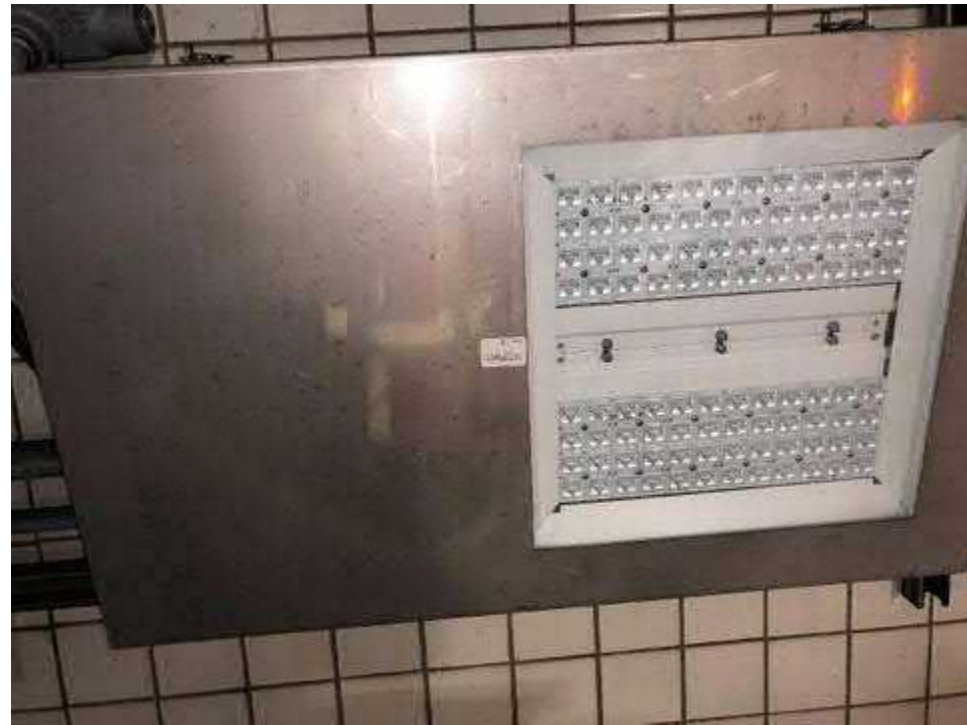
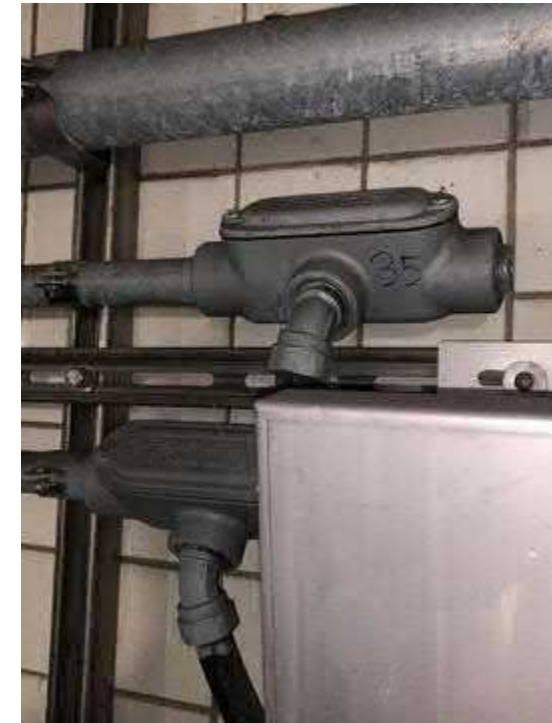
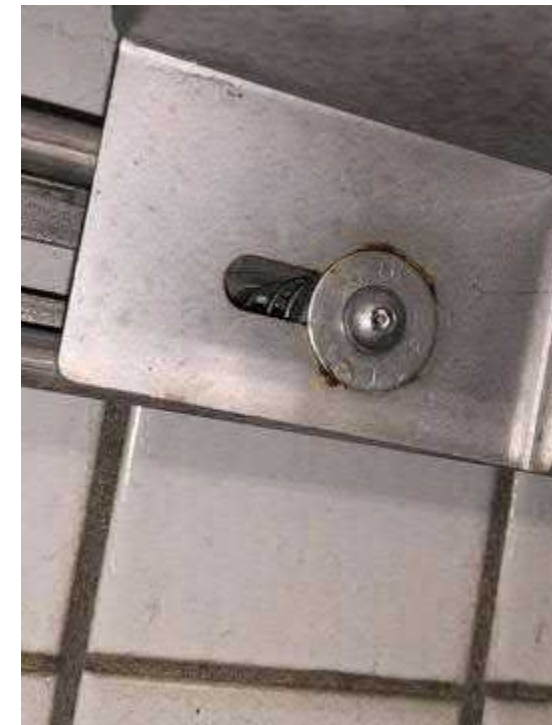
Lighting Fixture Information	
<b>Luminaire Tag or Number:</b>	SBR - West Wall - 59B
<b>Tunnel Direction and Side:</b>	SBR - West Wall
<b>Additional Information:</b>	T Bottom Left

Are there any signs of corrosion evident on the tunnel lighting system raceways?
Are the side entry conduits into the fixture tightly secured?
Are there any signs of corrosion on the fixture?
Is there any damage to the component housing or enclosure?
Is the light fixture secure to the mounting channels?
Long channel springnut misaligned?
Long channel springnut cracked?
Trans channel springnut misaligned?
Trans channel springnut cracked?
Trans channel wireway clip?
Housing clip disengaged?
Housing clip missing?
Lens clip disengaged?
Lens clip broken?
Lens cover cracked?
Wireway ears broken?
Luminaire functioning?

Yes	No	No	No	No	No	No	No	No	Yes	No	No	Yes	No	No	Yes	Yes
-----	----	----	----	----	----	----	----	----	-----	----	----	-----	----	----	-----	-----

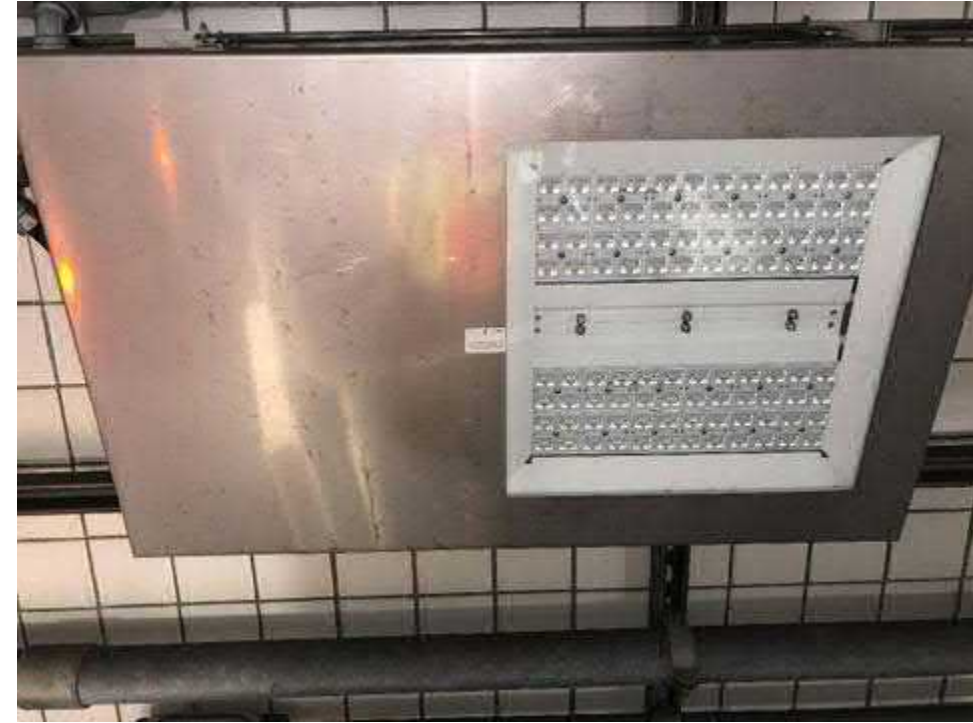
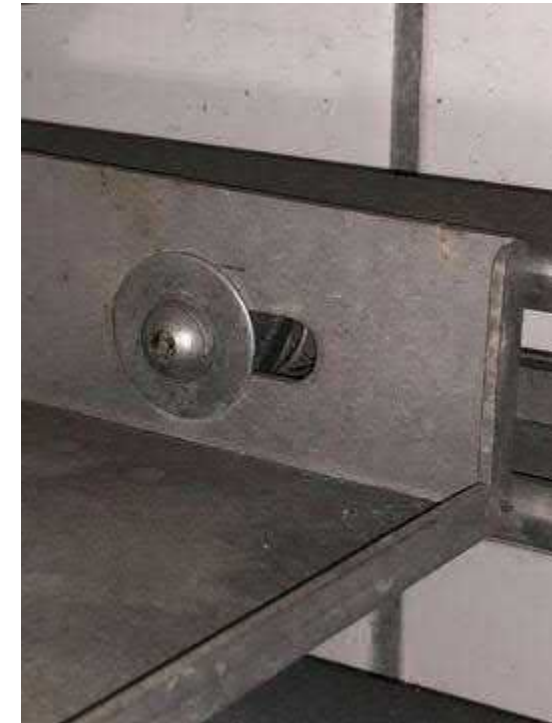
Lighting Fixture Information	
Luminaire Tag or Number:	SBR - East Wall - 59A
Tunnel Direction and Side:	SBR - East Wall
Additional Information:	Top Left

Are there any signs of corrosion evident on the tunnel lighting system raceways?	
Are the side entry conduits into the fixture tightly secured?	Yes
Are there any signs of corrosion on the fixture?	No
Is there any damage to the component housing or enclosure?	No
Is the light fixture secure to the mounting channels?	Yes
Long channel springnut misaligned?	No
Long channel springnut cracked?	No
Trans channel springnut misaligned?	Yes
Trans channel springnut cracked?	No
Trans channel wireway clip?	Yes
Housing clip disengaged?	No
Housing clip missing?	No
Lens clip disengaged?	No
Lens clip broken?	No
Lens cover cracked?	No
Wireway ears broken?	No
Luminaire functioning?	Yes

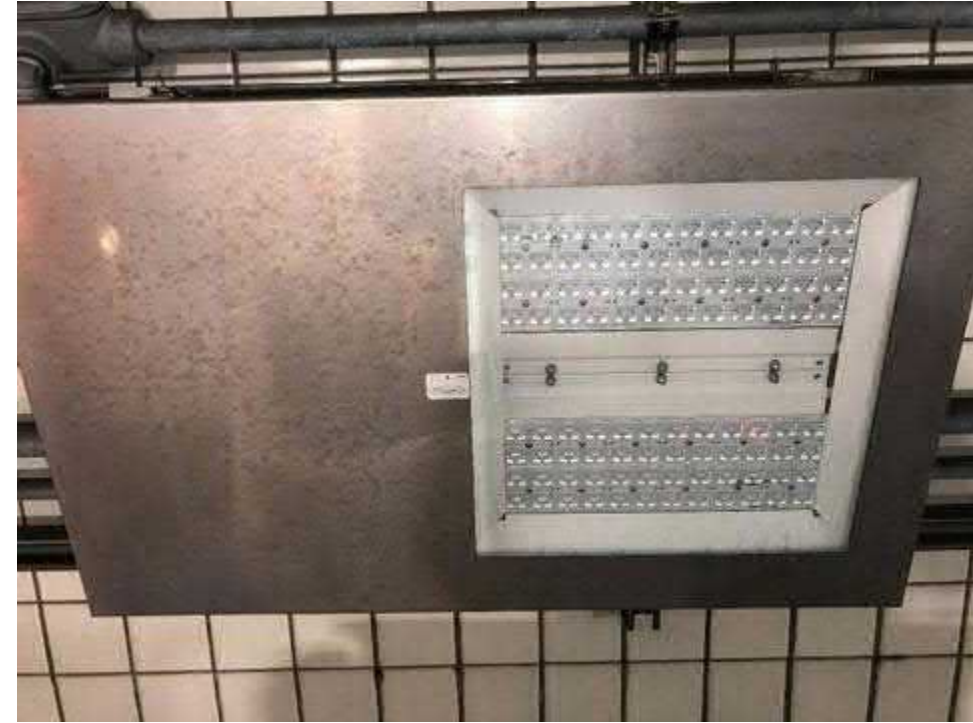
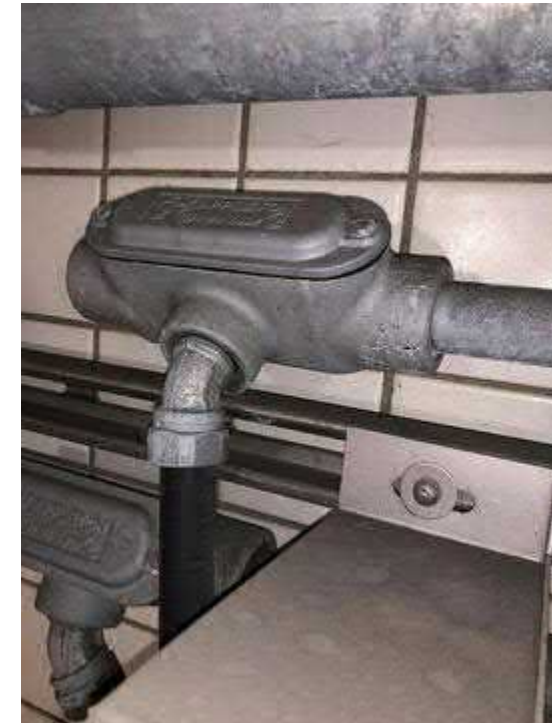
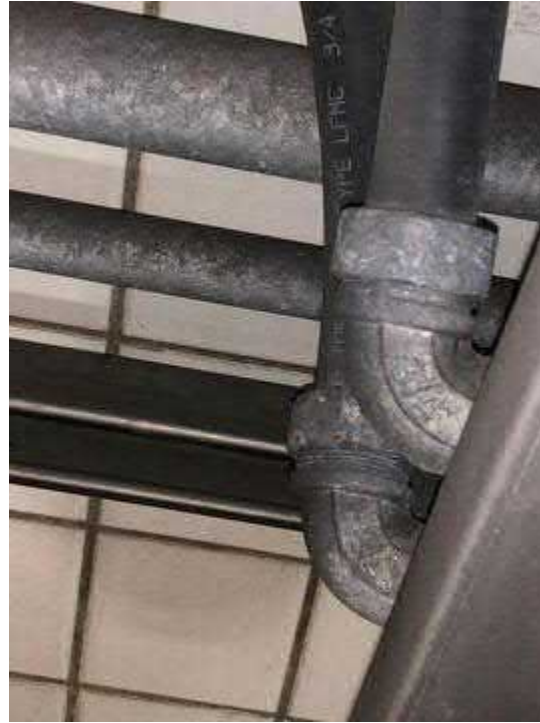
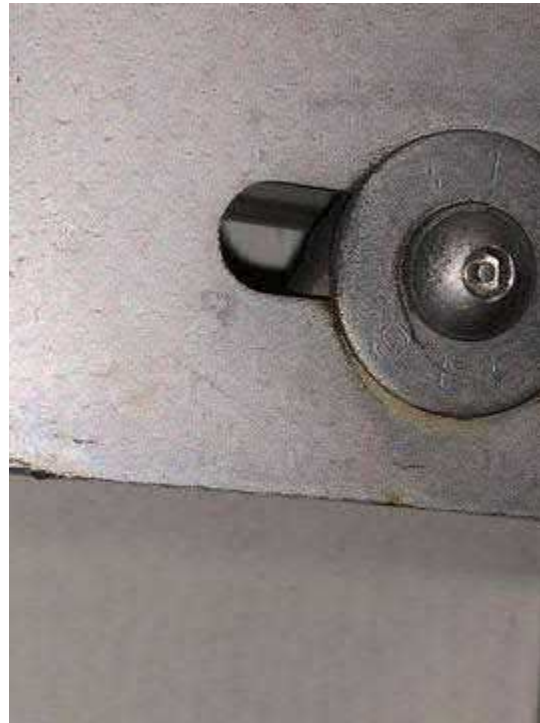
Lighting Fixture Information	
Luminaire Tag or Number:	SBR - East Wall - 59B
Tunnel Direction and Side:	SBR - East Wall
Additional Information:	T Side Entry L Bottom Left

Are there any signs of corrosion evident on the tunnel lighting system raceways?	Yes
Are the side entry conduits into the fixture tightly secured?	Yes
Are there any signs of corrosion on the fixture?	No
Is there any damage to the component housing or enclosure?	No
Is the light fixture secure to the mounting channels?	Yes
Long channel springnut misaligned?	No
Long channel springnut cracked?	No
Trans channel springnut misaligned?	Yes
Trans channel springnut cracked?	No
Trans channel wireway clip?	Yes
Housing clip disengaged?	No
Housing clip missing?	No
Lens clip disengaged?	No
Lens clip broken?	No
Lens cover cracked?	No
Wireway ears broken?	No
Luminaire functioning?	Yes

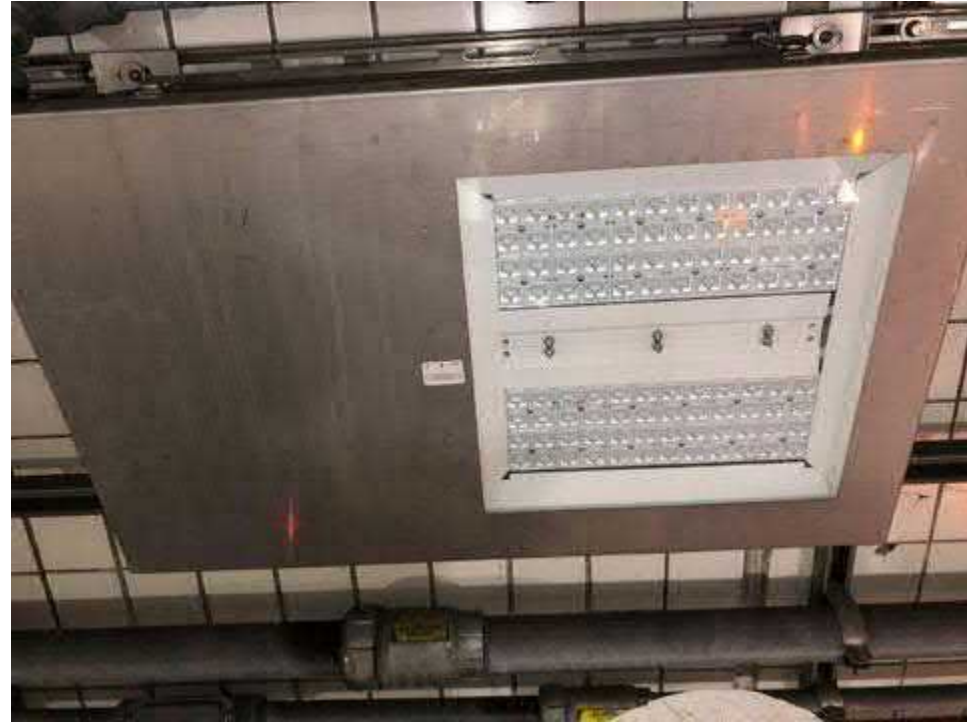
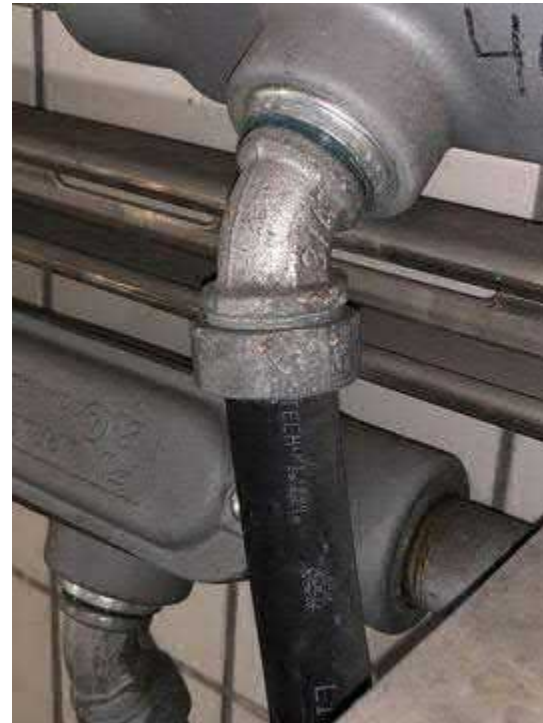
Lighting Fixture Information	
Luminaire Tag or Number:	SBR - West Wall - 64A
Tunnel Direction and Side:	SBR - West Wall
Additional Information:	T

Are there any signs of corrosion evident on the tunnel lighting system raceways?	
Are the side entry conduits into the fixture tightly secured?	Yes
Are there any signs of corrosion on the fixture?	No
Is there any damage to the component housing or enclosure?	No
Is the light fixture secure to the mounting channels?	Yes
Long channel springnut misaligned?	No
Long channel springnut cracked?	No
Trans channel springnut misaligned?	No
Trans channel springnut cracked?	No
Trans channel wireway clip?	Yes
Housing clip disengaged?	No
Housing clip missing?	No
Lens clip disengaged?	No
Lens clip broken?	No
Lens cover cracked?	No
Wireway ears broken?	No
Luminaire functioning?	Yes

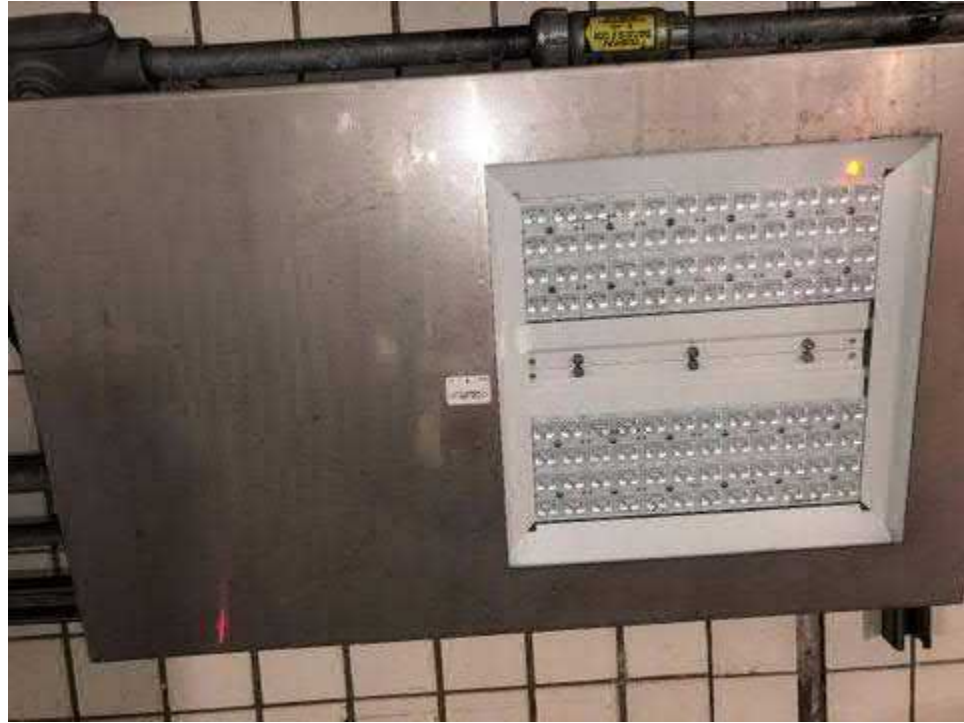
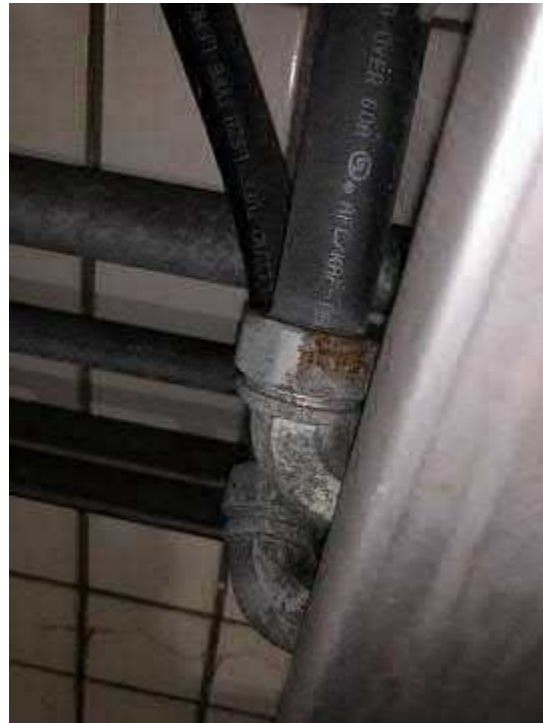
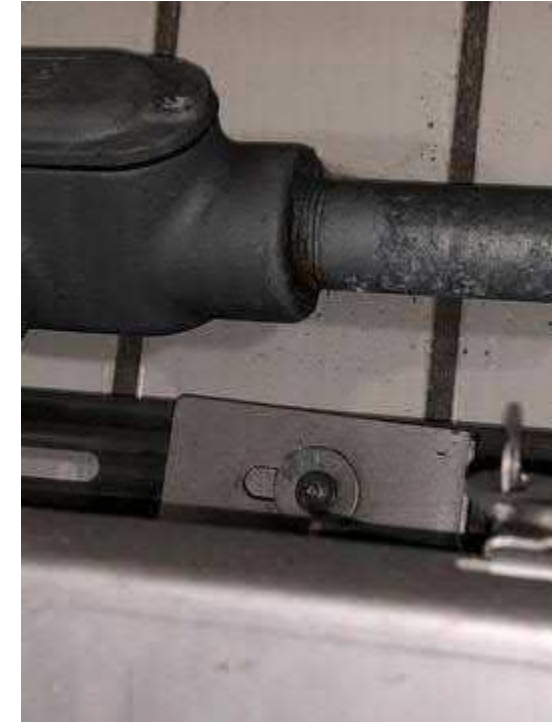
Lighting Fixture Information	
Luminaire Tag or Number:	SBR - West Wall - 64B
Tunnel Direction and Side:	SBR - West Wall
Additional Information:	T Side Entry L

Are there any signs of corrosion evident on the tunnel lighting system raceways?	Yes
Are the side entry conduits into the fixture tightly secured?	Yes
Are there any signs of corrosion on the fixture?	No
Is there any damage to the component housing or enclosure?	No
Is the light fixture secure to the mounting channels?	Yes
Long channel springnut misaligned?	No
Long channel springnut cracked?	No
Trans channel springnut misaligned?	No
Trans channel springnut cracked?	No
Trans channel wireway clip?	Yes
Housing clip disengaged?	No
Housing clip missing?	No
Lens clip disengaged?	No
Lens clip broken?	No
Lens cover cracked?	No
Wireway ears broken?	No
Luminaire functioning?	Yes

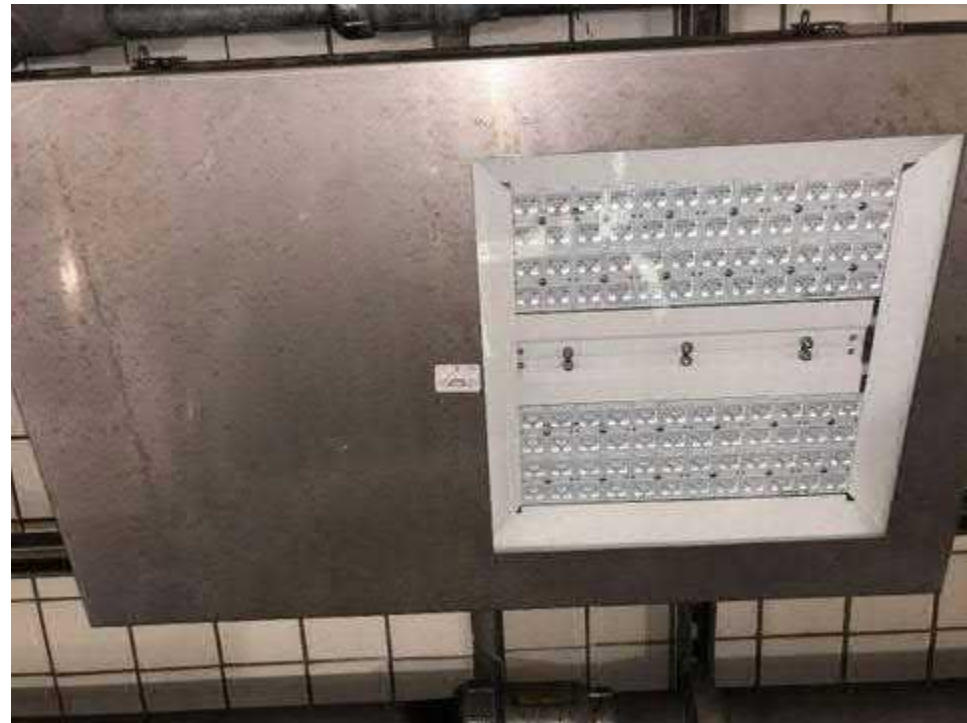
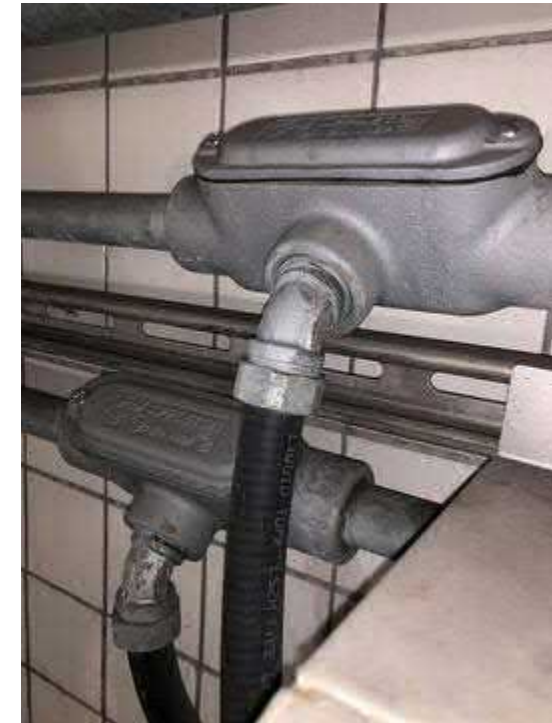
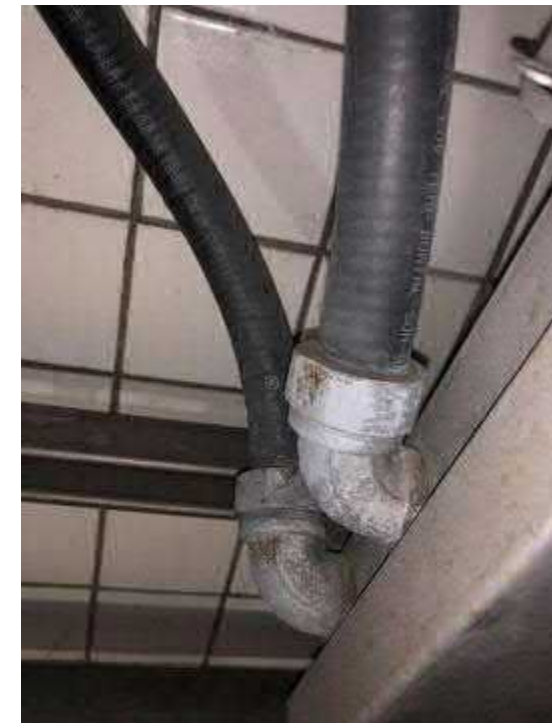
Lighting Fixture Information	
<b>Luminaire Tag or Number:</b>	SBR - East Wall - 64A
<b>Tunnel Direction and Side:</b>	SBR - East Wall
<b>Additional Information:</b>	T Side Entry L

Are there any signs of corrosion evident on the tunnel lighting system raceways?
Are the side entry conduits into the fixture tightly secured?
Are there any signs of corrosion on the fixture?
Is there any damage to the component housing or enclosure?
Is the light fixture secure to the mounting channels?
Long channel springnut misaligned?
Long channel springnut cracked?
Trans channel springnut misaligned?
Trans channel springnut cracked?
Trans channel wireway clip?
Housing clip disengaged?
Housing clip missing?
Lens clip disengaged?
Lens clip broken?
Lens cover cracked?
Wireway ears broken?
Luminaire functioning?

Yes	No	No	No	No	No	No	Yes	No	No	No		Yes	No	No	Yes	Yes
-----	----	----	----	----	----	----	-----	----	----	----	--	-----	----	----	-----	-----

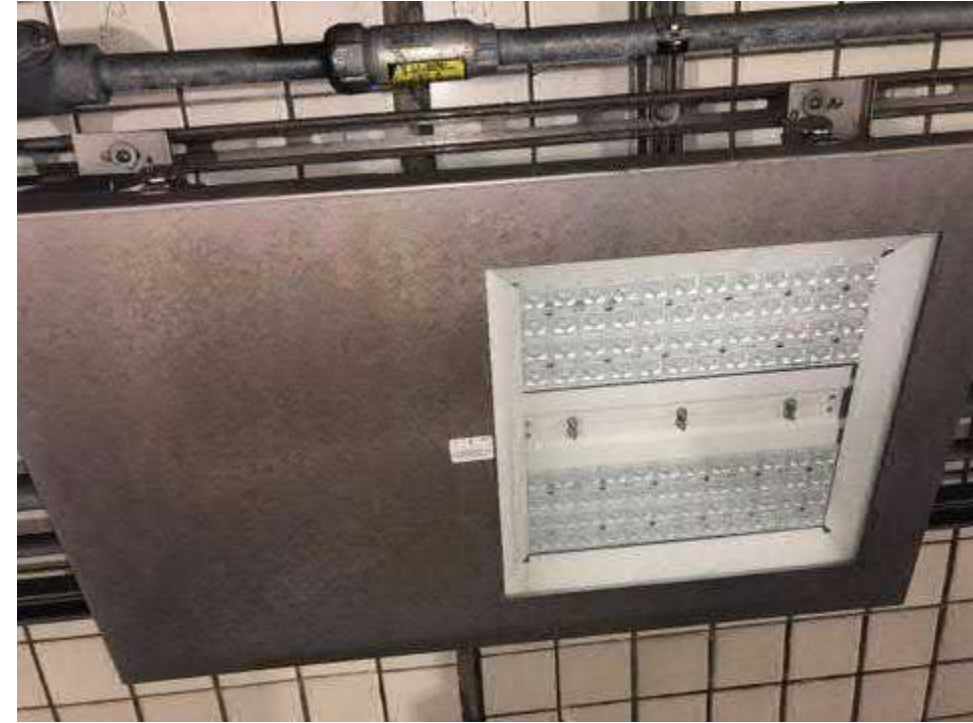
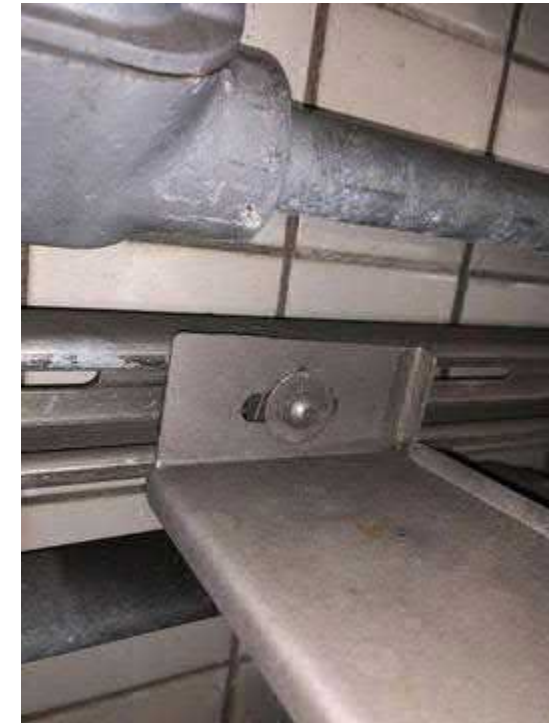
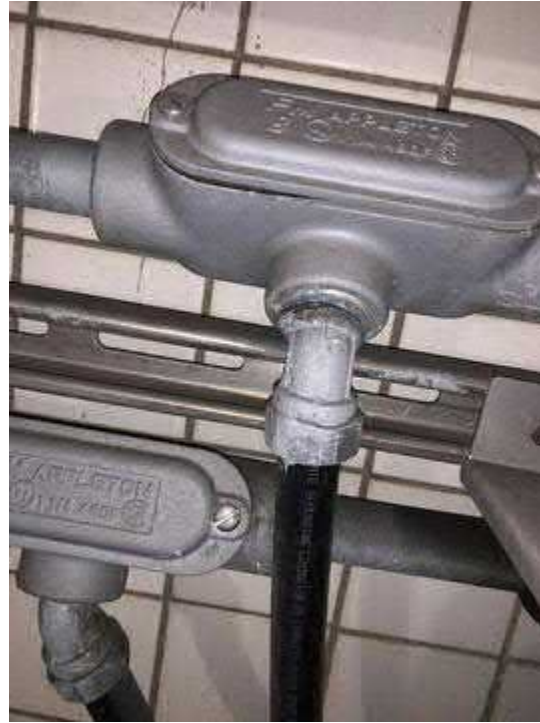
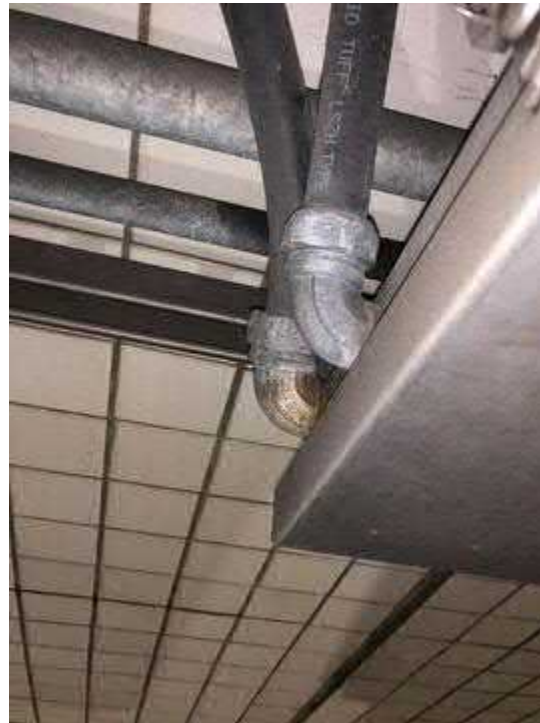
Lighting Fixture Information	
Luminaire Tag or Number:	SBR - East Wall - 64B
Tunnel Direction and Side:	SBR - East Wall
Additional Information:	T Side Entry L Top Left

Are there any signs of corrosion evident on the tunnel lighting system raceways?	Yes
Are the side entry conduits into the fixture tightly secured?	Yes
Are there any signs of corrosion on the fixture?	No
Is there any damage to the component housing or enclosure?	No
Is the light fixture secure to the mounting channels?	Yes
Long channel springnut misaligned?	No
Long channel springnut cracked?	No
Trans channel springnut misaligned?	Yes
Trans channel springnut cracked?	No
Trans channel wireway clip?	No
Housing clip disengaged?	No
Housing clip missing?	No
Lens clip disengaged?	No
Lens clip broken?	No
Lens cover cracked?	No
Wireway ears broken?	No
Luminaire functioning?	Yes

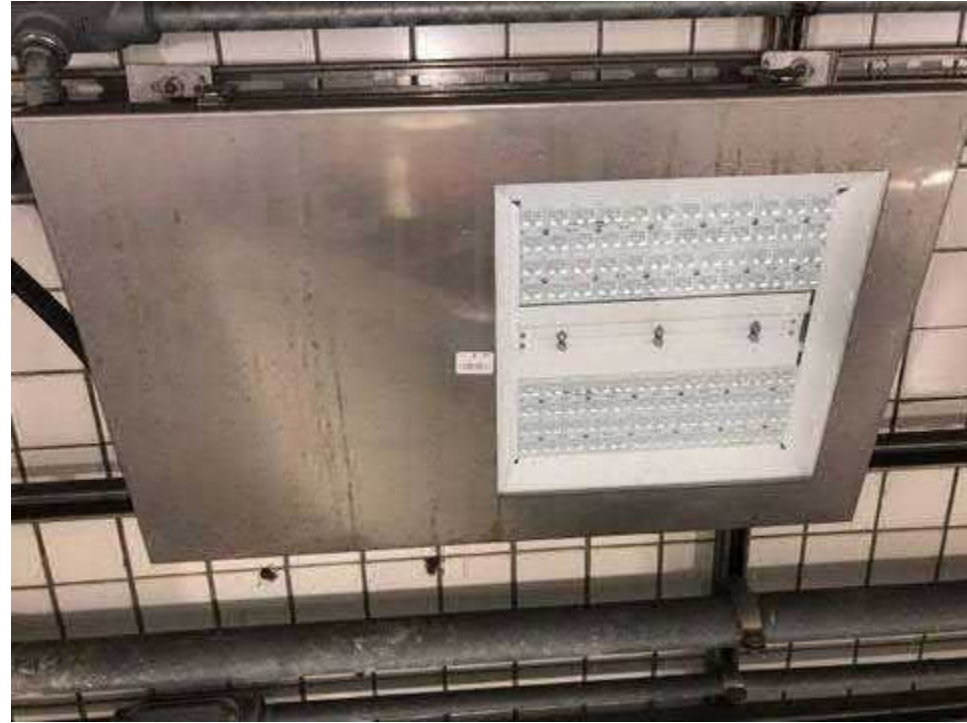
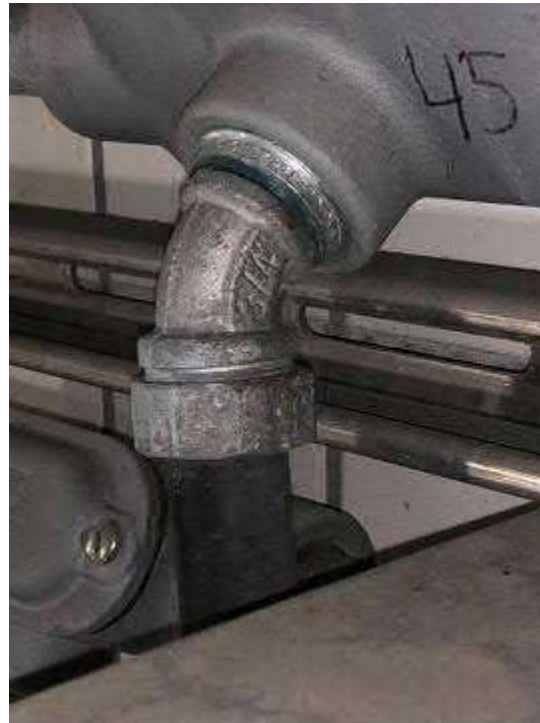
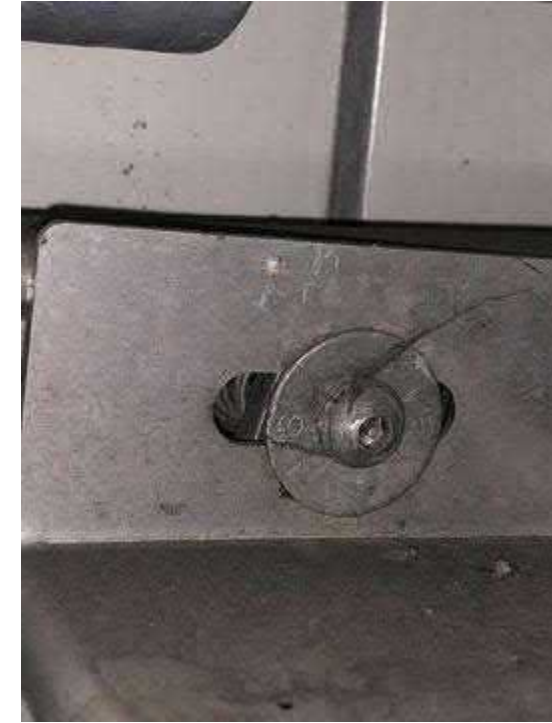
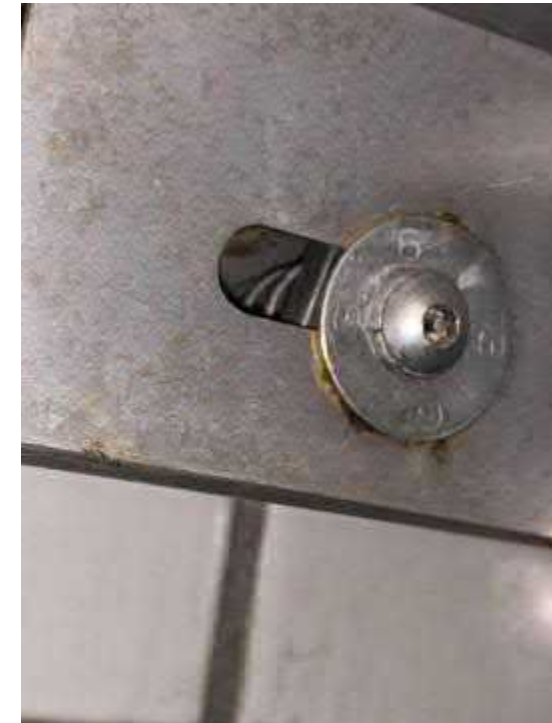
Lighting Fixture Information	
Luminaire Tag or Number:	SBR - West Wall - 69A
Tunnel Direction and Side:	SBR - West Wall
Additional Information:	T Side Entry Loose Top Left Bottom Left

Are there any signs of corrosion evident on the tunnel lighting system raceways?	Yes
Are the side entry conduits into the fixture tightly secured?	Yes
Are there any signs of corrosion on the fixture?	
Is there any damage to the component housing or enclosure?	No
Is the light fixture secure to the mounting channels?	Yes
Long channel springnut misaligned?	No
Long channel springnut cracked?	No
Trans channel springnut misaligned?	Yes
Trans channel springnut cracked?	No
Trans channel wireway clip?	Yes
Housing clip disengaged?	No
Housing clip missing?	No
Lens clip disengaged?	No
Lens clip broken?	No
Lens cover cracked?	No
Wireway ears broken?	No
Luminaire functioning?	Yes

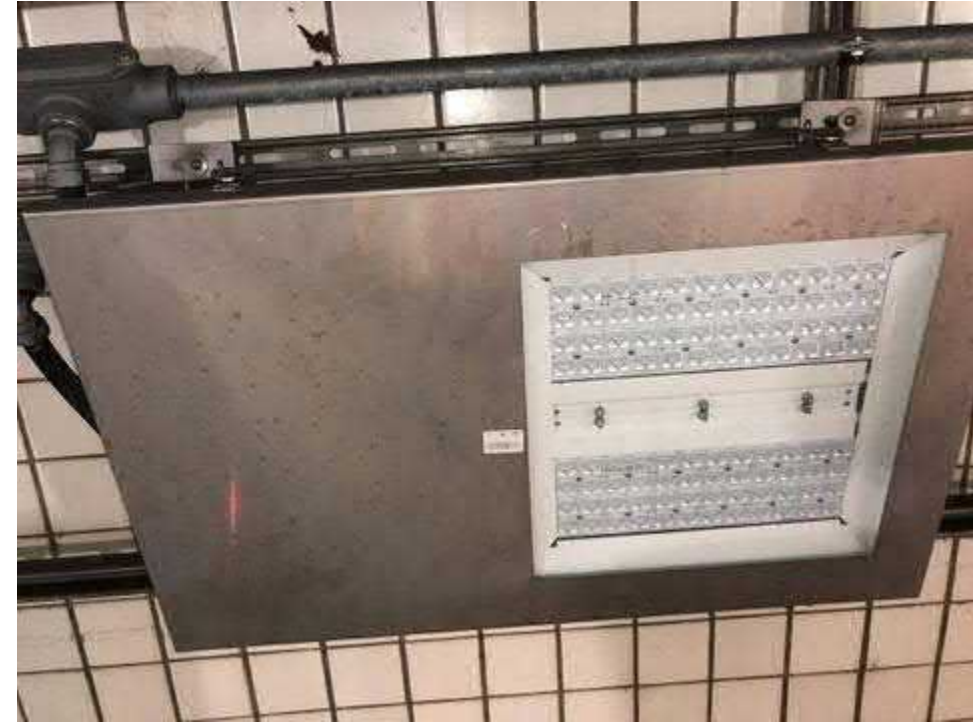
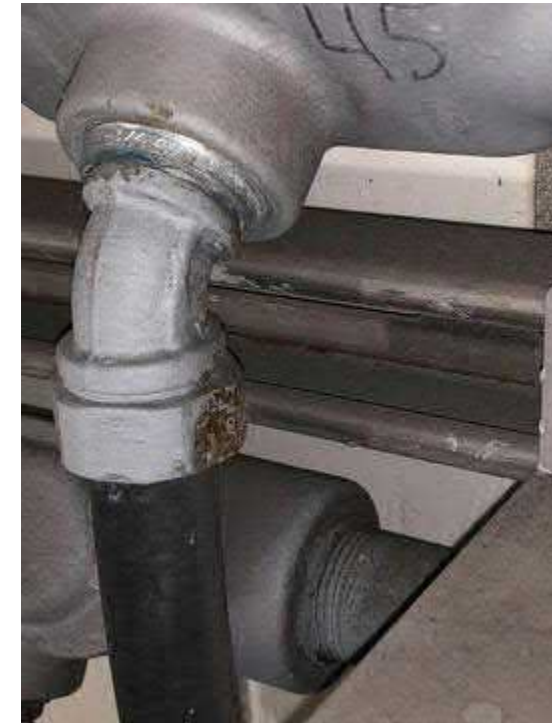
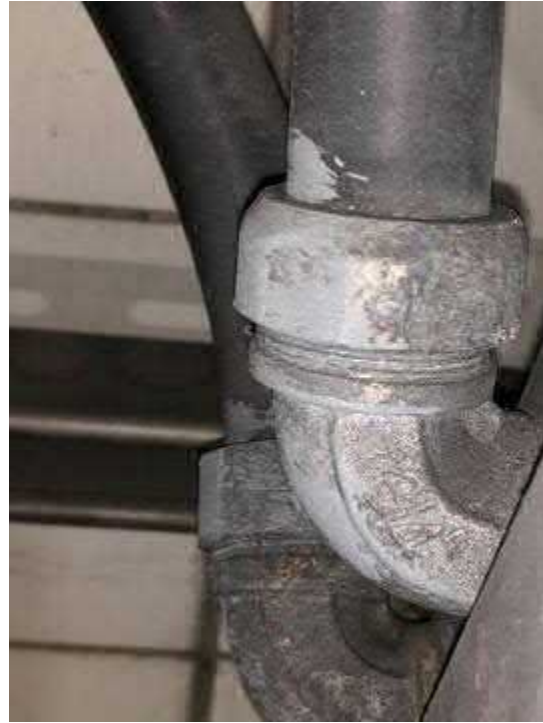
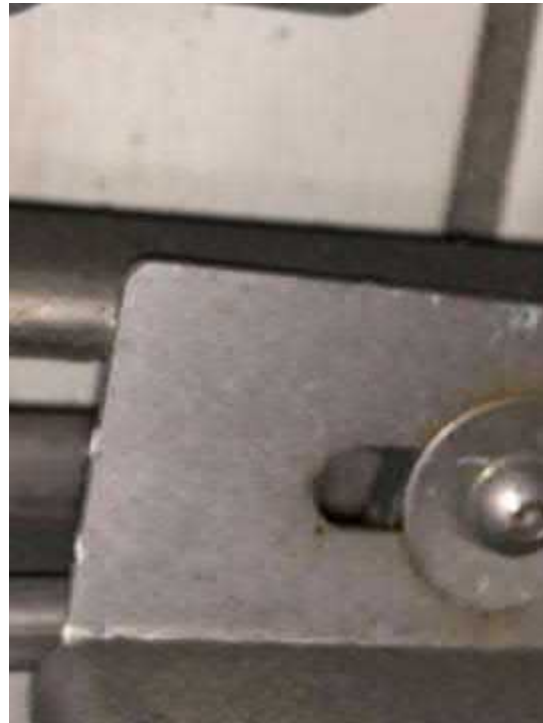
Lighting Fixture Information	
Luminaire Tag or Number:	SBR - West Wall - 69B
Tunnel Direction and Side:	SBR - West Wall
Additional Information:	T Side Entry L Side Entry Loose Top Left

Are there any signs of corrosion evident on the tunnel lighting system raceways?	Yes
Are the side entry conduits into the fixture tightly secured?	Yes
Are there any signs of corrosion on the fixture?	No
Is there any damage to the component housing or enclosure?	No
Is the light fixture secure to the mounting channels?	Yes
Long channel springnut misaligned?	No
Long channel springnut cracked?	No
Trans channel springnut misaligned?	Yes
Trans channel springnut cracked?	No
Trans channel wireway clip?	Yes
Housing clip disengaged?	No
Housing clip missing?	No
Lens clip disengaged?	No
Lens clip broken?	No
Lens cover cracked?	No
Wireway ears broken?	No
Luminaire functioning?	Yes

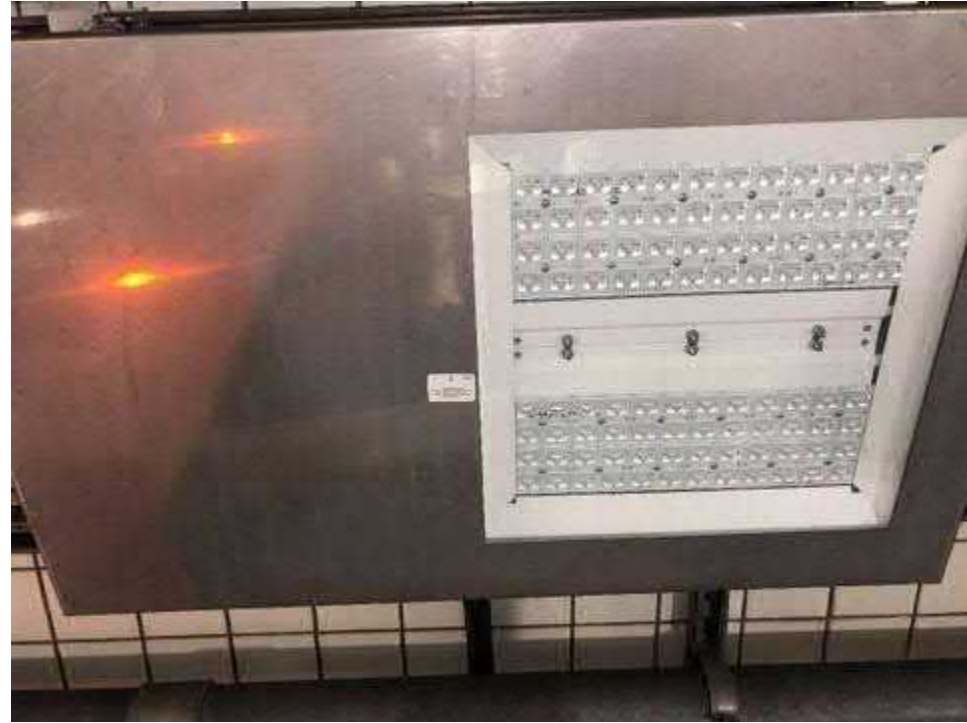
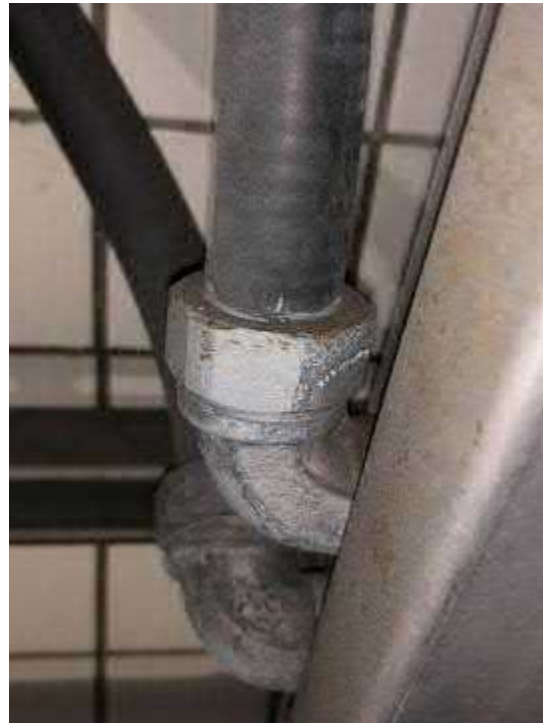
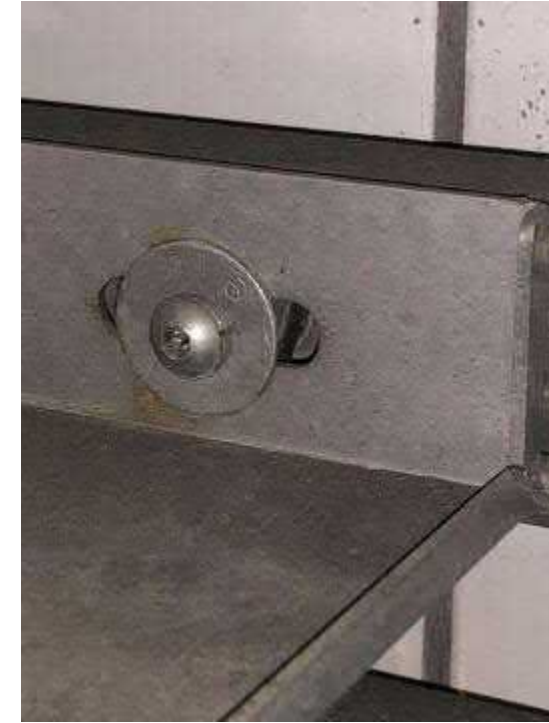
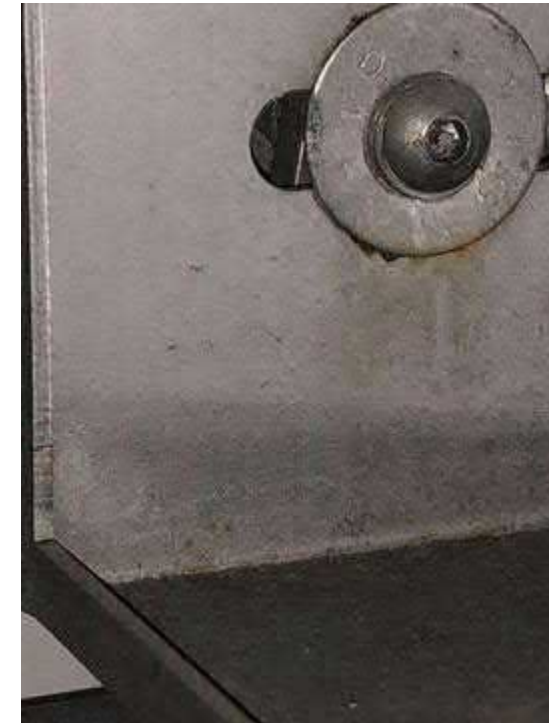
Lighting Fixture Information	
Luminaire Tag or Number:	SBR - East Wall - 69A
Tunnel Direction and Side:	SBR - East Wall
Additional Information:	Side Emtry L Both Top

Are there any signs of corrosion evident on the tunnel lighting system raceways?	Yes
Are the side entry conduits into the fixture tightly secured?	Yes
Are there any signs of corrosion on the fixture?	
Is there any damage to the component housing or enclosure?	No
Is the light fixture secure to the mounting channels?	Yes
Long channel springnut misaligned?	No
Long channel springnut cracked?	No
Trans channel springnut misaligned?	Yes
Trans channel springnut cracked?	No
Trans channel wireway clip?	Yes
Housing clip disengaged?	No
Housing clip missing?	No
Lens clip disengaged?	No
Lens clip broken?	No
Lens cover cracked?	No
Wireway ears broken?	No
Luminaire functioning?	Yes
