# **Lytle Tunnel (HAM-71-0134) Inspection Report Fall 2020**

PID 105470

November, 2020

Ohio Department of  
Transportation  
District 8  
505 South State Route 741  
Lebanon, OH 45036

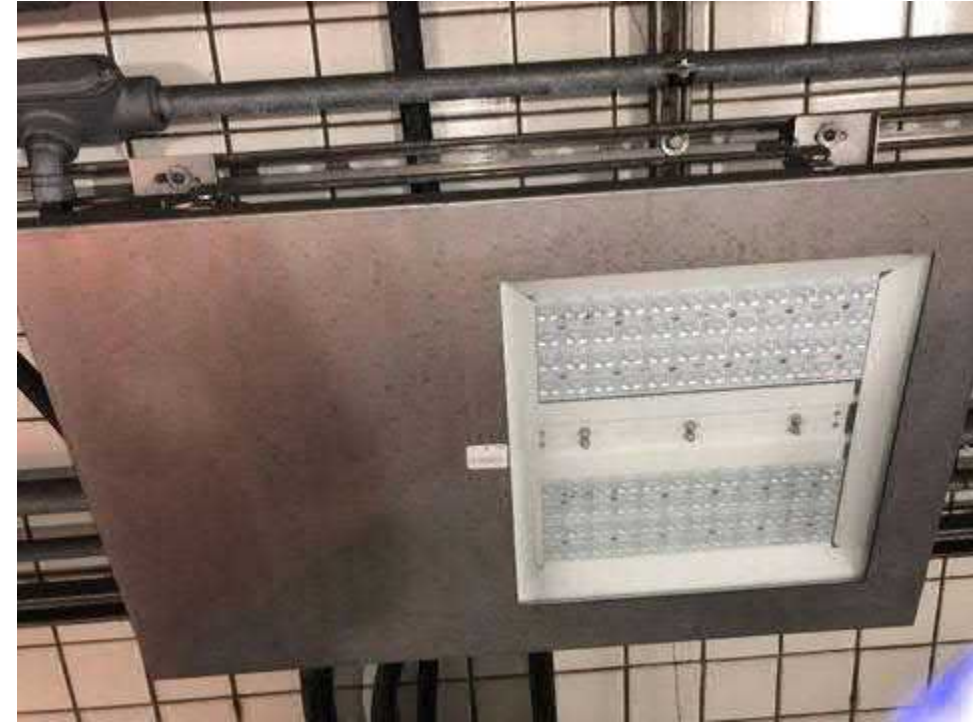
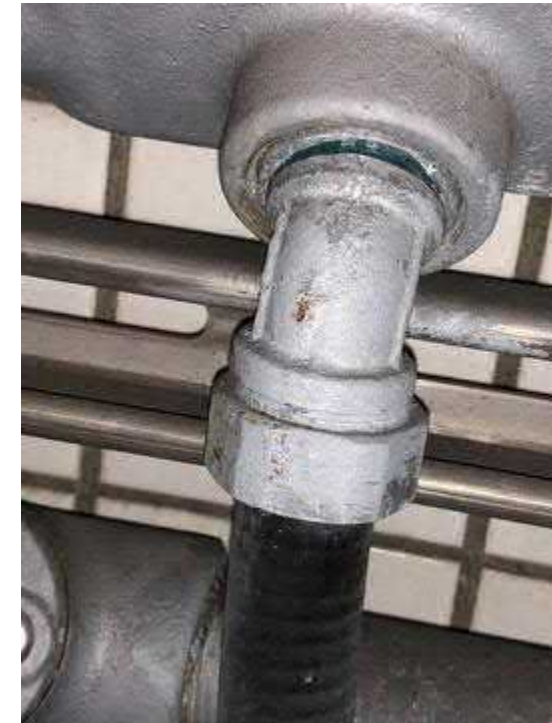
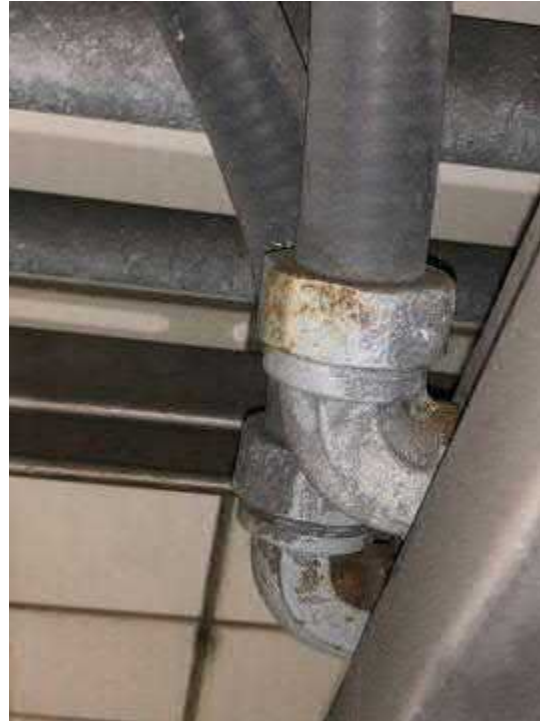
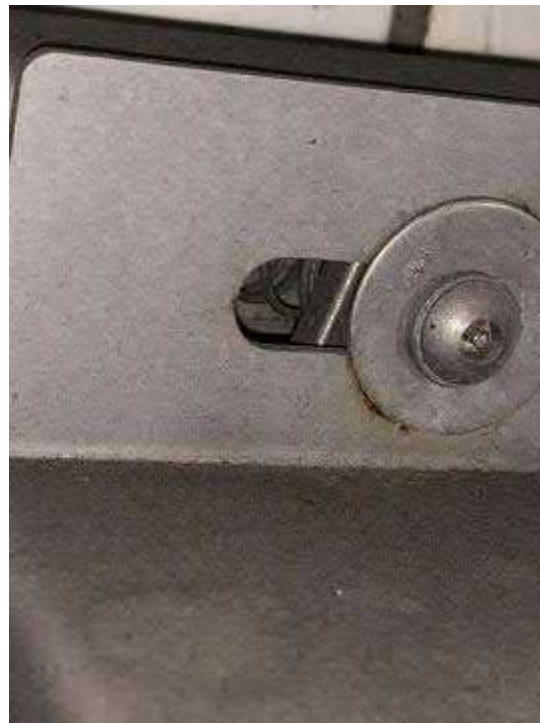
Lighting Fixture Information	
Luminaire Tag or Number:	SBR - East Wall - 69B
Tunnel Direction and Side:	SBR - East Wall
Additional Information:	T Side Entry L Top Left

Are there any signs of corrosion evident on the tunnel lighting system raceways?	Yes
Are the side entry conduits into the fixture tightly secured?	Yes
Are there any signs of corrosion on the fixture?	No
Is there any damage to the component housing or enclosure?	No
Is the light fixture secure to the mounting channels?	Yes
Long channel springnut misaligned?	
Long channel springnut cracked?	
Trans channel springnut misaligned?	Yes
Trans channel springnut cracked?	No
Trans channel wireway clip?	Yes
Housing clip disengaged?	No
Housing clip missing?	No
Lens clip disengaged?	No
Lens clip broken?	No
Lens cover cracked?	No
Wireway ears broken?	No
Luminaire functioning?	Yes

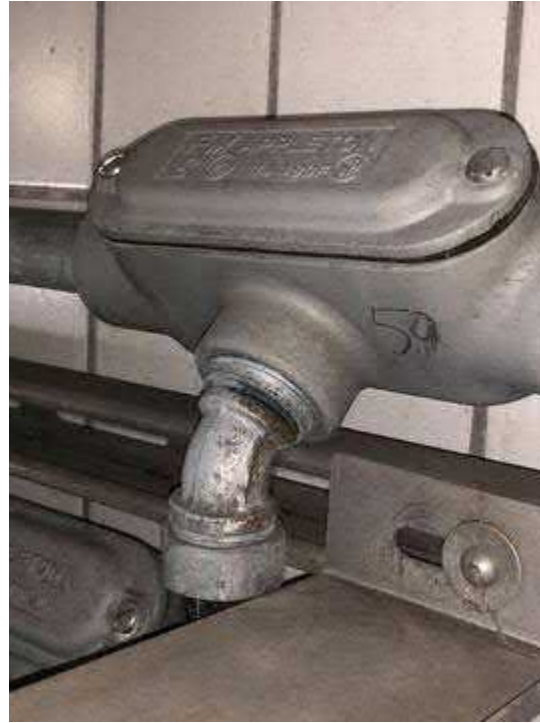
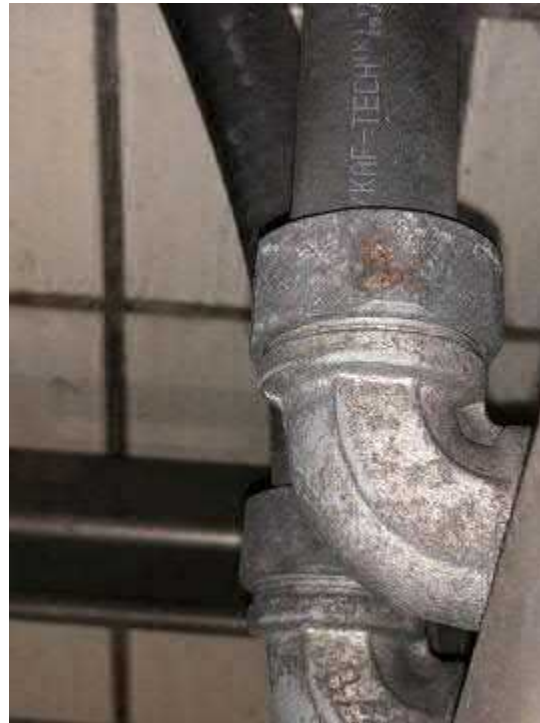
Lighting Fixture Information	
Luminaire Tag or Number:	SBR - West Wall - 82B
Tunnel Direction and Side:	SBR - West Wall
Additional Information:	T Side Entry L

Are there any signs of corrosion evident on the tunnel lighting system raceways?	No
Are the side entry conduits into the fixture tightly secured?	Yes
Are there any signs of corrosion on the fixture?	No
Is there any damage to the component housing or enclosure?	No
Is the light fixture secure to the mounting channels?	Yes
Long channel springnut misaligned?	No
Long channel springnut cracked?	No
Trans channel springnut misaligned?	No
Trans channel springnut cracked?	No
Trans channel wireway clip?	Yes
Housing clip disengaged?	No
Housing clip missing?	No
Lens clip disengaged?	No
Lens clip broken?	No
Lens cover cracked?	No
Wireway ears broken?	No
Luminaire functioning?	Yes

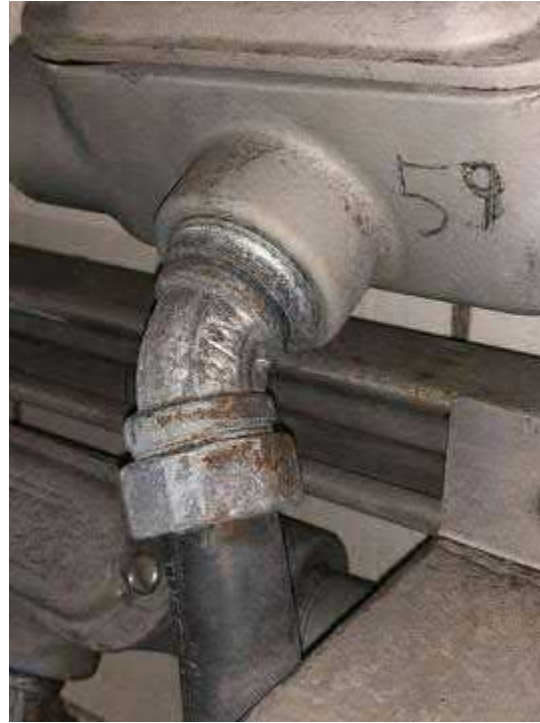
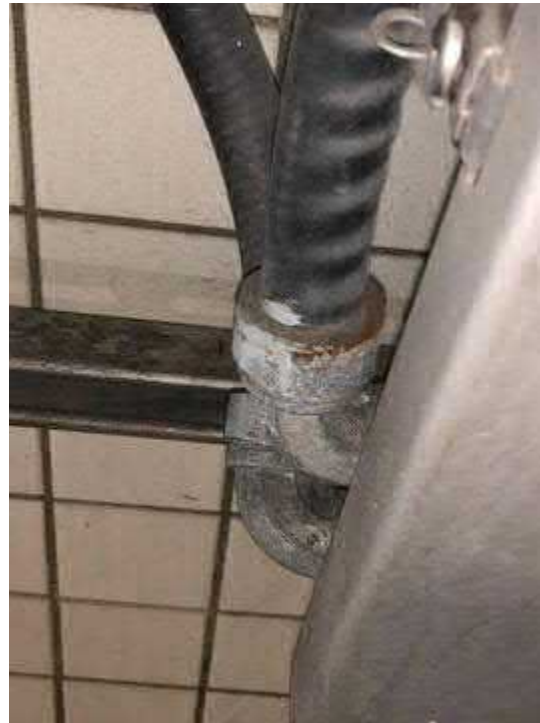
Lighting Fixture Information	
Luminaire Tag or Number:	SBR - East Wall - 82A
Tunnel Direction and Side:	SBR - East Wall
Additional Information:	Side Entry L Bottom Left

Are there any signs of corrosion evident on the tunnel lighting system raceways?	Yes
Are the side entry conduits into the fixture tightly secured?	Yes
Are there any signs of corrosion on the fixture?	No
Is there any damage to the component housing or enclosure?	No
Is the light fixture secure to the mounting channels?	Yes
Long channel springnut misaligned?	No
Long channel springnut cracked?	No
Trans channel springnut misaligned?	Yes
Trans channel springnut cracked?	No
Trans channel wireway clip?	Yes
Housing clip disengaged?	No
Housing clip missing?	No
Lens clip disengaged?	No
Lens clip broken?	No
Lens cover cracked?	No
Wireway ears broken?	No
Luminaire functioning?	Yes

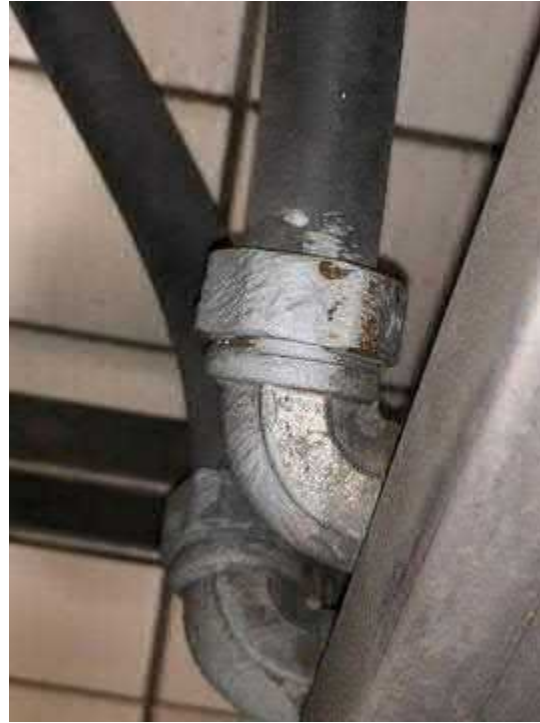
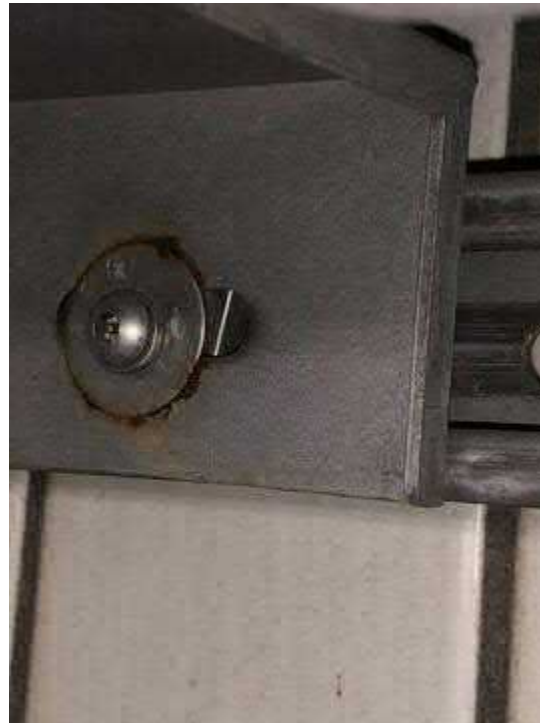
Lighting Fixture Information	
Luminaire Tag or Number:	SBR - East Wall - 82B
Tunnel Direction and Side:	SBR - East Wall
Additional Information:	T Side Entry Bottom Right

Are there any signs of corrosion evident on the tunnel lighting system raceways?	Yes
Are the side entry conduits into the fixture tightly secured?	Yes
Are there any signs of corrosion on the fixture?	No
Is there any damage to the component housing or enclosure?	
Is the light fixture secure to the mounting channels?	Yes
Long channel springnut misaligned?	No
Long channel springnut cracked?	No
Trans channel springnut misaligned?	Yes
Trans channel springnut cracked?	No
Trans channel wireway clip?	Yes
Housing clip disengaged?	No
Housing clip missing?	No
Lens clip disengaged?	No
Lens clip broken?	No
Lens cover cracked?	No
Wireway ears broken?	No
Luminaire functioning?	Yes

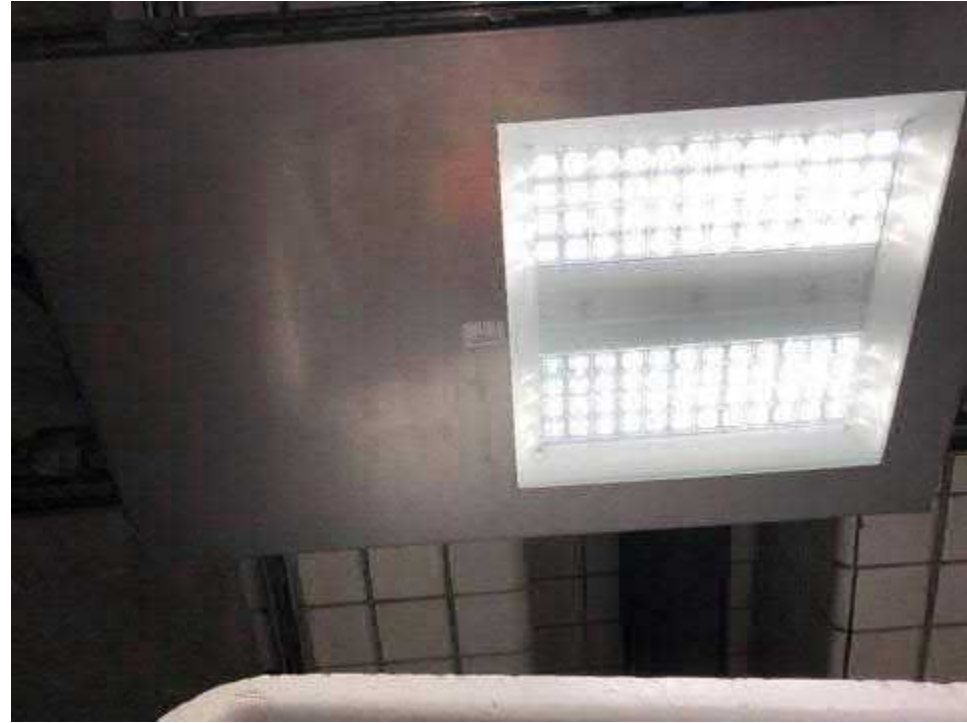
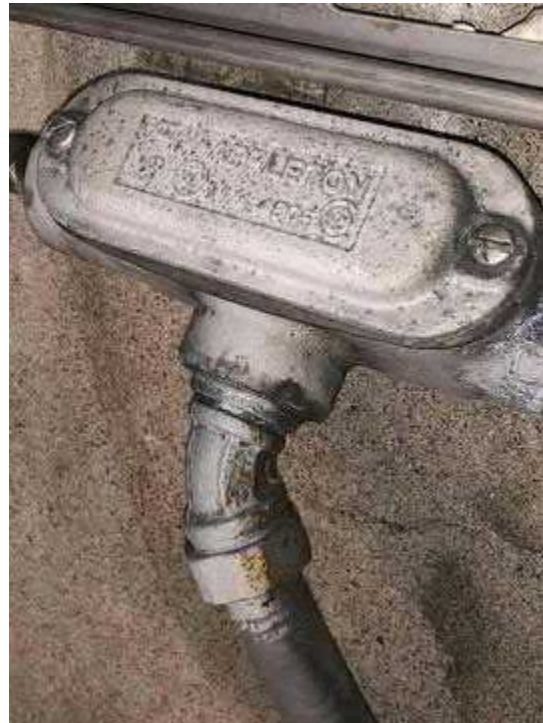
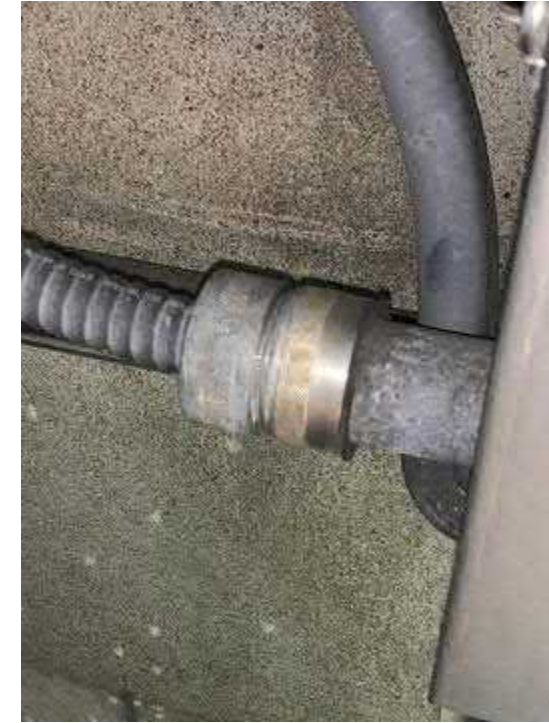
Lighting Fixture Information	
<b>Luminaire Tag or Number:</b>	SB - West Wall - 6A
<b>Tunnel Direction and Side:</b>	SB - West Wall
<b>Additional Information:</b>	T Top Right Fixture Hooks Misaligned

Are there any signs of corrosion evident on the tunnel lighting system raceways?
Are the side entry conduits into the fixture tightly secured?
Are there any signs of corrosion on the fixture?
Is there any damage to the component housing or enclosure?
Is the light fixture secure to the mounting channels?
Long channel springnut misaligned?
Long channel springnut cracked?
Trans channel springnut misaligned?
Trans channel springnut cracked?
Trans channel wireway clip?
Housing clip disengaged?
Housing clip missing?
Lens clip disengaged?
Lens clip broken?
Lens cover cracked?
Wireway ears broken?
Luminaire functioning?

Yes	No	No	No	No	No	No	Yes	No	Yes	No	No	Yes	Yes	No	Yes	Yes
-----	----	----	----	----	----	----	-----	----	-----	----	----	-----	-----	----	-----	-----

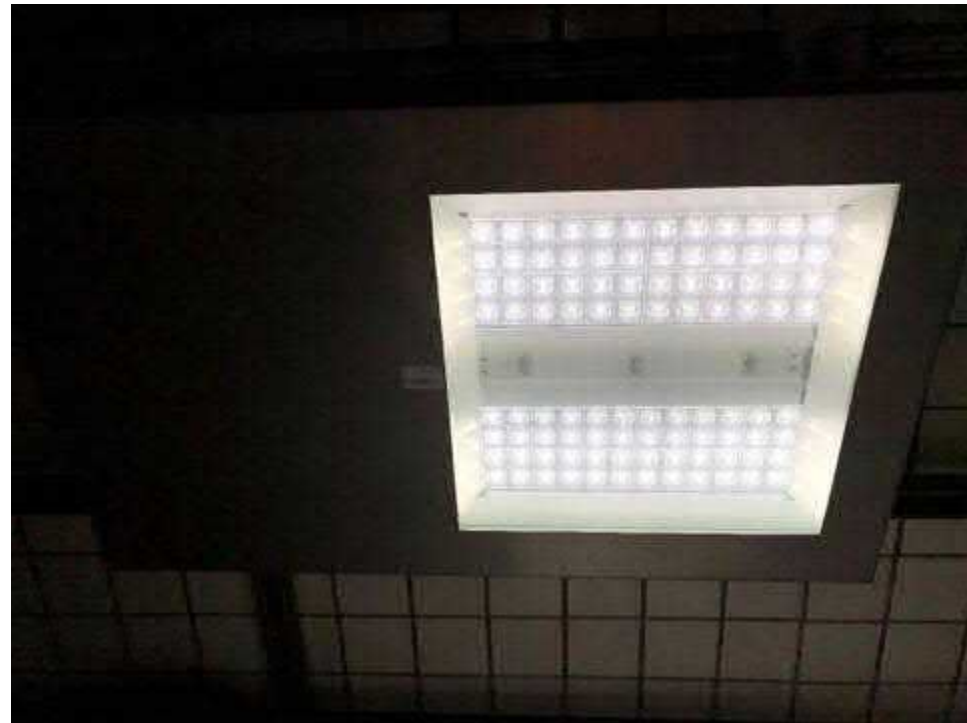
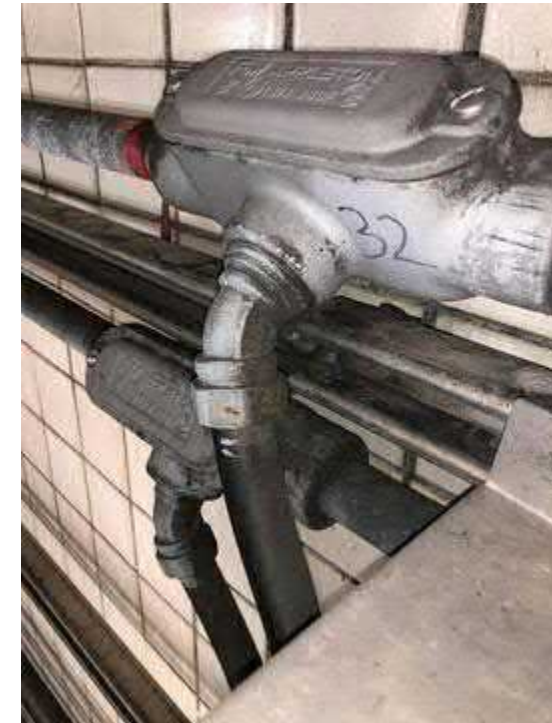
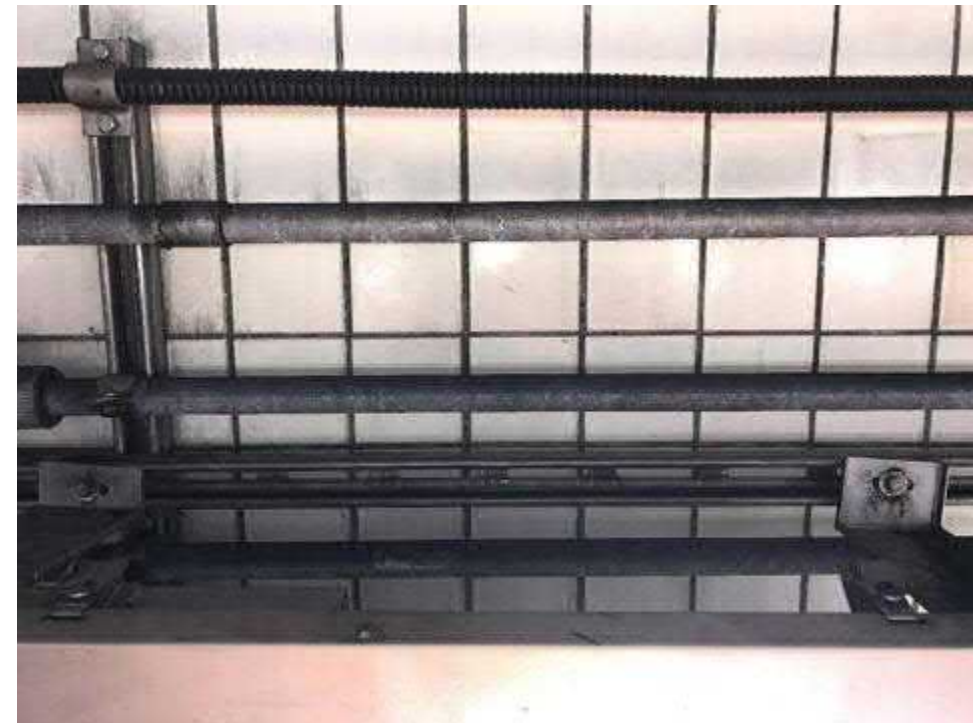
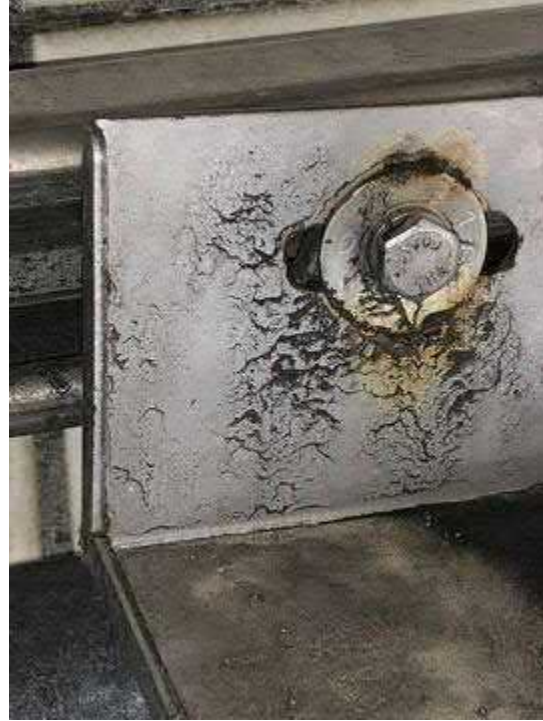
Lighting Fixture Information	
Luminaire Tag or Number:	SB - West Wall - 6B
Tunnel Direction and Side:	SB - West Wall
Additional Information:	SEL T

Are there any signs of corrosion evident on the tunnel lighting system raceways?
Are the side entry conduits into the fixture tightly secured?
Are there any signs of corrosion on the fixture?
Is there any damage to the component housing or enclosure?
Is the light fixture secure to the mounting channels?
Long channel springnut misaligned?
Long channel springnut cracked?
Trans channel springnut misaligned?
Trans channel springnut cracked?
Trans channel wireway clip?
Housing clip disengaged?
Housing clip missing?
Lens clip disengaged?
Lens clip broken?
Lens cover cracked?
Wireway ears broken?
Luminaire functioning?

Yes	No	No	No	No	No	No	Yes	No	No	No	No	Yes	No	No	Yes	Yes
-----	----	----	----	----	----	----	-----	----	----	----	----	-----	----	----	-----	-----

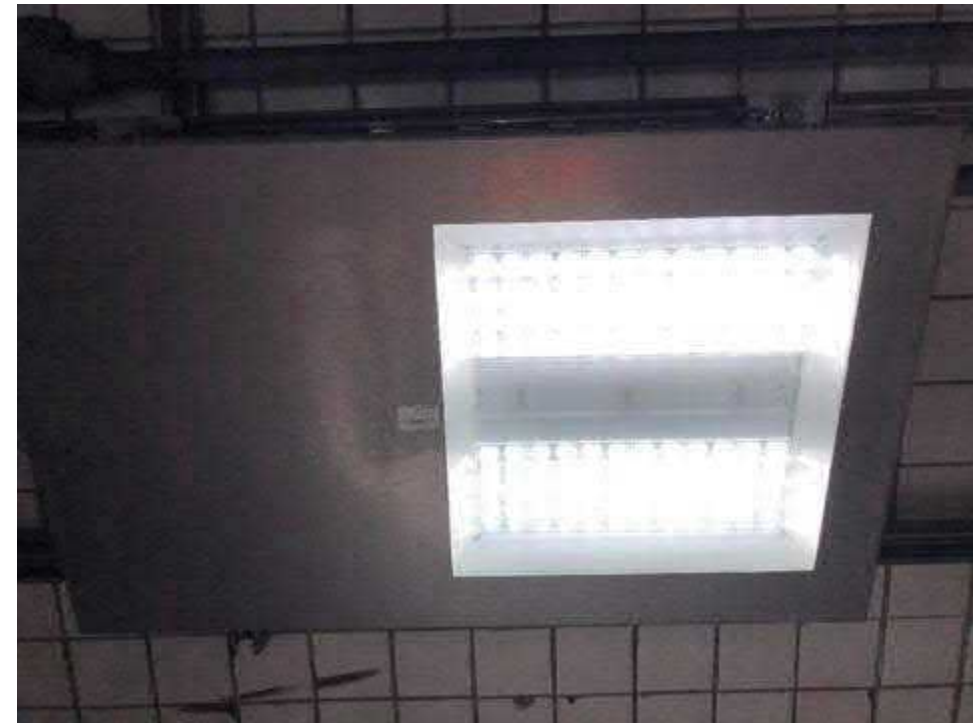
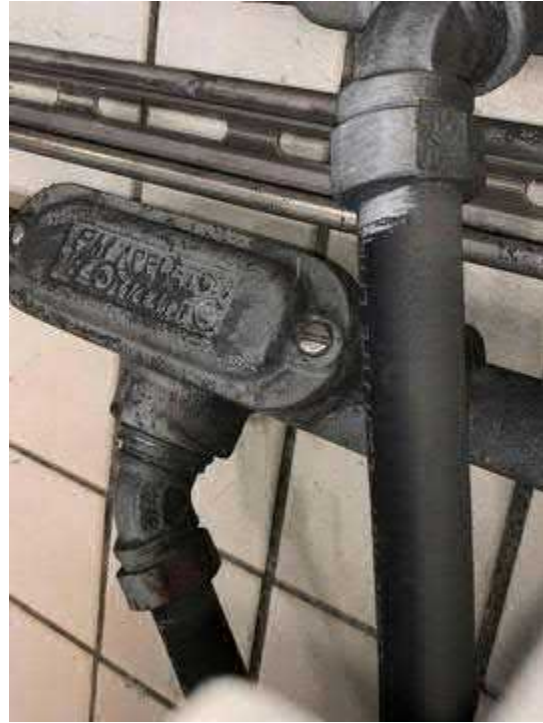
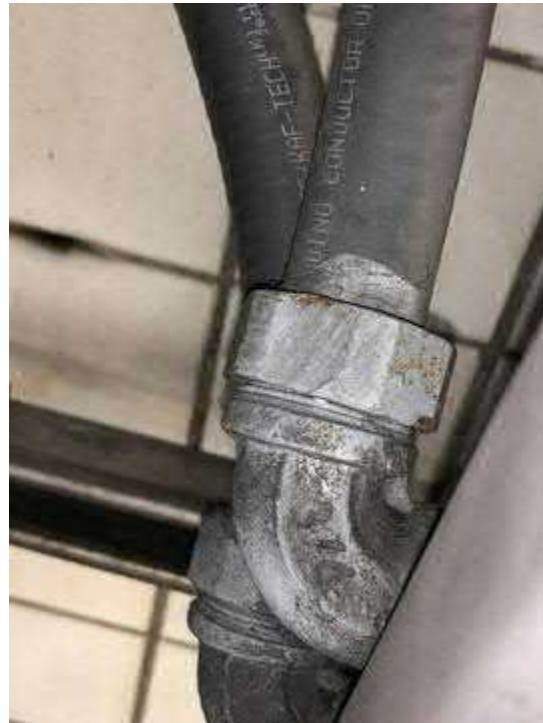
Lighting Fixture Information	
Luminaire Tag or Number:	SB - West Wall - 11A
Tunnel Direction and Side:	SB - West Wall
Additional Information:	T SEL SE Loose Both Bottom

Are there any signs of corrosion evident on the tunnel lighting system raceways?	Yes
Are the side entry conduits into the fixture tightly secured?	Yes
Are there any signs of corrosion on the fixture?	No
Is there any damage to the component housing or enclosure?	No
Is the light fixture secure to the mounting channels?	Yes
Long channel springnut misaligned?	No
Long channel springnut cracked?	No
Trans channel springnut misaligned?	Yes
Trans channel springnut cracked?	No
Trans channel wireway clip?	Yes
Housing clip disengaged?	No
Housing clip missing?	No
Lens clip disengaged?	No
Lens clip broken?	No
Lens cover cracked?	No
Wireway ears broken?	No
Luminaire functioning?	Yes

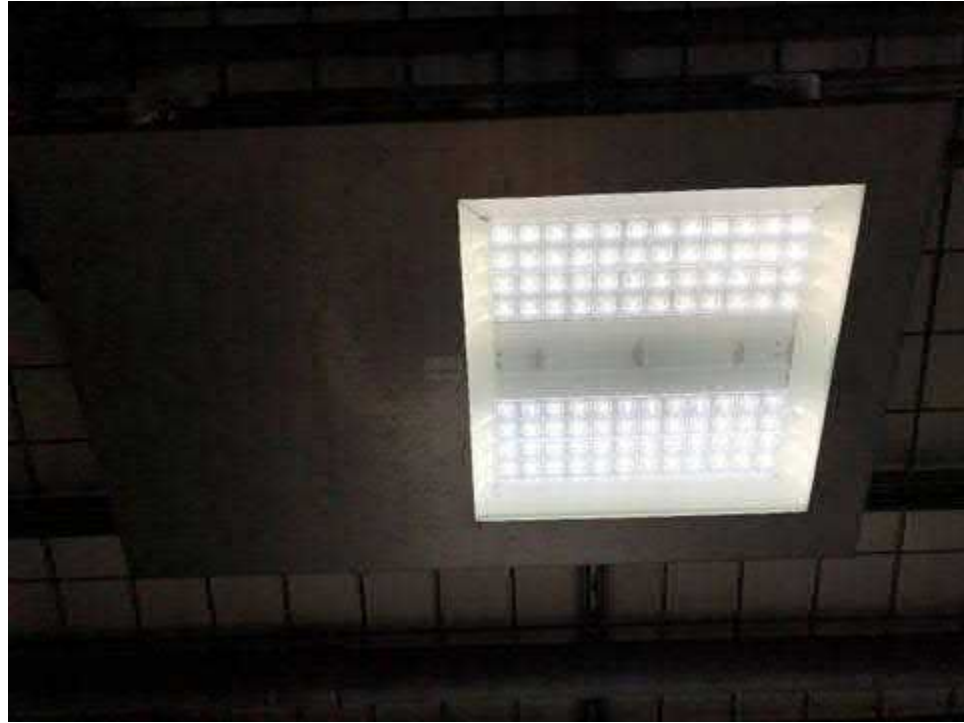
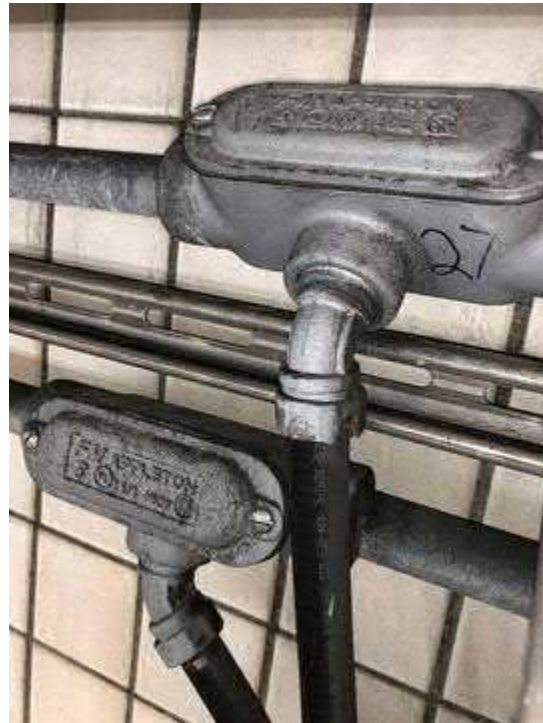
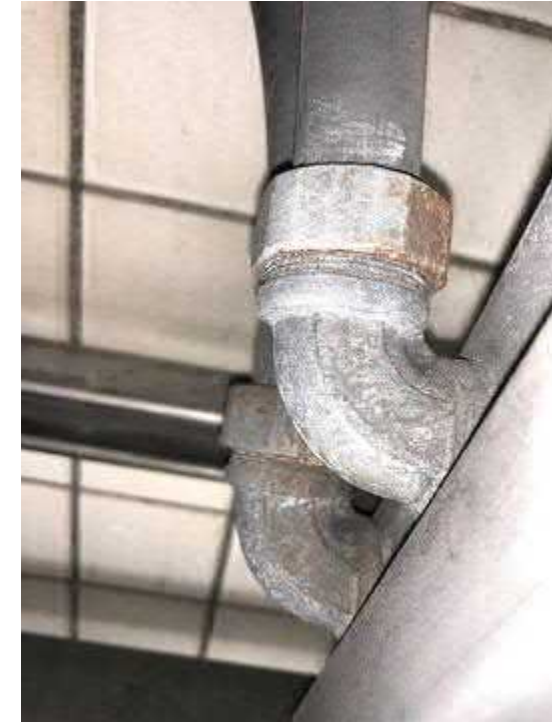
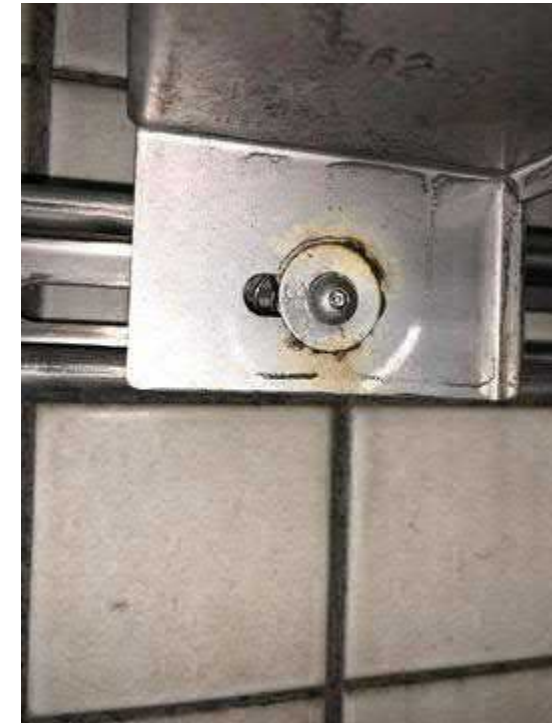
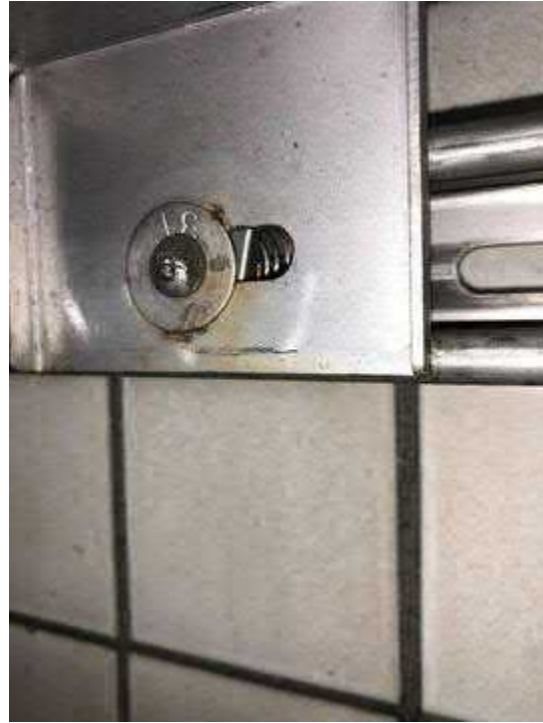
Lighting Fixture Information	
Luminaire Tag or Number:	SB - West Wall - 11B
Tunnel Direction and Side:	SB - West Wall
Additional Information:	T SEL TOP LEFT

Are there any signs of corrosion evident on the tunnel lighting system raceways?
Are the side entry conduits into the fixture tightly secured?
Are there any signs of corrosion on the fixture?
Is there any damage to the component housing or enclosure?
Is the light fixture secure to the mounting channels?
Long channel springnut misaligned?
Long channel springnut cracked?
Trans channel springnut cracked?
Trans channel springnut misaligned?
Trans channel springnut cracked?
Trans channel wireway clip?
Housing clip disengaged?
Housing clip missing?
Lens clip disengaged?
Lens clip broken?
Lens cover cracked?
Wireway ears broken?
Luminaire functioning?

Yes	No	No	No	No	No	No	Yes	No	Yes	No	No		No	No	Yes	Yes
-----	----	----	----	----	----	----	-----	----	-----	----	----	--	----	----	-----	-----

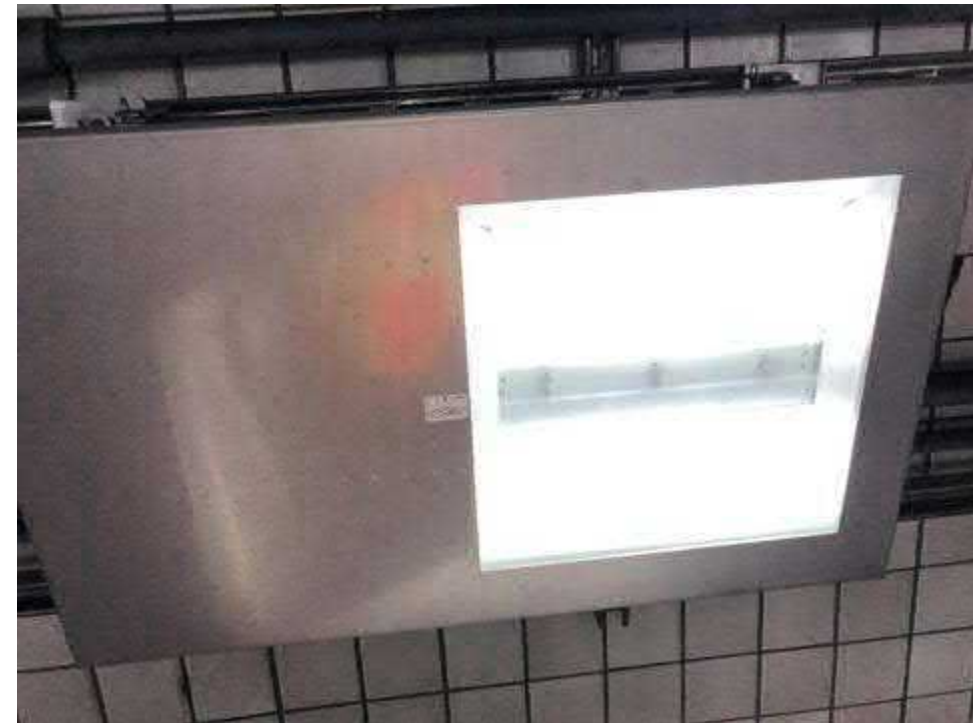
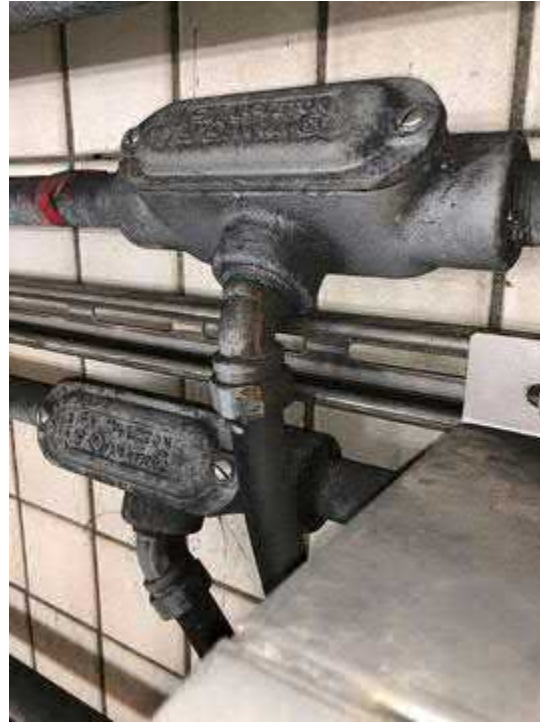
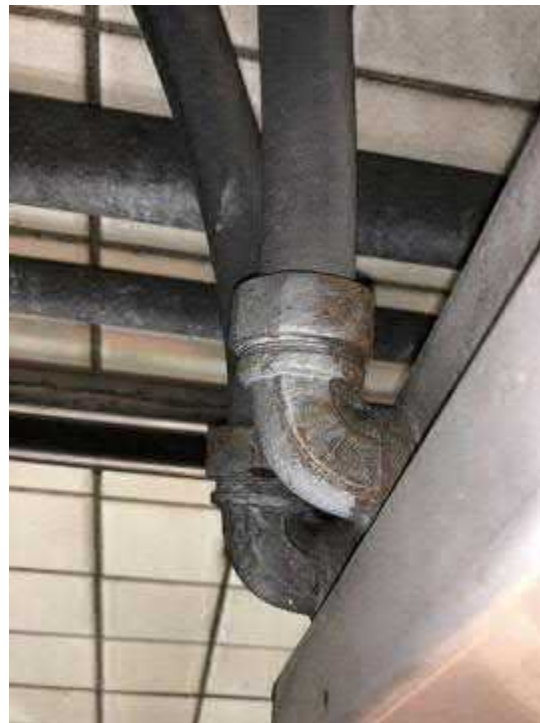
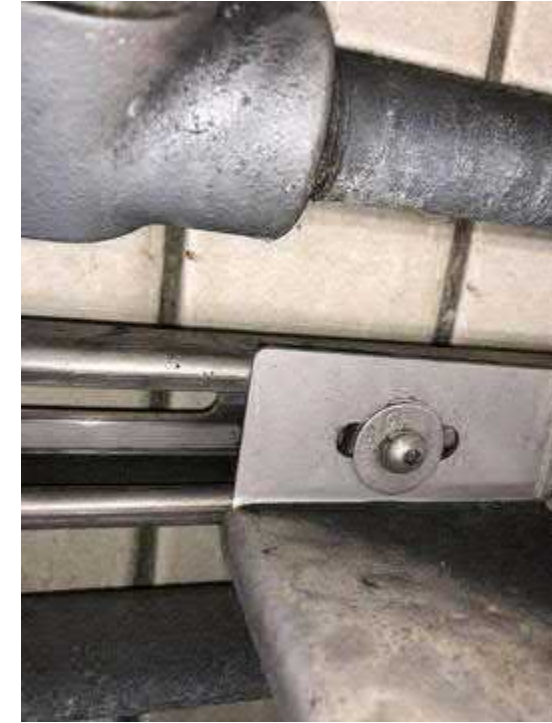
Lighting Fixture Information	
Luminaire Tag or Number:	SB - West Wall - 16A
Tunnel Direction and Side:	SB - West Wall
Additional Information:	T SEL TOP LEFT BOTTOM RIGHT

Are there any signs of corrosion evident on the tunnel lighting system raceways?
Are the side entry conduits into the fixture tightly secured?
Are there any signs of corrosion on the fixture?
Is there any damage to the component housing or enclosure?
Is the light fixture secure to the mounting channels?
Long channel springnut misaligned?
Long channel springnut cracked?
Trans channel springnut misaligned?
Trans channel springnut cracked?
Trans channel wireway clip?
Housing clip disengaged?
Housing clip missing?
Lens clip disengaged?
Lens clip broken?
Lens cover cracked?
Wireway ears broken?
Luminaire functioning?

Yes	No	No	No	No	No	No	Yes	No	Yes	No	No	Yes	No	Yes	No	Yes
-----	----	----	----	----	----	----	-----	----	-----	----	----	-----	----	-----	----	-----

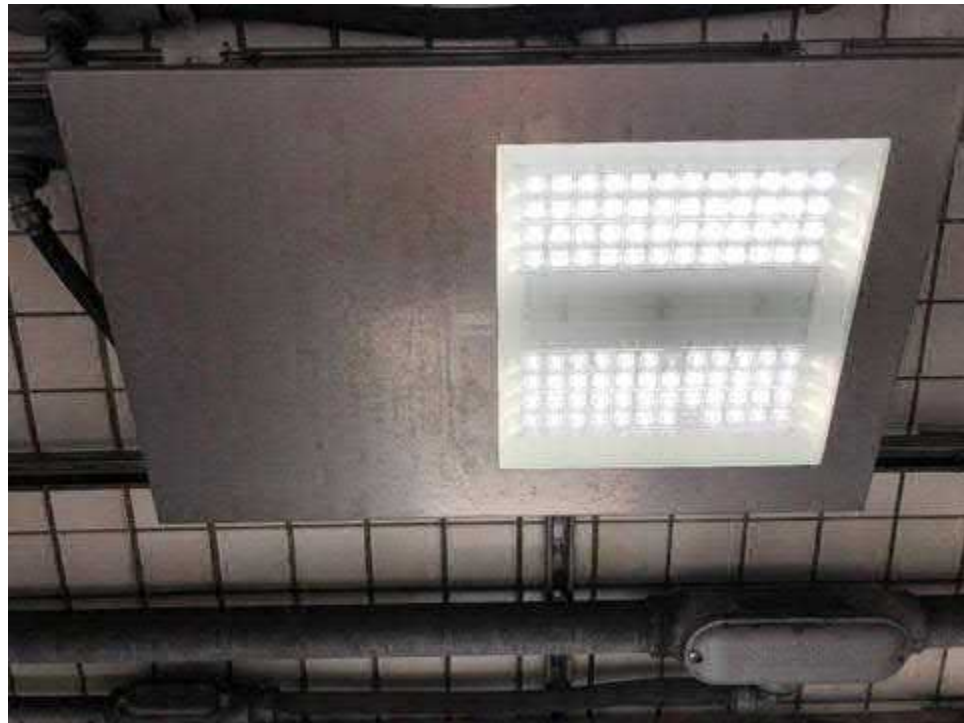
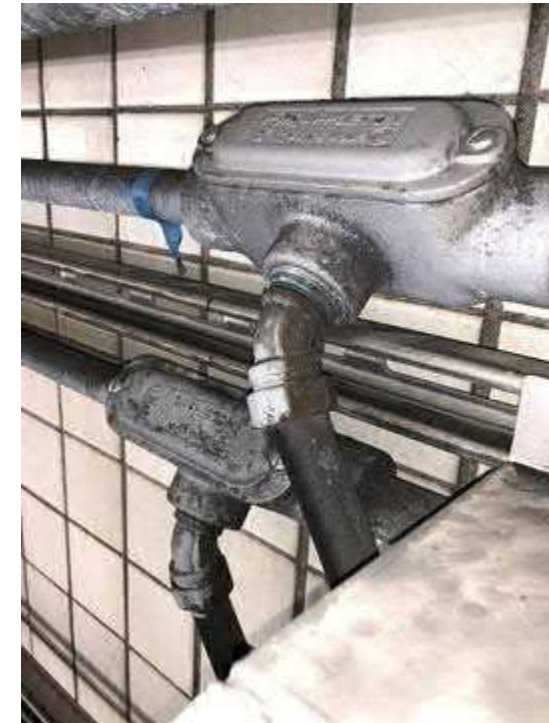
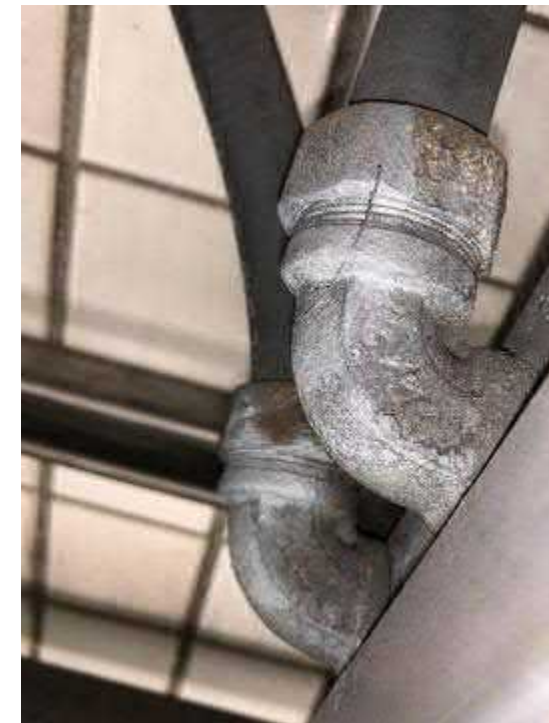
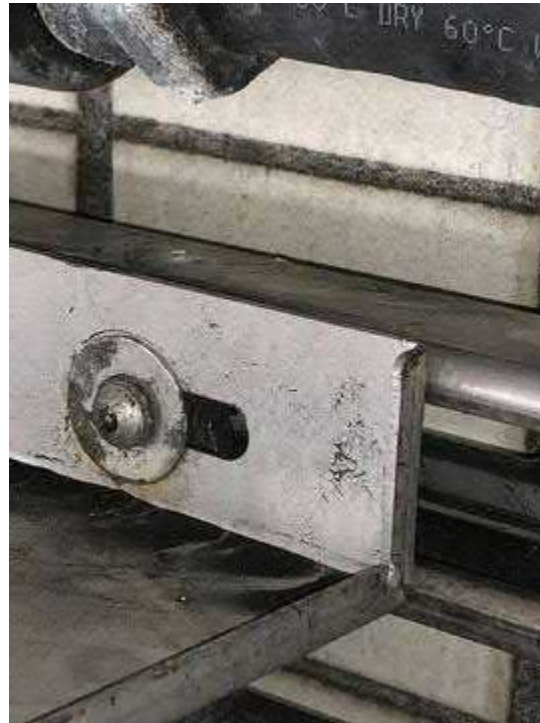
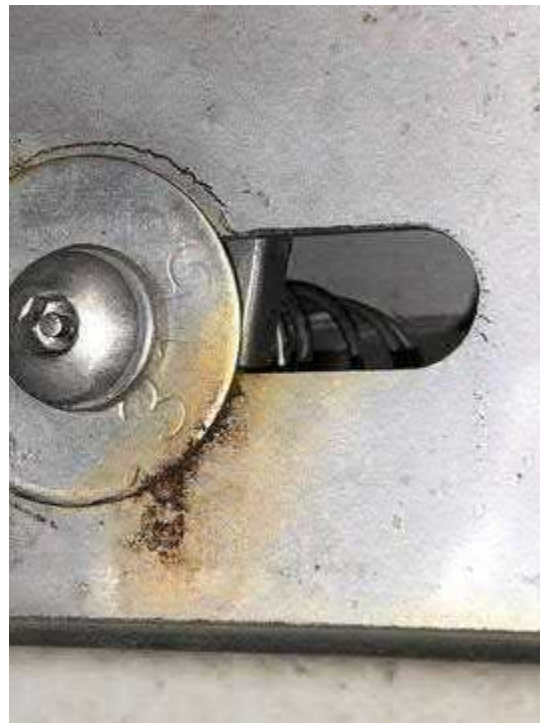
Lighting Fixture Information	
Luminaire Tag or Number:	SB - West Wall - 16B
Tunnel Direction and Side:	SB - West Wall
Additional Information:	T SEL BOTTOM RIGHT

Are there any signs of corrosion evident on the tunnel lighting system raceways?	Yes
Are the side entry conduits into the fixture tightly secured?	Yes
Are there any signs of corrosion on the fixture?	No
Is there any damage to the component housing or enclosure?	No
Is the light fixture secure to the mounting channels?	Yes
Long channel springnut misaligned?	No
Long channel springnut cracked?	No
Trans channel springnut misaligned?	Yes
Trans channel springnut cracked?	No
Trans channel wireway clip?	Yes
Housing clip disengaged?	No
Housing clip missing?	No
Lens clip disengaged?	No
Lens clip broken?	No
Lens cover cracked?	No
Wireway ears broken?	No
Luminaire functioning?	Yes

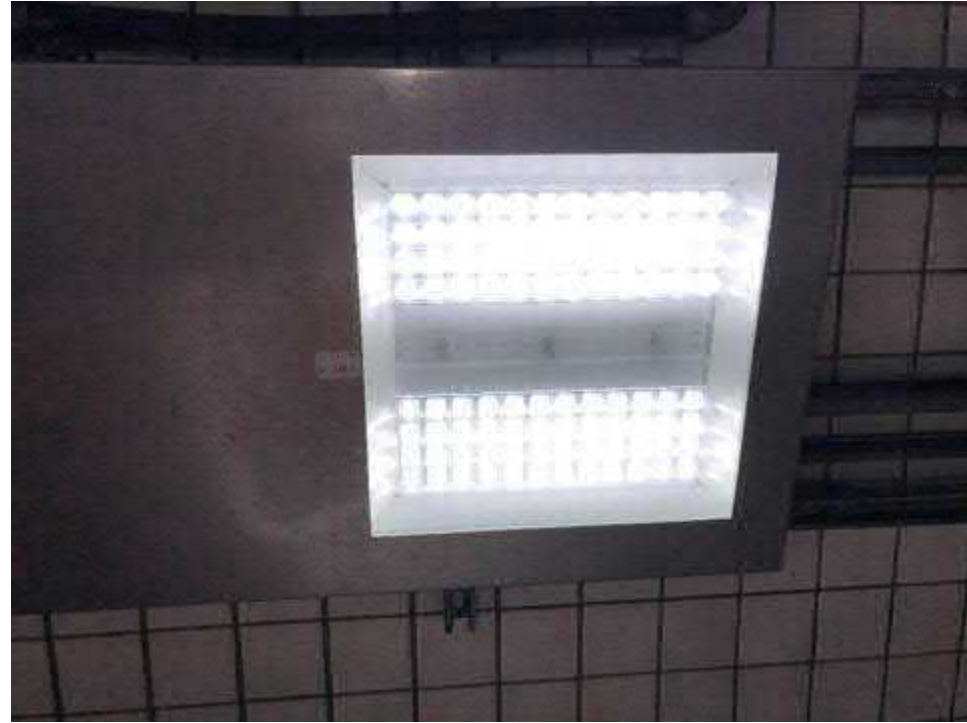
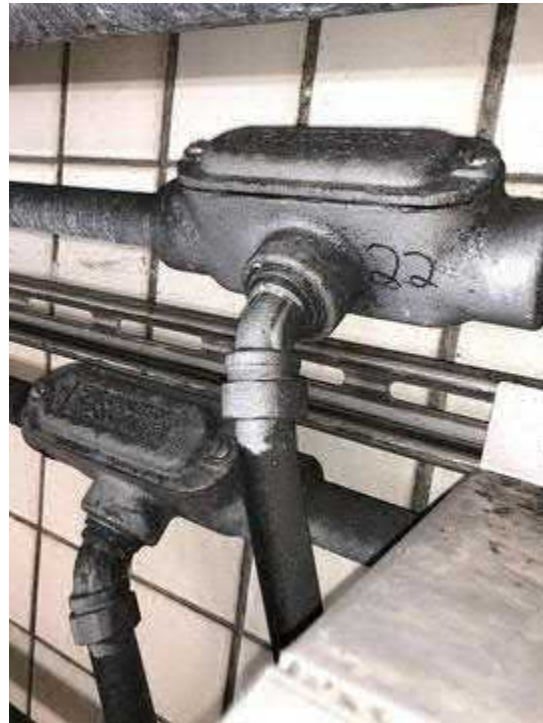
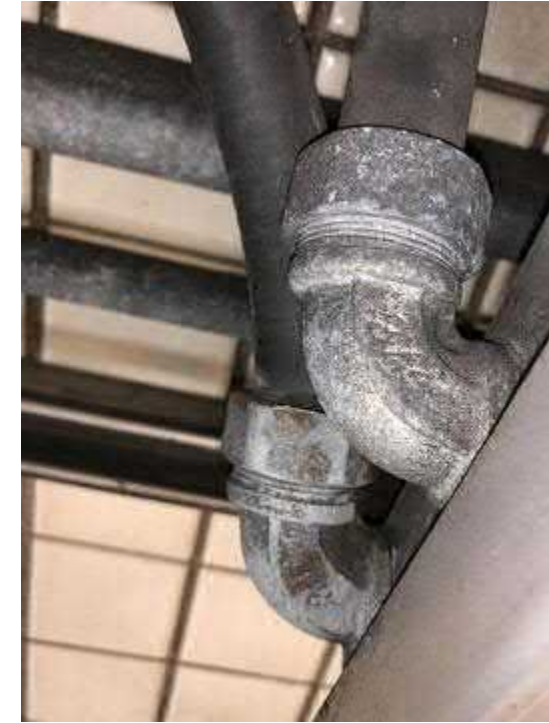
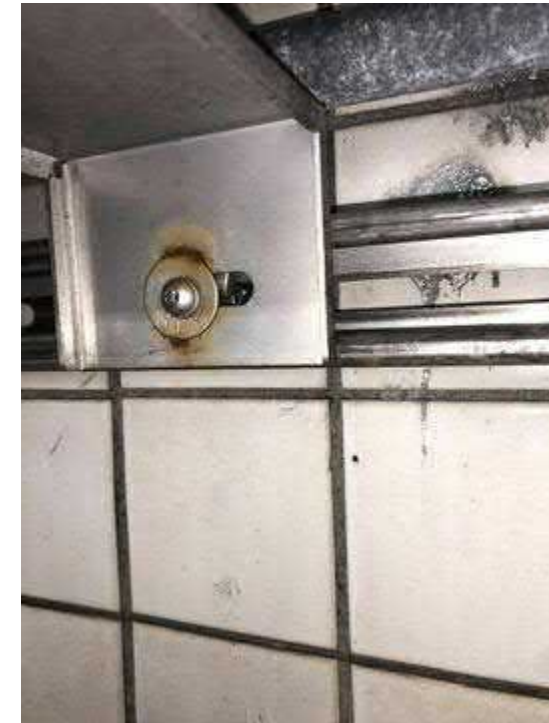
Lighting Fixture Information	
Luminaire Tag or Number:	SB - West Wall - 21A
Tunnel Direction and Side:	SB - West Wall
Additional Information:	T SEL SE LOOSE

Are there any signs of corrosion evident on the tunnel lighting system raceways?	Yes
Are the side entry conduits into the fixture tightly secured?	No
Are there any signs of corrosion on the fixture?	No
Is there any damage to the component housing or enclosure?	No
Is the light fixture secure to the mounting channels?	Yes
Long channel springnut misaligned?	No
Long channel springnut cracked?	No
Trans channel springnut misaligned?	No
Trans channel springnut cracked?	No
Trans channel wireway clip?	Yes
Housing clip disengaged?	No
Housing clip missing?	No
Lens clip disengaged?	No
Lens clip broken?	No
Lens cover cracked?	No
Wireway ears broken?	No
Luminaire functioning?	Yes

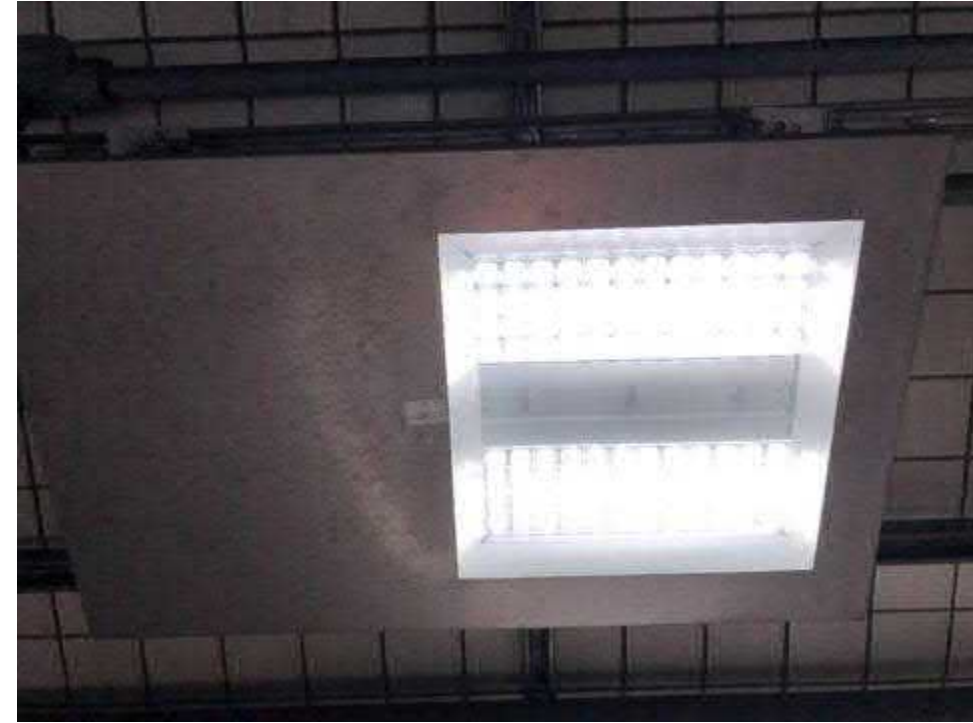
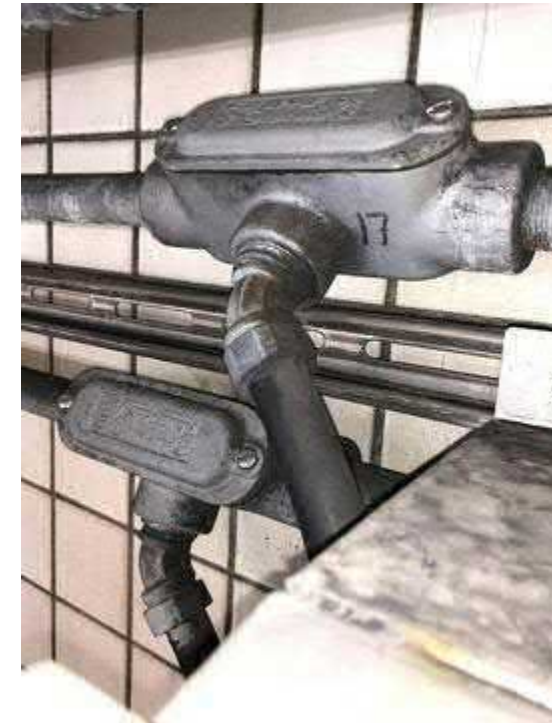
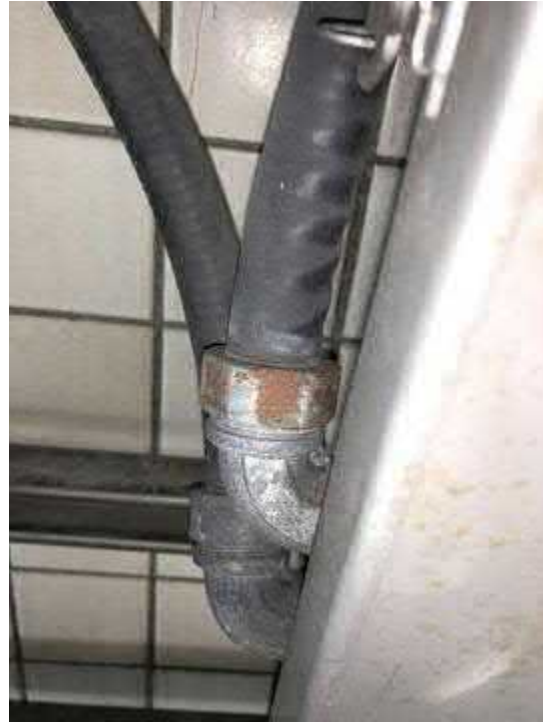
Lighting Fixture Information	
Luminaire Tag or Number:	SB - West Wall - 21B
Tunnel Direction and Side:	SB - West Wall
Additional Information:	T SEL BOTTOM RIGHT SCREW HEAD RUSTING

Are there any signs of corrosion evident on the tunnel lighting system raceways?
Are the side entry conduits into the fixture tightly secured?
Are there any signs of corrosion on the fixture?
Is there any damage to the component housing or enclosure?
Is the light fixture secure to the mounting channels?
Long channel springnut misaligned?
Long channel springnut cracked?
Trans channel springnut misaligned?
Trans channel springnut cracked?
Trans channel wireway clip?
Housing clip disengaged?
Housing clip missing?
Lens clip disengaged?
Lens clip broken?
Lens cover cracked?
Wireway ears broken?
Luminaire functioning?
