# **Lytle Tunnel (HAM-71-0134) Inspection Report Fall 2020**

PID 105470

November, 2020

Ohio Department of  
Transportation  
District 8  
505 South State Route 741  
Lebanon, OH 45036

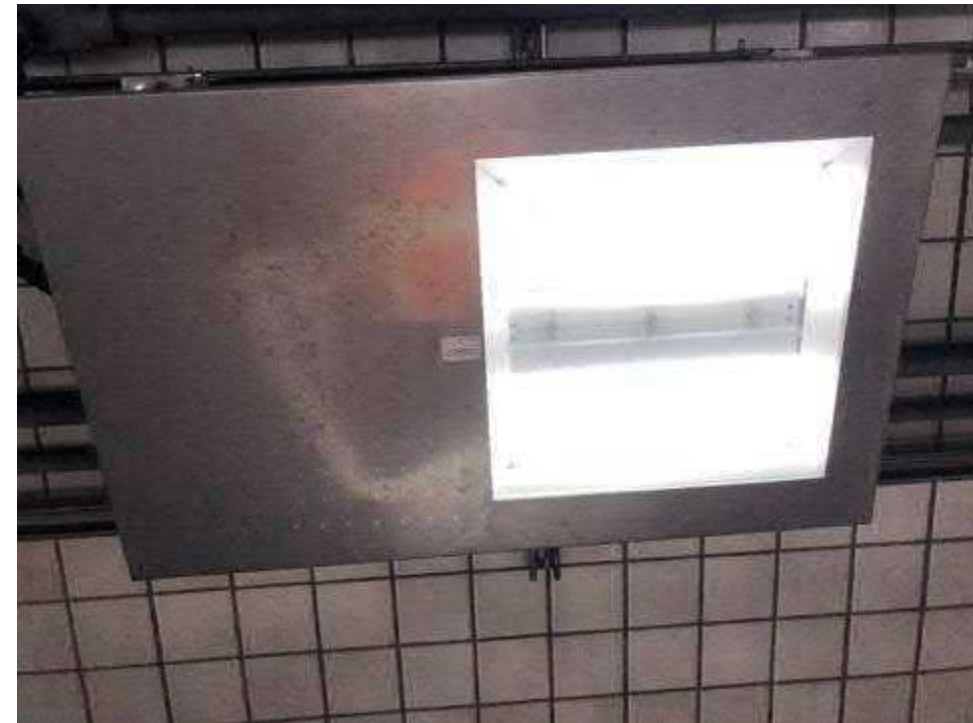
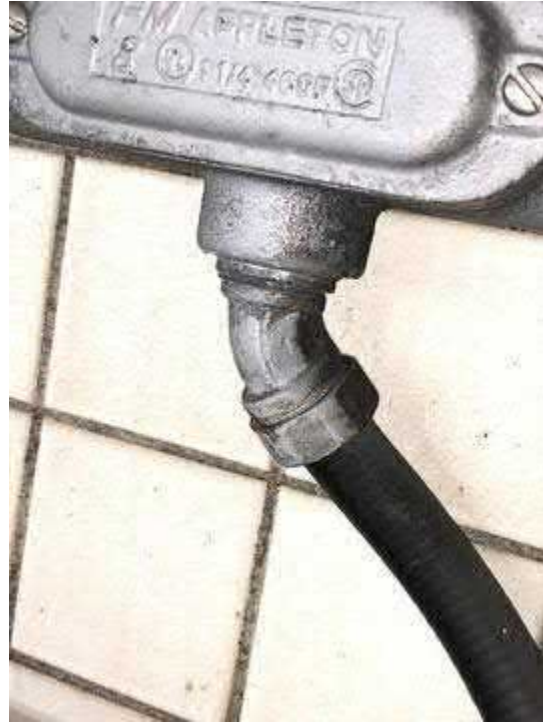
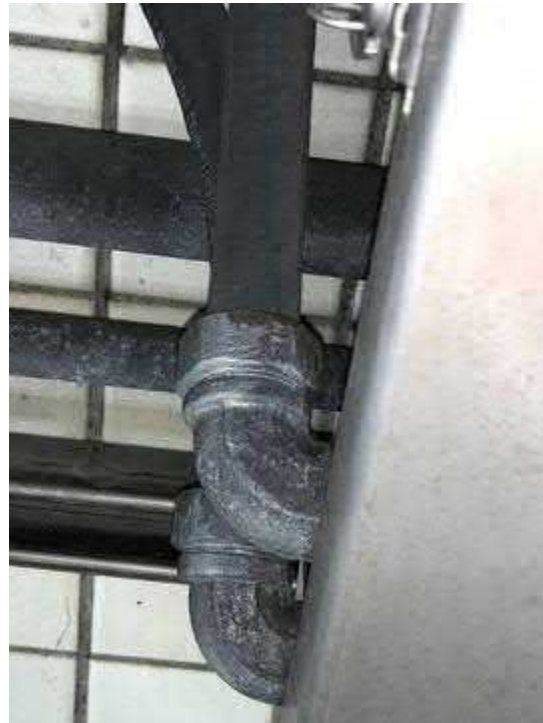
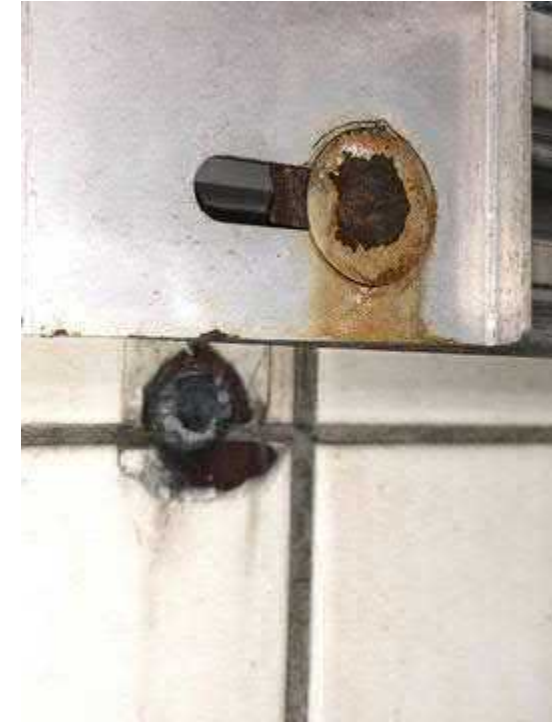
Lighting Fixture Information	
Luminaire Tag or Number:	SB - West Wall - 26A
Tunnel Direction and Side:	SB - West Wall
Additional Information:	T SEL TOP LEFT BOTTOM LEFT

Are there any signs of corrosion evident on the tunnel lighting system raceways?
Are the side entry conduits into the fixture tightly secured?
Are there any signs of corrosion on the fixture?
Is there any damage to the component housing or enclosure?
Is the light fixture secure to the mounting channels?
Long channel springnut misaligned?
Long channel springnut cracked?
Trans channel springnut misaligned?
Trans channel springnut cracked?
Trans channel wireway clip?
Housing clip disengaged?
Housing clip missing?
Lens clip disengaged?
Lens clip broken?
Lens cover cracked?
Wireway ears broken?
Luminaire functioning?

Yes	No	No	No	No	No		Yes	No	Yes	No	No	Yes	No	No	Yes	Yes
-----	----	----	----	----	----	--	-----	----	-----	----	----	-----	----	----	-----	-----

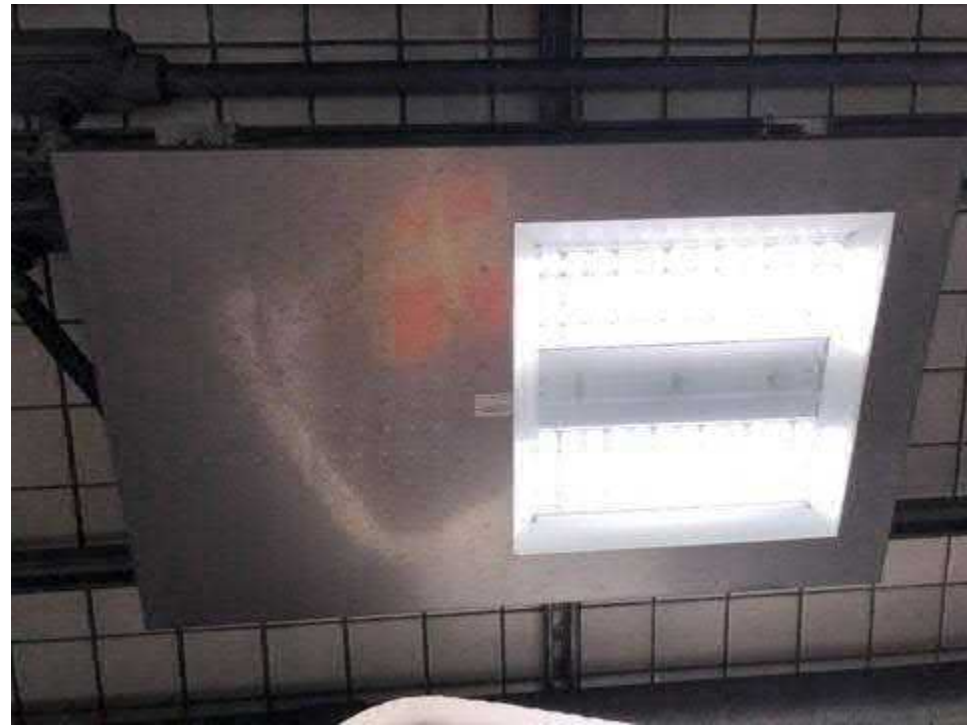
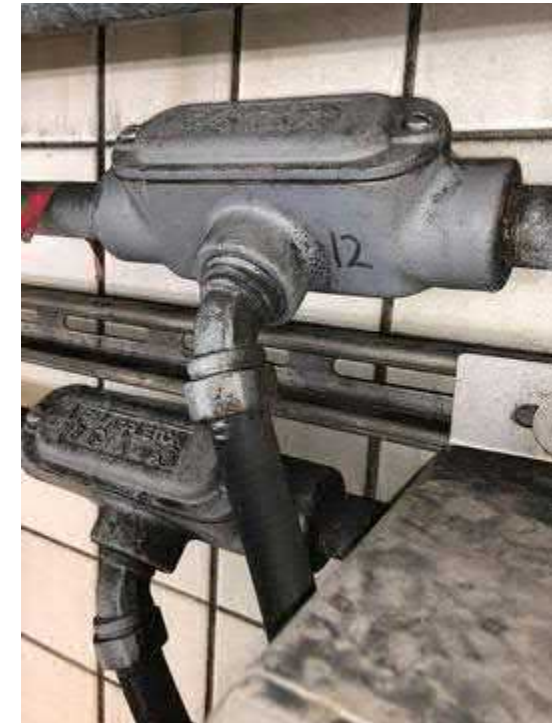
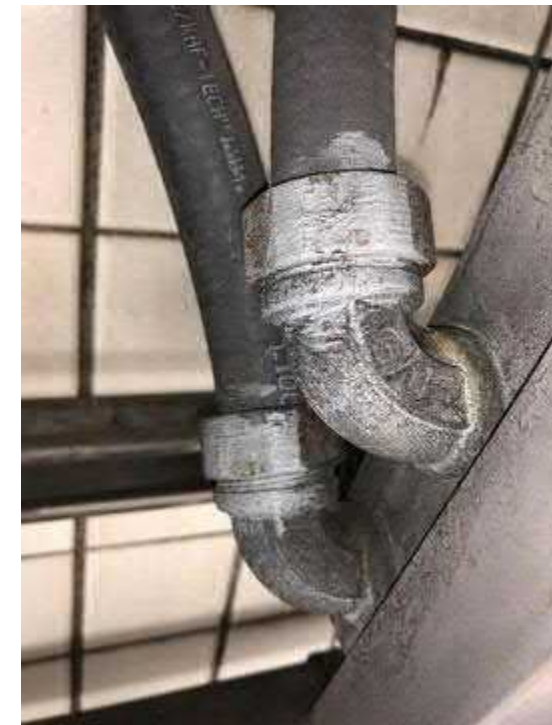
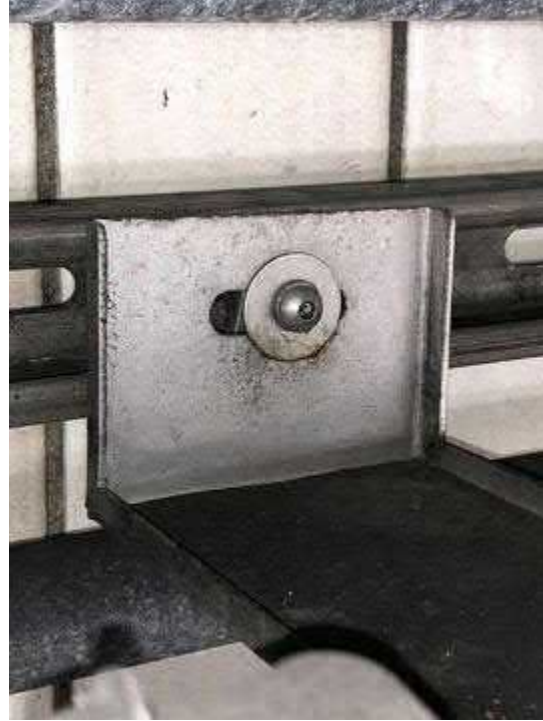
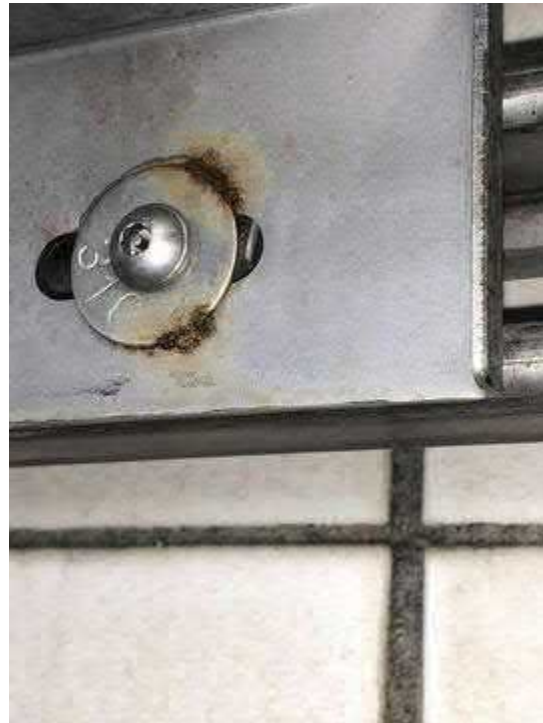
Lighting Fixture Information	
Luminaire Tag or Number:	SB - West Wall - 26B
Tunnel Direction and Side:	SB - West Wall
Additional Information:	T SEL BOTH TOP

Are there any signs of corrosion evident on the tunnel lighting system raceways?	Yes
Are the side entry conduits into the fixture tightly secured?	Yes
Are there any signs of corrosion on the fixture?	No
Is there any damage to the component housing or enclosure?	No
Is the light fixture secure to the mounting channels?	Yes
Long channel springnut misaligned?	No
Long channel springnut cracked?	No
Trans channel springnut misaligned?	Yes
Trans channel springnut cracked?	No
Trans channel wireway clip?	Yes
Housing clip disengaged?	No
Housing clip missing?	No
Lens clip disengaged?	No
Lens clip broken?	No
Lens cover cracked?	
Wireway ears broken?	No
Luminaire functioning?	Yes

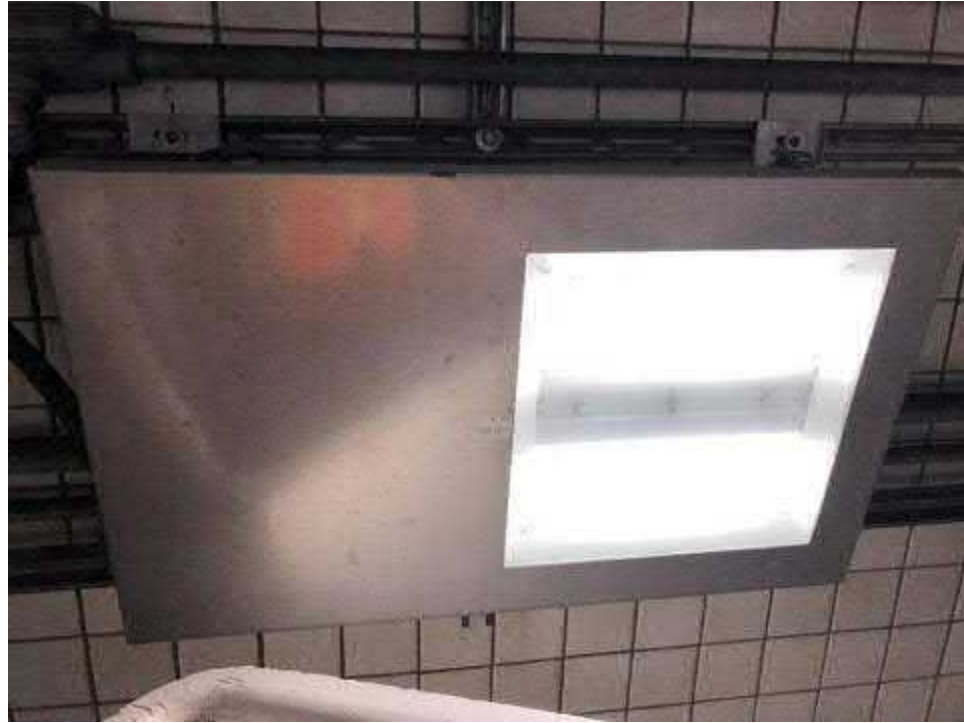
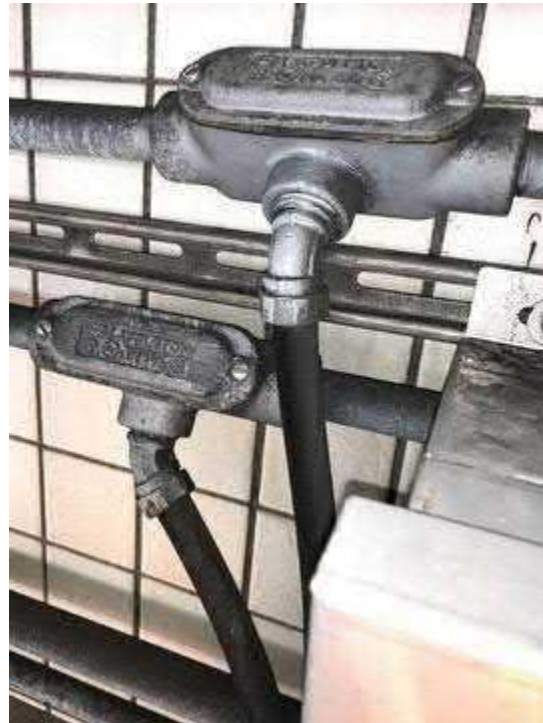
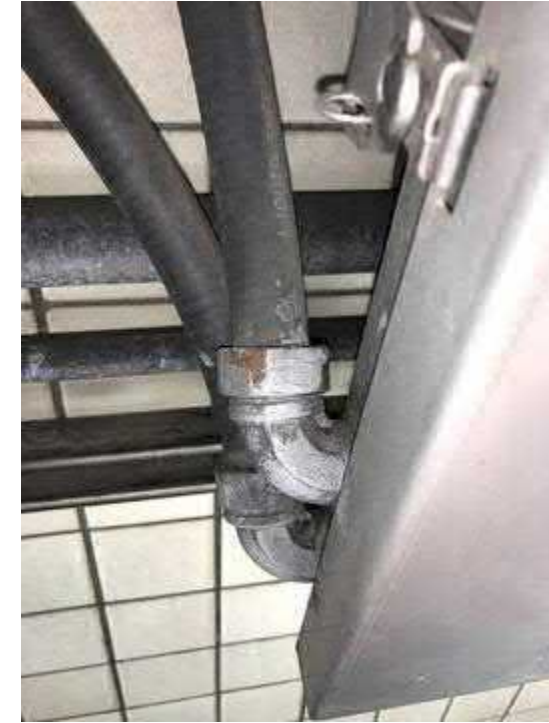
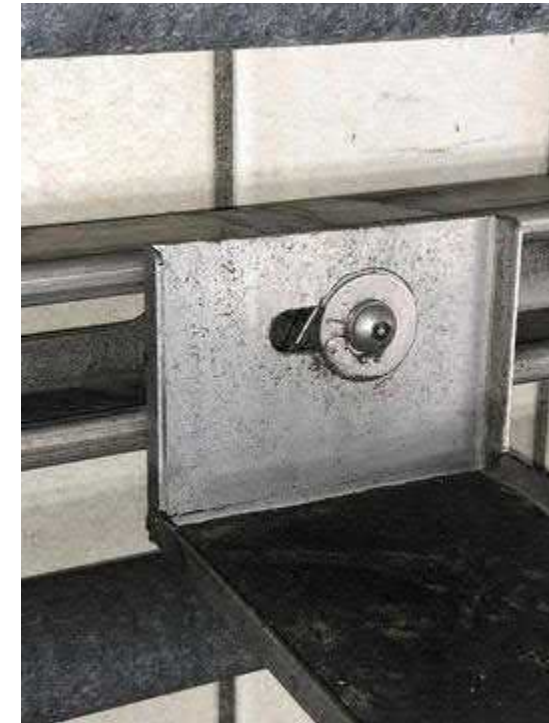
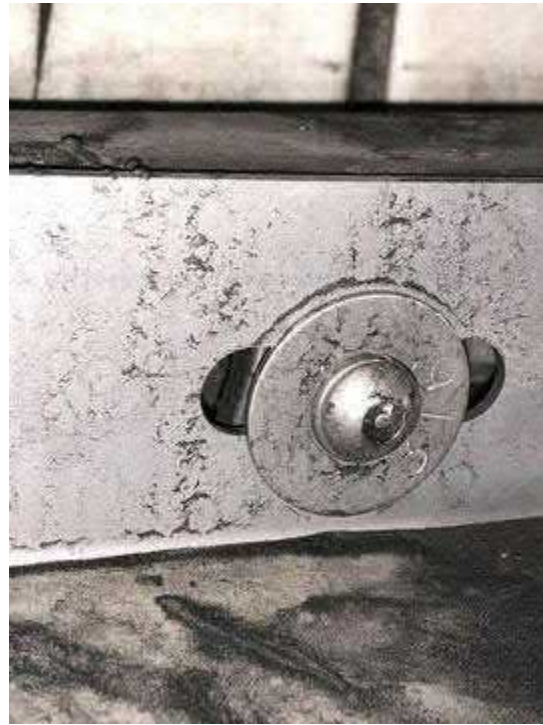
Lighting Fixture Information	
Luminaire Tag or Number:	SB - West Wall - 31A
Tunnel Direction and Side:	SB - West Wall
Additional Information:	T SEL RIGHT CLIP

Are there any signs of corrosion evident on the tunnel lighting system raceways?
Are the side entry conduits into the fixture tightly secured?
Are there any signs of corrosion on the fixture?
Is there any damage to the component housing or enclosure?
Is the light fixture secure to the mounting channels?
Long channel springnut misaligned?
Long channel springnut cracked?
Trans channel springnut misaligned?
Trans channel springnut cracked?
Trans channel wireway clip?
Housing clip disengaged?
Housing clip missing?
Lens clip disengaged?
Lens clip broken?
Lens cover cracked?
Wireway ears broken?
Luminaire functioning?

Yes	No	No	No	Yes	No	No	Yes	No	No	No	No	No	No	No	No	Yes	Yes
-----	----	----	----	-----	----	----	-----	----	----	----	----	----	----	----	----	-----	-----

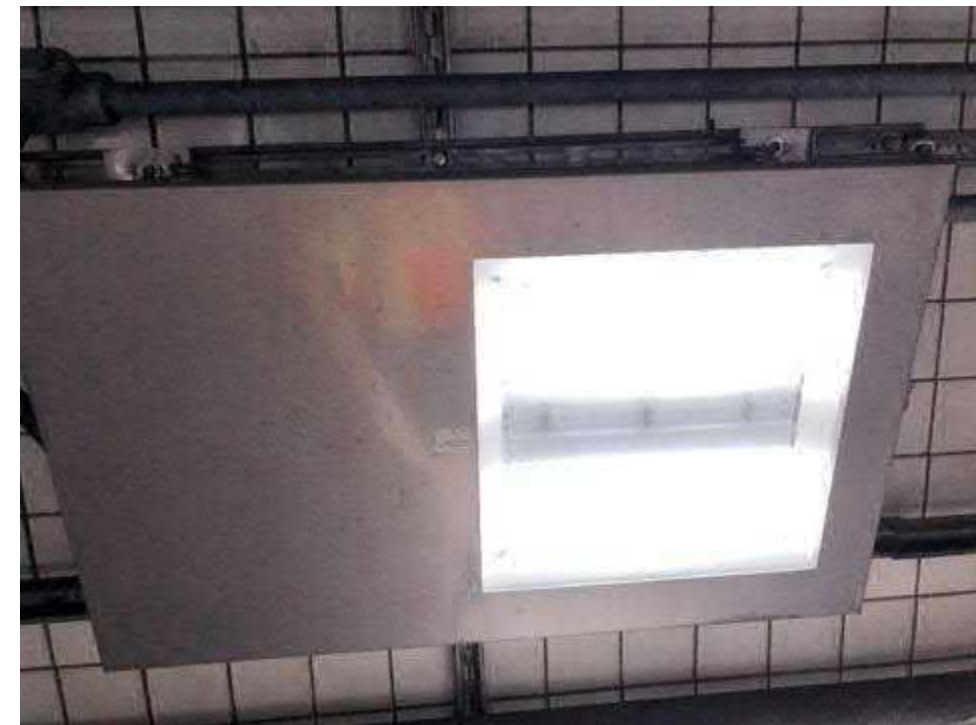
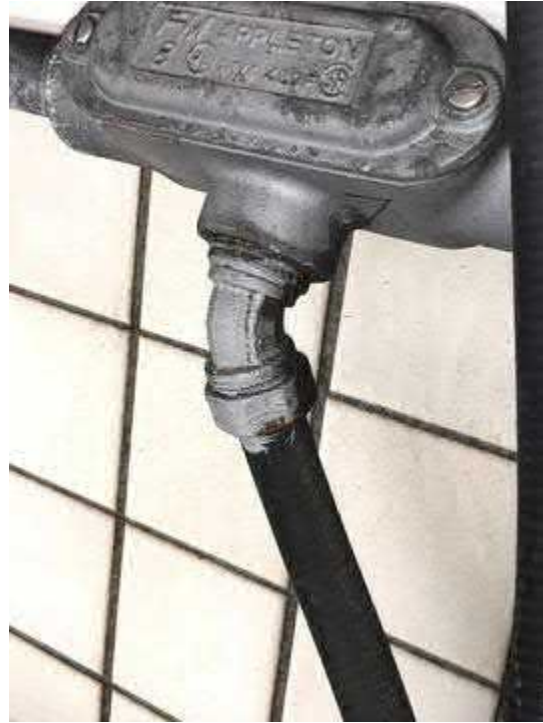
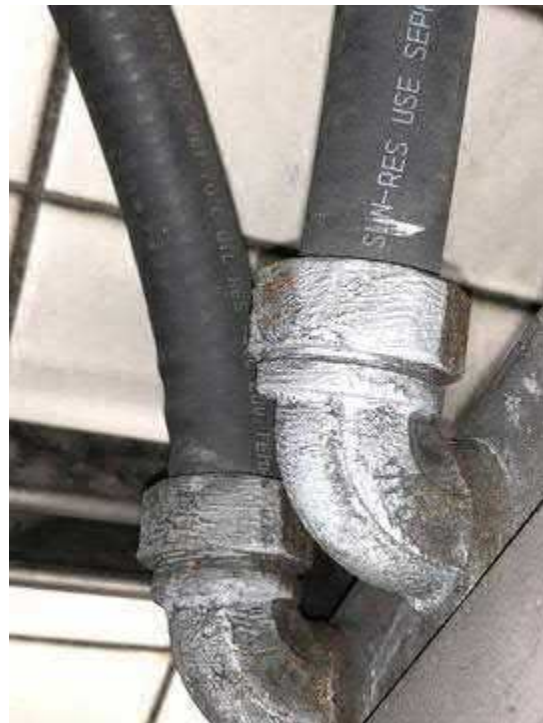
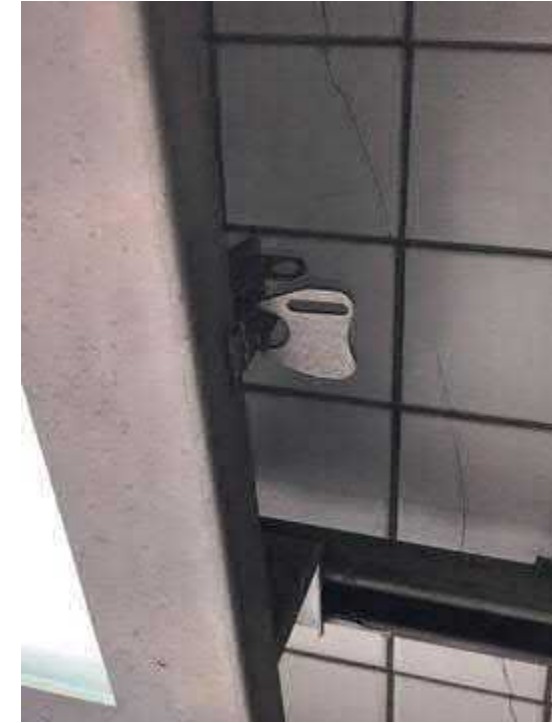
Lighting Fixture Information	
Luminaire Tag or Number:	SB - West Wall - 31B
Tunnel Direction and Side:	SB - West Wall
Additional Information:	T SEL SE LOOSE TOP LEFT

Are there any signs of corrosion evident on the tunnel lighting system raceways?
Are the side entry conduits into the fixture tightly secured?
Are there any signs of corrosion on the fixture?
Is there any damage to the component housing or enclosure?
Is the light fixture secure to the mounting channels?
Long channel springnut misaligned?
Long channel springnut cracked?
Trans channel springnut misaligned?
Trans channel springnut cracked?
Trans channel wireway clip?
Housing clip disengaged?
Housing clip missing?
Lens clip disengaged?
Lens clip broken?
Lens cover cracked?
Wireway ears broken?
Luminaire functioning?

Yes	No	No	No	No	No	No	Yes	No	Yes	No	No	Yes		No	No	Yes
-----	----	----	----	----	----	----	-----	----	-----	----	----	-----	--	----	----	-----

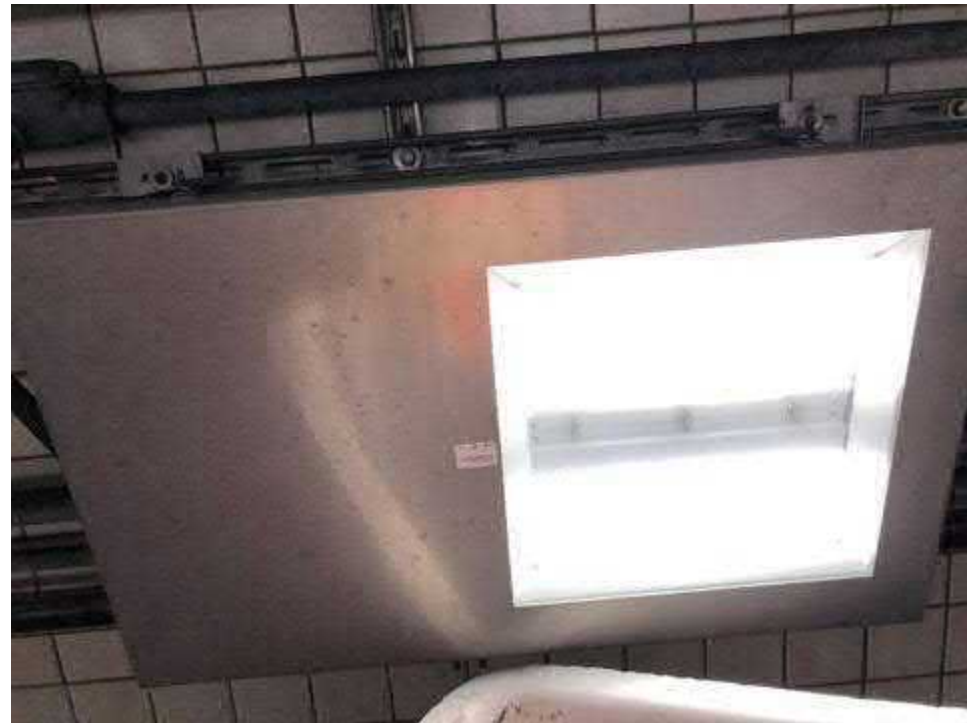
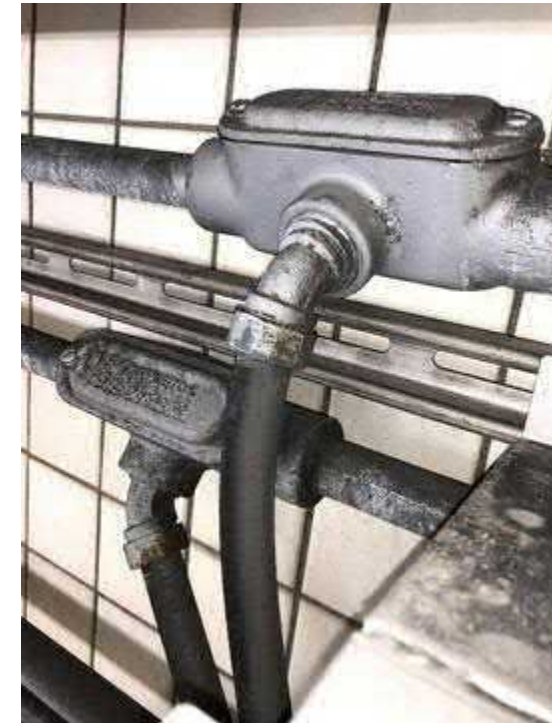
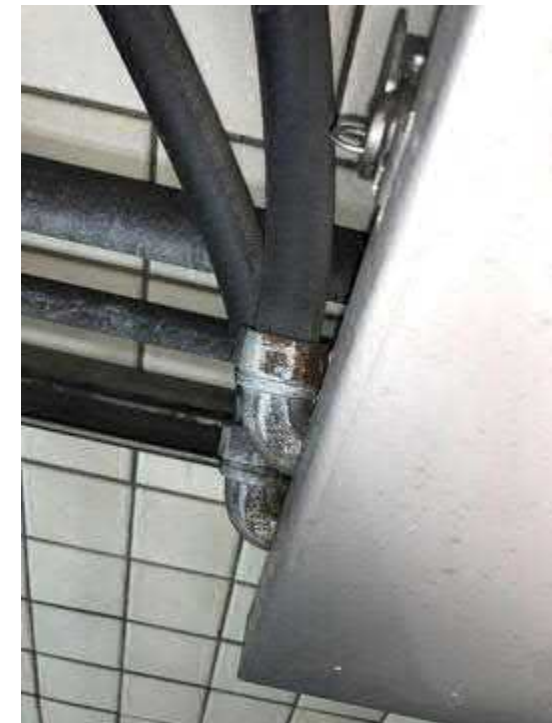
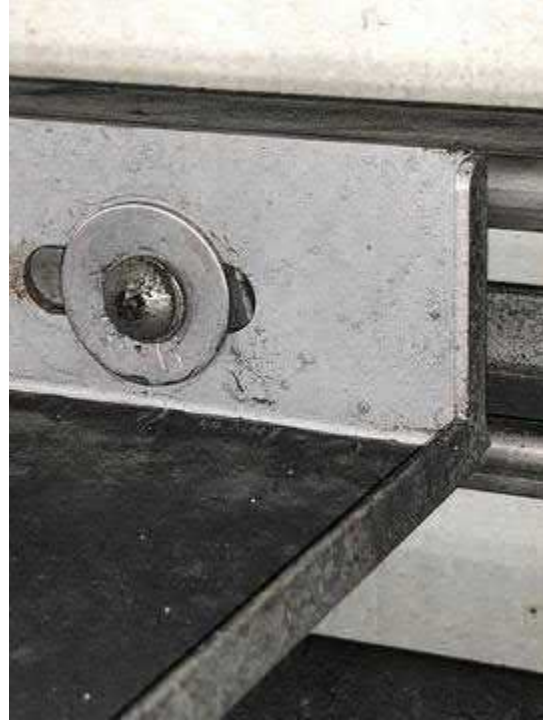
Lighting Fixture Information	
Luminaire Tag or Number:	SB - West Wall - 36A
Tunnel Direction and Side:	SB - West Wall
Additional Information:	T SEL SE LOOSE TOP RIGHT

Are there any signs of corrosion evident on the tunnel lighting system raceways?
Are the side entry conduits into the fixture tightly secured?
Are there any signs of corrosion on the fixture?
Is there any damage to the component housing or enclosure?
Is the light fixture secure to the mounting channels?
Long channel springnut misaligned?
Long channel springnut cracked?
Trans channel springnut cracked?
Trans channel springnut misaligned?
Trans channel wireway clip?
Housing clip disengaged?
Housing clip missing?
Lens clip disengaged?
Lens clip broken?
Lens cover cracked?
Wireway ears broken?
Luminaire functioning?

Yes	No	No	No	No	No	No	Yes	No	Yes	No	No	Yes	No	No	Yes	Yes
-----	----	----	----	----	----	----	-----	----	-----	----	----	-----	----	----	-----	-----

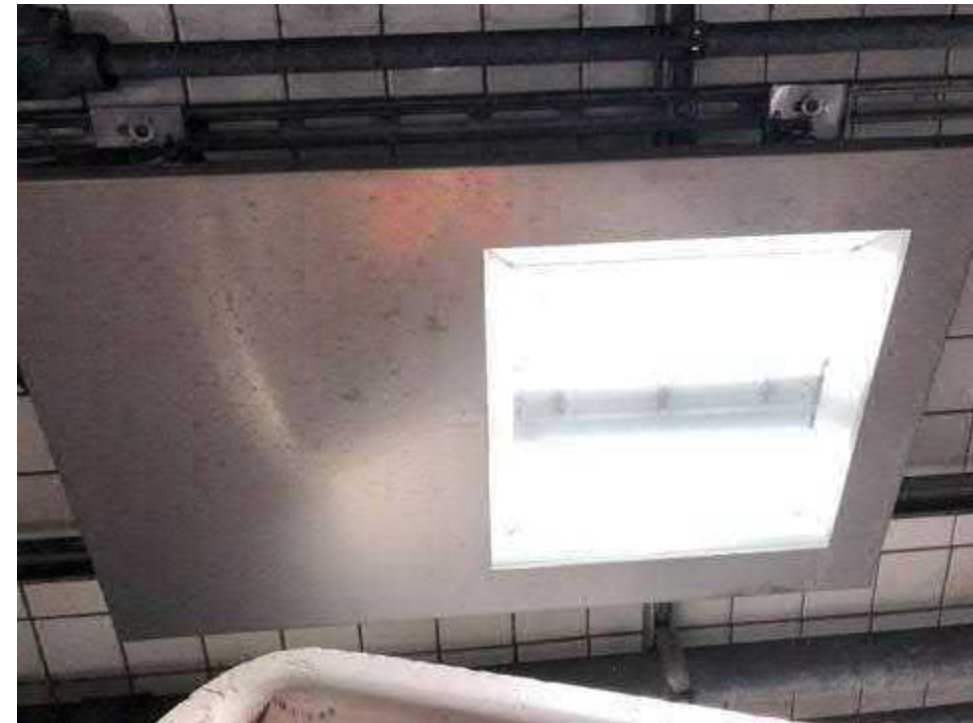
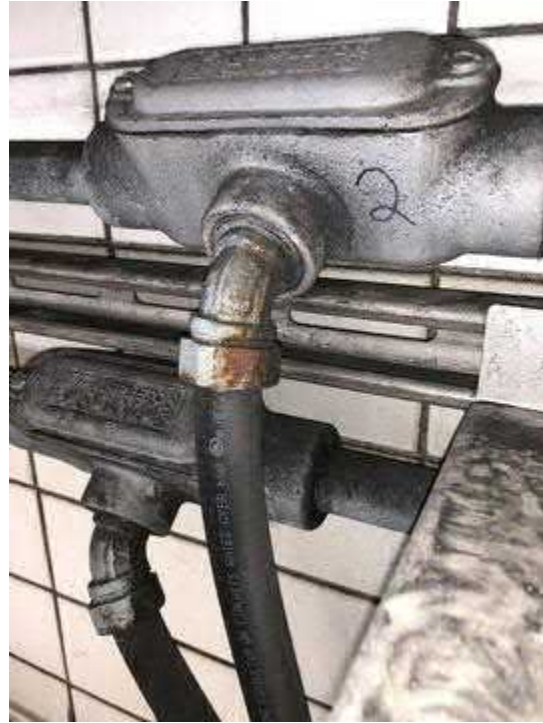
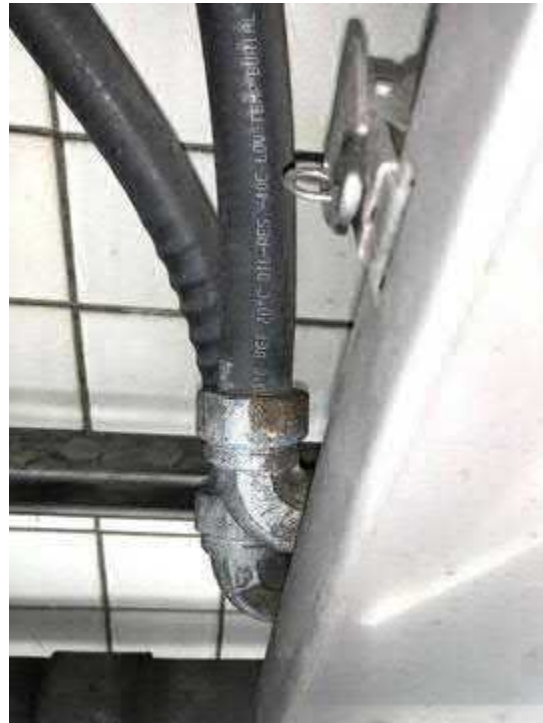
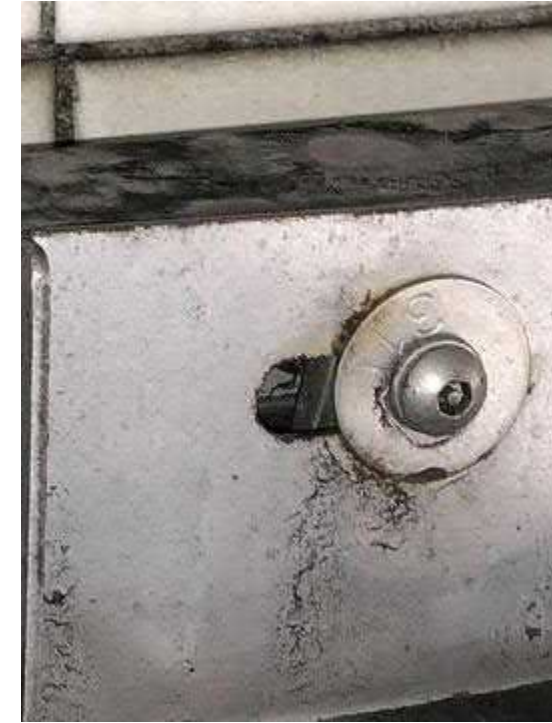
Lighting Fixture Information	
Luminaire Tag or Number:	SB - West Wall - 36B
Tunnel Direction and Side:	SB - West Wall
Additional Information:	T SEL BOTTOM RIGHT

Are there any signs of corrosion evident on the tunnel lighting system raceways?
Are the side entry conduits into the fixture tightly secured?
Are there any signs of corrosion on the fixture?
Is there any damage to the component housing or enclosure?
Is the light fixture secure to the mounting channels?
Long channel springnut misaligned?
Long channel springnut cracked?
Trans channel springnut misaligned?
Trans channel springnut cracked?
Trans channel wireway clip?
Housing clip disengaged?
Housing clip missing?
Lens clip disengaged?
Lens clip broken?
Lens cover cracked?
Wireway ears broken?
Luminaire functioning?

Yes	No	No	No	No	No	No	Yes	No	Yes	No	No	Yes	No	No	Yes	Yes
-----	----	----	----	----	----	----	-----	----	-----	----	----	-----	----	----	-----	-----

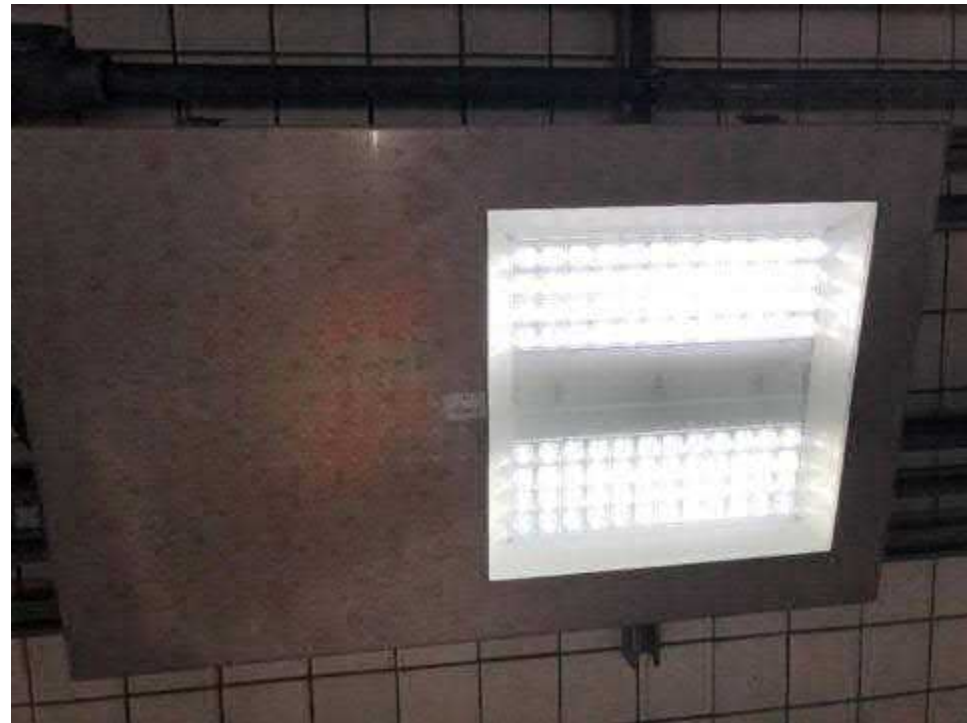
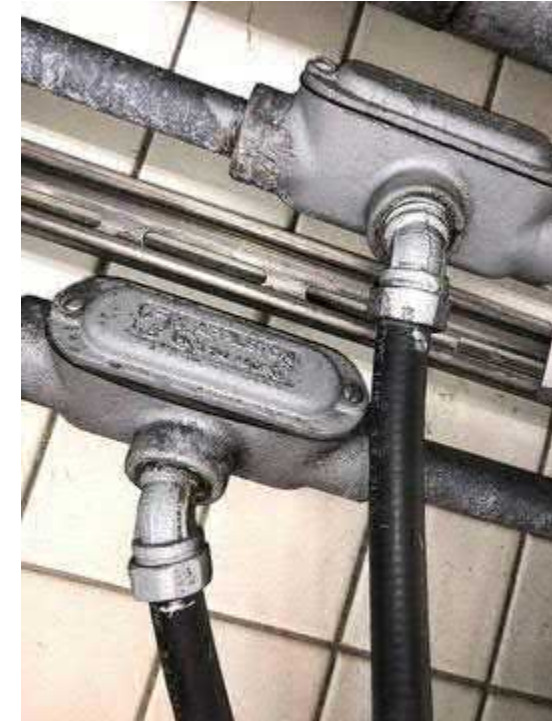
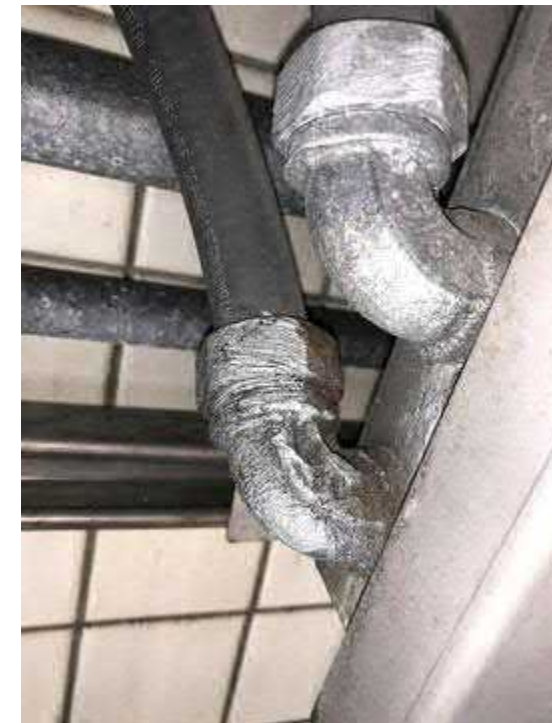
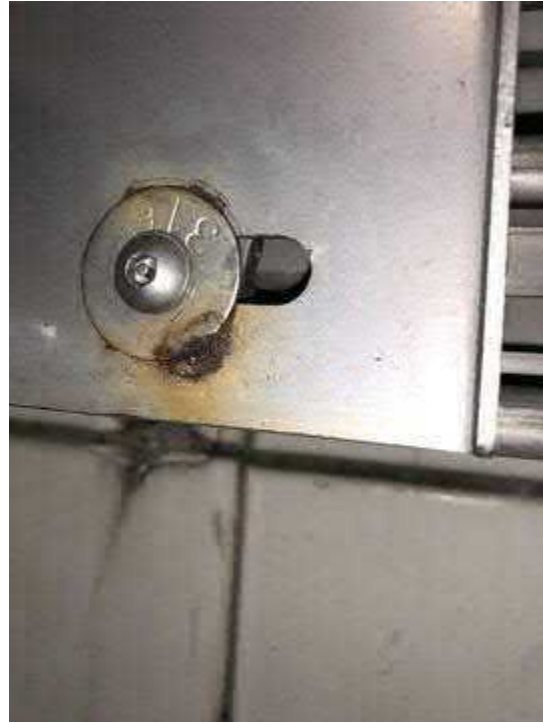
Lighting Fixture Information	
Luminaire Tag or Number:	SB - West Wall - 41A
Tunnel Direction and Side:	SB - West Wall
Additional Information:	T SEL SE LOOSE

Are there any signs of corrosion evident on the tunnel lighting system raceways?
Are the side entry conduits into the fixture tightly secured?
Are there any signs of corrosion on the fixture?
Is there any damage to the component housing or enclosure?
Is the light fixture secure to the mounting channels?
Long channel springnut misaligned?
Long channel springnut cracked?
Trans channel springnut cracked?
Trans channel springnut misaligned?
Trans channel wireway clip?
Housing clip disengaged?
Housing clip missing?
Lens clip disengaged?
Lens clip broken?
Lens cover cracked?
Wireway ears broken?
Luminaire functioning?

Yes	No	No	No	No	No	No	Yes		No	No	No	Yes	No	No	No	Yes
-----	----	----	----	----	----	----	-----	--	----	----	----	-----	----	----	----	-----

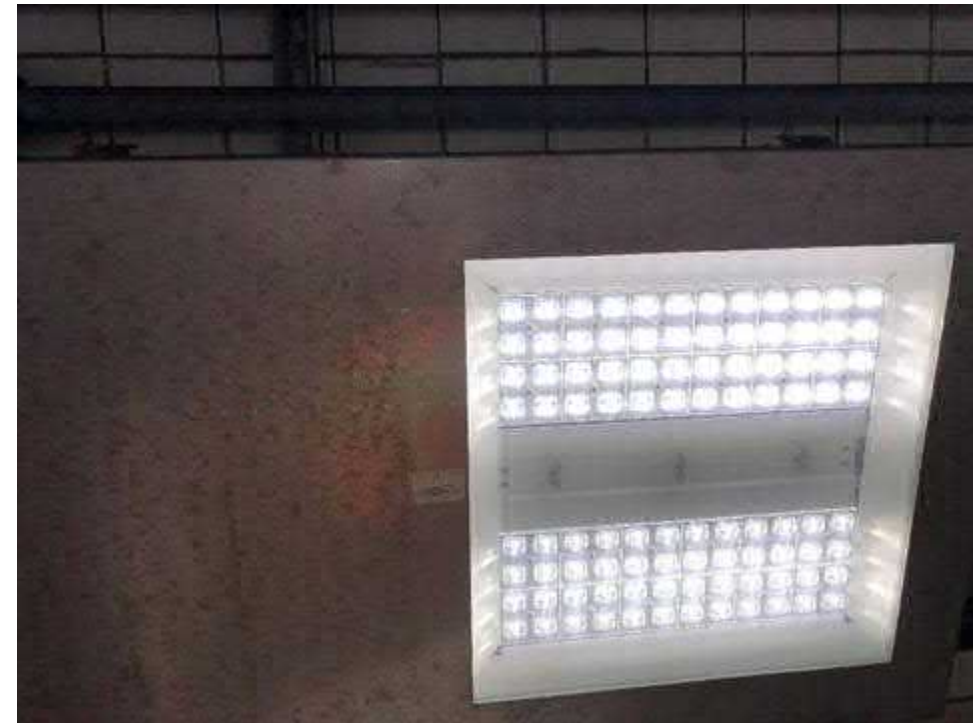
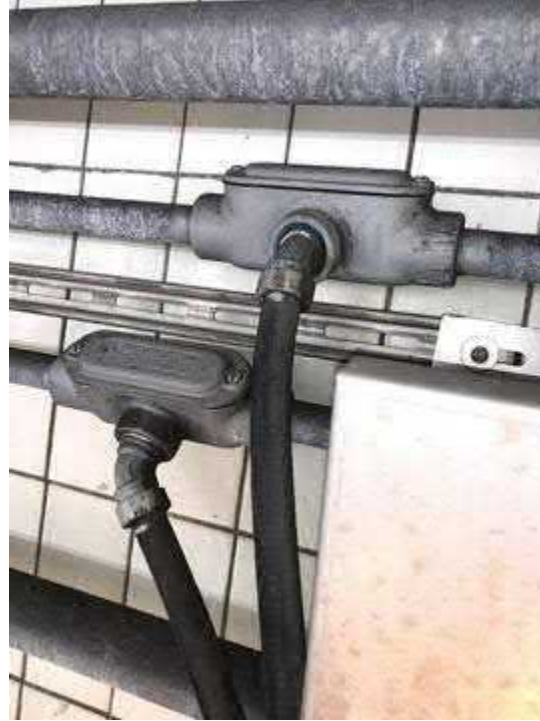
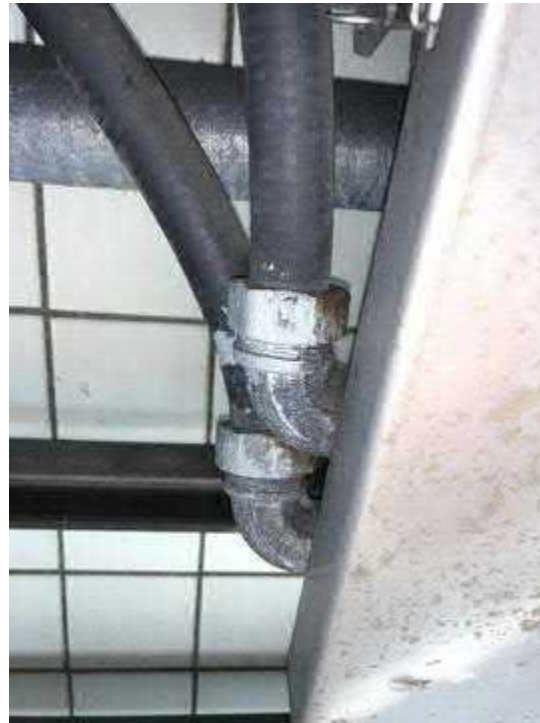
Lighting Fixture Information	
Luminaire Tag or Number:	SB - West Wall - 41B
Tunnel Direction and Side:	SB - West Wall
Additional Information:	T SEL SE LOOSE TOP LEFT

Are there any signs of corrosion evident on the tunnel lighting system raceways?	Yes
Are the side entry conduits into the fixture tightly secured?	No
Are there any signs of corrosion on the fixture?	No
Is there any damage to the component housing or enclosure?	No
Is the light fixture secure to the mounting channels?	Yes
Long channel springnut misaligned?	No
Long channel springnut cracked?	No
Trans channel springnut misaligned?	Yes
Trans channel springnut cracked?	No
Trans channel wireway clip?	Yes
Housing clip disengaged?	No
Housing clip missing?	No
Lens clip disengaged?	No
Lens clip broken?	No
Lens cover cracked?	No
Wireway ears broken?	No
Luminaire functioning?	No

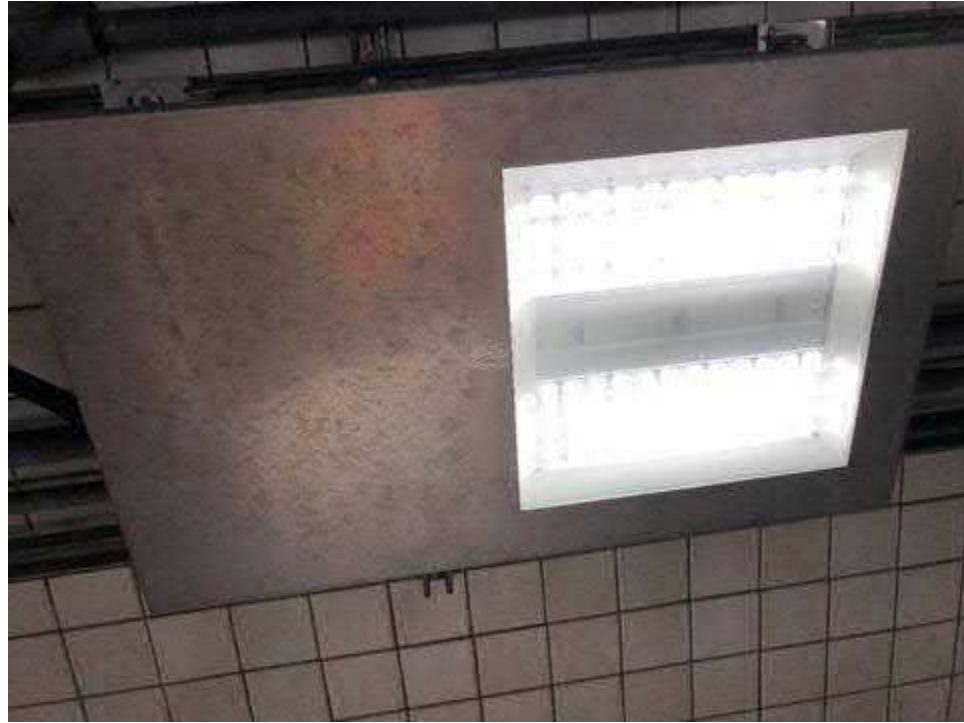
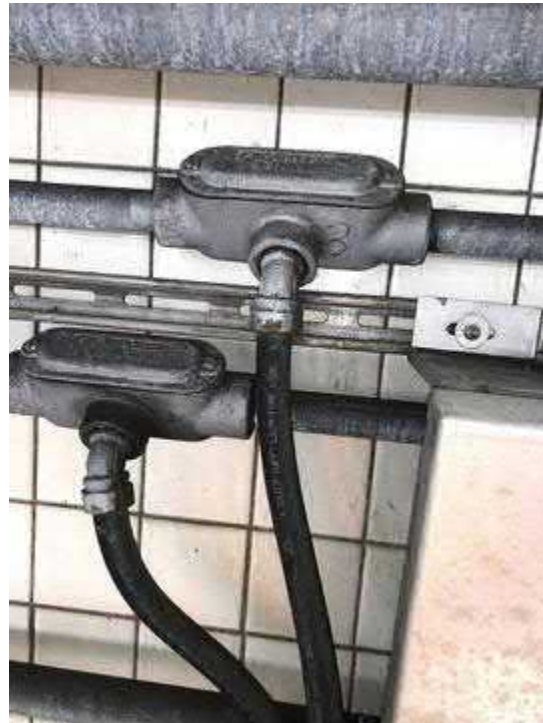
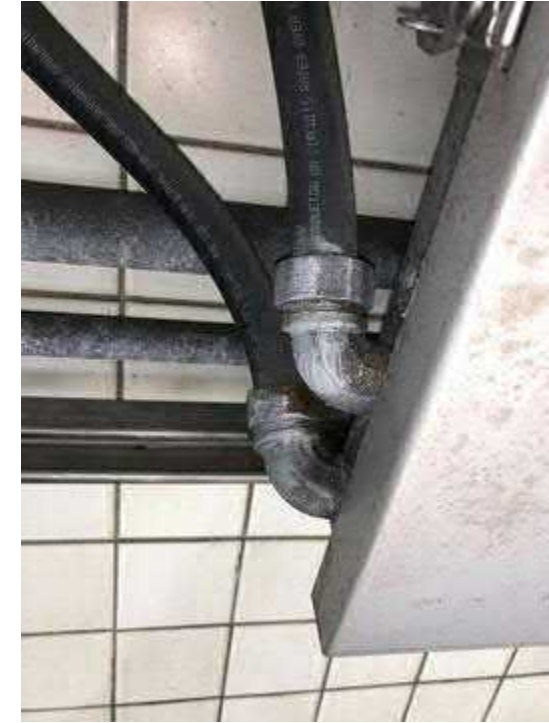
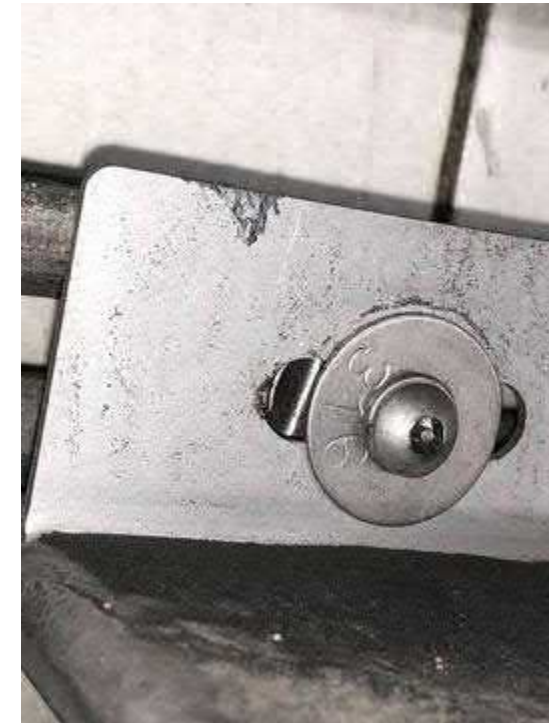
Lighting Fixture Information	
Luminaire Tag or Number:	SB - West Wall - 46A
Tunnel Direction and Side:	SB - West Wall - 46A
Additional Information:	T SEL SE LOOSE

Are there any signs of corrosion evident on the tunnel lighting system raceways?	Yes
Are the side entry conduits into the fixture tightly secured?	No
Are there any signs of corrosion on the fixture?	No
Is there any damage to the component housing or enclosure?	No
Is the light fixture secure to the mounting channels?	Yes
Long channel springnut misaligned?	No
Long channel springnut cracked?	No
Trans channel springnut misaligned?	Yes
Trans channel springnut cracked?	No
Trans channel wireway clip?	Yes
Housing clip disengaged?	No
Housing clip missing?	No
Lens clip disengaged?	No
Lens clip broken?	No
Lens cover cracked?	No
Wireway ears broken?	No
Luminaire functioning?	Yes

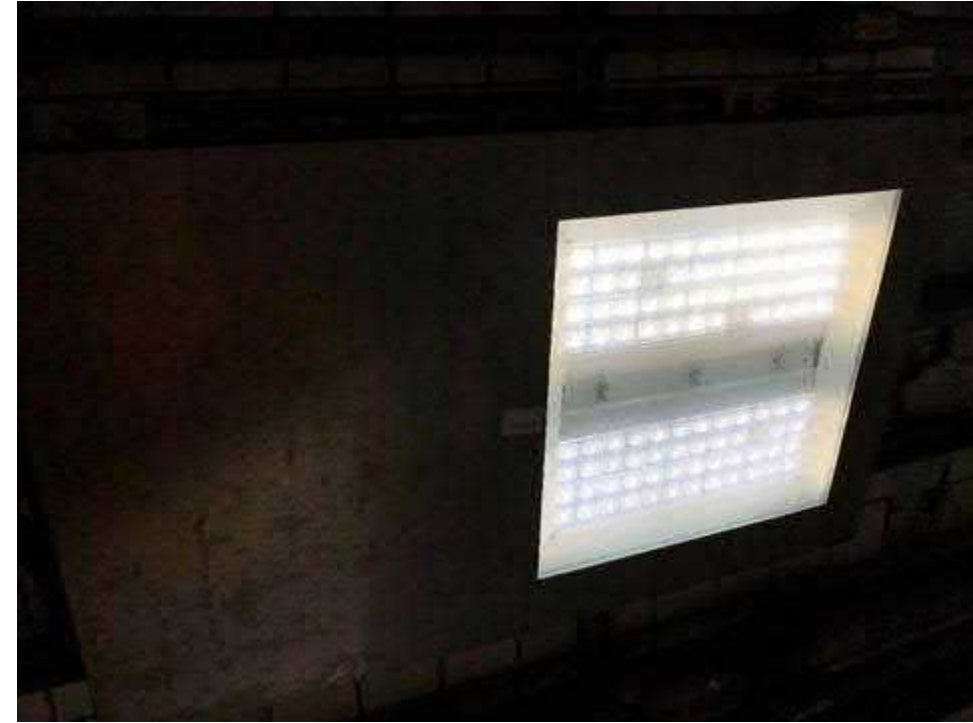
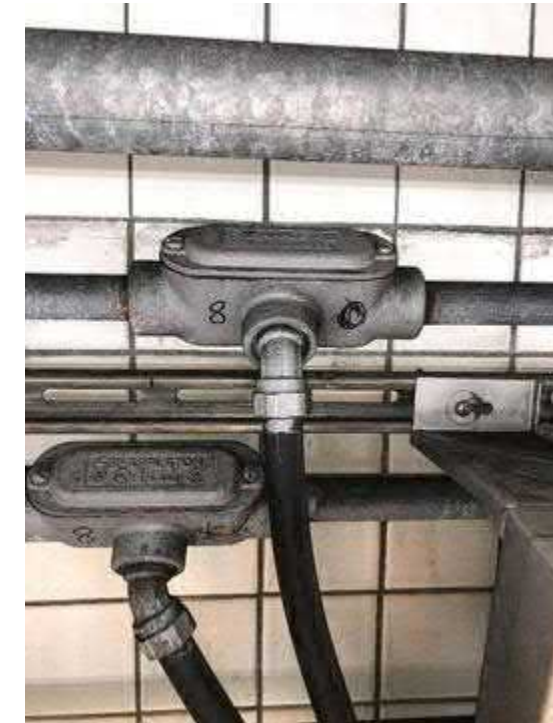
Lighting Fixture Information	
Luminaire Tag or Number:	SB - West Wall - 46B
Tunnel Direction and Side:	
Additional Information:	T SEL SE LOOSE BOTTOM LEFT

Are there any signs of corrosion evident on the tunnel lighting system raceways?	Yes
Are the side entry conduits into the fixture tightly secured?	No
Are there any signs of corrosion on the fixture?	No
Is there any damage to the component housing or enclosure?	No
Is the light fixture secure to the mounting channels?	Yes
Long channel springnut misaligned?	No
Long channel springnut cracked?	No
Trans channel springnut misaligned?	Yes
Trans channel springnut cracked?	No
Trans channel wireway clip?	Yes
Housing clip disengaged?	No
Housing clip missing?	No
Lens clip disengaged?	No
Lens clip broken?	No
Lens cover cracked?	No
Wireway ears broken?	No
Luminaire functioning?	Yes

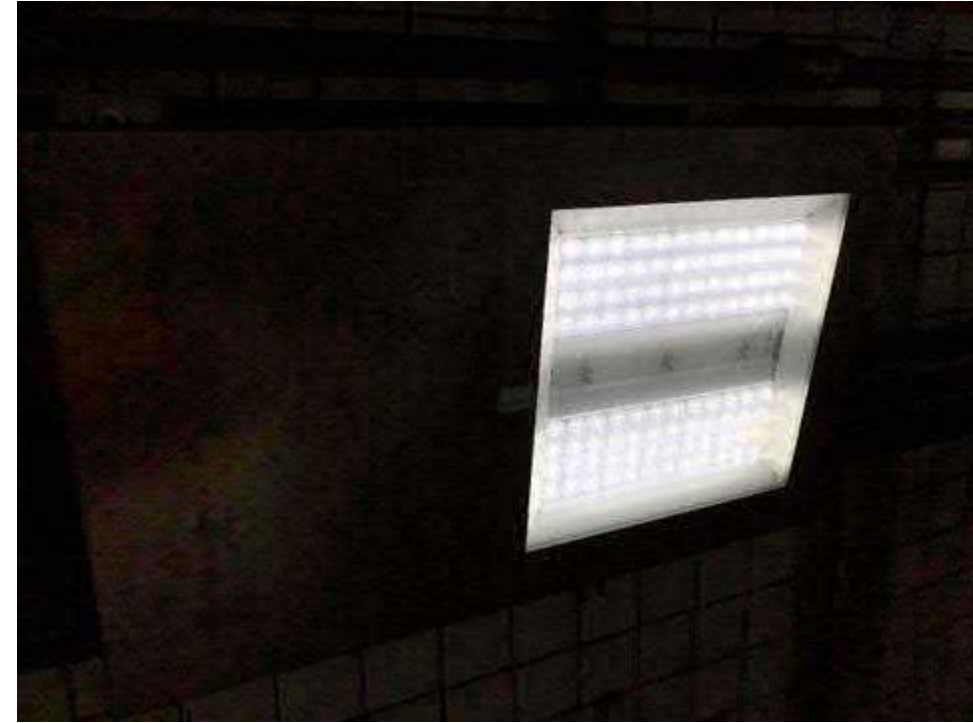
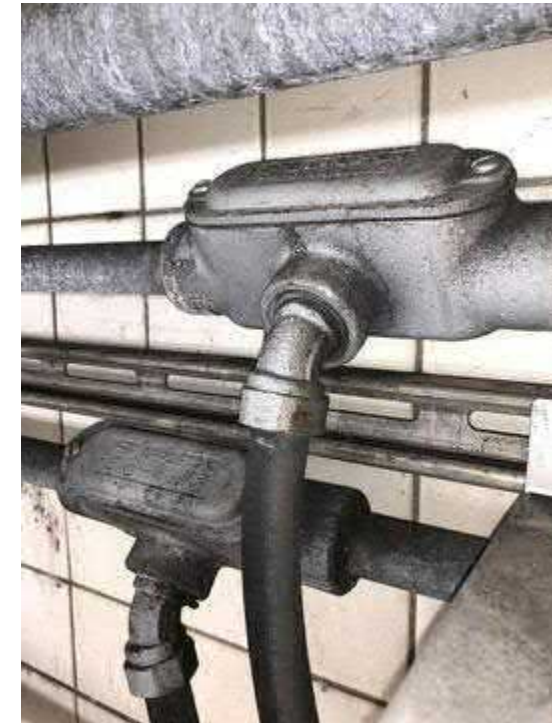
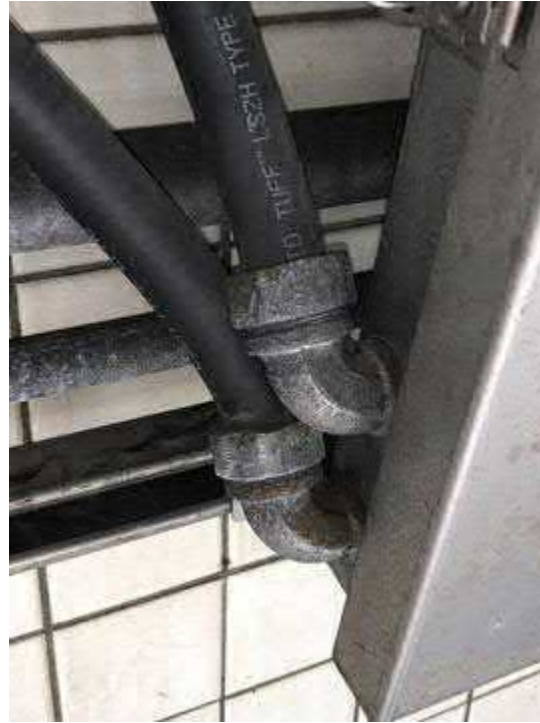
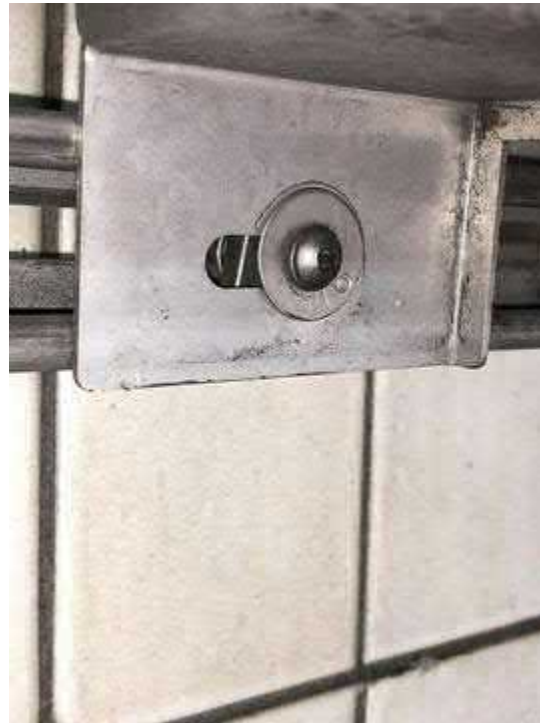
Lighting Fixture Information	
Luminaire Tag or Number:	SB - West Wall - 51A
Tunnel Direction and Side:	SB - West Wall
Additional Information:	T SEL TOP LEFT

Are there any signs of corrosion evident on the tunnel lighting system raceways?	Yes
Are the side entry conduits into the fixture tightly secured?	Yes
Are there any signs of corrosion on the fixture?	No
Is there any damage to the component housing or enclosure?	No
Is the light fixture secure to the mounting channels?	Yes
Long channel springnut misaligned?	No
Long channel springnut cracked?	No
Trans channel springnut misaligned?	Yes
Trans channel springnut cracked?	No
Trans channel wireway clip?	Yes
Housing clip disengaged?	No
Housing clip missing?	No
Lens clip disengaged?	No
Lens clip broken?	No
Lens cover cracked?	No
Wireway ears broken?	No
Luminaire functioning?	Yes
