# **Lytle Tunnel (HAM-71-0134) Inspection Report Fall 2020**

PID 105470

November, 2020

Ohio Department of  
Transportation  
District 8  
505 South State Route 741  
Lebanon, OH 45036

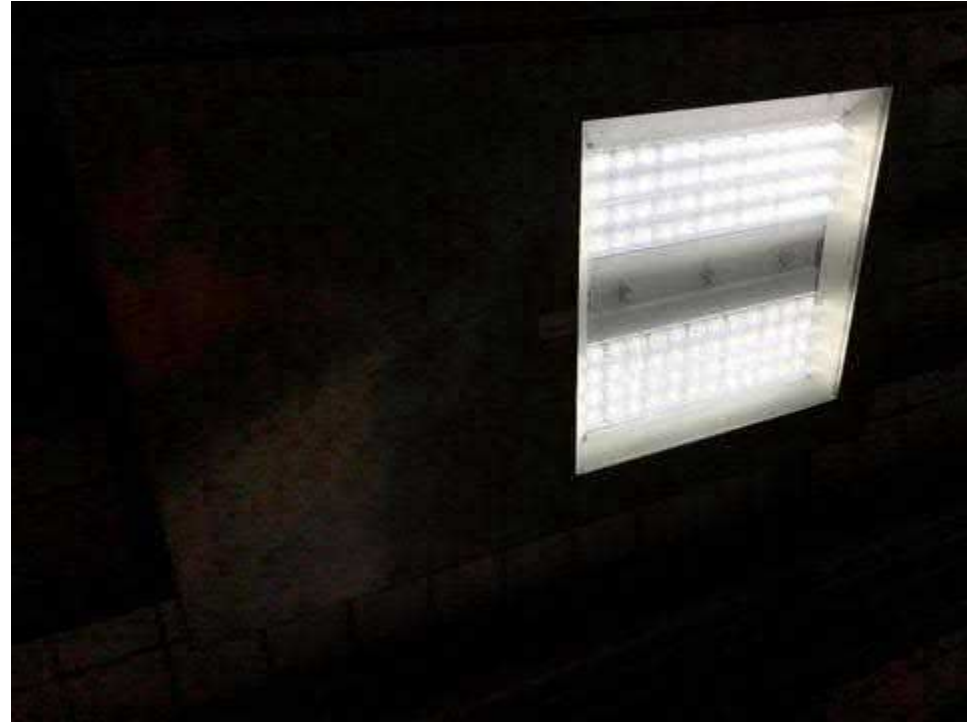
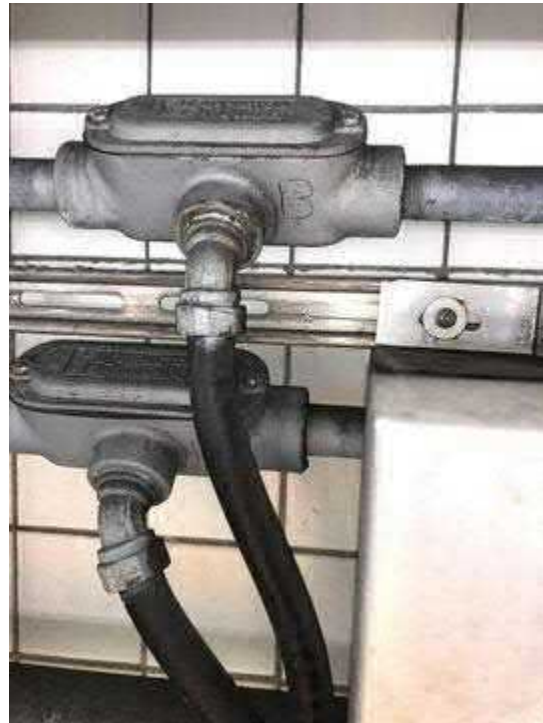
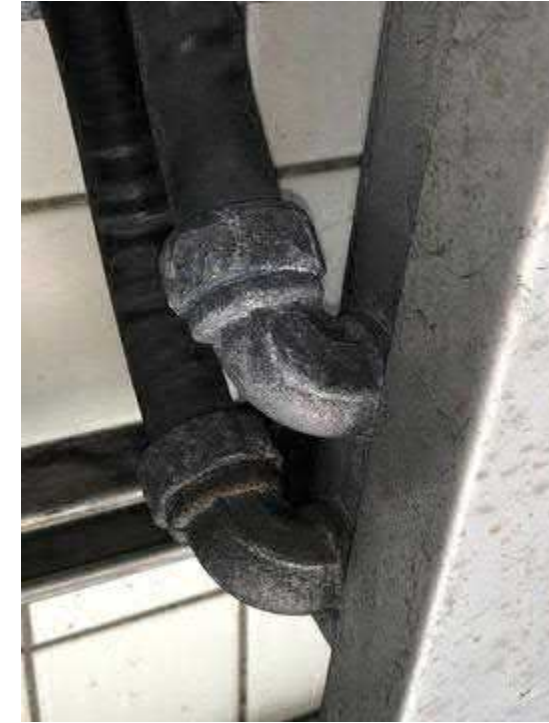
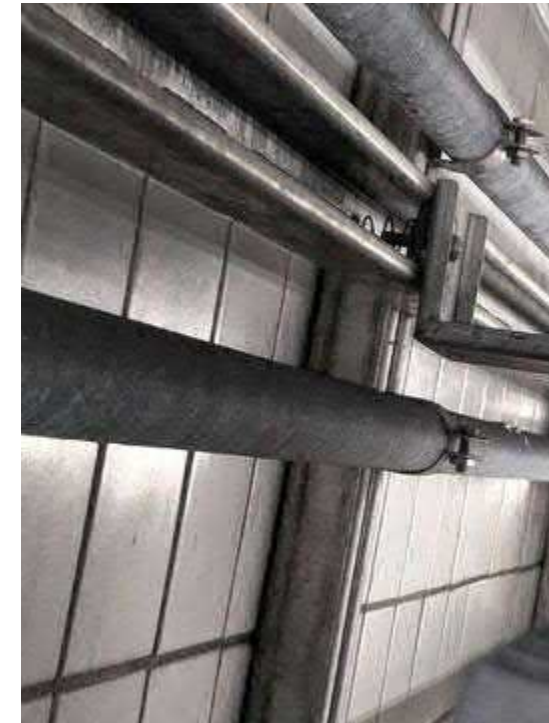
Lighting Fixture Information	
Luminaire Tag or Number:	SB - West Wall - 51B
Tunnel Direction and Side:	SB - West Wall
Additional Information:	T SEL TOP LEFT BOTTOM LEFT

Are there any signs of corrosion evident on the tunnel lighting system raceways?	Yes
Are the side entry conduits into the fixture tightly secured?	Yes
Are there any signs of corrosion on the fixture?	Yes
Is there any damage to the component housing or enclosure?	No
Is the light fixture secure to the mounting channels?	Yes
Long channel springnut misaligned?	No
Long channel springnut cracked?	No
Trans channel springnut misaligned?	Yes
Trans channel springnut cracked?	No
Trans channel wireway clip?	Yes
Housing clip disengaged?	No
Housing clip missing?	No
Lens clip disengaged?	No
Lens clip broken?	No
Lens cover cracked?	No
Wireway ears broken?	No
Luminaire functioning?	Yes

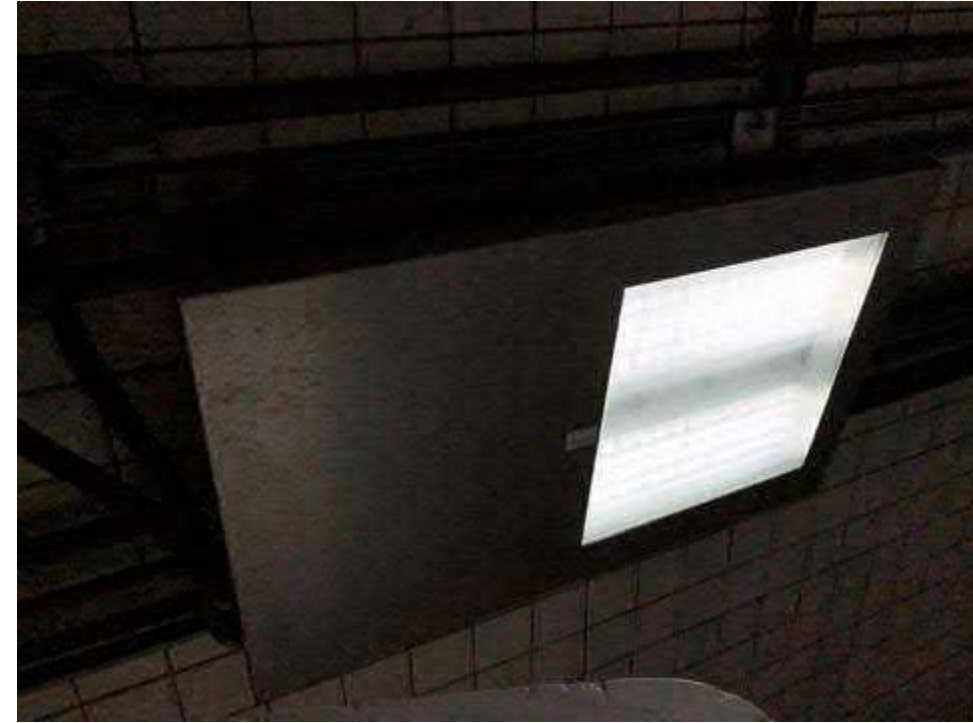
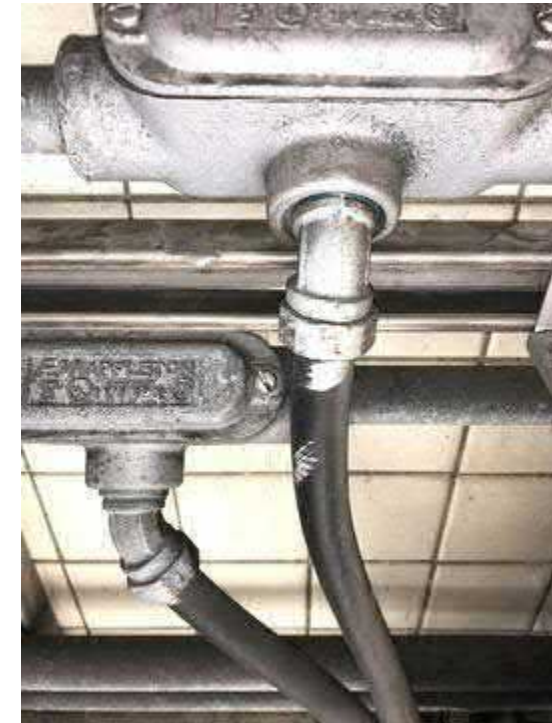
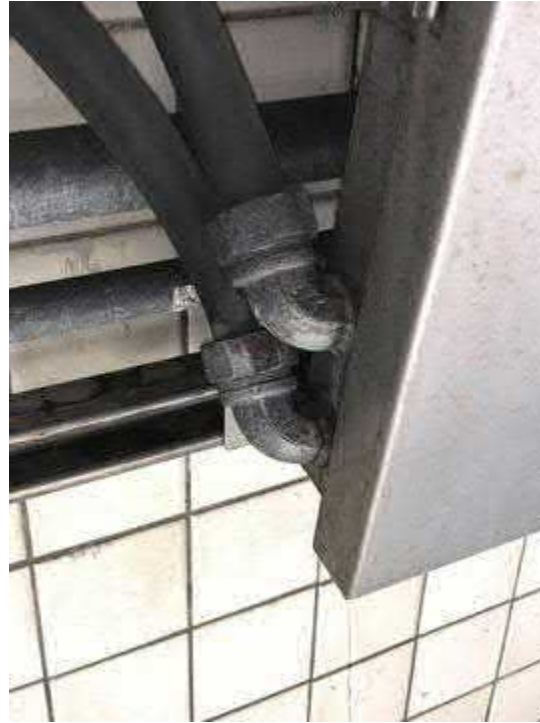
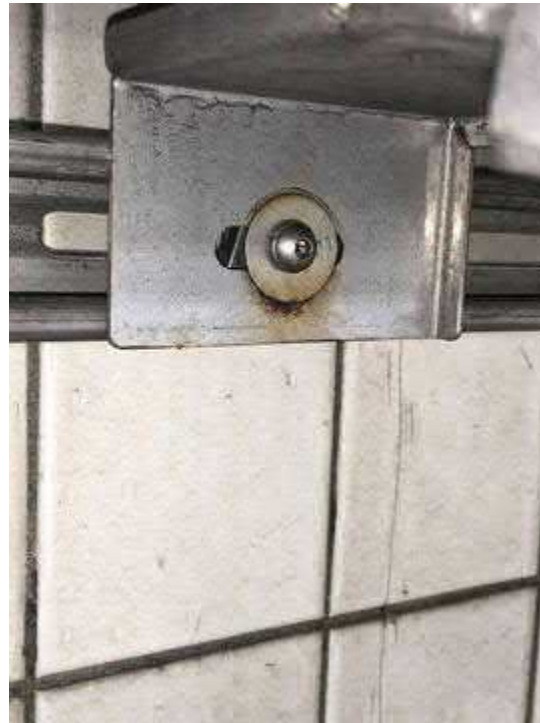
Lighting Fixture Information	
Luminaire Tag or Number:	SB - West Wall - 56A
Tunnel Direction and Side:	SB - West Wall
Additional Information:	T SEL TOP LEFT BOTH BOTTOM

Are there any signs of corrosion evident on the tunnel lighting system raceways?	Yes
Are the side entry conduits into the fixture tightly secured?	Yes
Are there any signs of corrosion on the fixture?	No
Is there any damage to the component housing or enclosure?	No
Is the light fixture secure to the mounting channels?	Yes
Long channel springnut misaligned?	No
Long channel springnut cracked?	No
Trans channel springnut misaligned?	Yes
Trans channel springnut cracked?	No
Trans channel wireway clip?	Yes
Housing clip disengaged?	No
Housing clip missing?	No
Lens clip disengaged?	No
Lens clip broken?	No
Lens cover cracked?	No
Wireway ears broken?	No
Luminaire functioning?	Yes

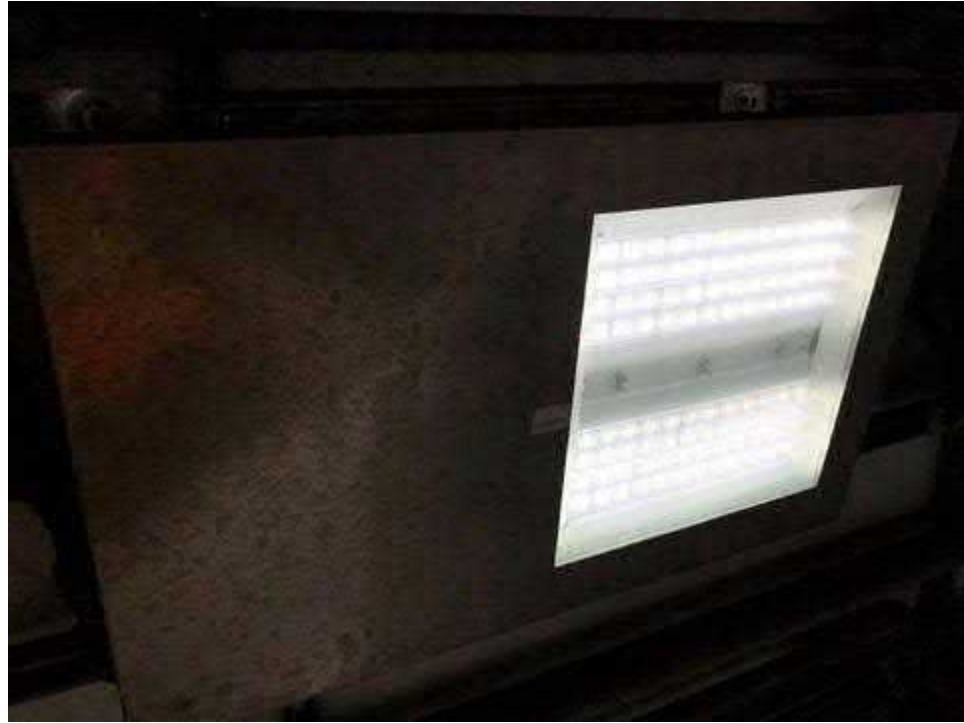
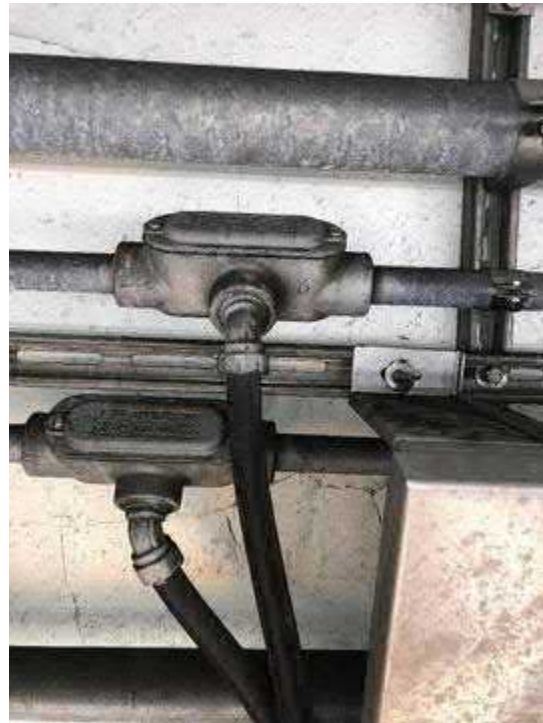
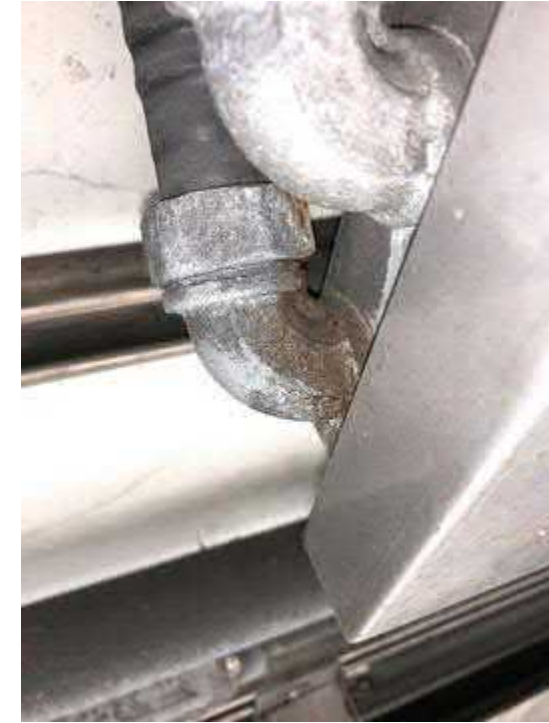
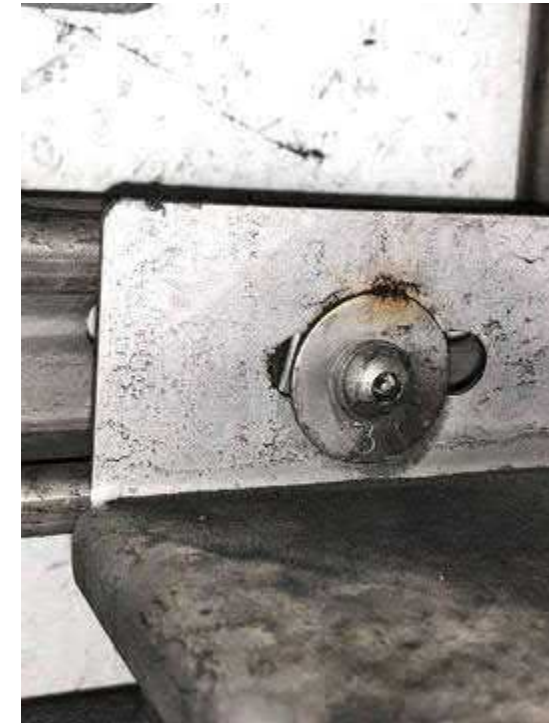
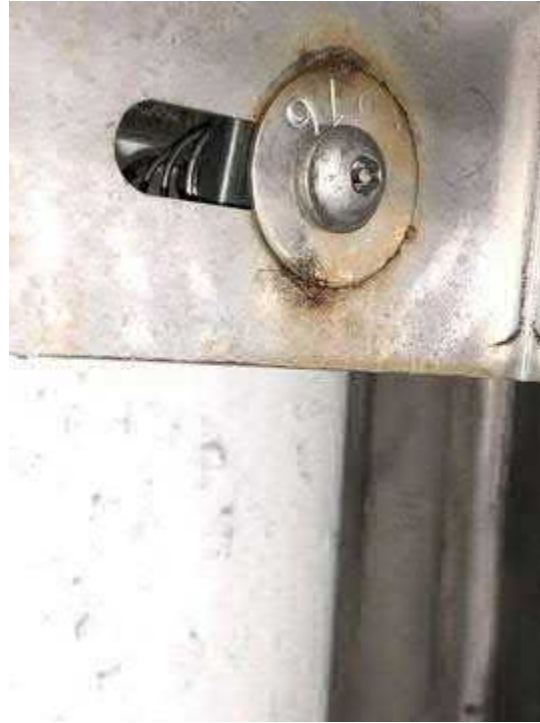
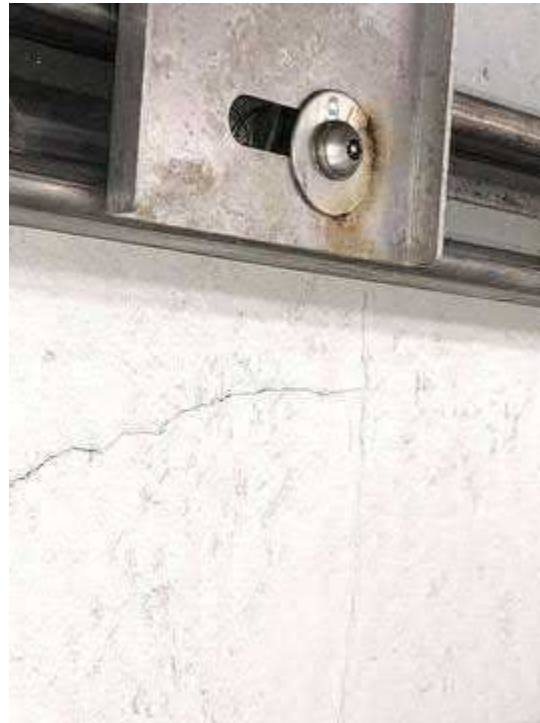
Lighting Fixture Information	
Luminaire Tag or Number:	SB - West Wall - 56B
Tunnel Direction and Side:	SB - West Wall
Additional Information:	T SEL TOP LEFT

Are there any signs of corrosion evident on the tunnel lighting system raceways?	Yes
Are the side entry conduits into the fixture tightly secured?	Yes
Are there any signs of corrosion on the fixture?	No
Is there any damage to the component housing or enclosure?	No
Is the light fixture secure to the mounting channels?	No
Long channel springnut misaligned?	No
Long channel springnut cracked?	No
Trans channel springnut misaligned?	Yes
Trans channel springnut cracked?	No
Trans channel wireway clip?	Yes
Housing clip disengaged?	No
Housing clip missing?	No
Lens clip disengaged?	No
Lens clip broken?	No
Lens cover cracked?	No
Wireway ears broken?	No
Luminaire functioning?	Yes

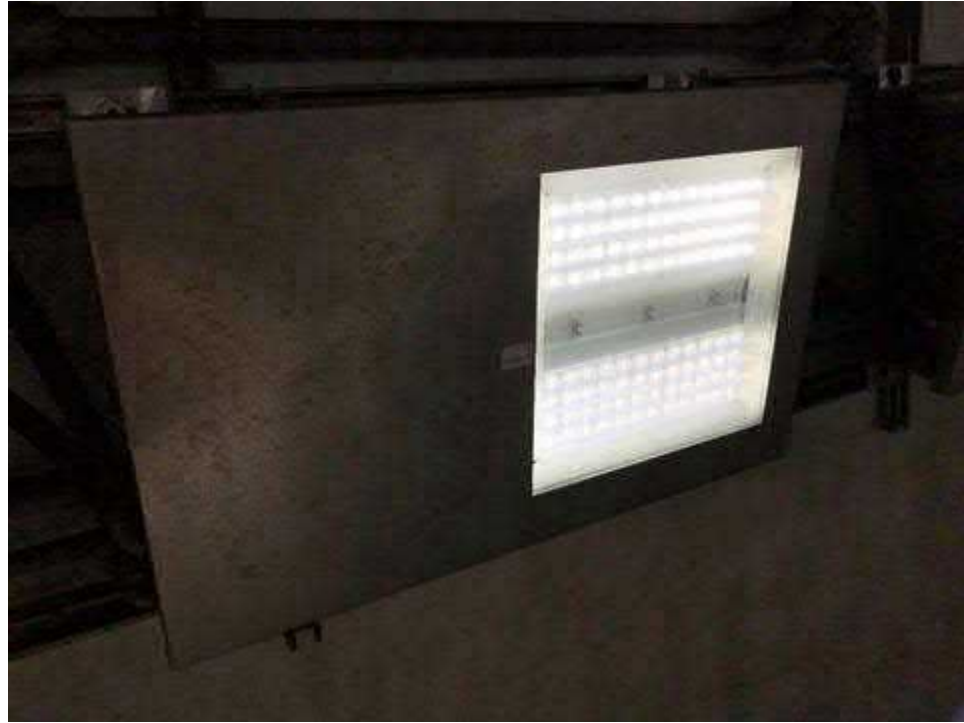
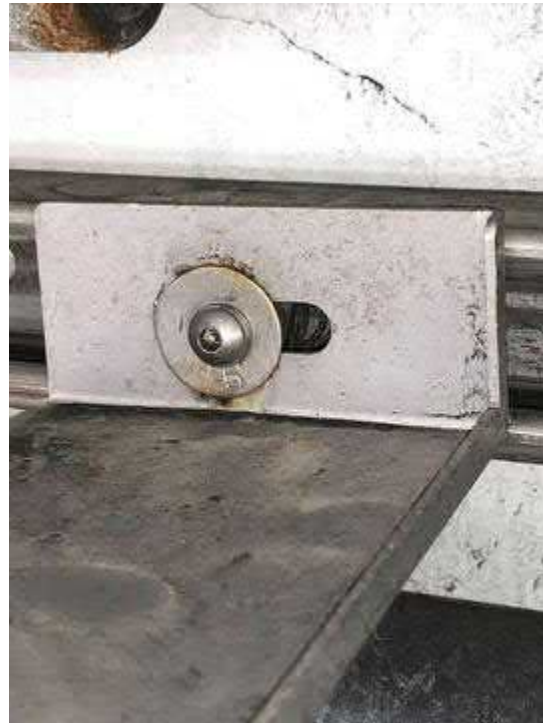
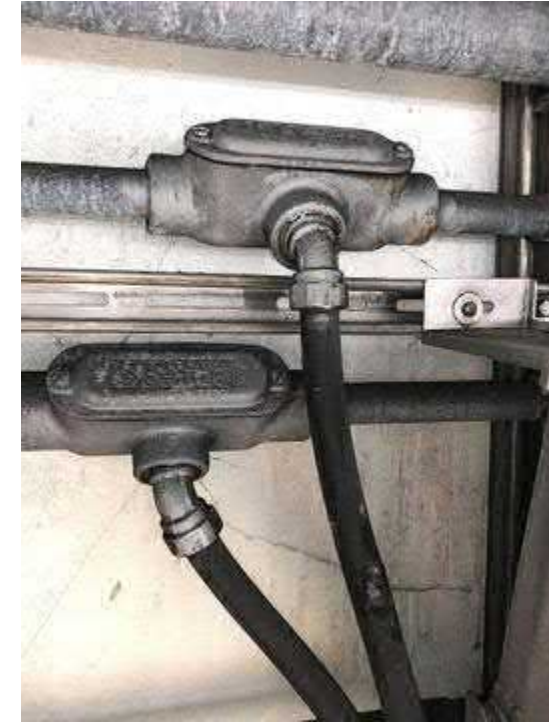
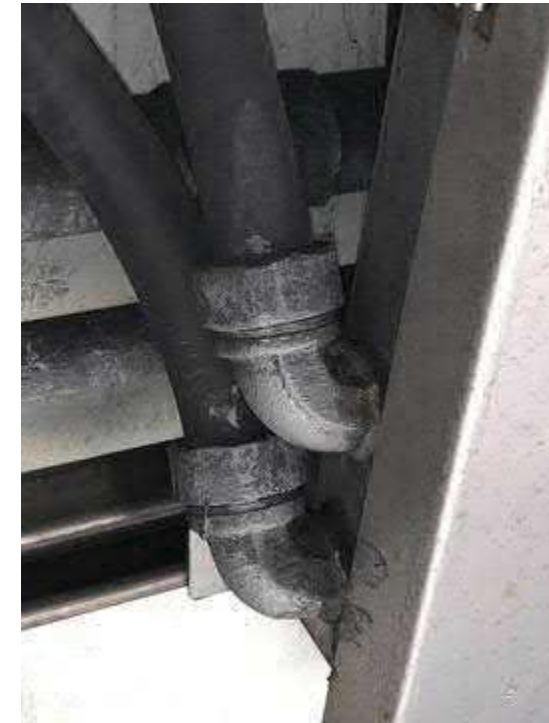
Lighting Fixture Information	
Luminaire Tag or Number:	SB - West Wall - 61A
Tunnel Direction and Side:	SB - West Wall
Additional Information:	T SEL SE LOOSE TOP RIGHT BOTTOM RIGHT

Are there any signs of corrosion evident on the tunnel lighting system raceways?	Yes
Are the side entry conduits into the fixture tightly secured?	No
Are there any signs of corrosion on the fixture?	No
Is there any damage to the component housing or enclosure?	No
Is the light fixture secure to the mounting channels?	No
Long channel springnut misaligned?	
Long channel springnut cracked?	
Trans channel springnut misaligned?	Yes
Trans channel springnut cracked?	No
Trans channel wireway clip?	Yes
Housing clip disengaged?	No
Housing clip missing?	No
Lens clip disengaged?	No
Lens clip broken?	No
Lens cover cracked?	No
Wireway ears broken?	No
Luminaire functioning?	Yes

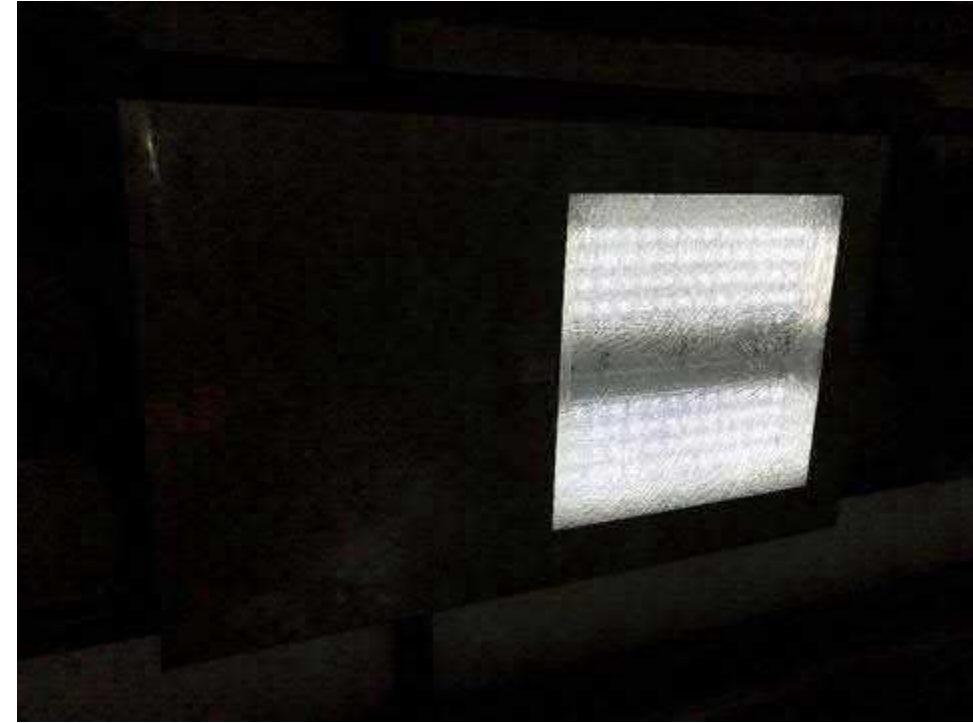
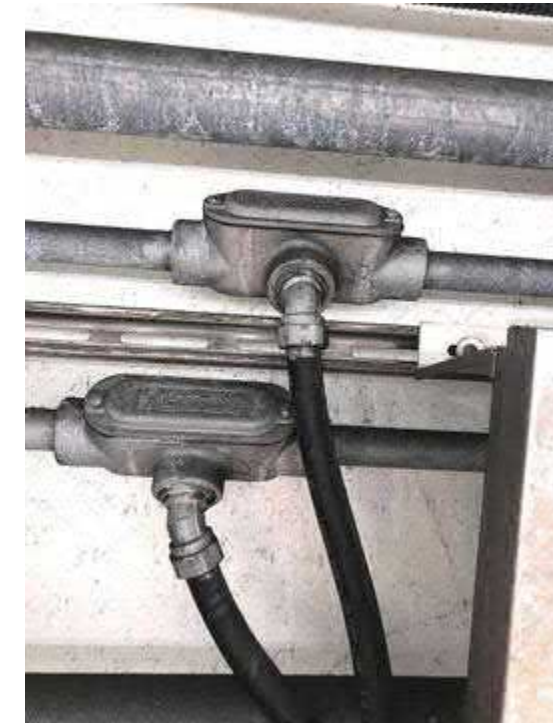
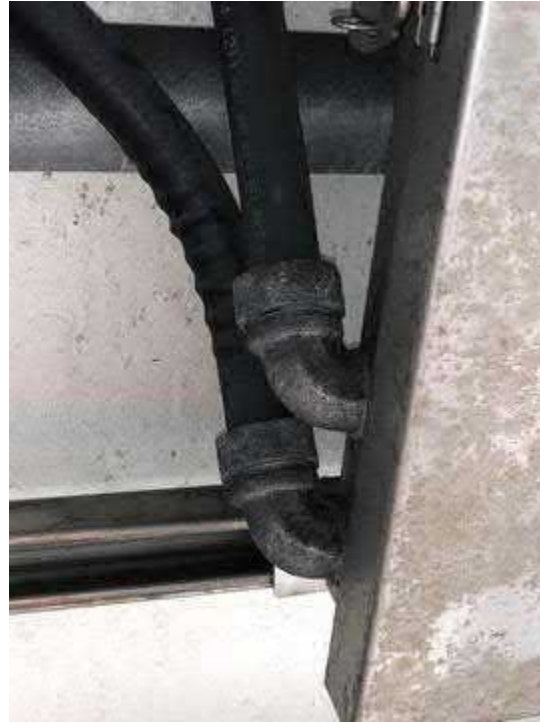
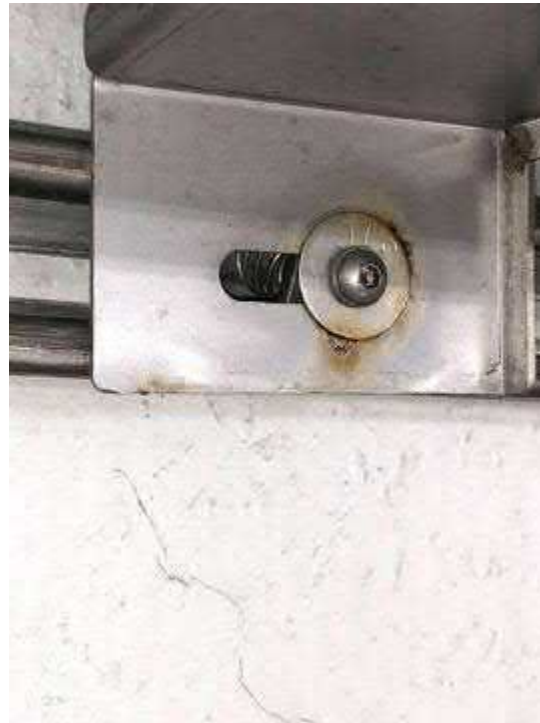
Lighting Fixture Information	
Luminaire Tag or Number:	SB - West Wall - 61B
Tunnel Direction and Side:	SB - West Wall
Additional Information:	T SEL SE LOOSE

Are there any signs of corrosion evident on the tunnel lighting system raceways?	Yes
Are the side entry conduits into the fixture tightly secured?	No
Are there any signs of corrosion on the fixture?	No
Is there any damage to the component housing or enclosure?	No
Is the light fixture secure to the mounting channels?	No
Long channel springnut misaligned?	No
Long channel springnut cracked?	No
Trans channel springnut misaligned?	Yes
Trans channel springnut cracked?	No
Trans channel wireway clip?	Yes
Housing clip disengaged?	No
Housing clip missing?	No
Lens clip disengaged?	No
Lens clip broken?	No
Lens cover cracked?	No
Wireway ears broken?	No
Luminaire functioning?	Yes

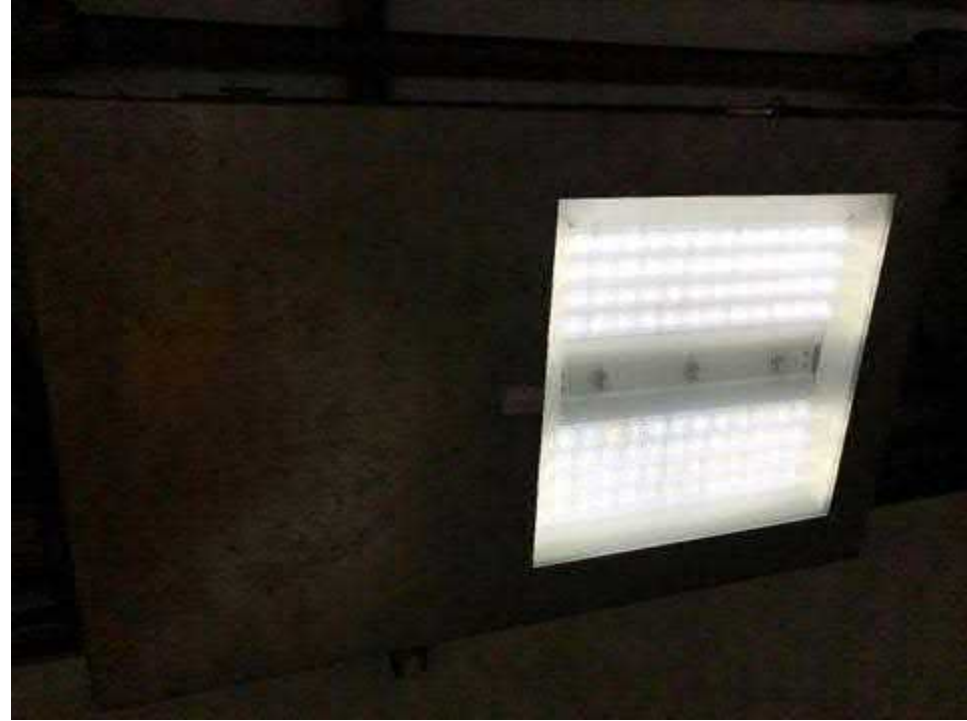
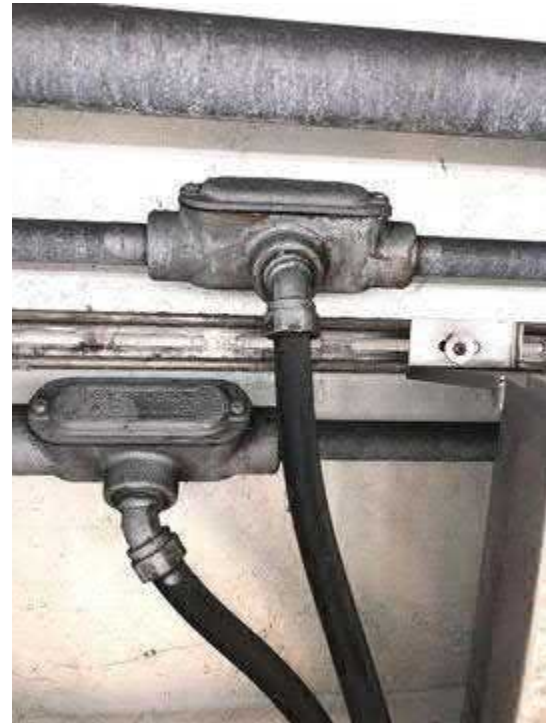
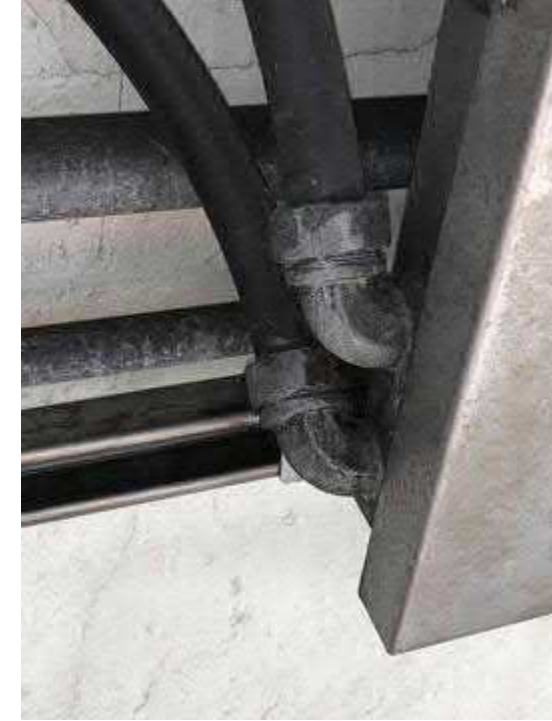
Lighting Fixture Information	
Luminaire Tag or Number:	SB - West Wall - 66A
Tunnel Direction and Side:	SB - West Wall
Additional Information:	T SEL SE LOOSE TOP RIGHT BOTTOM RIGHT

Are there any signs of corrosion evident on the tunnel lighting system raceways?
Are the side entry conduits into the fixture tightly secured?
Are there any signs of corrosion on the fixture?
Is there any damage to the component housing or enclosure?
Is the light fixture secure to the mounting channels?
Long channel springnut misaligned?
Long channel springnut cracked?
Trans channel springnut misaligned?
Trans channel springnut cracked?
Trans channel wireway clip?
Housing clip disengaged?
Housing clip missing?
Lens clip disengaged?
Lens clip broken?
Lens cover cracked?
Wireway ears broken?
Luminaire functioning?

Yes	No	No	No	No	No	No	Yes	No	Yes	No	No	Yes		No	Yes	Yes
-----	----	----	----	----	----	----	-----	----	-----	----	----	-----	--	----	-----	-----

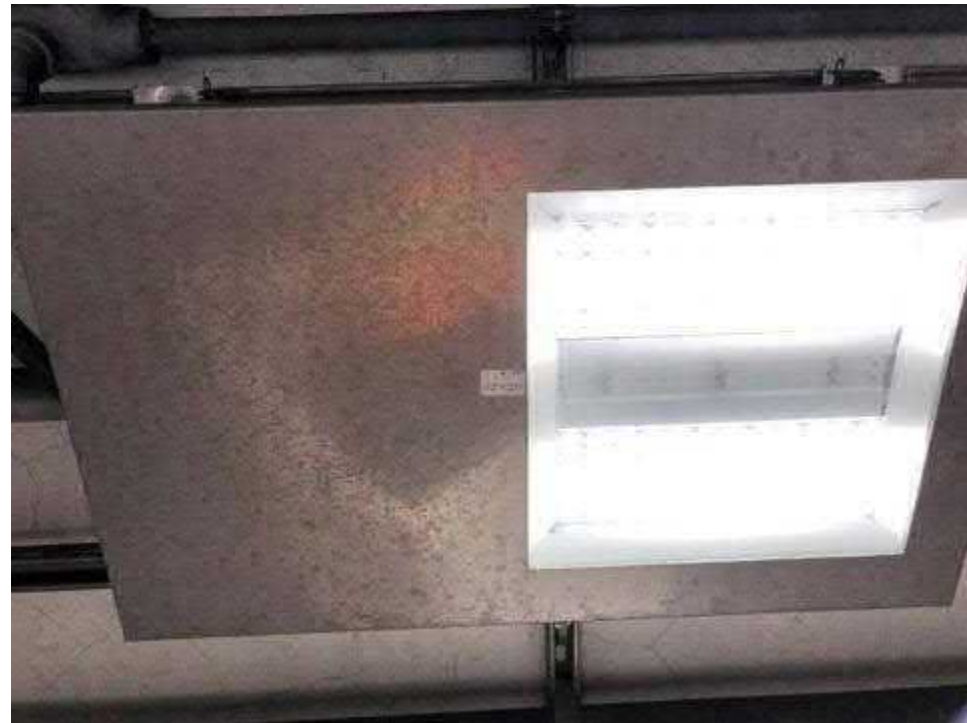
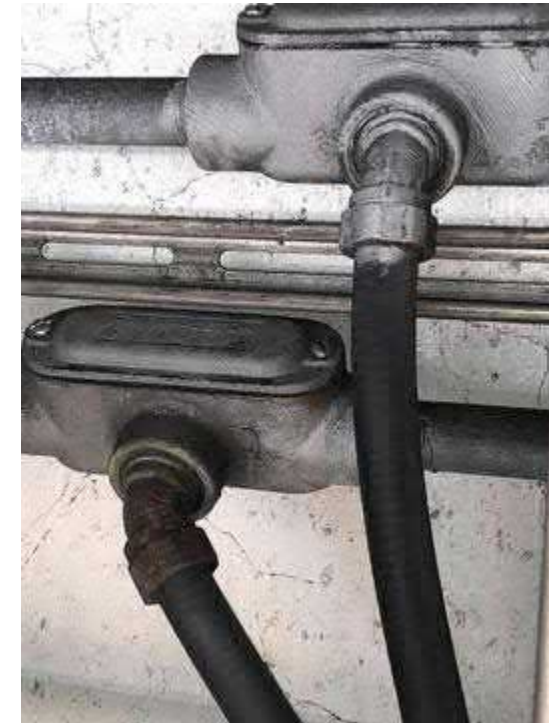
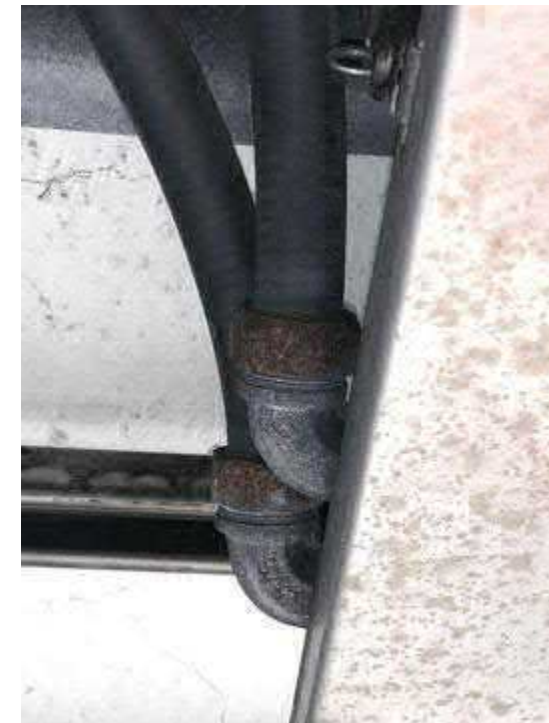
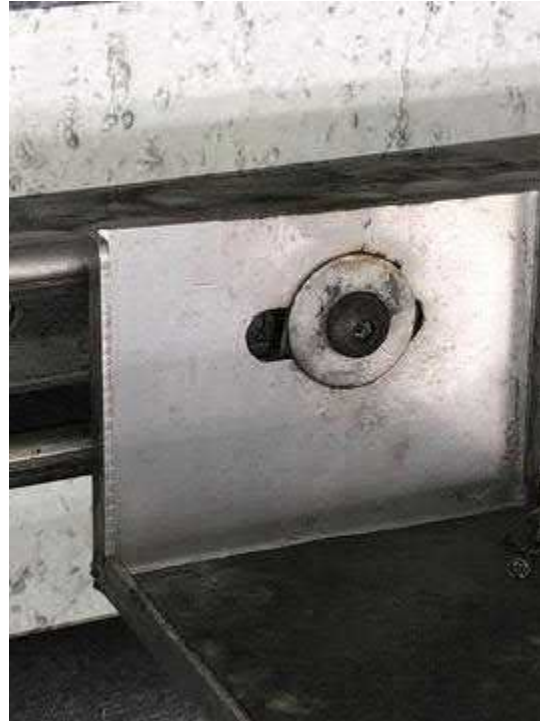
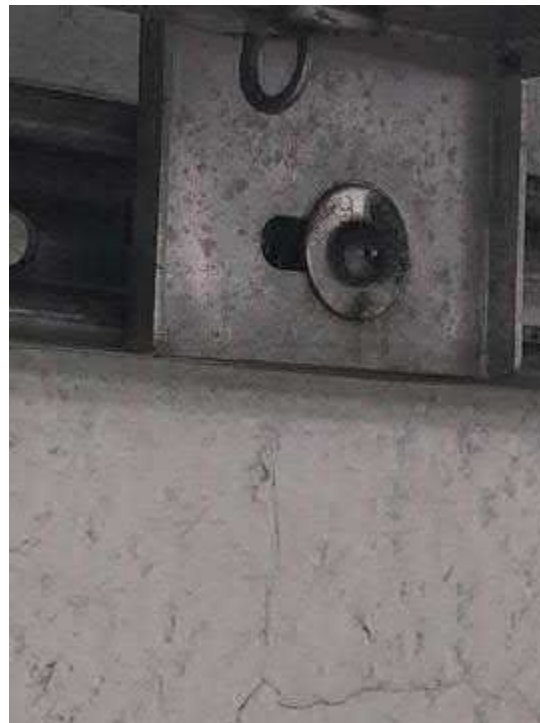
Lighting Fixture Information	
Luminaire Tag or Number:	SB - West Wall - 66B
Tunnel Direction and Side:	SB - West Wall
Additional Information:	T SEL TOP RIGHT

Are there any signs of corrosion evident on the tunnel lighting system raceways?	Yes
Are the side entry conduits into the fixture tightly secured?	Yes
Are there any signs of corrosion on the fixture?	Yes
Is there any damage to the component housing or enclosure?	Yes
Is the light fixture secure to the mounting channels?	Yes
Long channel springnut misaligned?	No
Long channel springnut cracked?	No
Trans channel springnut misaligned?	Yes
Trans channel springnut cracked?	No
Trans channel wireway clip?	Yes
Housing clip disengaged?	No
Housing clip missing?	No
Lens clip disengaged?	No
Lens clip broken?	No
Lens cover cracked?	No
Wireway ears broken?	No
Luminaire functioning?	Yes

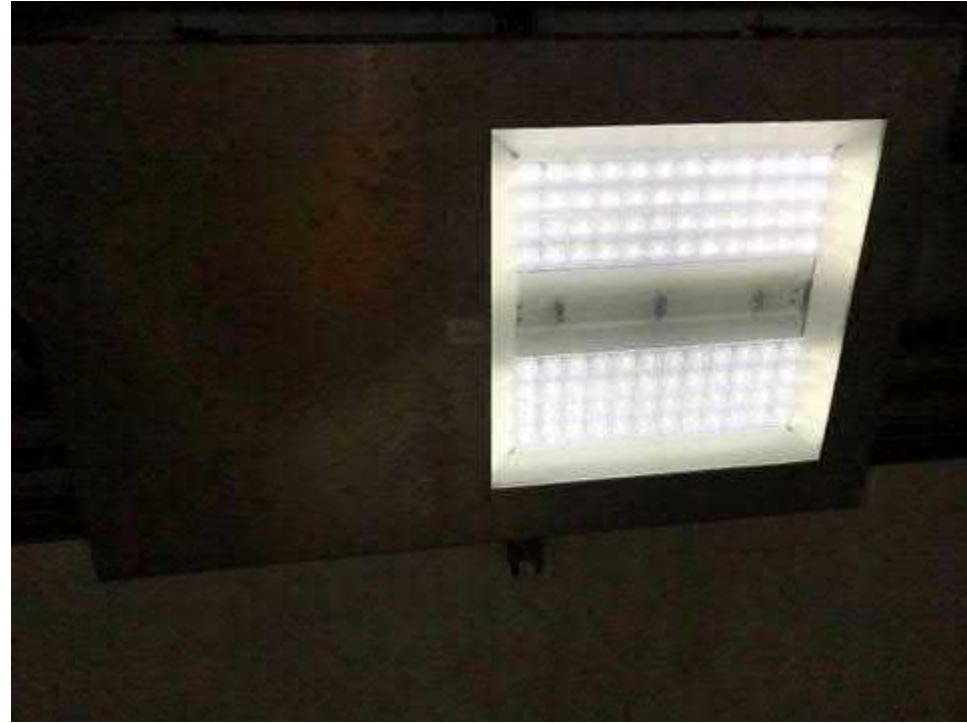
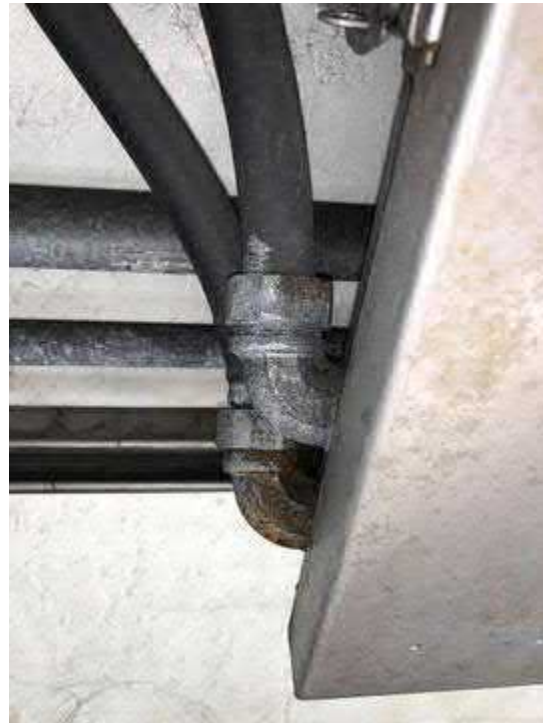
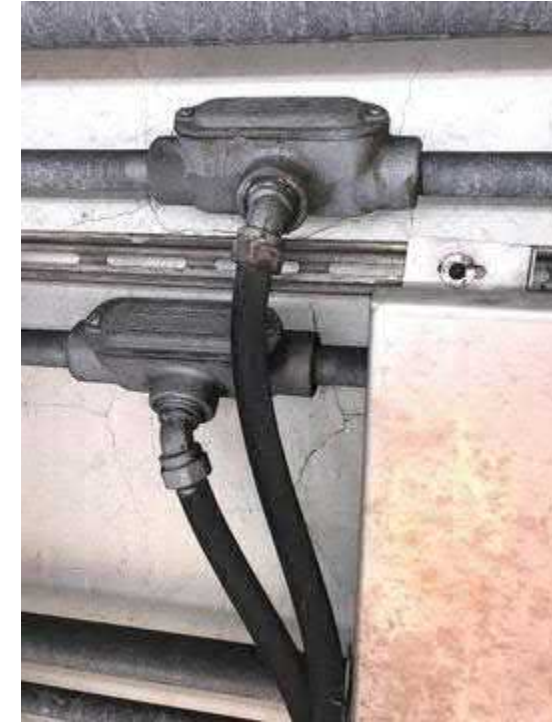
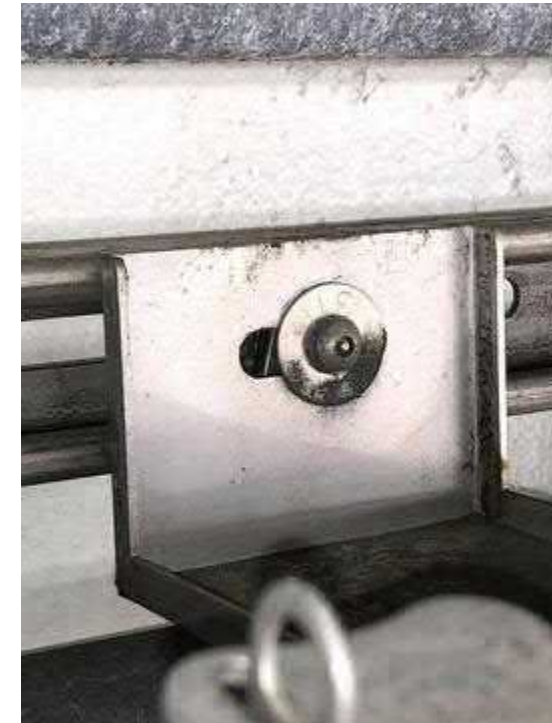
Lighting Fixture Information	
Luminaire Tag or Number:	SB - West Wall - 71A
Tunnel Direction and Side:	SB - West Wall
Additional Information:	T SEL SE LOOSE BOTTOM RIGHT

Are there any signs of corrosion evident on the tunnel lighting system raceways?	Yes
Are the side entry conduits into the fixture tightly secured?	No
Are there any signs of corrosion on the fixture?	No
Is there any damage to the component housing or enclosure?	No
Is the light fixture secure to the mounting channels?	No
Long channel springnut misaligned?	Yes
Long channel springnut cracked?	No
Trans channel springnut misaligned?	Yes
Trans channel springnut cracked?	No
Trans channel wireway clip?	Yes
Housing clip disengaged?	No
Housing clip missing?	No
Lens clip disengaged?	No
Lens clip broken?	No
Lens cover cracked?	No
Wireway ears broken?	No
Luminaire functioning?	Yes

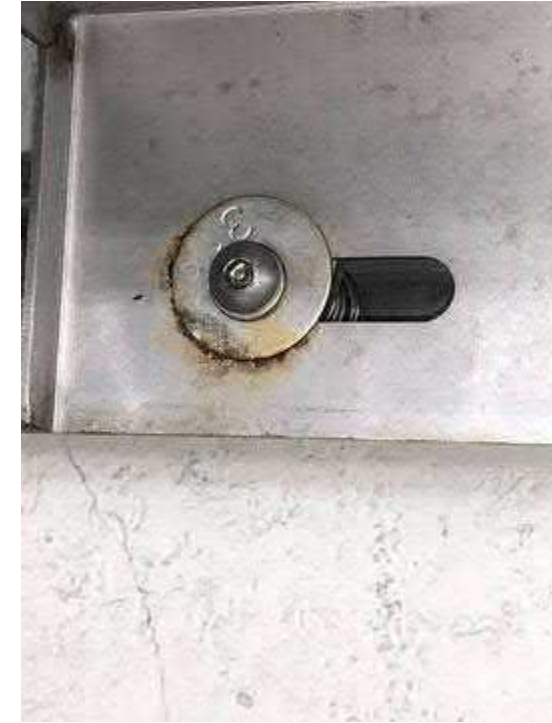
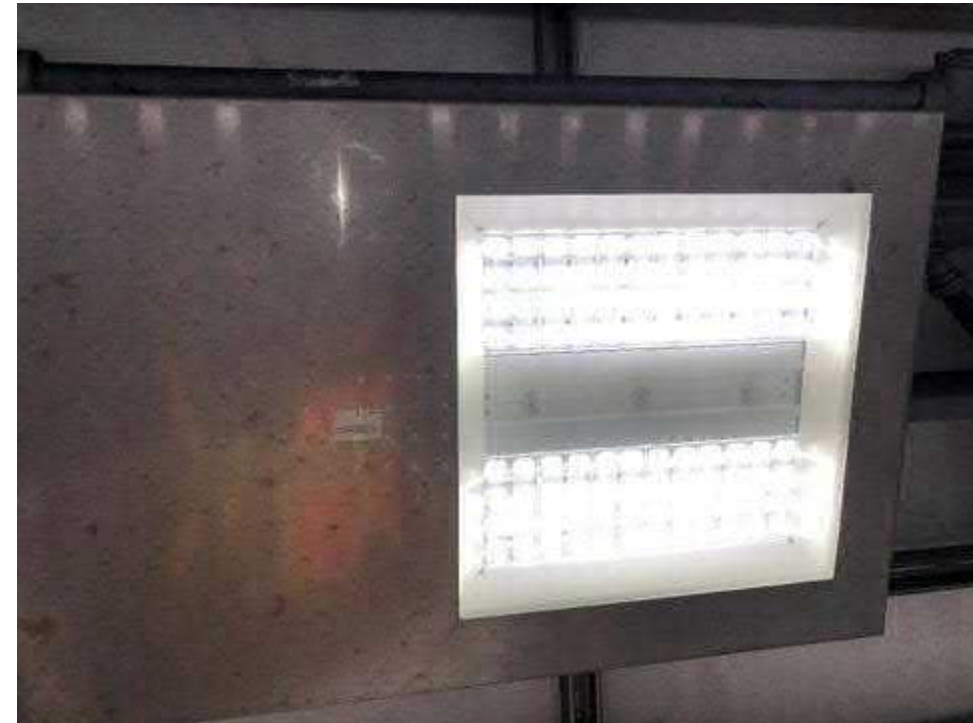
Are there any signs of corrosion evident on the tunnel lighting system raceways?	Yes
Are the side entry conduits into the fixture tightly secured?	Yes
Are there any signs of corrosion on the fixture?	No
Is there any damage to the component housing or enclosure?	No
Is the light fixture secure to the mounting channels?	Yes
Long channel springnut misaligned?	No
Long channel springnut cracked?	No
Trans channel springnut misaligned?	Yes
Trans channel springnut cracked?	No
Trans channel wireway clip?	Yes
Housing clip disengaged?	No
Housing clip missing?	No
Lens clip disengaged?	No
Lens clip broken?	No
Lens cover cracked?	No
Wireway ears broken?	No
Luminaire functioning?	Yes

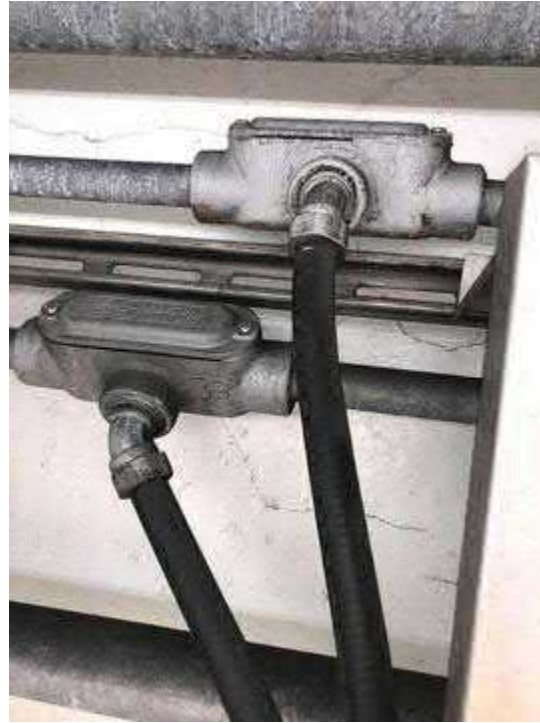
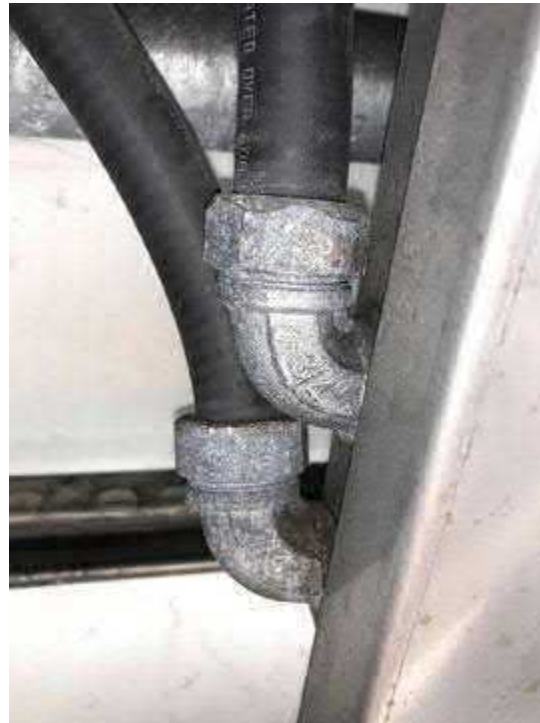
**Tunnel Lighting Section**

Lighting Fixture Information	
Luminaire Tag or Number:	SB - West Wall - 71B
Tunnel Direction and Side:	SB - West Wall
Additional Information:	T SEL BOTTOM LEFT

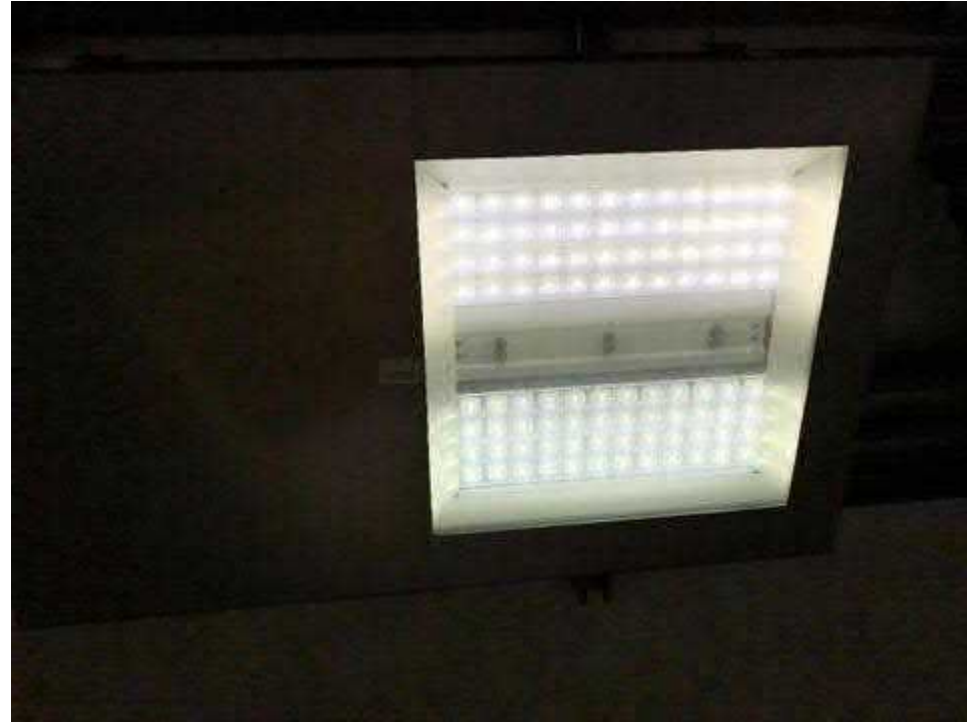
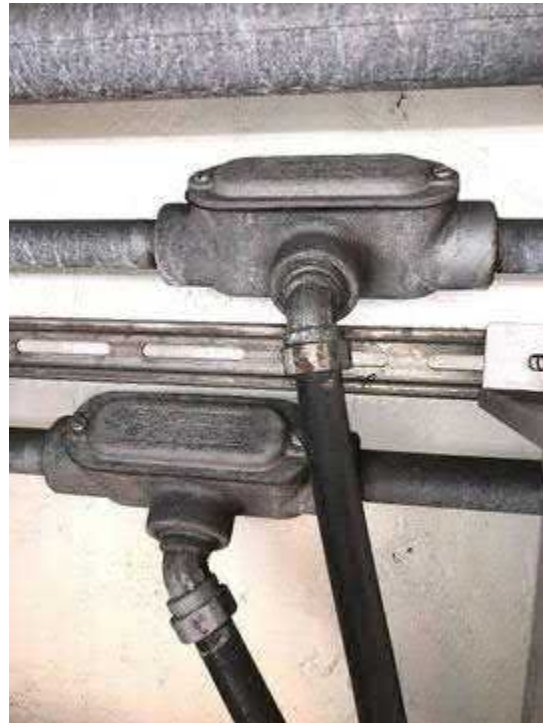
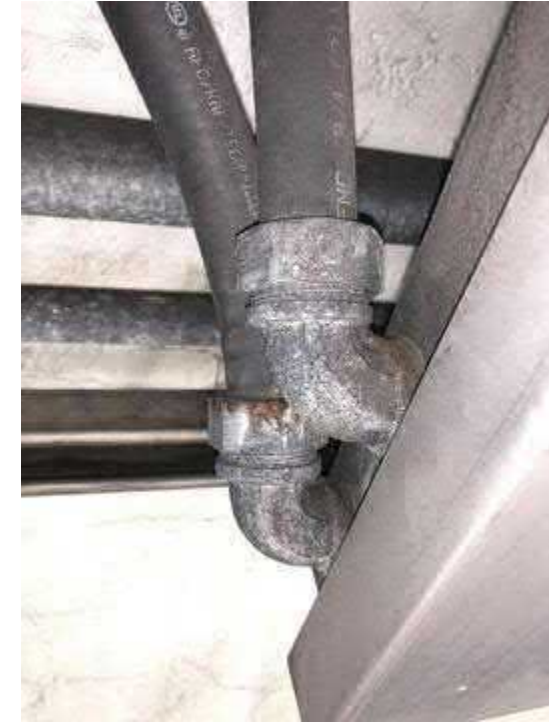
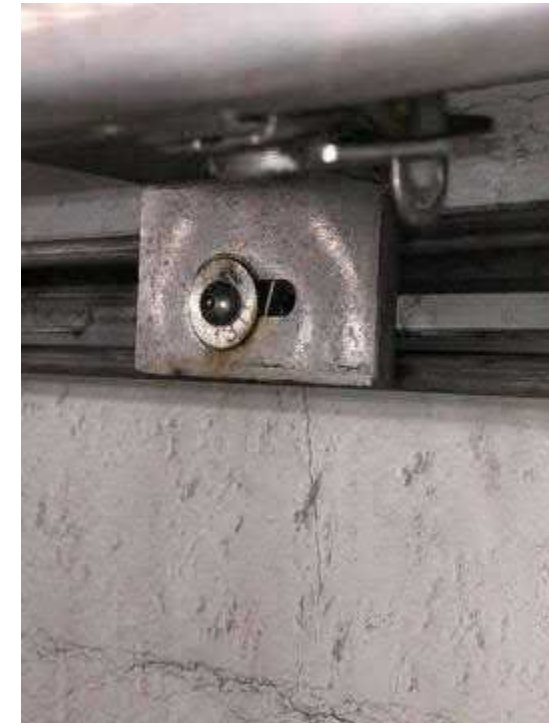
**Tunnel Lighting Section**

Lighting Fixture Information	
Luminaire Tag or Number:	SB - West Wall - 76A
Tunnel Direction and Side:	SB - West Wall
Additional Information:	T SEL SE LOOSE BOTTOM LEFT

Are there any signs of corrosion evident on the tunnel lighting system raceways?	Yes
Are the side entry conduits into the fixture tightly secured?	No
Are there any signs of corrosion on the fixture?	No
Is there any damage to the component housing or enclosure?	No
Is the light fixture secure to the mounting channels?	Yes
Long channel springnut misaligned?	No
Long channel springnut cracked?	No
Trans channel springnut misaligned?	Yes
Trans channel springnut cracked?	No
Trans channel wireway clip?	Yes
Housing clip disengaged?	No
Housing clip missing?	No
Lens clip disengaged?	No
Lens clip broken?	No
Lens cover cracked?	No
Wireway ears broken?	No
Luminaire functioning?	Yes
