# **Lytle Tunnel (HAM-71-0134) Inspection Report Fall 2020**

PID 105470

November, 2020

Ohio Department of  
Transportation  
District 8  
505 South State Route 741  
Lebanon, OH 45036

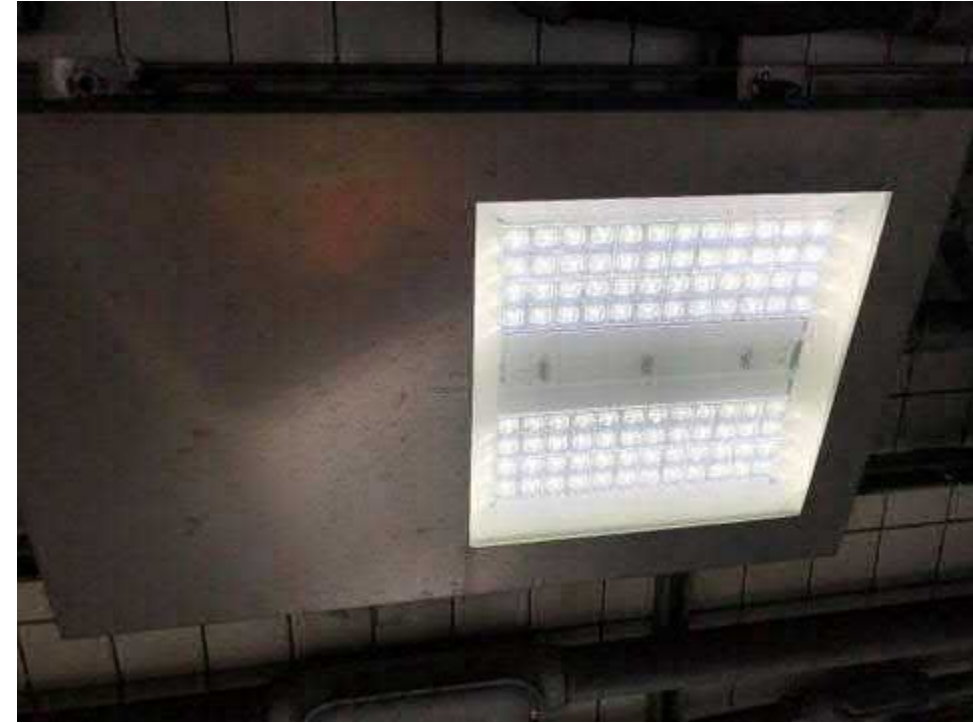
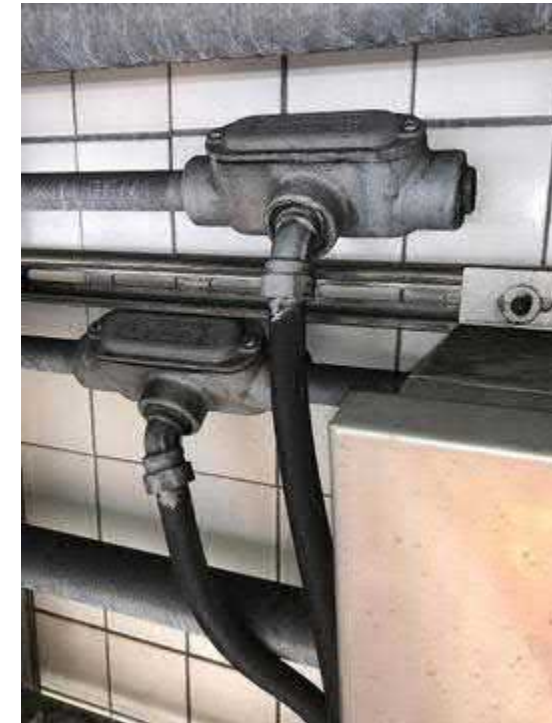
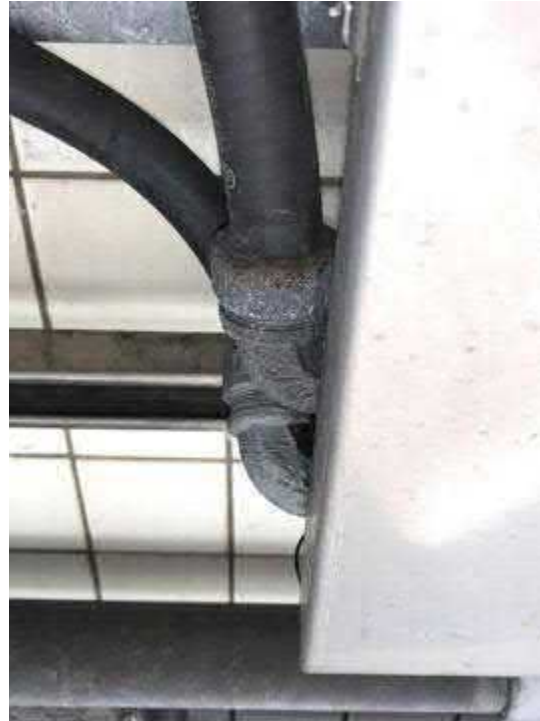
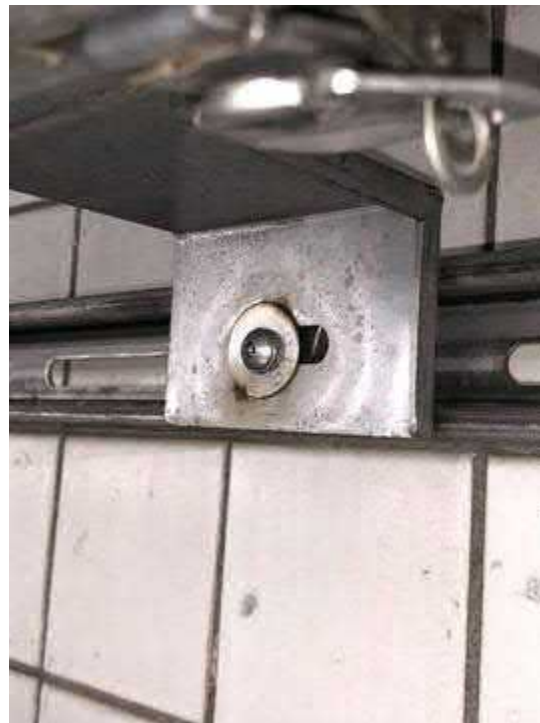
**Tunnel Lighting Section**

Lighting Fixture Information	
Luminaire Tag or Number:	SB - West Wall - 76B
Tunnel Direction and Side:	SB - West Wall
Additional Information:	T SEL SE LOOSE

Are there any signs of corrosion evident on the tunnel lighting system raceways?	Yes
Are the side entry conduits into the fixture tightly secured?	No
Are there any signs of corrosion on the fixture?	No
Is there any damage to the component housing or enclosure?	No
Is the light fixture secure to the mounting channels?	Yes
Long channel springnut misaligned?	No
Long channel springnut cracked?	No
Trans channel springnut misaligned?	No
Trans channel springnut cracked?	No
Trans channel wireway clip?	No
Housing clip disengaged?	No
Housing clip missing?	NA
Lens clip disengaged?	No
Lens clip broken?	No
Lens cover cracked?	No
Wireway ears broken?	No
Luminaire functioning?	Yes

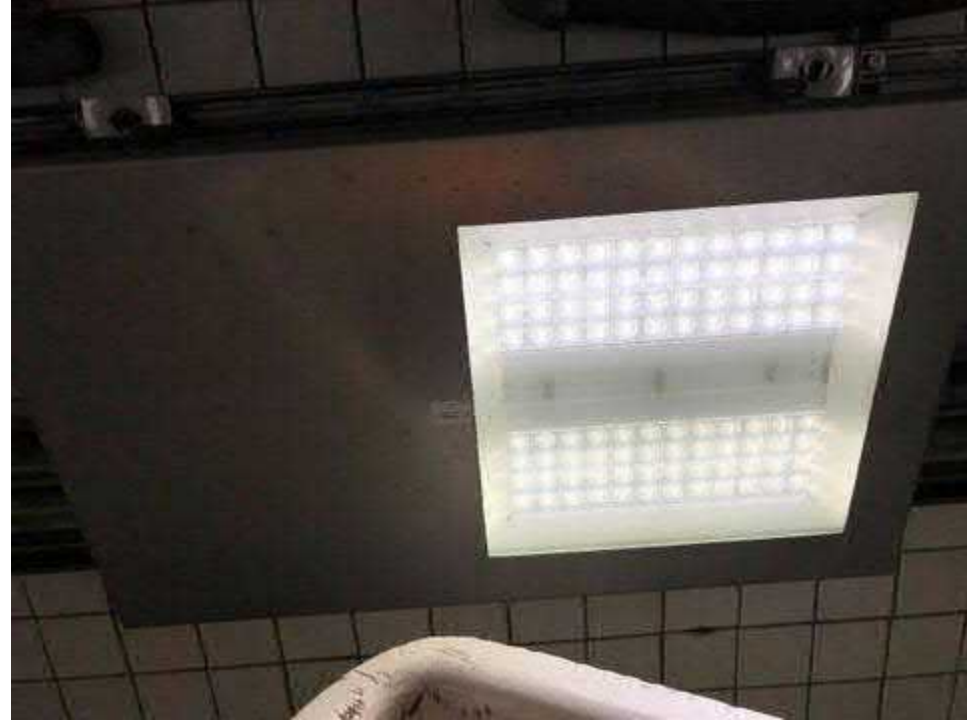
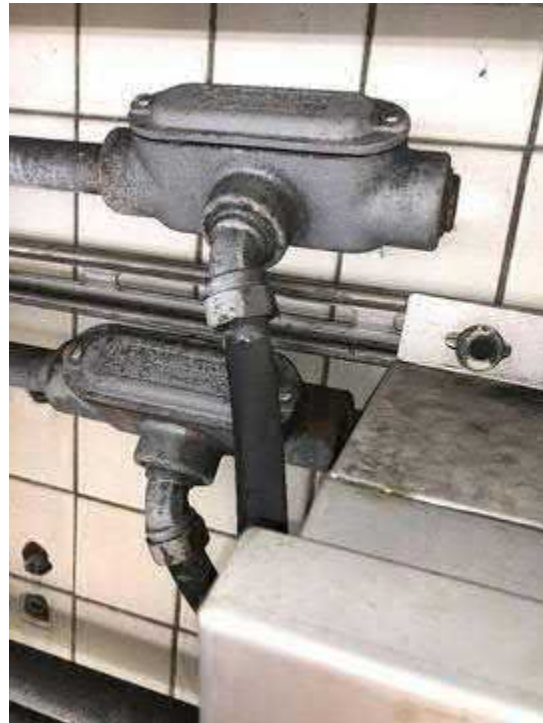
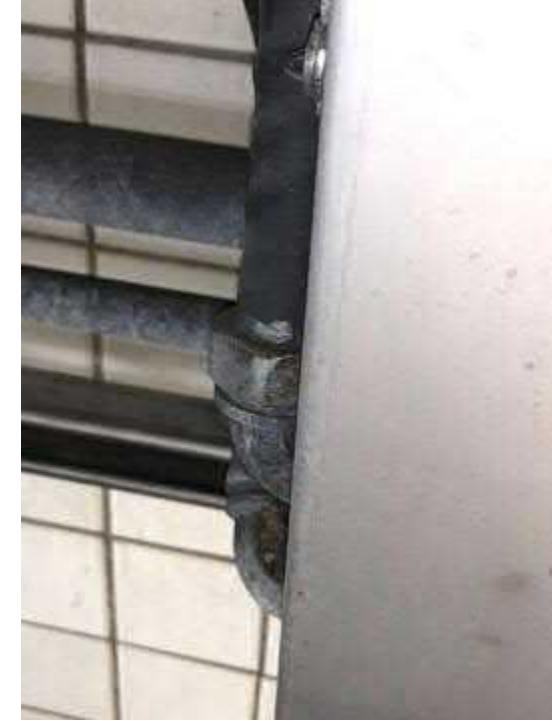
**Tunnel Lighting Section**

Lighting Fixture Information	
Luminaire Tag or Number:	SB - West Wall - 85A
Tunnel Direction and Side:	SB - West Wall
Additional Information:	T SEL SE LOOSE TOP RIGHT BOTH BOTTOM

Are there any signs of corrosion evident on the tunnel lighting system raceways?
Are the side entry conduits into the fixture tightly secured?
Are there any signs of corrosion on the fixture?
Is there any damage to the component housing or enclosure?
Is the light fixture secure to the mounting channels?
Long channel springnut misaligned?
Long channel springnut cracked?
Trans channel springnut misaligned?
Trans channel springnut cracked?
Trans channel wireway clip?
Housing clip disengaged?
Housing clip missing?
Lens clip disengaged?
Lens clip broken?
Lens cover cracked?
Wireway ears broken?
Luminaire functioning?

Yes	No	No	No	No	No	No	Yes	No	Yes	No	No	Yes	No	No	No	Yes
-----	----	----	----	----	----	----	-----	----	-----	----	----	-----	----	----	----	-----

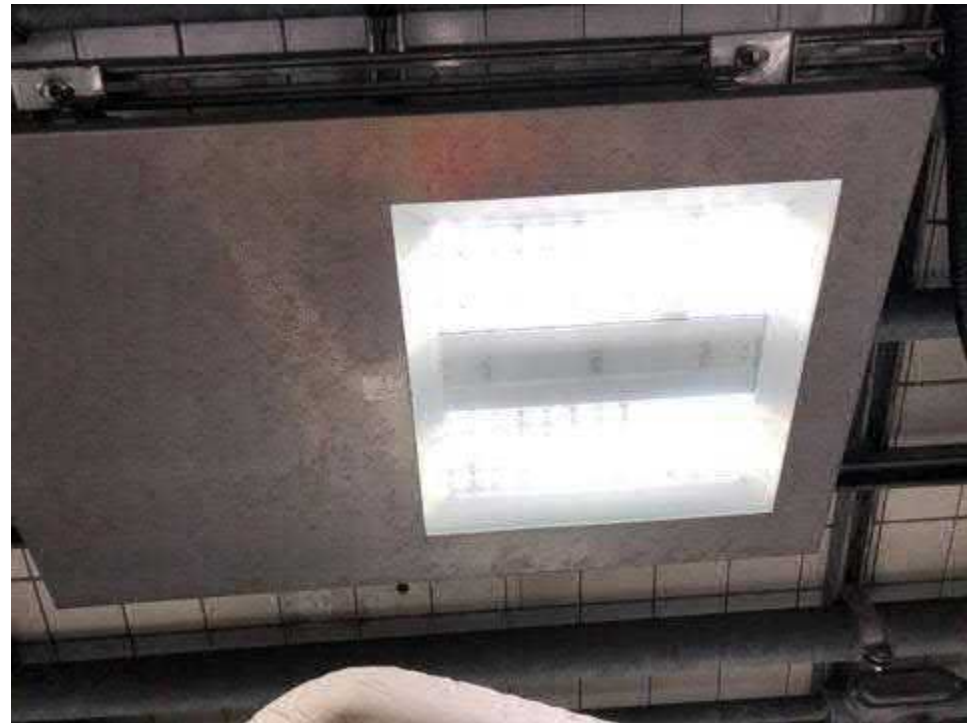
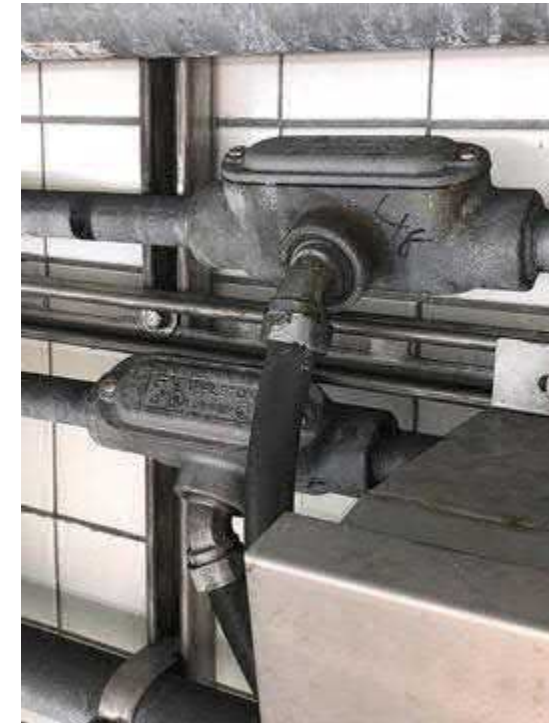
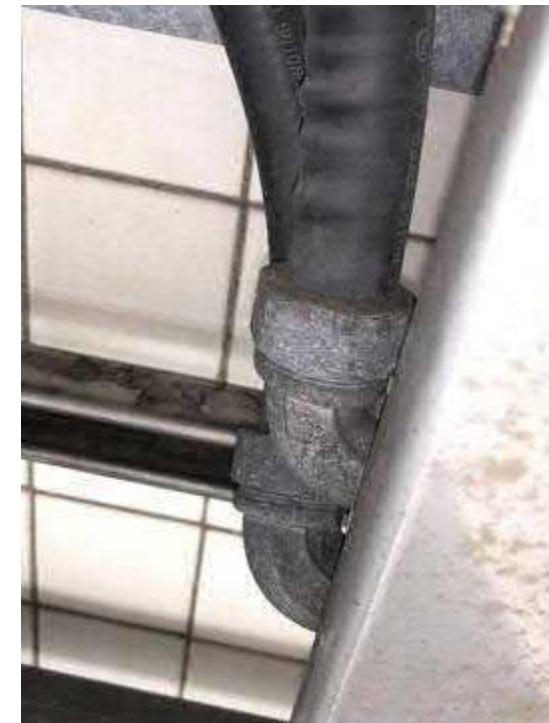
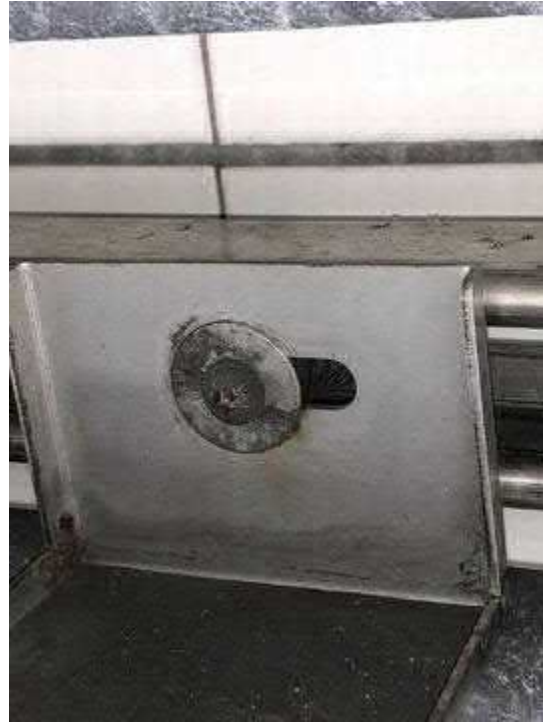
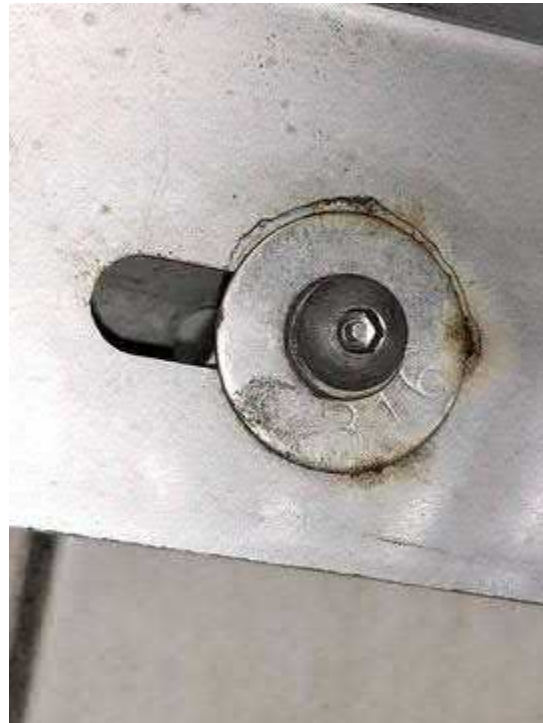
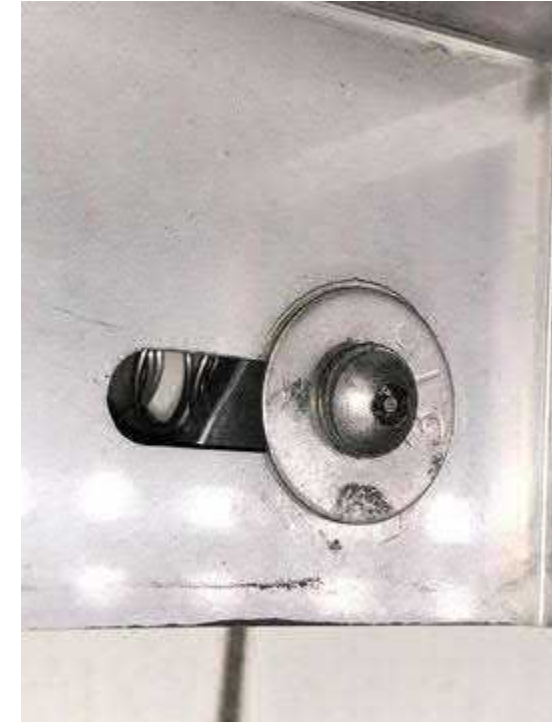
**Tunnel Lighting Section**

Lighting Fixture Information	
Luminaire Tag or Number:	SB - West Wall - 85B
Tunnel Direction and Side:	SB - West Wall
Additional Information:	T SEL SE LOOSE BOTTOM RIGHT

Are there any signs of corrosion evident on the tunnel lighting system raceways?
Are the side entry conduits into the fixture tightly secured?
Are there any signs of corrosion on the fixture?
Is there any damage to the component housing or enclosure?
Is the light fixture secure to the mounting channels?
Long channel springnut misaligned?
Long channel springnut cracked?
Trans channel springnut misaligned?
Trans channel springnut cracked?
Trans channel wireway clip?
Housing clip disengaged?
Housing clip missing?
Lens clip disengaged?
Lens clip broken?
Lens cover cracked?
Wireway ears broken?
Luminaire functioning?

Yes	No	No	No	No	No	No	Yes	No	Yes	No	No	Yes	No	No	Yes	Yes
-----	----	----	----	----	----	----	-----	----	-----	----	----	-----	----	----	-----	-----

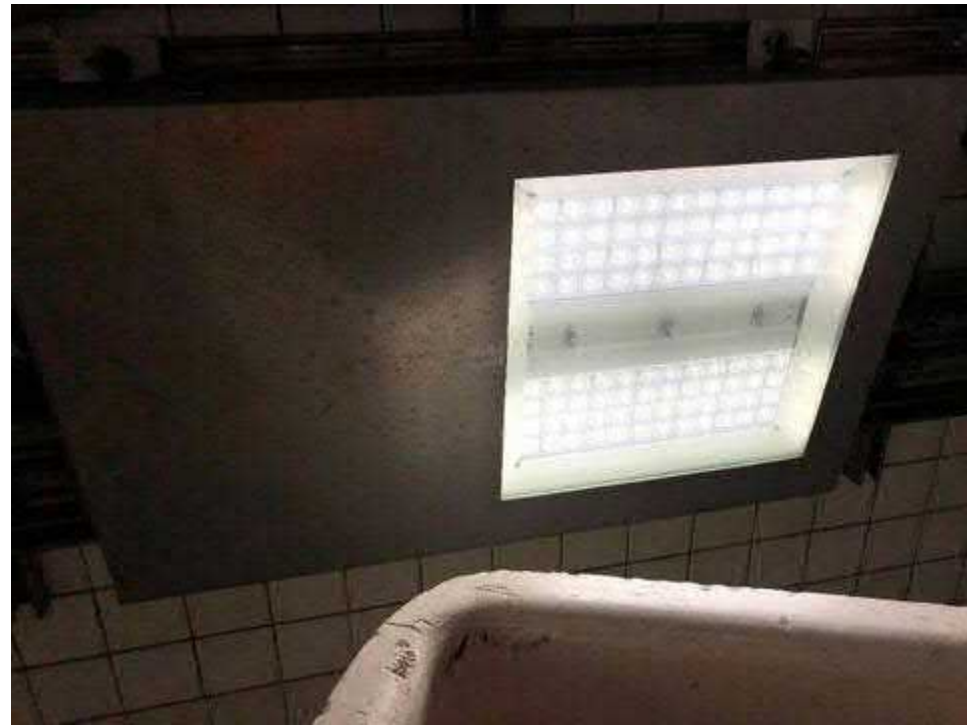
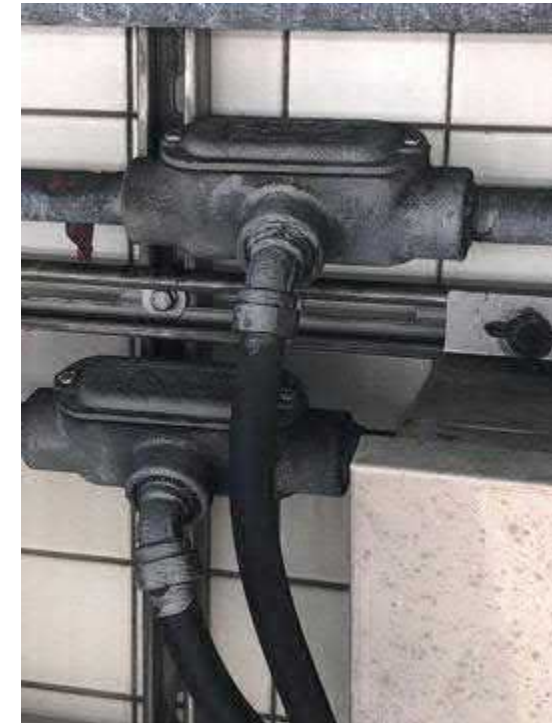
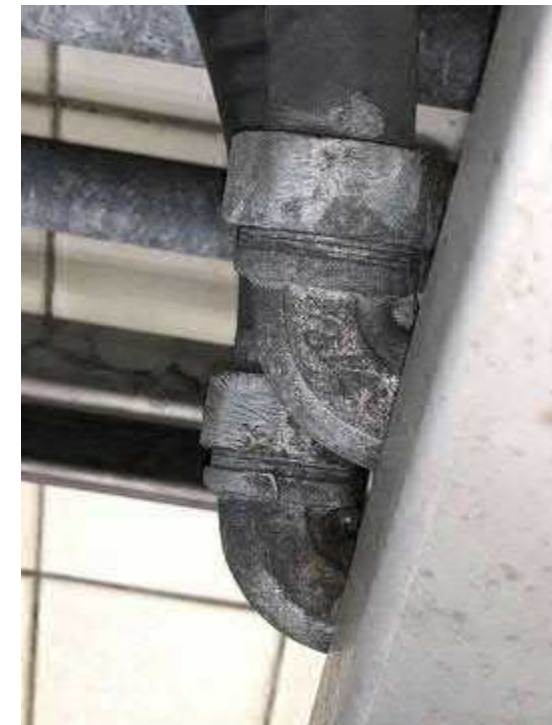
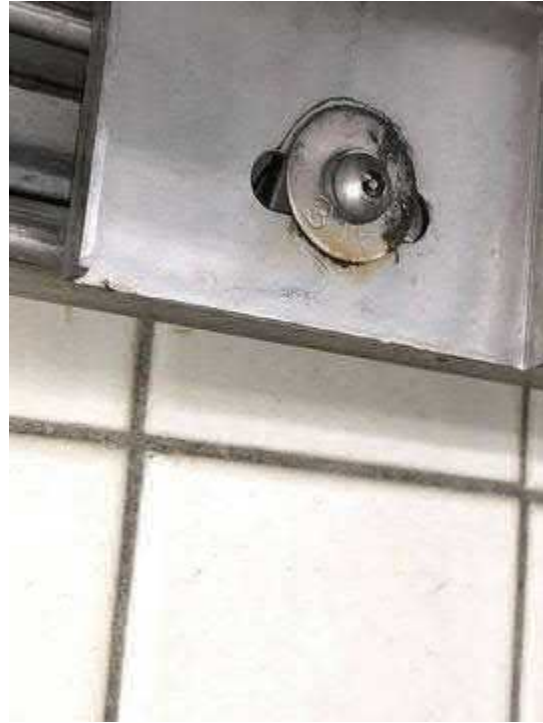
**Tunnel Lighting Section**

Lighting Fixture Information	
Luminaire Tag or Number:	SB - West Wall - 94A
Tunnel Direction and Side:	SB - West Wall
Additional Information:	T SEL SE LOOSE BOTTOM LEFT

Are there any signs of corrosion evident on the tunnel lighting system raceways?
Are the side entry conduits into the fixture tightly secured?
Are there any signs of corrosion on the fixture?
Is there any damage to the component housing or enclosure?
Is the light fixture secure to the mounting channels?
Long channel springnut misaligned?
Long channel springnut cracked?
Trans channel springnut cracked?
Trans channel springnut misaligned?
Trans channel springnut cracked?
Trans channel wireway clip?
Housing clip disengaged?
Housing clip missing?
Lens clip disengaged?
Lens clip broken?
Lens cover cracked?
Wireway ears broken?
Luminaire functioning?

Yes	No	No	No	No	No	No	Yes	No	No	No	No	Yes	No	No	No	Yes
-----	----	----	----	----	----	----	-----	----	----	----	----	-----	----	----	----	-----

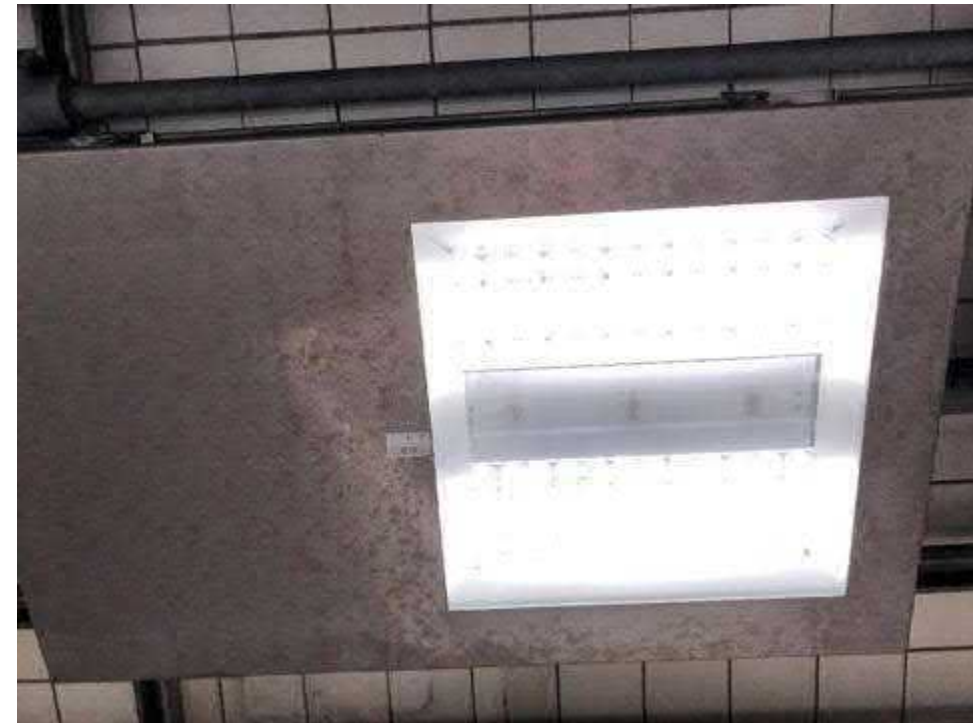
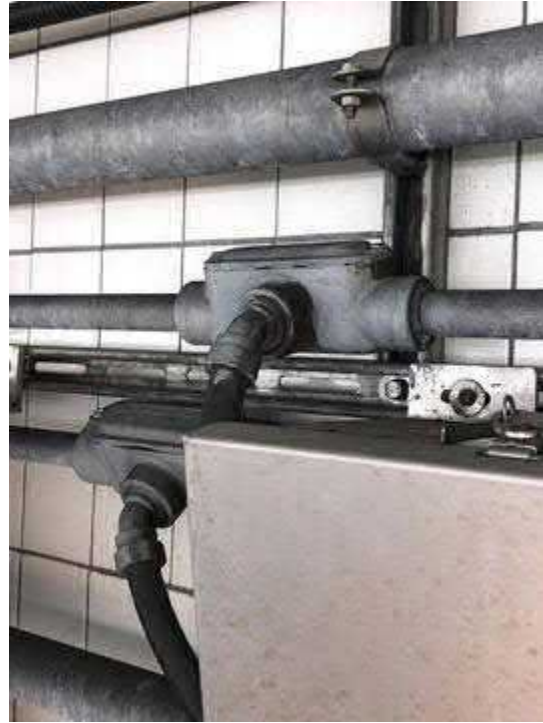
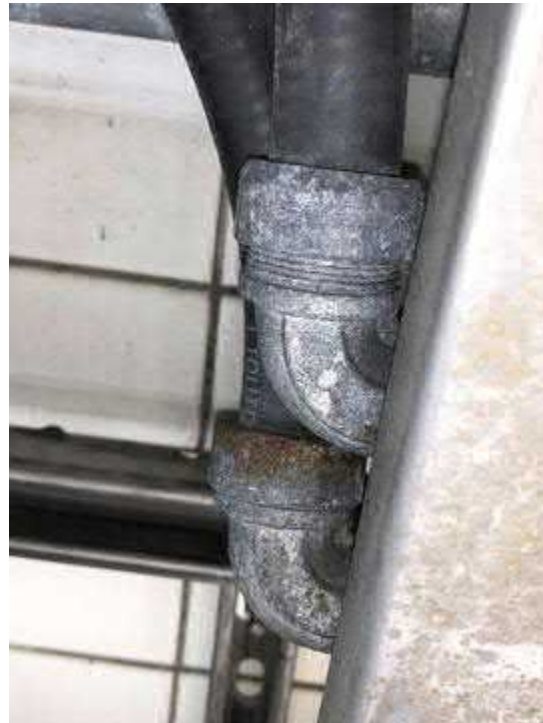
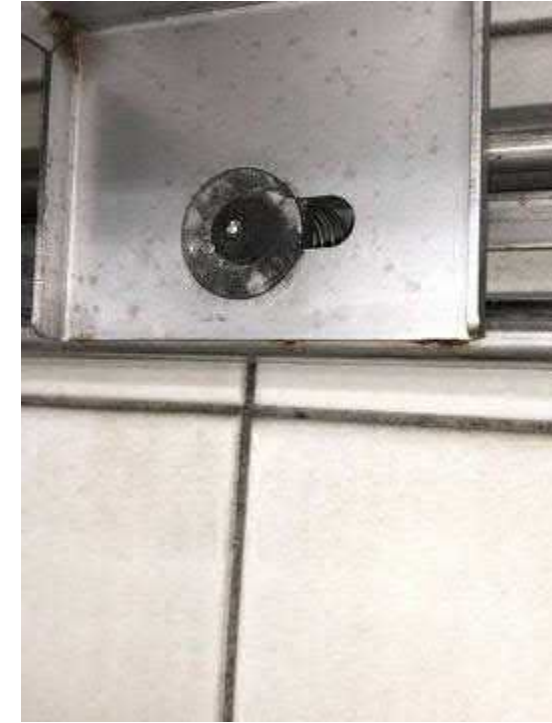
**Tunnel Lighting Section**

Lighting Fixture Information	
<b>Luminaire Tag or Number:</b>	SB - West Wall - 94B
<b>Tunnel Direction and Side:</b>	SB - West Wall
<b>Additional Information:</b>	T SEL TOP RIGHT BOTTOM RIGHT

Are there any signs of corrosion evident on the tunnel lighting system raceways?
Are the side entry conduits into the fixture tightly secured?
Are there any signs of corrosion on the fixture?
Is there any damage to the component housing or enclosure?
Is the light fixture secure to the mounting channels?
Long channel springnut misaligned?
Long channel springnut cracked?
Trans channel springnut misaligned?
Trans channel springnut cracked?
Trans channel wireway clip?
Housing clip disengaged?
Housing clip missing?
Lens clip disengaged?
Lens clip broken?
Lens cover cracked?
Wireway ears broken?
Luminaire functioning?

Yes	No	No	No	No	No	No	Yes	No	Yes	No	No	Yes	No	No	Yes	Yes
-----	----	----	----	----	----	----	-----	----	-----	----	----	-----	----	----	-----	-----

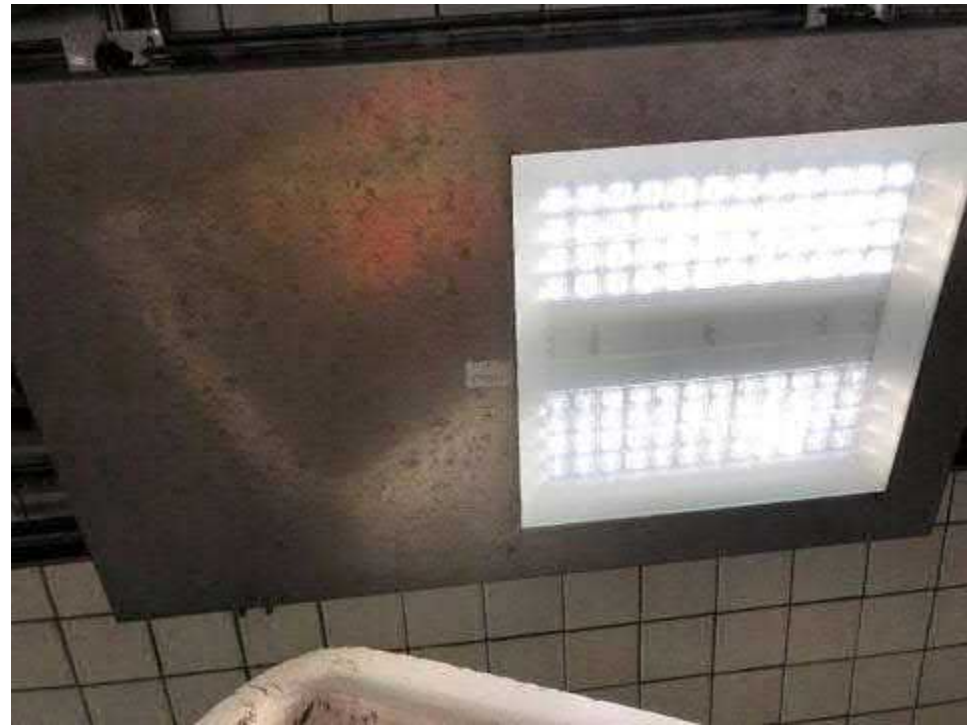
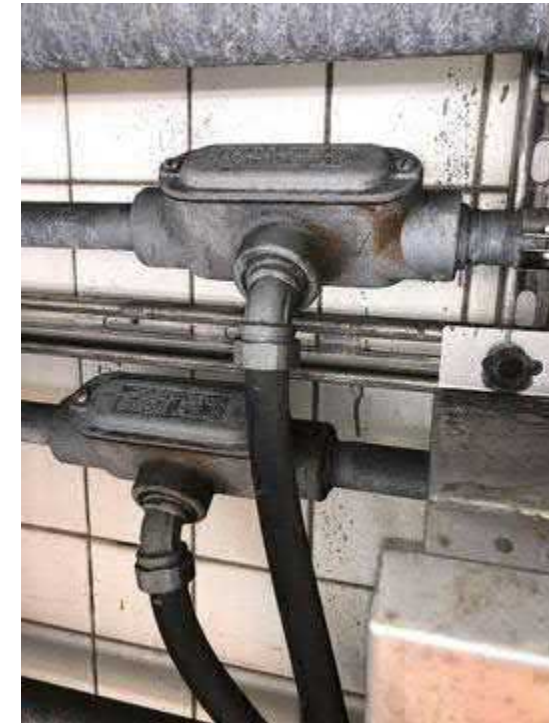
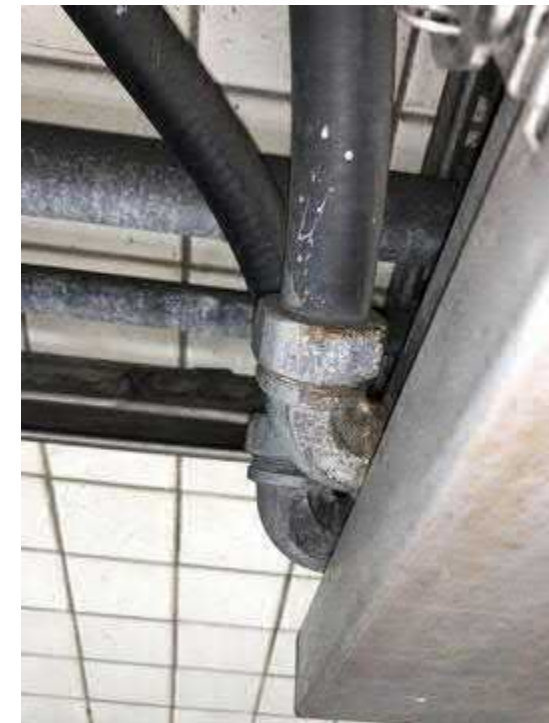
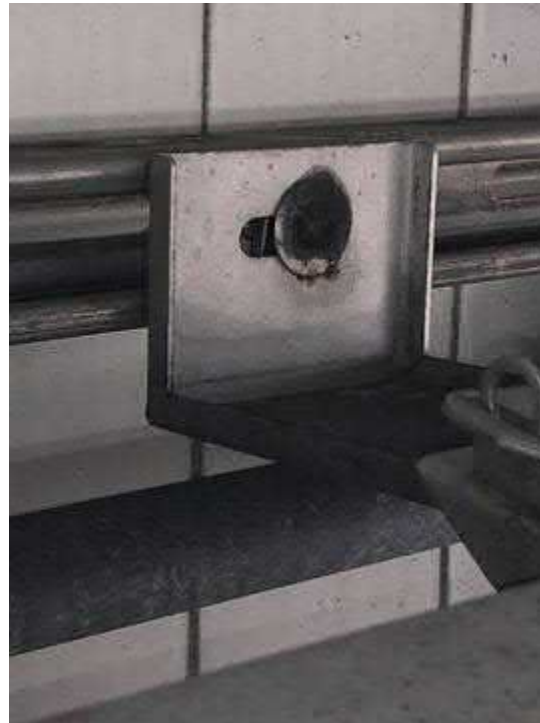
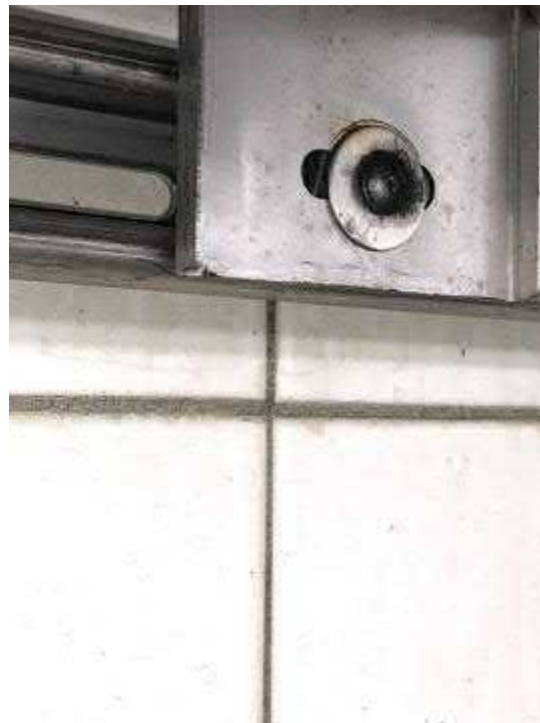
**Tunnel Lighting Section**

Lighting Fixture Information	
Luminaire Tag or Number:	SB - West Wall - 103A
Tunnel Direction and Side:	SB - West Wall
Additional Information:	T TOP RIGHT BOTTOM RIGHT

Are there any signs of corrosion evident on the tunnel lighting system raceways?	No
Are the side entry conduits into the fixture tightly secured?	Yes
Are there any signs of corrosion on the fixture?	No
Is there any damage to the component housing or enclosure?	No
Is the light fixture secure to the mounting channels?	No
Long channel springnut misaligned?	No
Long channel springnut cracked?	No
Trans channel springnut misaligned?	Yes
Trans channel springnut cracked?	No
Trans channel wireway clip?	Yes
Housing clip disengaged?	
Housing clip missing?	No
Lens clip disengaged?	No
Lens clip broken?	No
Lens cover cracked?	No
Wireway ears broken?	No
Luminaire functioning?	Yes

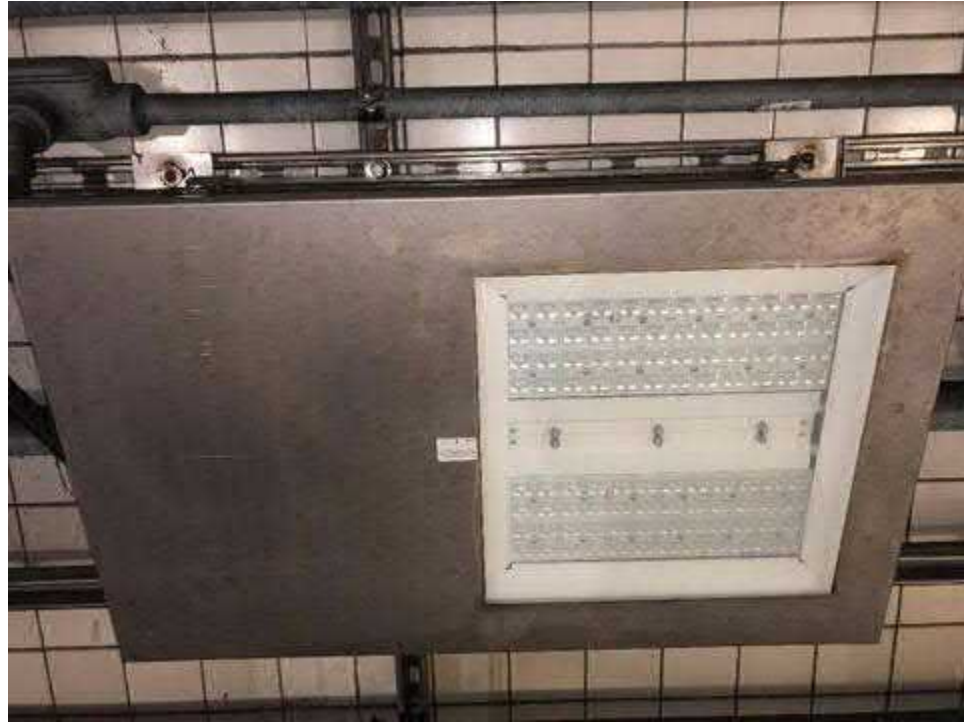
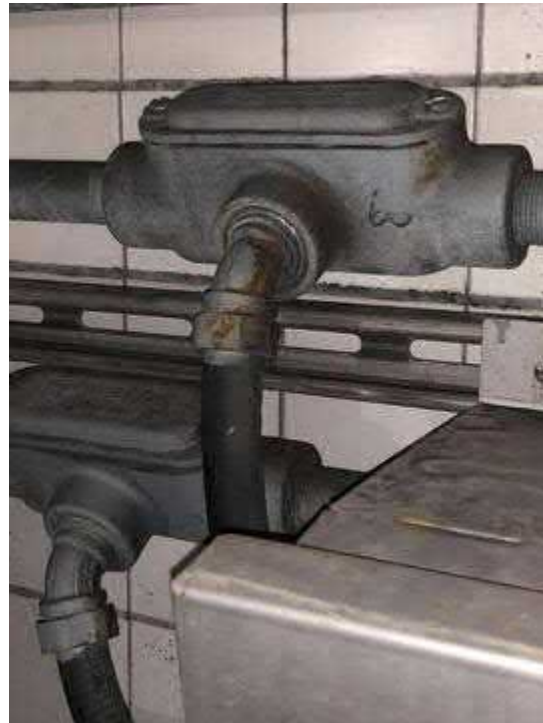
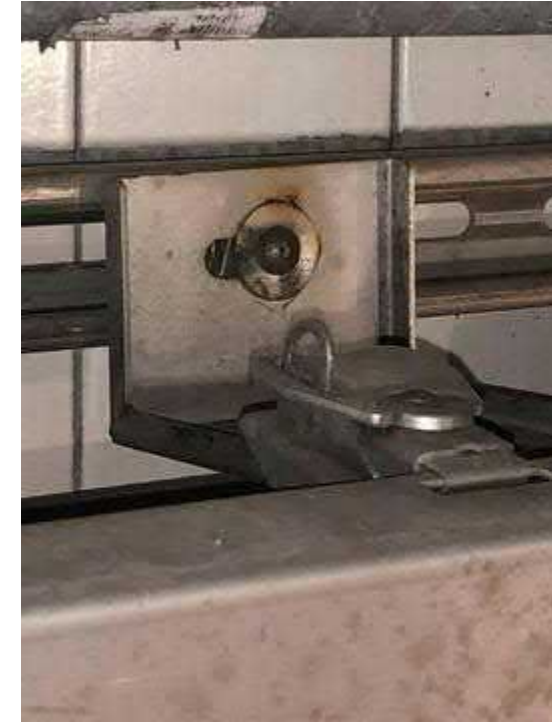
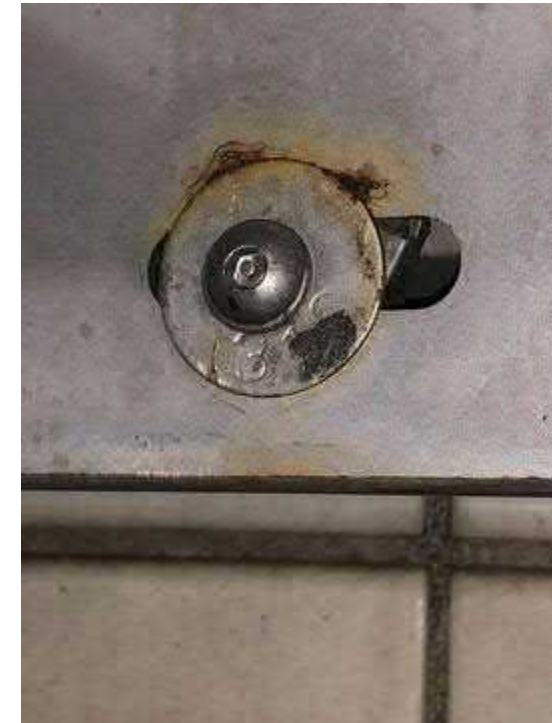
**Tunnel Lighting Section**

Lighting Fixture Information	
Luminaire Tag or Number:	SB - West Wall - 103B
Tunnel Direction and Side:	SB - West Wall
Additional Information:	T SEL BOTTOM LEFT

Are there any signs of corrosion evident on the tunnel lighting system raceways?	Yes
Are the side entry conduits into the fixture tightly secured?	Yes
Are there any signs of corrosion on the fixture?	No
Is there any damage to the component housing or enclosure?	No
Is the light fixture secure to the mounting channels?	Yes
Long channel springnut misaligned?	No
Long channel springnut cracked?	No
Trans channel springnut misaligned?	Yes
Trans channel springnut cracked?	No
Trans channel wireway clip?	Yes
Housing clip disengaged?	No
Housing clip missing?	No
Lens clip disengaged?	No
Lens clip broken?	No
Lens cover cracked?	No
Wireway ears broken?	No
Luminaire functioning?	Yes

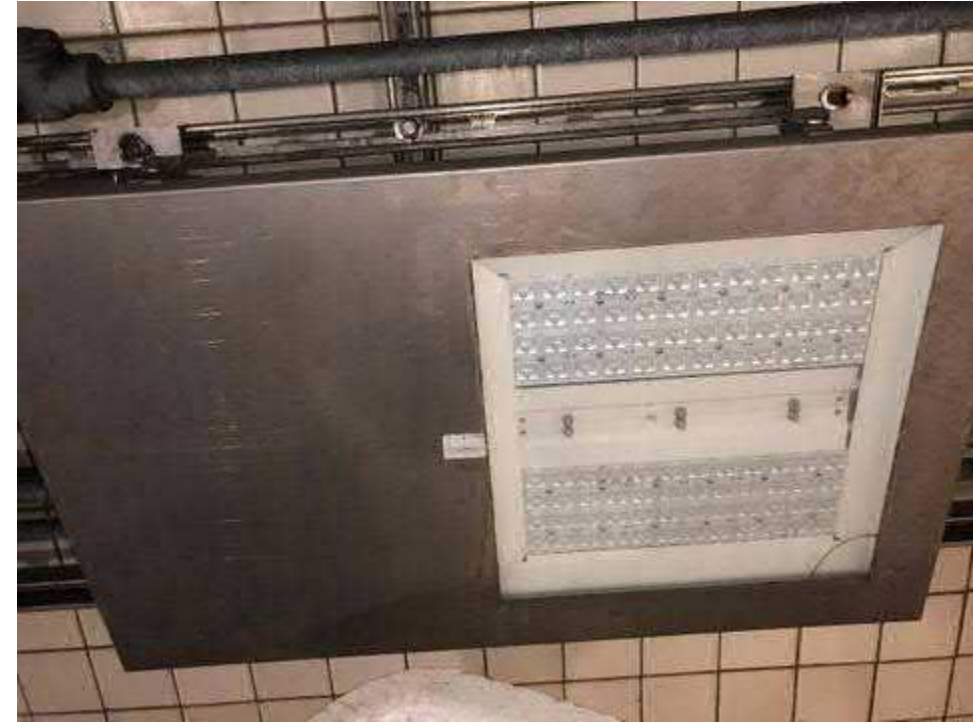
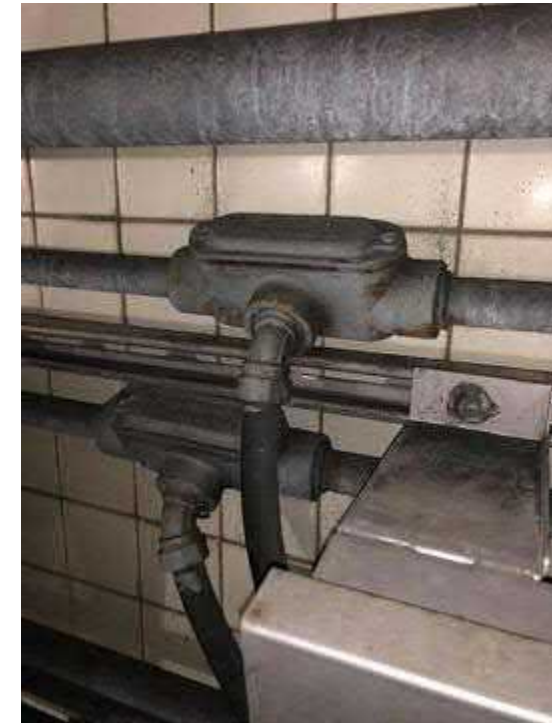
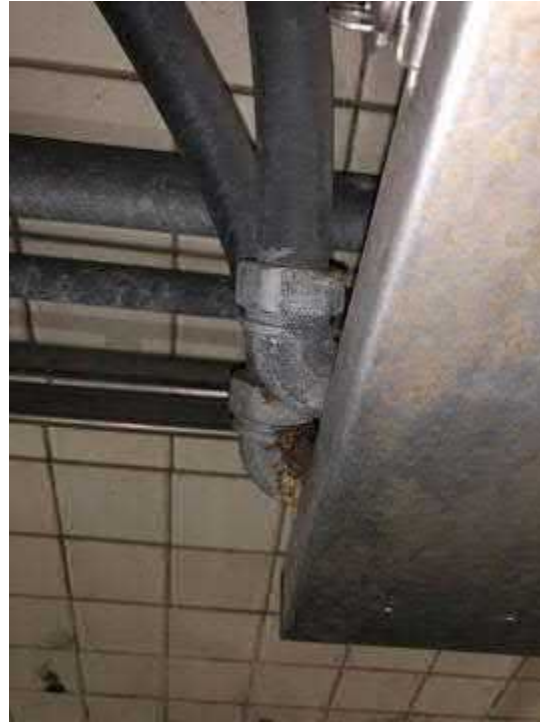
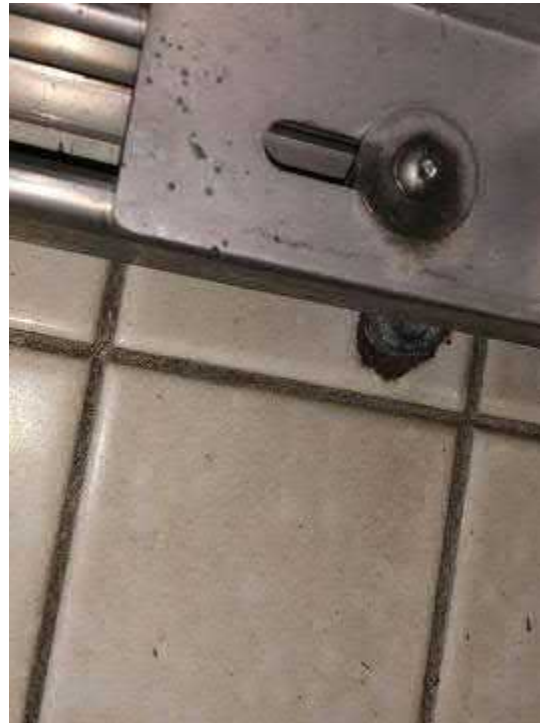
**Tunnel Lighting Section**

Lighting Fixture Information	
Luminaire Tag or Number:	SB - West Wall - 112A
Tunnel Direction and Side:	SB - West Wall
Additional Information:	T

Are there any signs of corrosion evident on the tunnel lighting system raceways?	Yes
Are the side entry conduits into the fixture tightly secured?	Yes
Are there any signs of corrosion on the fixture?	No
Is there any damage to the component housing or enclosure?	Yes
Is the light fixture secure to the mounting channels?	Yes
Long channel springnut misaligned?	No
Long channel springnut cracked?	No
Trans channel springnut misaligned?	No
Trans channel springnut cracked?	No
Trans channel wireway clip?	Yes
Housing clip disengaged?	No
Housing clip missing?	No
Lens clip disengaged?	No
Lens clip broken?	No
Lens cover cracked?	No
Wireway ears broken?	No
Luminaire functioning?	Yes

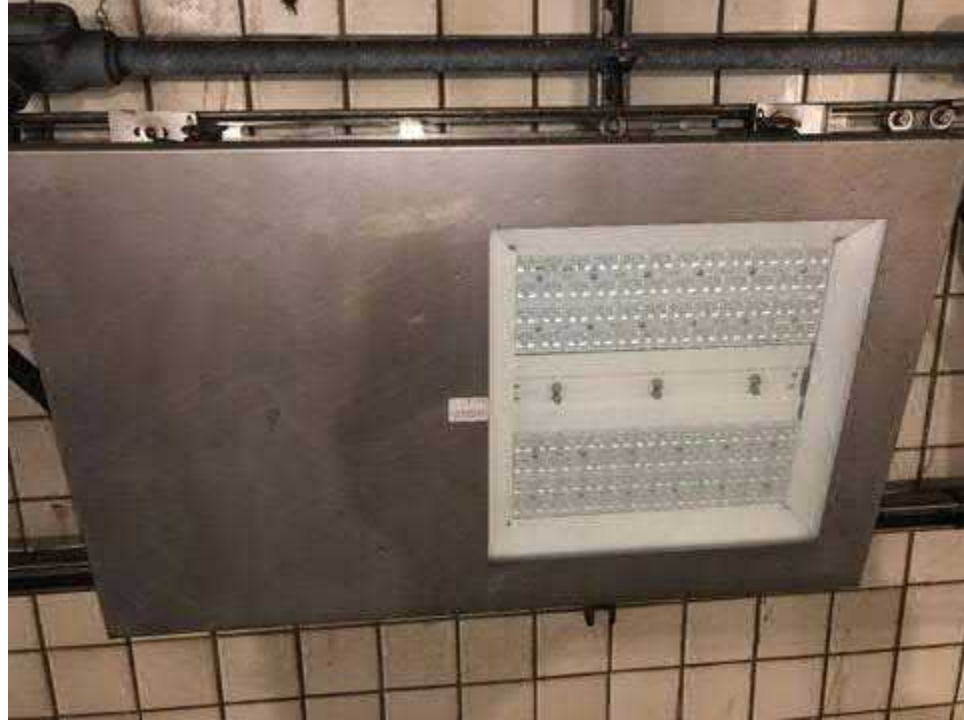
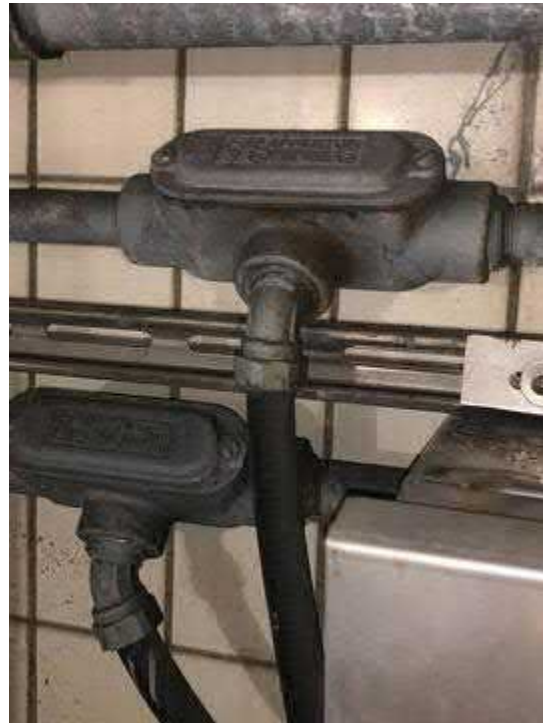
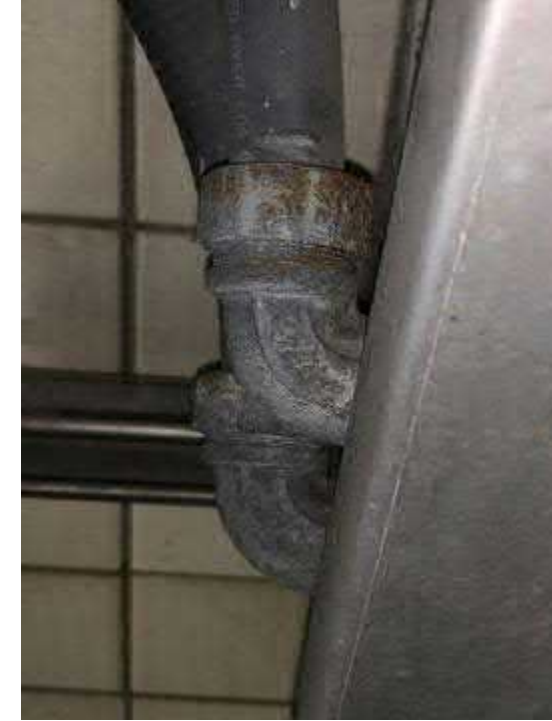
Lighting Fixture Information	
Luminaire Tag or Number:	SB - West Wall - 112B
Tunnel Direction and Side:	SB - West Wall
Additional Information:	T SEL

Are there any signs of corrosion evident on the tunnel lighting system raceways?	Yes
Are the side entry conduits into the fixture tightly secured?	Yes
Are there any signs of corrosion on the fixture?	No
Is there any damage to the component housing or enclosure?	No
Is the light fixture secure to the mounting channels?	Yes
Long channel springnut misaligned?	No
Long channel springnut cracked?	No
Trans channel springnut misaligned?	No
Trans channel springnut cracked?	No
Trans channel wireway clip?	Yes
Housing clip disengaged?	No
Housing clip missing?	No
Lens clip disengaged?	No
Lens clip broken?	No
Lens cover cracked?	No
Wireway ears broken?	No
Luminaire functioning?	Yes

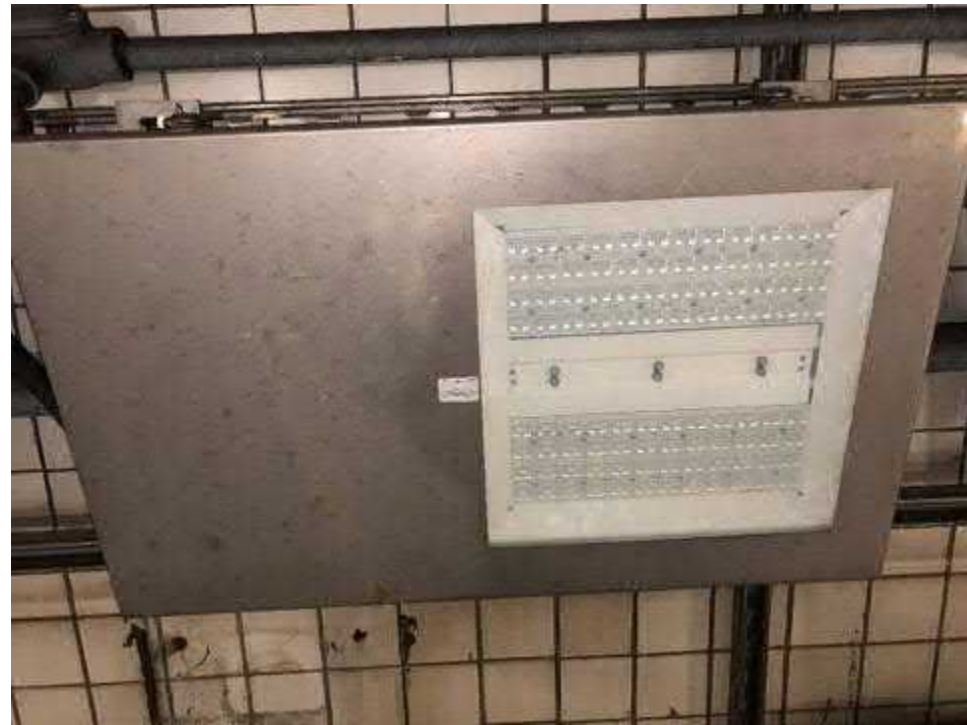
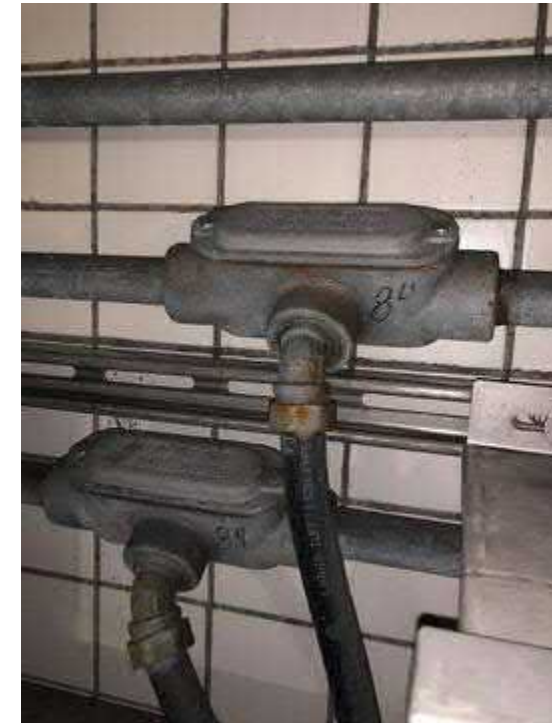
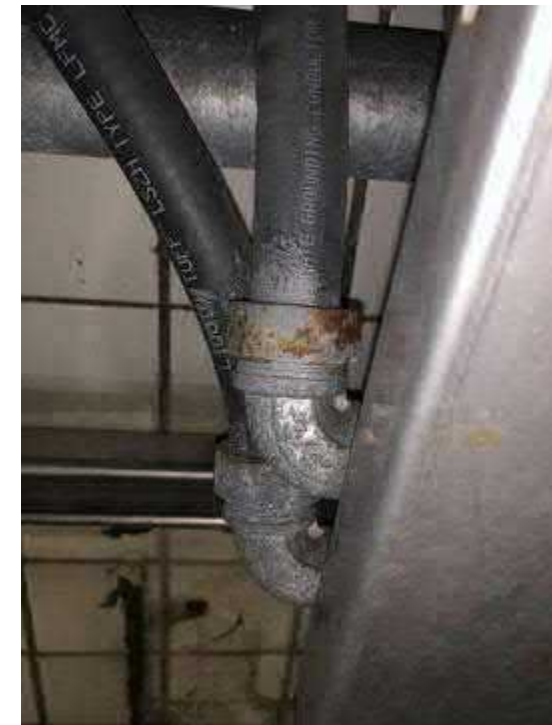
Lighting Fixture Information	
Luminaire Tag or Number:	SB - West Wall - 121A
Tunnel Direction and Side:	SB - West Wall
Additional Information:	T SEL

Are there any signs of corrosion evident on the tunnel lighting system raceways?
Are the side entry conduits into the fixture tightly secured?
Are there any signs of corrosion on the fixture?
Is there any damage to the component housing or enclosure?
Is the light fixture secure to the mounting channels?
Long channel springnut misaligned?
Long channel springnut cracked?
Trans channel springnut misaligned?
Trans channel springnut cracked?
Trans channel wireway clip?
Housing clip disengaged?
Housing clip missing?
Lens clip disengaged?
Lens clip broken?
Lens cover cracked?
Wireway ears broken?
Luminaire functioning?

Yes	No	No	No	No	No	No	Yes	No	No	No	No	Yes	No	No	Yes	Yes
-----	----	----	----	----	----	----	-----	----	----	----	----	-----	----	----	-----	-----
