# **Lytle Tunnel (HAM-71-0134) Inspection Report Fall 2020**

PID 105470

November, 2020

Ohio Department of  
Transportation  
District 8  
505 South State Route 741  
Lebanon, OH 45036

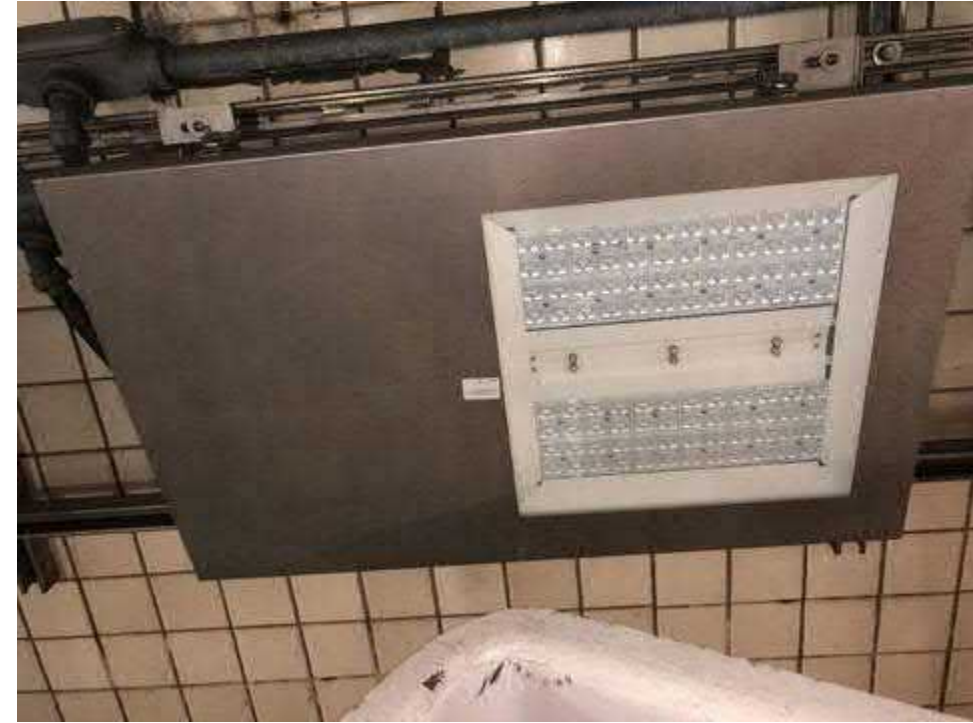
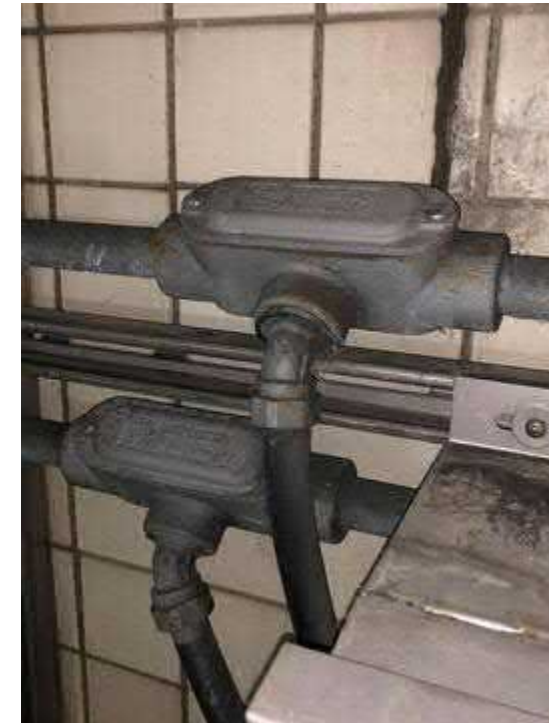
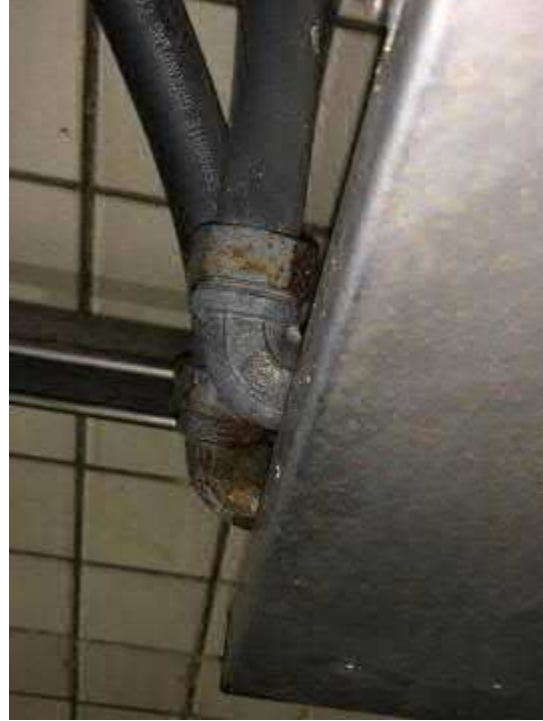
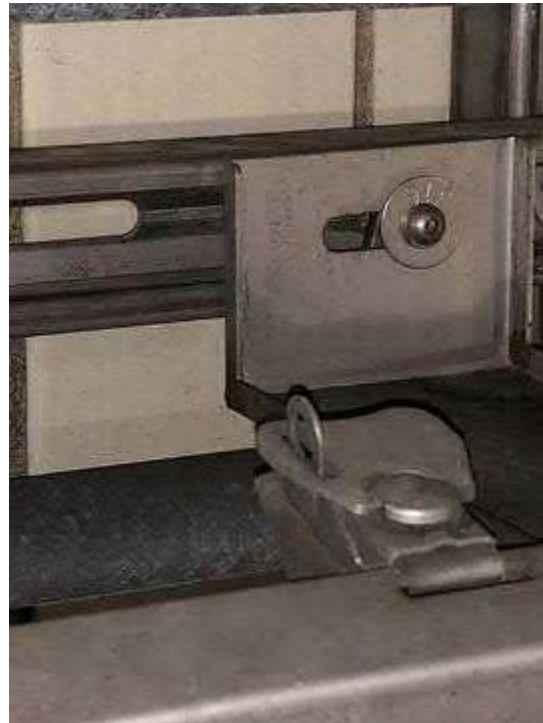
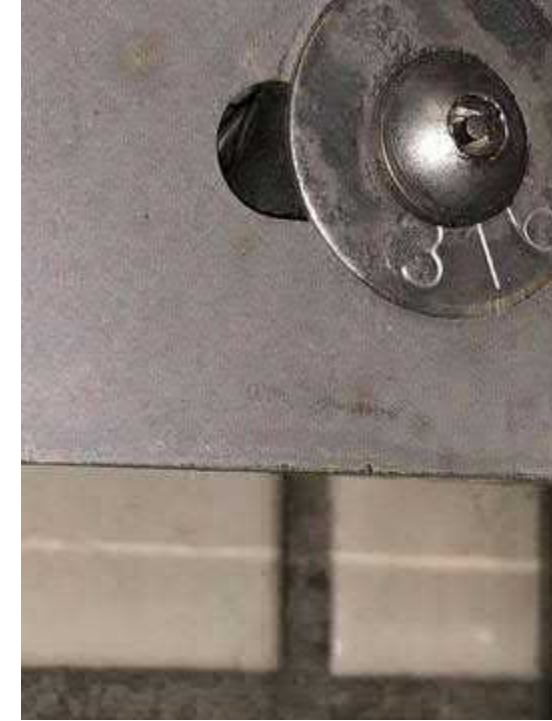
Lighting Fixture Information	
Luminaire Tag or Number:	SB - West Wall - 121B
Tunnel Direction and Side:	SB - West Wall
Additional Information:	T SEL TOP RIGHT BOTTOM RIGHT

Are there any signs of corrosion evident on the tunnel lighting system raceways?	Yes
Are the side entry conduits into the fixture tightly secured?	Yes
Are there any signs of corrosion on the fixture?	No
Is there any damage to the component housing or enclosure?	No
Is the light fixture secure to the mounting channels?	Yes
Long channel springnut misaligned?	No
Long channel springnut cracked?	No
Trans channel springnut misaligned?	Yes
Trans channel springnut cracked?	No
Trans channel wireway clip?	Yes
Housing clip disengaged?	No
Housing clip missing?	No
Lens clip disengaged?	No
Lens clip broken?	No
Lens cover cracked?	No
Wireway ears broken?	No
Luminaire functioning?	Yes

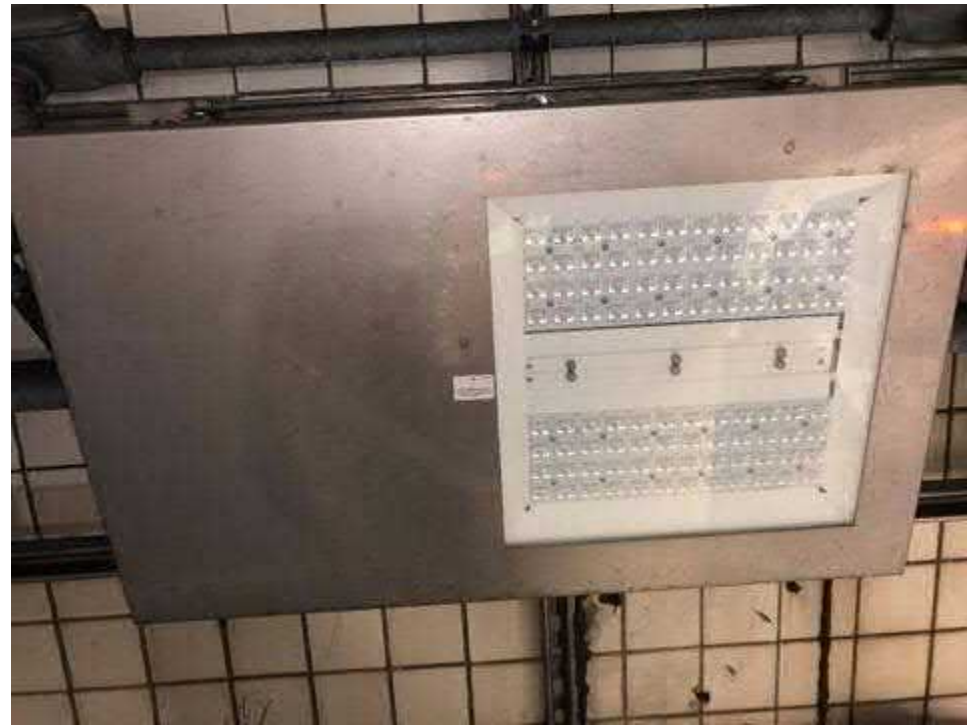
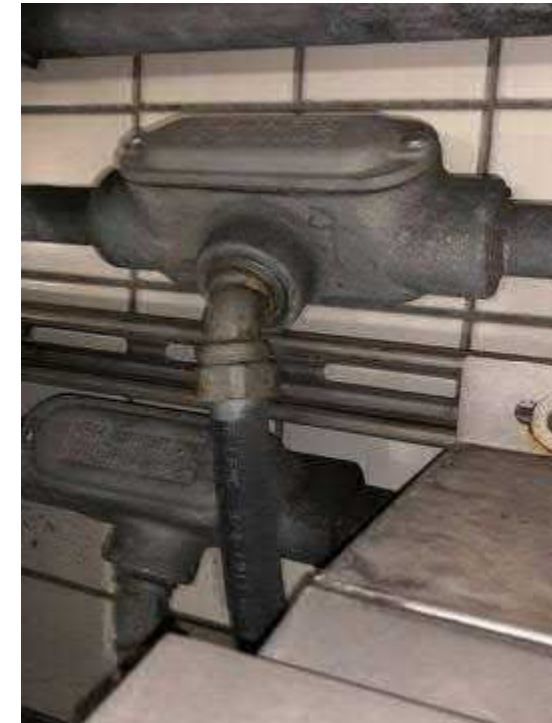
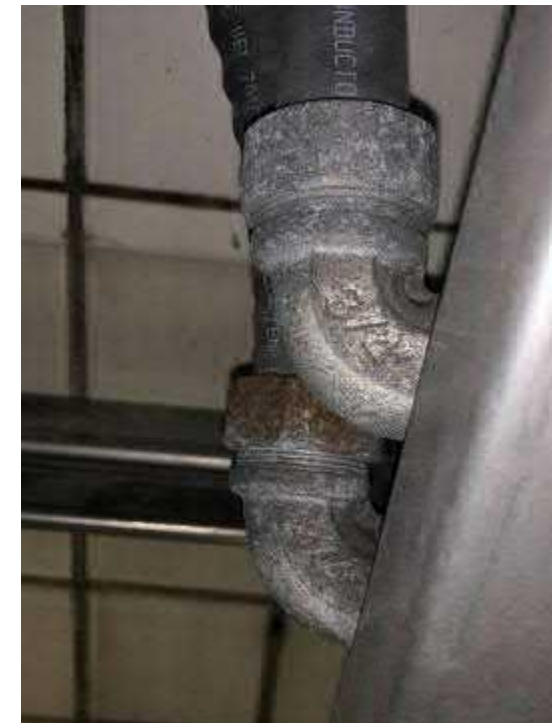
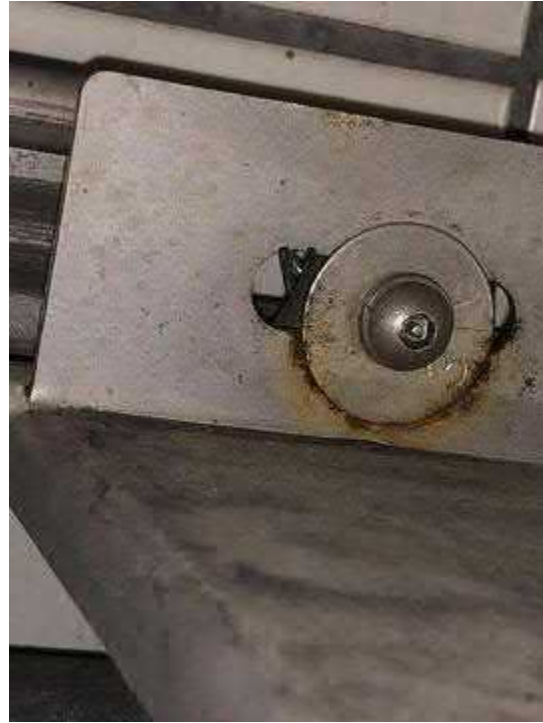
Lighting Fixture Information	
Luminaire Tag or Number:	SB - West Wall - 130A
Tunnel Direction and Side:	
Additional Information:	T SEL TOP LEFT

Are there any signs of corrosion evident on the tunnel lighting system raceways?
Are the side entry conduits into the fixture tightly secured?
Are there any signs of corrosion on the fixture?
Is there any damage to the component housing or enclosure?
Is the light fixture secure to the mounting channels?
Long channel springnut misaligned?
Long channel springnut cracked?
Trans channel springnut misaligned?
Trans channel springnut cracked?
Trans channel wireway clip?
Housing clip disengaged?
Housing clip missing?
Lens clip disengaged?
Lens clip broken?
Lens cover cracked?
Wireway ears broken?
Luminaire functioning?

Yes	No	No	No	No	No	No	Yes	No	Yes	No	No	Yes	No	No	Yes	Yes
-----	----	----	----	----	----	----	-----	----	-----	----	----	-----	----	----	-----	-----

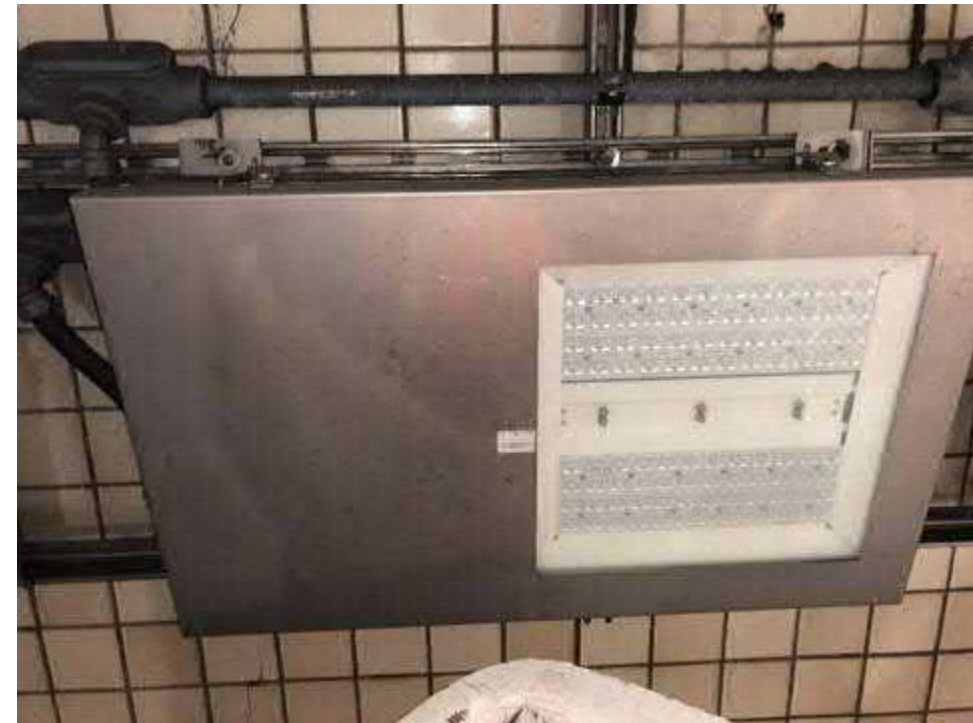
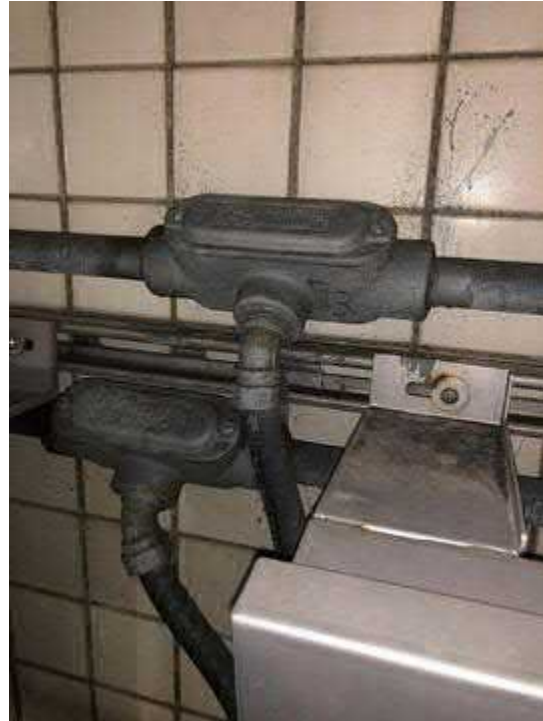
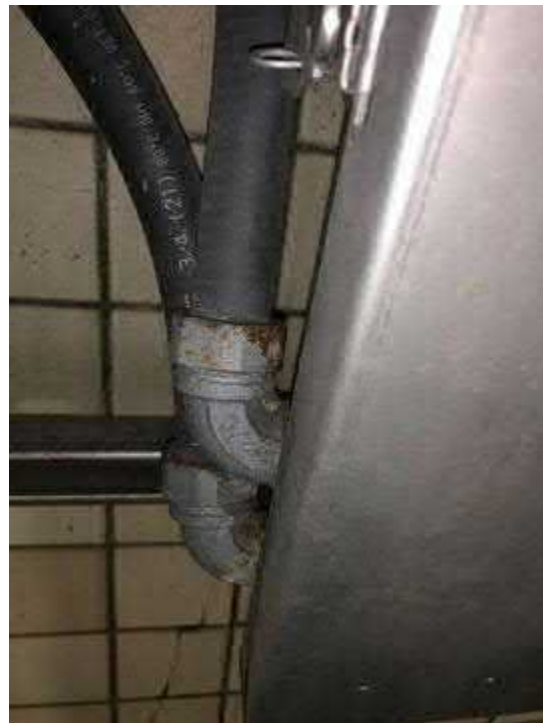
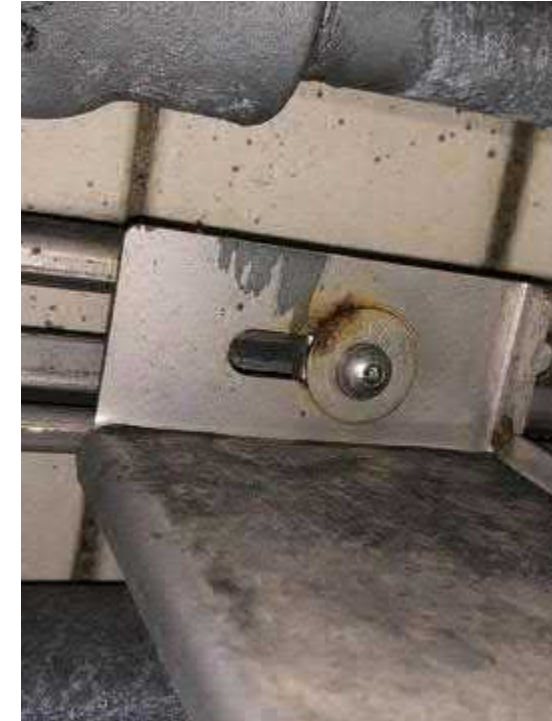
Lighting Fixture Information	
Luminaire Tag or Number:	SB - West Wall - 130B
Tunnel Direction and Side:	SB - West Wall
Additional Information:	T SEL TOP LEFT

Are there any signs of corrosion evident on the tunnel lighting system raceways?
Are the side entry conduits into the fixture tightly secured?
Are there any signs of corrosion on the fixture?
Is there any damage to the component housing or enclosure?
Is the light fixture secure to the mounting channels?
Long channel springnut misaligned?
Long channel springnut cracked?
Trans channel springnut cracked?
Trans channel springnut misaligned?
Trans channel springnut cracked?
Trans channel wireway clip?
Housing clip disengaged?
Housing clip missing?
Lens clip disengaged?
Lens clip broken?
Lens cover cracked?
Wireway ears broken?
Luminaire functioning?

Yes	No	No	No	No	No	No	Yes	No	Yes	No	No	No	Yes	No	Yes	Yes
-----	----	----	----	----	----	----	-----	----	-----	----	----	----	-----	----	-----	-----

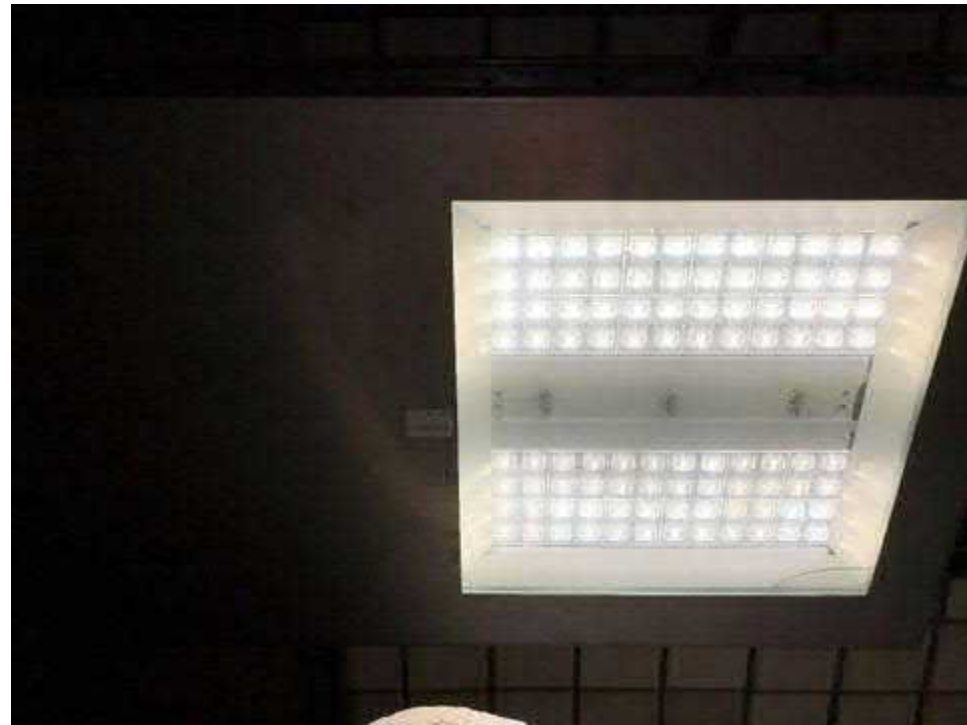
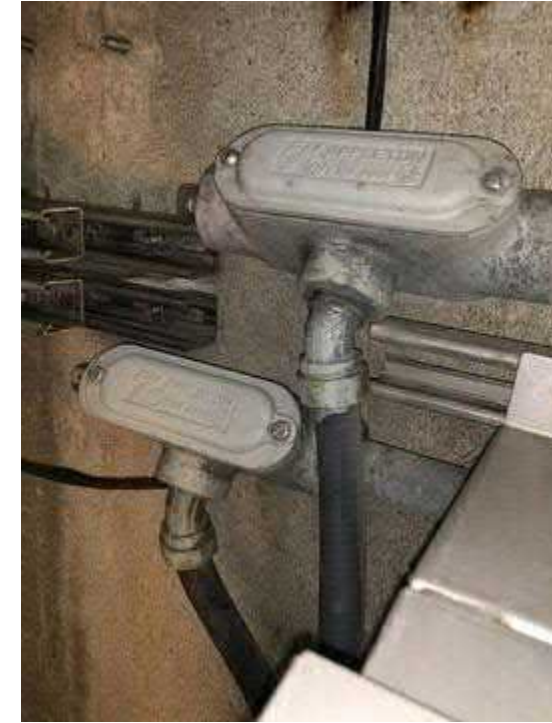
Lighting Fixture Information	
Luminaire Tag or Number:	SB - East Wall - 144A
Tunnel Direction and Side:	SB - East WallTT
Additional Information:	T

Are there any signs of corrosion evident on the tunnel lighting system raceways?
Are the side entry conduits into the fixture tightly secured?
Are there any signs of corrosion on the fixture?
Is there any damage to the component housing or enclosure?
Is the light fixture secure to the mounting channels?
Long channel springnut misaligned?
Long channel springnut cracked?
Trans channel springnut misaligned?
Trans channel springnut cracked?
Trans channel wireway clip?
Housing clip disengaged?
Housing clip missing?
Lens clip disengaged?
Lens clip broken?
Lens cover cracked?
Wireway ears broken?
Luminaire functioning?

Yes	No	No	No	No	No	No	Yes	No	Yes	No	No	No	No	No	Yes	Yes
-----	----	----	----	----	----	----	-----	----	-----	----	----	----	----	----	-----	-----

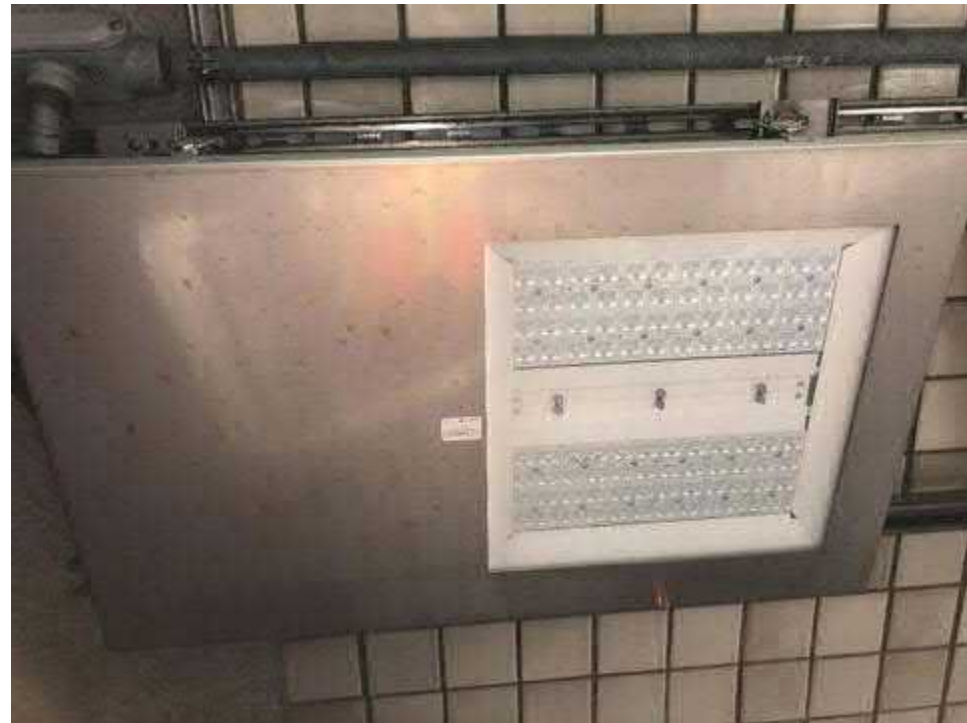
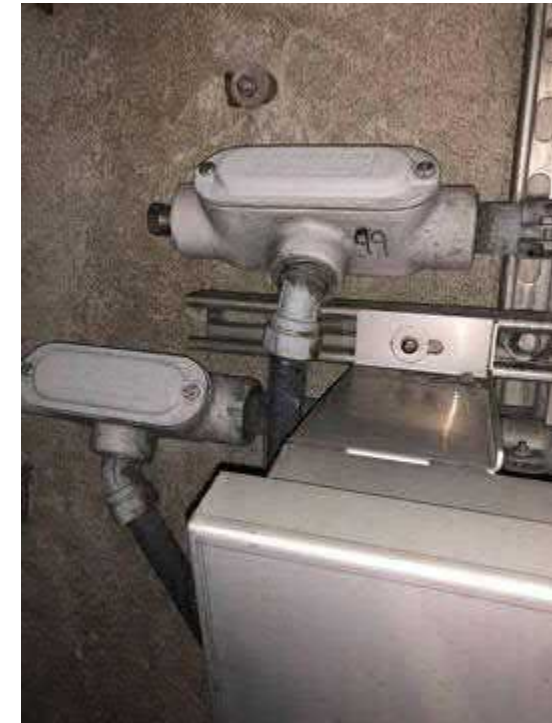
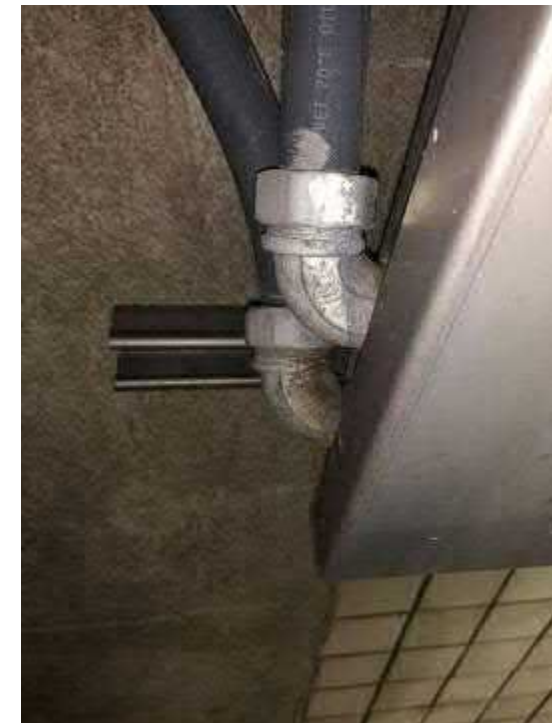
Lighting Fixture Information	
<b>Luminaire Tag or Number:</b>	SB - East Wall - 144B
<b>Tunnel Direction and Side:</b>	SB - East Wall
<b>Additional Information:</b>	T SEL

Are there any signs of corrosion evident on the tunnel lighting system raceways?
Are the side entry conduits into the fixture tightly secured?
Are there any signs of corrosion on the fixture?
Is there any damage to the component housing or enclosure?
Is the light fixture secure to the mounting channels?
Long channel springnut misaligned?
Long channel springnut cracked?
Trans channel springnut misaligned?
Trans channel springnut cracked?
Trans channel wireway clip?
Housing clip disengaged?
Housing clip missing?
Lens clip disengaged?
Lens clip broken?
Lens cover cracked?
Wireway ears broken?
Luminaire functioning?

Yes	No	No	No	No	No	No	Yes	No	Yes	No	No	Yes	No	No	Yes	Yes
-----	----	----	----	----	----	----	-----	----	-----	----	----	-----	----	----	-----	-----

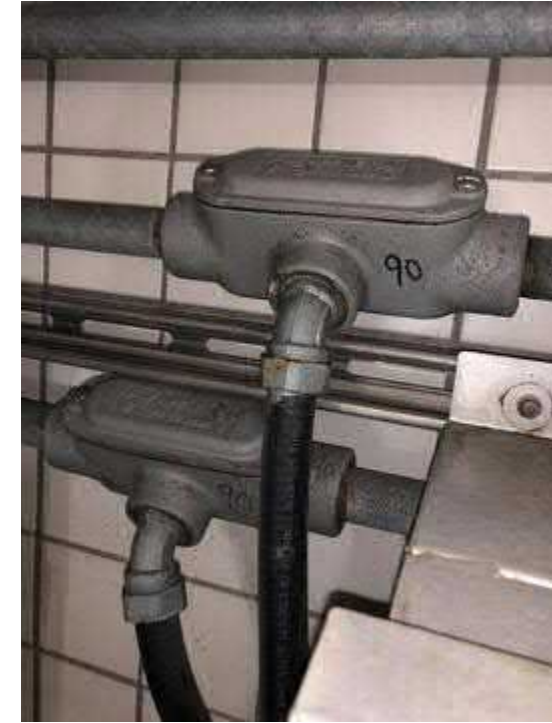
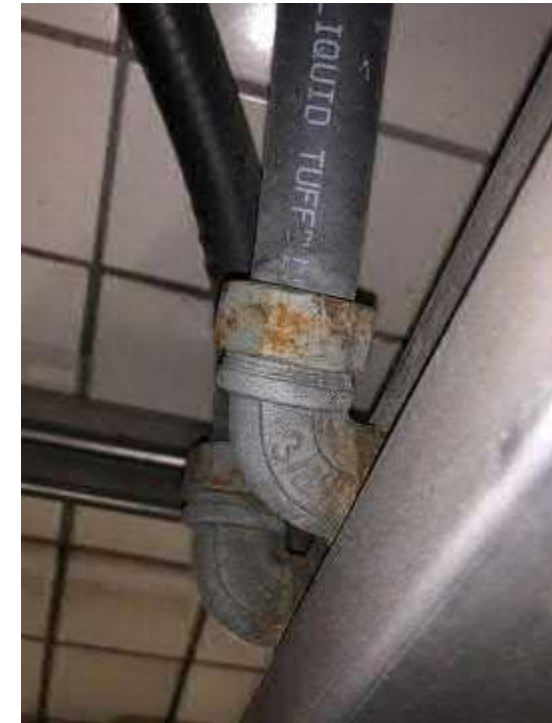
Lighting Fixture Information	
Luminaire Tag or Number:	SB - East Wall - 135A
Tunnel Direction and Side:	SB - East Wall
Additional Information:	T SEL

Are there any signs of corrosion evident on the tunnel lighting system raceways?	Yes
Are the side entry conduits into the fixture tightly secured?	Yes
Are there any signs of corrosion on the fixture?	No
Is there any damage to the component housing or enclosure?	No
Is the light fixture secure to the mounting channels?	Yes
Long channel springnut misaligned?	
Long channel springnut cracked?	No
Trans channel springnut misaligned?	No
Trans channel springnut cracked?	No
Trans channel wireway clip?	Yes
Housing clip disengaged?	No
Housing clip missing?	No
Lens clip disengaged?	No
Lens clip broken?	No
Lens cover cracked?	No
Wireway ears broken?	No
Luminaire functioning?	Yes

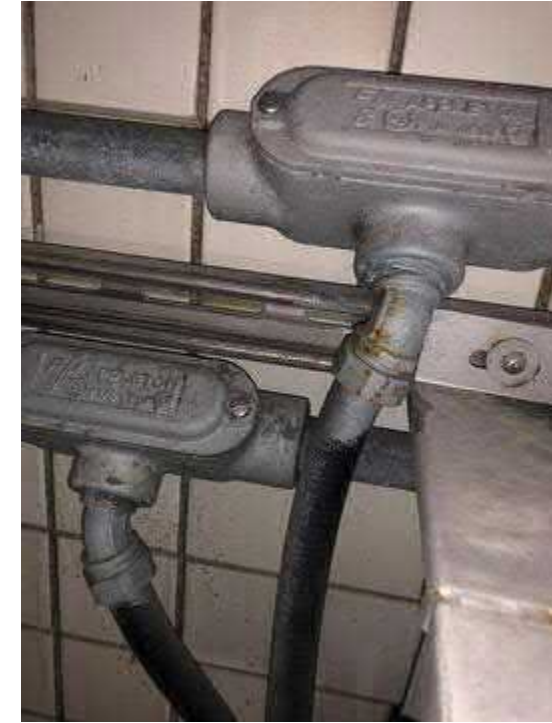
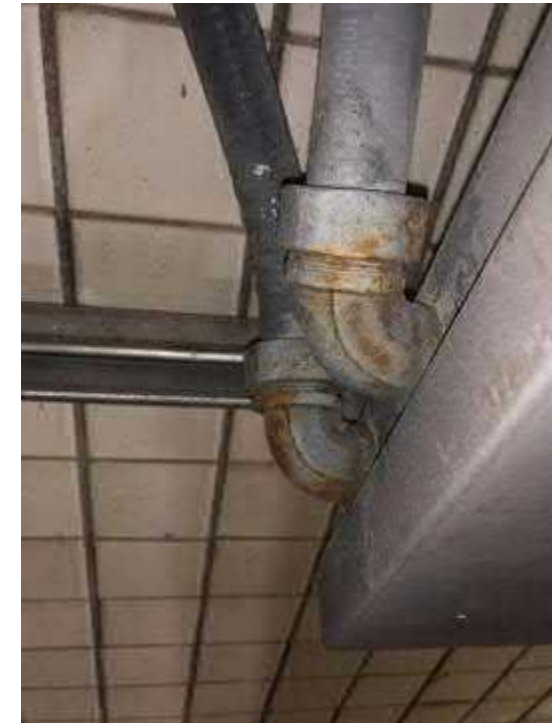
Lighting Fixture Information	
Luminaire Tag or Number:	SB - East Wall - 135B
Tunnel Direction and Side:	SB - East Wall
Additional Information:	T SEL

Are there any signs of corrosion evident on the tunnel lighting system raceways?	Yes
Are the side entry conduits into the fixture tightly secured?	Yes
Are there any signs of corrosion on the fixture?	No
Is there any damage to the component housing or enclosure?	No
Is the light fixture secure to the mounting channels?	Yes
Long channel springnut misaligned?	No
Long channel springnut cracked?	No
Trans channel springnut misaligned?	No
Trans channel springnut cracked?	No
Trans channel wireway clip?	Yes
Housing clip disengaged?	No
Housing clip missing?	No
Lens clip disengaged?	No
Lens clip broken?	No
Lens cover cracked?	No
Wireway ears broken?	No
Luminaire functioning?	Yes

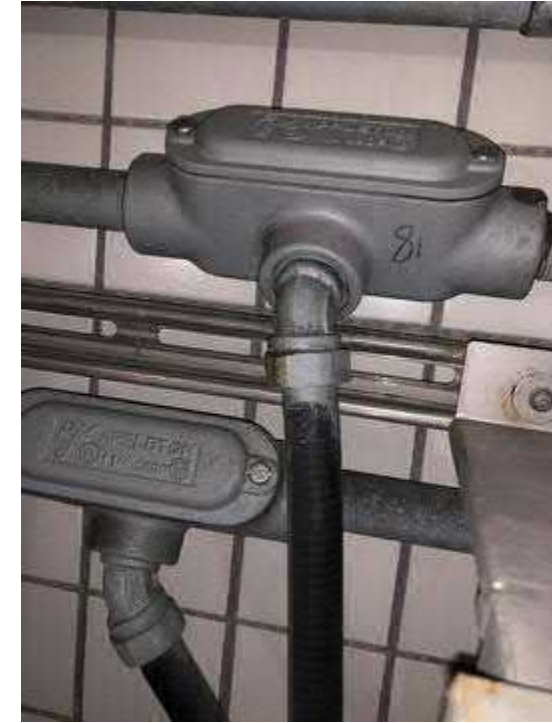
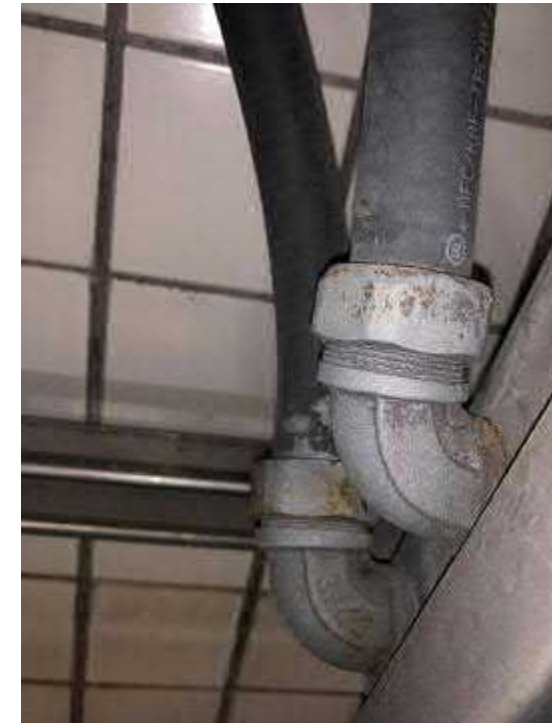
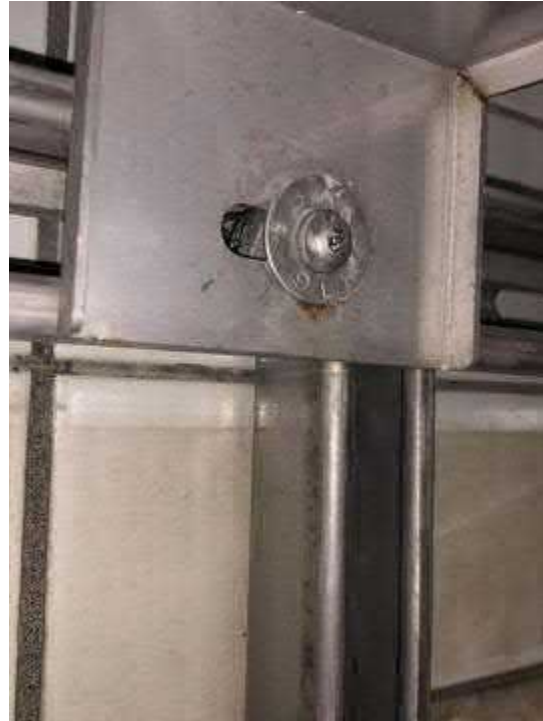
Lighting Fixture Information	
Luminaire Tag or Number:	SB - East Wall - 126A
Tunnel Direction and Side:	SB - East Wall - 18A
Additional Information:	T SEL BOTTOM RIGHT

Are there any signs of corrosion evident on the tunnel lighting system raceways?	Yes
Are the side entry conduits into the fixture tightly secured?	Yes
Are there any signs of corrosion on the fixture?	No
Is there any damage to the component housing or enclosure?	No
Is the light fixture secure to the mounting channels?	Yes
Long channel springnut misaligned?	No
Long channel springnut cracked?	No
Trans channel springnut misaligned?	Yes
Trans channel springnut cracked?	No
Trans channel wireway clip?	Yes
Housing clip disengaged?	
Housing clip missing?	No
Lens clip disengaged?	No
Lens clip broken?	No
Lens cover cracked?	No
Wireway ears broken?	No
Luminaire functioning?	Yes

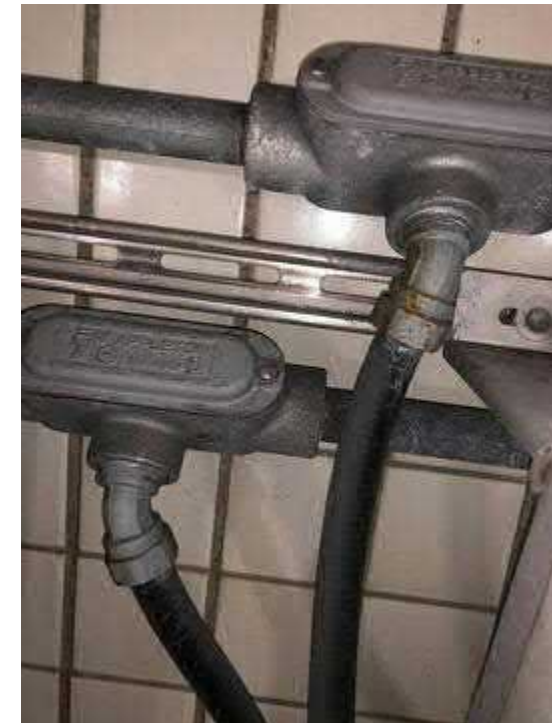
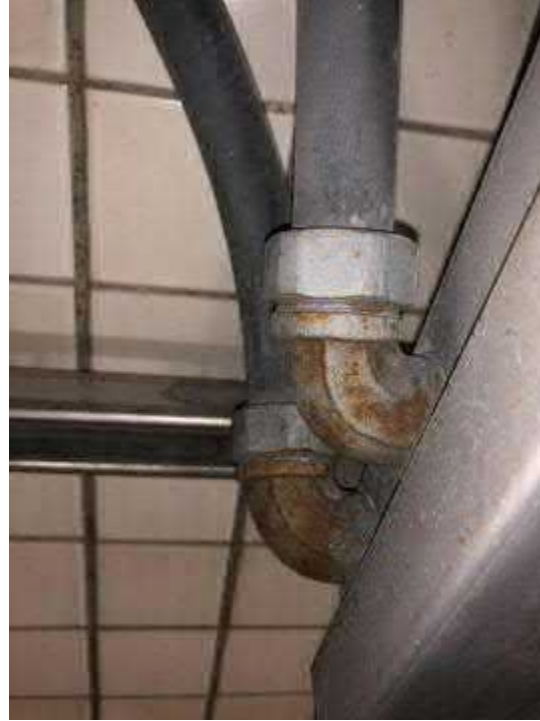
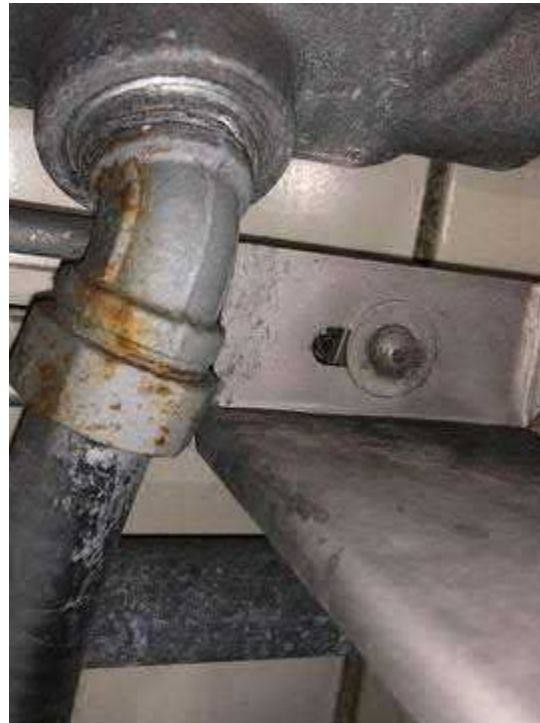
Lighting Fixture Information	
Luminaire Tag or Number:	SB - East Wall - 126B
Tunnel Direction and Side:	SB - East Wall
Additional Information:	T SEL BADLY TOP LEFT

Are there any signs of corrosion evident on the tunnel lighting system raceways?
Are the side entry conduits into the fixture tightly secured?
Are there any signs of corrosion on the fixture?
Is there any damage to the component housing or enclosure?
Is the light fixture secure to the mounting channels?
Long channel springnut misaligned?
Long channel springnut cracked?
Trans channel springnut cracked?
Trans channel springnut misaligned?
Trans channel springnut cracked?
Trans channel wireway clip?
Housing clip disengaged?
Housing clip missing?
Lens clip disengaged?
Lens clip broken?
Lens cover cracked?
Wireway ears broken?
Luminaire functioning?

Yes	No	No	No	No	No	No	Yes	No	Yes	No	No	No	No	No	Yes	Yes
-----	----	----	----	----	----	----	-----	----	-----	----	----	----	----	----	-----	-----

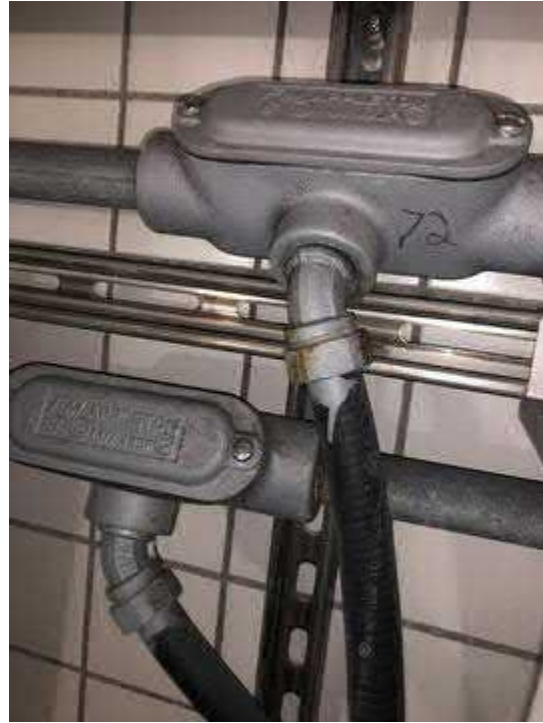
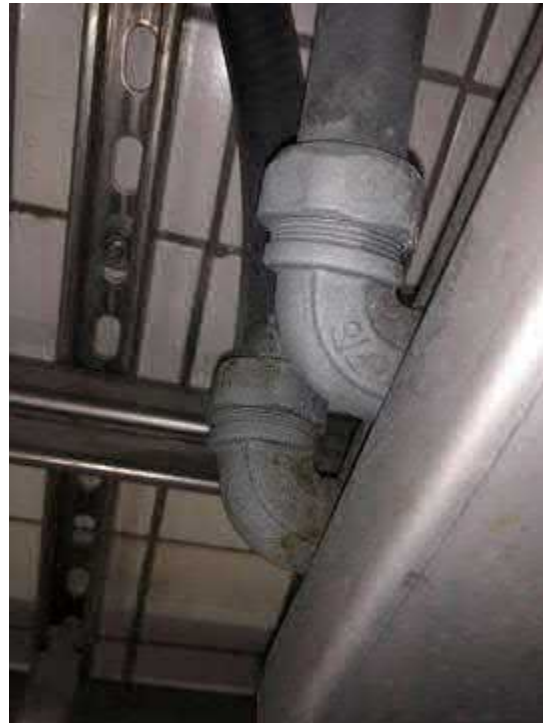
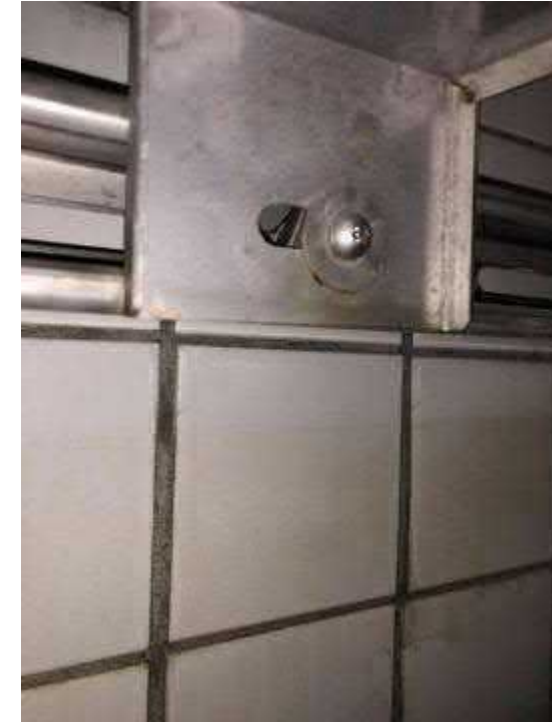
Lighting Fixture Information	
Luminaire Tag or Number:	SB - East Wall - 117A
Tunnel Direction and Side:	SB - East Wall
Additional Information:	T SEL BOTTOM RIGHT

Are there any signs of corrosion evident on the tunnel lighting system raceways?	Yes
Are the side entry conduits into the fixture tightly secured?	Yes
Are there any signs of corrosion on the fixture?	No
Is there any damage to the component housing or enclosure?	No
Is the light fixture secure to the mounting channels?	Yes
Long channel springnut misaligned?	No
Long channel springnut cracked?	No
Trans channel springnut misaligned?	Yes
Trans channel springnut cracked?	No
Trans channel wireway clip?	Yes
Housing clip disengaged?	No
Housing clip missing?	No
Lens clip disengaged?	No
Lens clip broken?	No
Lens cover cracked?	No
Wireway ears broken?	No
Luminaire functioning?	Yes

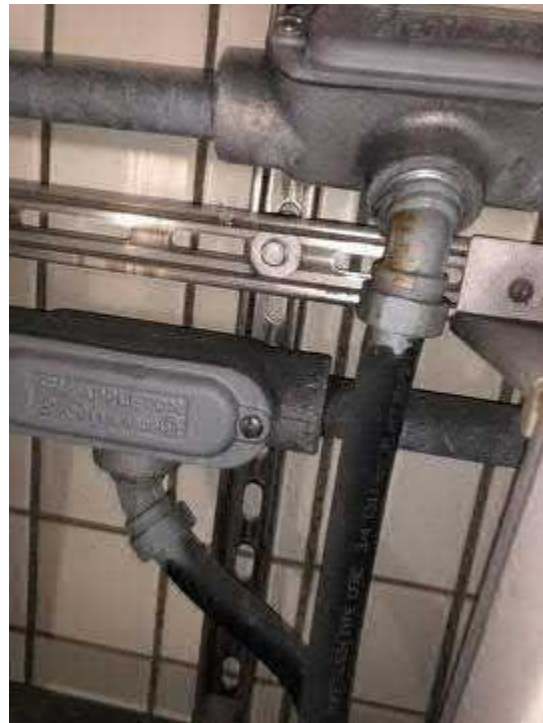
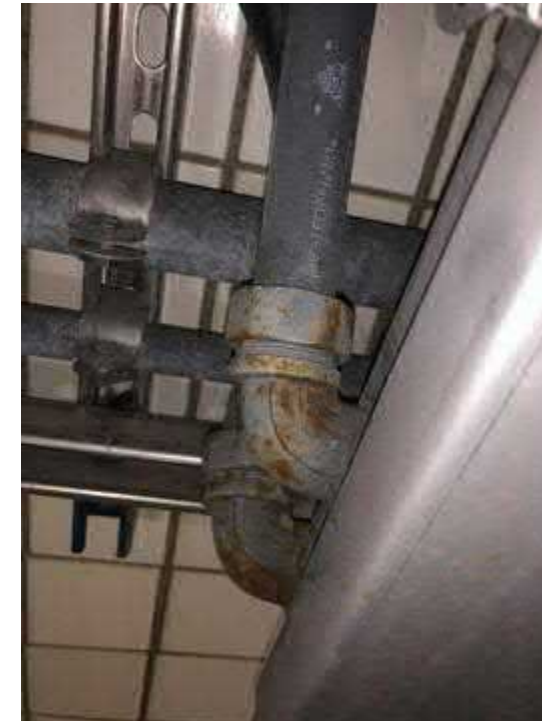
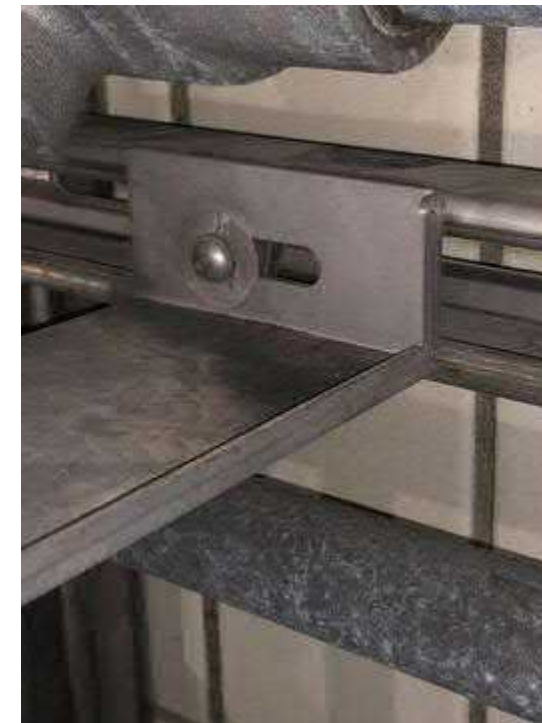
**Tunnel Lighting Section**

Lighting Fixture Information	
Luminaire Tag or Number:	SB - East Wall - 108A
Tunnel Direction and Side:	SB - East Wall
Additional Information:	T SEL FUXTURE TOP RIGHT

Are there any signs of corrosion evident on the tunnel lighting system raceways?	Yes
Are the side entry conduits into the fixture tightly secured?	Yes
Are there any signs of corrosion on the fixture?	Yes
Is there any damage to the component housing or enclosure?	No
Is the light fixture secure to the mounting channels?	No
Long channel springnut misaligned?	No
Long channel springnut cracked?	No
Trans channel springnut misaligned?	Yes
Trans channel springnut cracked?	No
Trans channel wireway clip?	Yes
Housing clip disengaged?	No
Housing clip missing?	
Lens clip disengaged?	No
Lens clip broken?	No
Lens cover cracked?	No
Wireway ears broken?	No
Luminaire functioning?	Yes

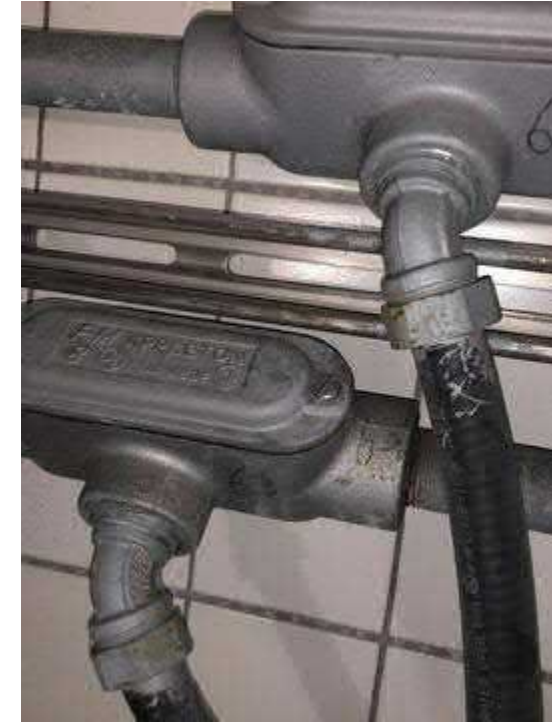
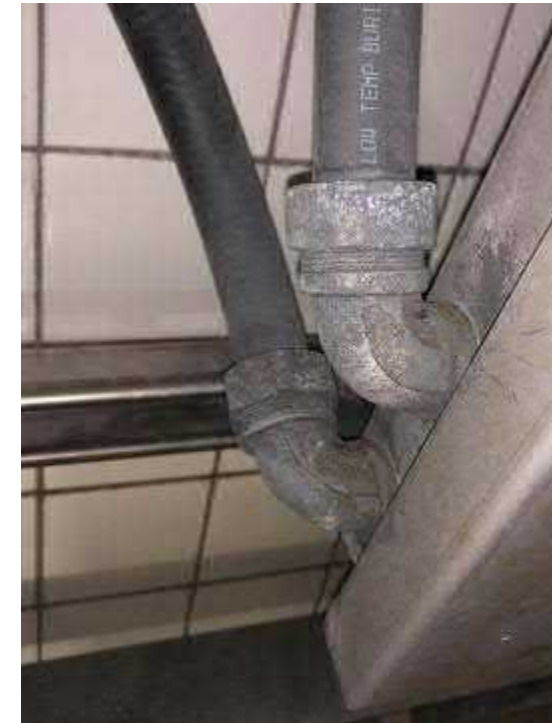
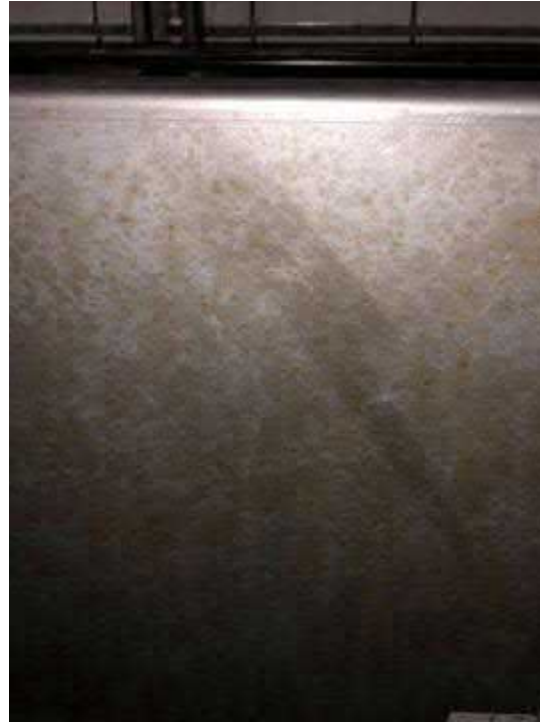
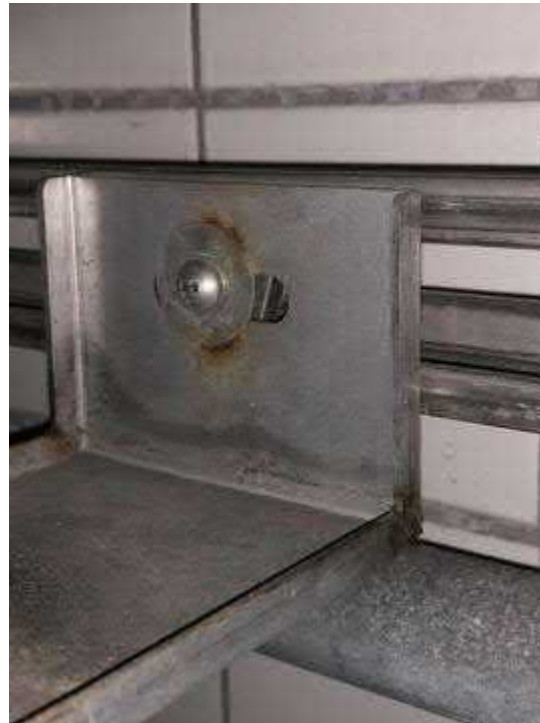
**Tunnel Lighting Section**

Lighting Fixture Information	
Luminaire Tag or Number:	SB - East Wall - 108B
Tunnel Direction and Side:	SB - East Wal
Additional Information:	T SEL

Are there any signs of corrosion evident on the tunnel lighting system raceways?	Yes
Are the side entry conduits into the fixture tightly secured?	Yes
Are there any signs of corrosion on the fixture?	No
Is there any damage to the component housing or enclosure?	No
Is the light fixture secure to the mounting channels?	Yes
Long channel springnut misaligned?	No
Long channel springnut cracked?	No
Trans channel springnut misaligned?	Yes
Trans channel springnut cracked?	No
Trans channel wireway clip?	Yes
Housing clip disengaged?	No
Housing clip missing?	No
Lens clip disengaged?	No
Lens clip broken?	No
Lens cover cracked?	No
Wireway ears broken?	No
Luminaire functioning?	Yes

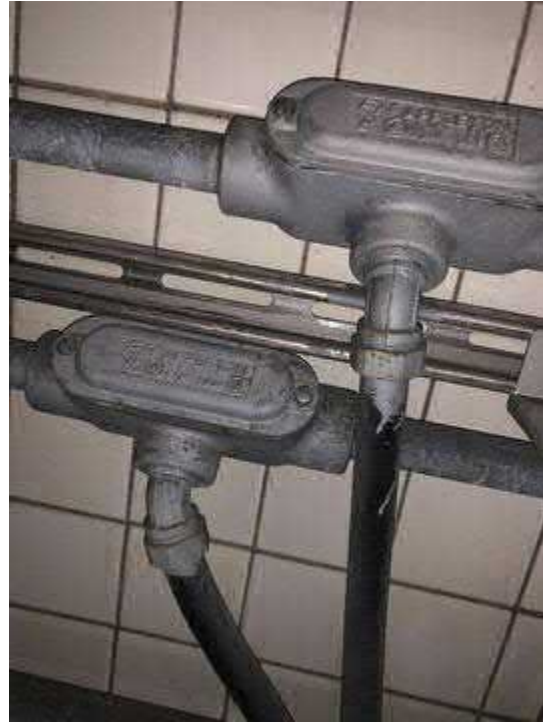
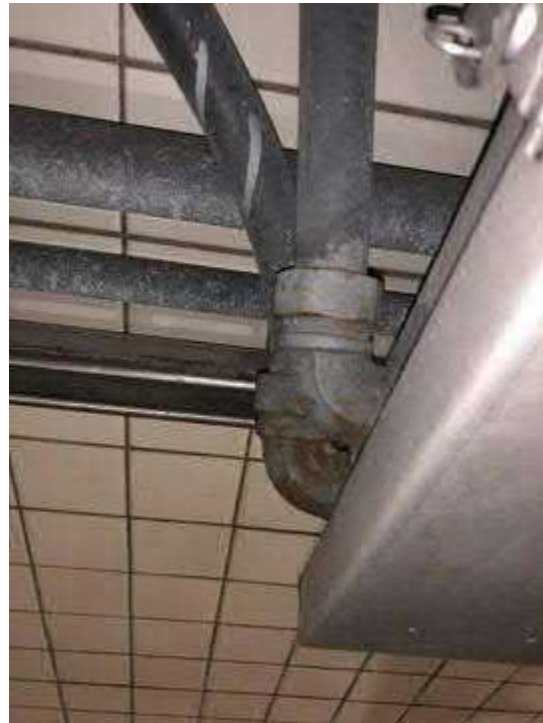
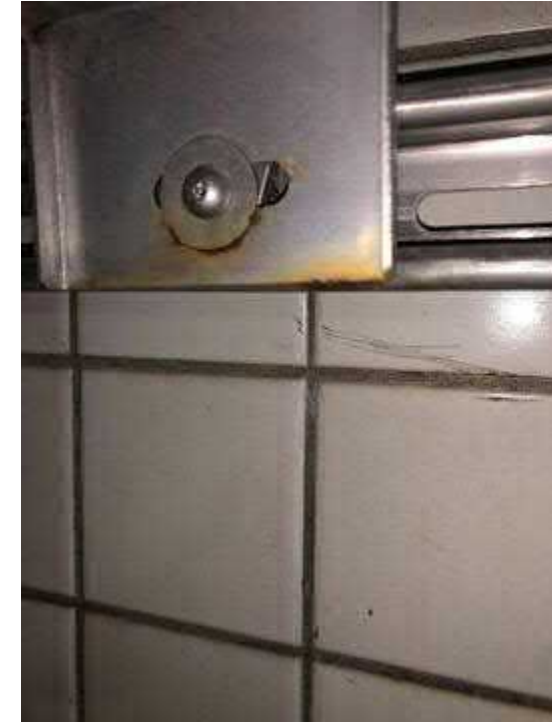
**Tunnel Lighting Section**

Lighting Fixture Information	
<b>Luminaire Tag or Number:</b>	SB - East Wall - 99A
<b>Tunnel Direction and Side:</b>	SB - East Wall
<b>Additional Information:</b>	T SEL SE LOOSE BOTTOM LEFT

Are there any signs of corrosion evident on the tunnel lighting system raceways?
Are the side entry conduits into the fixture tightly secured?
Are there any signs of corrosion on the fixture?
Is there any damage to the component housing or enclosure?
Is the light fixture secure to the mounting channels?
Long channel springnut misaligned?
Long channel springnut cracked?
Trans channel springnut misaligned?
Trans channel springnut cracked?
Trans channel wireway clip?
Housing clip disengaged?
Housing clip missing?
Lens clip disengaged?
Lens clip broken?
Lens cover cracked?
Wireway ears broken?
Luminaire functioning?

Yes	No	No	No	No	No	No	Yes	No	No	No	No	Yes	No	No	No	Yes
-----	----	----	----	----	----	----	-----	----	----	----	----	-----	----	----	----	-----

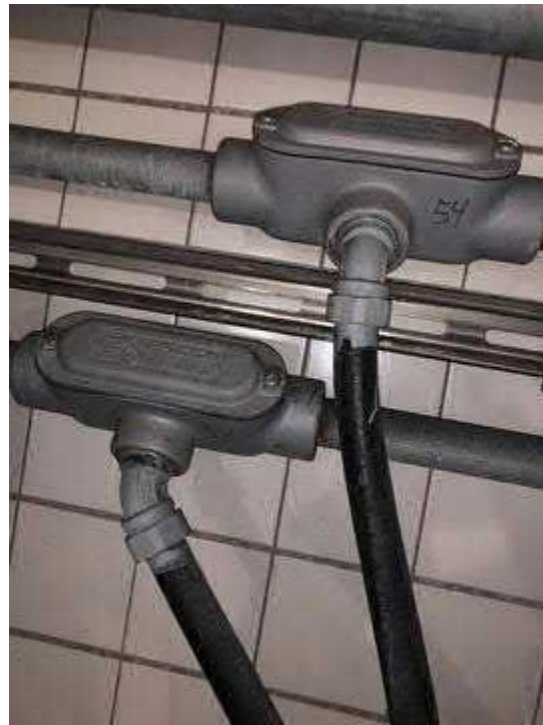
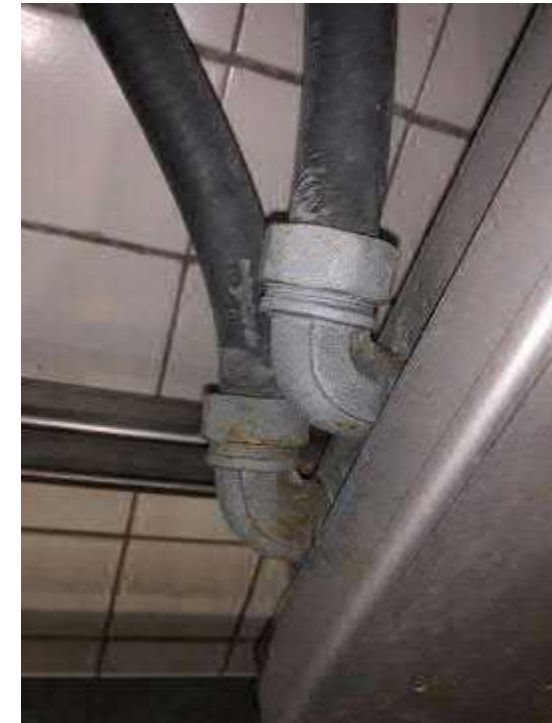
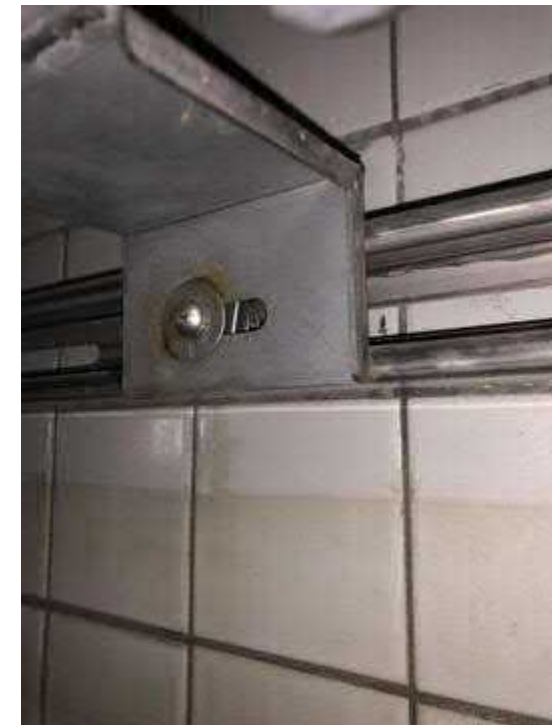
**Tunnel Lighting Section**

Lighting Fixture Information	
Luminaire Tag or Number:	SB - East Wall - 99B
Tunnel Direction and Side:	SB - East Wall
Additional Information:	T SEL BOTTOM RIGHT

Are there any signs of corrosion evident on the tunnel lighting system raceways?	Yes
Are the side entry conduits into the fixture tightly secured?	Yes
Are there any signs of corrosion on the fixture?	No
Is there any damage to the component housing or enclosure?	No
Is the light fixture secure to the mounting channels?	Yes
Long channel springnut misaligned?	No
Long channel springnut cracked?	No
Trans channel springnut misaligned?	Yes
Trans channel springnut cracked?	No
Trans channel wireway clip?	Yes
Housing clip disengaged?	No
Housing clip missing?	No
Lens clip disengaged?	No
Lens clip broken?	No
Lens cover cracked?	No
Wireway ears broken?	No
Luminaire functioning?	Yes
