# **Lytle Tunnel (HAM-71-0134) Inspection Report Fall 2020**

PID 105470

November, 2020

Ohio Department of  
Transportation  
District 8  
505 South State Route 741  
Lebanon, OH 45036

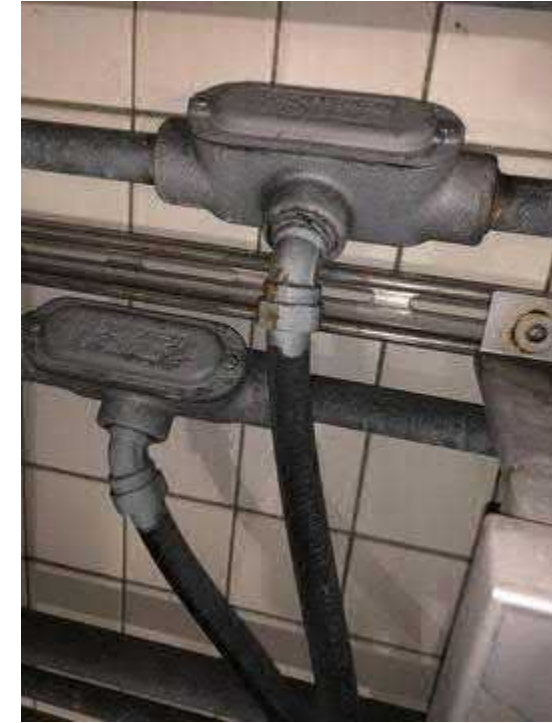
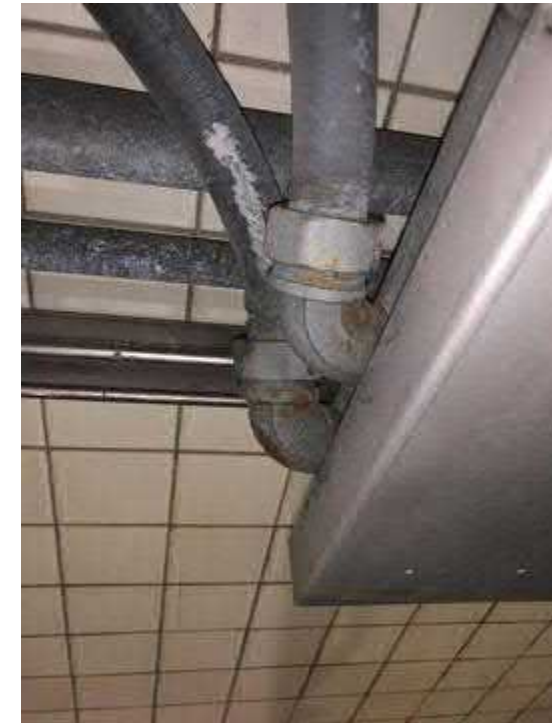
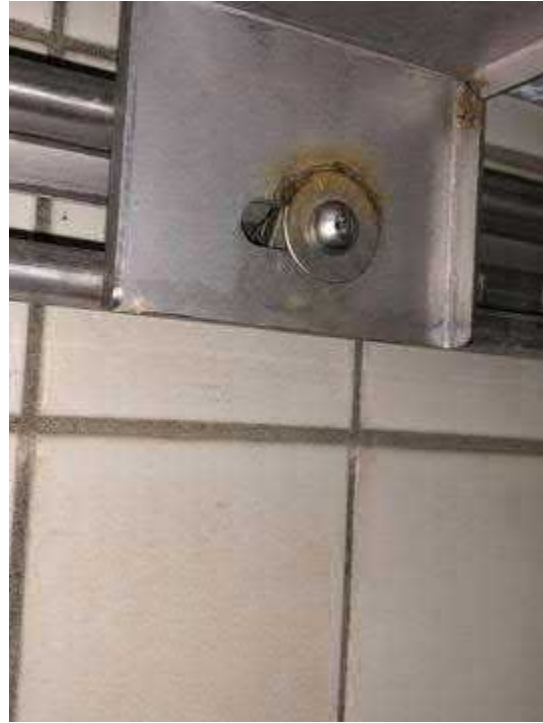
**Tunnel Lighting Section**

Lighting Fixture Information	
Luminaire Tag or Number:	SB - East Wall - 90A
Tunnel Direction and Side:	SB - East Wall
Additional Information:	T SEL SE LOOSE BOTTOM LEFT

Are there any signs of corrosion evident on the tunnel lighting system raceways?
Are the side entry conduits into the fixture tightly secured?
Are there any signs of corrosion on the fixture?
Is there any damage to the component housing or enclosure?
Is the light fixture secure to the mounting channels?
Long channel springnut misaligned?
Long channel springnut cracked?
Trans channel springnut cracked?
Trans channel springnut misaligned?
Trans channel springnut cracked?
Trans channel wireway clip?
Housing clip disengaged?
Housing clip missing?
Lens clip disengaged?
Lens clip broken?
Lens cover cracked?
Wireway ears broken?
Luminaire functioning?

Yes	No	No	No	No	No	No	Yes	No	No	No	No	Yes	No	No	No	Yes
-----	----	----	----	----	----	----	-----	----	----	----	----	-----	----	----	----	-----

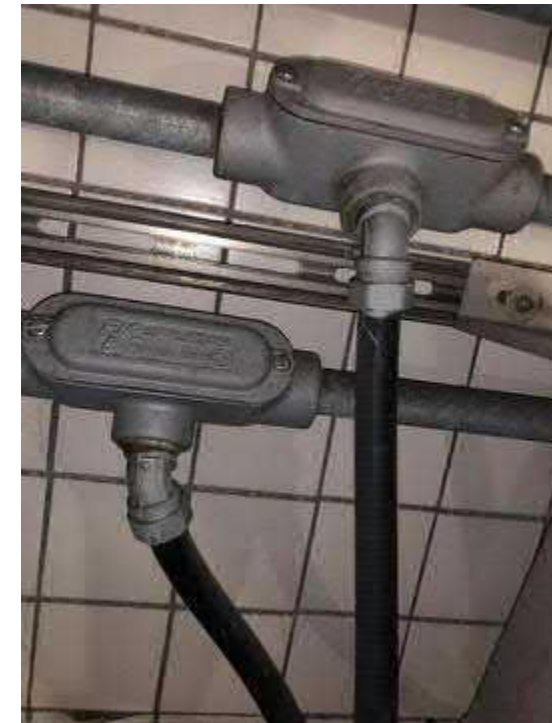
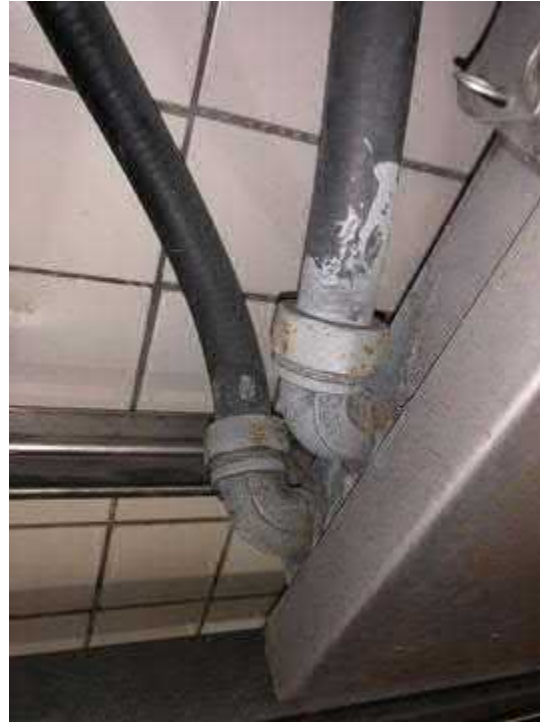
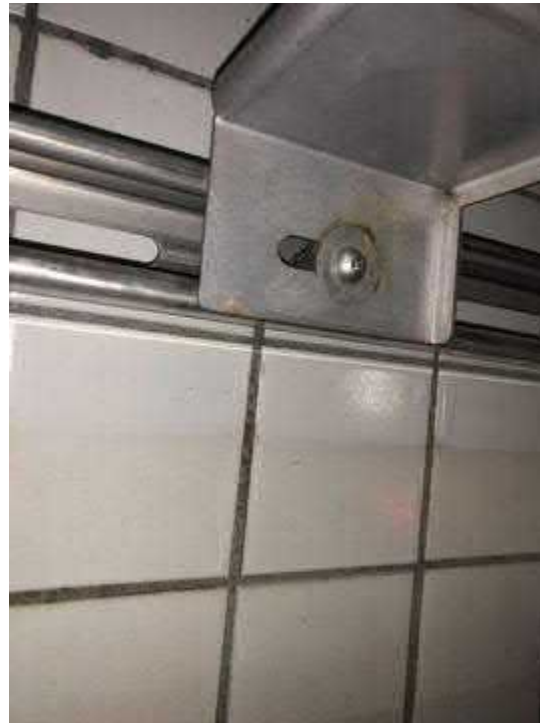
**Tunnel Lighting Section**

Lighting Fixture Information	
Luminaire Tag or Number:	SB - East Wall - 90B
Tunnel Direction and Side:	SB - East Wall
Additional Information:	T SEL BOTTOM RIGHT

Are there any signs of corrosion evident on the tunnel lighting system raceways?	No
Are the side entry conduits into the fixture tightly secured?	Yes
Are there any signs of corrosion on the fixture?	No
Is there any damage to the component housing or enclosure?	No
Is the light fixture secure to the mounting channels?	Yes
Long channel springnut misaligned?	No
Long channel springnut cracked?	No
Trans channel springnut misaligned?	Yes
Trans channel springnut cracked?	No
Trans channel wireway clip?	Yes
Housing clip disengaged?	No
Housing clip missing?	No
Lens clip disengaged?	No
Lens clip broken?	No
Lens cover cracked?	No
Wireway ears broken?	No
Luminaire functioning?	Yes

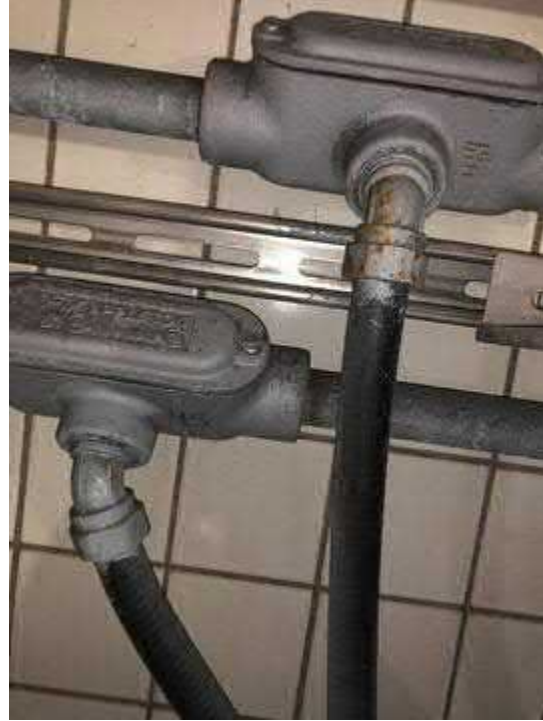
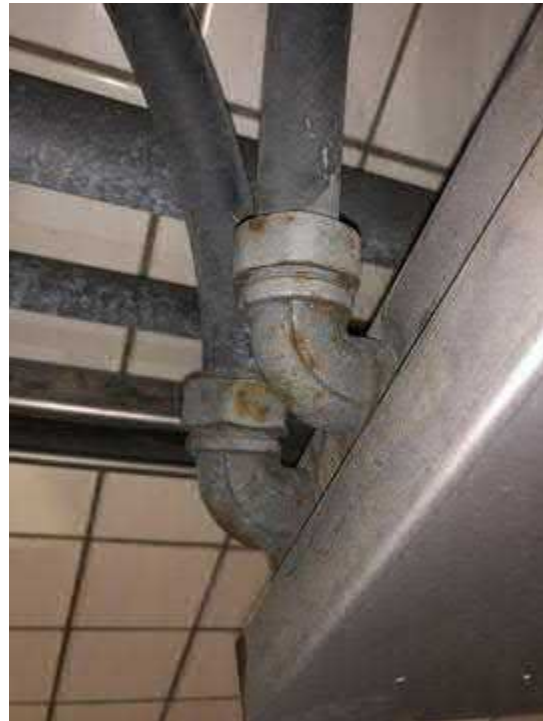
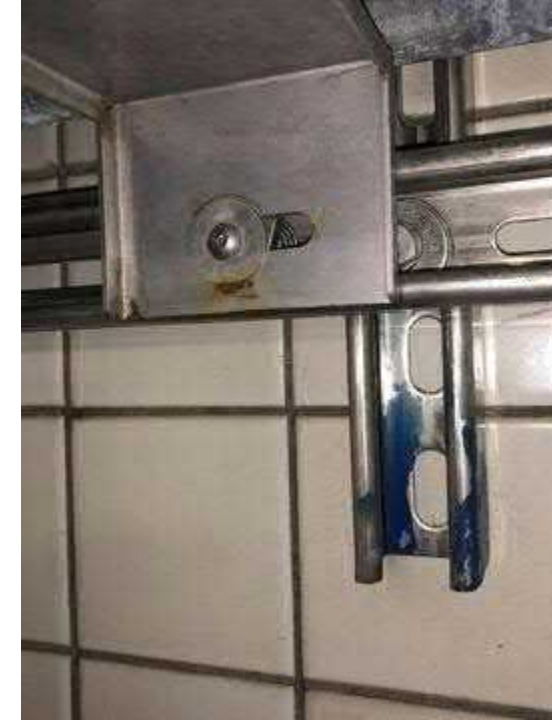
**Tunnel Lighting Section**

Lighting Fixture Information	
Luminaire Tag or Number:	SB - East Wall - 81A
Tunnel Direction and Side:	SB - East Wall
Additional Information:	T SEL

Are there any signs of corrosion evident on the tunnel lighting system raceways?
Are the side entry conduits into the fixture tightly secured?
Are there any signs of corrosion on the fixture?
Is there any damage to the component housing or enclosure?
Is the light fixture secure to the mounting channels?
Long channel springnut misaligned?
Long channel springnut cracked?
Trans channel springnut misaligned?
Trans channel springnut cracked?
Trans channel wireway clip?
Housing clip disengaged?
Housing clip missing?
Lens clip disengaged?
Lens clip broken?
Lens cover cracked?
Wireway ears broken?
Luminaire functioning?

Yes	No	No	No	No	No	No	Yes	No	No	No	No	Yes	No	No	Yes	Yes
-----	----	----	----	----	----	----	-----	----	----	----	----	-----	----	----	-----	-----

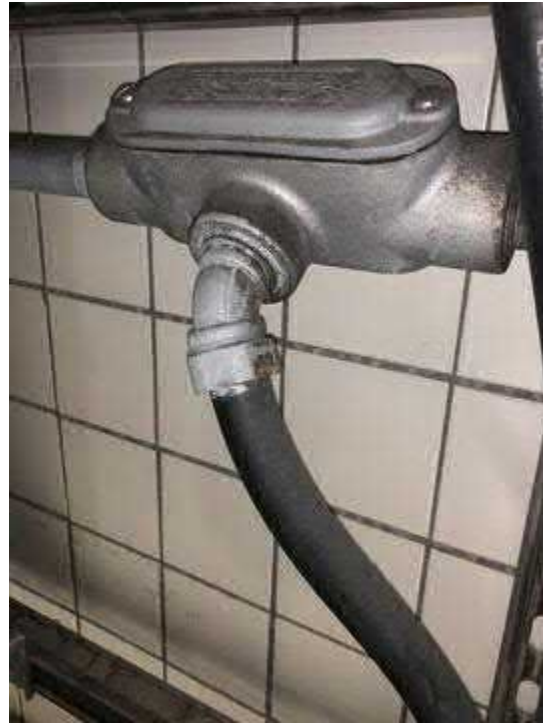
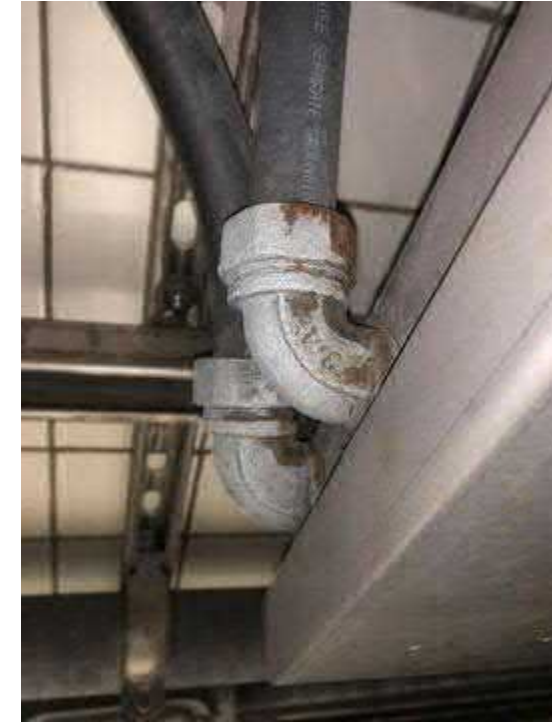
**Tunnel Lighting Section**

Lighting Fixture Information	
<b>Luminaire Tag or Number:</b>	SB - East Wall - 81B
<b>Tunnel Direction and Side:</b>	SB - East Wall
<b>Additional Information:</b>	T SEL SE LOOSE TOP RIGHT

Are there any signs of corrosion evident on the tunnel lighting system raceways?
Are the side entry conduits into the fixture tightly secured?
Are there any signs of corrosion on the fixture?
Is there any damage to the component housing or enclosure?
Is the light fixture secure to the mounting channels?
Long channel springnut misaligned?
Long channel springnut cracked?
Trans channel springnut misaligned?
Trans channel springnut cracked?
Trans channel wireway clip?
Housing clip disengaged?
Housing clip missing?
Lens clip disengaged?
Lens clip broken?
Lens cover cracked?
Wireway ears broken?
Luminaire functioning?

Yes	No	No	No	No	No	No	Yes	No	Yes	No	No	No	No	No	No	Yes
-----	----	----	----	----	----	----	-----	----	-----	----	----	----	----	----	----	-----

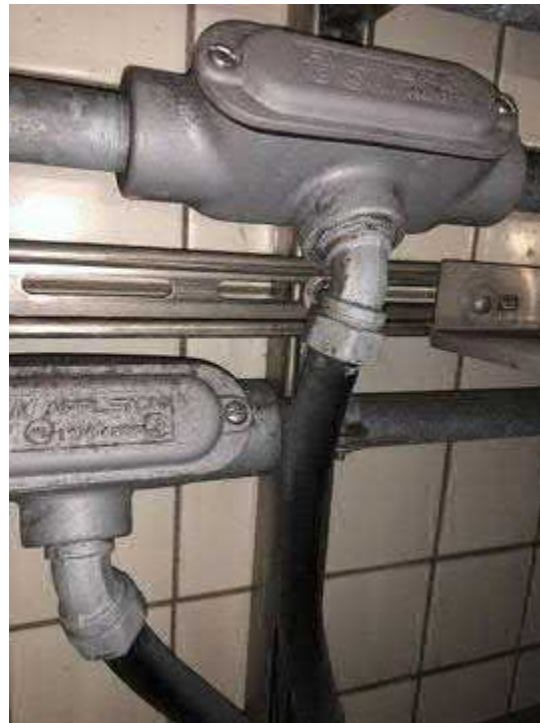
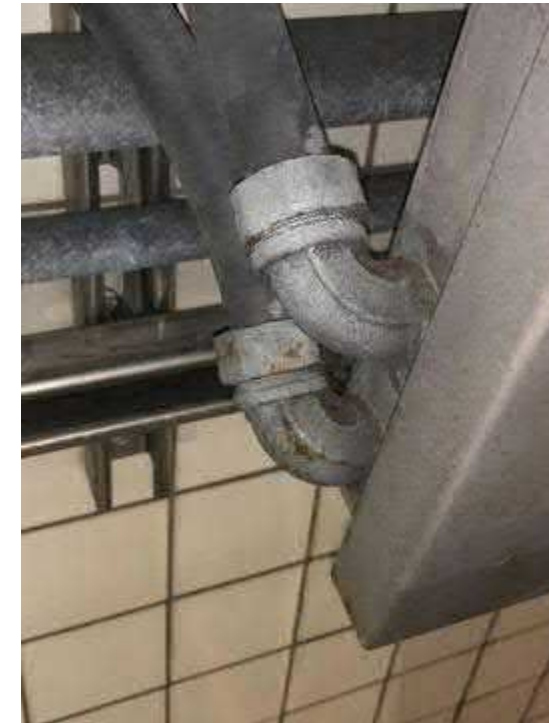
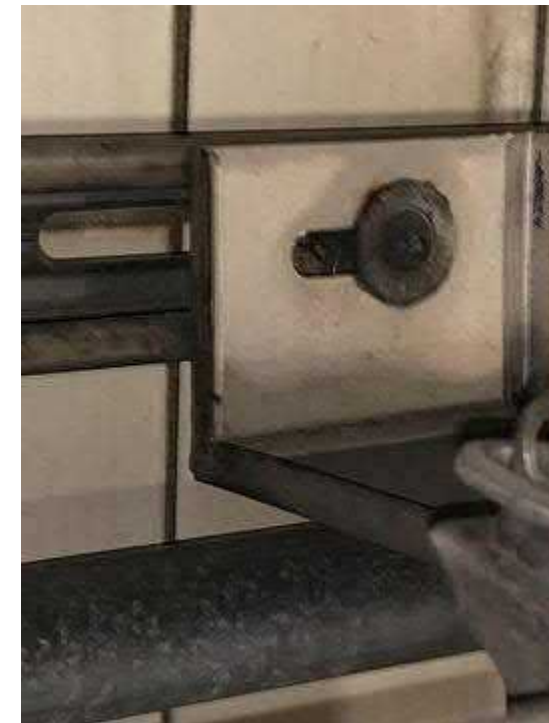
**Tunnel Lighting Section**

Lighting Fixture Information	
Luminaire Tag or Number:	SB - East Wall - 72A
Tunnel Direction and Side:	SB - East Wall
Additional Information:	T SEL SE LOOSE TOP LEFT CLIP DISENGAGED

Are there any signs of corrosion evident on the tunnel lighting system raceways?	Yes
Are the side entry conduits into the fixture tightly secured?	No
Are there any signs of corrosion on the fixture?	No
Is there any damage to the component housing or enclosure?	No
Is the light fixture secure to the mounting channels?	No
Long channel springnut misaligned?	No
Long channel springnut cracked?	No
Trans channel springnut misaligned?	No
Trans channel springnut cracked?	No
Trans channel wireway clip?	No
Housing clip disengaged?	No
Housing clip missing?	No
Lens clip disengaged?	Yes
Lens clip broken?	No
Lens cover cracked?	No
Wireway ears broken?	No
Luminaire functioning?	Yes

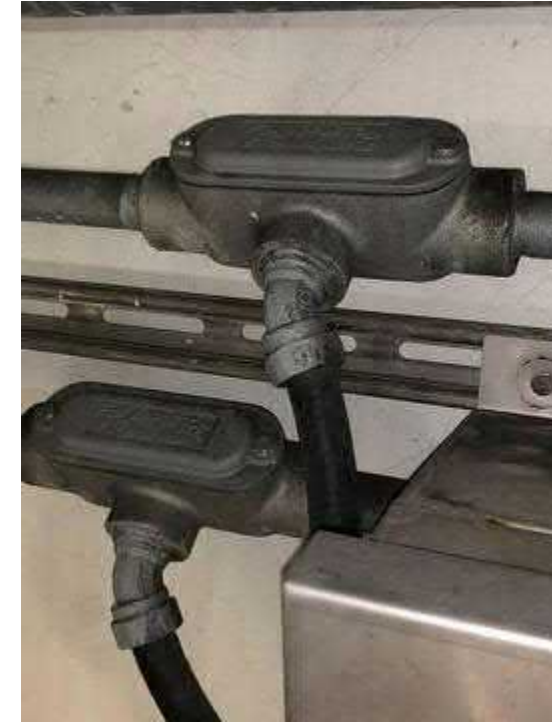
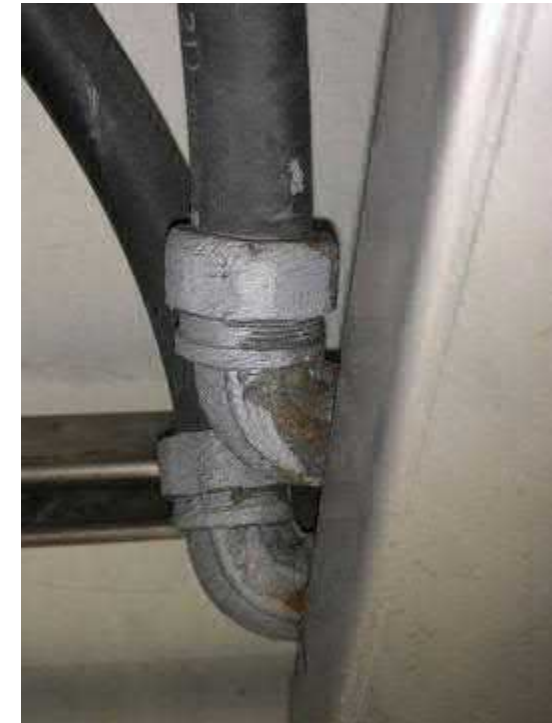
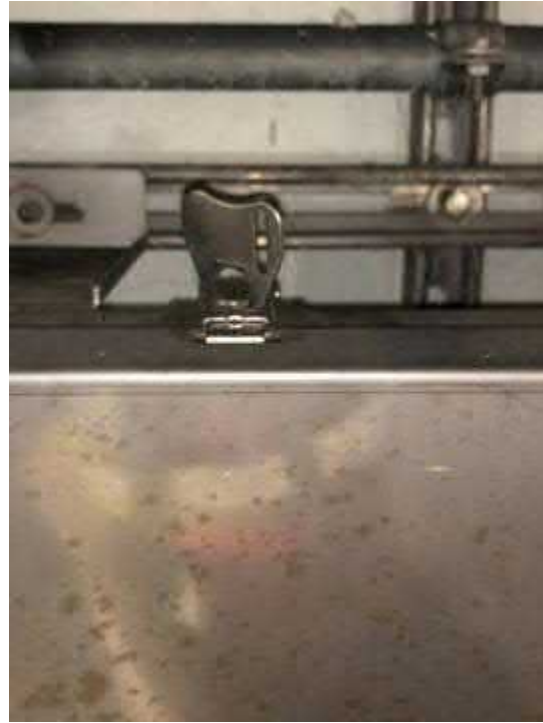
**Tunnel Lighting Section**

Lighting Fixture Information	
Luminaire Tag or Number:	SB EAST WALL - 63A
Tunnel Direction and Side:	SB EAST WALL
Additional Information:	T SEL BOTTOM LEFT

Are there any signs of corrosion evident on the tunnel lighting system raceways?
Are the side entry conduits into the fixture tightly secured?
Are there any signs of corrosion on the fixture?
Is there any damage to the component housing or enclosure?
Is the light fixture secure to the mounting channels?
Long channel springnut misaligned?
Long channel springnut cracked?
Trans channel springnut cracked?
Trans channel springnut misaligned?
Trans channel wireway clip?
Housing clip disengaged?
Housing clip missing?
Lens clip disengaged?
Lens clip broken?
Lens cover cracked?
Wireway ears broken?
Luminaire functioning?

Yes	No	No	No	No	No	No	Yes	No	Yes	No	No	Yes	No	No	Yes	Yes
-----	----	----	----	----	----	----	-----	----	-----	----	----	-----	----	----	-----	-----

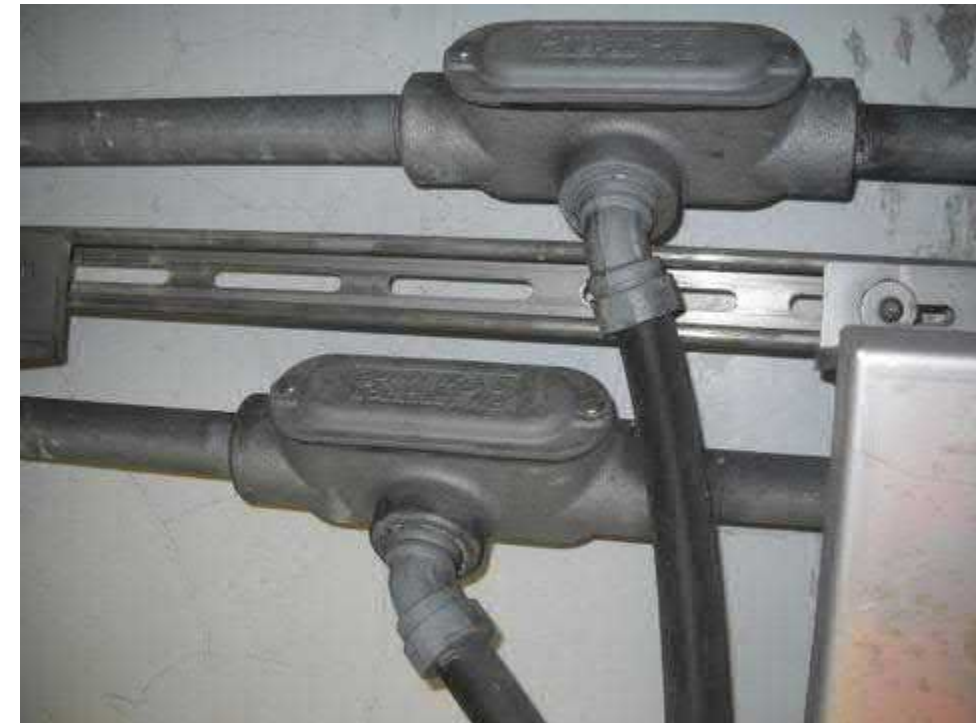
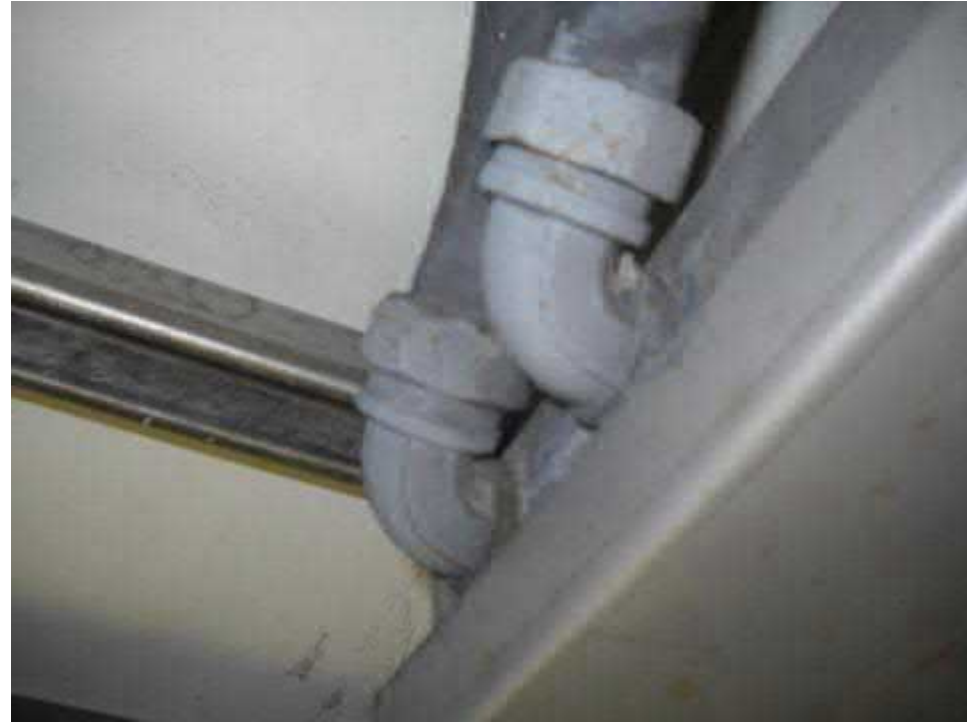
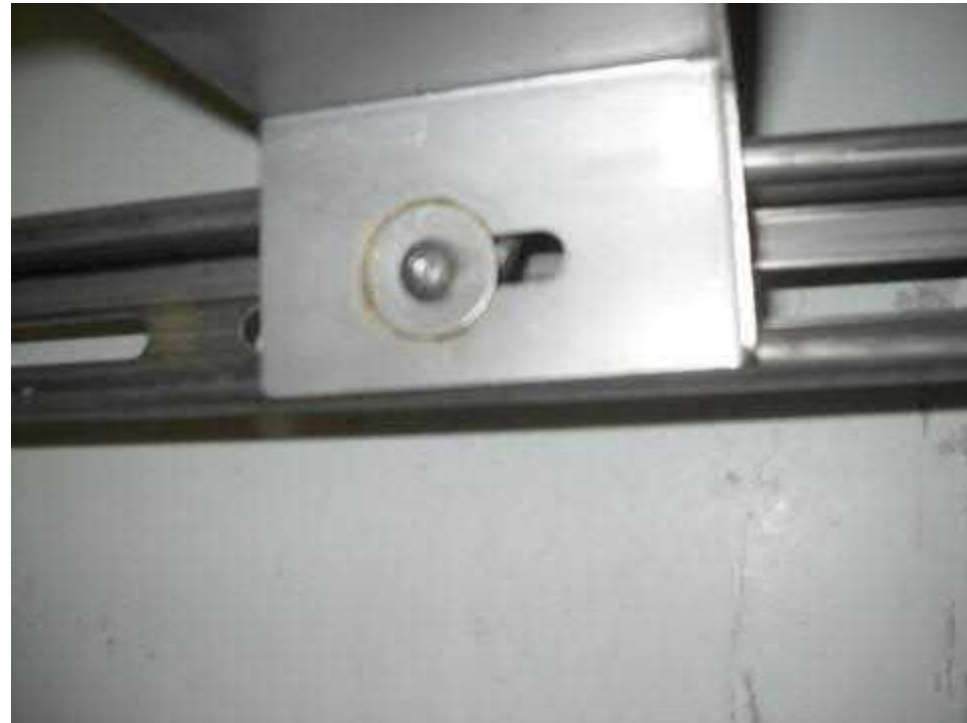
**Tunnel Lighting Section**

Lighting Fixture Information	
Luminaire Tag or Number:	SB EAST WALL - 63B
Tunnel Direction and Side:	SB EAST WALL
Additional Information:	T SEL BOTTOM RIGHT

Are there any signs of corrosion evident on the tunnel lighting system raceways?	Yes
Are the side entry conduits into the fixture tightly secured?	Yes
Are there any signs of corrosion on the fixture?	No
Is there any damage to the component housing or enclosure?	No
Is the light fixture secure to the mounting channels?	Yes
Long channel springnut misaligned?	No
Long channel springnut cracked?	No
Trans channel springnut misaligned?	Yes
Trans channel springnut cracked?	No
Trans channel wireway clip?	Yes
Housing clip disengaged?	No
Housing clip missing?	No
Lens clip disengaged?	No
Lens clip broken?	No
Lens cover cracked?	No
Wireway ears broken?	No
Luminaire functioning?	Yes

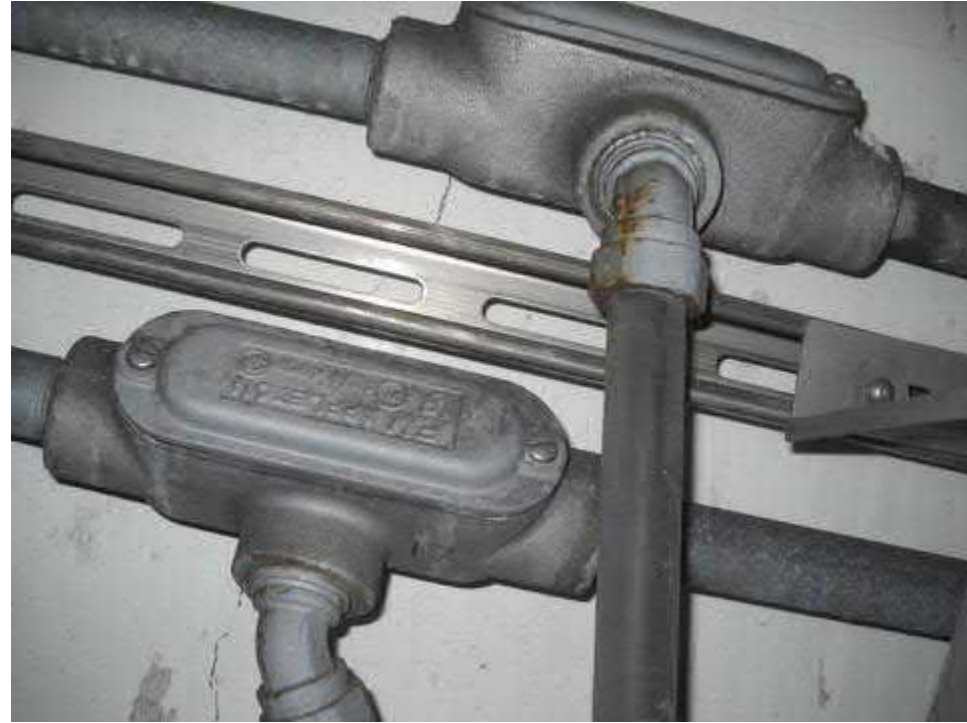
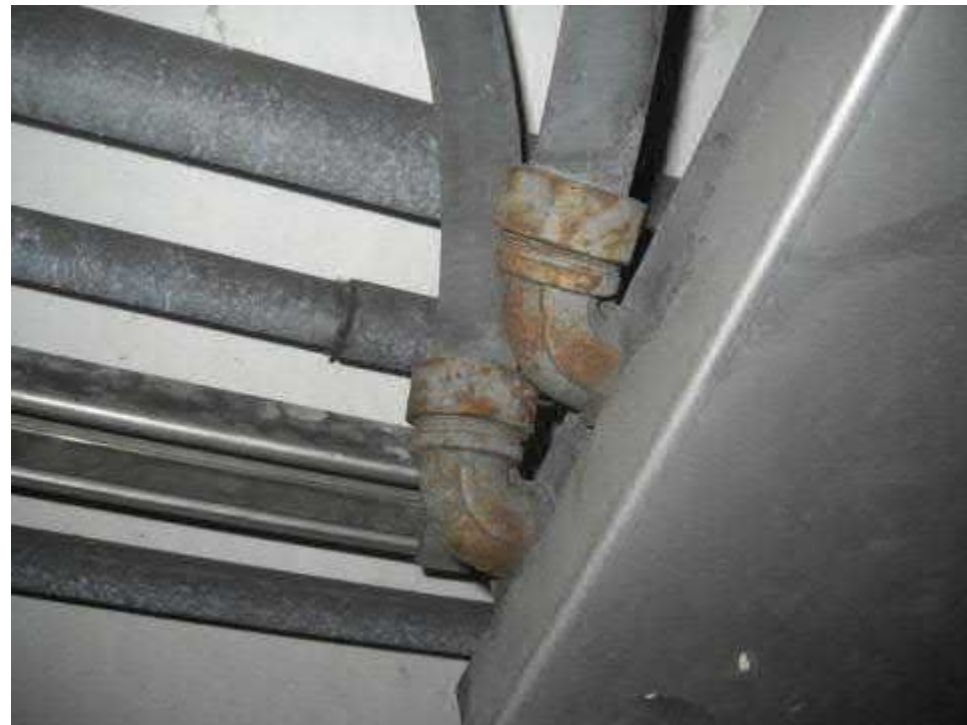
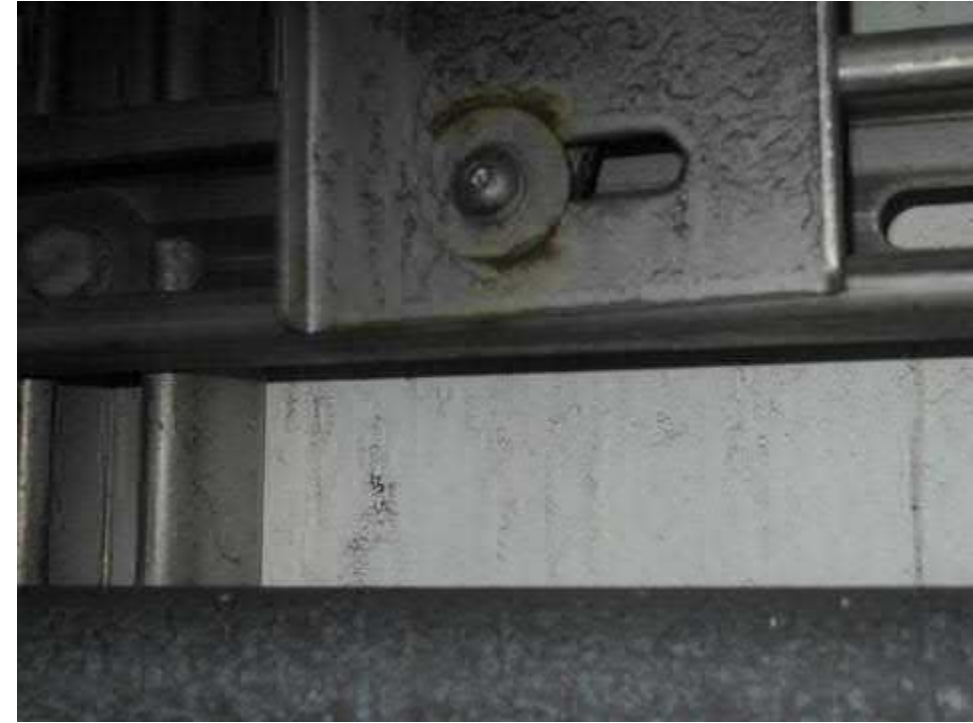
**Tunnel Lighting Section**

Lighting Fixture Information	
Luminaire Tag or Number:	SB EAST WALL - 54A
Tunnel Direction and Side:	SB EAST WALL
Additional Information:	T SEL TOP RIGHT

Are there any signs of corrosion evident on the tunnel lighting system raceways?
Are the side entry conduits into the fixture tightly secured?
Are there any signs of corrosion on the fixture?
Is there any damage to the component housing or enclosure?
Is the light fixture secure to the mounting channels?
Long channel springnut misaligned?
Long channel springnut cracked?
Trans channel springnut misaligned?
Trans channel springnut cracked?
Trans channel wireway clip?
Housing clip disengaged?
Housing clip missing?
Lens clip disengaged?
Lens clip broken?
Lens cover cracked?
Wireway ears broken?
Luminaire functioning?

Yes	No	No	No	No	No	No	Yes	No	Yes	No	No	Yes	No	Yes	Yes	Yes
-----	----	----	----	----	----	----	-----	----	-----	----	----	-----	----	-----	-----	-----

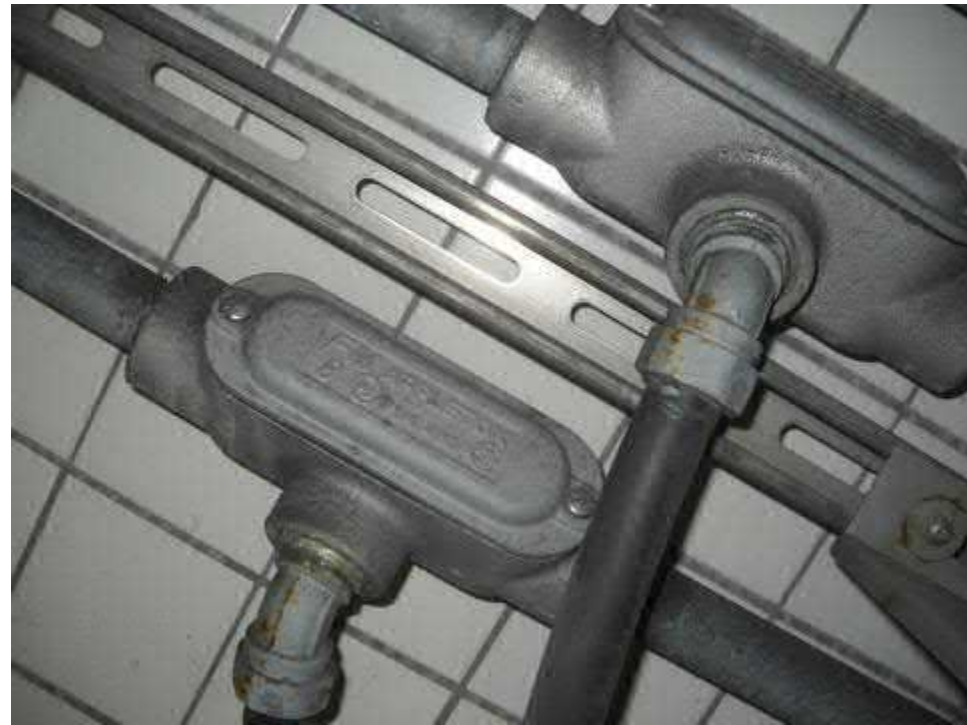
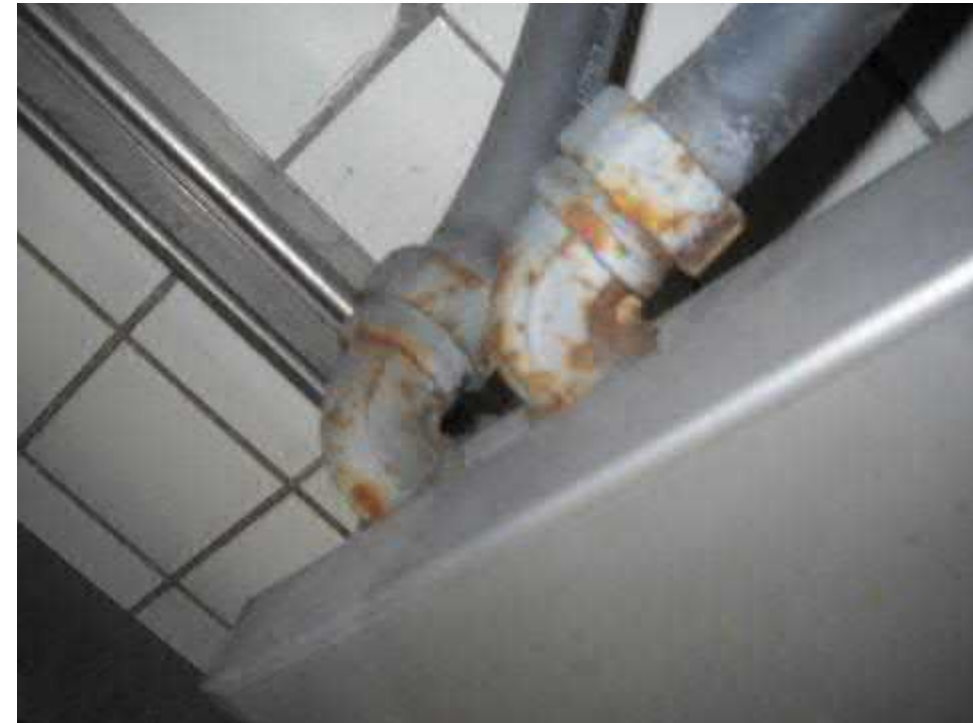
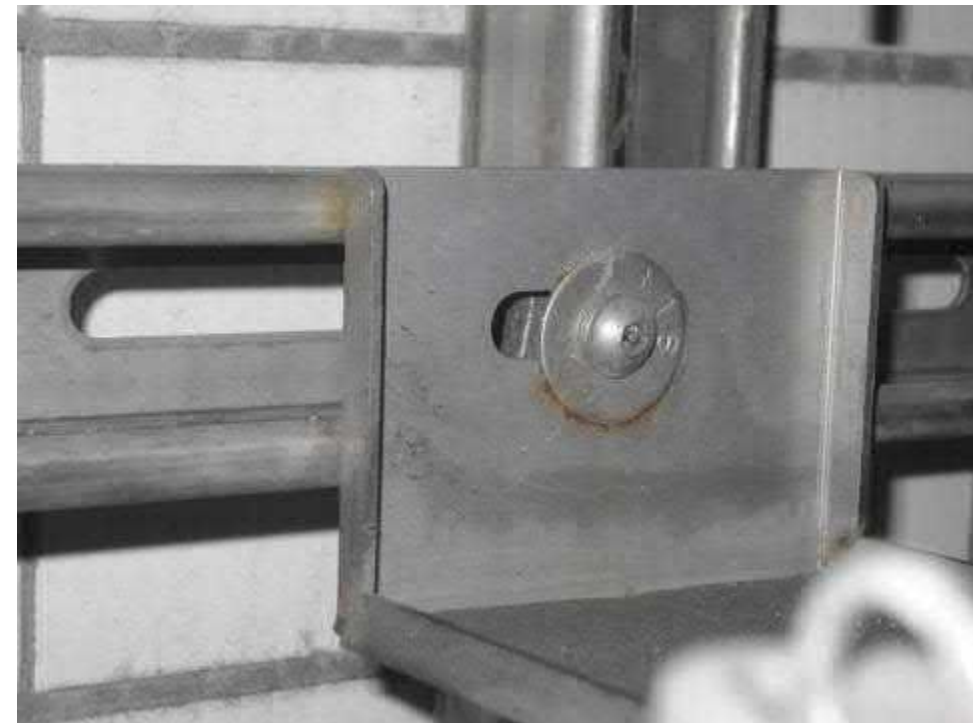
**Tunnel Lighting Section**

Lighting Fixture Information	
Luminaire Tag or Number:	SB EAST WALL - 54B
Tunnel Direction and Side:	SB EAST WALL
Additional Information:	T SEL

Are there any signs of corrosion evident on the tunnel lighting system raceways?	Yes
Are the side entry conduits into the fixture tightly secured?	Yes
Are there any signs of corrosion on the fixture?	No
Is there any damage to the component housing or enclosure?	No
Is the light fixture secure to the mounting channels?	Yes
Long channel springnut misaligned?	No
Long channel springnut cracked?	No
Trans channel springnut misaligned?	Yes
Trans channel springnut cracked?	No
Trans channel wireway clip?	Yes
Housing clip disengaged?	No
Housing clip missing?	No
Lens clip disengaged?	No
Lens clip broken?	No
Lens cover cracked?	No
Wireway ears broken?	No
Luminaire functioning?	Yes

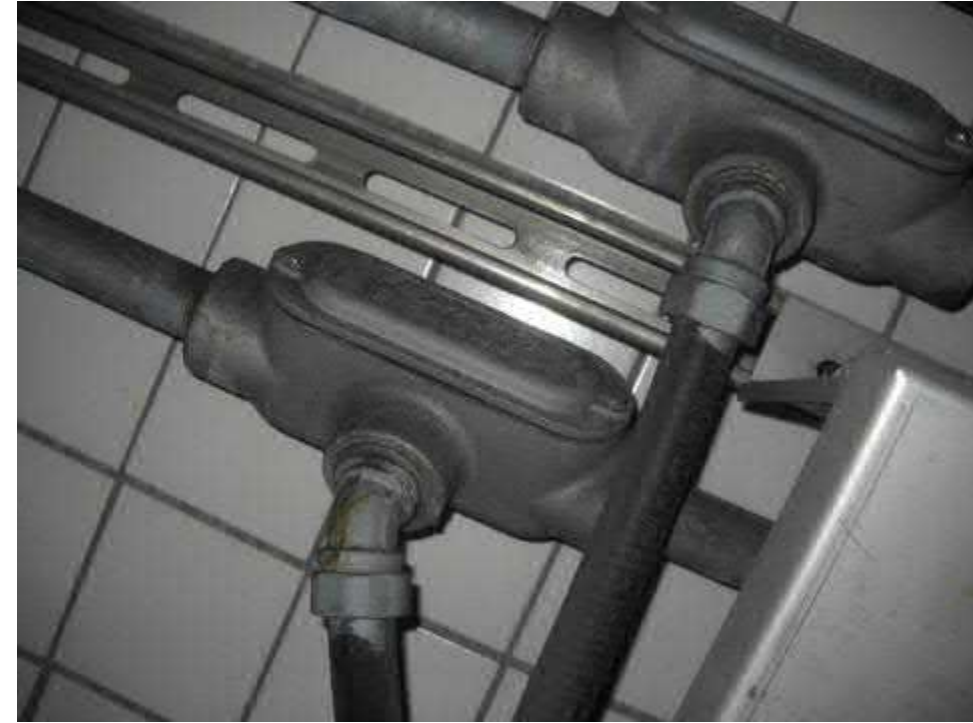
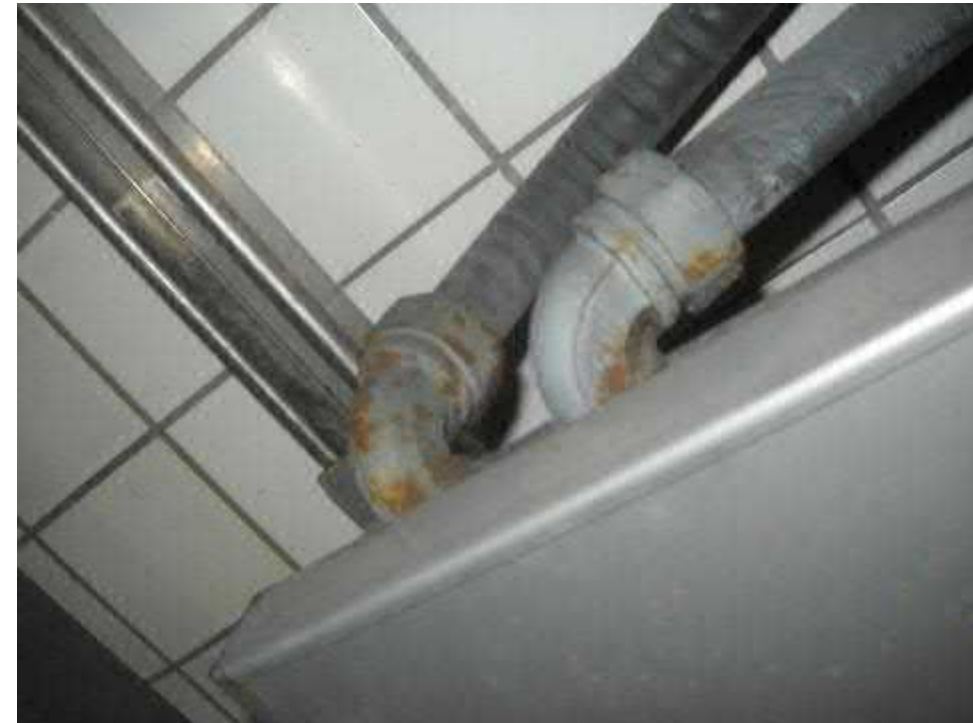
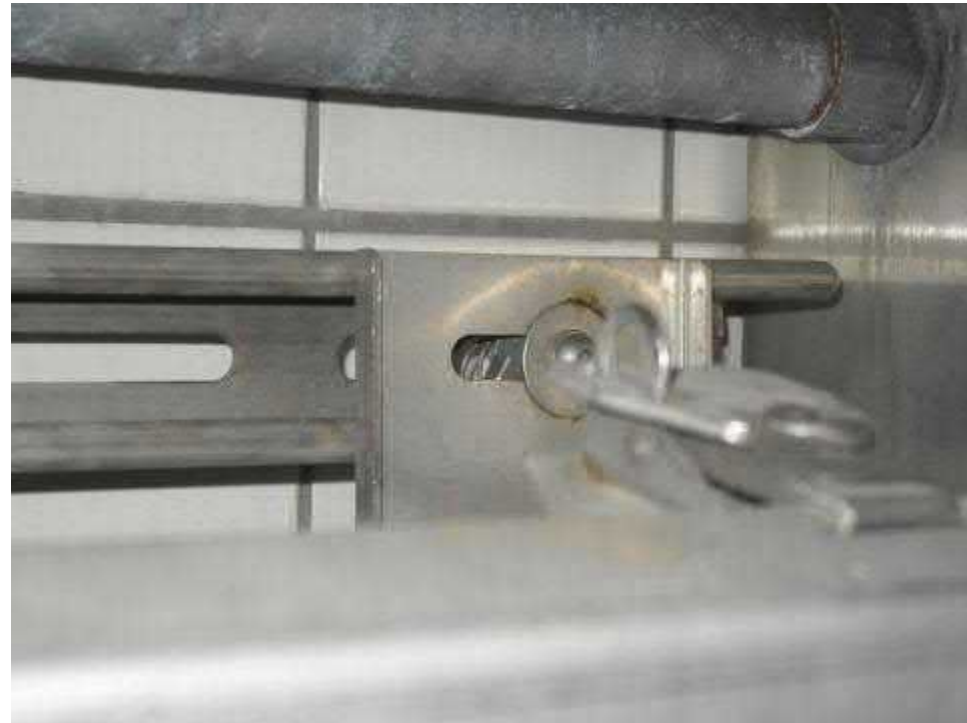
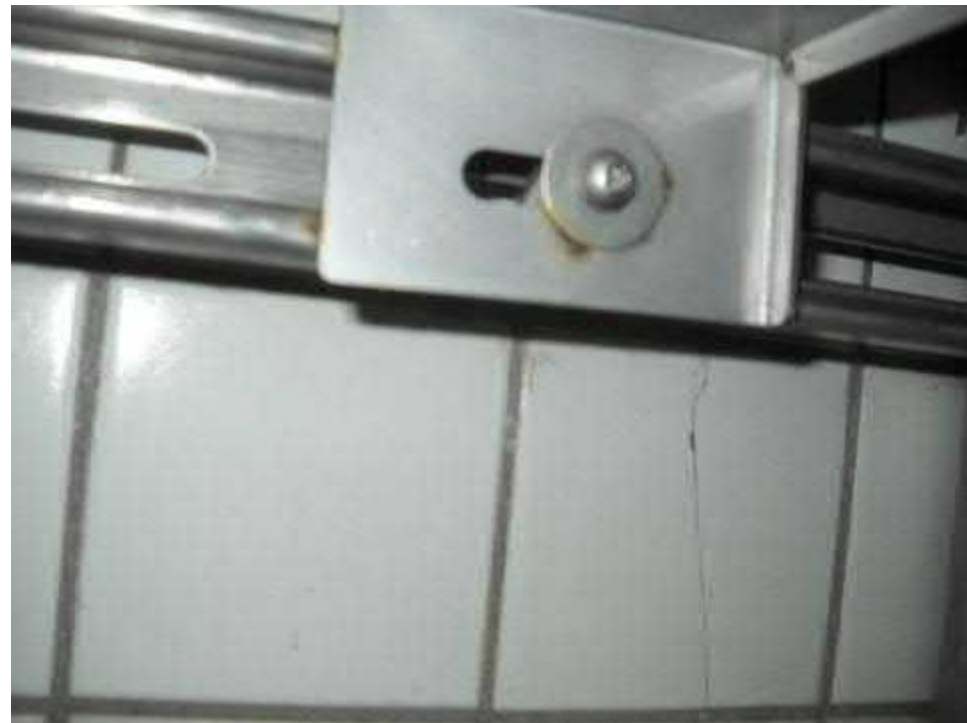
Lighting Fixture Information	
Luminaire Tag or Number:	SB EAST WALL - 45A
Tunnel Direction and Side:	SB EAST WALL
Additional Information:	T SEL TOP RIGHT BOTTOM LEFT

Are there any signs of corrosion evident on the tunnel lighting system raceways?	Yes
Are the side entry conduits into the fixture tightly secured?	Yes
Are there any signs of corrosion on the fixture?	No
Is there any damage to the component housing or enclosure?	No
Is the light fixture secure to the mounting channels?	No
Long channel springnut misaligned?	No
Long channel springnut cracked?	No
Trans channel springnut misaligned?	Yes
Trans channel springnut cracked?	No
Trans channel wireway clip?	Yes
Housing clip disengaged?	
Housing clip missing?	No
Lens clip disengaged?	No
Lens clip broken?	No
Lens cover cracked?	No
Wireway ears broken?	No
Luminaire functioning?	Yes

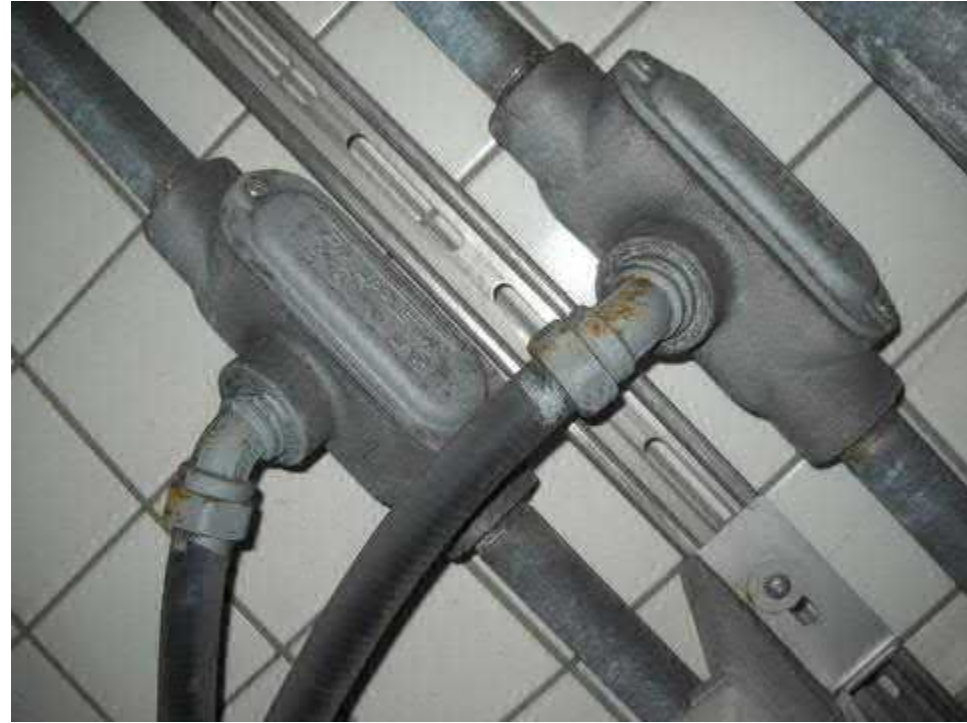
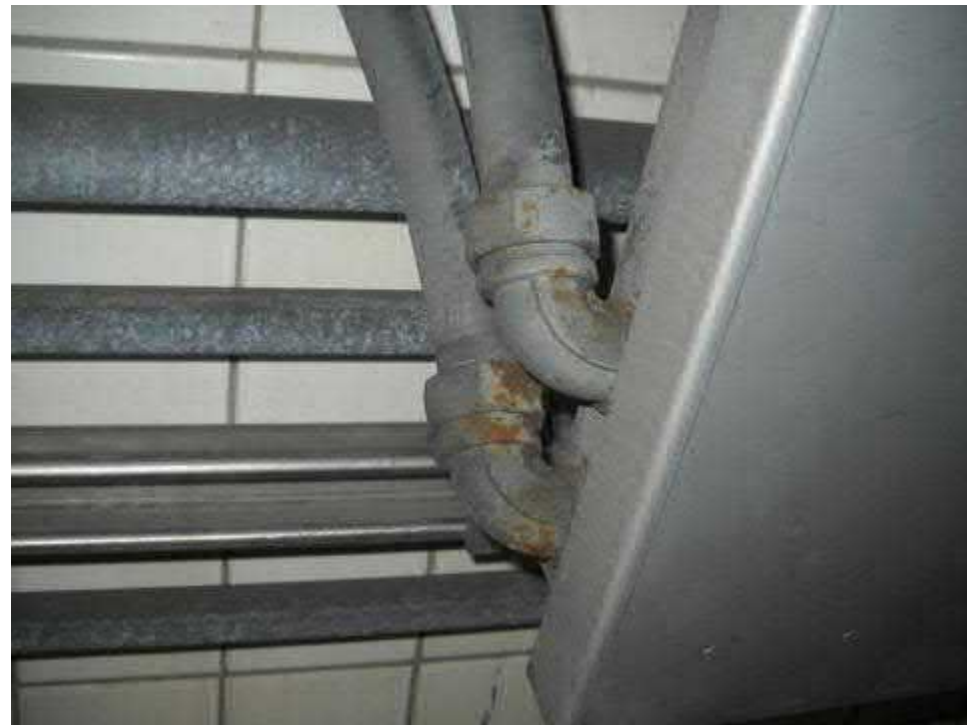
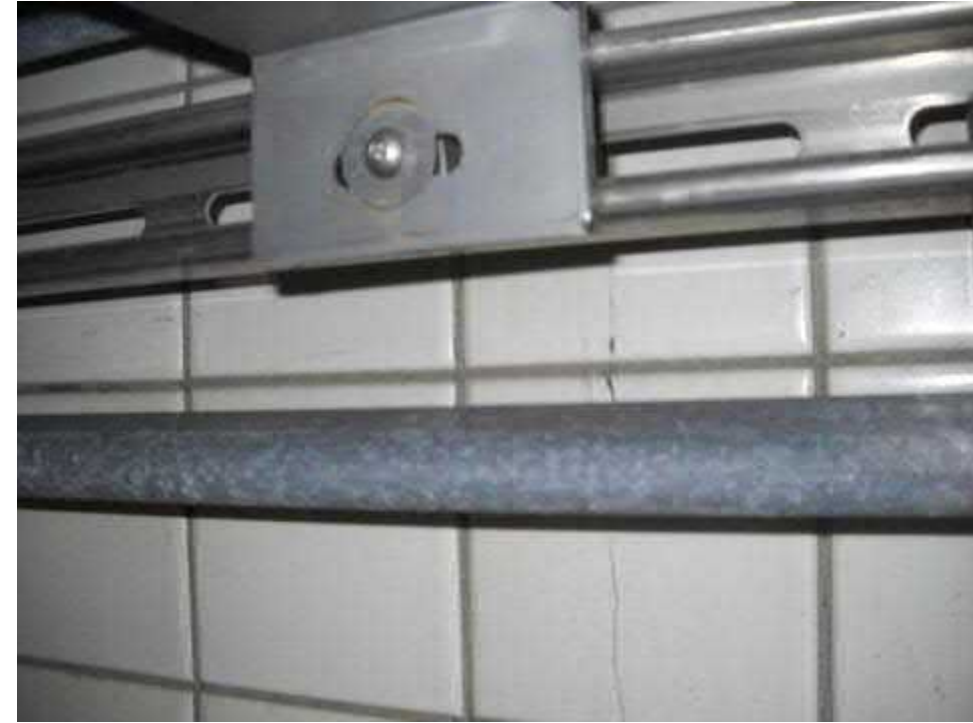
Lighting Fixture Information	
Luminaire Tag or Number:	SB EAST WALL - 45B
Tunnel Direction and Side:	SB EAST WALL
Additional Information:	T SEL BOTTOM LEFT

Are there any signs of corrosion evident on the tunnel lighting system raceways?	Yes
Are the side entry conduits into the fixture tightly secured?	Yes
Are there any signs of corrosion on the fixture?	No
Is there any damage to the component housing or enclosure?	No
Is the light fixture secure to the mounting channels?	Yes
Long channel springnut misaligned?	No
Long channel springnut cracked?	No
Trans channel springnut misaligned?	Yes
Trans channel springnut cracked?	No
Trans channel wireway clip?	Yes
Housing clip disengaged?	No
Housing clip missing?	No
Lens clip disengaged?	No
Lens clip broken?	No
Lens cover cracked?	No
Wireway ears broken?	No
Luminaire functioning?	Yes
