# **Lytle Tunnel (HAM-71-0134) Inspection Report Fall 2020**

PID 105470

November, 2020

Ohio Department of  
Transportation  
District 8  
505 South State Route 741  
Lebanon, OH 45036

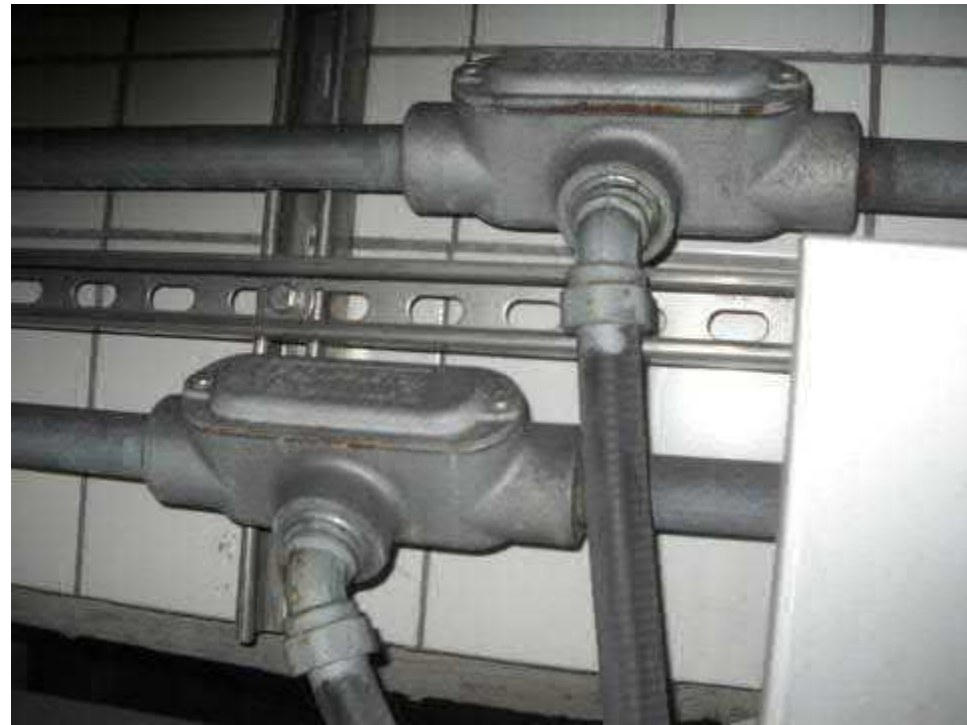
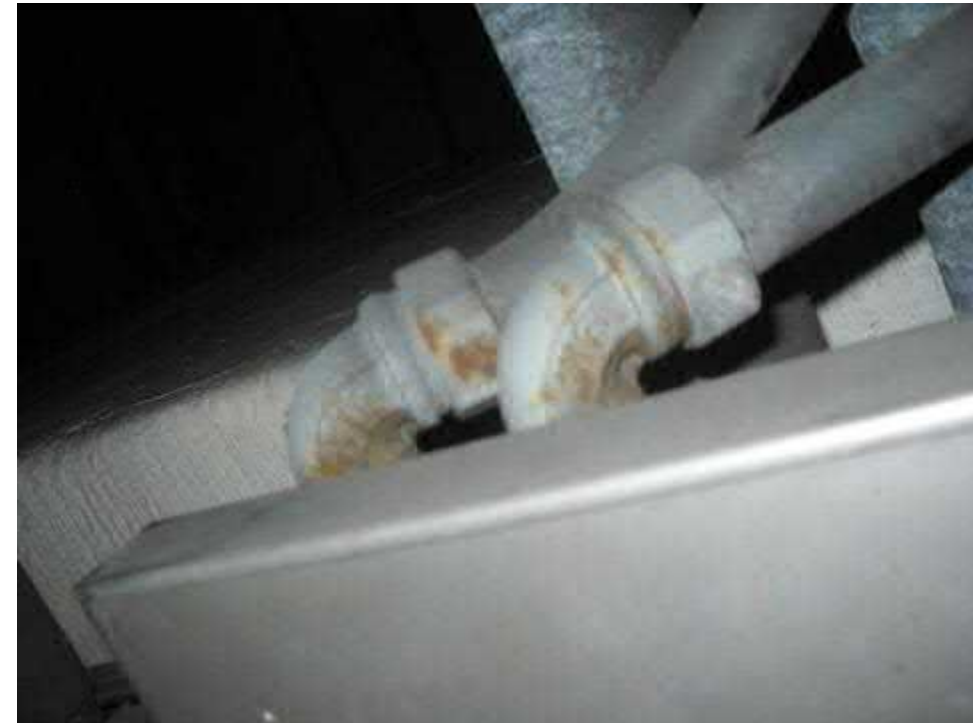
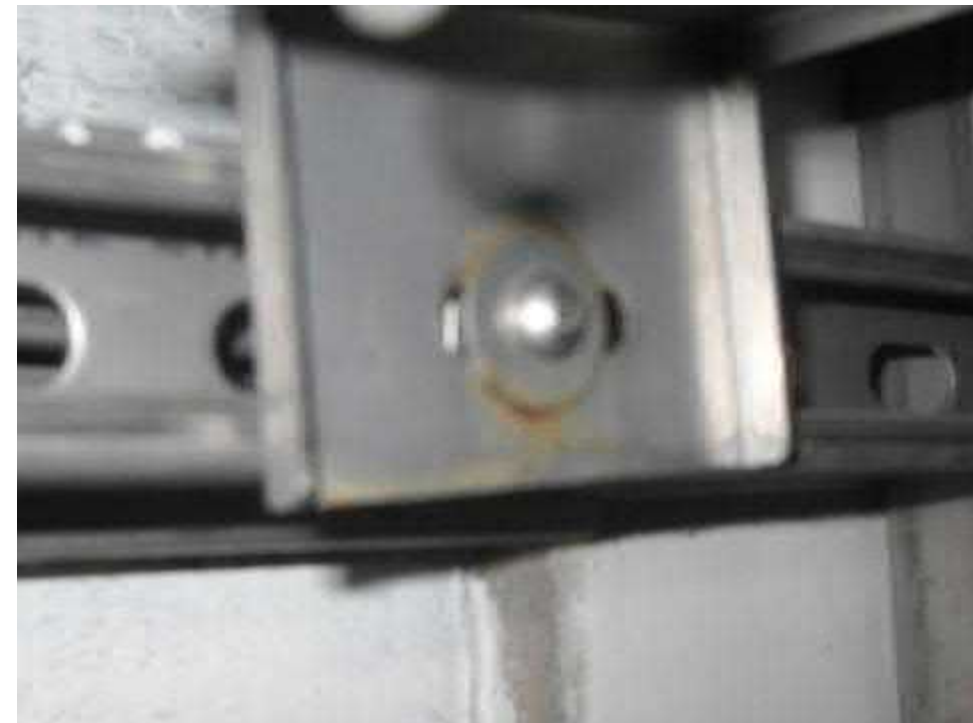
Lighting Fixture Information	
Luminaire Tag or Number:	SB EAST WALL - 36A
Tunnel Direction and Side:	SB EAST WALL
Additional Information:	T SEL BOTTOM RIGHT

Are there any signs of corrosion evident on the tunnel lighting system raceways?
Are the side entry conduits into the fixture tightly secured?
Are there any signs of corrosion on the fixture?
Is there any damage to the component housing or enclosure?
Is the light fixture secure to the mounting channels?
Long channel springnut misaligned?
Long channel springnut cracked?
Trans channel springnut misaligned?
Trans channel springnut cracked?
Trans channel wireway clip?
Housing clip disengaged?
Housing clip missing?
Lens clip disengaged?
Lens clip broken?
Lens cover cracked?
Wireway ears broken?
Luminaire functioning?

Yes	No	No	No	No	No	No	Yes	No	Yes	No	No	Yes	No	No	Yes	Yes
-----	----	----	----	----	----	----	-----	----	-----	----	----	-----	----	----	-----	-----

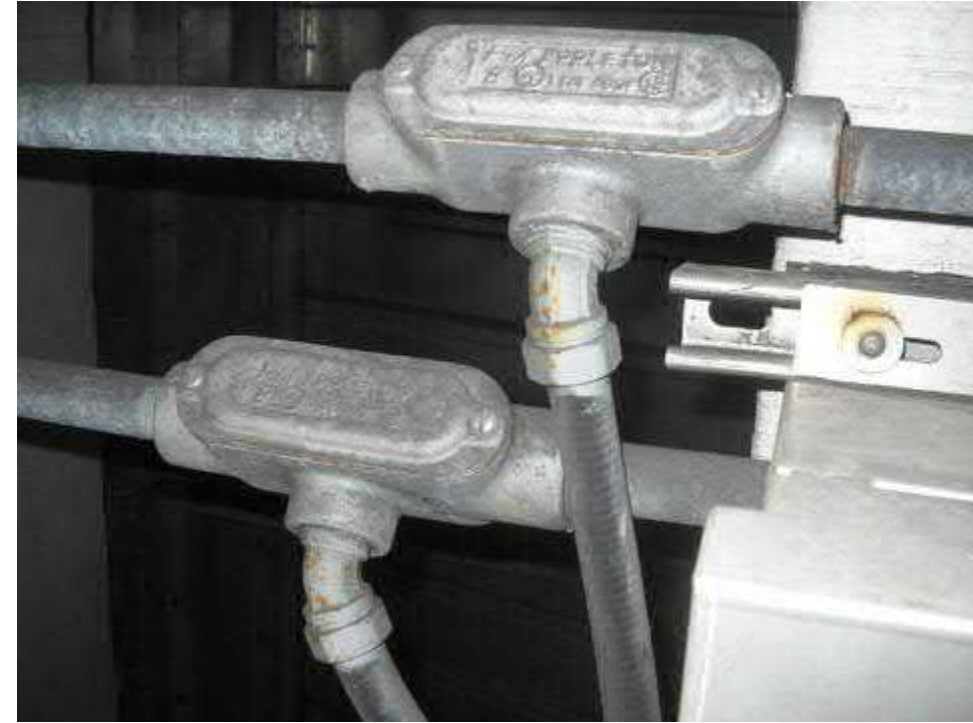
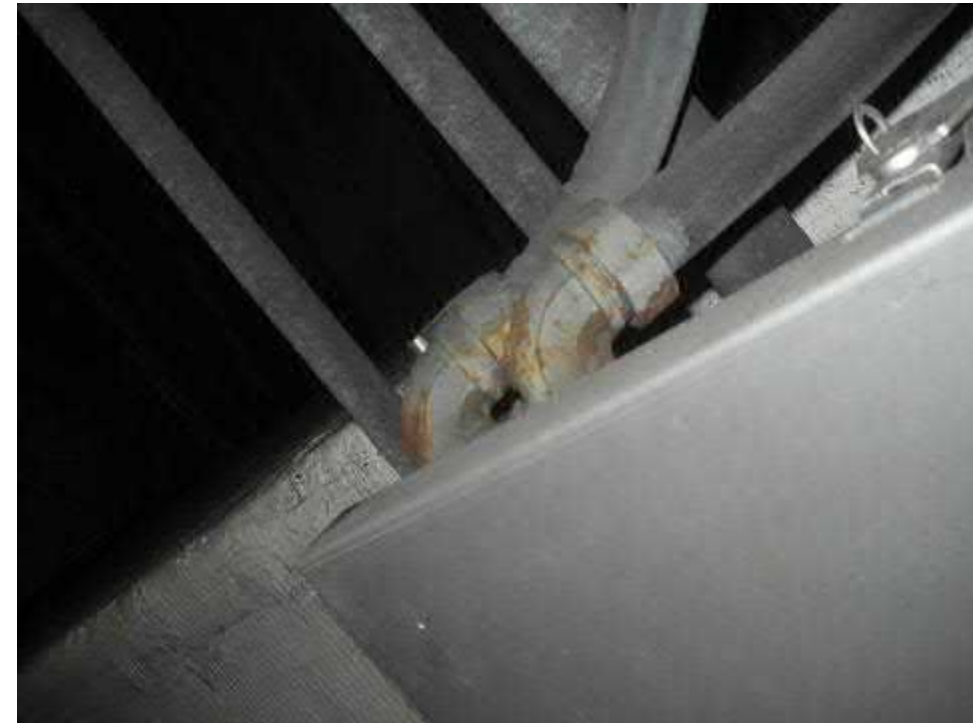
Lighting Fixture Information	
Luminaire Tag or Number:	SB EAST WALL - 36B
Tunnel Direction and Side:	SB EAST WALL
Additional Information:	T SEL SE LOOSE

Are there any signs of corrosion evident on the tunnel lighting system raceways?	Yes
Are the side entry conduits into the fixture tightly secured?	No
Are there any signs of corrosion on the fixture?	No
Is there any damage to the component housing or enclosure?	No
Is the light fixture secure to the mounting channels?	Yes
Long channel springnut misaligned?	No
Long channel springnut cracked?	No
Trans channel springnut misaligned?	No
Trans channel springnut cracked?	No
Trans channel wireway clip?	Yes
Housing clip disengaged?	No
Housing clip missing?	No
Lens clip disengaged?	No
Lens clip broken?	No
Lens cover cracked?	No
Wireway ears broken?	No
Luminaire functioning?	Yes

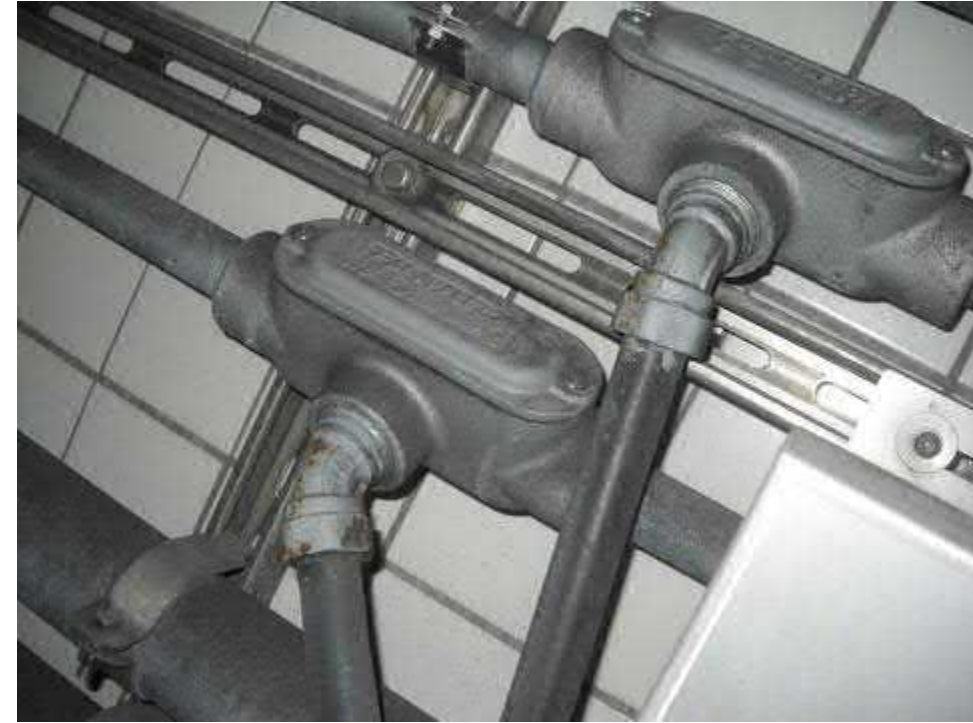
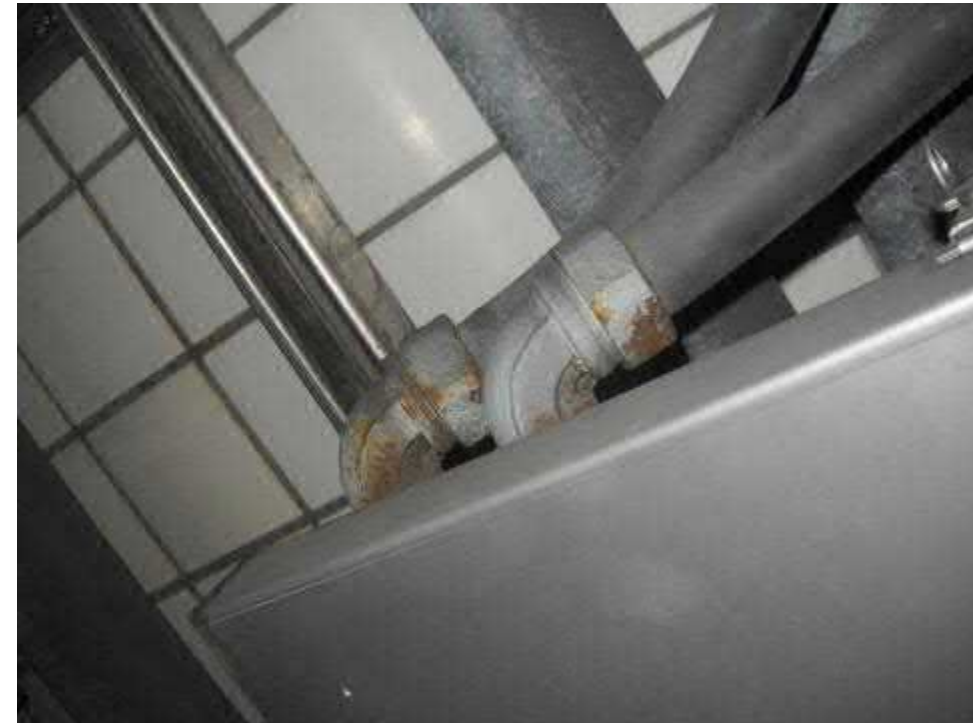
Lighting Fixture Information	
Luminaire Tag or Number:	SB EAST WALL - 27A
Tunnel Direction and Side:	SB EAST WALL
Additional Information:	T SEL

Are there any signs of corrosion evident on the tunnel lighting system raceways?	Yes
Are the side entry conduits into the fixture tightly secured?	Yes
Are there any signs of corrosion on the fixture?	No
Is there any damage to the component housing or enclosure?	No
Is the light fixture secure to the mounting channels?	Yes
Long channel springnut misaligned?	No
Long channel springnut cracked?	No
Trans channel springnut misaligned?	No
Trans channel springnut cracked?	No
Trans channel wireway clip?	Yes
Housing clip disengaged?	No
Housing clip missing?	No
Lens clip disengaged?	No
Lens clip broken?	No
Lens cover cracked?	No
Wireway ears broken?	No
Luminaire functioning?	Yes

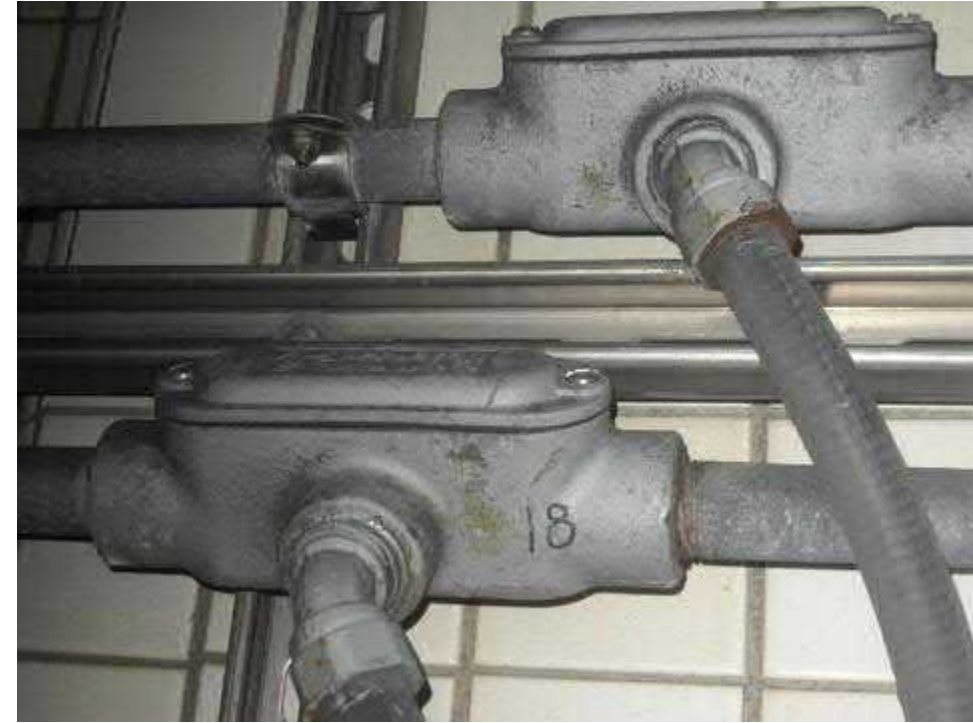
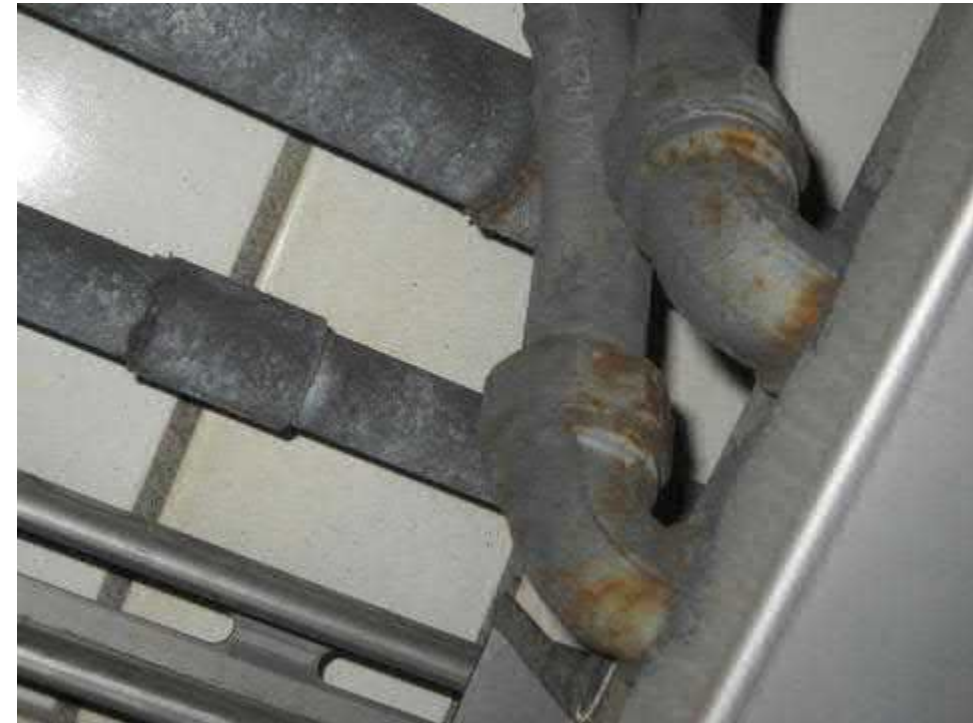
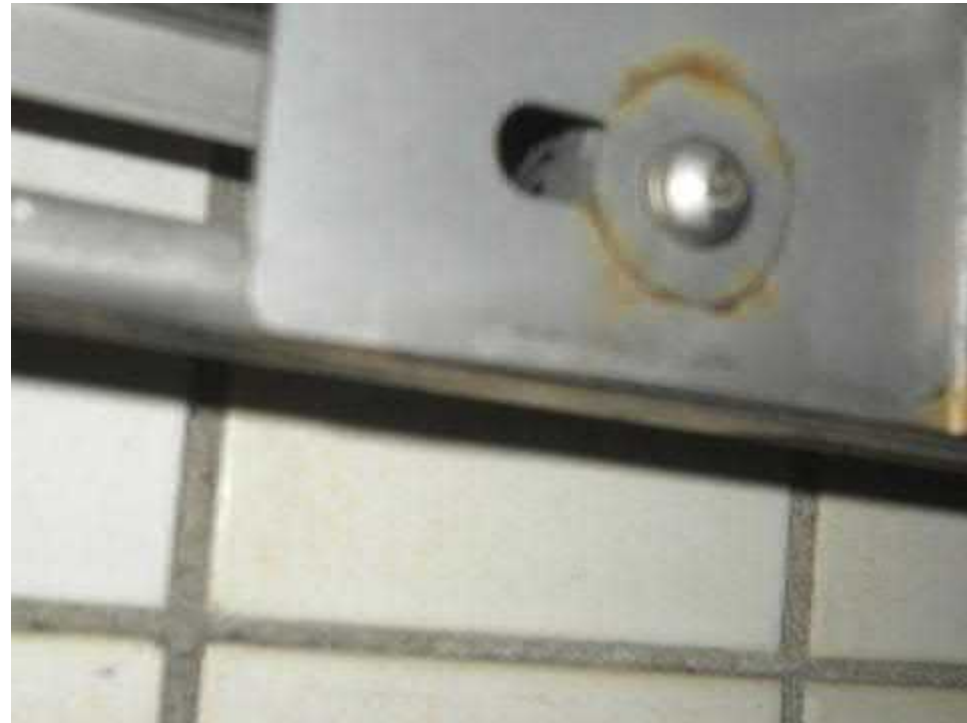
Lighting Fixture Information	
Luminaire Tag or Number:	SB EAST WALL - 27B
Tunnel Direction and Side:	SB EAST WALL
Additional Information:	T SEL BOTTOM LEFT

Are there any signs of corrosion evident on the tunnel lighting system raceways?	Yes
Are the side entry conduits into the fixture tightly secured?	Yes
Are there any signs of corrosion on the fixture?	No
Is there any damage to the component housing or enclosure?	No
Is the light fixture secure to the mounting channels?	Yes
Long channel springnut misaligned?	No
Long channel springnut cracked?	No
Trans channel springnut misaligned?	Yes
Trans channel springnut cracked?	No
Trans channel wireway clip?	Yes
Housing clip disengaged?	No
Housing clip missing?	No
Lens clip disengaged?	No
Lens clip broken?	No
Lens cover cracked?	No
Wireway ears broken?	No
Luminaire functioning?	Yes

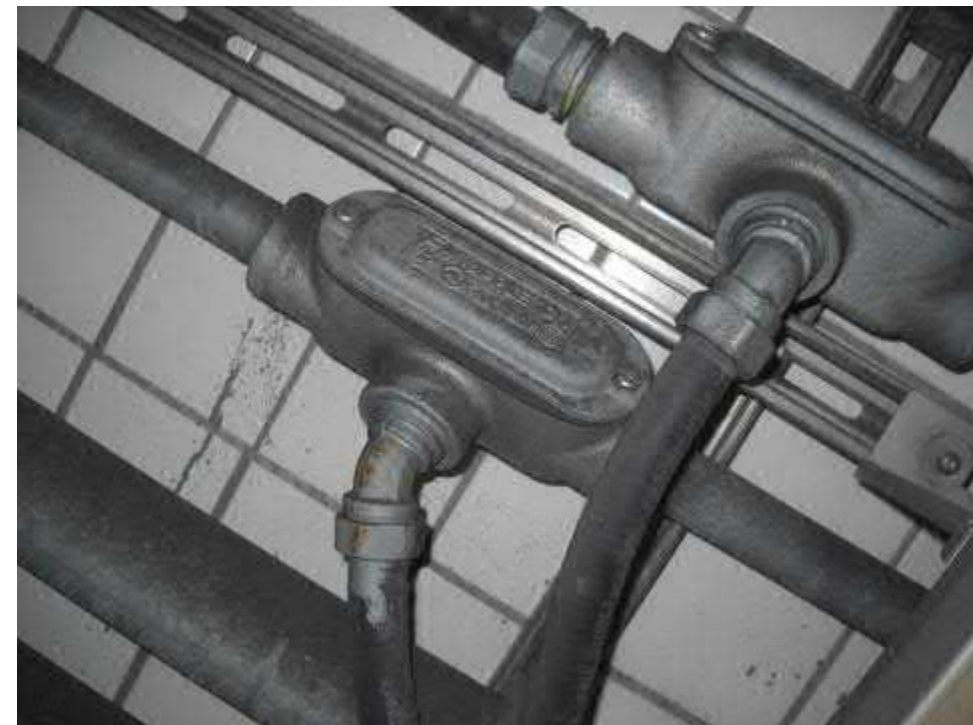
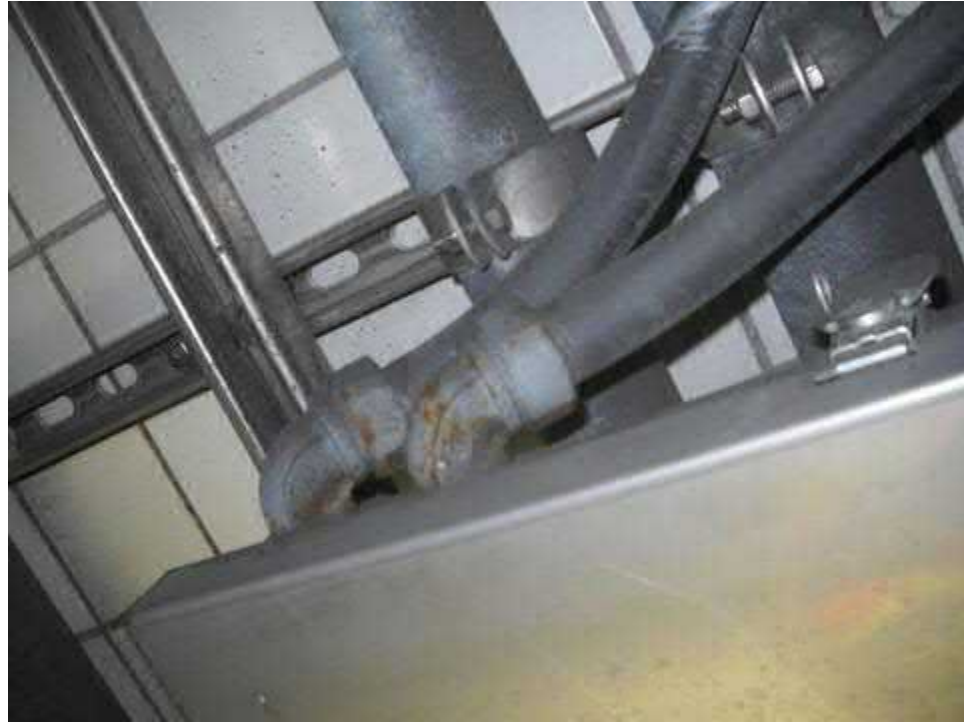
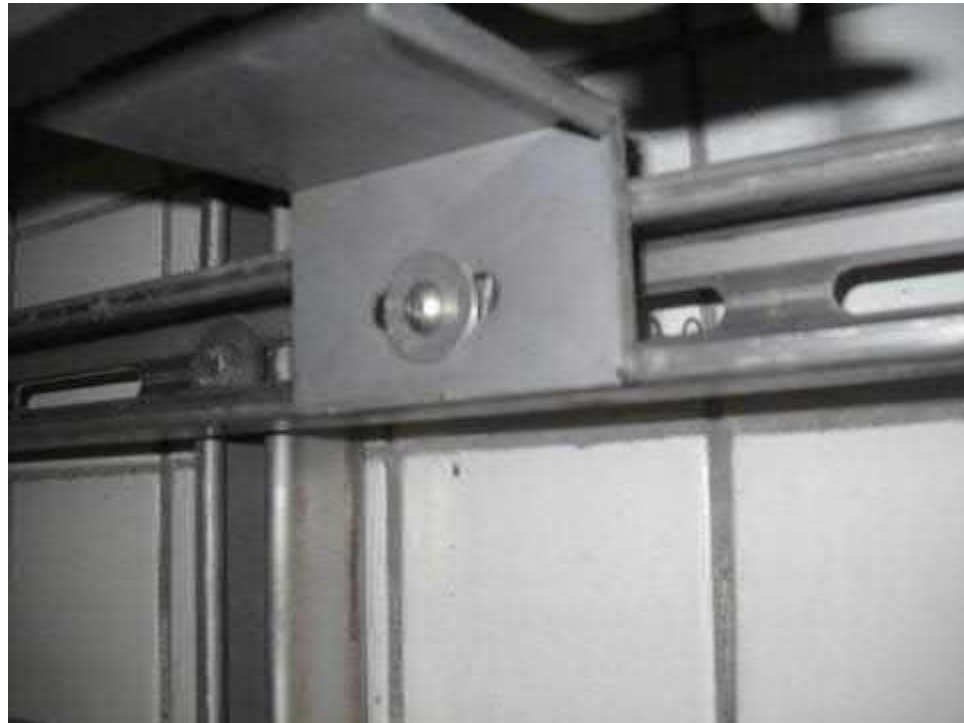
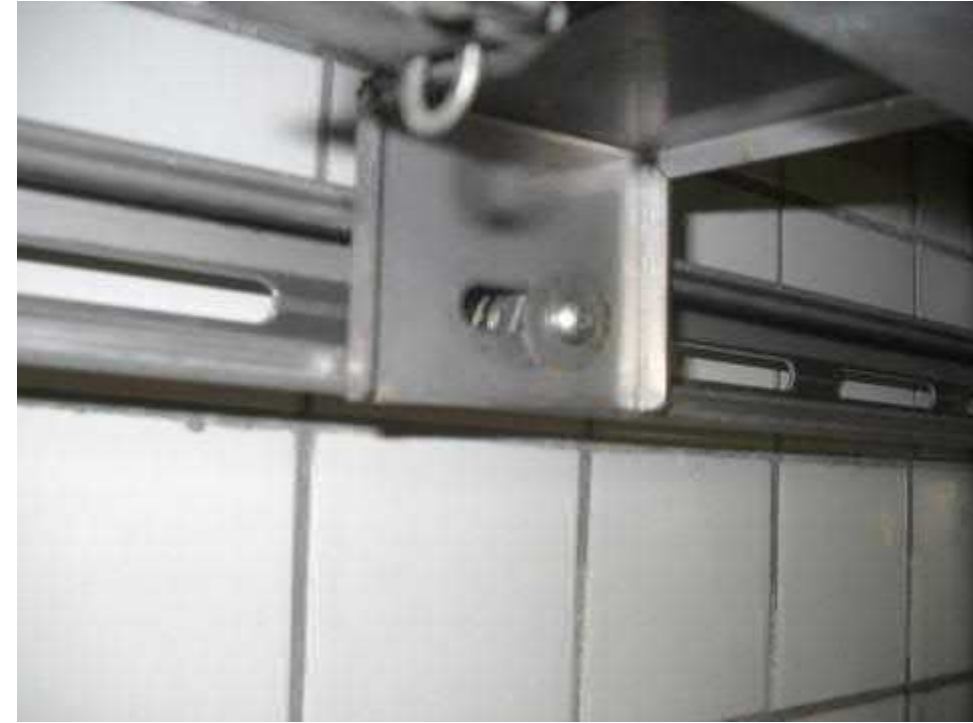
Lighting Fixture Information	
Luminaire Tag or Number:	SB EAST WALL - 18A
Tunnel Direction and Side:	SB EAST WALL
Additional Information:	T SEL BOTH BOTTOM

Are there any signs of corrosion evident on the tunnel lighting system raceways?
Are the side entry conduits into the fixture tightly secured?
Are there any signs of corrosion on the fixture?
Is there any damage to the component housing or enclosure?
Is the light fixture secure to the mounting channels?
Long channel springnut misaligned?
Long channel springnut cracked?
Trans channel springnut cracked?
Trans channel springnut misaligned?
Trans channel springnut cracked?
Trans channel wireway clip?
Housing clip disengaged?
Housing clip missing?
Lens clip disengaged?
Lens clip broken?
Lens cover cracked?
Wireway ears broken?
Luminaire functioning?

Yes	No	No	No	No	No	No	Yes	No	Yes	No	No	Yes	No	No	Yes	Yes
-----	----	----	----	----	----	----	-----	----	-----	----	----	-----	----	----	-----	-----

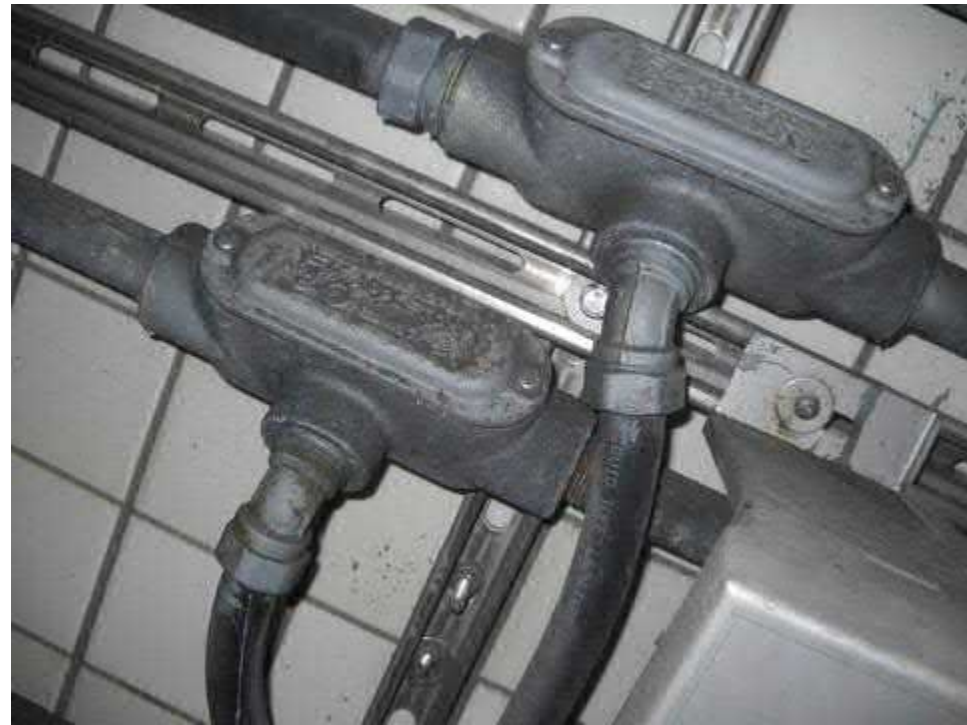
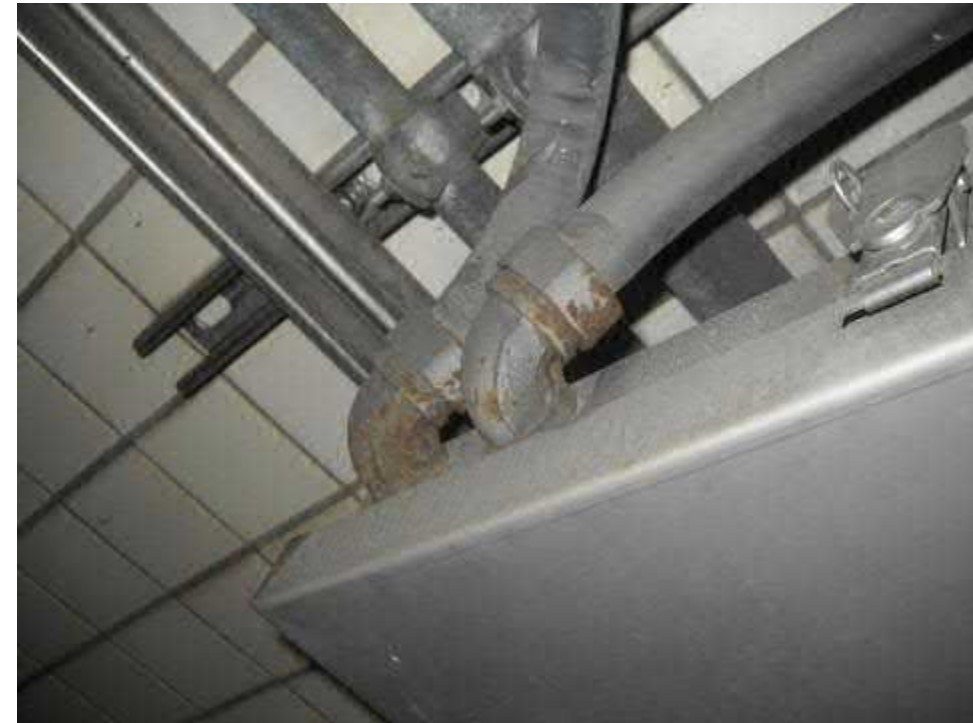
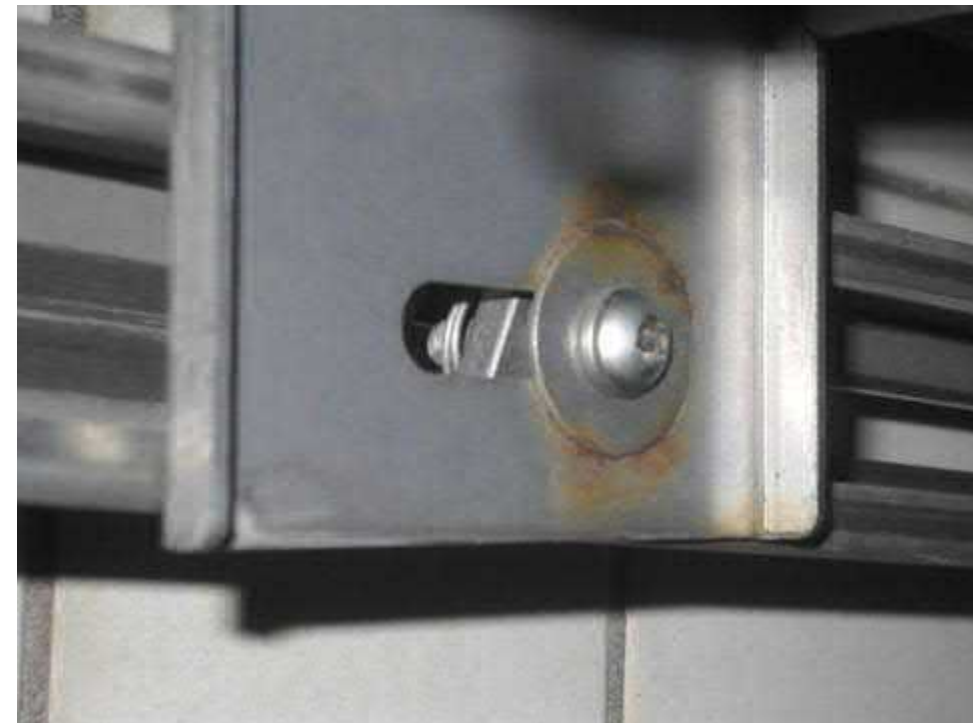
Lighting Fixture Information	
Luminaire Tag or Number:	SB EAST WALL - 18B
Tunnel Direction and Side:	SB EAST WALL
Additional Information:	T SEL BOTTOM RIGHT

Are there any signs of corrosion evident on the tunnel lighting system raceways?
Are the side entry conduits into the fixture tightly secured?
Are there any signs of corrosion on the fixture?
Is there any damage to the component housing or enclosure?
Is the light fixture secure to the mounting channels?
Long channel springnut misaligned?
Long channel springnut cracked?
Trans channel springnut misaligned?
Trans channel springnut cracked?
Trans channel wireway clip?
Housing clip disengaged?
Housing clip missing?
Lens clip disengaged?
Lens clip broken?
Lens cover cracked?
Wireway ears broken?
Luminaire functioning?

Yes	No	No	No	No	No	No	Yes	No	Yes	No	No	Yes	No	No	Yes	Yes
-----	----	----	----	----	----	----	-----	----	-----	----	----	-----	----	----	-----	-----

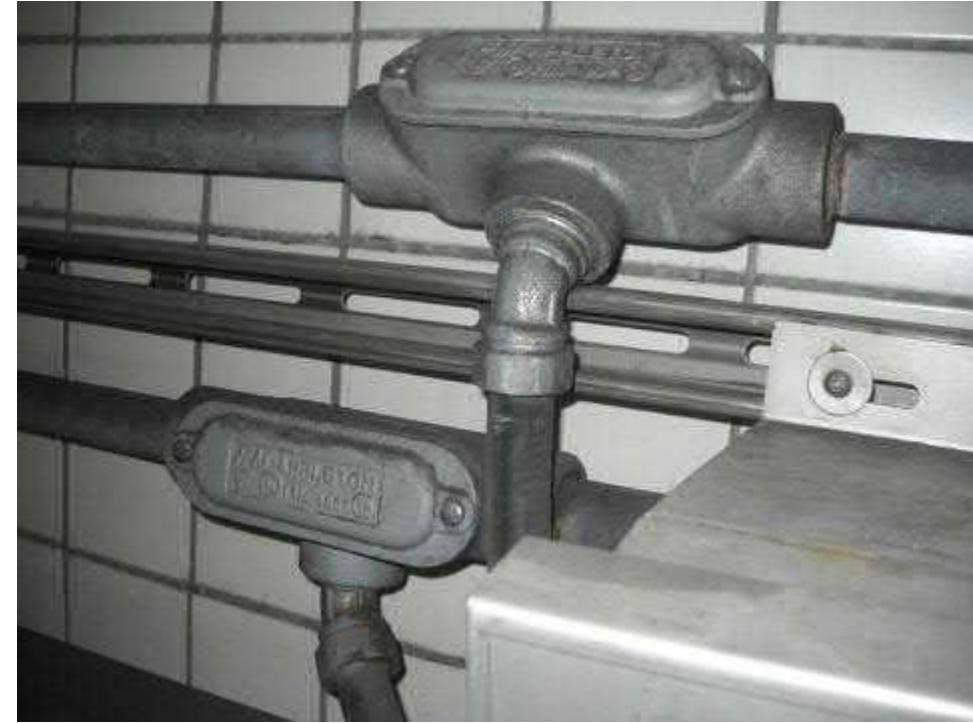
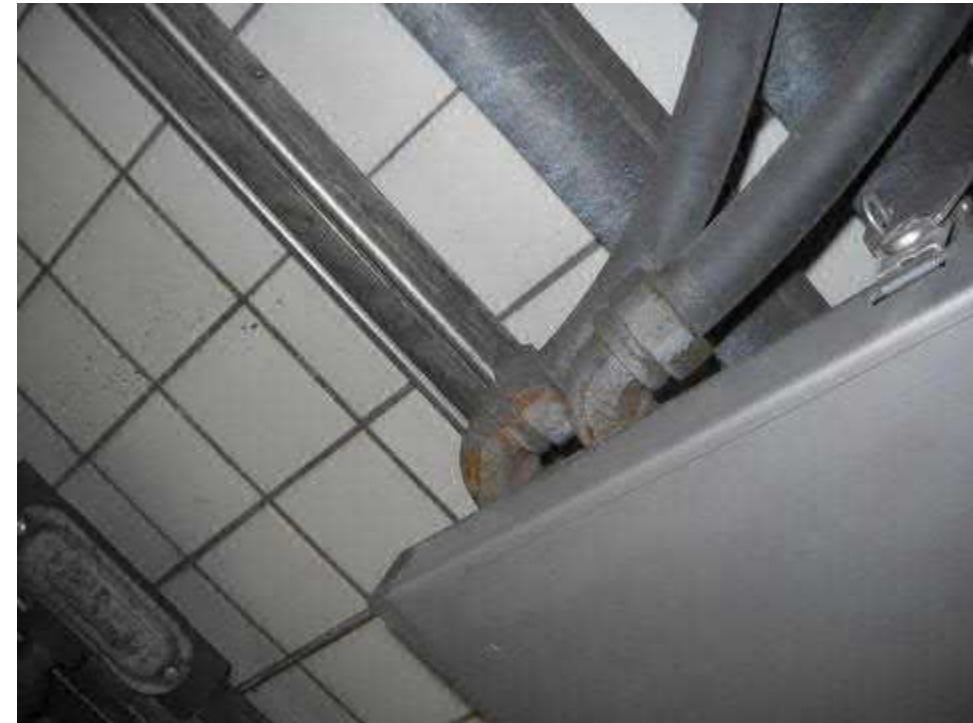
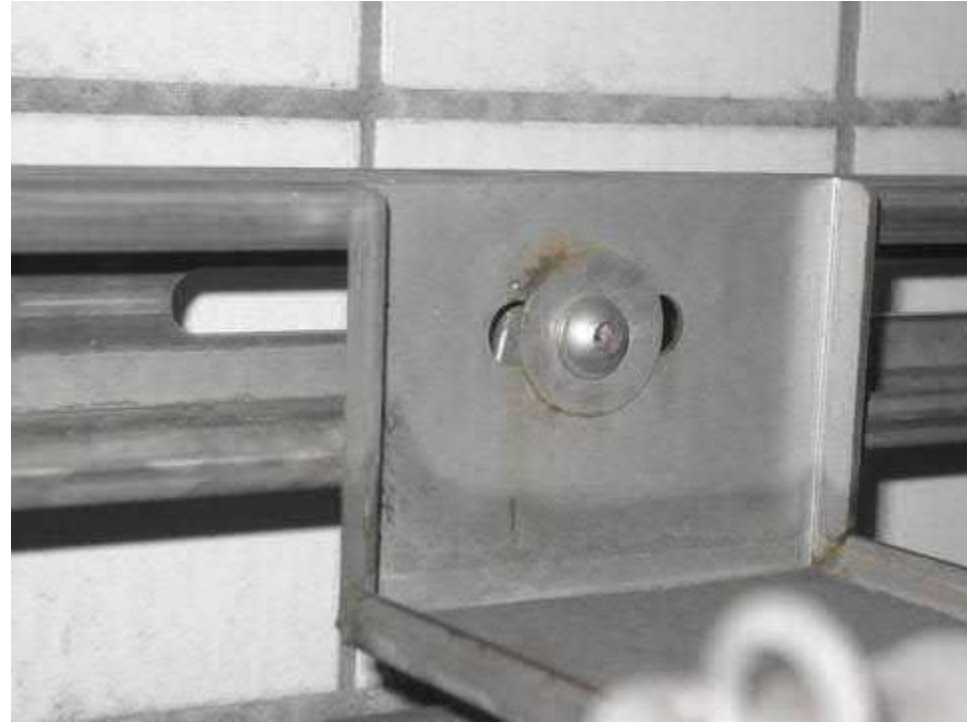
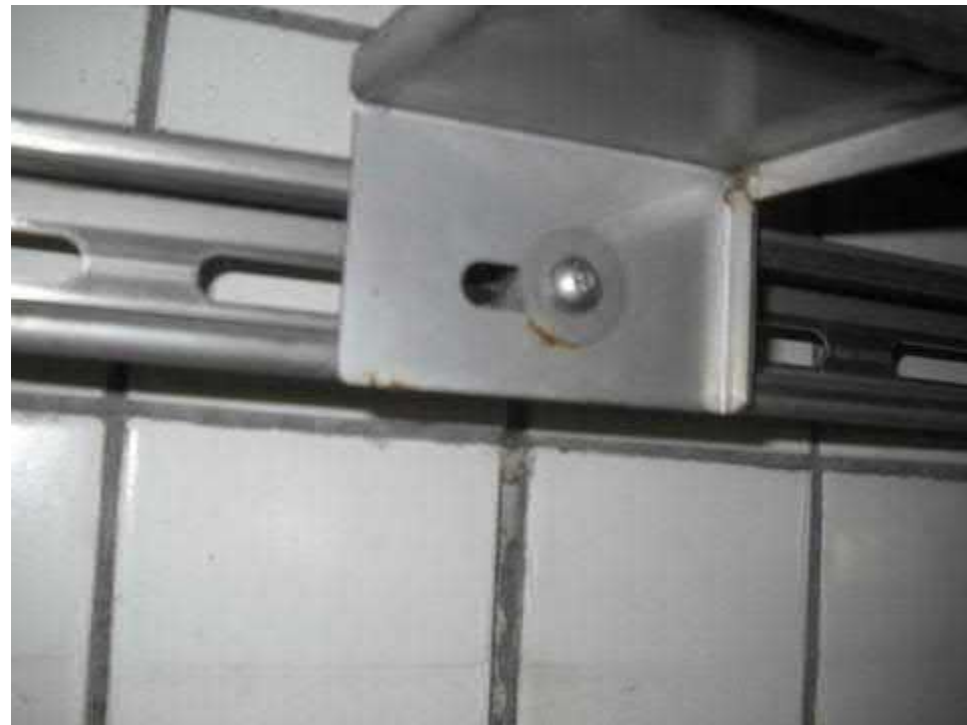
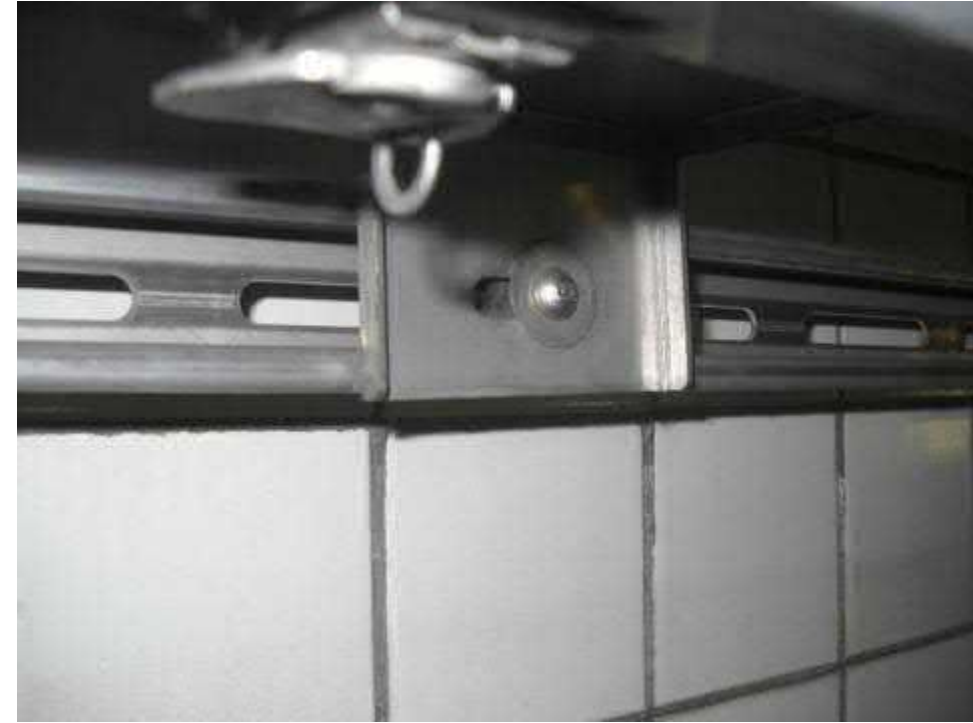
Lighting Fixture Information	
Luminaire Tag or Number:	SB EAST WALL – 9A
Tunnel Direction and Side:	SB EAST WALL
Additional Information:	T SEL TOP RIGHT BOTH BOTTOM

Are there any signs of corrosion evident on the tunnel lighting system raceways?	Yes
Are the side entry conduits into the fixture tightly secured?	Yes
Are there any signs of corrosion on the fixture?	No
Is there any damage to the component housing or enclosure?	No
Is the light fixture secure to the mounting channels?	Yes
Long channel springnut misaligned?	No
Long channel springnut cracked?	No
Trans channel springnut misaligned?	Yes
Trans channel springnut cracked?	No
Trans channel wireway clip?	Yes
Housing clip disengaged?	No
Housing clip missing?	No
Lens clip disengaged?	No
Lens clip broken?	No
Lens cover cracked?	No
Wireway ears broken?	No
Luminaire functioning?	Yes

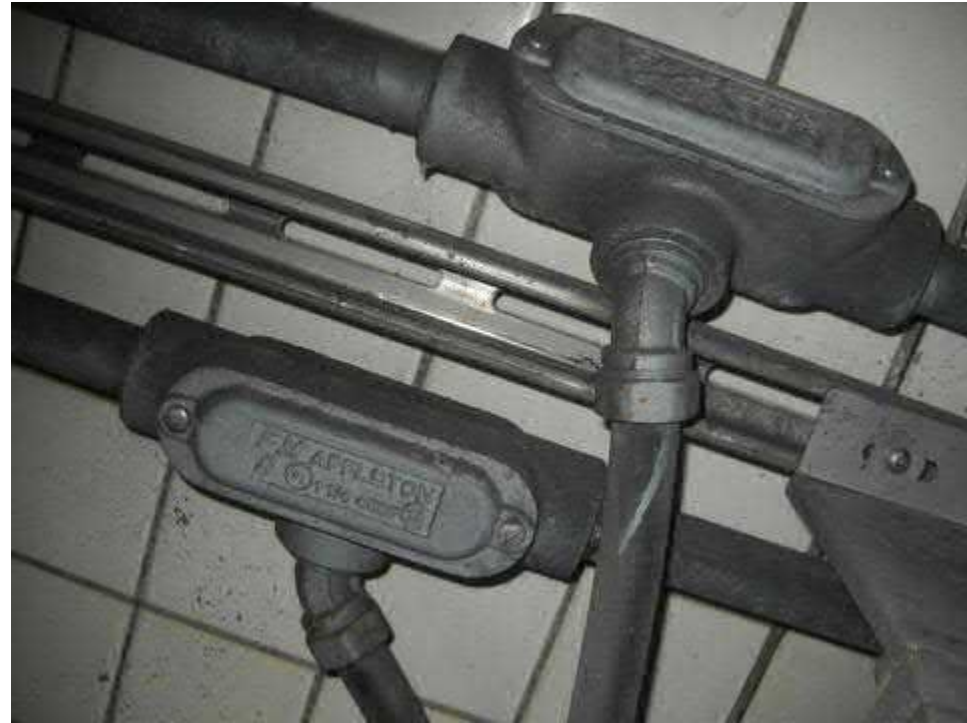
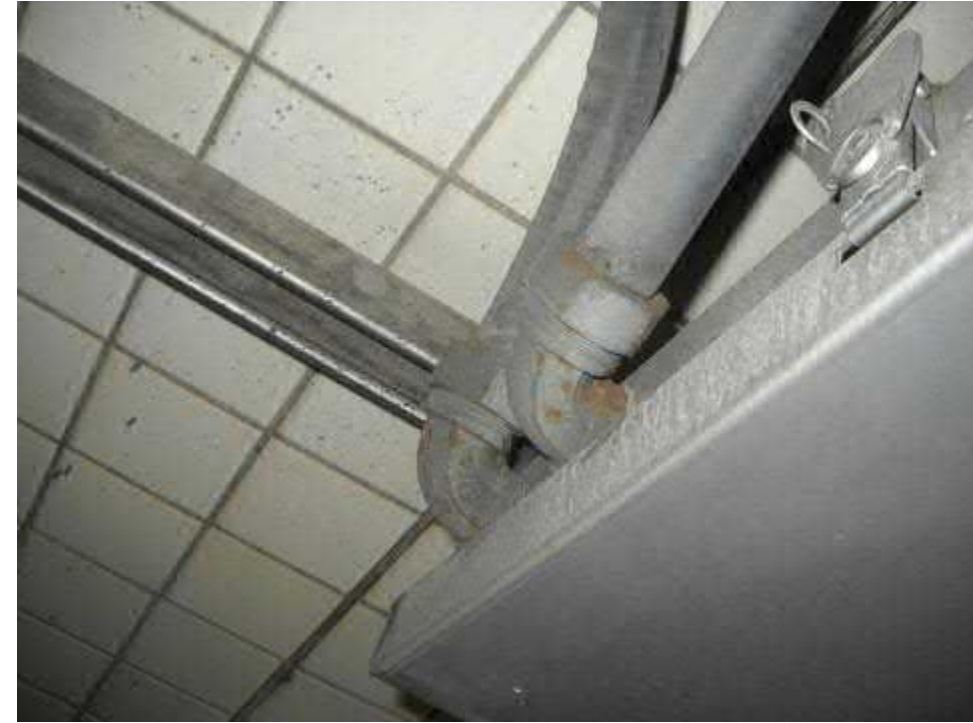
Lighting Fixture Information	
Luminaire Tag or Number:	SB EAST WALL – 9B
Tunnel Direction and Side:	SB EAST WALL
Additional Information:	T SEL

Are there any signs of corrosion evident on the tunnel lighting system raceways?
Are the side entry conduits into the fixture tightly secured?
Are there any signs of corrosion on the fixture?
Is there any damage to the component housing or enclosure?
Is the light fixture secure to the mounting channels?
Long channel springnut misaligned?
Long channel springnut cracked?
Trans channel springnut misaligned?
Trans channel springnut cracked?
Trans channel wireway clip?
Housing clip disengaged?
Housing clip missing?
Lens clip disengaged?
Lens clip broken?
Lens cover cracked?
Wireway ears broken?
Luminaire functioning?

Yes	No	No	No	No	No	No	Yes	No	No	No	No	Yes	No	No	Yes	Yes
-----	----	----	----	----	----	----	-----	----	----	----	----	-----	----	----	-----	-----

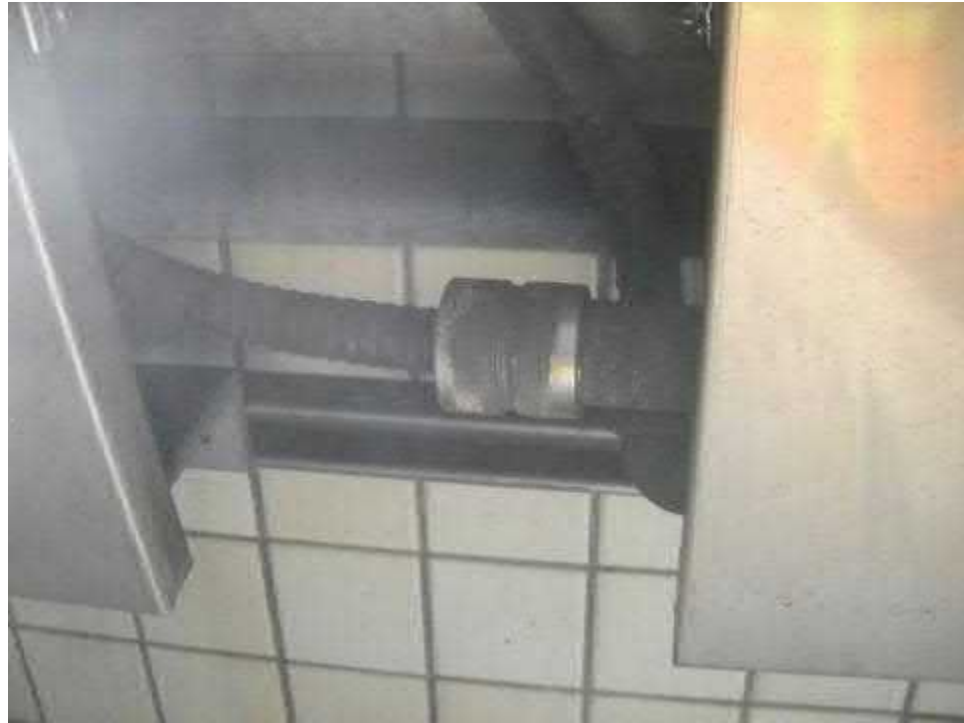
Lighting Fixture Information	
Luminaire Tag or Number:	SB EAST WALL - 1A
Tunnel Direction and Side:	SB EAST WALL
Additional Information:	SEL

Are there any signs of corrosion evident on the tunnel lighting system raceways?
Are the side entry conduits into the fixture tightly secured?
Are there any signs of corrosion on the fixture?
Is there any damage to the component housing or enclosure?
Is the light fixture secure to the mounting channels?
Long channel springnut misaligned?
Long channel springnut cracked?
Trans channel springnut misaligned?
Trans channel springnut cracked?
Trans channel wireway clip?
Housing clip disengaged?
Housing clip missing?
Lens clip disengaged?
Lens clip broken?
Lens cover cracked?
Wireway ears broken?
Luminaire functioning?

Yes	No	No	No	No	No	No	Yes	No	No	No	No	Yes	No	No	Yes	Yes
-----	----	----	----	----	----	----	-----	----	----	----	----	-----	----	----	-----	-----
