# Routine and NSTM Member Inspection Report

## HAM-42-0264R 2025 Routine and NSTM Member Inspection Report (VAR-District 8 Bridge Inspections for Steel Pier Caps)

SFN: 3101223, PID: 109781

August 23, 2025

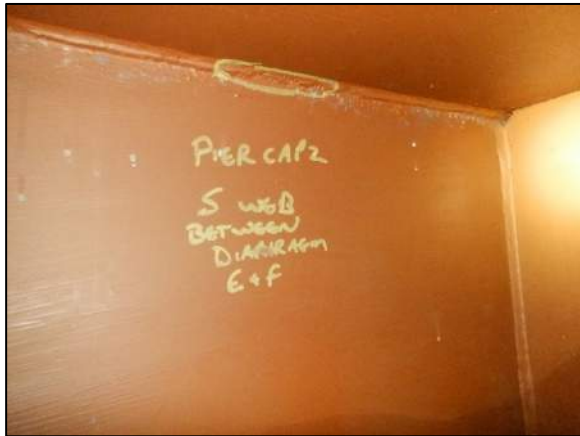
The drilled holes and sawcut retrofits are present at all girders except Girder A. There are localized areas of porosity in the fillet welds between both webs and the top flange (Photo 3). There is a 1" L x 1/2" H weld undercut in the fillet weld at the bottom of the south web and bottom flange between the two stiffeners between Girder C and D diaphragms.

Photo 3: Weld Porosity in South Web Between Diaphragm E and F

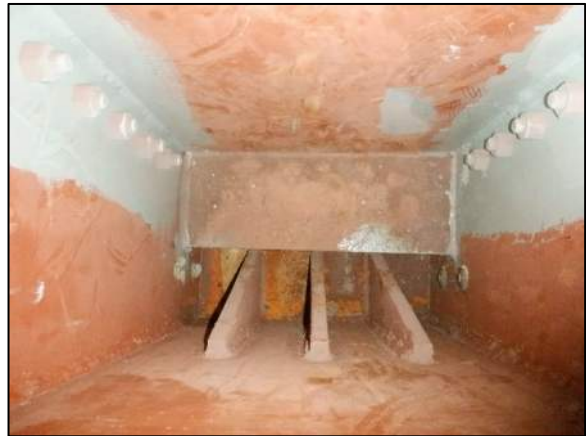
The interior paint is in SATISFACTORY condition [6] with some light scattered surface rust. Isolated areas of heavy pitting were noted along the bottom of both web plates at the west bearings (Photo 6). The lower flange at the East Bearing has active corrosion. Lower corners have areas of rust at east end of cap.

Photo 6: Typical Pitting on Bottom Flange and Bottom of Webs

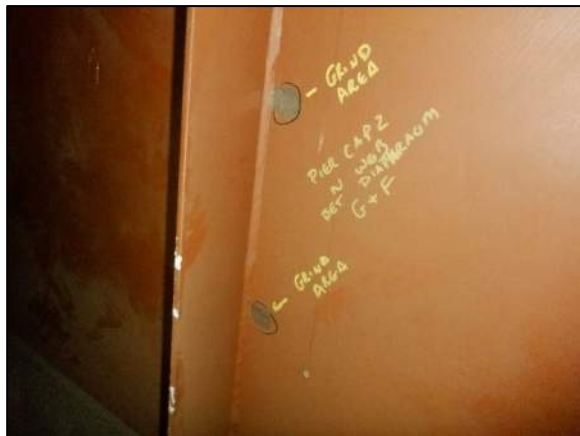
- Between Girders B and C on north web west of stiffener
- Between the Girders C and D diaphragms
- West of the stiffener between Girders D and E diaphragms
- West of the stiffener between Girders E and F diaphragms
- Two areas at east side of stiffener between Girder F and G diaphragms (Photo 4)
- Bottoms of stiffeners between Girders C and E.

Photo 4: Removed Tack Weld, Ground Area Left Unpainted on North Web Between Girder G and F

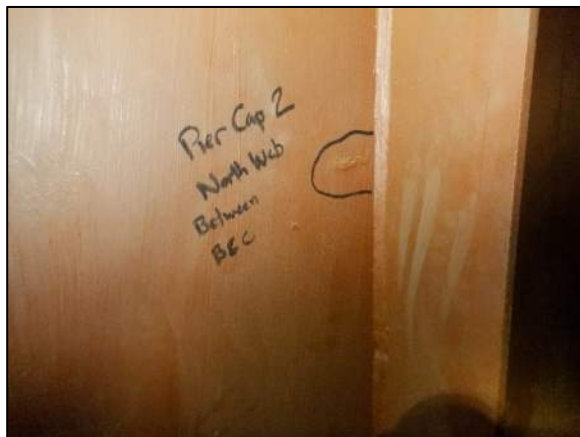
- Two tack welds west of the stiffener between A and B (Photo 5)
- One tack weld east of the stiffener between B and C

Photo 5: N Web Remaining Tack Welds Between Girder A and B

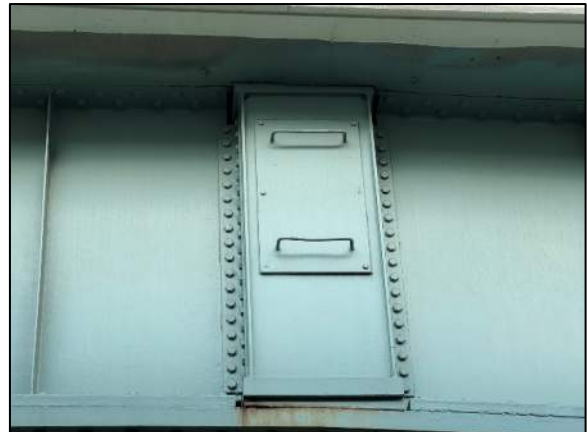
The exterior of the pier cap is in good condition (Photo 7). The welded connection of a drainpipe support bracket on the north web was replaced with a bolted connection (Photo 8). Both cap doors are in place and secure (Photo 9). One bolt is missing on the east access hatch.

*Photo 9: West Hatch for Pier 2*

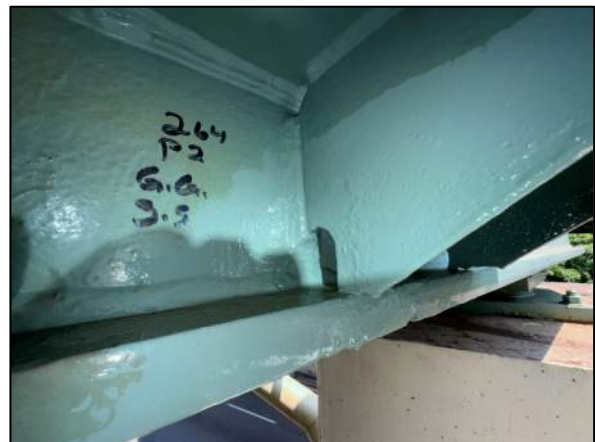
*Photo 10: Retrofit at Bottom of Knee Brace at Girder G*

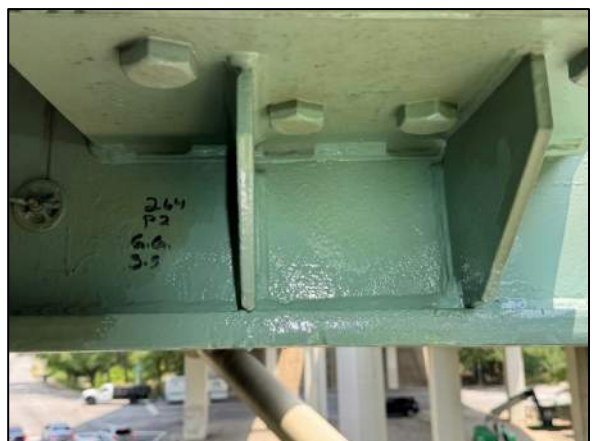
*Photo 11: Retrofit at South Web and Bottom of Knee Brace at Girder G*

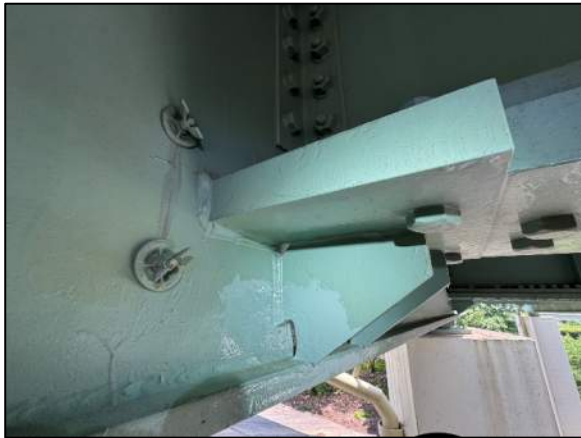
*Photo 12: North Web, Knee Brace, retrofit below Girder C. Undercut Welds at Bottom of Knee Brace*

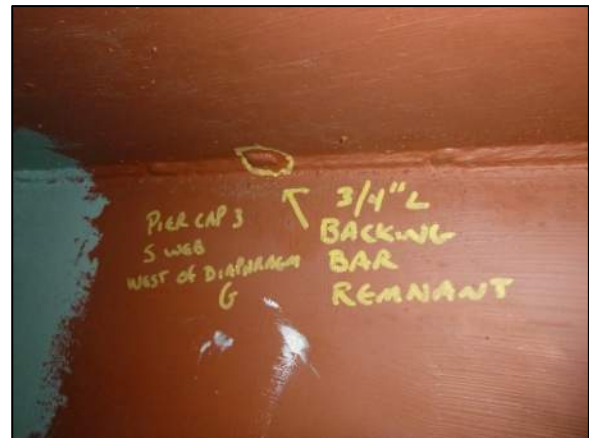
There is a 3/4" L backer bar remnant in the fillet weld between the top flange and south web, west of the Girder G diaphragm (Photo 15).

Photo 15: 3/4" Backer Bar Remnant Between South Web, Top Flange, West of Girder G Diaphragm

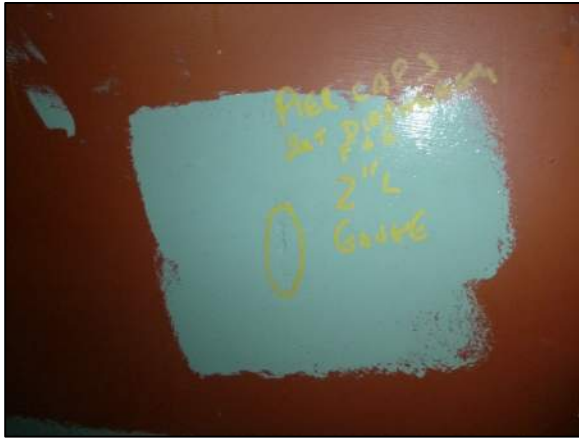
Photo 17: 2" L Gouge Between Diaphragm F and E,  
North Web

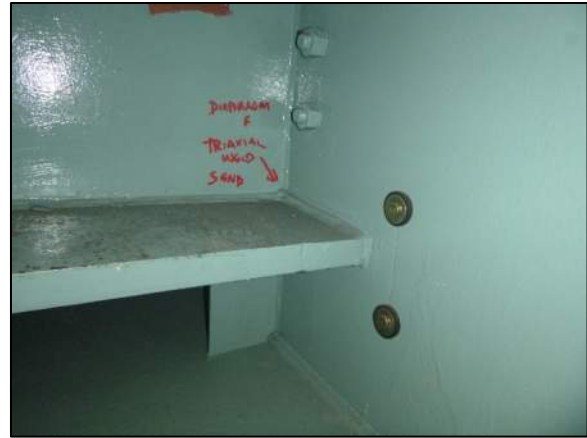
At several locations in the tension zones, the fillet welds of the web and flange plates intersect the fillet welds of the web plates and stiffeners. Those weld intersections were coped. The fillet weld between the north web and the Girder F bottom flange tie plate intersects the fillet weld of the web and stiffeners plates (Photo 20).

Photo 20: Triaxial Weld at Diaphragm F

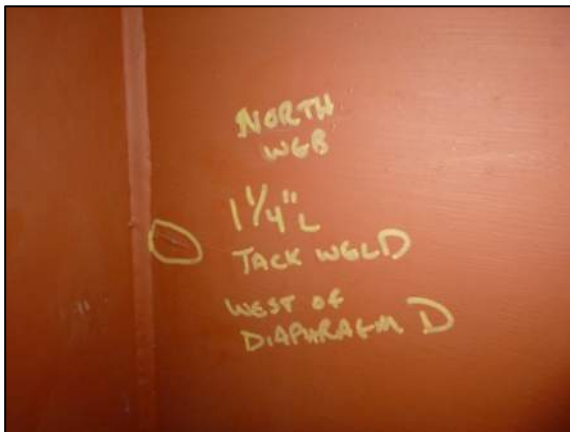
Photo 18: 1 1/4" L Tack Weld West of Diaphragm D,  
North Web

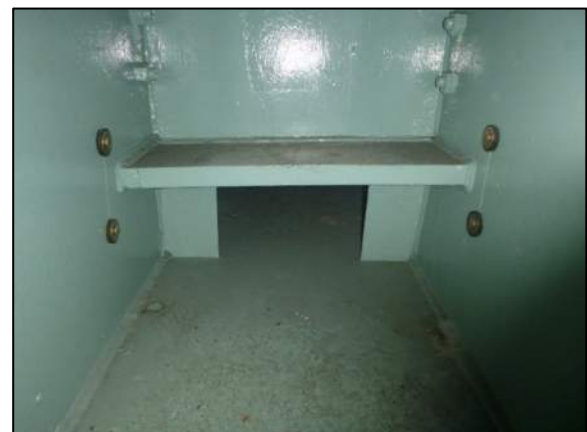
The interior paint is in GOOD condition [7]. An isolated area of moderate pitting was noted on the bottom flange at the east bearing. In the last rehabilitation project, areas of rust were cleaned and painted, and the corrosion is no longer active (Photo 21).

Photo 21: Painted Interior; Bottom Flange and Web.  
Typical Dog-Bone Retrofit

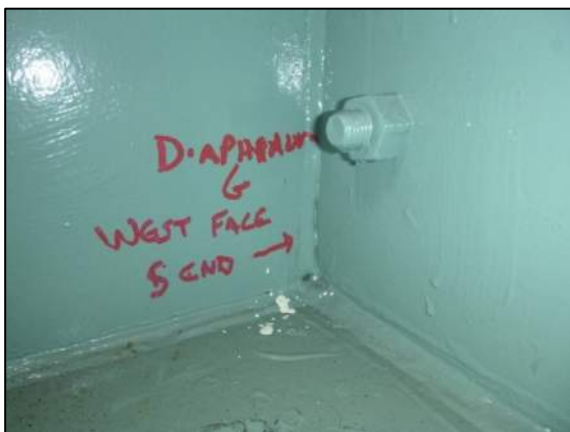
Photo 19: 3" Undercut in Fillet Weld Between  
Diaphragm and S Web

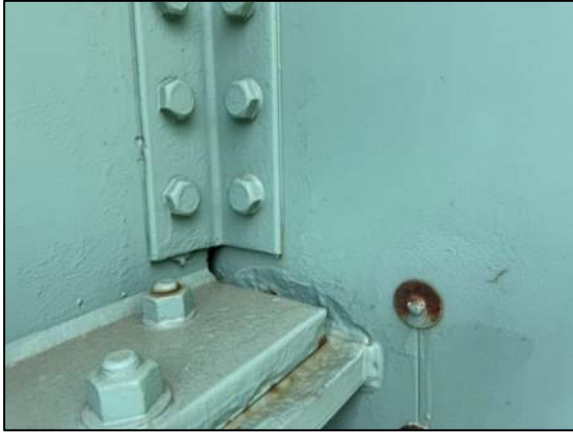
The exterior paint is in GOOD condition [7]. A 7" L x 2" H area of up to 3/16" D painted over pitting exists on the south web of the pier cap above the bottom flange tie plate of Girder G (Photo 24). There is also a 7" L x 2" H area of pitting on the north web of the pier cap above the bottom flange tie plate of Girder A. Active corrosion exists on the fillet weld between the knee brace and north web below Girder G. The crack has not propagated into the base metal. Typical porosity exists in the toe of weld at bottom flange of Girder C and North Web (Photo 25).

*Photo 24: 7" L X 2" H Area of Up To 3/16" Section Loss in South Web and Girder G Tie Plate*

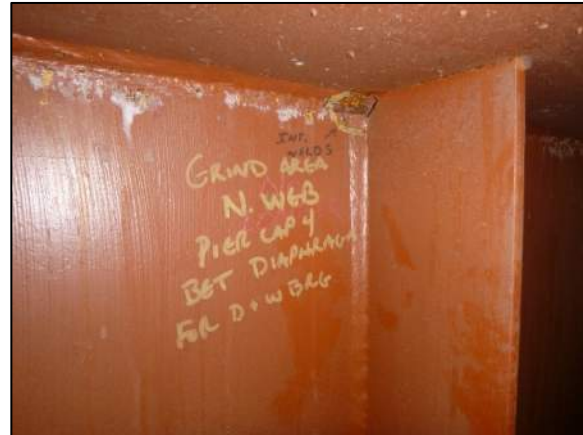
Isolated locations of intersecting fillet welds have been ground down, left unpainted and starting to rust, to create a weld cope mainly at the intersection of the web stiffeners, north web, and top flange (Photo 33).

Photo 33: Unpainted Ground Area at Fillet Weld Intersection Between Girder D and West Bearing Stiffener

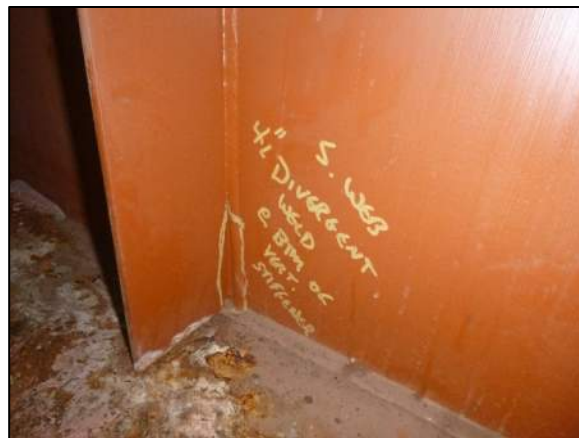
Photo 31: Divergent Fillet Weld in Interface of South Web and Vertical Web Stiffener, West of Girder D Diaphragm

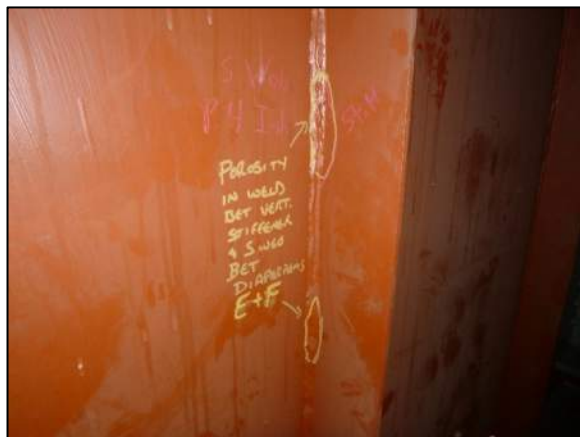
Photo 32: Fillet Weld Porosity Between South Web and Vertical Web Stiffener Between Girder E and F Diaphragms

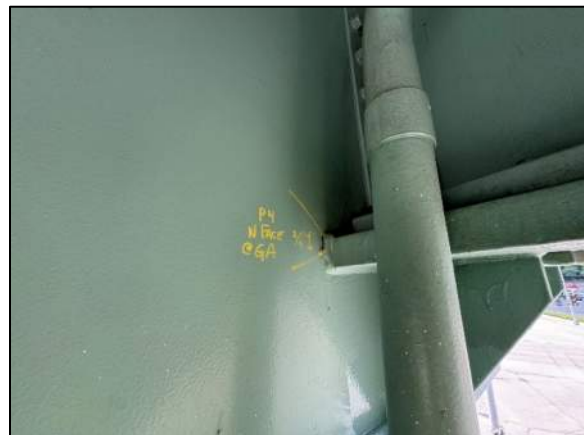
*Photo 35: 3/4" H X 1/8" D Inclusion of Fillet Weld Between East Side of Girder A Bottom Flange and North Web*

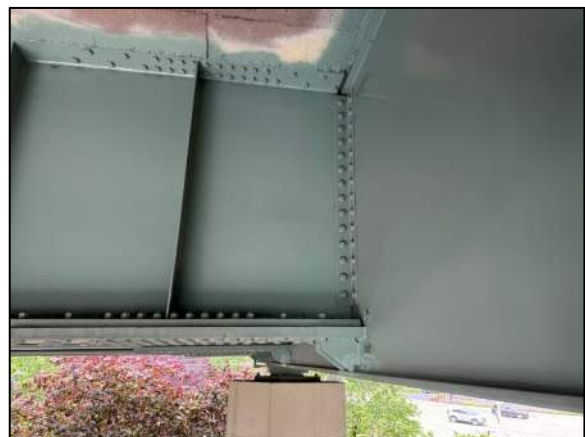
*Photo 36: Typical Girder to Pier cap connection with knee plate retrofit*

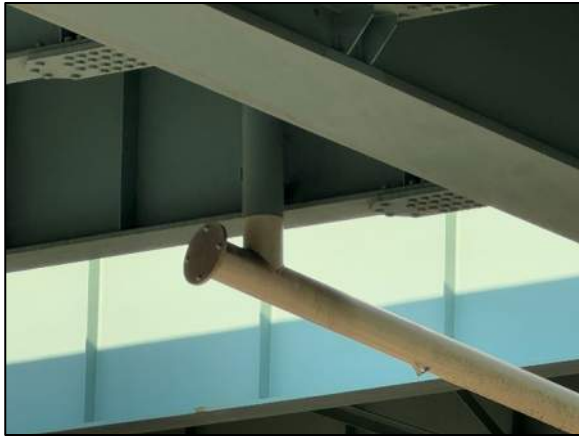
Photo 41: Down Spout Scupper Connection

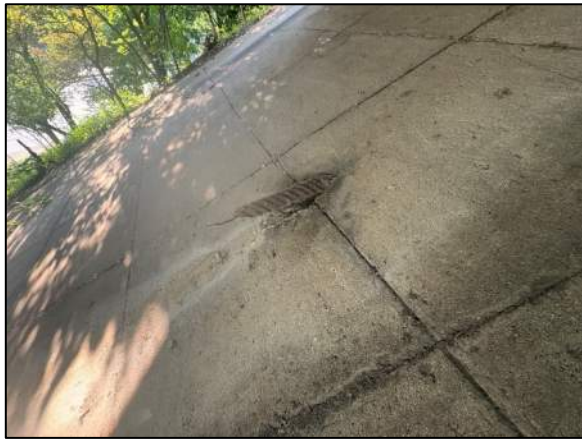
Photo 42: Abutment 2 Slope Protection Drainpipe  
Section Loss

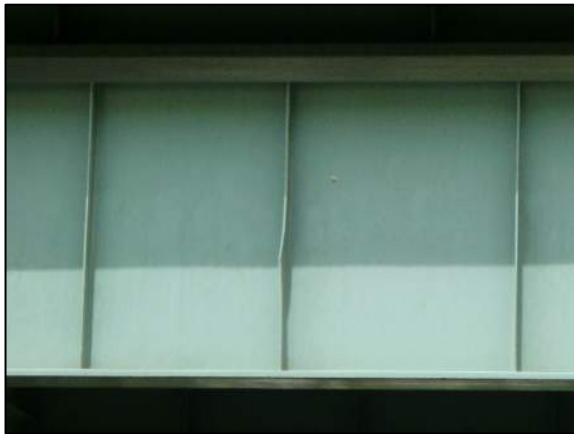
*Photo 45: Bent Web Stiffener in Span 3 On Girder G*

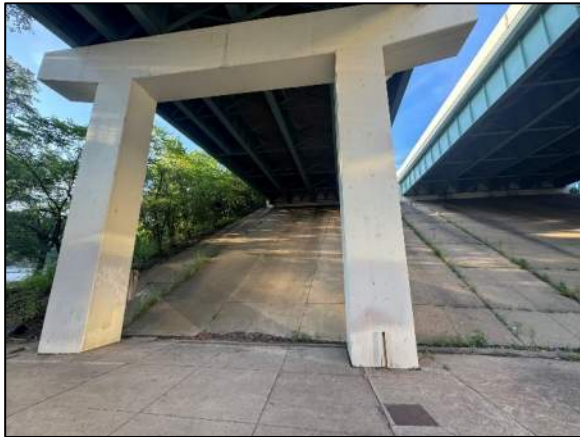
*Photo 60: Abutment 2 Slope Protection Vegetation Growing Through Joints*
