# NSTM Member Inspection Report

**HAM-50-1903L**

## **2025 NSTM Member Inspection Report (VAR-District 8 Bridge Inspections for Steel Pier Caps)**

**SFN: 3102807, PID: 109781**

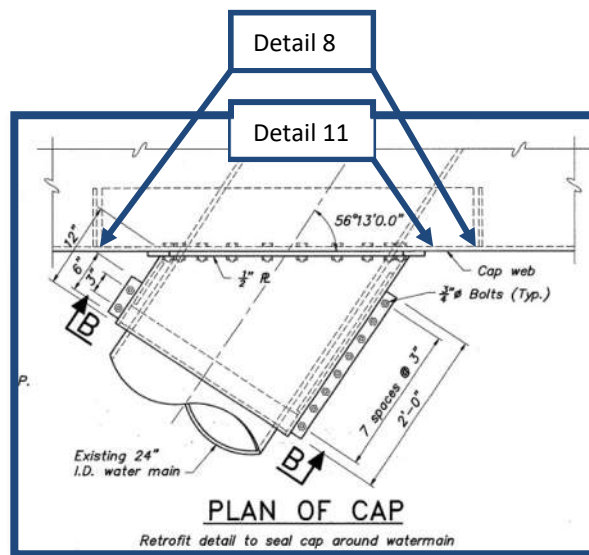
Figure 6: Water main portal detail.

During the rehabilitation project, a bolted sleeve was added to holes that were previously cut into the web plates to allow installation of a 24" water main through the pier cap. Some of the bolts that connect the conduit sleeves to the web plates were cut through the fillet welds of the longitudinal web stiffeners surrounding the conduit holes (Photo 4). The remains of the fillet welds around the bolt holes are thin and vulnerable to crack initiation. During the inspection no signs of distress were found in the welds.
