# NSTM Member Inspection Report

## HAM-71-0197W 2025 NSTM Member Inspection Report (VAR-District 8 Bridge Inspections for Steel Pier Caps)

SFN: 3106659, PID: 109781

September 11, 2025

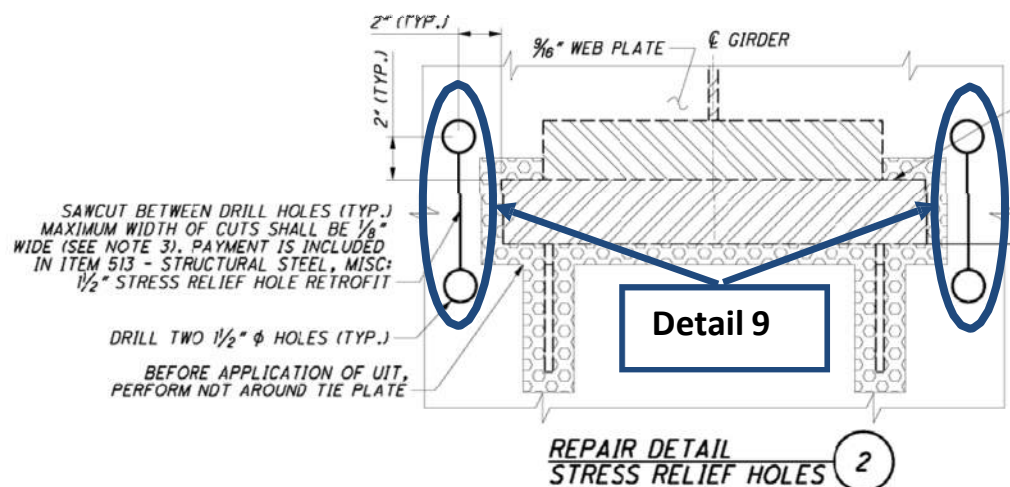
Figure 5: Drilled hole stress relief retrofit in web plates.

The exterior paint is in Good Condition [7] with small, isolated spots of minor corrosion. During a previous rehabilitation, the bolted connections of the drainpipe support brackets remain, but the drainpipes appear to be rerouted (Photo 5). The web plates were retrofit with stress relief drilled holes connected by vertical saw cuts adjacent to the welded connections of the bottom flange tie plates of the interior girders at both webs, Girder T at the east web, and Girder Z at the west web. Porosity was noticed in the fillet welds around the bottom flange tie plates, but they appear to be sound. Fillet welds between the west web and knee braces below Girders X, Y, and Z intersect the groove weld of the web and bottom flange (Photo 6). There was a small crack indication previously noted above the weld on one bottom flange knee brace on the east face of Girder U connection, but it was verified that the weld was not cracked. Corrosion exists where paint was previously removed.

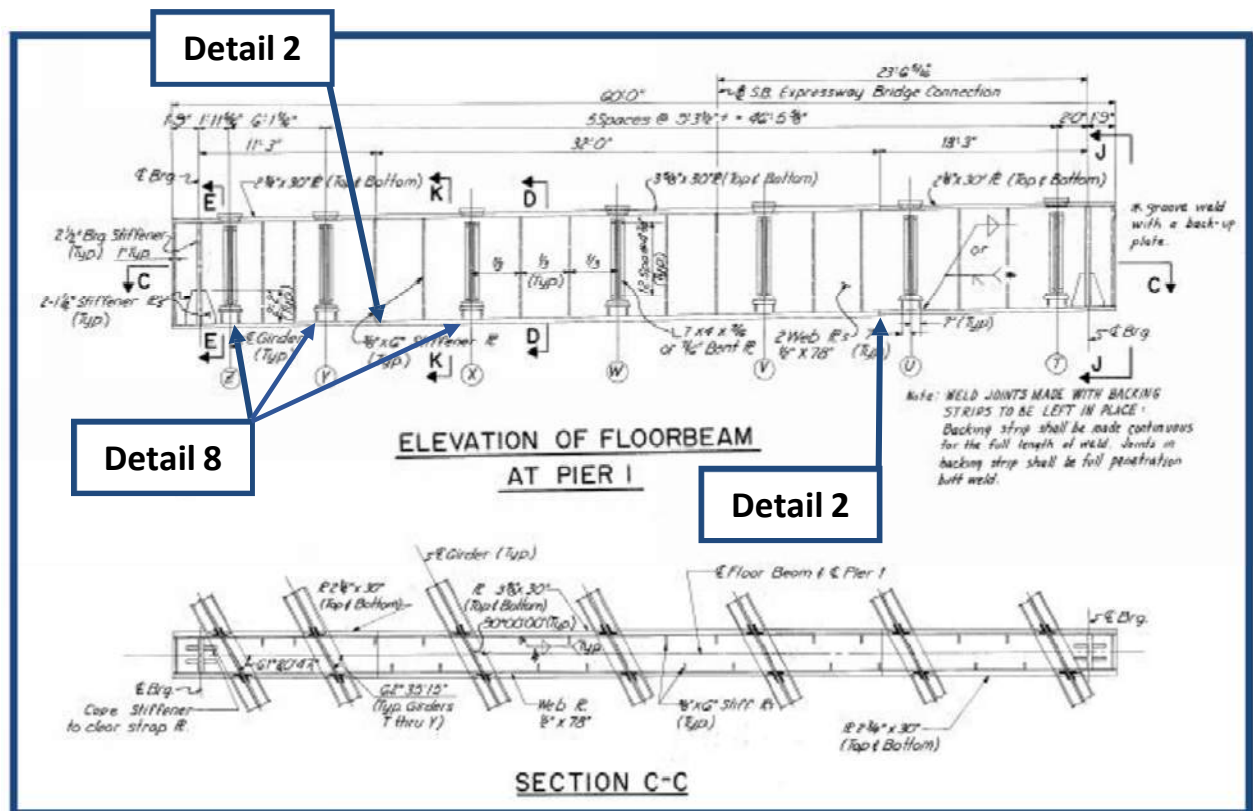
Figure 6: Plan and Elevation of Pier Cap 1 with Fatigue Prone Details.

Category: B.

Location: Both web plates on each side of all interior girders, east web plate on each side of girder T, and west web plate on each side of girder Z.
