# Routine and NSTM Member Inspection Report

## **HAM-71-0248L** **2025 Routine and NSTM Member Inspection** **Report** **(VAR-District 8 Bridge Inspections for Steel Pier** **Caps)**

**SFN: 3106780, PID: 109781**

August 23, 2025

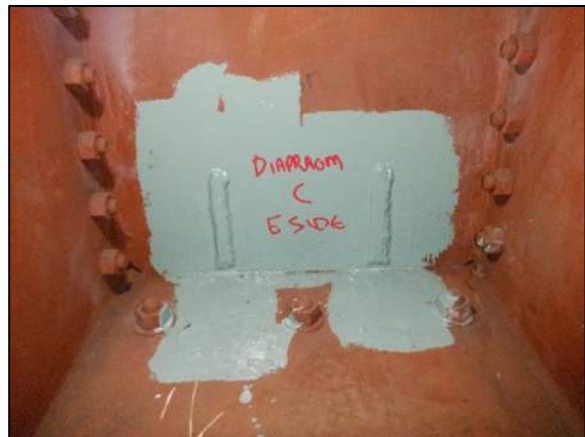
A discontinuous fillet weld was observed at the stiffener east of the Girder B diaphragm. The knee braces at Girder C and D diaphragms were removed and the fillet welds were ground from the bottom flange (Photo 2). There is a 1-1/8" L tack weld west of the stiffener between Girder C and D diaphragms on the north web (Photo 3). There are several ground tack welds on both web plates, three of which were not completely removed.

*Photo 2: Knee Braces Removed and Fillet Welds Ground Out at Girder C Diaphragm*

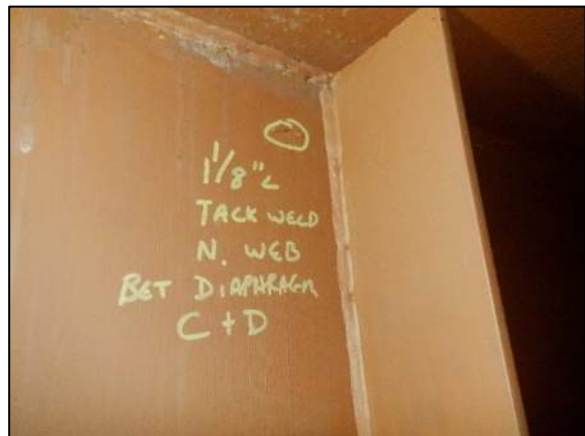
*Photo 3: 1-1/8" Tack Weld on North Web Between Girder C and D*

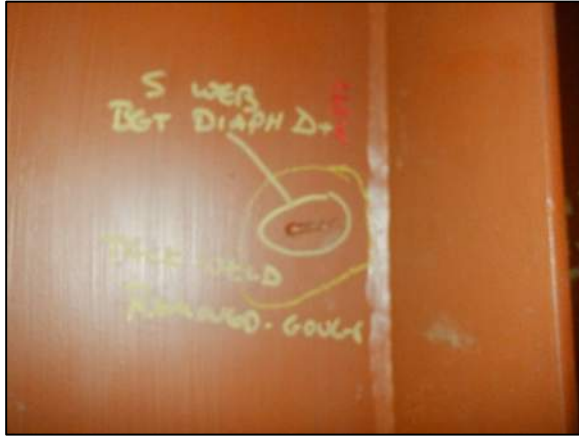
There are six total gouges caused by tack weld removal between Girder D and E diaphragms, three on each web (Photo 4). Between Girder E and F diaphragms, there is one moderate gouge and 3 minor gouges from tack weld removal along the south web, and one on the north web.

*Photo 4: Gouge in South Web Between Girder D and C from Tack Weld Removal*

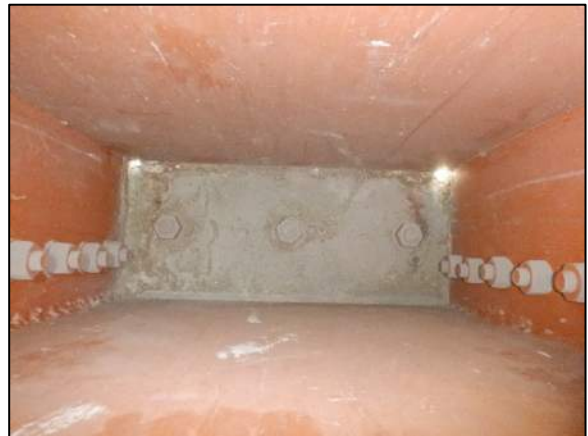
*Photo 8: Typical Pitting in Bottom Flange Between Diaphragm and End Cap Openings*

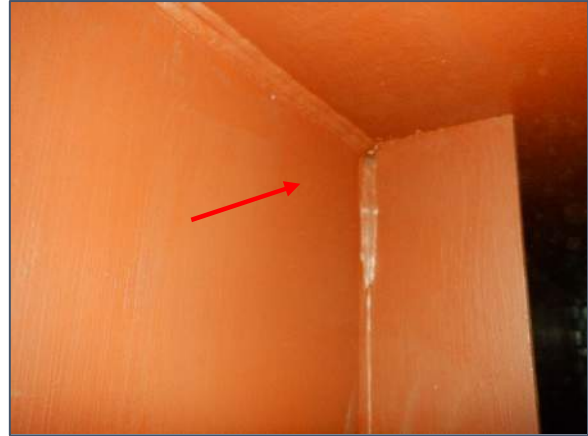
Knee braces have been removed from the diaphragms at the interior girders. At multiple locations in the tension zones, the fillet welds between the web and flange plates intersect the fillet welds between the web plates and vertical web stiffeners/diaphragms. The cope is ineffective for the intersecting weld between the top of the vertical web stiffener and the top flange plate at various locations (Photo 12). Multiple weld passes over single welds can be observed in isolated locations throughout the pier cap between the vertical web stiffeners and the web (Photo 13). A 1/4" and a 1/2" diameter weld spot exists on the bottom flange at the Girder C diaphragm. There are two tack welds up to 3/4" L on the north web between the west bearing and Girder B diaphragm, which are ground but not completely removed. There is one 1/2" L shallow gouge in the north web just east of the east bearing diaphragm (Photo 14).

Photo 12: Ineffective Weld Cope Between Web Stiffener and Web Plates

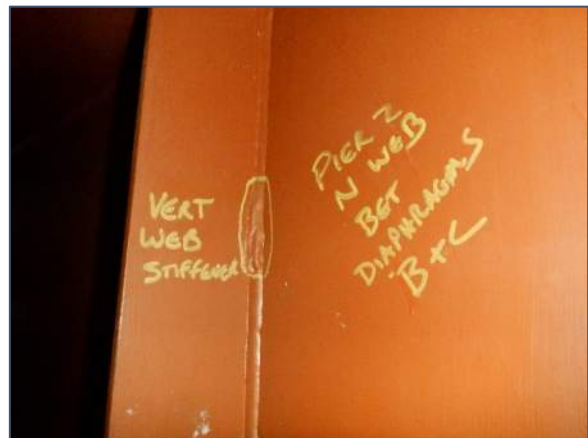
Photo 13: Multiple Weld Passes Between Web Stiffener and North Web Between Girder B and C

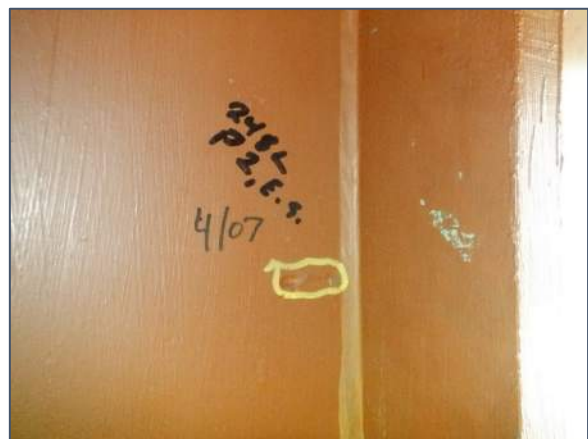
Photo 14: 1/2" L Gouge in North Web, East of East Bearing Diaphragm

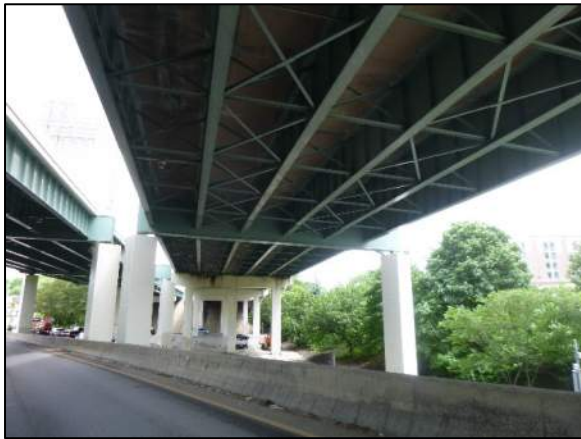
Pier Cap 3 is in GOOD condition [7] (Photo 19) with isolated areas of heavy pitting and section loss. At the time of inspection cap was dry.

*Photo 19: General Elevation Pier Cap 3*

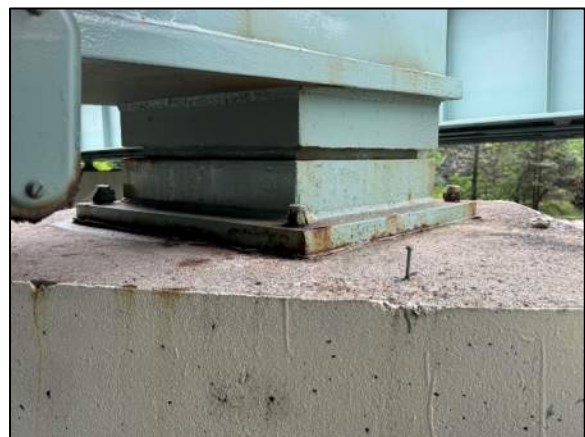
The exterior paint is in Very Good Condition [8]. The anchor bolts are missing all nuts. The pot bearings have light rust spots and corrosion starting along the lower edge of the masonry plate but appear to function properly (Photo 25).

*Photo 25: Typical, West Column Pot Bearing*

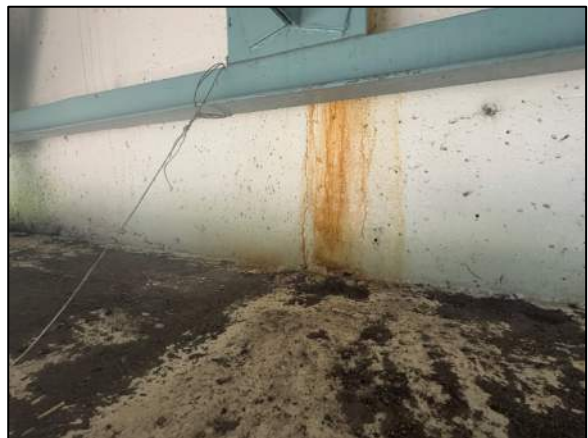
*Photo 36: Typical Debris Build Up at Abutment 1; Girder A*

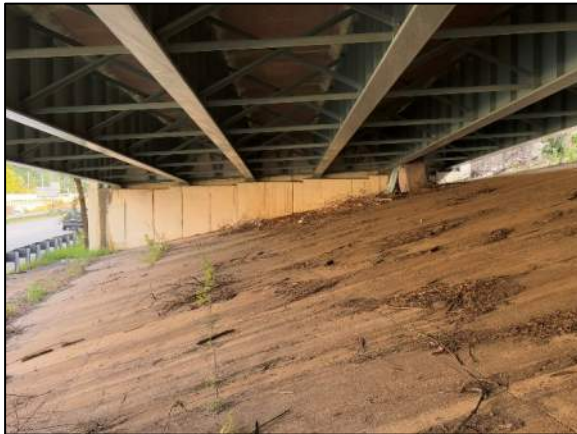
The concrete slope protection is in fair condition. Light vegetation growth is present near Abutment 1 between the joints along the fascia of the bridge. There is an accumulation of debris and tree trimmings south of Pier 1 along the entrance ramp (Photo 50). There is cracks and broken slope protection at Abutment 2 near Pier 5 column (Photo 51). Vegetation growth is present along the full height of the joints on the west side of the slope protection near Abutment 2. The corrugated metal drainpipes are corroded with section loss (Photo 52).

Photo 50: Debris Along Slope Protection Next to Pier 1

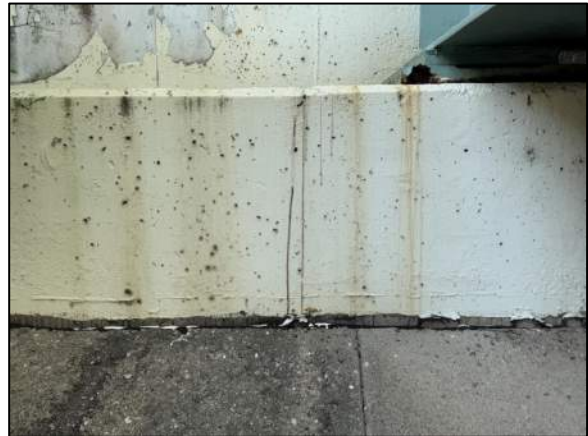
There is 1" of slope wall settlement along the Abutment 2 stem (Photo 53).

Photo 53: Up to 1" Settlement Along Full Length of Abutment Stem
