# NSTM Member Inspection Report

**HAM-71-0248R**

## 2025 NSTM Member Inspection Report (VAR-District 8 Bridge Inspections for Steel Pier Caps

**SFN: 3106802, PID: 109781**

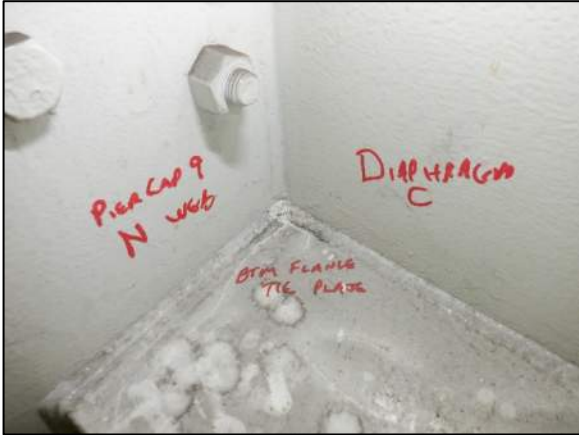
The fillet welds along the pier cap diaphragms, pier cap webs and the girder tie plates are not sufficiently coped resulting in triaxial welds (Photo 8).

*Photo 8: West Face of The Girder C Diaphragm, Tie Plate, and the North Web; Intersecting Welds Not Sufficiently Coped*

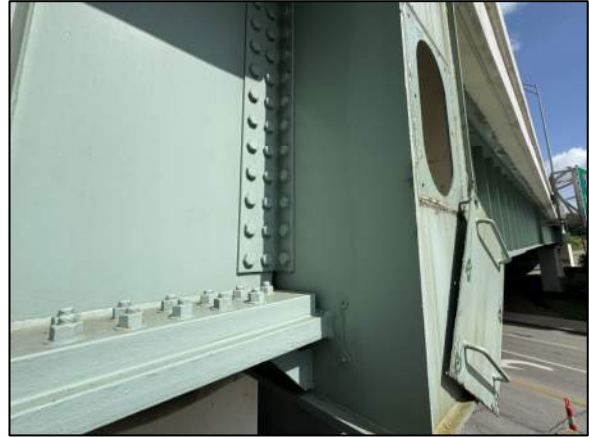
The exterior paint is in GOOD CONDITION [7] with active corrosion on the top flange ends and minor pitting on the top of the bottom flange on both ends (Photo 15).

*Photo 15: Pitting Along the Top of The Bottom Flange, Knee Brace, And Web*

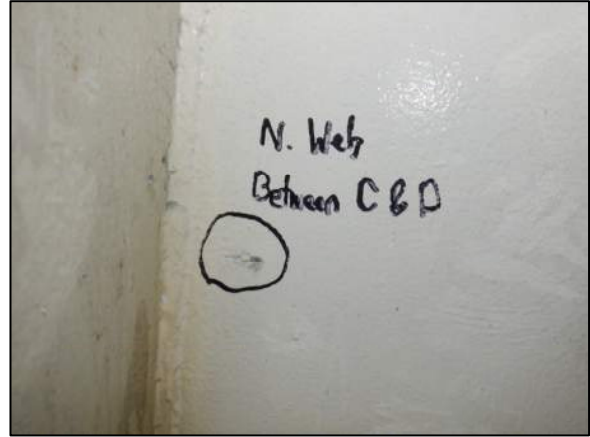
Photo 21: Tack Weld Between Girder C and D in North Web

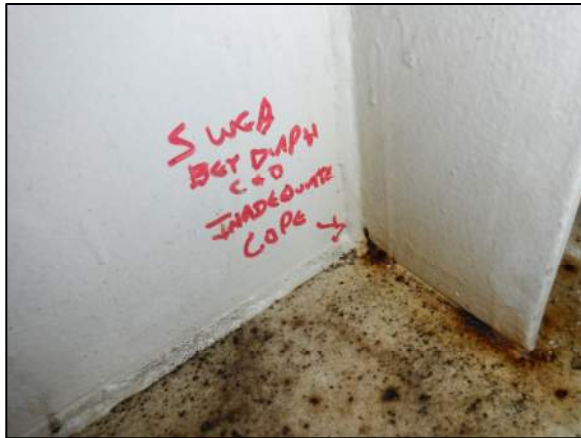
Photo 19: Insufficient Cope in South Web Between Diaphragm C and D

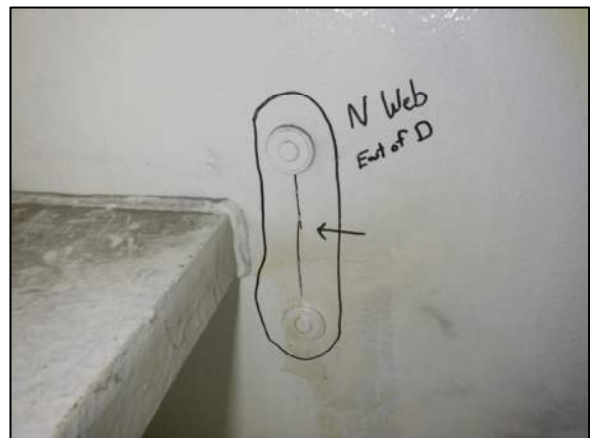
Photo 22: Mis-Cut Dog Bone Retrofit in North Web East of Girder D

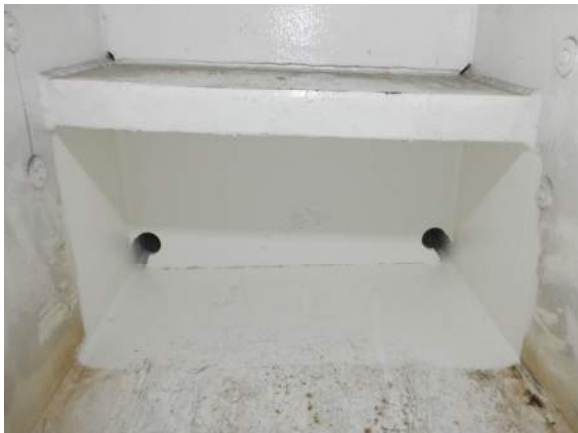
The previously noted weld deficiencies at the Girder D diaphragm have been repaired and recently painted (Photo 20).

Photo 20: Underside of Bottom Flange Tie Plate, Recently Painted

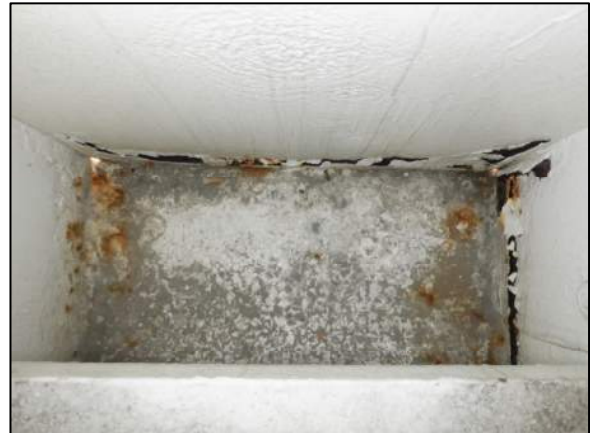
Photo 23: Moderate Pitting on Bottom Flange and Bottom of Webs Between Girder J and East End Plate

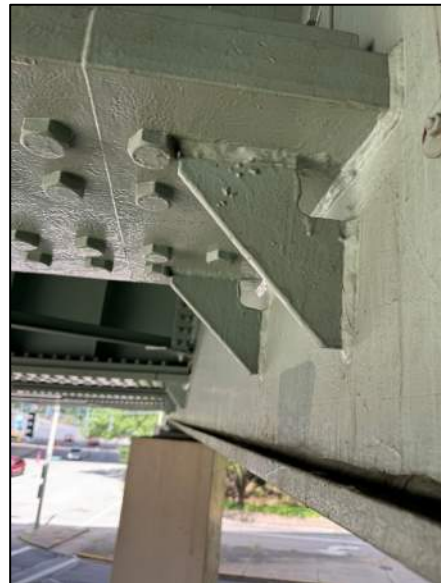
Photo 25: Typical Coped Knee Braces

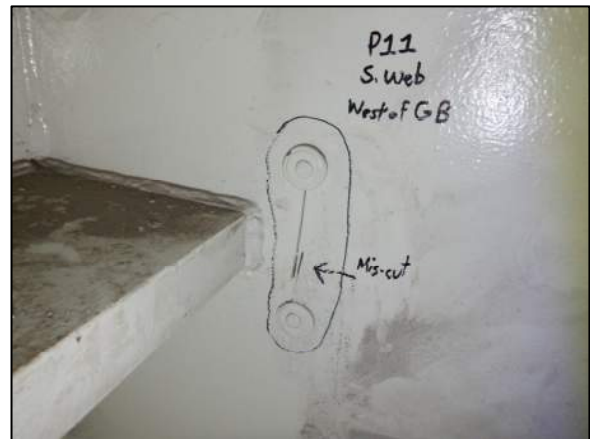
Photo 34: Mis-cut In Dog Bone Retrofit in South Web, West of Girder B

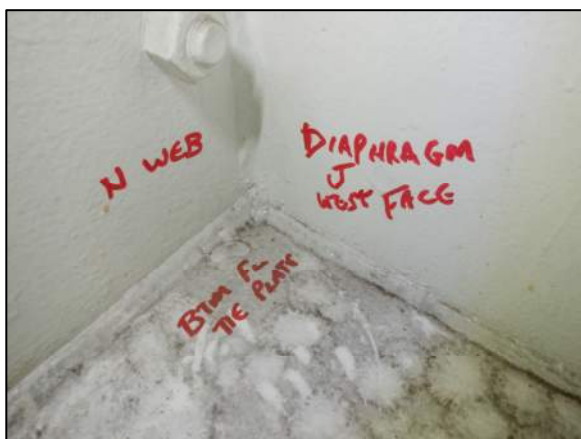
Photo 32: Triaxial Weld Between North Web, West Face of Diaphragm J and Bottom Flange Tie Plate

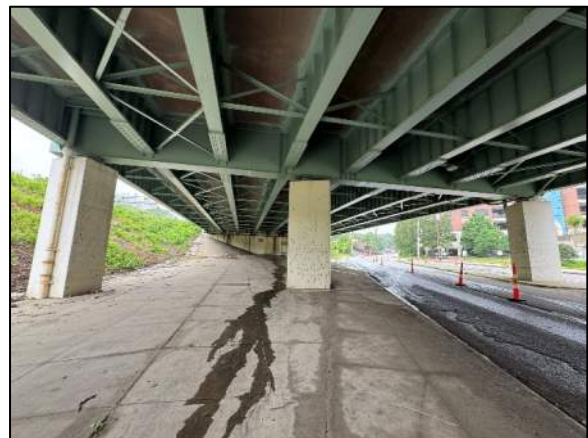
*Photo 41: Pier Cap 12 Elevation*

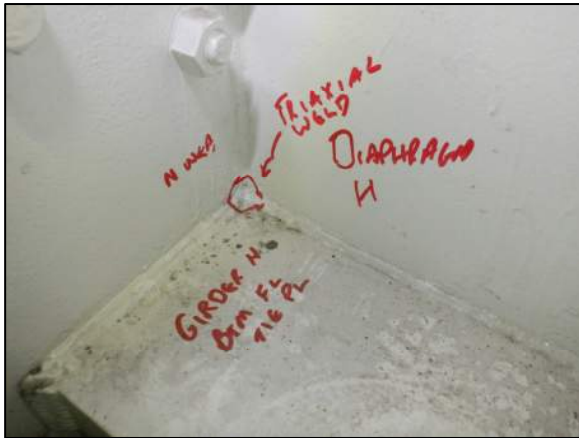
Photo 43: Triaxial Weld Between North Web, Diaphragm H, And Bottom Flange Tie Plate

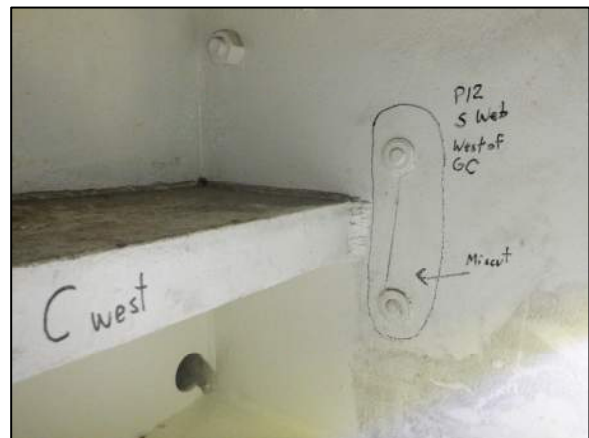
Photo 46: Mis-Cut Vertical Cut in South Web Dog Bone Retrofit, West of Girder C

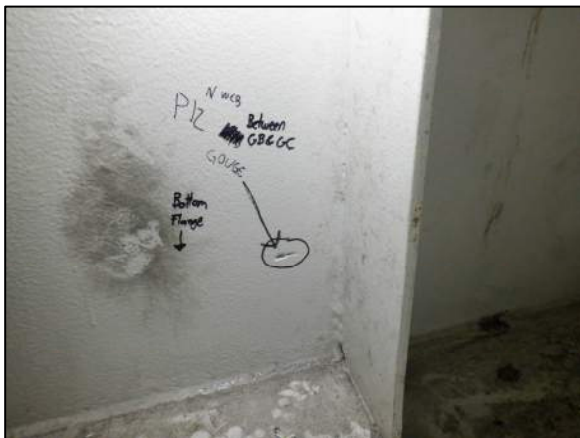
Photo 44: Gouge in North Web, Near Bottom Flange, Between Girder B and Girder C
