# NSTM Member Inspection Report

## HAM-75-1102R 2025 NSTM Member Inspection Report (VAR-District 8 Bridge Inspections for Steel Pier Caps)

SFN: 3110443, PID: 109781

September 09, 2025

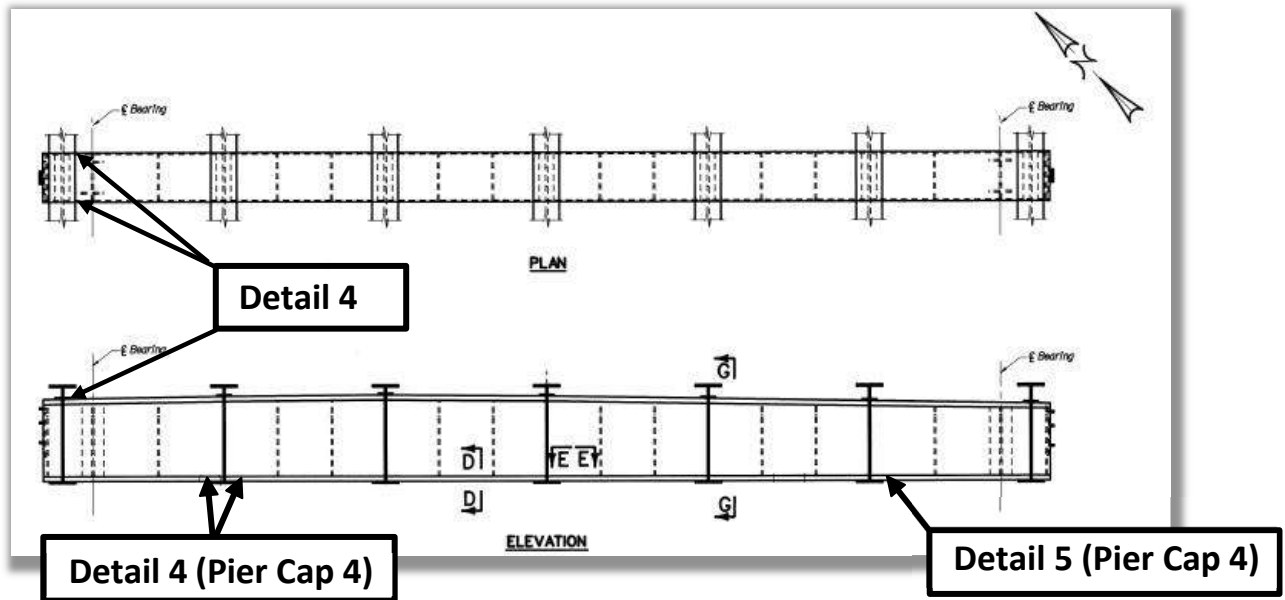
Figure 3: Plan and elevation of Pier Caps 3 & 4 with Fatigue Prone Details

Category: B

Location: All girder web plates on each side of the pier cap top flange.
