# NSTM Member Inspection Report

**HAM-562-0147**

## **2025 NSTM Member Inspection Report (VAR-District 8 Bridge Inspections for Steel Pier Caps)**

**SFN: 3113914, PID: 109781**

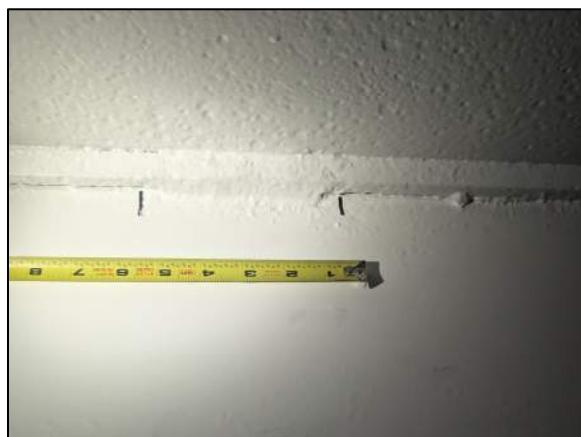
Throughout the interior of the pier cap, welds along the backer bars are still present between both flange plates and web plates (Photo 7). As part of the 1993 rehabilitation project, the longitudinal stiffeners were cut and removed from the tension zones of the web plates. Stress relief holes were drilled through the web plates at the removal locations near the longitudinal stiffener terminations and plugged. At several locations, sections of the unremoved longitudinal stiffener plates remain on the web plates adjacent to the stress relief holes. Between Girders 7 and 8 the removal of the intersections of the longitudinal and transverse stiffener welds was ineffective, some locations missing plugs (Photo 8).

*Photo 7: 5" fillet weld along backer bar between the top flange and east web plate between Girders 9 and 9A*

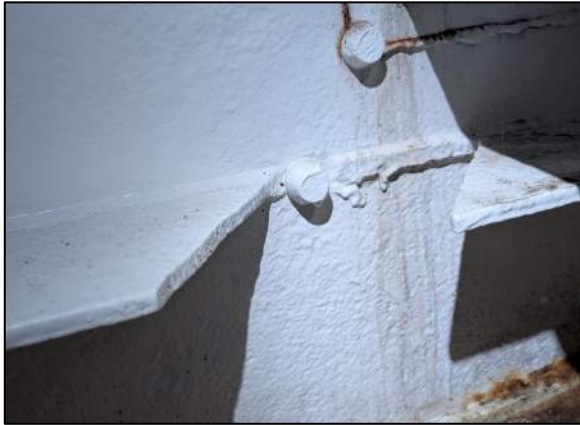
*Photo 8: Typical incomplete longitudinal stiffener removal between Girders 7 and 8*

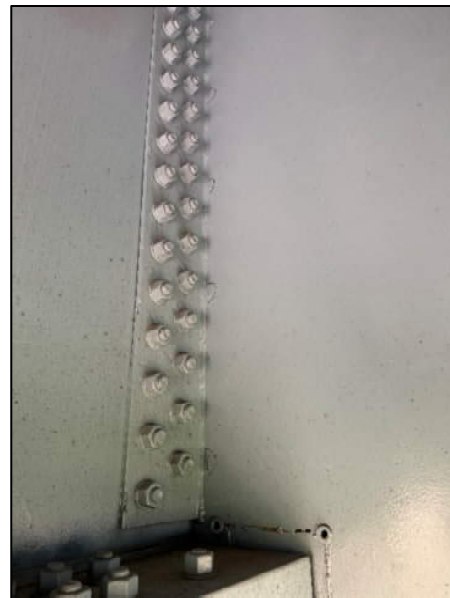
There is a 3/4" tack weld on the west web plate adjacent to the south side of Girder 6 (Photo 11). There are five 1" long tack welds on the west web on the south side of Girder 9 (Photo 12). There is a similar condition with four 1" long tack welds on the west web on the south side of Girder 10.

*Photo 12: Five 1" tack welds on the west web at the south face of Girder 9*

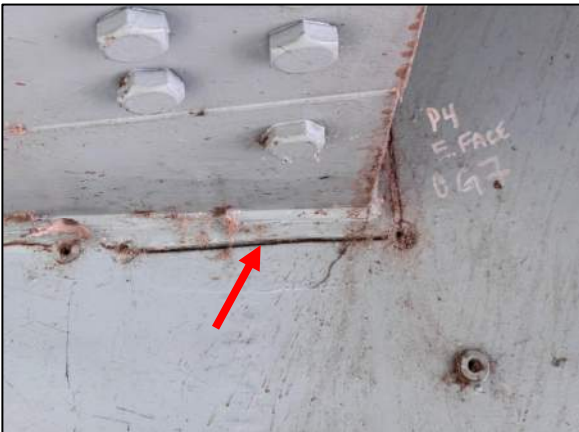
As part of the 1993 rehabilitation, the stress relief hole and sawcut retrofits were performed at Girders 7 through 10 only. Thin cracks have begun to form in the epoxy sealant that also exhibit are showing rust staining (Photo 13). There are also some areas that are missing the epoxy sealer on the east web plate at Girders 7 and 9 (Photo 14). There are also missing retrofit hole expansion plugs on the west web at Girder 10 and between Girders 7 and 8 (Photo 15). These issues are likely the cause of the corrosion issues on the interior of pier cap.

*Photo 14: Missing epoxy on the east web retrofit at Girder 7*

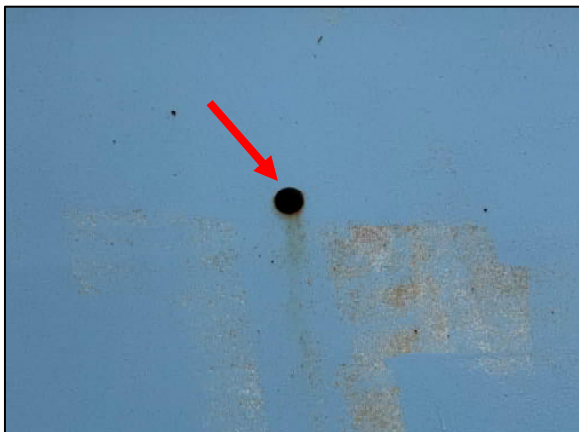
*Photo 15: Missing expansion plug in the west web retrofit hole south of Girder 10*

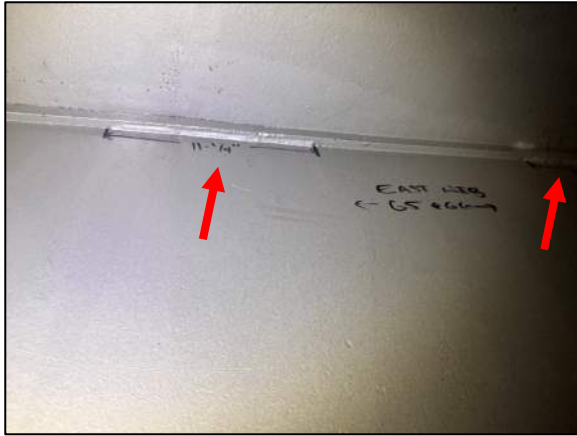
- 6" long fillet weld between the top flange and the west web between Girders 5 and 6.
- 6" long and 11-1/4" long fillet welds on the east web between Girders 5 and 6 (Photo 21).

Photo 21: 6" & 11-1/4" long fillet welds between the top flange and east web between Girders 5 and 6

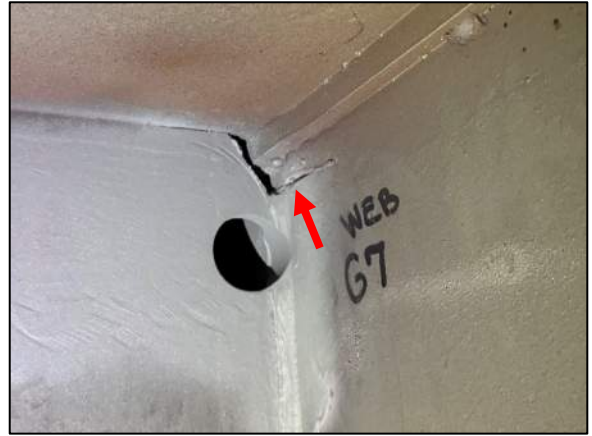
Photo 24: 1-1/2" gouge in east web on the south side of Girder 7

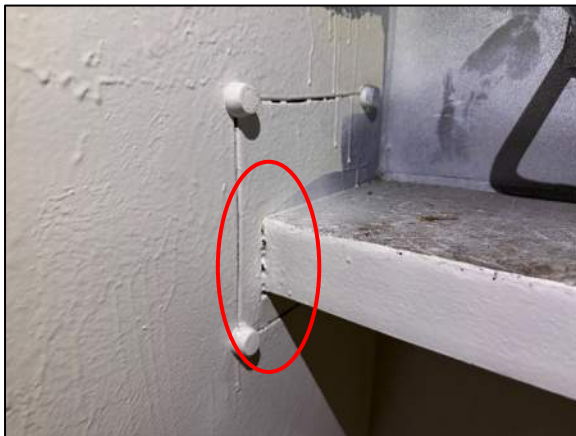
- Short tack welds between the south vertical face of the Girder 8 bottom flange and both web plates (Photo 22).
- 10-1/2" long fillet weld between the top flange and the east web between Girders 7 and 8 at the vertical web stiffener.

Photo 22: Tack welds on webs on the south side of Girder 8 bottom flange

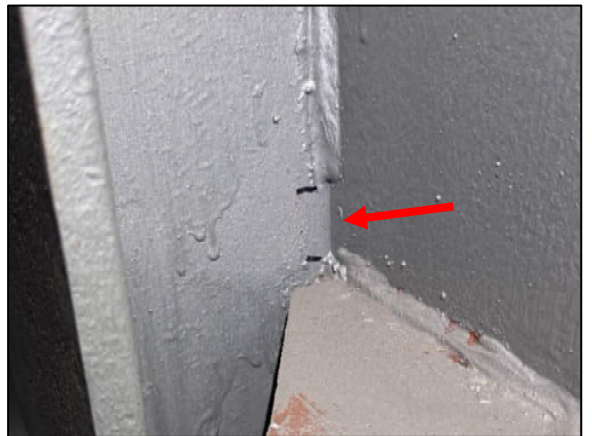
Photo 25: 1-1/2" discontinuity in weld between west web and a transverse stiffener between Girders 7 and 8

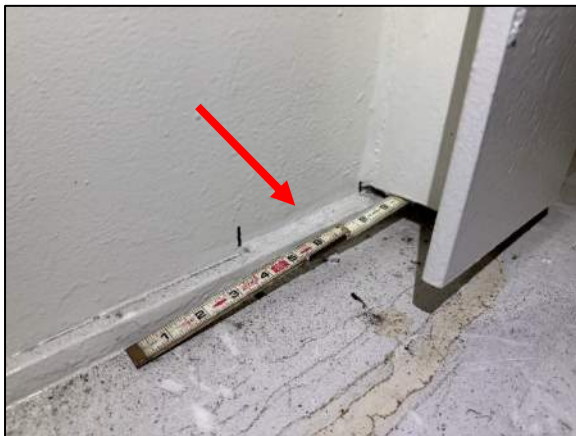
Photo 23: 5-1/4" fillet weld between the east web and bottom flange between Girders 7 and 8

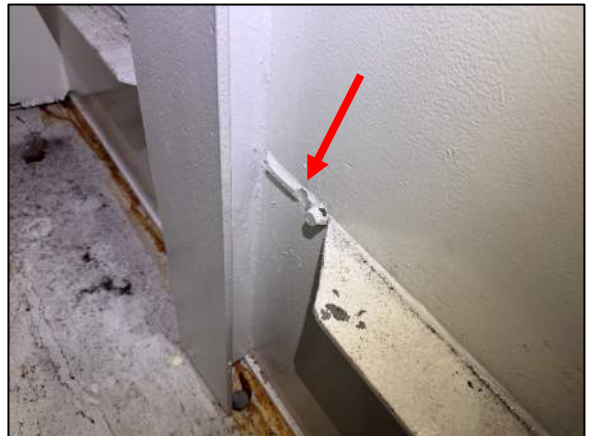
Photo 26: Incomplete removal of longitudinal stiffener between Girder 6 and 7

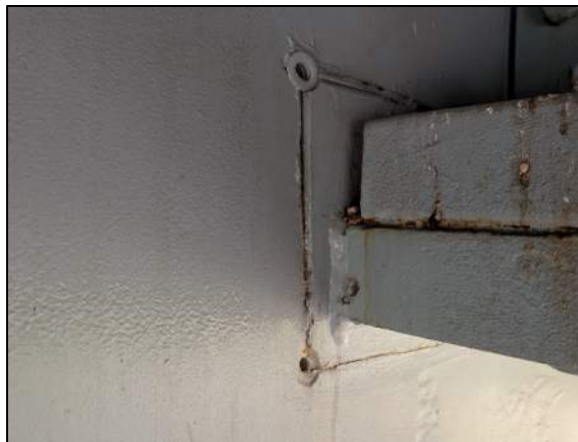
*Photo 31: Retrofit in west web deflected up to 1/4"  
at Girder 6*

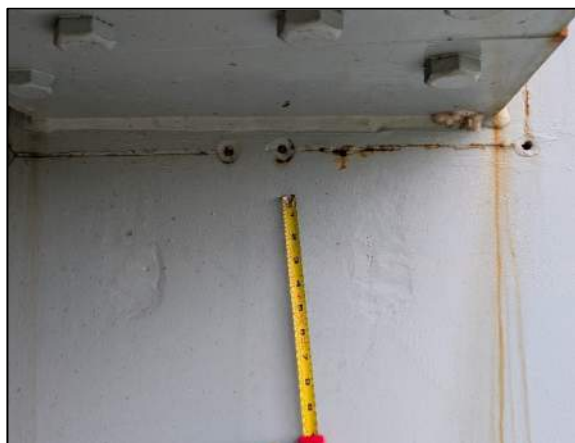
*Photo 32: Typical overgrinding on web plate during  
girder knee brace removal (Girder 10 west web)*

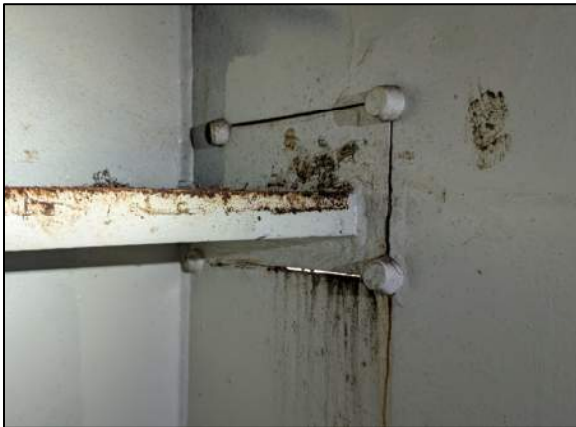
*Photo 39: Typical leakage, bubbling paint, and surface corrosion due to missing epoxy sealant at Girder 7 retrofit*

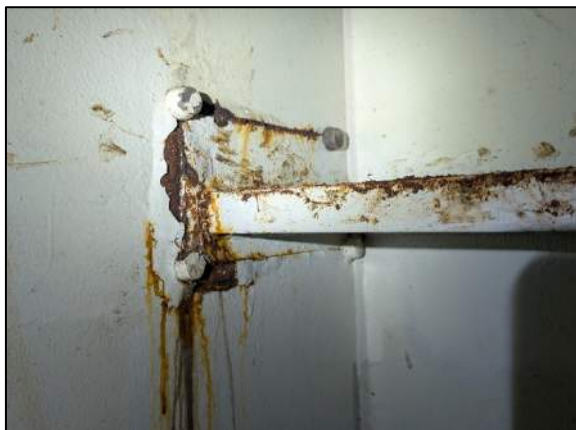
*Photo 40: Typical leakage, bubbling paint, and surface corrosion due to missing epoxy sealant at Girder 6 retrofit*

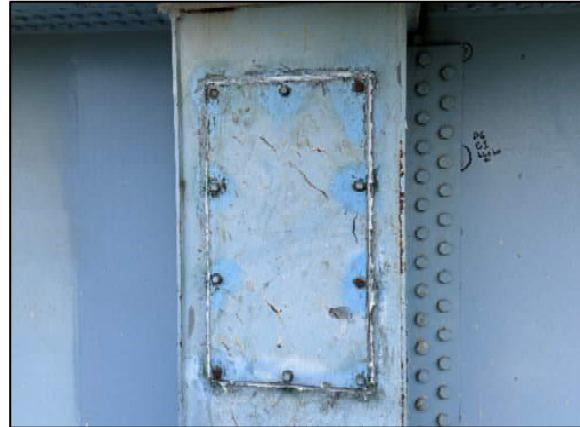
*Photo 41: Areas of missing paint and surface corrosion at the north end*

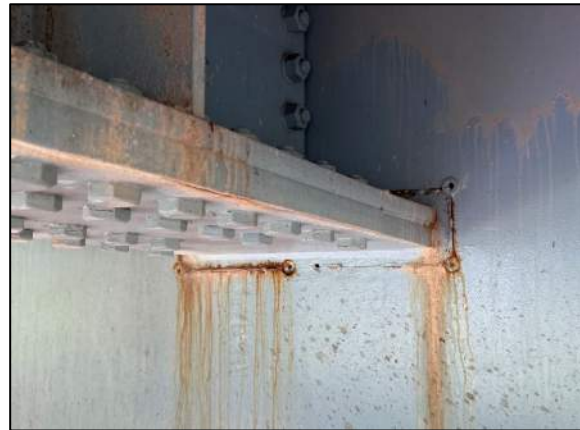
*Photo 42: Corrosion is beginning to reactivate at previously painted over section loss at Girder 6 and pier cap east web plate*

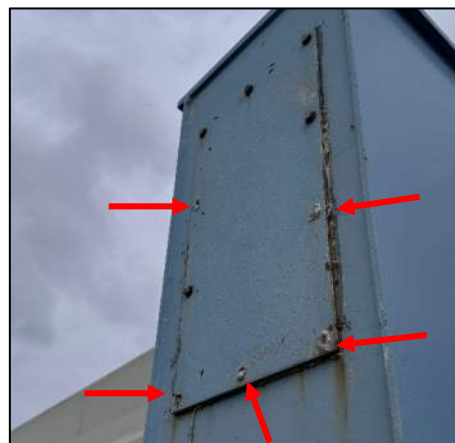
*Photo 43: Five missing bolts on south hatch*

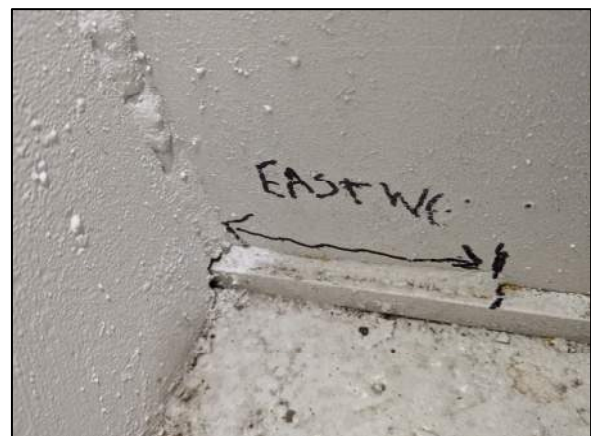
Photo 52: 5-1/2" long fillet weld at bottom flange between south bearing diaphragm and south end plate.

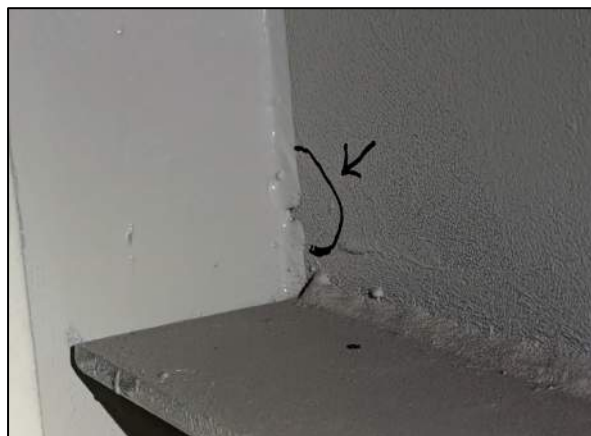
A 1/4-inch-long discontinuity exists in the fillet weld of the west web and top weld along the transverse stiffener between Girders 7 and 8 (Photo 53). Isolated locations of overlapping passes and porosity in the welds were found in the transverse stiffeners throughout the pier cap.

Photo 53: 1-1/4" discontinuity in the transverse stiffener weld on west web between Girders 7 and 8

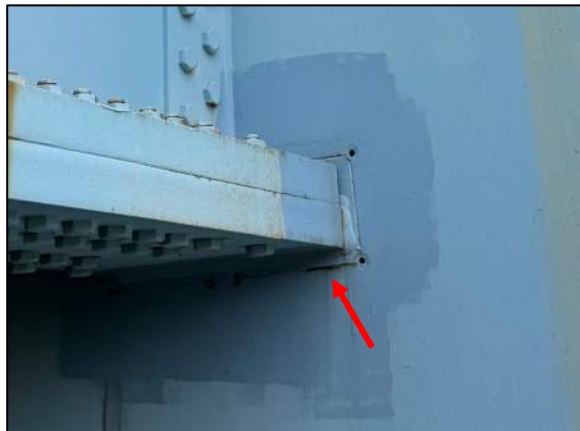
*Photo 58: Missing epoxy sealant east web retrofit on the south side of Girder 10*

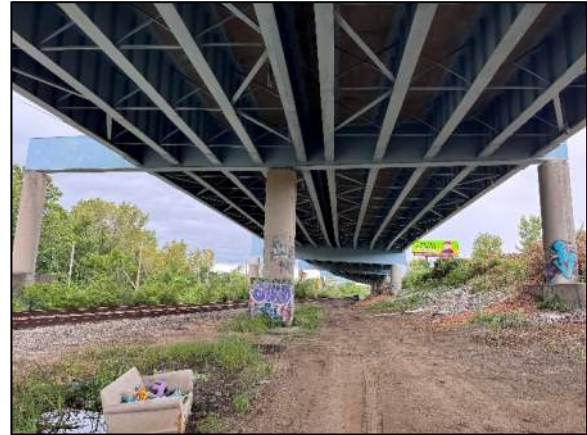
*Photo 59: Elevation of Pier Cap 8*

Pier Cap 8 is in Satisfactory [6] (Photo 59). As part of a 1993 rehabilitation project, retrofits were installed in the webs for the pier cap that consist of drilled holes above and below each girder's bottom flange ends at the webs and are connected with three sawcuts. The welded knee braces were removed from the pier cap web plates below every girder bottom flange tie plate. To remove all welds, the surfaces were ground smooth. In the tension zones of the pier cap webs, the ends of the longitudinal stiffeners were clipped and tapered. The ends of the longitudinal stiffener welds were ground flush with the pier cap webs and stress relief holes were drilled through the web plates near the ends of the stiffeners. As part of the 2015 rehabilitation, welds between the interior backer bars and top flange or web plates were removed. Blasting and painting was performed along the interior and exterior based upon limits noted in the rehabilitation plans. Drilled holes and sawcut locations were also cleaned, resealed, and had expansion plugs installed in the holes.

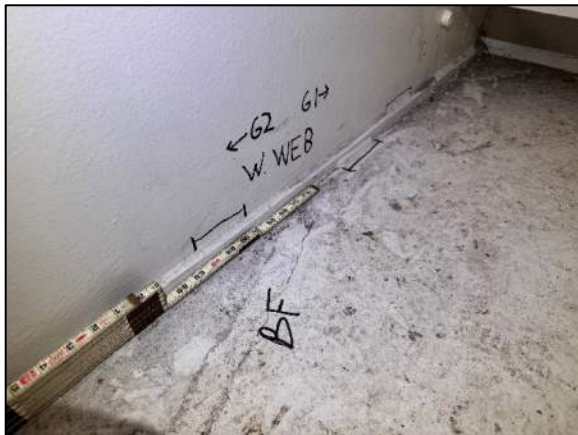
Photo 63: Random fillet welds between bottom flange and west web between Girders 1 and 2

| Location | Web | Flange | Plate | Weld Length(s) (in) | Notes |
|---|---|---|---|---|---|
| Girder 1 to Girder 2 | West | Bottom | Web | (2) 3-1/2", (2) 4-1/2", 5-1/2" | Photo 63 |

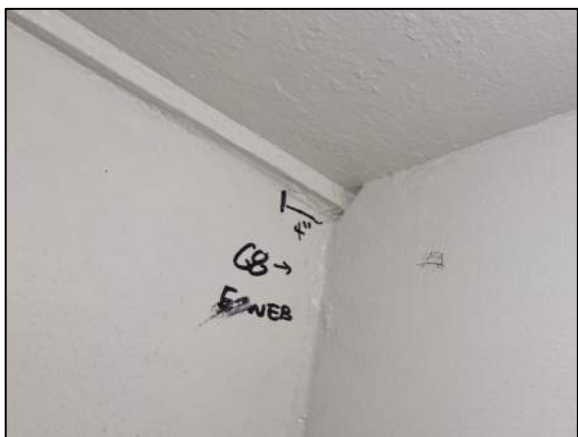
Photo 64: 4" fillet weld between the east web and top flange at Girder 8

| Location | Web | Flange | Plate | Weld Length(s) (in) | Notes |
|---|---|---|---|---|---|
| | East | Top | Flange | 4" | Weld extends through web cope (Photo 64) |

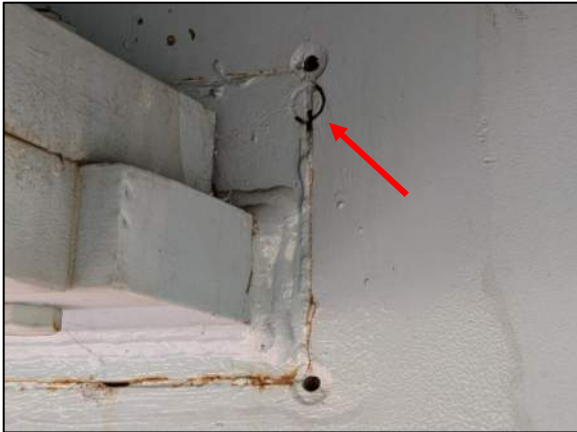
As part of the 1993 rehabilitation project, the drill hole and sawcut retrofits were performed at all girders. At Girder 5 on the west web, a partially miss-drilled hole was noted at the top right corner (Photo 68). The correct hole was drilled closer to the weld intersection. The east web retrofit on the south side of Girder 7 is bowing inward up to 1/16". The top corner of the east and west web retrofits on the south side of Girder 6 are bowing outward up to 1/8" (Photo 69). There are areas of missing epoxy sealant at the sawcut retrofits at Girder 10.

*Photo 68: Miss-drilled retrofit hole in the west web at Girder 5*

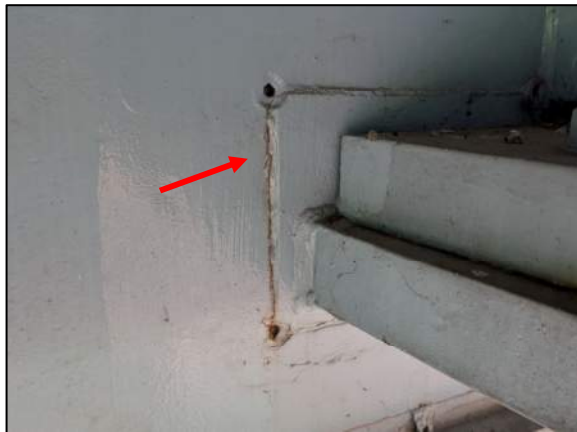
*Photo 69: 1/16" bowing of the east web retrofit on the south side of Girder 6*

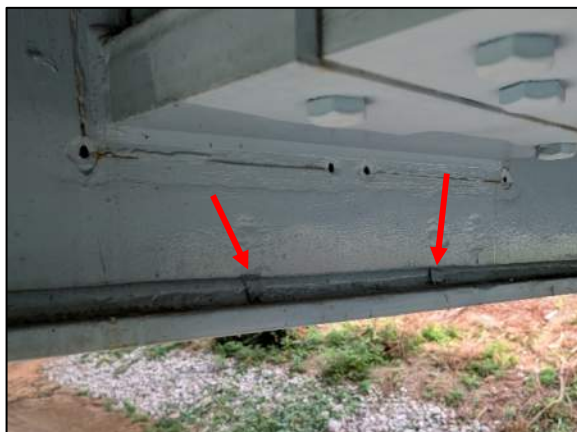
As part of the 2015 rehabilitation project, knee braces were removed from the webs below Girders 1 through 10. Remnants of the fillet welds for the knee braces remain and intersect the weld between bottom flange plate and web plate on each side of the girder (Photo 70).

*Photo 70: Remnants of knee braces and fillet welds, typical at all girders*

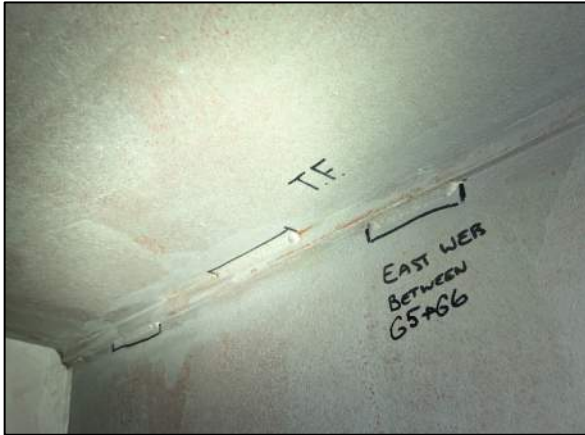
*Photo 74: Fillet welds between the east web and top flange between Girders 5 and 6*

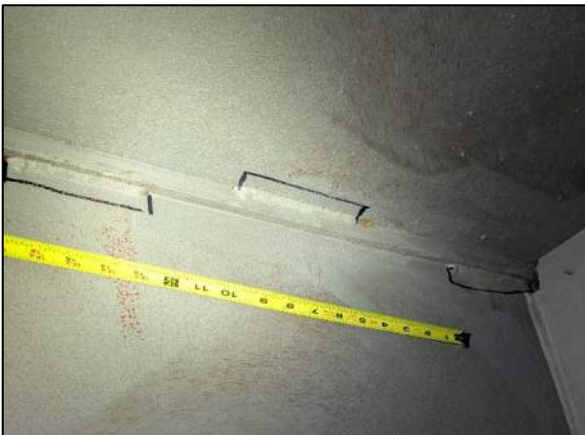
*Photo 75: Fillet welds between the east web and top flange between Girders 5 and 6*
