# NSTM Member Inspection Report

## HAM-75-1192R 2025 NSTM Member Inspection Report (VAR-District 8 Bridge Inspections for Steel Caps) SFN: 3110656, PID: 109781

October 2, 2025

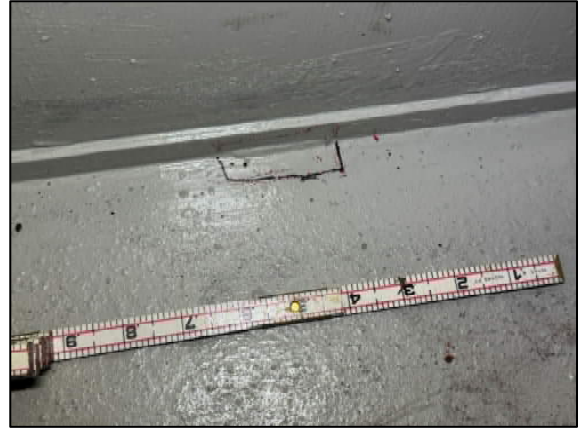
Photo 7: 2-1/4" tack weld between the bottom flange and north web of Pier Cap 5, west of Girder 3

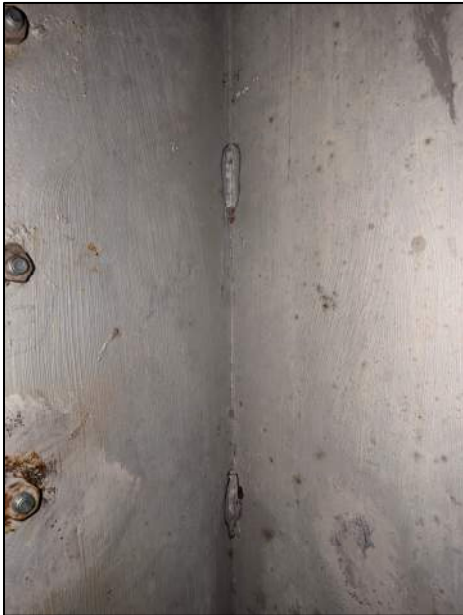
Photo 5: Tack welds ranging from 1.5" to 4" at the west end of the north end of Pier Cap 5

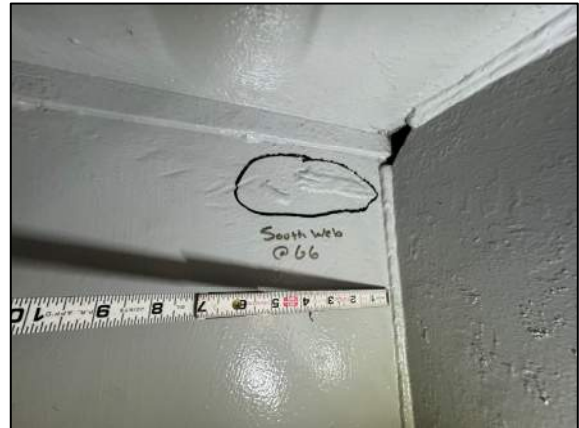
Photo 8: 3" x 1" plug weld on the south web of Pier Cap 5, east of Girder 6

Location: One plug weld in the north web plate between Girders 5 and 6; one plug weld in the south web plate at Girder 6 (2 total).

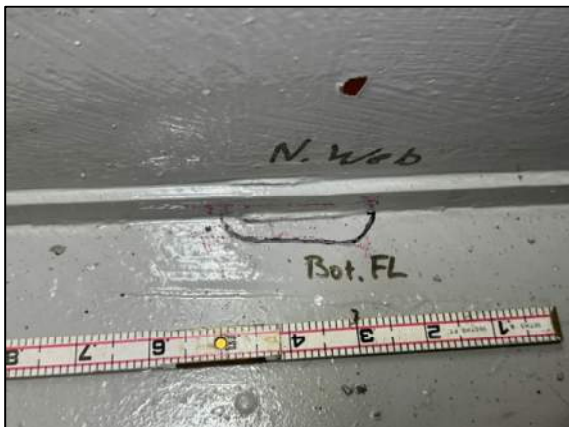
Photo 6: Typical 3" tack weld between the bottom flange and north web of Pier Cap 5, east of Girder 3

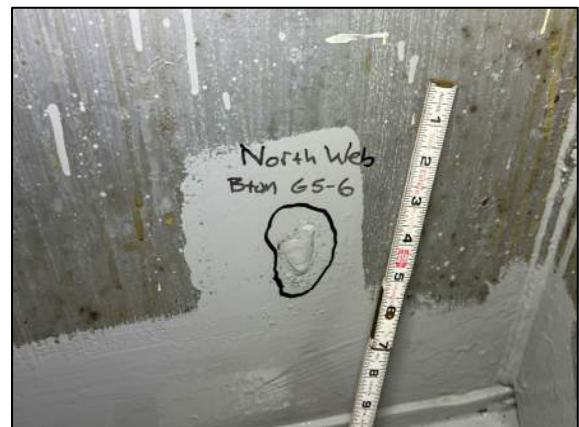
Photo 9: 2" x 1" plug weld on the north web of Pier Cap 5, between Girder 5 and Girder 6

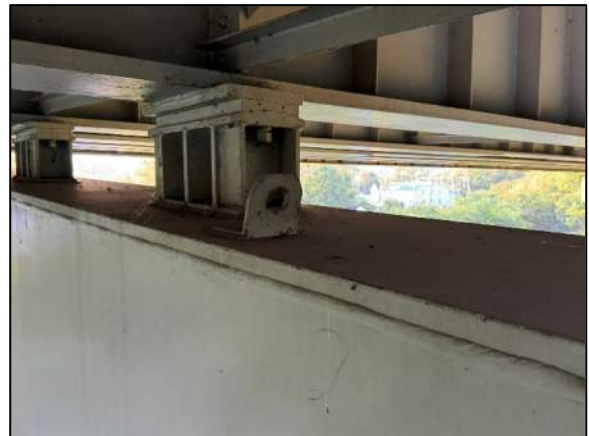
Photo 12: Lifting angle welded in place on top of Pier Cap 5 at Girder 2

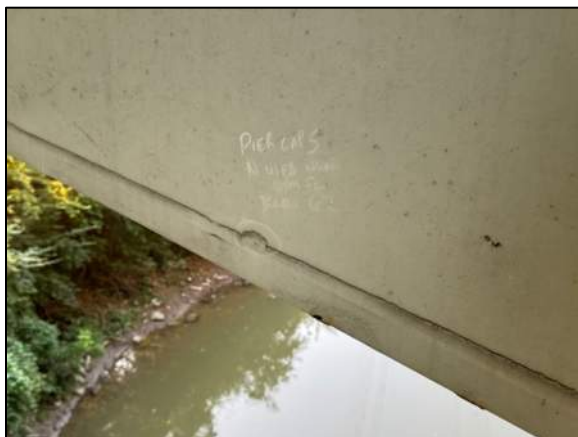
Photo 10: Typical overlapping weld beads on bottom flange of Pier Cap 5, south web below Girder 4

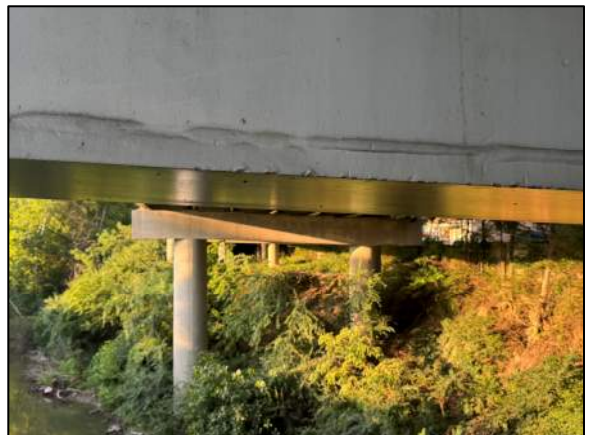
Photo 13: Gouges from construction on the north face of the bottom flange of Pier Cap 5 at Girder 2

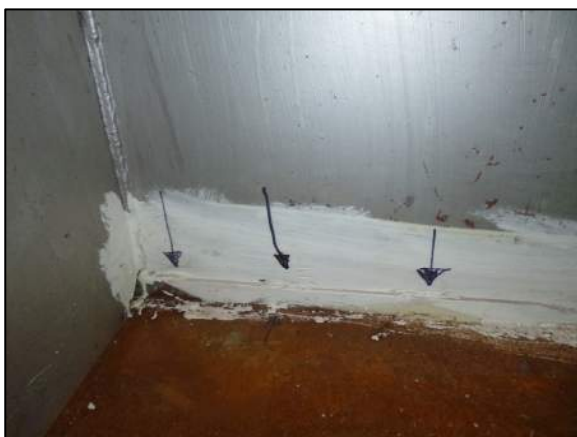
During the 1993 rehabilitation project, tack welds along the bottom flange, webs and backer bars were ground down. A total of 40 partially removed welds were noted between the north web and the backer bars. A total of 36 partially removed welds were noted between the bottom flange and the backer bars (Photo 21). Random tack welds were also observed throughout the pier cap. Select portions of bottom flange backer bar have been removed throughout the length of the pier cap to eliminate butt joints (Photo 22). A random spot weld was also noted on the north web between Girder 1 and the west diaphragm approximately 3' above the bottom flange (Photo 23).

Photo 21: Typical partially removed tack welds on the bottom flange backer bar of Pier Cap 16

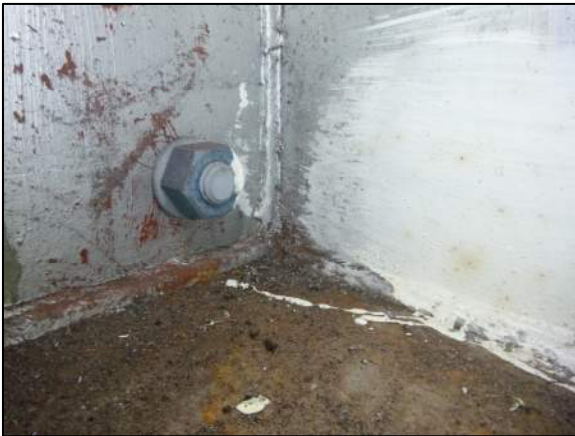
The fillet welds along the pier cap diaphragms, pier cap webs and the girder tie plates are not sufficiently coped resulting in triaxial welds (Photo 26). As part of the 1993 rehabilitation project, the 1" diameter drilled and bolted stress relief holes were installed in the pier cap webs adjacent to all girder diaphragms above the girder tie plates. At an earlier date, drilled, sawcut and bolted retrofits were added in the pier cap webs, at the tips of the girder bottom flanges.

*Photo 26: Typical triaxial weld above girder tie plate*

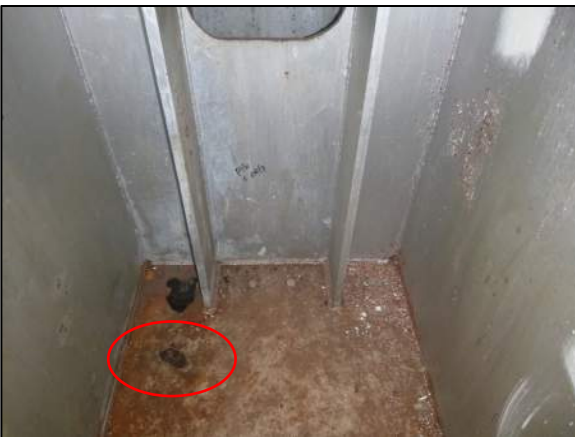
During the inspection, feces was observed at the east end of the pier cap adjacent to the diaphragm above the east bearing (Photo 27). This condition was not noted in previous reports.

*Photo 27: Feces encountered at east end above east bearing.*

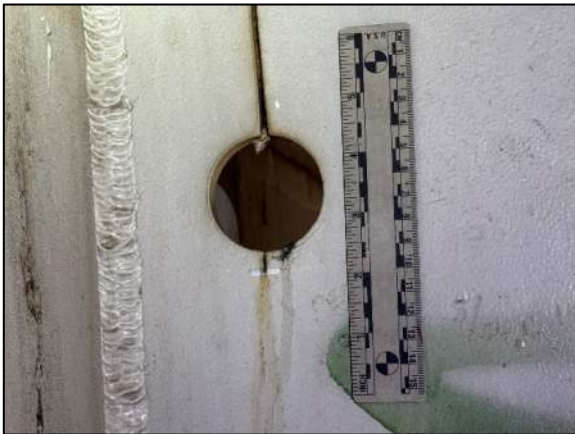
The drilled and bolted retrofits noted above are also visible on the exterior of the pier caps. In addition to the pier cap web retrofits, 2" Diameter stress relief holes were drilled through all girder webs adjacent to the pier cap top flange and connected with sawcuts. On the north side of the pier at Girder 3, the sawcut extends 5/16" beyond the lower hole; no cracks were noted (Photo 31). Also, on the north face, the stress relief holes in web of Girder 4 exhibit partial sawcuts that do not connect the drilled holes. The west side of this web exhibits shallow and partial sawcuts between the holes, as well as slightly below the bottom hole (Photo 32). On the south web at Girders 2 and 4, there are minor gouges below the bottom hole due to sloppy sawcuts. No significant changes were observed during the 2025 inspection.

Photo 31: Sawcut retrofit extending 5/16" past the stress relief hole on Girder 3 at the north web of Pier Cap 16

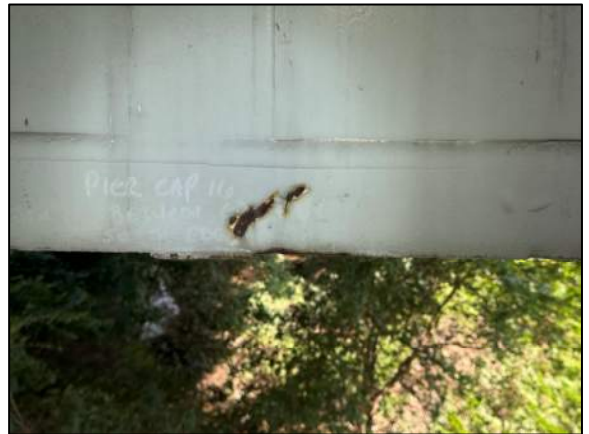
Photo 34: 4" tack weld between Girders 3 and 4 on the south face of the Pier Cap 16 bottom flange

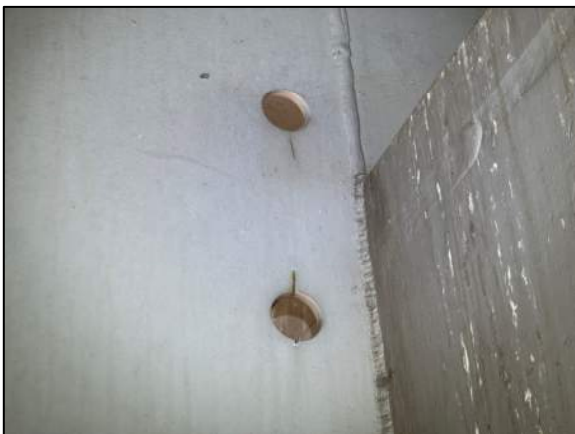
Photo 32: Stress relief holes in the web of Girder 4 at the north web of Pier Cap 16 not connected

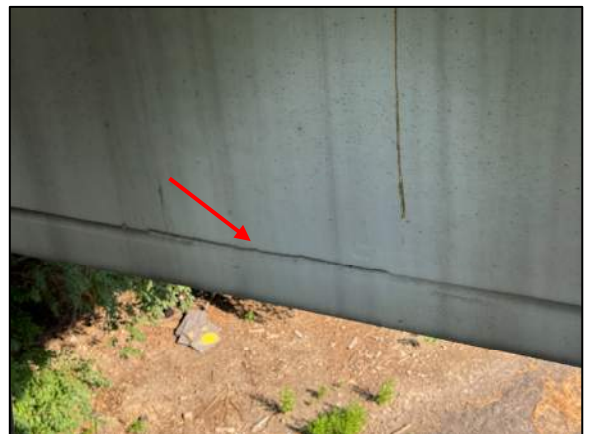
Photo 35: 18" overlapping weld under Girder 5 between the south web and bottom flange of Pier Cap 16

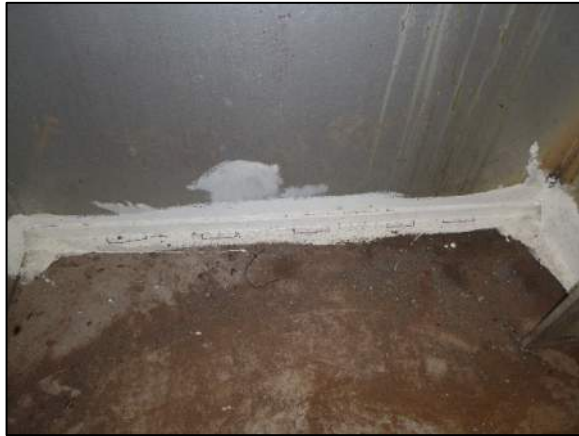
During the 1993 rehabilitation project, tack welds along the bottom flange, webs and backer bars were ground down, however; some were missed or only partially ground (Photo 39). Select portions of the backer bar were removed throughout the length of the pier cap to eliminate butt joints and bent sections. The fillet welds connecting the pier cap diaphragms to the webs and girder bottom flange tie plates typically exhibit ripples, discontinuities, and overlapping beads with no signs of distress noted.

*Photo 39: Partially ground fillet welds from the bottom flange backer bar retrofit at Pier Cap 20*

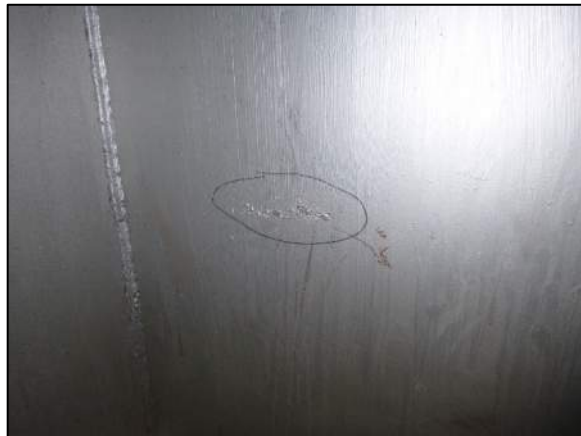
A total of six tack welds were also noted at random along the pier cap webs and flanges (Photos 42). The welds at the diaphragms are typically sloppy and poorly developed, displaying discontinuities, a lack of fusion, and overlapping (Photo 43).

*Photo 42: 4-1/2" of weld material on the south web of Pier Cap 20, east of the west bearing.*

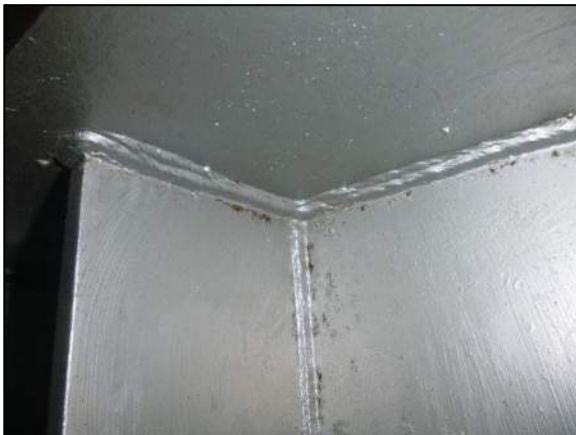
The fillet welds along the pier cap diaphragms, pier cap webs and the girder tie plates are not sufficiently coped resulting in triaxial welds (Photo 40). As part of the 1993 rehabilitation project, the 1" diameter drilled and bolted stress relief holes were installed in the pier cap webs adjacent to all girder diaphragms above girder tie plates. At an earlier date, drilled, sawcut and bolted retrofits were added in the pier cap webs, at the tips of the girder bottom flanges. On the north web, an additional hole was drilled on the

*Photo 40: Typical triaxial welds at the girder bottom flanges and Pier Cap 20 diaphragms*

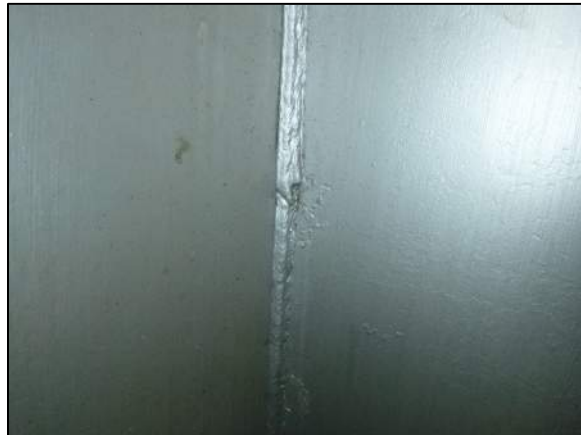
*Photo 43: Sloppy welds at the diaphragms of Pier Cap 20*

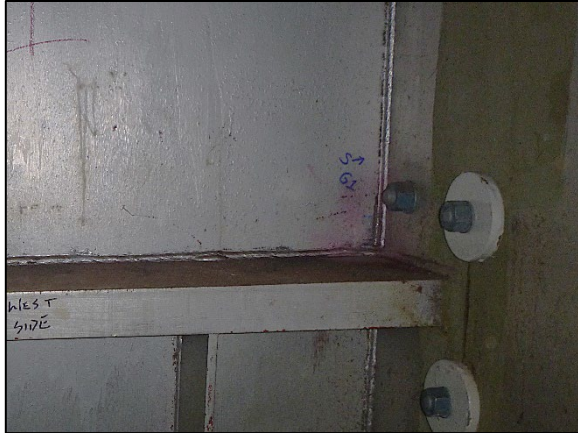
*Photo 44: General location view of removed slag on Girder 1*

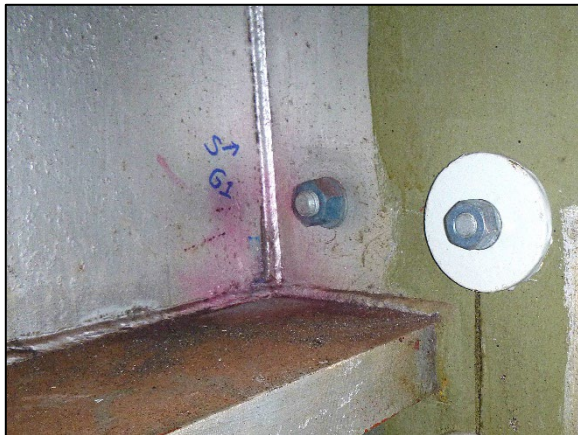
*Photo 45: General location view of removed slag on Girder 1 (Closeup)*

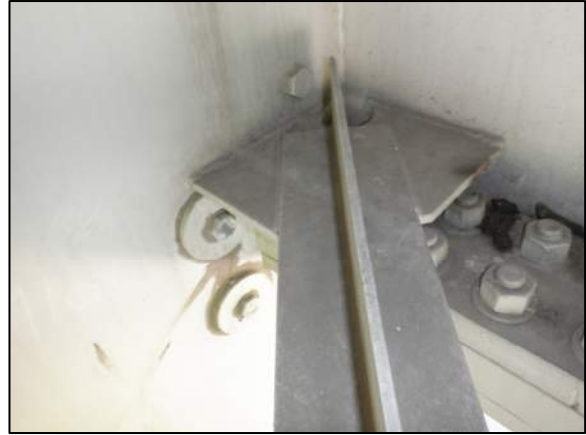
The lower lateral bracing gusset plates are welded to the web plates at Girders 2 and 6. During rehabilitation, the gusset plates were retrofitted with circular copes from the corner of the plate adjacent to the girder connections to the pier cap webs. The 2" Diameter circular copes were cut near the intersection of the welds but did not fully remove the fillet welds at the web plates (Photo 50).

*Photo 50: Typical lateral bracing cope detail at Pier Cap 20, fillet welds not completely removed*

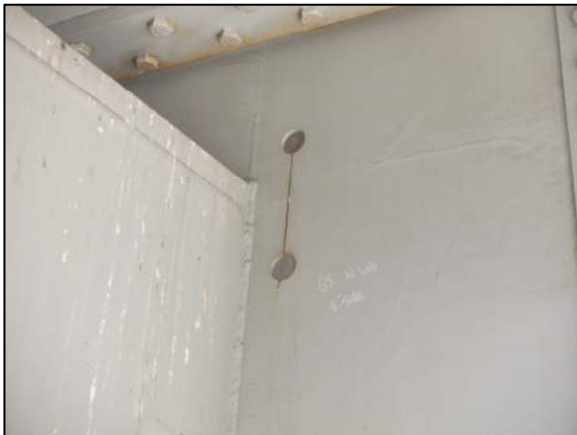
The drilled and bolted retrofits noted above are visible from the exterior of the pier cap. During the 1993 rehabilitation, 2" Diameter holes were drilled through the girder webs above and below the top flange of the pier cap. These holes are open and connected with a sawcut. At Girder 5 on the north web, an errant sawcut extends approximately 9/16" past the bottom stress relief hole (Photo 48). Smaller additional overcuts were also noted on the east face of Girder 2 on the south web of the pier cap (Photo 49), on the west face of Girder 3 on the south web of the pier cap, and on the west face of Girder 1 on the south web of the pier cap. No cracks were noted beyond the overcuts.

*Photo 48: Sawcut retrofit extending 9/16" past stress relief hole on Girder 5 at the north web*

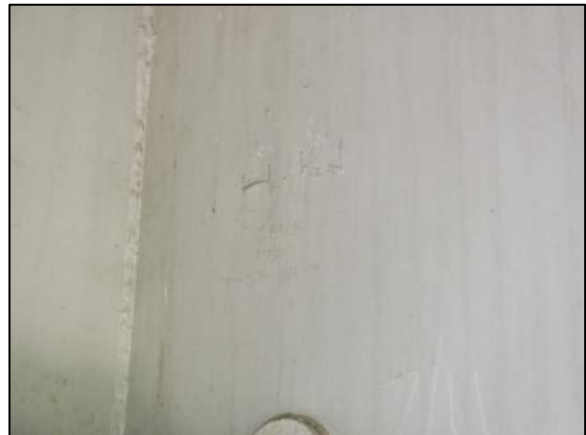
- South web on the east side of Girder 3: 1-3/8" longitudinal weld and a 2" longitudinal weld (Photo 51).
- Bottom of south web between Girders 1 and 2: three discontinuous lengths of weld material, up to 1-1/2" L.
- South web between Girders 5 and 6: a 3" x 1" area of errant weld material.

*Photo 51: Tack welds on the south web of Pier Cap 20, east of Girder 3 above the girder flange*

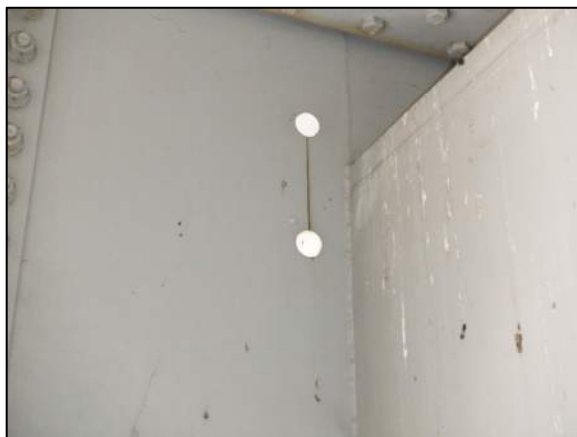
*Photo 49: Numerous overcuts up to 1/8" on the Girder retrofits*

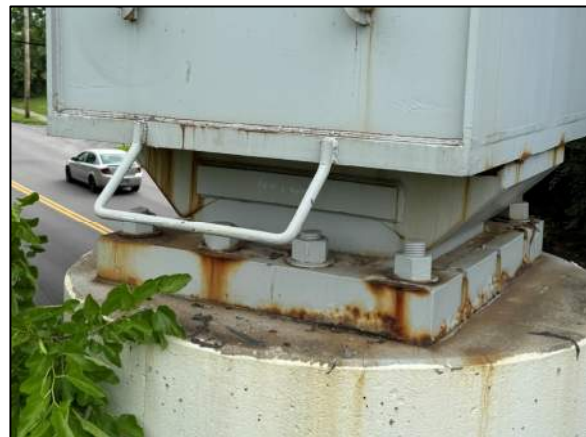
*Photo 52: East Bearing cap Pier Cap 20 displaying peeling paint*
