# FRACTURE CRITICAL PIER CAP INSPECTION REPORT

SFN3102807 (HAM-50-1903L)  
US 50 WB OVER MILL CREEK/CSX  
TRANSPORTATION/CENTRAL  
RAILROAD OF INDIANA  
HAMILTON COUNTY, OH  
DISTRICT 8

July 2023

US 50 WB over MILL CREEK/CSX TRANSPORTATION/CENTRAL RAILROAD OF INDIANA •  
SFN3102807 (HAM-50-1903L) • Hamilton County, OH • July 2023

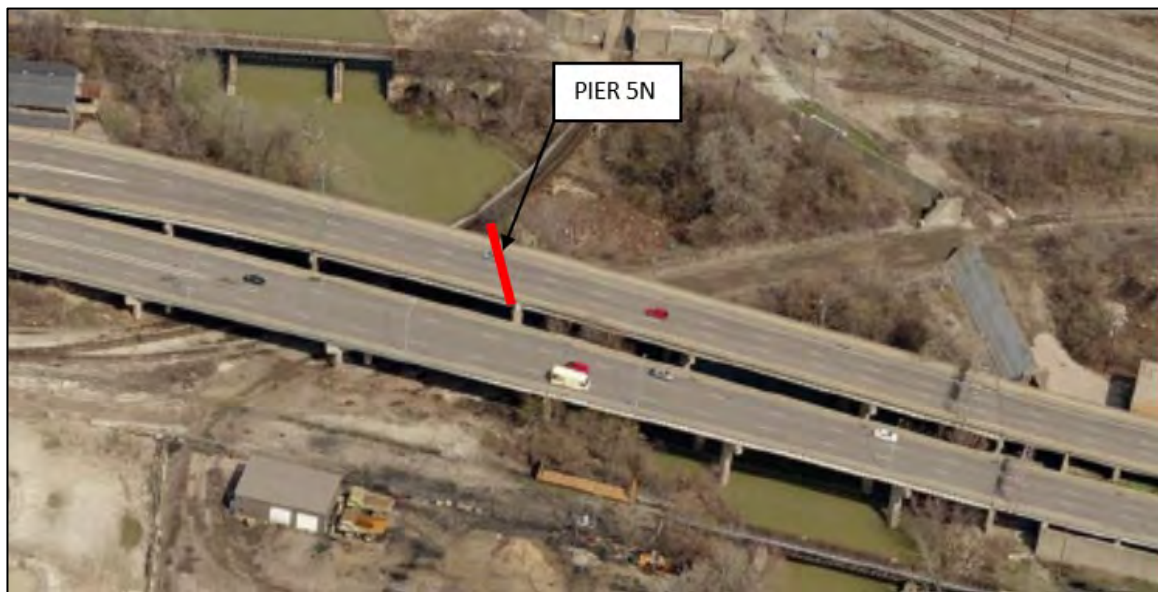
Figure 2: Fracture Critical Pier Cap Location

The structure has one fracture critical pier cap located at Pier 5N. This cap spans over the Central Railroad of Indiana track (See Figure 2). Pier Cap 5N is a 67 ft.-5in. simply supported welded steel box beam. A 24 in. diameter water line passes through the cap at mid-span. The nomenclature and girder designations shown on the design plans were used in the fracture critical inspection of the pier cap. The bridge was rehabilitated in 2015 to widen US 50. Structural improvements, including fatigue retrofits, were performed on the pier cap in 1993 and 2013. The 1993 rehabilitation included several fatigue-prone weld details. Two 2 in. diameter stress-relief holes were drilled through the longitudinal girder webs at their connection to the top flange of the pier cap (both north and south face) and then connected with a vertical sawcut. Tack welds between the longitudinal girder bottom flanges and the bottom flanges of the pier caps were ground out. Tack welds that attached the backer bars to the pier cap webs and bottom flange plates were ground out. Sections of backer bar that had bent away from the web plates of the pier caps were removed.

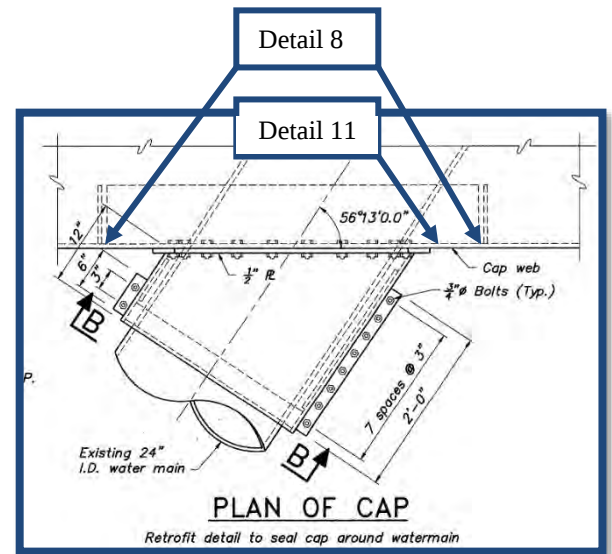
**Figure 3:** Water main portal detail.

Fillet welds between longitudinal stiffeners and web plates. Category: B

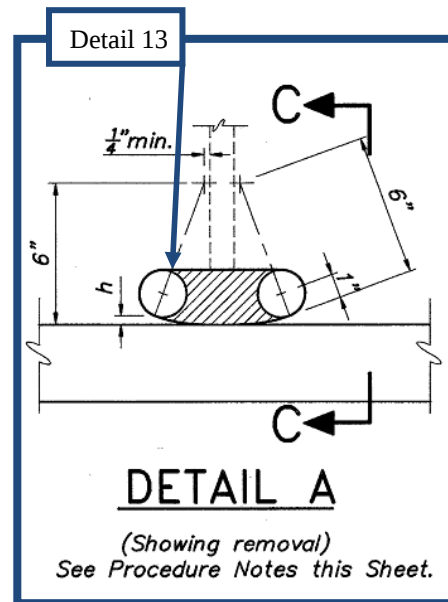
Figure 5: Weld intersection retrofit.

Weld intersection removal holes in web plates. Category: C

Location: Bottom of web plates at all transverse stiffeners.
