# FRACTURE CRITICAL PIER CAP INSPECTION REPORT

SFN3103811 (HAM-50-2910)

US-50 OVER NORFOLK SOUTHERN,  
INDIANA AND OHIO RAILROAD, DUCK  
CREEK, AND RED BANK ROAD  
HAMILTON COUNTY, OH  
DISTRICT 8

March 2024

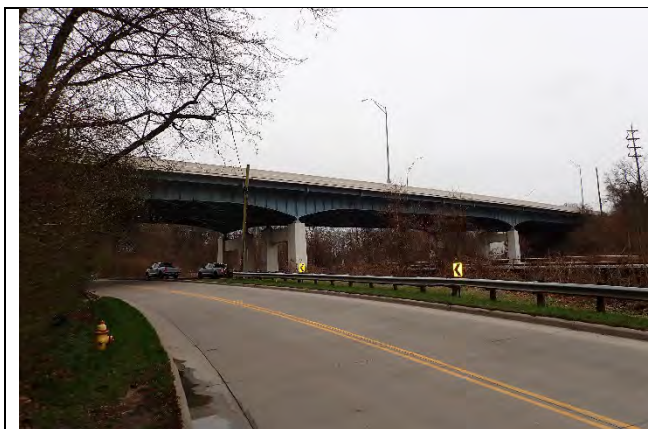
Photograph 1: General elevation, looking southwest.

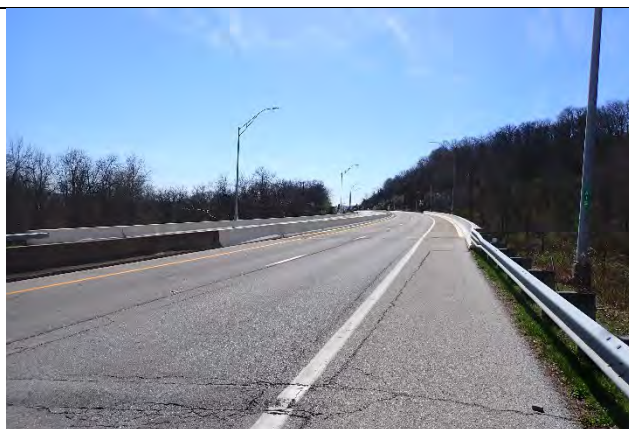
Photograph 2: General endview, looking west.

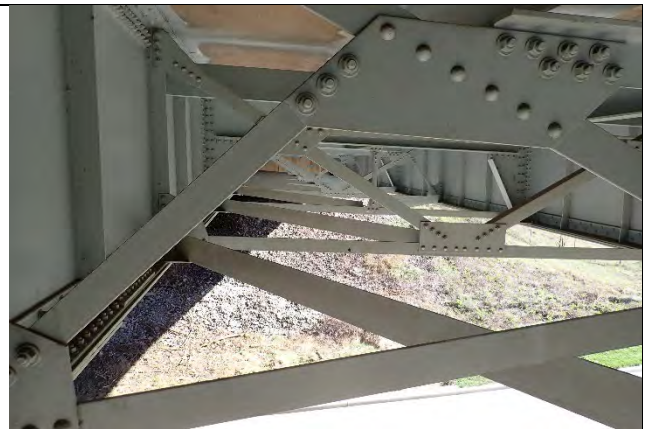
Photograph 12: Typical girder configuration, looking east.

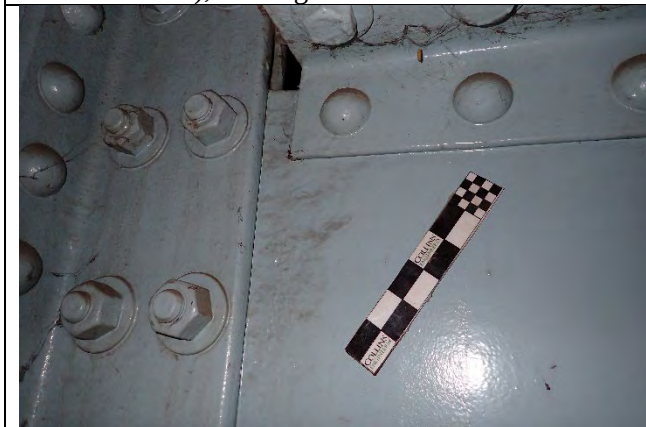
The girders typically exhibited localized painted over pitting up to 1/16 in. deep on the knee brace web plates at the angle connections to the girders. The support bracing typically exhibited painted over pitting up to 1/16 in. deep. Pack rust was present between the girders and the masonry plates, causing minor distortion. This is heaviest at the Rear Abutment and is not a concern at this time. The previously noted small area of corrosion from leakage in Girder 2 in Span 2 had been painted over. The beam ends of Girders 2 through 4 at the Rear Abutment exhibited corrosion from leakage through the joints. Isolated locations of pack rust up to 1/4 in. was present between the deck on the girder top flanges; this has been caused by deck leakage.

Photograph 13: Typical localized painted over pitting of 1/16 in. on the knee brace web plates at angle connections to the girders (Span Girder 1 at Forward Abutment shown), looking east.

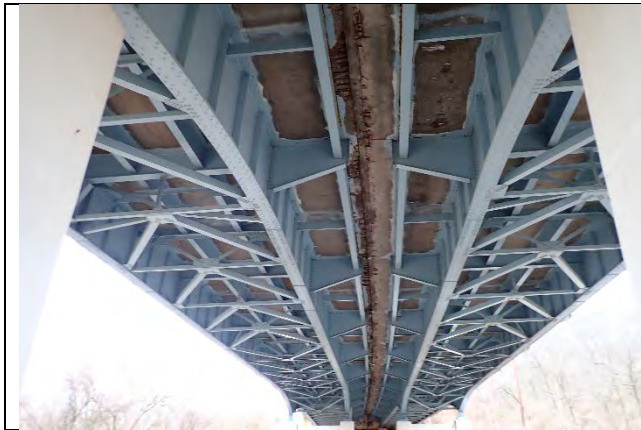
Photograph 15: General view of the superstructure, looking east.

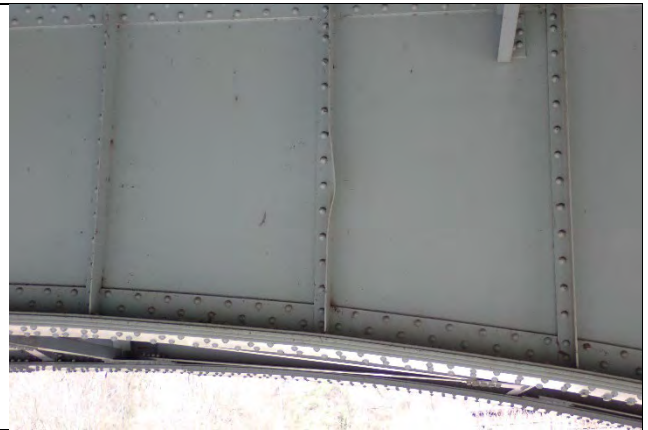
Photograph 16: Close up of vertical stiffener bent approximately 2.5 ft above the bottom flange (Span 2 Girder 2 south face), looking north.

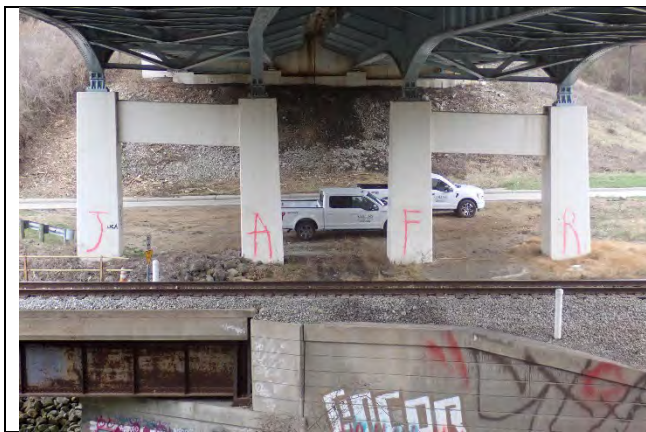
Column 1 of Pier 1 exhibited two shallow spalls measuring 5 in. diameter by up to 1.5 in. deep located 2 ft above the ground. Columns 1 and 3 of Pier 1 exhibited small spalls; Column 3 exhibited 3 small spalls with exposed reinforcing steel due to lack of cover for the horizontal bars. Column 2 of Pier 2 exhibited four shallow spalls measuring 5 in. diameter by up to 1.5 in. deep located 2 ft above the ground. Column 4 of Pier 2 exhibited a spall located at the left edge of the bearing seat 4 ft long by 10 in. vertical by 3 in. deep with one exposed horizontal reinforcing bar and seven exposed vertical reinforcing bars with approximately 20% section loss.

Photograph 23: Typical pier configuration (Pier 2 shown), looking east.

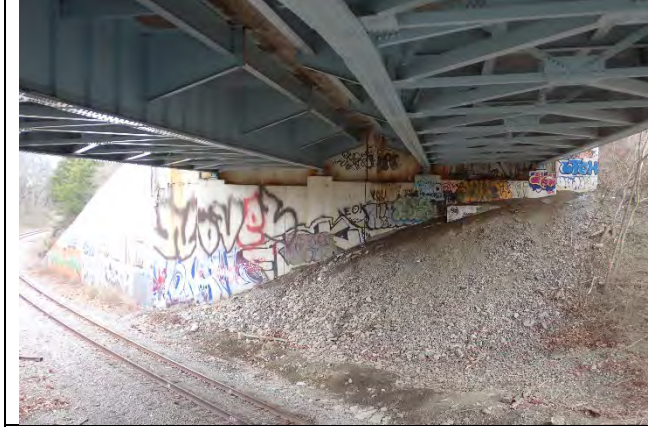
Photograph 26: Overall view of Rear Abutment, looking west.

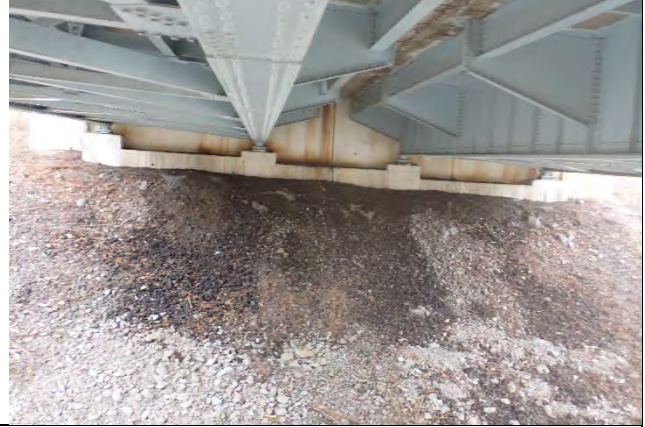
Photograph 27: Overall view of Forward Abutment, looking east.

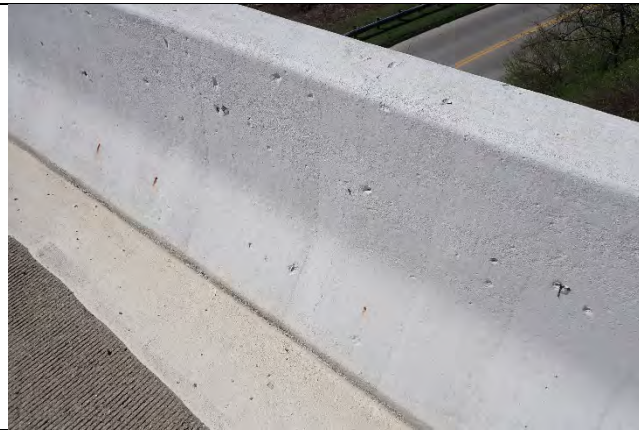
Photograph 31: Typical rail configuration, north rail in Span 3 westbound shown, looking northwest.

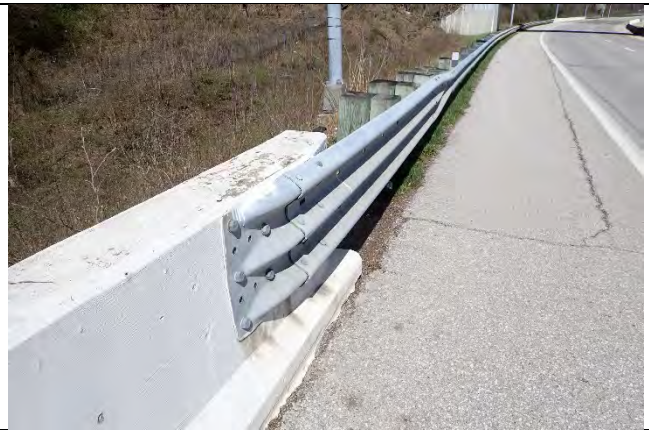
Photograph 32: Typical approach rail transition configuration, looking northeast.

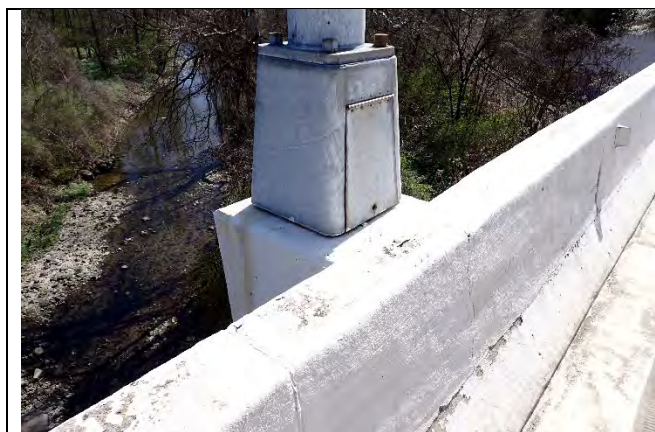
Photograph 41: Typical bridge light, looking southwest.
