# BRENT SPENCE APPROACH BRIDGE

HAM-71-0000L

SFN: 3105946

## 2025 In-Depth/NSTM Inspection Report

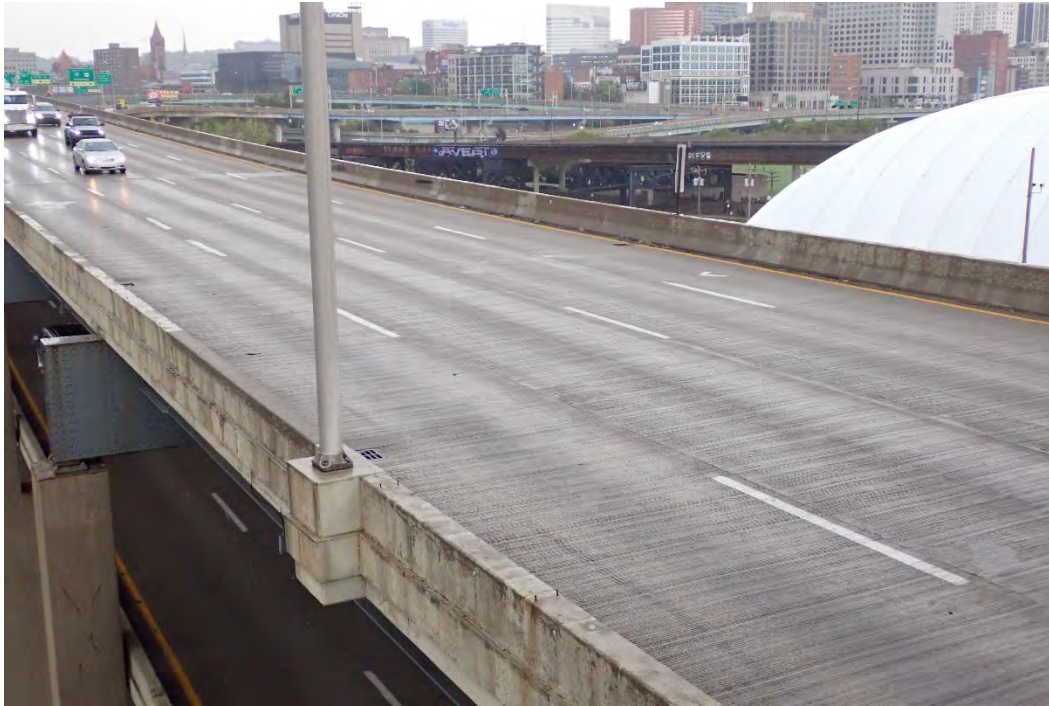
The reinforced concrete deck is in SATISFACTORY CONDITION [6-NBIS] overall (Photo 1 & Photo 2), due to isolated spalling on the deck underside with exposed rebar and transverse cracking throughout girder bays (Photo 3).

*Photo 1 - Typical top of deck at Span 1A, looking northeast.*

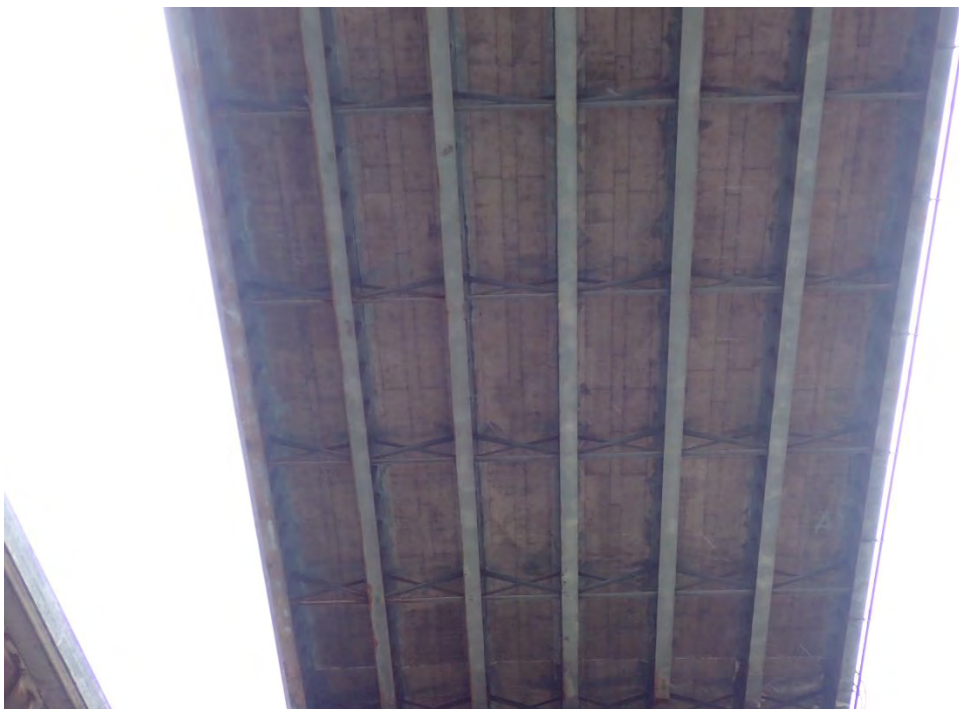
*Photo 2 - Typical deck underside at Span 15A, looking south.*

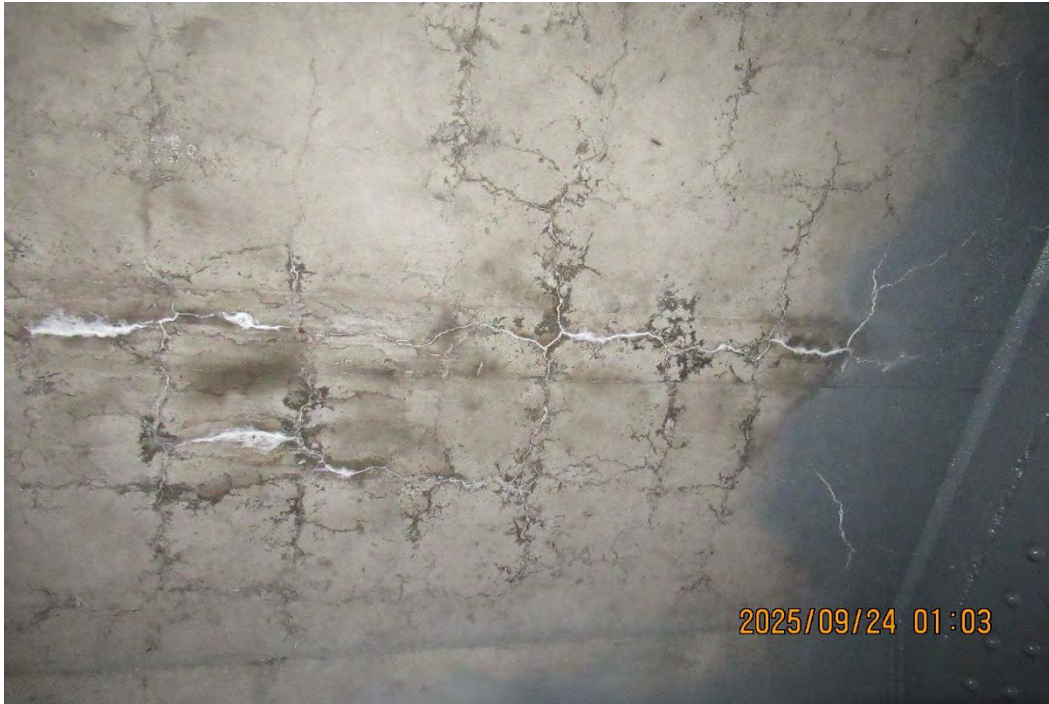
*Photo 3 – Typical transverse cracking with efflorescence throughout girder bay sat Span 11A Bay 4, looking west*

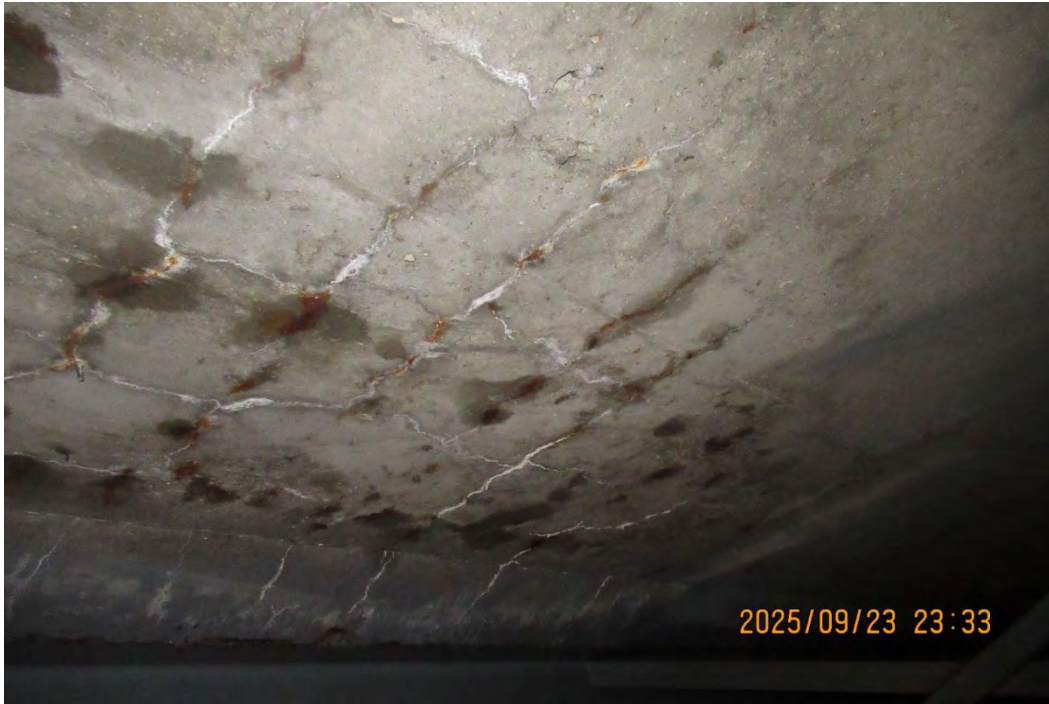
*Photo 5 - Hairline transverse and map cracking with efflorescence at the underside of Deck in Span 8A.*

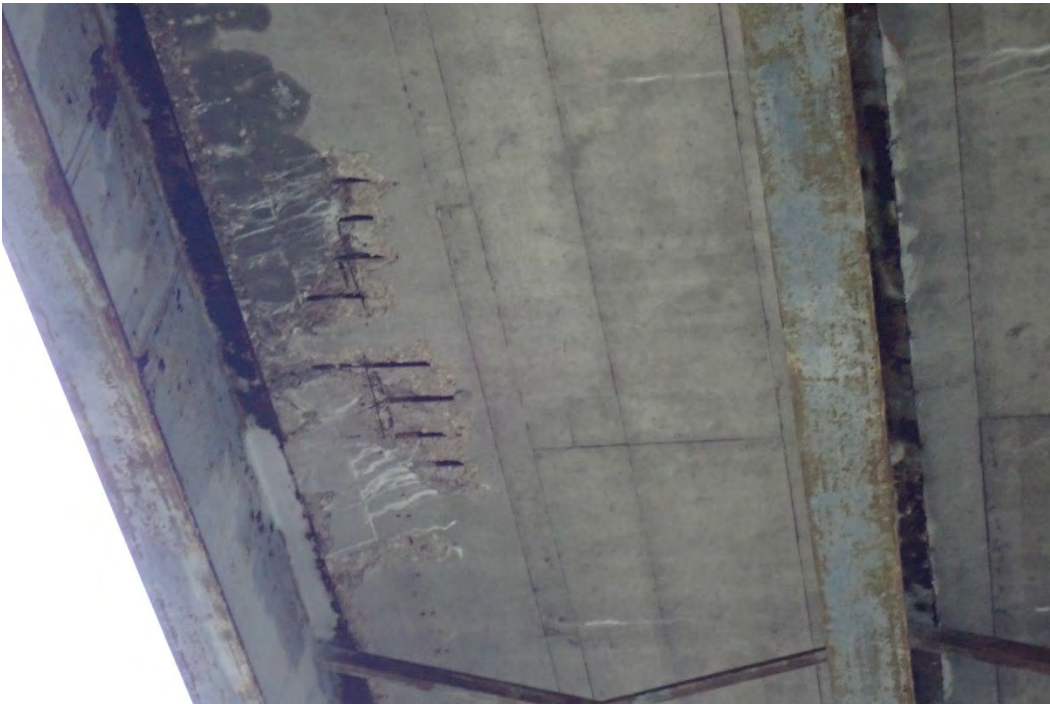
| Deck Defects | |
|---|---|
| Span 26B | Four spalls up to 3' long by 3' wide by 3" deep with rebar exposed between Girders D and E at the second cross frame from Pier 25B (Photo 8). |

*Photo 8 - Typical spalling with exposed rebar on the underside of deck at Span 26B, looking south.*

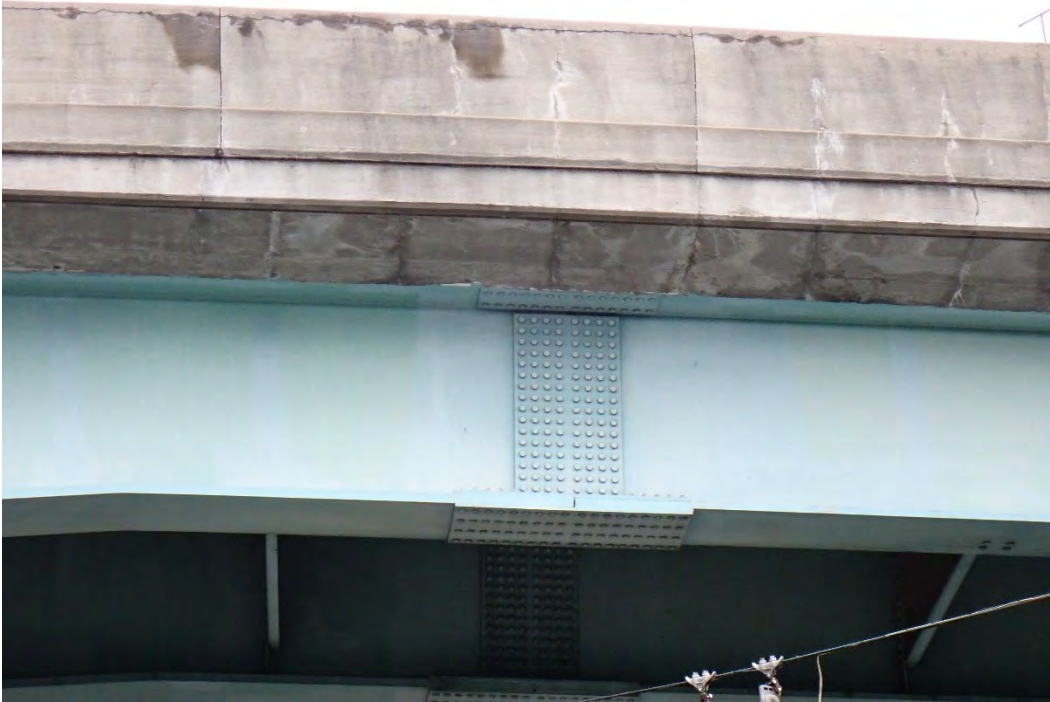
The deck overhangs typically exhibit hairline map cracking and isolated spalls with exposed reinforcement (Photo 9).

Photo 9 - Typical deck overhang at Span 3, looking north. Note: minor transverse cracking along with efflorescence.

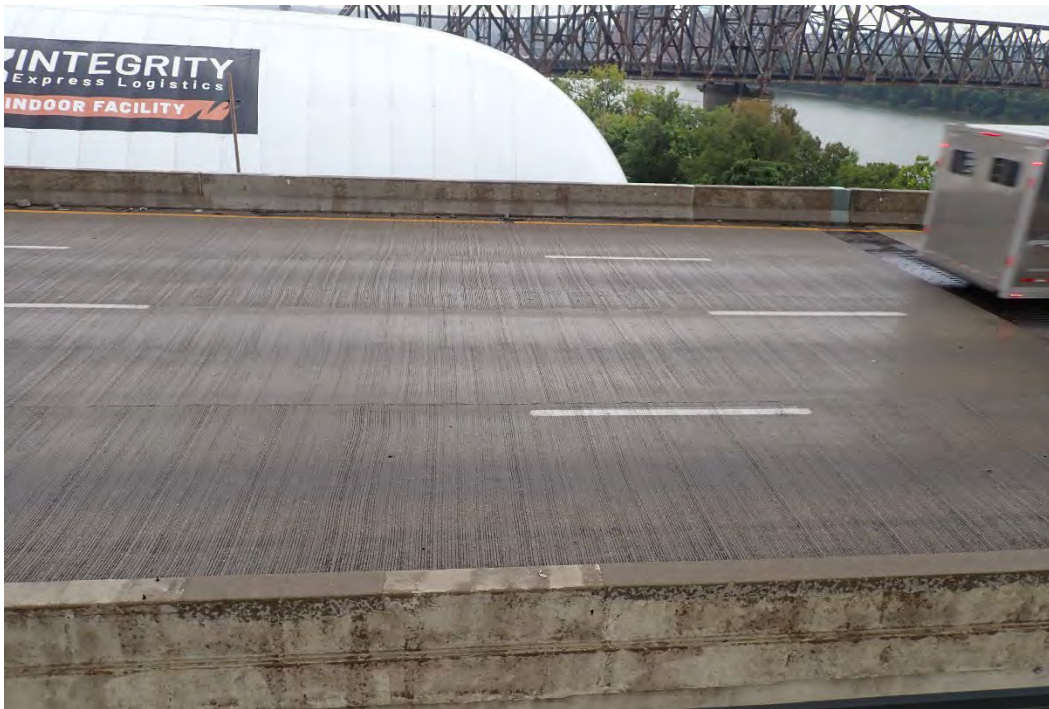
The wearing surface is in SATISFACTORY CONDITION [6-NBIS] overall with minor spalls and hairline to moderate longitudinal, diagonal, and transverse cracks throughout (Photo 11). The wearing surface was visually inspected from a 135-foot manlift and driven as slowly as safety permitted. Small shallow pop-out spalls less than 6" in diameter are typical throughout spans (Photo 12). There are typical full-width transverse hairline cracks spaced 24" to 4' apart throughout the FWW spans. The high-friction treatment of the wearing surface in these spans is worn in the travel lanes, but is still present. There are multiple isolated concrete and asphalt patches throughout Spans 5A, 6A, 8A, 14A, and 25B (Photo 13 & Photo 14). Based on the 2020 ODOT Concrete Wearing Surface Delamination Report (Appendix B), there are several areas of delamination throughout the deck.

*Photo 11 - Typical top of deck at Span 1A, looking east.*

- Repair spalls and seal cracks in the wearing surface.
- Repair spalls, delaminations, and seal cracks in concrete railings throughout structure.
- Spot paint areas of corrosion in pier box cap interiors.
- Clean and apply protective coating on Spans 15A to 28B.
- Repair isolated spalls and delaminations on concrete substructure units throughout the structure.

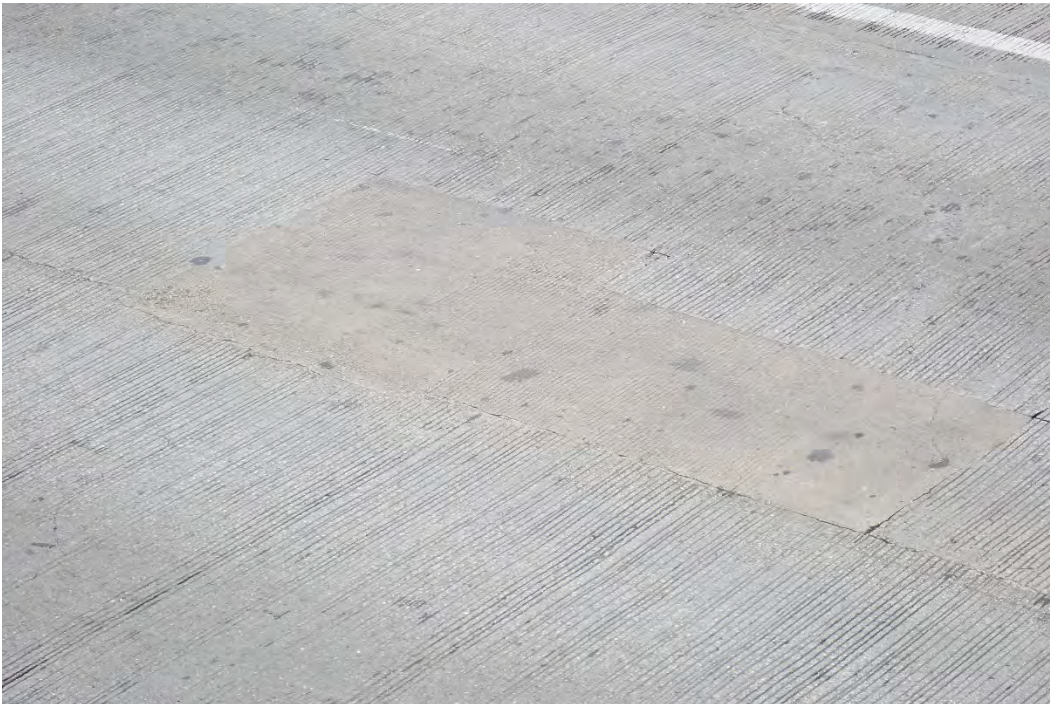
*Photo 13 - Typical concrete deck repair at Span 5A, looking northeast.*

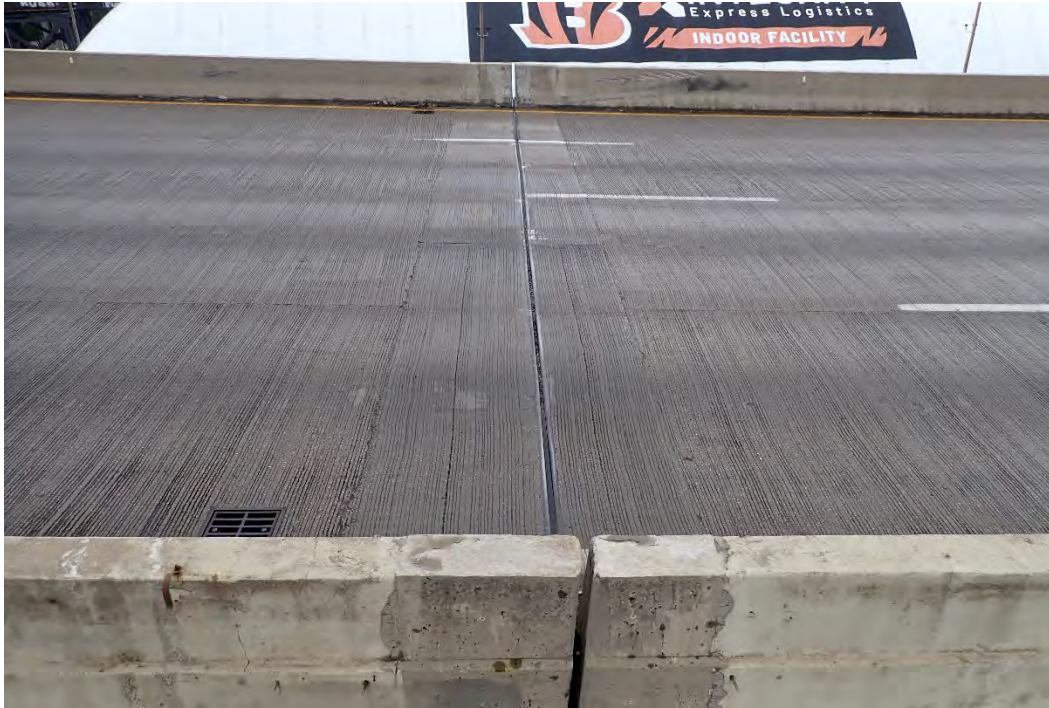
The expansion joints are in FAIR CONDITION [5-NBIS] overall with minor to heavy debris accumulation, deterioration, and isolated areas of leakage (Photo 15). There are strip seal expansion joints located at Piers 4A, 8A, 12A, 15A, 19A, 23B, 28B, 7 (FWW), 4 (FWW), and the Wall Pier (Photo 16). The joints typically exhibit minor debris accumulation throughout the entire length, and minor tears are present at Piers 15A, 23B, 28B, and 7 (FWW). Signs of water leakage were noted at several joint locations.

*Photo 16 - Typical strip seal joint at Pier 4A, looking east.*

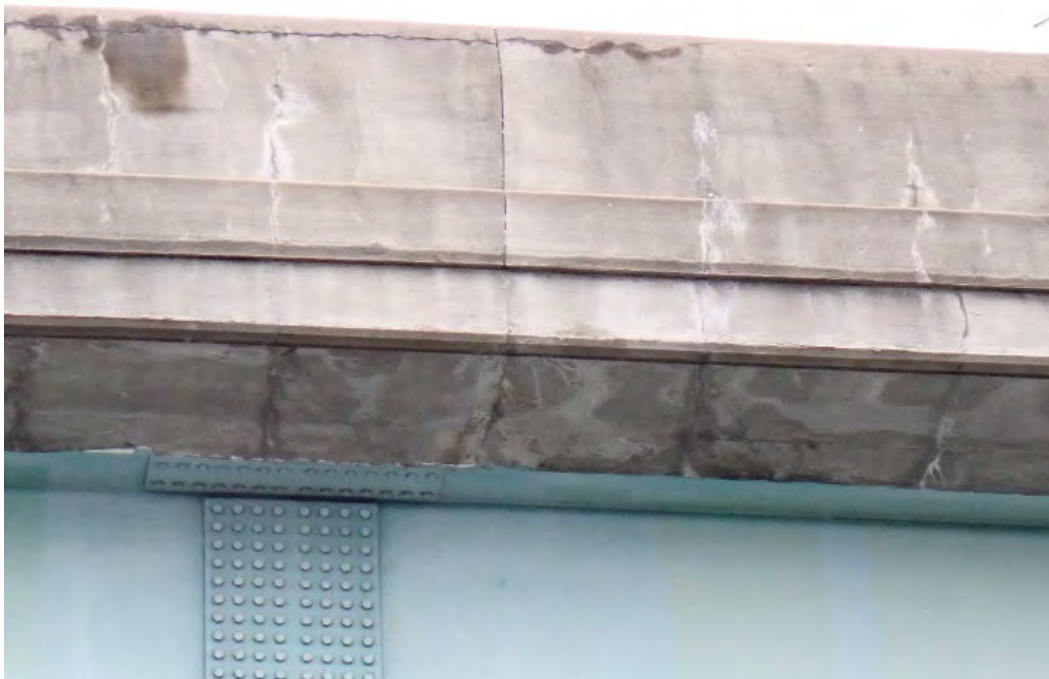
*Photo 17 - Typical concrete bridge railing with vertical hairline cracking and efflorescence at Span 3, looking northeast.*

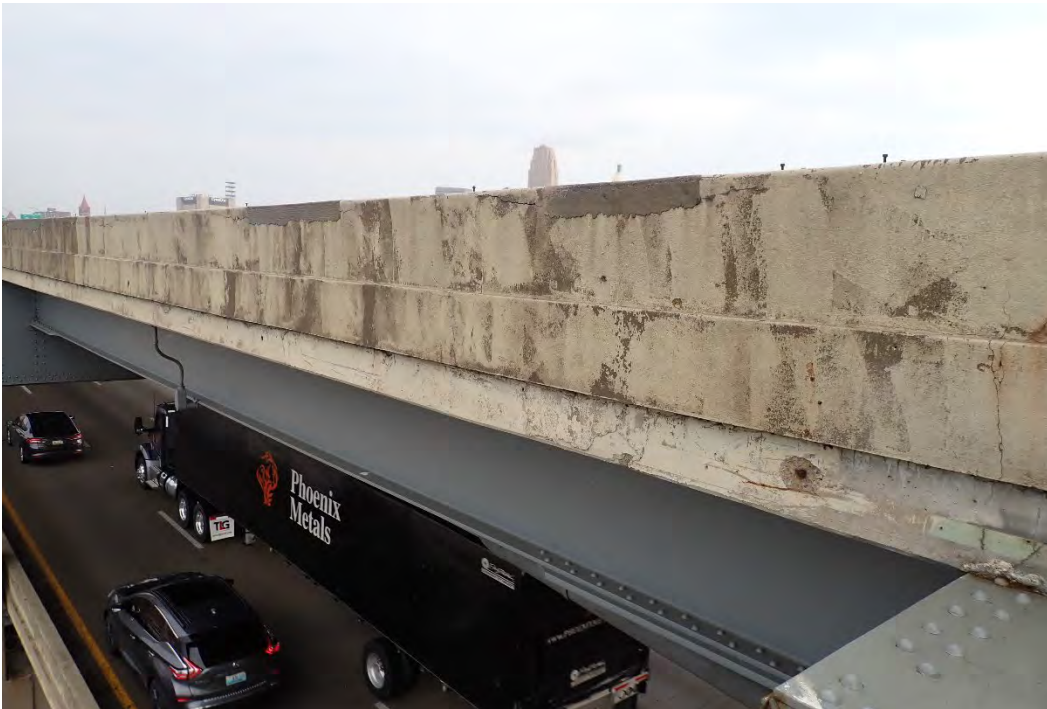
There are isolated minor spalls throughout the railings in the original bridge spans that have been repaired (Photo 20 & Photo 21). The west railing of the River Pier joint has a previously noted 12" long by 6" high by 2" deep spall with exposed reinforcement (Photo 22). The area is surrounded by delaminated concrete and wide longitudinal and vertical cracks with water and rust staining. The previously noted 18" long by 6" high by 2" deep spall on the top east edge of the east railing at a sign connection in Span 3A has been repaired, along with several other sections of railing throughout the structure. The sign was moved to a different location in Span 2A. Isolated concrete patches are present throughout both railings, typically at the top edge. The patches are sound and in good condition overall.

*Photo 20 - Typical concrete patch on railing top at Span 3A, looking northeast.*

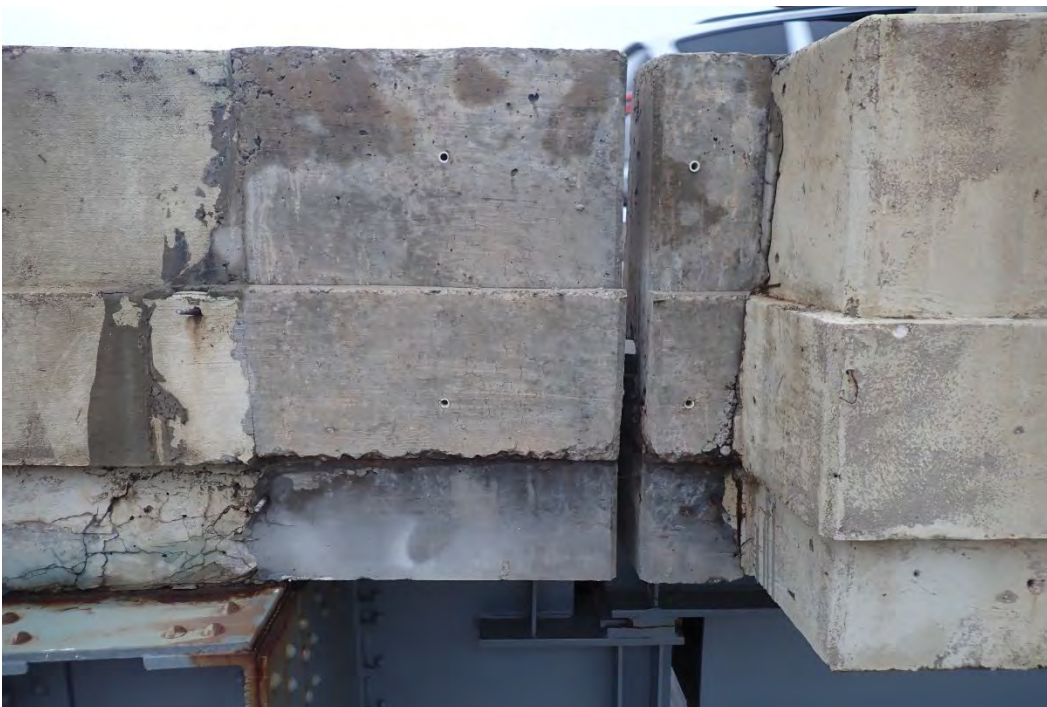
*Photo 21 - Typical concrete bridge railing repair at a joint location at Pier 7A, looking east.*

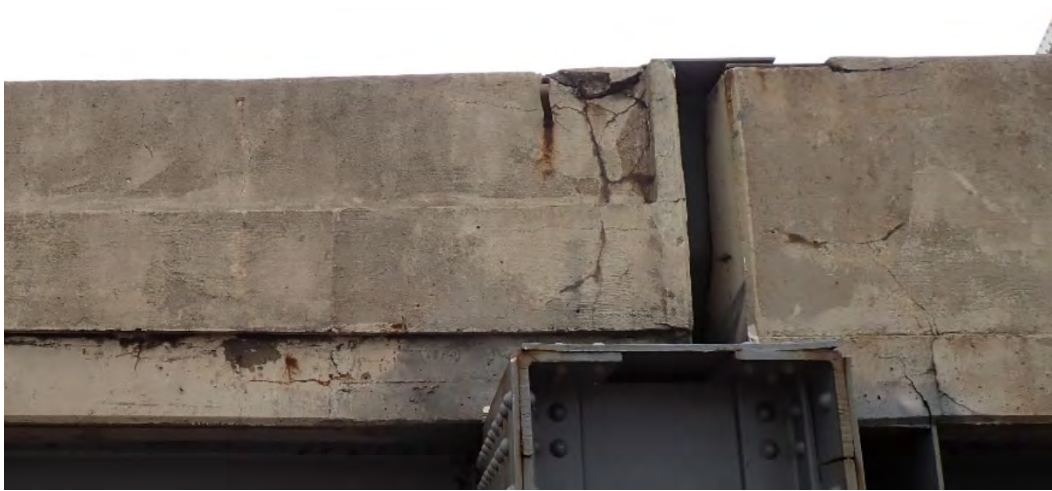
*Photo 22 - Spall with exposed reinforcement, surrounded by delaminated concrete, at the River Pier, looking east.*

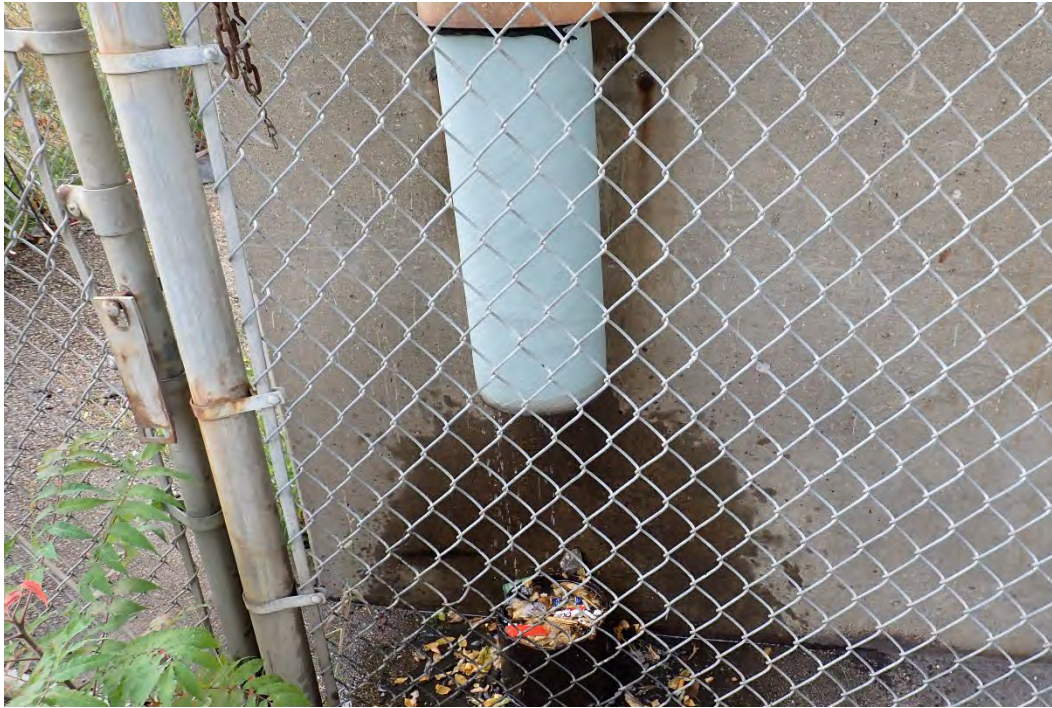
The bridge deck drainage is in POOR CONDITION [4-NBIS], due to multiple drainpipes being completely or partially clogged at the deck level scupper locations (Photo 23) and at the ground level (Photo 24), causing water ponding on the deck. Scuppers that are 100% clogged are located in Spans 3A, 6A, 8A, 9A, 10A, 17A, 18A, 19A, and at the Wall Pier in Span 1 (FWW). The drain grate in the left lane of Span 2A is missing (Photo 25). The drainage grate over the scupper near the east railing at Pier 19A has multiple broken bars.

*Photo 24 - Drain pipe impacted with debris and disconnected at base at Pier 6A, looking west.*

- Remove debris/ clean clogged deck drains, scuppers, and clogged drainpipes.
- Repair broken/ missing/ disconnected/ drainpipes and bulging boots throughout.

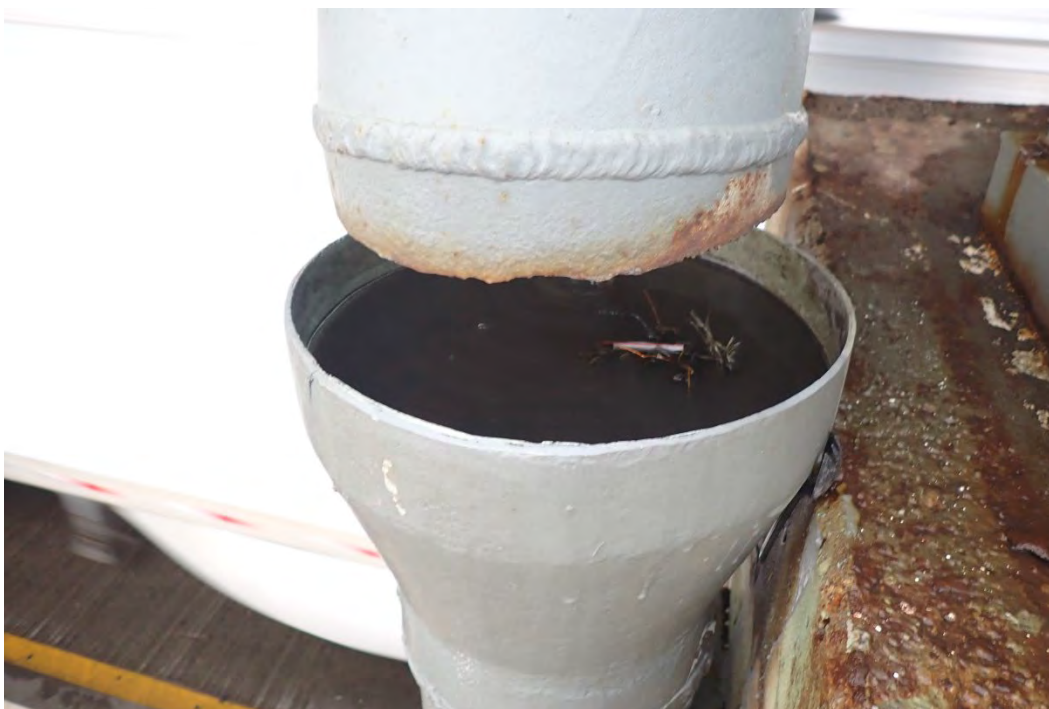
There are disconnected and misaligned drain boots at Piers 4A, 6A, 8A, 18A, 19A, and 22B (Photo 26). There are numerous locations where there is a large gap between the deck drainpipe and the drainpipe attached to the pier columns. The exposed drainage bells are typically fully clogged with debris (Photo 27 & Photo 28). The drainpipe T-joint is disconnected on the north face of Column 1 at Pier 12A, and the pipe is cracked, but this condition has not changed from the 2024 inspection. The most downspouts are partially or completely disconnected at the ground termination of Column 2 at Pier 4A. The missing pipe has caused erosion of the asphalt material below Pier 18A. Various locations throughout are also disconnected from the underground drainage termination, but do not show signs of erosion. Several drainpipes are cracked with corrosion holes through the pipe wall throughout the structure (Photo 29).

*Photo 27 - Typical clogged drainpipe at Pier 8A, looking east.*

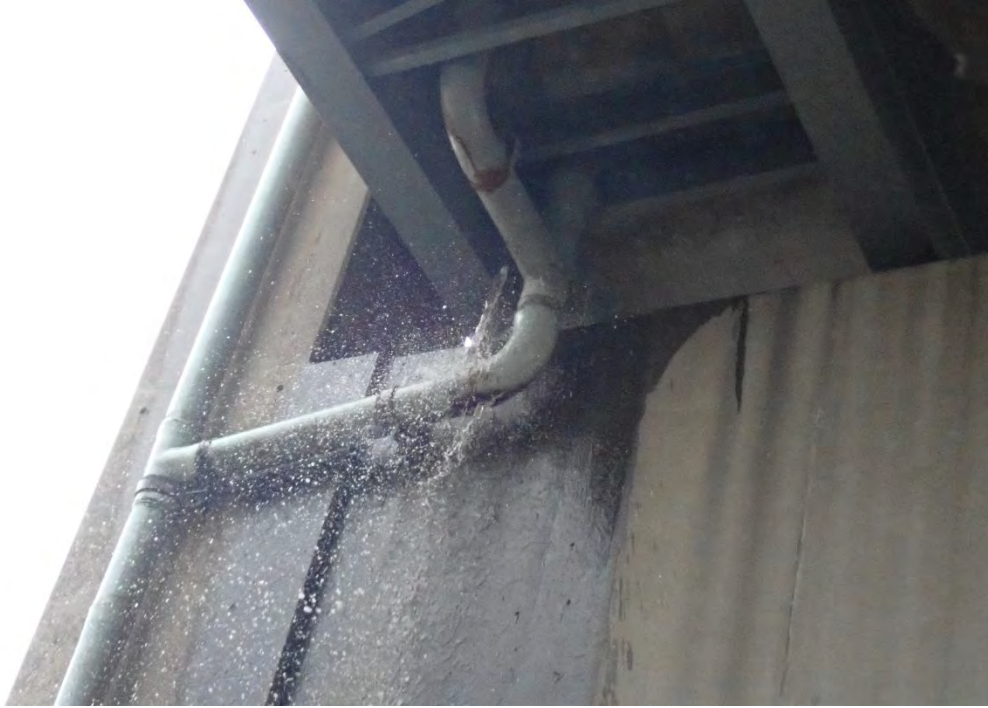
*Photo 28 - Clogged and overflowing drainpipe at Pier 2A, looking south.*

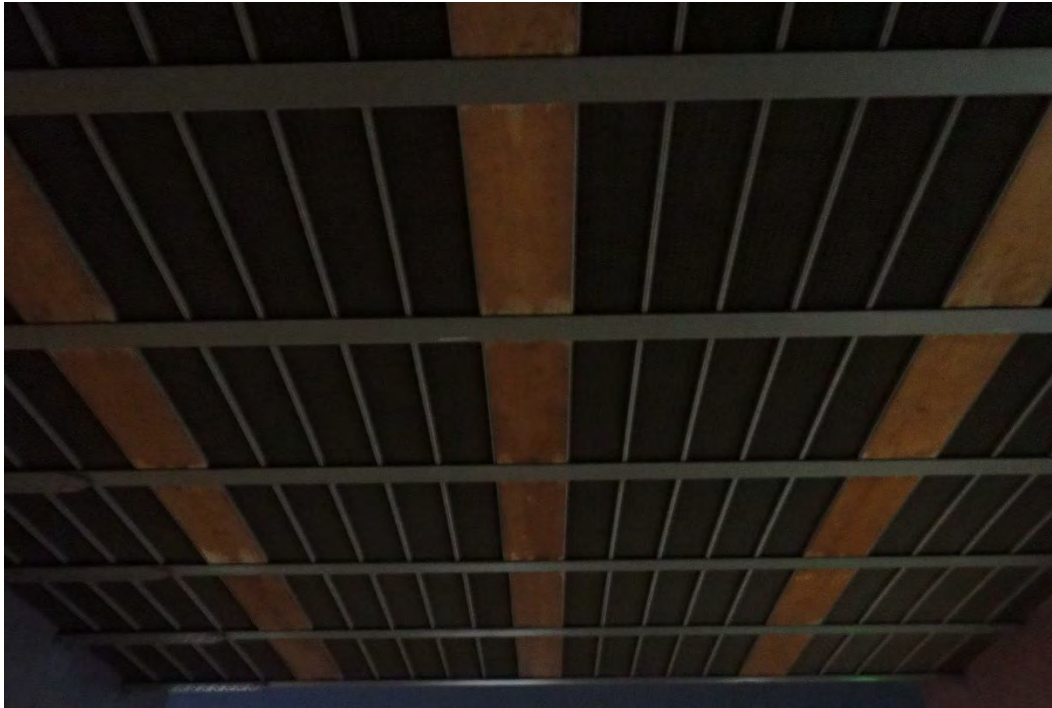
There is metal grating and wood shielding between interior bays of Spans 1A to 11A and portions of Spans 12A to 14A; therefore, only the bottom flanges were inspected with hands-on techniques (Photo 30). The shielding could not be removed, so the remaining portions of the girders were inspected visually through the grating. The girders in Spans 1A to 14A are in good condition overall. There is up to 1/8" painted over pitting typical for fascia girders in Spans 1A to 14A, most notable at box cap seats (Photo 31 & Photo 32). Typically, there is up to 3/4" thick painted over pack rust between the girder bottom flange and seat angles at the steel box pier caps in these spans; in some cases, the angles are bent up to 2" (Photo 33). The bottom flange of Girder G in Span 1A is bent upward 1/2" over 18" length (Photo 34). There are two, 1" diameter, corrosion holes in the web of Girder F between the bearing stiffeners at the hinge assembly at Pier 4A. There is a bent stiffener at the bottom flange of Girder E in Span 13A (Photo 35).

*Photo 30 - Typical girder layout with debris screens between River Pier and Pier 13A, Span 1A looking east.*

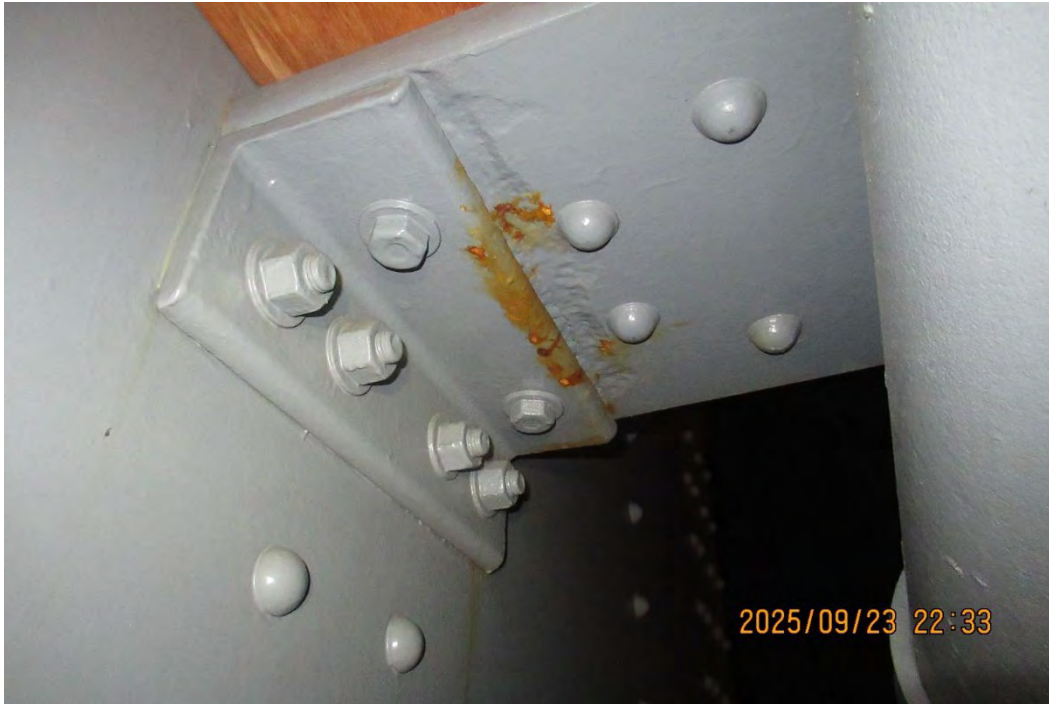
Photo 32 - 1/8" pitting on bottom flange of girder at Pier 6A, looking south. Note: Corrosion has been painted over.

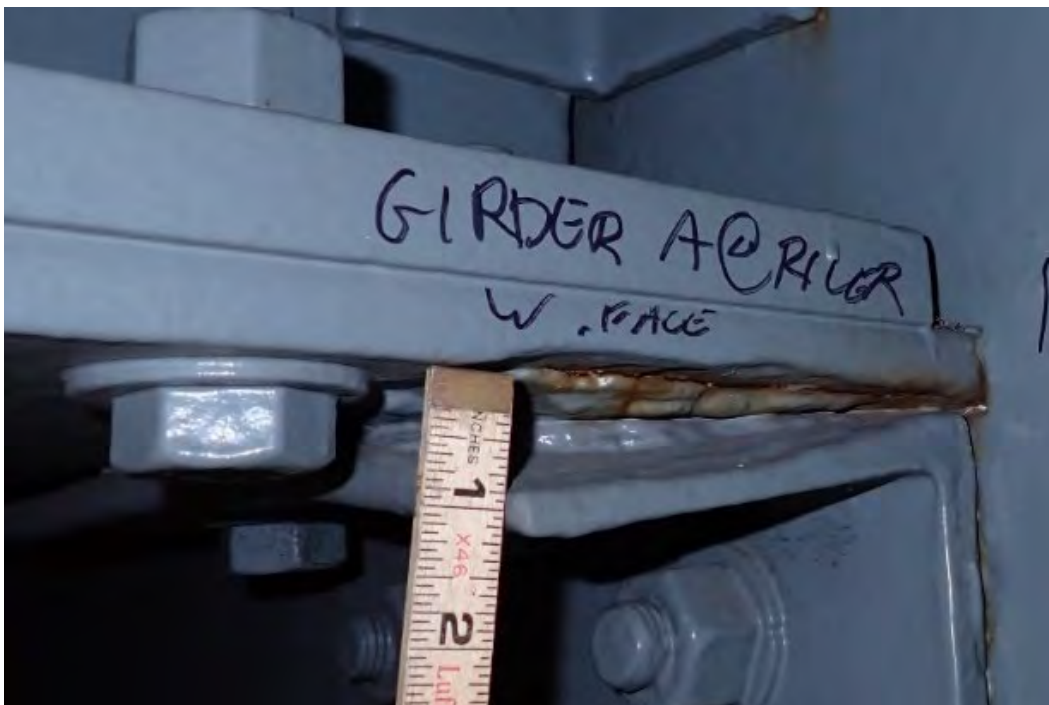
Photo 33 - 1" of pack rust between girder and bottom flange angle at River Pier Girder A, looking southwest.

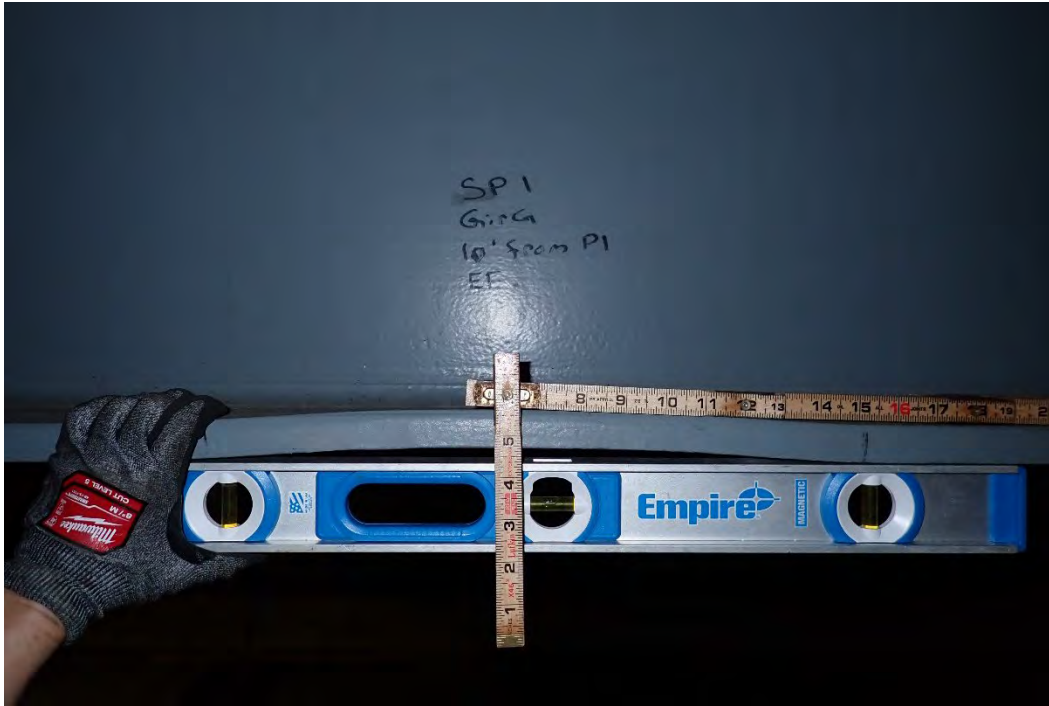
Photo 34 – Deflection in Girder G in Span 1.

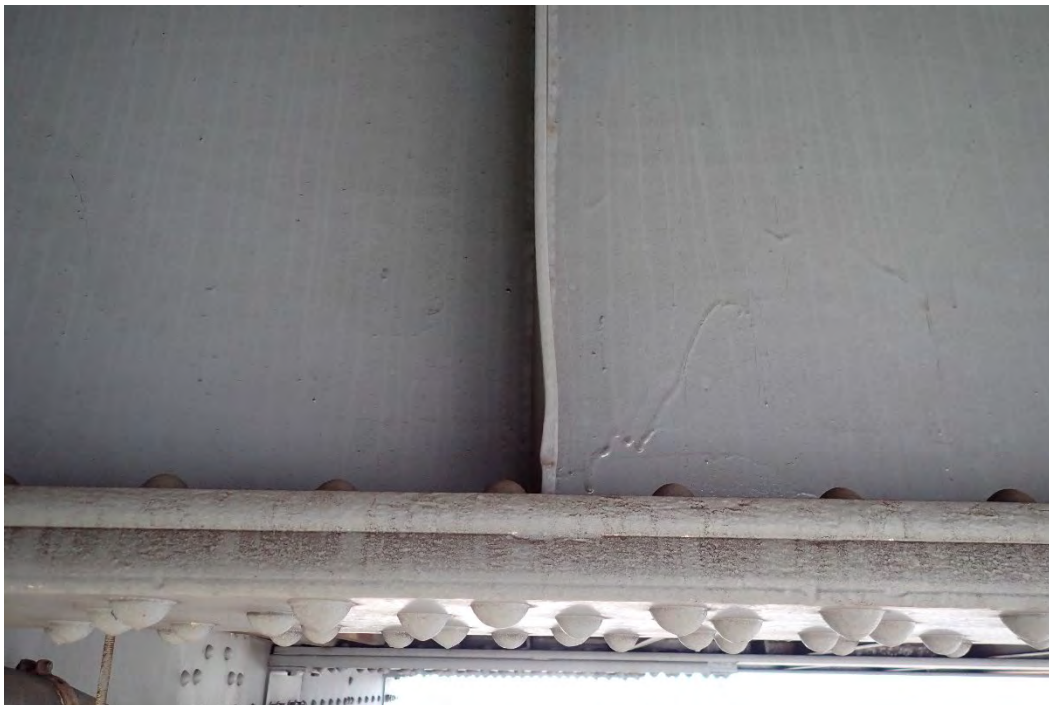
Photo 35 - Typical warped/ bent stiffeners at bottom flange of Girder E Span 13A, looking east.

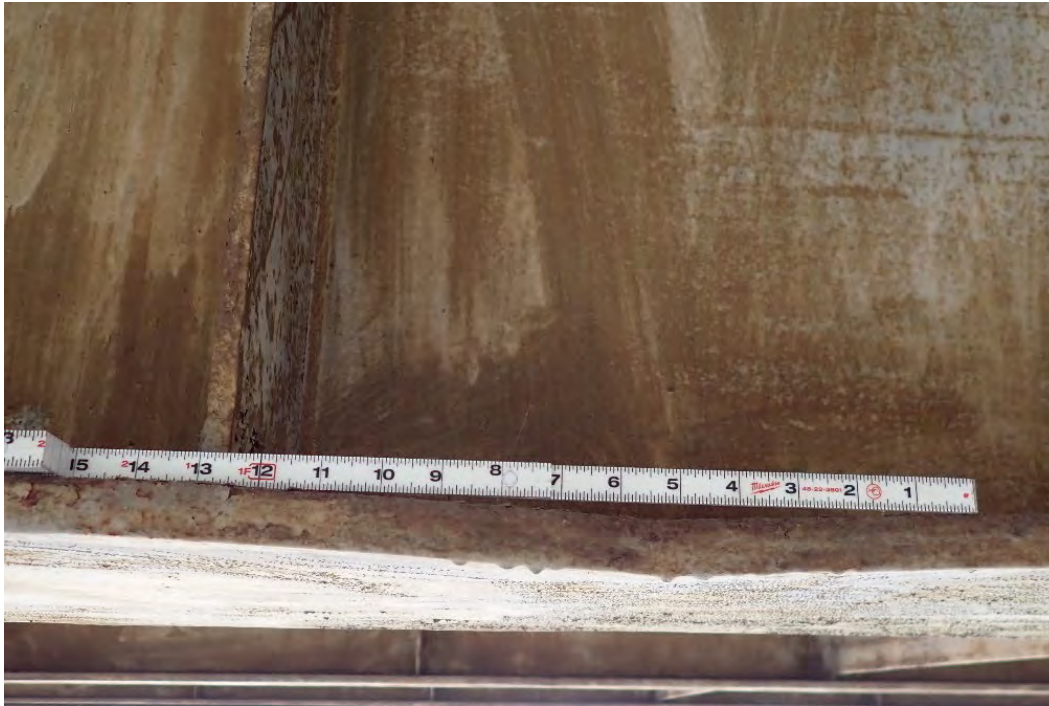
*Photo 38 - Bent bottom flange of Girder E of Span 17A, looking west.*

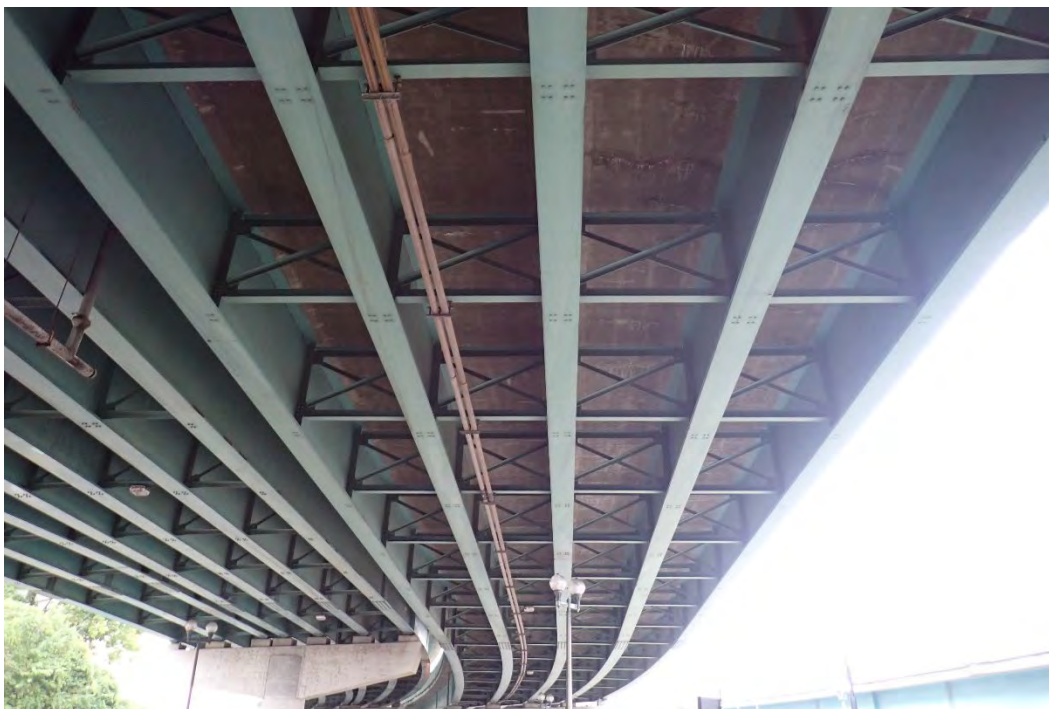
The girders in Spans 1 to 10 (FWW) are in good condition, with no significant defects noted (Photo 39, Photo 40, & Photo 41).

*Photo 39 - Typical girder layout and condition at FWW Span 4, looking southeast.*

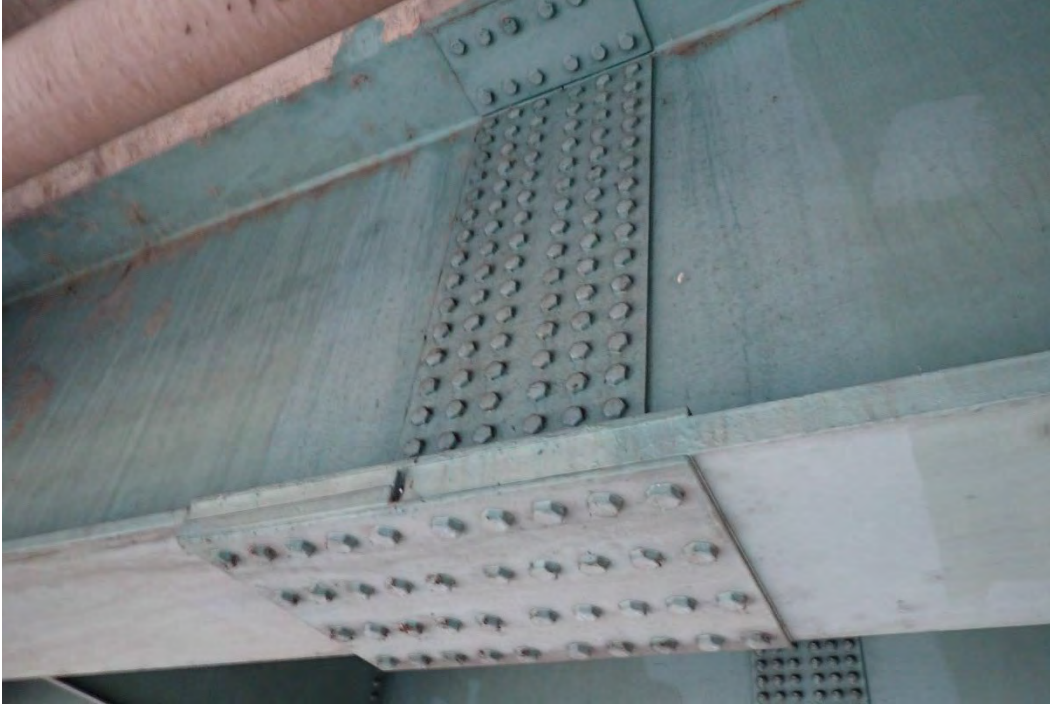
*Photo 40 - Typical girder bolted connection at FWW Span 3, looking north.*

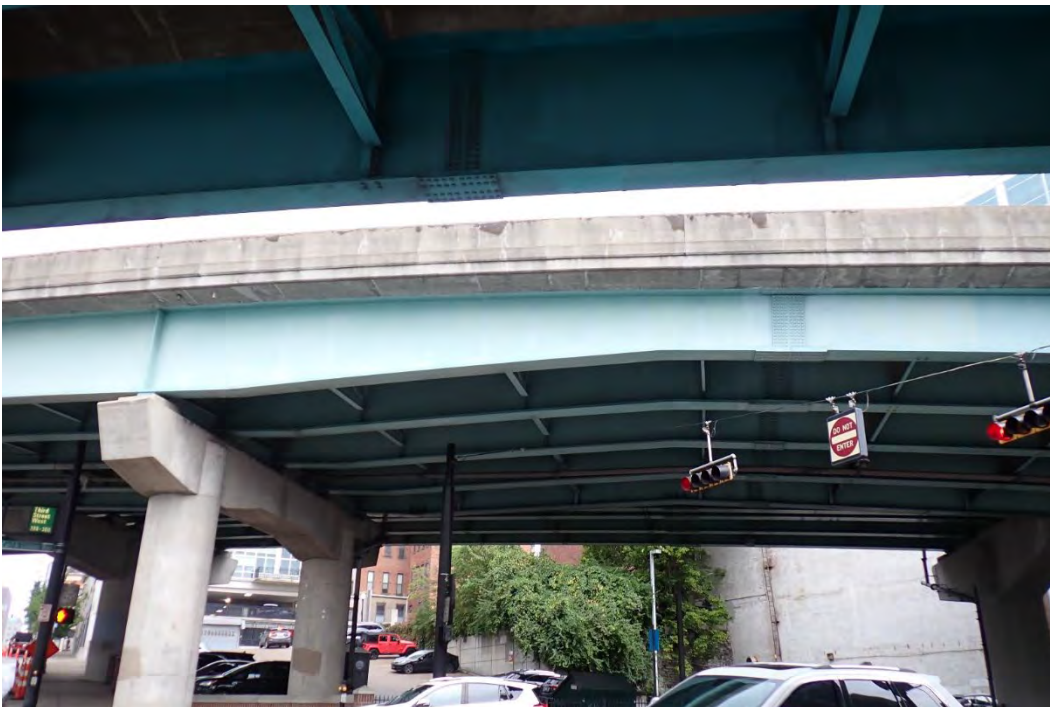
*Photo 41 - Typical girder depth transition at FWW Span 4, looking north.*

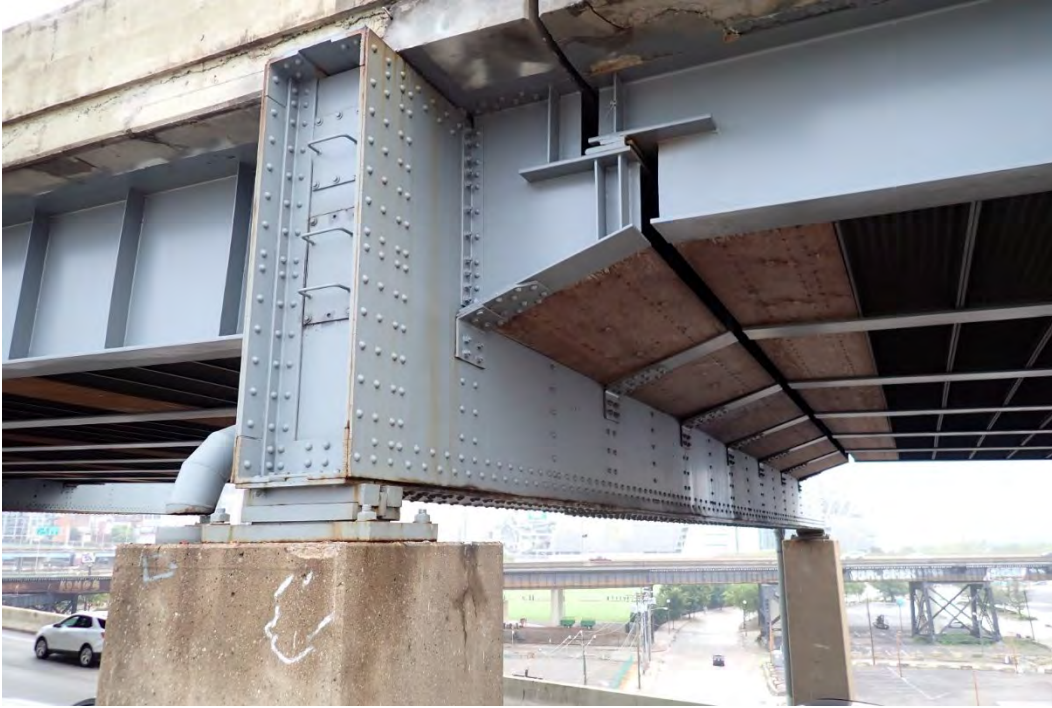
Fifteen steel box caps and one plate cap are in FAIR CONDITION [NBIS-5] overall (Photo 42 & Photo 43), typically 1" thick pack rust between the bottom of the web plates and the interior bottom flange angles, and up to 1/8" deep active pitting throughout the web plates, angles, and bottom flange plates on the box caps between the River Pier and Pier 13A.

Photo 42 - Typical box cap elevation view at Pier 8A, looking northeast.

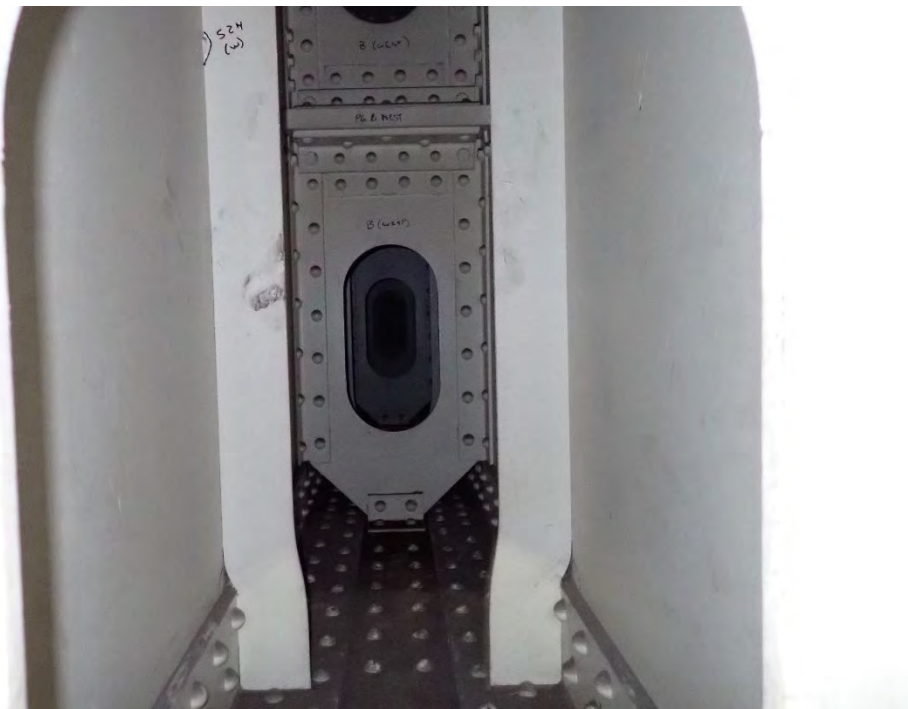
Photo 43 - Typical box cap interior view at Pier 6A, looking east.

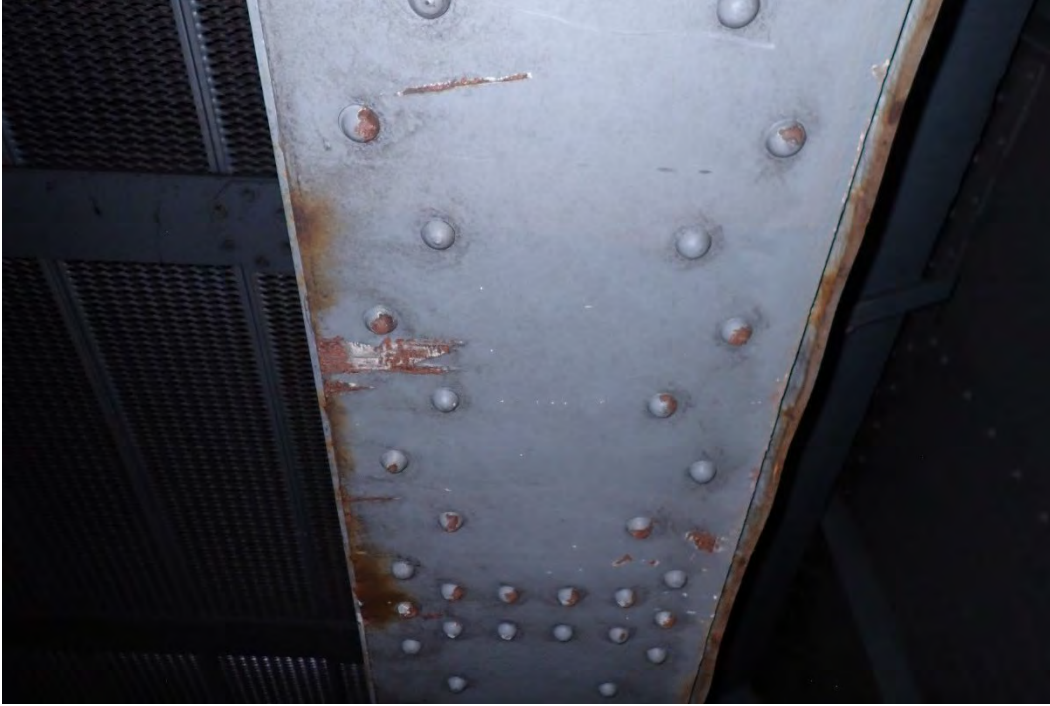
*Photo 45 - Impact scrapes to bottom flange and rivets removed protective coating on River Pier, looking east.*
