# BRENT SPENCE APPROACH BRIDGE

HAM-71-0000L

SFN: 3105946

## 2025 In-Depth/NSTM Inspection Report

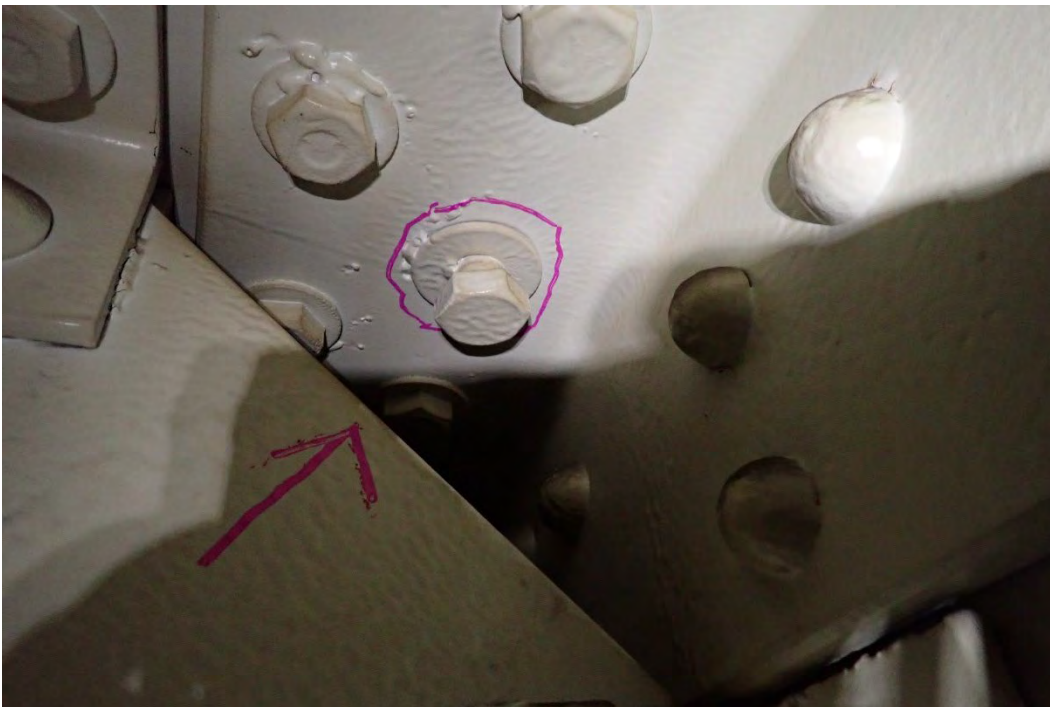
*Photo 46 - Not fully seated bolt at the south top flange angle of Girder E, looking east.*

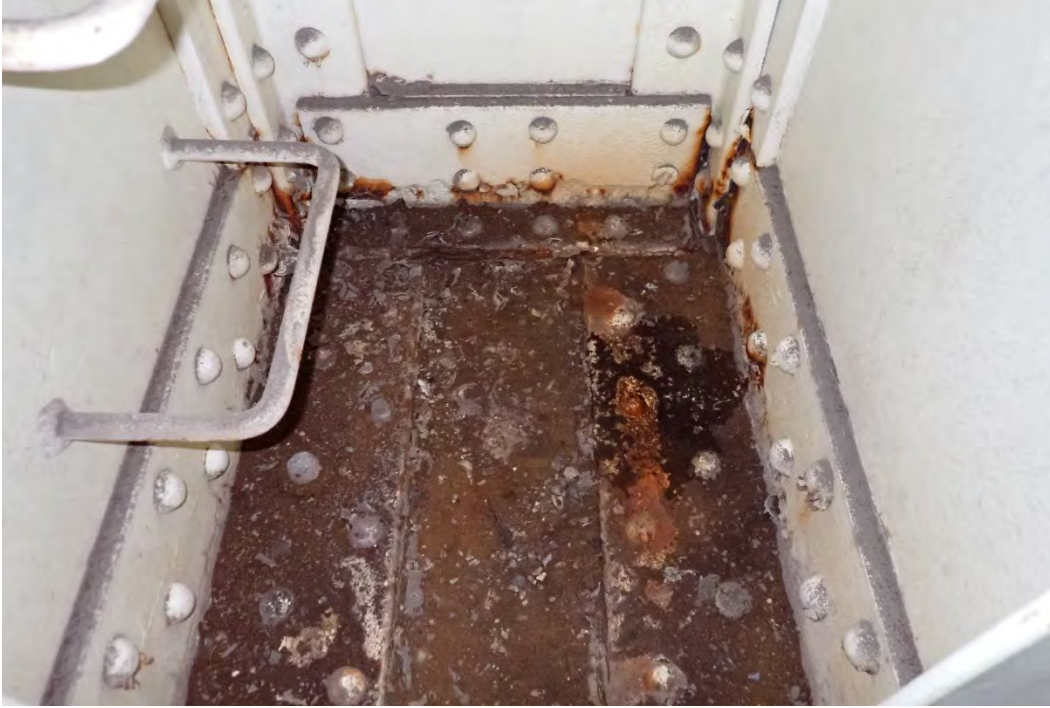
The pier cap interior is in FAIR CONDITION [5-NBIS]. The interior of the cap was dry with no signs of moisture intrusion at the time of the inspection. The entire bottom surface was covered by up to 1/2" of granular debris and dust (Photo 52).

*Photo 52 - Typical dry box cap interior with light surface corrosion at Pier 2A, looking east.*

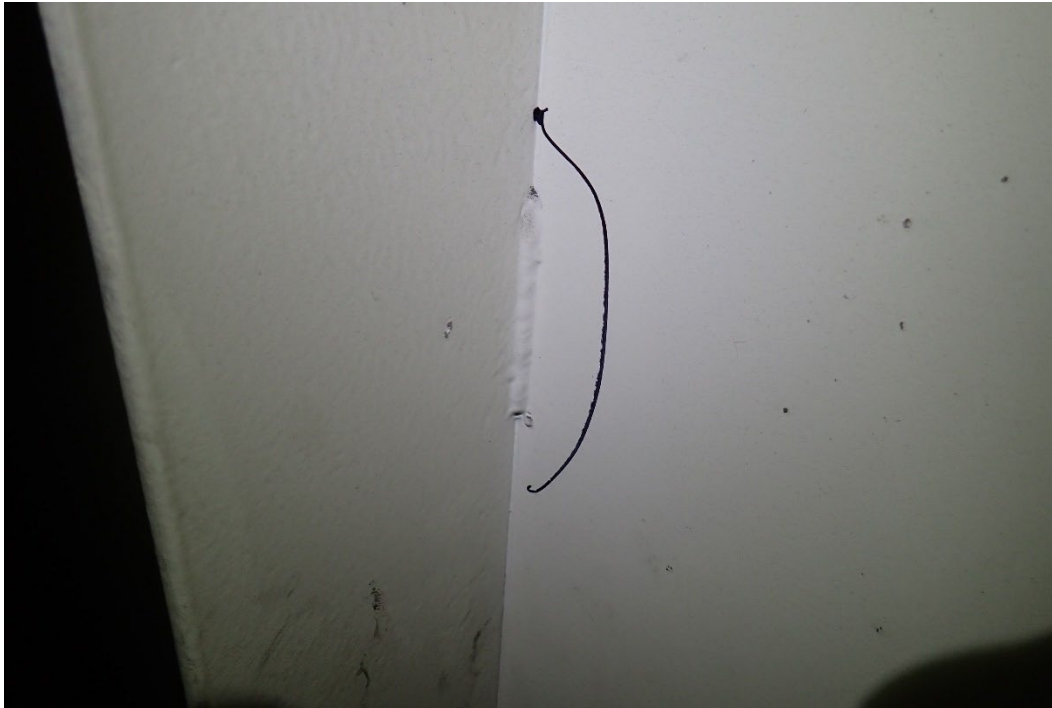
Photo 54 - Typical tack welds in box cap interior at Pier 3A.

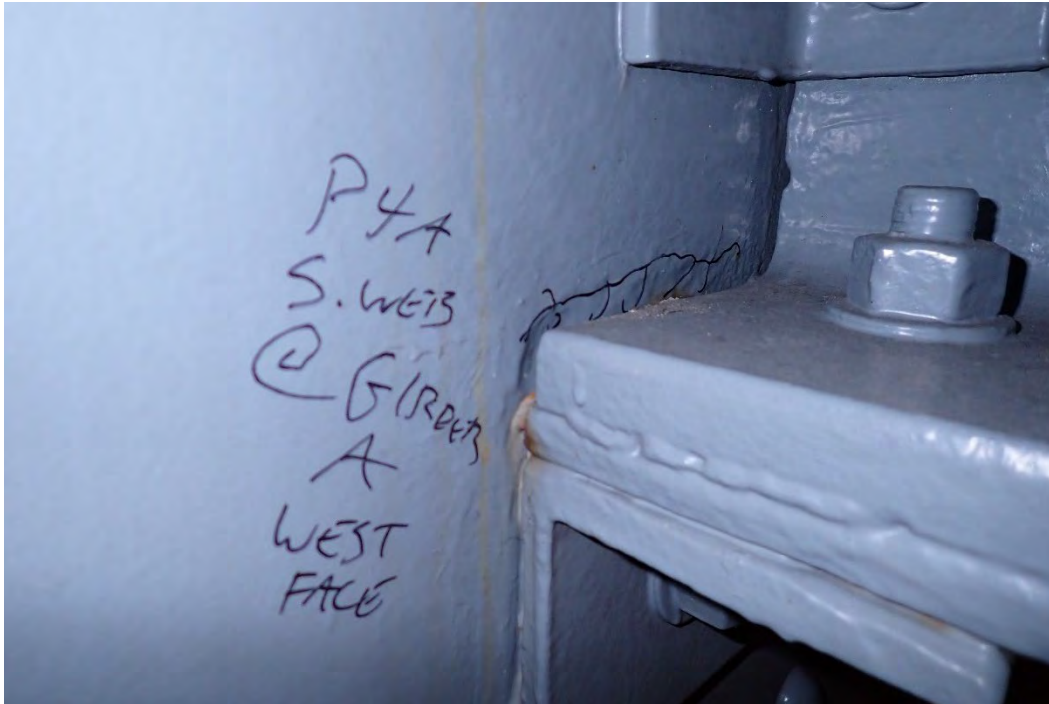
Photo 57 - Up to 1/8" section loss of box cap south web at Girder A seat at Pier 4A, looking north.

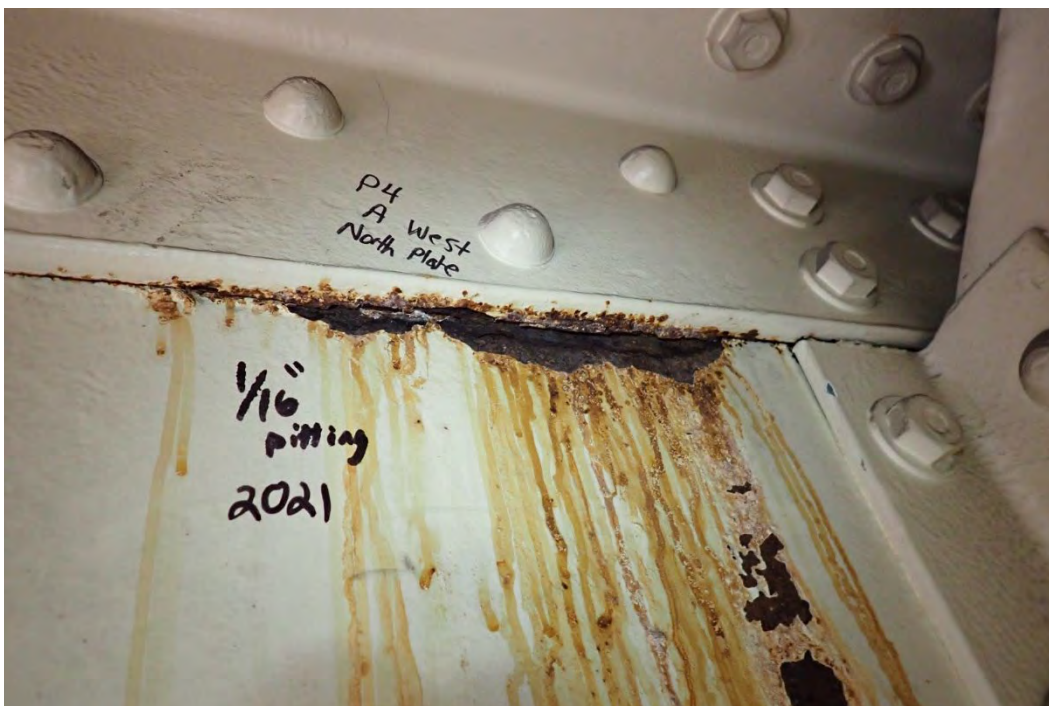
Photo 58 - Typical minor corrosion between the top flange angles, web plates, and filler plates at Pier 4A, looking north.

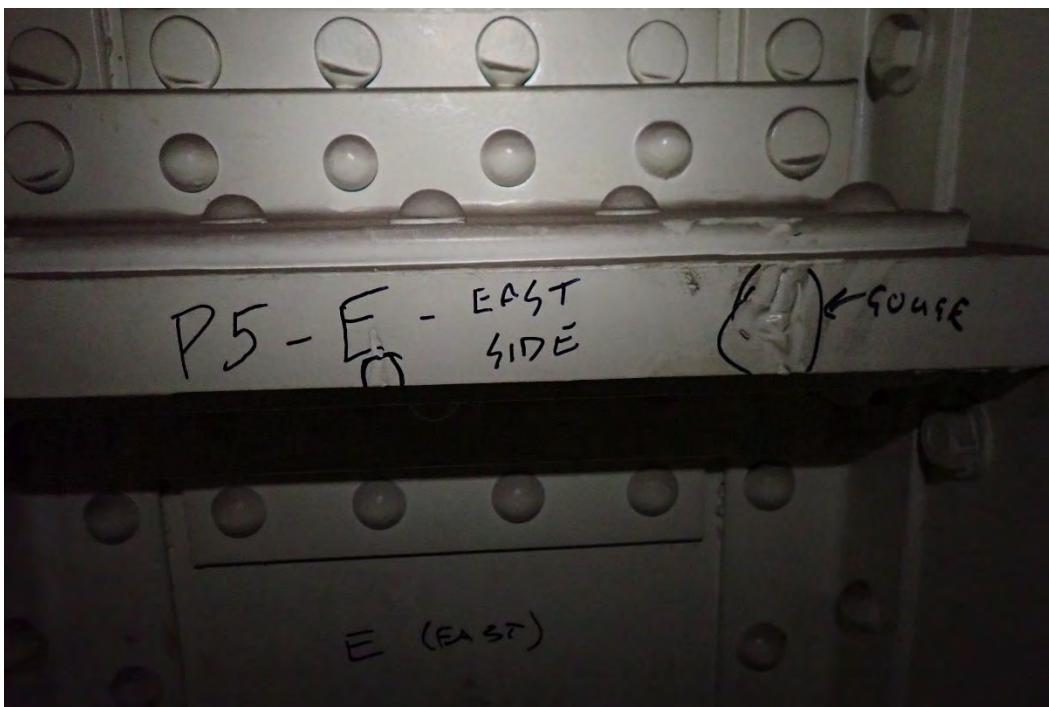
The protective coating on the interior is in satisfactory condition (Photo 62), except for failures at either end of the pier cap, which are causing minor active corrosion.

Photo 62 - Interior box cap coating in good condition at East end of Pier 5A.

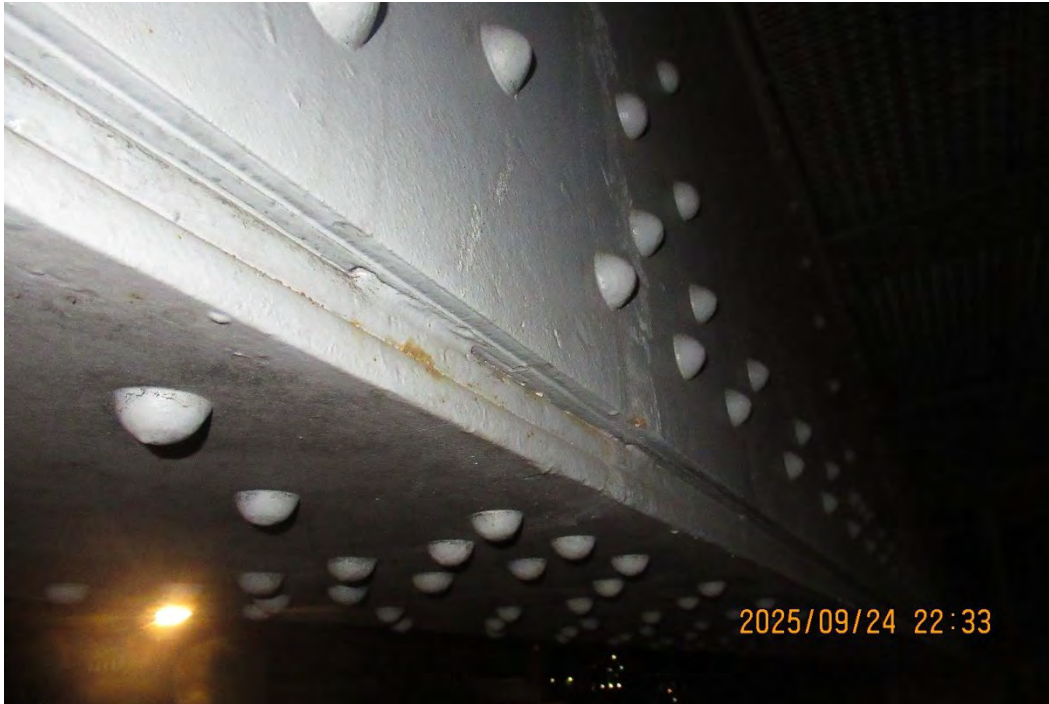
There are three tack welds between the north edge of the bottom flange plate and the north bottom flange angle below Girders C and E (Photo 63). No signs of distress were noted near the tack weld locations.

*Photo 63 – Typical tack welds between the north edge of the bottom flange plate and the north bottom flange angle.*

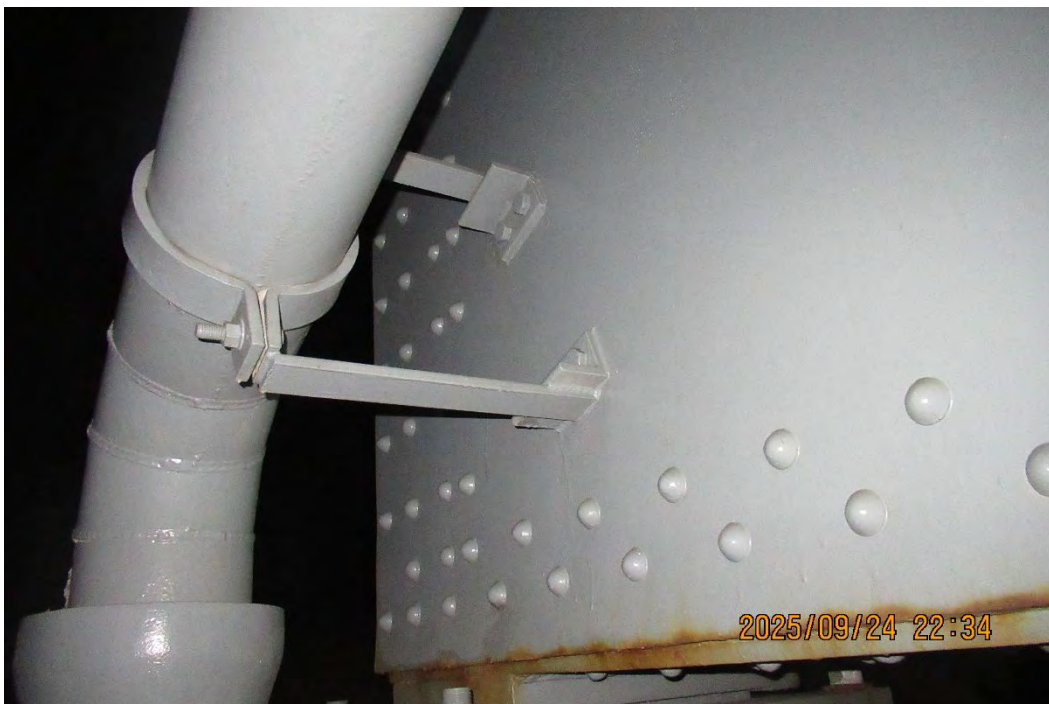
Two drainpipe support brackets are attached to the north web with bolts (Photo 64).

*Photo 64 – Typical drainpipe support brackets attached to the north web with bolts.*

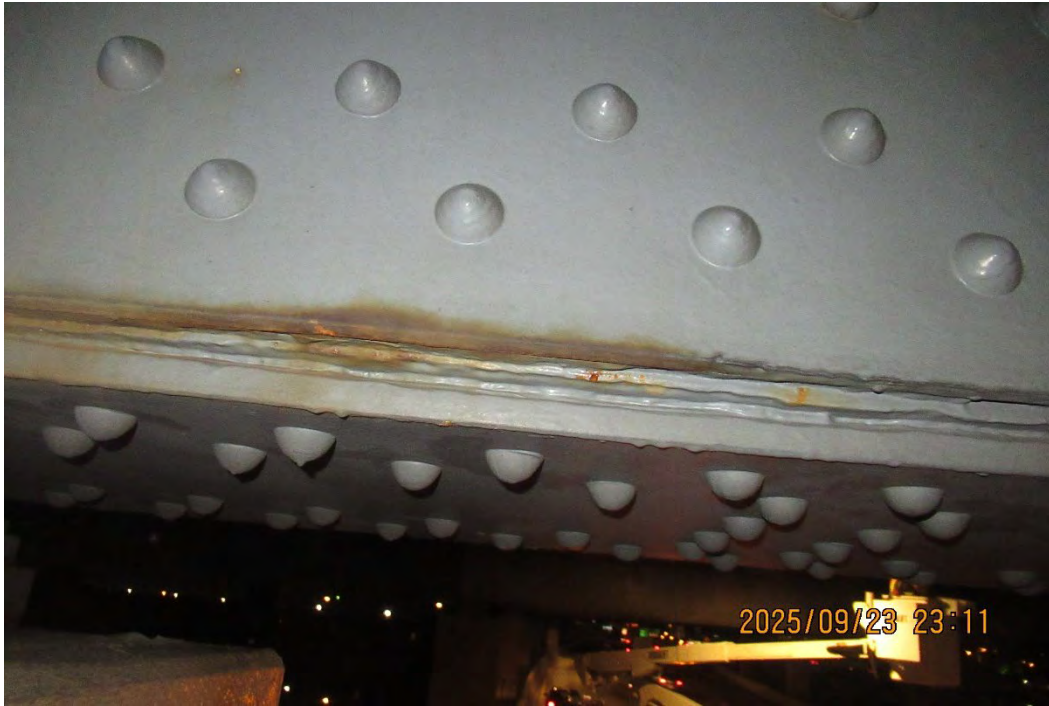
Photo 67 - 1/2" of pack rust between box cap web and bottom flange at Pier 7A. Note: Pack rust has been painted over.

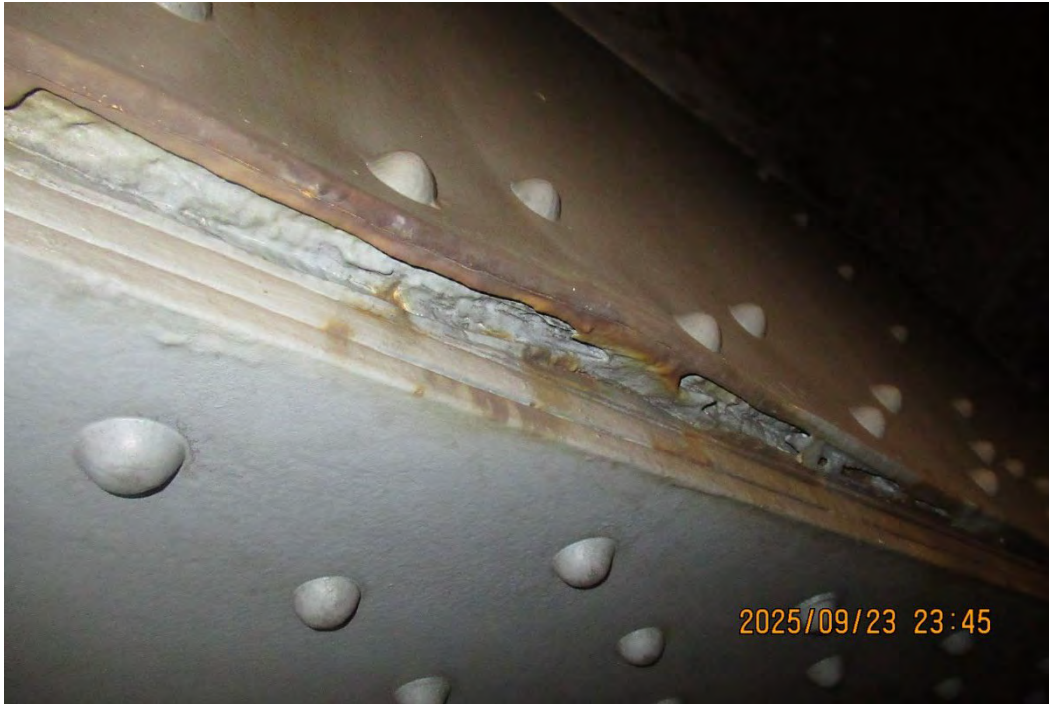
The exterior of Pier Cap 8A is in GOOD CONDITION [7-NBIS]. There is up to 1 1/2" thick pack rust between the south web plate and the bottom flange angle that has been filled with steel putty and painted along the entire width of the pier cap (Photo 69). Isolated sections of the steel putty were removed during the 2021 painting contract. Still, the remaining putty is in satisfactory condition and functions as intended, with only isolated areas of rust staining throughout. There is up to 3/8" thick pack rust present between the seat angles and the south web plate at girder connection locations (Photo 69).

Photo 69 - Pack rust between box cap web and bottom flange at Pier 8A. Note: Pack rust has been painted over.

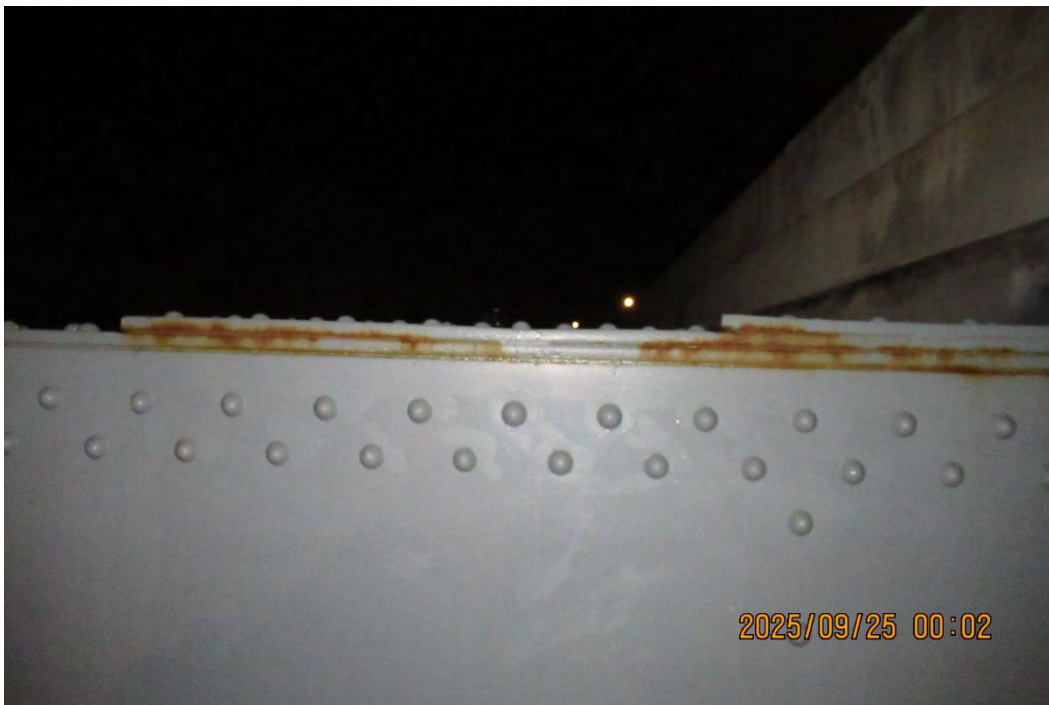
The exterior of Pier Cap 9A is in SATISFACTORY CONDITION [6-NBIS]. There is up to 1 1/8" thick pack rust between the south web plate and the bottom flange angle that has been caulked and painted along the entire width of the pier cap (Photo 71). The pack rust has been previously filled with putty and painted. The putty appears to be in good condition and is functioning as intended. There is up to 3/4" thick pack rust present between the top flange cover plates east of Girder G, and intermittent pack rust between the bottom flange cover plates throughout (Photo 72).

Photo 72 - 3/4" pack rust on top flange cover plates at Girder G of box cap of Pier 9A, looking south.

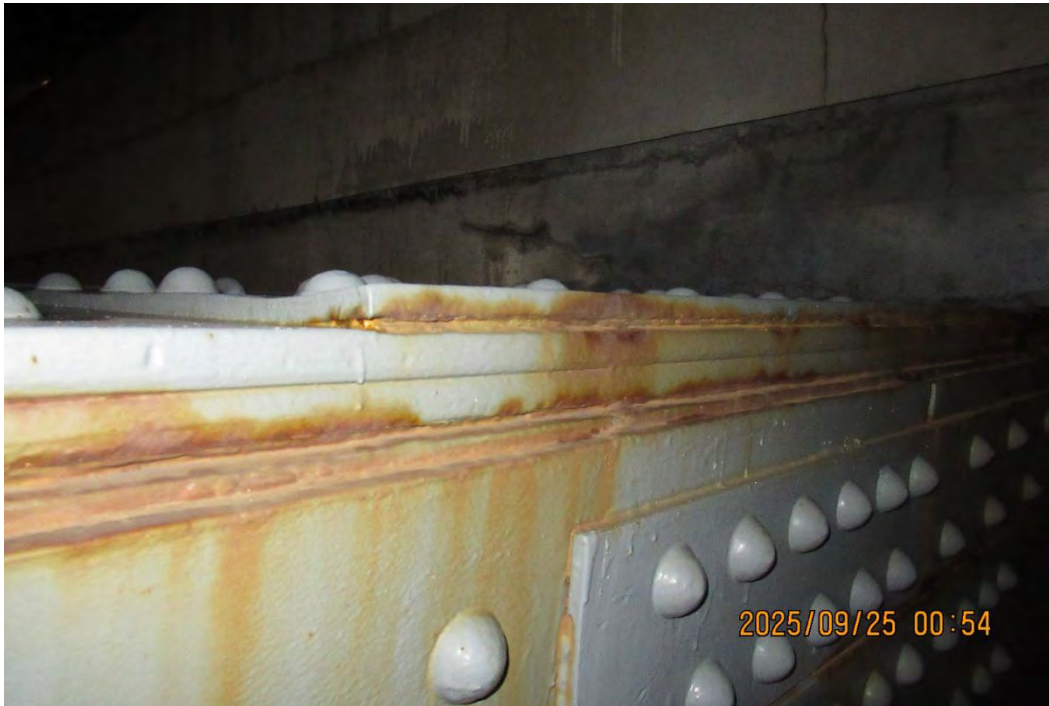
Pack rust up to 1/2" thick is present between the south web plate and the top flange angle at the west end of the cap (Photo 76).

Photo 76 - 1/4" of pack rust on box cap cover plates of Pier 10A, looking south.

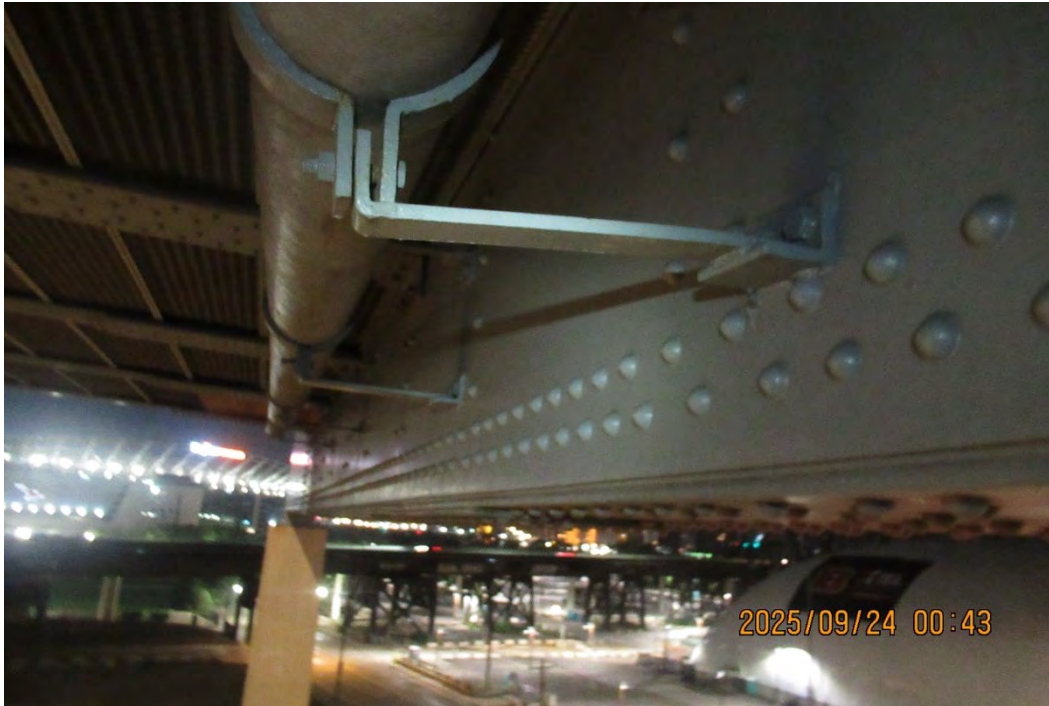
There are eight drainpipe support brackets that are attached with bolts on the north web plate between Girder B and Girder F (Photo 77).

*Photo 77 - Typical pipe connection bracket on the north face of Pier 10A, looking east.*

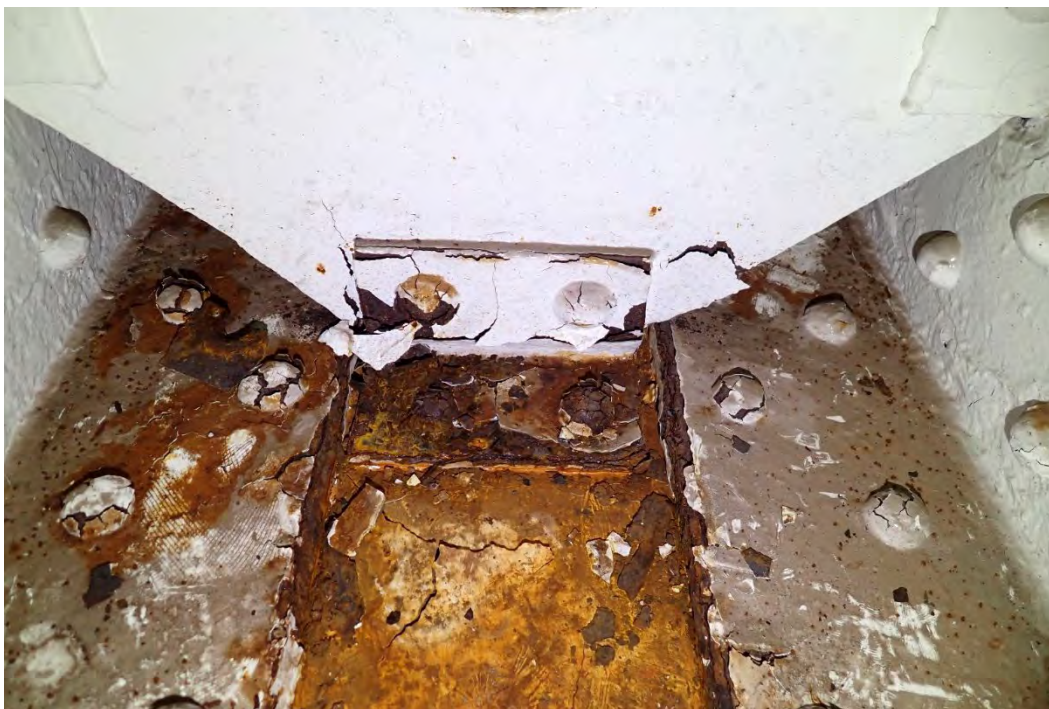
*Photo 78 - Section loss with 1/4" of steel thickness remaining on internal diaphragm bottom angle and rivets of Girder G in box cap of Pier 10A, looking east.*

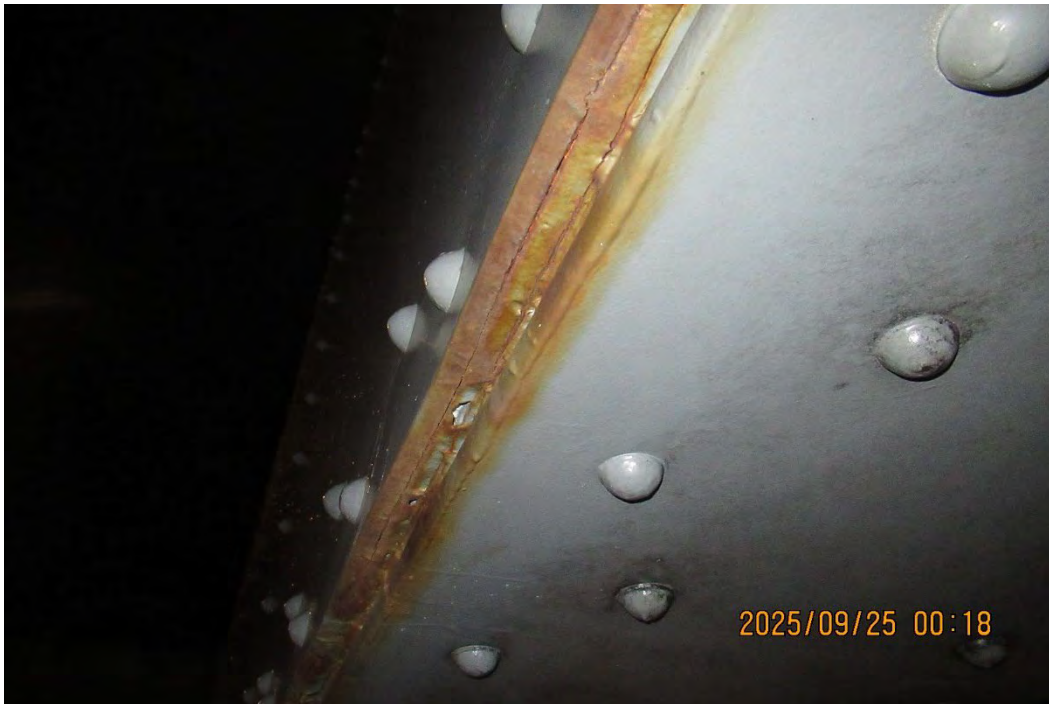
The exterior of Pier Cap 11A is in GOOD CONDITION [7-NBIS]. There is up to 1/2" thick pack rust between the web plates and the bottom flange angles that has been filled with steel putty and painted along the entire width of the pier cap (Photo 79). The putty is in good condition and functions as intended.

*Photo 79 - Bottom flange angles that has been filled with steel putty and painted along the entire width of the pier cap.*

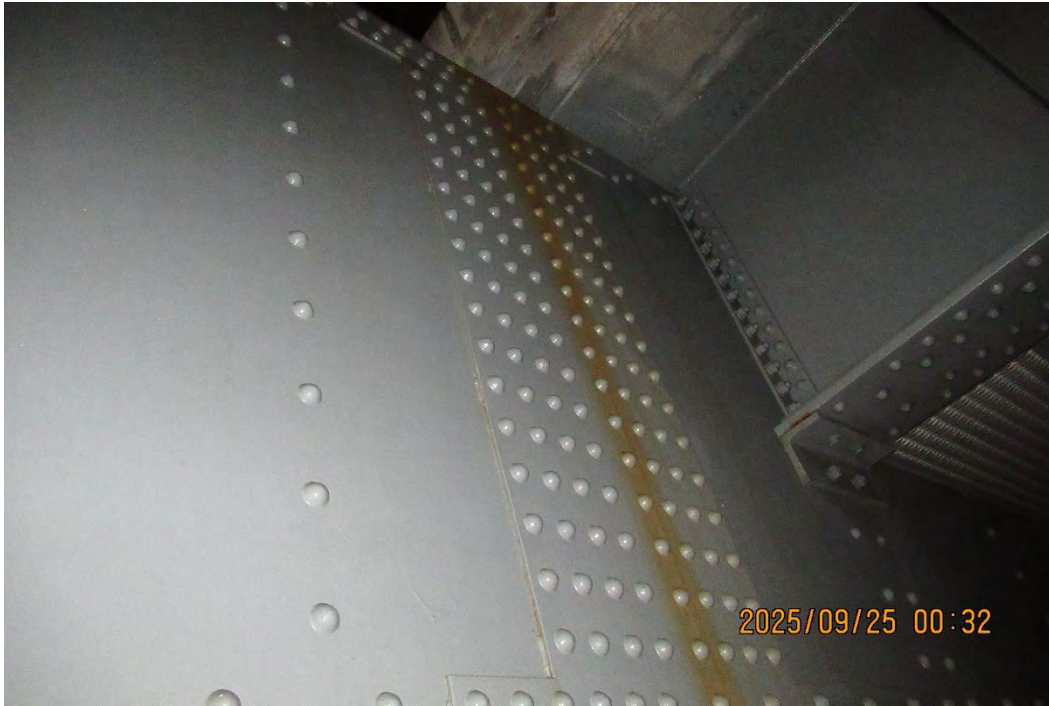
The protective coating system on the exterior of the pier cap is in good condition (Photo 80).

*Photo 80 - Protective coating system on the exterior of the pier cap is in good condition at Pier 11A, looking north.*

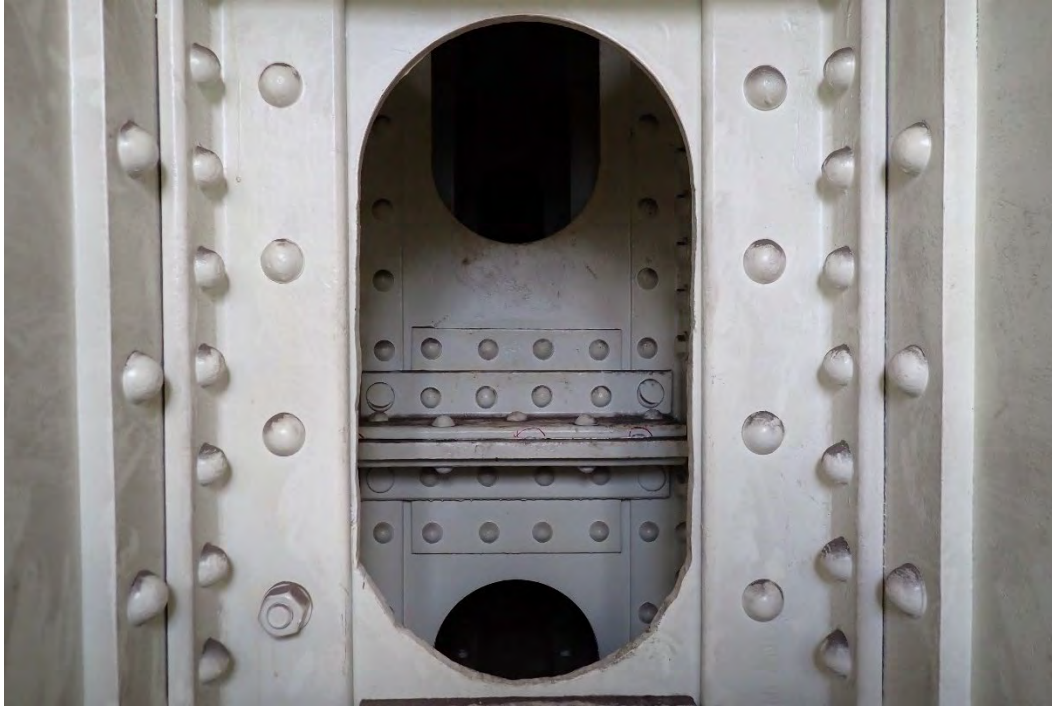
The interior of Pier Cap 12A is in SATISFACTORY CONDITION [6-NBIS]. The interior of the cap was dry with no signs of moisture intrusion at the time of the inspection (Photo 83). The entire bottom surface was covered by up to 1/2" of granular debris and dust. There is a mis-drilled hole in the south top flange angle between Girders F and G.

*Photo 83 - Interior of the cap was dry with no signs of moisture intrusion at the time of the inspection.*

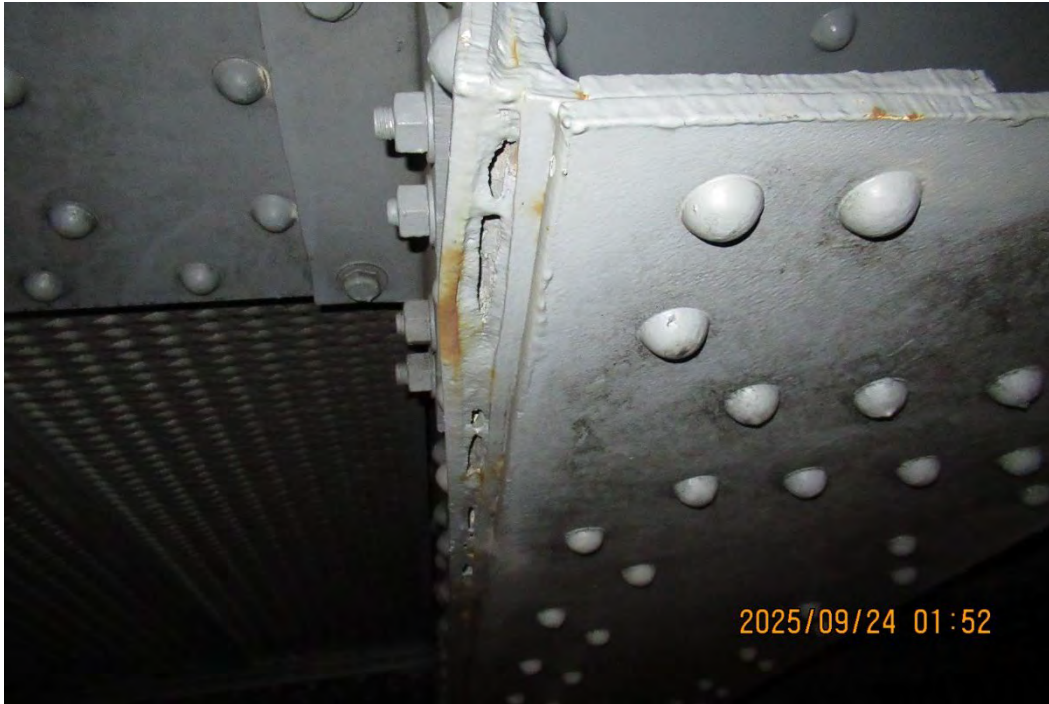
The exterior of Pier Cap 13A is in GOOD CONDITION [7-NBIS]. There is up to 1" thick pack rust between the web plates and the bottom flange angles that has been filled with steel putty and painted along the entire width of the pier cap (Photo 84). The putty is in good condition and functions as intended.

Photo 84 - Painted over pack rust up to 1" at the south web of Pier 13A's box cap, looking west.

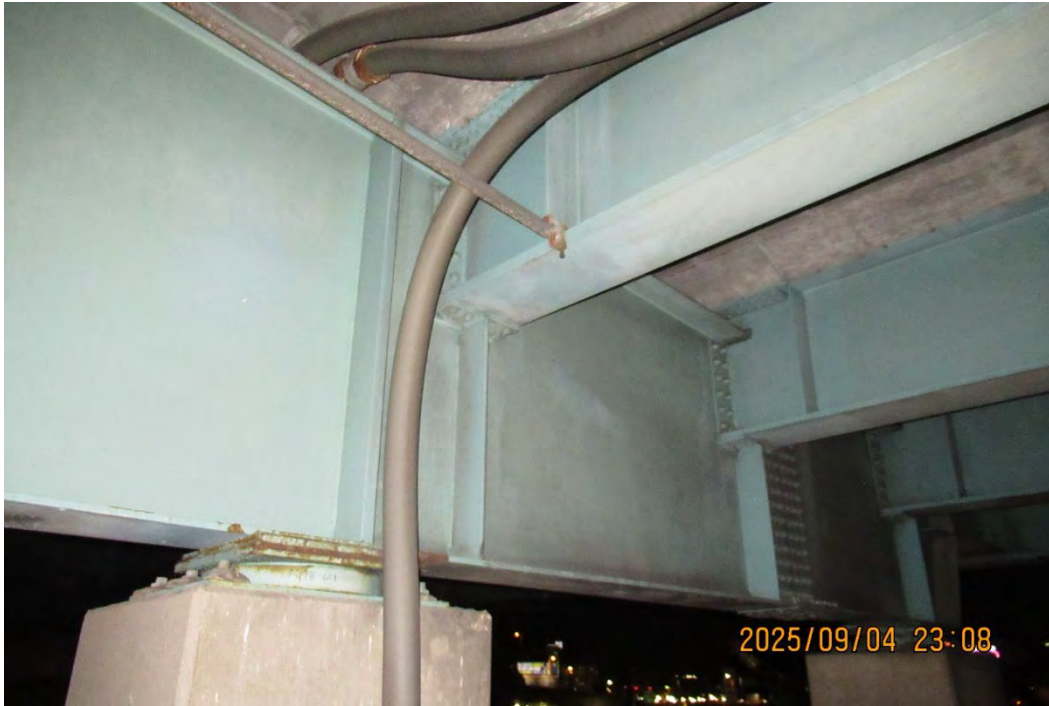
The Non-Redundant Steel Tension Member welded steel plate pier cap is in GOOD CONDITION [7-NBIS] overall (Photo 86). The protective coating system on the pier cap is in satisfactory condition. There is minor active corrosion on the bottom flange at the bearing locations and along the welds of the bearing plates (Photo 87). There is also minor active corrosion on the bottom flange splice plate bolts (Photo 88).

*Photo 86 - West elevation of pier cap at Pier 29B.*

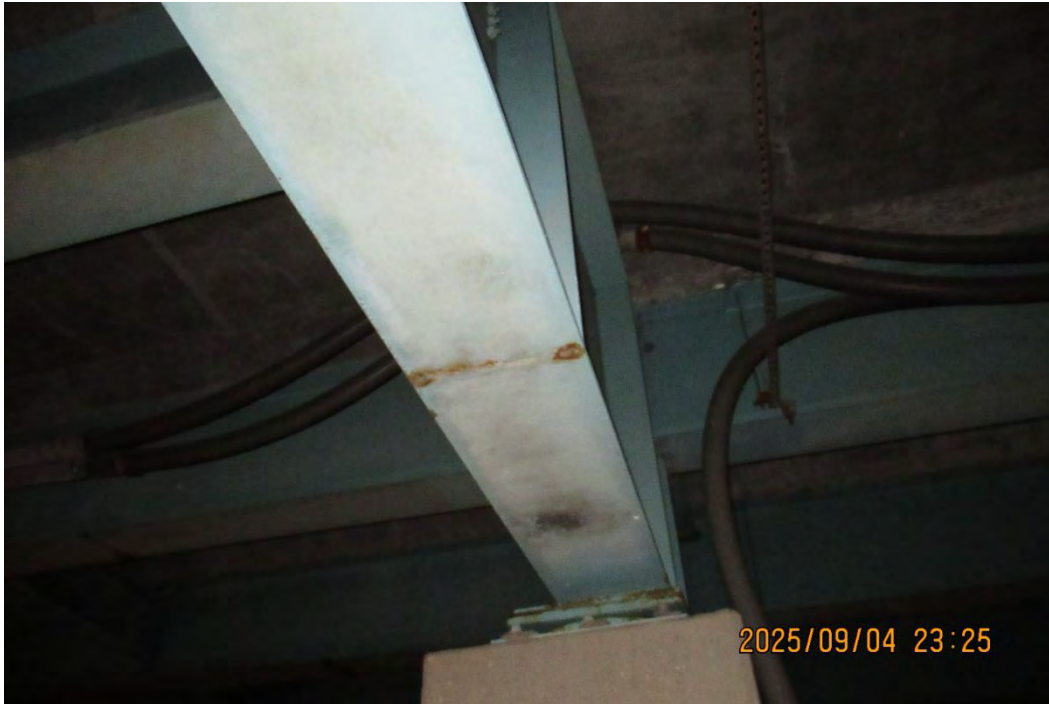
*Photo 87 - Surface corrosion of the bottom flange at stiffener plate weld on north end of pier cap, at Pier 29B*

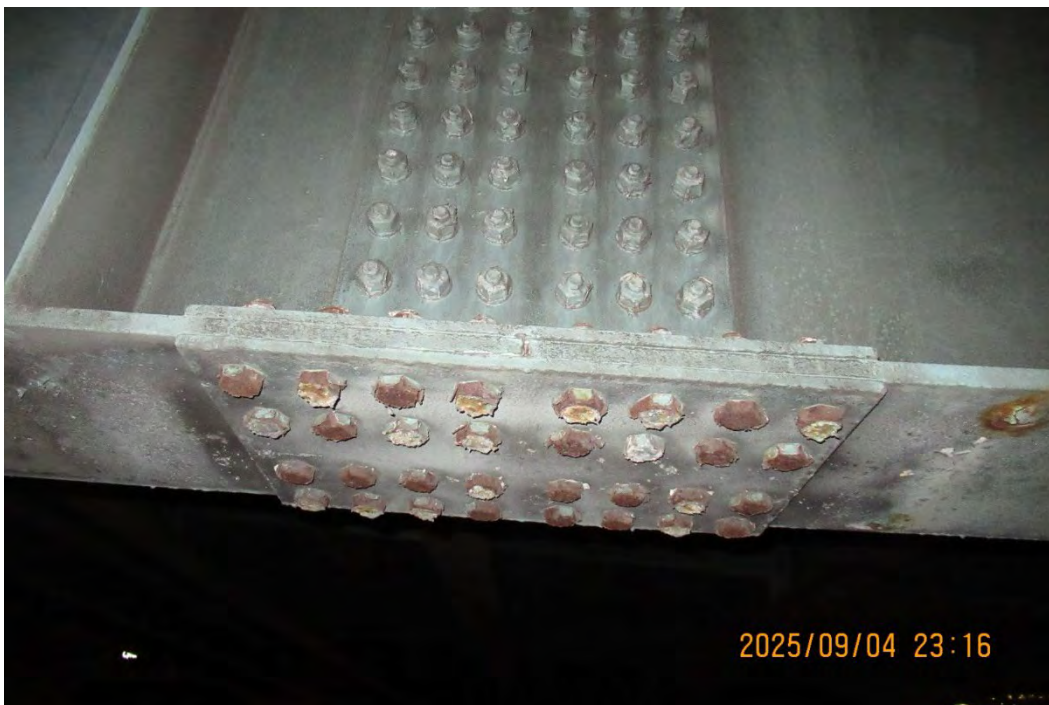
*Photo 88 - Typical surface corrosion at pier cap bolted splice connection on Pier 29B.*

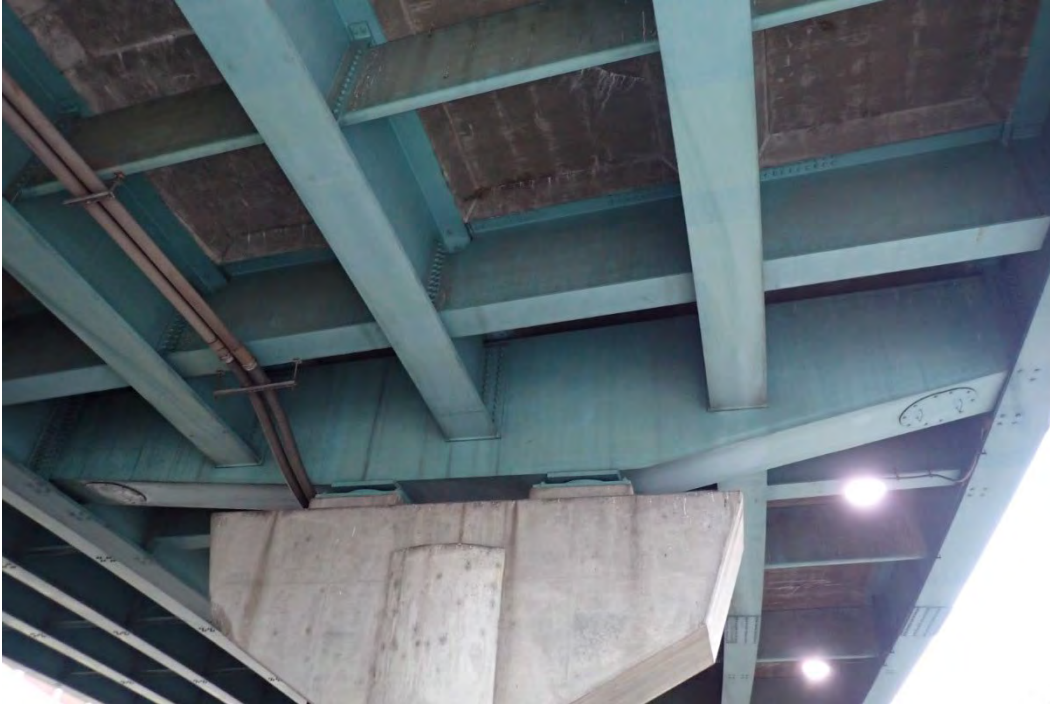
The Non-Redundant Steel Tension Member steel box pier cap is in GOOD CONDITION [7-NBIS] overall (Photo 89).

*Photo 89 - East elevation of box cap at FWW Pier 2, looking west.*

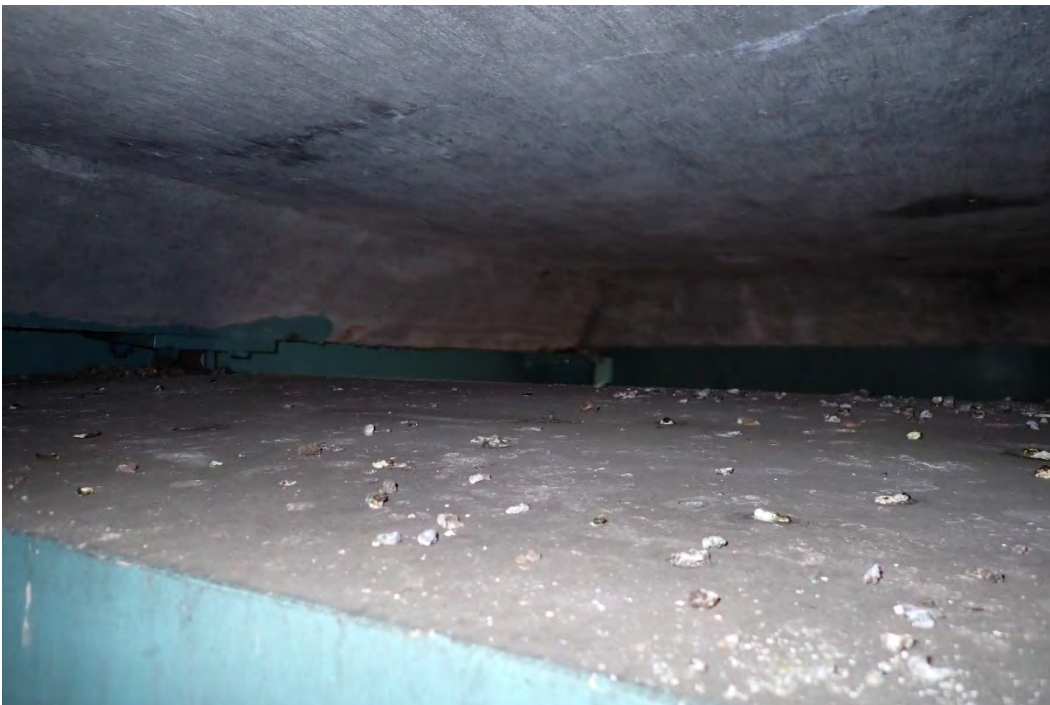
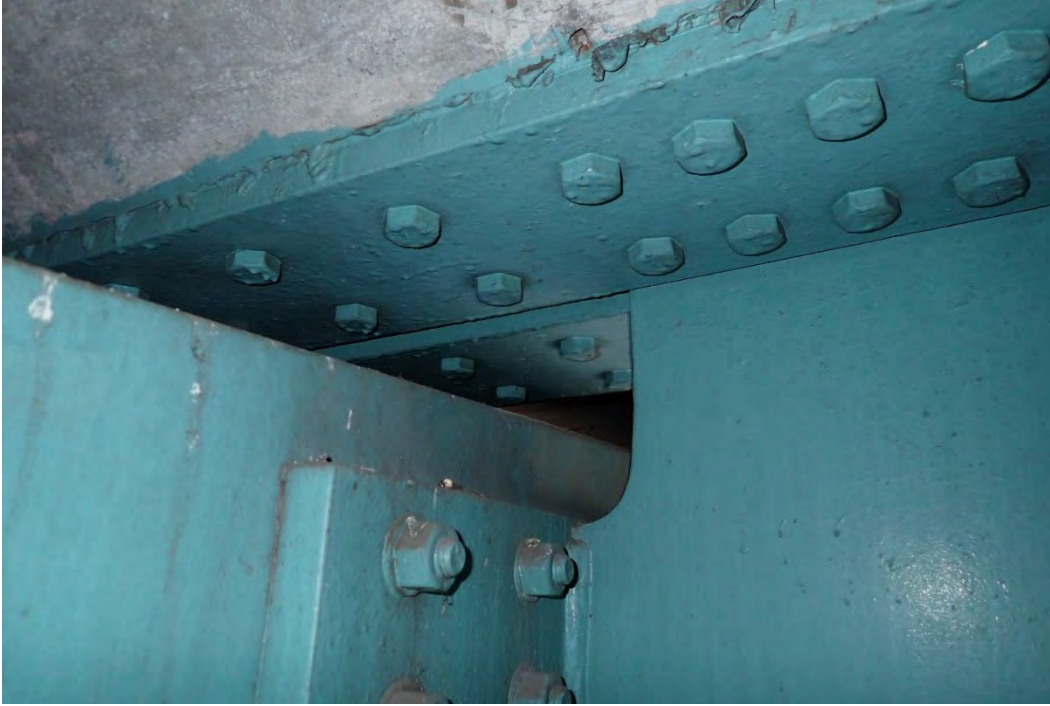
The exterior of Pier Cap 2 (FWW) is in VERY GOOD CONDITION [8-NBIS]. No deficiencies were noted (Photo 90 & Photo 91).

*Photo 90 - Top side of top flange of box cap at FWW Pier 2, looking north.*

*Photo 91 - Typical girder connection to FWW Pier 2 on west face, looking southwest.*

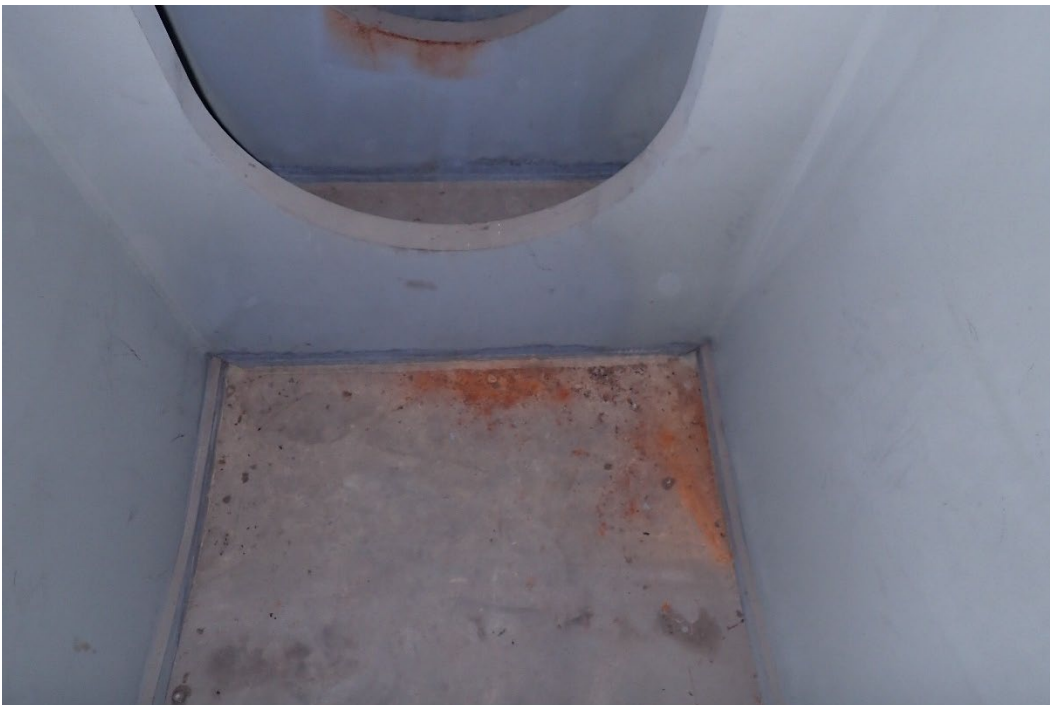
The interior of Pier Cap 2 (FWW) is in GOOD CONDITION [7-NBIS]. The interior of the cap was dry with no signs of moisture intrusion at the time of the inspection. The entire bottom surface was covered by up to 1/2" of granular debris and dust. There are isolated areas of very minor surface corrosion throughout (Photo 92).

*Photo 92 - Minor surface corrosion in box cap interior, at FWW Pier 2, looking north.*

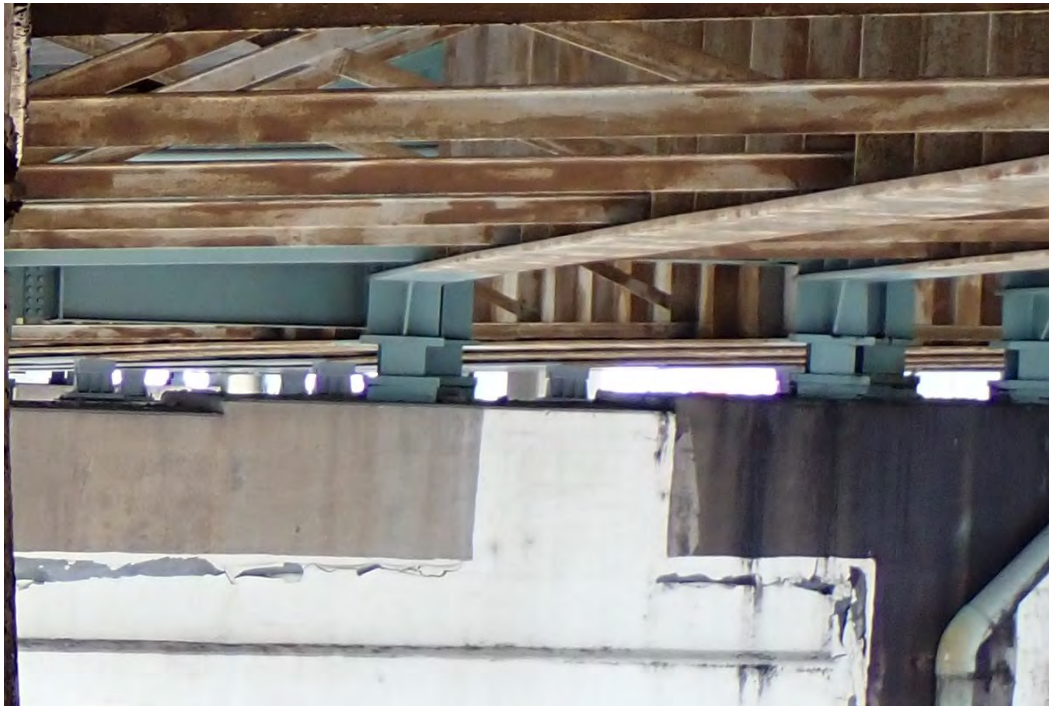
The elastomeric bearings are in SATISFACTORY CONDITION [6-NBIS] overall (Photo 93). Elastomeric bearings are present at Piers 15A, 16A, 19A, 23B, and 28B. The bearings typically have some minor areas of surface corrosion and isolated paint failure. The elastomeric bearing pads beneath Girder A and E in Span 23B and Girder A in Span 24B at Pier 23B exhibit minor expansion and rust staining between the layers. The remaining bearings showed very few signs of expansion and were in a neutral position.

*Photo 93 - Typical Elastomeric bearings on Pier 15A, looking south.*

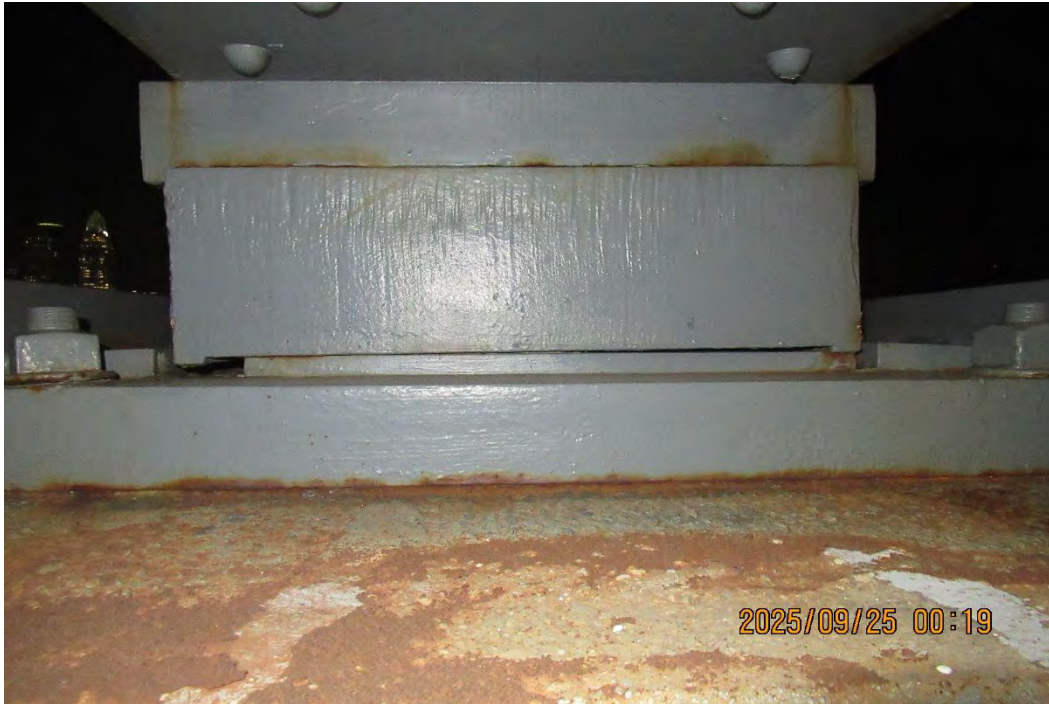
The east bearing of Pier Cap 11A has a retrofit to the bearing plate (Photo 94) and the south keeper lug of the rocker plate is misaligned and sitting on top of the masonry plate (Photo 95). There are loose anchor nuts at the west bearing of Pier Cap 8A, the east bearing of Pier Cap 12A, and the east bearing of Pier Cap 13A (Photo 96).

Photo 95 – The upper portion of the bearing has shifted creating a gap between the upper bearing and sole plate of the east bearing of Pier 11A, looking east.

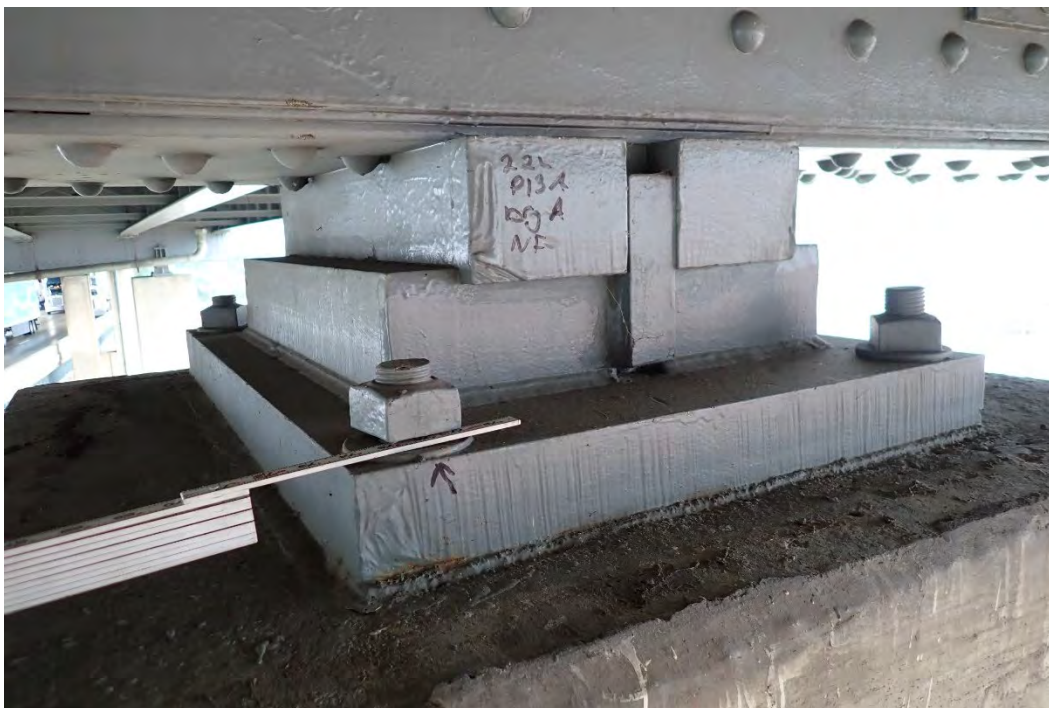
Photo 96 - Bearing nut is backed off at Pier 13A, looking southwest.
