# BRENT SPENCE APPROACH BRIDGE

HAM-71-0000L

SFN: 3105946

## 2025 In-Depth/NSTM Inspection Report

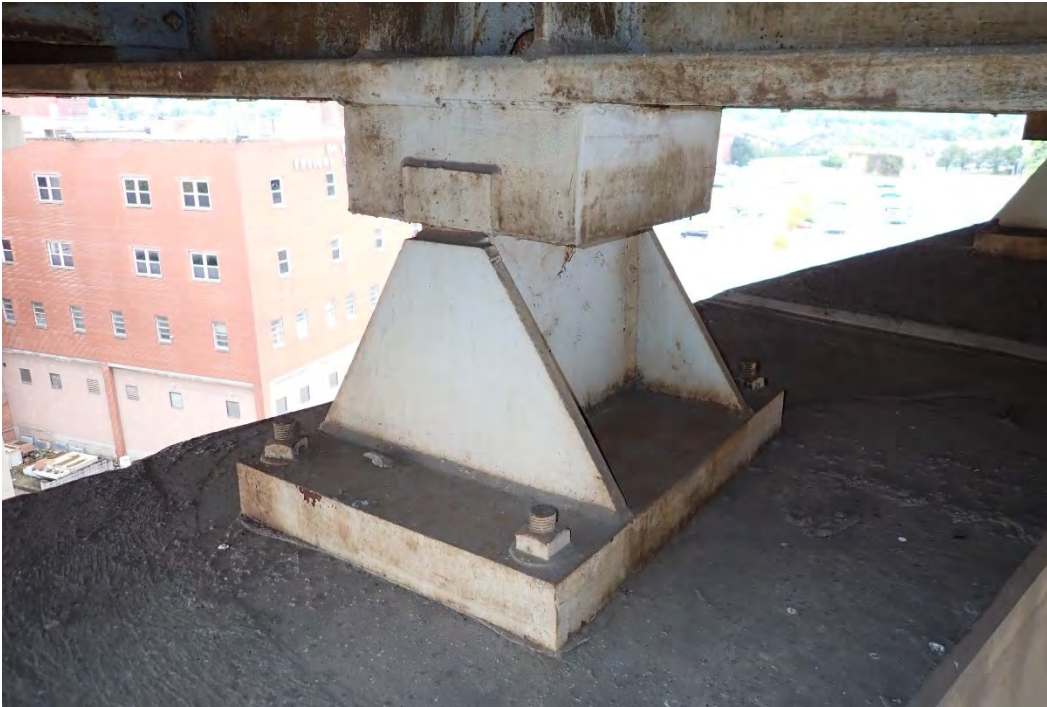
The fixed bearings are in SATISFACTORY CONDITION [6-NBIS] overall and typically exhibit paint failure and moderate surface corrosion throughout (Photo 97). There are two loose anchors on bearing B at Pier 12A. Bearing A at Pier 12A has ½" deformation in the stiffener. Bearings B and A at Pier 13A have loose anchor nuts.

*Photo 97 - Typical fixed bearing at Pier 17A, looking east.*

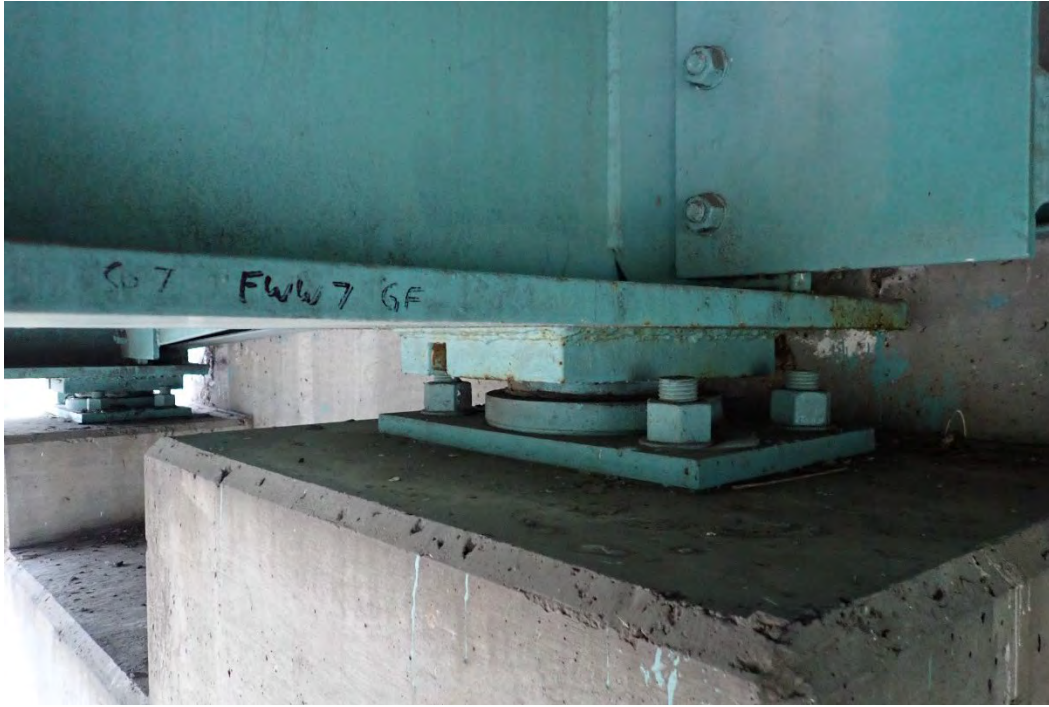
The pot bearings of the FWW spans are in SATISFACTORY CONDITION [6-NBIS] overall (Photo 98). The pot bearings typically exhibit minor paint failure and moderate to heavy surface corrosion throughout—isolated locations of the elastomeric bulging or extruding from the bearing pot. The Teflon pad at Bearing 7 on Pier 6 is extruded from the pot bearing.

*Photo 98 - Typical pot bearing at FWW Pier 7, looking southwest.*

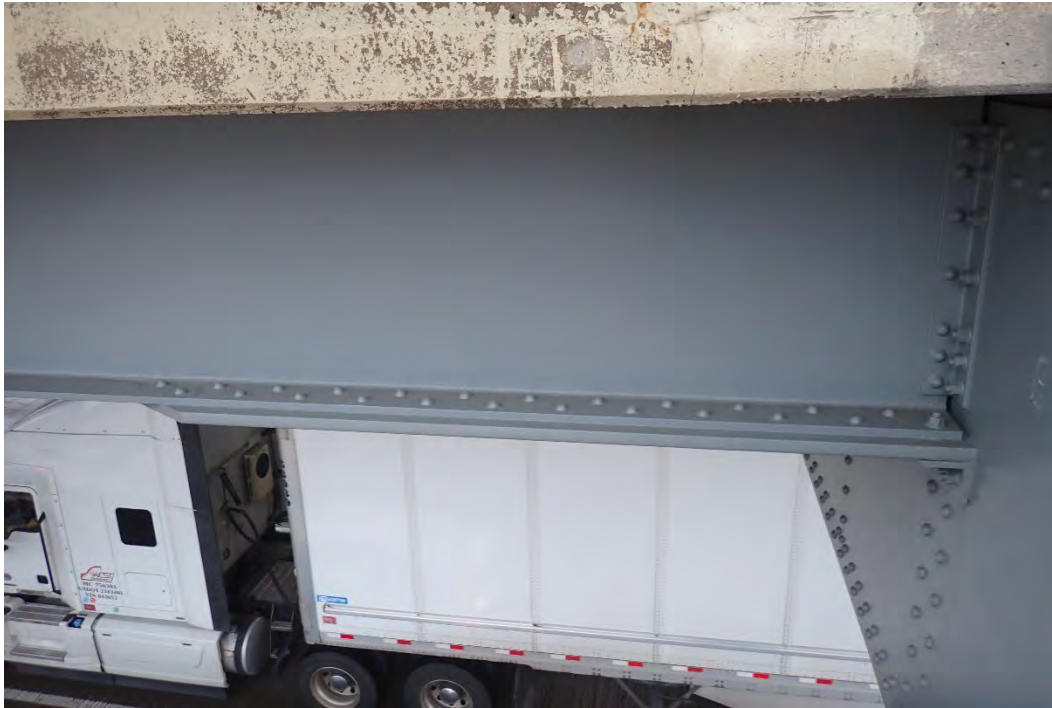
*Photo 100 - Typical girder protective coating in good condition overall, from River Pier to Pier 15A. Photo of Pier 7A, looking east.*

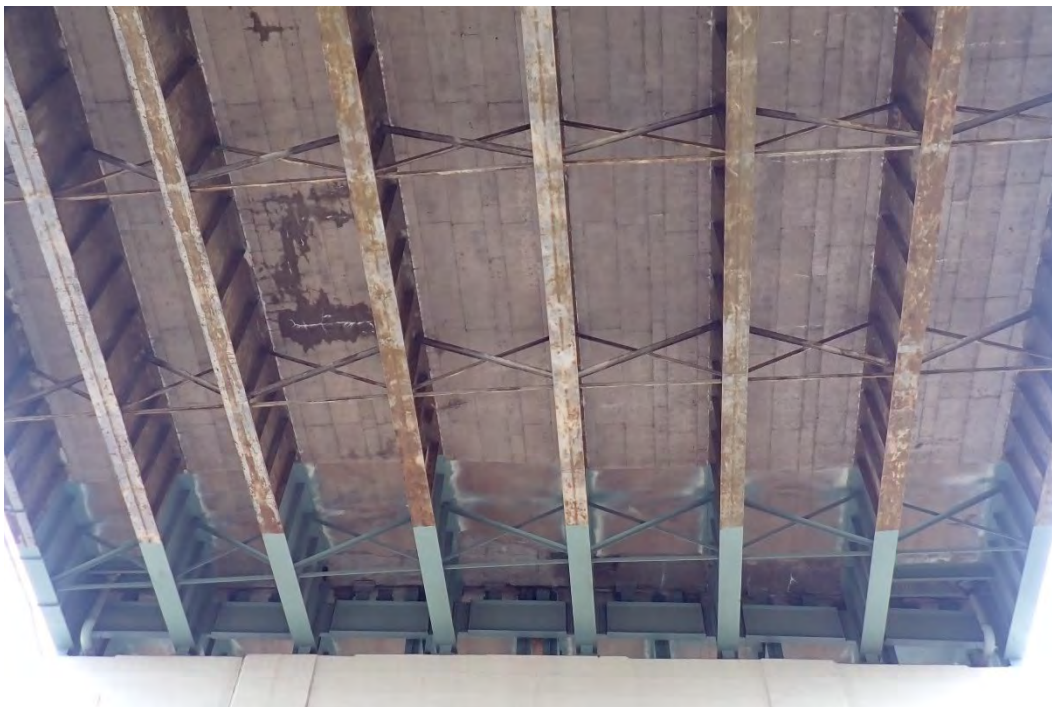
*Photo 101 - Superstructure paint condition near deck joint at Pier 19A, looking north.*

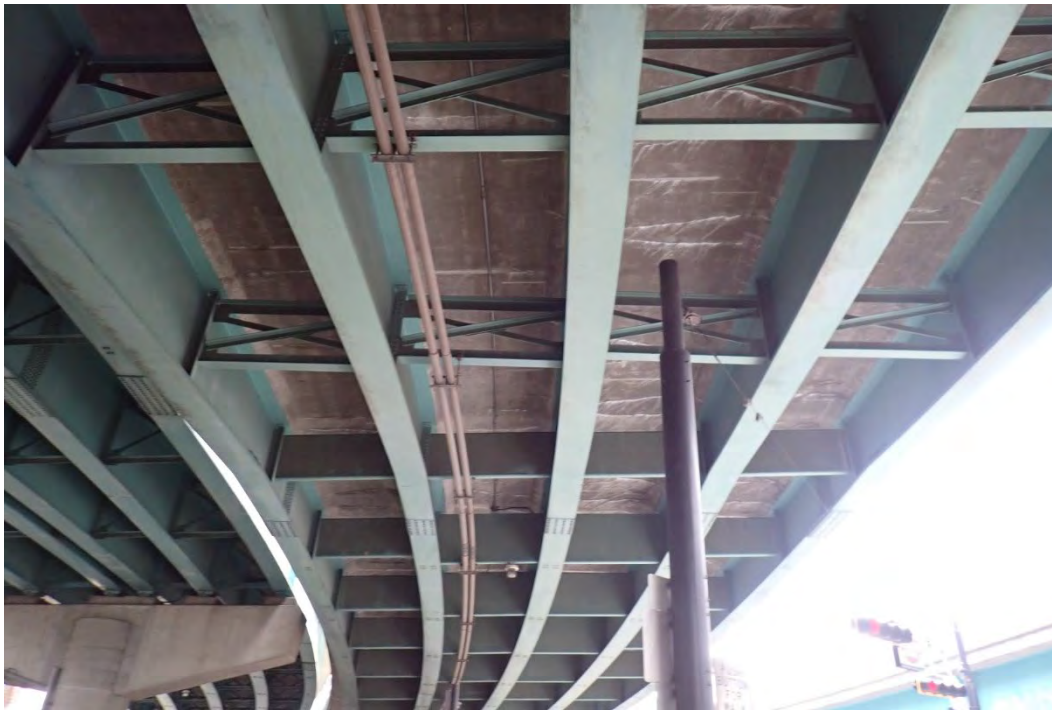
The paint on the FWW spans is typically in good condition with small areas of isolated surface rust (Photo 103).

*Photo 103 Typical protective coating condition of superstructure from Pier 28B to Wall Pier. Photo of FWW Span 3, looking east.*

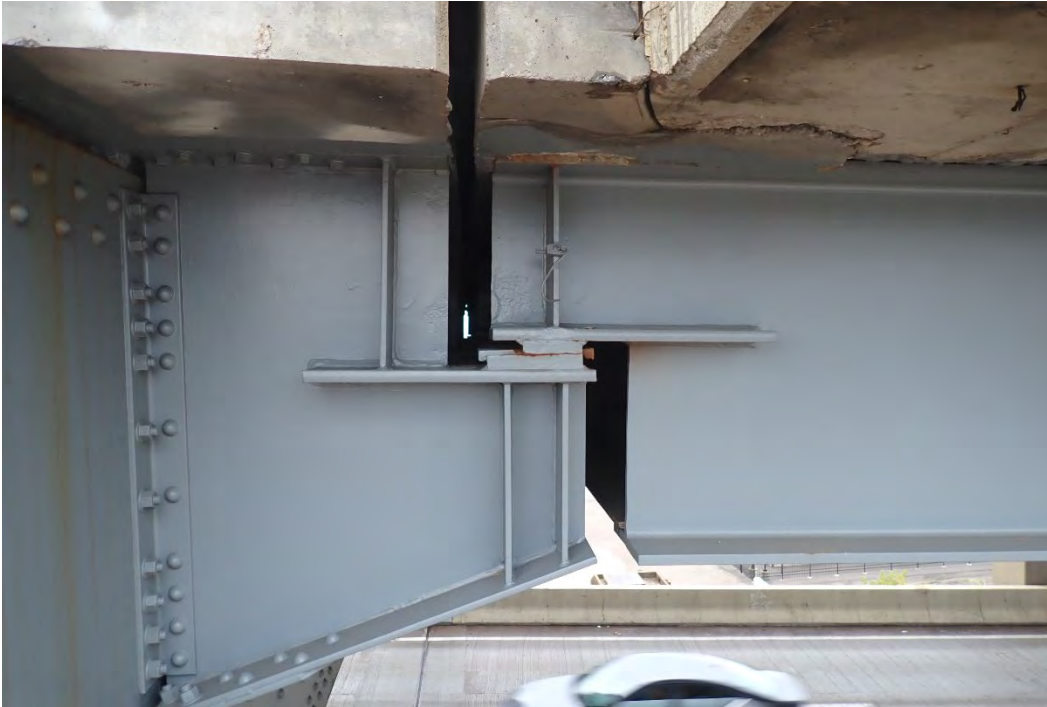
The steel seated-hinge assemblies in Spans 4A, 8A and 12A are in FAIR CONDITION [5-NBIS] (Photo 104). The 2021 inspection noted that the bronze shim plate of the Girder C hinge in Span 4A was shifted 2" to the south. Still, no indication of significant additional displacement was observed during the 2025 inspection. There are isolated areas of painted-over section loss on several of the bearing plates.

*Photo 104 - Typical girder seat assembly detail at Pier 7A, looking east.*

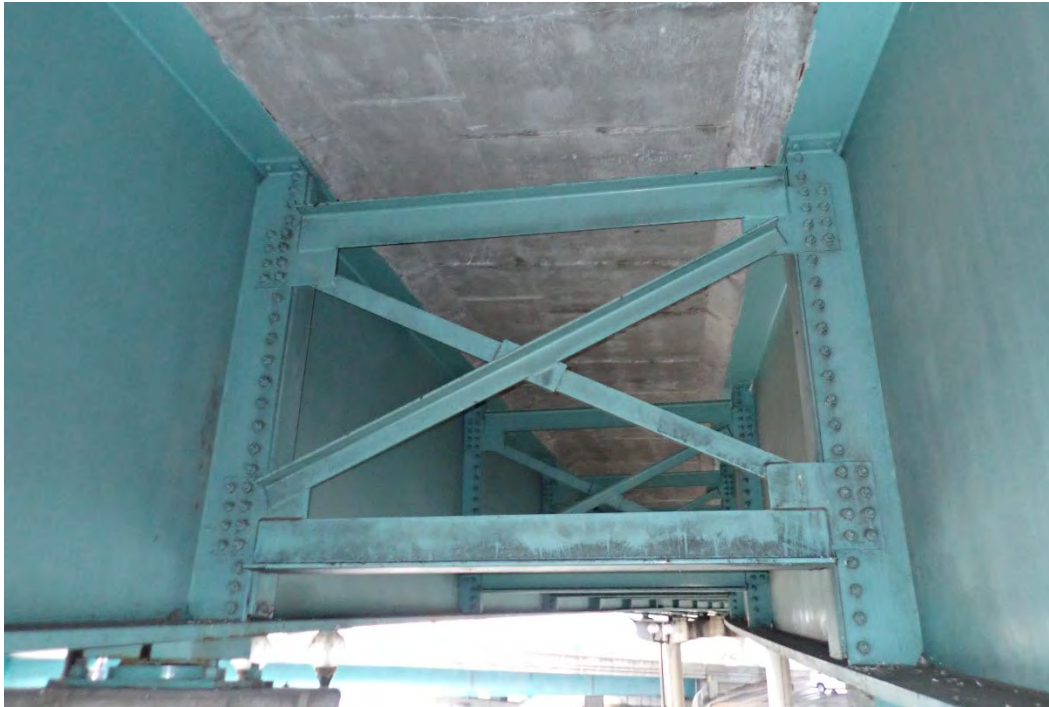
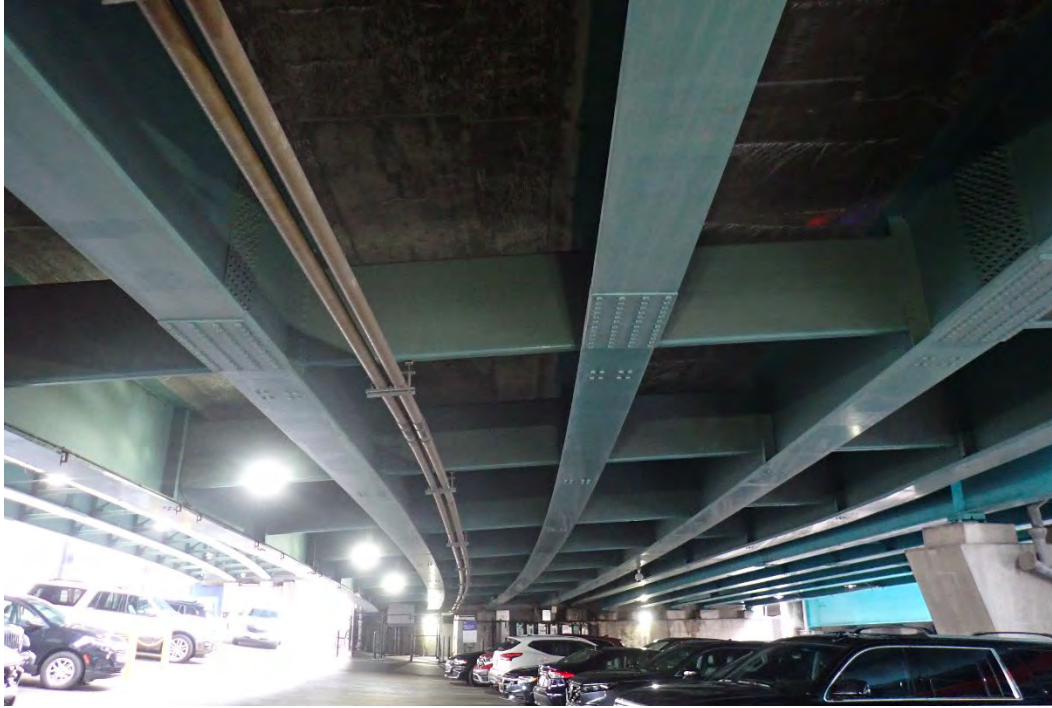
The diaphragms and cross frames are in GOOD CONDITION [7-NBIS] with only minor surface corrosion typical for Span 10 (FWW) through Span 1 (FWW) (Photo 105 & Photo 106) and significant coating failure with minor surface corrosion throughout the original Span 15A through Span 28B (Photo 107). Span 1A through 14A are in good condition with little surface corrosion present (Photo 108).

*Photo 105 - Typical cross-frame diaphragm of FWW spans, at FWW Pier 3, looking west.*

*Photo 106 - Typical solid diaphragms at Span 1, looking east.*

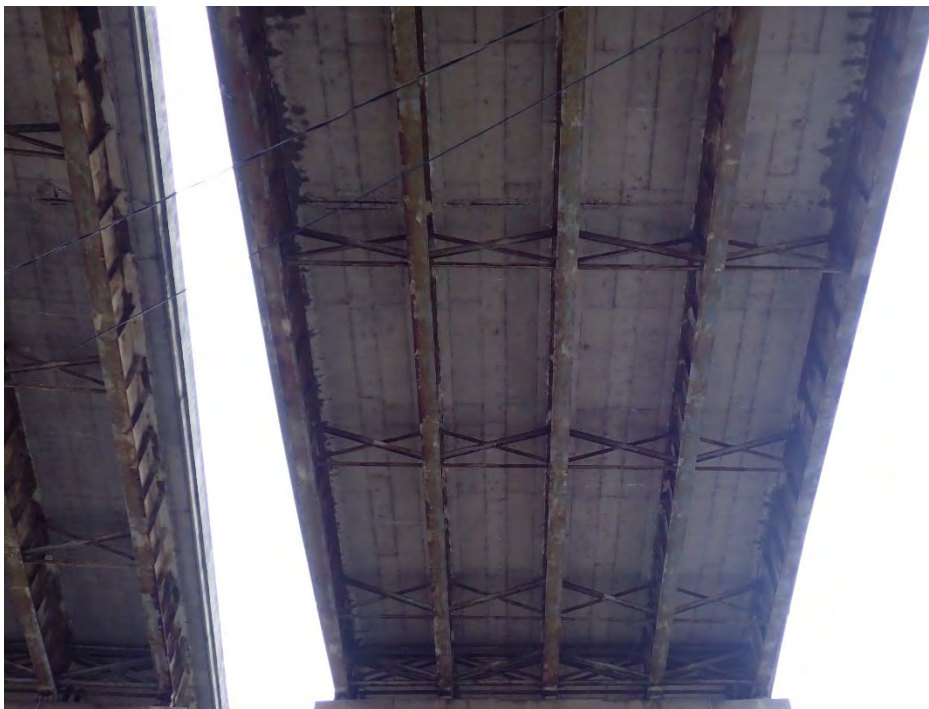
*Photo 107 - Typical cross frame layout in Span 21B, looking north.*

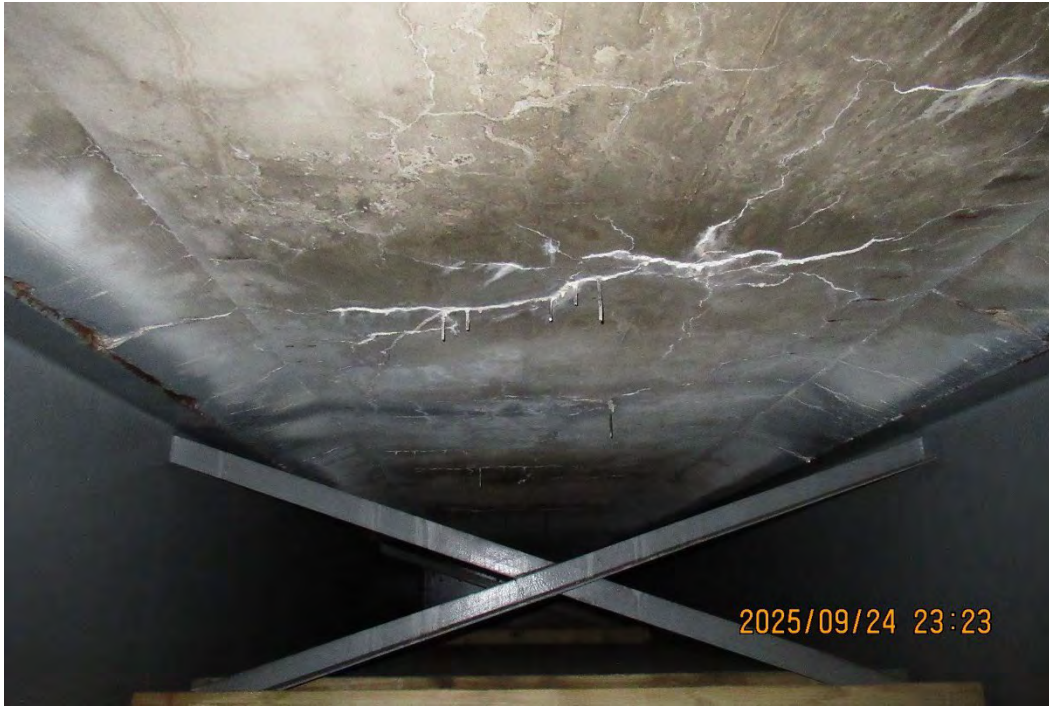
*Photo 108 - Typical cross-frame diaphragm for spans between the River Pier and Pier 15A.*

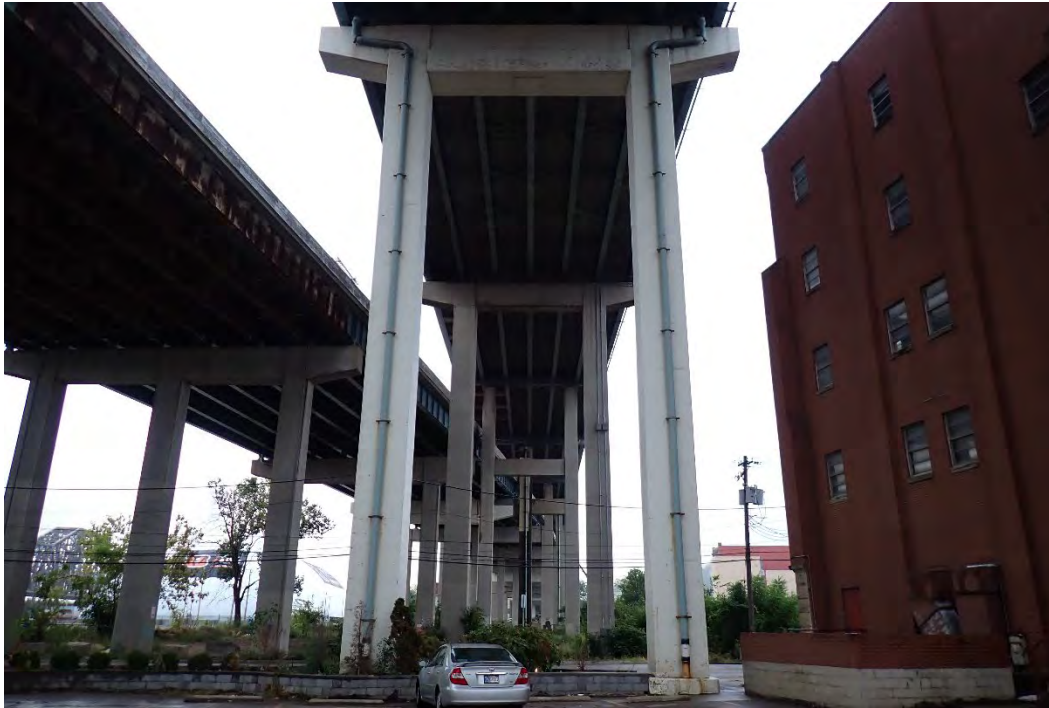
*Photo 111 - Elevation of Pier 15A, looking south. Note: Pier columns wrapped in FRP, and deck drainpipes fastened to pier columns.*

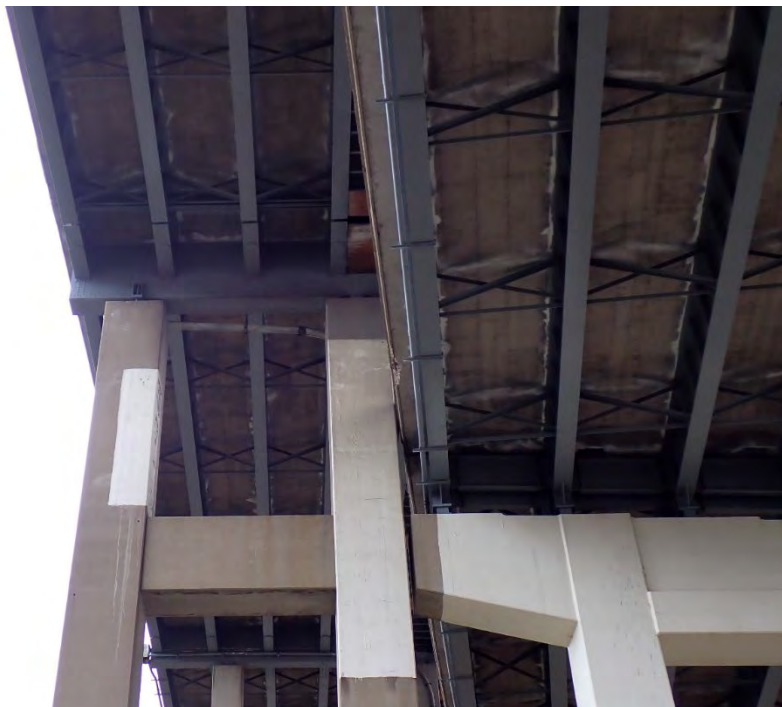
*Photo 112 - Typical FRP application on Pier 12A, looking north.*

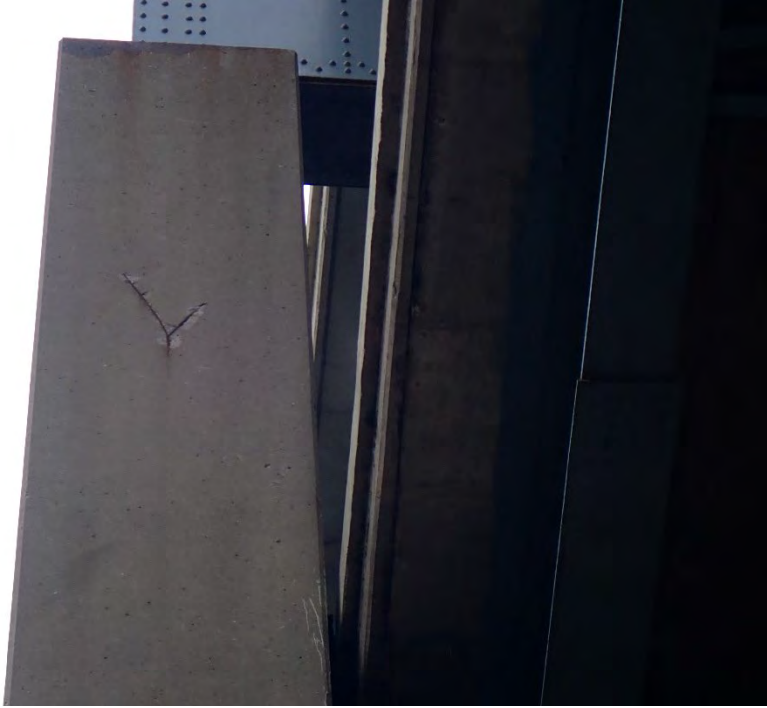
*Photo 113 - Minor spalling around rebar on Pier 5A east column, looking south.*

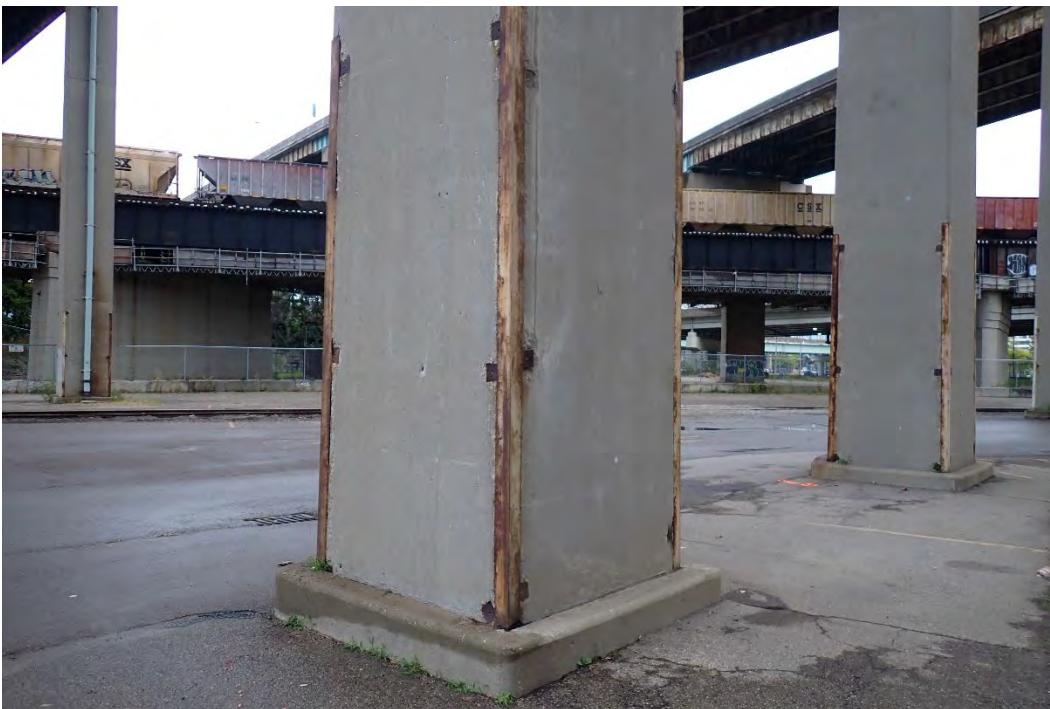
*Photo 118 - Non-typical column corner armor at Pier 16A, looking northeast. Note: Armor is also present on Pier 17A.*

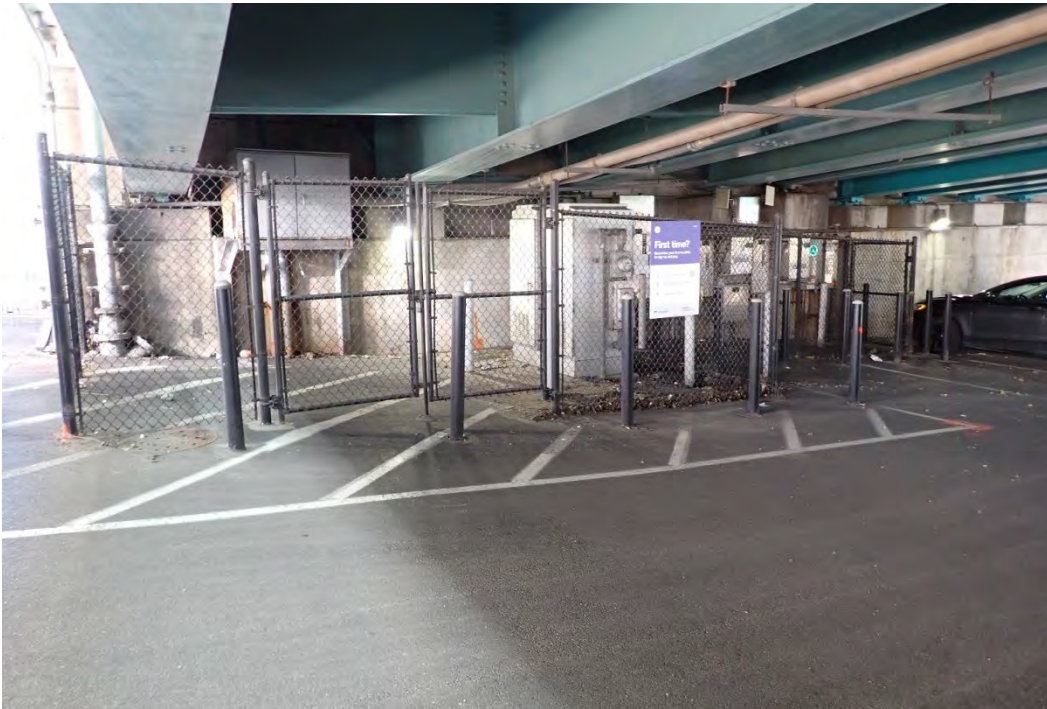
The reinforced concrete pier wall is in GOOD CONDITION [7-NBIS] with no significant deficiencies noted (Photo 120). Most of the Wall Pier is inaccessible due to a chain link fence and installed utilities.

*Photo 120 - FWW Wall Pier, looking East.*

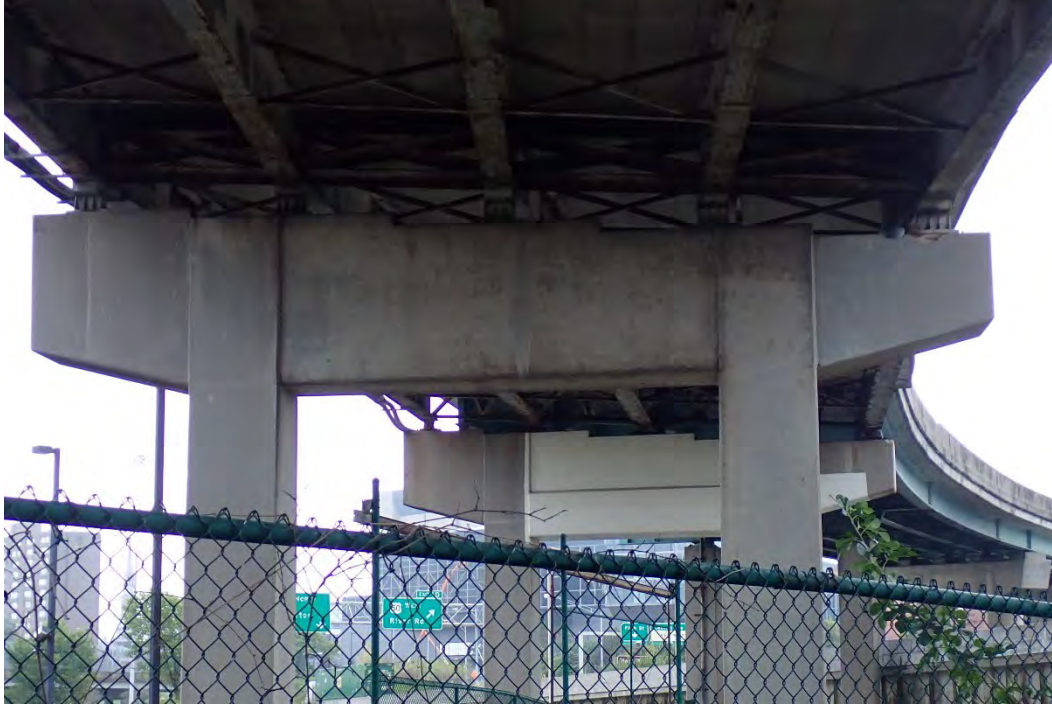
| Reinforced Concrete Pier Cap Defects | |
|---|---|
| Pier Cap 27B | Two 24" long by 12" wide by up to 3" deep spalls with exposed reinforcement adjacent to either side of the Girder E bearing (no loss of bearing area noted at the time of the inspection). |

*Photo 121 - Typical pier cap at Pier 27B, looking north.*

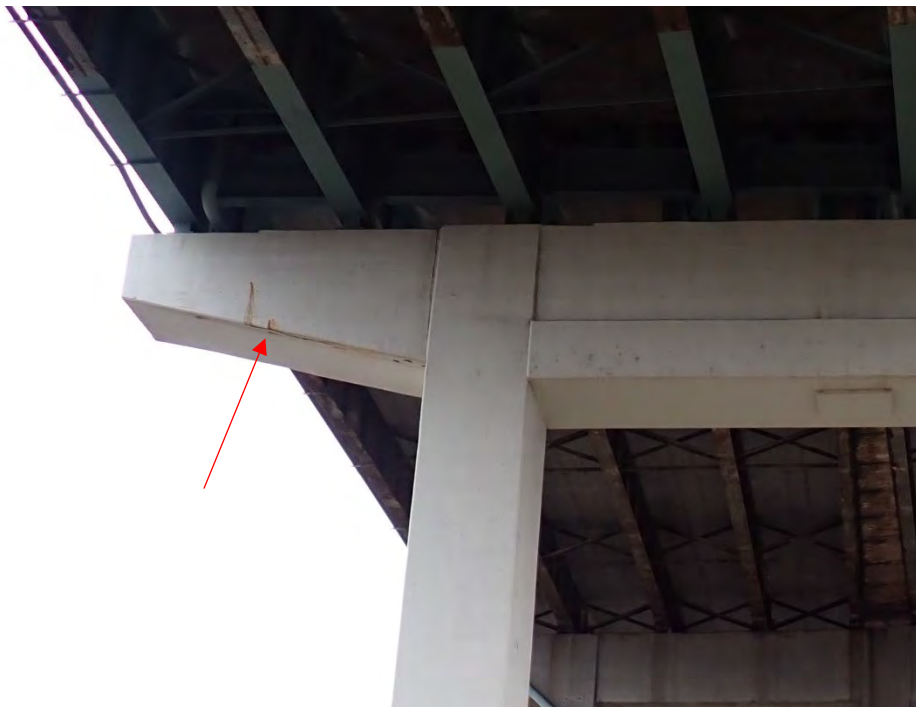
*Photo 124 - Transverse cracks with rust staining along the bottom south edge of the west overhang of Pier 19A, looking north*

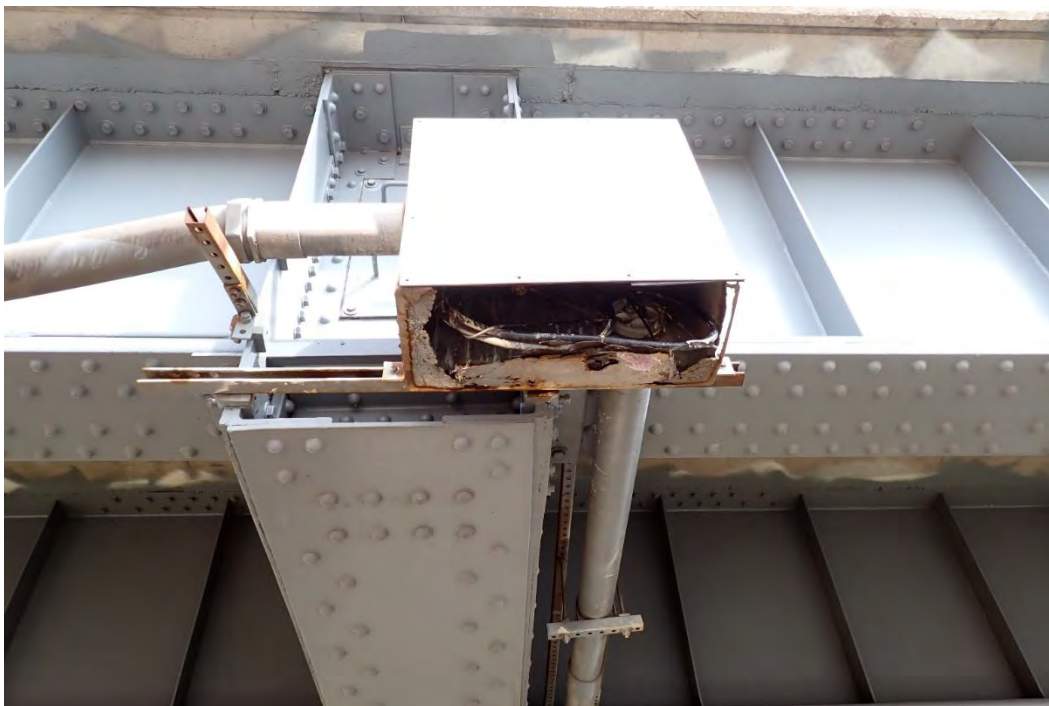
The utilities on the structure are in SATISFACTORY CONDITION [6-NBIS] overall, however there is a utility junction box with areas of 100% section loss throughout the bottom and side plates at Pier 13A (Photo 125). The section loss has exposed the internal electrical wiring, and the box is impeding access to the west pier cap hatch. The junction box at the west end of Pier 26B has active corrosion and missing connections. There are multiple nonfunctioning roadway lights throughout Spans 1A-12A, and one lens is shattered in both Spans 9A and 11A. Some of the light pole handhole covers are missing.

Photo 125 - Utility box with bottom 100% corroded on Pier 13A, looking east.

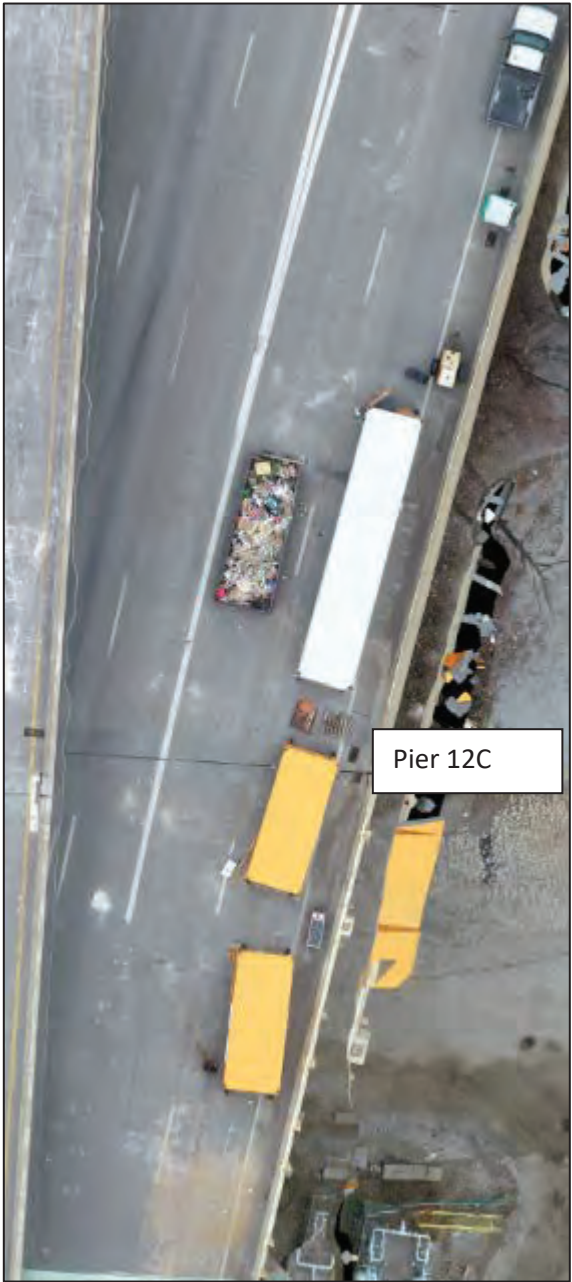
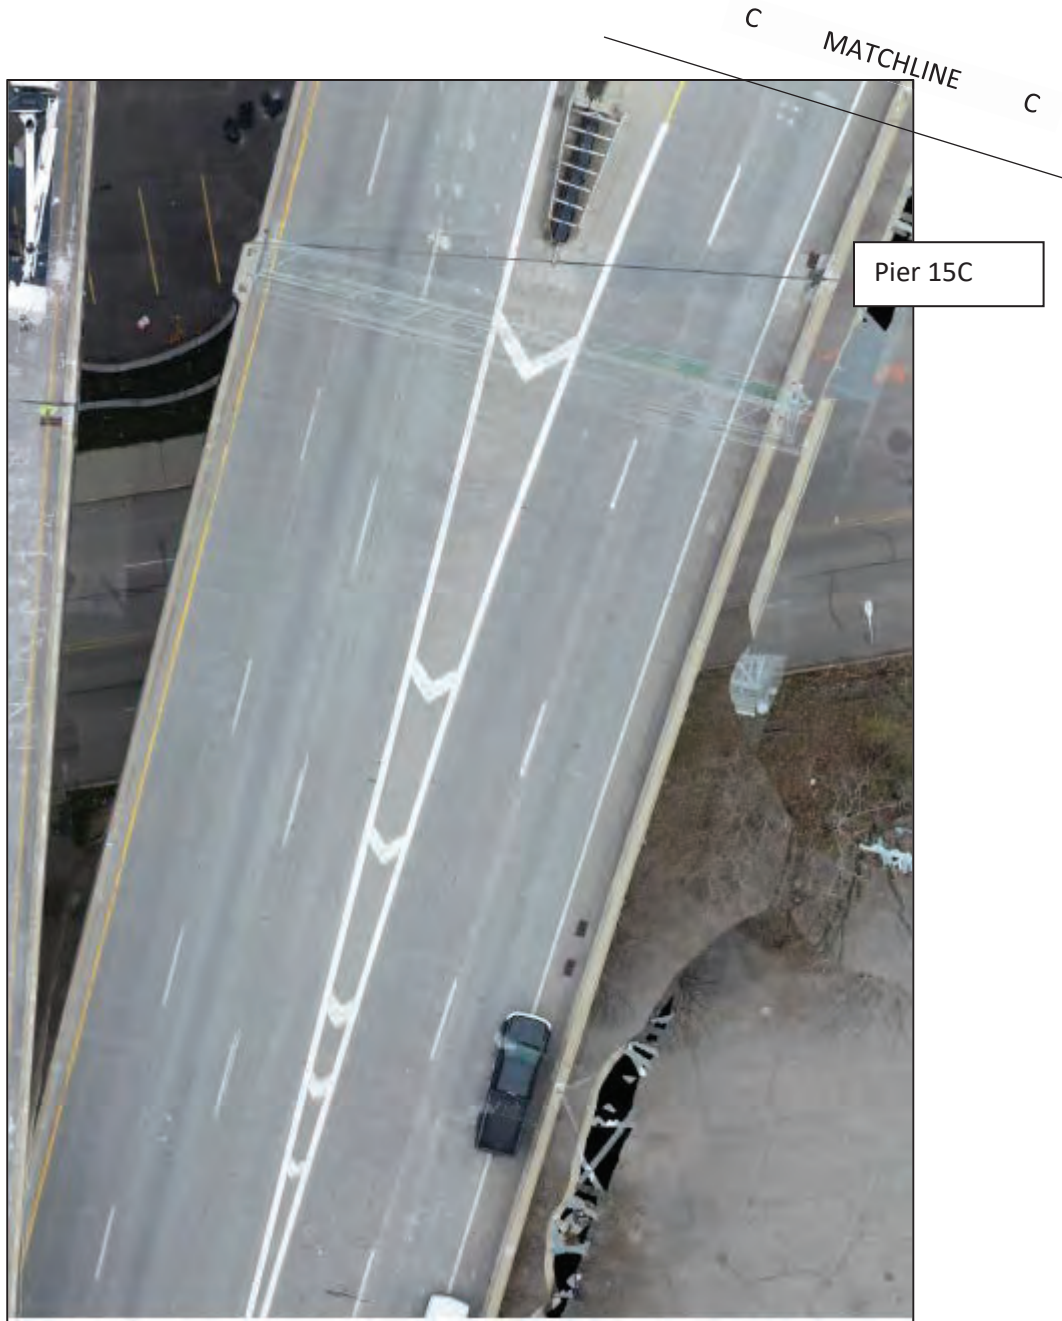
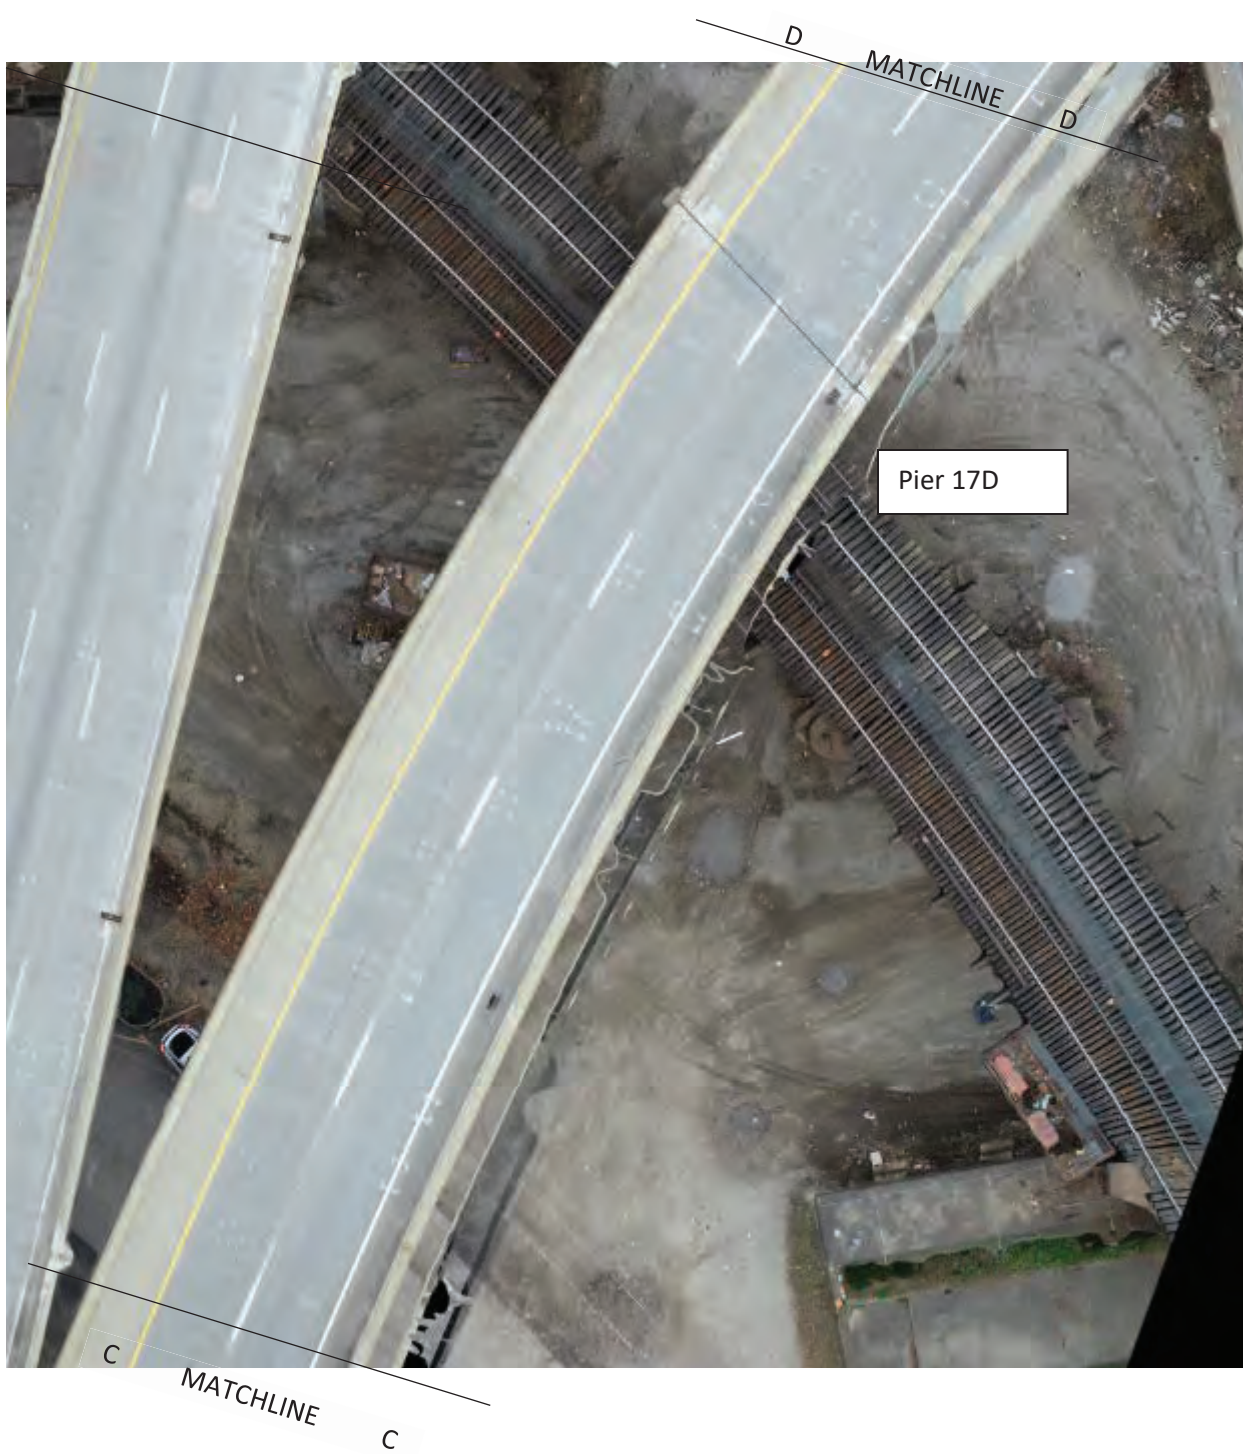
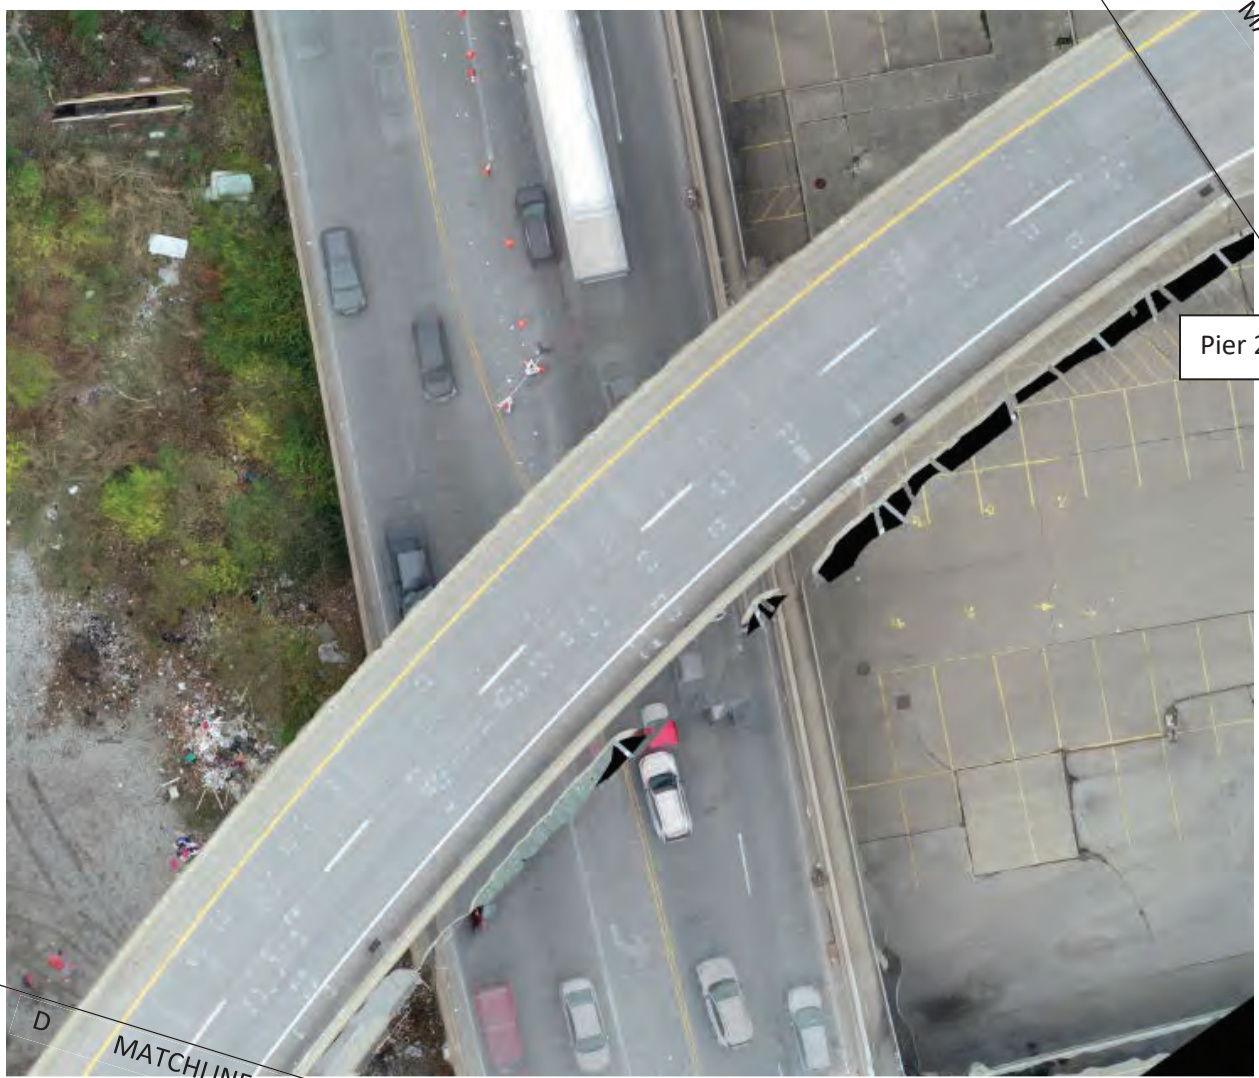
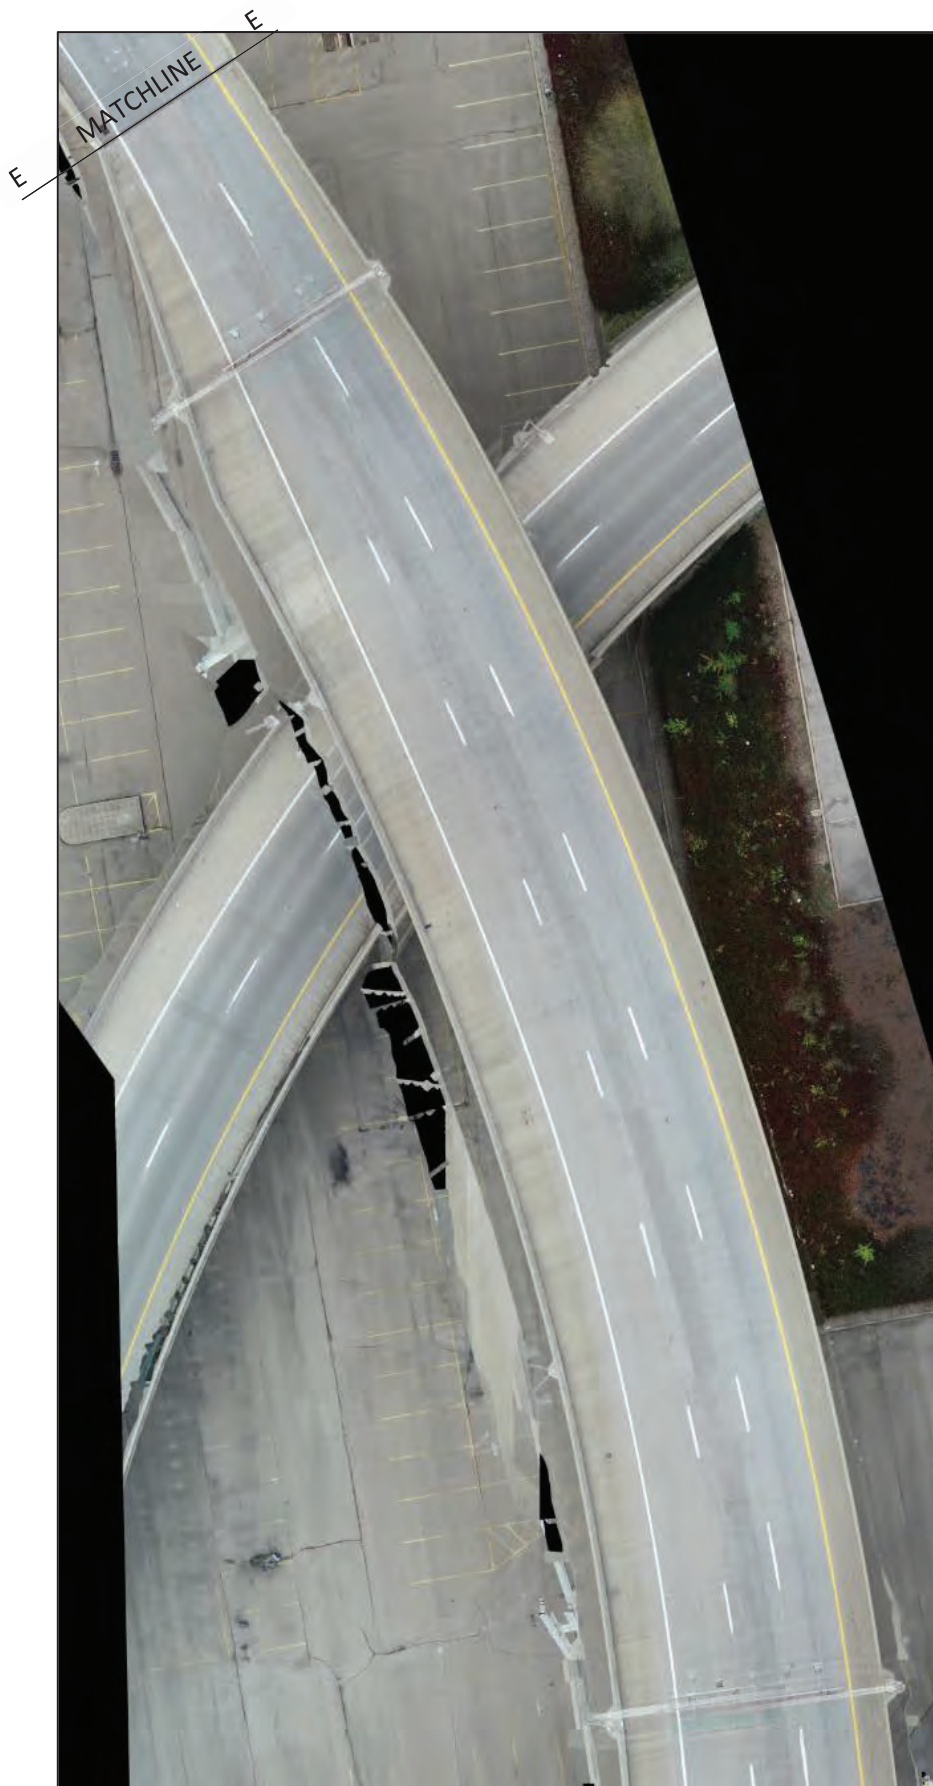
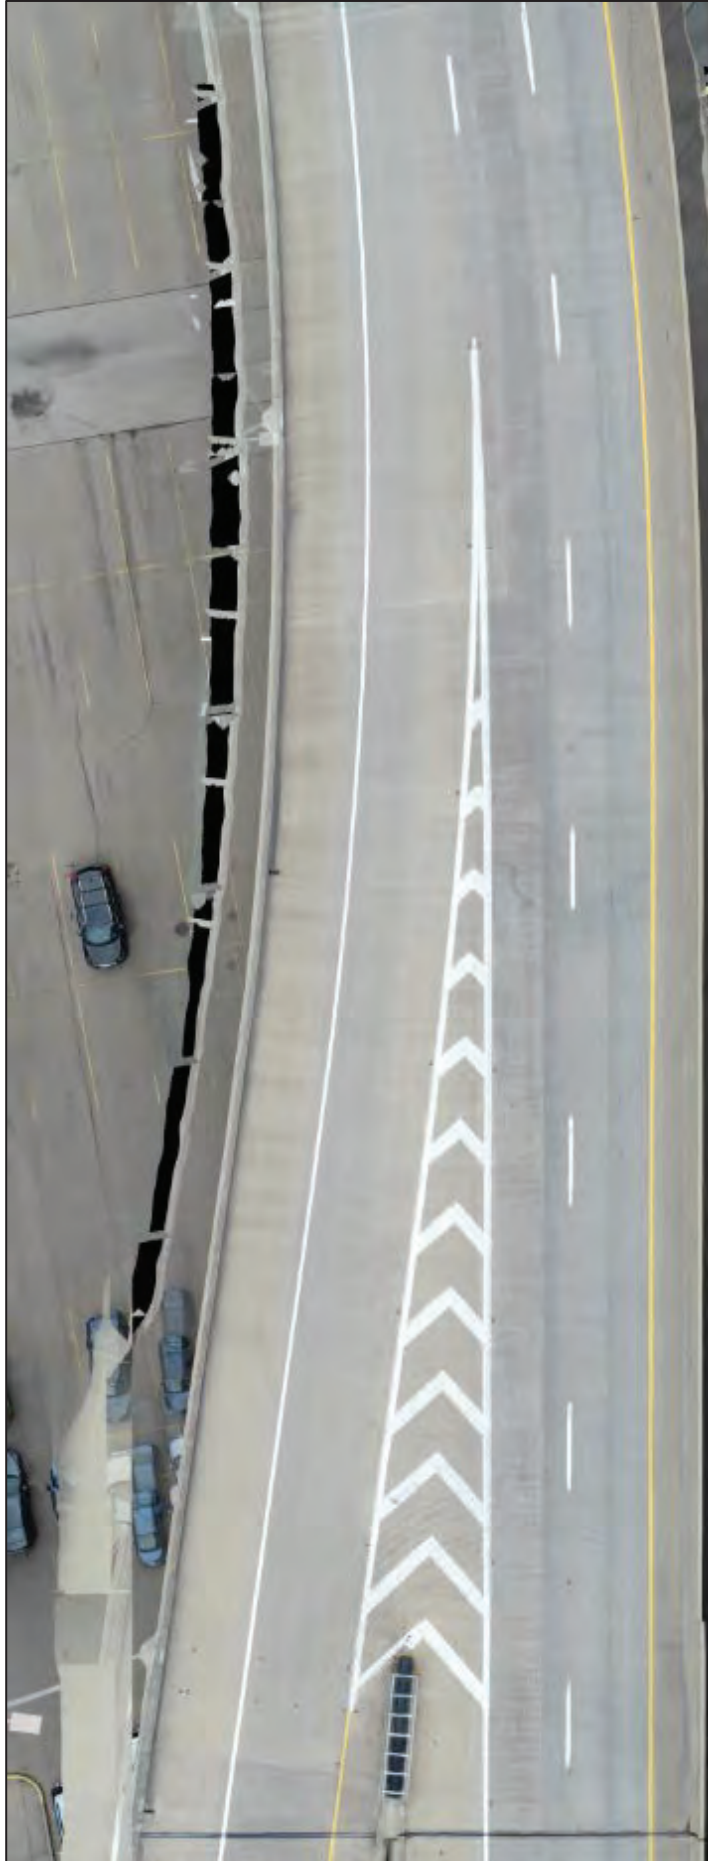
WEARING SURFACE DELAMINATIONS, IDENTIFIED BY ODOT DECEMBER 2020

White painted rectangles denotes delaminated areas
