# BRENT SPENCE APPROACH BRIDGE

HAM-71-0000R

## 2025 In-Depth Inspection Report

Inspection Date: September 22-26, 2025

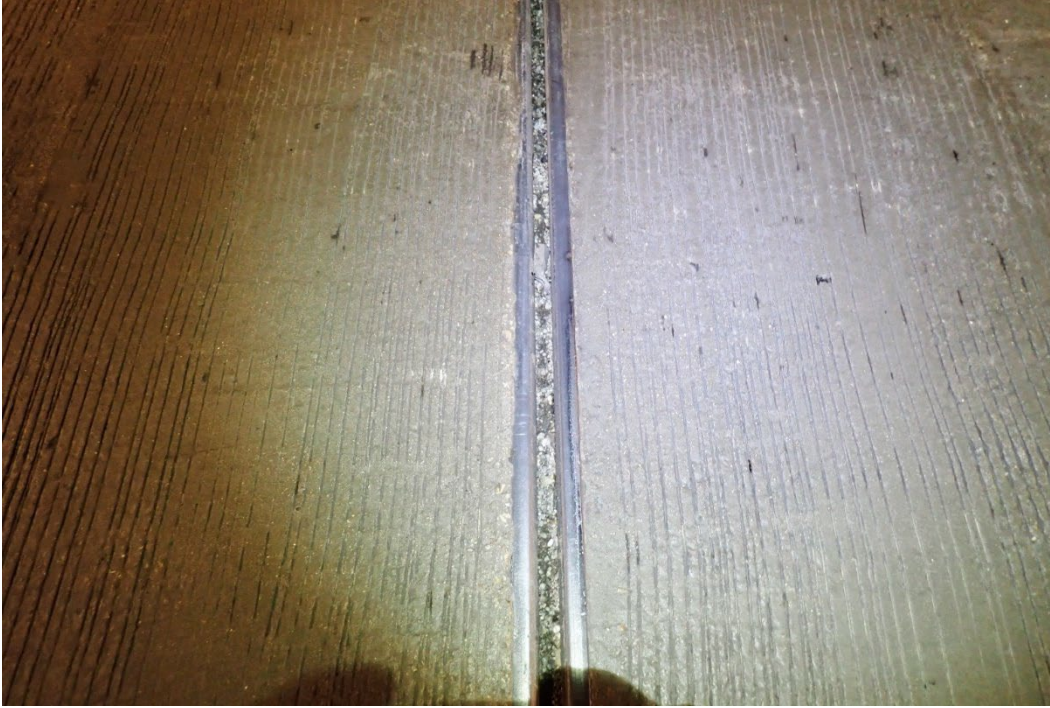
The expansion joints are in FAIR CONDITION [NBIS-5] overall with minor to heavy debris accumulation, deterioration, and isolated areas of leakage. Expansion joints are located at Piers 4A, 8A, 12C, 15C, 17C, 20D, and 5 (Photo 19). There is loosely packed debris in expansion joints on the deck (Photo 20). There is a tear on Pier 5 allowing free-flow water through the joint. Leakage onto pier caps is evident, as well as active corrosion on the girders and bearings below these joints.

*Photo 20 - Typical debris impactation at strip seal joint at Pier 4, looking east.*

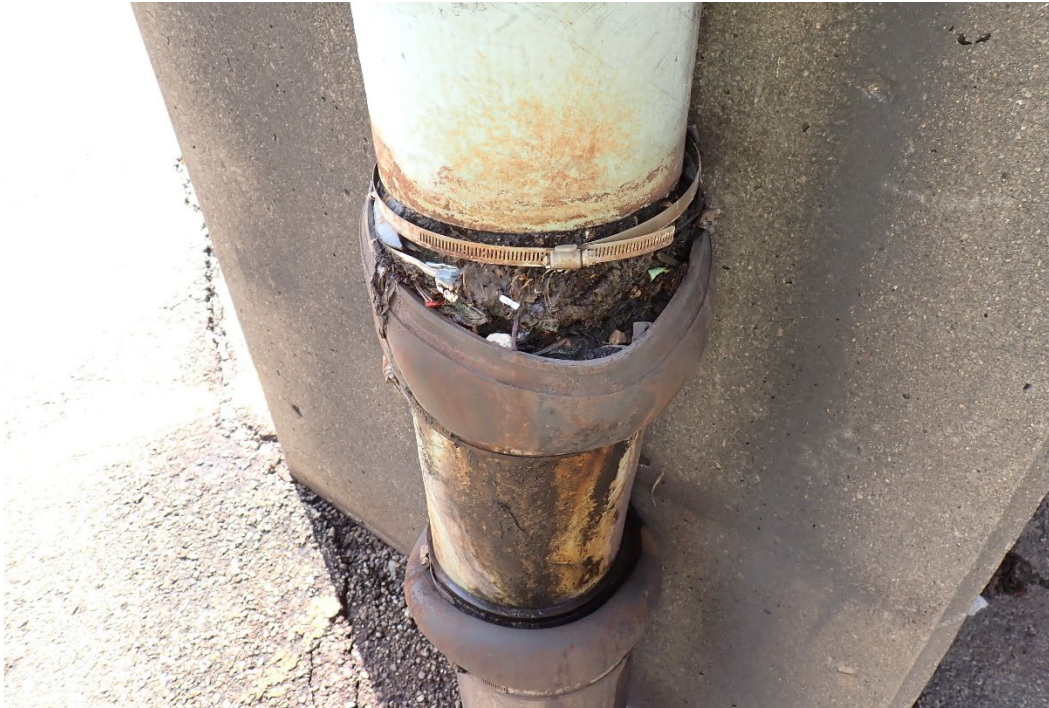
The drainage system is in POOR CONDITION [4-NBIS] due to multiple drainpipes being completely or partially clogged at the deck level scupper locations (Photo 28) and at the ground level (Photo 29), causing water ponding on the deck. The drain grate in Span 2A is missing (Photo 30). There are several disconnected and misaligned drain boots at column bases. The exposed drainage bells are typically fully clogged with debris (Photo 31 & Photo 32).

*Photo 29 - Drain pipe fully impacted with debris and disconnected at base at Pier 19D, looking west.*

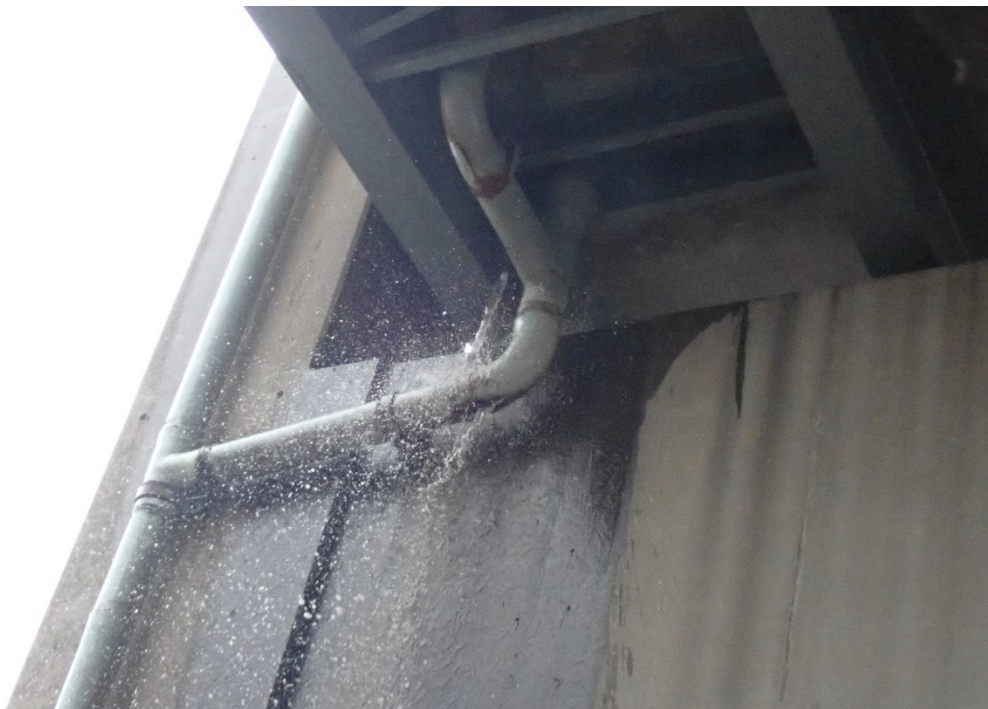
*Photo 32 - Clogged and overflowing drainpipe at Pier 2A, looking south.*

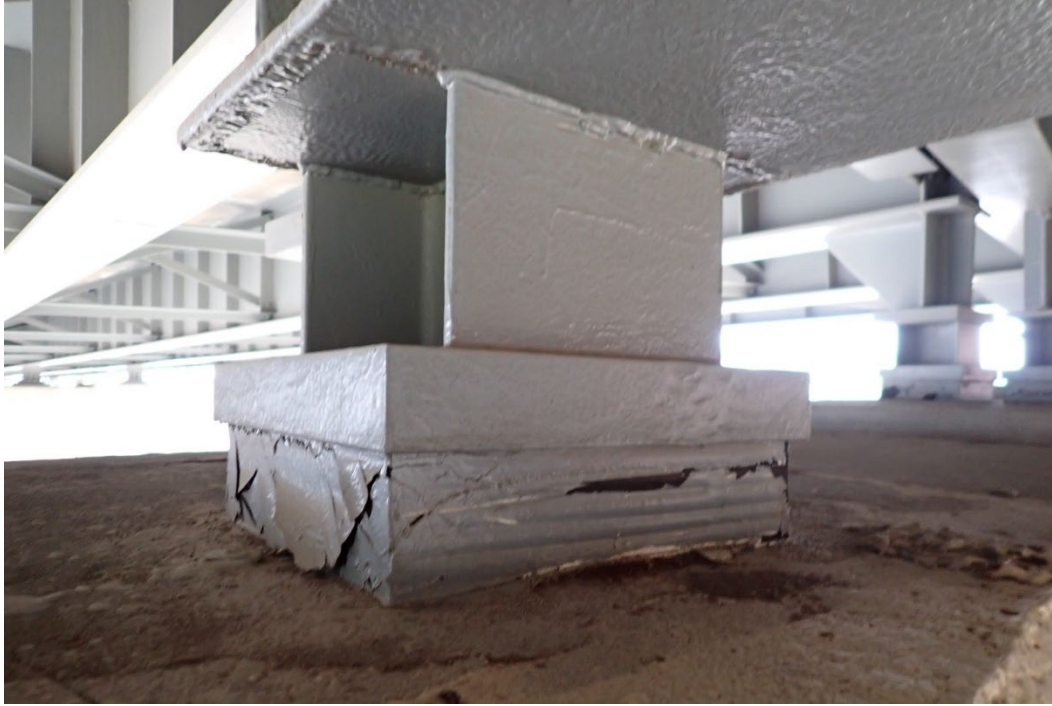
The Elastomeric Bearings are in GOOD CONDITION [NBIS-7] overall (Photo 40 & Photo 41). There are elastomeric bearings at the River Pier, Piers 12C, 15C, and 17D. The bearings typically have minor surface corrosion and isolated paint failure. The bearings exhibited few signs of expansion and were in a neutral position.

*Photo 41 - Typical bearing pad at Girder D in Pier 12C, looking southwest.*

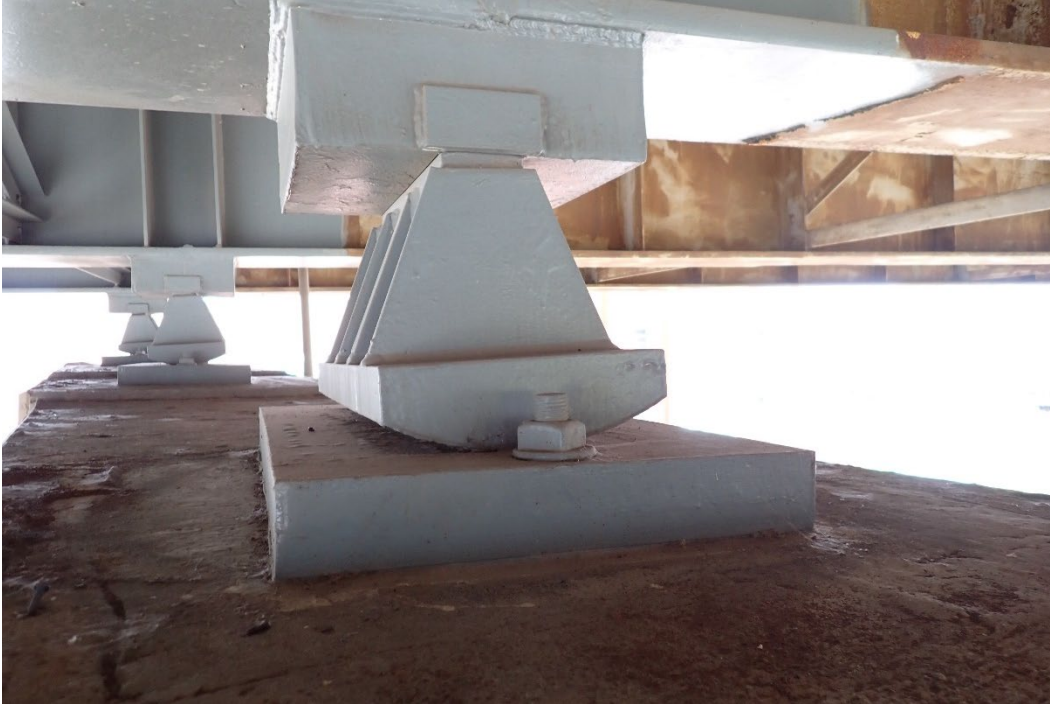
The Moveable Bearings are in POOR CONDITION [NBIS-4] overall (Photo 42). The steel rocker bearings typically exhibit moderate section and minor corrosion of the sole plate (Photo 43). The movable bearings have typically had active corrosion and pack rust between the rocker and masonry plate cleaned away and painted. Resulting in intermittent areas of painted-over pitting.

*Photo 42 - Typical rocker bearing at Girder C at Pier 14C, looking northwest.*

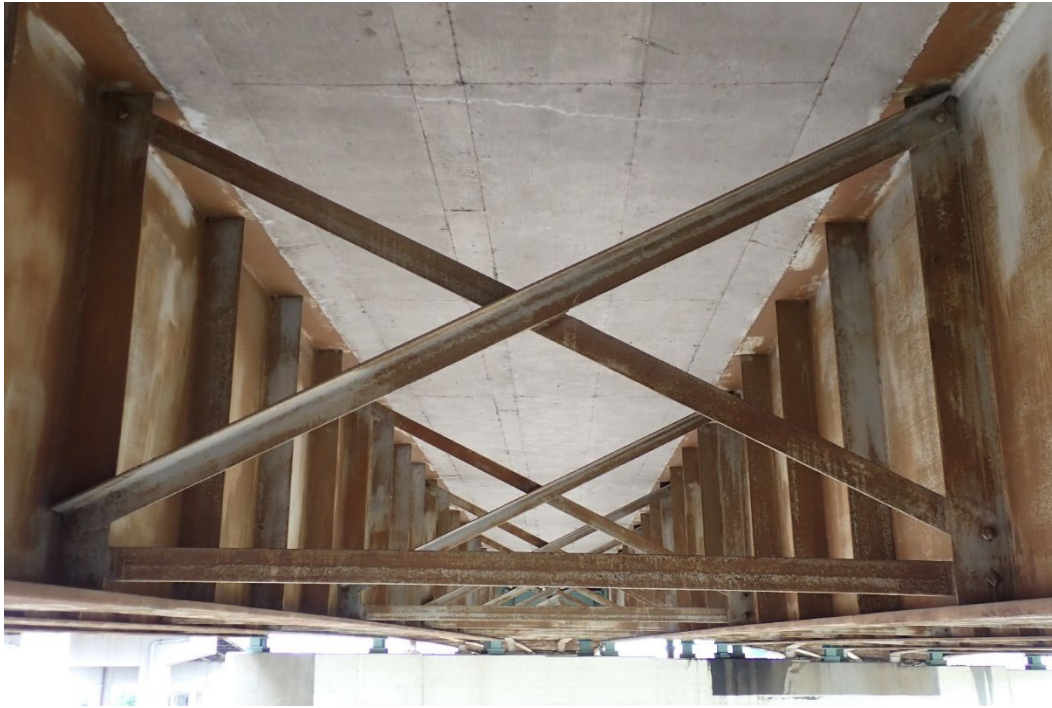
The Steel cross-frames and diaphragms were in GOOD CONDITION [NBIS-7] during the inspection, and no significant changes to defects were noted (Photo 52). There was paint failure on the non-painted spans (Photo 53). Cross frame #5 on Span 14 is bent out of plane. A broken weld at end of cross frame of Girder G in Span 9A was observed (Photo 54).

*Photo 53 - Typical cross brace diaphragm at Span 15C, Bay 3, looking north.*

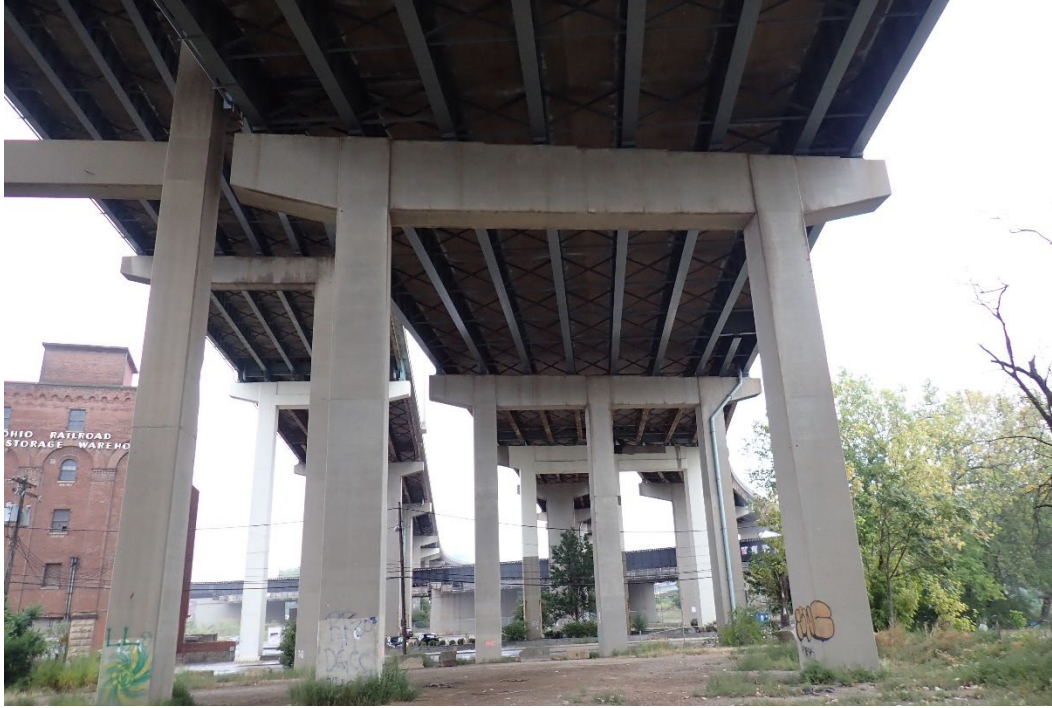
The Pier Columns/bents are in GOOD CONDITION [NBIS-7] overall (Photo 55 & Photo 56), isolated small spalls, exposed rebar, and hairline cracking were observed on columns (Photo 57 & Photo 58). Typically, the round columns in the reconfiguration portion of the bridge are in better condition than the older rectangular columns (Photo 59).

*Photo 56 - Typical two-column pier at Pier 13C, looking north.*

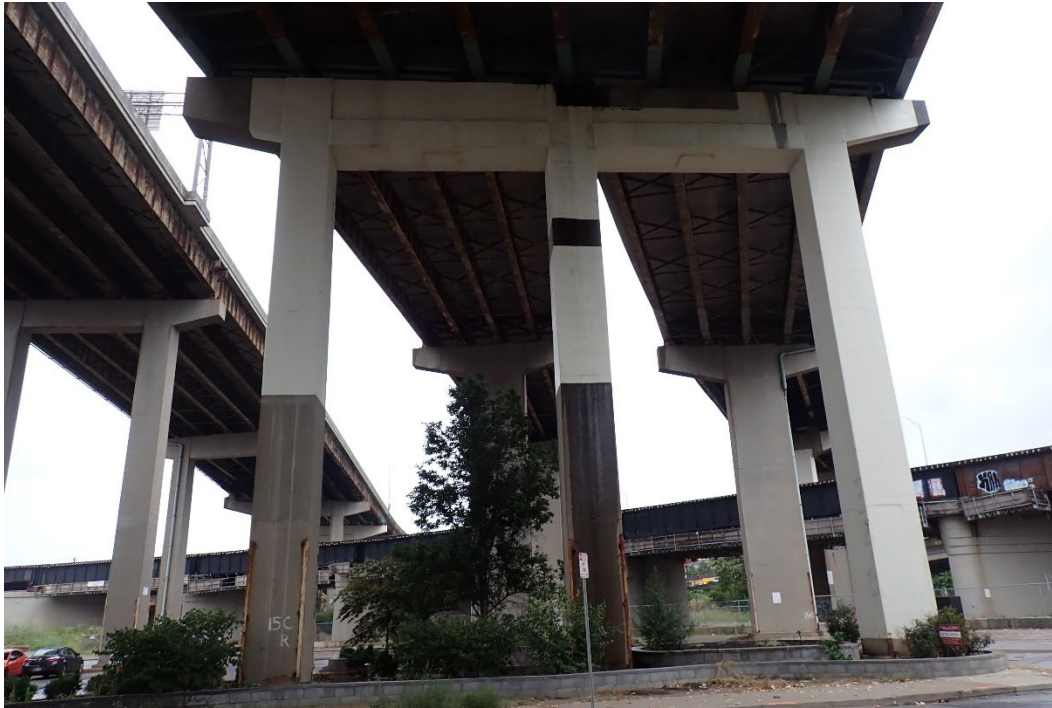
Concrete patching was observed on several columns and FRP wrapping on the River Pier, Piers 4A, 5A, 7A, 8A, 12C, and 15C (Photo 60). Patches are typically sound, and the FRP wrapping is in good condition with only isolated areas of peeling/failing protective coating. There are isolated small spalls without any exposed reinforcing, mainly on the corners, including Piers River, 1A, 5A, 6A, and 19D (Photo 61).

*Photo 60 - Typical FRP wrap on Pier 15C, looking north.*

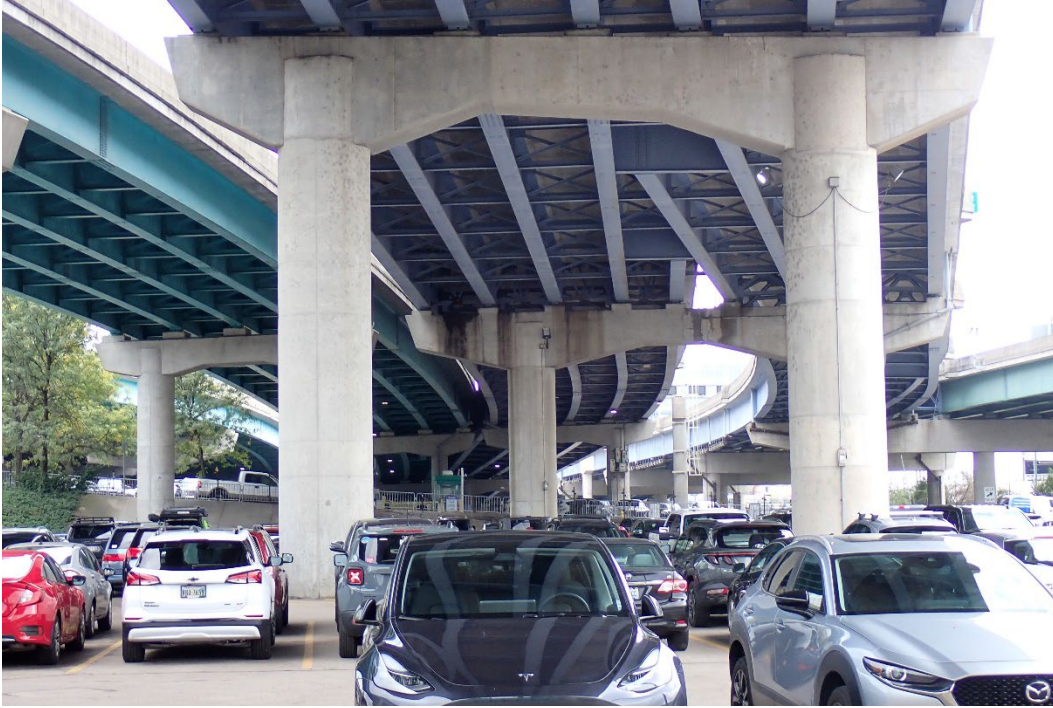
The reinforced concrete pier caps are in SATISFACTORY CONDITION [6-NBIS] (Photo 65 & Photo 66). Hairline cracking and minor spalls were observed, along with isolated larger spalling with exposed rebar on the top and bottom of the pier caps.

*Photo 66 - Pier 4 looking east.*

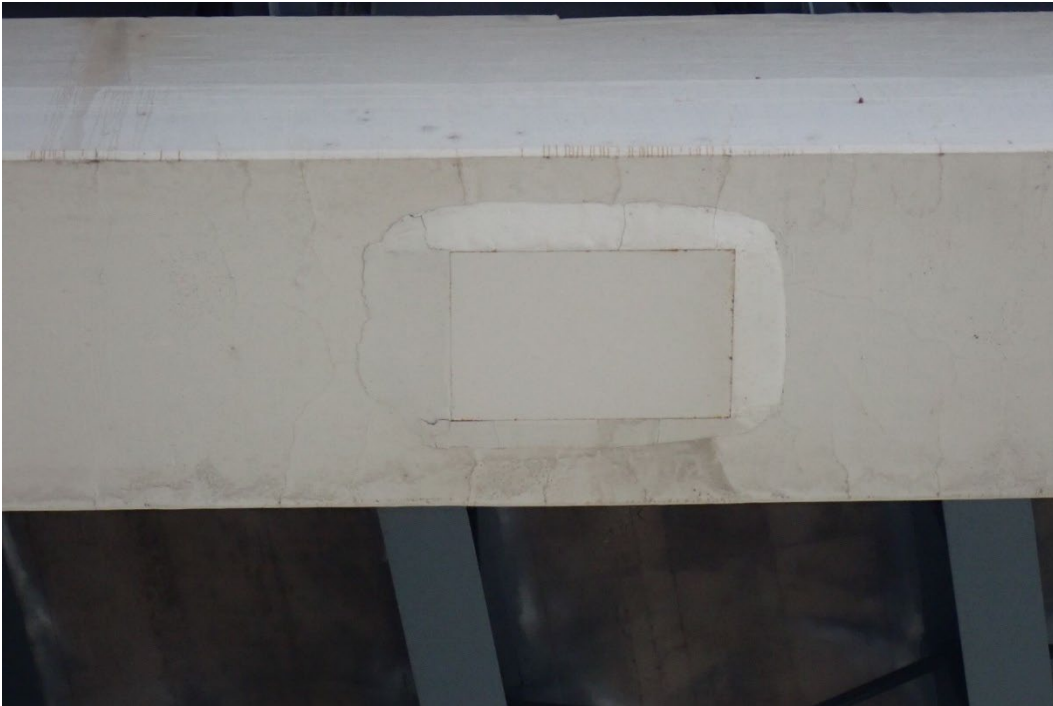
Isolated areas have concrete patches (Photo 67), and FRP wrapping is applied to the River Pier and Piers 4A, 5A, 7A, 8A, 12C, 15C, 17D, and 20D. There are areas on both sides of Pier 12C where the FRP is delaminating from the concrete (Photo 68). There is moderate cracking on the north face of Pier 20D with minor cracking on the overhangs (Photo 69). There are small concrete spalls with exposed rebar on the caps of Piers 1A, 3A, 5A, 10A, and 11A.

*Photo 67 – Steel plate embedded in patched concrete surface of the bottom flange pier cap underside at Pier 12C.*

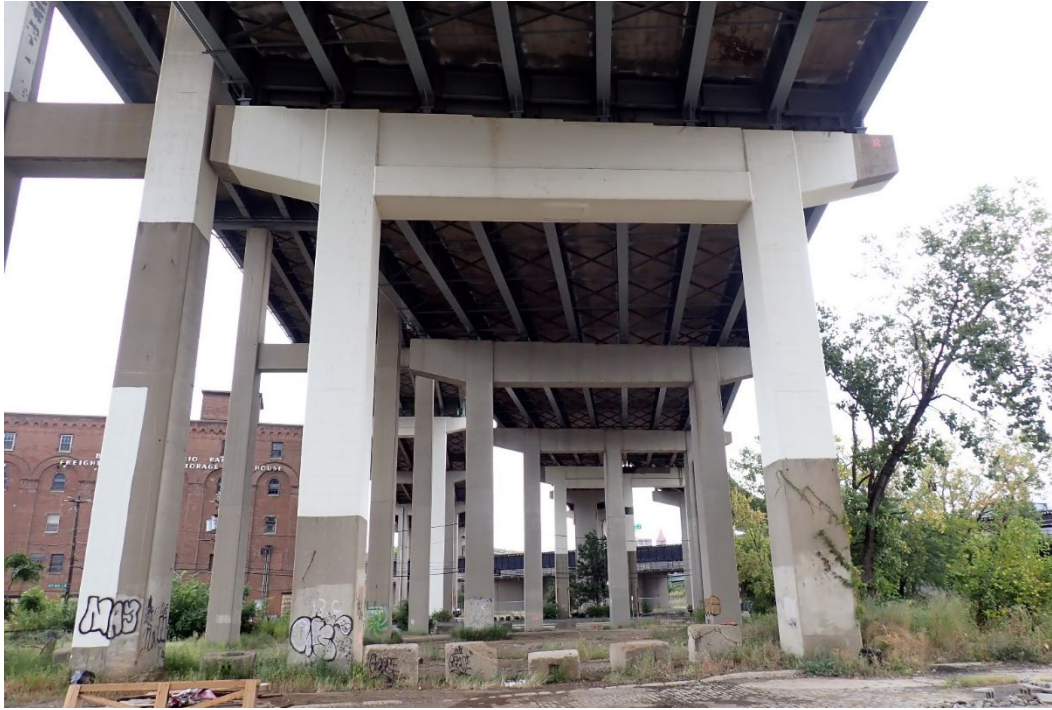
*Photo 68 - Typical FRP wrap of pier cap and columns, at Pier 12C, looking north.*

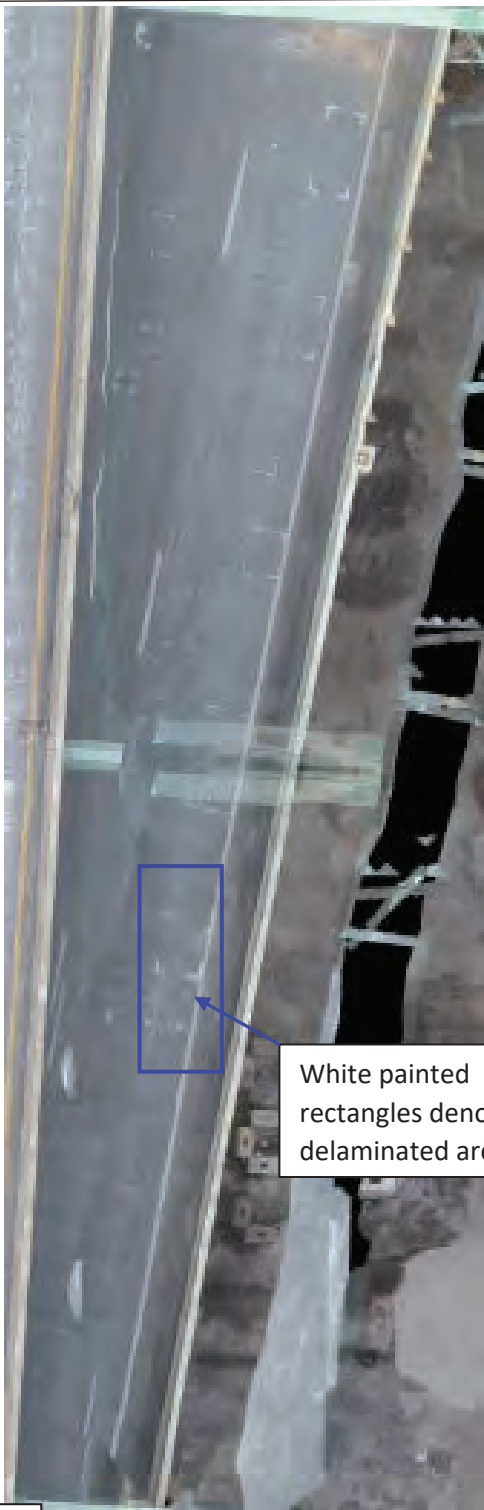
Pier 8A

White painted rectangles denotes delaminated areas
