# 2025 IN-DEPTH AND NSTM INSPECTION REPORT

BRIDGE NO. HAM-75-0022R

SFN: 3108805

Submitted to ODOT, District 8  
November 17, 2025

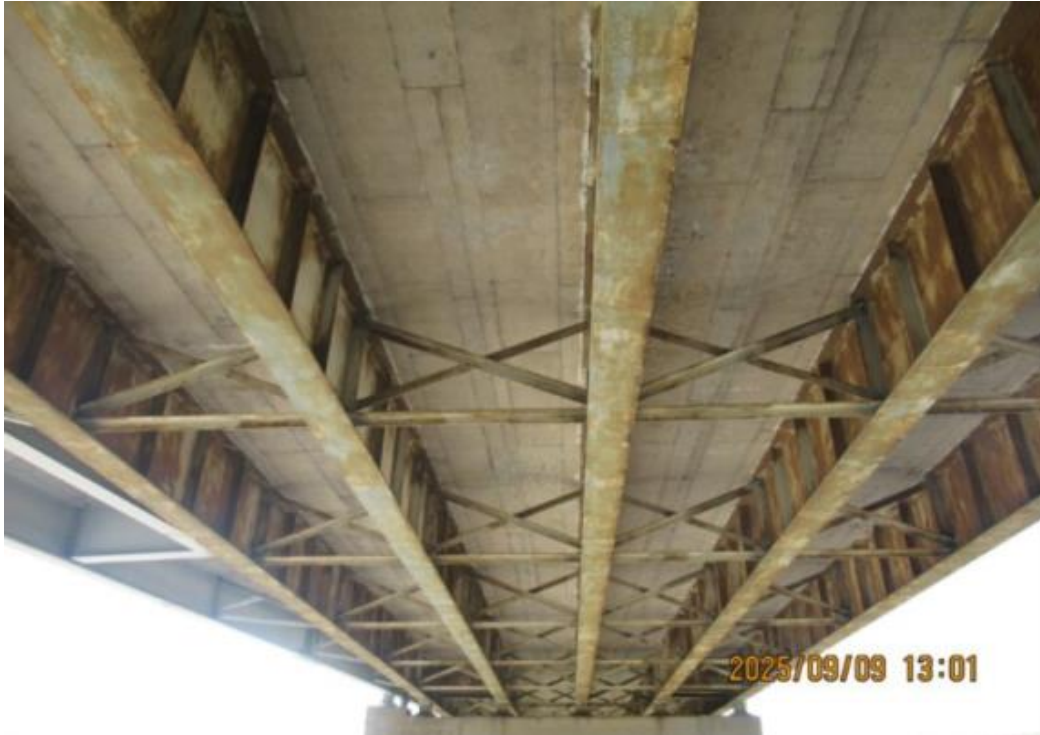
*Photo 13: Typical framing plan (Span 22C shown)*

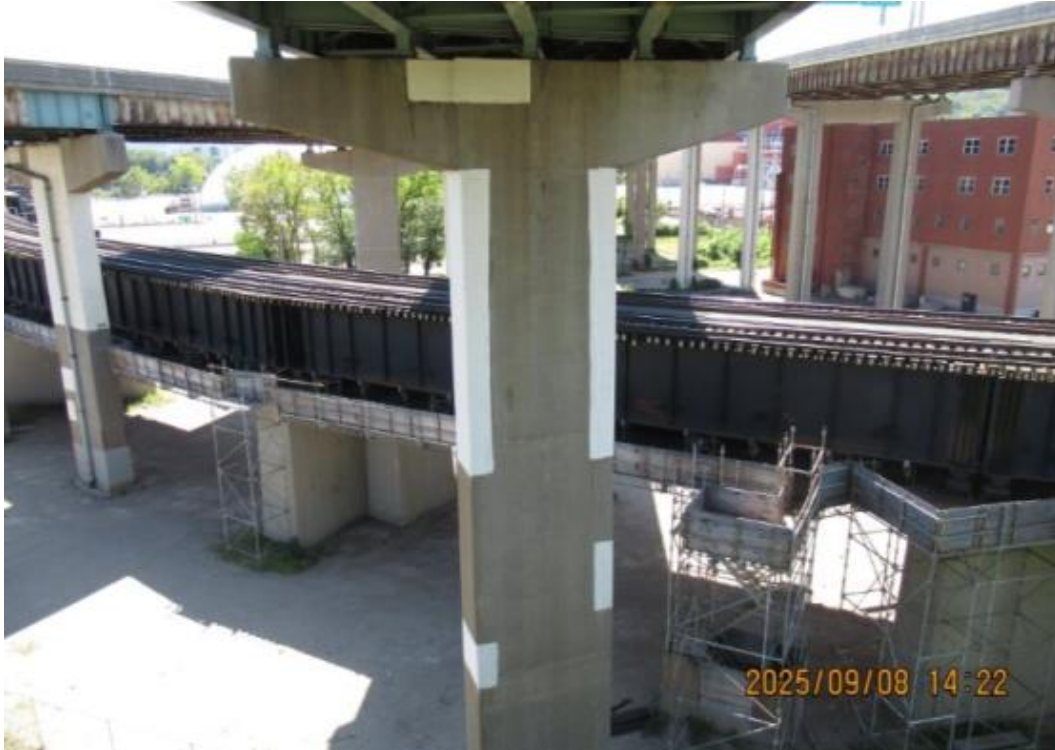
The reinforced concrete pier walls are in **SATISFACTORY CONDITION (6)** with hairline map cracking typical throughout. A shallow spall around the corner armor is present at the base of Pier 16C. Vertical hairline cracks are present on Pier 18C. Concrete patching and FRP wrap were applied to Pier Wall 18C as part of the 2017 rehabilitation. There is a 10" W x 4"H section of FRP that is peeling and cracking on the south face of Pier 18C. Several shallow spalls with exposed reinforcing bars are present on the south and west faces of Pier 19C due to shallow cover (Photo 23).

*Photo 22: Typical concrete pier wall (Pier 17C)*

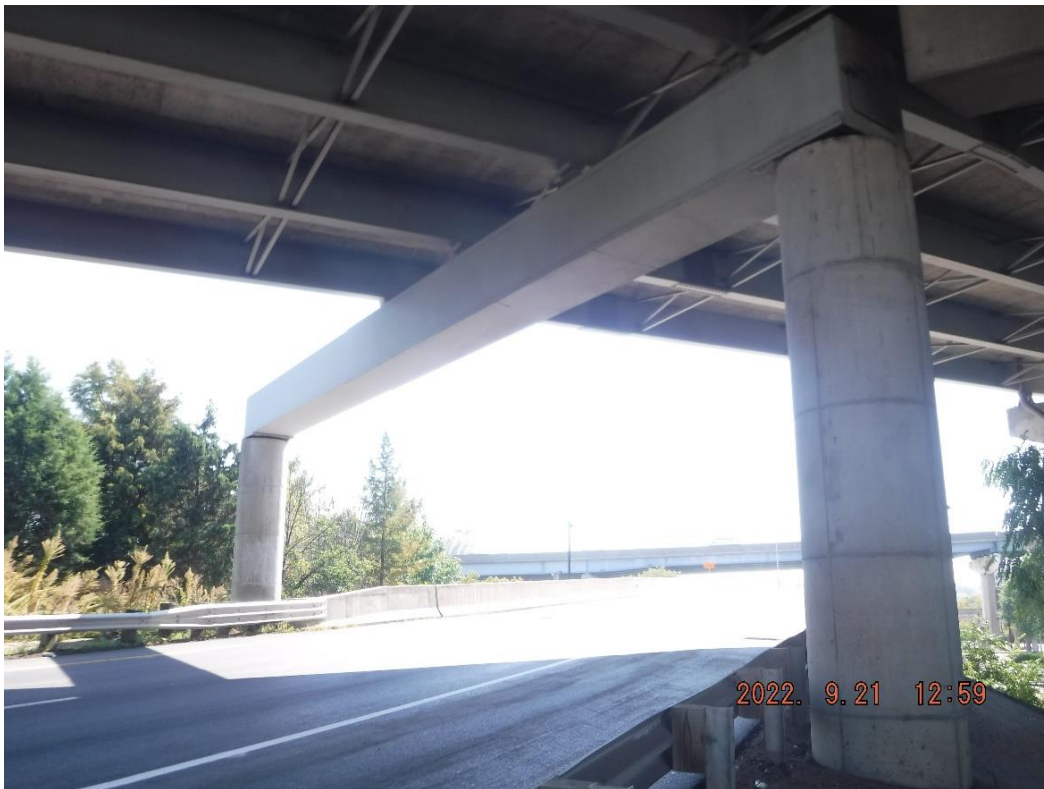
The pier cap exterior is in **GOOD CONDITION (7)**. There are areas of surface corrosion scattered throughout the pier cap exterior, particularly on the top flange at the east end and along the edges of both flanges. There are minor scrapes with surface corrosion in the bottom flange (Photo 30) over the U.S. 50 ramp to 2<sup>nd</sup> Street. The bottom flange bearing plates at both columns exhibit minor surface corrosion (Photo 31).

The exterior steel protective coating is paint and is in **POOR CONDITION (4)** with isolated areas of surface corrosion and minor peeling. There is little to no paint remaining on the bearing plates over the columns.

*Photo 29: Pier Cap 25J looking south*

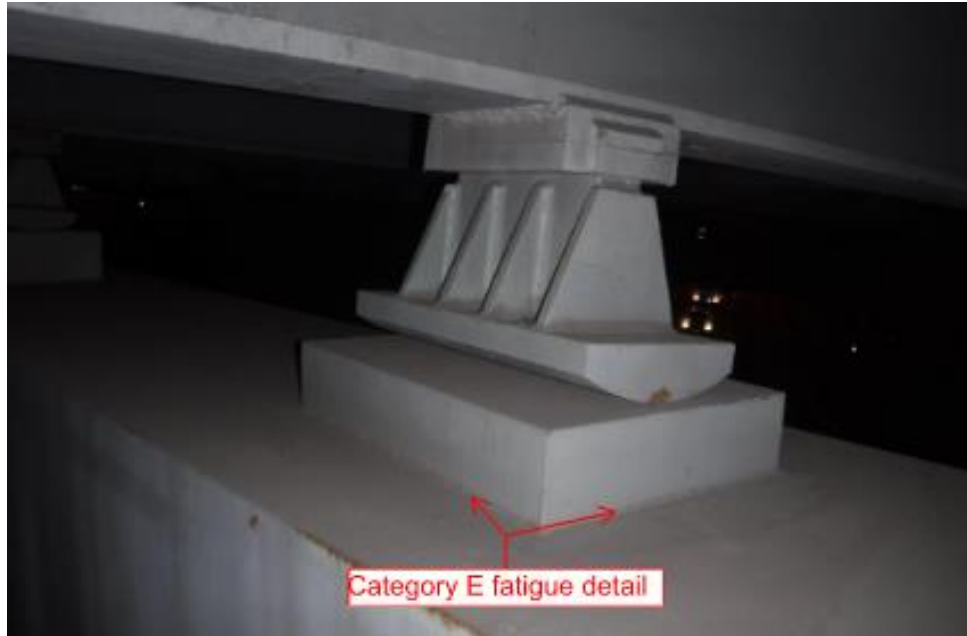
The fatigue prone details of steel pier cap 25J are in **GOOD CONDITION (7)** with no significant deficiencies noted. The fatigue prone details present include fatigue category C' and E'. Category C': Typical interior transverse diaphragm fillet weld connection to pier cap webs and flanges. Category E: Steel bearing pedestal to top flange fillet weld connection with length  $L > 4$  in. and a thickness  $t > 1.0$  in. parallel or transverse to the direction of primary stress.

*Photo 35: Fatigue detail (Pier 25J)*

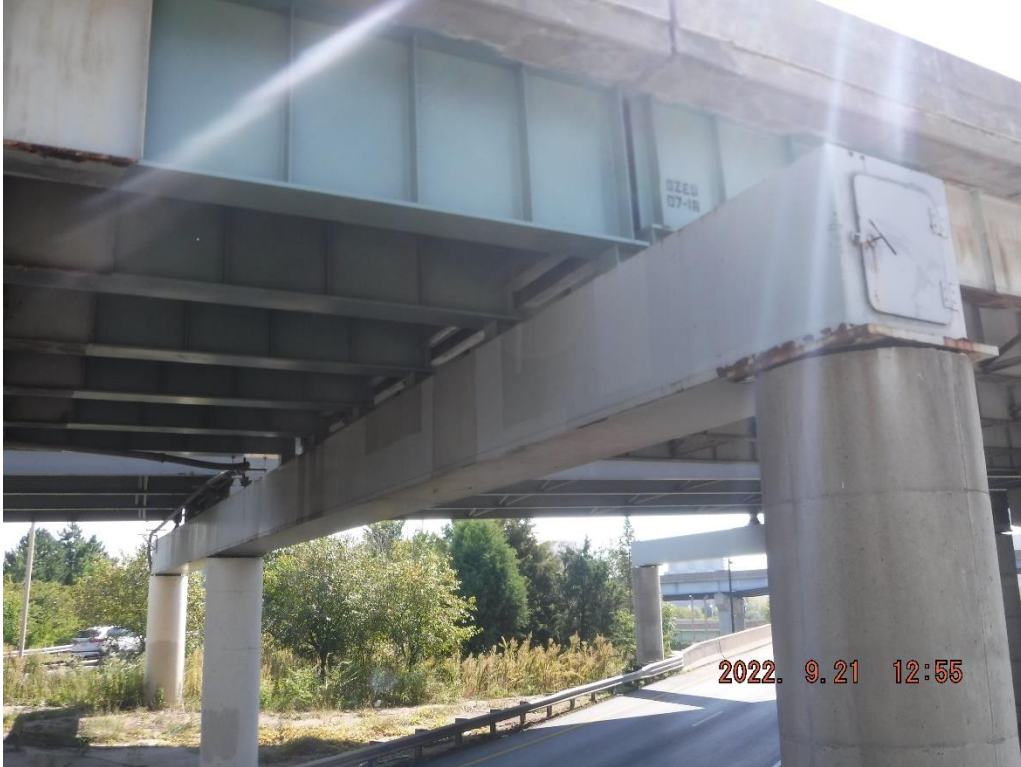
The exterior of steel pier cap 26C/J is in **SATISFACTORY CONDITION (6)**. There is minor surface corrosion throughout the exterior of the pier cap, particularly on the top flange at the ends, and along the edges of both flanges. There is 6" x 6" x 3/16" deep section loss in top flange at west end (Photo 37). There is laminating corrosion with section loss less than 1/16" deep on the undersides of the bearing plates at all columns (Photo 38). On the bottom flange at the openings there is section loss up to 1/16" (Photo 39).

The exterior steel protective coating is paint and is in **POOR CONDITION (4)** with isolated areas of peeling on the top coat along the bottom of the web plates. There is little to no paint remaining on the bearing plates over the columns.

*Photo 36: Pier Cap 26C/J looking south*

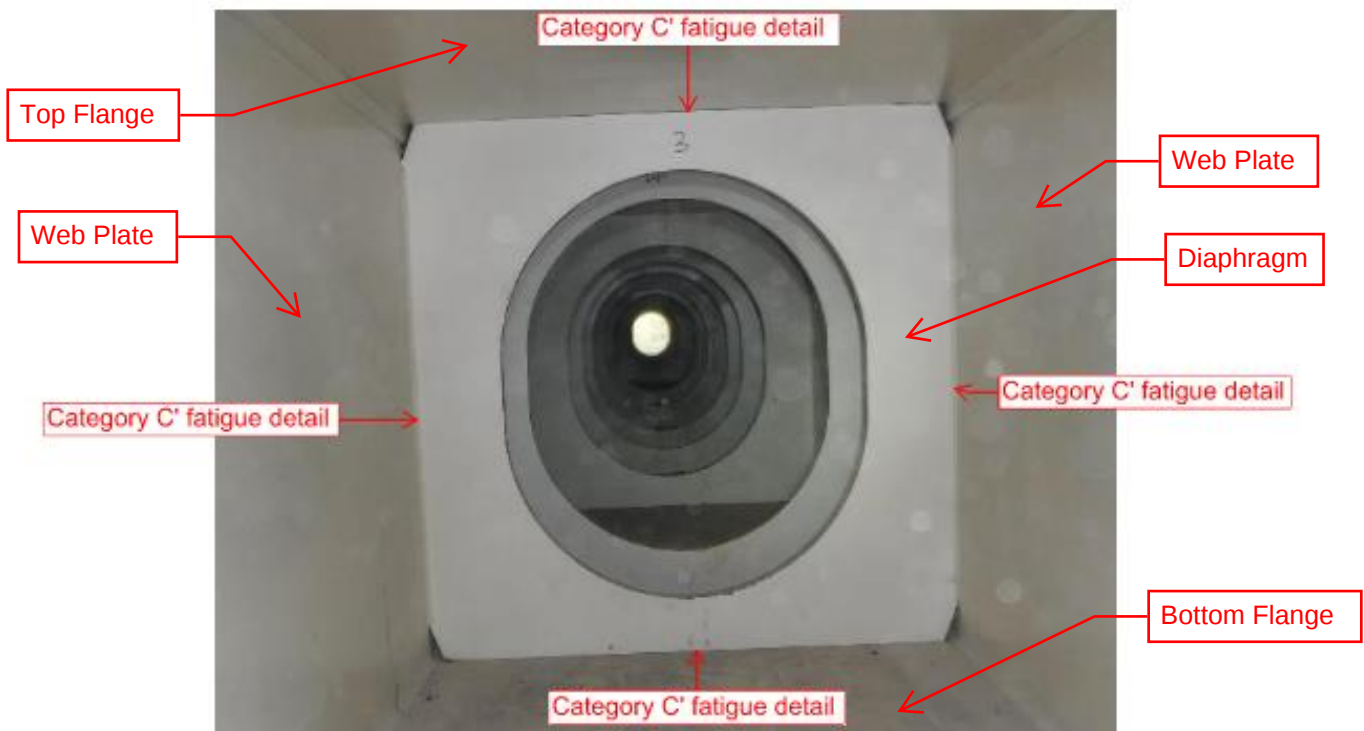
The fatigue prone details of steel pier cap 26C/J are in **SATISFACTORY CONDITION (6)**, with no significant deficiencies noted. The fatigue prone details present include C', D, and E' fatigue categories.

- Category C': Typical interior transverse diaphragm fillet weld connection to pier cap webs and flanges.
- Category D: Hole in north web plate in Bay 17 filled with a non-high strength bolt.
- Category E': Bearing plate to top flange fillet weld connection with length  $L > 4$  in. and at thickness  $t \geq 1.0$  in. parallel or transverse to the direction of primary stress.

*Photo 43: Category C' fatigue detail - Diaphragm fillet welds to webs and flanges*

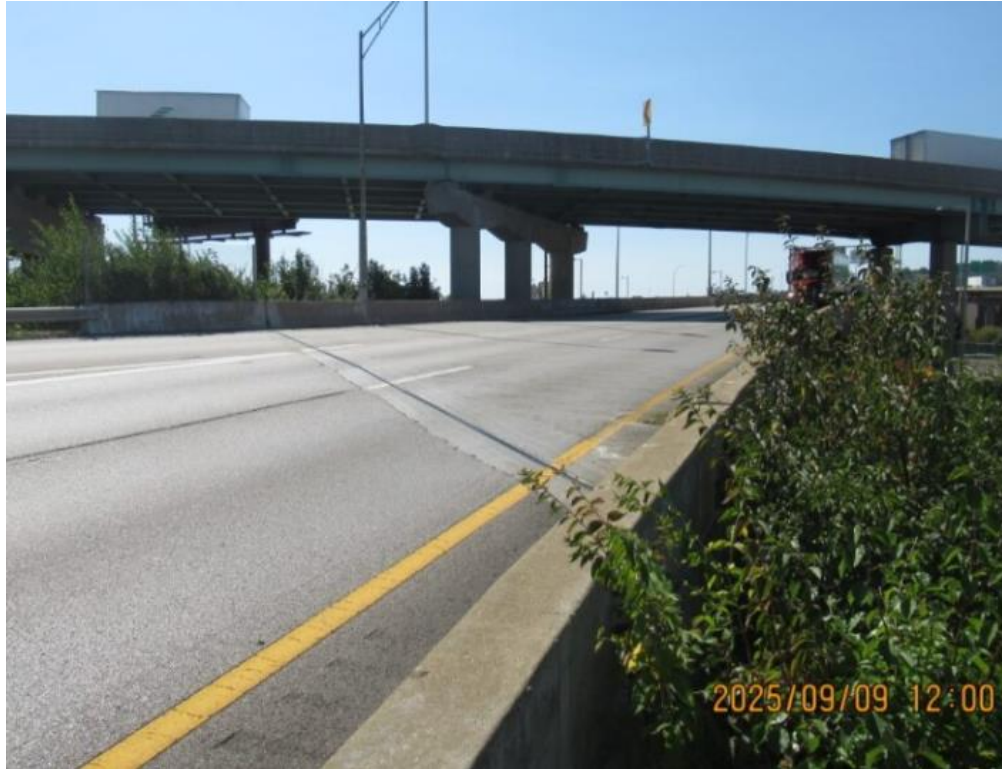
The north approach slab is in good condition and is covered with an asphalt wearing surface.

*Photo 54: North approach slab looking east*

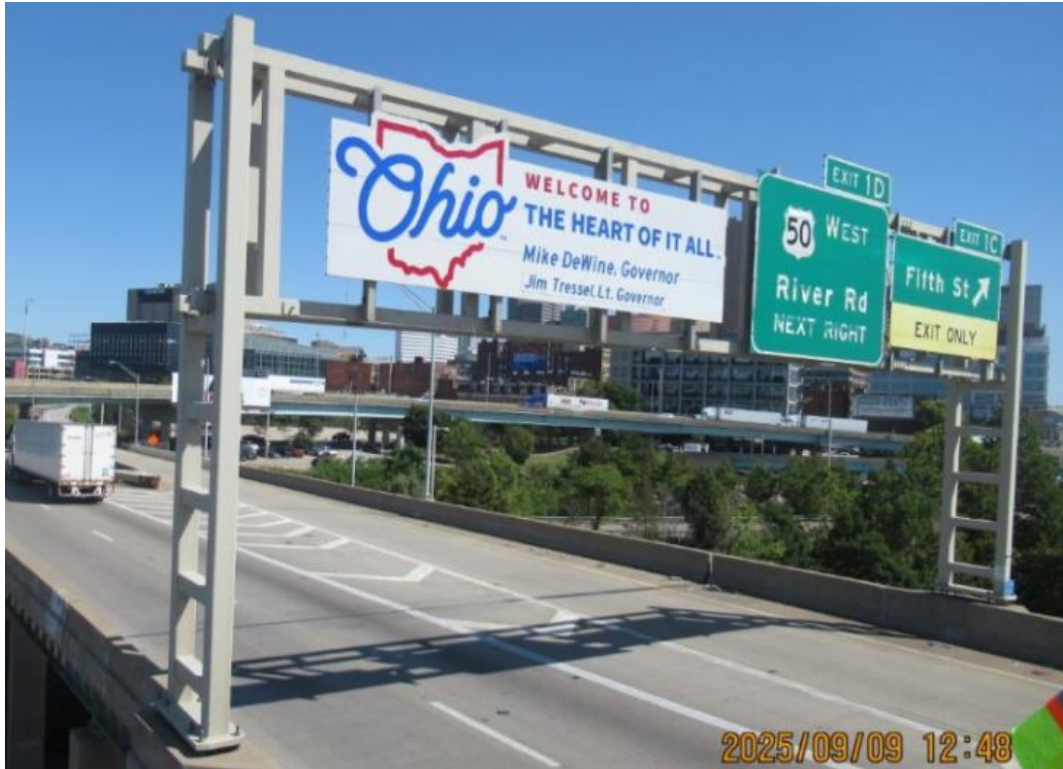
There is one overhead sign support mounted to the railings near Pier 23C. The sign support is in good condition with no significant deficiencies noted for the support structure or the anchorage to the railings. Detailed inspection of the overhead sign structure was outside the scope of this inspection.

*Photo 55: Overhead sign support mounted to railings near Pier 23C*
