ODOT District 8  
2024 In-Depth & NSTM Inspection Report

Bridge No. HAM-50-2180N  
SFN: 3103390

**2024 IN-DEPTH & NONREDUNDANT STEEL  
TENSION MEMBER (NSTM) INSPECTION REPORT**

**BRIDGE NO. HAM-50-2180N**

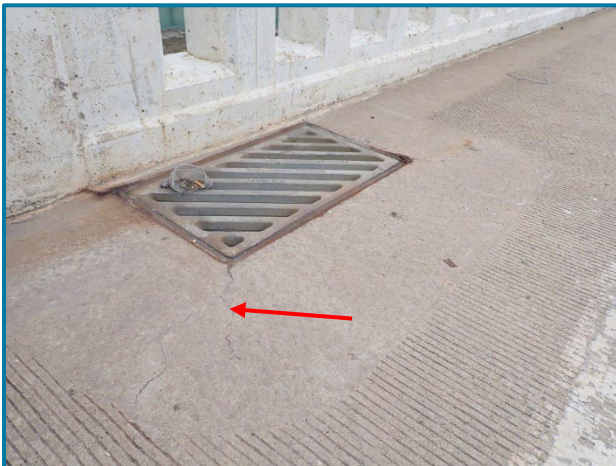
The monolithic concrete wearing surface is in satisfactory condition overall with some minor longitudinal and transverse cracking throughout. There are isolated locations of moderate to wide cracks near drainage scuppers and expansion joints. At the drainage scuppers, the cracks are propagating from the corners of the scupper grate (see [Photo 5](#)). For the expansion joints, the cracking is typically near the areas where the joint armor bends (see [Photo 6](#)). In the shoulder between Piers 16 and 17, there is some trash and a small (3 ft long) discarded tree.

Photo 5 – Moderate to wide cracks propagating from the scupper grate corner (near Pier 10).

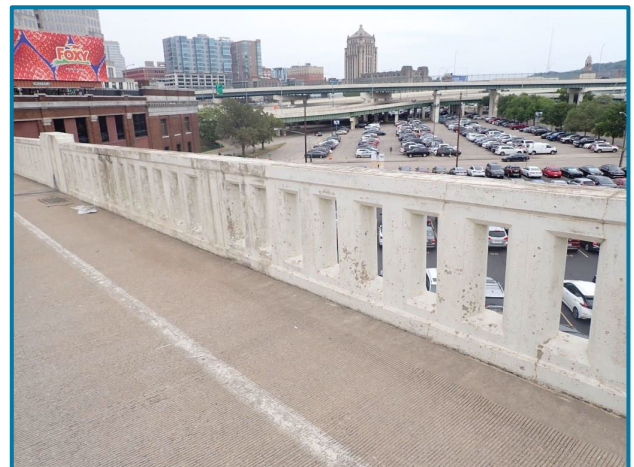
The bridge railings are in SATISFACTORY CONDITION [6-SNBI] overall with isolated locations of wide cracking, delaminations, and spalls with exposed rebar (see [Photo 7](#)).

Photo 7 – Bridge railing (looking northwest).

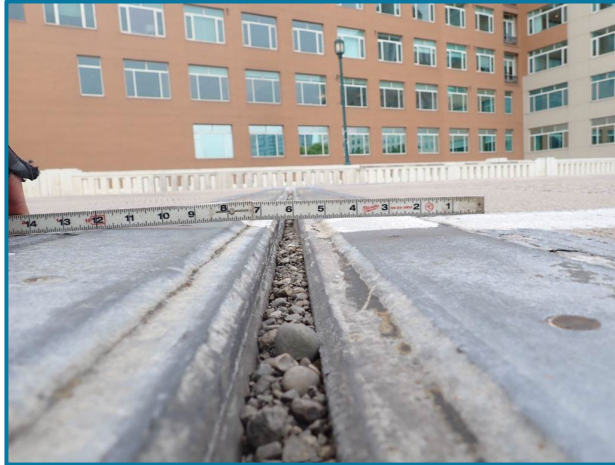
At Pier 3, the expansion joint has a 1/2" vertical offset (see Photo 16). The horizontal measurements of the joint openings were taken at the exterior edge of the white striping on the left and right sides of the bridge. The measurements compare well to past measurements at similar temperatures. See Table 3 for the current and previous two inspection cycle measurements. At both Abutment 1 (Rear Abutment) and Abutment 18 (Forward Abutment), there is a concrete header that runs along the full length of the

Photo 16 – 1/2" vertical offset in the deck joint (Pier 3 shown, looking south).

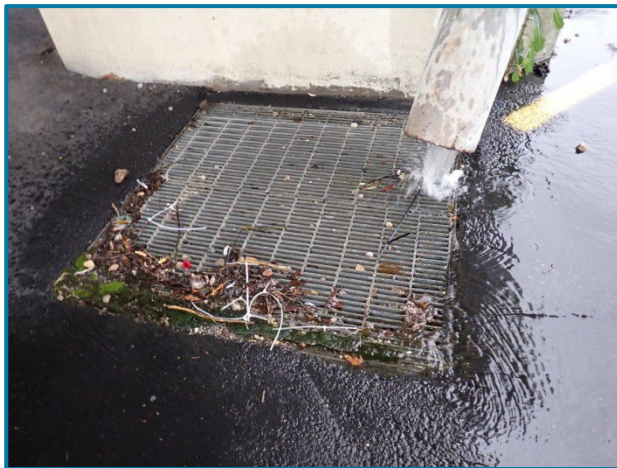
Photo 19 – Grate partially obstructed and drainpipe not directly aimed at grate center (Pier 5 shown, looking north).

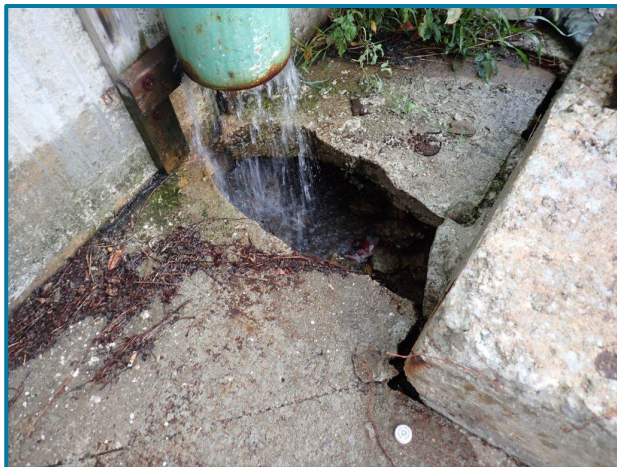
Photo 21 – Broken slope protection with a void underneath drainpipe (Pier 12 shown, looking northeast).

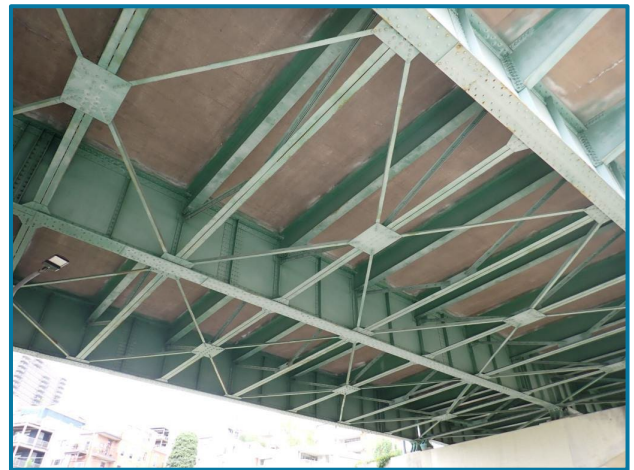
Photo 24 – Approach span girders (Span 14 shown, looking south).

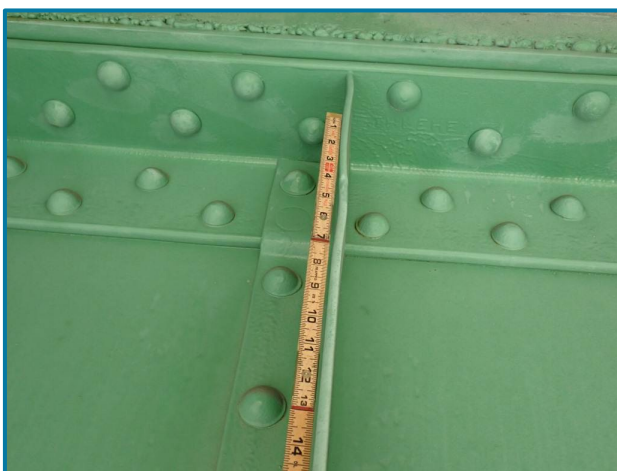
The steel built-up riveted plate girders are located in the approach spans. In Spans 1 - 4 and 12 - 17, there are three girder lines (see Photo 24). The girders are in satisfactory condition. There are isolated locations of stiffeners with distortion. The distortion noted does not exceed 1/4" over 4" to 12" (see Photo 25). In Span 14, the South Girder has 1'-2" of torch cut edges on the bottom flange (see Photo 26). In Span 12, there are multiple locations where the bottom flange is distorted (see Photo 27). Each occurs over a small area (8" to 12").

Photo 25 – 1/4" distortion over 4" at the stiffener (North Girder, Span 15, looking south).

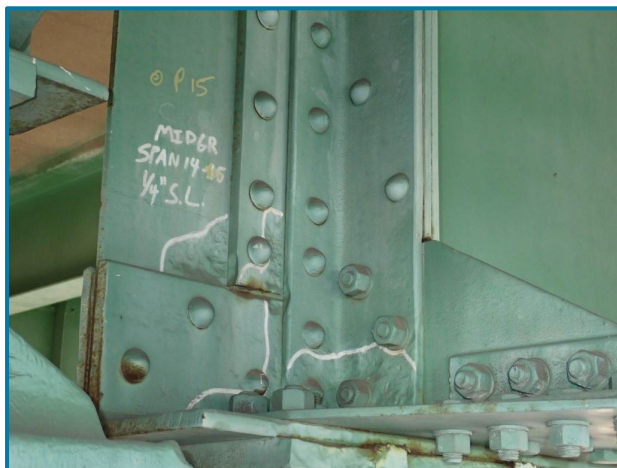
Photo 30 – 1/4" pitting at the Center Girder end (Span 14 shown, looking southwest).

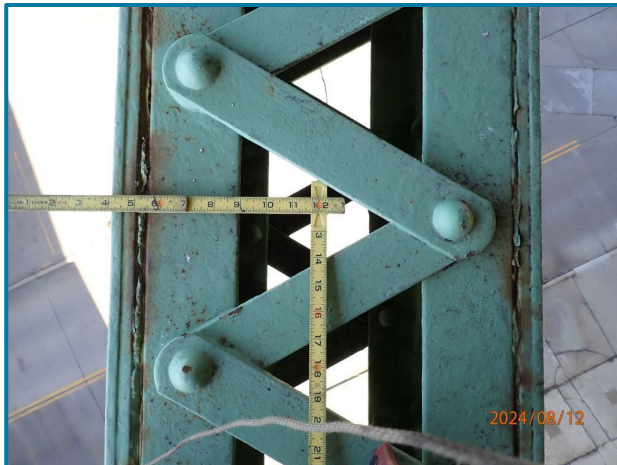
The lower chord is in satisfactory condition. Throughout the truss length, the lower chord has various levels of pack rust between the web and flange components and internal stiffeners. The pack rust is commonly located on both sides and varies from 1/16" to 1" thickness (see Photo 33). The areas of thicker pack rust have caused the web plate to warp giving it a wavelike appearance (see Photo 34).

Photo 33 – 1/2" pack rust between the web and flange components (L6L7 of the South Truss, Span 10).

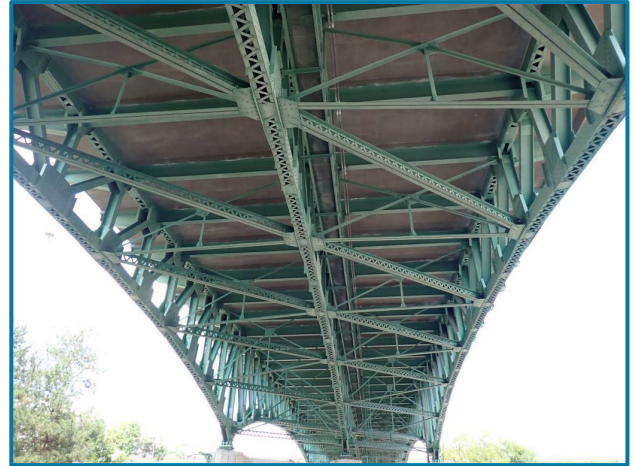
The steel truss is in satisfactory condition overall. The truss is located in Spans 5 through 11 and consists of three truss lines (see Photo 32). The following sections (lower chord, diagonals, verticals, and upper chord) describe the deficiency findings for the truss components that contribute to the overall condition rating.

Photo 32 – Steel truss has three truss lines (Span 6 shown, looking east).

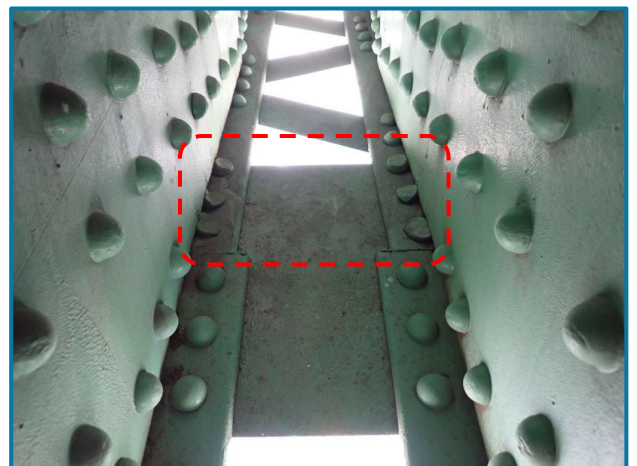
Three locations of rivet heads, inside the lower chord, show deformation due to clearance with the interior gusset plate ([see Photo 43](#)). The rivet heads were not properly shaped as a result, but they are currently still functioning. The locations where this occurs are as follows:

Photo 43 – Deformation of the rivet heads inside the lower chord (L32 of the South Truss, Span 9).

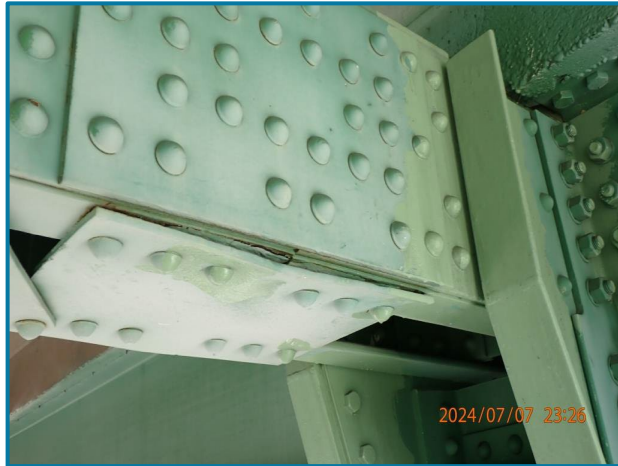
The upper chord is in satisfactory condition. Pack rust is located at isolated locations. U42U43 bottom batten plate has 3/4" pack rust between the plate and the upper chord bottom flange (see Photo 44). The top batten plates or splice plates also have isolated locations of pack rust underneath averaging 1/2". There are isolated locations of pack rust distorting the fill plates (see Photo 45).

Photo 44 – 3/4" pack rust at the bottom batten plate (U42U43 of the North Truss, Span 9).

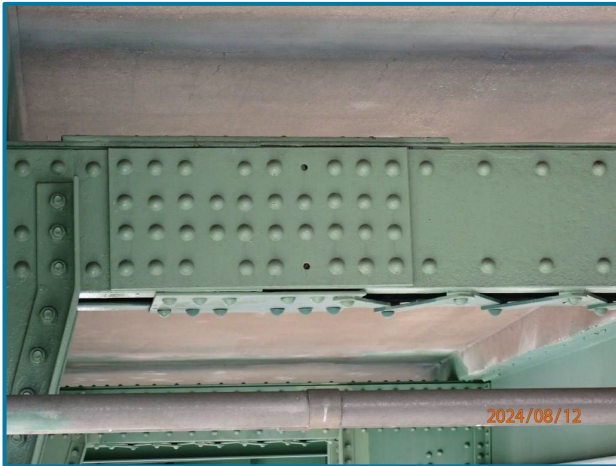
Photo 49 – Misdrilled holes in the splice plate (U9U10 of the Center Truss, Span 10).

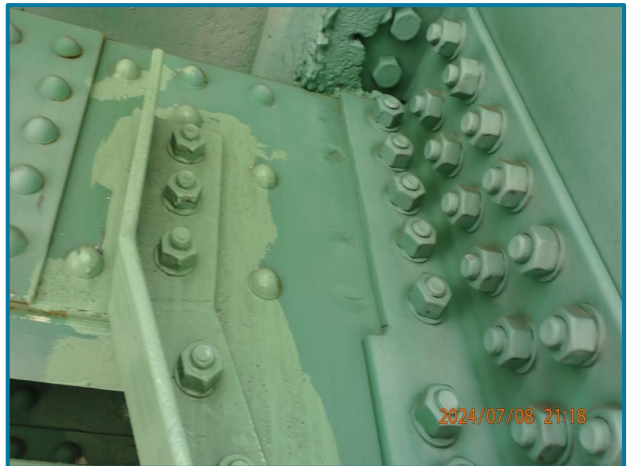
Photo 50 – Four plug welds on each side of the upper chord member (U25 of the North Truss, Span 8).

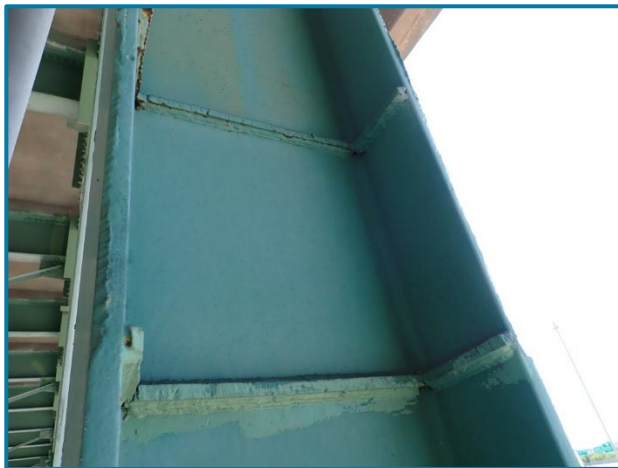
Several of the welds attaching items to the vertical are of poor quality. Throughout the truss, there are locations where the remains of a previously welded attachment are still on the vertical ([see Photo 53](#)). The attachment was torch cut off and the partial pieces of steel remain welded. Many verticals have errant welds attached to the flange and locations of gouging ([see Photo 54](#)).

Photo 53 – Remains of a welded attachment (U0L0 of the South Truss, Span 10).

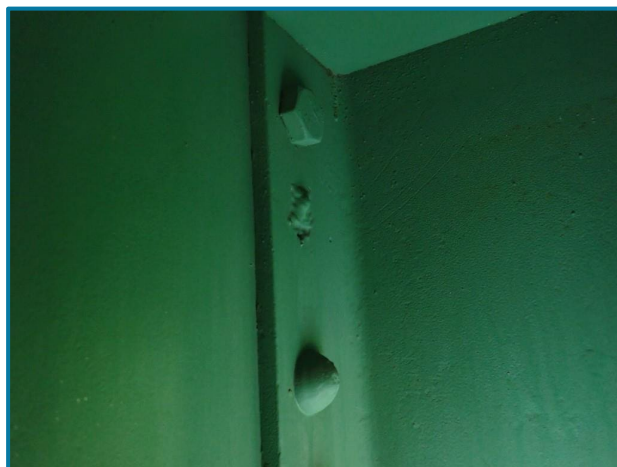
Photo 56 – Rivet head has been torch cut off (U20 of the North Truss, Span 11).

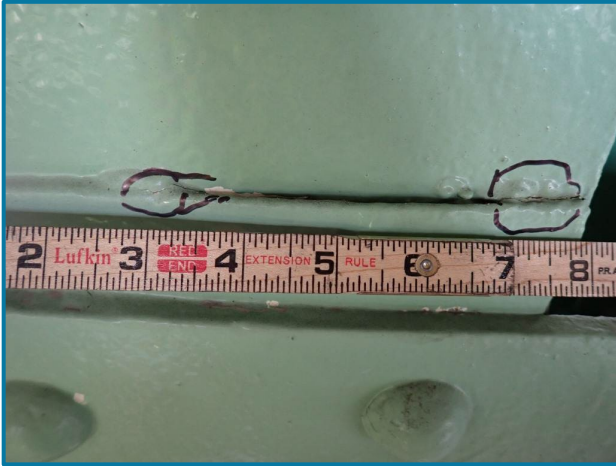
Ten cracks are currently noted at the verticals and are summarized in Table 4 below. One of the cracks is in the fill plate between the gusset plate and the vertical, two occur at the catwalk attachment, and the remaining are at the fill plate weld to the vertical. No cracks changed in size from the previous inspection.

Photo 57 – 1" crack and broken weld at the fill plate welds to the vertical (U13L13 of the Center Truss, Span 6).

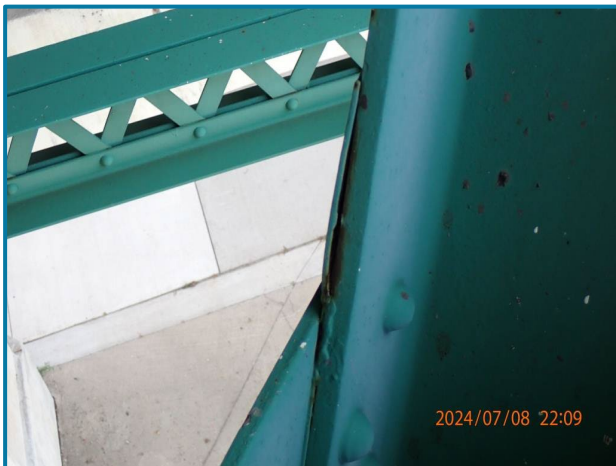
The diagonals are in satisfactory condition. There is an isolated location at U16L17 that has 1/8" pack rust between the fill plate and the diagonal ([see Photo 59](#)). At L33 of U32L33, Span 9 of the North Truss, there is surface corrosion with an area of pack rust forming ([see Photo 60](#)).

Photo 59 – 1/8" pack rust at the fill plate causing distortion to the plate (U16L17 of the North Truss, Span 8).

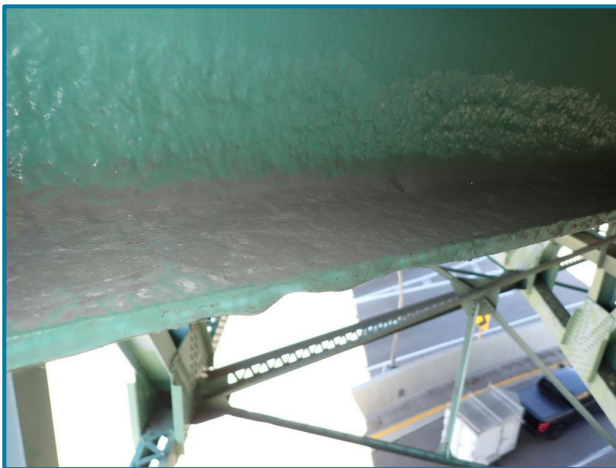
The floorbeams have some locations of painted over pitting. The pitting is typically across the length of the bottom flange and up to 4" H on the lower portion of the web (see [Photo 63](#)). In this area, the bottom flange has areas of reduced flange thickness. The floorbeam on the south side of U39, Center Truss, Span 9, has a 3/8" vertical overcut (see [Photo 64](#)). No additional issues are noted at this location. There is a misdrilled hole at the floorbeam connection to the gusset plate at U15, South Truss, Span 6. Over Pier 10, North Truss, Span 10, there is a blind hole in the top floorbeam flange.

Photo 63 – 1/8" section loss across the bottom flange and lower web (over Pier 10 looking west).

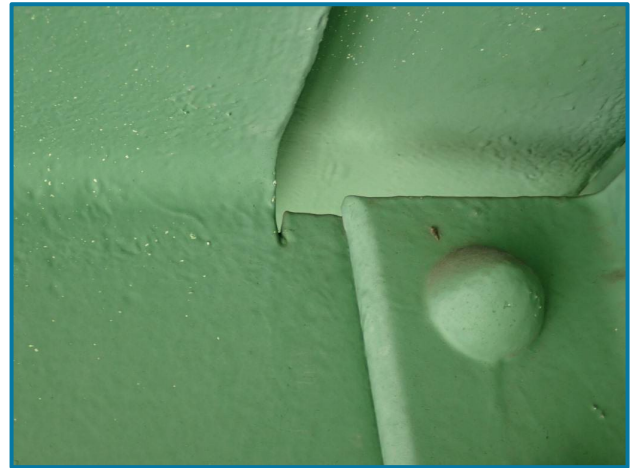
Photo 64 – 3/8" overcut in the floorbeam cope (south side of U39, Center Truss, Span 9).

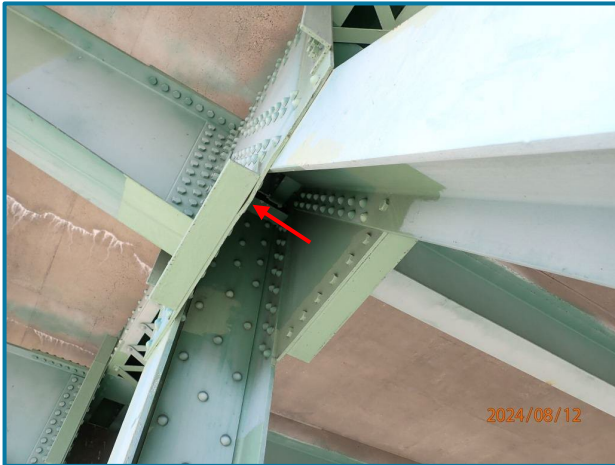
The steel gusset plates are in satisfactory condition. There has been some rehabilitation work done to the gusset plates due to the bowing/deformation (see Photo 65). Stiffening angles have been added to several gusset plates. At U33 of the South Truss in Span 9, there is an isolated location of deformation in the gusset plate in an area where pack rust is not contributing, but a stiffening angle is in place (see Photo 66). Pack rust up to 1/2" is typical throughout the truss between the gusset plates and truss members (see Photo 67). In Span 5 of the South Truss at L0, there is up to 1" pack rust between the lower lateral bracing fill plate and the inboard gusset plate (see Photo 68).

Photo 66 – Distortion to the gusset plate at the stiffening angle (U33, South Truss, Span 9, looking up).

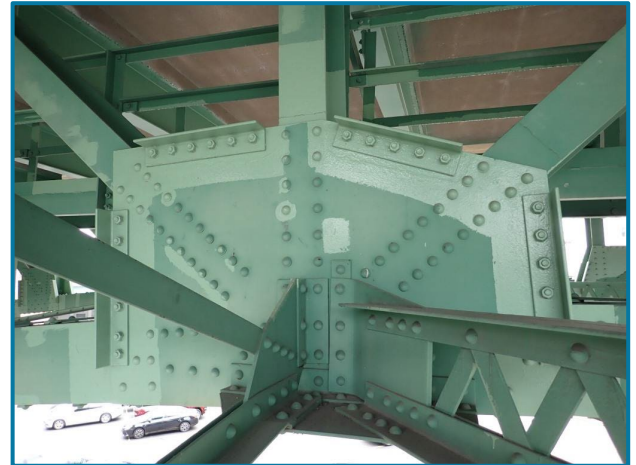
Photo 65 – Rehabilitation work to stiffen the gusset plates that were bowed (looking west).

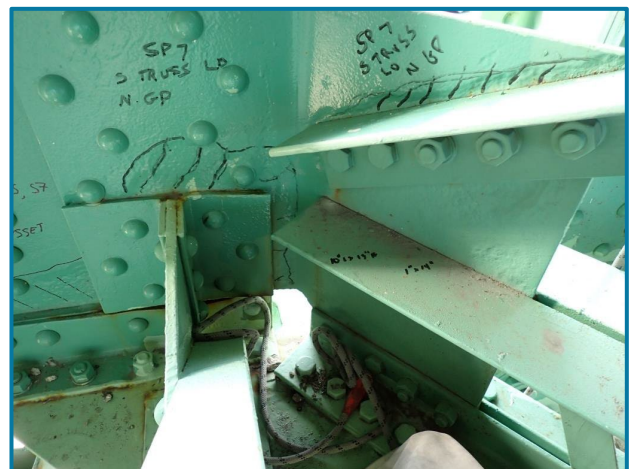
Photo 72 – 3/16" painted over pitting to multiple locations on the gusset plate (L0, South Truss, Span 7).

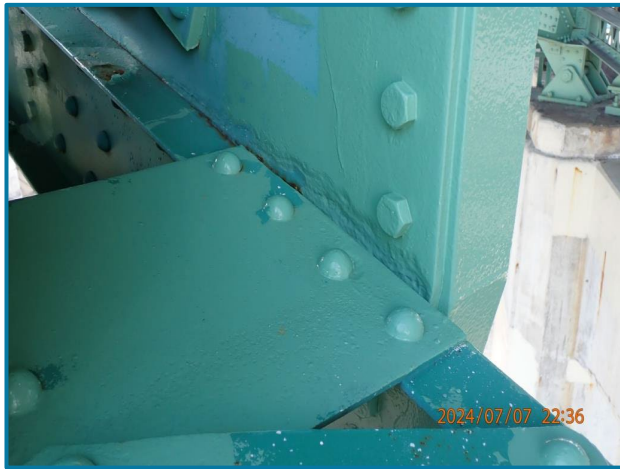
Photo 73 – 3/16" painted over pitting adjacent to the lower chord (L1, North Truss, Span 10).

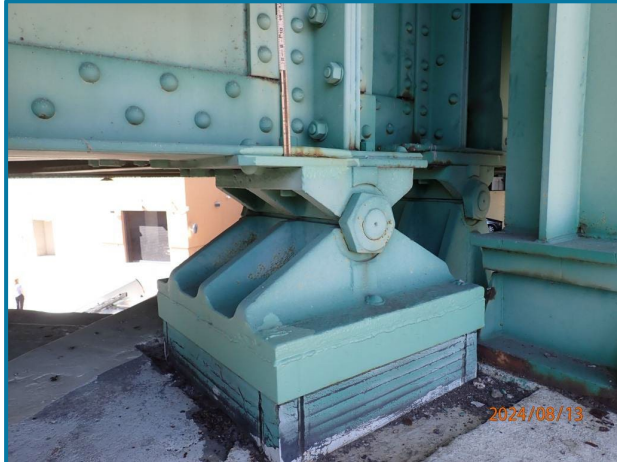
Photo 75 – 3/16" pack rust between the lower chord and the bearing (North Truss, Span 4, looking southwest).

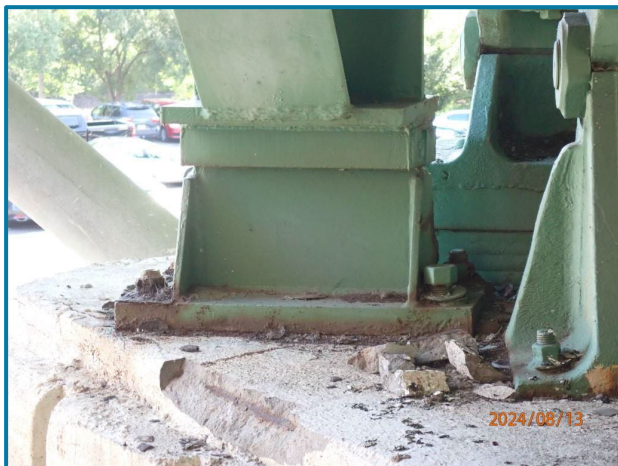
Photo 78 – 1 loose anchor nut and 2 with 30% section loss (Pier 4, North Girder, Span 3, looking east).

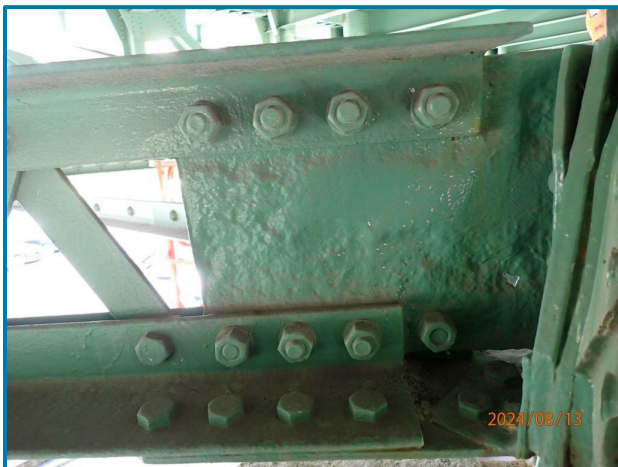
The sway bracing is in satisfactory condition. The batten plates commonly have painted over pitting up to 3/16" ([see Photo 81](#)). At the ends of the bottom strut, there are isolated locations where there is pack rust between the flange angles and either the batten plate or the lower gusset plate ([see Photo 82](#)).

Photo 81 – Painted over pitting up to 3/16" (L0, Center Truss, Span 5, looking northeast).

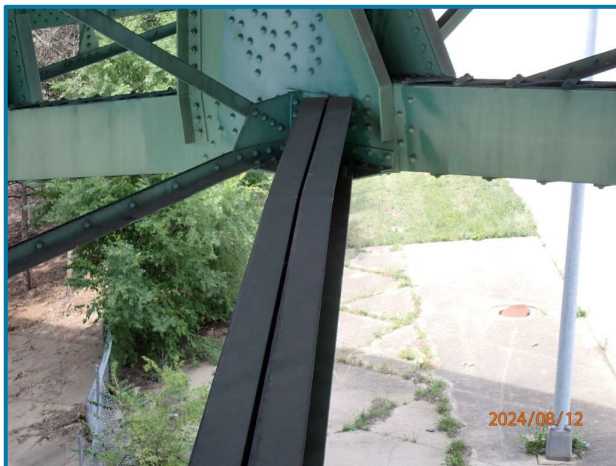
Photo 84 – Impact damage to the lower lateral bracing (6' south of L18, Center Truss, Span 8, looking north).

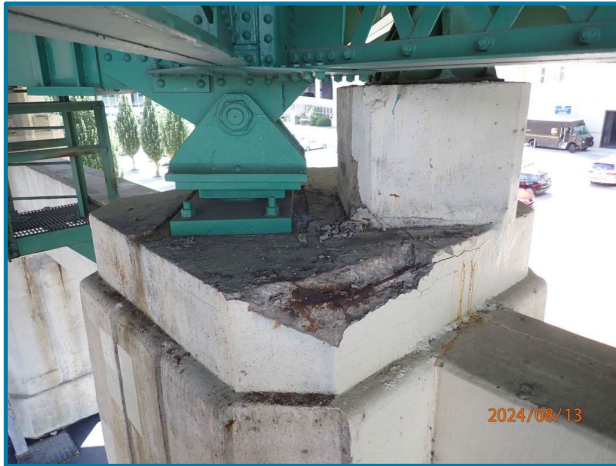
Photo 87 – 4' L x 8" W x 6" D spall with exposed rebar (Pier 5, Center Column, North Face, looking southwest).

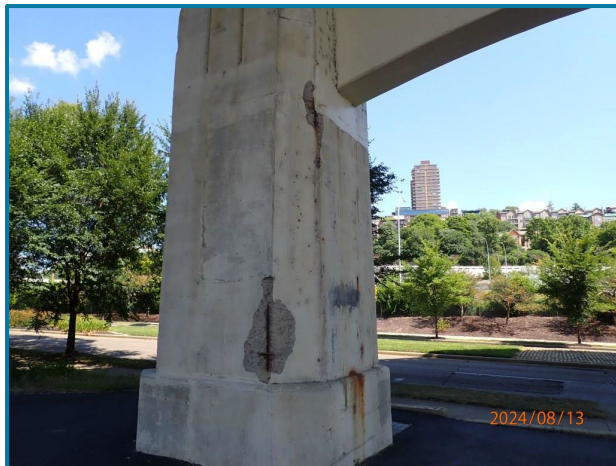
Photo 89 – Two spalls with exposed rebar (Pier 7, North Column, South and West Faces, looking northeast).

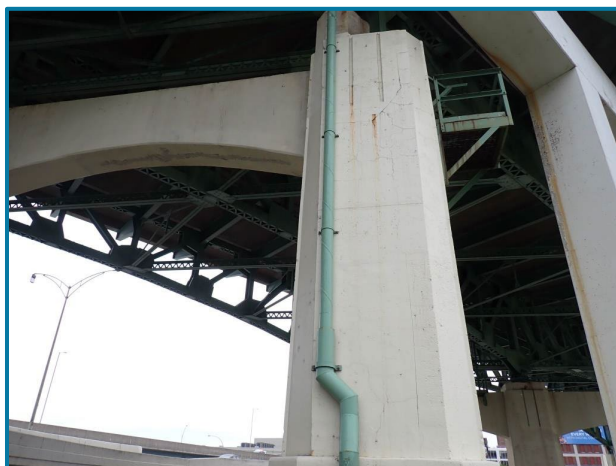
Photo 91 – Hairline cracking with rust staining (Pier 12, North Column, East Face, looking west).

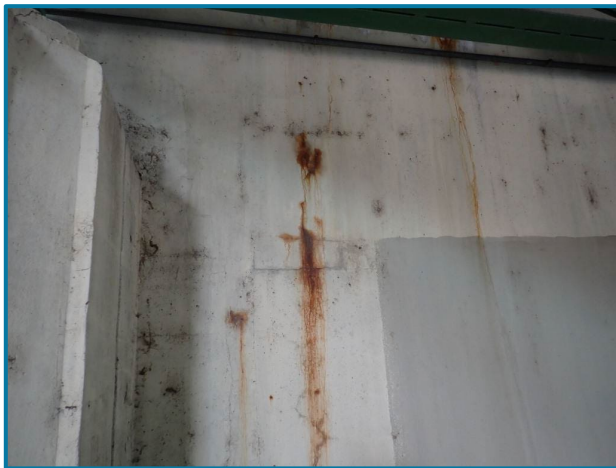
| ABUTMENT | DEFECT | SIZE | PHOTO |
|---|---|---|---|
| 1 | Cracking with rust staining and/or efflorescence | Hairline | <a href="#">93</a> |

Photo 93 – Hairline cracking with rust staining (Abutment 1, East Face, looking west).

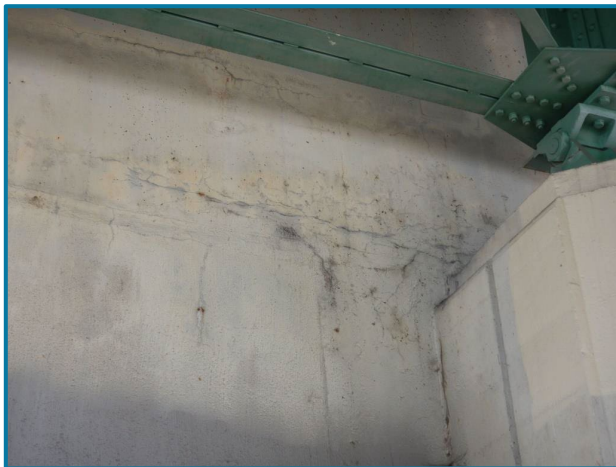
| ABUTMENT | DEFECT | SIZE | PHOTO |
|---|---|---|---|
| 18 | Map cracking | 5' L x 2' H | <a href="#">95</a> |

Photo 95 – Hairline map cracking over an area of 5' L x 2' H (Abutment 18, West Face, looking east).

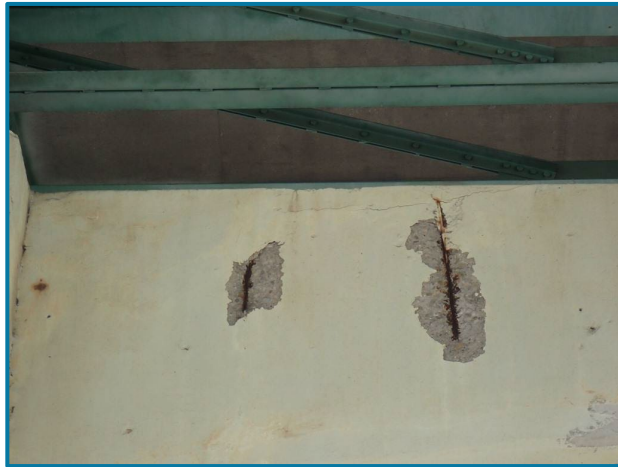
| PIER | PIER FACE | DEFECT | SIZE | PHOTO |
|---|---|---|---|---|
| 13 | East/Bottom | Spall with Exposed Rebar; Crack<br>Spall with Exposed Rebar<br>Spall with Exposed Rebar | 1' L x 1'-6" H x 1" D; 6' L x 1/16"<br>1' L x 3' H x 1" D<br>1' L x 1' H x 1" D | <a href="#">99</a><br><a href="#">99</a> |

Photo 99 – 1' L x 3' H x 1" D and 1' L x 1' H x 1" D spalls with exposed rebar (Pier 13, East Face, looking west).

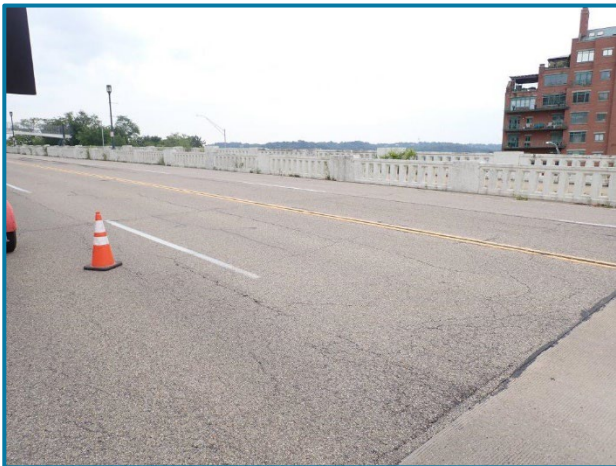
The approach pavement is in satisfactory condition. Majority of the deficiencies noted are located at the east approach pavement. There is abundant wide map cracking near the East Approach Slab and wide random cracking to the remainder of the pavement at the east end (see Photo 104). The approach pavement at the west end exhibits less deterioration (see Photo 105).

Photo 104 – Wide map and random cracking in the approach pavement (East Approach, looking southeast).

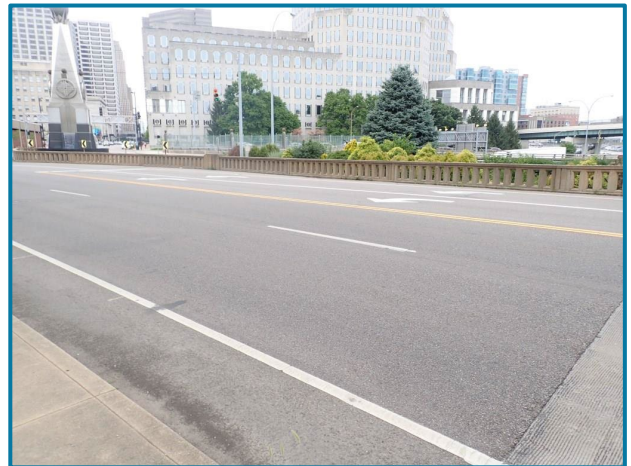
Photo 105 – Approach pavement at the west end of the bridge (West Approach, looking northwest).
